**DETAILED STUDY OF
THE 22 AUGUST 2005
LANDSLIDE AND
DISTRESS ON THE
NATURAL HILLSIDE
AT KWUN YAM SHAN,
BELOW TATE'S RIDGE**

GEO REPORT No. 239

Maunsell Geotechnical Services Limited

**GEOTECHNICAL ENGINEERING OFFICE
CIVIL ENGINEERING AND DEVELOPMENT DEPARTMENT
THE GOVERNMENT OF THE HONG KONG
SPECIAL ADMINISTRATIVE REGION**

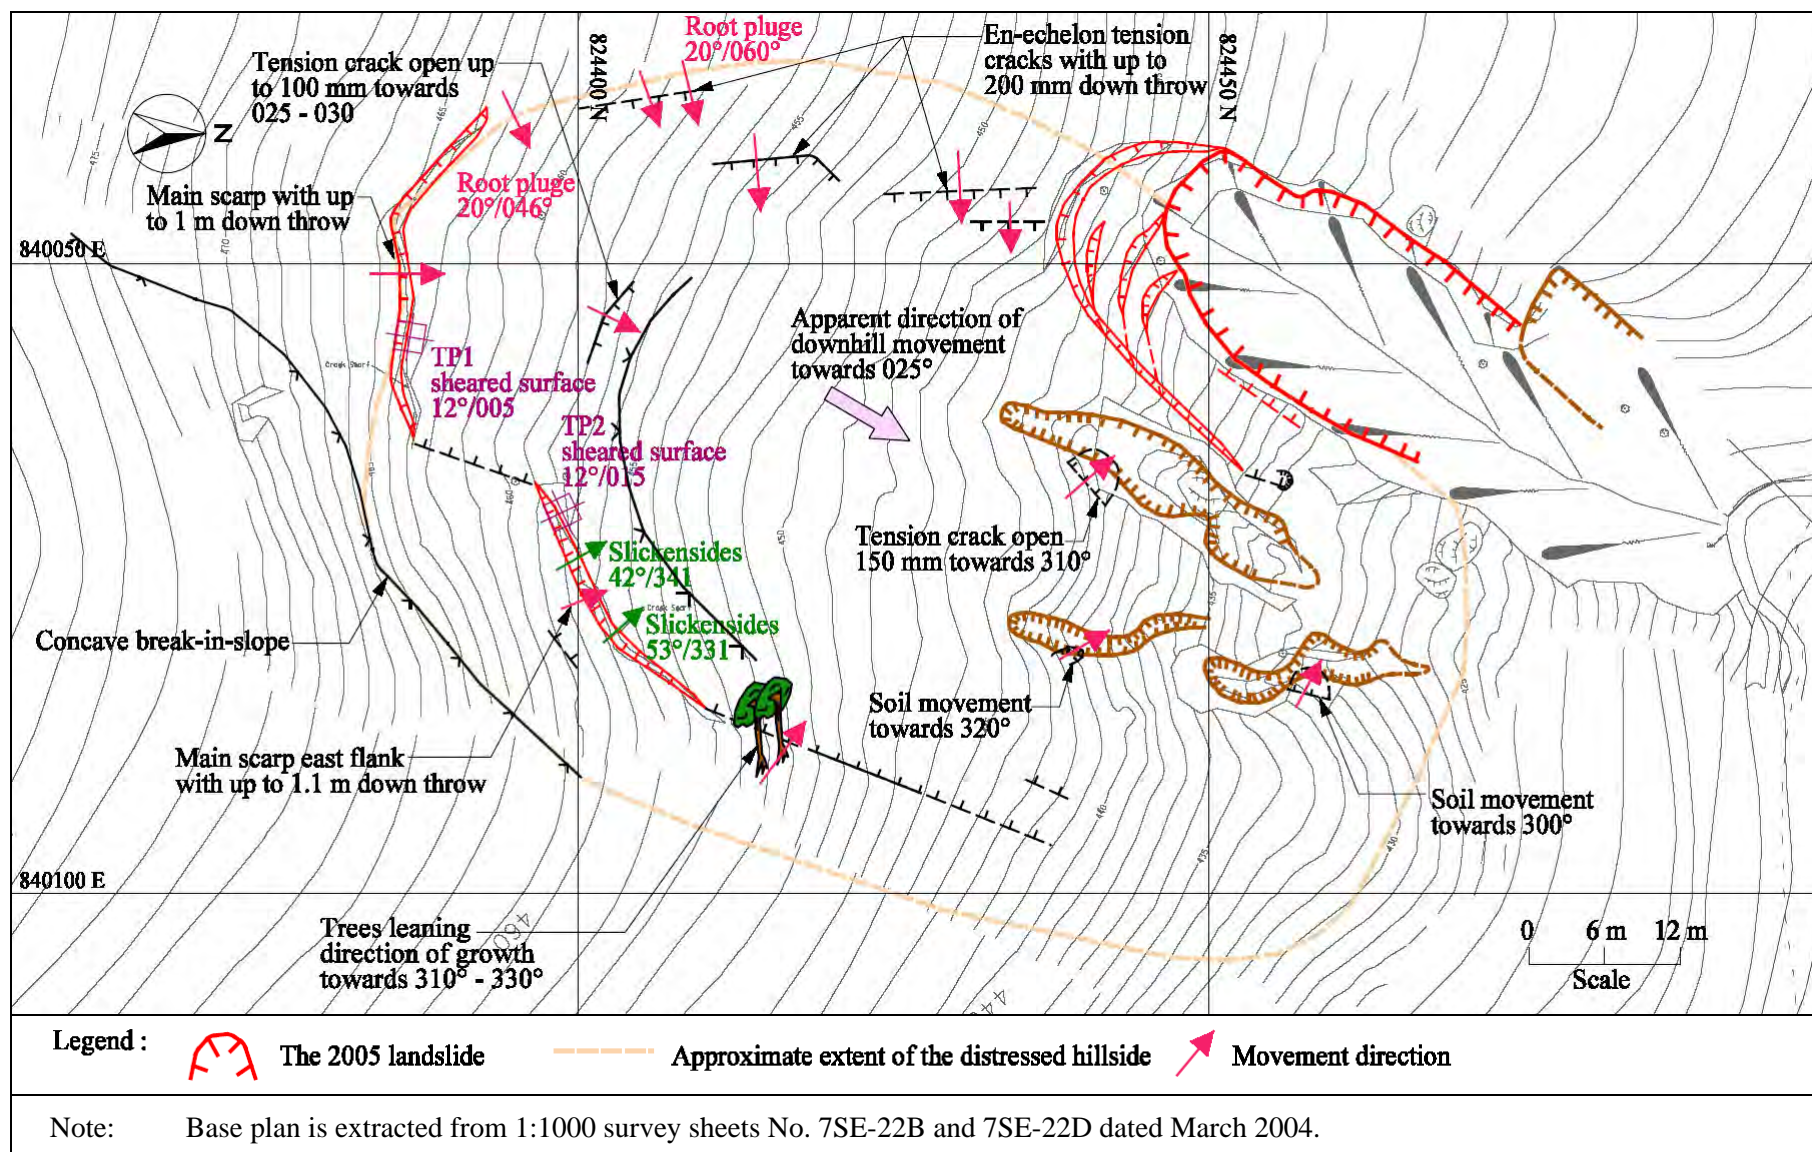
Figure 8 - Movement Observed within the Distressed Hillside

The contrasting surface expressions between the distinct tension cracks on the eastern and southern main scarps of the distressed hillside, with up to 1.1 m of vertical displacement, and the less distinct en echelon tension cracks on the western flank with a vertical displacement of about 0.2 m, support the postulation that the large ground mass undergoing displacement probably comprises separate blocks of material possibly moving in different directions (Figure 8).

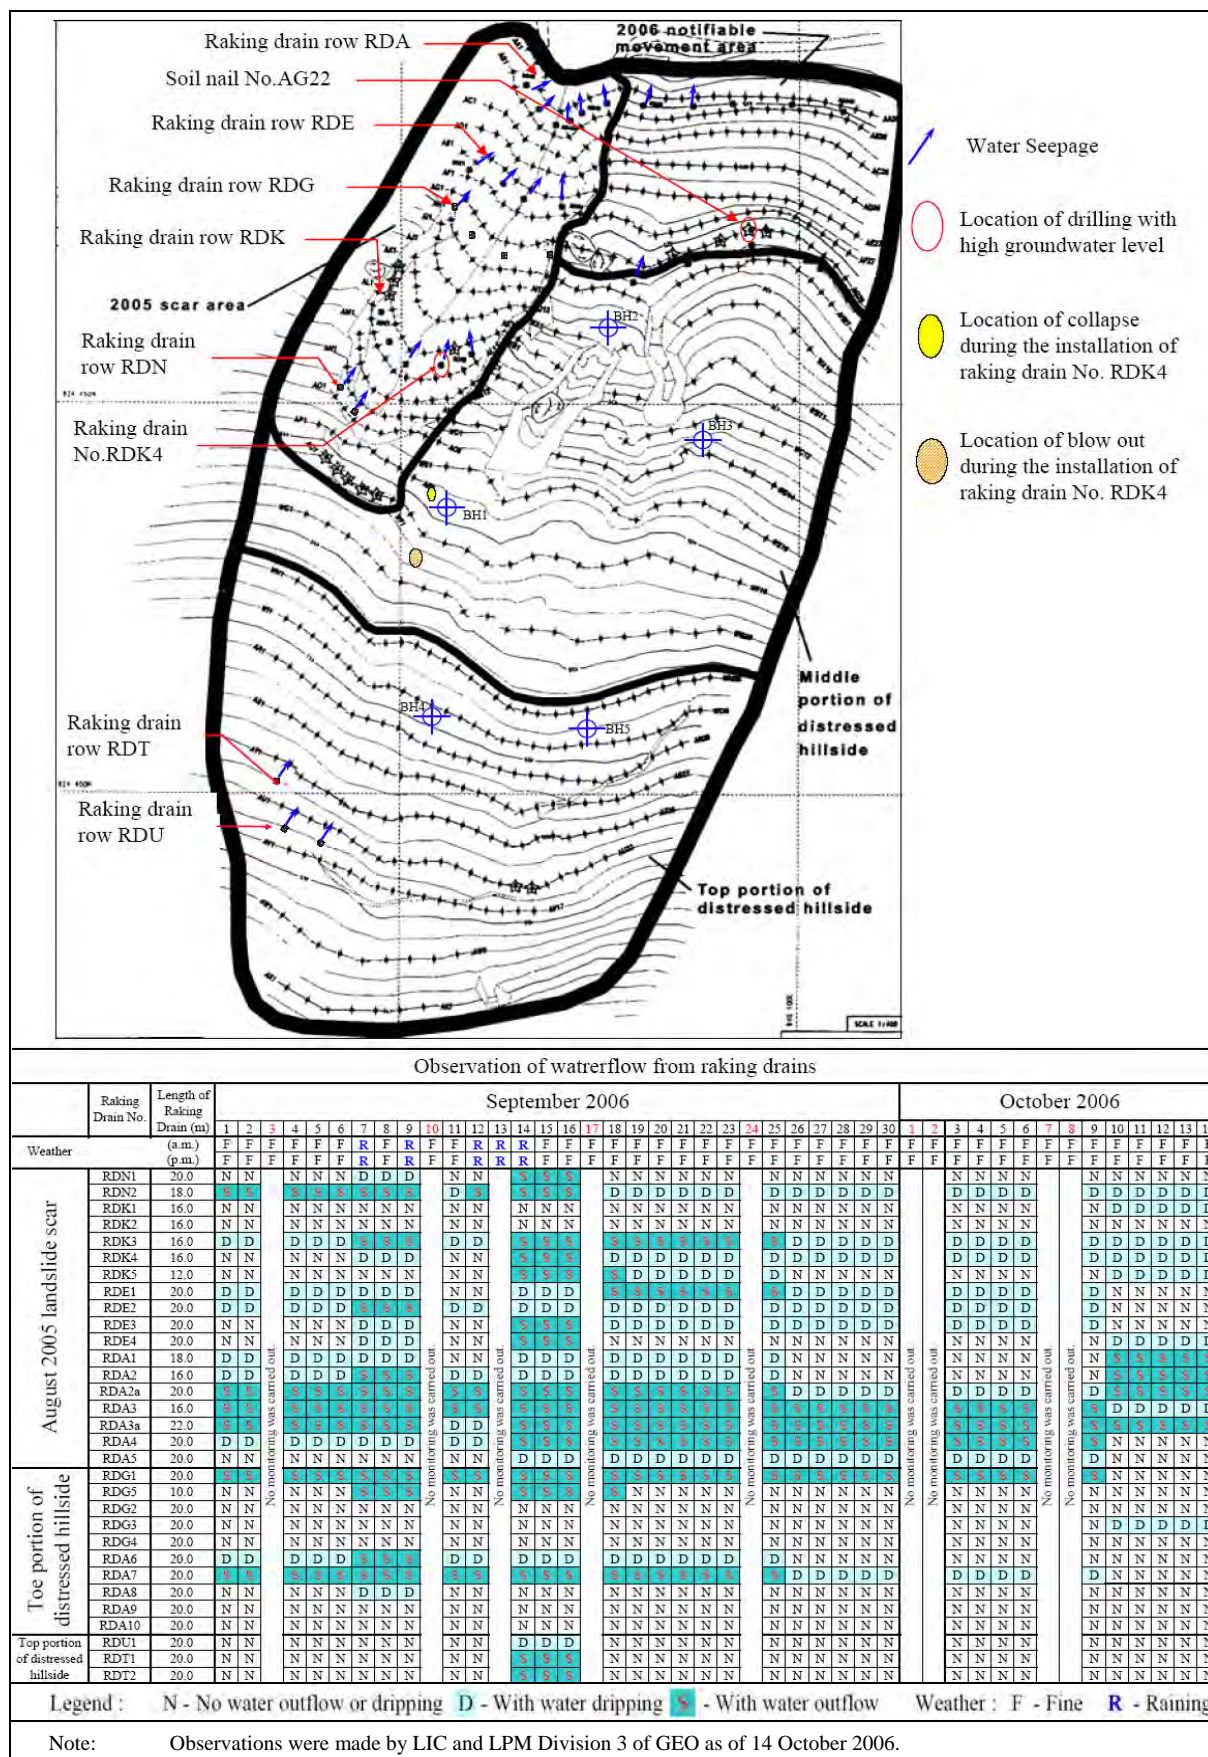
Figure 9 - Field Observations during the Remedial Works

After the mid September 2006 rainstorm, groundwater flow rates from some of the raking drains were observed to be greater than from others (Figure 9). The drains with the higher flow rates had probably intercepted more transmissive groundwater pathways, indicating that preferential flow paths are present in the subsurface material, which are likely to have promoted rapid groundwater flow towards the landslide site.

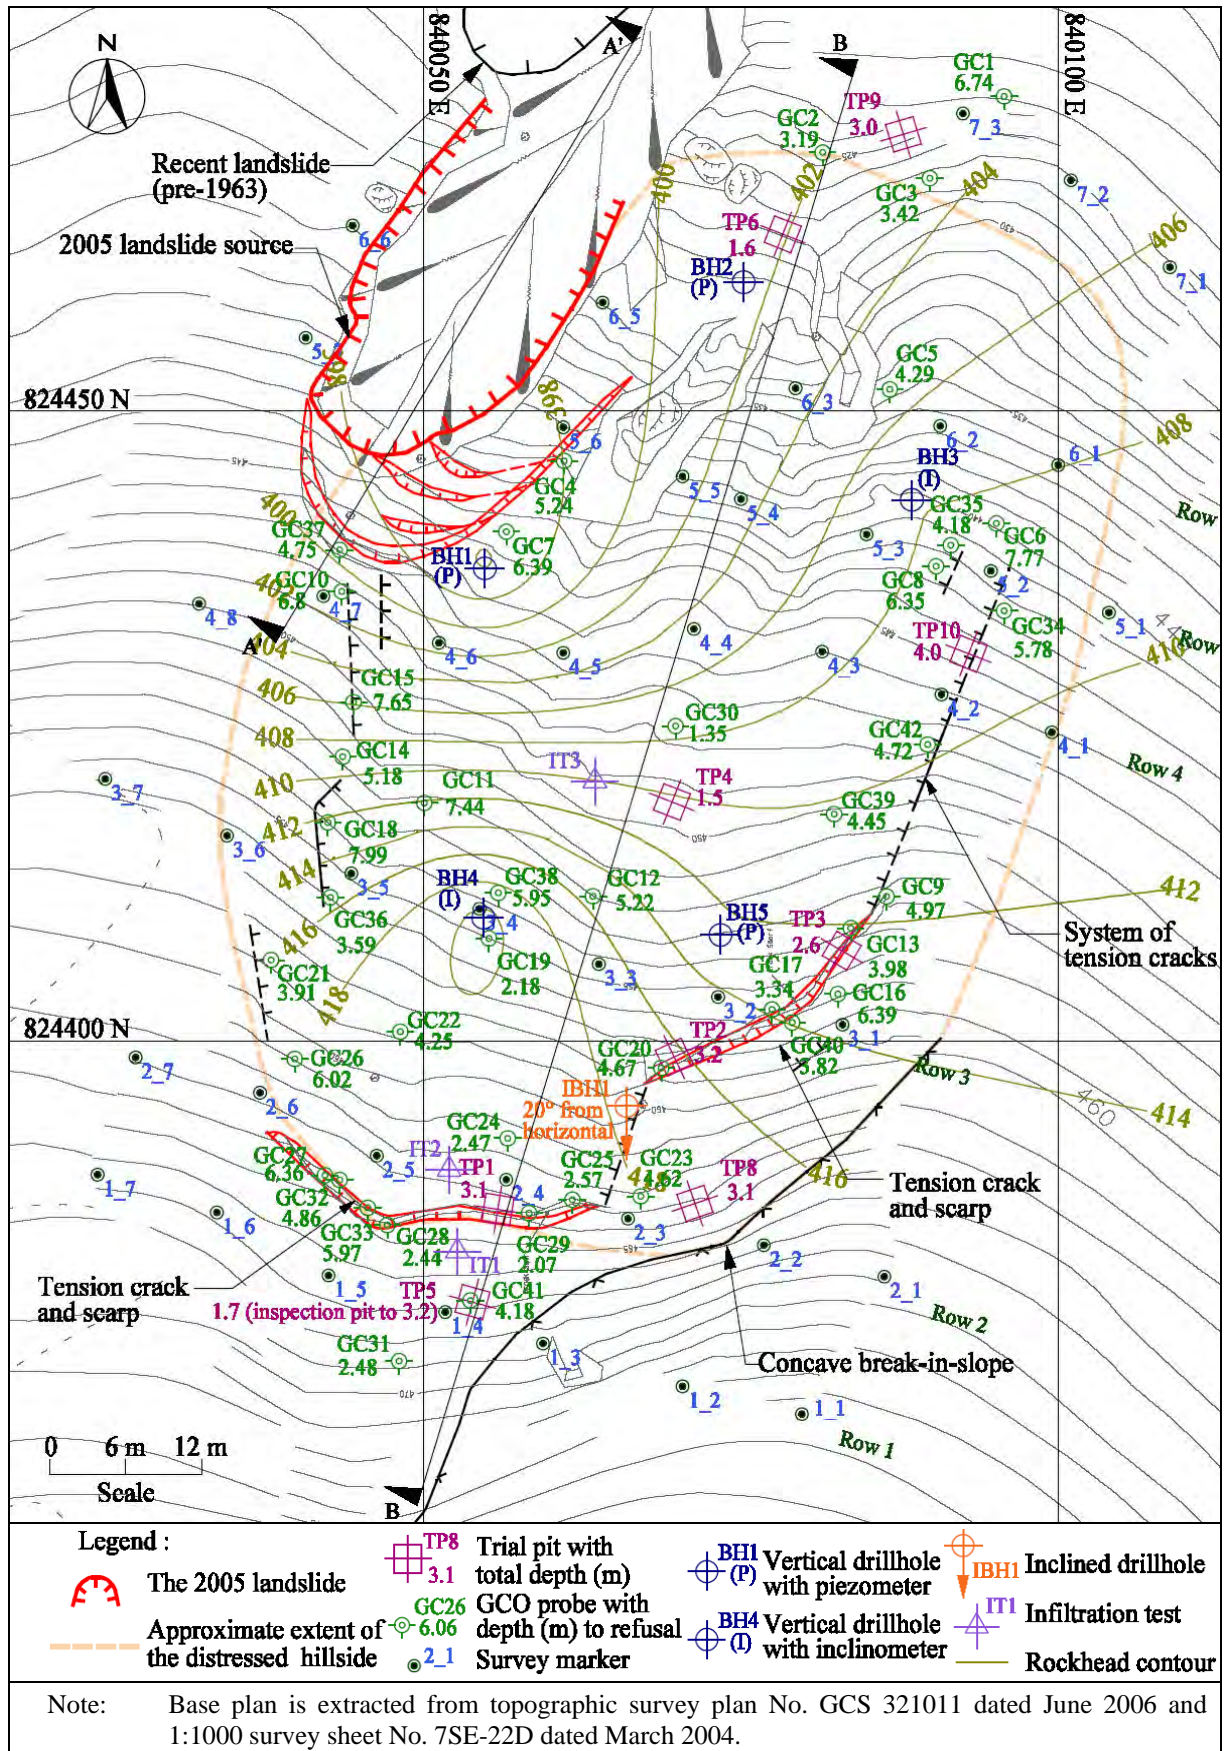
Figure 10 - Ground Investigation Layout and Rockhead Contour

In trial pits Nos. TP1 to TP3, through the eastern and southern tension cracks (Figure 10), the slip surface was observed to dip steeply and run through the front of the trial pit with no apparent indication of a flattening off of the slip surface towards a shallow basal surface (see Appendix C). Notably, possible evidence of shearing along discontinuous planar joint surfaces as indicated by a light brown discolouration of kaolin within the joints, was identified at about 2.5 m below ground level and in the upslope sides of trial pits Nos. TP1 and TP2 (see Appendix C). The discontinuous surfaces were shallow dipping at 12°/005° in trial pit No. TP1 and 12°/015° in trial pit No. TP2 (Figure 8). This compares with an apparent overall downhill direction of movement of the distressed hillside towards a bearing of 025°. The significance of these discontinuous apparently sheared surfaces is unclear; their presence, however, highlights the complex nature of the movement and kinematics of the large ground mass. The monitoring records from the in-place inclinometers have not shown a trend of downhill movement within the distressed hillside (see Section 5.2).

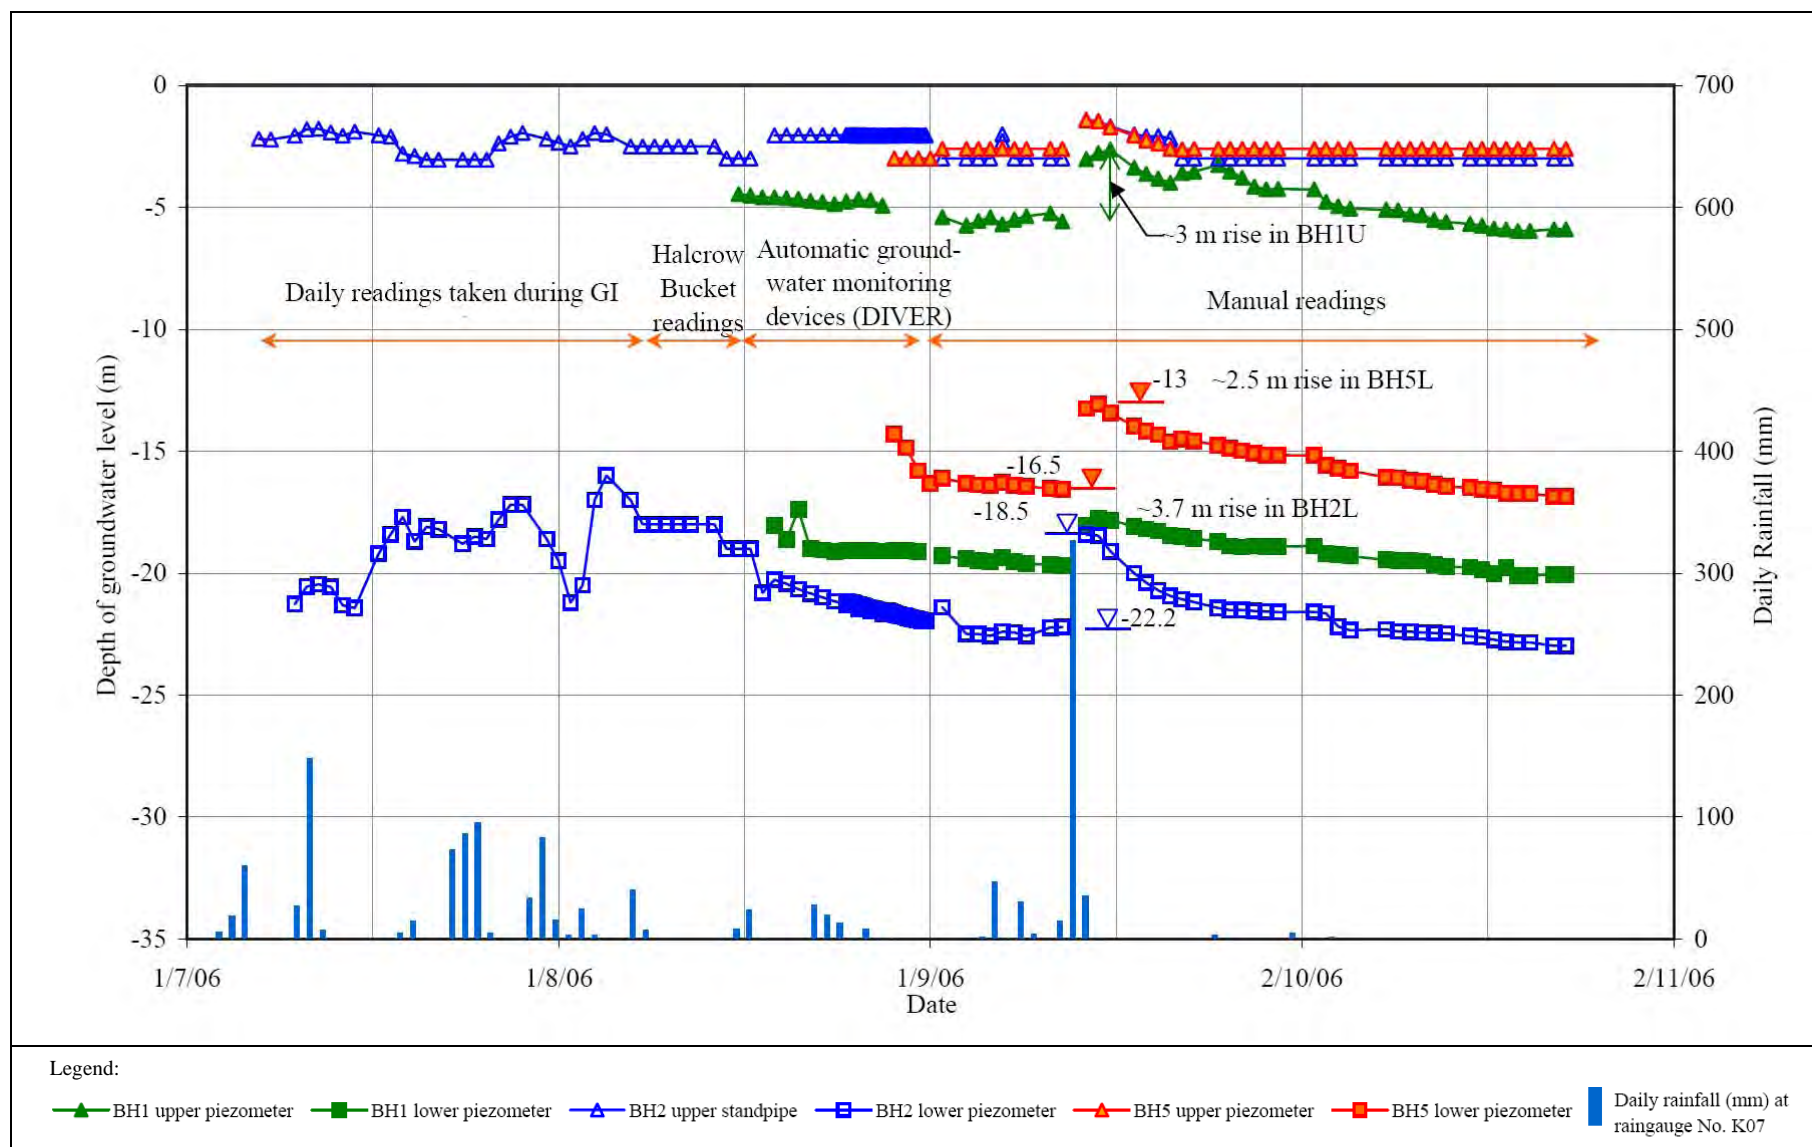
Figure 17 - Records of Groundwater Monitoring between July 2006 and October 2006

The rapid groundwater rise (3.7 m rise in the base groundwater table) and the slow rate of dissipation of water (10 to 12 days after the initial rise) observed following the September 2006 rainstorm (see Figure 17) suggest that prolonged intense rainfall, such as that of the August 2005 rainstorm, may invoke some unusual hydrogeological conditions and could potentially lead to a significant rise in the base groundwater, despite a fairly small catchment area of about 20,000 m² plan area.

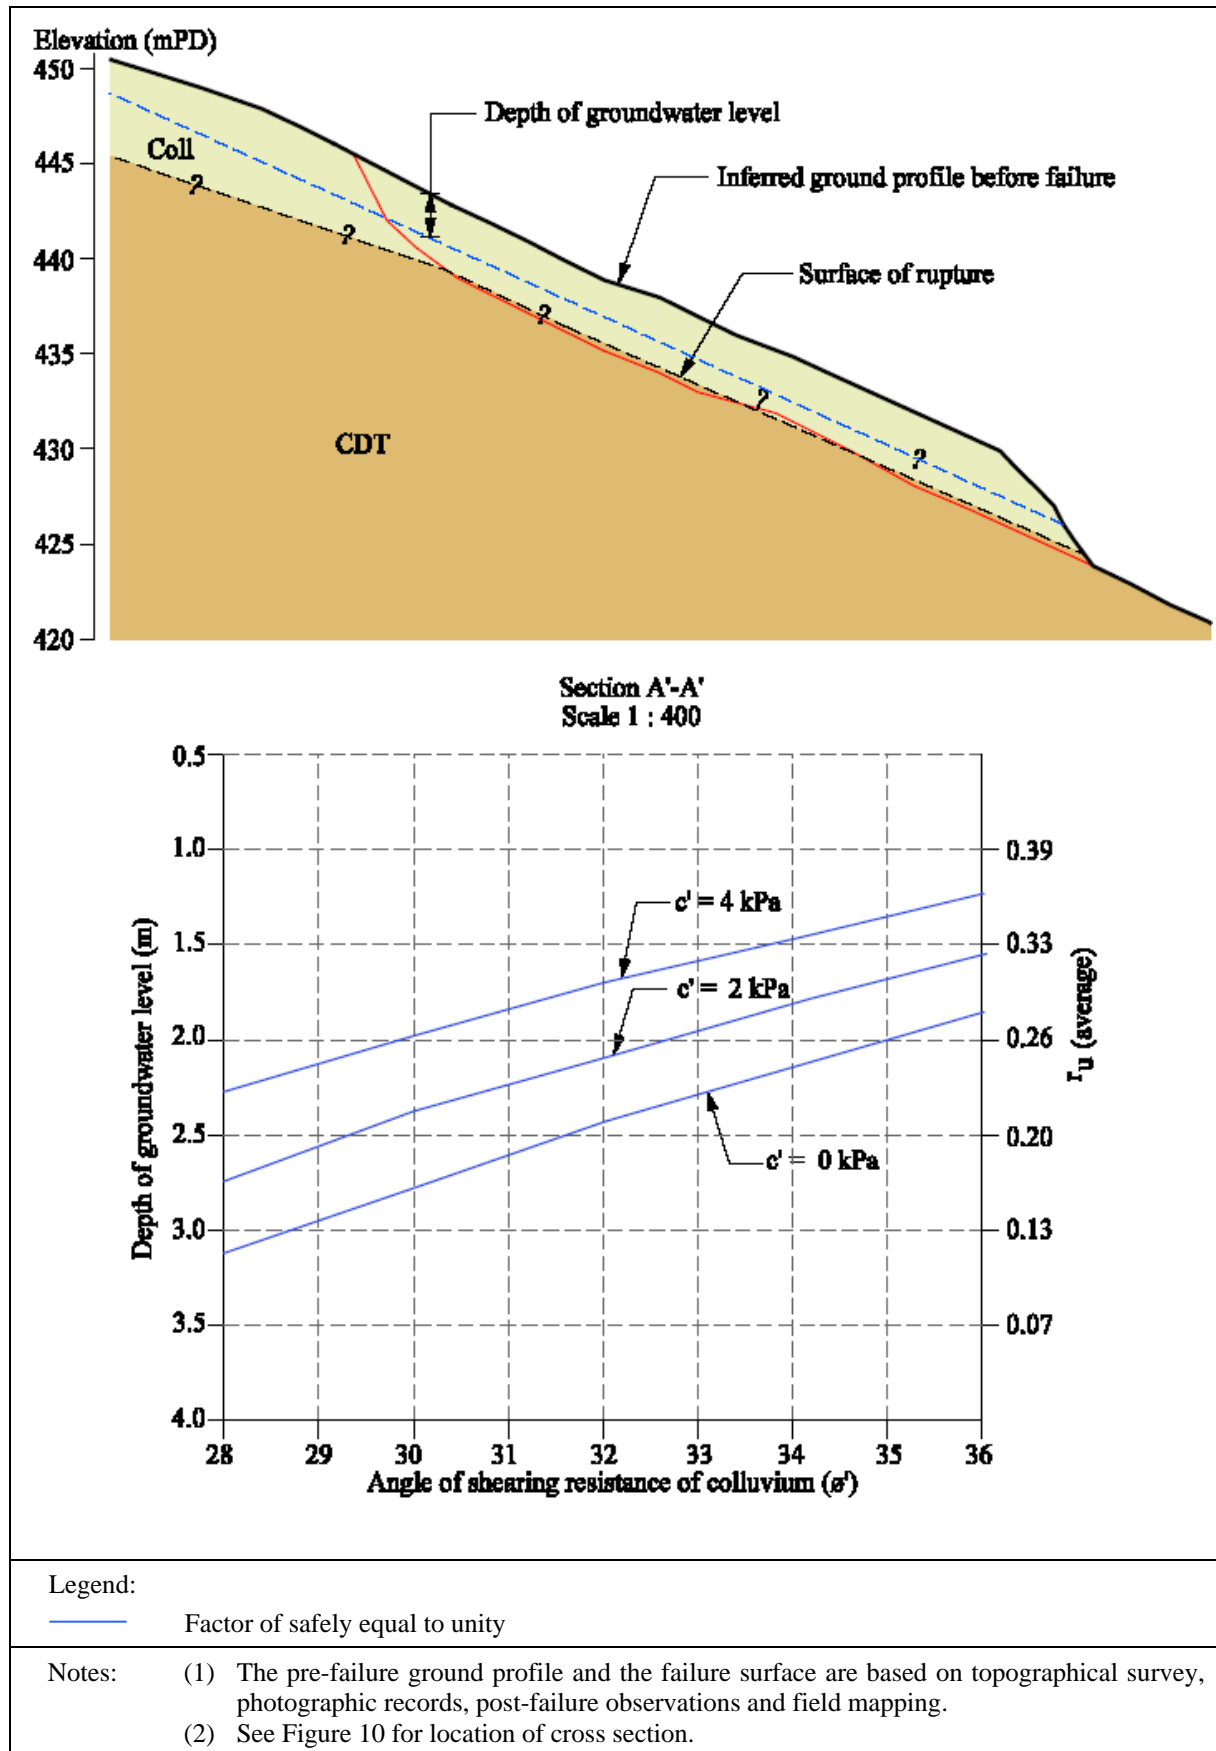
Figure 20 - Summary of Theoretical Stability Analyses of the August 2005 Landslide

A cross-section of the August 2005 landslide site and the input parameters adopted in the analyses are shown in Figure 20. The pre-failure ground profile within the failed area was interpolated from the detailed topographical survey of the two flanks of the landslide undertaken after the failure, with suitable adjustment of ground levels based on the evidence from API that a smaller landslide may have occurred at the same location as the 2005

The results of the analyses are presented in Figure 20 for shear strength parameters of $c' = 0$ to 4 kPa and $\phi' = 28^\circ$ to 36° . The results indicate that for the ranges of shear strength parameters along the failure surface, a groundwater level of between 1.2 m and 3.1 m below ground surface would have been sufficient for failure to occur. Using the shear strength parameters of $c' = 3$ kPa and $\phi' = 30^\circ$ for colluvium (both young and old colluvium are assumed to have the same shear strength parameters, see Section 5.5) that were derived from laboratory tests, a groundwater level of about 2.6 m below ground surface, corresponding to a rise of about 2.5 m above the colluvium/CDT interface, would have been sufficient for failure.

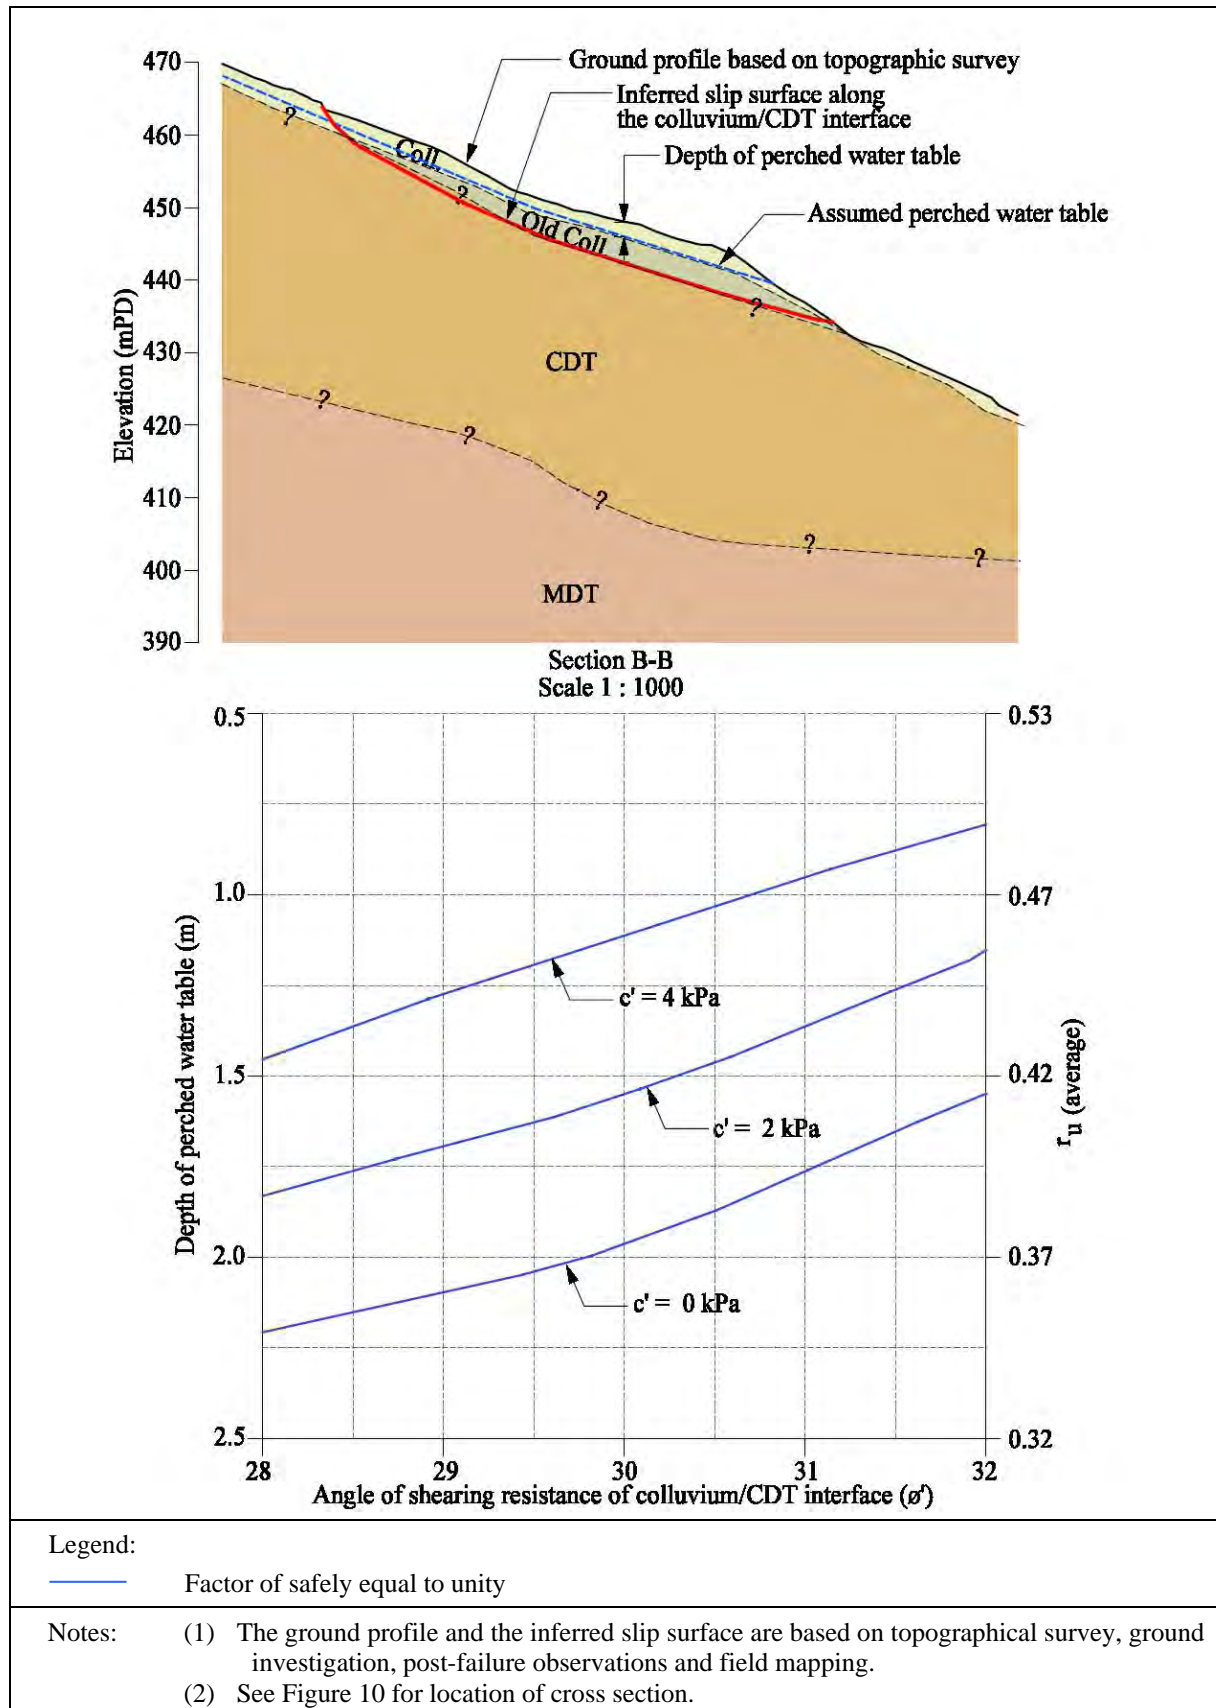
Figure 21 - Summary of Theoretical Stability Analyses of the Distressed Hillside (Shallow Failure)

A cross-section of the distressed hillside and the input parameters adopted in the analyses are shown in Figures 21 and 22. The ground profile of the hillside was obtained from topographical survey and the geological profile of the section was determined from field mapping and ground investigation information. A range of groundwater profiles was assumed in the analyses to simulate the possible groundwater conditions.

The results of the analyses are presented in Figures 21 and 22.

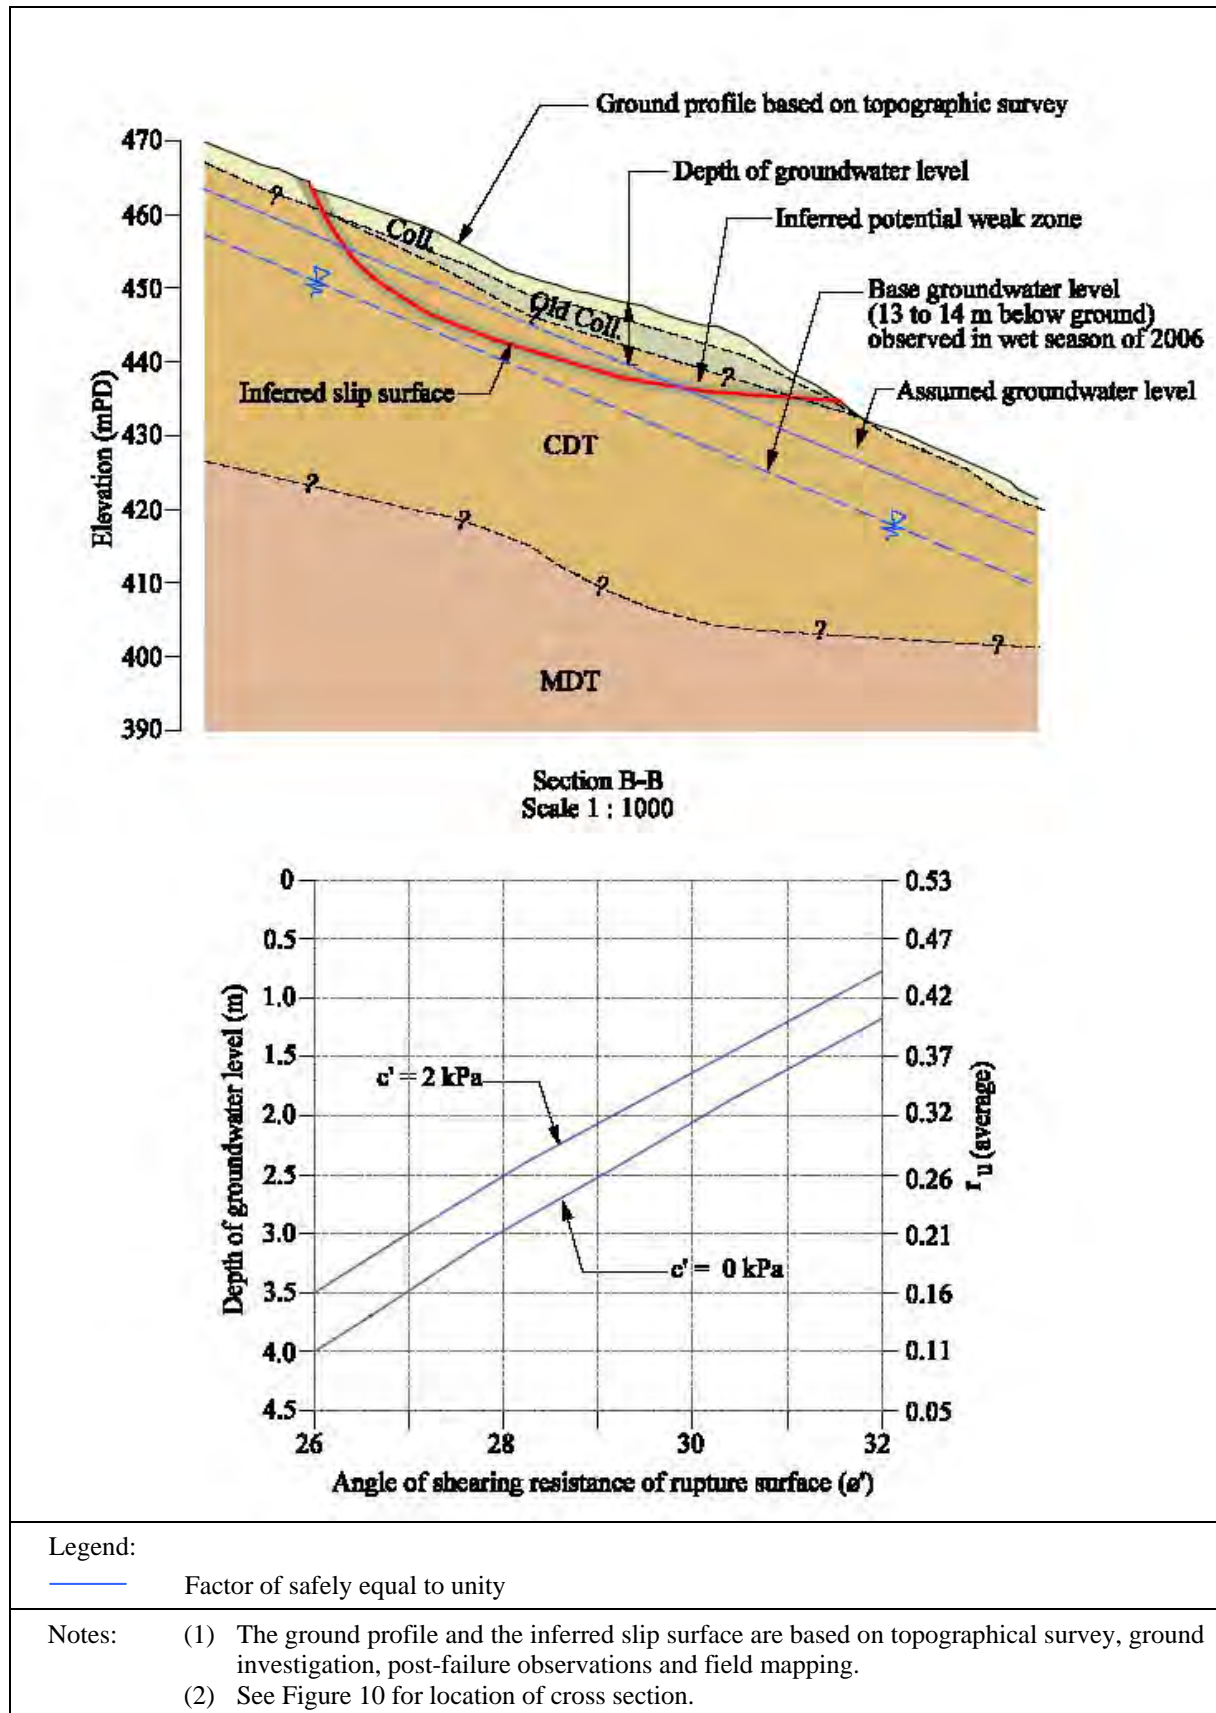
Figure 22 - Summary of Theoretical Stability Analyses of the Distressed Hillside (Deep-seated Failure)

The results for Case B show that if the shear strength parameters of the materials along the failure surface are of $c' = 0$ kPa and 2 kPa and $\phi' = 26^\circ$, a deep-seated failure (i.e. along the possible weaker materials within CDT at a depth of about 10 m depth) would be feasible with a rise in base groundwater level of about 8.5 m to 9 m (assuming a base groundwater level of about 13 m to 14 m below ground level during the wet season, see Section 7.2). When $c' = 0$ kPa and 2 kPa and $\phi' = 32^\circ$, the base groundwater level would need to rise between 12.5 m and 13 m to reduce the factor of safety to below 1.0 and potentially initiate failure (Figure 22).

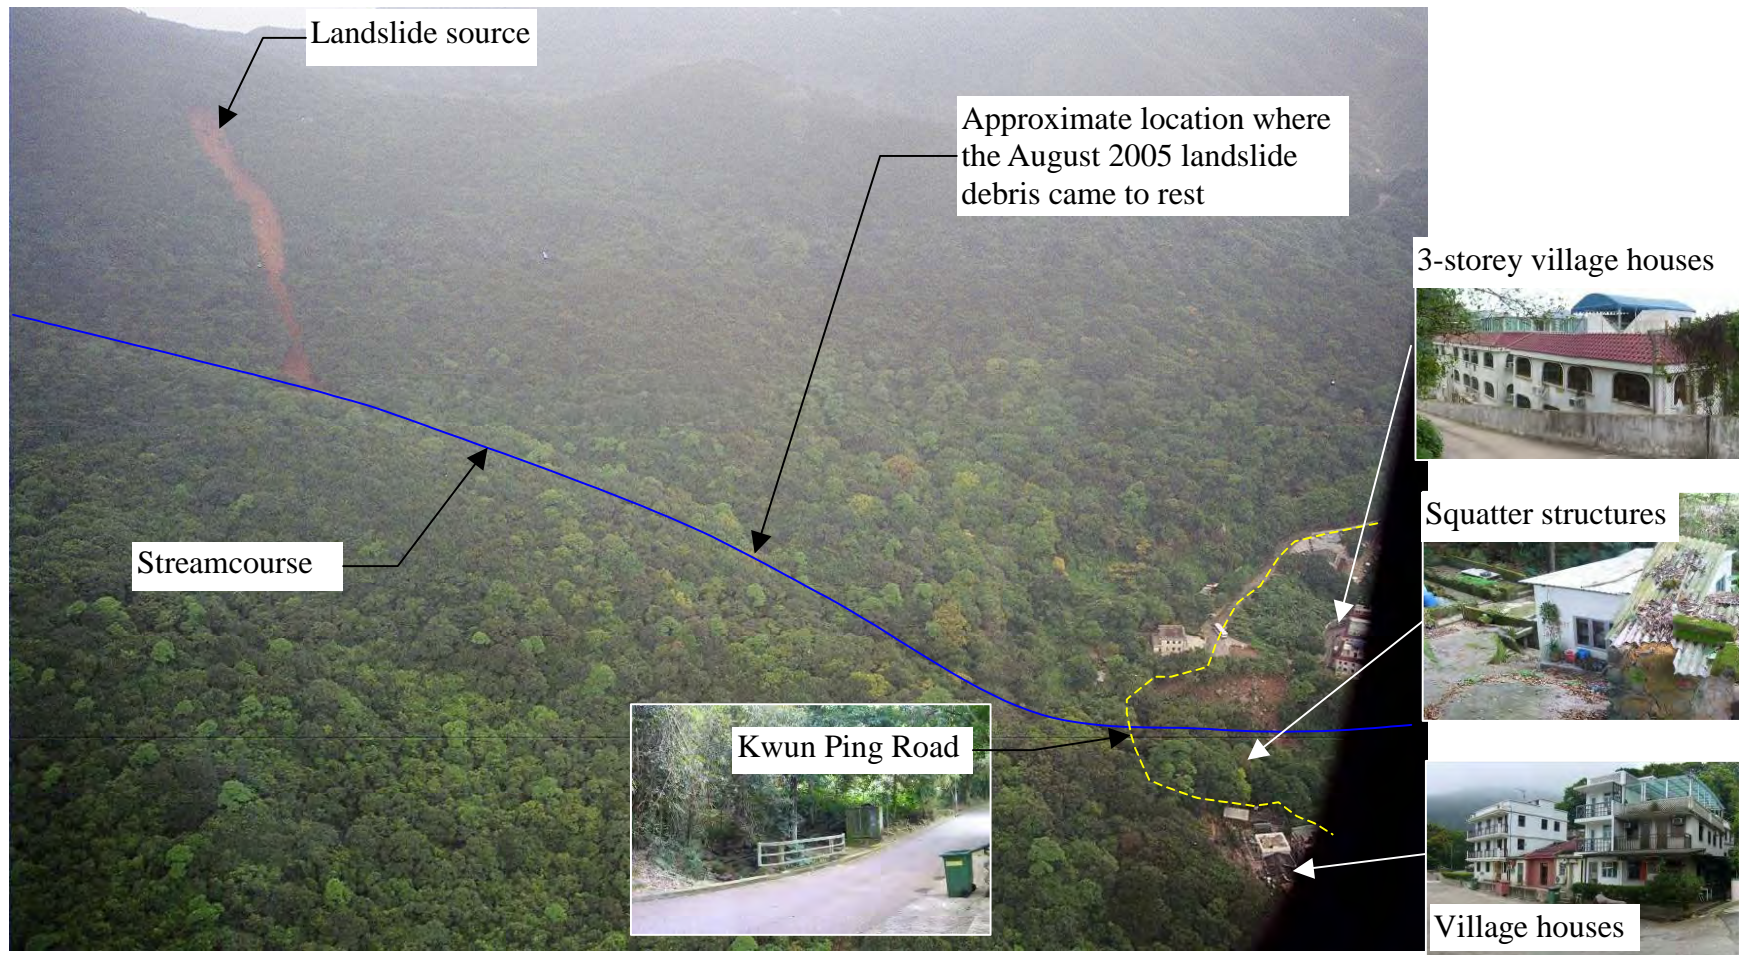
Plate 2 - Oblique Aerial View of the August 2005 Landslide and the Facilities at Kwun Ping Road
(Photograph taken on 28 August 2005)

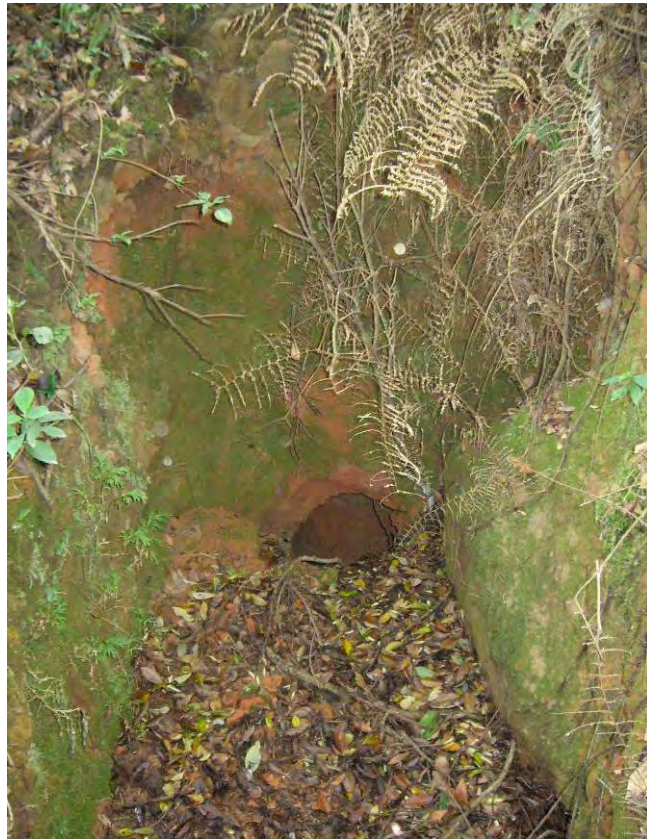
Plate 4 - Entrance to Wartime Tunnel
(Photograph taken on 10 March 2006)

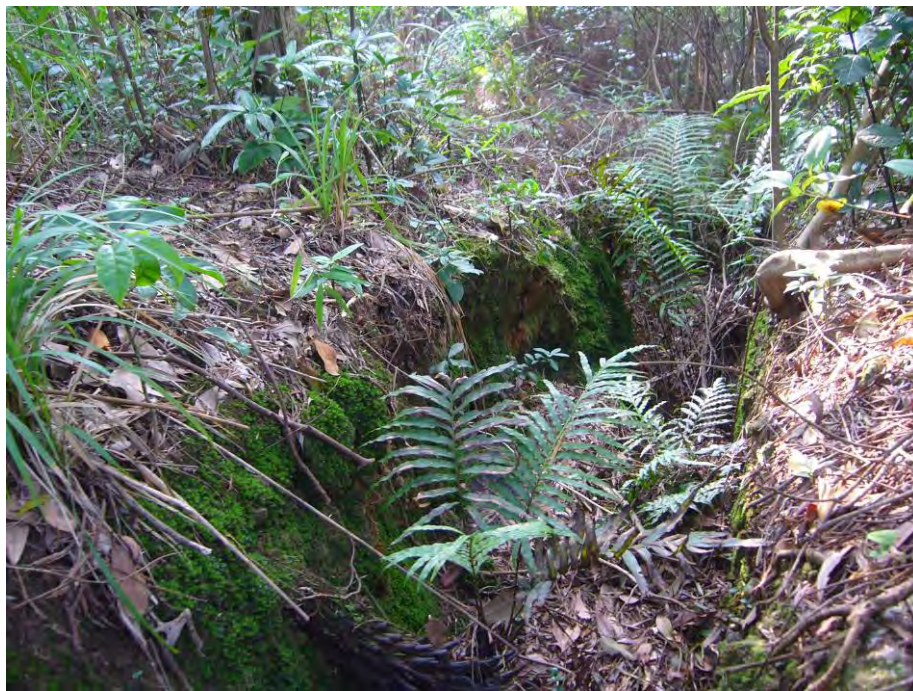
Plate 5 - Wartime Trench above the Distressed Hillside
(Photograph taken on 29 May 2006)

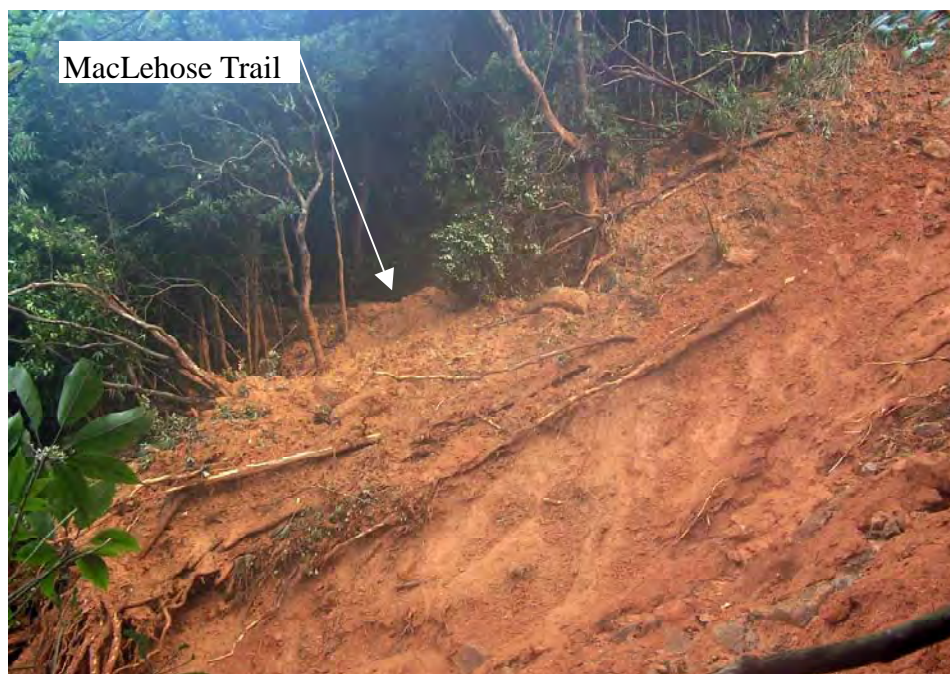
Plate 12 - Debris Trail Showing Entrainment of MacLehose Trail
(Photograph taken on 25 August 2005)

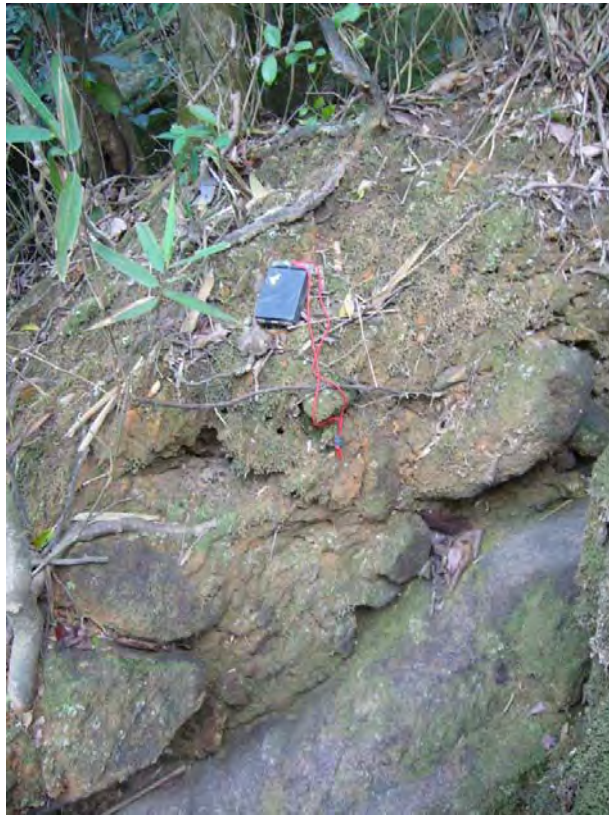
Plate 13 - Old Landslide Debris adjacent to the Pre-1963 Landslide Scar
(Photograph taken on 15 March 2006)

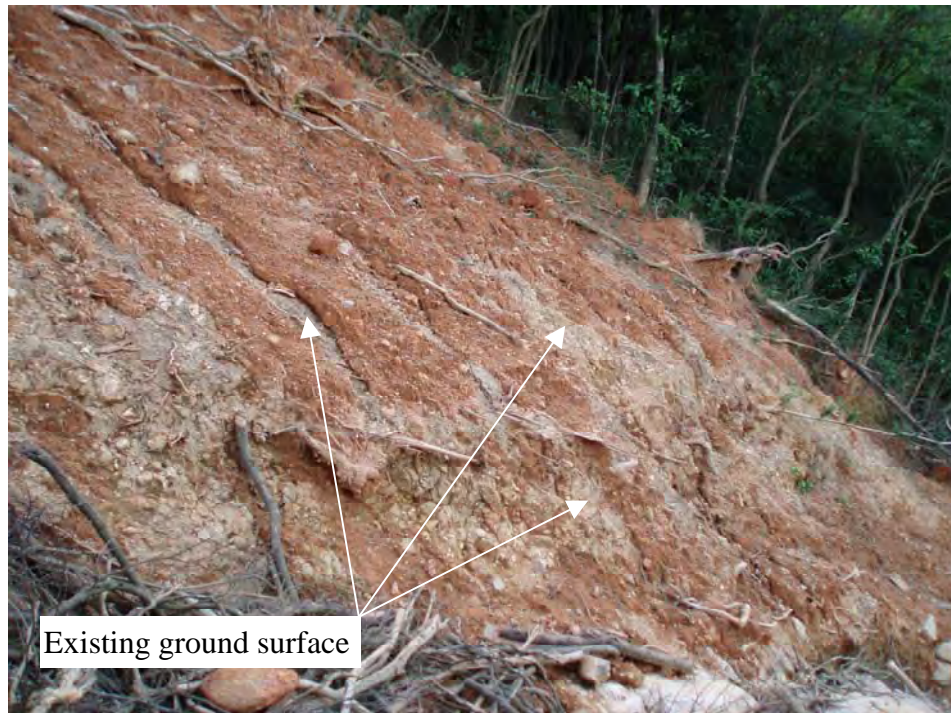
Plate 15 - Existing Ground Surface Exposed in the Base of the Debris Trail
(Photograph taken on 25 May 2005)

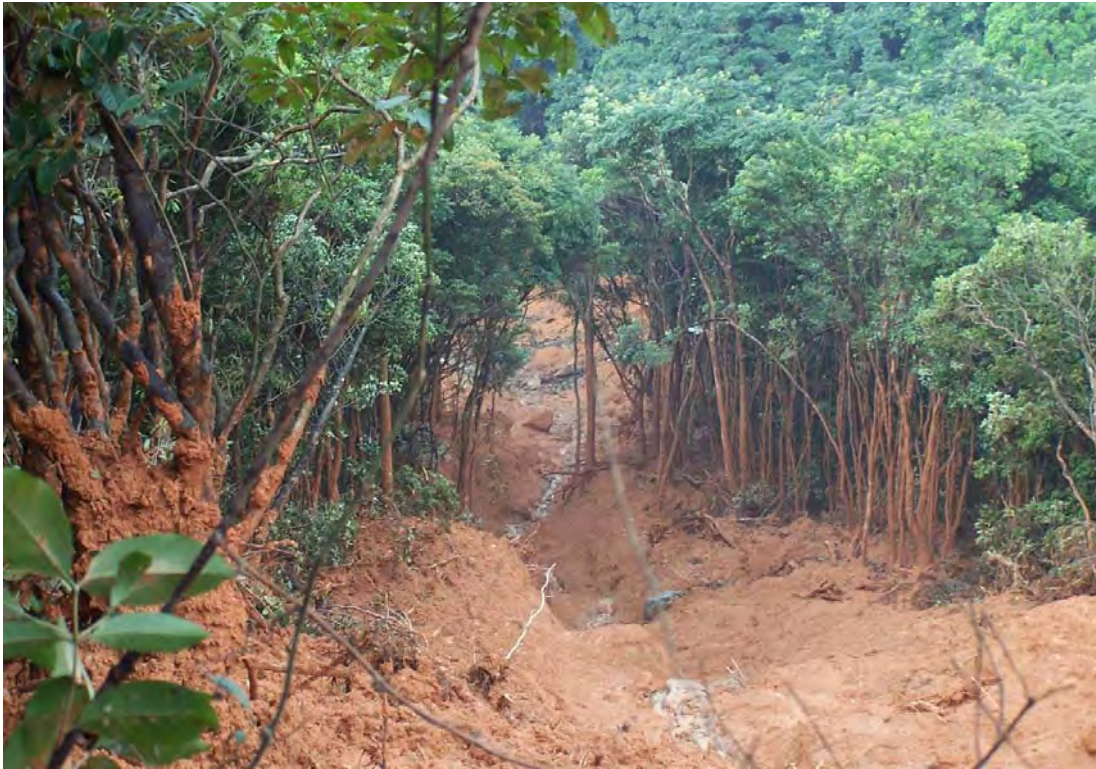
Plate 17 - Lower Portion of the Upper Debris Trail
(Photograph taken on 25 August 2005)

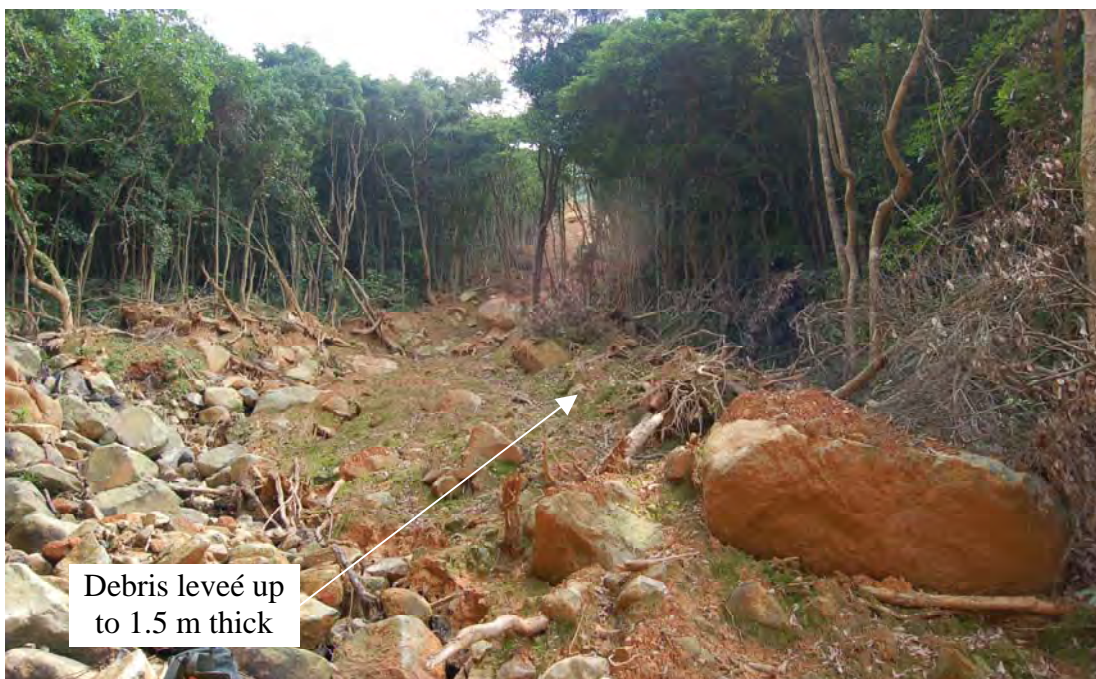
Plate 18 - Debris Trail at Chainage CH220 Showing Deposition of Debris
on the Inside Bend (Photograph taken on 25 May 2006)
