**DETAILED STUDY OF
THE 22 AUGUST 2005
LANDSLIDE AND
DISTRESS ON THE
NATURAL HILLSIDE
AT KWUN YAM SHAN,
BELOW TATE'S RIDGE**

GEO REPORT No. 239

Maunsell Geotechnical Services Limited

**GEOTECHNICAL ENGINEERING OFFICE
CIVIL ENGINEERING AND DEVELOPMENT DEPARTMENT
THE GOVERNMENT OF THE HONG KONG
SPECIAL ADMINISTRATIVE REGION**

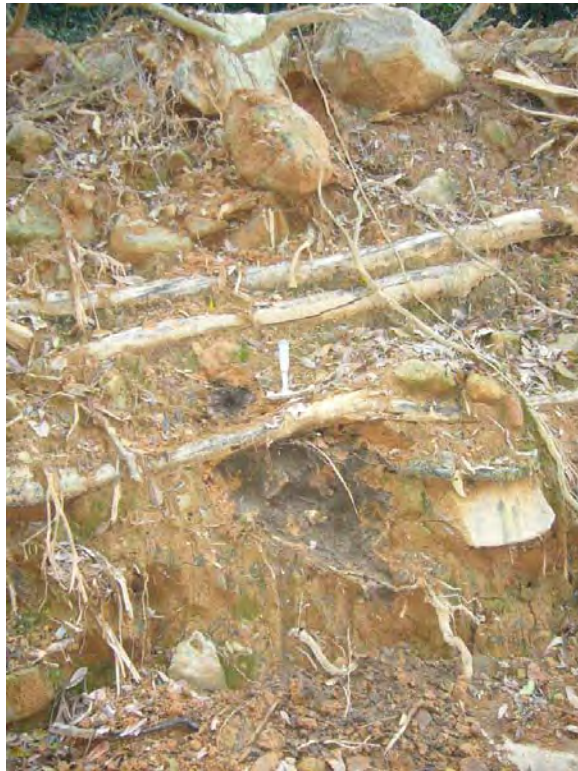
Plate 19 - Trees and Soil Adjacent to the Debris Trail Buried by Previous Landsliding (Photograph taken on 10 March 2006)

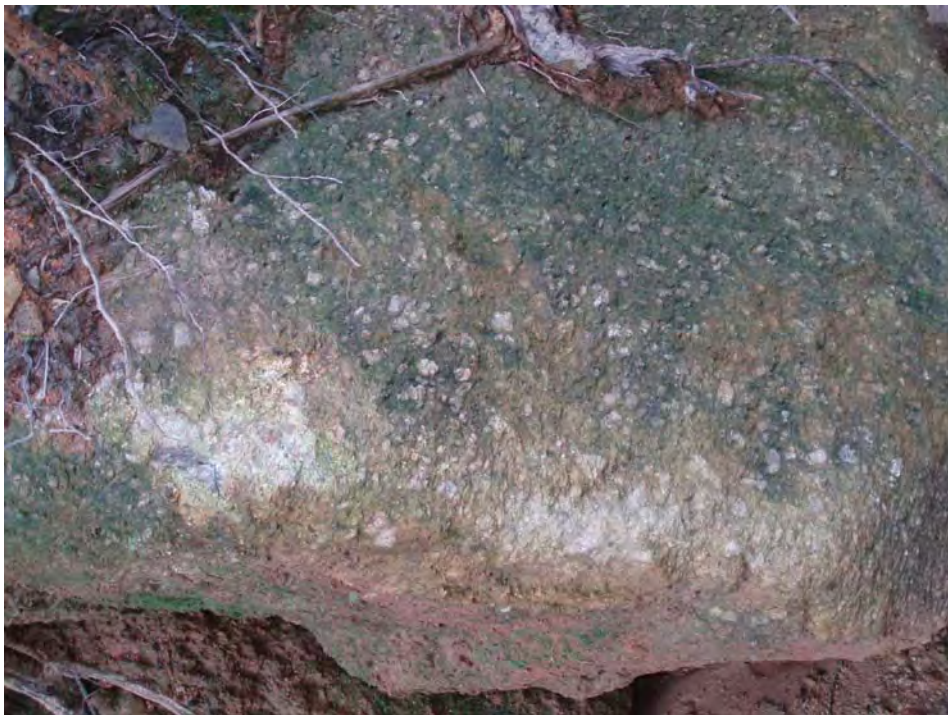
Plate 20 - Boulder of Feldsparphyric Rhyolite at CH270 of the Debris Trail (Photograph taken on 28 April 2006)

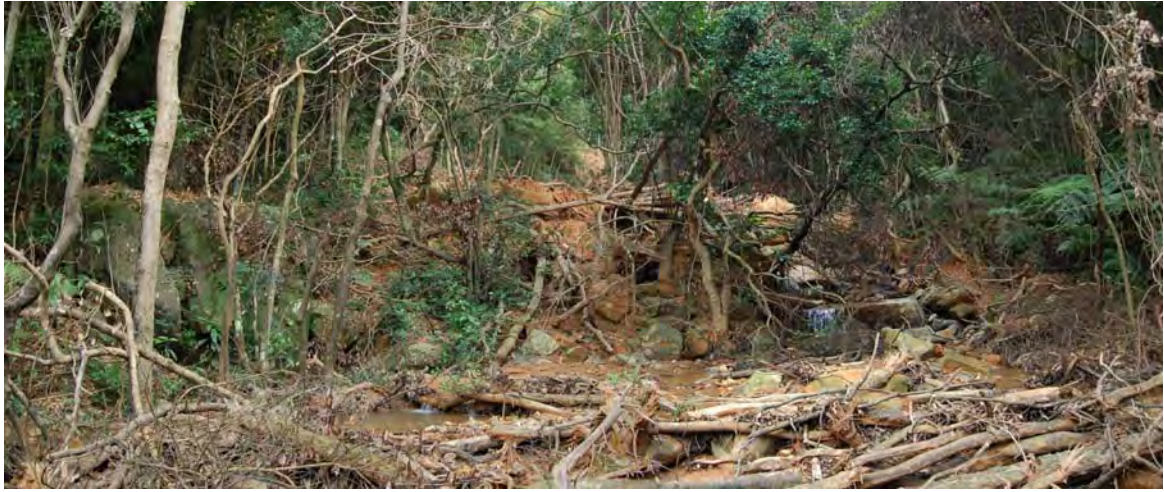
Plate 21 - View of the Upper Boulder Dam from Downstream
(Photograph taken on 22 March 2006)

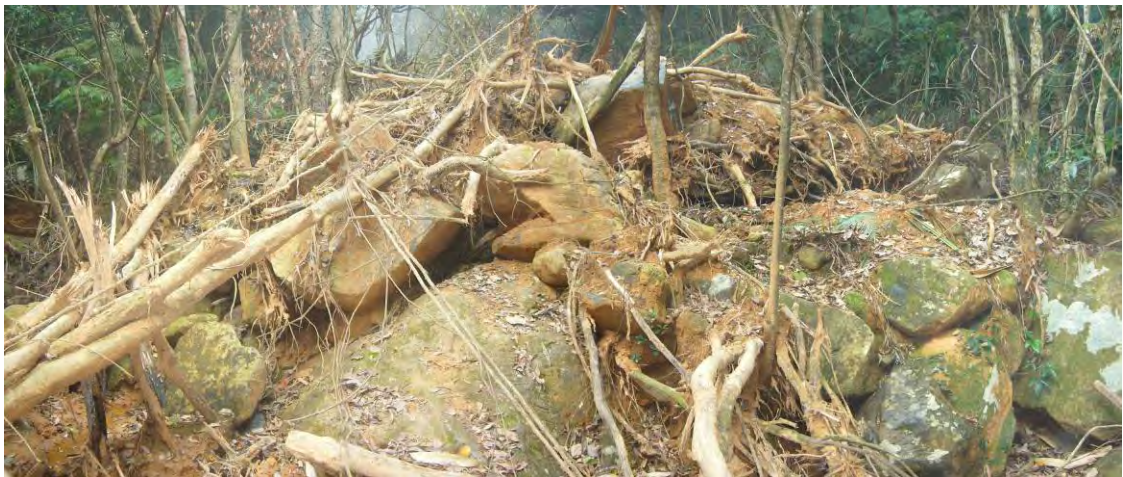
Plate 22 - View of the Lower Boulder Dam from Downstream
(Photograph taken on 22 March 2006)

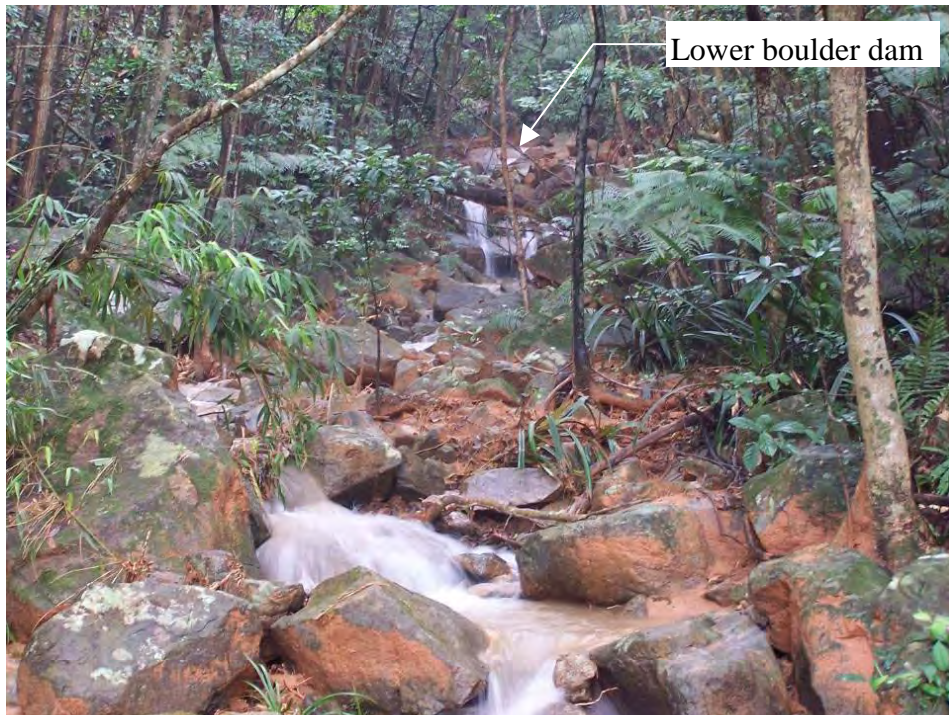
Plate 23 - View along Streamcourse Looking Uphill towards Boulder Dam
(Photograph taken on 24 August 2005)

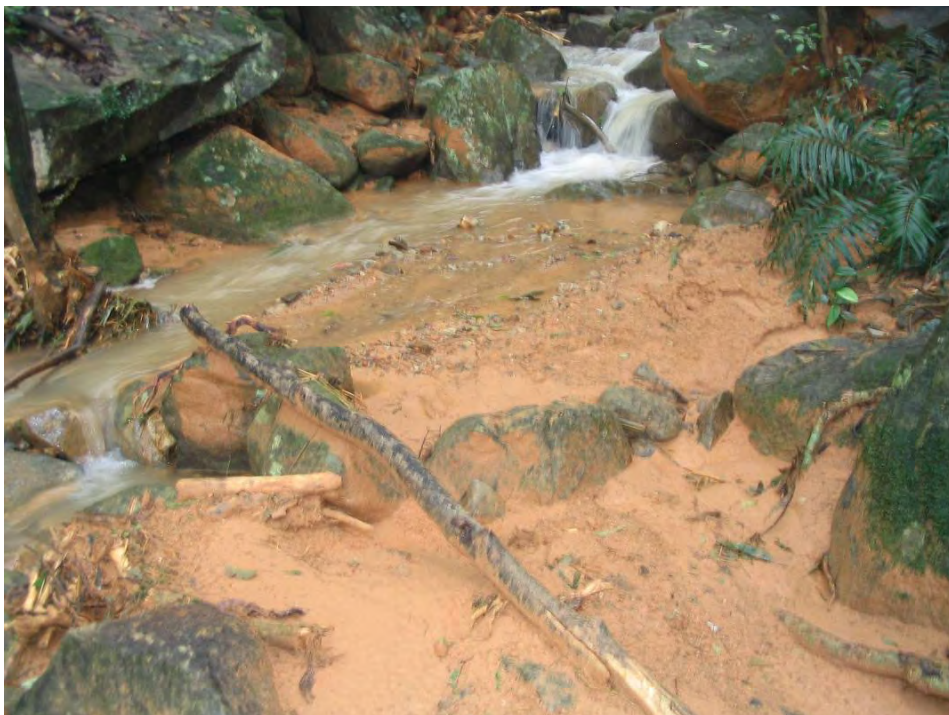
Plate 24 - Washout Debris in Streamcourse below the Boulder Dams
(Photograph taken on 24 August 2005)

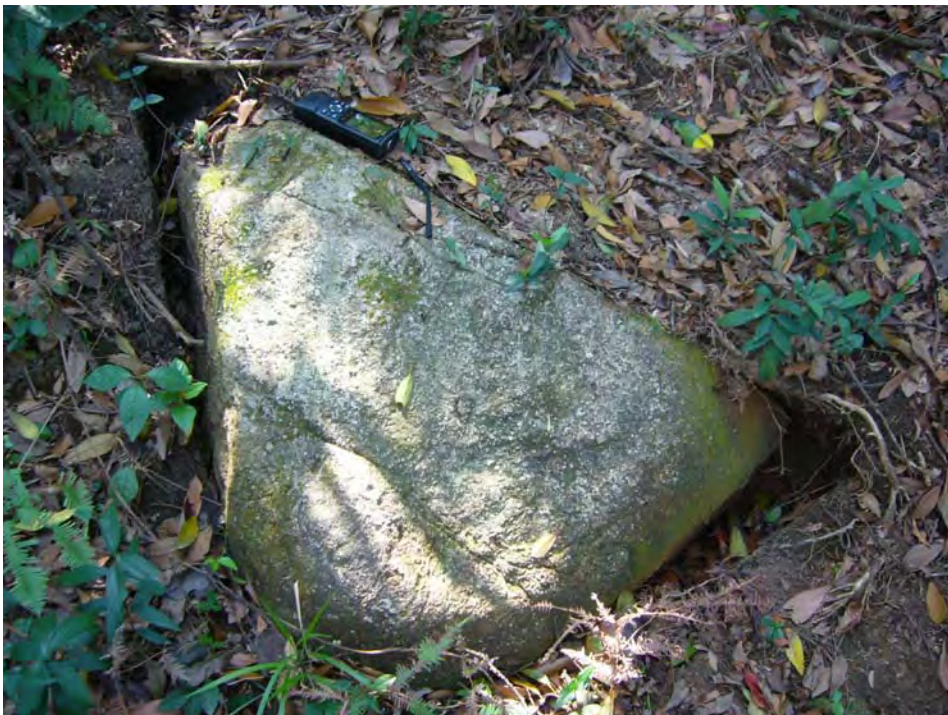
Plate 28 - Boulder with Soil Movement within the Main Body of the
Distressed Hillside (Photograph taken on 10 March 2006)

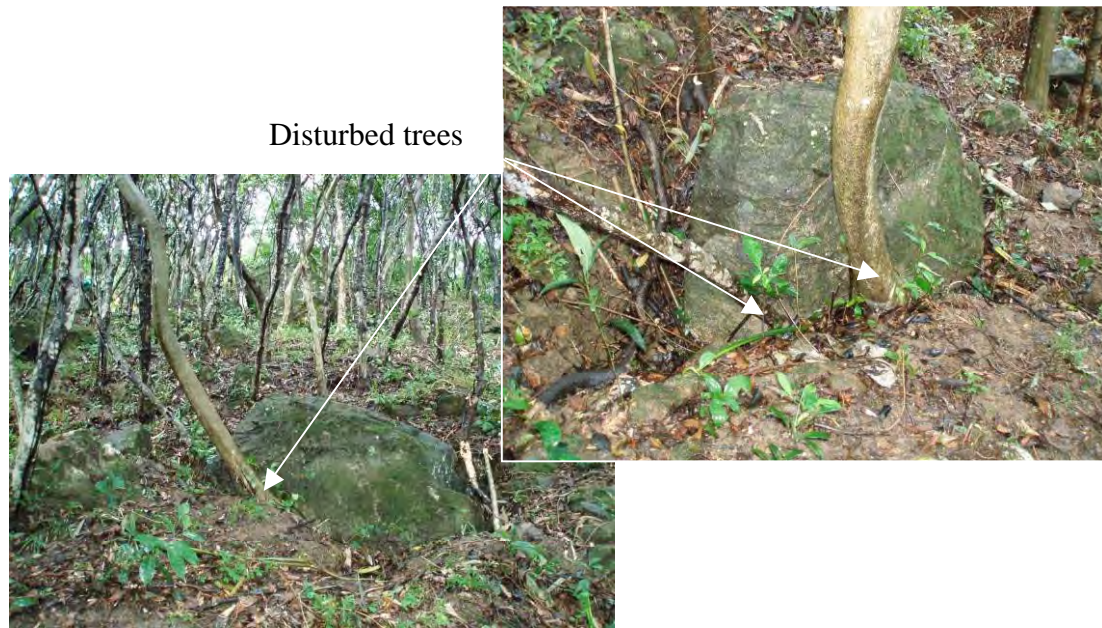
Plate 30 - Trees Disturbed by Boulder Movements and Subsurface Collapse
(Photograph taken on 10 July 2006)

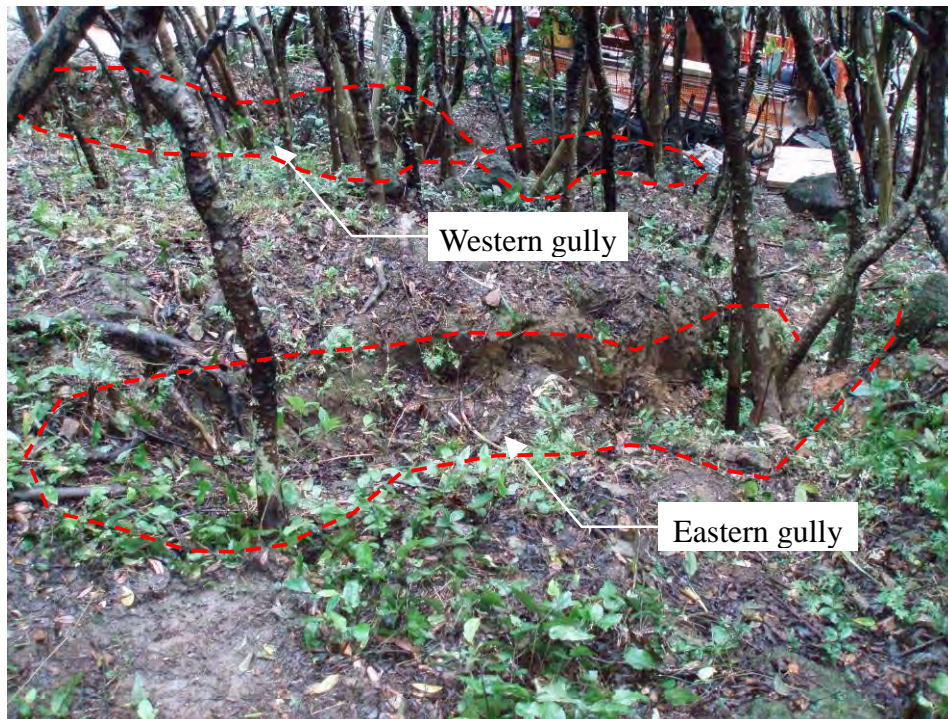
Plate 32 - The Eastern and Western Gullies
(Photograph taken on 14 June 2006)

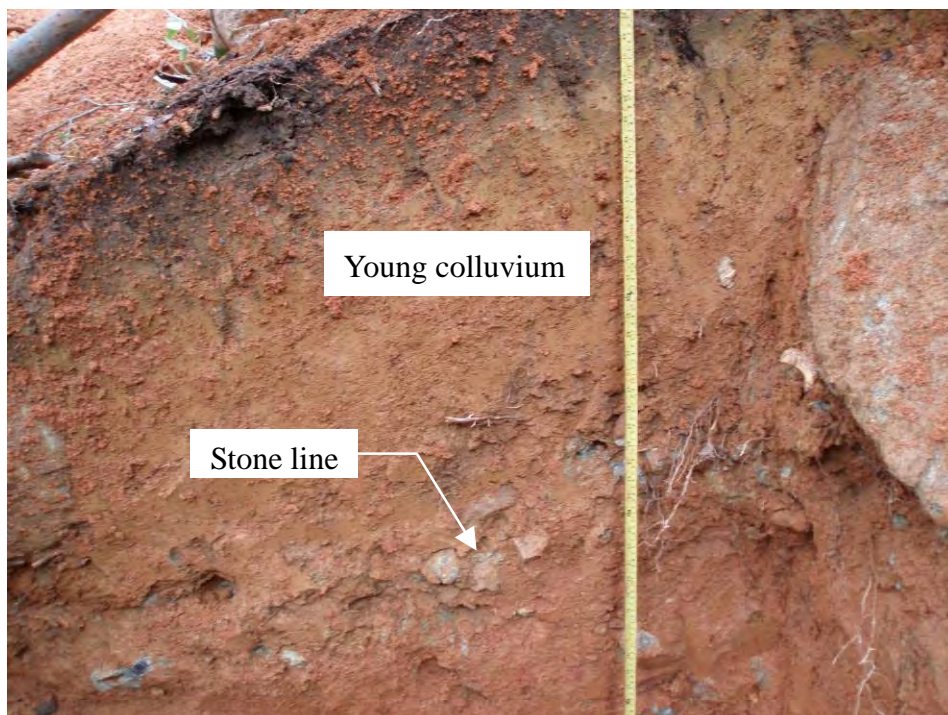
the soil mass), marking the probable base of a landslide, support the likely landslide debris related origin of the young colluvium (Plate 33). Where the young colluvium was exposed in the tension cracks, its consistency was firm to stiff.

Plate 33 - Stone Line in Trial Pit No. TP10 Marking the Base of a Past Landslide
(Photograph taken on 14 June 2006)

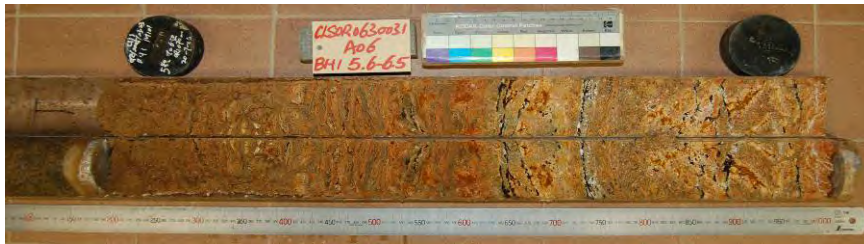
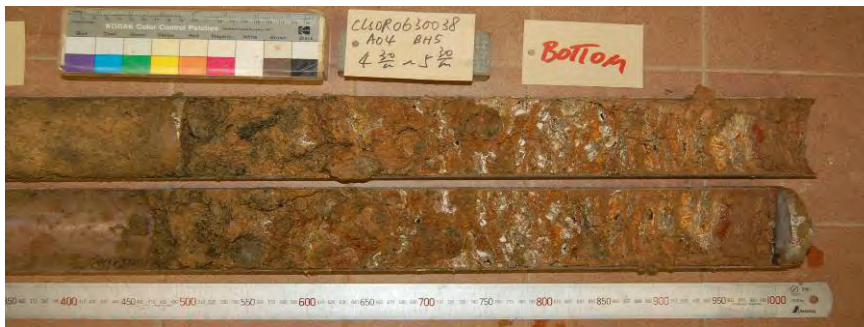
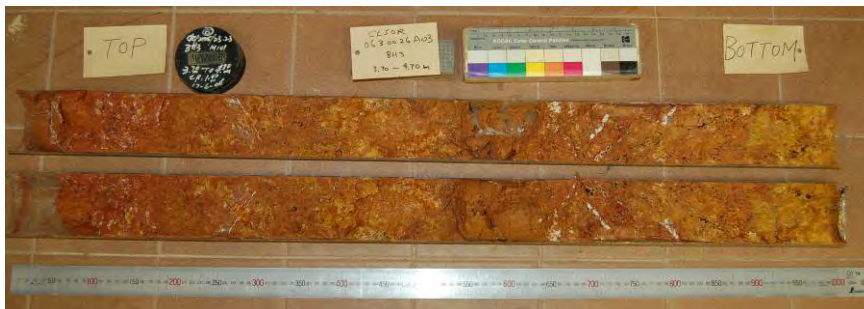
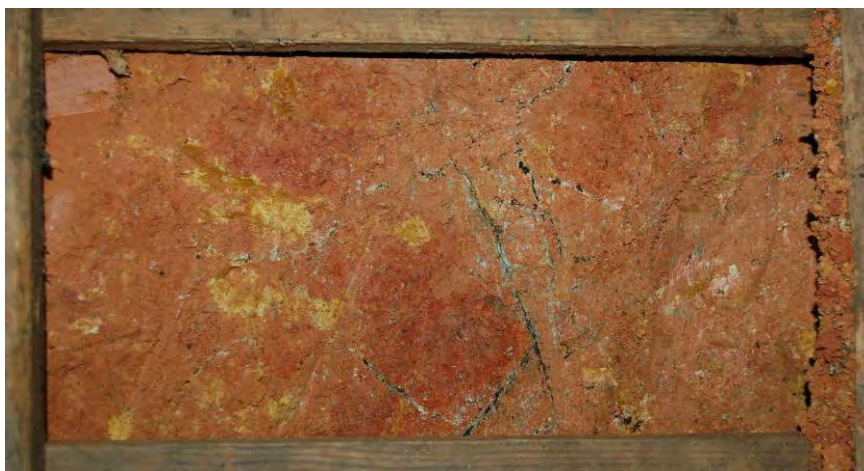
(a) Old Colluvium
BH1

(b) Old Colluvium
with Kaolin in
BH5

(c) Old colluvium in
BH3

(d) Old colluvium in
TP10

Plate 34 - Old Colluvium Observed in Split Mazier Samples and Trial Pit

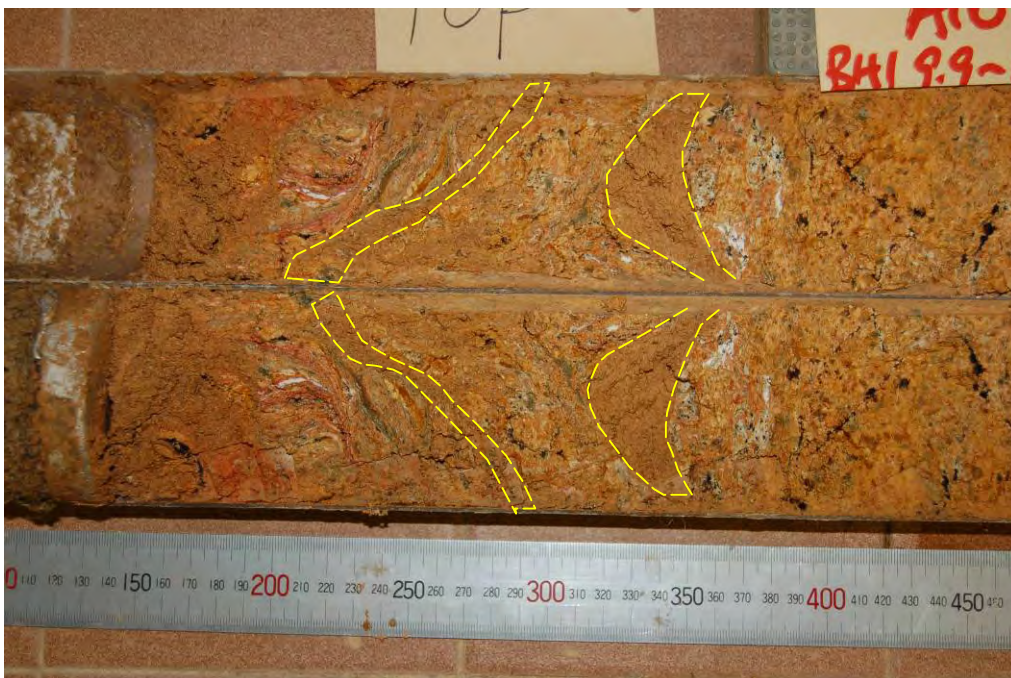
The clay bands observed in drillhole No. BH1 comprised a thin, soft, moist light brown clay of about 5 mm maximum thickness dipping at about 45°, with a sub-horizontal lens of soft moist light brown slightly sandy clay located about 60 mm below (Plate 38). Bands of wet sandy clay up to 200 mm thick were also observed in drillhole No. BH1 between depths of about 3.7 m and 3.8 m, and about 4.8 m and 5 m within the old colluvium. The lower sandy clay band was marked by an abrupt horizontal boundary with the material below. The origin of these clayey bands is unclear. Thin clay laminae/bands are not uncommon in a weathered volcanic tuff sequence. Sewell et al (2000) note that possible pyroclastic fall deposits “include finely laminated, white to light grey and orangish brown, very fine ash tuffs with variable crystal components”. However, none of the clay bands observed at the subject site appeared finely laminated, and the consistency in the sub-horizontal orientation and relatively consistent thickness suggest a different origin to that of pyroclastic fall.

Plate 38 - Clay Bands at 10 m Depth in Drillhole No. BH1

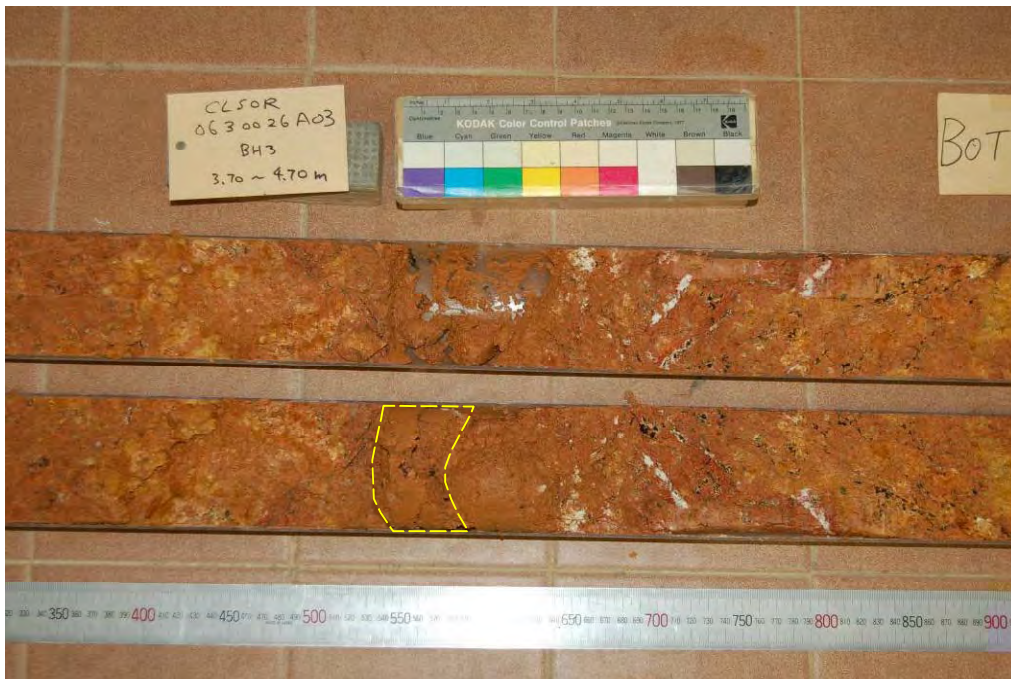
In drillhole No. BH3, the clay band encountered at a depth of 4.2 m (taken through old colluvium) was soft, moist, dark reddish brown sandy clay of about 20 mm thickness (Plate 39). The clay bands in drillhole No. BH4 encountered at a depth of 4.3 m (at old colluvium) comprised a bifurcating band of soft to firm greenish brown clay of about 2 mm to 5 mm thickness located about 60 mm above an undulating 5 mm thick soft to firm greenish brown clay (Plate 40).

Plate 39 - Clay Bands at 4.2 m Depth in Drillhole No. BH3

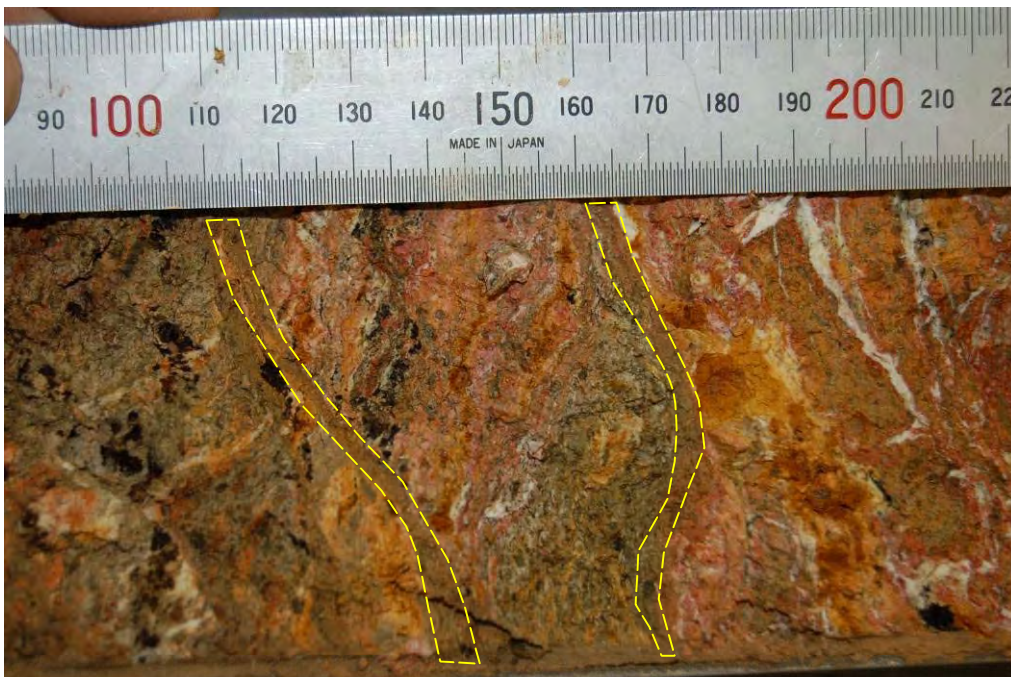
Plate 40 - Clay Bands at 4.2 m Depth in Drillhole No. BH4

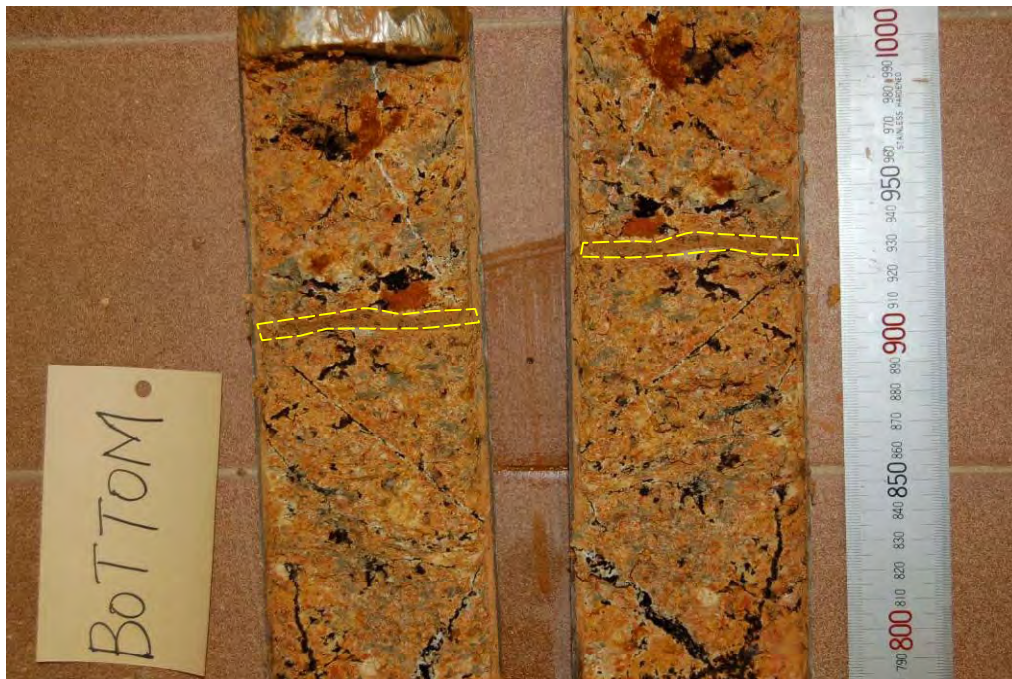
At a depth of 11.5 m in drillhole No. BH4 (within the CDT layer), the clay band comprises 5 mm thick sub-horizontal soft light reddish brown slightly sandy clay (Plate 41). There appears to be no obvious evidence of displacement of the CDT on either side of the clay band, although there is a lack of distinct structure (e.g. a joint or bedding plane) from which observation of displacement can be made readily.

Plate 41 - Clay Bands at 11.5 m Depth in Drillhole No. BH4

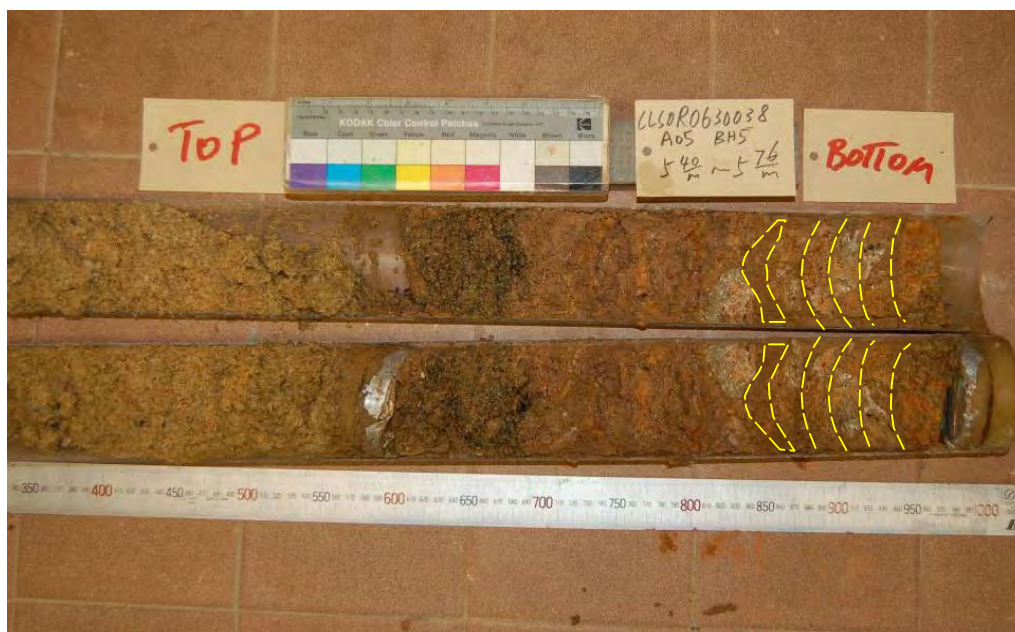
Clay bands were encountered in drillhole No. BH5 at three different levels. The uppermost bands were encountered at a depth of 5.7 m within the old colluvium and comprised three parallel sub-horizontal soft to firm reddish brown clay bands (Plate 42), spaced at about 20 mm to 30 mm apart. The corresponding Mazier sample was taken after a falling head permeability test was carried out (between depths of 4.4 m and 5.4 m). There is evidence of disturbance to the material recovered in the top of the sample and this may also account for the disturbance of the material below the sands. The subject Mazier sample was taken immediately above a large MDT corestone, which was encountered between depths of about 5.8 m and 7.6 m.

Plate 42 - Clay Bands at 5.7 m Depth in Drillhole No. BH5

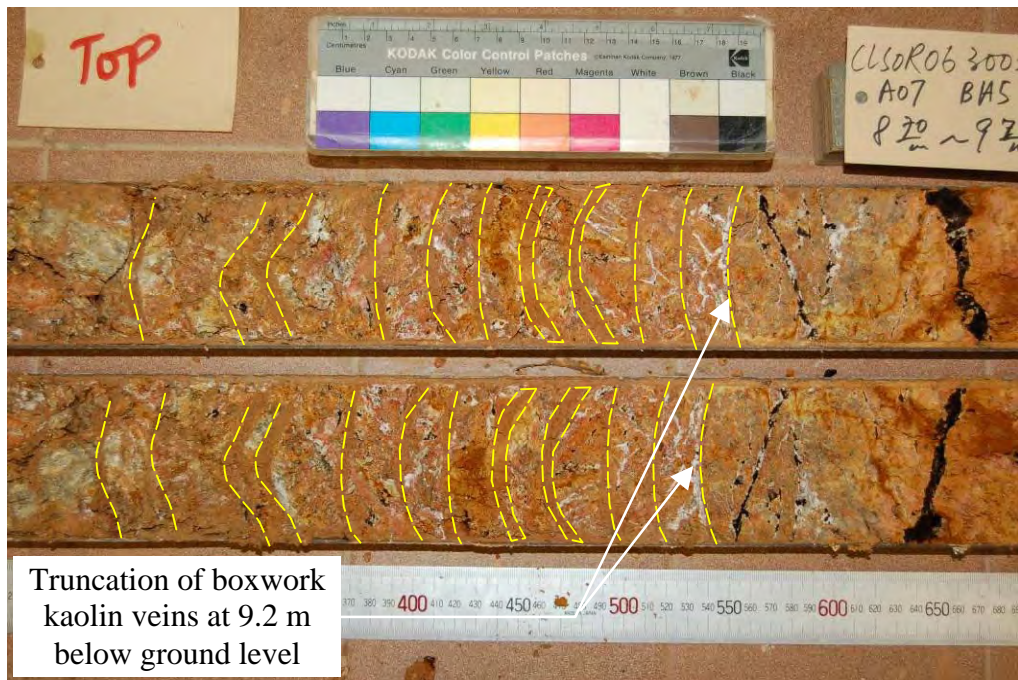
The second level of clay bands in drillhole No. BH5 was observed at about 9 m depth within the CDT. The clay bands comprised soft to firm light reddish brown clay of about 3 mm to 8 mm in thickness (Plate 43). There were 12 bands, which were sub-horizontal and very regularly spaced at between 25 mm and 35 mm. The clay bands prevail in a portion of the CDT that has a concentration of kaolin in the form of boxwork veins. Displacement appeared negligible across the upper bands whereas an apparent cutting of the boxwork veining was evident towards a depth of 9.2 m.

Plate 43 - Clay Bands at 9 m Depth in Drillhole No. BH5

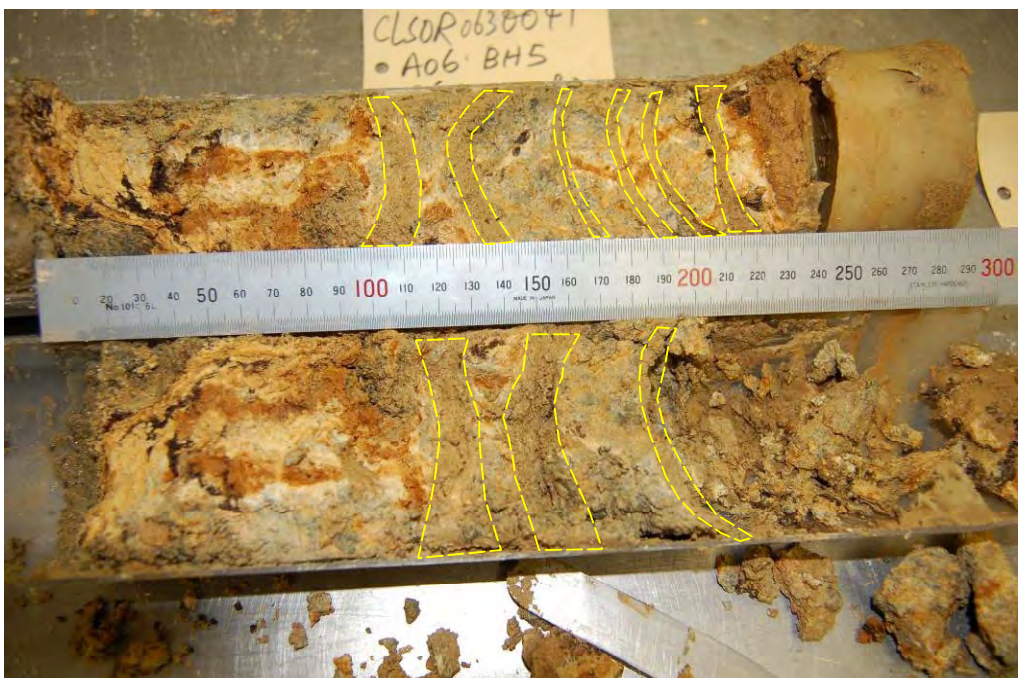
The third and deepest set of clay bands encountered in drillhole BH5 was observed in the sample taken from depths of about 18.6 m and 18.8 m (Plate 44). The clay bands are in the form of a series of sub-parallel, 5 mm to 10 mm thick, very soft, moist, light greenish brown sandy clay. The sample was taken below the main ground water level (measured at about 17 m depth) and from between two MDT corestones.

Plate 44 - Clay Bands at 18.7 m Depth in Drillhole No. BH5

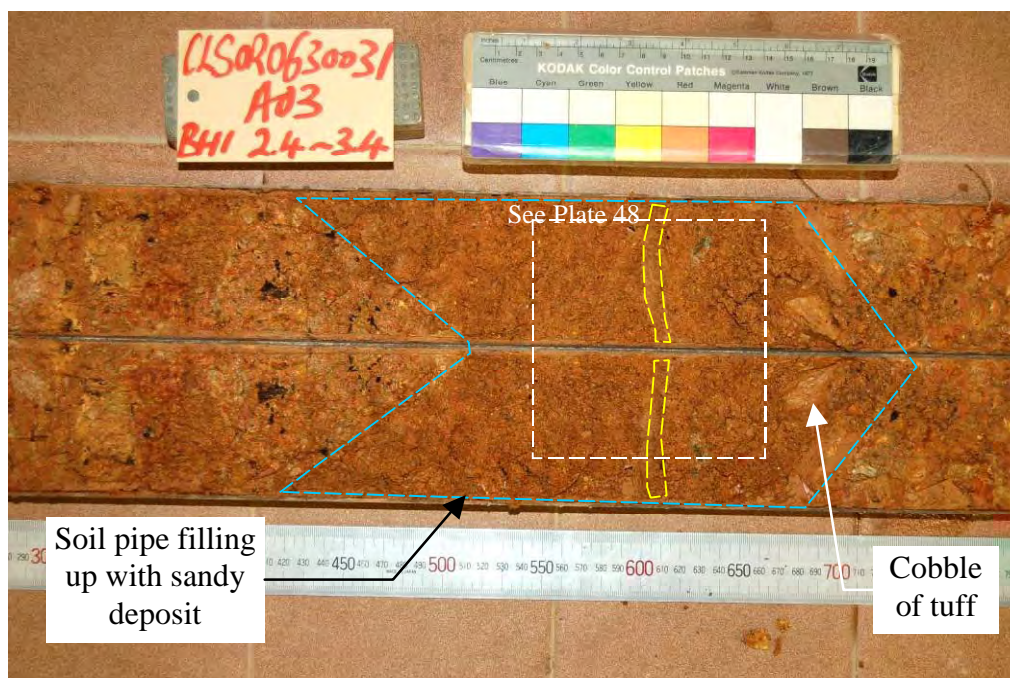
In drillhole No. BH1, erosion pipes were encountered at depths of between 1.7 m and 1.9 m in young colluvium, and between 2.9 m and 3.1 m in old colluvium. The deposit in the lower erosion pipe was observed to be a 'fining up' sequence of sands (Plate 47), with a sub-horizontal 10 mm thick clay layer at about the mid-height of the choked soil pipe (Plate 48).

Plate 47 - Sandy Soil Pipe Deposit with Horizontal Clay Layer at 3 m Depth in Drillhole No. BH1

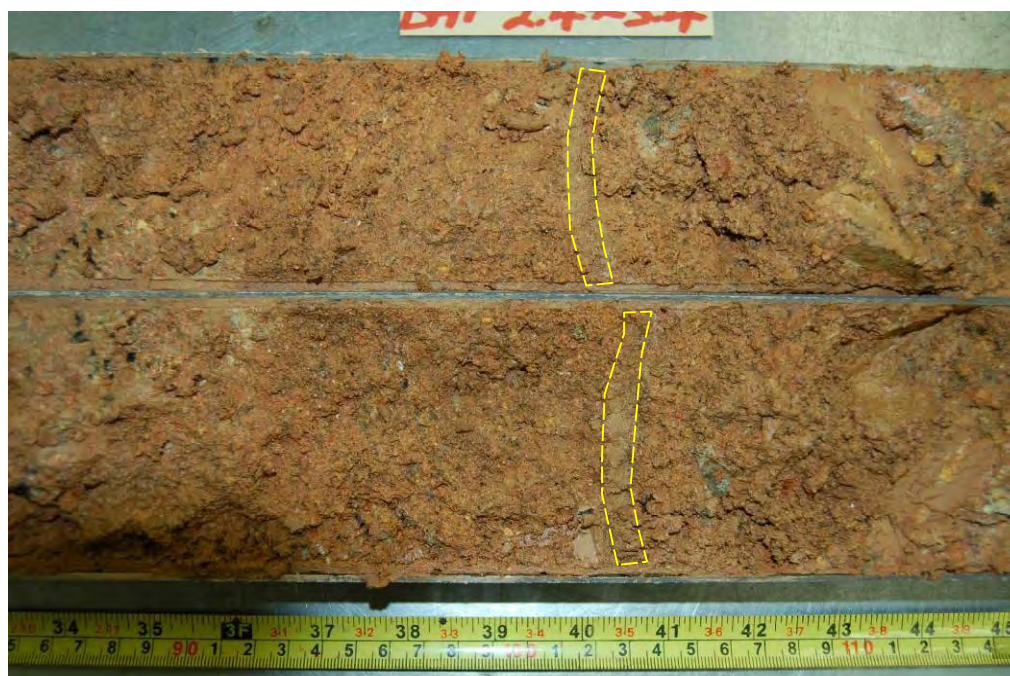
Plate 48 - Sub-horizontal Clay Layer in Pipe Deposit at 3 m Depth in Drillhole No. BH1

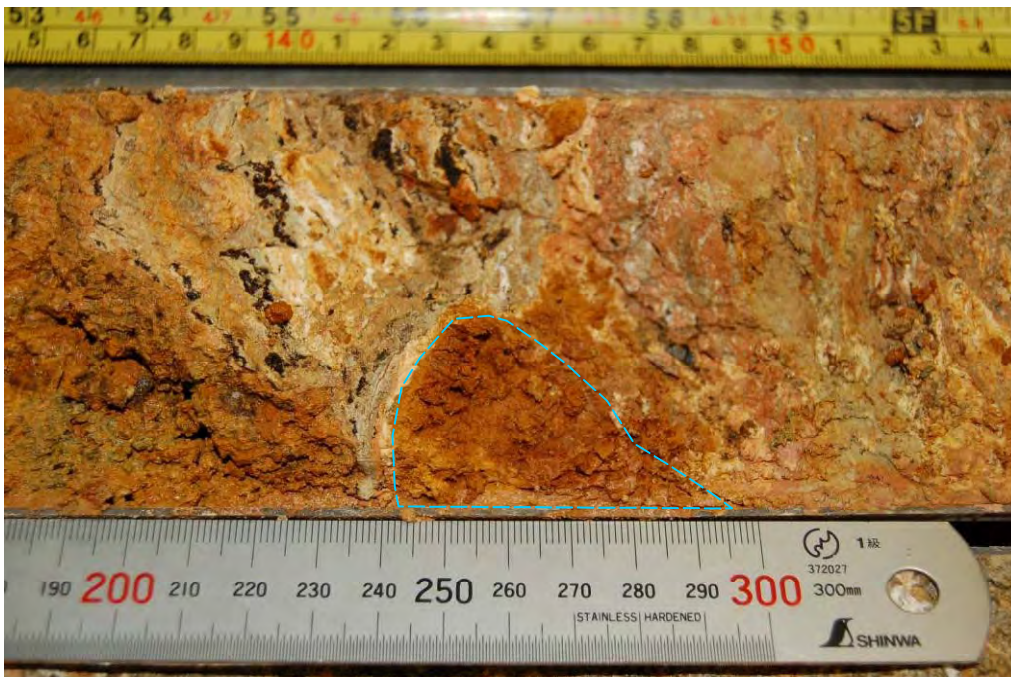
Dark reddish brown stained patches were observed throughout the CDT (Plate 49). These patches appeared to be the incipient stages of soil pipe development. The stained patches varied in size from several millimetres up to 80 mm across, and were characterised by the presence of reddish brown iron oxide stained quartz and a reduction or absence of fine material, in contrast to the surrounding CDT.

Plate 49 - Incipient Soil Pipe Development in Completely Decomposed Tuff

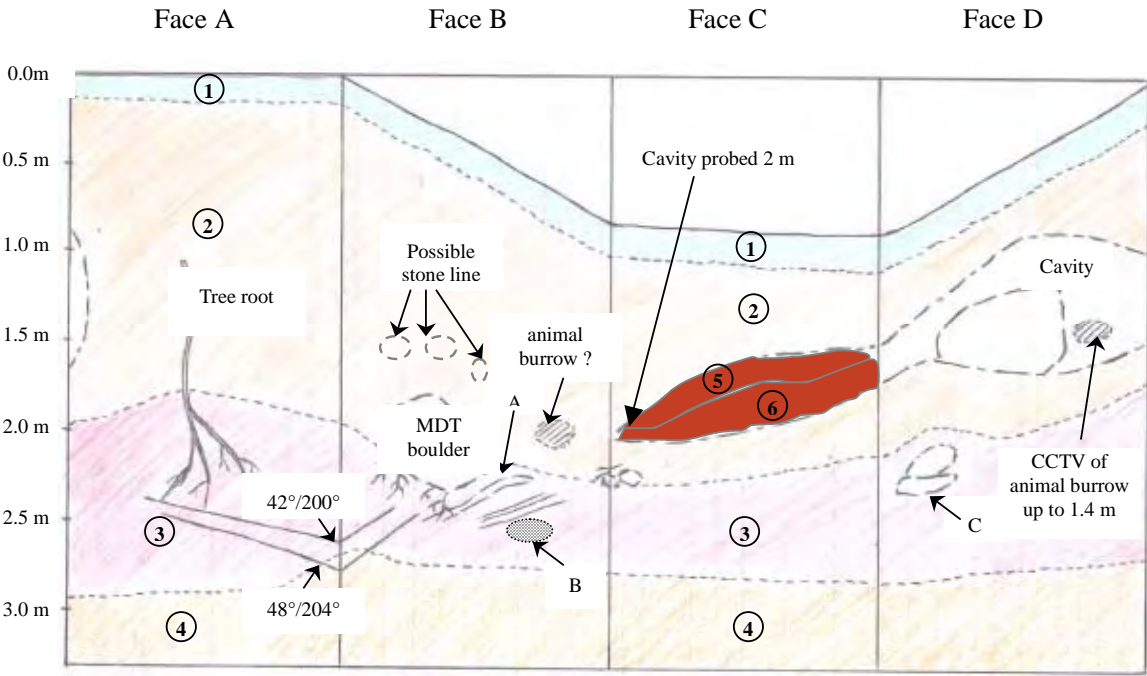
Figure C3 - Trail Pit Record for TP 8

<p>Notes: A - veins appear to bend towards boundary with Young Colluvium B - box work of kaolin veins C - joint surface with orientation 50°/258°, slickenside on joint surface at 40°/305°</p>
