**DETAILED STUDY OF
THE 20 AUGUST 2005
DEBRIS FLOOD AT
ROUTE TWISK, TSUEN WAN**

GEO REPORT No. 240

Maunsell Geotechnical Services Limited

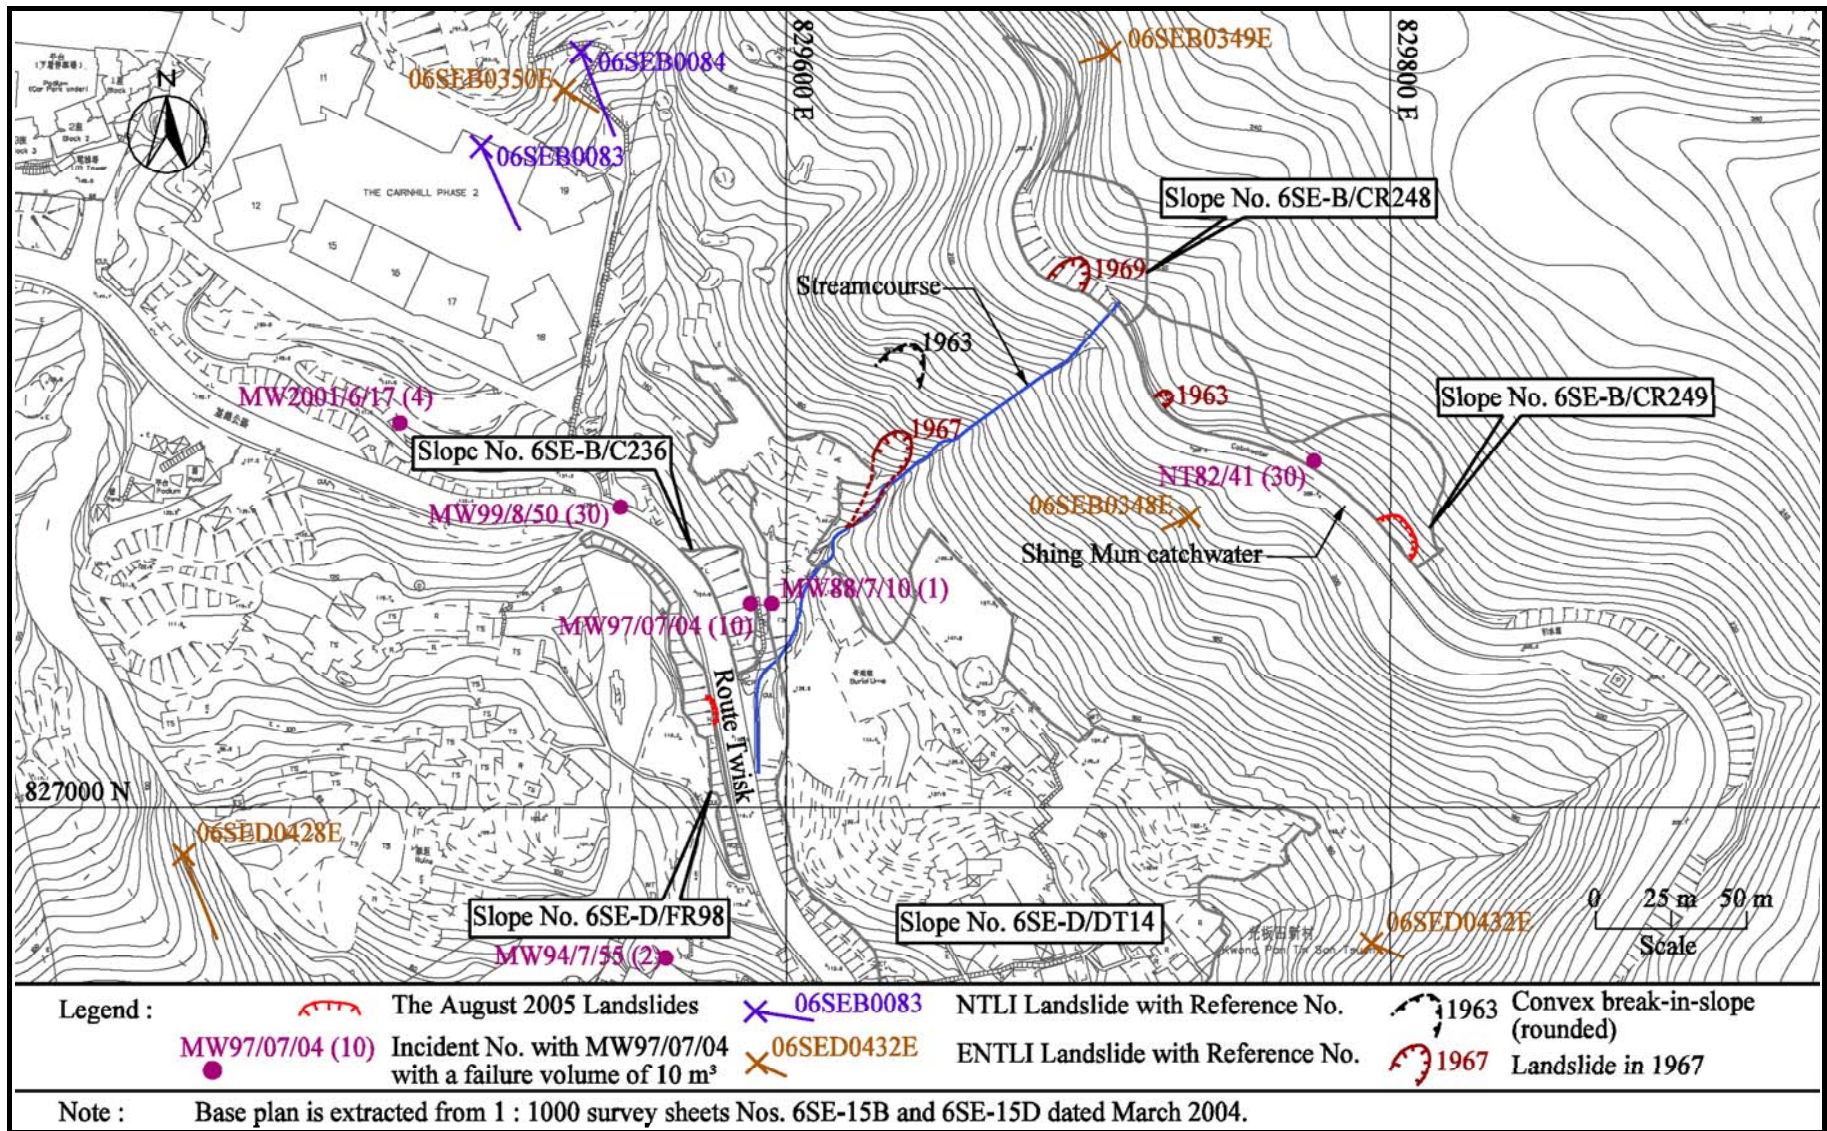
Figure 7 - Past Instabilities

Some landslides occurred along or near the concerned section of Route Twisk (Figure 7), involving failure volumes from about 1 m³ to 30 m³.

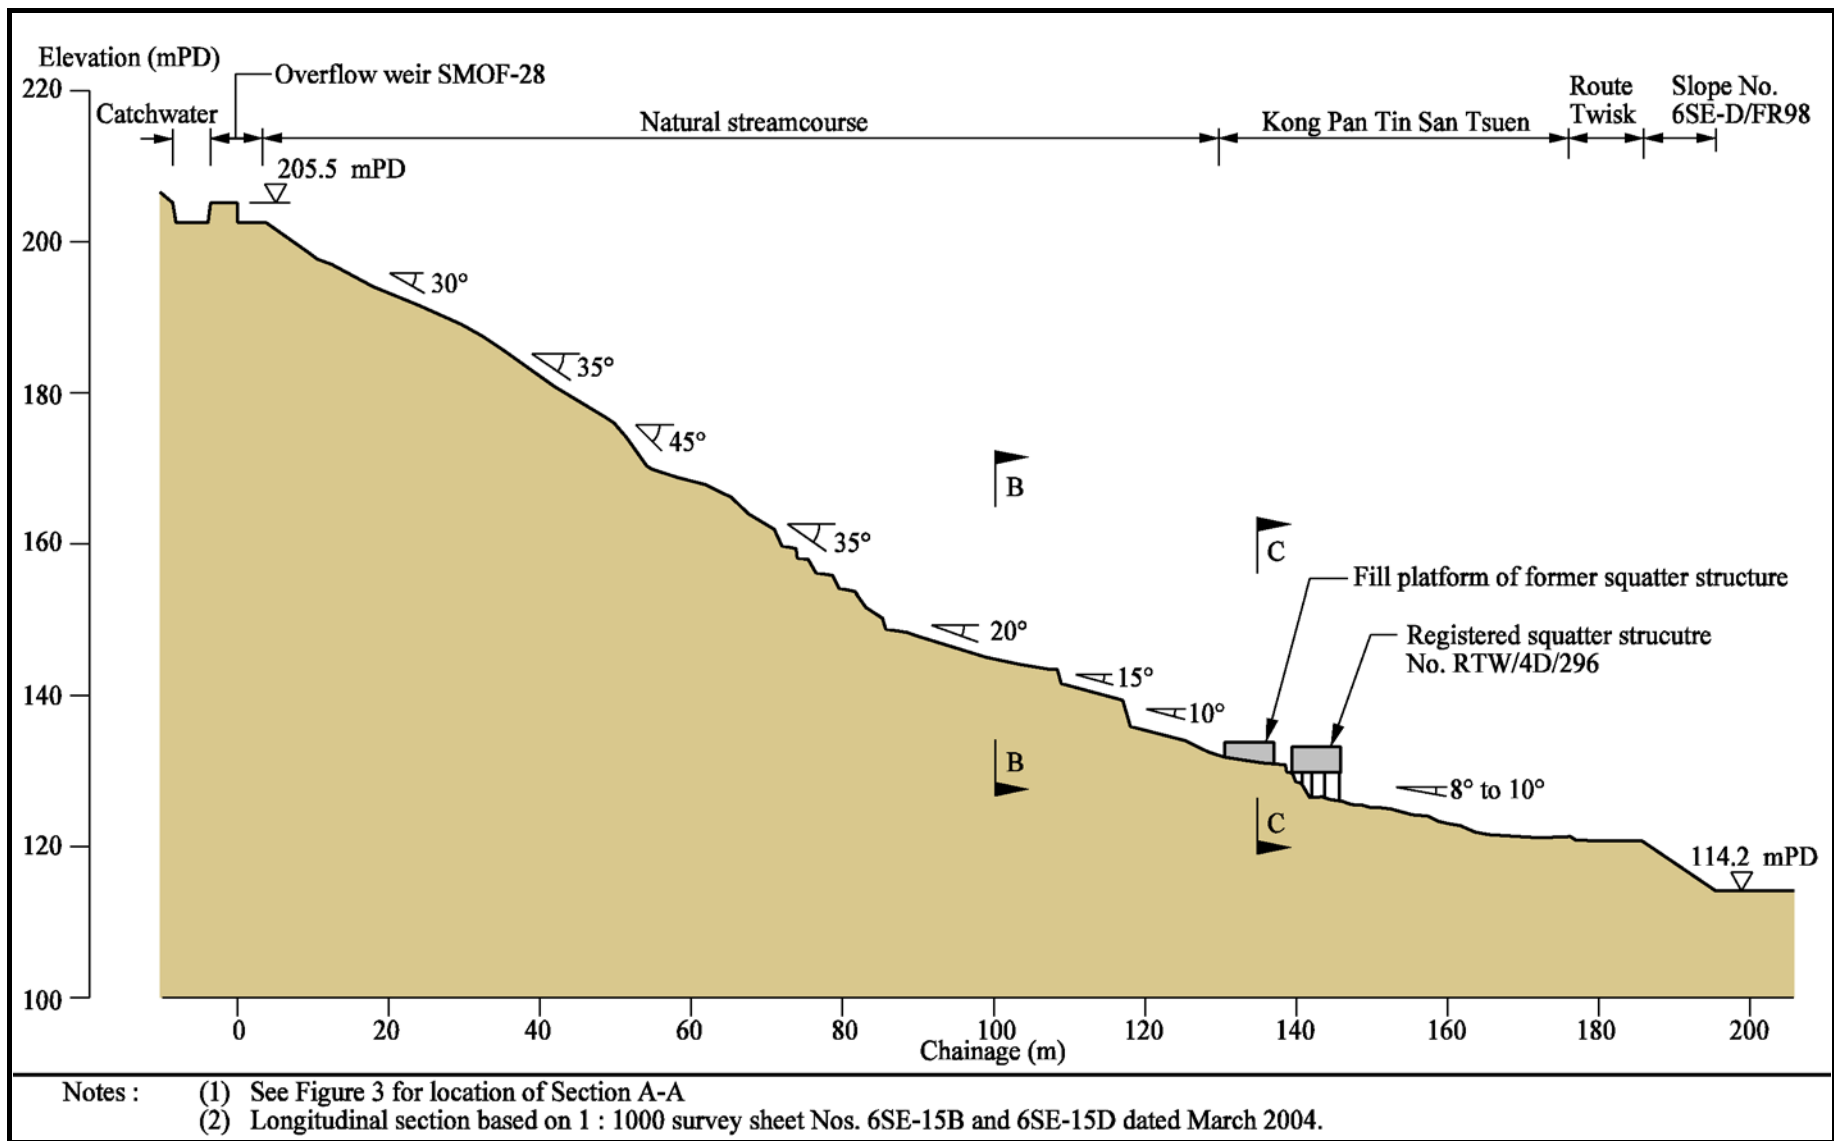
Figure 8 - Longitudinal Section of Streamcourse

From chainage CH 57 to chainage CH 86, the streamcourse narrows to a width of about 3 m to 4 m with MDT exposed in the bed and both sides of the streamcourse. There is a series of steps of about 1 m to 2 m drop along the bed of the streamcourse, giving an overall gradient of about 35° (Figure 8). There was little erosion and deposition along this section of the streamcourse (Figure 3 and Plate 18).

The gradient of the streamcourse at the middle portion of the trail reduces significantly to about 10° to 20° with some small drops of about 1.5 m high at chainage CH 108 and 2.5 m high at chainage CH 116 respectively (Figure 8). The bed of the streamcourse comprises mostly highly to moderately decomposed tuff (H/MDT) with colluvium present on both sides of the streamcourse (Plate 19). The width of the streamcourse is typically about 2 m to 3 m wide with a local narrower width of about 1 m at chainages CH 88 and CH 100 (Plates 19 and 20). The streamcourse widens downstream of chainage CH 116.

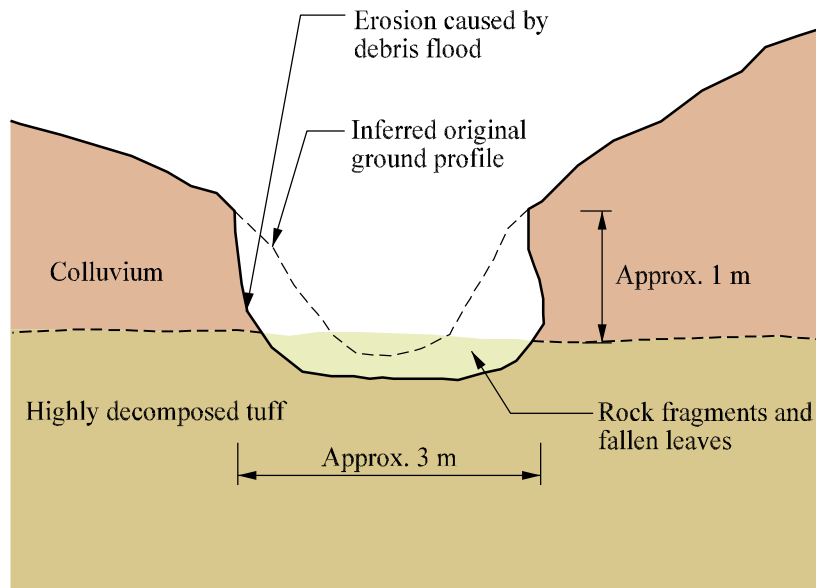
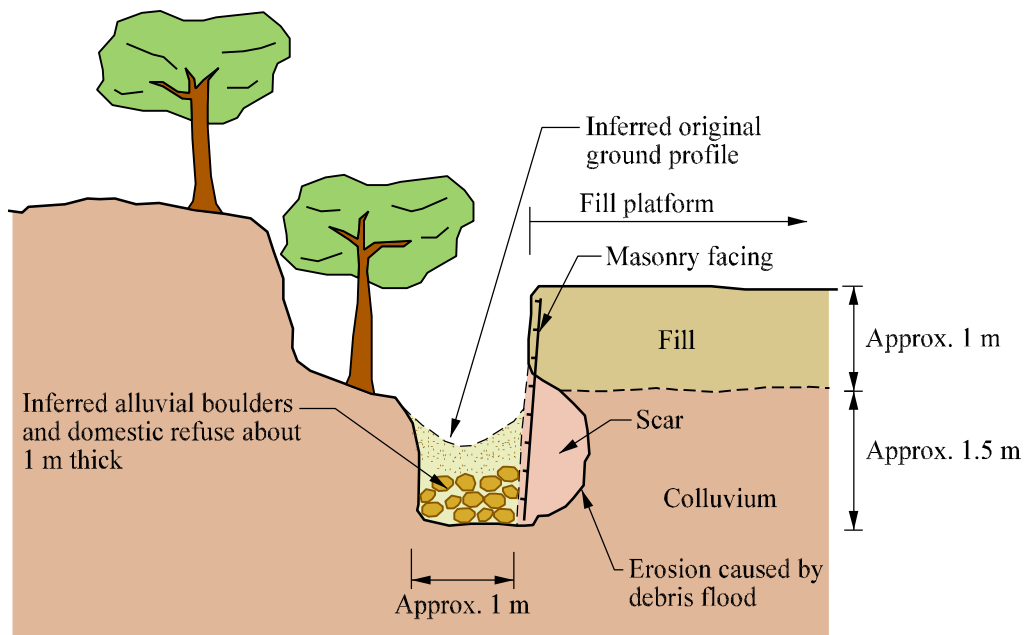
Figure 9 - Cross-sections B-B and C-C of Streamcourse

Erosion at the sides (about 1 m deep) and base of the streamcourse (about 0.3 m deep) was observed between chainages CH 88 and CH 108. In total, about 20 m³ of materials was eroded (Figures 3 and 9). Colluvium, which comprised brown and reddish brown, sandy clayey silt, was exposed on both sides of the streamcourse (Plate 21). HDT, comprising reddish brown to yellowish brown sandy silt, was also observed just above the eroded bed of the streamcourse. In this section of the streamcourse, deposition of angular rock fragments was observed on the stream bed (Plate 20). However, it was difficult to determine whether or not these rock fragments were deposited as a result of the August 2005 incident.

The fill platform was undercut by the debris flood and created a scar of about 5.5 m wide by 1.5 m high, with a maximum depth of about 0.8 m (with a volume of about 5 m³, see Figure 9 and Plate 25). Colluvium was exposed behind the masonry facing, which provided some protection to the side slope of the streamcourse. Further downstream, the soil underneath the poles supporting the squatter structure was eroded. The erosion area was

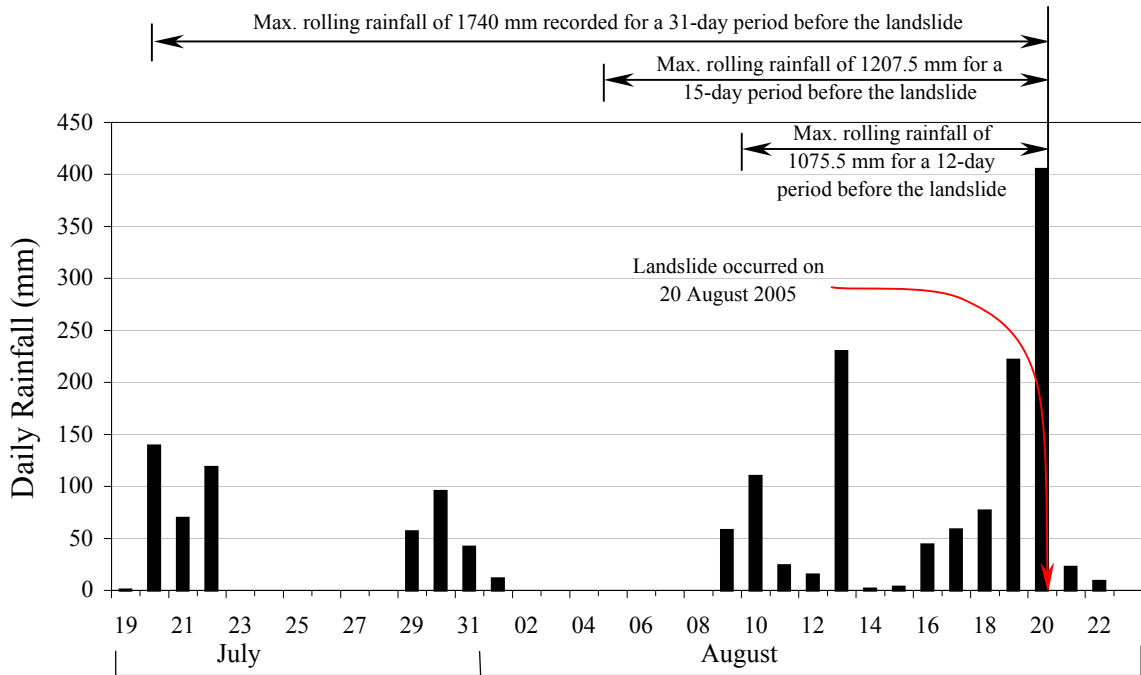
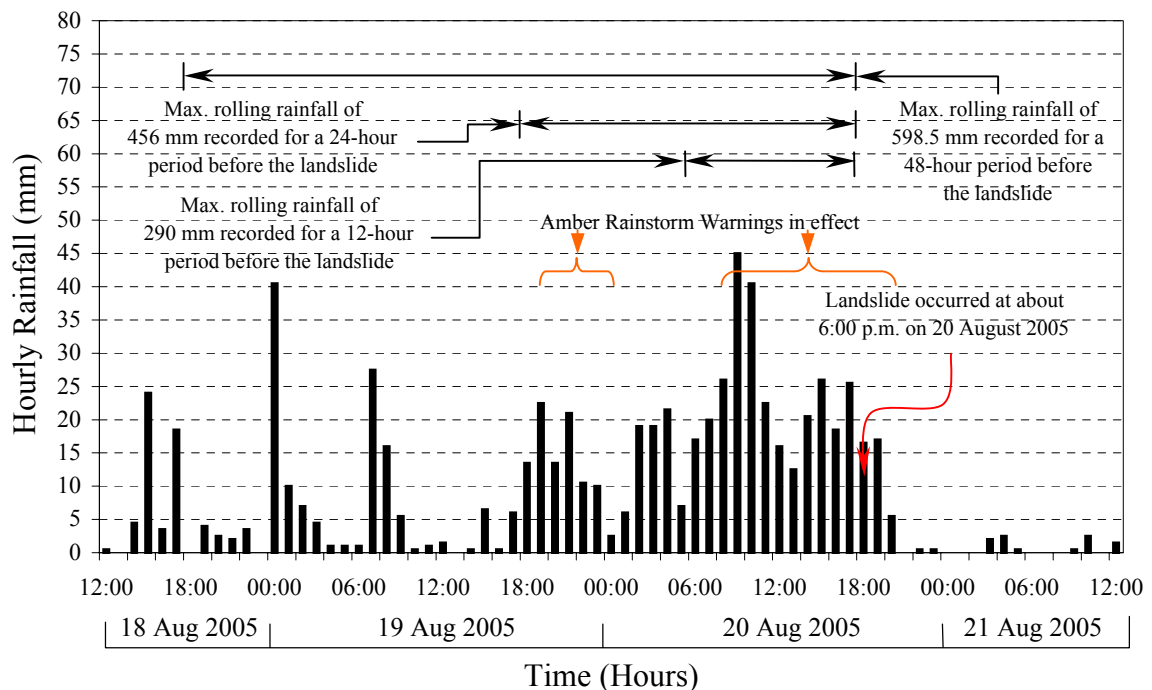
Figure 10 - Daily and Hourly Rainfall Recorded at GEO Raingauge No. N38

Rainfall data were obtained from the nearest GEO automatic raingauge No. N38, which is located about 1 km to the southwest of the August 2005 landslide at Po Leung Kuk Lee Shing Pik College at On Yin Street, Chai Wan Kok, Tsuen Wan (Figure 1). The raingauge records and transmits rainfall data at 5-minute intervals to the GEO and the Hong Kong Observatory (HKO). The daily rainfall recorded by raingauge No. N38 over the month preceding the debris flood and associated landslides, together with the hourly rainfall readings for the period between 18 and 21 August 2005, are presented in Figure 10. Records from another nearby GEO automatic raingauge No. N03, which is about 1.9 km to the southeast of the August 2005 landslides, were also examined. The pattern of rainfall recorded at this raingauge was broadly similar to that recorded at raingauge No. N38, although the rainfall was slightly less intense at raingauge No. N03.

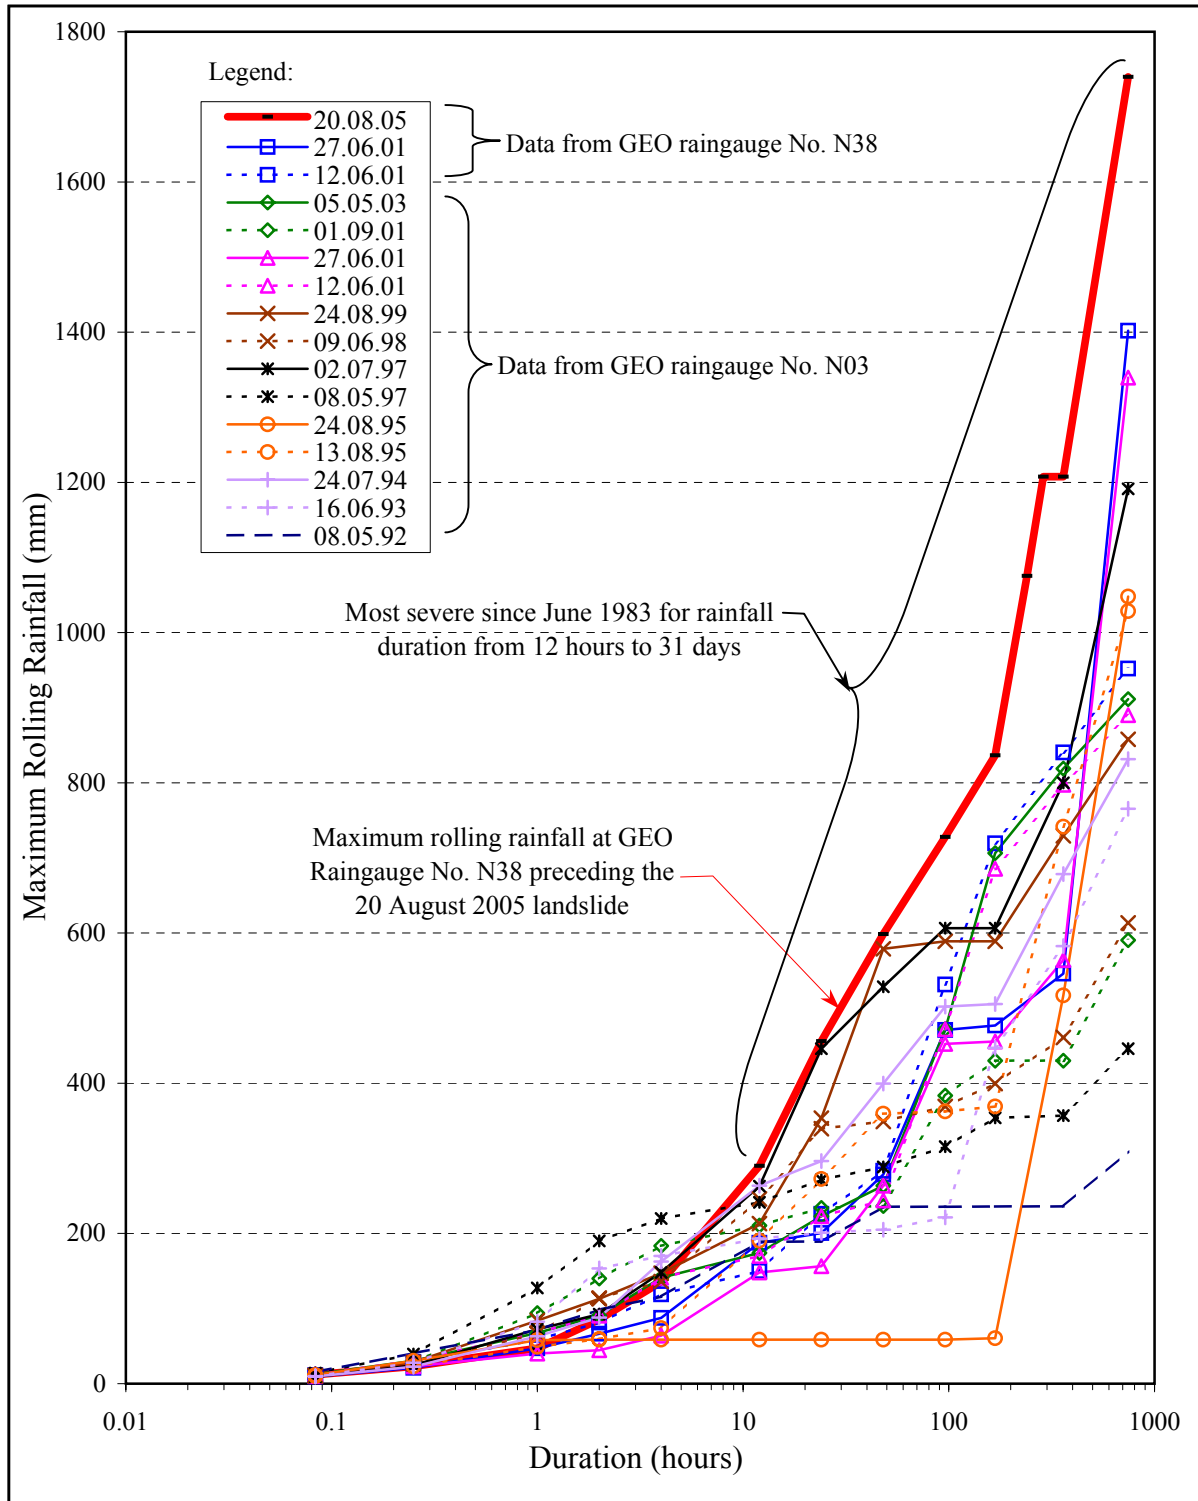
Figure 11 - Maximum Rolling Rainfall for Previous Major Rainstorms at GEO Raingauges Nos. N03 and N38

The maximum rolling rainfall for the August 2005 rainstorm has been compared with the past significant rainstorms recorded by raingauges Nos. N03 and N38 between 1983 and 2004 (Figure 11). The August 2005 rainstorm is the most severe for rainfall durations between 12 hours and 31 days.

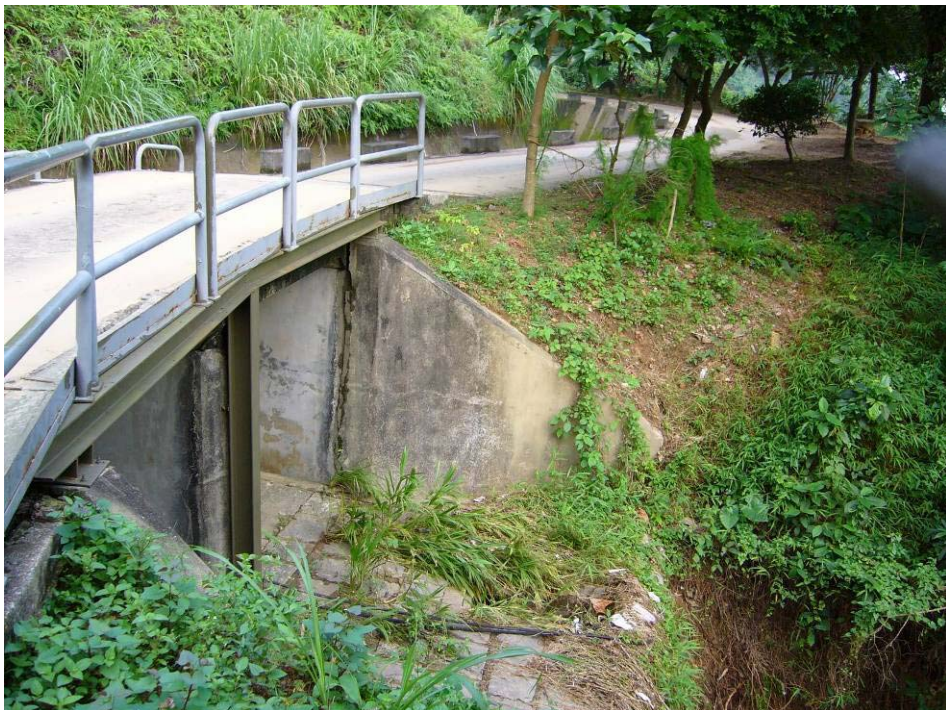
Plate 6 - View of Overflow Weir SMOF-28
(Photograph taken on 26 August 2005)

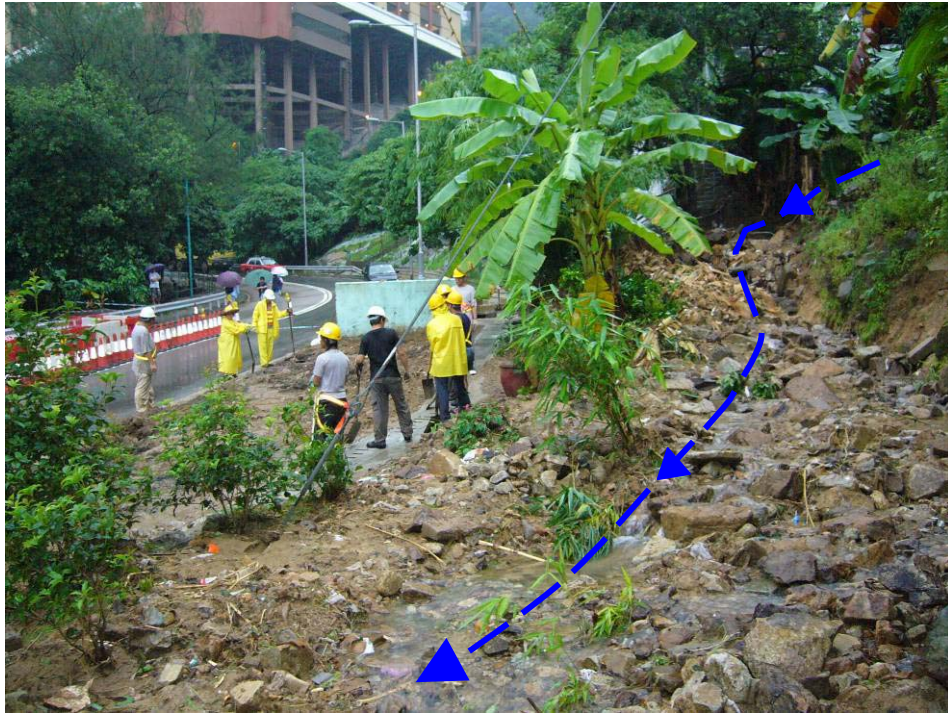
mostly unconstrained (Plate 7). The longitudinal gradient of this section of the streamcourse is also relatively gentle (about 8°).

Plate 7 - View of Streamcourse between the Sharp Bend and Cross-road Culvert
(Photograph taken on 21 August 2005)

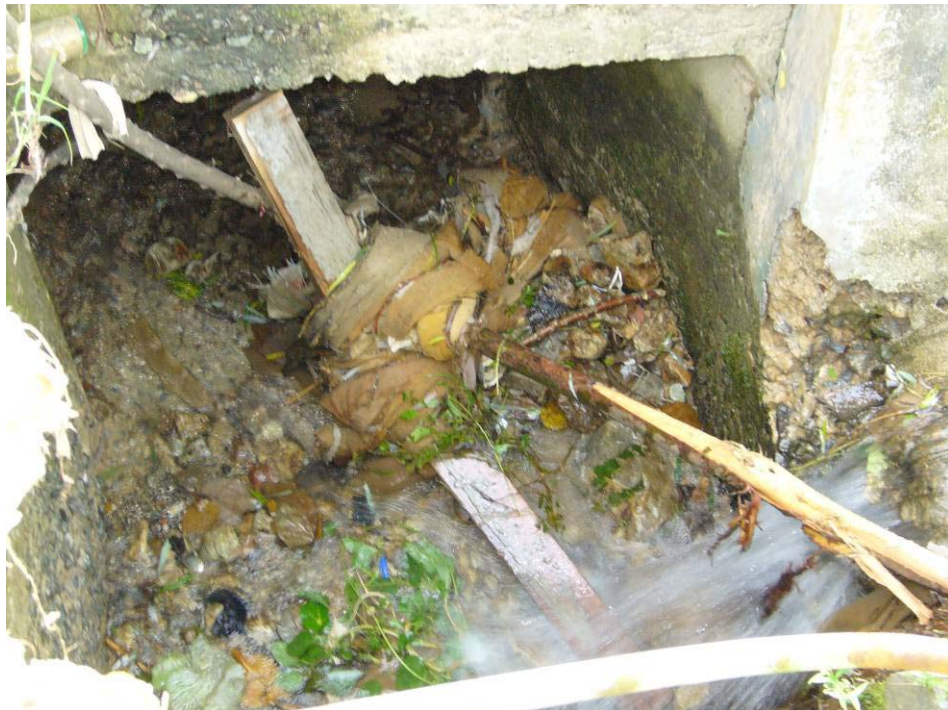
Plate 8 - Inlet of 1.4 m x 1.4 m Cross-road Culvert
(Photograph taken on 26 August 2005)

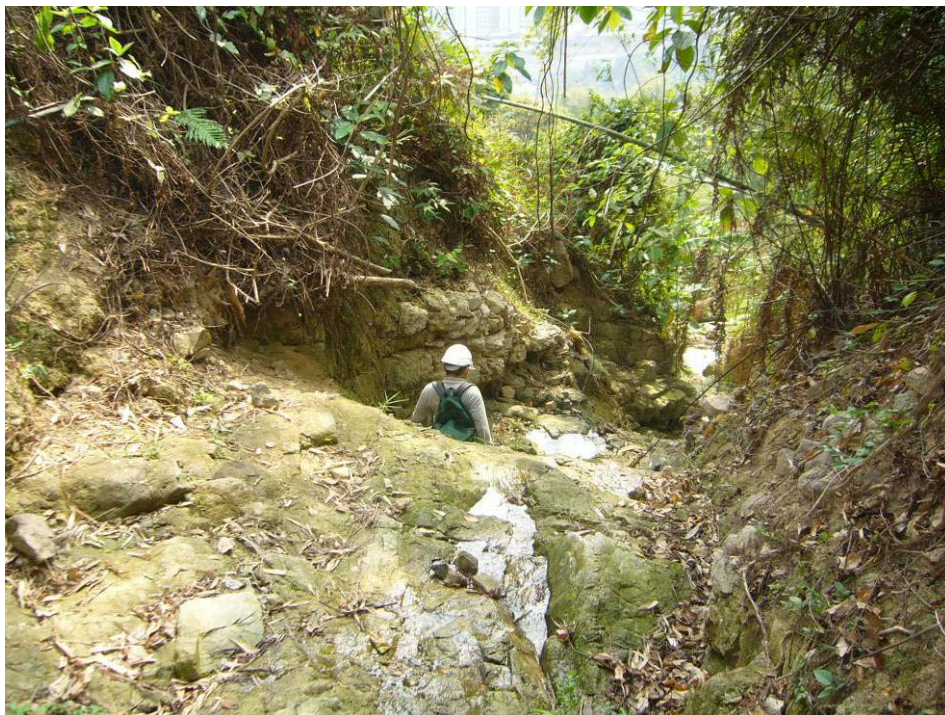
Plate 18 - View of the Upper Portion of the Debris Flood Trail at CH 73
(Photograph taken on 22 February 2006)

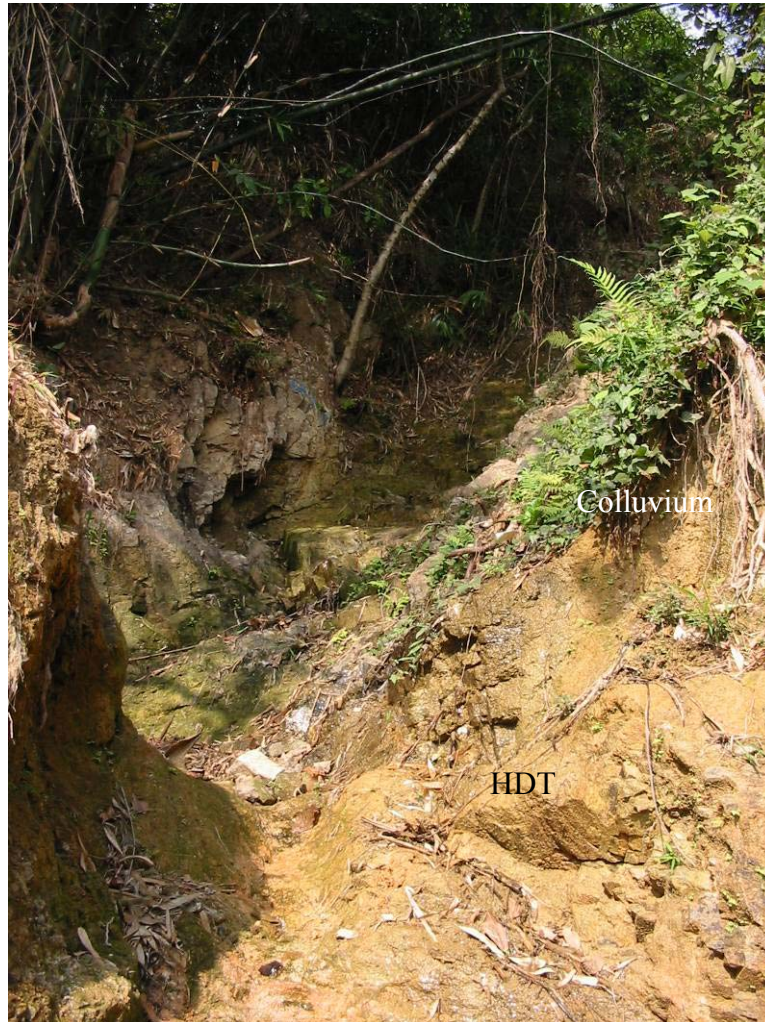
Plate 19 - View of Middle Portion of the Debris Flood Trail at CH 88
(Photograph taken on 22 February 2006)

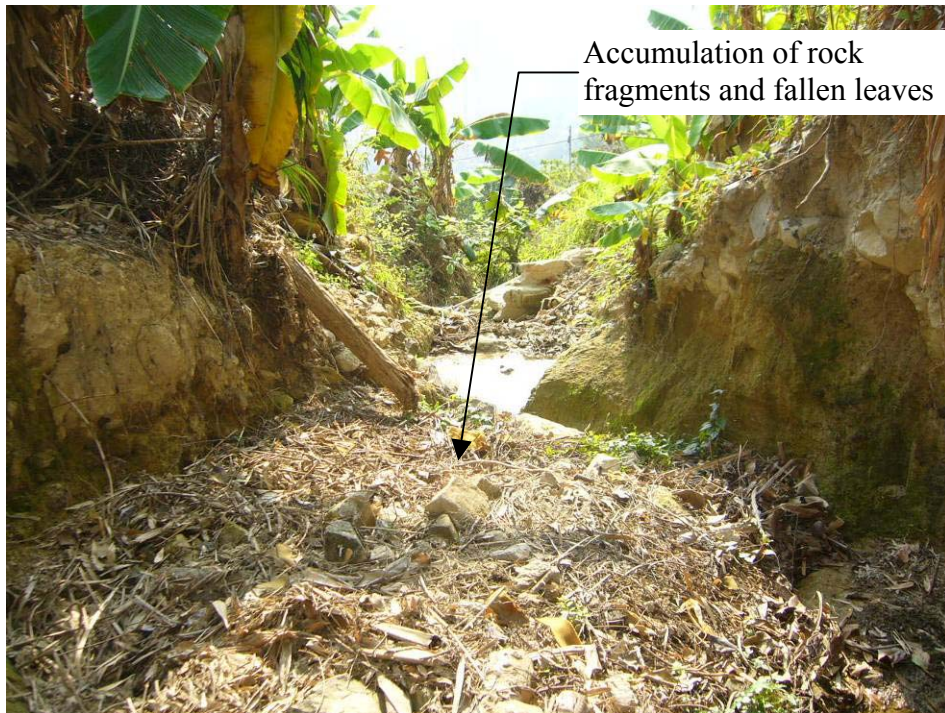
Plate 20 - View of Middle Portion of the Debris Flood Trail at CH 100
(Photograph taken on 22 February 2006)

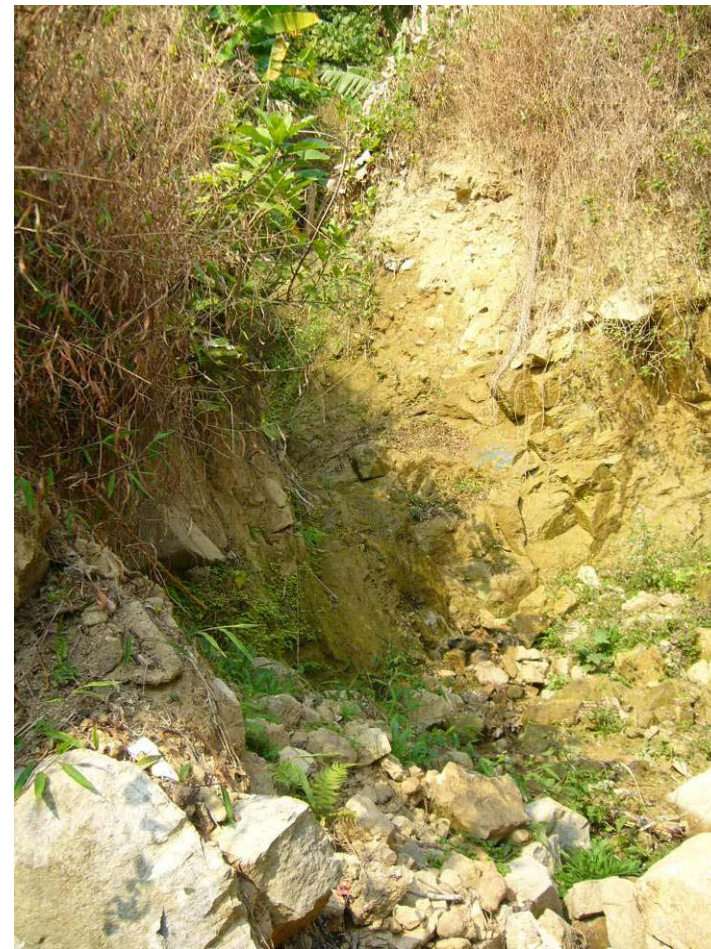
Between chainages CH 108 and CH 116, both sides of the streamcourse are relatively steep (about 60° to 70° with no access for close inspection) but no signs of recent erosion were apparent (Plate 22). Fine deposit of about 2 m³ was observed at chainage CH 110. The streamcourse drops by 2.5 m at chainage CH 116 (Plate 23) and between chainages CH 116 and CH 130, the gradient of the streamcourse is about 10° (Figure 8). Significant erosion was observed near chainage CH 126 (Figure 3 and Plate 24) on the southern side of the streamcourse where an erosion scar, about 3 m high by 6 m wide, was observed. Colluvium, which comprised yellowish brown sandy silt with many sub-angular to sub-rounded, cobble-sized rock fragments, was observed in the erosion scar (Plate 24). Minor erosion was noted on the northern side and along the bed of the streamcourse along this section. The volume of eroded materials was about 20 m³.

Plate 23 - View of the Steeper Section of the Debris Flood Trail at CH 116
(Photograph taken on 22 February 2006)

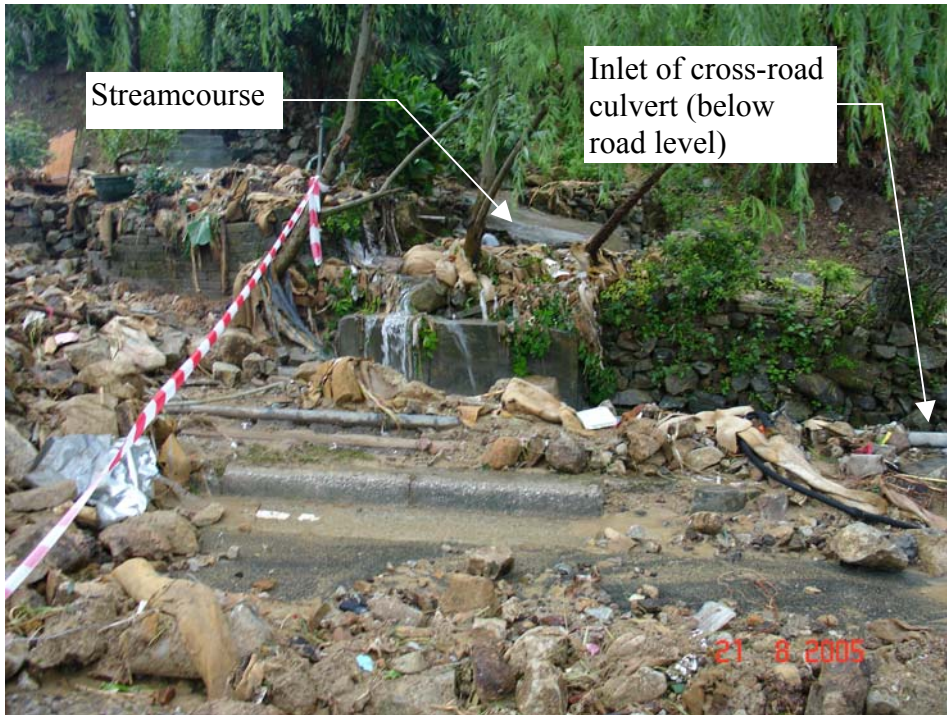
Plate 28 - Area in the Vicinity of Inlet of the Cross-road Culvert
(Photograph taken by HyD on 21 August 2005)

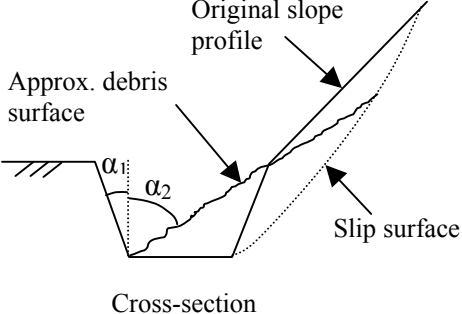
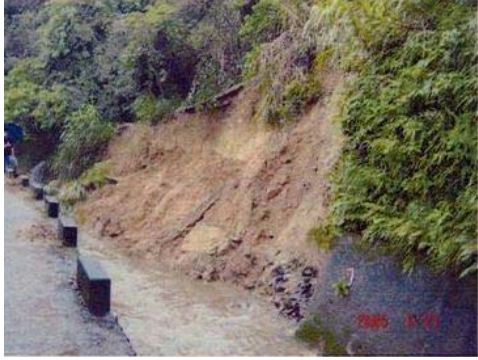
Partially Blocked Catchwater Channel
