**REVIEW OF THE 22 AUGUST 2005
LANDSLIDE ON THE NATURAL
HILLSIDE ABOVE SLOPE
NO. 7SW-D/C2 AT LION ROCK
TUNNEL ROAD, SHA TIN**

GEO REPORT No. 241

Maunsell Geotechnical Services Limited

**This report is largely based on GEO Landslide Study Report
No. LSR 7/2007 produced in August 2007**

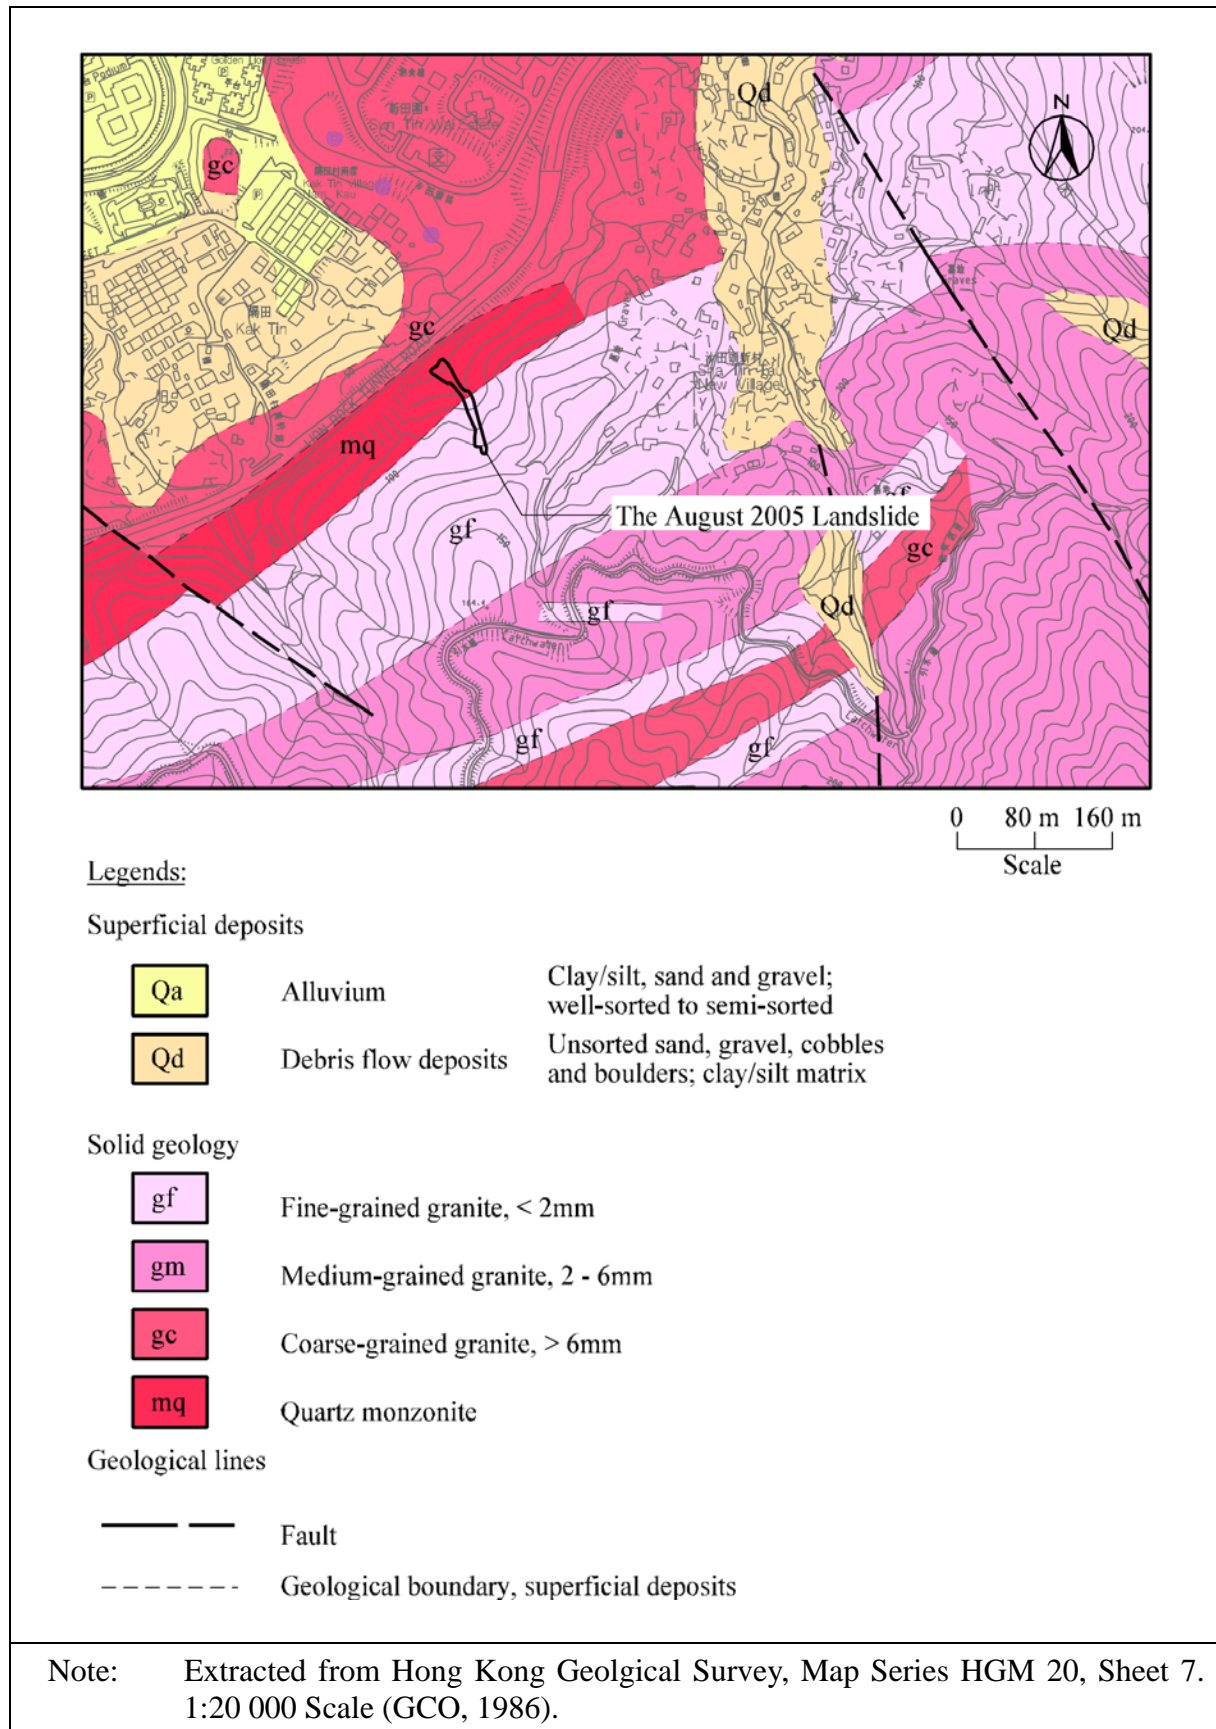
Figure 4 - Regional Geology

Based on the published geology map (Figure 4), field inspection and the results of the previous GI, the solid geology in the vicinity of the 22 August 2005 landslide comprises completely decomposed to moderately decomposed fine- and coarse-grained granite, with quartz monzonite encountered in the exploratory holes along Lion Rock Tunnel Road.

According to the Geology Map Sheet No. 7 (GCO, 1986), faults are inferred in the granite and quartz monzonite in the area (Figure 4), that are sub-parallel to the apparent alignment of the turning point in the streamcourse in the southeast adjacent catchment, the saddle and the August 2005 landslide source (Figure 2) and may relate to a possible structural influence on hydrogeology. The above can only be conjectured in the absence of a detailed hydrogeological investigation. It is noteworthy that grain size variations in the granitic material observed in the vicinity of the landslide often result in differences in weathering and may also result in local variations in joint pattern and spacing, which could in turn influence the local hydrogeology which is likely to be complex.

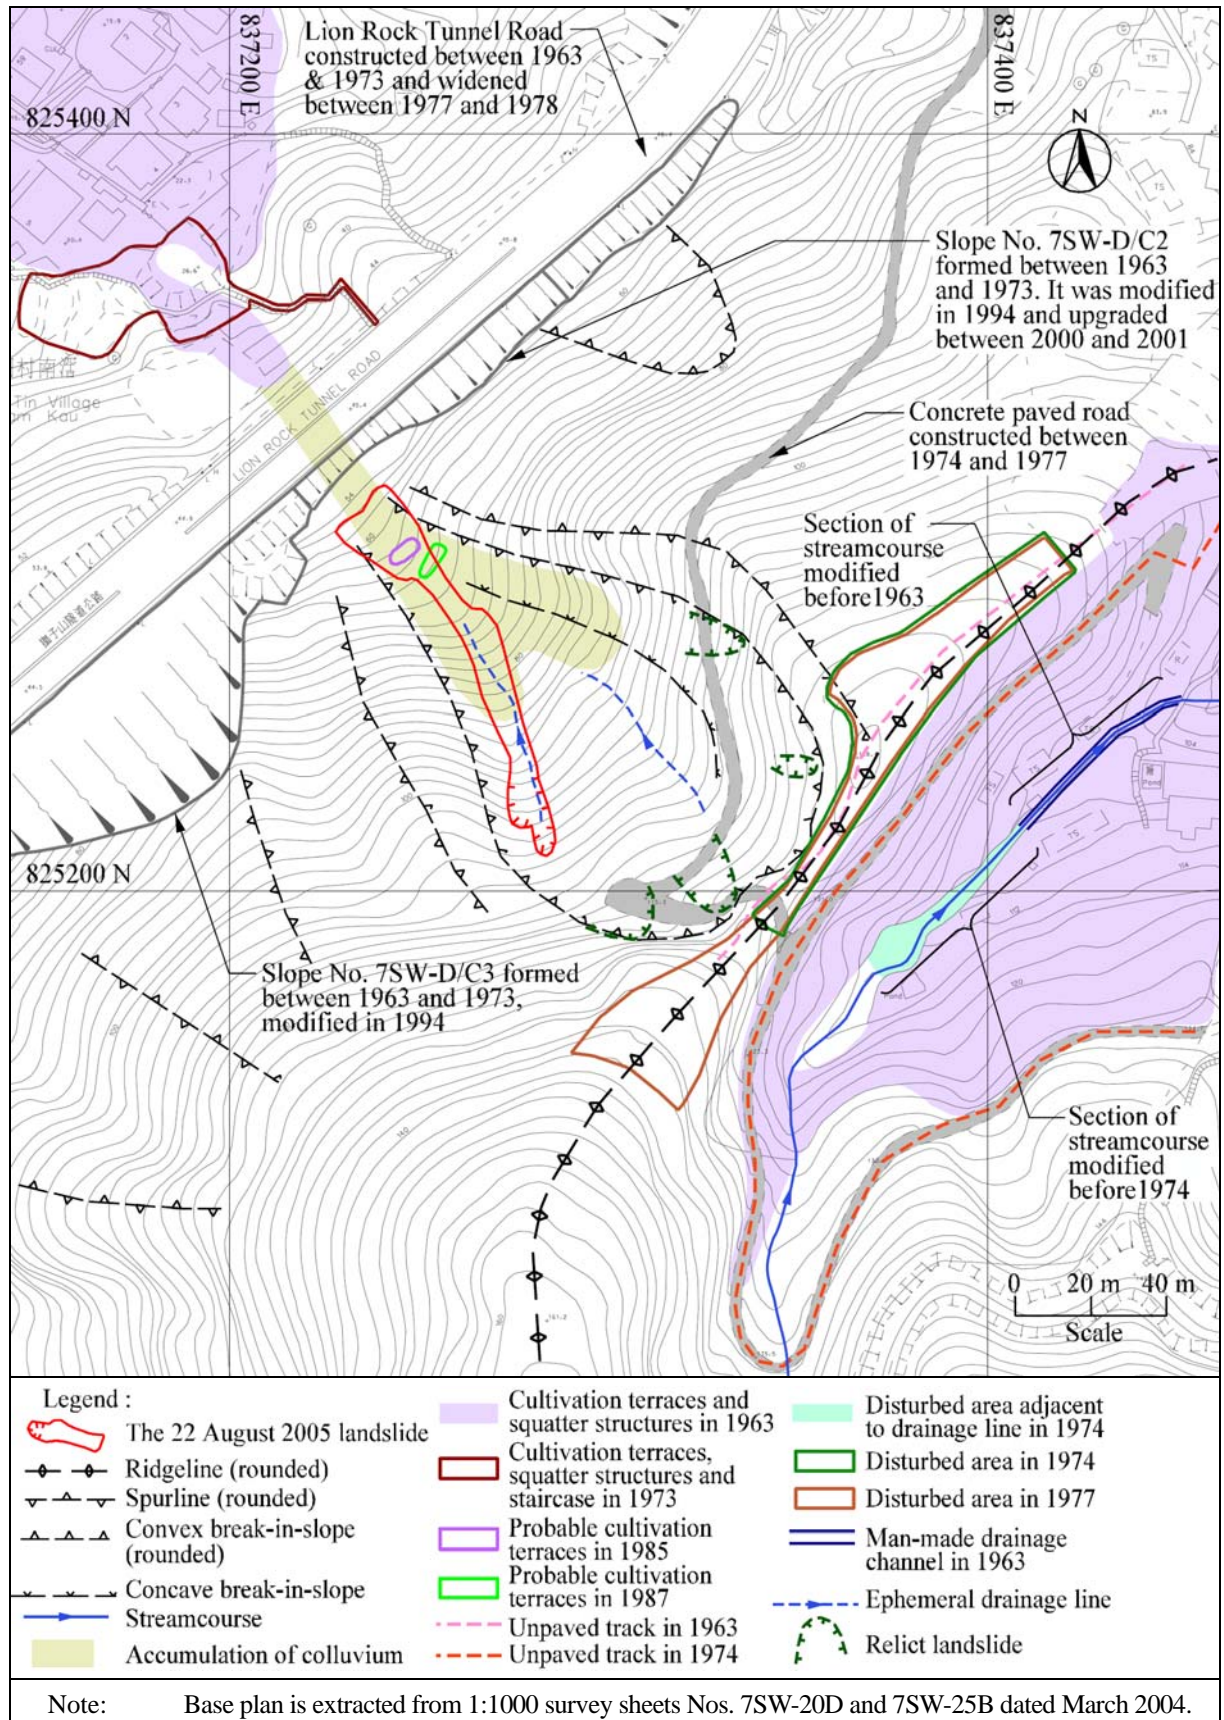
Figure 5 - Site History and Geomorphology

The August 2005 landslide is located on weathered granitic terrain at a concave break-in-slope towards the southern edge of a shallow topographical depression where there is an accumulation of colluvium (Figure 5). The landslide source area is also situated near the head of a poorly defined minor ephemeral drainage line that runs down the topographical depression in an approximately north-northwest direction (Figure 5). While the catchment above the landslide site is relatively small (plan area of approximately 2,000 m²), the convergence of both surface and sub-surface water flows is likely to occur during heavy rainstorms.

From aerial photographs, the depression in which the August 2005 landslide occurred can be seen as a distinct feature on the northern flank of an east-northeast trending ridgeline between two rounded spurs that trend northwest and north-northwest (Plate A1). A number of relict landslides, identified as a series of distinct convex breaks-in-slope, can be seen along the crown of the depression (Figure 5), and a hummocky morphology, possibly indicative of

There is an apparent alignment of the August 2005 landslide, the saddle in the southwest-northeast ridgeline southeast of the landslide and the point where the streamcourse in the southeast adjacent catchment is observed to change direction of flow (Figure 5). This suggests that the development of the saddle and a possible hydrogeological connectivity between the streamcourse and the August 2005 landslide has a structural control. There was no obvious evidence of a fault at the landslide site either from site inspection or aerial photograph interpretation, although joints measured at slope No. 7SW-D/C570 had a strike trending approximately sub-parallel to the apparent alignment.

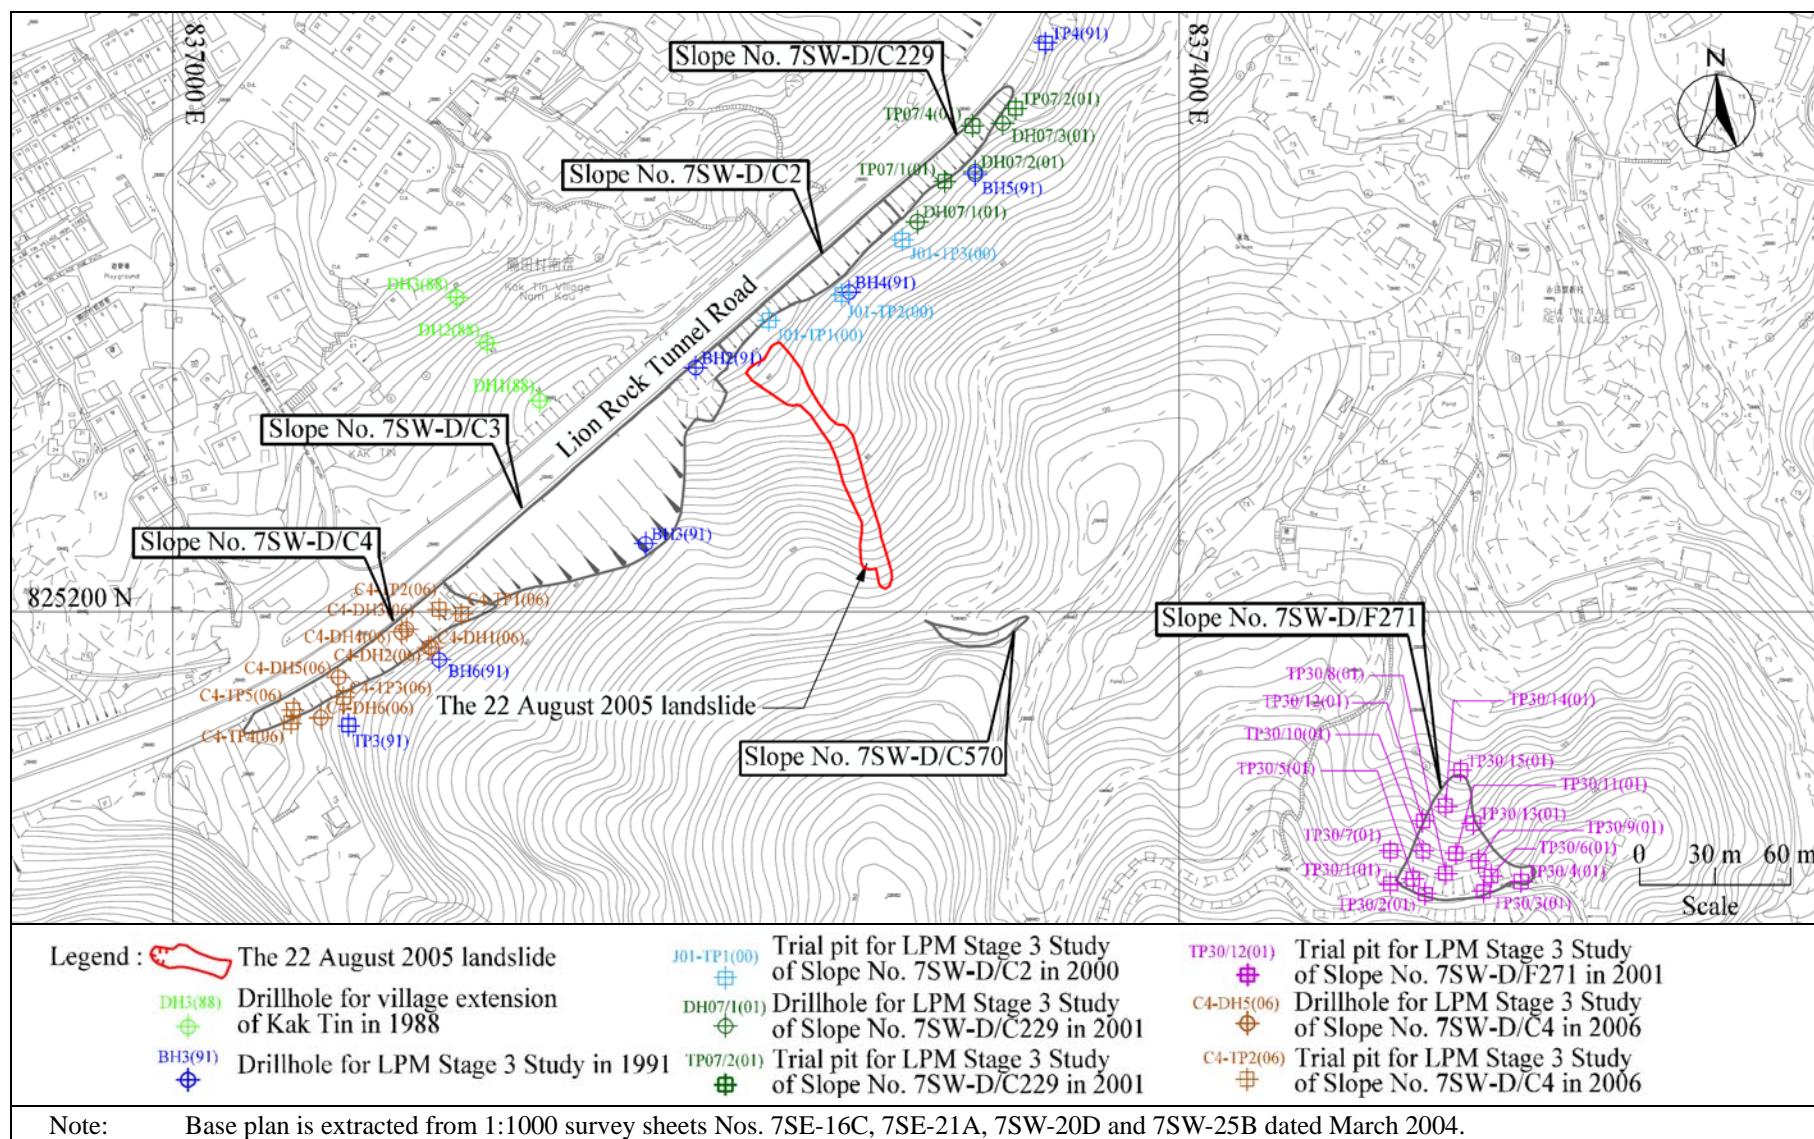
Figure 8 - Previous Ground Investigation

No GI was carried out as part of this study and therefore a review of the results from the previous GI in the vicinity of the August 2005 landslide was carried out. A summary of the previous GI carried out in the vicinity of the study area is shown in Table 2 and the locations of the GI stations are shown in Figure 8. A discussion of the relevant GI is provided below.

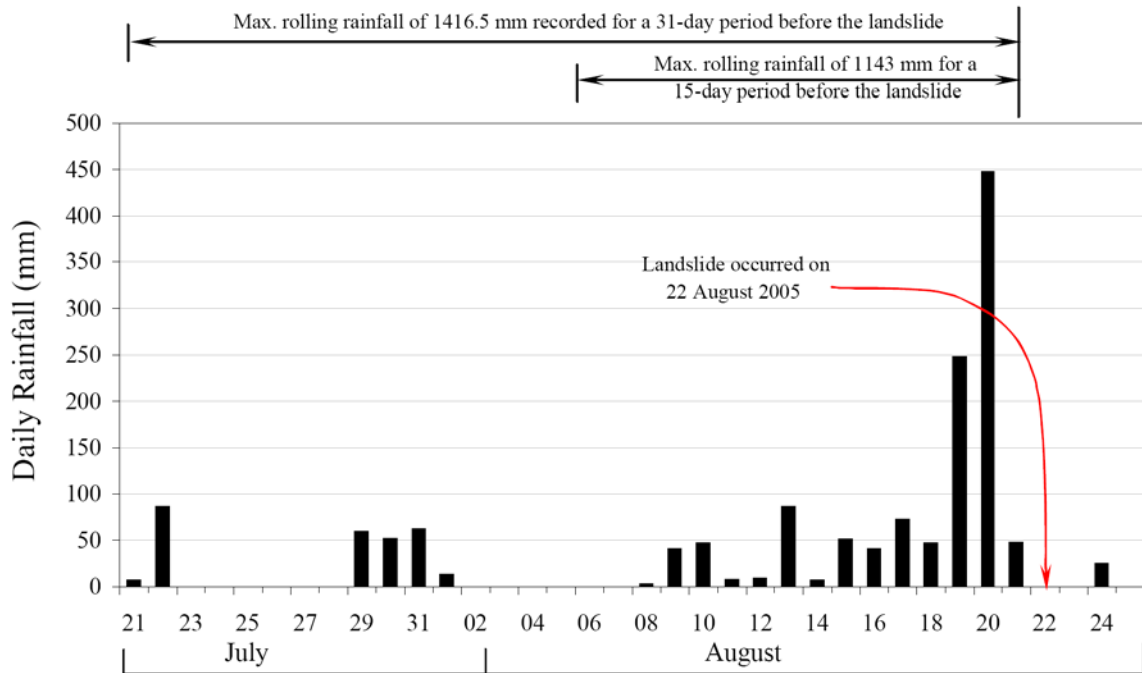
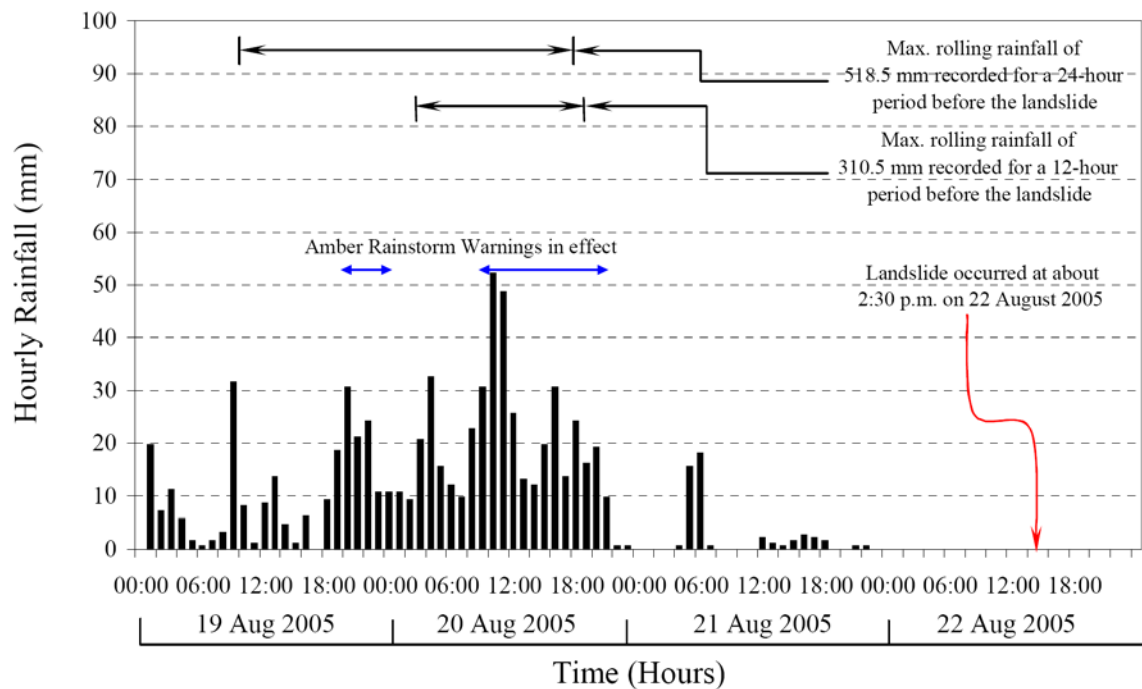
Figure 9 - Daily and Hourly Rainfall Recorded at GEO Raingauge No. N42

Rainfall data were obtained from the nearest GEO automatic raingauge No. N42, which is located about 0.5 km to the north of the August 2005 landslide on the roof of Wing Wai House, Sun Tin Wai Estate, Sha Tin (Figure 1). The raingauge records and transmits rainfall data at 5-minute intervals to the GEO and the Hong Kong Observatory (HKO). The daily rainfall recorded by raingauge No. N42 over the month preceding the landslides, together with the hourly rainfall readings for the period between 19 and 22 August 2005, are presented in Figure 9. Records from another nearby GEO automatic raingauge No. N01, which is about 1.9 km to the west of the August 2005 landslides, were also examined. The pattern of rainfall recorded at this raingauge is broadly similar to those recorded at raingauge No. N42 but with a slightly higher intensity.

(a) Daily Rainfall Recorded at GEO Raingauge No. N42 between 21 July 2005 and 25 August 2005

(b) Hourly Rainfall Recorded at GEO Raingauge No. N42 between 19 August 2005 and 22 August 2005

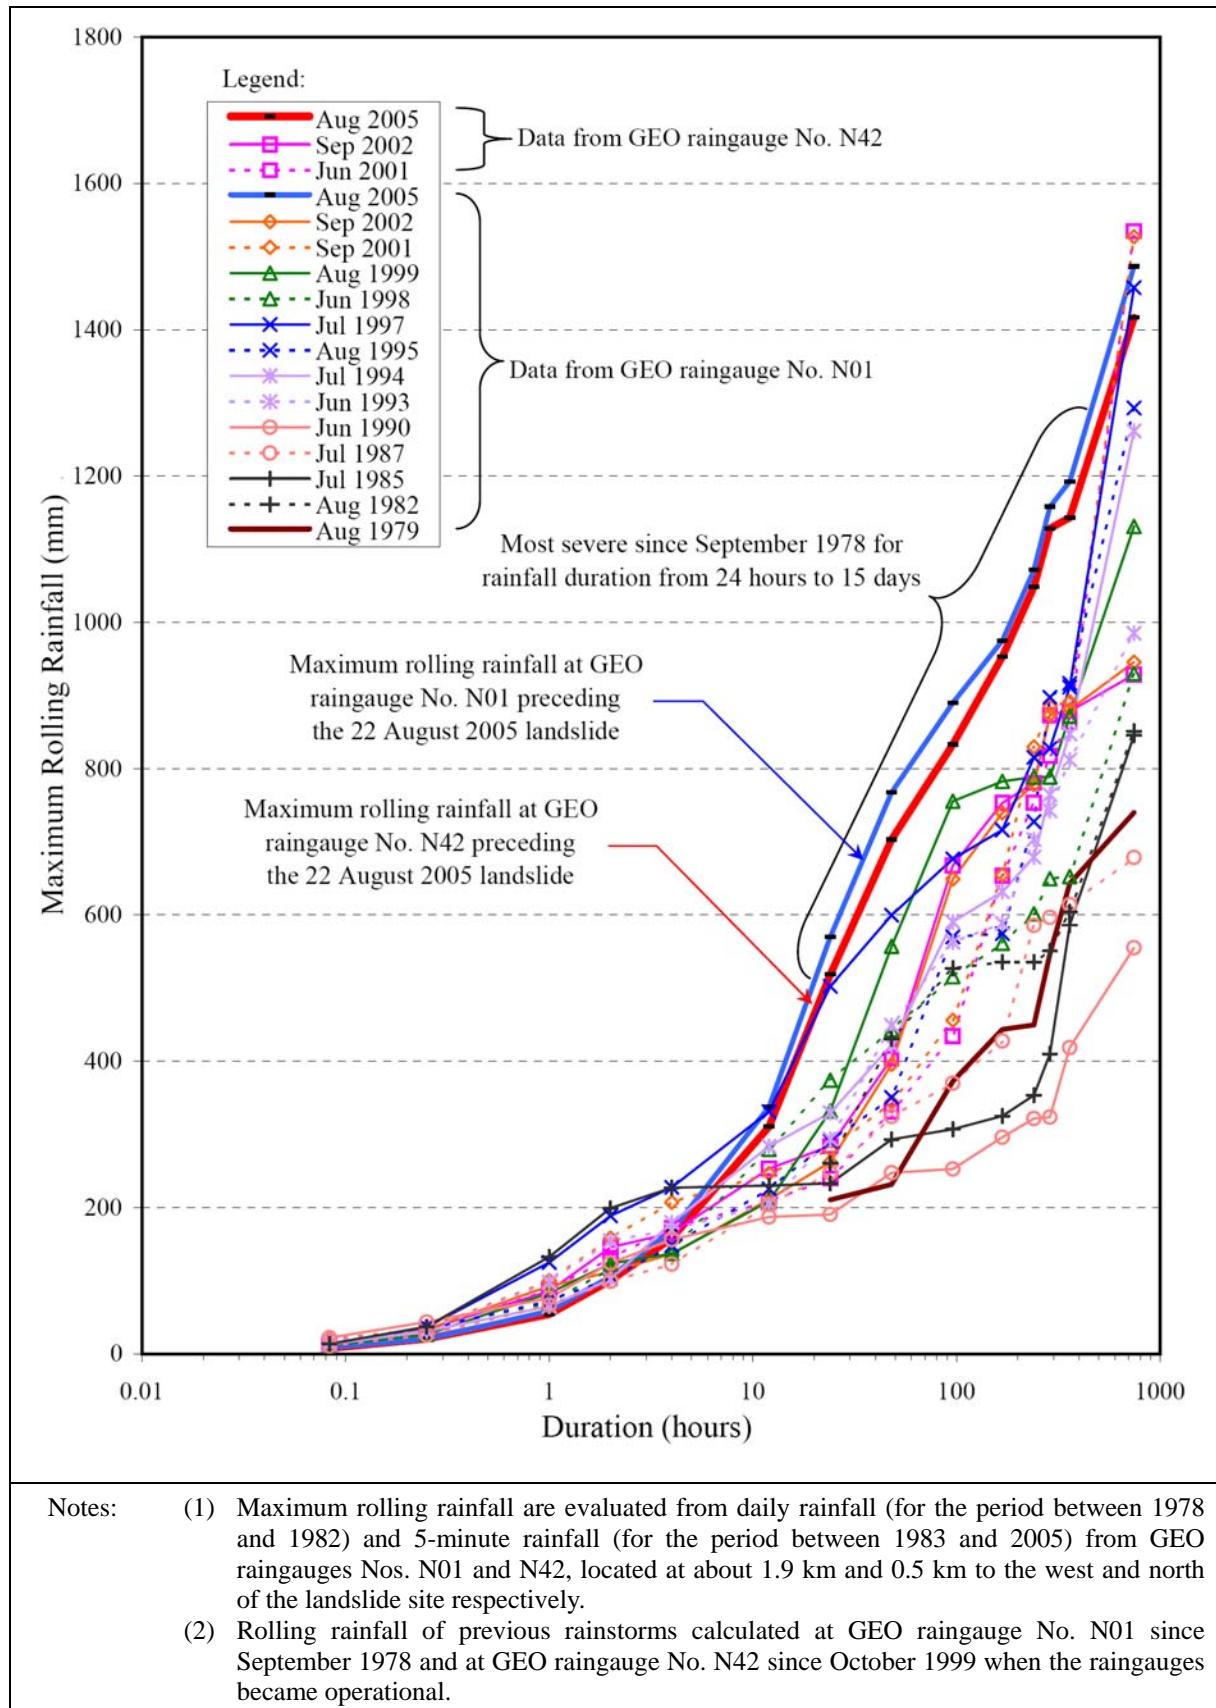
Figure 10 - Maximum Rolling Rainfall for Previous Major Rainstorms at GEO Raingauges Nos. N01 and N42

The maximum rolling rainfall for the August 2005 rainstorm has been compared with the past significant rainstorms recorded by raingauges Nos. N01 and N42 between 1979 and 2004 (Figure 10). The August 2005 rainstorm is the most severe for rainfall durations between 24 hours and 15 days.

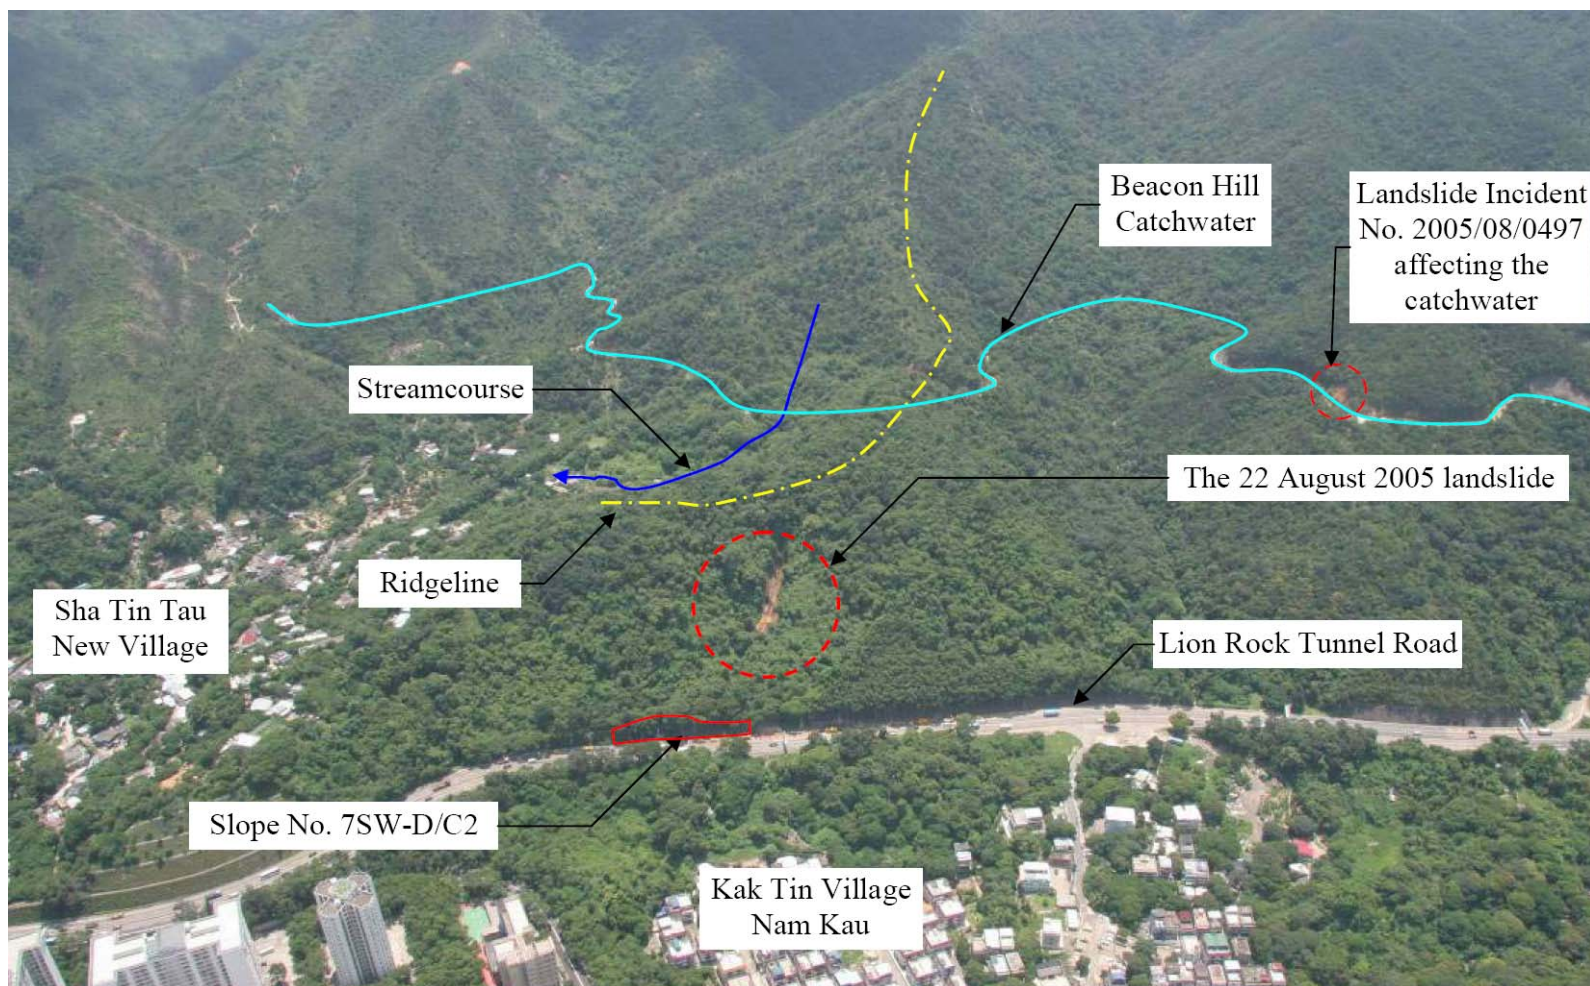
Plate 1 - Oblique Aerial View of the 22 August 2005 Landslide (Photograph taken on 23 August 2005)

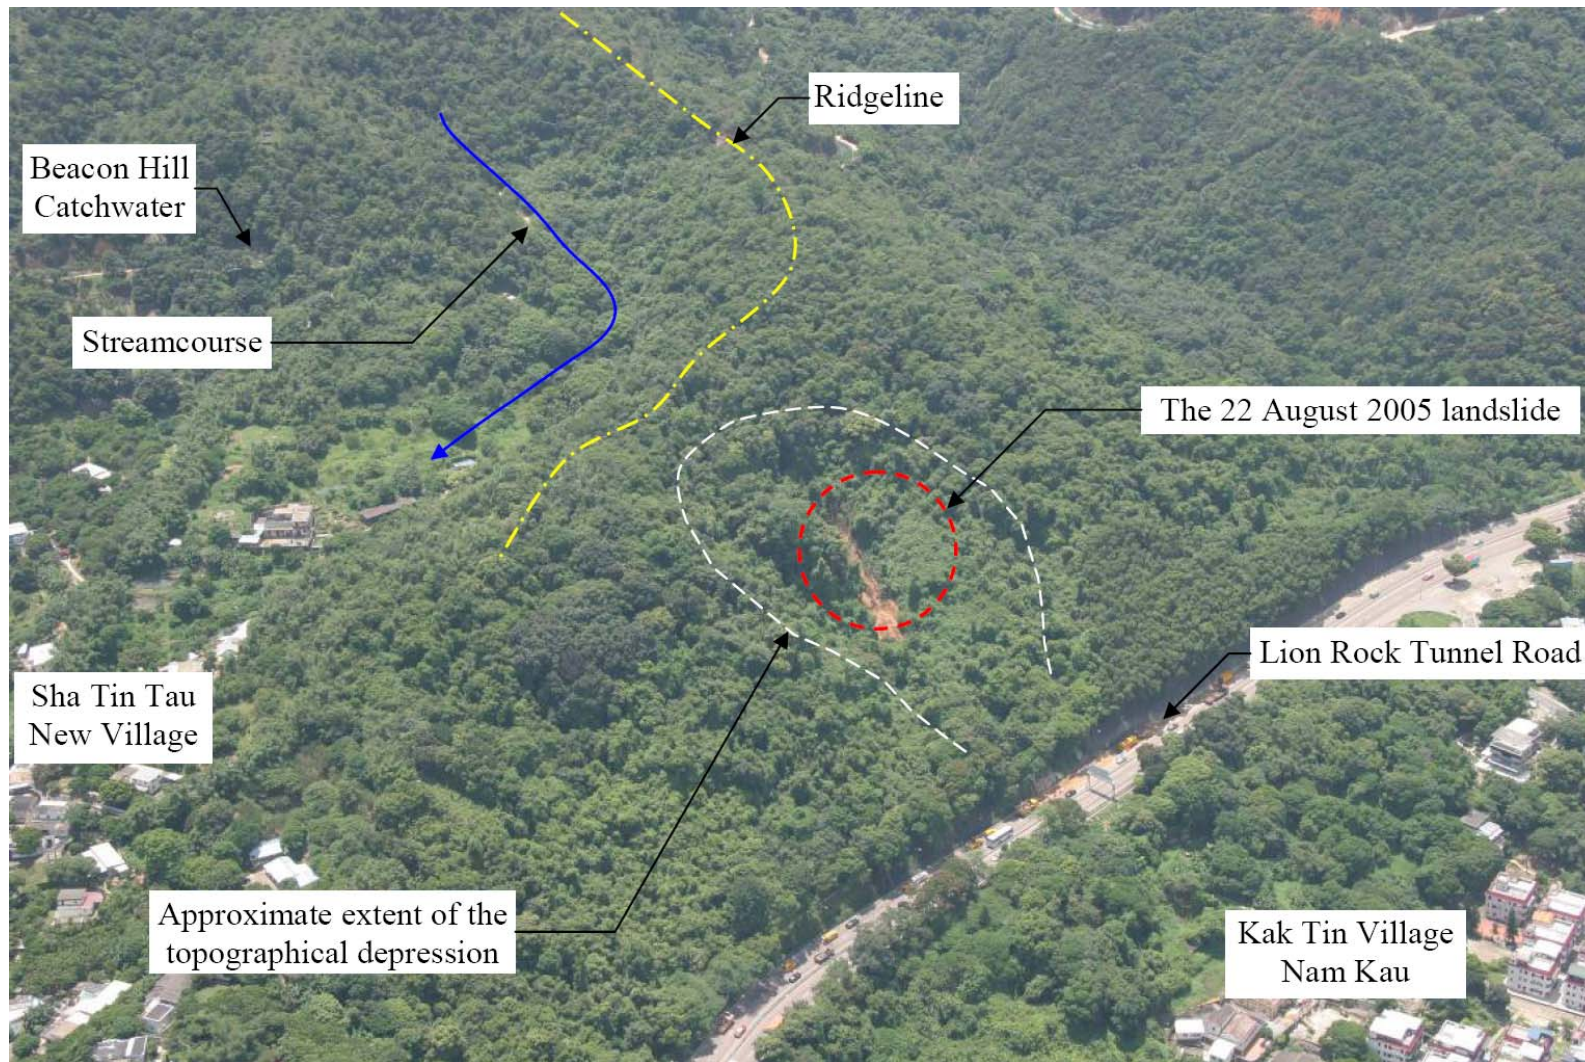
Plate 2 - Oblique Aerial View of the Landslide Site (Photograph taken on 23 August 2005)

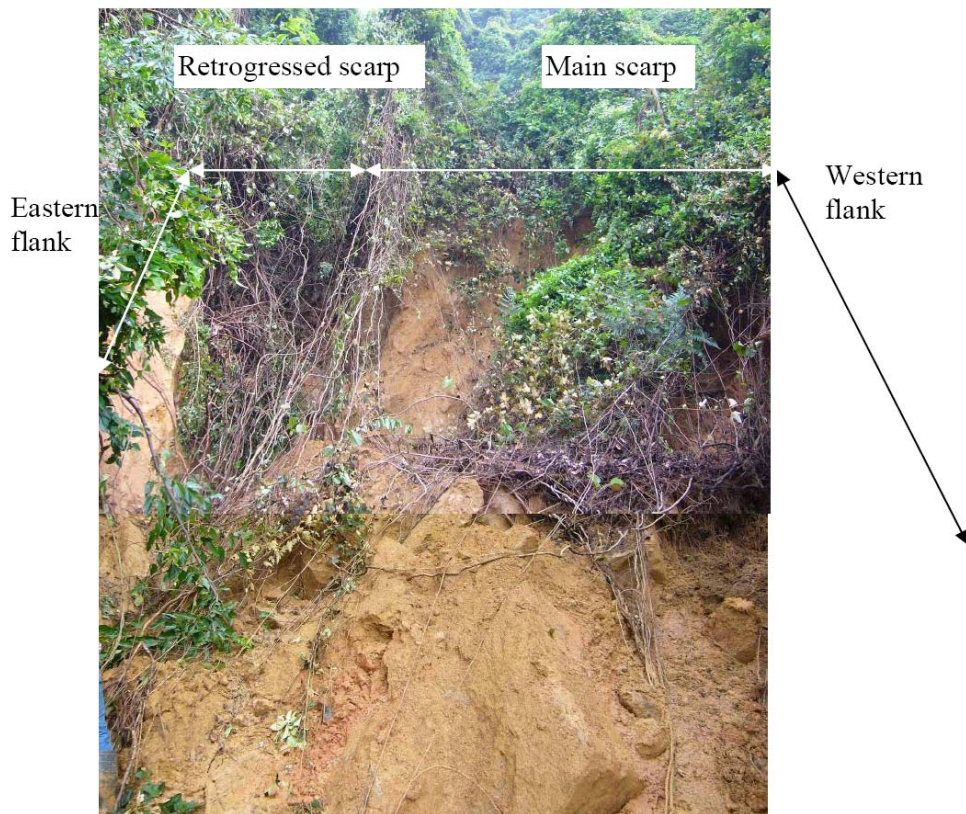
Plate 5 - General View of Source: Looking from Near Toe of Rupture to Main Scarp
(Photograph taken on 24 August 2005)

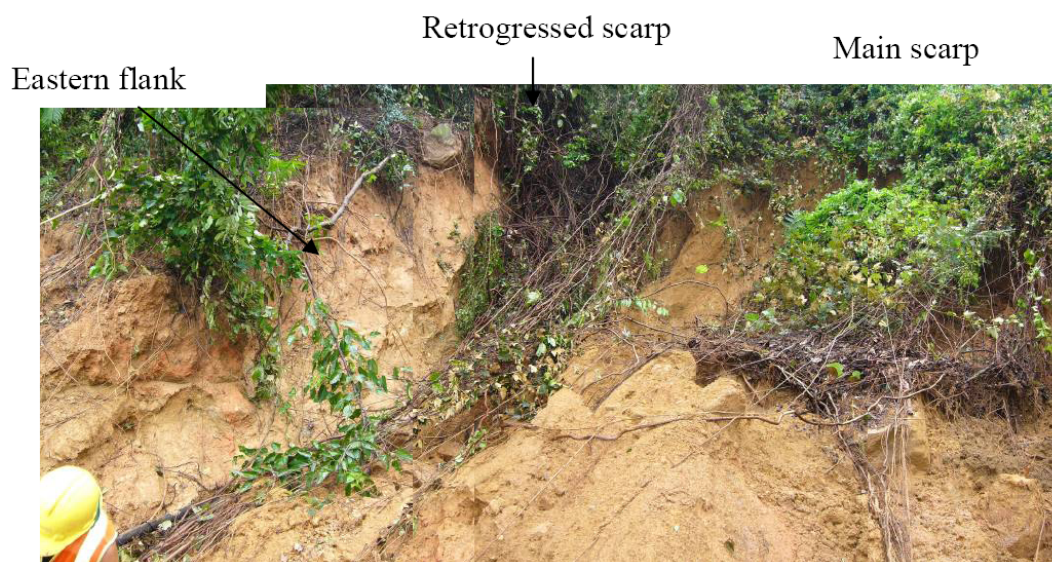
Plate 6 - General View of Source: Looking from Toe of Rupture towards
Retrogressed Scarp (Photograph taken on 24 August 2005)

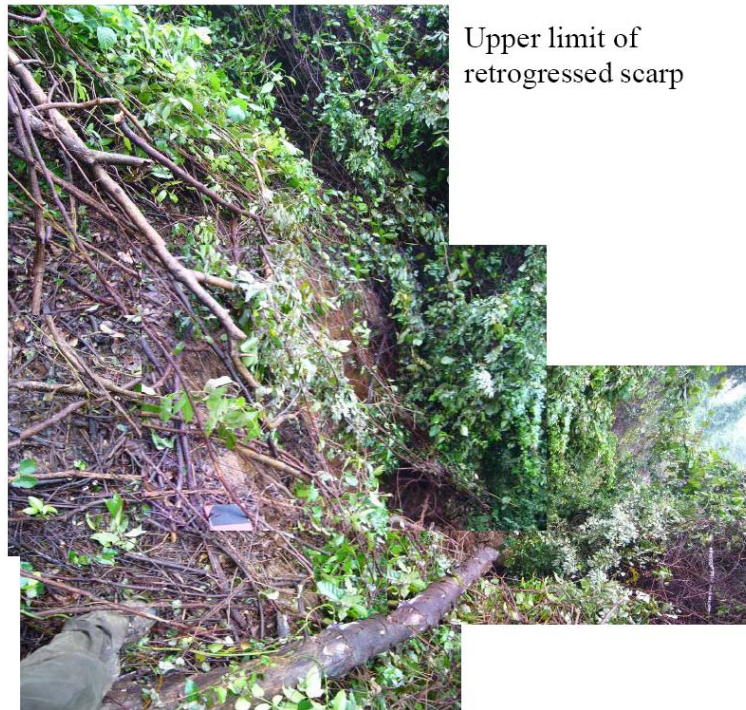
Plate 8 - Scarp of Retrogressed Source from Undisturbed Ground Surface Looking Downslope (Photograph taken on 24 August 2005)

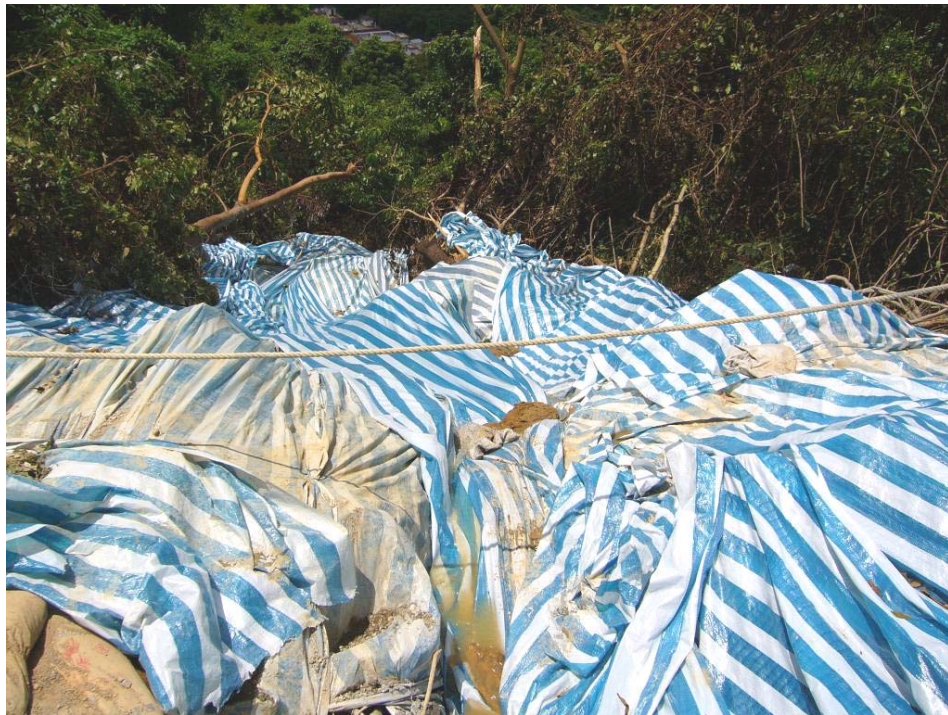
Plate 19 - Debris Trail: Looking Downslope from Toe of Rupture
(Photograph taken on 29 August 2005)

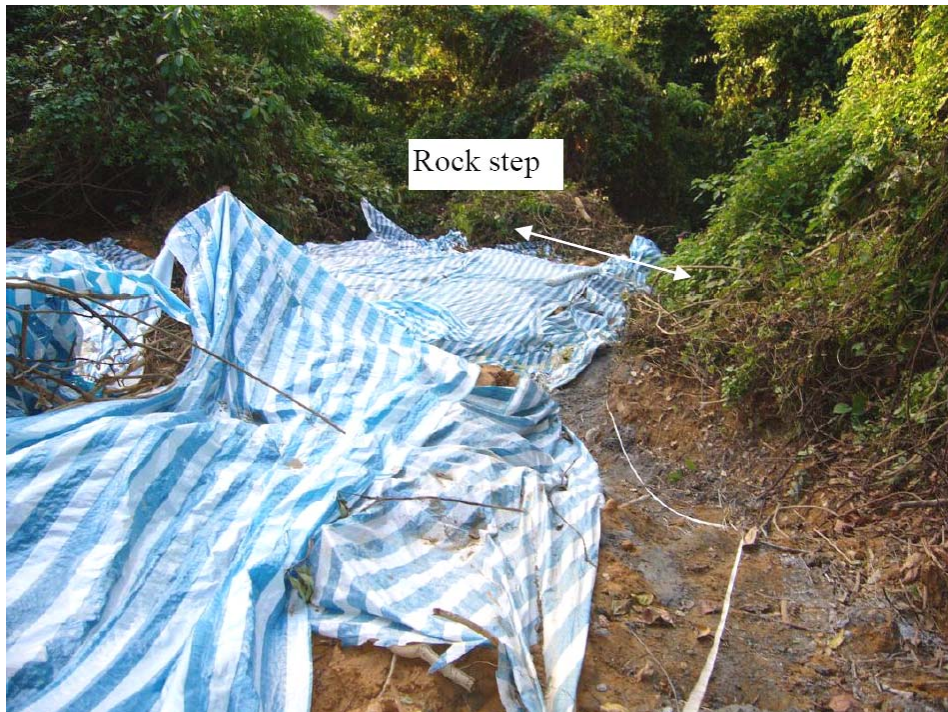
Plate 20 - Debris Trail: Looking Downslope to Rock Step
(Photograph taken on 29 August 2005)

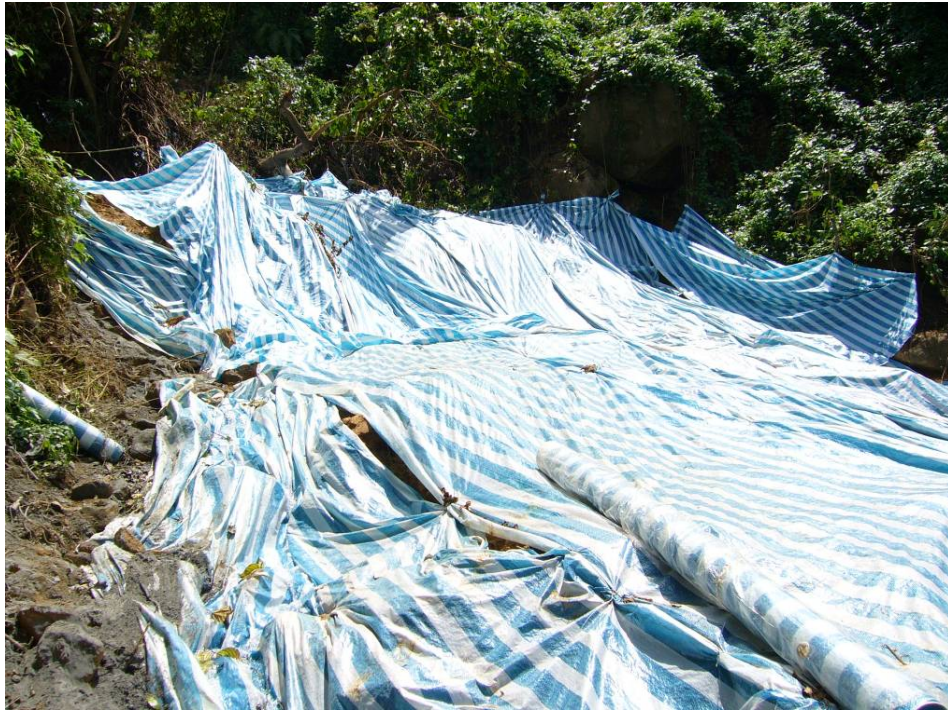
Plate 21 - Debris Trail: Looking Upslope to Rock Step
(Photograph taken on 29 August 2005)

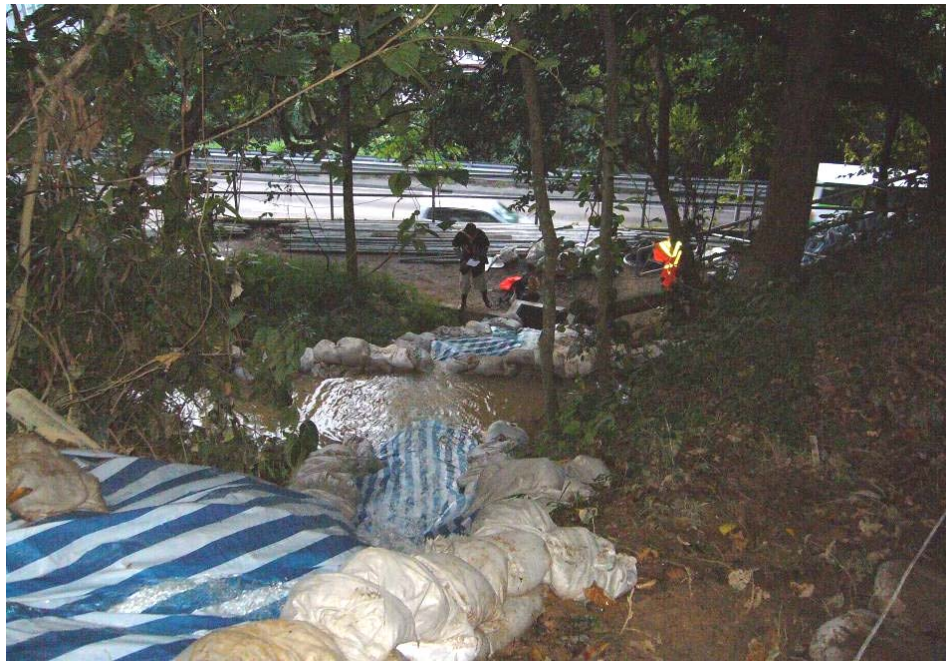
Plate 25 - Debris Trail: Looking Downslope to Slope No. 7SW-D/C2 and Lion Rock Tunnel Road (Photograph taken on 29 August 2005)

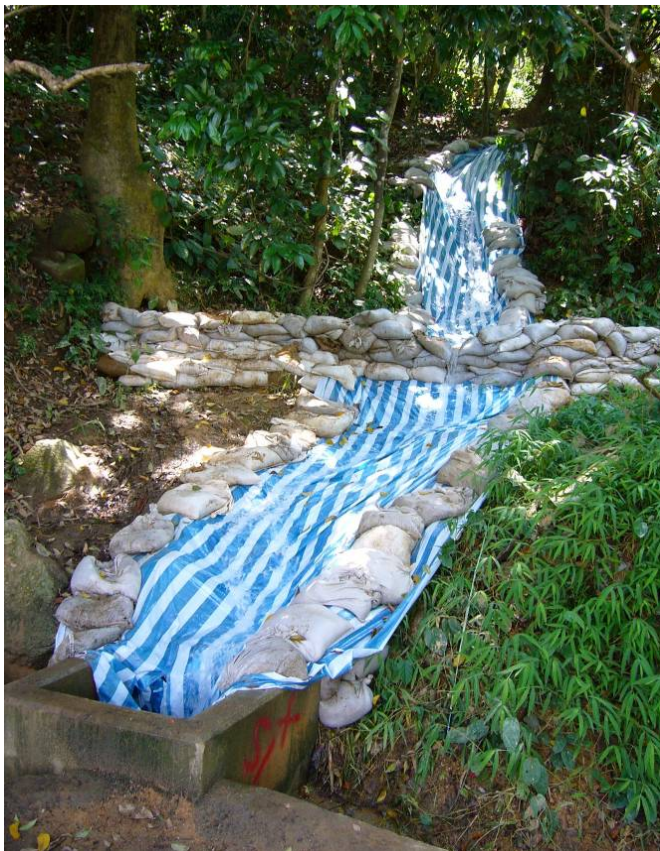
Plate 26 - Debris Trail: Looking Upslope from Slope No. 7SW-D/C2 (Photograph taken on 29 August 2005)

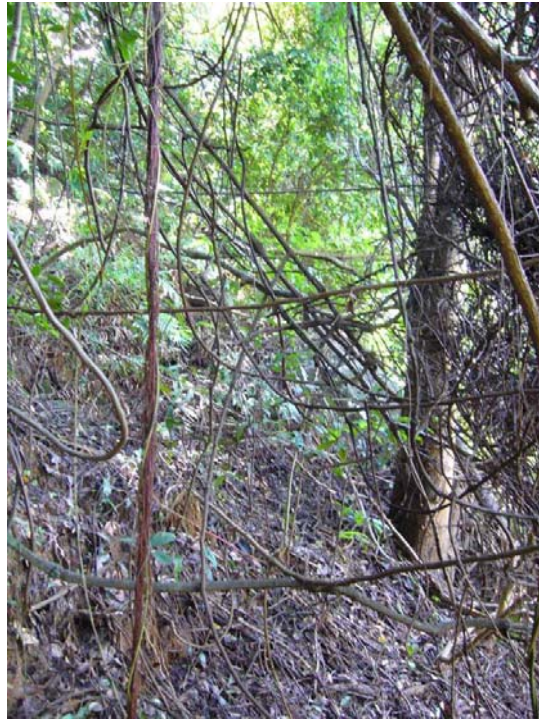
Plate 27 - View of Hillside area behind the Landslide Scar
(Photograph taken on 23 August 2005)

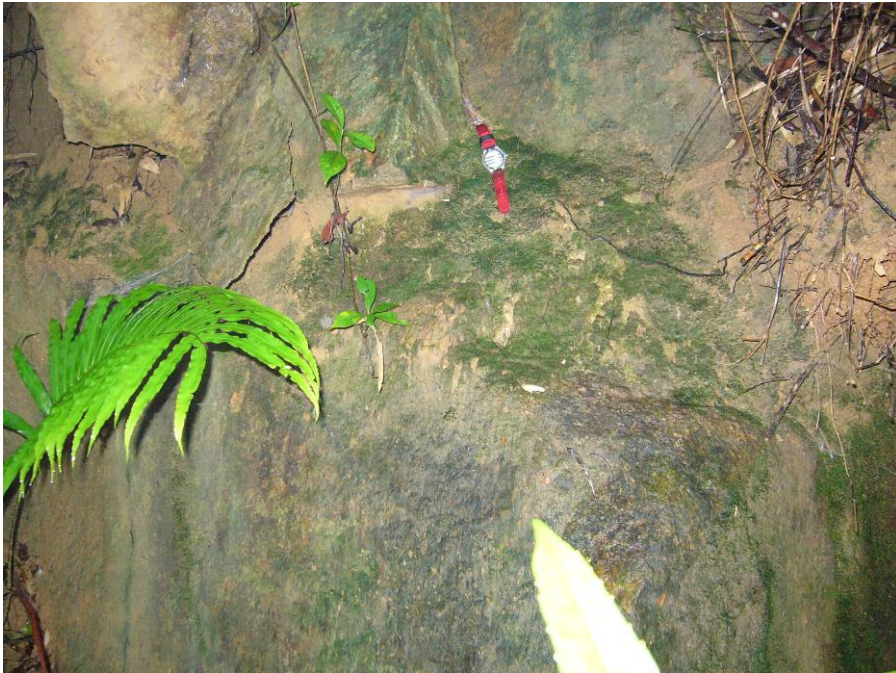
Another exposure, approximately 10 m west of slope No. 7SW-D/C570, comprised moderately decomposed fine-grained granite with relatively widely spaced joints (about 1.5 m). A poorly-developed stress relief joint daylighted from the slope at this location (Plate 29). An exposure approximately 5 m to the west of the above exposure also comprised fine-grained granite with closely spaced joints. The joints were steeply dipping between 70° and 80° towards an orientation of 220° with the strike of the joints trending 340° - 160° .

Plate 29 - Exposure of Moderately Decomposed Granite Rock Upslope (Southwest) of Landslide Source (Located west of the exposure in Plate 28, Photograph taken on 25 August 2005)
