**REVIEW OF THE 22 AUGUST 2005
LANDSLIDE ON THE NATURAL
HILLSIDE ABOVE SLOPE
NO. 7SW-D/C2 AT LION ROCK
TUNNEL ROAD, SHA TIN**

GEO REPORT No. 241

Maunsell Geotechnical Services Limited

**This report is largely based on GEO Landslide Study Report
No. LSR 7/2007 produced in August 2007**

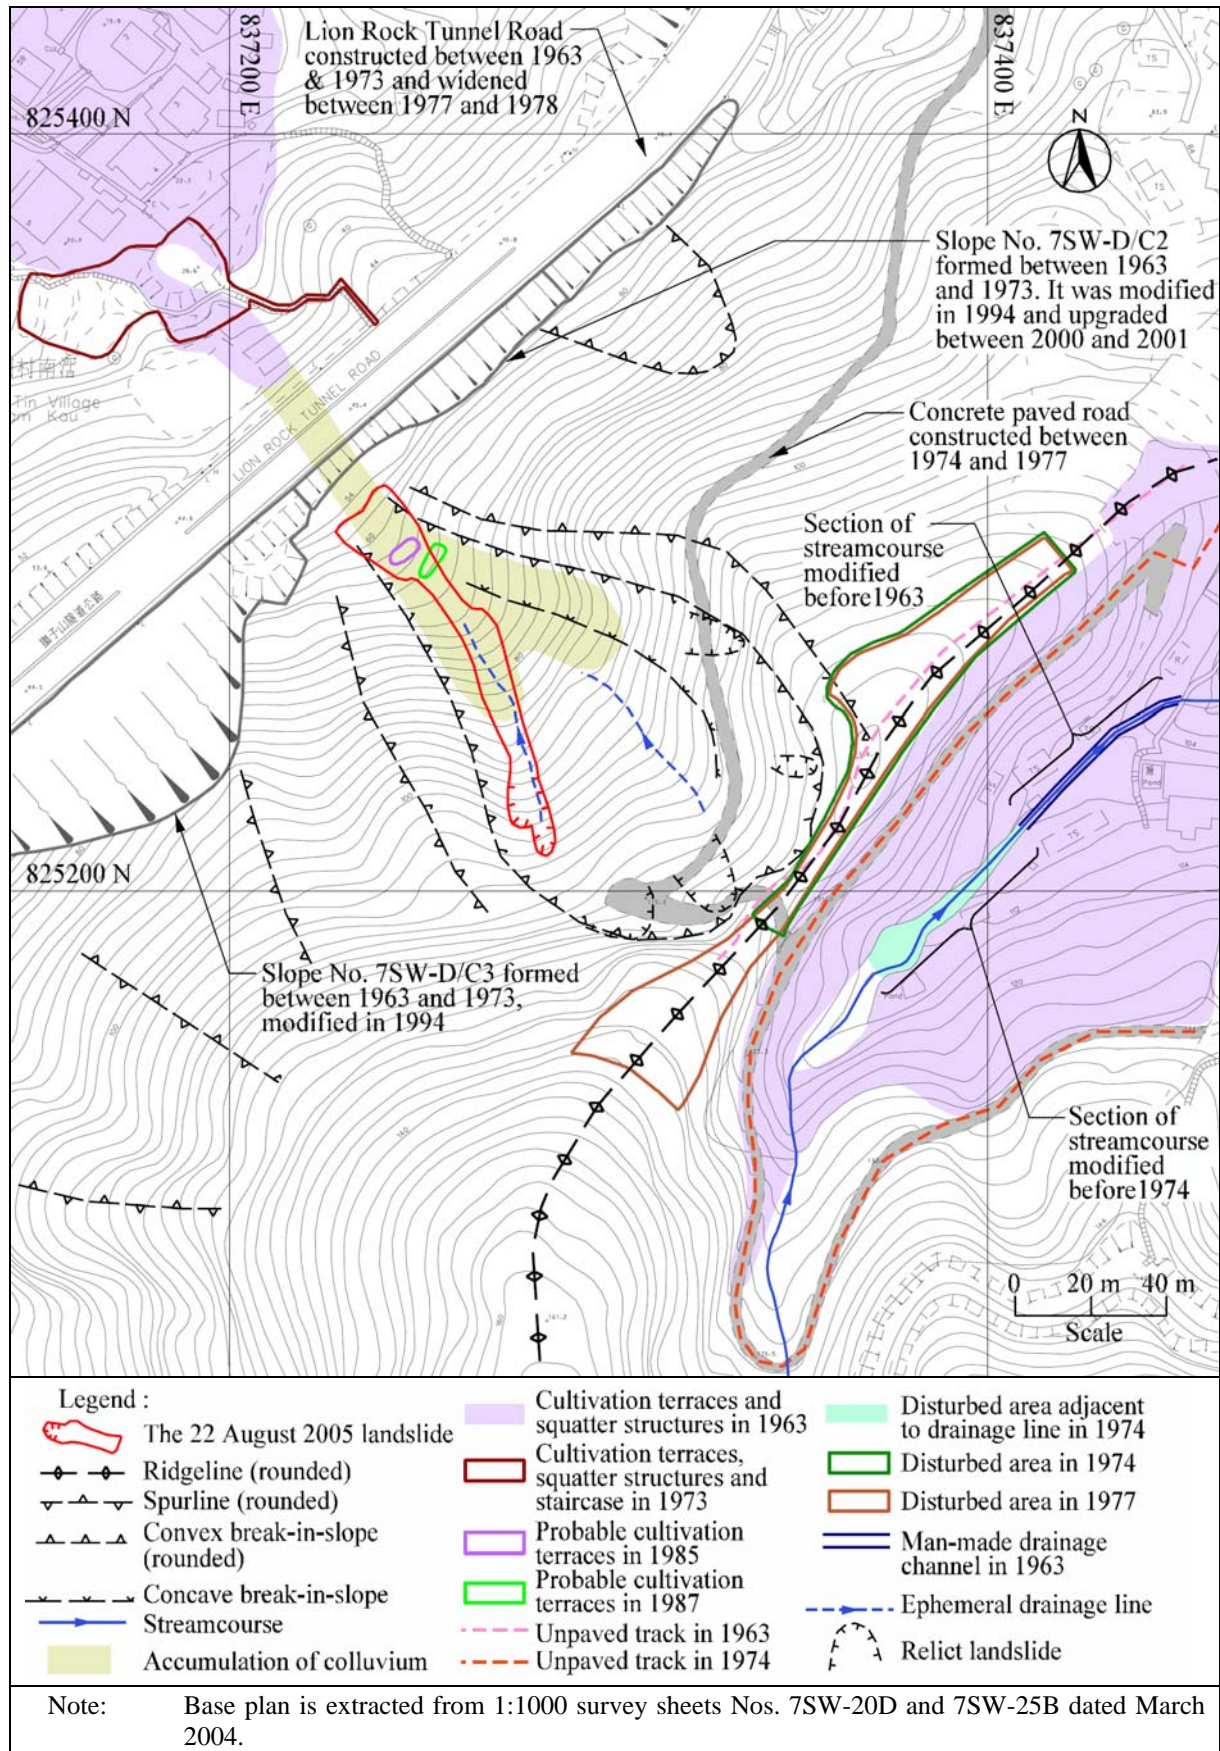
Figure A1 - Aerial Photograph Interpretation

Four relict landslides are visible within the depression between two spurs. All of them are located near the crest of the study catchment. They can be seen as shallow depressions and are covered with thin vegetation. Accumulation of colluvium is observed at the footslopes area.

A shallow topographical depression can be seen northeast of the study area, possibly related to landslide activities, although no debris was noted at the toe area and the depression.
