**REPORT ON THE 22 MAY 2013
DISTRESS AT A REINFORCED
FILL WALL AT A
CONSTRUCTION SITE
ABOVE SHUN ON ROAD,
SAU MAU PING**

*Fugro Scott Wilson Joint Venture
for
Geotechnical Engineering Office
Civil Engineering and
Development Department
The Government of The Hong Kong
Special Administrative Region*

December 2013
(minor amendments made in November 2020)

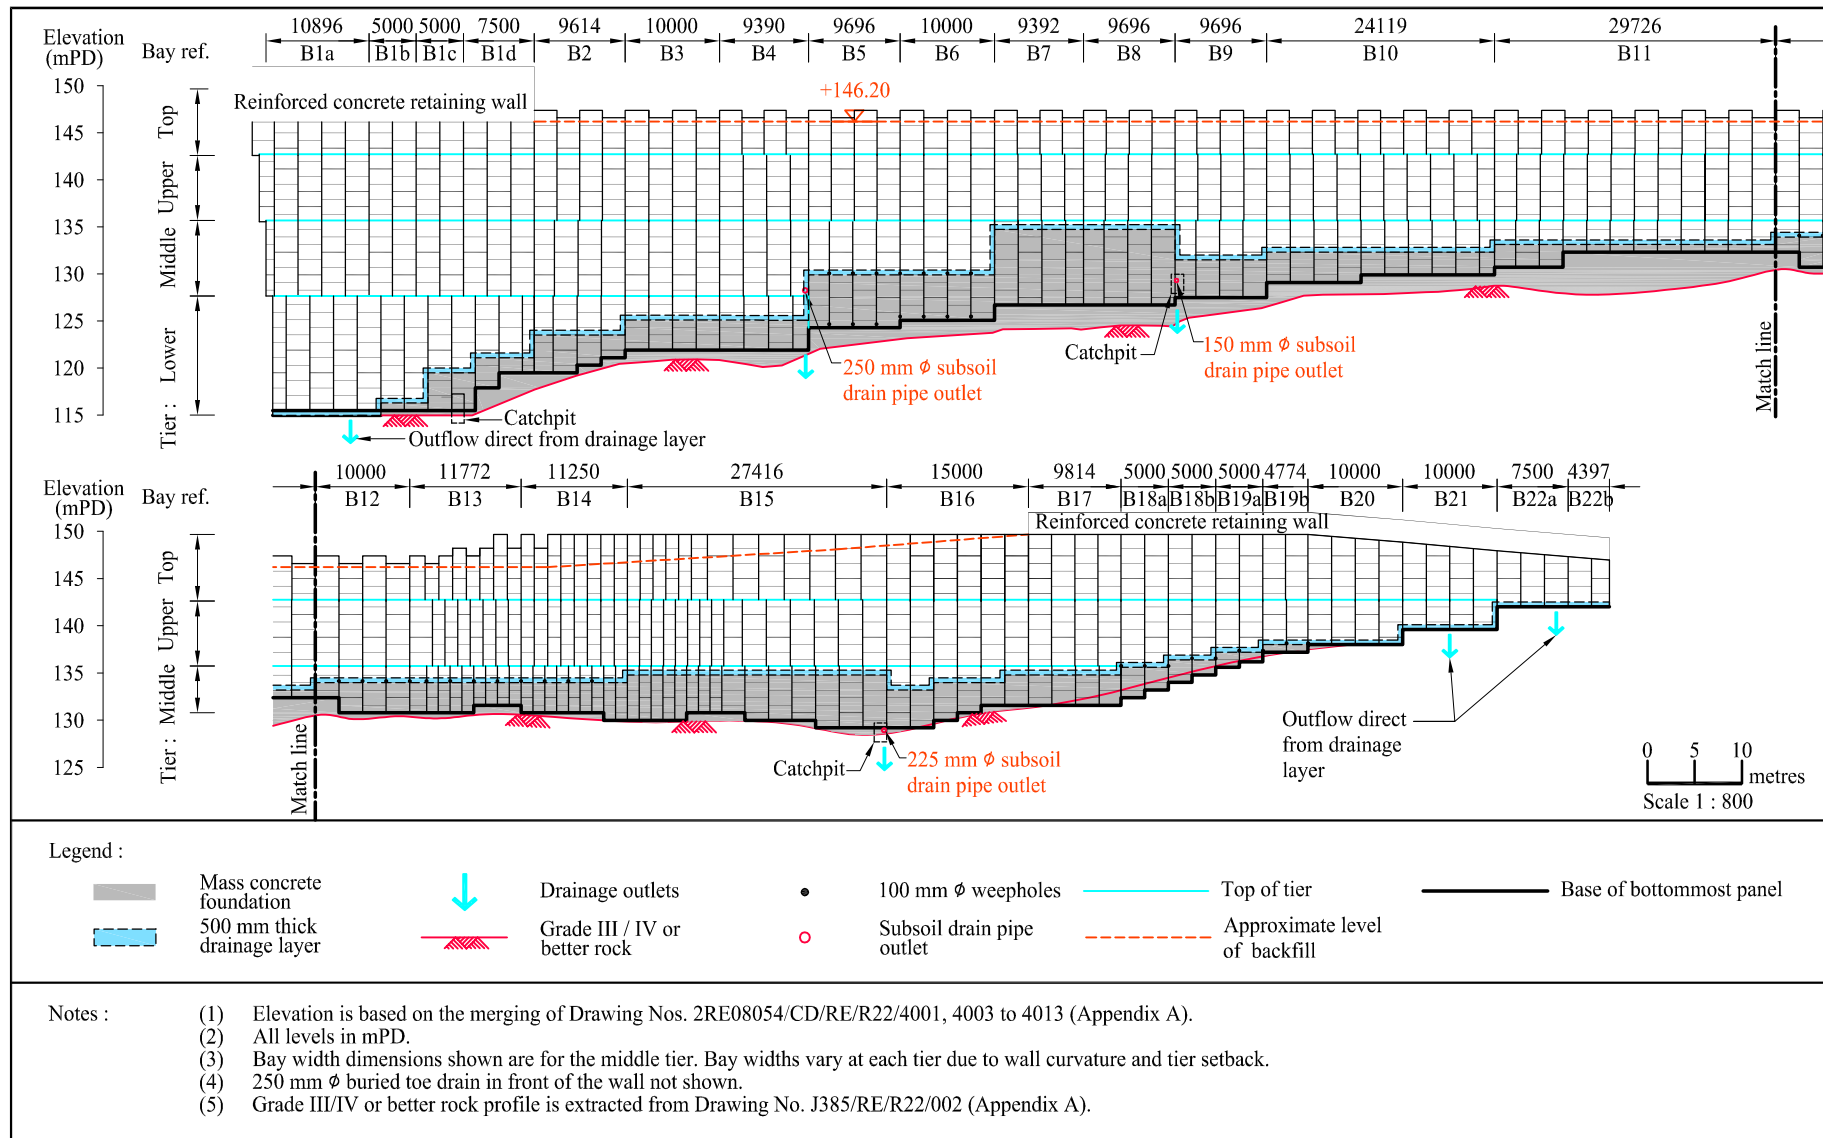
Figure 2.2 Elevation of Wall R22

At the steps of the mass concrete foundations, the adjacent base drainage layers are connected to each other by vertical drainage layers which are referred to in the report as '*vertical connecting drainage layer*' (Figure 2.2). The inclined drainage layer at the back of the wall was designed to extend up to two-thirds of the retained height of the reinforced fill body.

perforated subsoil drain pipes prescribed at Bay 9 and Bay 15 respectively. A 250 mm diameter toe drain was buried underneath the footpath in front of the wall discharging the direct outflow from the base drainage layer. Additionally, a row of weepholes (100 mm diameter at 2.5 m horizontal spacing) were prescribed at the concrete facing panels along the base drainage layer at Bay 5, Bay 6, Bays 12 to 14 and Bays 18a to 19b (Figure 2.2).

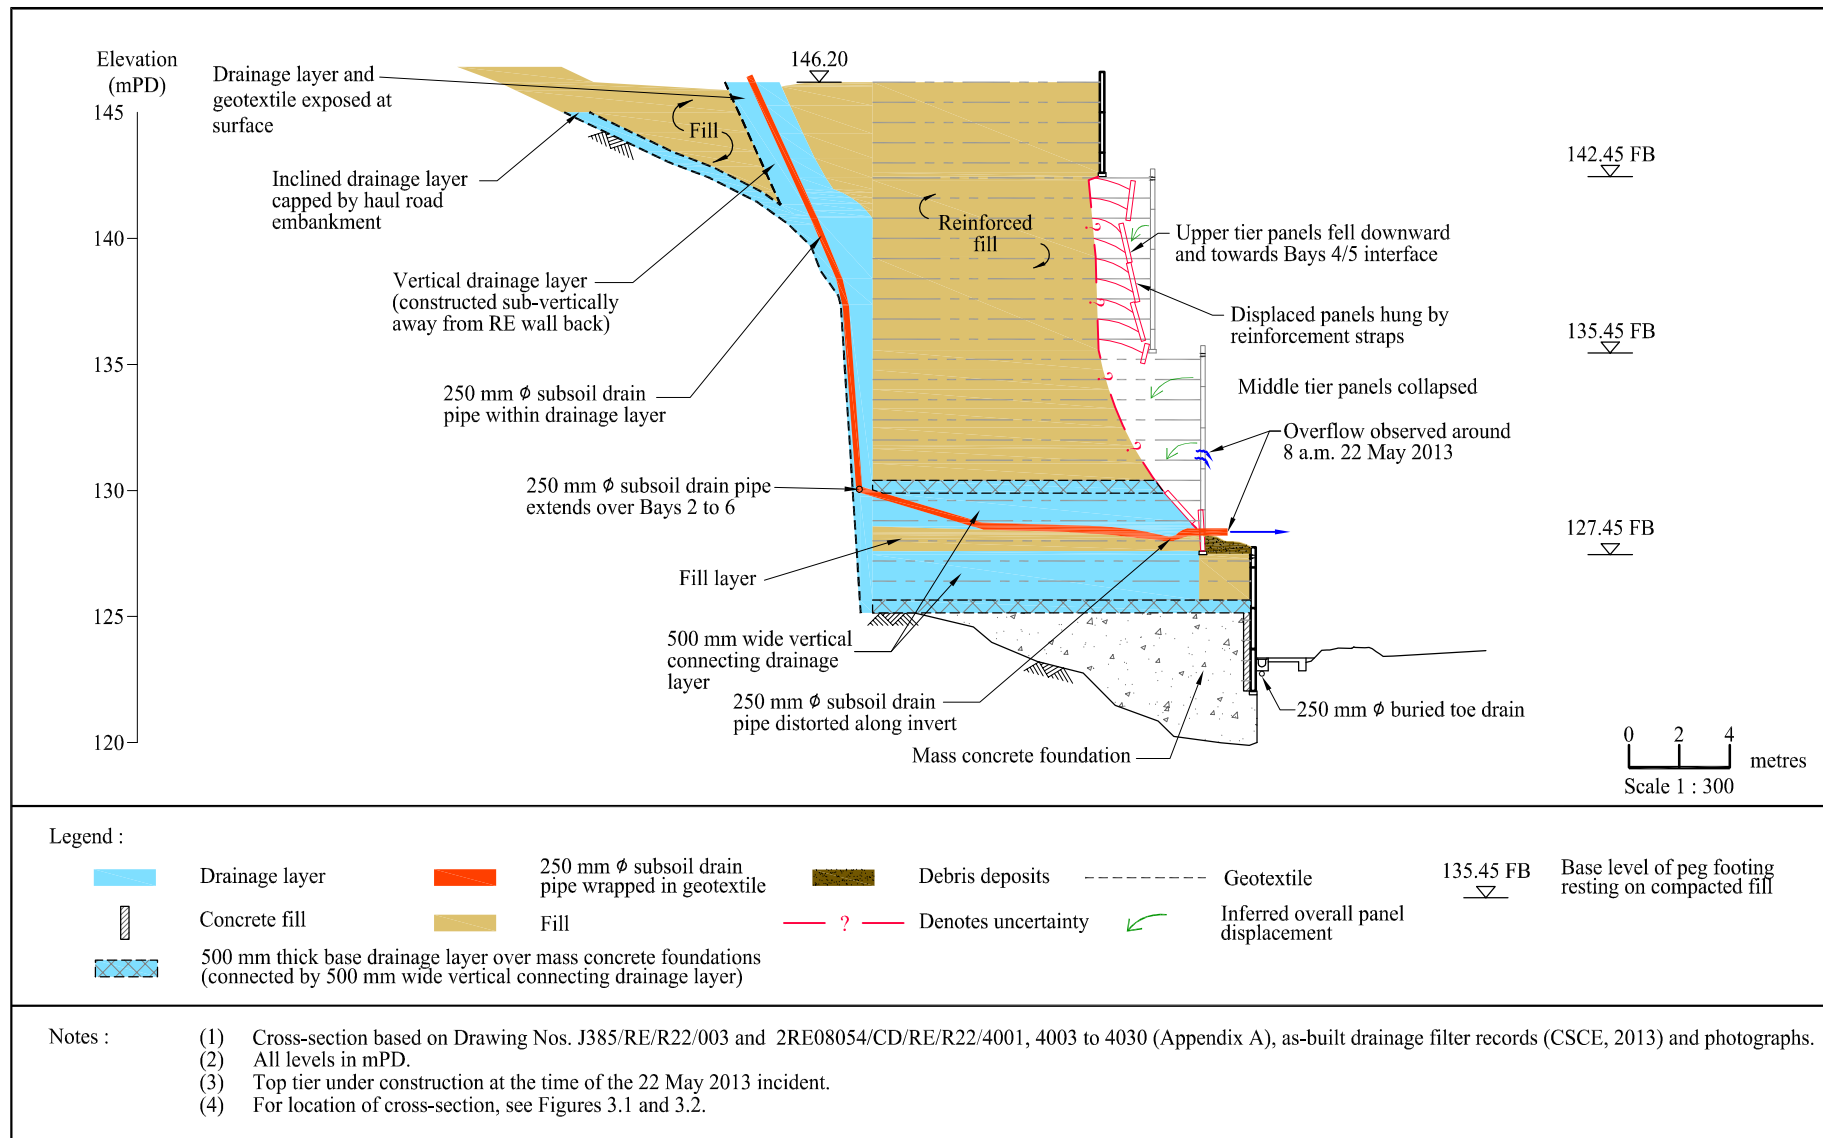
Figure 3.3 Cross-section A-A of the 22 May 2013 Incident of Wall R22 at the Interface between Bays 4 and 5

Following the incident on 24 July 2012 (see Section 8), additional 100 mm diameter weepholes at the joints of dummy panels were prescribed at Bays 5 and 6 and an additional 250 mm diameter half-perforated subsoil drain pipe embedded sub-horizontally at the '*vertical connecting drainage layer*' at the interface between Bays 4 and 5 was prescribed. This outlet pipe was fed by three sub-vertical 250 mm diameter half-perforated subsoil drain pipes installed at the back of Bays 2 to 6. Underneath the 250 mm diameter subsoil drain outlet pipe was a layer of 600 mm thick compacted soil fill (Figure 3.3 and Plate 15).

At the time of the incident, the construction of the reinforced fill portion of the wall between Bay 2 and Bay 16 was on-going. The wall was generally constructed in accordance with the engineering design as mentioned above, except that the inclined and vertical drainage layers at the back of the wall were constructed as a single combined layer between Bay 3 and Bay 11 (Plate 16, Figures 3.3 to 3.5).

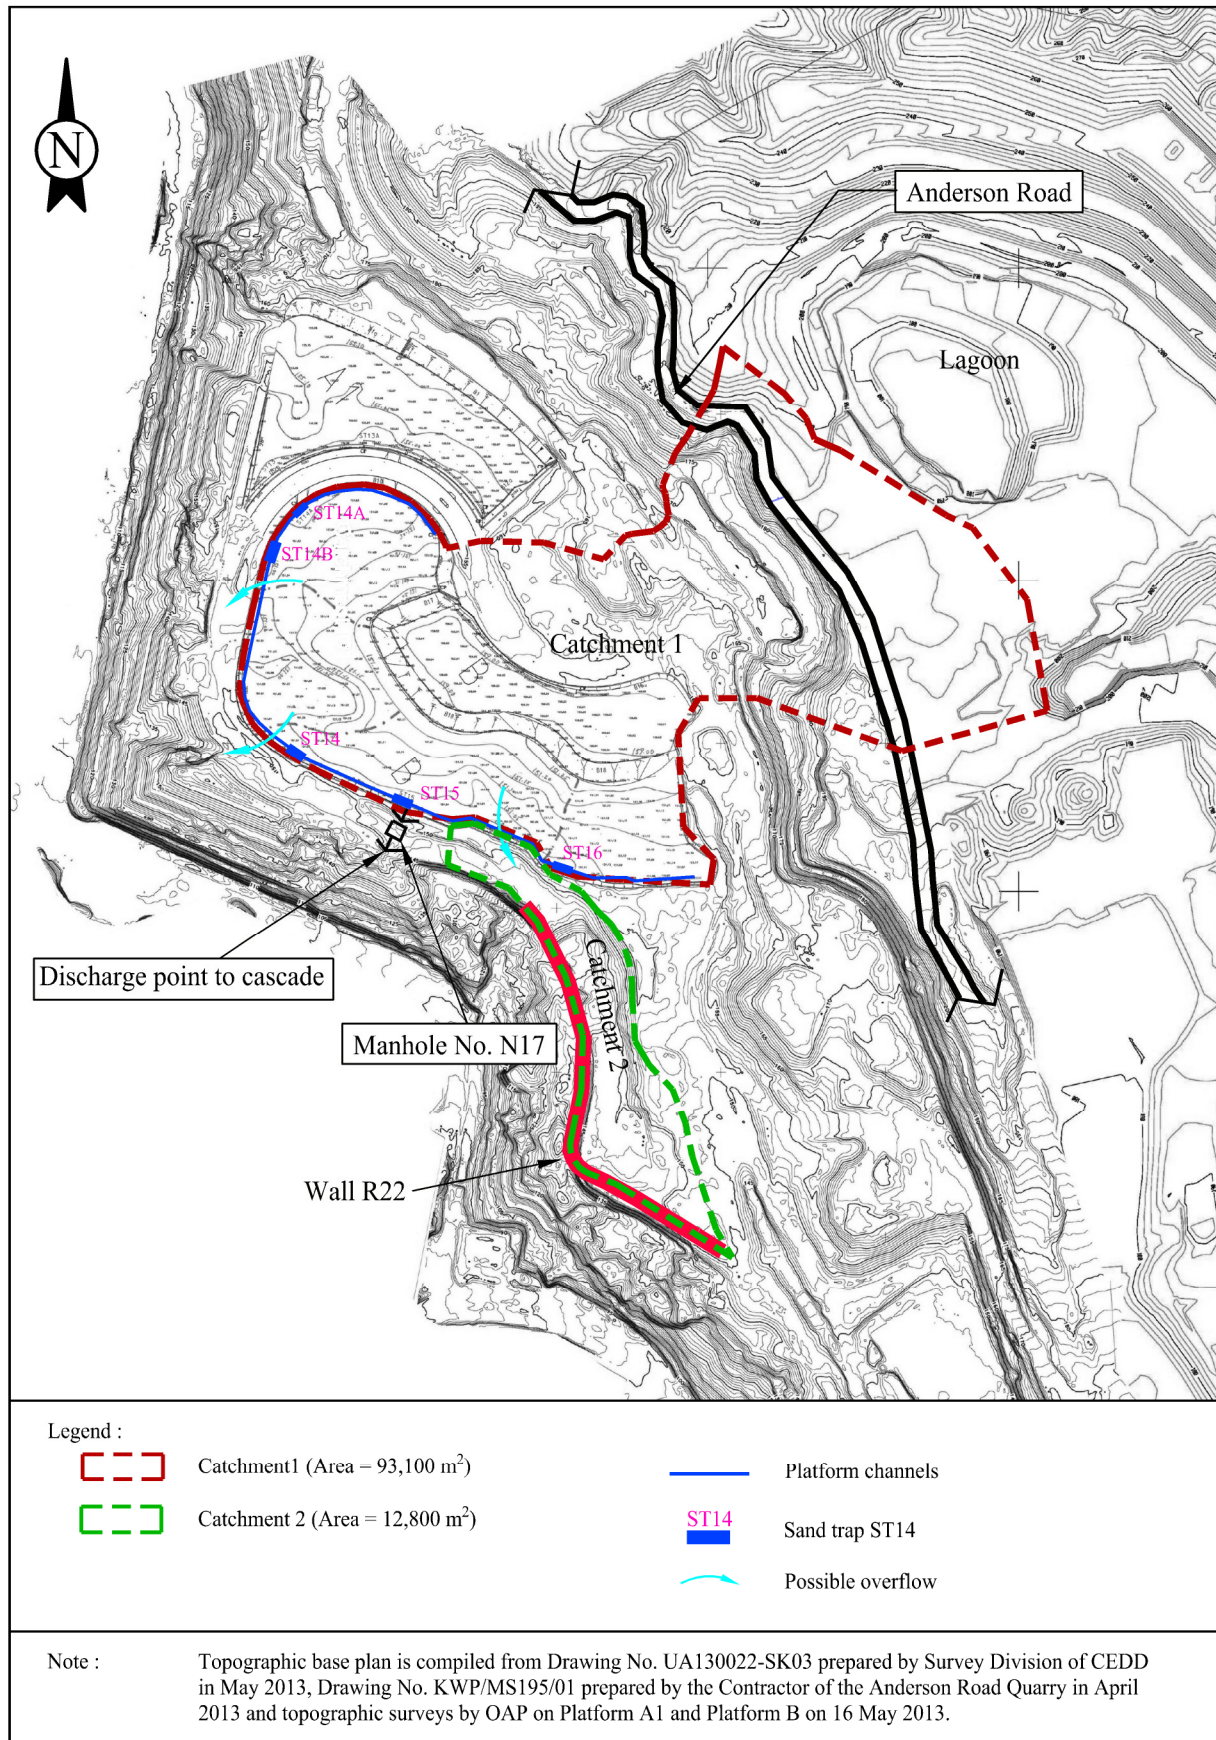
Figure 5.1 Catchment Boundary near Wall R22

Assessment of the site topography shows that the catchment area contributing surface runoff to Wall R22 covered Catchment 1 and Catchment 2 as shown in Figure 5.1.

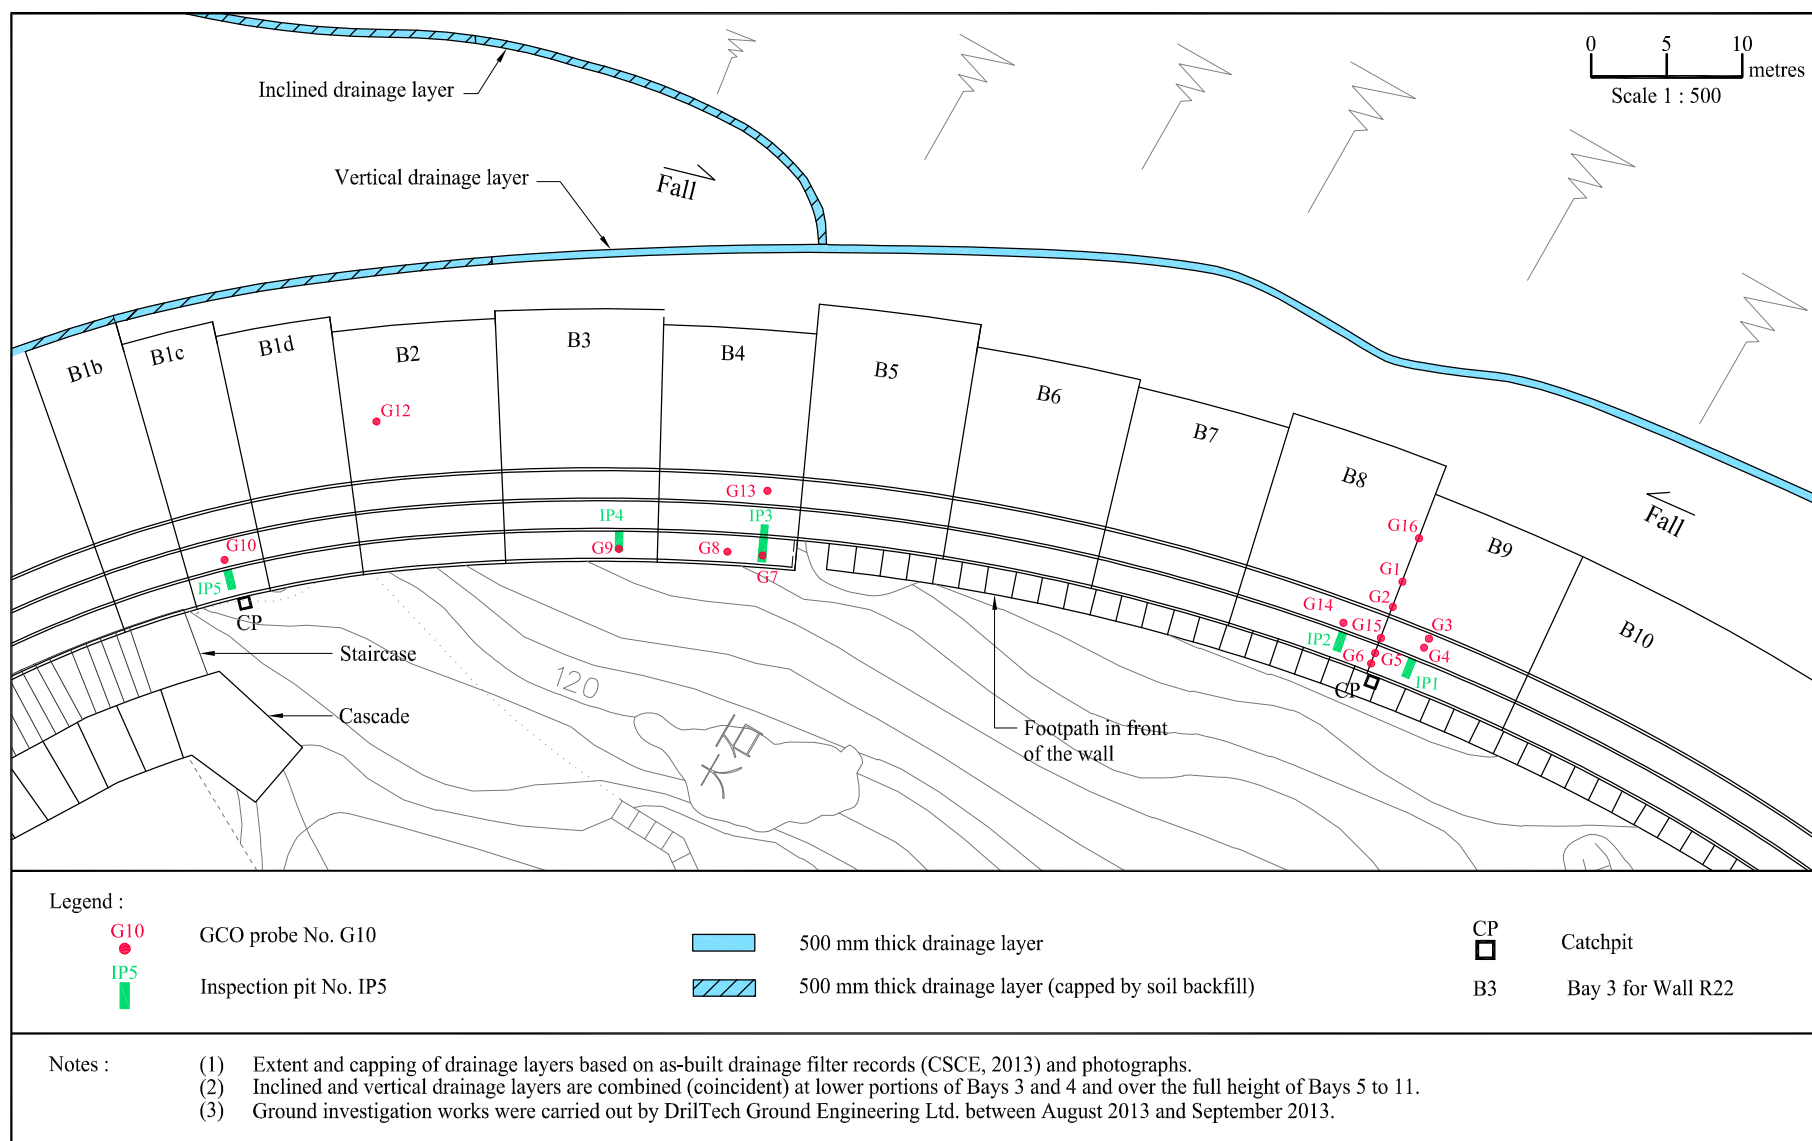
Figure 7.5 Ground Investigation at Wall R22 following the 22 May 2013 Incident

The post-incident ground investigation was undertaken by GI contractor, DrilTech Ground Engineering Ltd, from August 2013 to September 2013 following the urgent remedial works. The GI comprised 15 GCO probes tests and excavation of five inspection pits at various locations to identify the nature and condition of the materials involved in the 22 May 2013 incident. The locations of the post-incident ground investigation stations are shown in Figure 7.5.

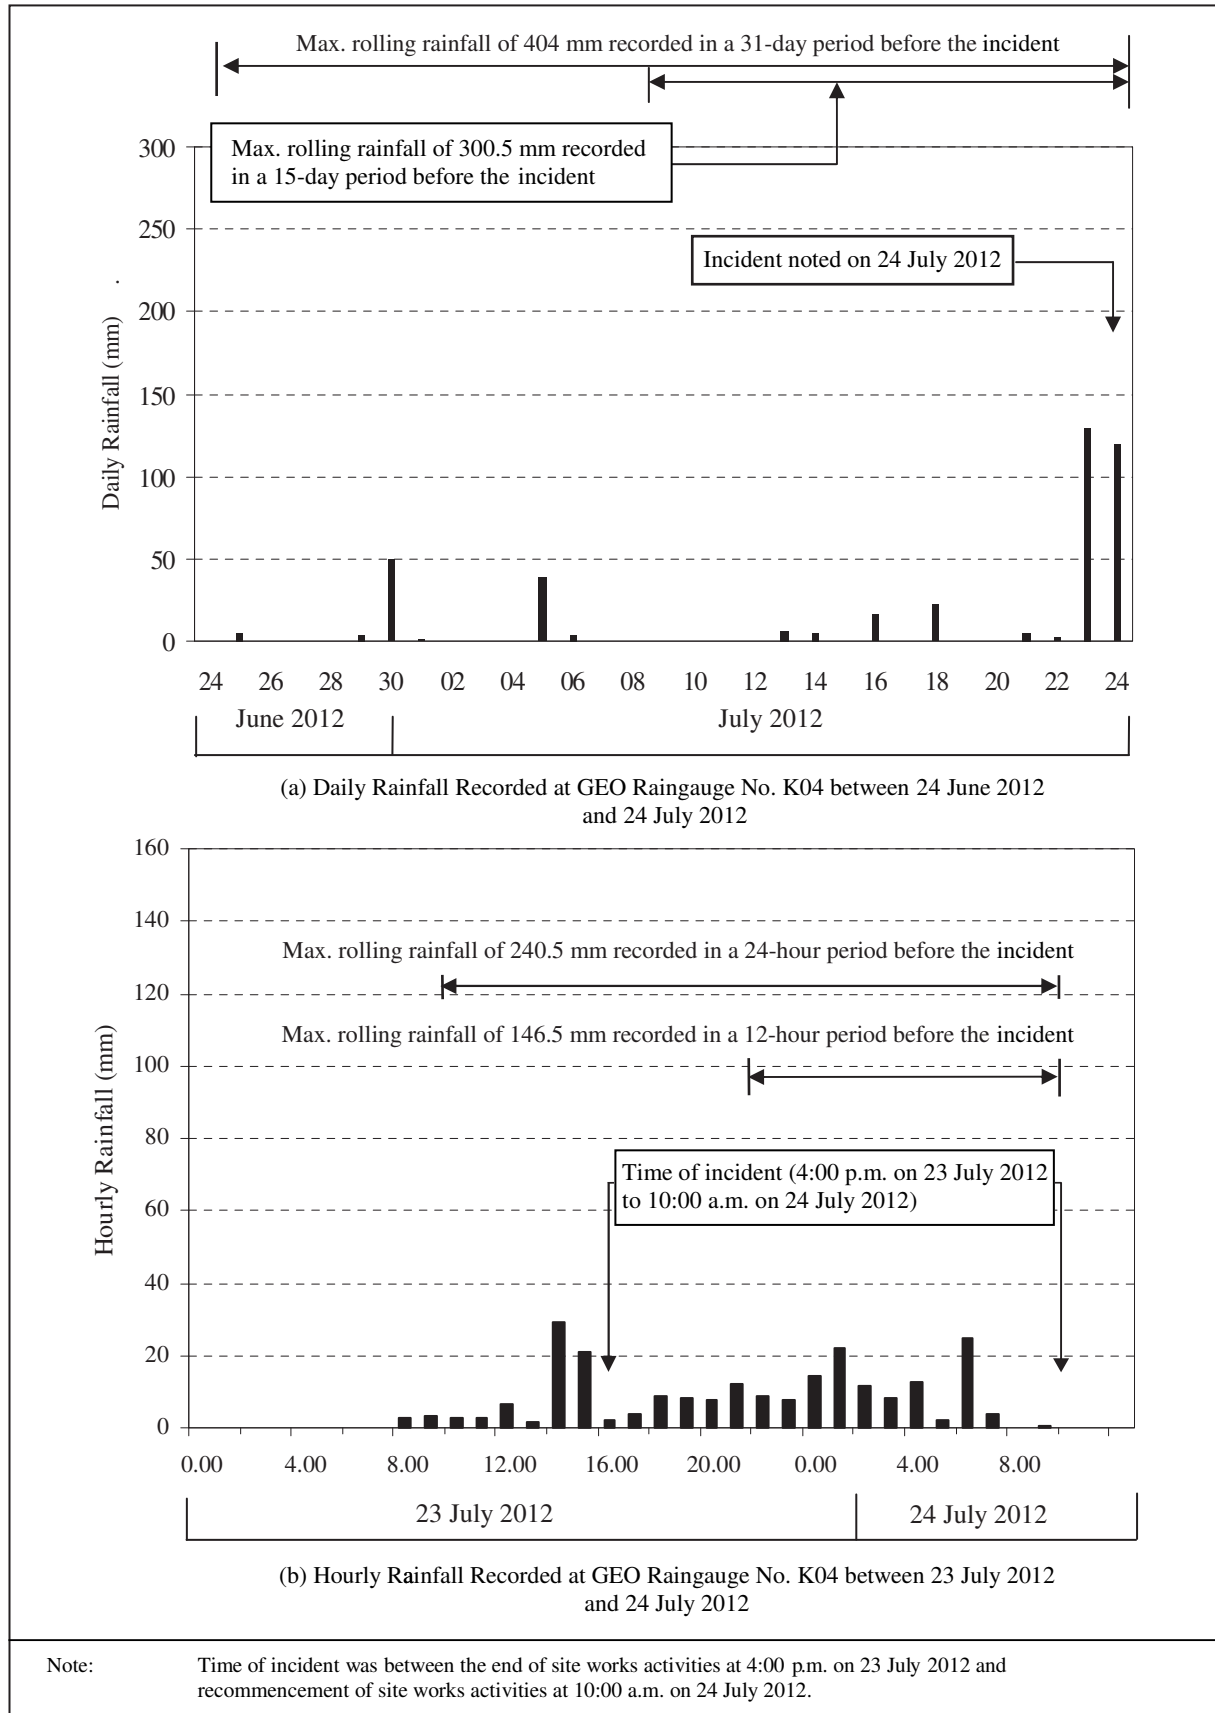
Figure 8.4 Daily and Hourly Rainfall Recorded at GEO Raingauge No. K04 in July 2012

The rainfall recorded at the nearest raingauge K04 before the 24 July 2012 incident was not particularly intense (Figure 8.4), with a return period generally of two years or less for various durations considered. The maximum hourly and 24 hours rolling rainfall preceding the incident were about 29 mm and 241 mm respectively.

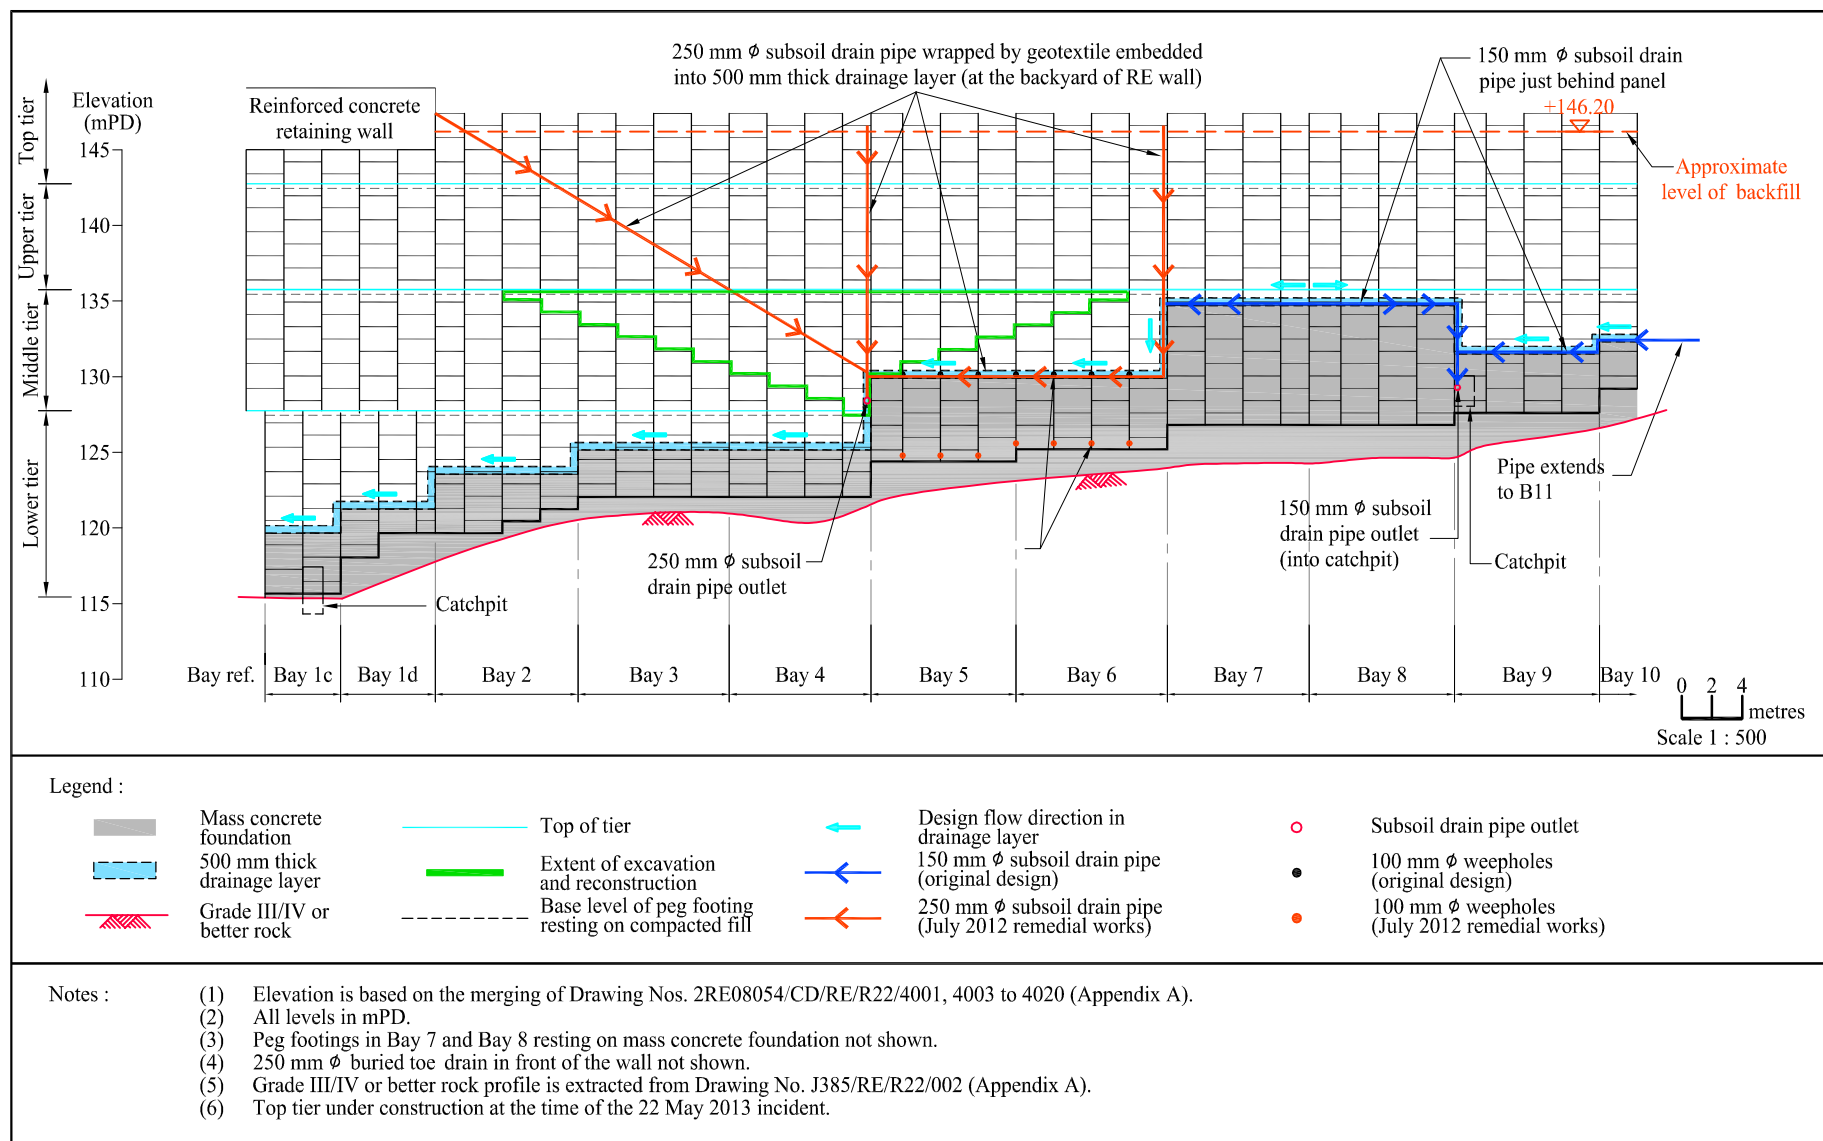
Figure 8.5 Elevation of Remedial Works to Wall R22 after July 2012 Incident

Before the incident, some seepage flow was noted through the joints of the panels near the interface between Bays 4 and 5 (Plate 17c). Following the 24 July 2012 incident, the wall was partially removed from Bay 2 to Bay 6 in a stepped profile down to the level of the collapsed panel (Figure 8.5). Additional internal drainage measures as mentioned in Section 7.1.2 were provided (Figure 8.6). CSCE and OAP also carried out field inspections to identify any seepage under heavy rainfalls subsequent to the 24 July 2012 incident.

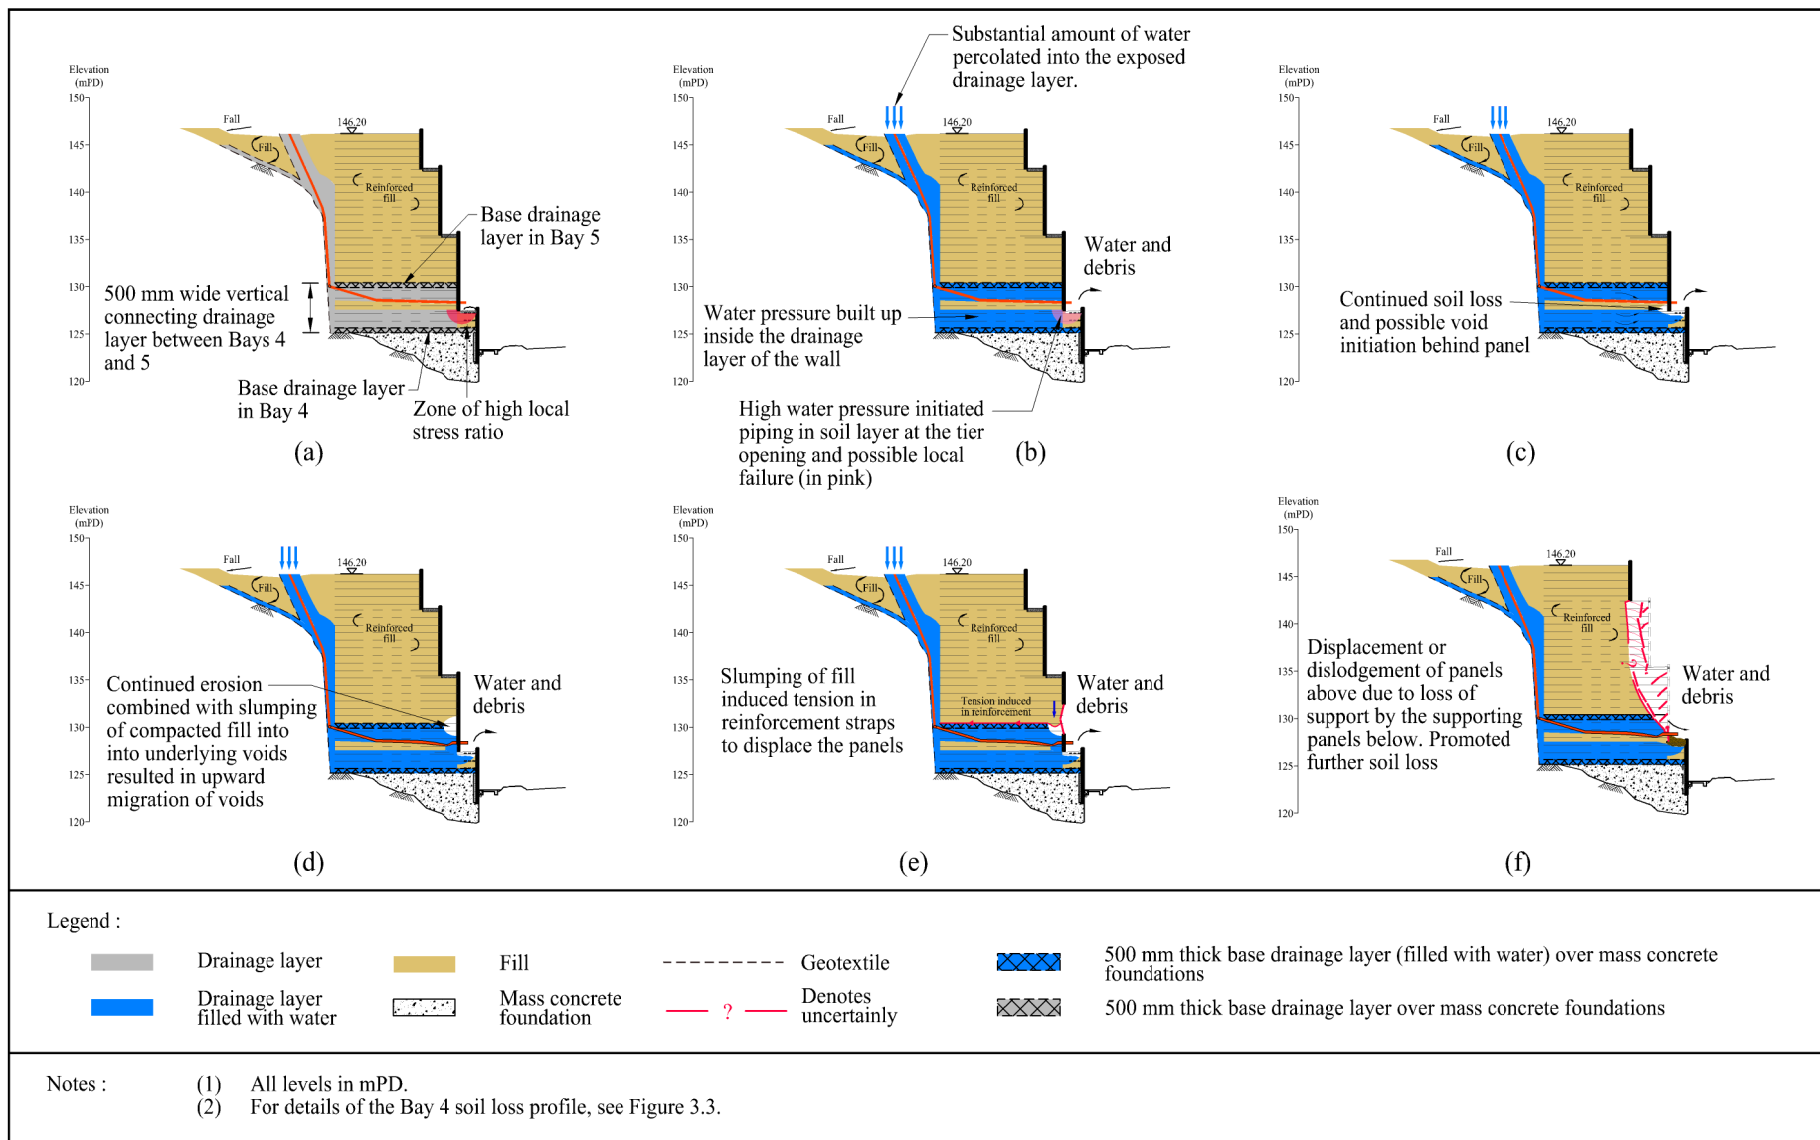
Figure 9.3 Sequence of Distress at Bays 4/5 of Wall R22

The distress would proceed with displacement or even dislodgement of the panels above due to loss of support by the supporting panels below, which could further promote soil loss. The postulated progression of the distress mechanism at the interface between Bays 4 and 5 is summarized in Figure 9.3 with each stage being numbered and described. The distress at the interface between Bays 6 and 7 appears to be more developed than that between Bays 4 and 5, with the formation of a sinkhole at the back, which could be due to a larger amount of water ingress into the wall or due to the presence of a subsoil drain pipe at the latter location which could help to reduce the volume of water issuing out of the top of the tier.

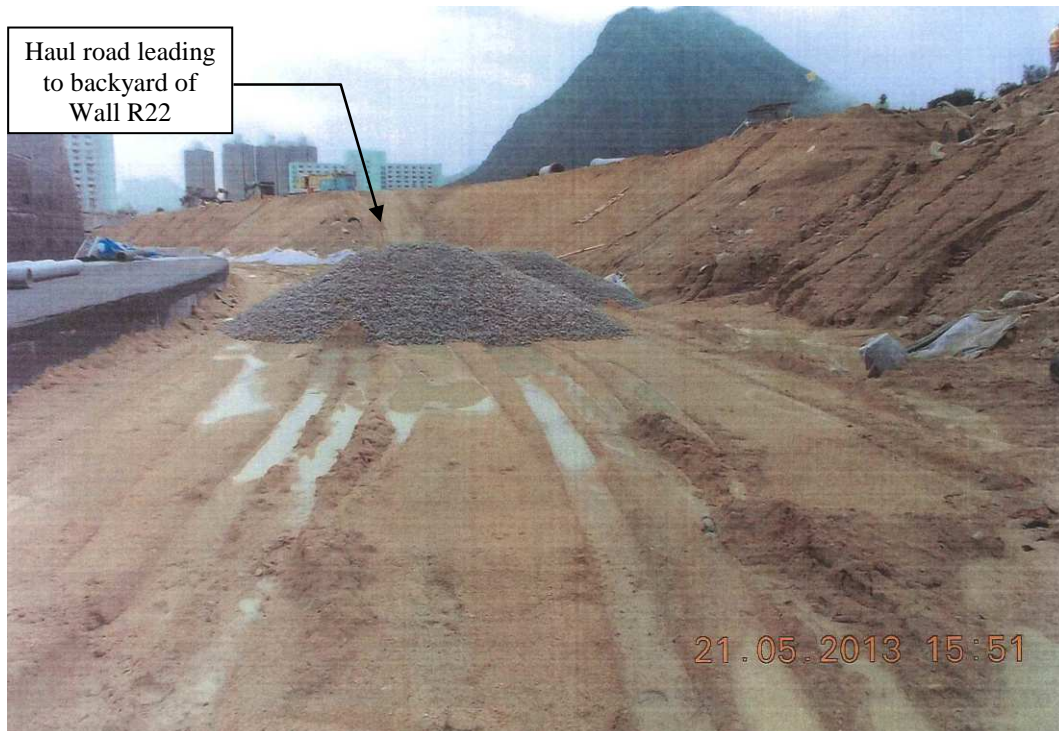
(a) Backyard Condition at Bay 2

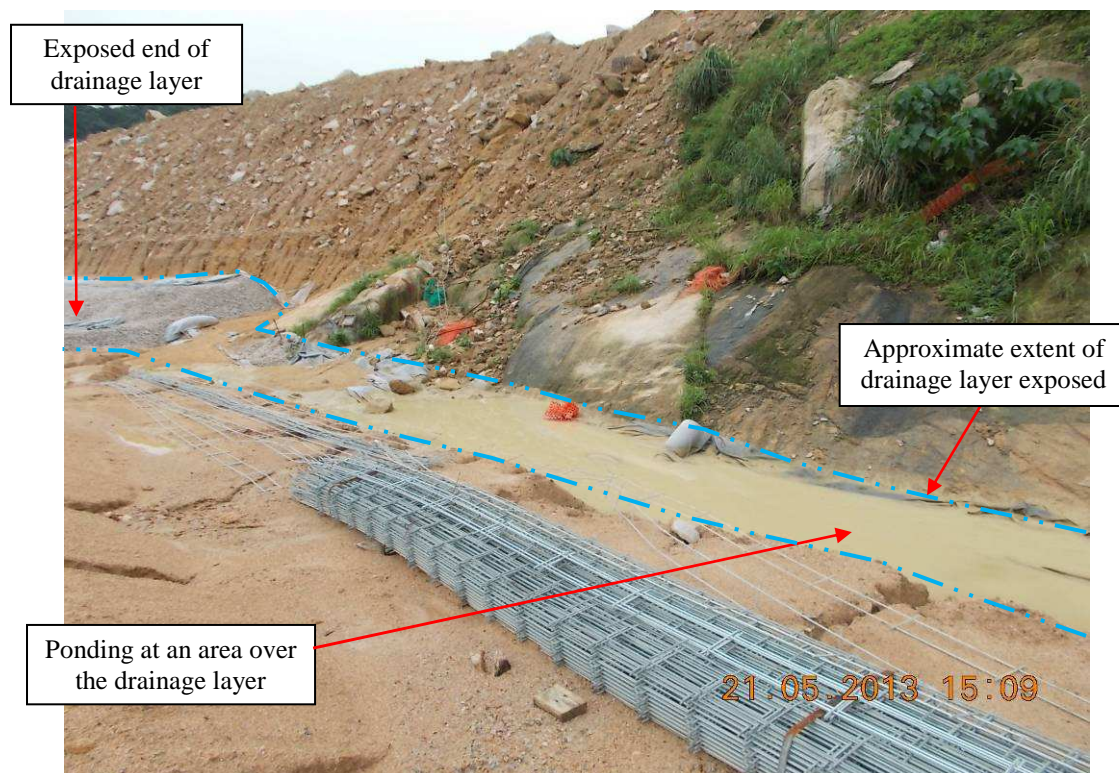
(b) Backyard Condition at Bay 4 to Bay 7

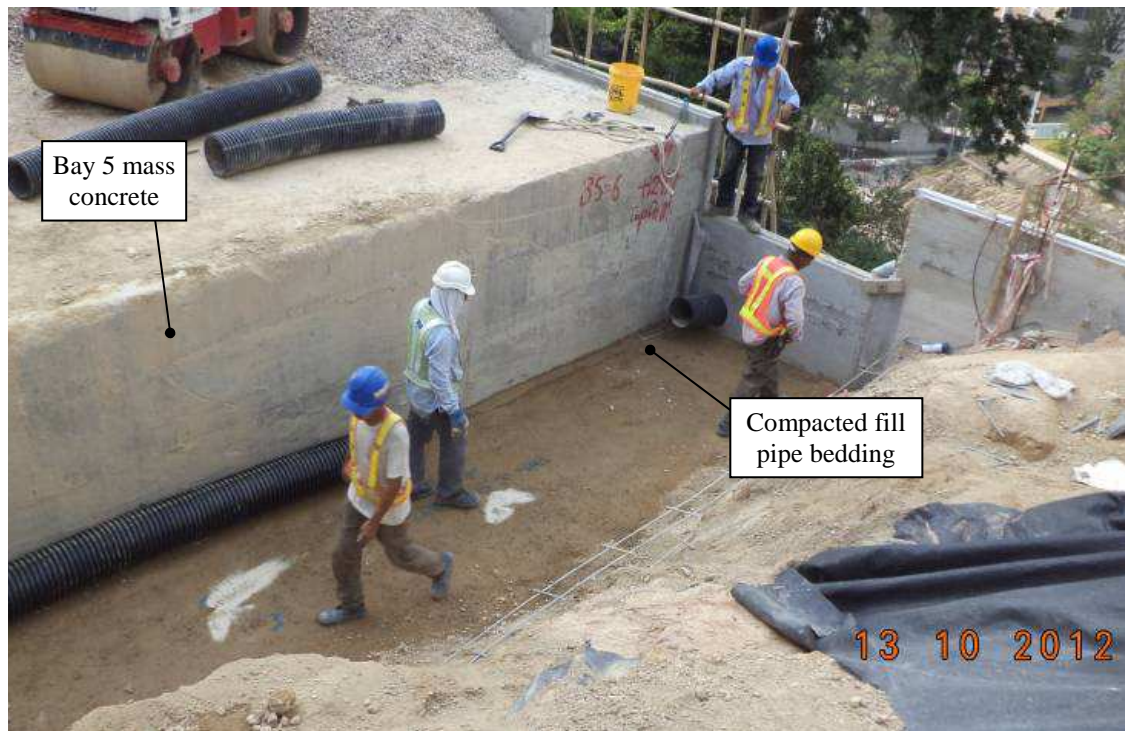
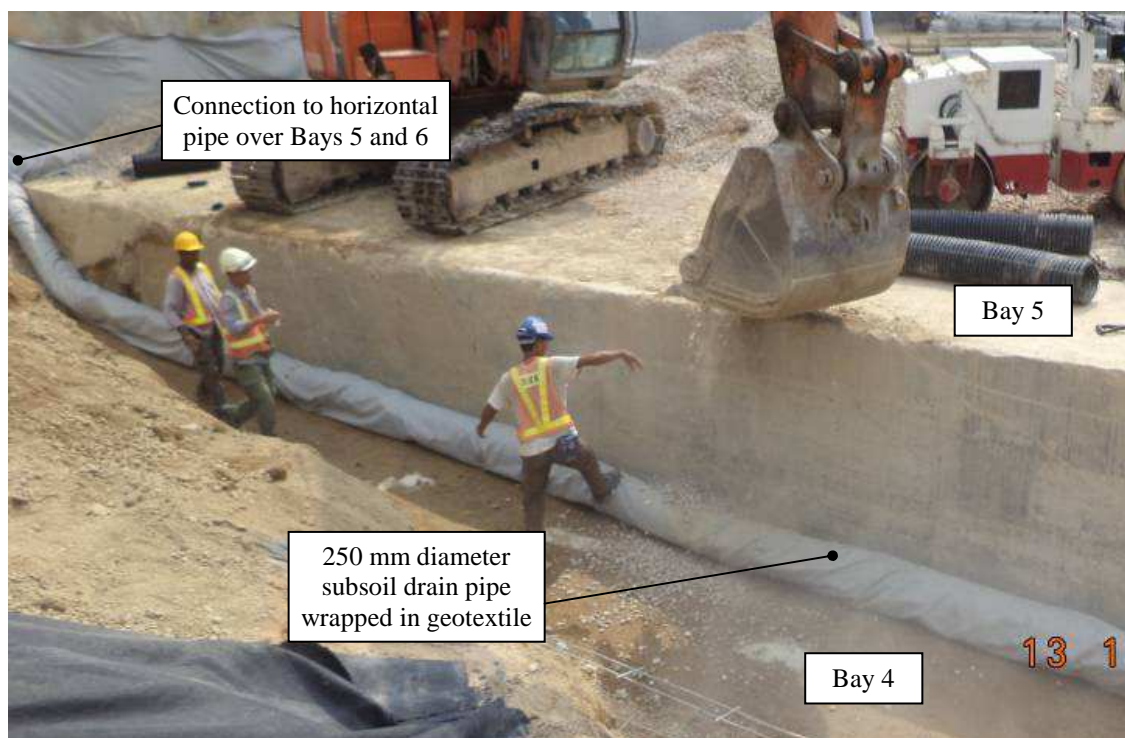
(a) Installation of Subsoil Drain Pipe at Bay 4 (Photograph taken on 13 October 2012)

(b) Placement of Vertical Connecting Drainage Layer above Subsoil Drain Pipe (Photograph taken on 13 October 2012)

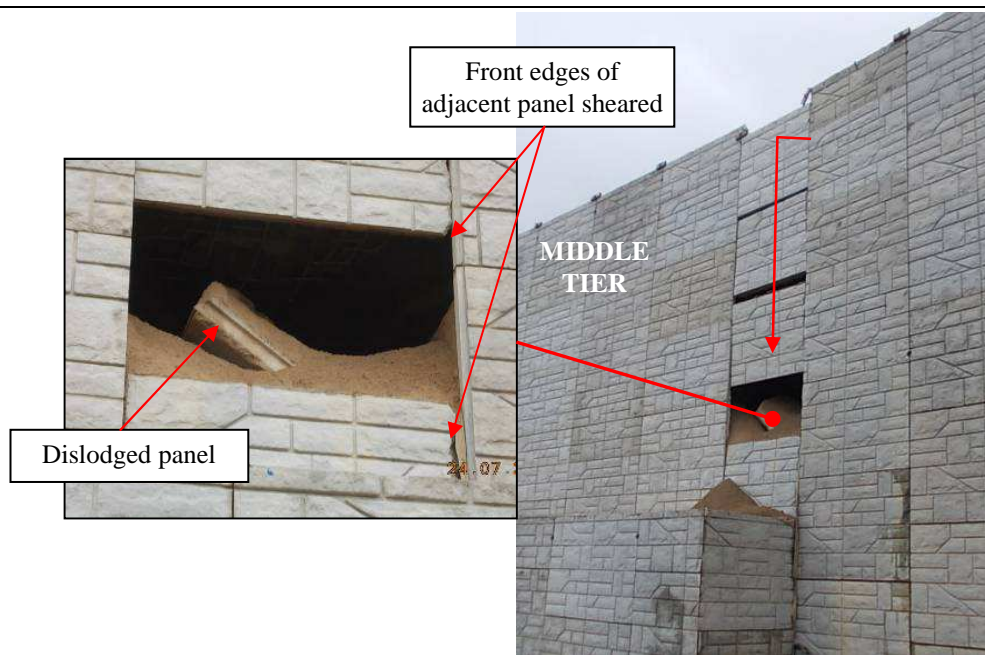
(a) Elevation View of July 2012 Incident at Bays 4/5

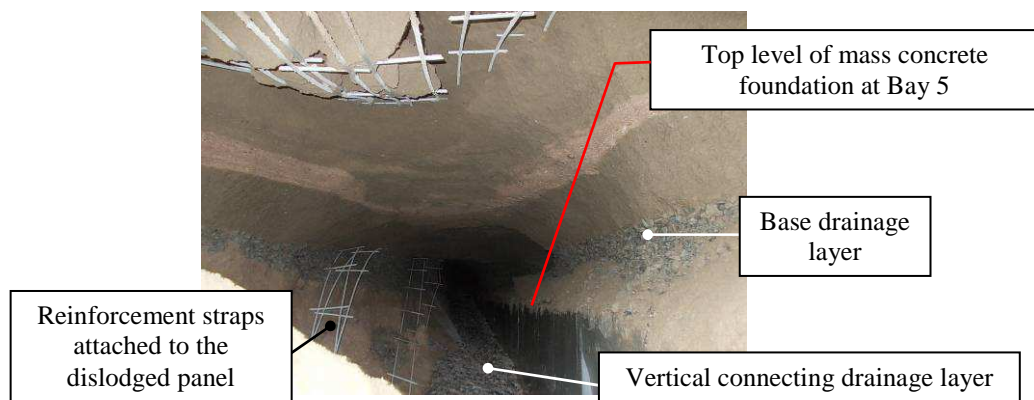
(b) Erosion alongside the Step in Mass Concrete Foundation at Bays 4/5

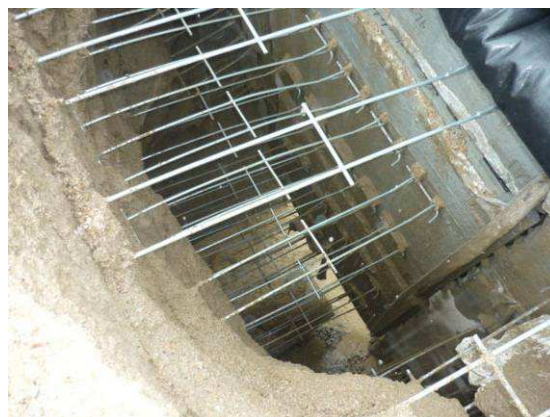
(c) Soil Loss behind Panels
