**REPORT ON THE 22 MAY 2013
LANDSLIDE ON A FILL SLOPE
AT A CONSTRUCTION SITE
ABOVE LEE ON ROAD,
SAU MAU PING**

*Fugro Scott Wilson Joint Venture
for
Geotechnical Engineering Office
Civil Engineering and
Development Department
The Government of The Hong Kong
Special Administrative Region*

December 2013
(minor amendments made in November 2020)

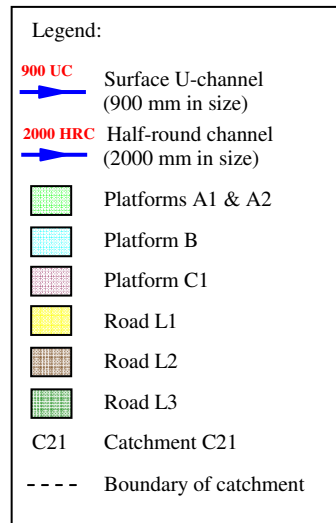
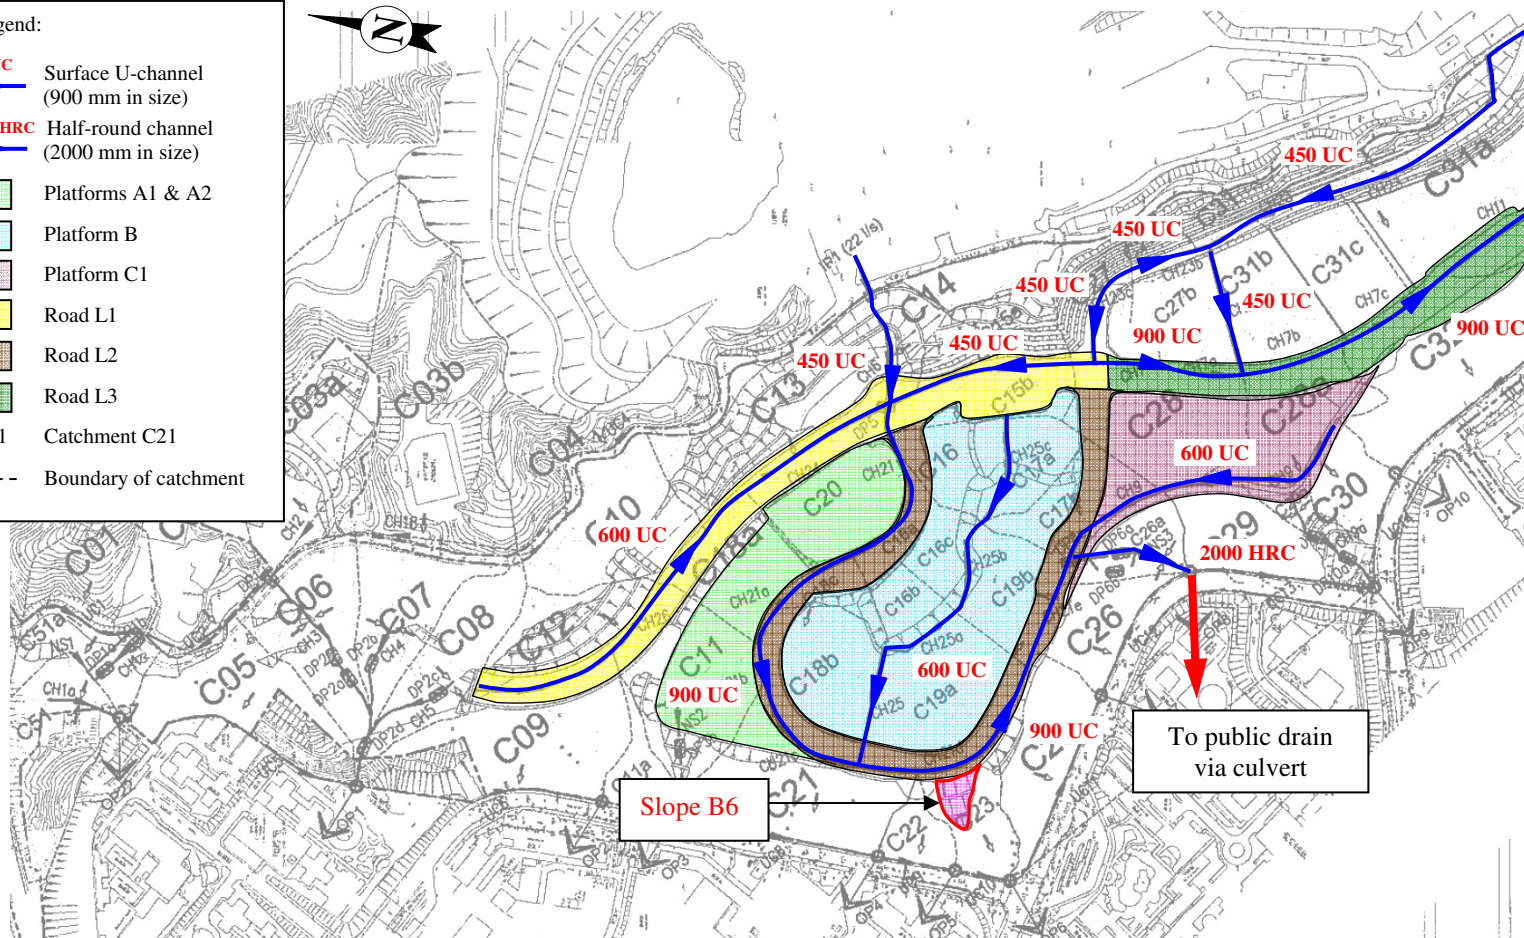
Figure 5.2 Schematic Layout Plan of Temporary Site Drainage Design

Based on the Contractor's latest temporary drainage design prior to the landslide (submitted to the Consultant on 9 May 2013), a series of U-channels, including a 900 mm U-channel along the crest of Slope B6, were to be provided (Figure 5.2). However, the channels

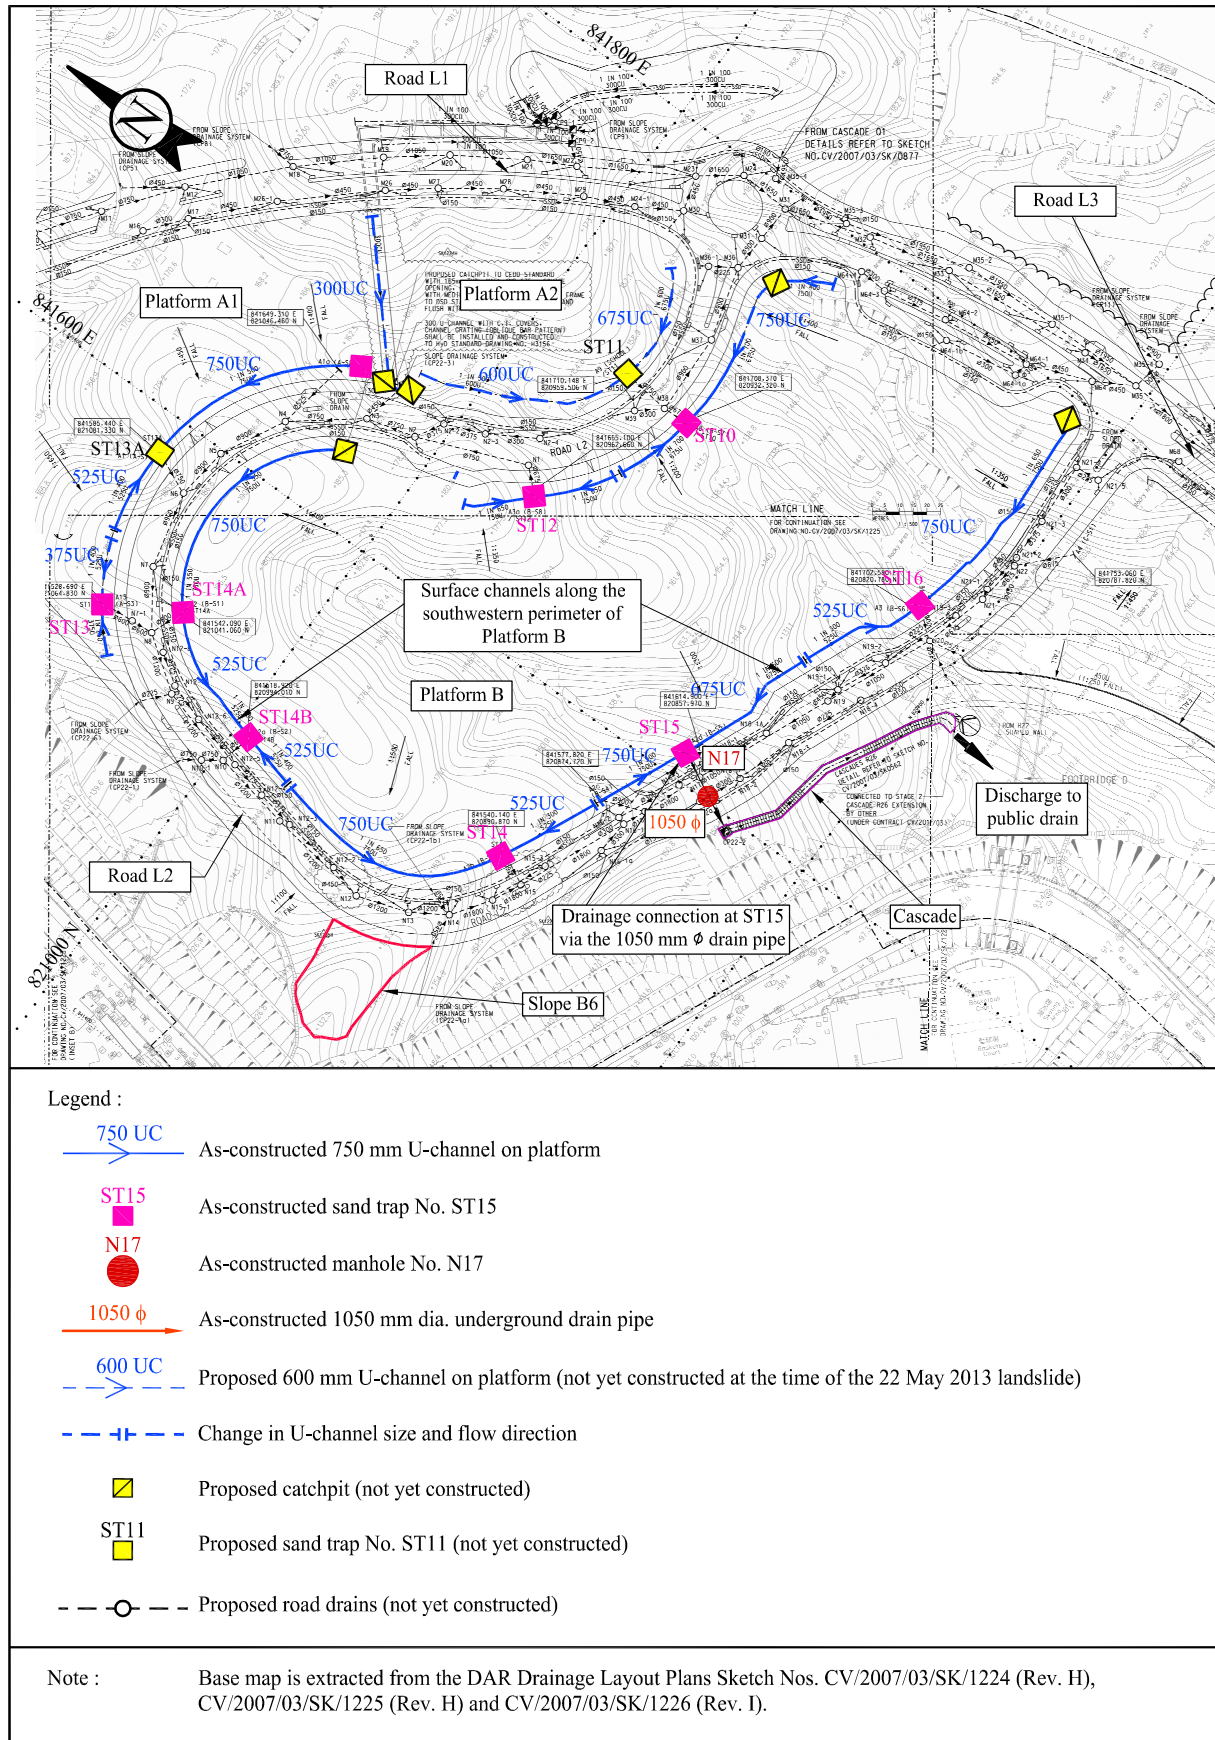
Figure 5.3 Layout Plan of Proposed Permanent Drainage Works

At the time of the landslide, the main drainage constructed over the northwestern portion of the DAR site comprised a series of U-channels and intervening sand traps along the periphery of Platform B (ranging in size from 525 mm to 750 mm) as shown in Figure 5.3. These drainage measures were part of the permanent drainage system for the DAR project (Figure 5.3). At Platform B, the U-channels generally have a fall of less than 1 in 220 in a herringbone fashion towards the sand traps (Figure 5.4(b)). The sand traps are intended to discharge flow into the drainage network under Road L2 as part of the permanent drainage system (Figure 5.3). Limited drainage works under Road L2 were constructed at the time of the landslide. Only one of the constructed sand traps (ST15 in Figure 5.3) was connected to the 2.5 m wide cascade channel, the main site drainage outlet (Figure 5.4). Given the as-built fall direction of these U-channels, surface flow against the invert fall would occur at some sections of U-channels (Figure 5.4), hampering the flow efficiency and capacity of these channels under the temporary drainage condition. The estimated size of the catchment for the platform U-channels was about 93,100 m² (i.e. Catchment 1 as shown in Figure 5.1).

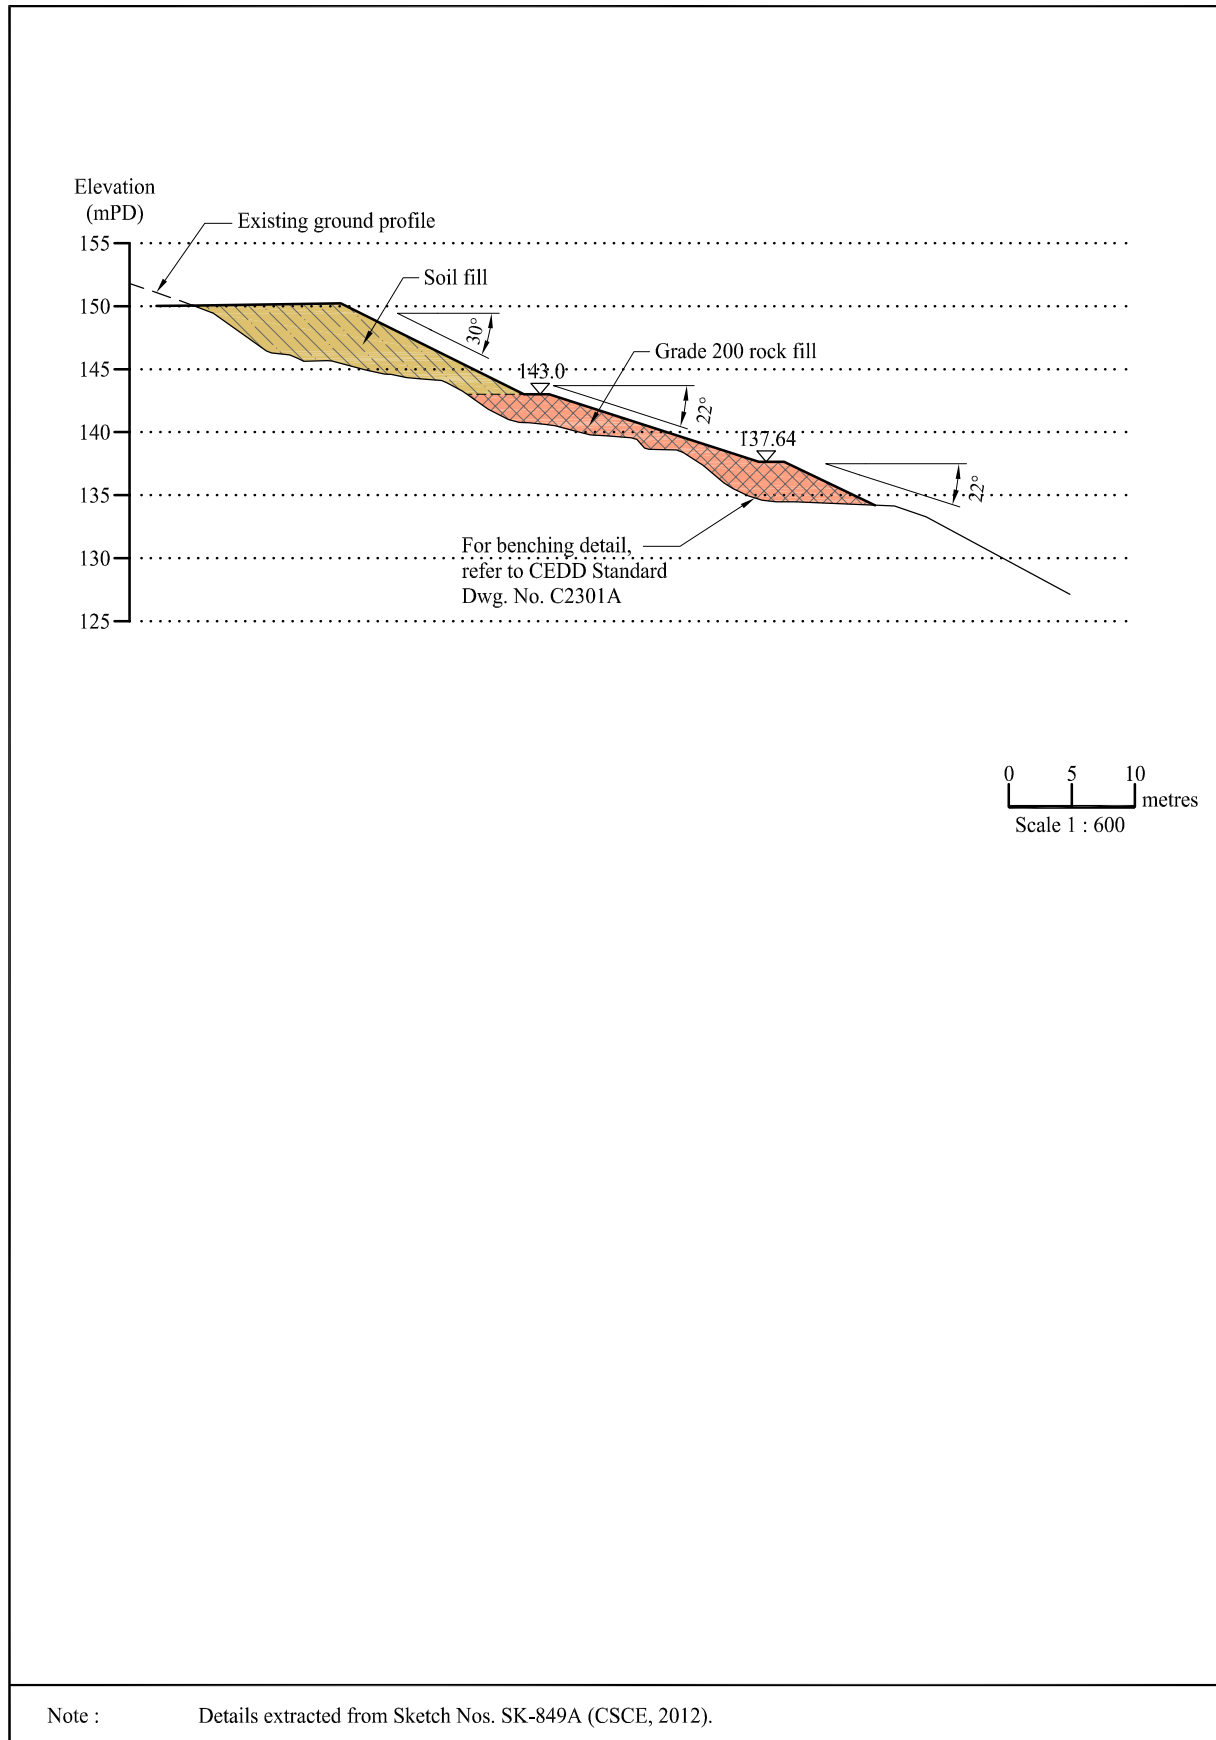
Figure 6.1 Typical Cross-section of Slope B6

Slope B6 was designed as a 17 m high fill slope formed in three slope batters with a gradient of 22° to 30° (Figure 6.1). The lower two batters were formed with rockfill and the upper batter with soil fill. A surface drainage system comprising 300 mm U-channels along the slope crest and berms, and 300 mm stepped channels along the northern and southern perimeters of the slope was proposed. Benching of the in-situ ground was specified and an internal drainage blanket comprising prefabricated drain, geotextile and filter pipes was proposed at the in-situ ground/fill interface. The rockfill portions were to be covered by a layer of top soil and the final surface of Slope B6 would be hydroseeded and erosion control matting would also be provided.

There was no evidence to suggest that the design and construction of Slope B6 contributed to the failure.

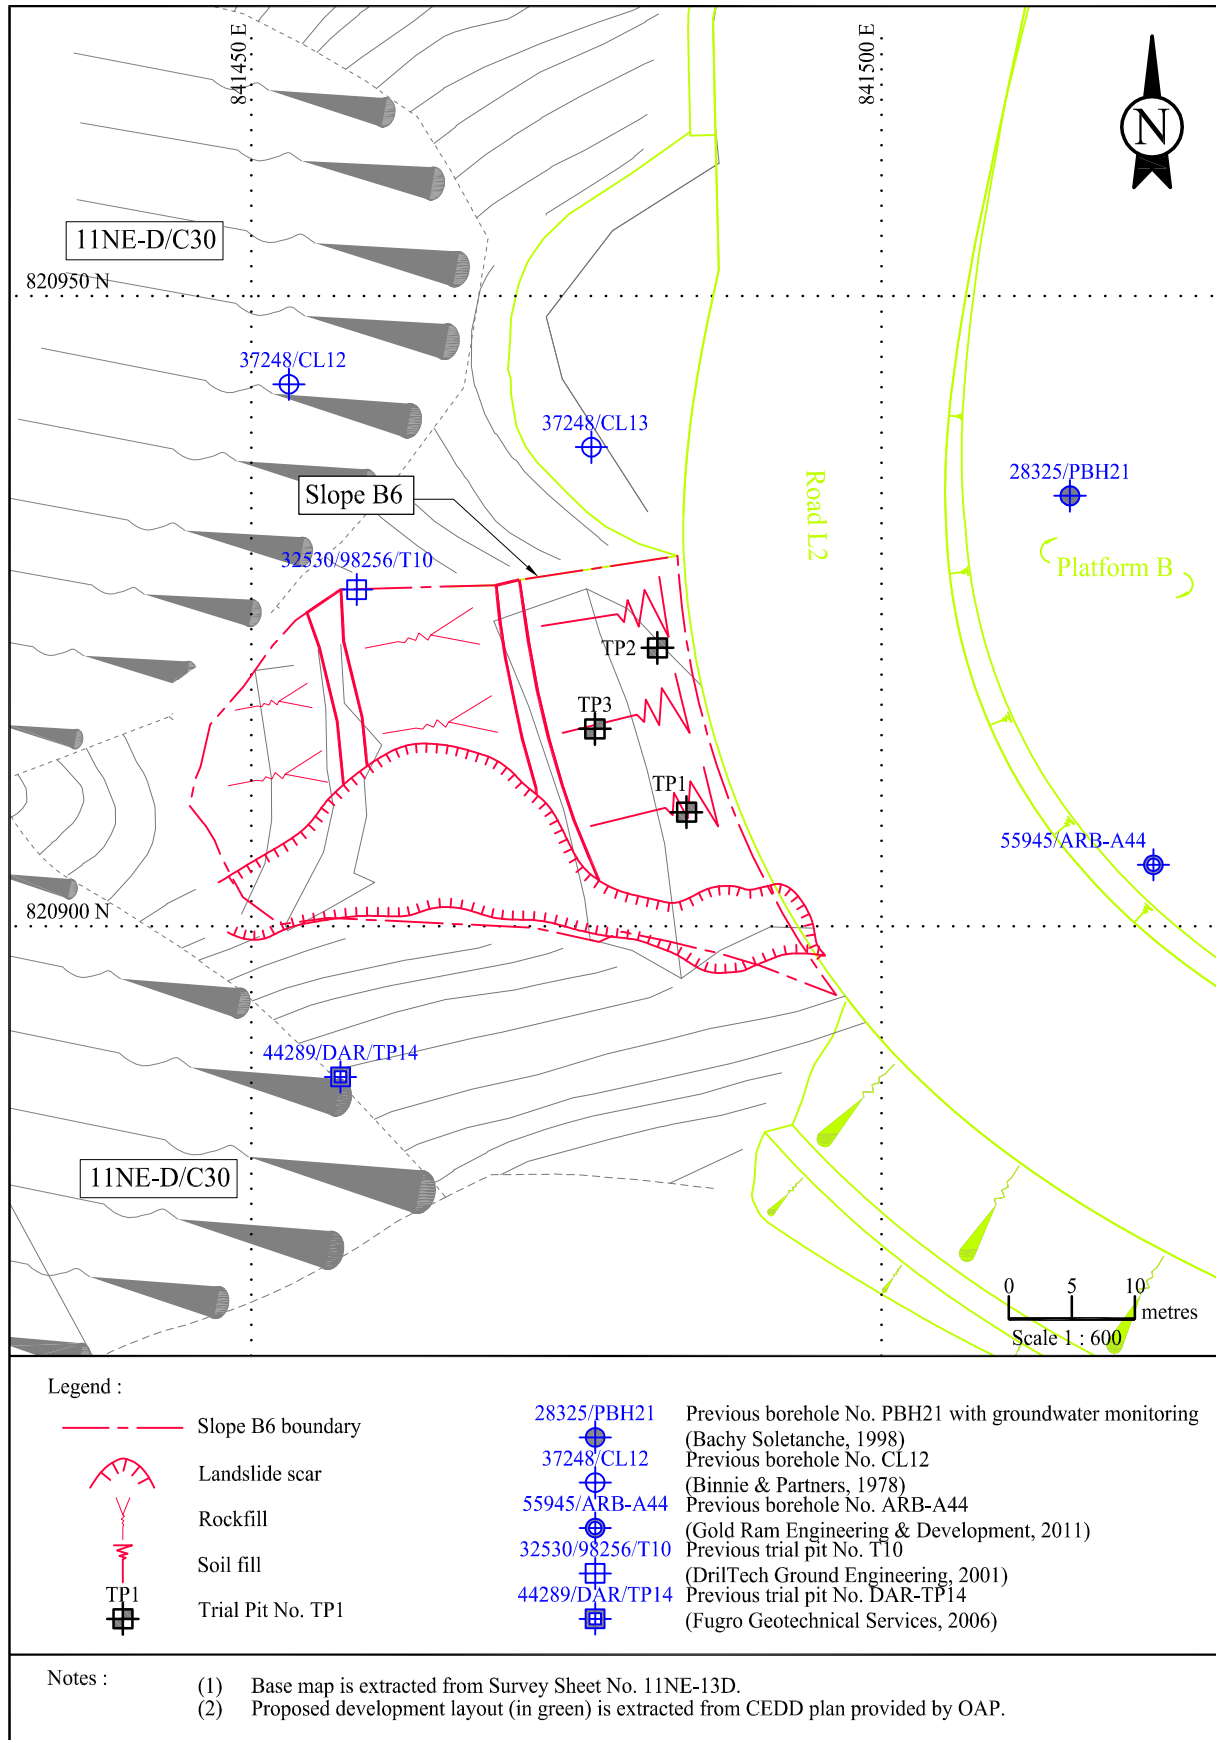
Figure 7.1 Ground Investigation Plan at Slope B6

Previous ground investigation (GI) records in the vicinity of Slope B6 include four drillholes and two trial pits (Figure 7.1). GI records indicate that the fill was likely to be underlain by around 8 m thick saprolite with bedrock at around +137 mPD below the slope crest. Groundwater monitoring records near the slope crest indicate that the groundwater (between 28 March 1998 and 4 April 1998) was below +147 mPD, some 3 m below the slope crest.

Additional post-failure ground investigation comprising 3 trial pits was undertaken on Slope B6 (Figure 7.1). Significant seepage was not observed in any of these trial pits.

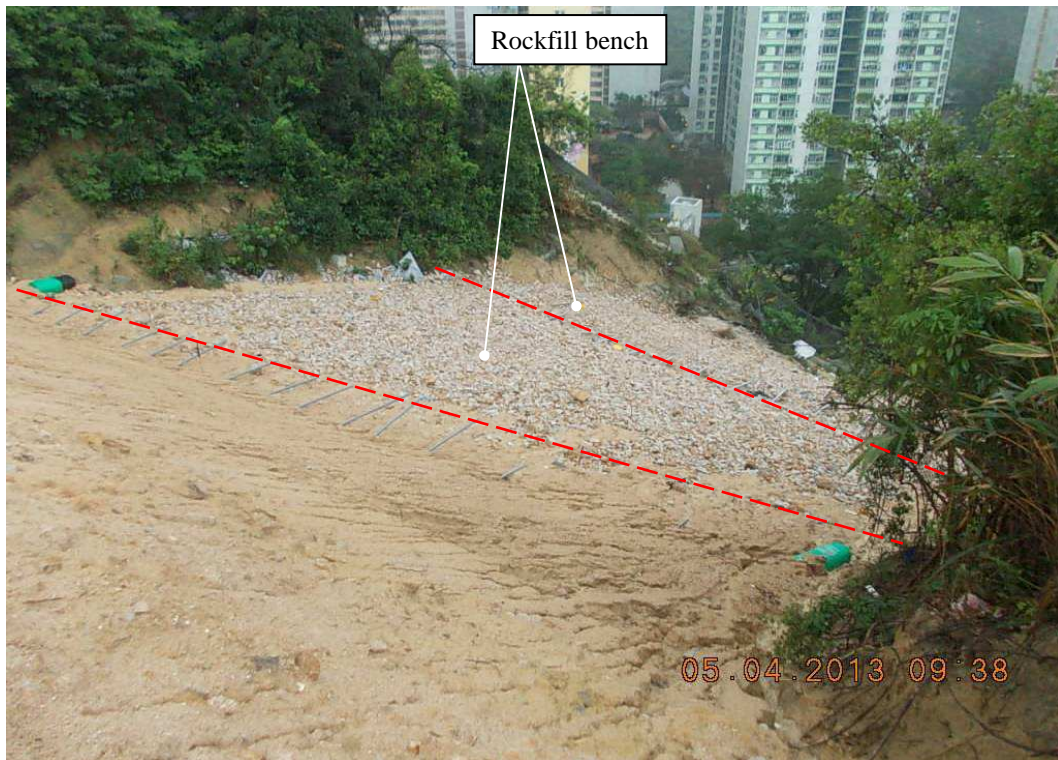
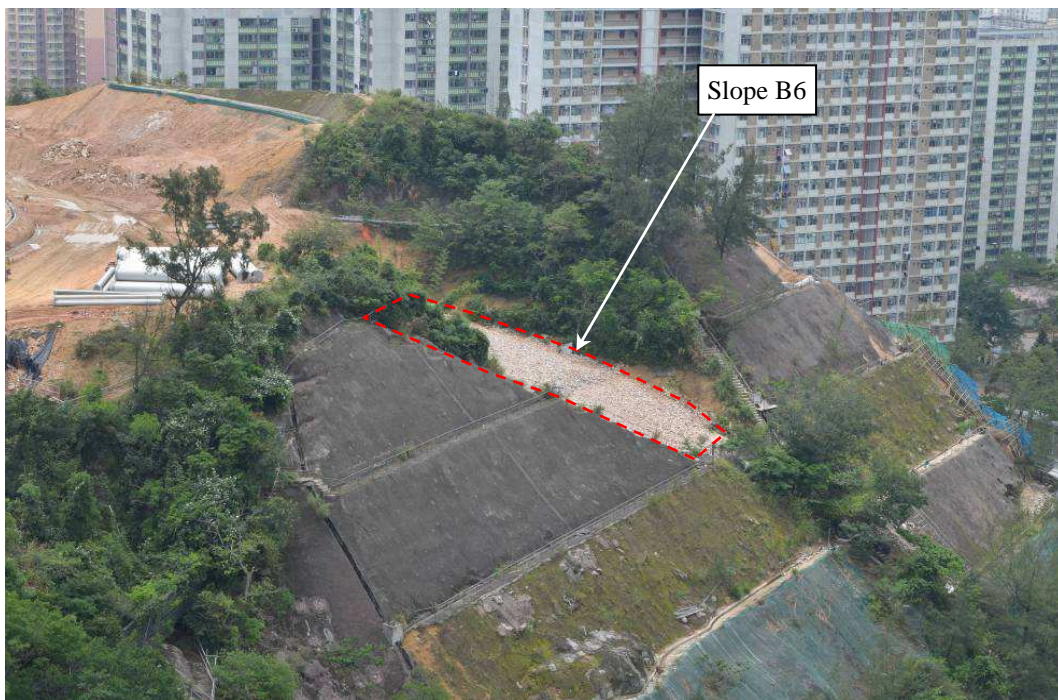
Plate 3 Conditions of Slope B6 prior to the 22 May 2013 Landslide

The construction of Slope B6 commenced around November 2010 and the slope filling works were substantially completed in February 2013 (Plate 3). Construction records showed that benching was provided at the base of the slope (Plate 20). According to the Contractor's method statement, vibratory roller was used for compaction of the fill materials. In-situ density tests conducted by the Government Public Works Laboratories showed the compacted soil fill complied with the specifications.

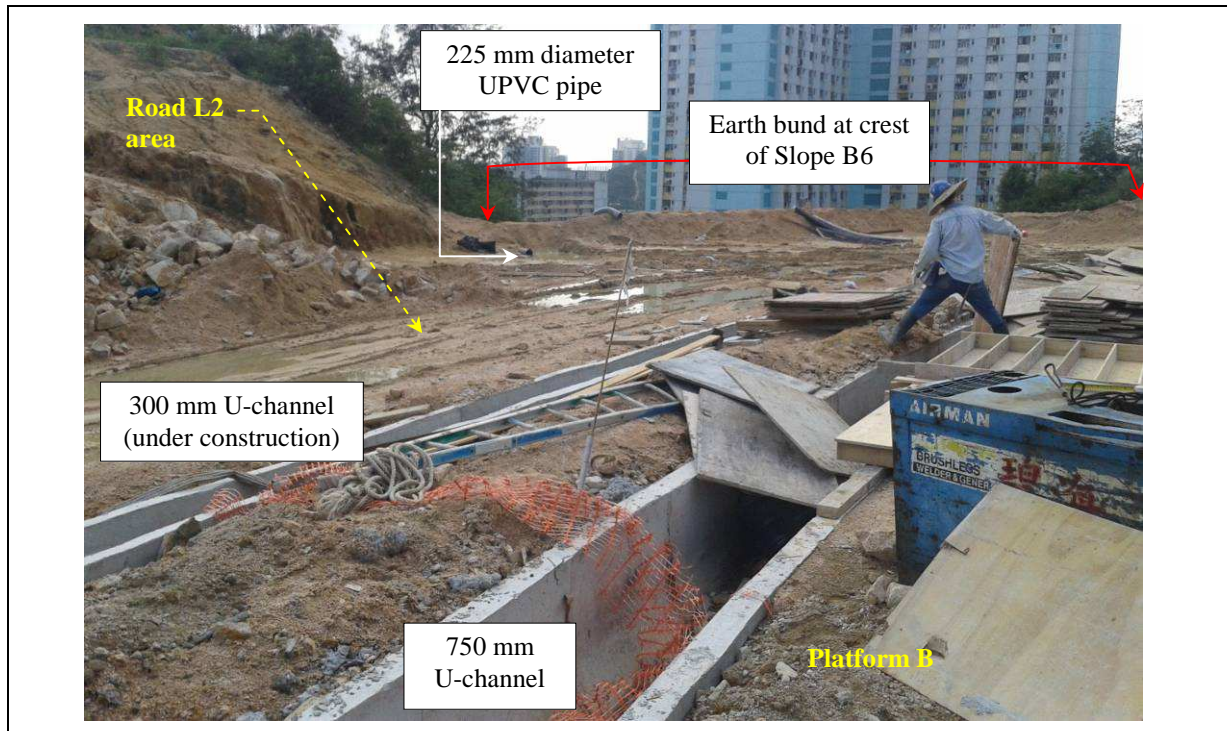
Plate 4 Condition of the Crest Area of Slope B6 prior to the 22 May 2013 Landslide (Photograph taken on 9 May 2013)

over the northwestern portion of the DAR site were under construction at the time of the incident. Based on record photos and post-failure inspections, the crest area of Slope B6 was built with a 1 m high temporary earth bund and equipped with a standby electric pump apparently provided for temporary drainage purposes (Plates 4 and 19).

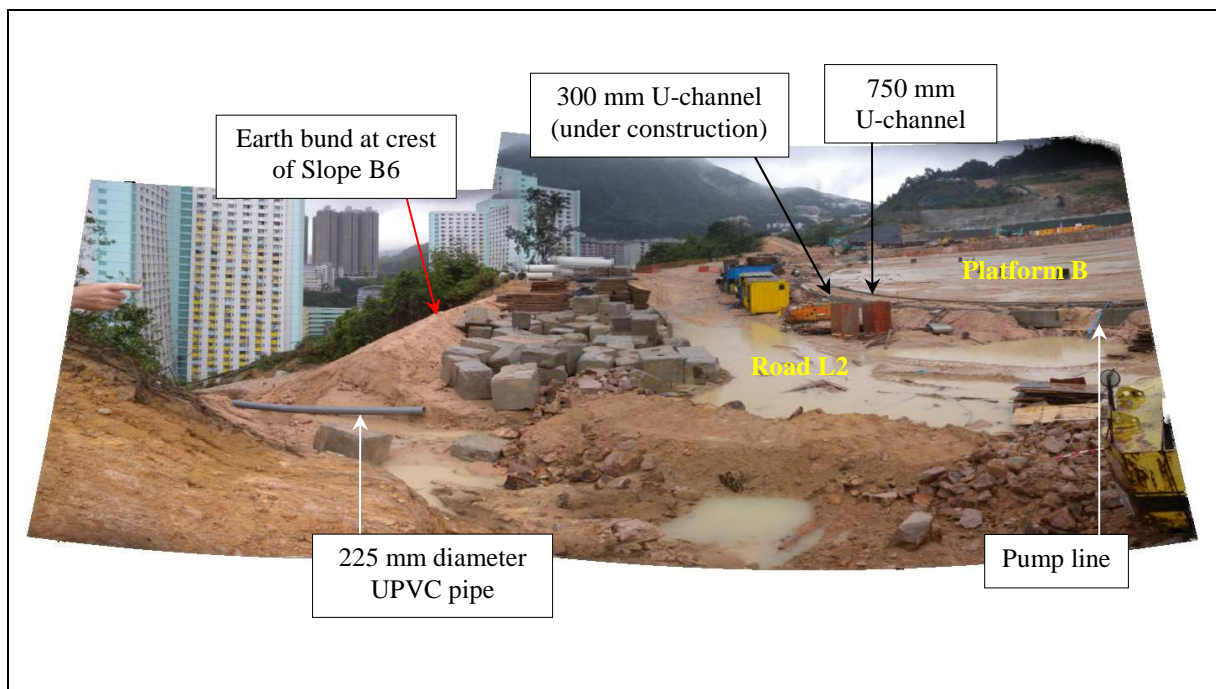
Runoff from Platforms A1 and A2 and Road L2 in the northwestern part of the DAR site (i.e. Catchment 2 in Figure 5.1) was another source of water reaching the crest area of Slope B6. The estimated size of the catchment was about 64,400 m². The site drainage system in this area was under construction at the time of the landslide and was not functional. The runoff would have flowed along a temporary haul road (Road L2) leading towards the crest area of Slope B6, which was a low point on the site.

Plate 5 Topographical Low Point at the Crest of Slope B6 (Photographs taken on 23 May 2013)

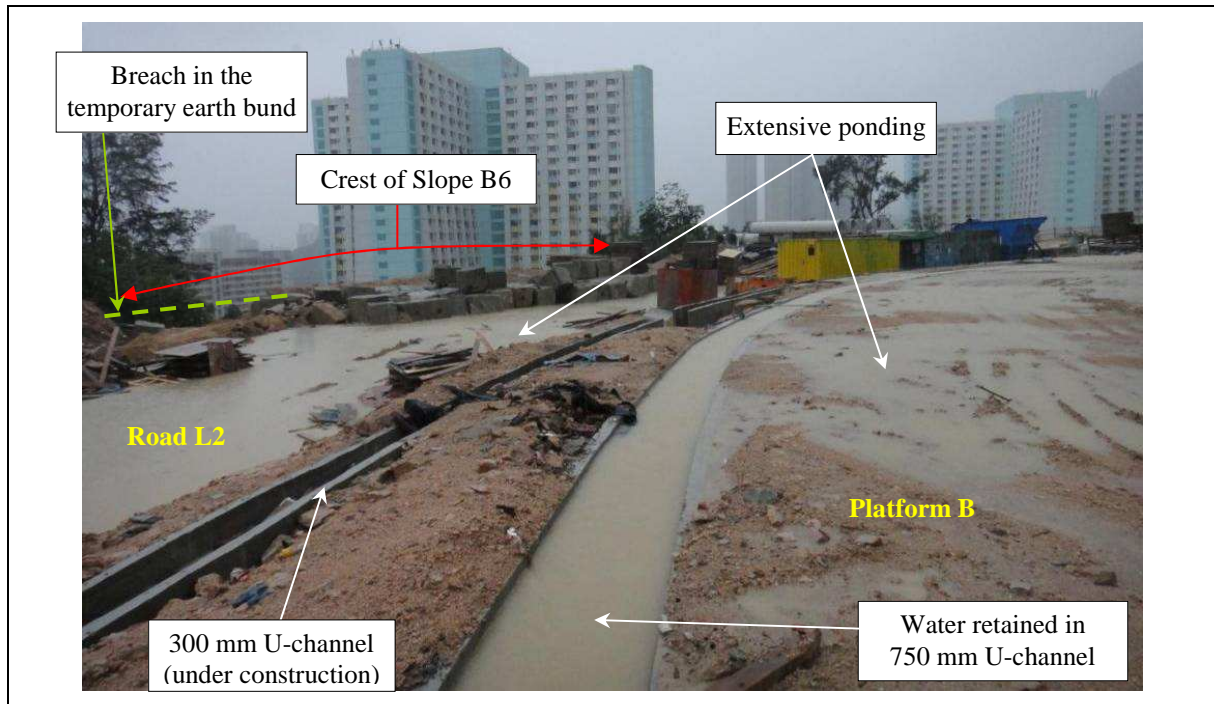
Plate 11 Crest Area of Slope B6 after the 22 May 2013 Landslide (Photograph taken at about 9:00 am on 22 May 2013)

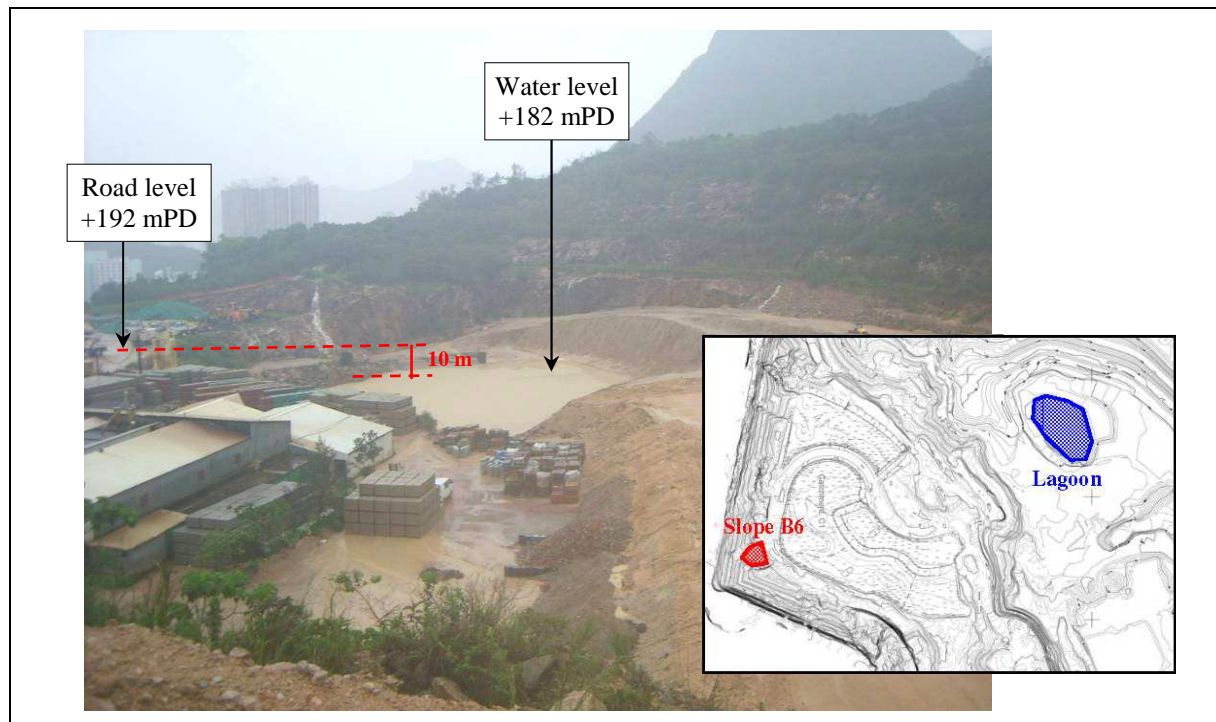
Plate 13 Condition of the Lagoon within the Anderson Road Quarry above the Northwestern Part of the DAR Site (Photograph taken in the morning of 22 May 2013)

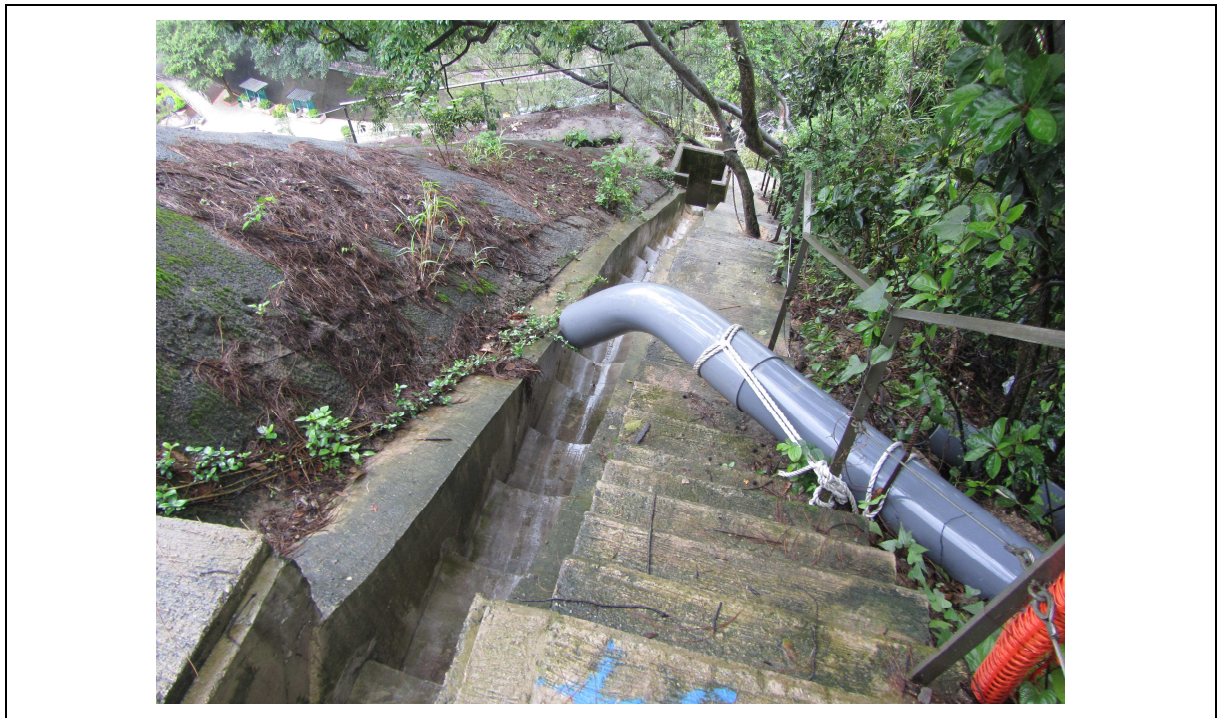
Plate 18 Discharge of 225 mm Diameter UPVC Pipe to Surface Drainage System of Slope 11NE-D/C30 (Photograph taken on 25 May 2013)

As discussed above, the crest area of Slope B6 was provided with a 1 m high temporary earth bund and a 225 mm diameter UPVC pipe connected to the surface drainage system of an adjacent slope (Plate 18). The standby electric pump was provided to pump out water accumulated at the crest area of Slope B6 back to the nearby periphery U-channels along Platform B (Plate 19). However, according to the Contractor, the pump was not in operation at the time of the landslide.
