REPORT ON THE FEI TSUI ROAD LANDSLIDE OF 13 AUGUST 1995

Volume 2

FINDINGS OF THE LANDSLIDE INVESTIGATION

*Geotechnical Engineering Office
Civil Engineering Department
Hong Kong Government*

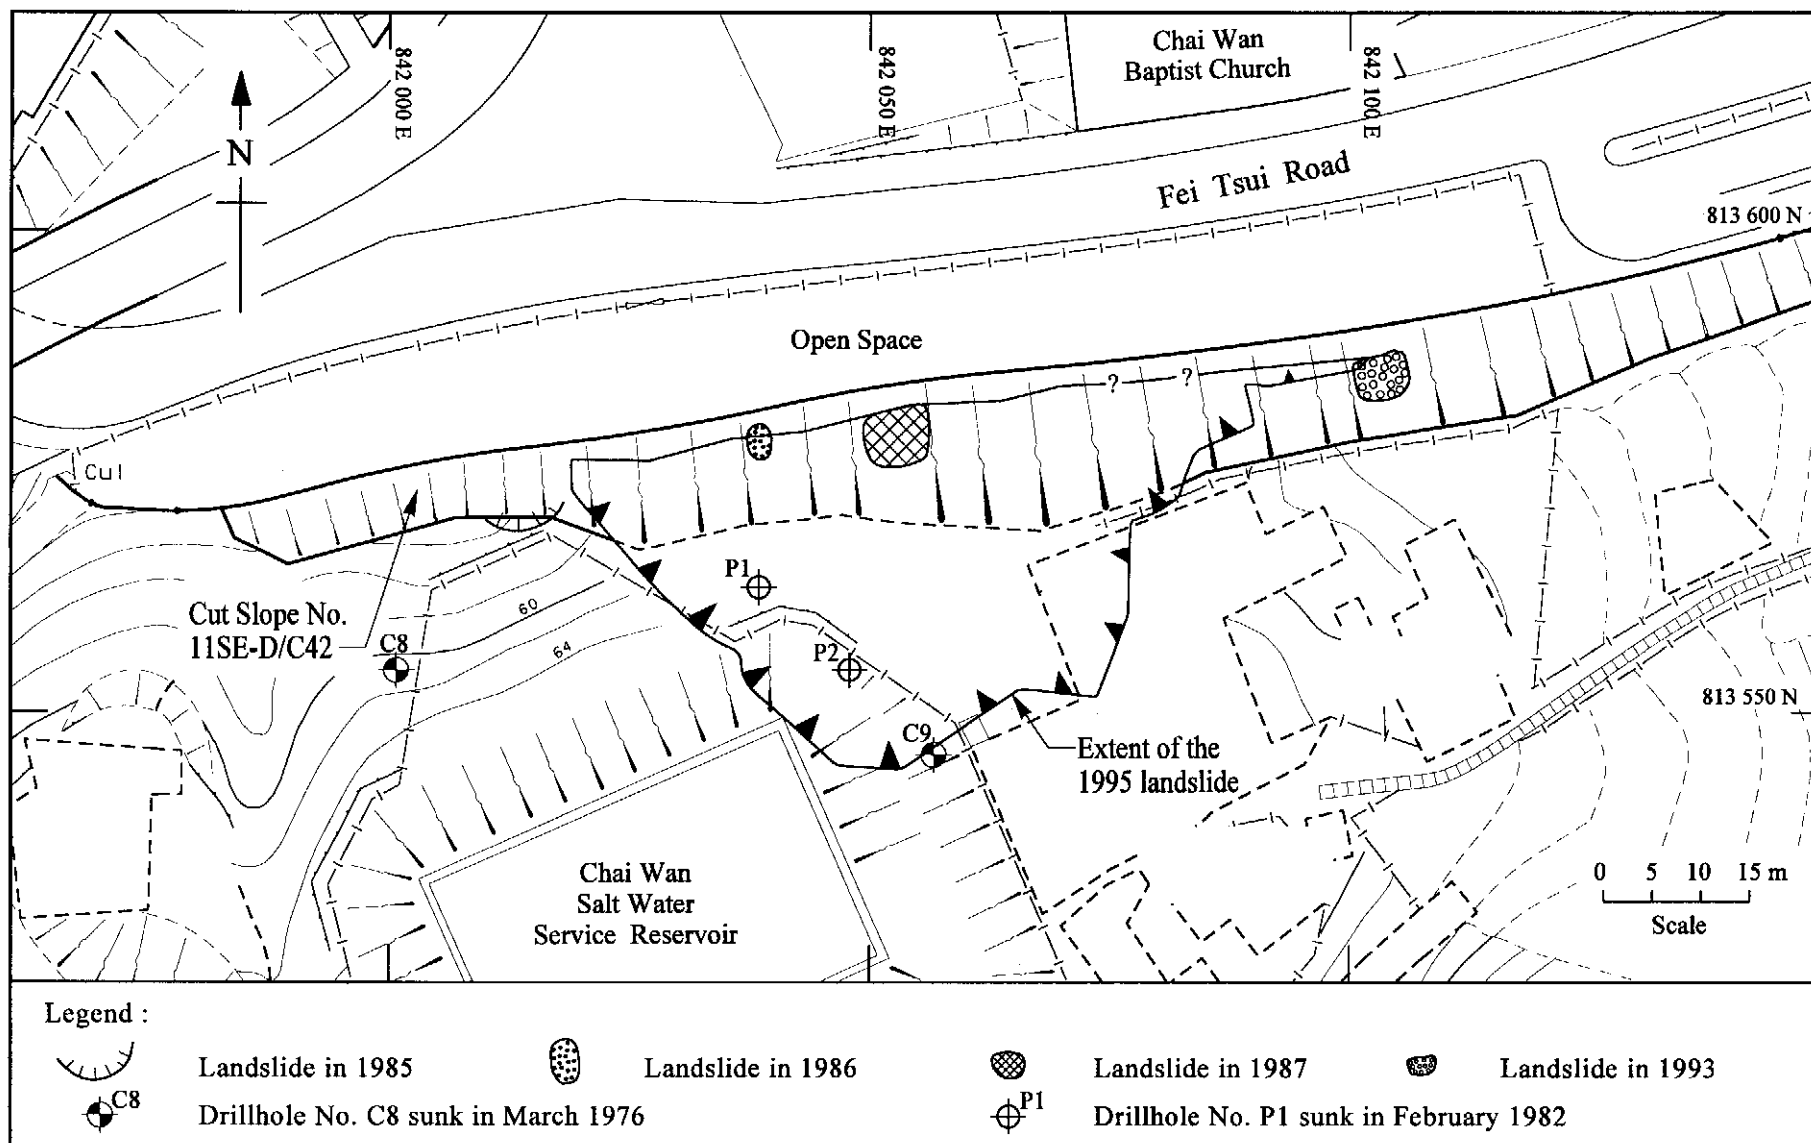
Figure 6 - Locations of Previous Landslides at Slope No. 11SE-D/C42

A number of small-scale landslides had occurred previously at the cut slope (Figure 6).

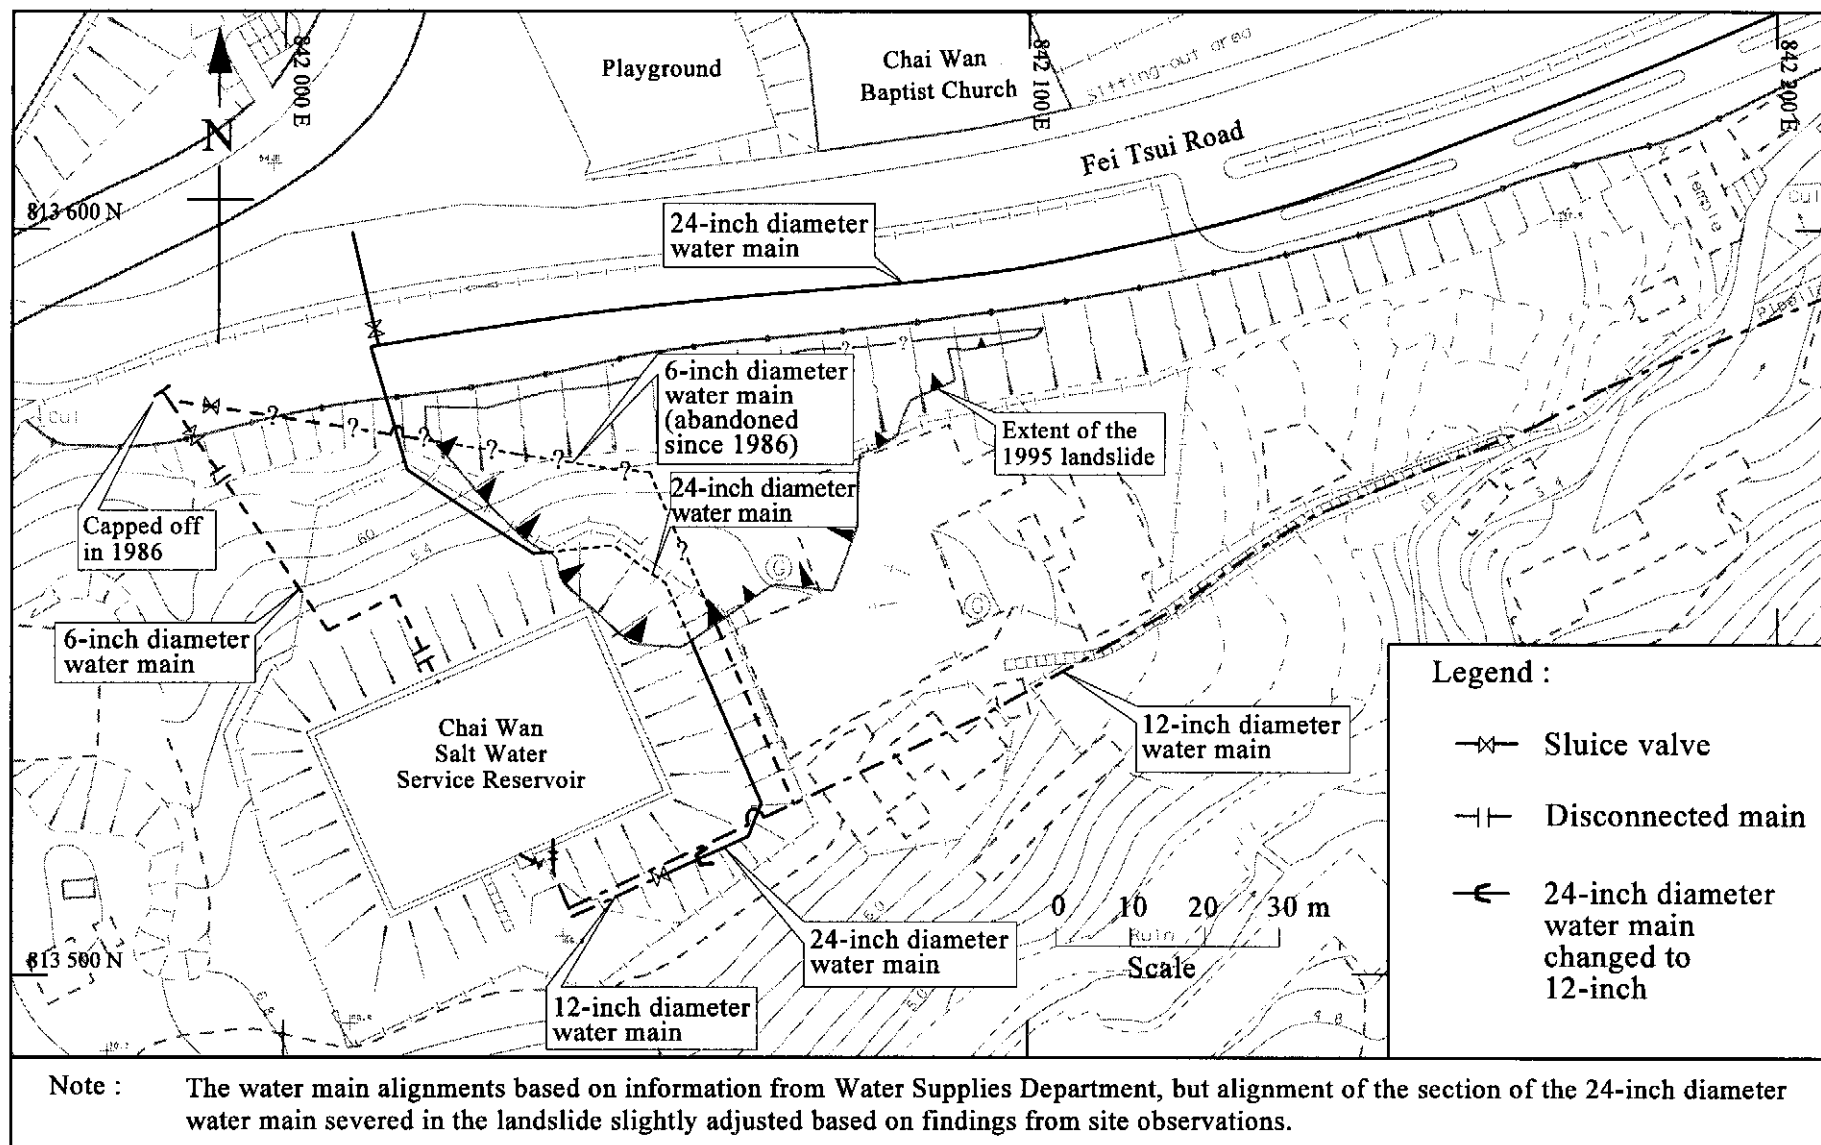
Figure 14 - Layout of Water Mains before the Landslide

and west compartments. According to WSD's records, two underground water mains traversed the western part of the site before the landslide. The 24-inch diameter water main was constructed of asbestos cement pipes about 4 m long, connected by joints which comprised asbestos cement sleeves and rubber sealing rings. The water main supplied salt water from the service reservoir to the Chai Wan area. The 6-inch diameter water main had been abandoned and capped off at a point near the toe of the cut slope (Figure 14) since 1986.

According to WSD's records, the section of the abandoned 6-inch water main that was severed in the landslide was connected to the service reservoir before the slope failure. Only 2.4 m of the water main were recovered by the WSD from the debris and less than 20 m of the water main were identified by the GEO from photographic records of the landslide debris. This is far short of the approximate 55-m length according to WSD's records of the water main alignment (Figure 14). Hence, there are uncertainties about the actual alignment and condition of this water main.

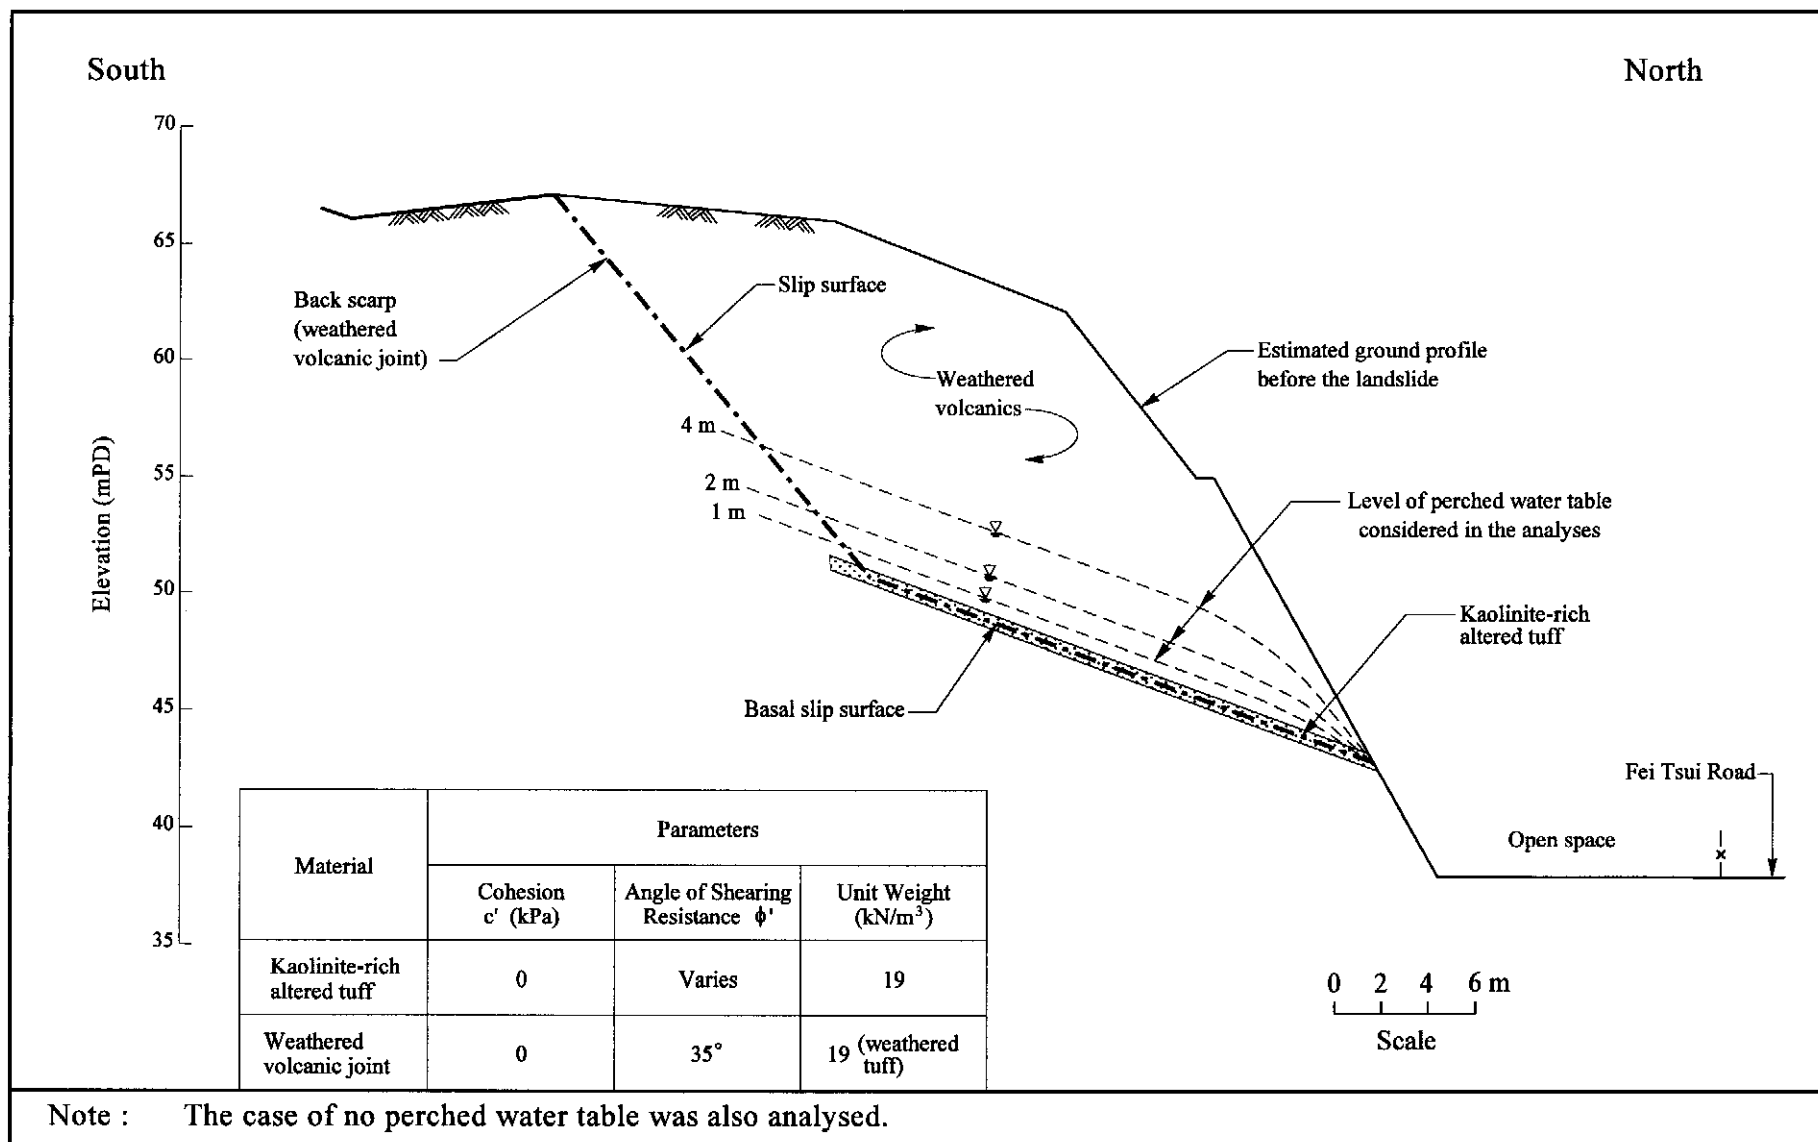
Figure 18 - Representative Cross-section of the Landslide for Theoretical Stability Analyses

Information obtained from the post-failure ground investigation field work, laboratory testing, and site observations and measurements was used in the analyses. A representative cross-section of the landslide site and the input parameters adopted in the analyses are shown in Figure 18. A perched water table up to 4 m above the altered tuff layer at the time of the landslide was assumed in the analyses.

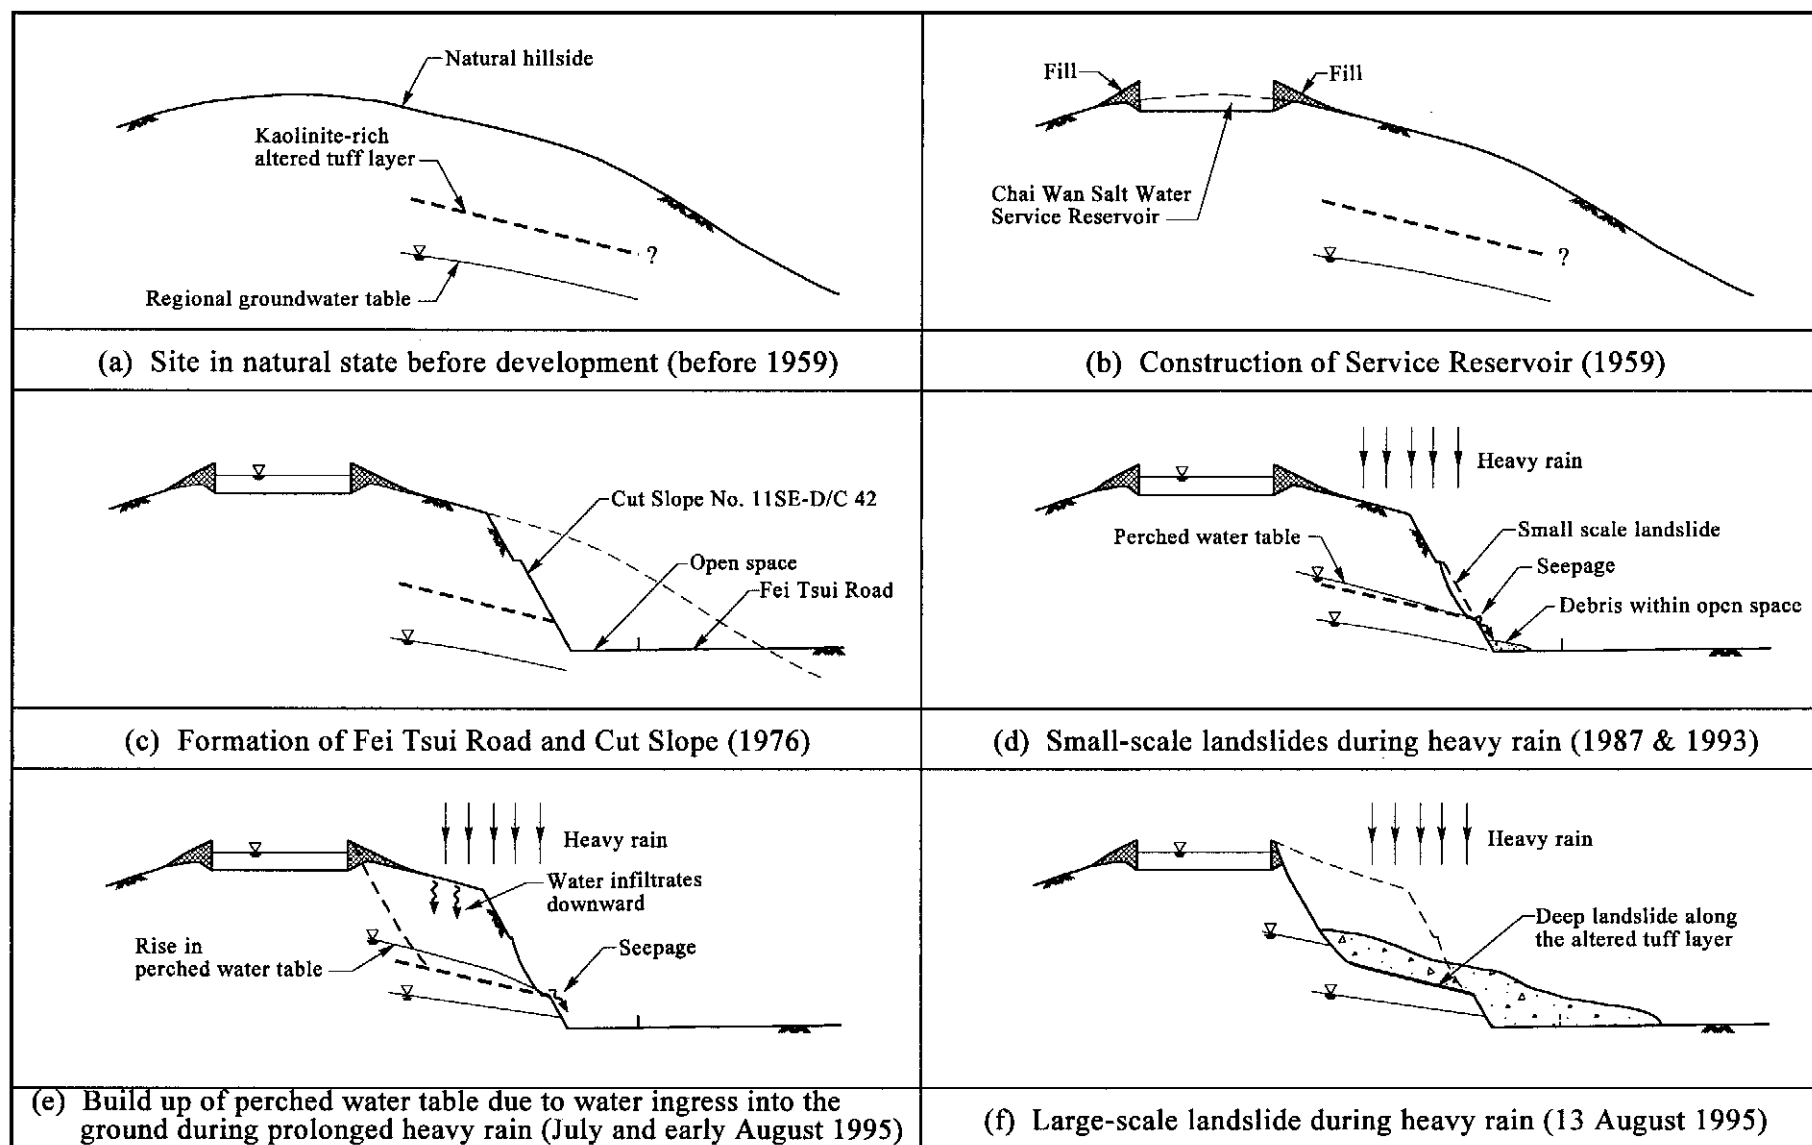
Figure 20 - Probable Sequence of Events

The re-constructed sequence of events which it is believed led to the landslide is illustrated in Figure 20.

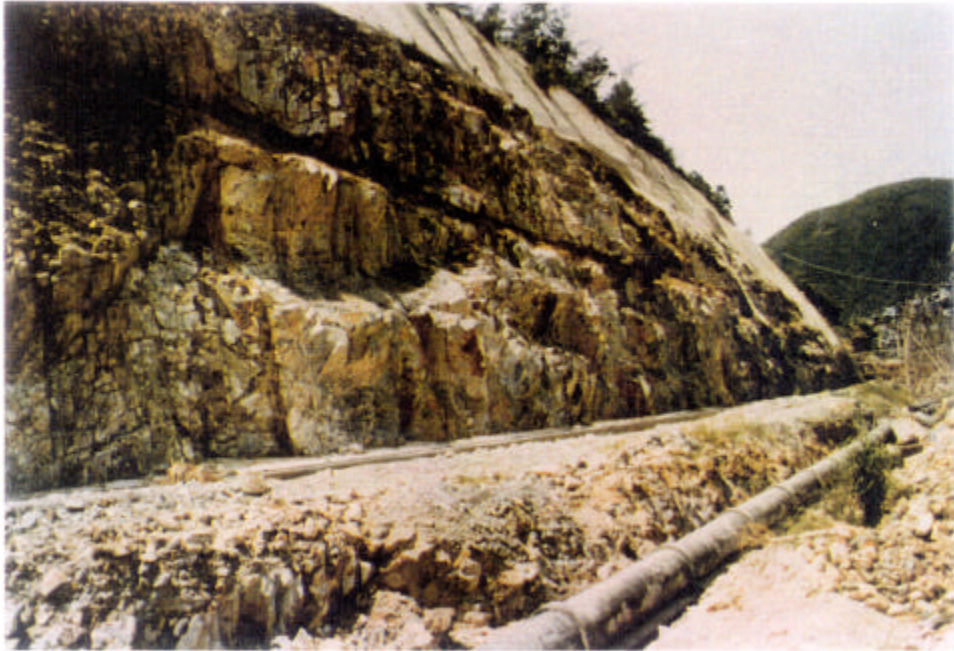
Plate 2 - Photograph of Cut Slope No. 11SE-D/C42 Taken after Slope Formation
(Reproduced from Plate 8 of Binnie, 1977. See Figure 21 for Location)

B&P observed that there was "a 4' wide berm at mid-height" and "beneath the berm the exposed rock face is closely jointed fresh to slightly decomposed volcanic rock with a prominent horizontal weathered seam midway between the road and the berm (plate 8). Beneath the service reservoir we noted seepage along sub-horizontal joints". Plate 8 in B&P's report is given as Plate 2 in this landslide investigation report.
