REPORT ON THE SHUM WAN ROAD LANDSLIDE OF 13 AUGUST 1995

FINDINGS OF THE LANDSLIDE INVESTIGATION

*Geotechnical Engineering Office
Civil Engineering Department
Hong Kong Government*

April 1996

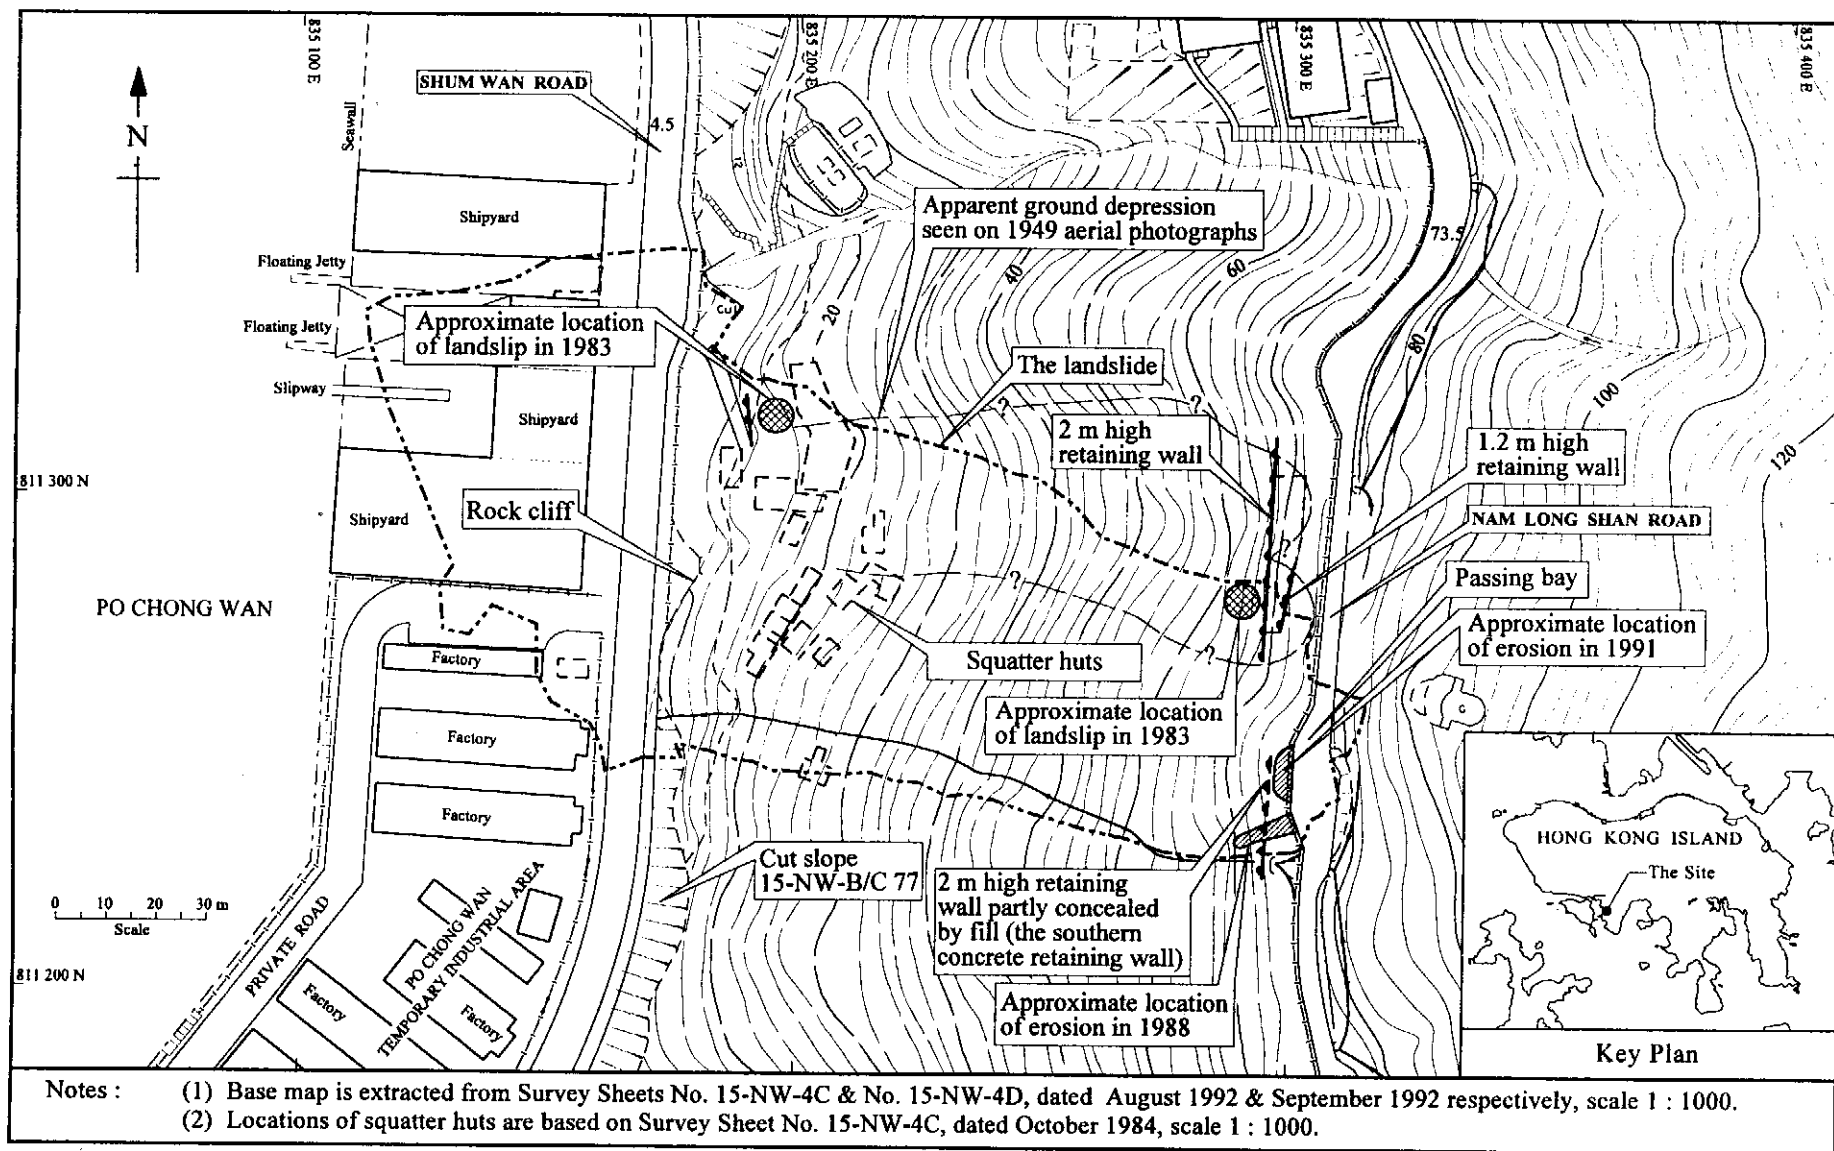
Figure 1 - Site Plan

A large ground depression in the hillside north of the landslide is apparent in the 1949 aerial photographs. It may indicate an ancient landslide scar (Figure 1).

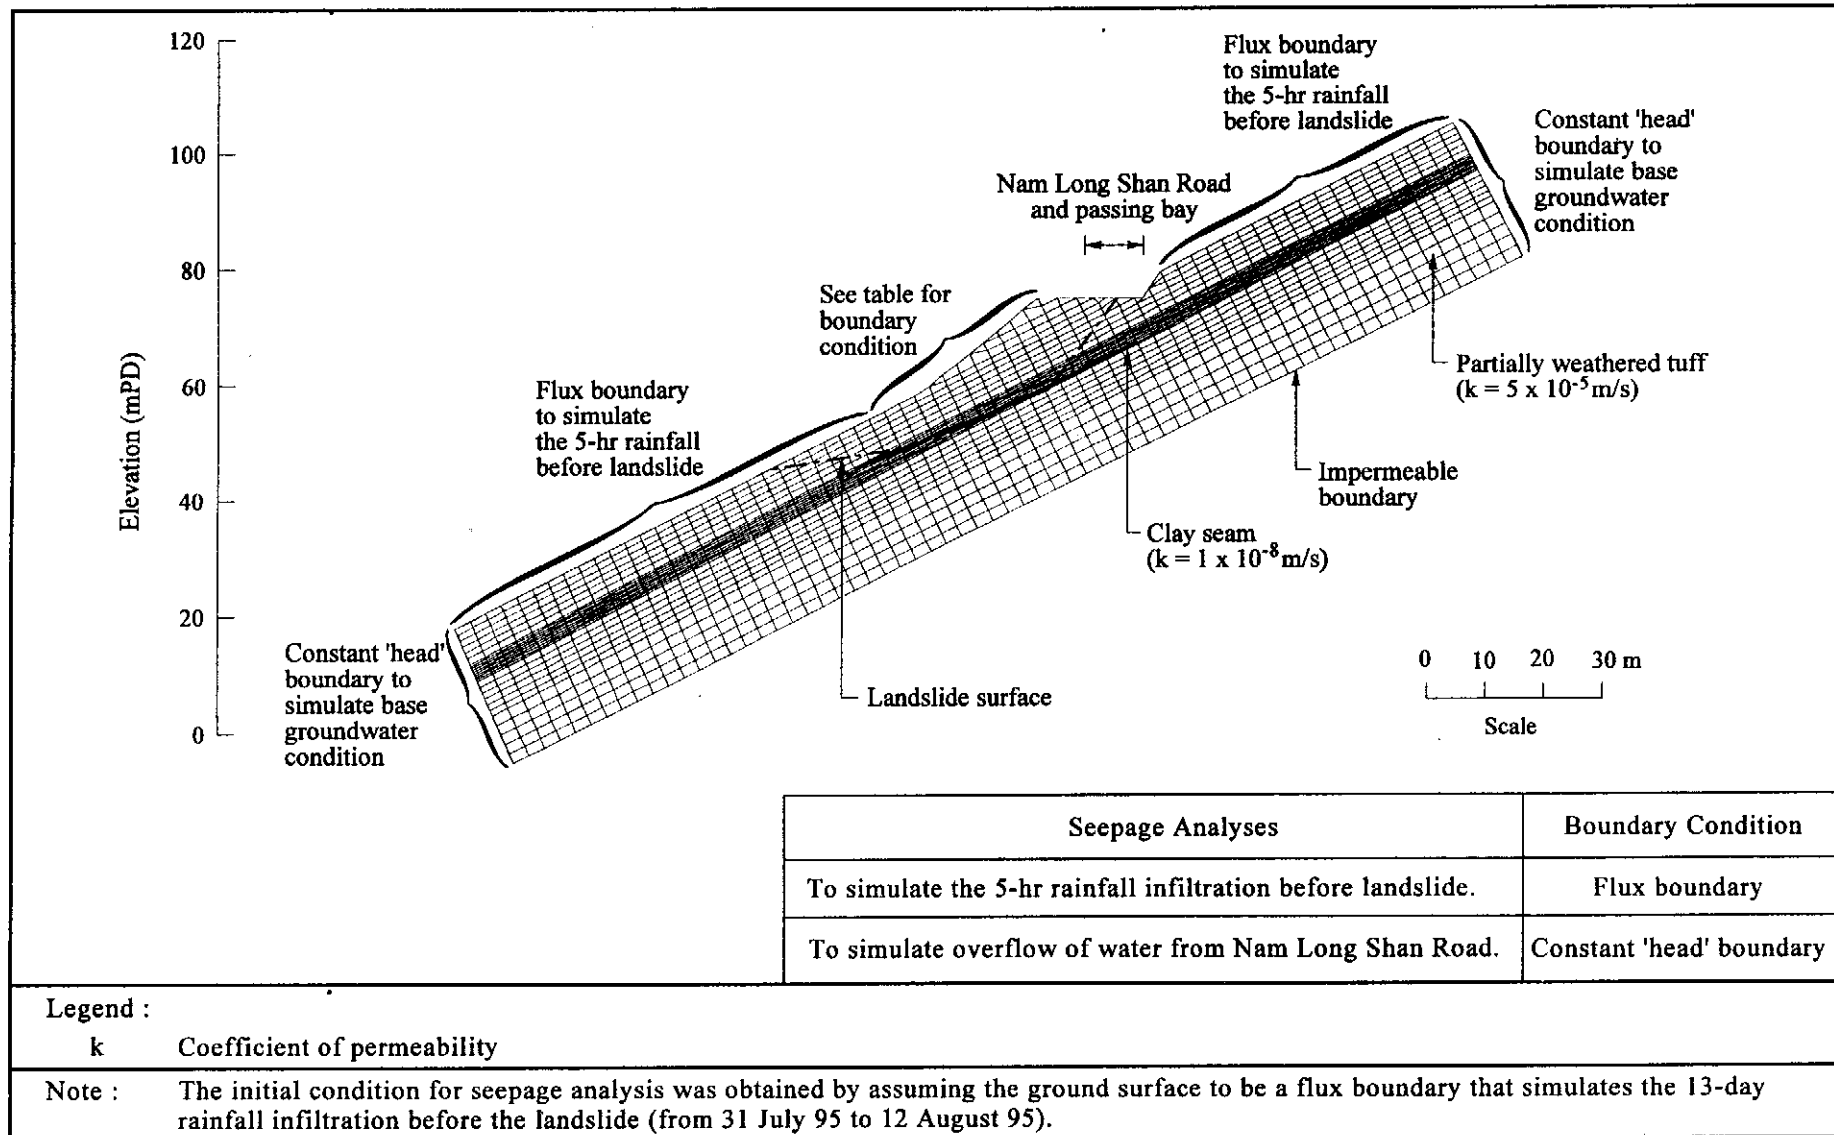
Figure 16 - Analytical Model for Seepage Analyses

About 380 mm of rain had fallen directly on the landslide area during the 30 hours prior to the main landslide. Water could have infiltrated the fill embankment below the passing bay and seep through the underlying partially weathered tuff. Seepage analysis using a finite element computer program (Figure 16) shows that this incident rainwater alone could have caused a low head (about 1 m) of perched water to build up on the clay seam.
