**DETAILED STUDY OF
20 AUGUST 2005 LANDSLIDE
BEHIND NURSES' QUARTERS
BLOCK A, QUEEN MARY
HOSPITAL, POK FU LAM**

GEO REPORT No. 242

Fugro Scott Wilson Joint Venture

**GEOTECHNICAL ENGINEERING OFFICE
CIVIL ENGINEERING AND DEVELOPMENT DEPARTMENT
THE GOVERNMENT OF THE HONG KONG
SPECIAL ADMINISTRATIVE REGION**

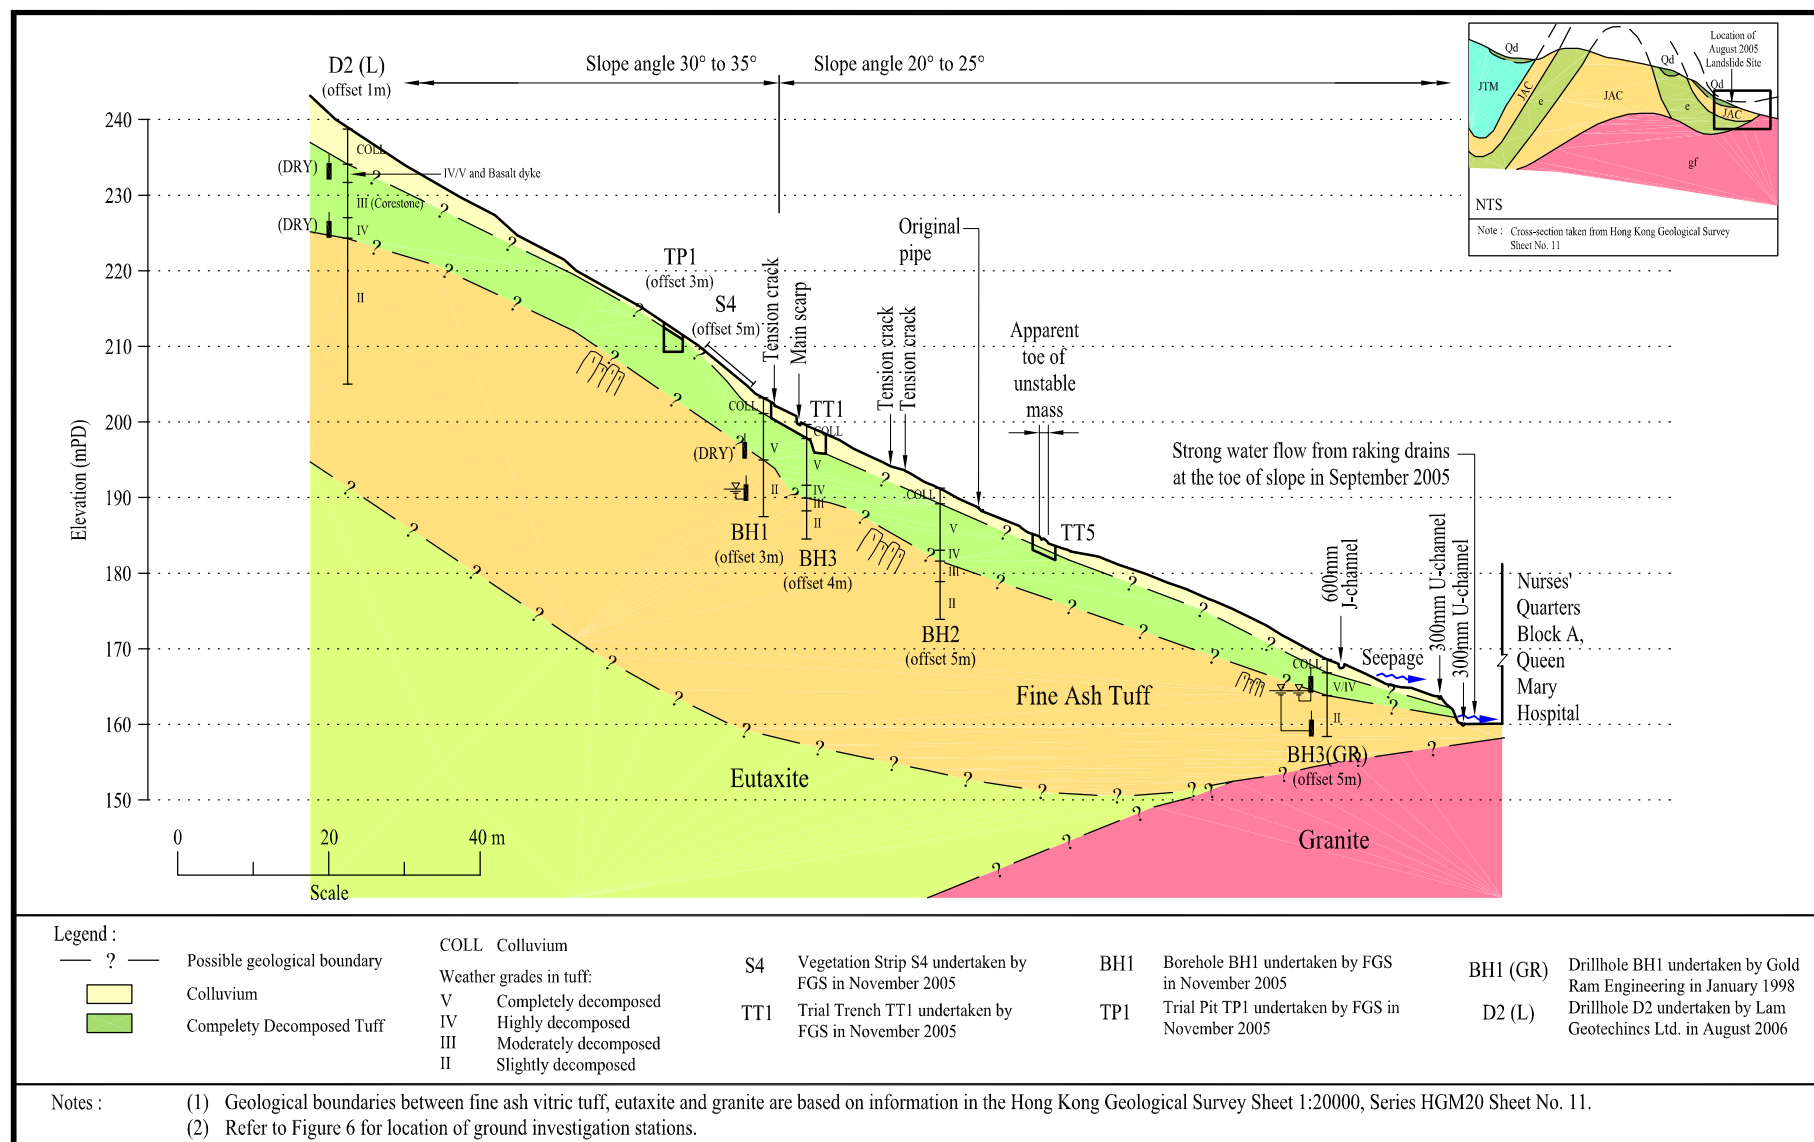
Figure 3 - Section A - A

This in turn could lead to higher groundwater levels within the bedrock and saprolite further upslope below the August 2005 landslide. However, groundwater was measured at a depth of about 11.5 m to 12.8 m below the main scarp of the August 2005 landslide (Figure 3 and Section 7.3), which suggests that the main groundwater table was located within bedrock and was therefore relatively deep below the distressed zone during the monitoring period.

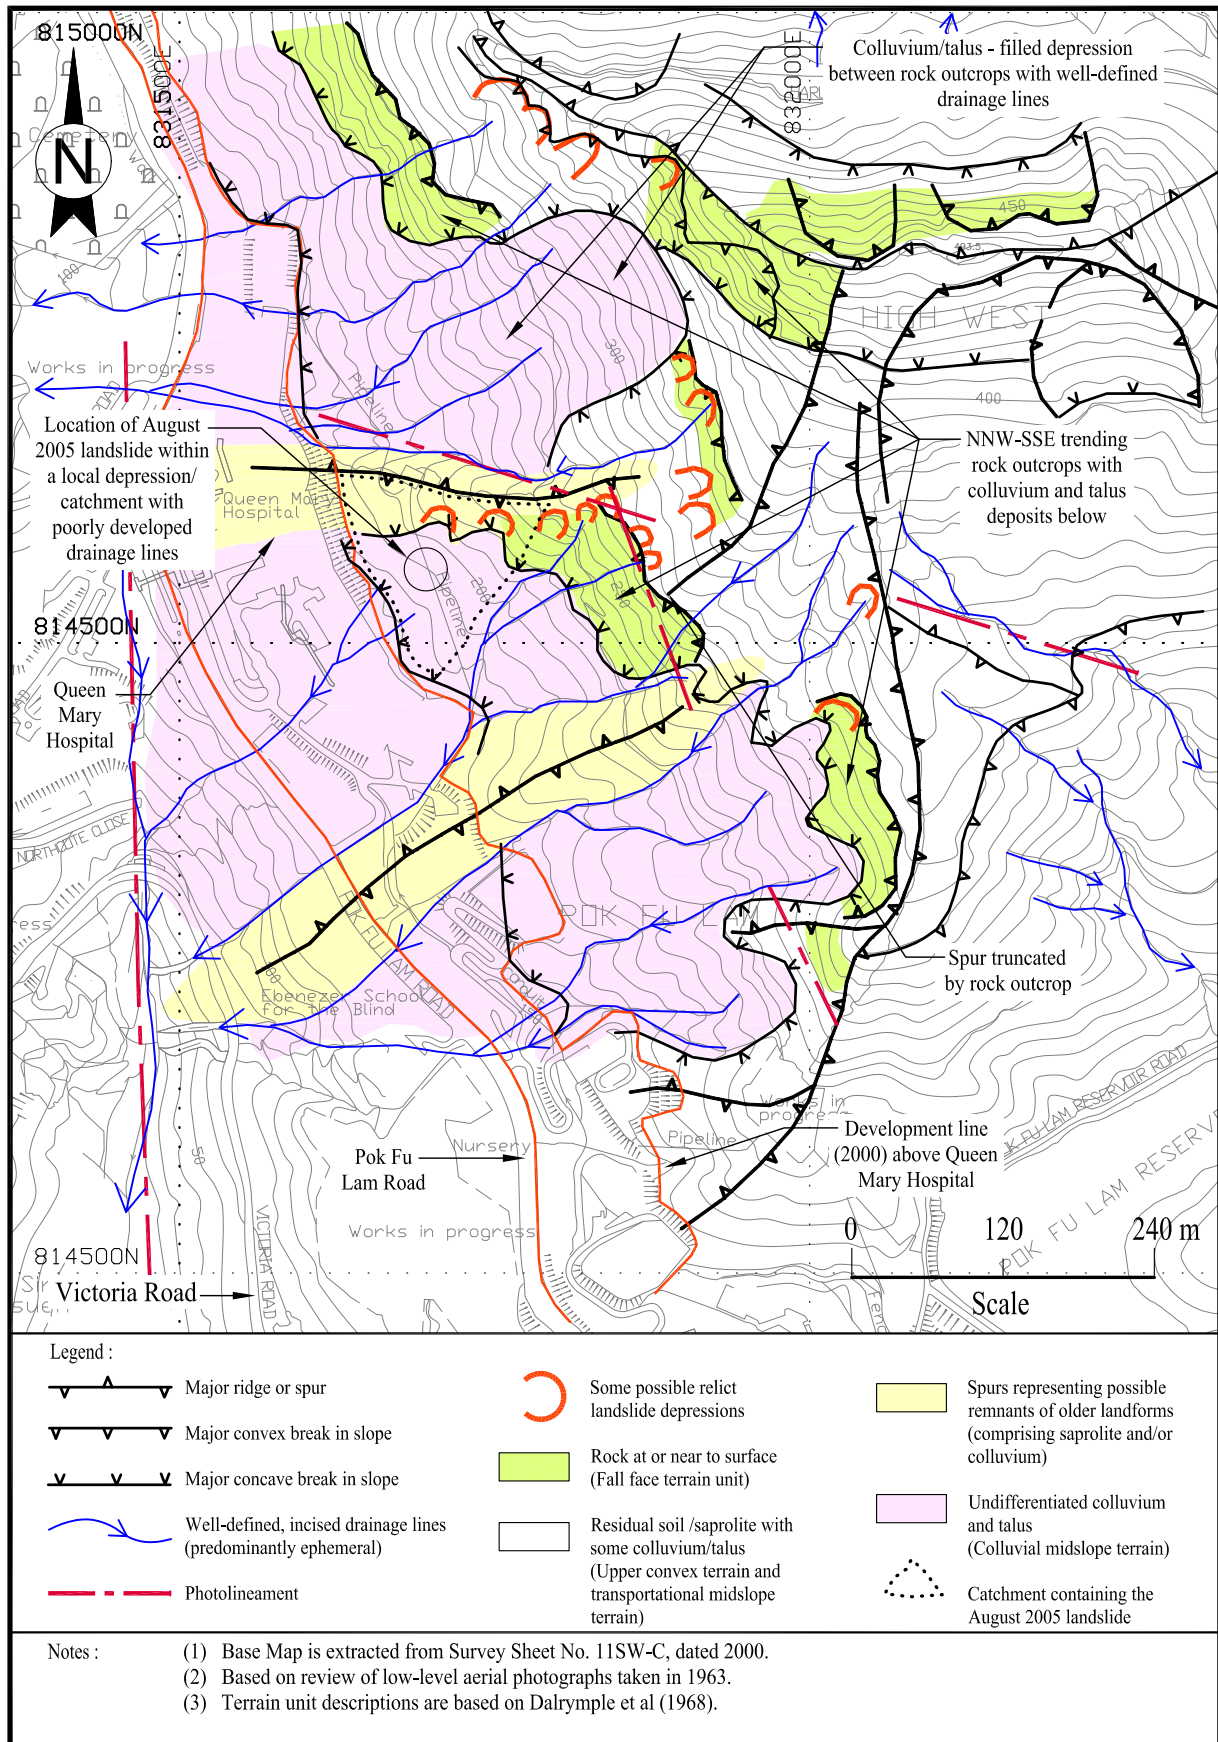
Figure 15 - Geomorphology Plan

A geomorphological plan of the site is shown in Figure 15. The August 2005 landslide occurred within a local catchment, which is smaller than the broader hillside catchments to the north and south of the landslide site. In addition, it contains relatively poorly developed drainage lines as compared to the well-defined, incised drainage lines within the adjoining hillside catchments.

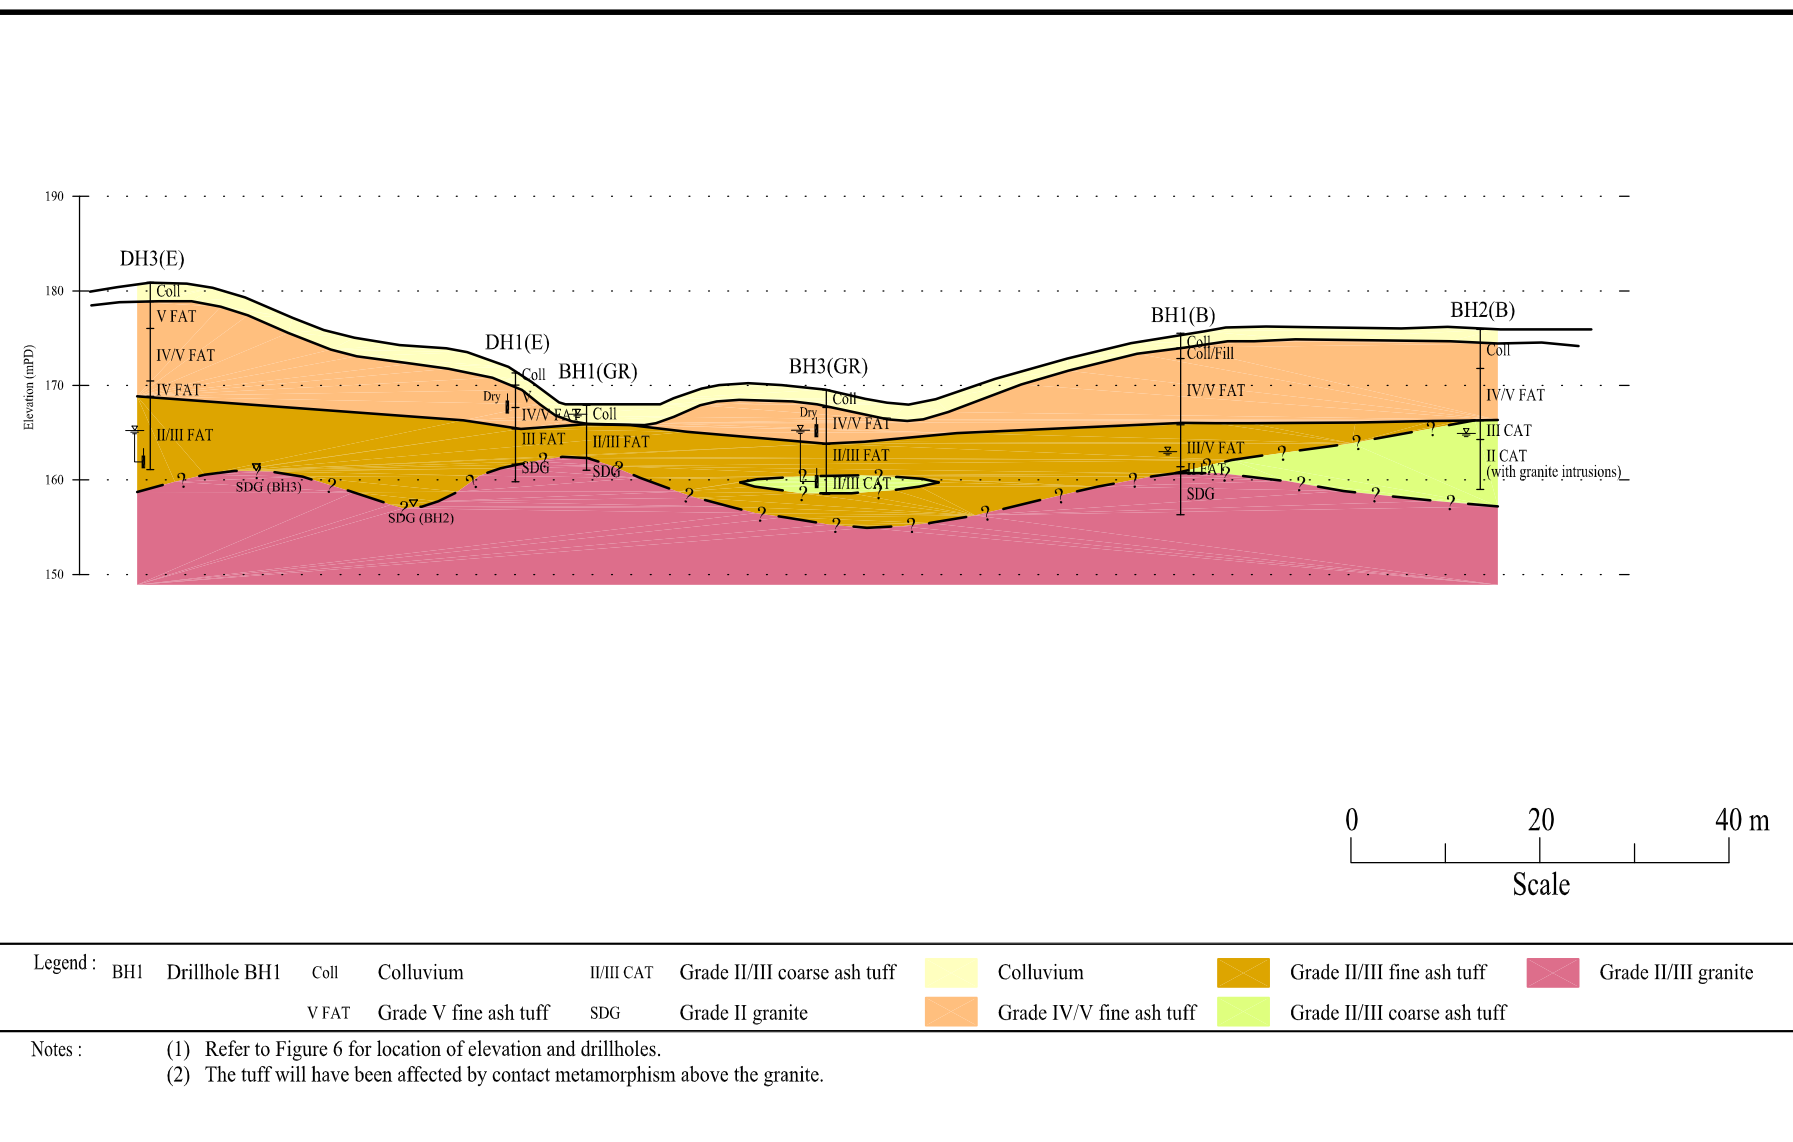
Figure 16 - Section B - B

Bedrock at the landslide site predominantly comprises fine ash tuff with local areas of fine to coarse ash tuff, the exception being along the lower southerly spur, where coarse ash tuff was encountered in drillhole BH2. In addition, the tuff is slightly micaceous in parts and locally comprises hornfels indicating that contact metamorphism has occurred. Coarse ash tuff was not encountered in any of the other drillholes in the area, but was encountered in the lower portions of the drainage lines to the north and south of the landslide catchment during field mapping. This suggests that the coarse ash tuff possibly occurs in laterally impersistent lenses across the site. Grade II/III granite was encountered beneath the fine ash tuff in some of the existing drillholes along the toe of the hillside indicating an undulating profile beneath the fine ash tuff. A section across the toe of the hillside is presented in Figure 16.

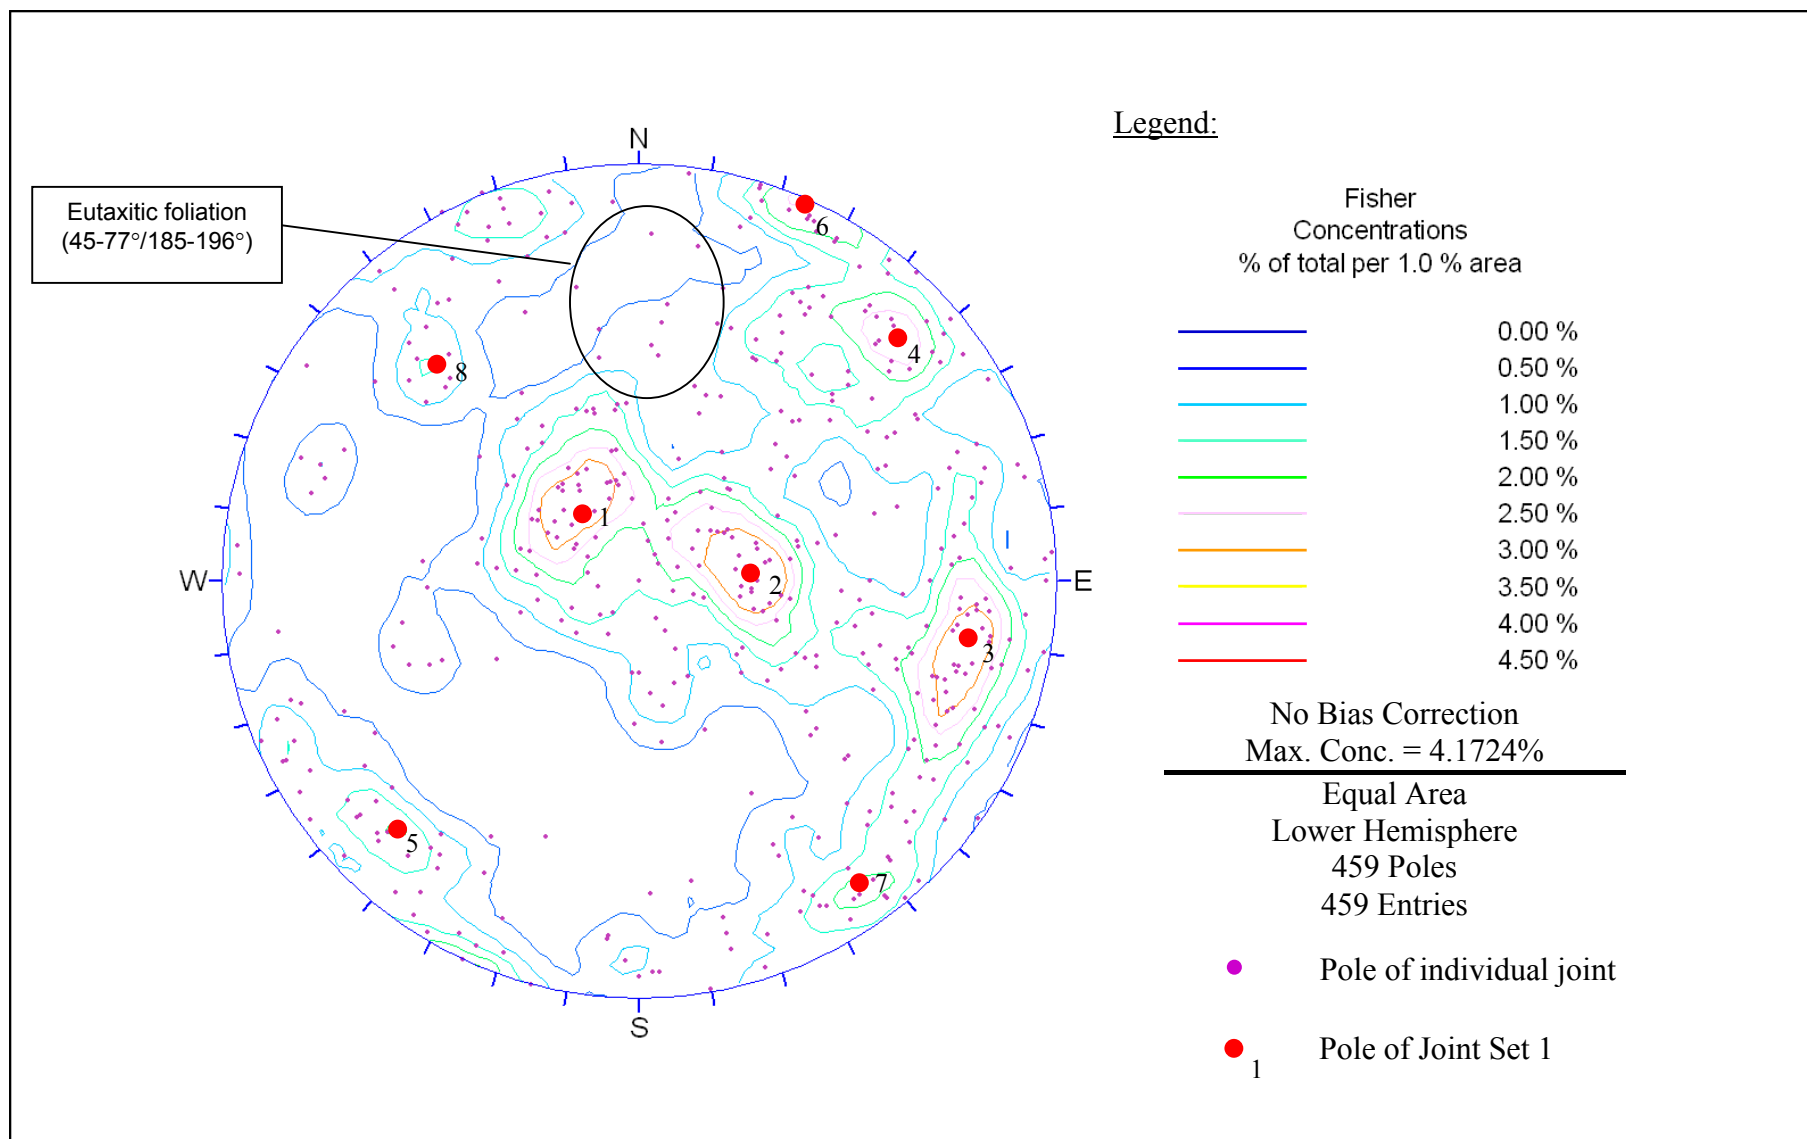
Figure 17 – Pole Concentration Contour for Joint Measurements

A stereoplot of joint measurements taken during field mapping and GI works has identified four principal joint sets, J1 to J4, and four secondary joint sets, J5 to J8 (Table 5 and Figure 17). Joints J1 and J2 are low angle joints (17° to 22°) dipping in a southeasterly direction (140°) and a westerly (267°) direction respectively. Joints J3 and J4 are steeply inclined joints (69° to 74°) dipping in a westerly direction (280°) and a southwesterly (227°) direction respectively. The secondary joints J5 to J8 are all steeply inclined joints (60° to 88°) dipping in various directions.

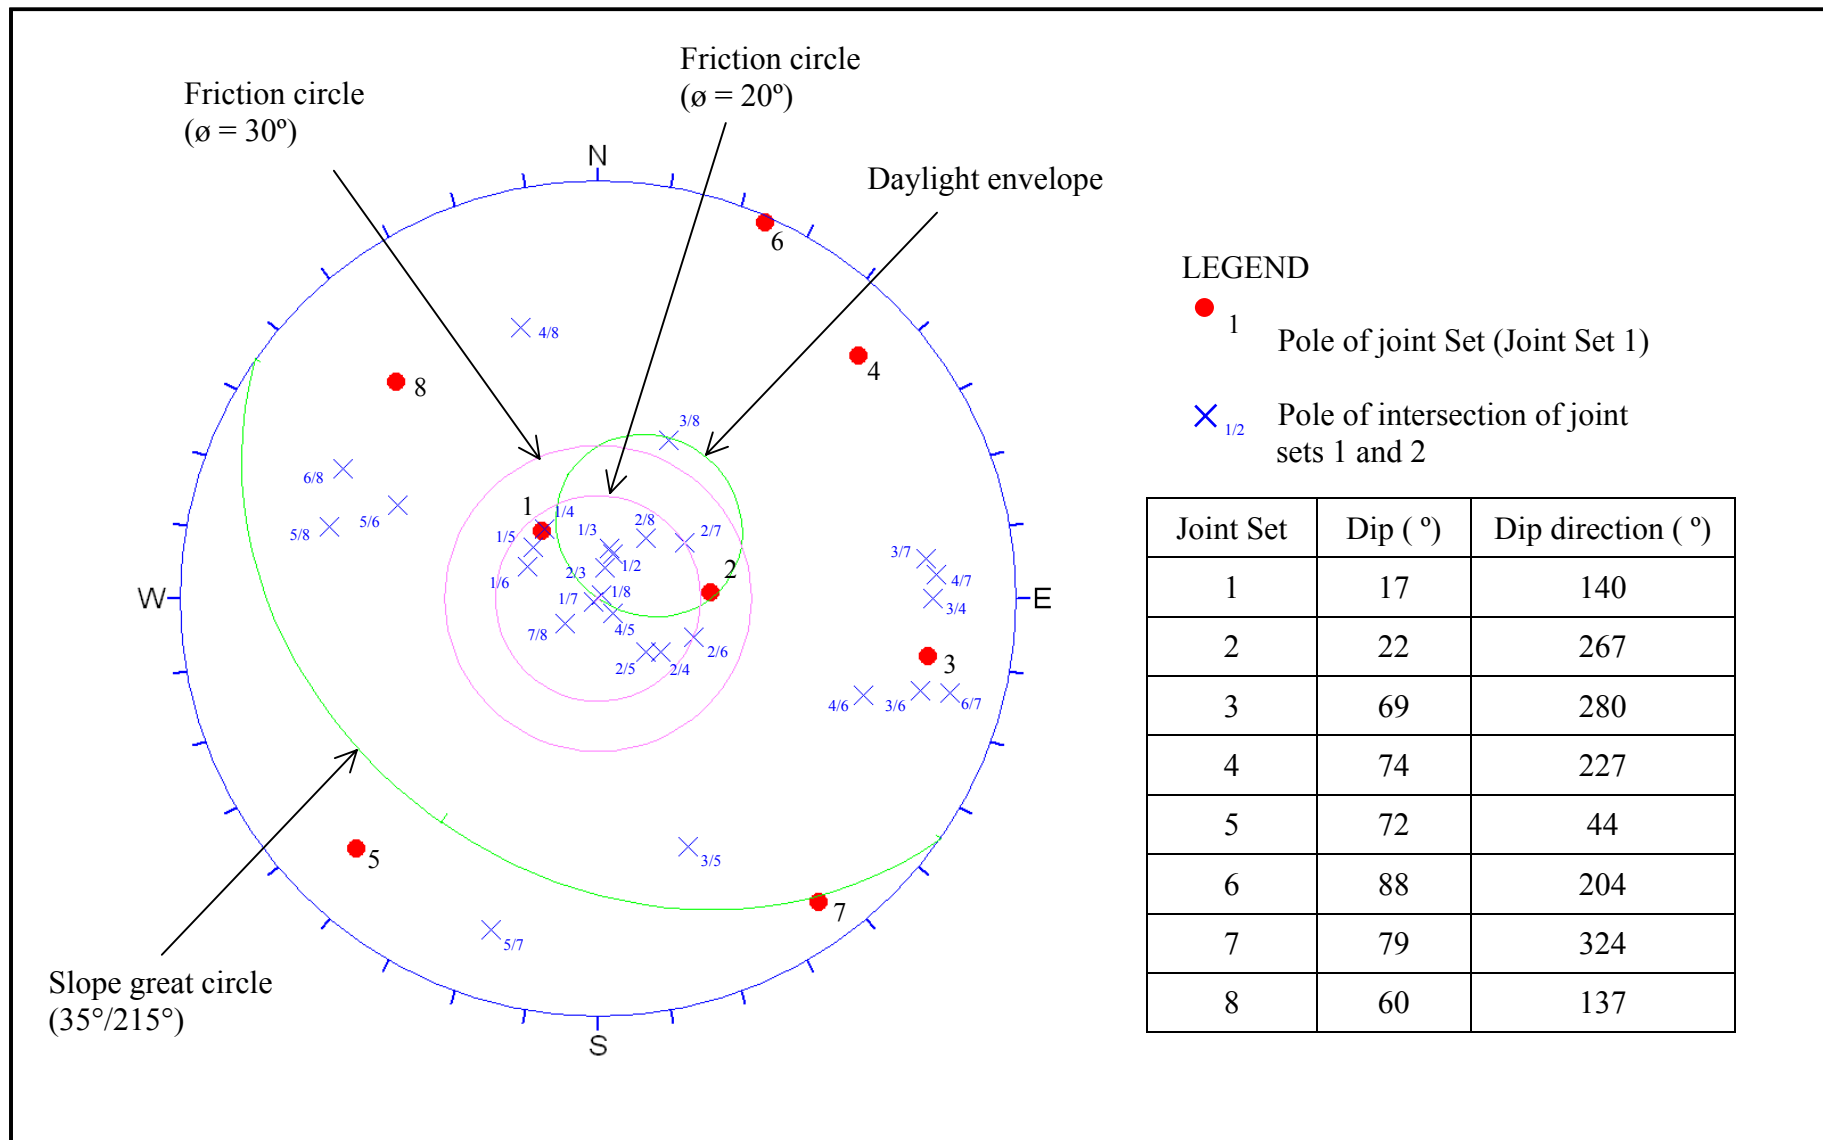
Figure 18 - Stereographic Projection of Discontinuity Survey Data

Stereographic projection of the joint set data on an equal-area stereoplot assuming a slope angle of 35° and a dip direction of the hillside of 215° , shows that the hillside could be liable to plane failure (for joint set J2) for a low effective friction angle of around 20° , even discounting any potential effect of groundwater pressure (Figure 18). The potential for wedge failure does exist between joint sets J3 and J8, but this mode of failure has not been observed in the relict landslide scars identified on site.

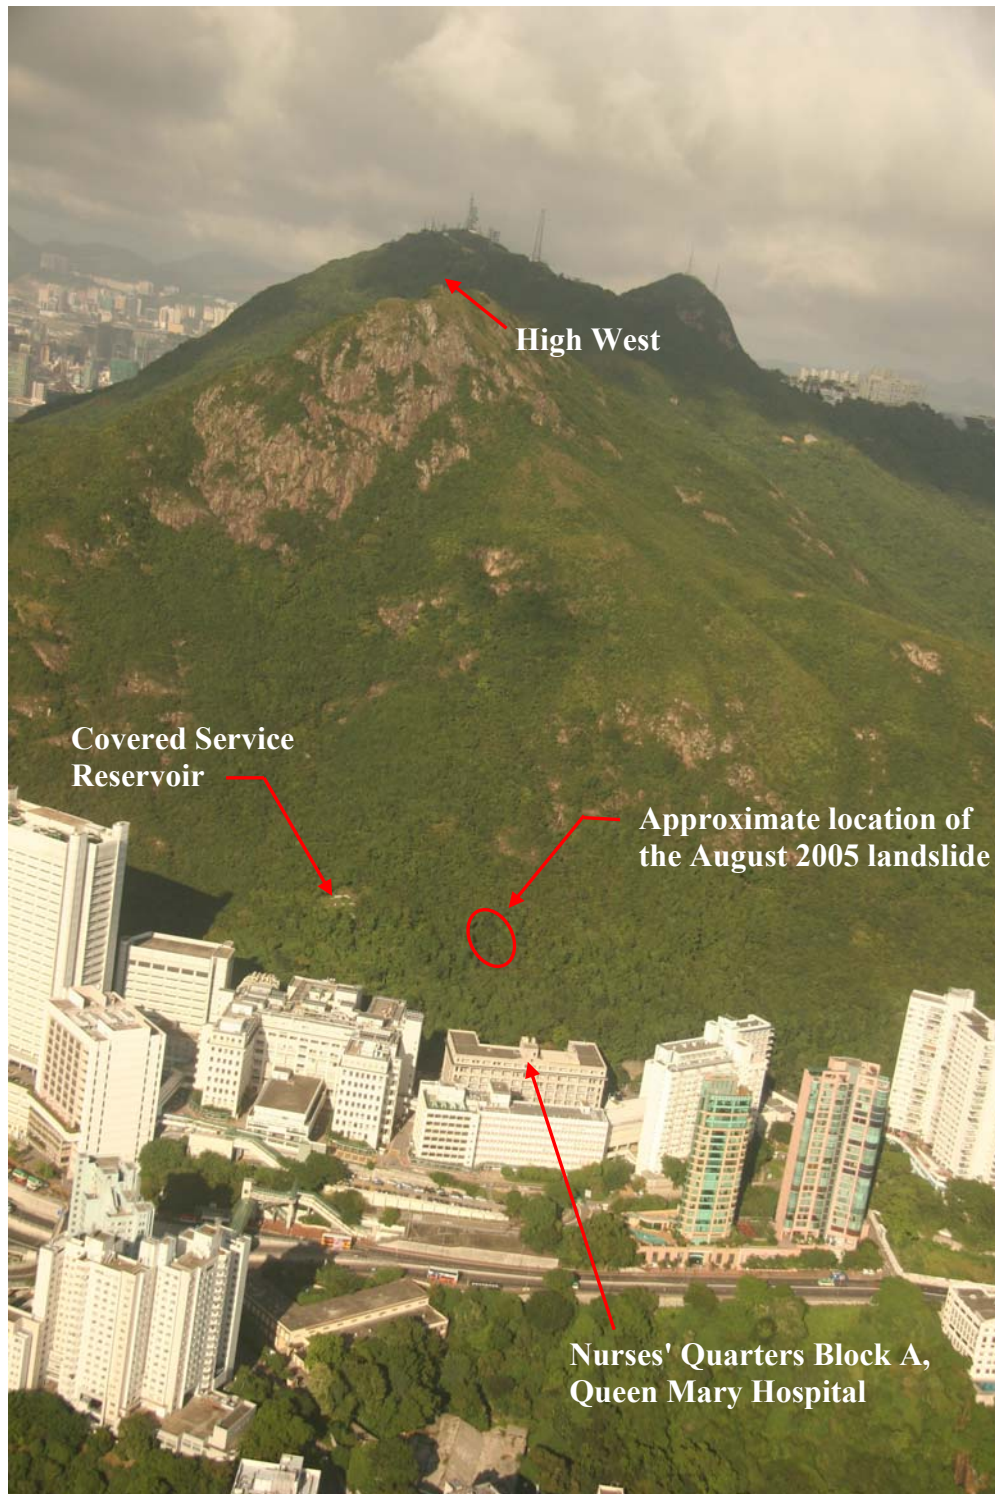
Plate 1 – General View of the August 2005 Landslide Site
(Photograph taken on 13 September 2005)

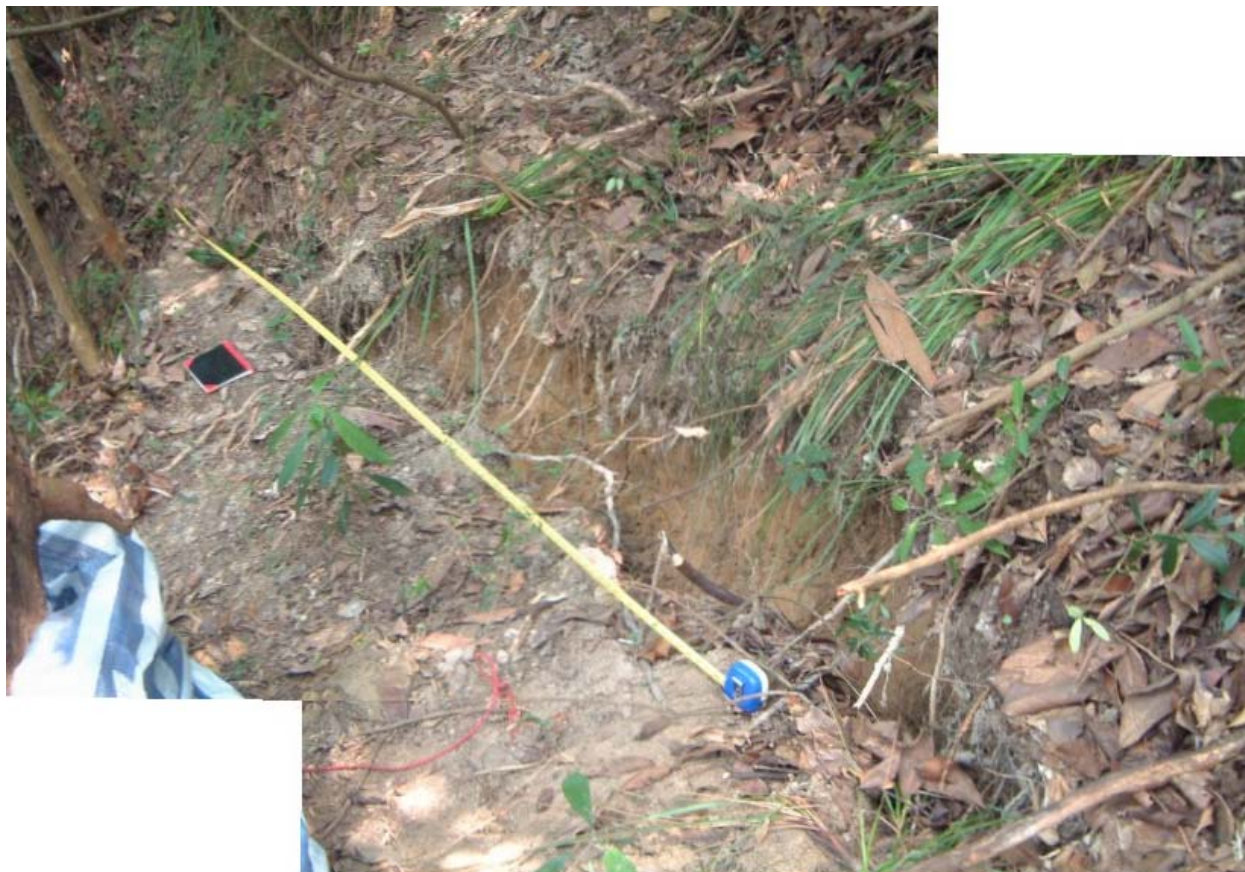
Plate 4 – View of the Northern End of the Main Scarp
(Photograph taken by FSW on 3 October 2005)

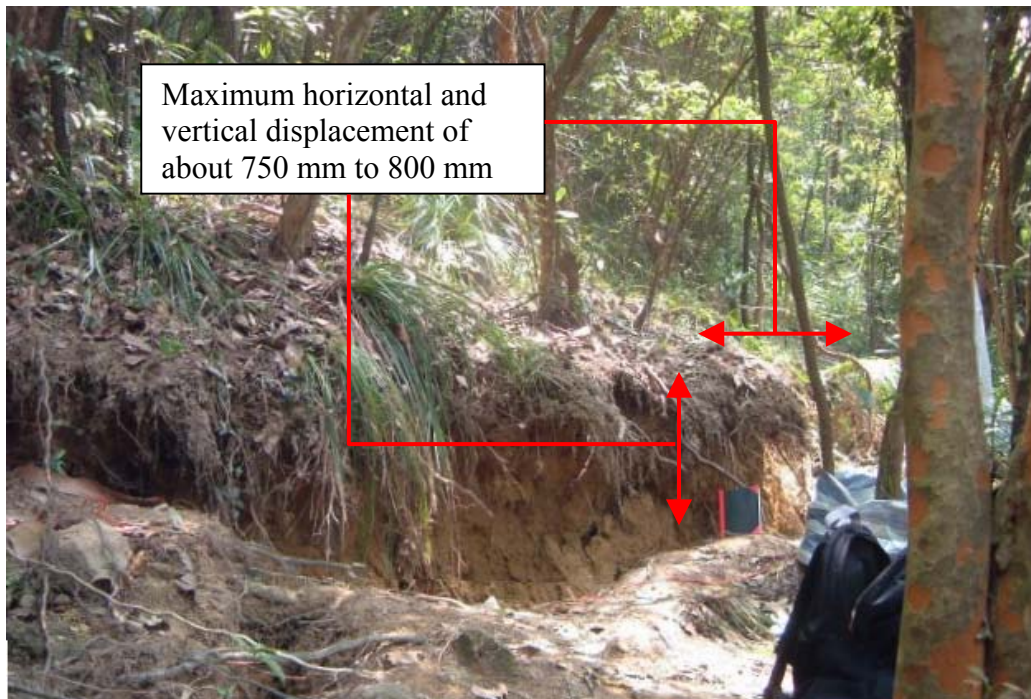
Plate 5 – View of Central Portion of the Main Scarp
(Photograph taken by FSW on 3 October 2005)

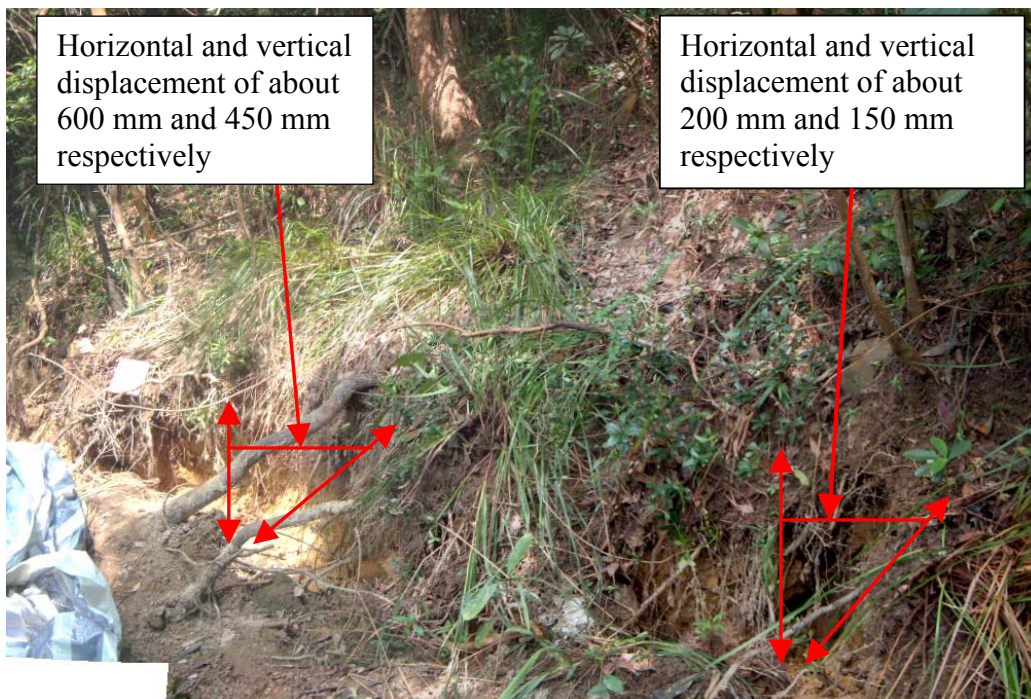
Plate 6 – View of the Southern End of the Main Scarp
(Photograph taken by FSW on 3 October 2005)

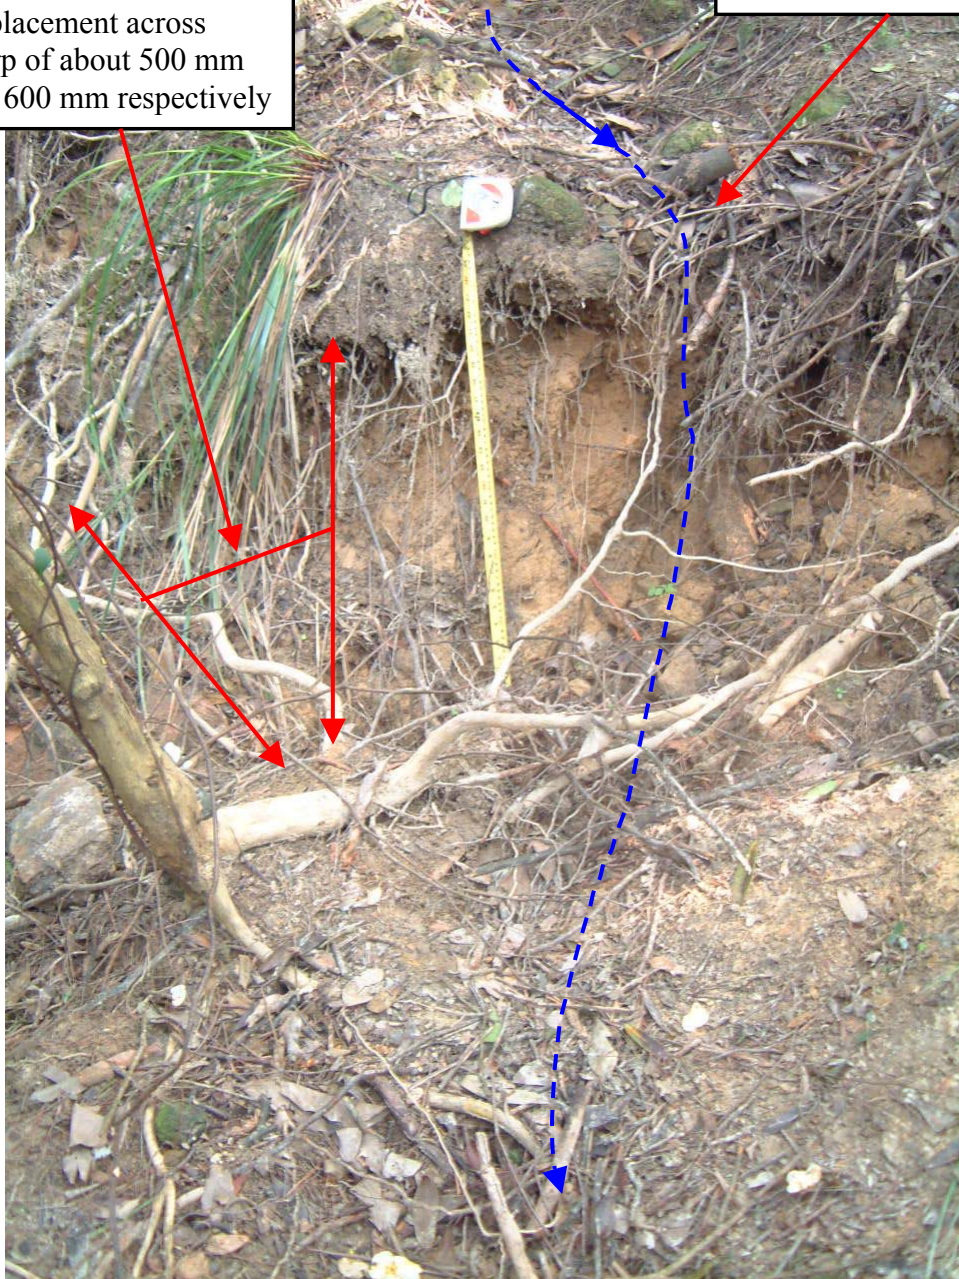
Horizontal and vertical displacement across scarp of about 500 mm and 600 mm respectively

An ephemeral drainage line passes through the secondary scarp

Plate 8 – View of Secondary Scarp along the Lower Northern Flank of the Landslide
(Photograph taken on 3 October 2005)

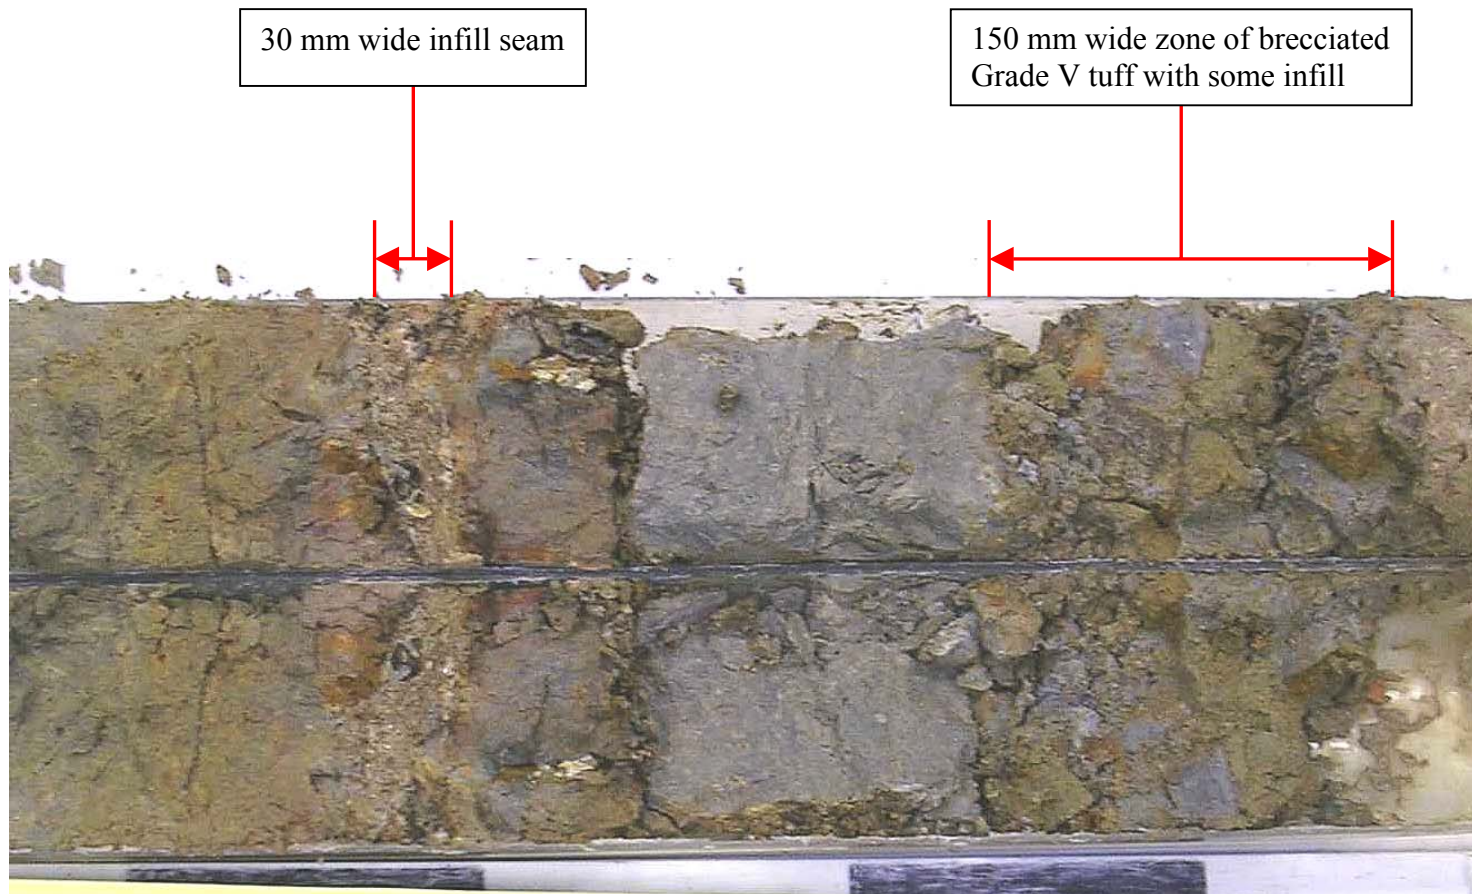
Plate 16 – View of Infill Seams in Drillhole BH2 at Depths of 8.7 m and 8.85 m
(Photograph taken by FSW on 30 December 2005)

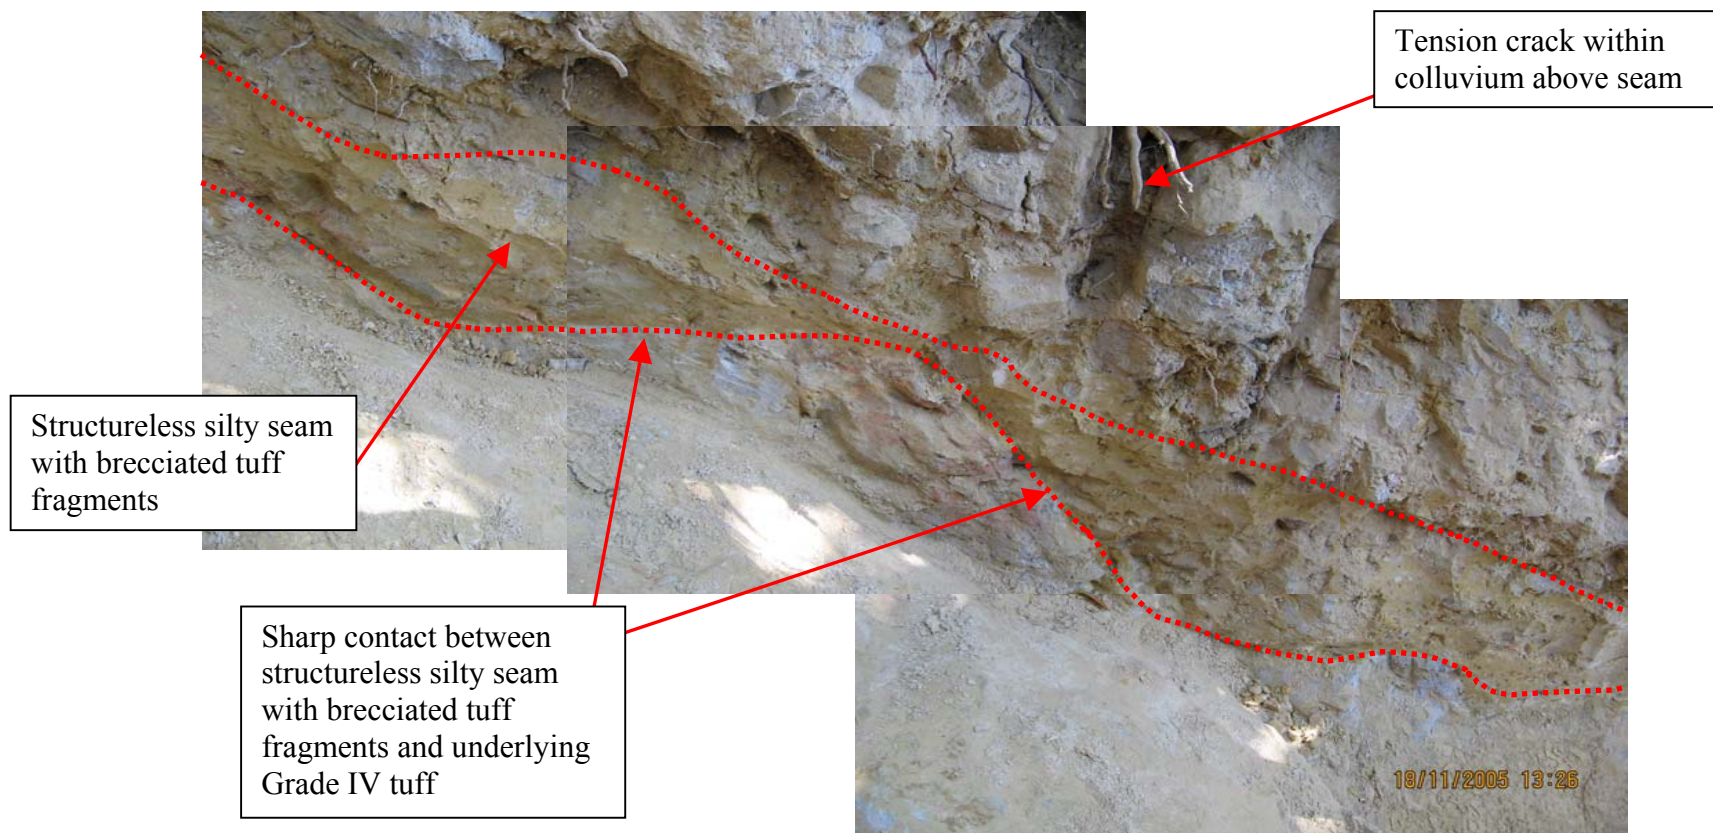
Plate 20 – View of Structureless Seam Observed between the Base of the Colluvium and the Underlying Tuff in Face B of Trial Trench TT1
(Photograph taken by FSW on 18 November 2005)

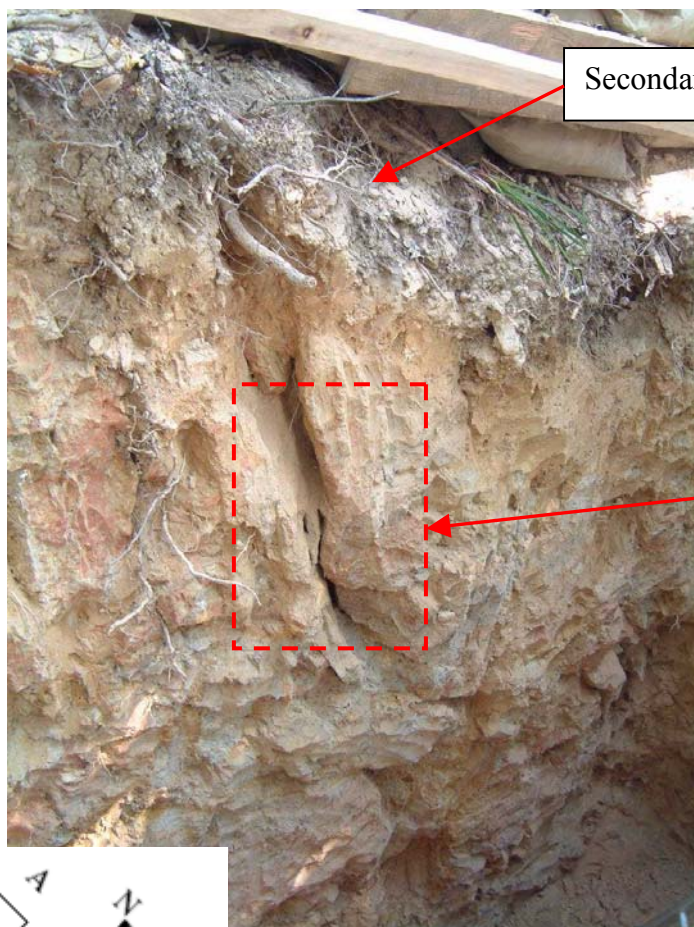
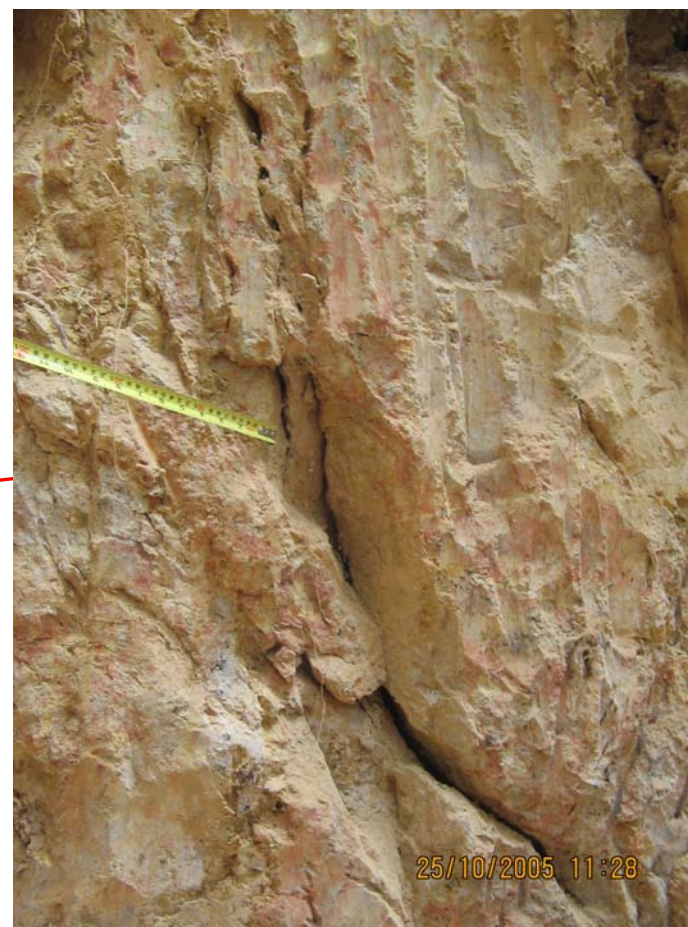
Plate 23 – View of Subsurface Cracking in Face B of Trial Trench TT2
(Photograph taken by FSW on 25 October 2005 and 19 November 2005)

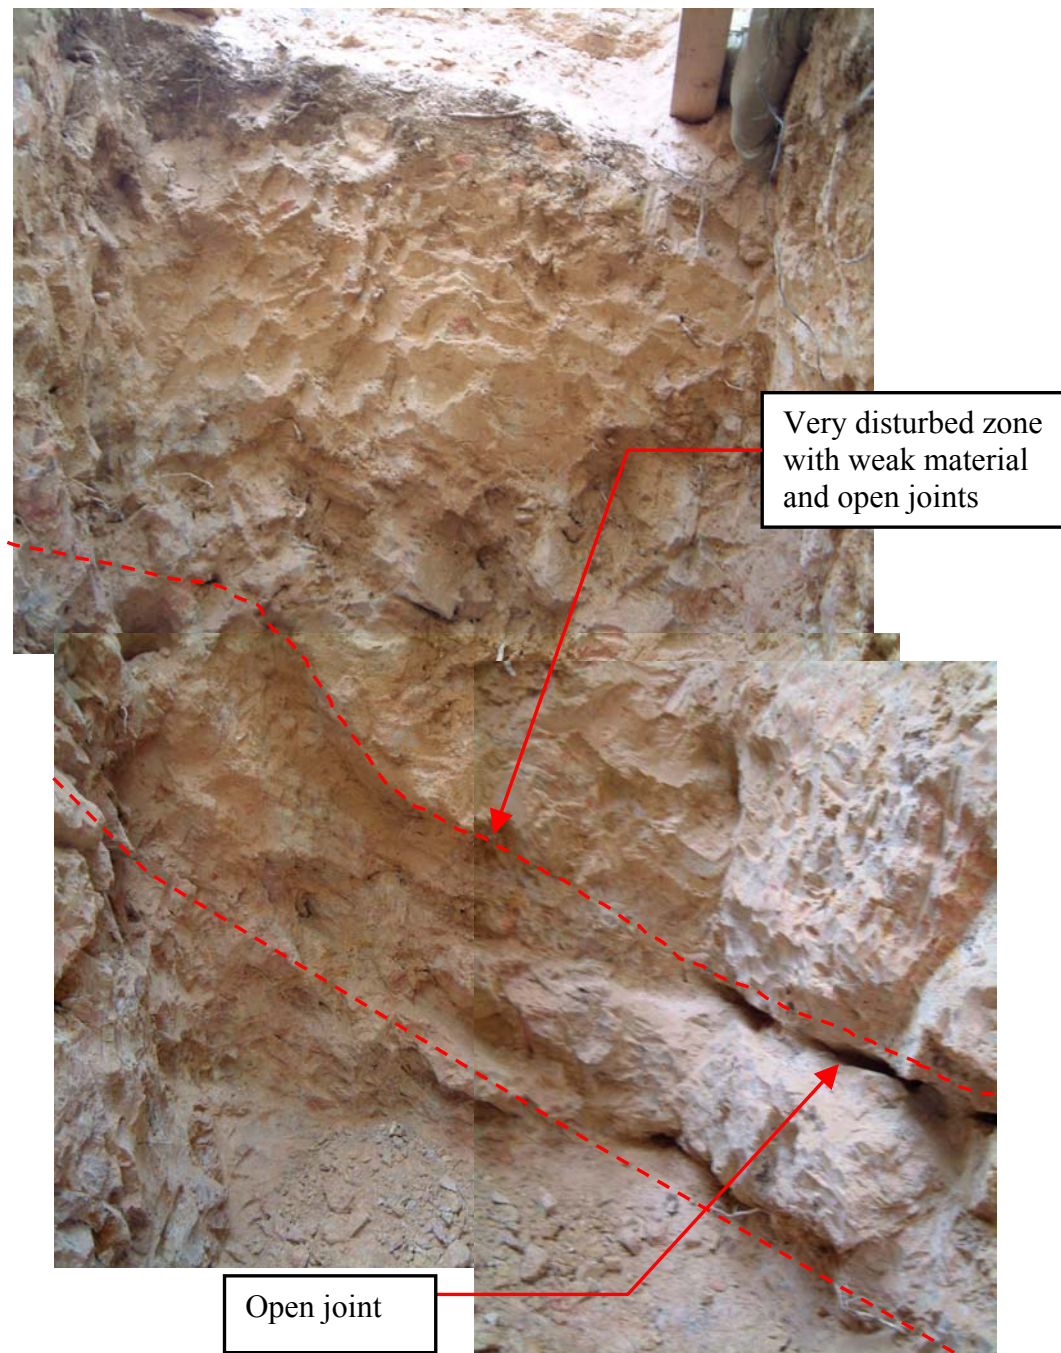
Plate 24 – View of Face C of Trial Trench TT2 Showing Disturbed Zone at a Depth of 2 m to 2.5 m
(Photograph taken by FSW on 19 November 2005)
