**DETAILED STUDY OF
20 AUGUST 2005 LANDSLIDE
BEHIND NURSES' QUARTERS
BLOCK A, QUEEN MARY
HOSPITAL, POK FU LAM**

GEO REPORT No. 242

Fugro Scott Wilson Joint Venture

**GEOTECHNICAL ENGINEERING OFFICE
CIVIL ENGINEERING AND DEVELOPMENT DEPARTMENT
THE GOVERNMENT OF THE HONG KONG
SPECIAL ADMINISTRATIVE REGION**

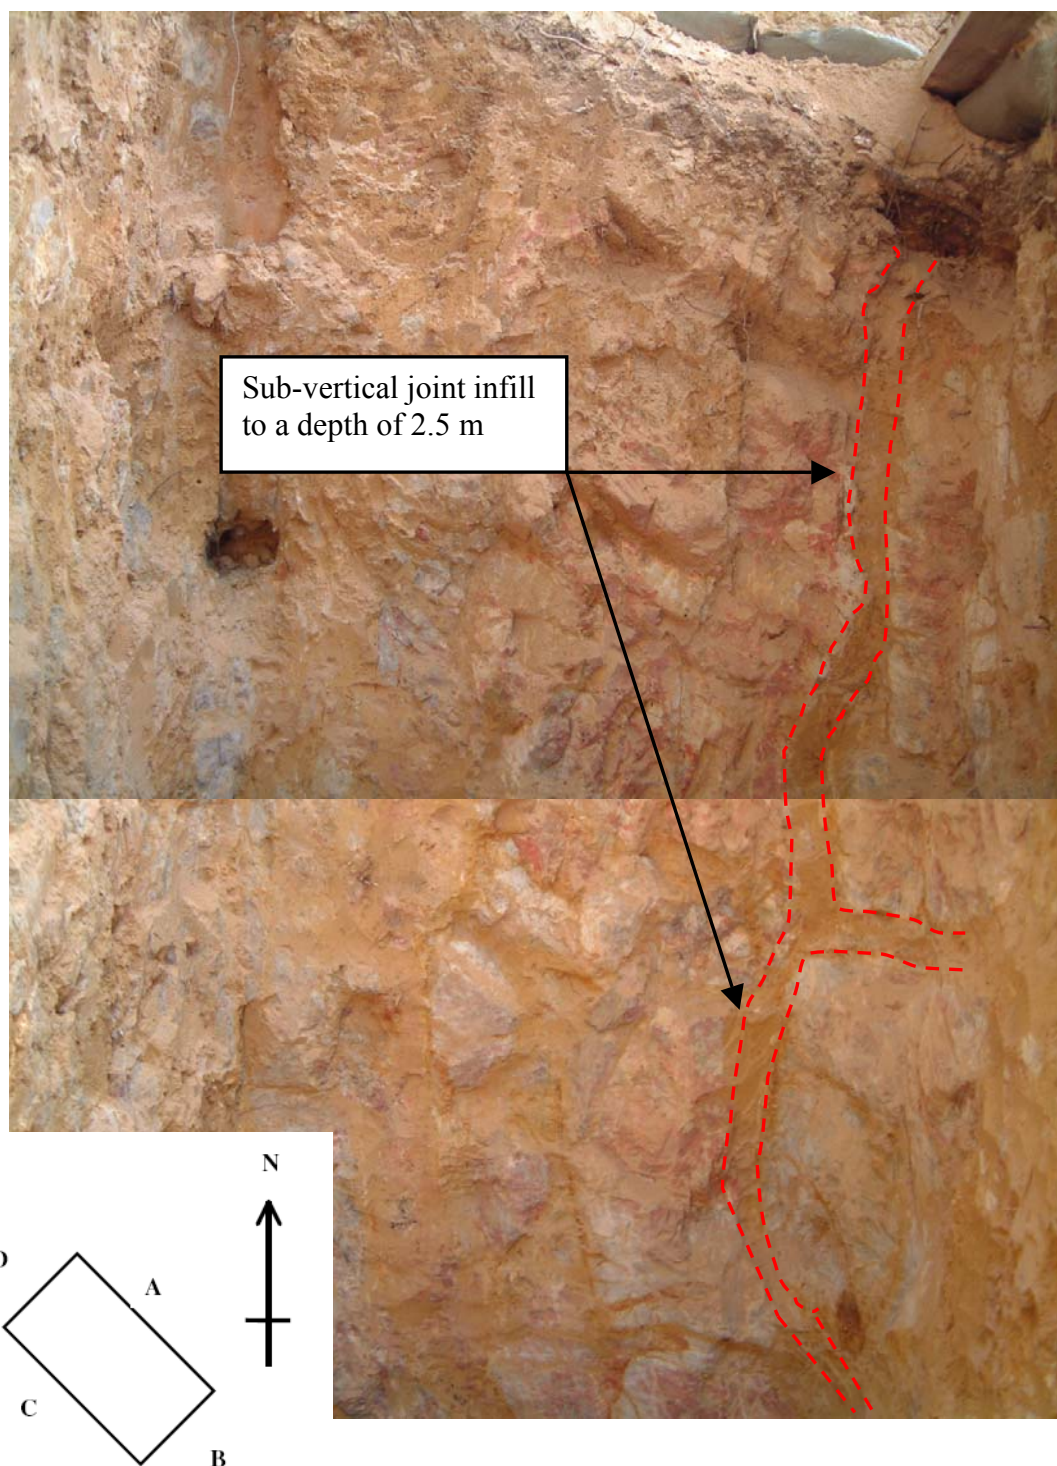
Plate 25 – View of Trial Trench TT6, Face B (Upper)
(Photograph taken by FSW on 19 November 2005)

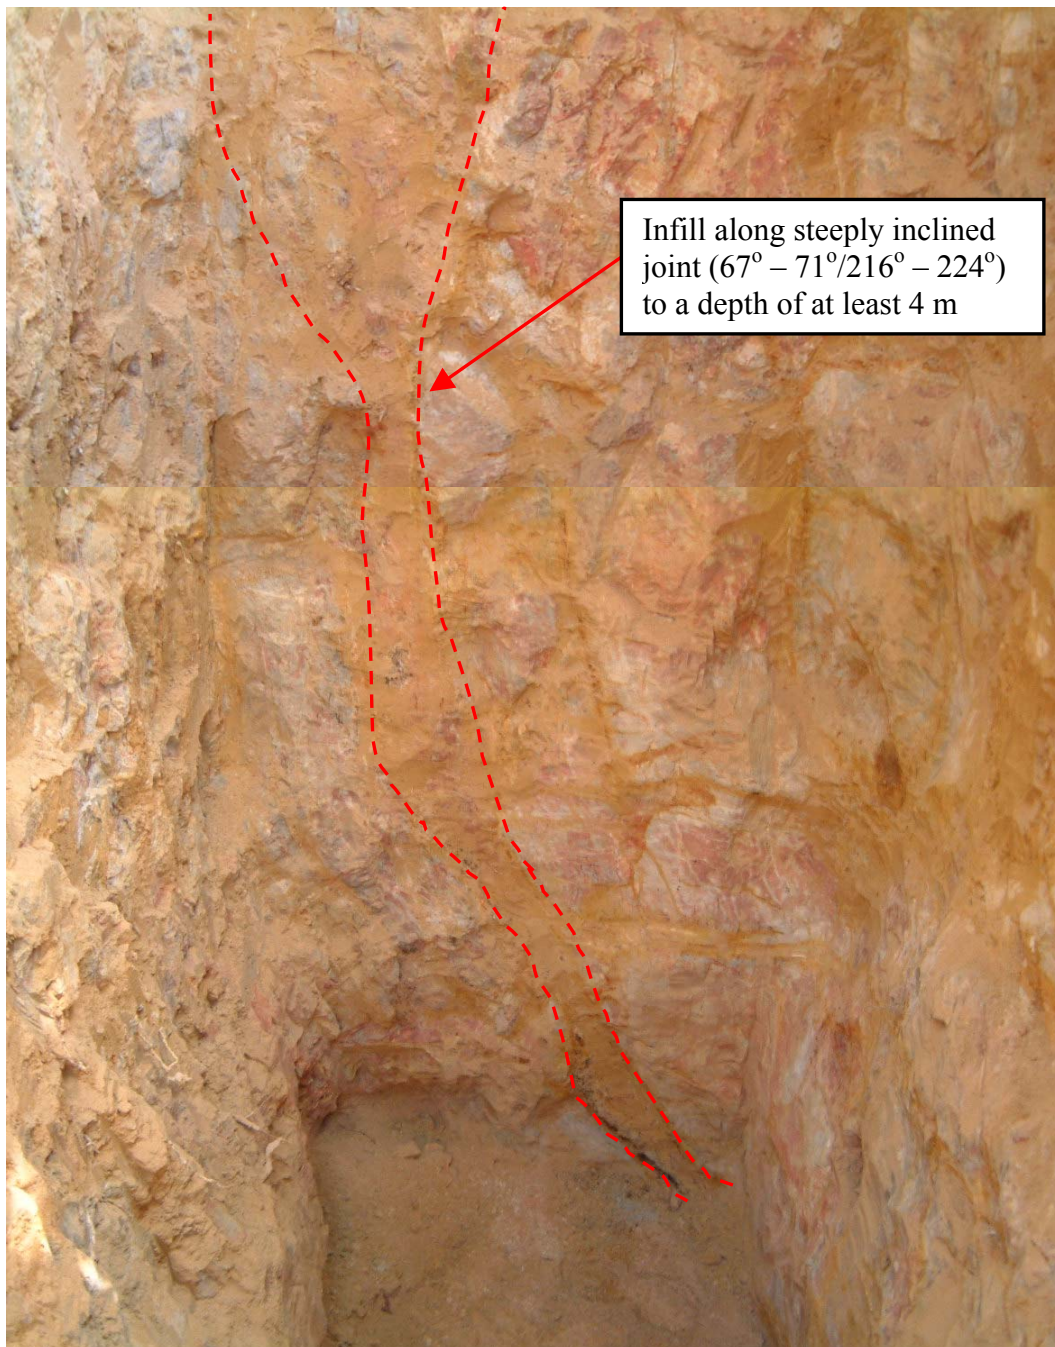
Plate 26 – View of Trial Trench TT6, Face B (Lower)
(Photograph taken by FSW on 19 November 2005)

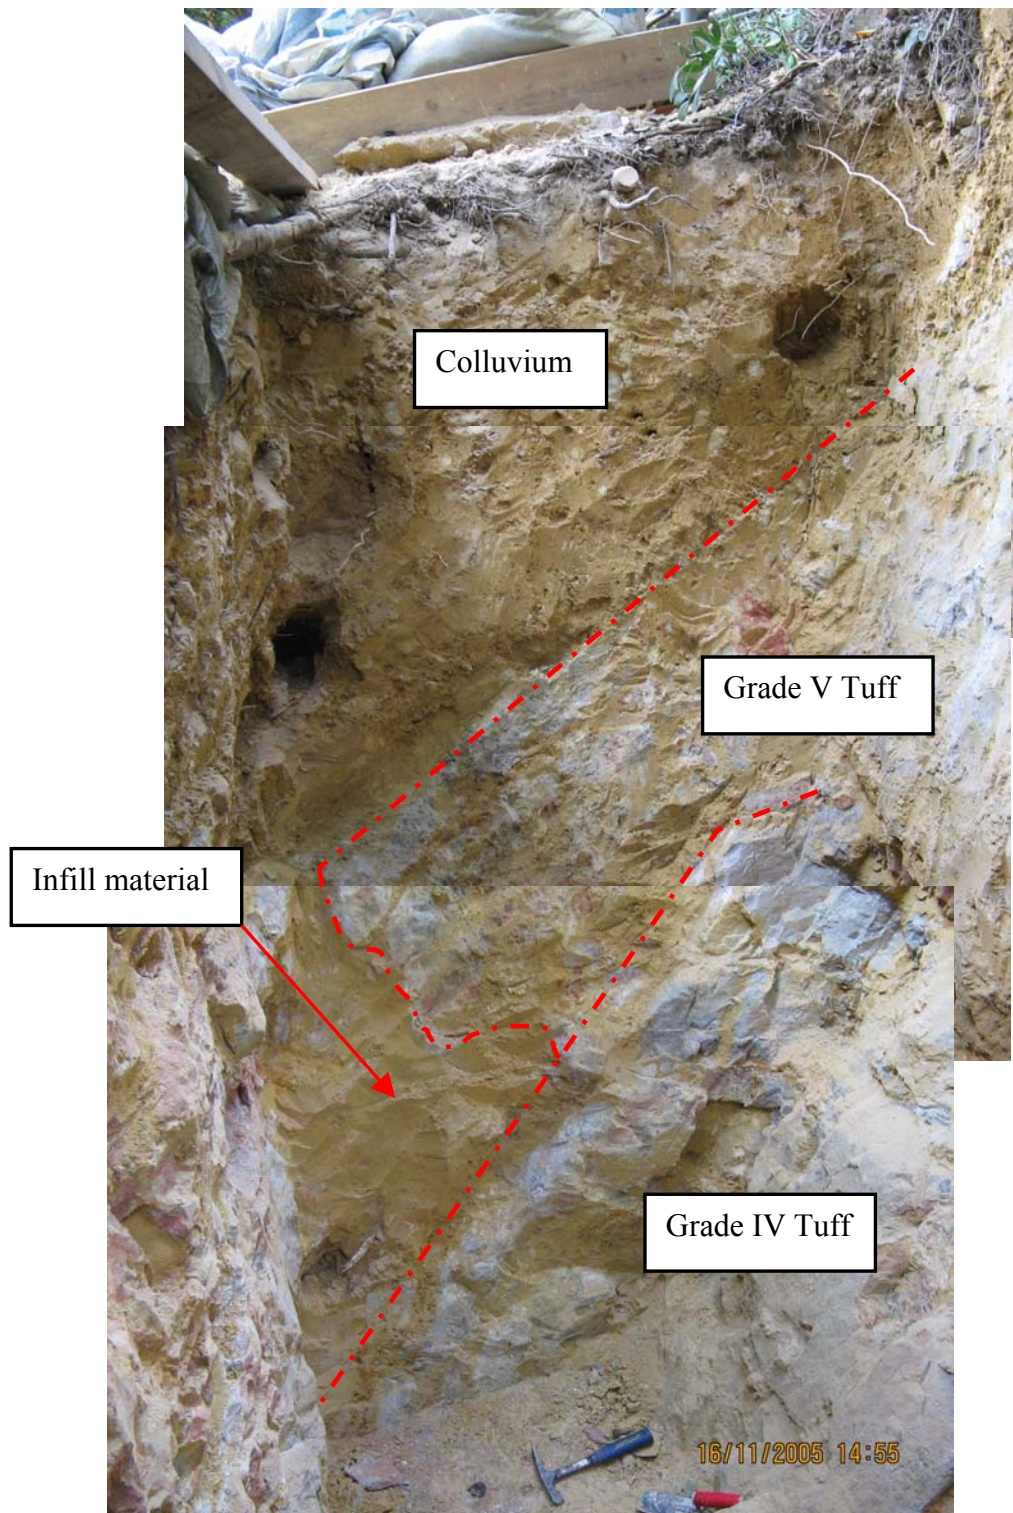
Plate 29 – View of Trial Trench TT6, Face D
(Photograph taken by FSW on 16 November 2005)

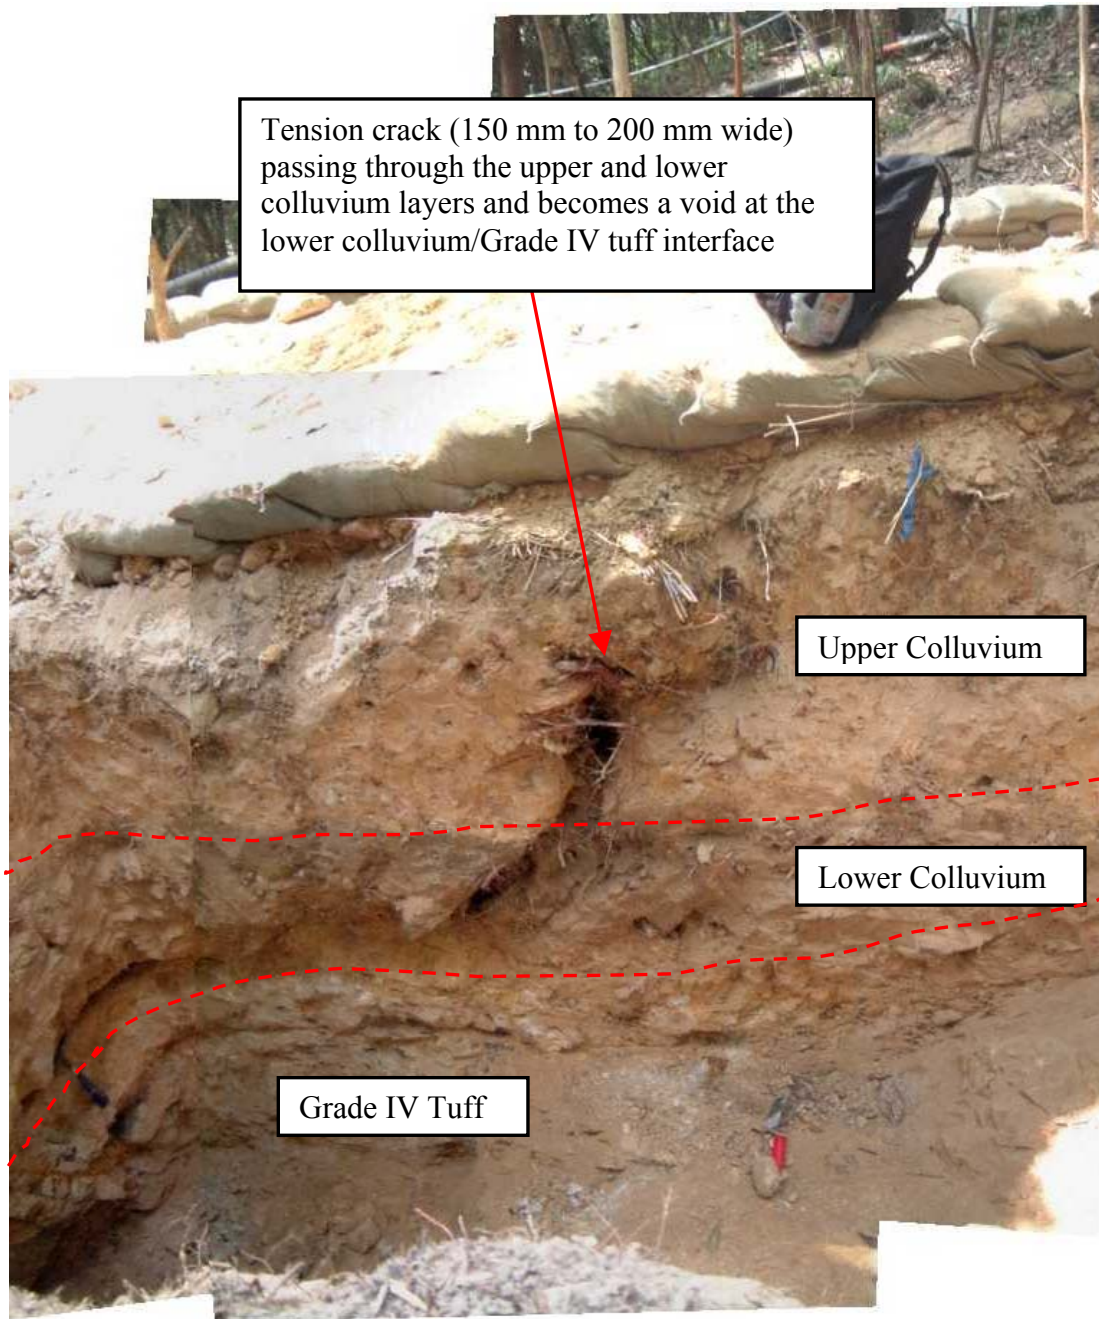
Plate 32 – View of Trial Trench TT7, Face D
(Photograph taken by FSW on 8 November 2005)

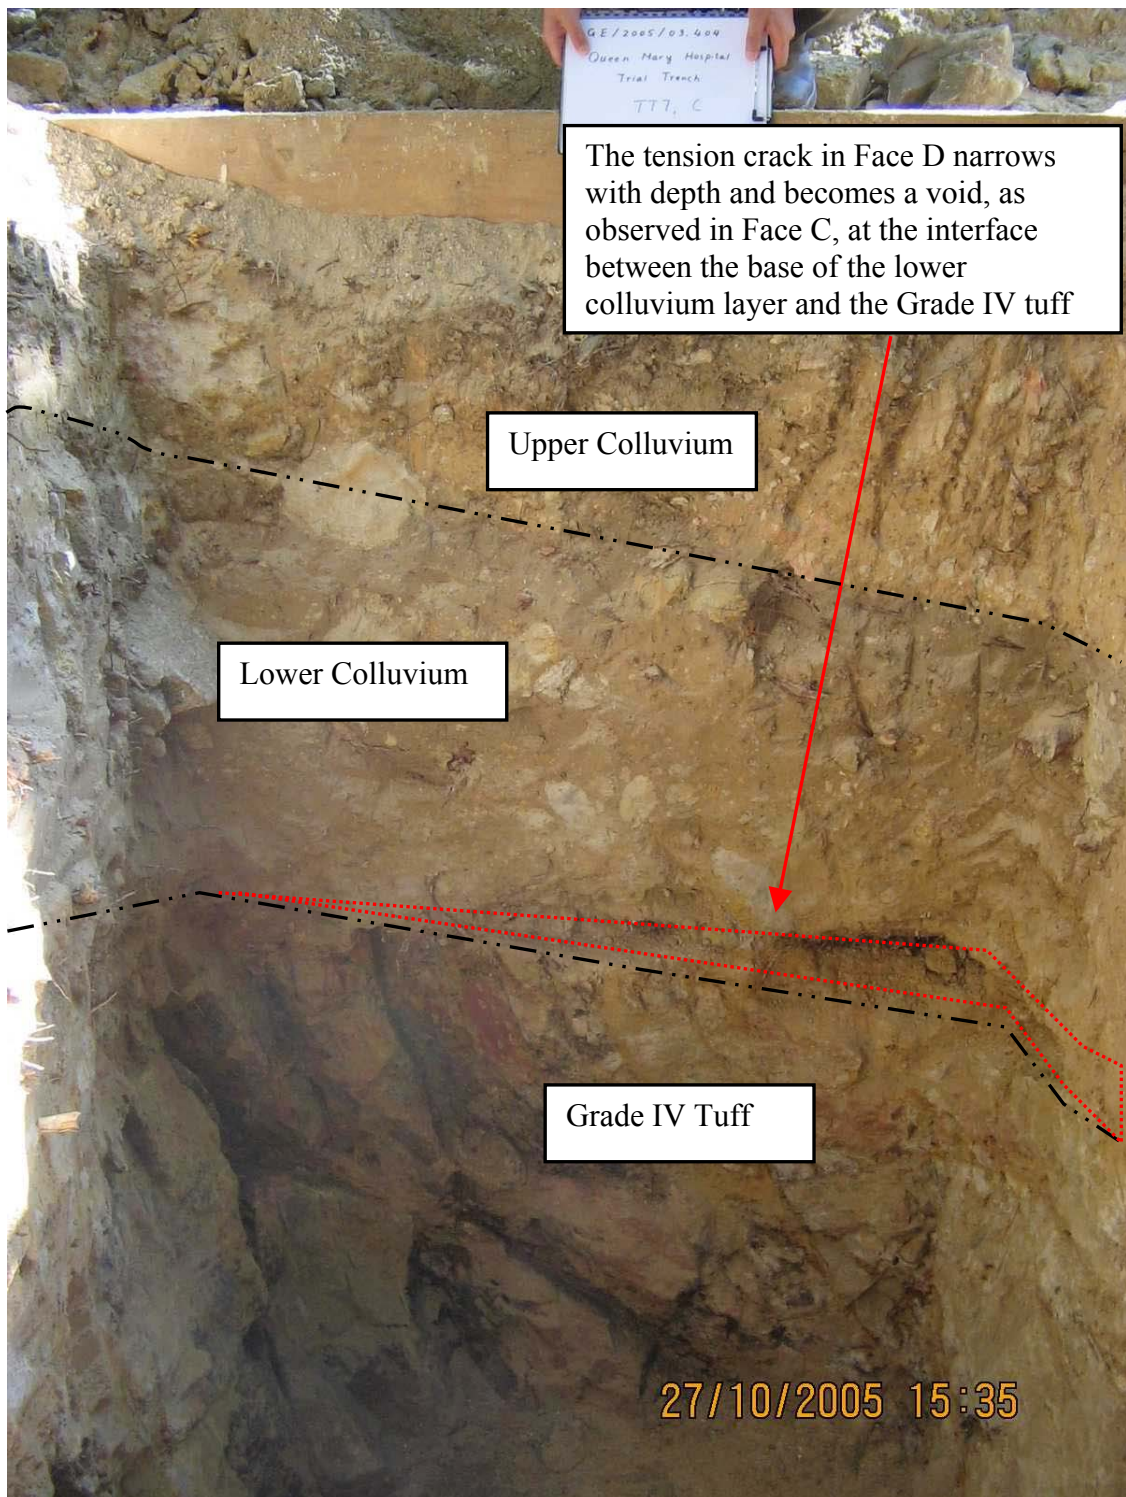
Plate 33 – View of Trial Trench TT7, Face C
(Photograph taken by FSW on 27 October 2005)

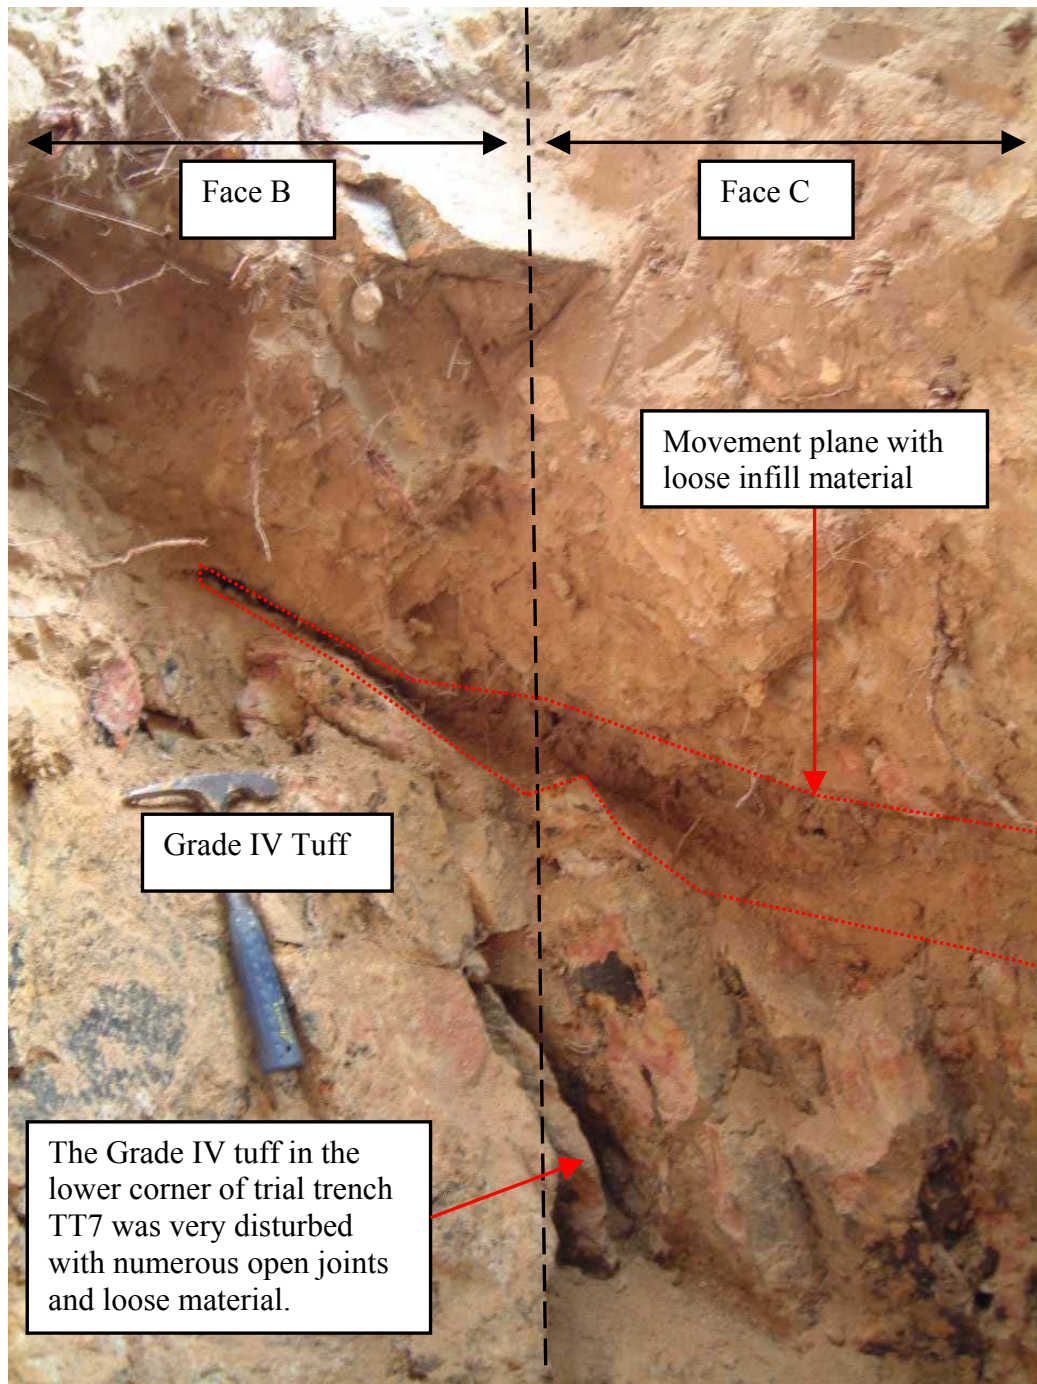
Plate 34 – View of Trial Trench TT7, Face B and Face C
(Photograph taken by FSW on 8 November 2005)

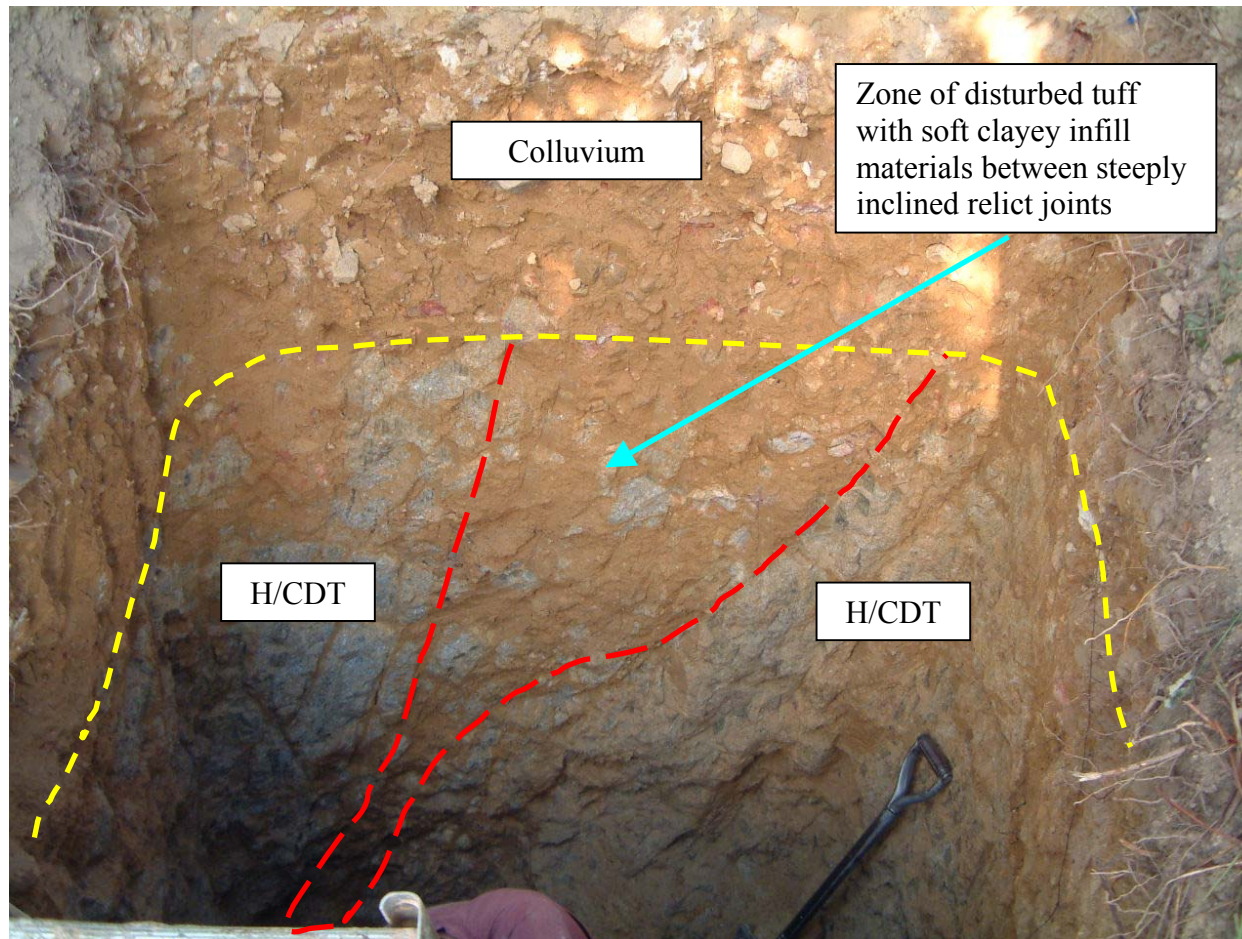
Plate 35 – Zone of Disturbed Tuff with Soft Clayey Infill Materials along Steeply Inclined Relict Joints within H/CDT Exposed in Face A of Trial Pit TP2
(Photograph taken by FSW on 18 November 2005)

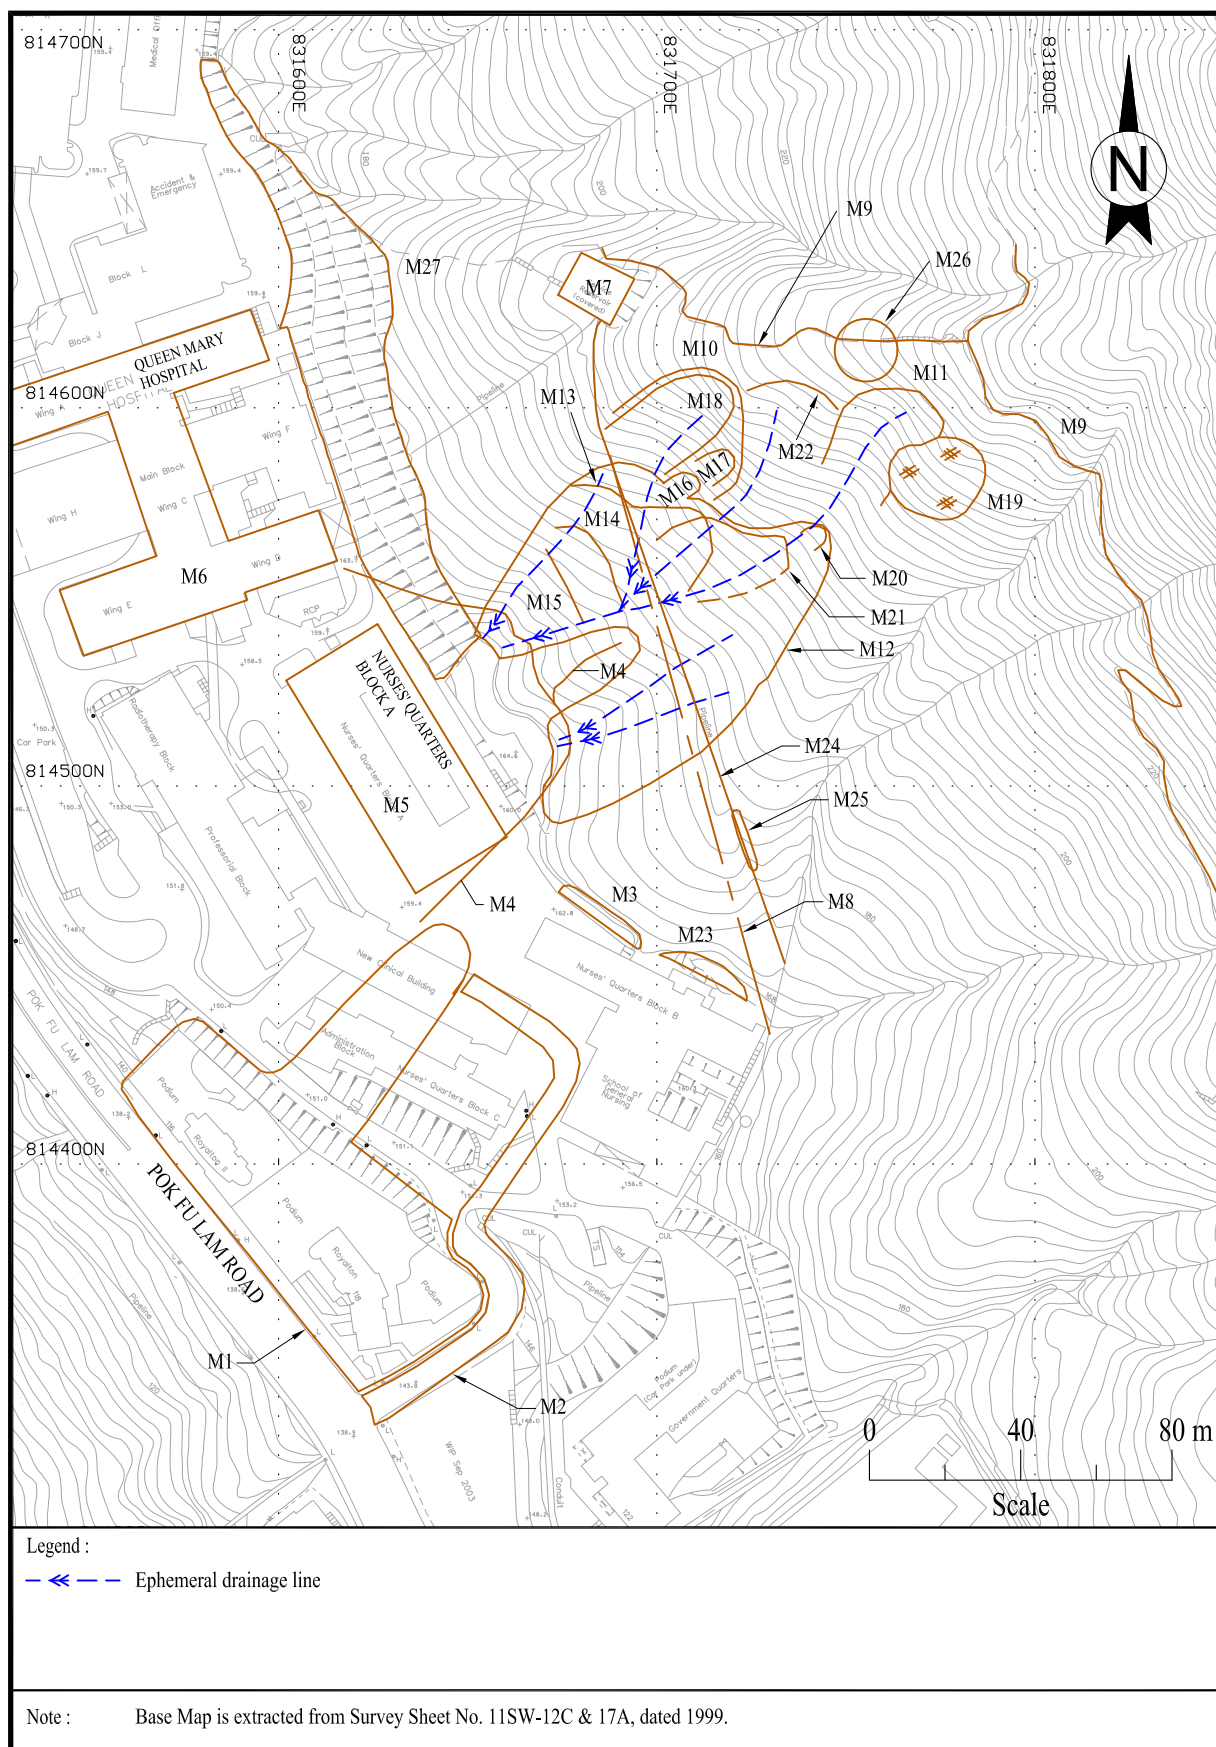
Figure A1 - API Plan

Two prominent areas of relict instability are observed within the catchment in the 1949 aerial photographs. One area comprises a single large relict landslide and the other comprises a cluster of several different landslides, which lies just to the north of the August 2005 landslide. A third, less prominent scar, located between the two relict scars noted in 1949, is evident in the 1963 aerial photographs. These scars were probably in existence in the 1924 aerial photographs, but the poor resolution of these photographs inhibited detailed observations. Possible minor scarps, indicating possible instability, were observed in proximity to the main scarp and toe of the August 2005 landslide in the 1963 aerial

photographs. In the 1972 aerial photographs, erosion and/or renewed localised instability was observed in the area of relict instability to the north of the August 2005 landslide.

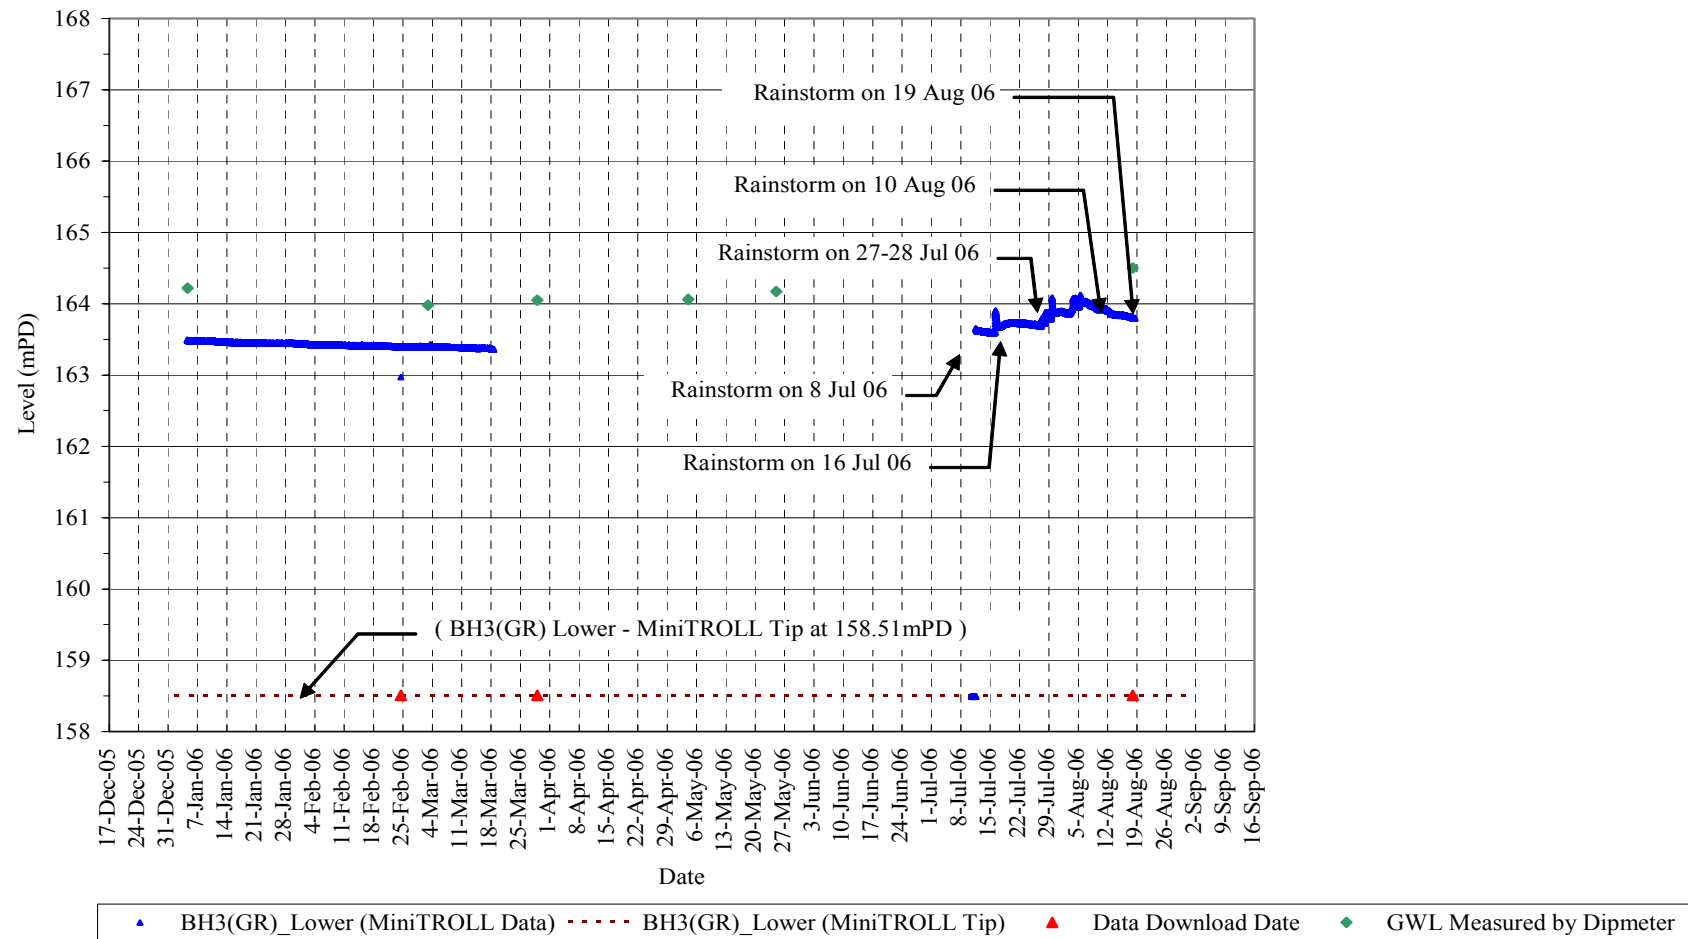
Figure B1 - Groundwater Monitoring for Drillhole BH3 (GR) Lower

Note: (1) MiniTROLL removed during site works from 19 March to 11 July 2006

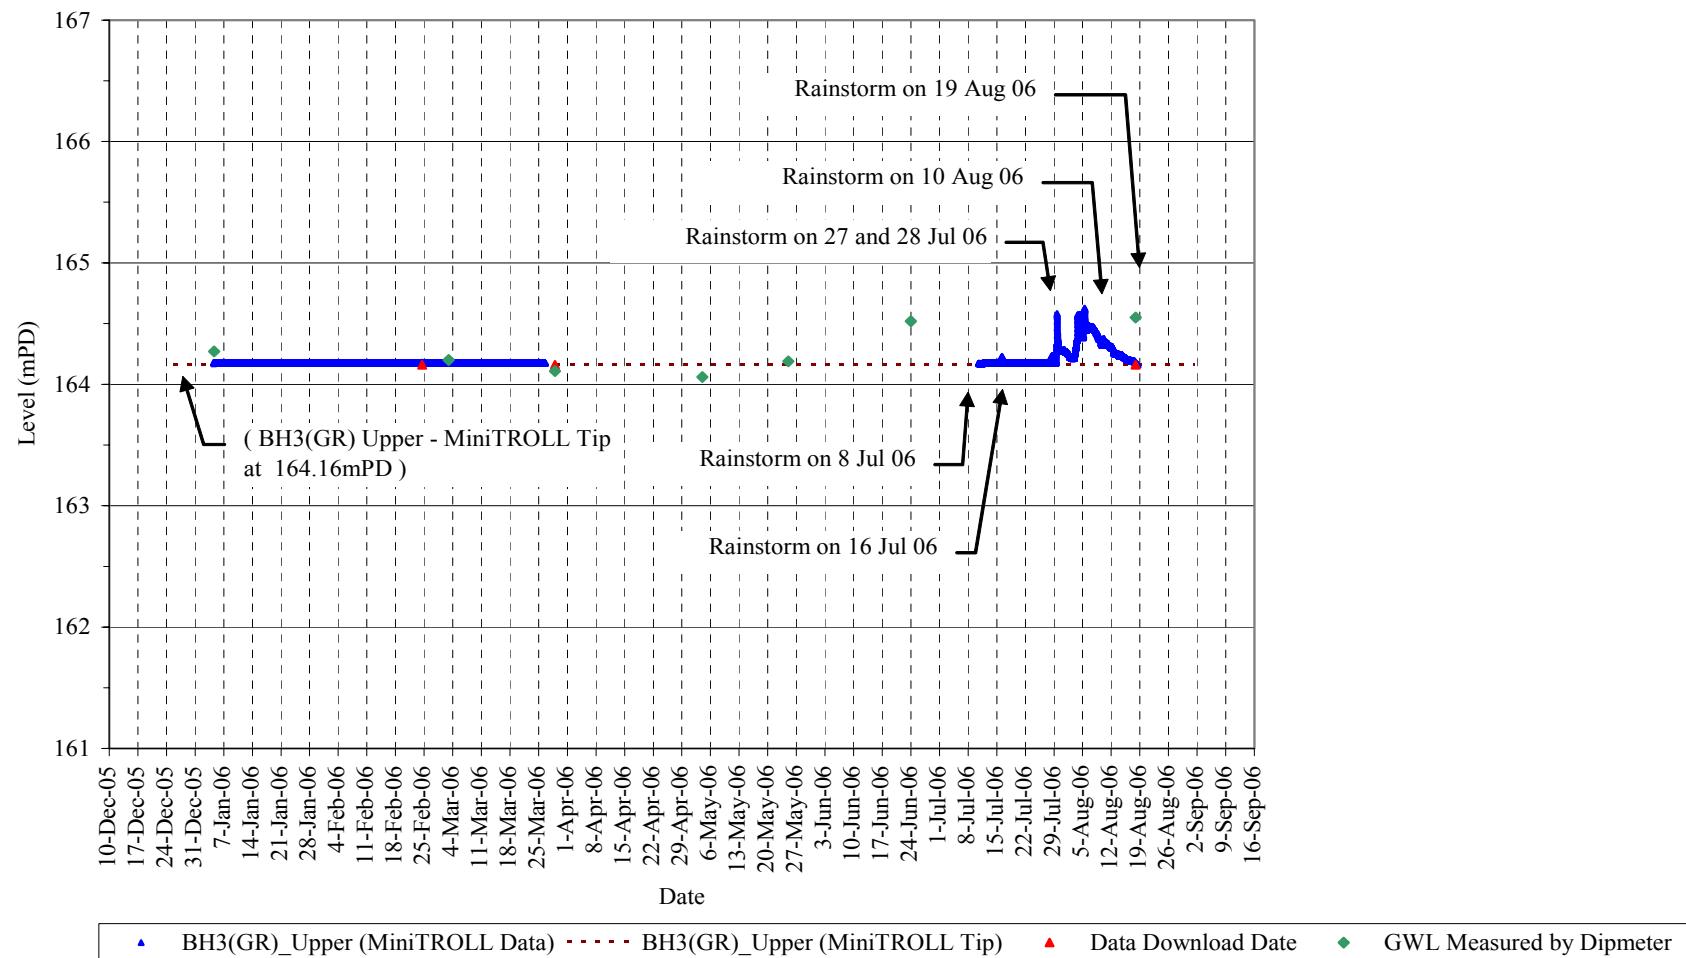
Figure B2 - Groundwater Monitoring for Drillhole BH3 (GR) Upper

Note: (1) MiniTROLL removed during site works from 29 March to 11 July 2006

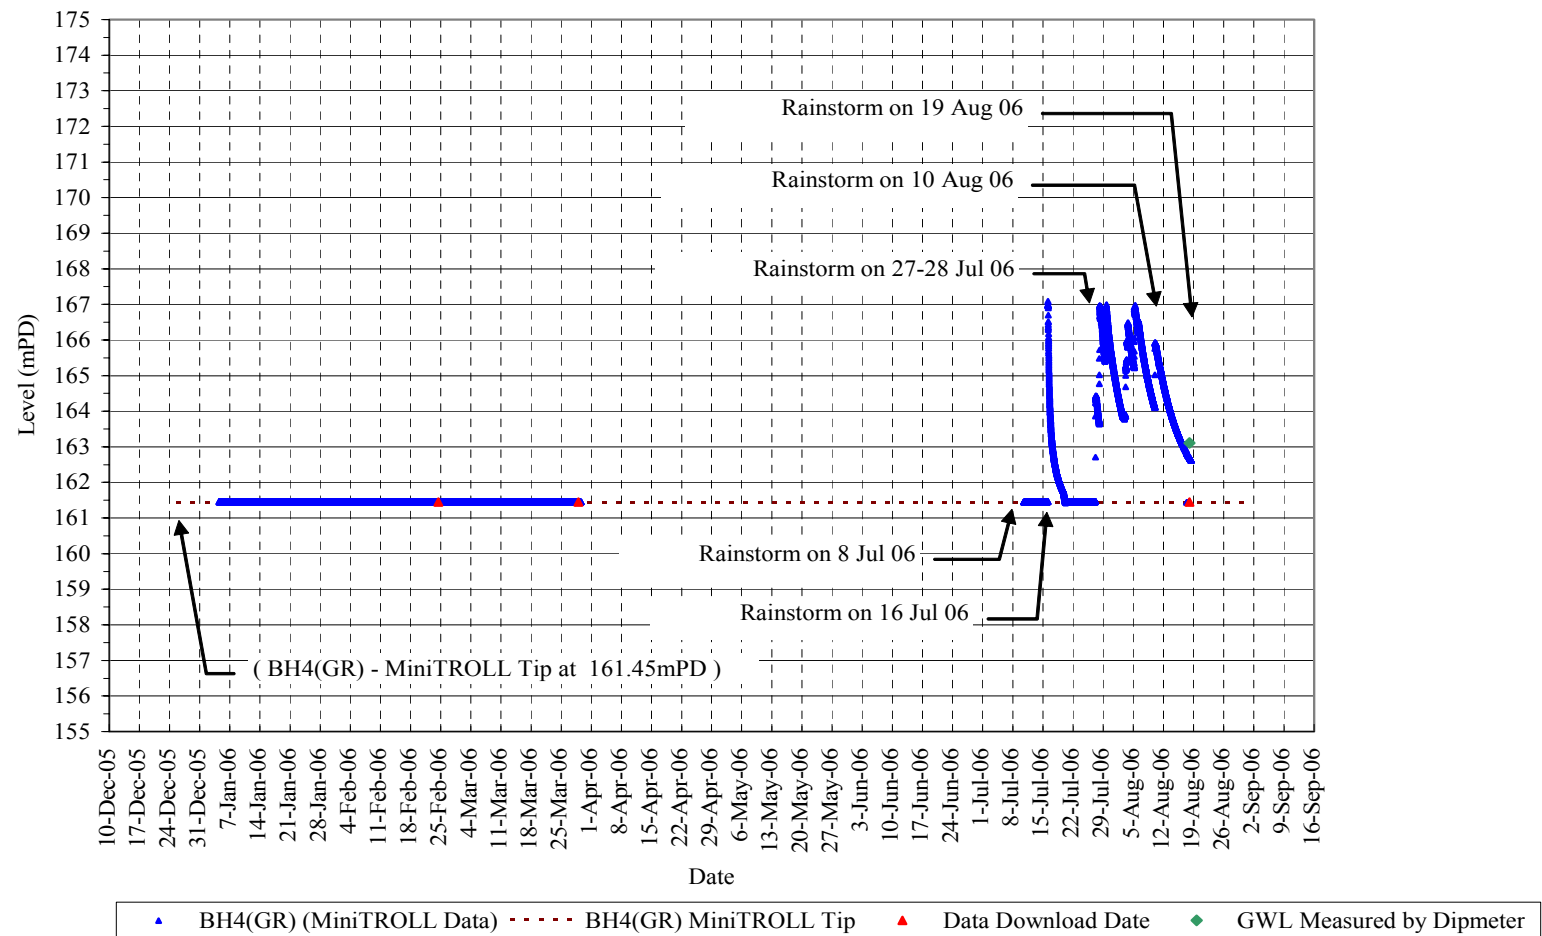
Figure B3 - Groundwater Monitoring for Drillhole BH4(GR)

Note: (1) MiniTROLL removed during site works from 29 March to 11 July 2006

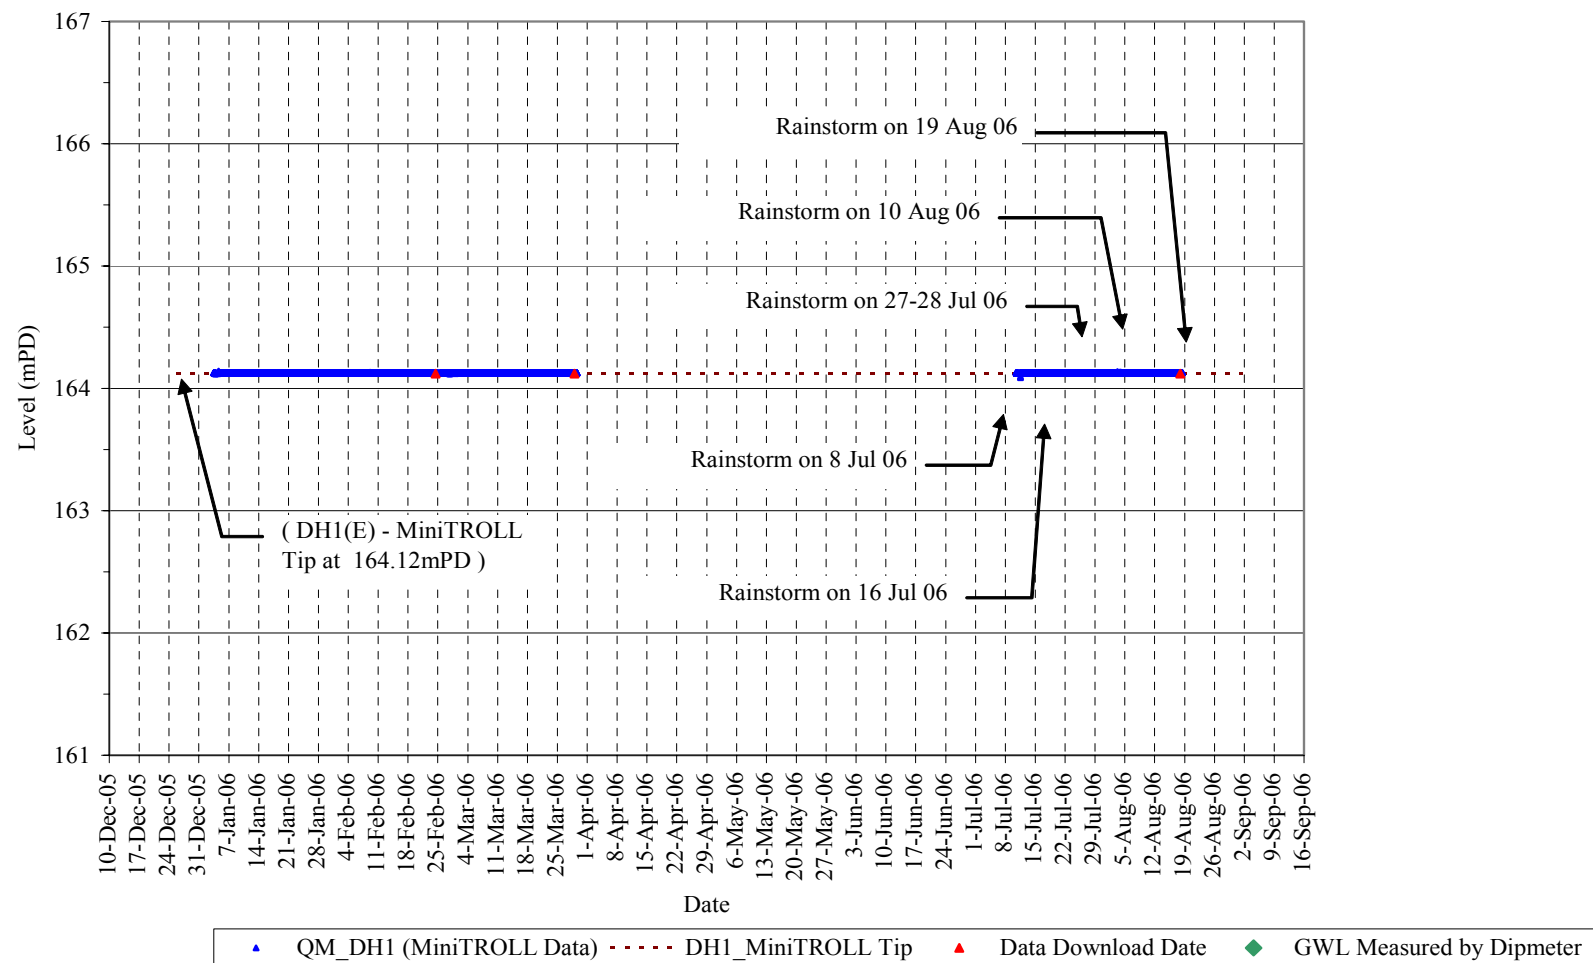
Figure B5 - Groundwater Monitoring for Drillhole DH1 (E)

Note: (1) MiniTROLL removed during site works from 29 March to 11 July 2006
