**REVIEW OF THE  
4 MAY 2007 ROCKFALL INCIDENT  
ON SLOPE NO. 11NE-C/C62  
AT HONG NING ROAD  
KWUN TONG**

**GEO REPORT No. 246**

**Halcrow China Limited**

**GEOTECHNICAL ENGINEERING OFFICE  
CIVIL ENGINEERING AND DEVELOPMENT DEPARTMENT  
THE GOVERNMENT OF THE HONG KONG  
SPECIAL ADMINISTRATIVE REGION**

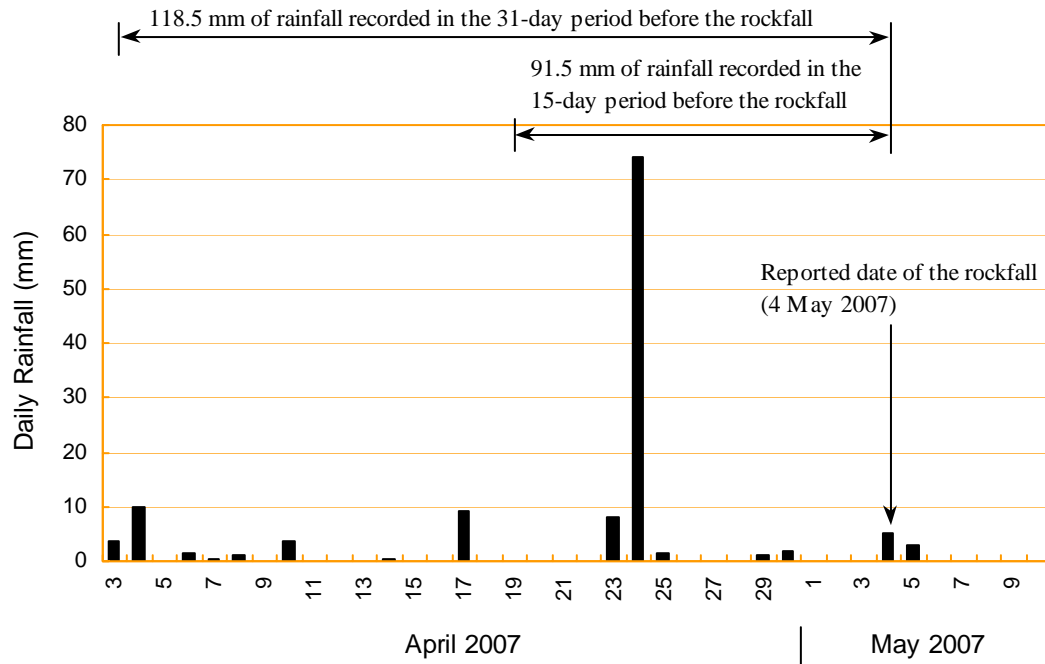
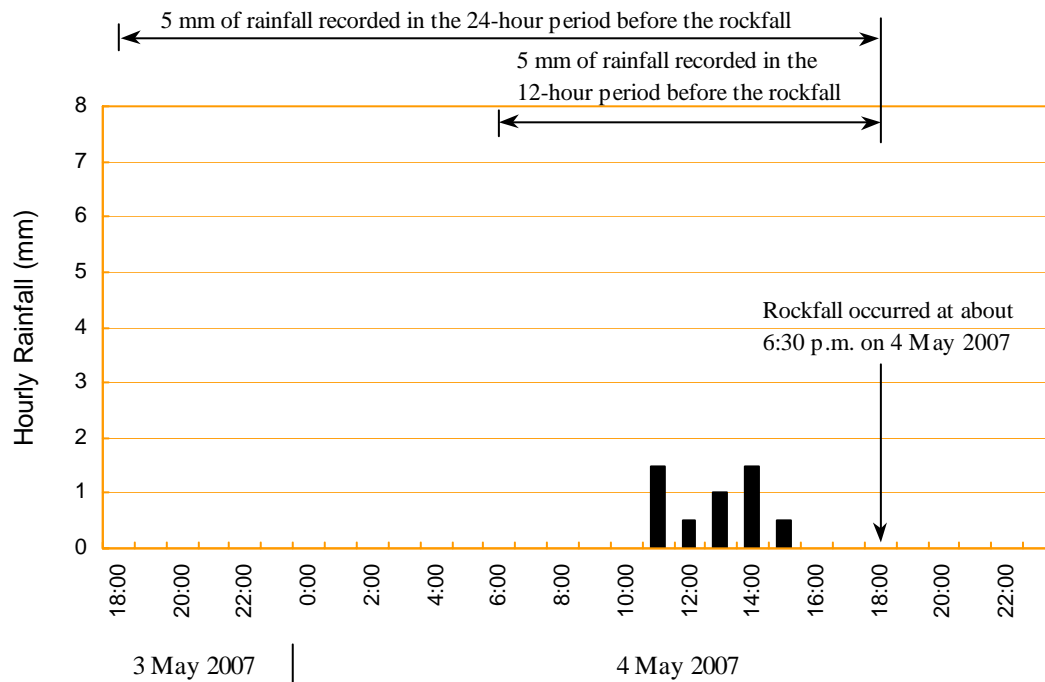
Figure 10 - Daily and Hourly Rainfall Recorded at GEO Raingauge No. K03

The daily rainfall for the period of 31 days before the incident and the hourly rainfall between 3 and 4 May 2007 are presented in Figure 10. The record of the daily rainfall shows that only 5 mm of rainfall was recorded on 4 May 2007. On the day of the rockfall, the record of the hourly rainfall shows that all the 5 mm of rainfall was recorded between 11:00 a.m. and 3:00 p.m., some three hours before the reported time of the rockfall.

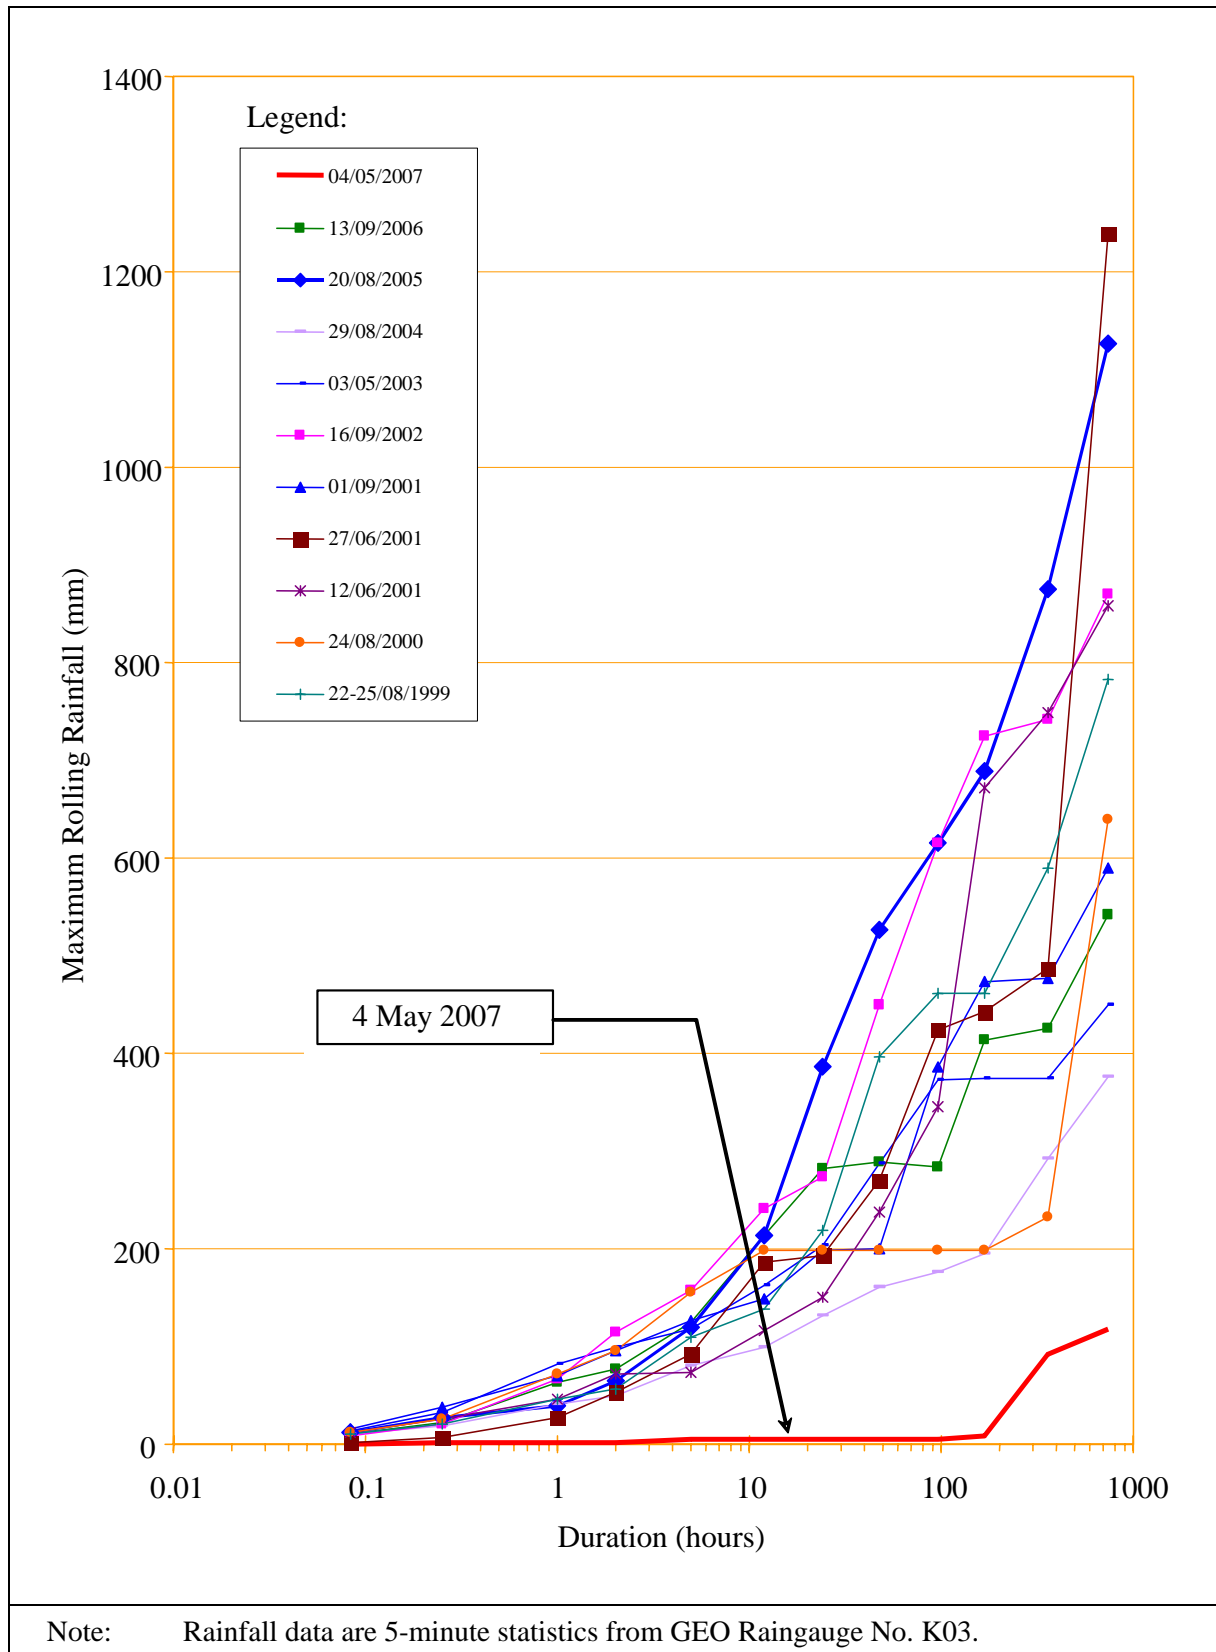
Figure 11 - Maximum Rolling Rainfall for Previous Major Rainstorms at GEO Raingauge No. K03 between August 1999 and May 2007

A comparison of the maximum rolling rainfall of the 4 May 2007 rainstorm with that of the past major rainstorms recorded by Raingauge No. K03 is presented in Figure 11. The rainstorm of 4 May 2007 was insignificant.

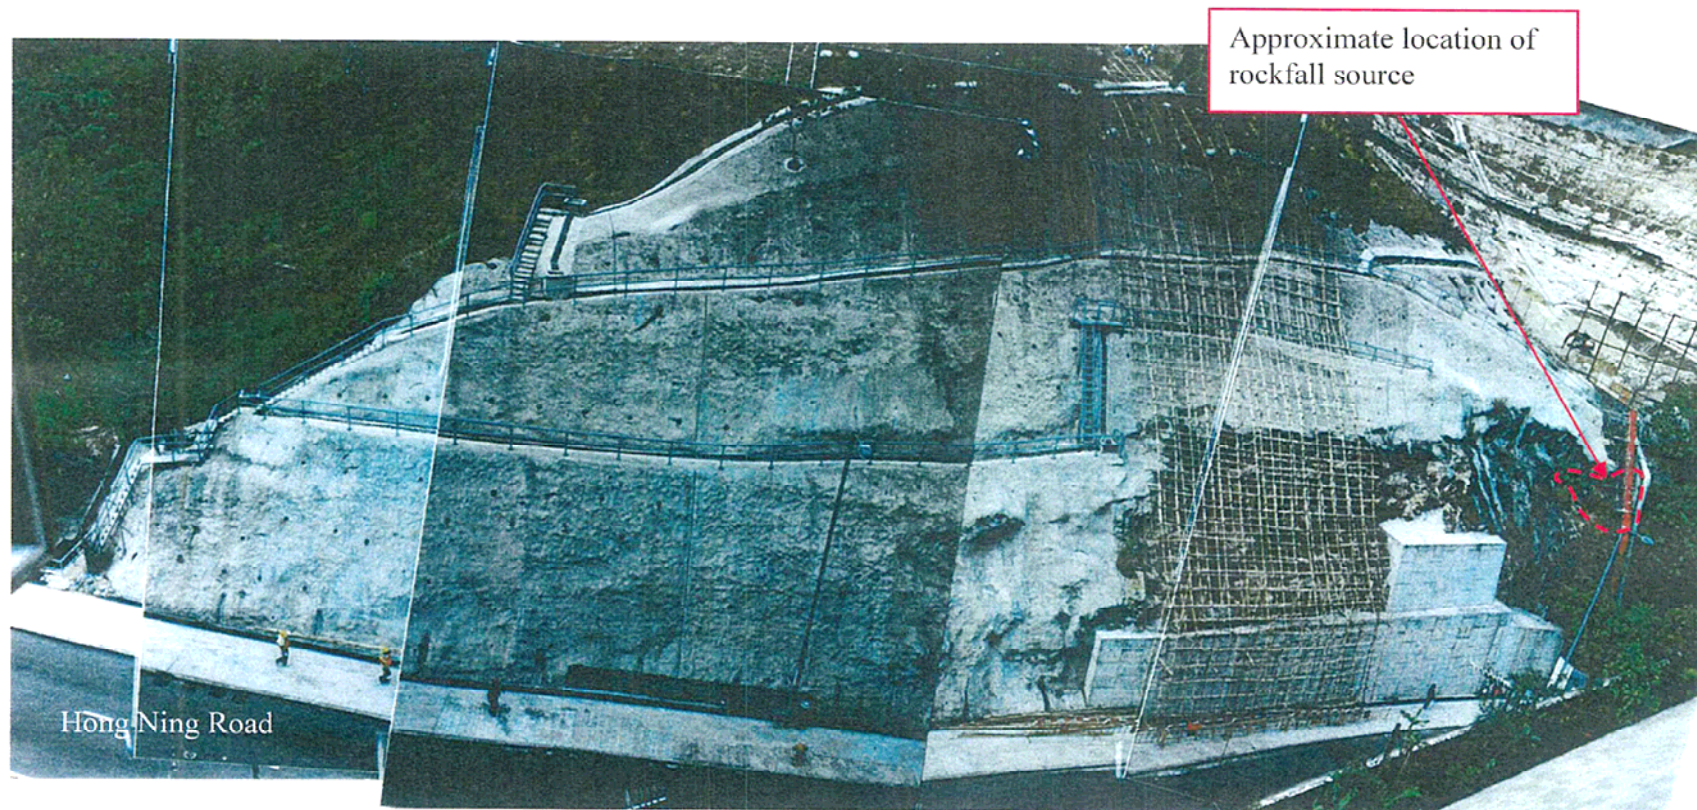
Plate 6 - General View of Slope No. 11NE-C/C62 in 2001 (Photograph taken on 18 January 2001)

slope under HyD's Term Contract No. 17/HY/1998. A record photograph of the RMI (Plate 6) shows the general view of the subject slope in 2001. In this photograph, the reinforced sprayed concrete applied under the above LPM slope upgrading works did not cover the slope portion at the 2007 rockfall source area.
