**REVIEW OF THE
20 AUGUST 2005 LANDSLIDE
ON SLOPE NO. 15NE-A/C152
AT MA HANG PRISON,
STANLEY**

GEO REPORT No. 247

Fugro Scott Wilson Joint Venture

**GEOTECHNICAL ENGINEERING OFFICE
CIVIL ENGINEERING AND DEVELOPMENT DEPARTMENT
THE GOVERNMENT OF THE HONG KONG
SPECIAL ADMINISTRATIVE REGION**

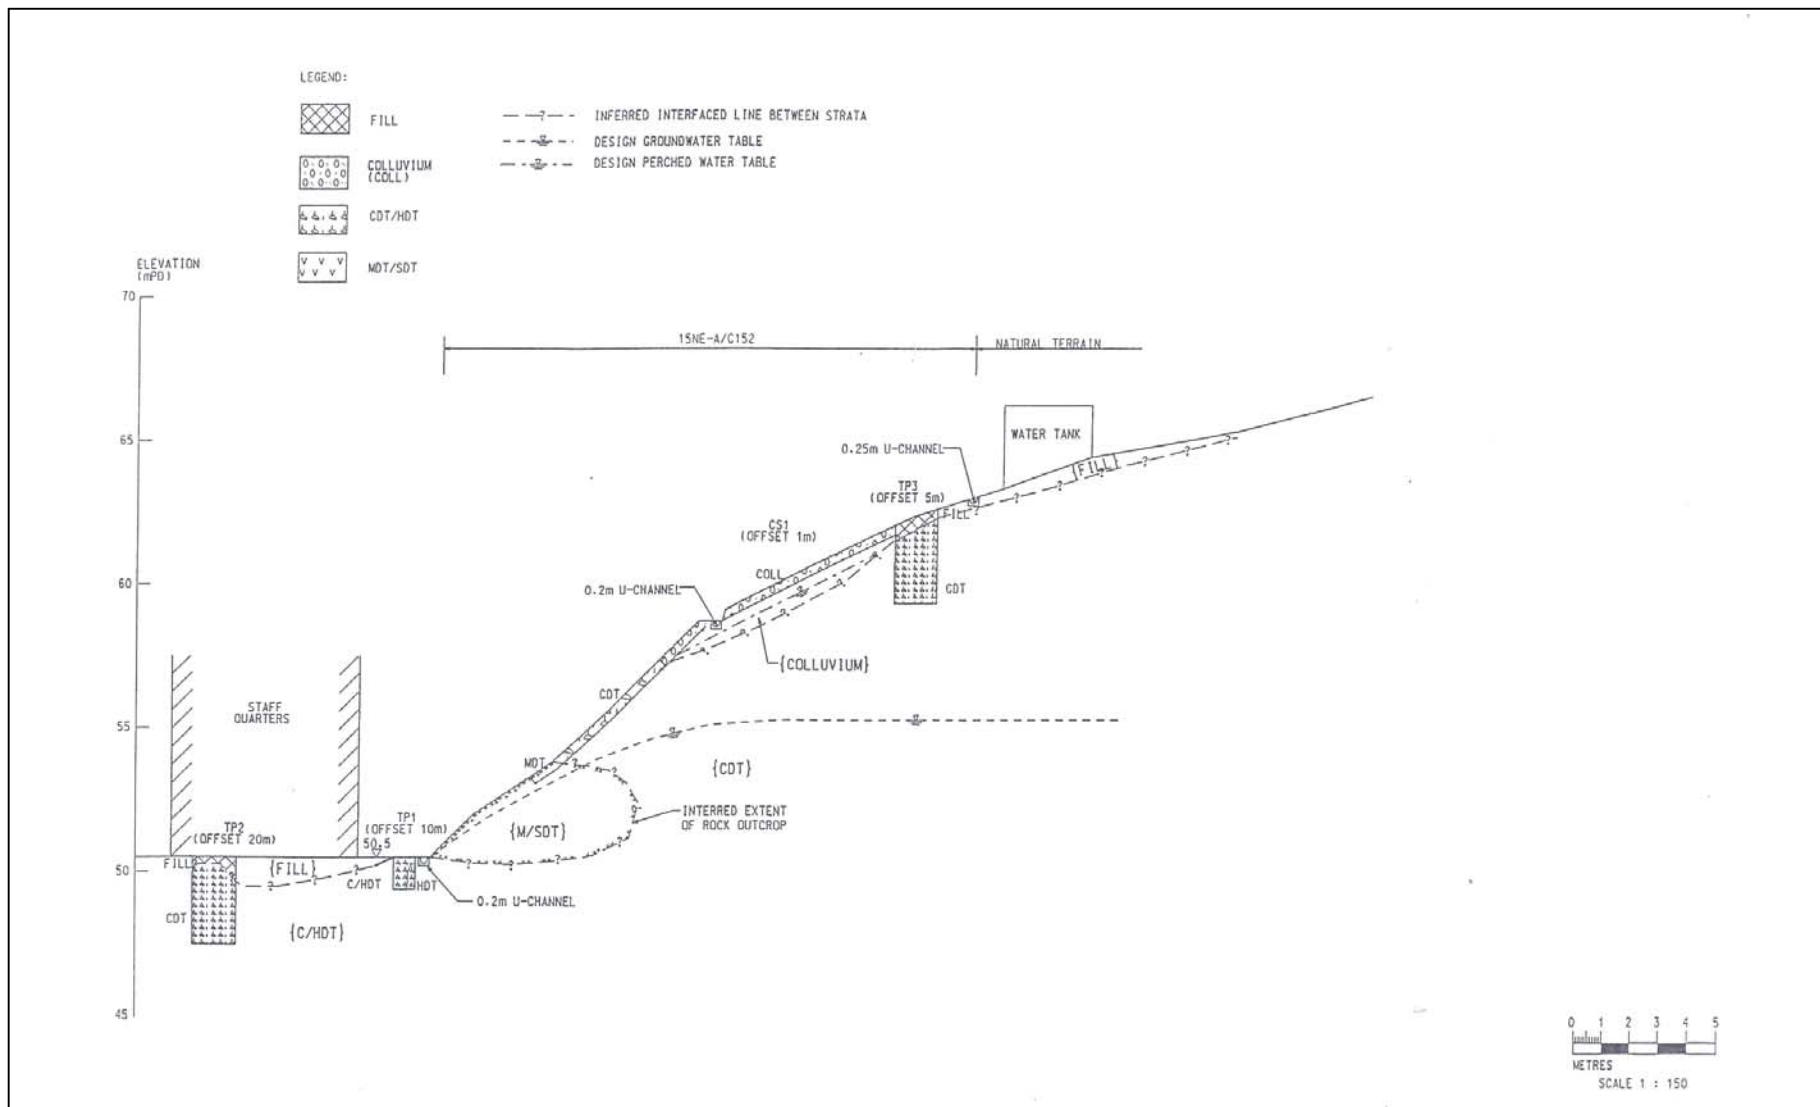
Figure 4 - Geological Section 1-1 through Slope No. 15NE-A/C152
(Extracted from Figure 4 of LPM Stage 3 Study Report No. S3R 107/99)

The local failure occurred near the top of the lower slope batter, at a section through the location of a locally extensive moderately decomposed rock mass that measures 18 m across and 4 m high (see Figure 8). The ground investigation undertaken under the LPM Stage 3 Study comprised trial pits and surface strips, with no boreholes, and no groundwater monitoring was undertaken. In the LPM design, this rock mass was judged to be a "boulder". In the stability analysis of this section, the LPM design ground model assumed a soil profile, ignoring the large "boulder". The corresponding groundwater condition adopted in the LPM Study was generally commensurate with the above assumed ground model (see Figure 5).

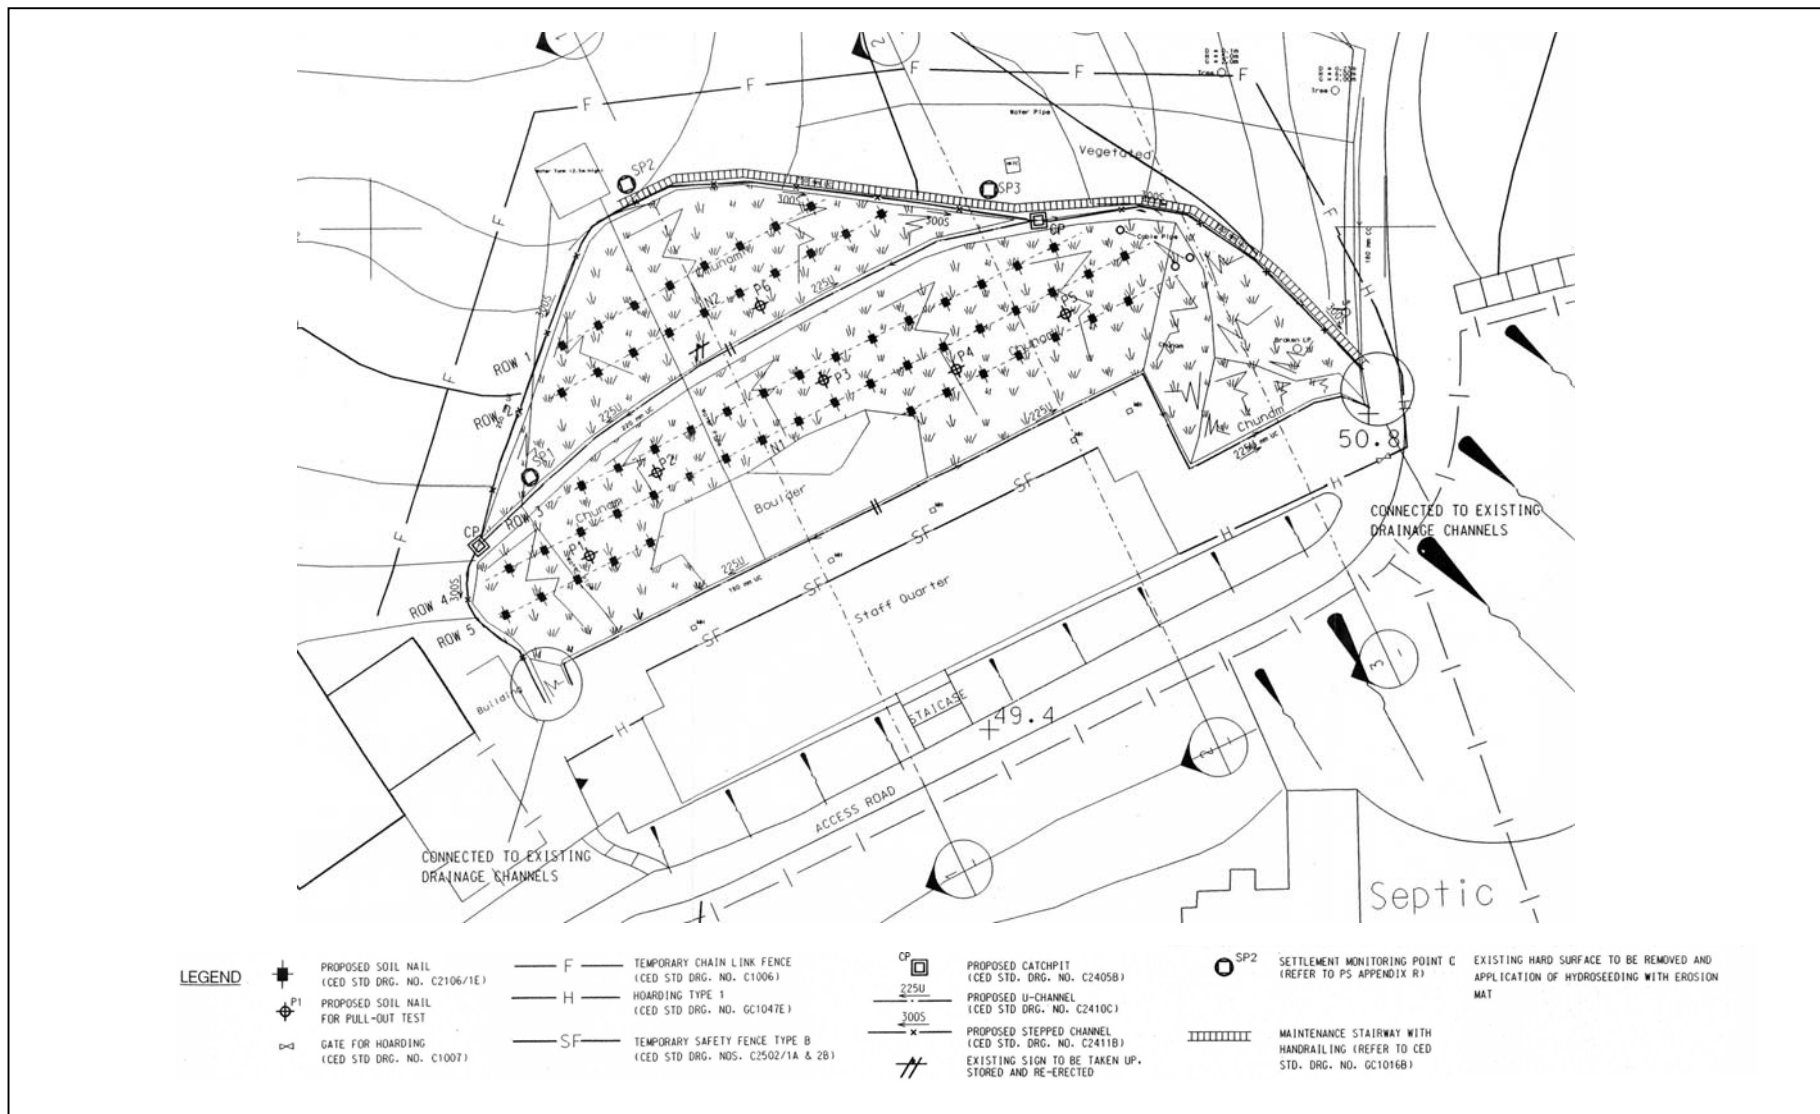
Figure 6 - Proposed Arrangement of Soil Nails (Extracted from Drawing No. LPM9918/1622 (Version 0) of LPM Stage 3 Study Report No. S3R 107/99)

Two soil nails from Row 2 within the lower batter (see Figure 7), with heads measuring about 400 mm and 500 mm square respectively and located about 3 m below the intermediate berm, were situated within the landslide scar (Figure 8, Plates 12 and 13). The exposed portions of these two soil nails were bent downward at about 30° to the horizontal, at approximately 0.5 m behind the slope face (Plate 14). The cement grout underneath the nail bars was found to have spalled and hence the nail reinforcement was exposed.

It did not appear that nails from Row 3 (see Figure 7), which were situated lower on the slope face immediately above the soil/rock interface, were affected by the failure, as the debris trail and the daylight of the surface of rupture passed between the locations of two soil nails in Row 3 (see Figure 8). A third soil nail head was observed within the debris trail on the rock outcrop below the scar, approximately 2.5 m above the slope toe (Plate 15). This nail head, which was one of the six additional soil nails installed across the rock outcrop (see Section 5.5), was noted to be intact and unaffected by the failure.

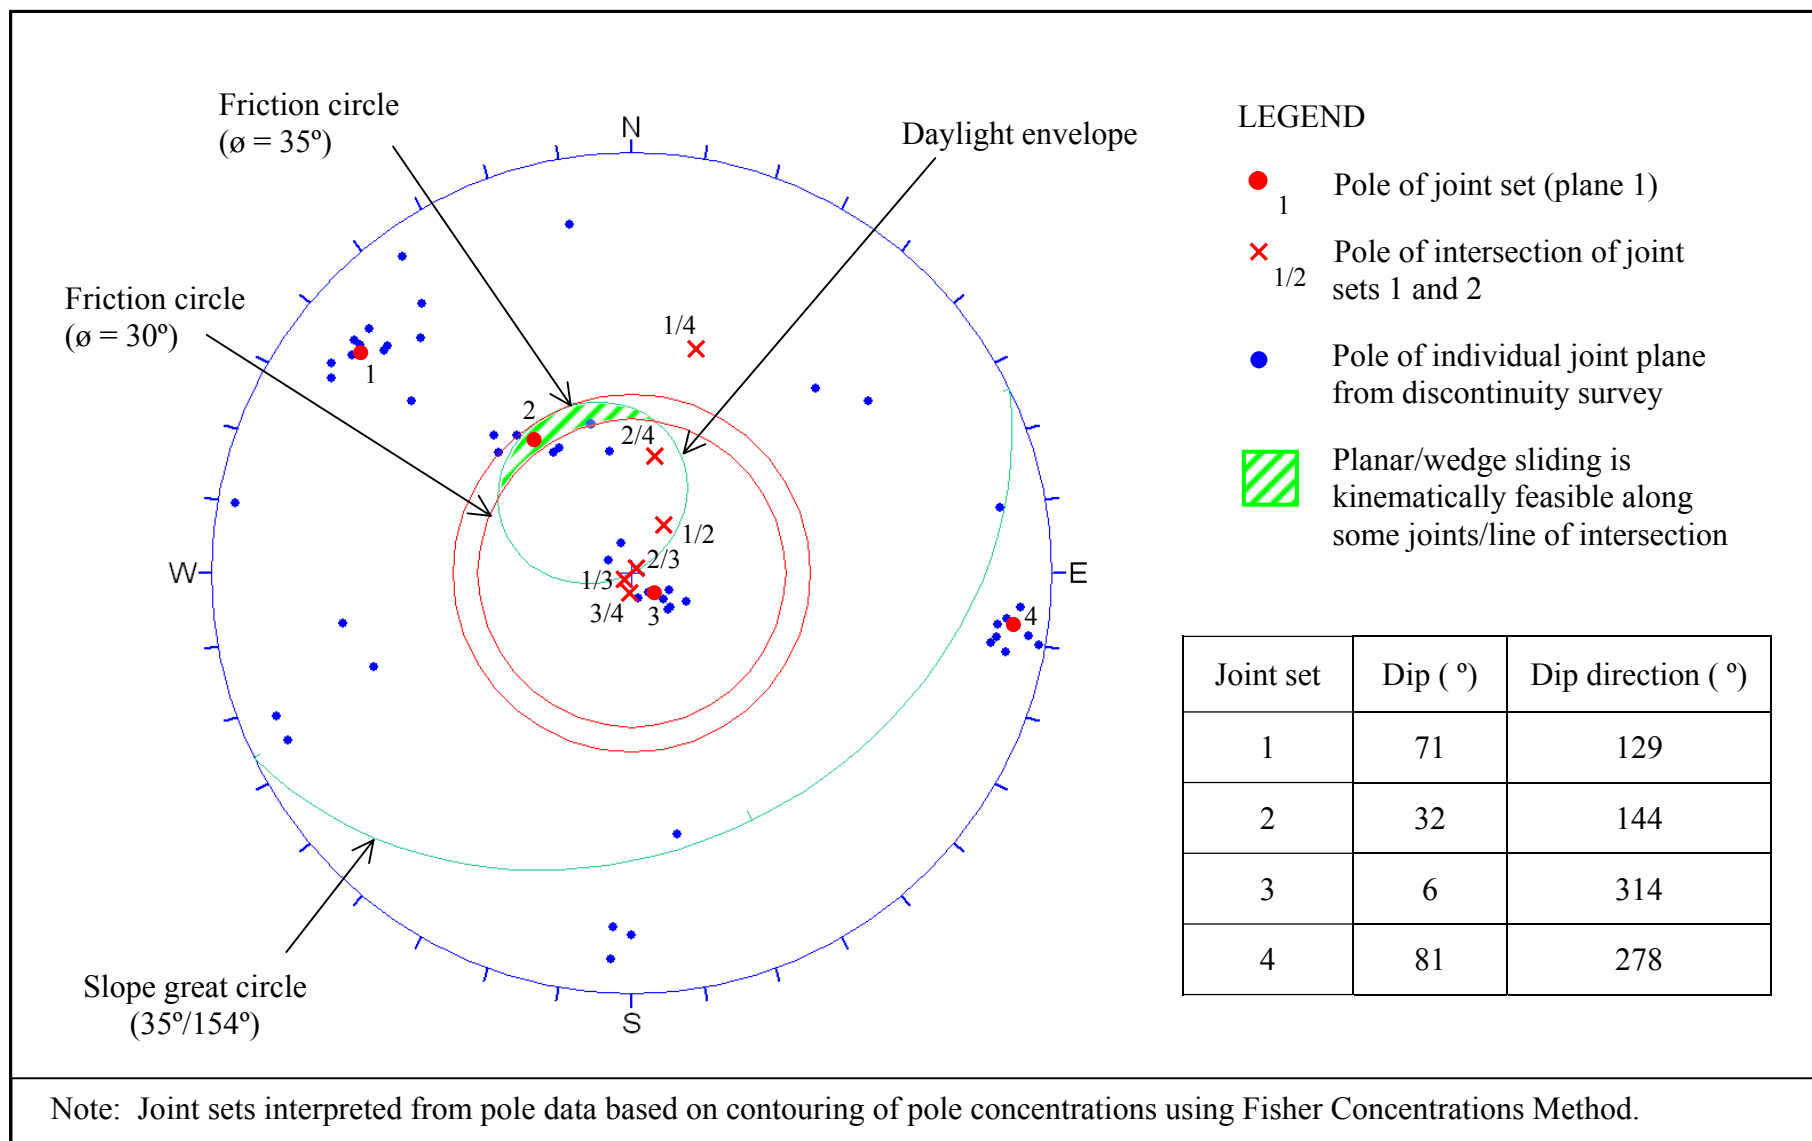
Figure 9 - Stereographic Projection of Discontinuity Survey Data

along the surface of rupture. Some fine-grained soils, comprising yellowish-brown silt, were also observed. No seepage was observed at the main scarp at the time of site inspection, and the exposed material was dry at the time of the inspections. Seepage was noted at the soil/rock interface immediately adjacent to both sides of the scar (Plate 9). No soil pipes could be observed at the main scarp. Adversely orientated joint sets, with dip/dip direction of $32^{\circ}/144^{\circ}$ (Joint Set 2) and $81^{\circ}/278^{\circ}$ (Joint Set 4), were noted on the rock exposed at slope toe (Figure 9). No obvious adverse relict joints were observed on the landslide scarp.

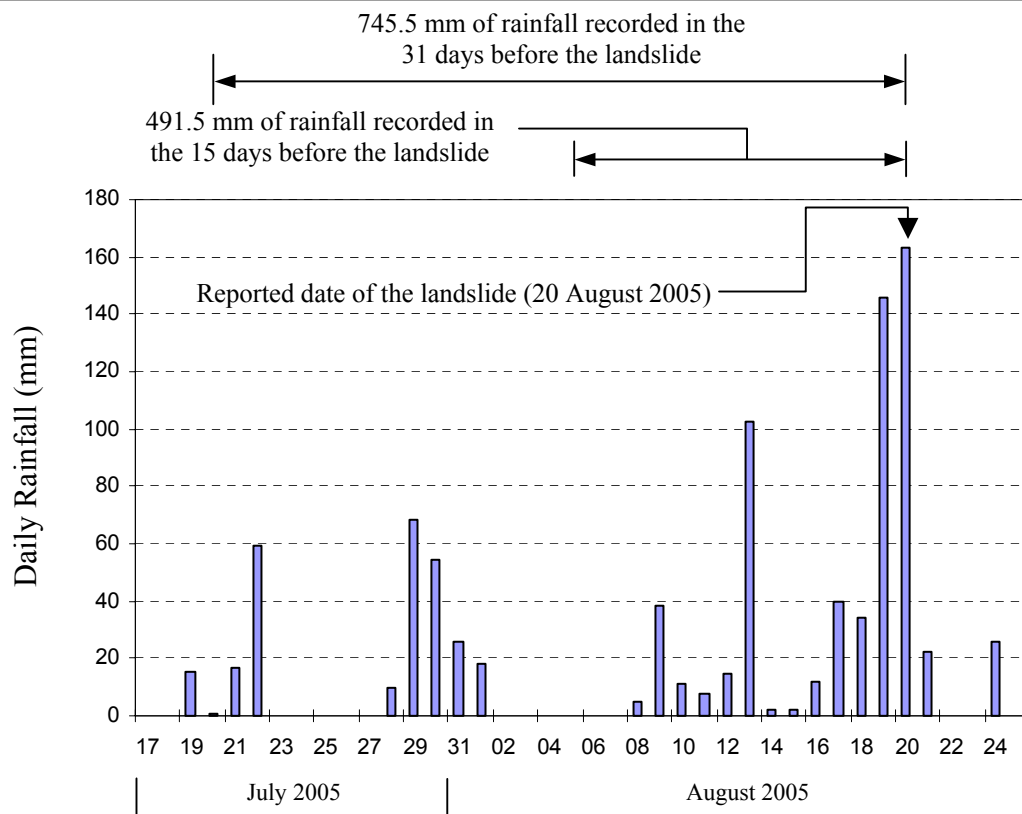
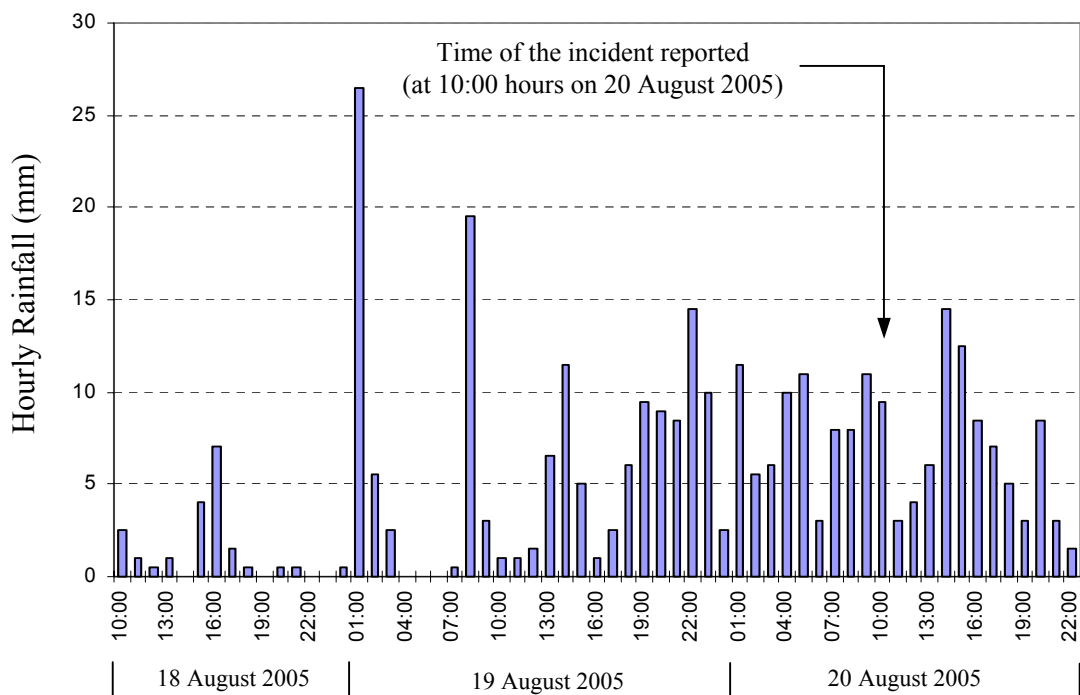
Figure 10 - Rainfall Recorded at GEO Raingauge No. H15 Preceding the 20 August 2005 Landslide

The daily rainfall recorded by raingauge No. H15 over the month preceding the landslide, together with the hourly rainfall readings for the period between 10:00 a.m. on 18 August 2005 and 10:00 p.m. on 20 August 2005, are presented in Figure 10. The maximum 24-hour and 12-hour rolling rainfall before the landslide was 168.5 mm and 104.5 mm respectively.

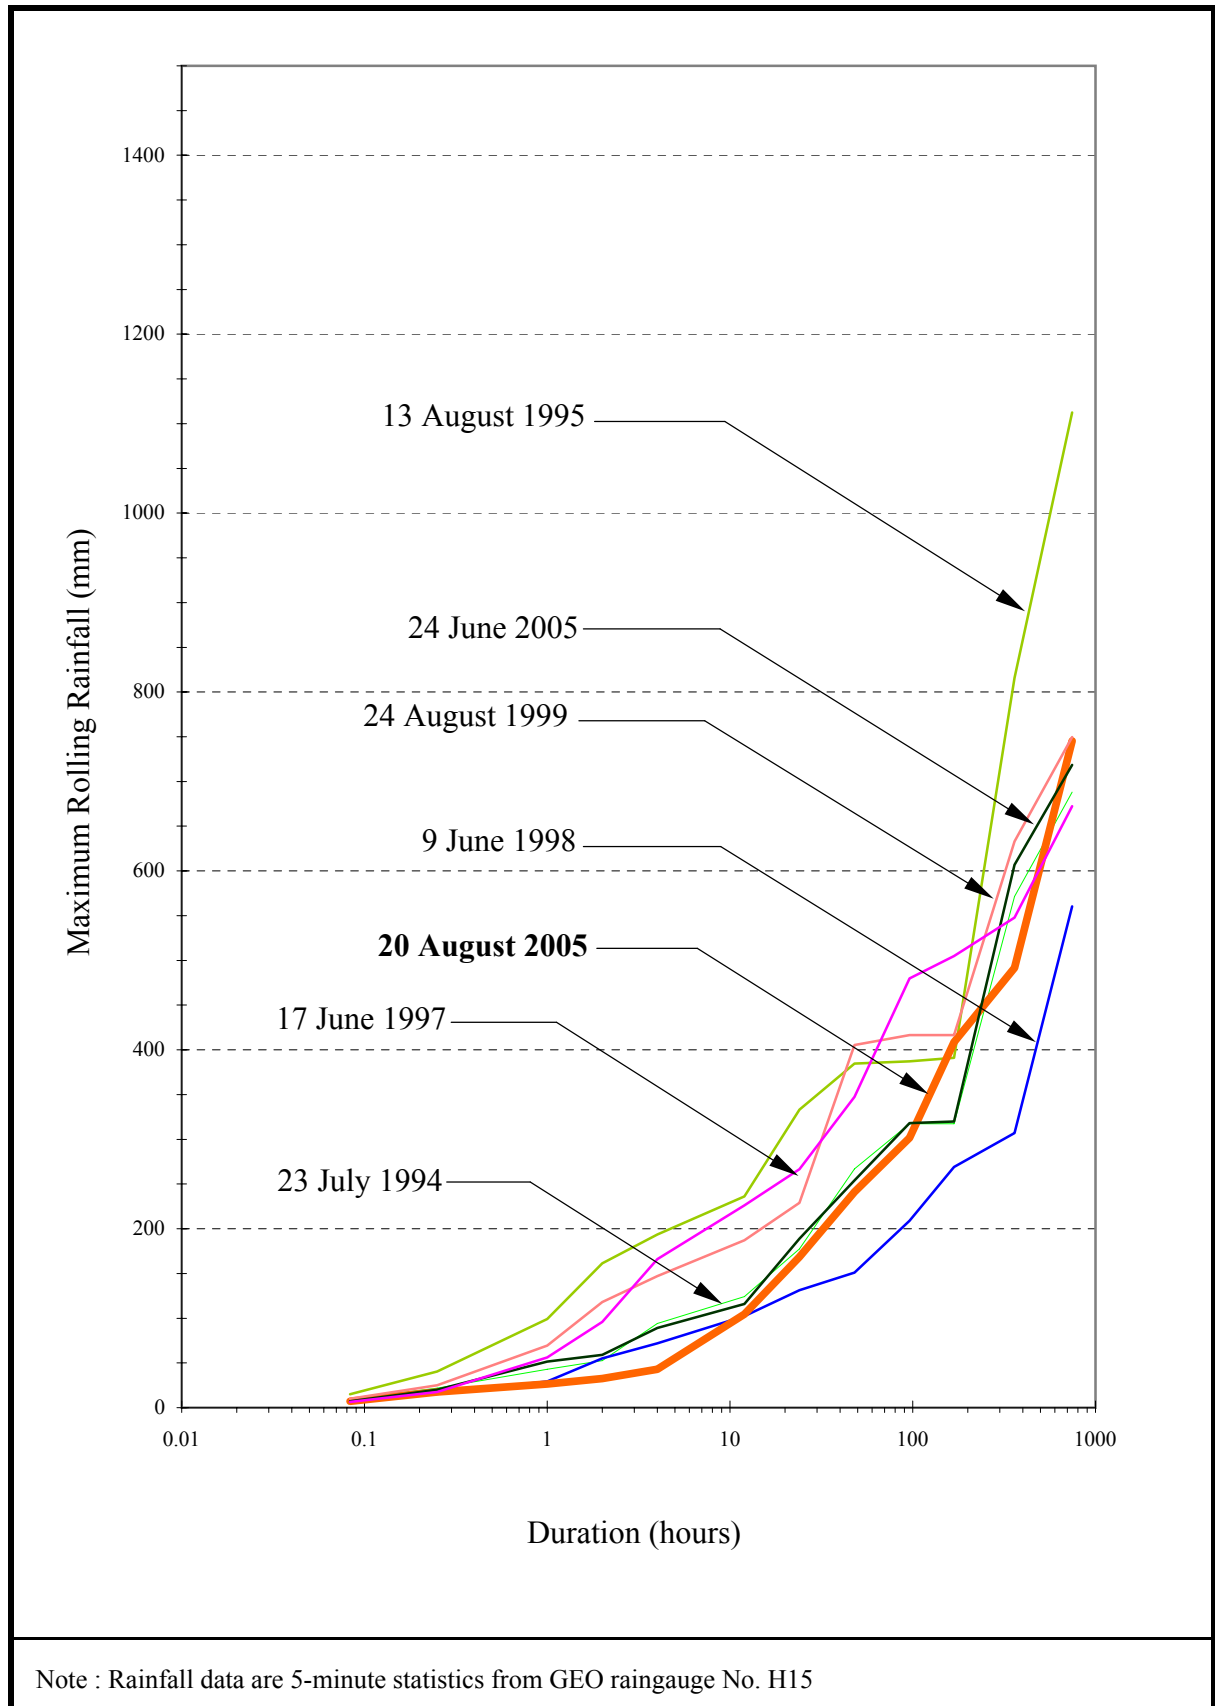
Figure 11 - Maximum Rolling Rainfall Preceding the 20 August 2005 Landslide and Selected Previous Major Rainstorms Recorded at GEO Raingauge No. H15

The maximum rolling rainfall for the rainstorm on 20 August 2005 has been compared with the past major rainstorms between the mid-1980's and 2005 recorded by raingauge No. H15, which came into operation in August 1979 (Figure 11). The maximum rolling rainfall for the rainstorm on 20 August 2005 was not the most severe for any duration when compared to the full data set of rainfall records.

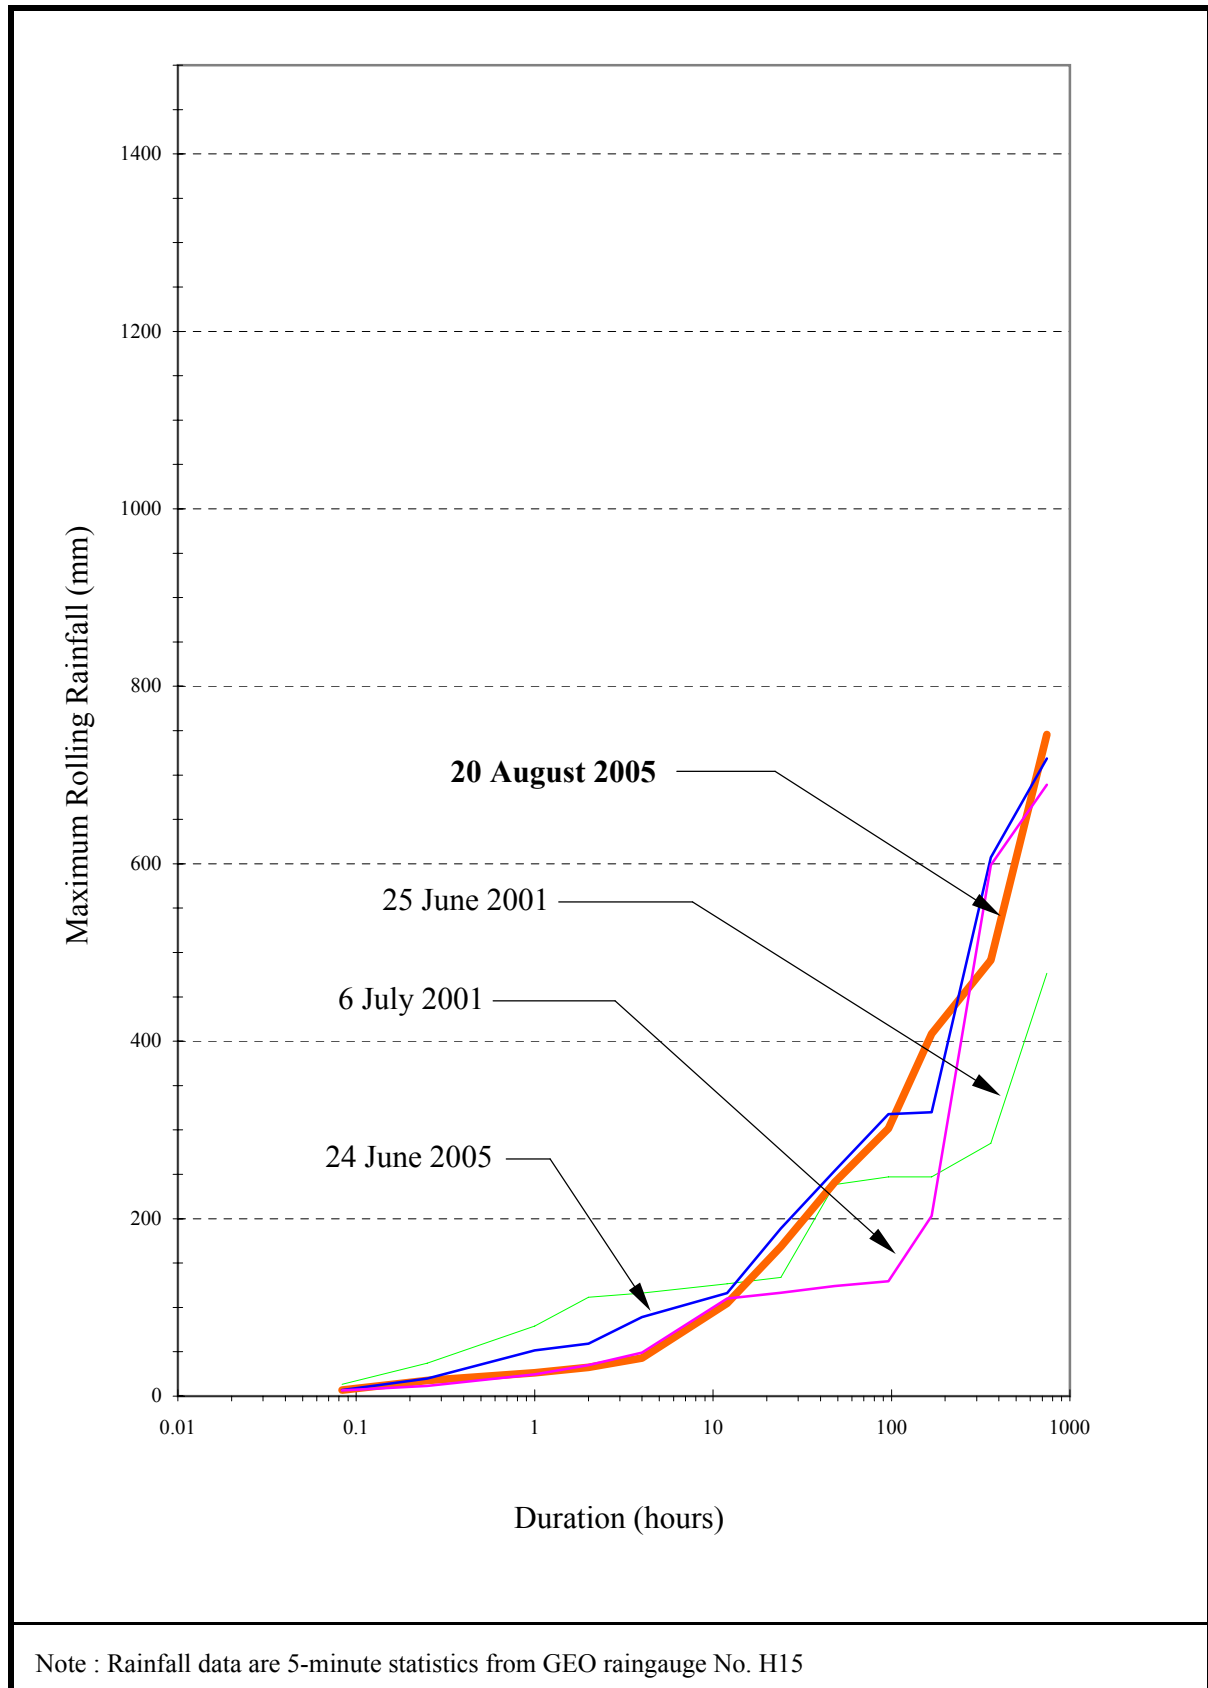
Figure 12 - Maximum Rolling Rainfall Preceding the 20 August 2005 Landslide and Selected Previous Major Rainstorms Recorded at GEO Raingauge No. H15 since Completion of LPM Works in March 2001

The maximum rolling rainfall for the rainstorm on 20 August 2005 has also been compared with the past major rainstorms since the LPM slope upgrading works were completed in March 2001 (Figure 12). This indicates that the maximum rolling rainfall for the rainstorm on 20 August 2005 was the highest for the 7-day and 31-day durations, but was not particularly severe for short durations.
