**REVIEW OF THE  
3 JUNE 2007 FAILURE OF A  
MASONRY RETAINING WALL  
ON HILLSIDE ADJACENT TO  
NO. 84 PEAK ROAD**

**GEO REPORT No. 250**

**Fugro Scott Wilson Joint Venture**

**GEOTECHNICAL ENGINEERING OFFICE  
CIVIL ENGINEERING AND DEVELOPMENT DEPARTMENT  
THE GOVERNMENT OF THE HONG KONG  
SPECIAL ADMINISTRATIVE REGION**

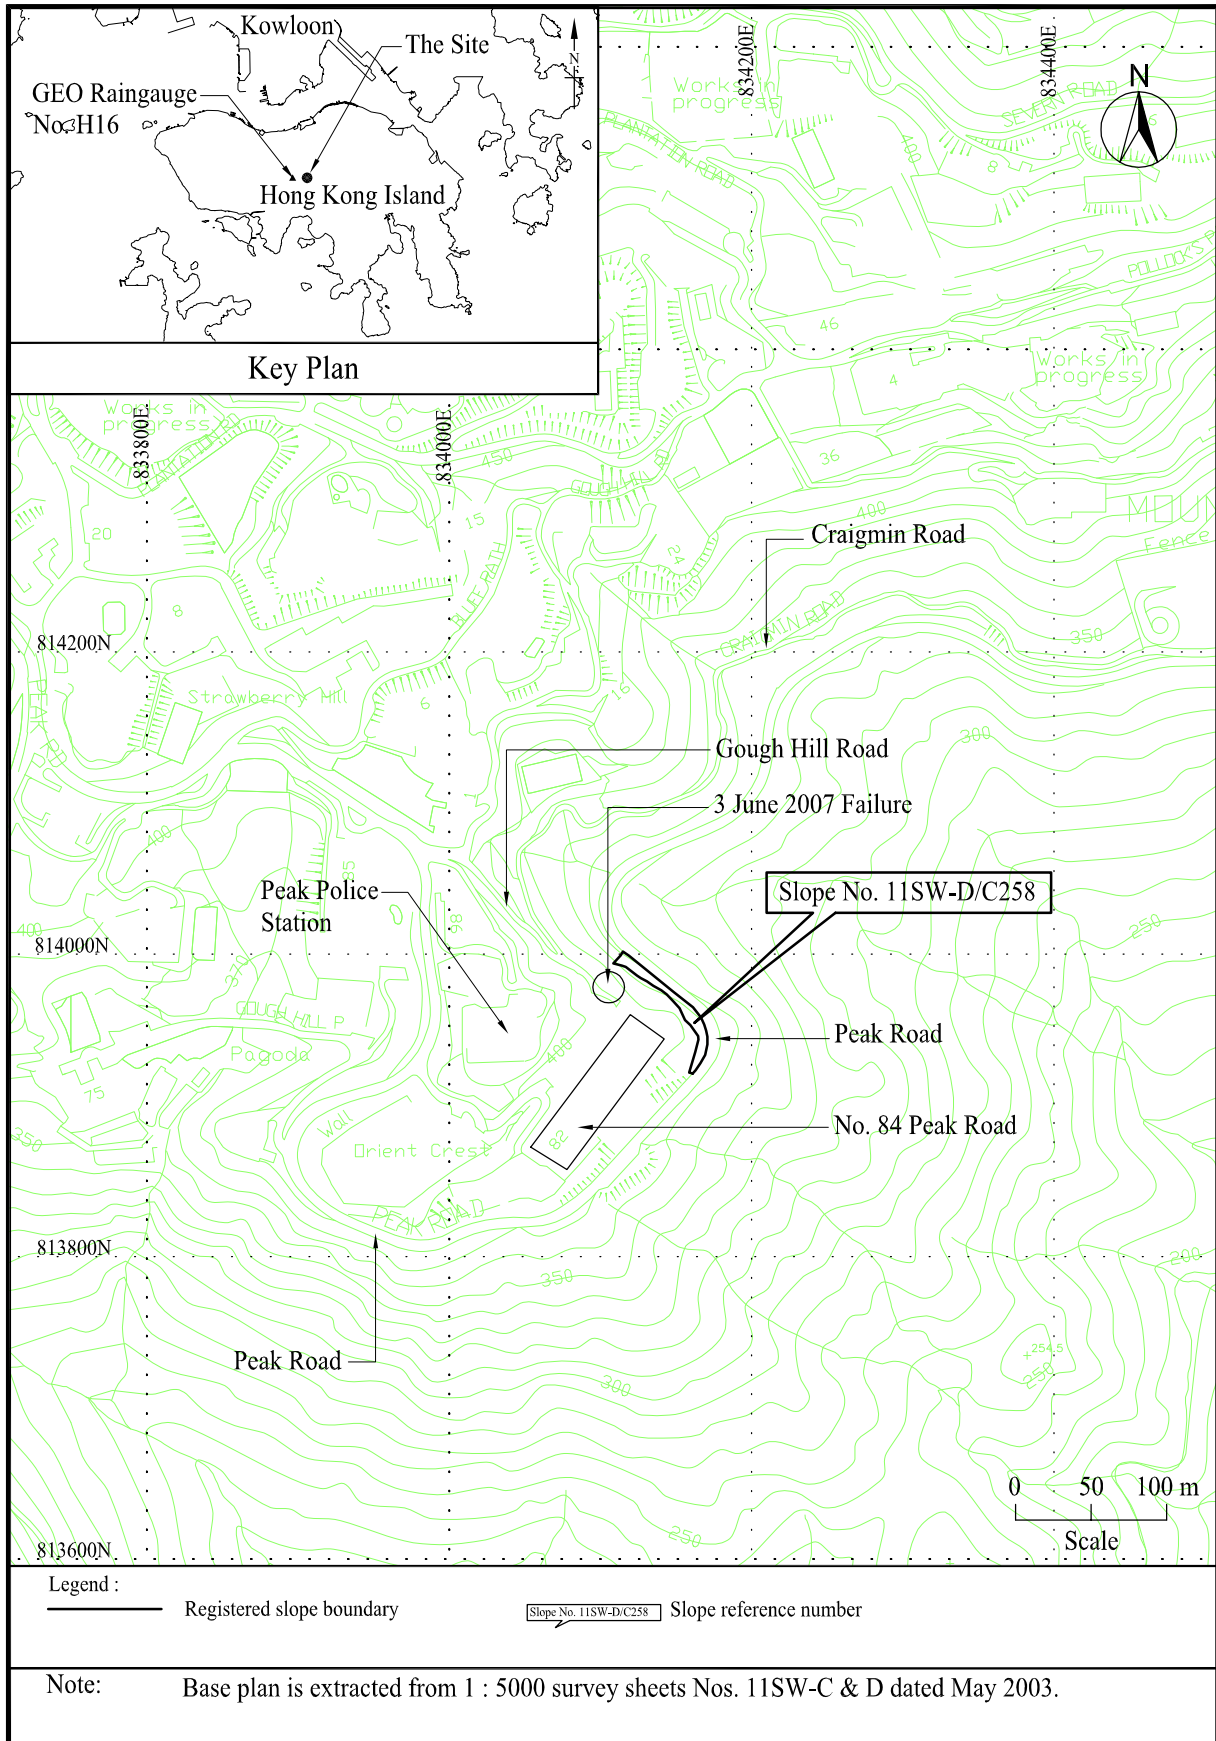
Figure 1 - Site Location Plan

Rainfall data were obtained from GEO automatic raingauge No. H16, which is the nearest raingauge to the June 2007 failure and located at The Peak, approximately 0.5 km to the west of the site (Figure 1). The raingauge records and transmits rainfall data at 5-minute intervals to the Hong Kong Observatory (HKO) and the GEO.

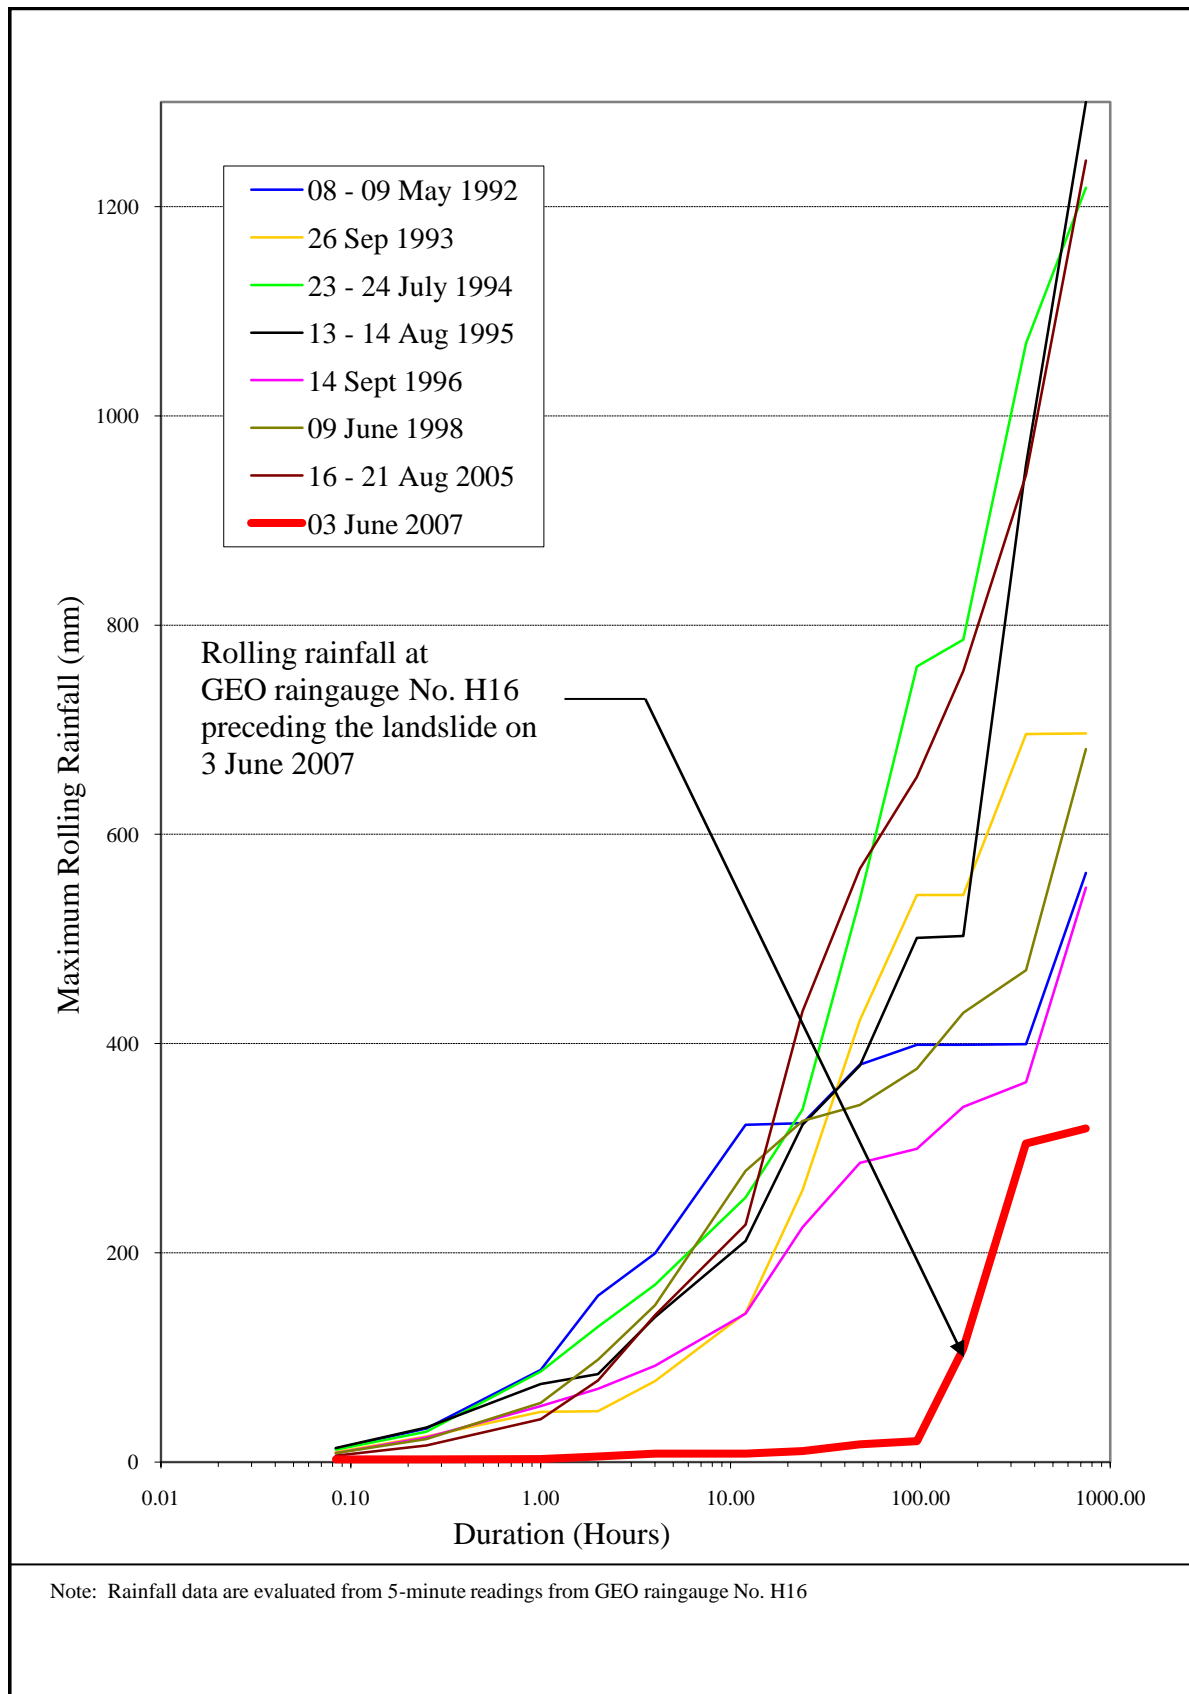
Figure 8 - Maximum Rolling Rainfall for the Rainstorm Preceding the Landslide and Selected Previous Major Rainstorms Recorded at GEO Raingauge No. H16

The maximum rolling rainfall for the rainstorm on 3 June 2007 has been compared with the past major rainstorms between 1983 and 2006 recorded by raingauge No. H16, which came into operation in 1983 (Figure 8). The maximum rolling rainfall for the rainstorm on 3 June 2007 is very light as compared to the previous significant rainstorms.

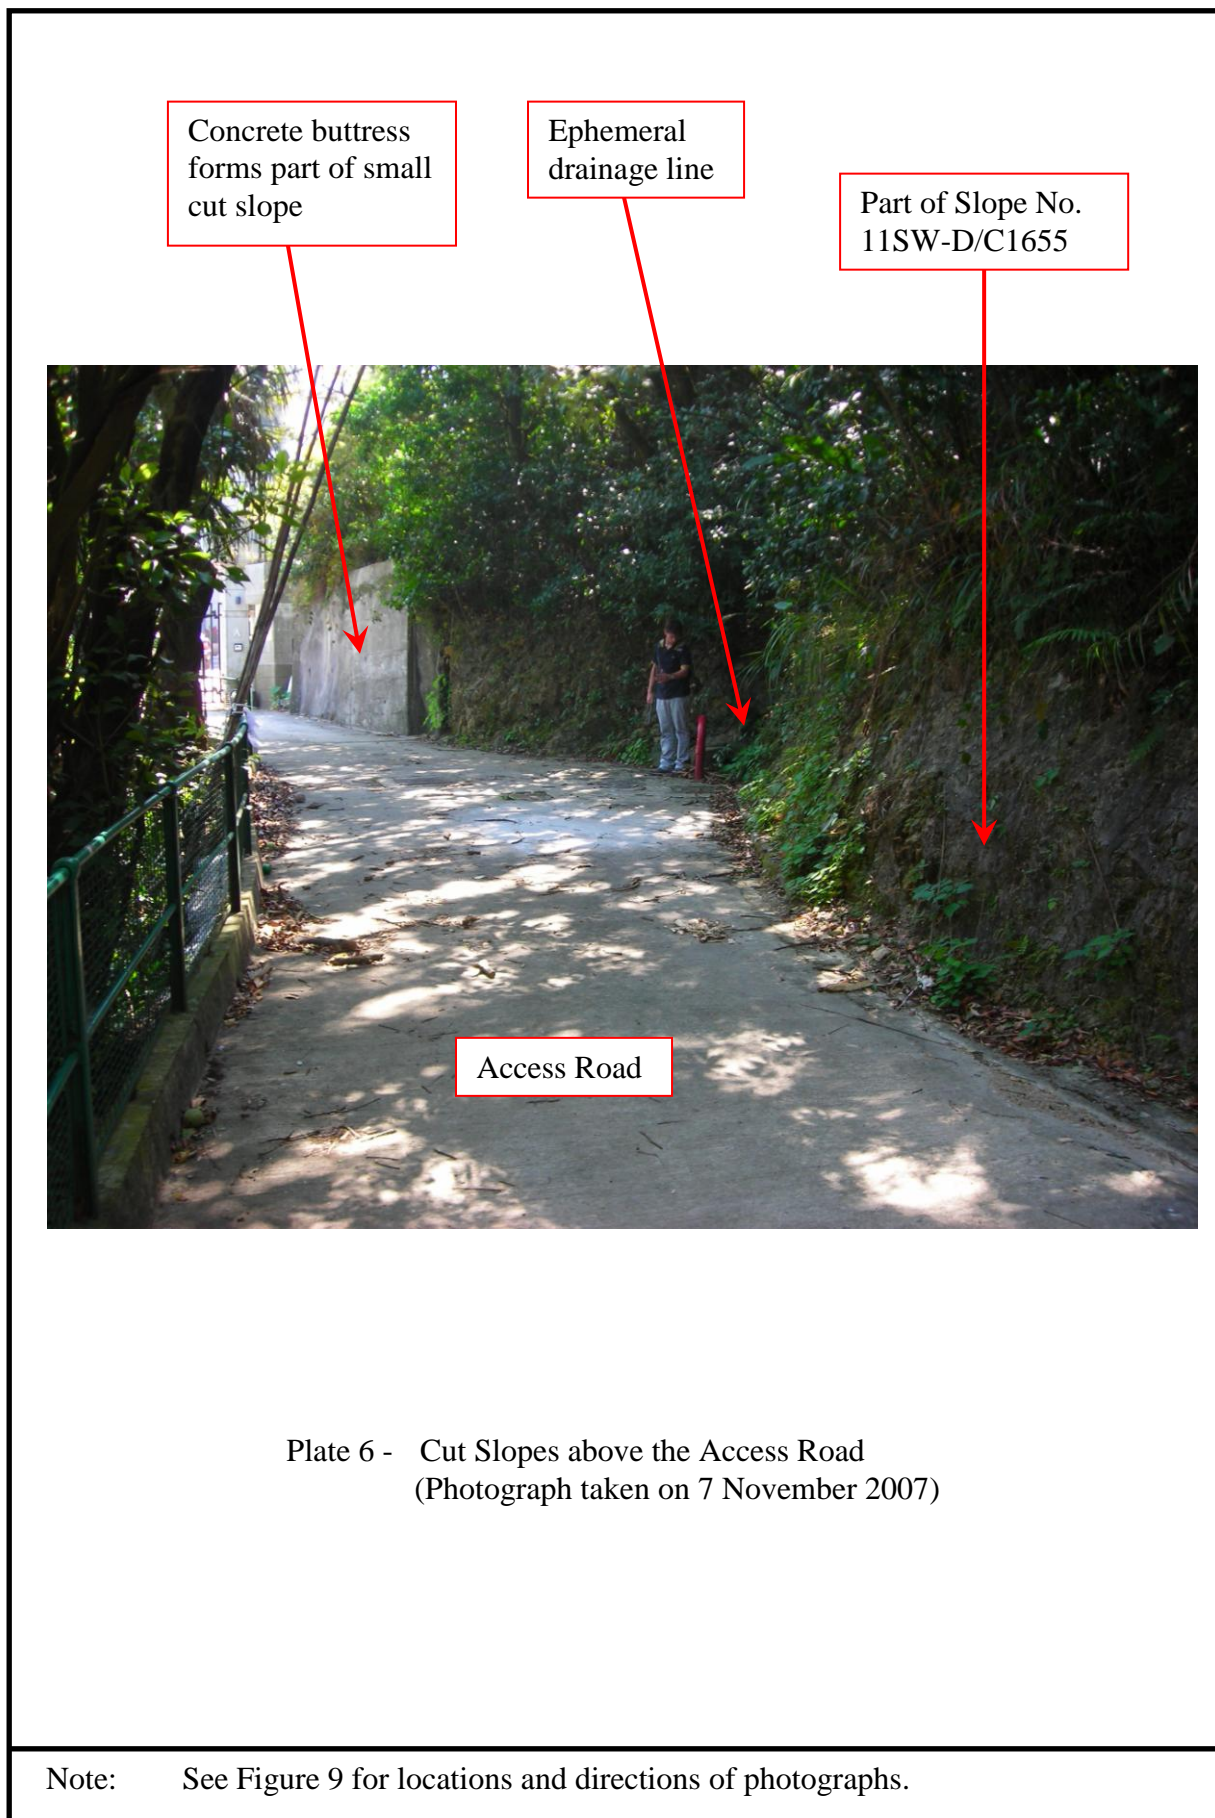
Plate 6 - Cut Slopes above the Access Road  
(Photograph taken on 7 November 2007)

Above the access road, slope No. 11SW-D/C1655 is composed of completely to highly decomposed fine ash tuff (C/HDT). The slope is covered with grass and shrubs. To the south of the ephemeral drainage line, the small cut slope comprises highly to moderately decomposed fine ash tuff (H/MDT), which is exposed on either side of a 3 m long by 2.94 m high concrete buttress (Figures 2 and 6, and Plate 6). A 0.5 m wide by 0.5 m deep, unlined crest channel is located at the crest of the small cut slope. The lower part of the ephemeral drainage line is composed of thin (<0.3 m thick) hillwash materials overlying H/MDT. There is no obvious evidence of any significant erosion within the channel or within the hillside further upslope towards the platform for the Peak Road Police Station. At the upper part of the drainage line, the hillside is covered with some loose fill materials, some scattered refuse and a small (about 1m high and 4 m long) masonry wall.
