STUDY ON MASONRY WALLS WITH TREES

GEO REPORT No. 257

C.M. Wong & Associates Limited & C.Y. Jim

**This report was prepared by C.M. Wong & Associates Limited and C.Y. Jim in
November 2005 under Consultancy Agreement No. CE 11/2004(GE)
for the sole and specific use of the Government of the
Hong Kong Special Administrative Region**

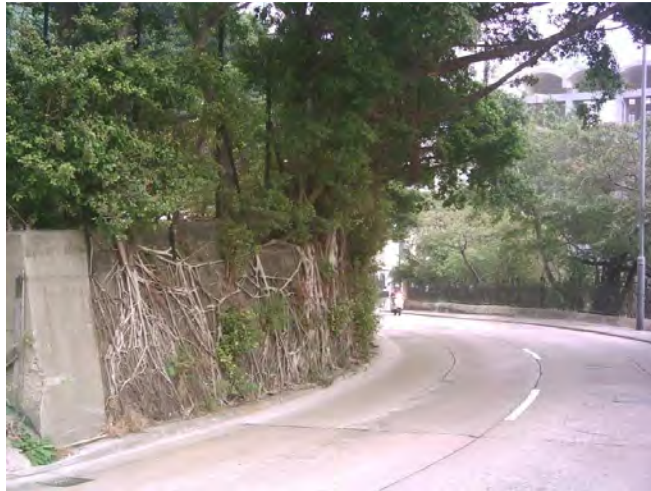
Figure 3 - The Surface Roots of Chinese Banyan Form a Dense Network Covering the Stone Façade at Hospital Road

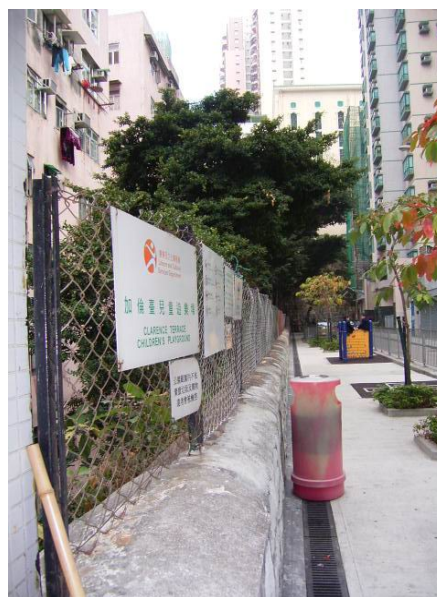
Figure 8 - Crest of Feature No. 11SW-A/R751

Photographs about the incident in Clarence Terrace Children's Playground were received from LCSD. (See Appendix B, Pages B39-B40) From the photos and site inspection carried on Feb 2005, the fallen tree was likely to be located at the children's playground behind the crest of Feature No. 11SW-A/R751, not on the wall. No incident records in 1999 at Feature No. 11SW-A/R751 could be found in GEO. As the photographs did not indicate any wall failure and no landslide incident report of the wall were found in GEO, it appears that this incident involved fallen tree only. The masonry wall did not fail.

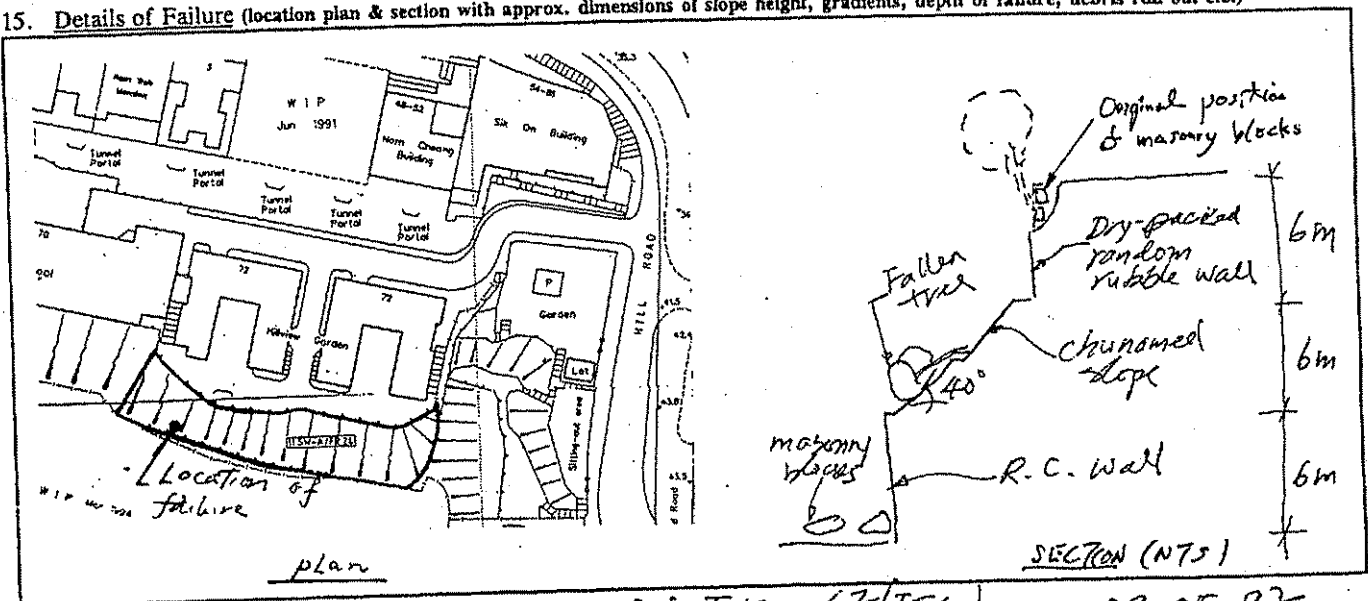
15. Details of Failure (location plan & section with approx. dimensions of slope height, gradients, depth of failure, debris run out etc.)

- ☒ Remove loose masonry blocks and cover the affected area with chinam
- ☐ Yes ☒ No
13. Is Further Inspection by District GE Required?
if Yes, Reason
14. Is Landslip Record Card Required: ☐ Yes (for debris vol. > 50 m³ or involving death)

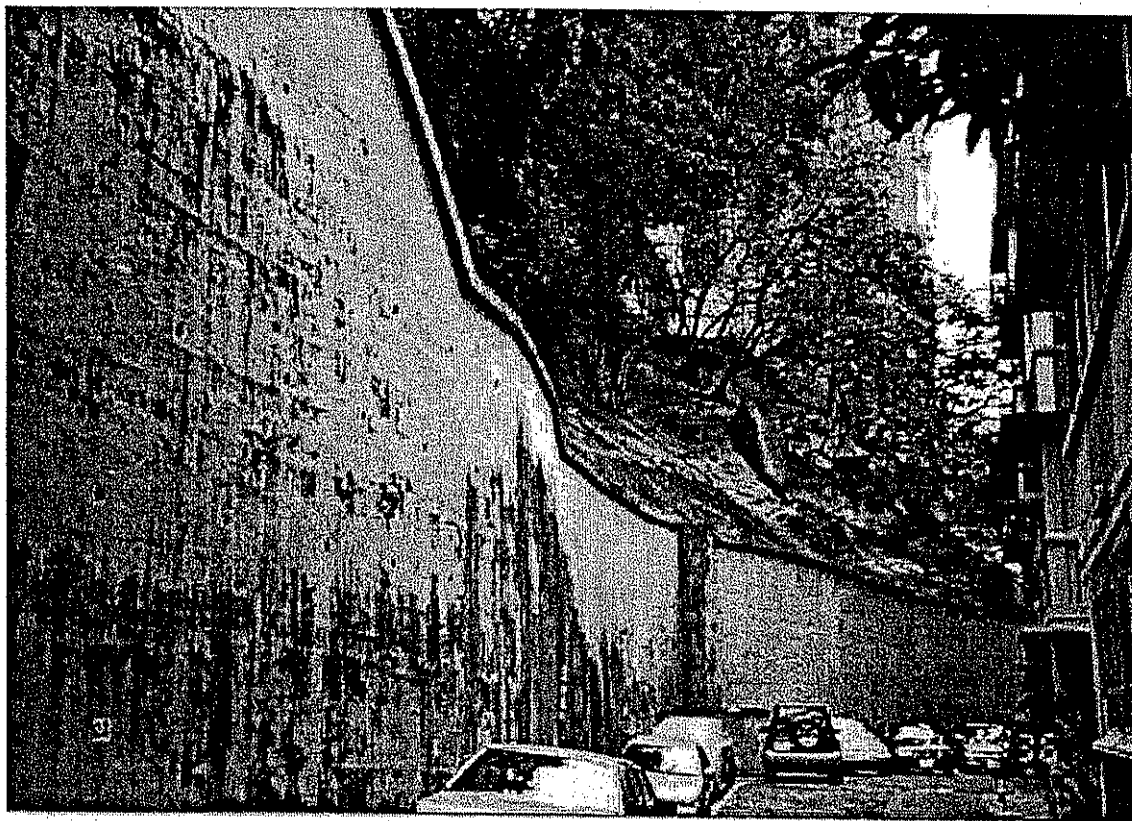
11SW-A/F 24

Based on the landslide incident report (HK97/5/2), Feature No. 11SW-A/FR24 was a dry-packed random rubble wall. A tree was located on the wall face near the crest of the feature. The incident recorded was a non landslip case. (See Appendix B, Pages B2-B12) A tree fell down and caused localized damage to the masonry wall (two masonry blocks fell down). No signs of past instability could be found on the feature during the site inspection carried out in Nov 2004.

Photo 1 : General View Right

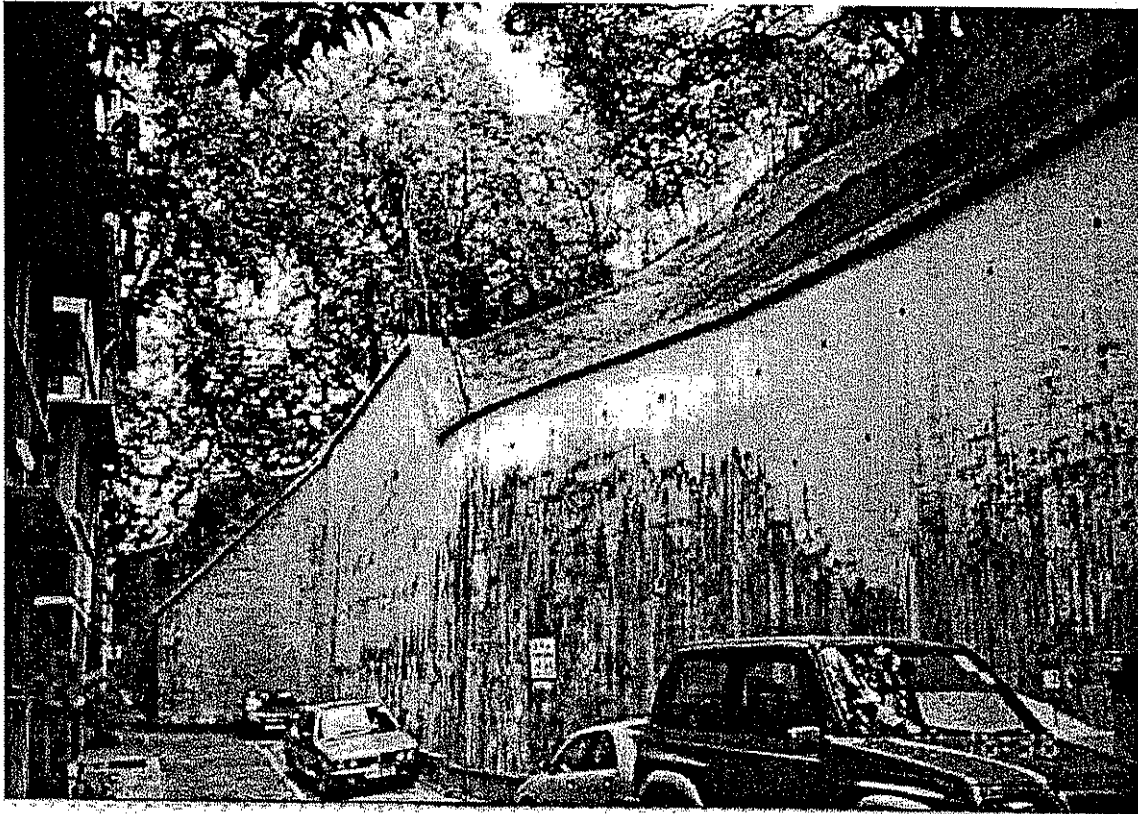
11SW-A/F 24

Photo 2 : General View Left

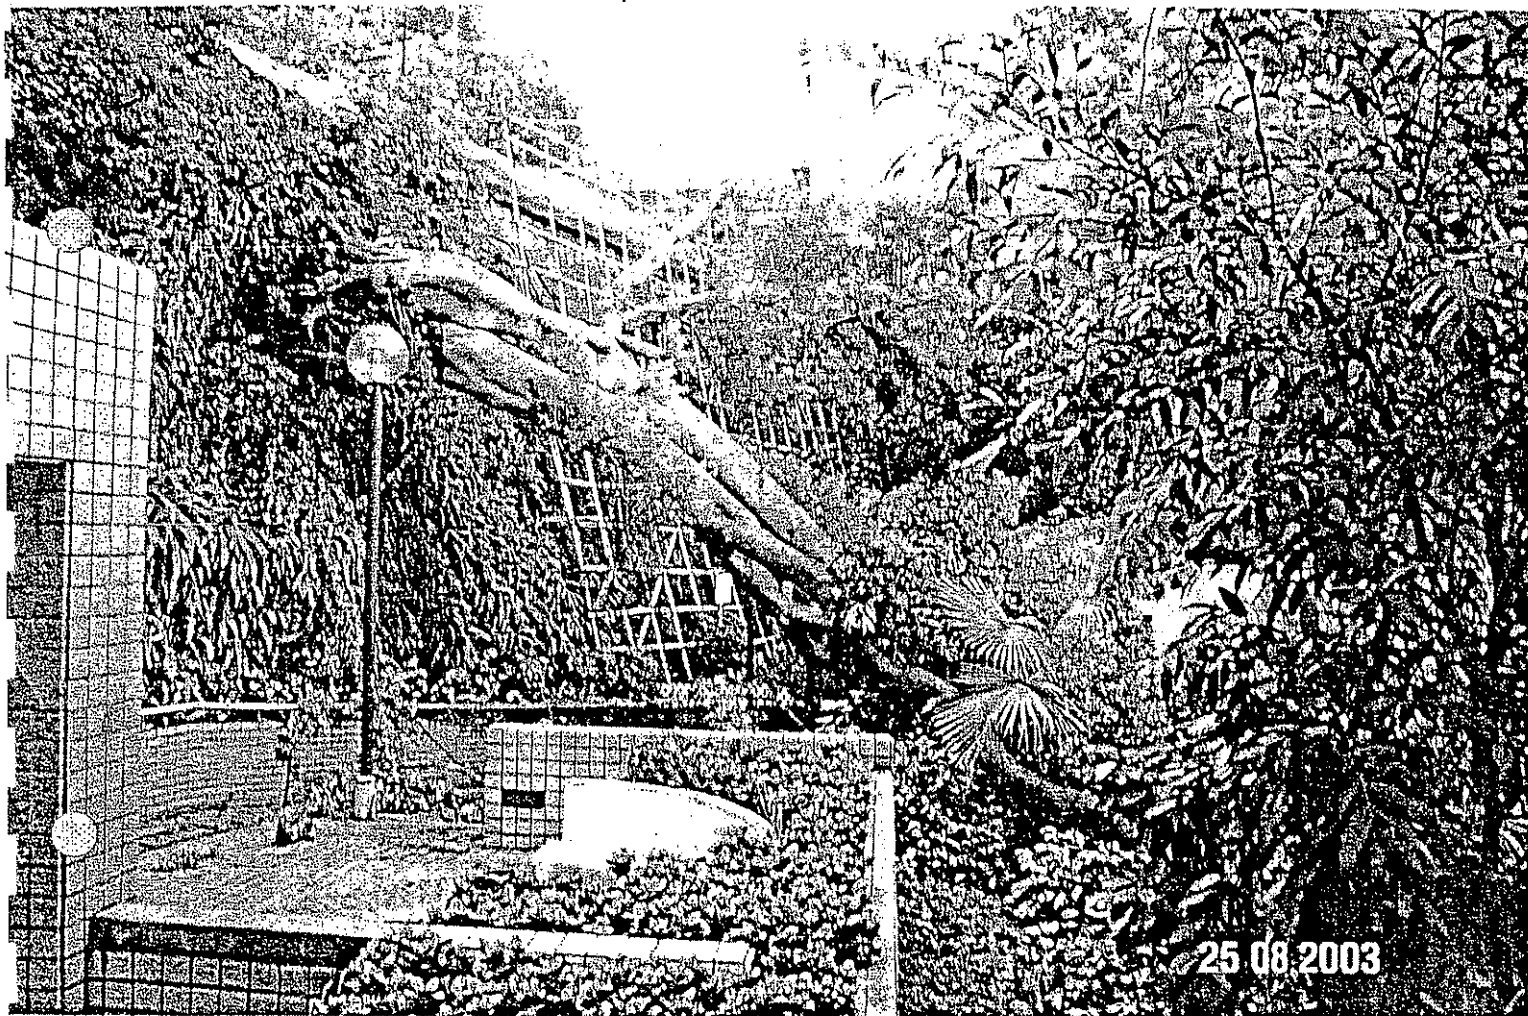
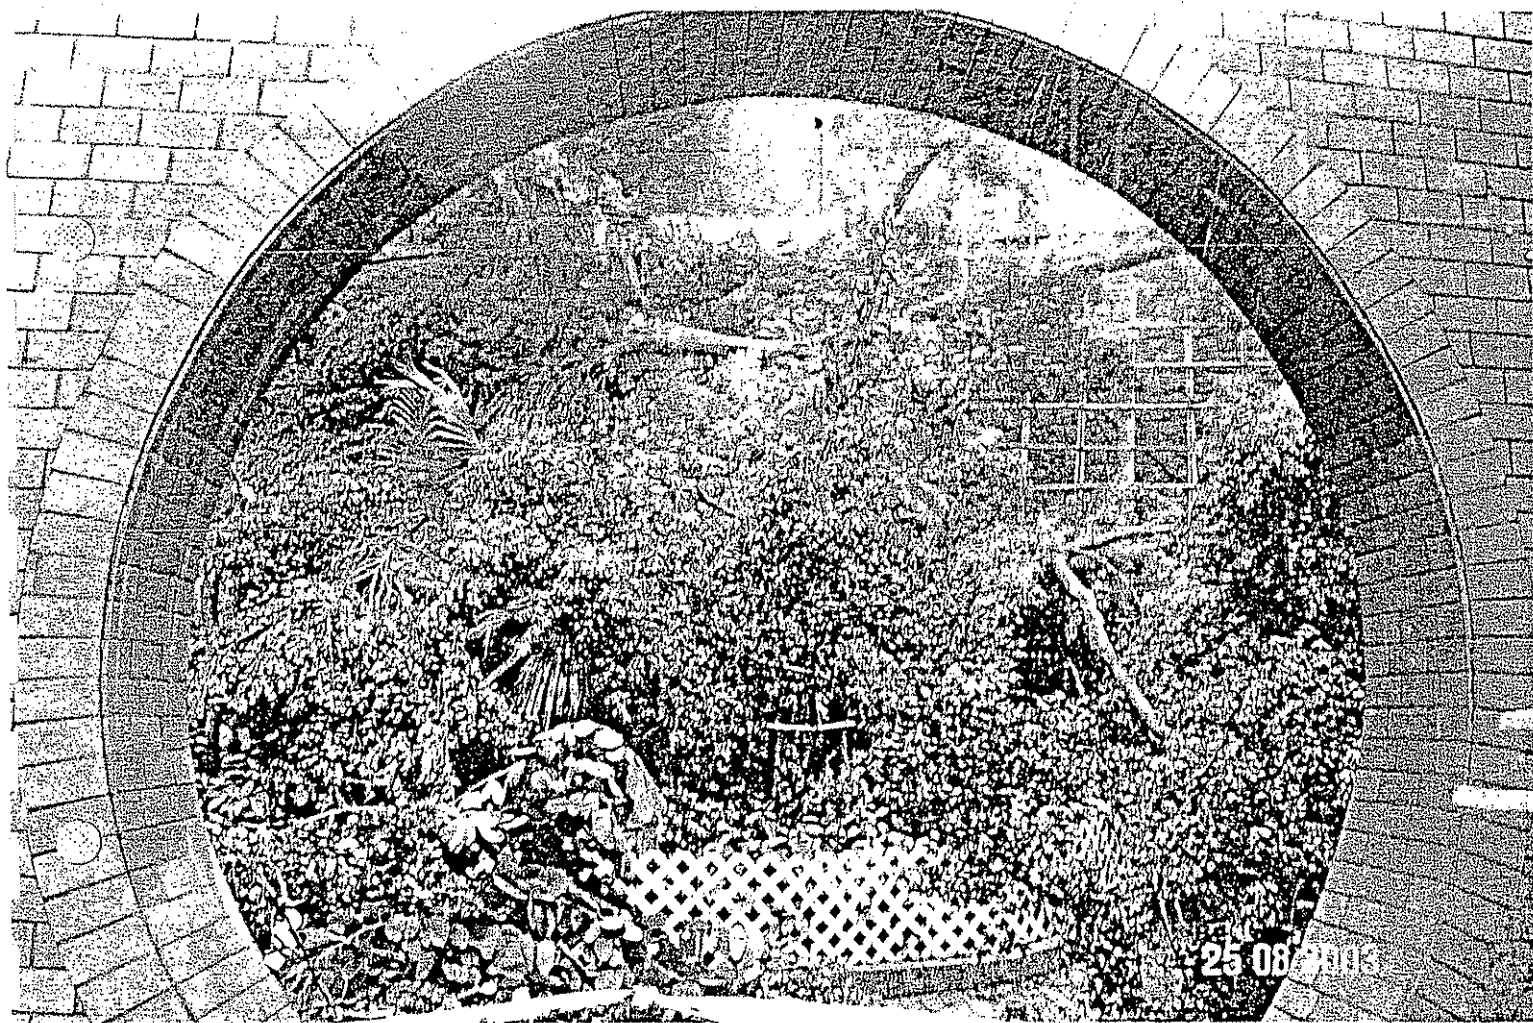
11SW-A/R120

Photographs about the incident in Ka Wai Man Road Garden on Sep 2003 were received from LCSD. (See Appendix B, Pages B13-B29) From site inspection in Feb 2005, the fallen tree was located at Feature No. 11SW-A/R120. Minor repair works were noted on the wall. The joints between masonry blocks at the location of the fallen tree were repaired by cement mortar.

414
Photos Taken on 24.8.2003
at Kow Wai Man Rd. Garden.

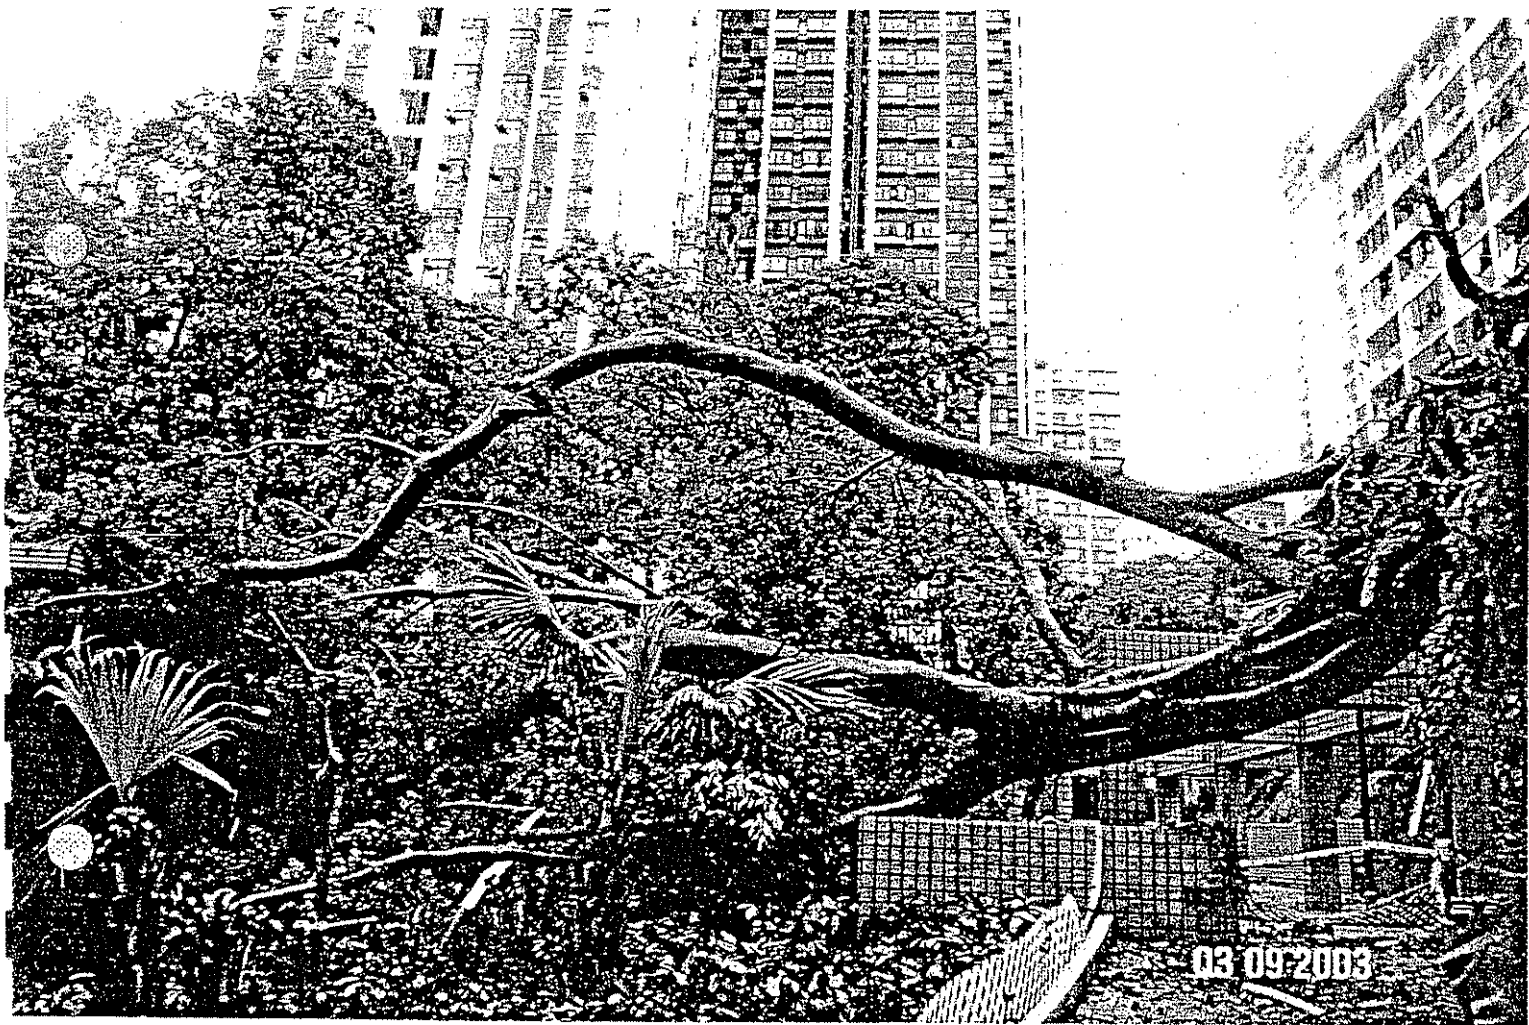
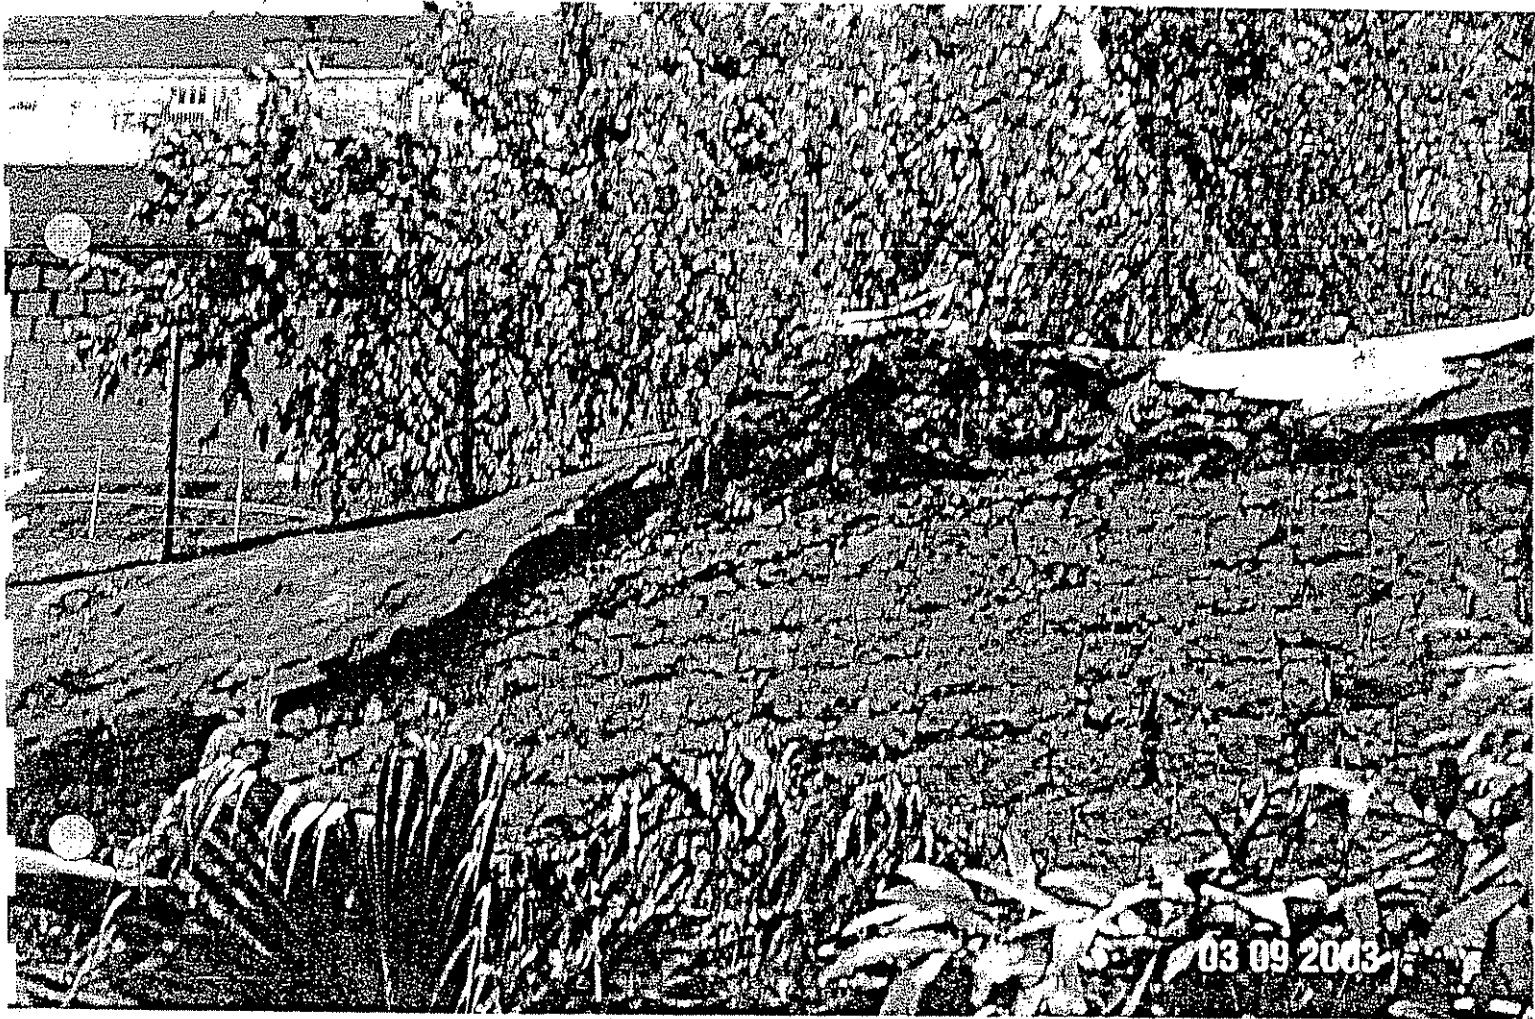
Photos Taken on 3.9.03

at Kai Wai Man Rd Garden

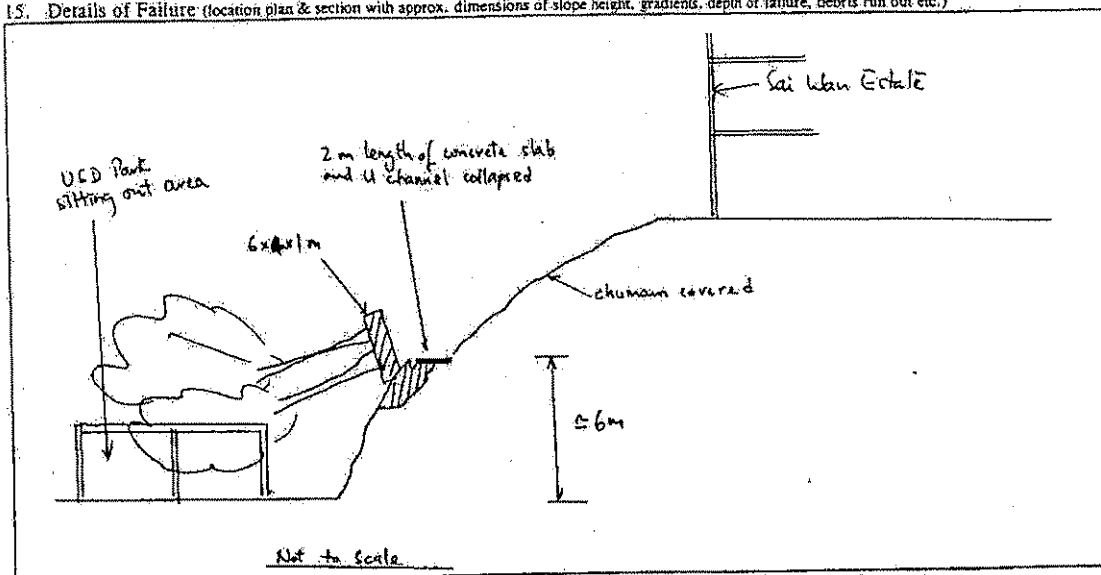
14. Is Landslip Record Card Required? ☐ Yes (for debris vol. > 50 m³ or involving death) ☒ No
15. Details of Failure (location plan & section with approx. dimensions of slope height, gradients, depth of failure, debris run out etc.)

13. Is Further Action by District GE Required? ☒ Yes ☐ No
If Yes, Reason Give advice to USD on slope stability under continuous washout overnight and re-open the park if appropriate.

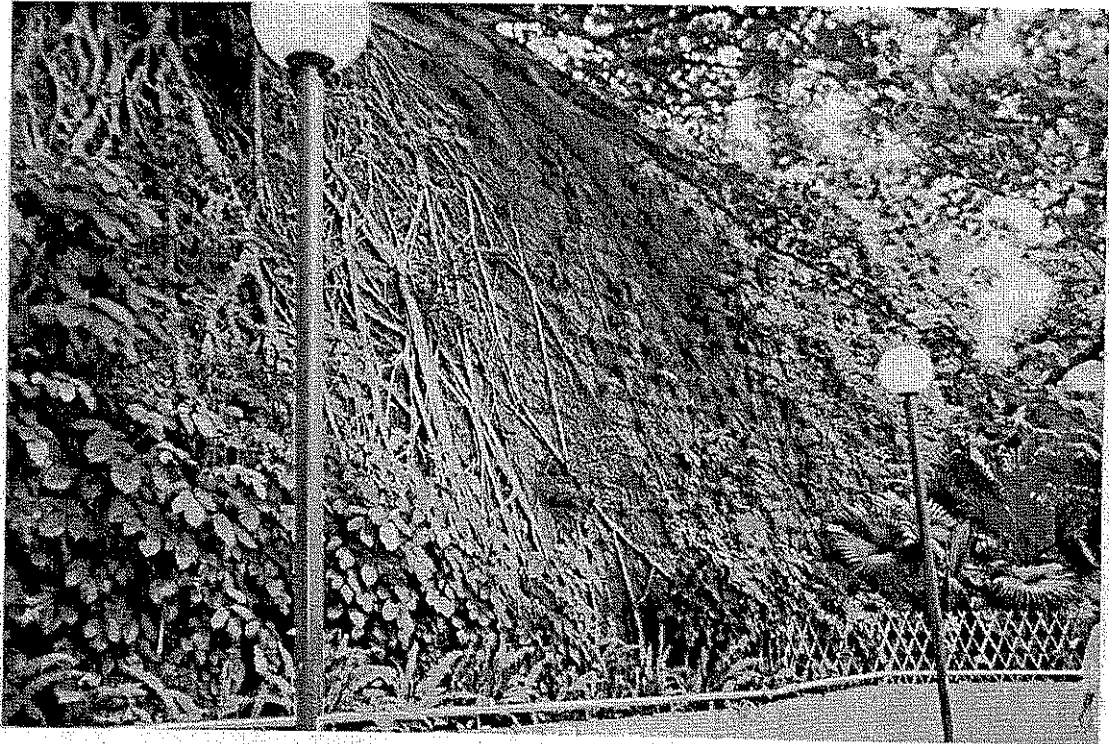
11SW-A/R 120 WESTERN PART OF FEATURE F7

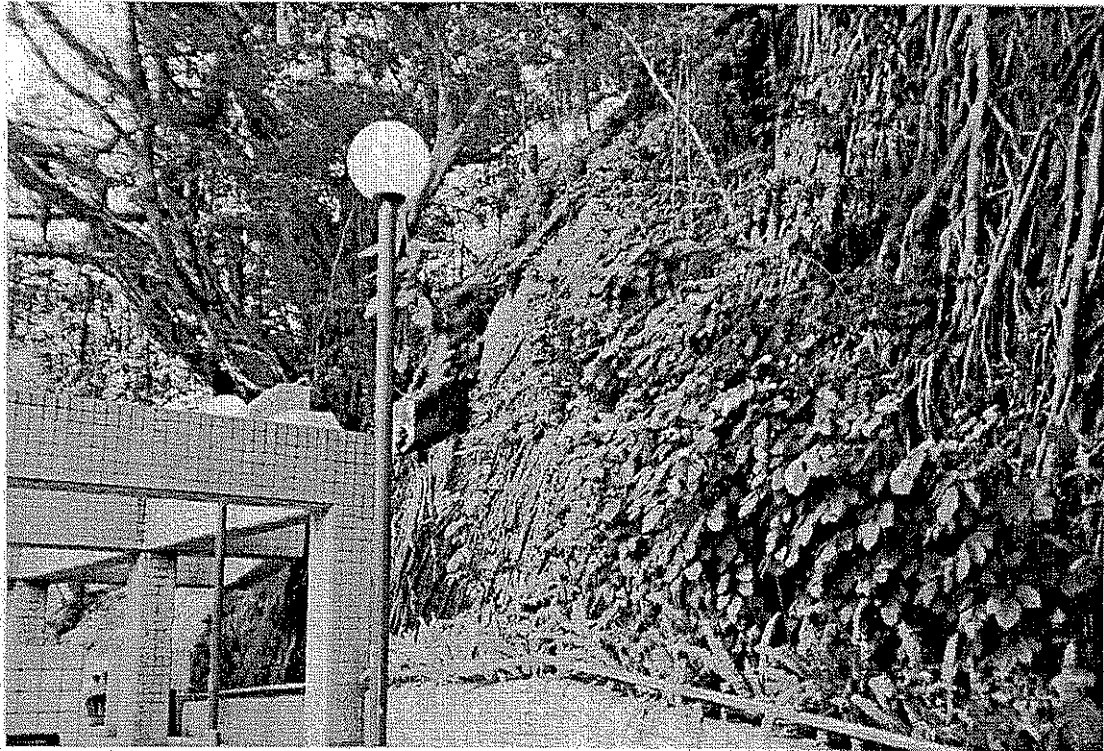
11SW-A/R 120

EASTERN PART OF FEATURE

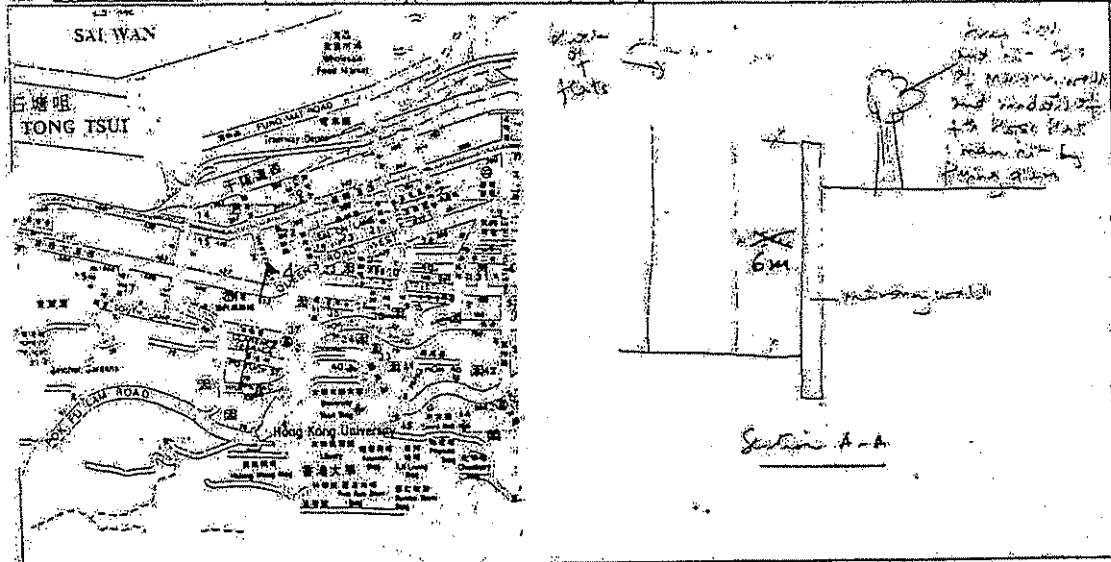
15. Details of Failure (location plan & section with approx. dimensions of slope height, gradients, depth of failure, debris run out etc.)

- Type of Failure: ☒ Significant sign of distress with no failure mass ☐ Washout
☐ Landslide ☐ Boulder fall from natural slope ☒ Retaining wall failure ☐ Rock fall
☐ Non landslide case (tree fall/building collapse) ☒ Retaining wall hit by fallen tree
 (Circle the principal type of failure if more than one type is involved)

- Consequence of Failure
☐ person(s) killed ☒ person(s) injured ☐ Squatter huts affected ☐ Carparks affected
☐ lane(s) of road blocked ☐ Building lot affected ☐ Construction site affected ☐ Pedestrian pavement affected
☐ Country park affected ☒ Open space affected ☒ Building access affected ☒ Handrails of Sai Wan 2nd opp. to feature were broken by tree fall

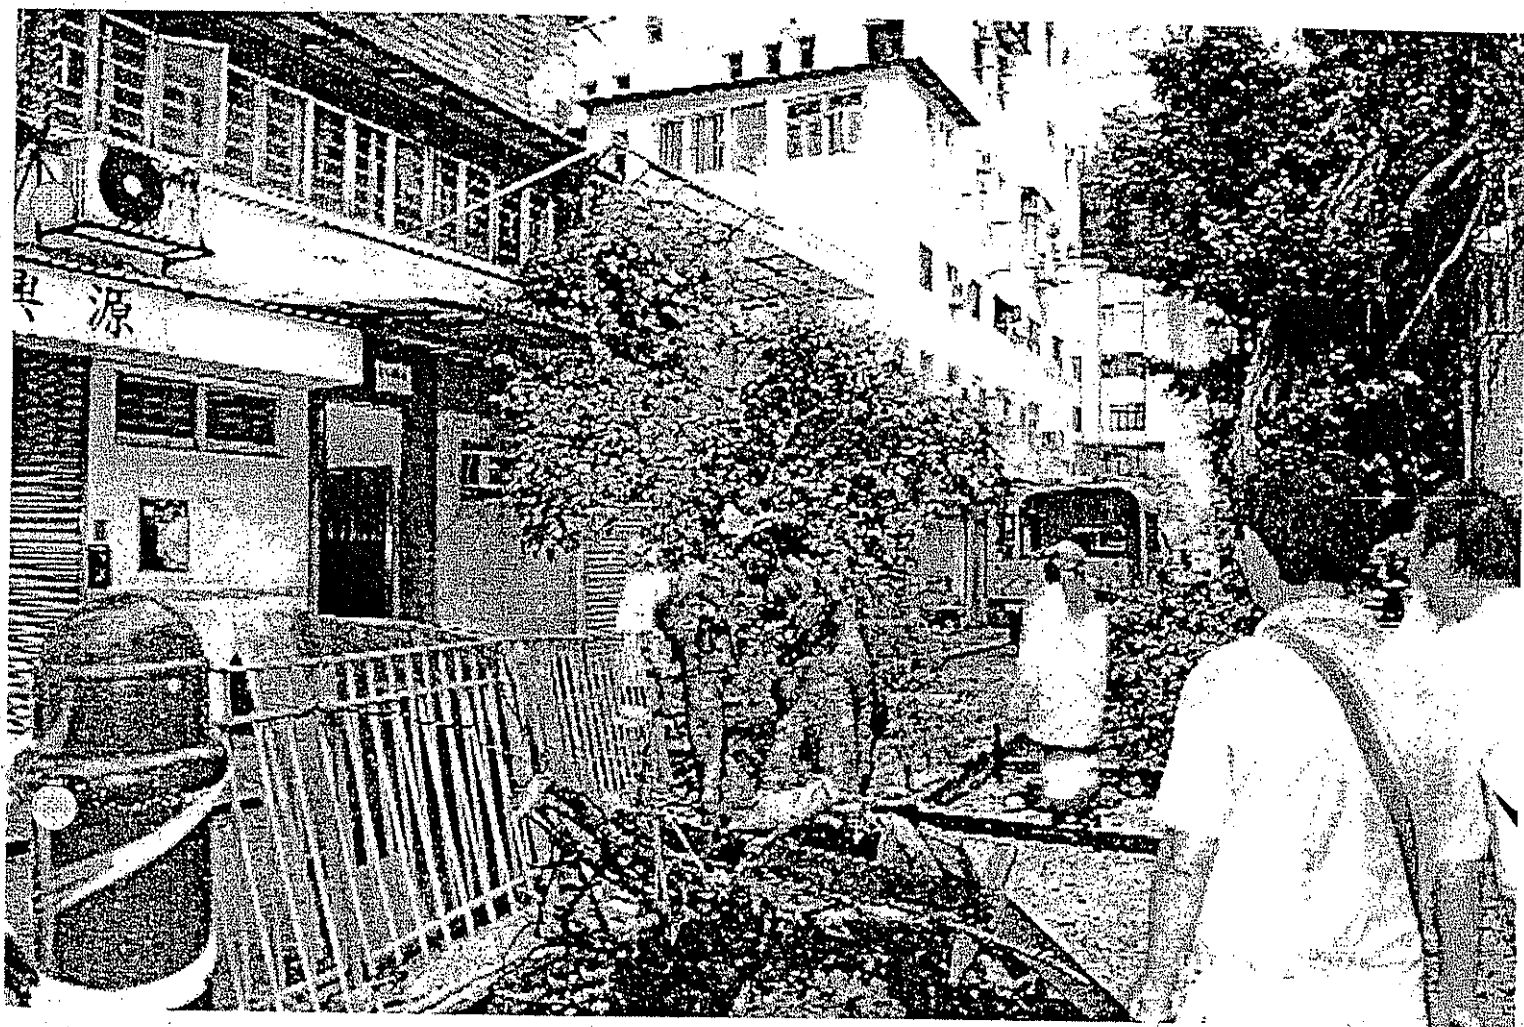
The trees immediately adjacent to the collapsed tree are in danger of falling.

photos taken at Clarence Terrace Children's Playground

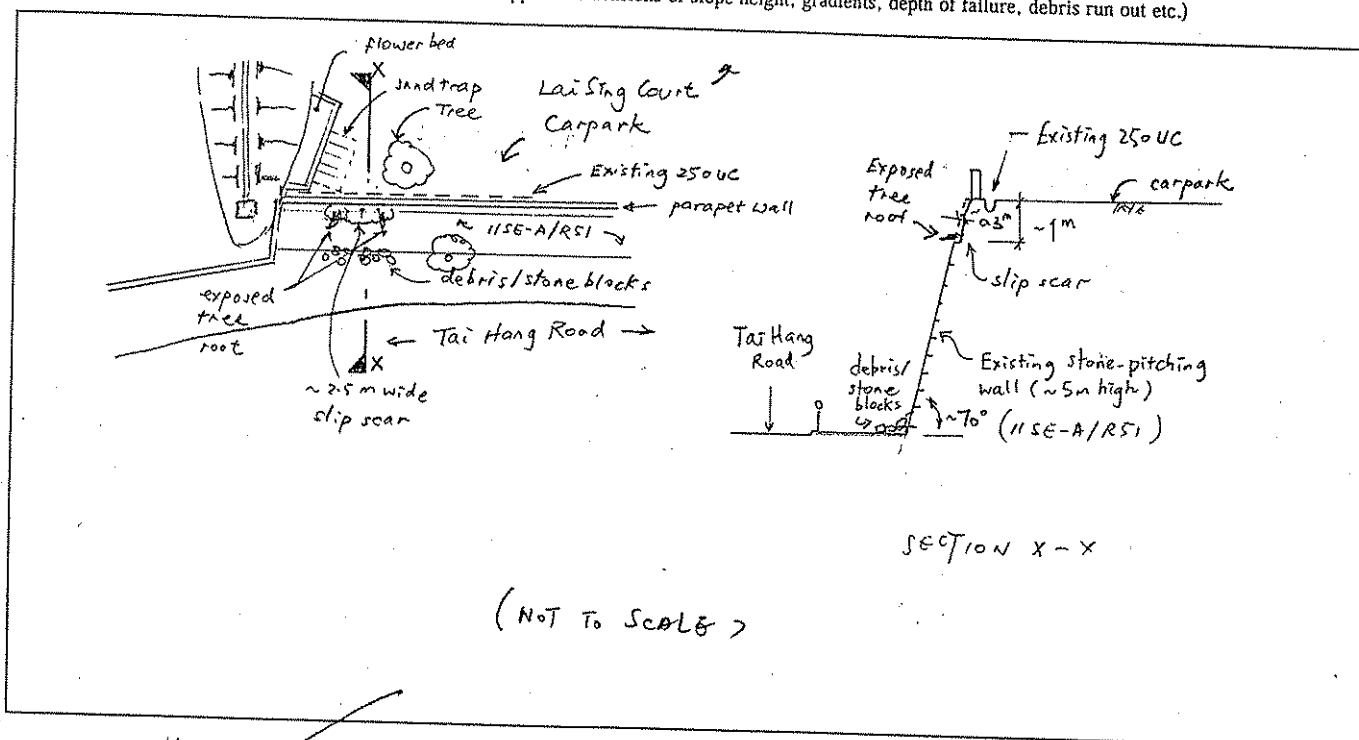
16. Details of Failure (location plan & section with approx. dimensions of slope height, gradients, depth of failure, debris run out etc.)

6. Type of Failure ☐ Significant sign of distress with no failure mass ☐ Washout
☐ Landslide ☐ Boulder fall from natural slope ☐ Retaining wall failure ☐ Rock fall
☒ Non landslip case (tree fall/ building collapse*/ adjacent stone pitching blocks) ☐
(Circle the principal type of failure if more than one type is involved) on wall pulled down

9. Scale of Failure approx. 1 m³ (Volume of slip scar*/debris*)
For boulder fall from natural slope (Approx. trajectory to be shown in Item 16)
Number of boulders involved Dimension and shape of boulders

11. Possible Contributing Causes of Failure (tick one or more) ☐ Infiltration ☐ wash-out
☐ seepage behind an impermeable surface ☐ groundwater (main/perched/unclassified)* ☐ rupture of water mains
☐ Insufficient maintenance contributed to failure ☒ Others Tree uprooted by strong wind pull down the adjacent stone pitching block near the crest of wall
(Circle the primary cause if more than one cause is involved)

| <input type="checkbox"/> Squatter huts permanently evacuated Hut No(s) | <input checked="" type="checkbox"/> Divert surface runoff from reaching failure area |
| <input type="checkbox"/> Squatter huts temporarily evacuated Hut No(s) | <input checked="" type="checkbox"/> Cover failure scar with tarpaulin properly secured against wind |
| <input checked="" type="checkbox"/> Close pedestrian pavement | <input checked="" type="checkbox"/> Provide surface protection (with weepholes) to trimmed failure surface |
| | <input checked="" type="checkbox"/> <u>remove loose debris/blocks and tree roots on slip surface</u> |

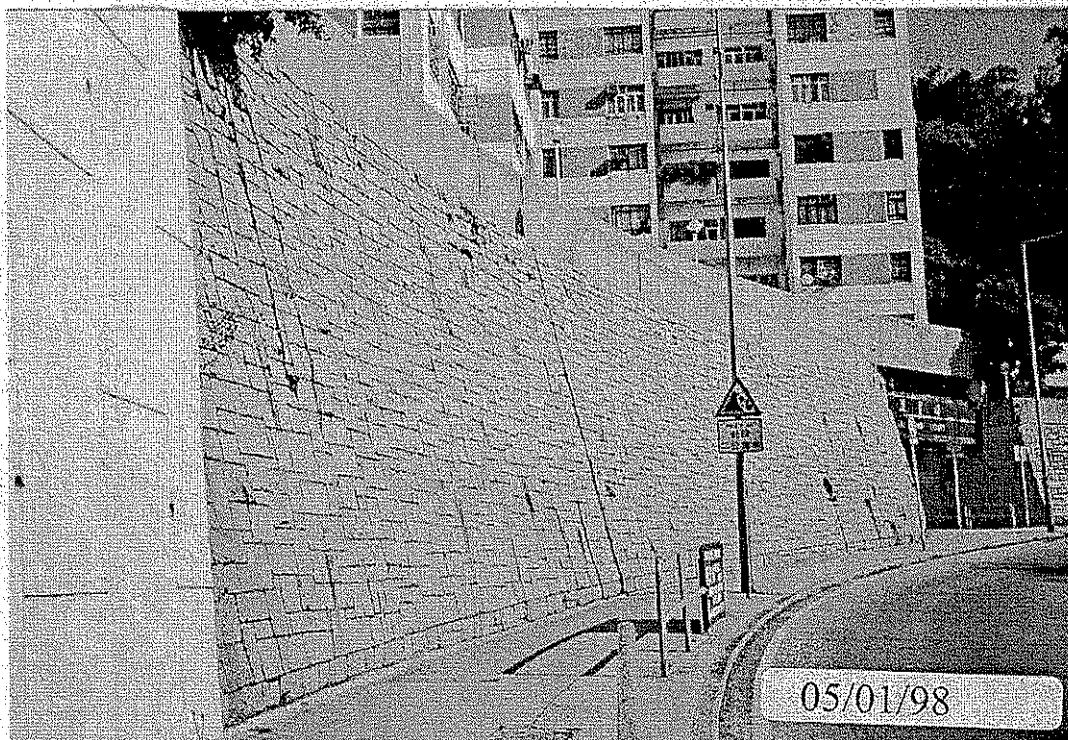
11SE-A/R51

GENERAL VIEW

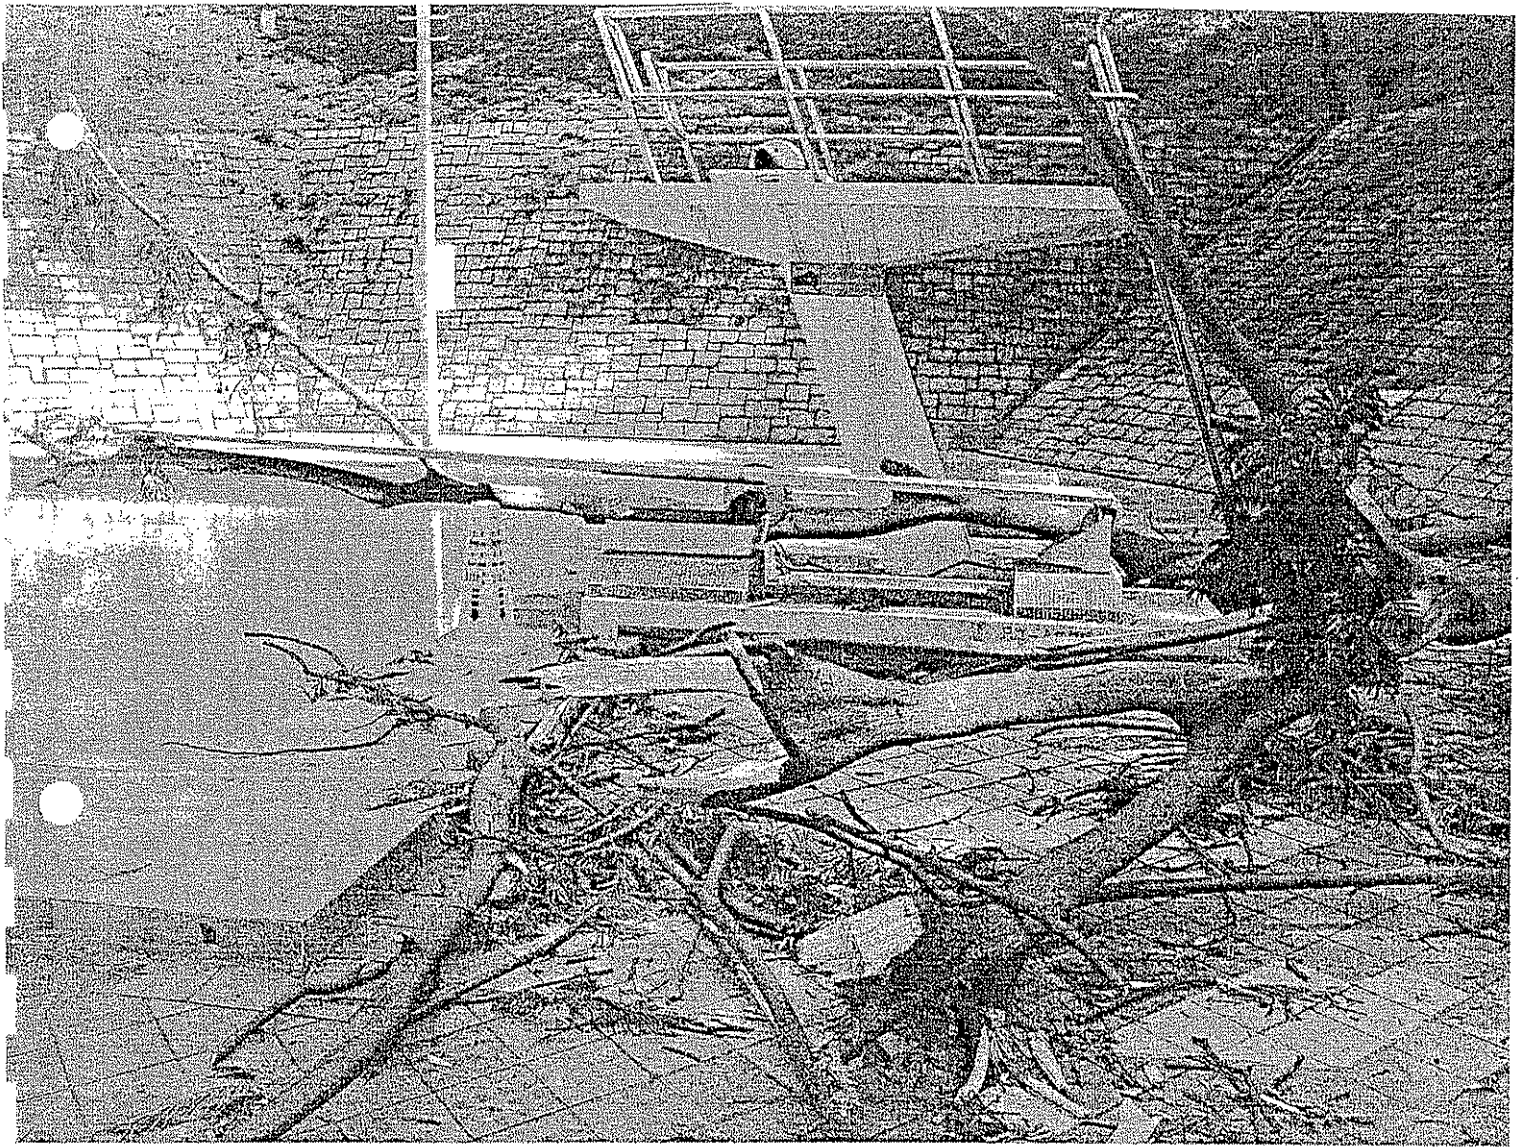
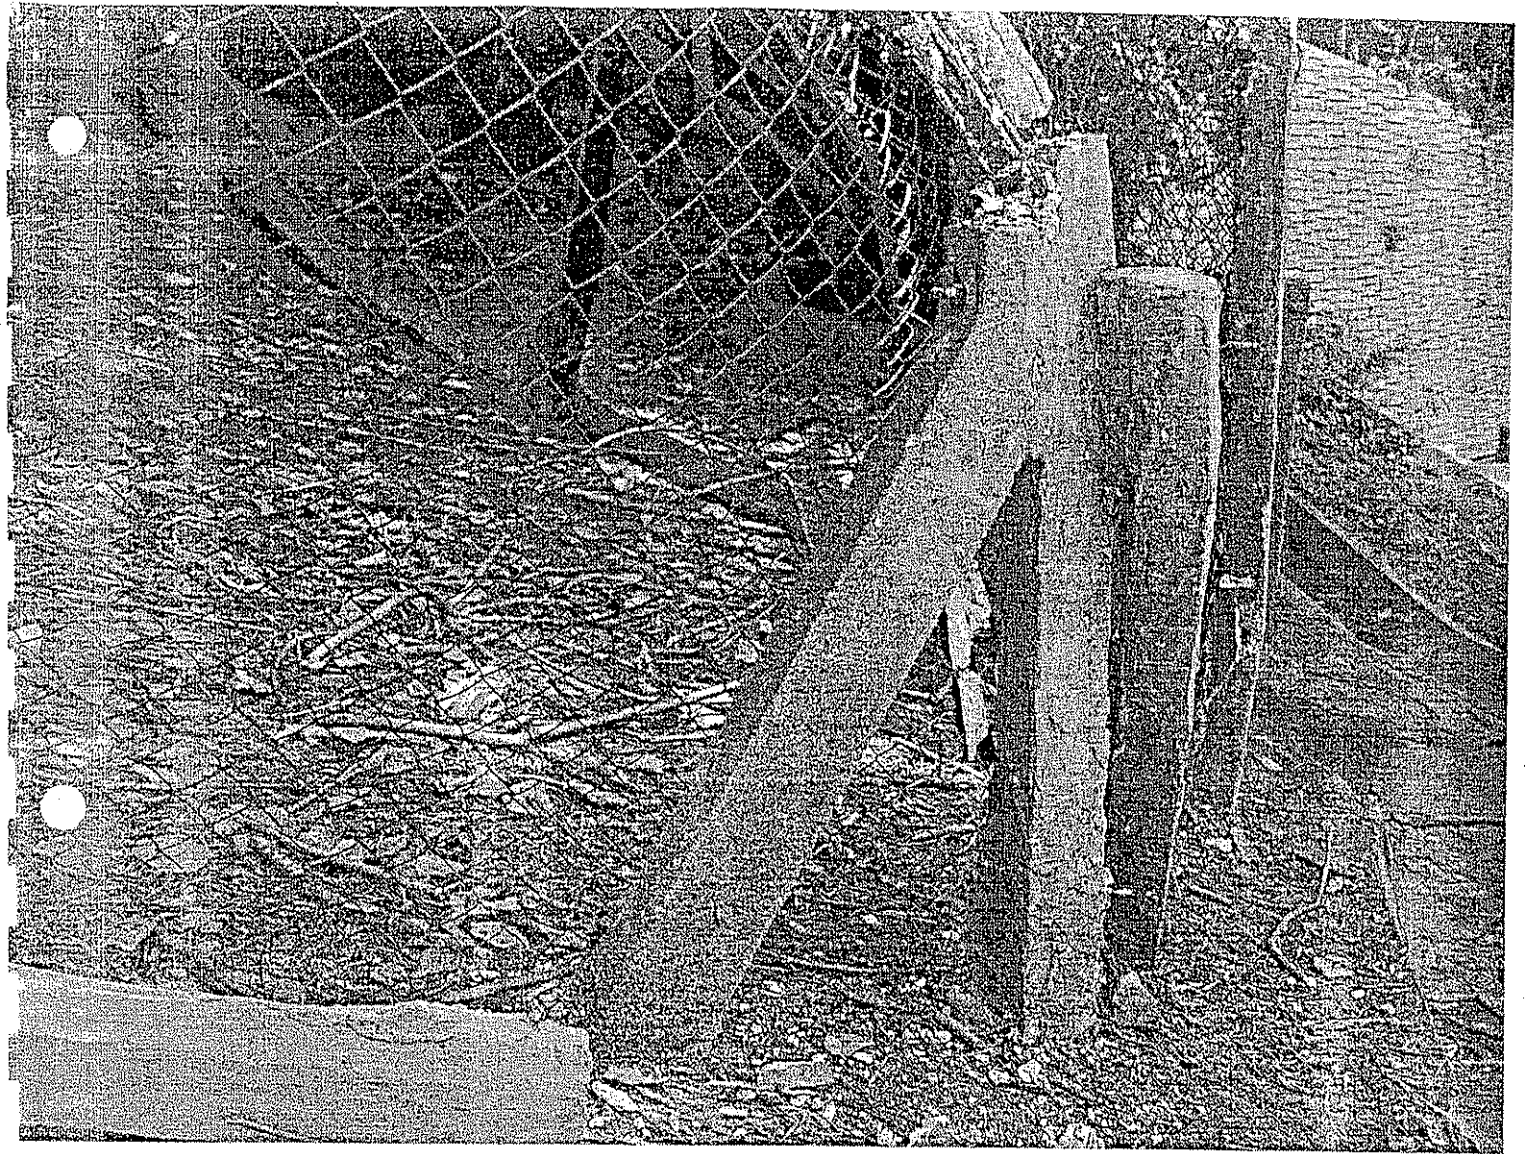
現場並沒有任何設施嚴重損毀，祇有幾塊池面磚損毀，而斜坡上的約有 3 米長的鐵網、4 條石屎柱及上斜坡鐵梯亦被大樹壓毀，跳池的彈板被樹幹的枝條壓着引致輕微移位。

Tree felling accident on 17.9.2004
Venue: Lei Cheng Uk Swimming Pool

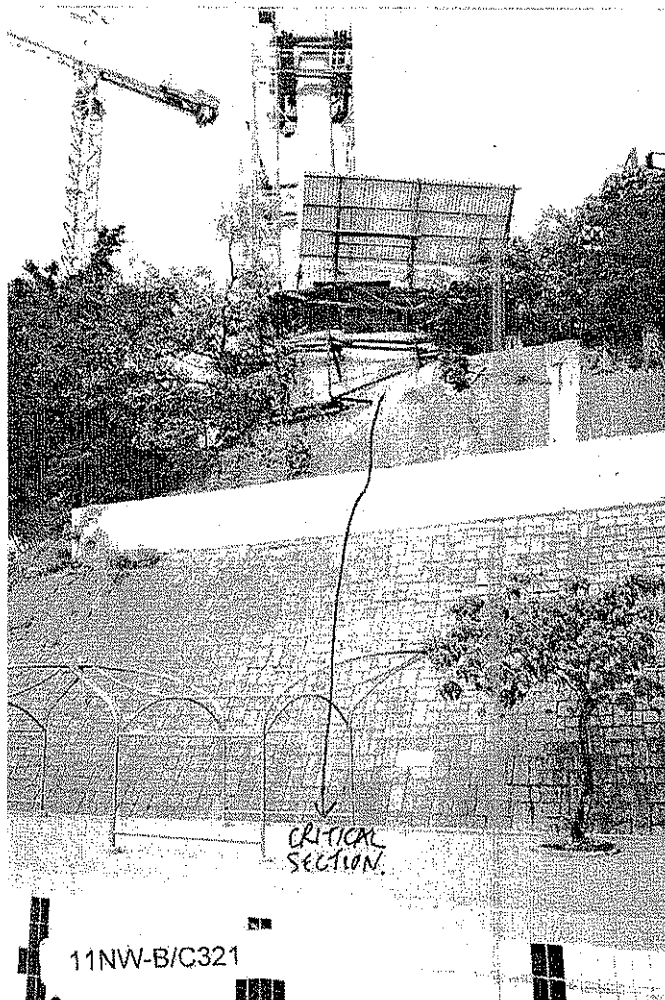
11NW-B/C 321

WESTERN SIDE BY LARGE
SWIMMING POOL

CRITICAL
SECTION

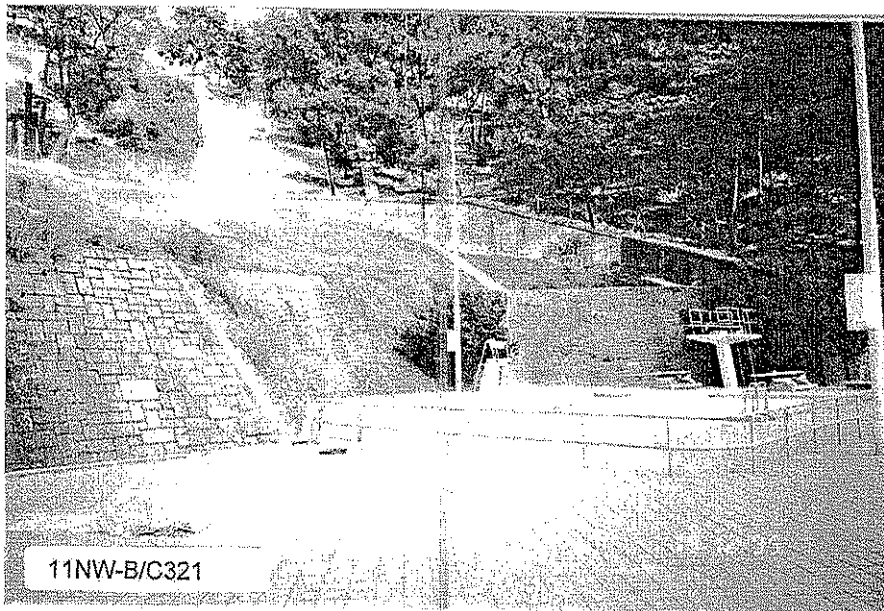
11NW-B/C 321

EASTERN END.
