Review of the 12 September 2007 Rockfall Incident on Slope No. 7SW-C/C67 at Kwai Shing Circuit Kwai Chung

GEO Report No. 263

Halcrow China Limited

**Geotechnical Engineering Office
Civil Engineering and Development Department
The Government of the Hong Kong
Special Administrative Region**

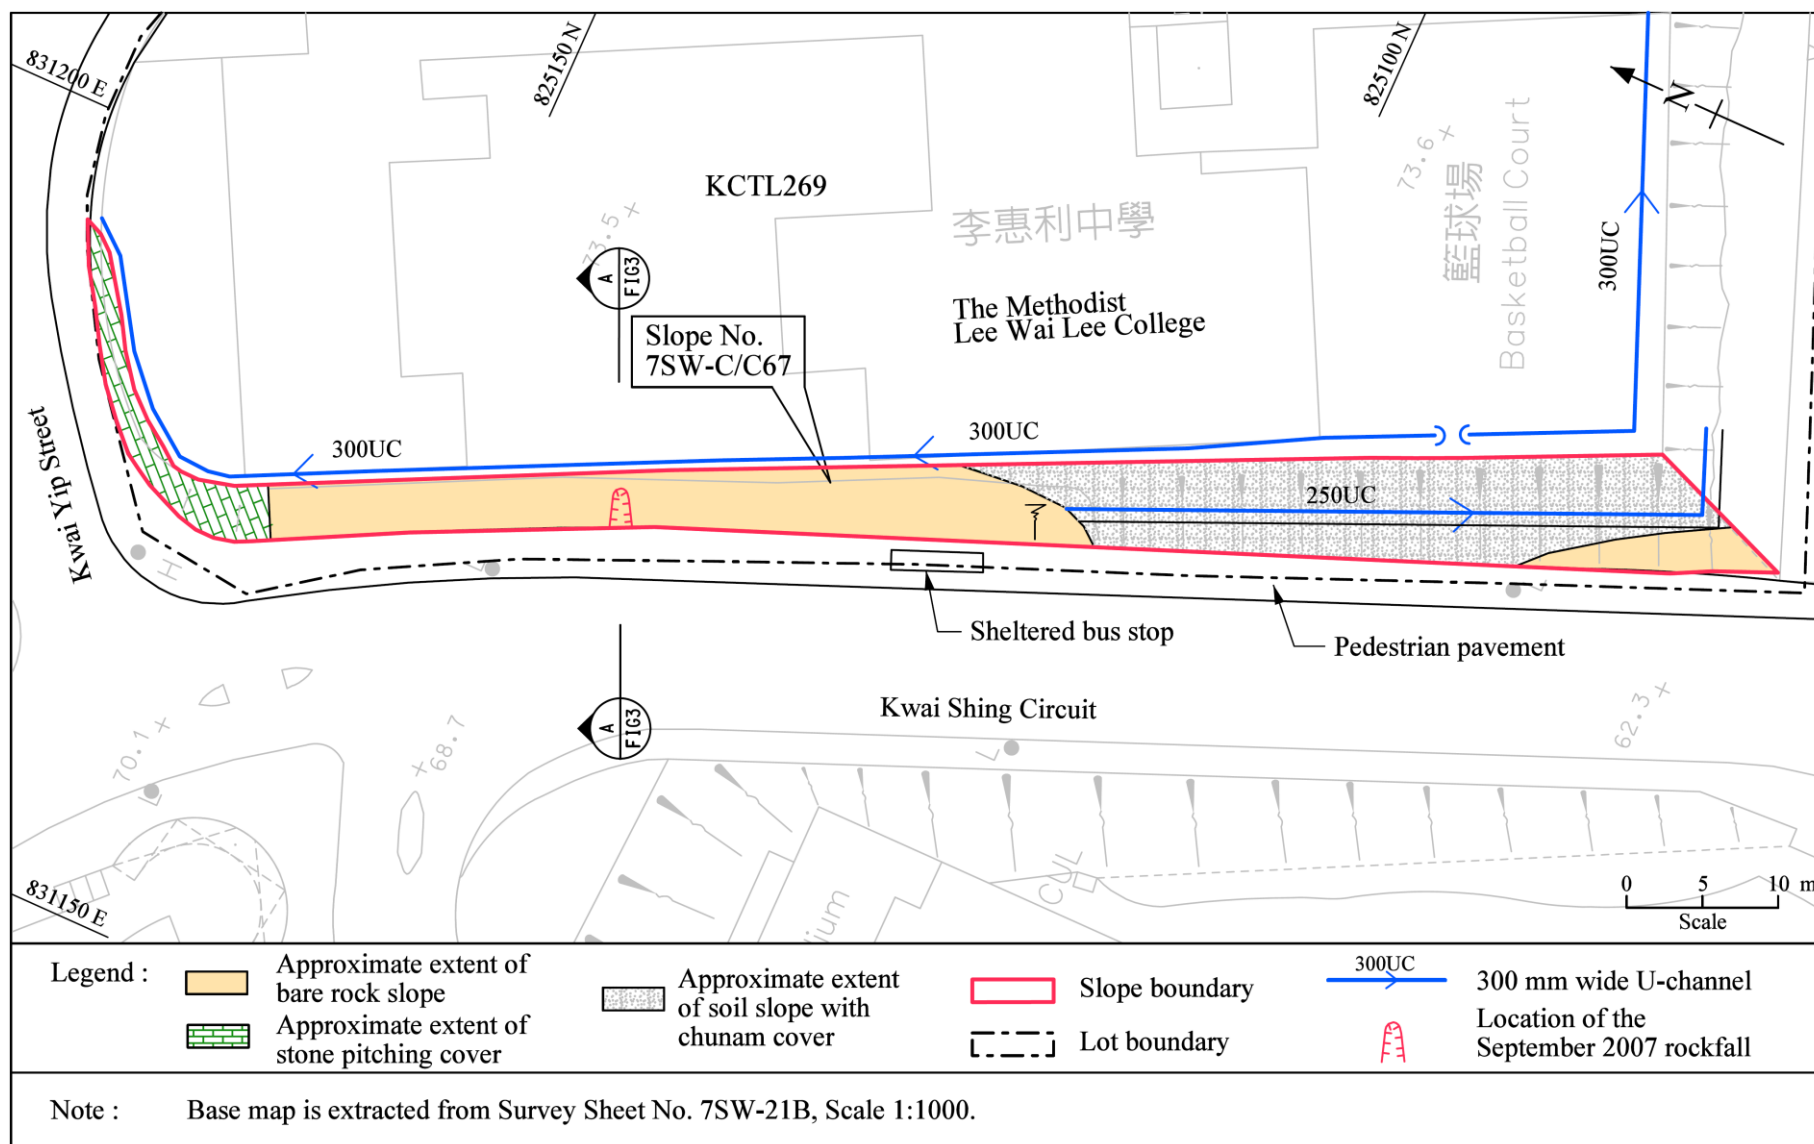
Figure 2.1 Site Layout Plan

The surface drainage system on the subject slope comprises a 250 mm wide U-channel on the berm and two 300 mm wide U-channels with cast-iron covers on the slope crest, as shown in Figure 2.1. Runoff collected in the crest channels is discharged directly to the drainage system of the School, while that collected in the berm channel is discharged to the berm channel of the adjoining slope No. 7SW-C/C68.

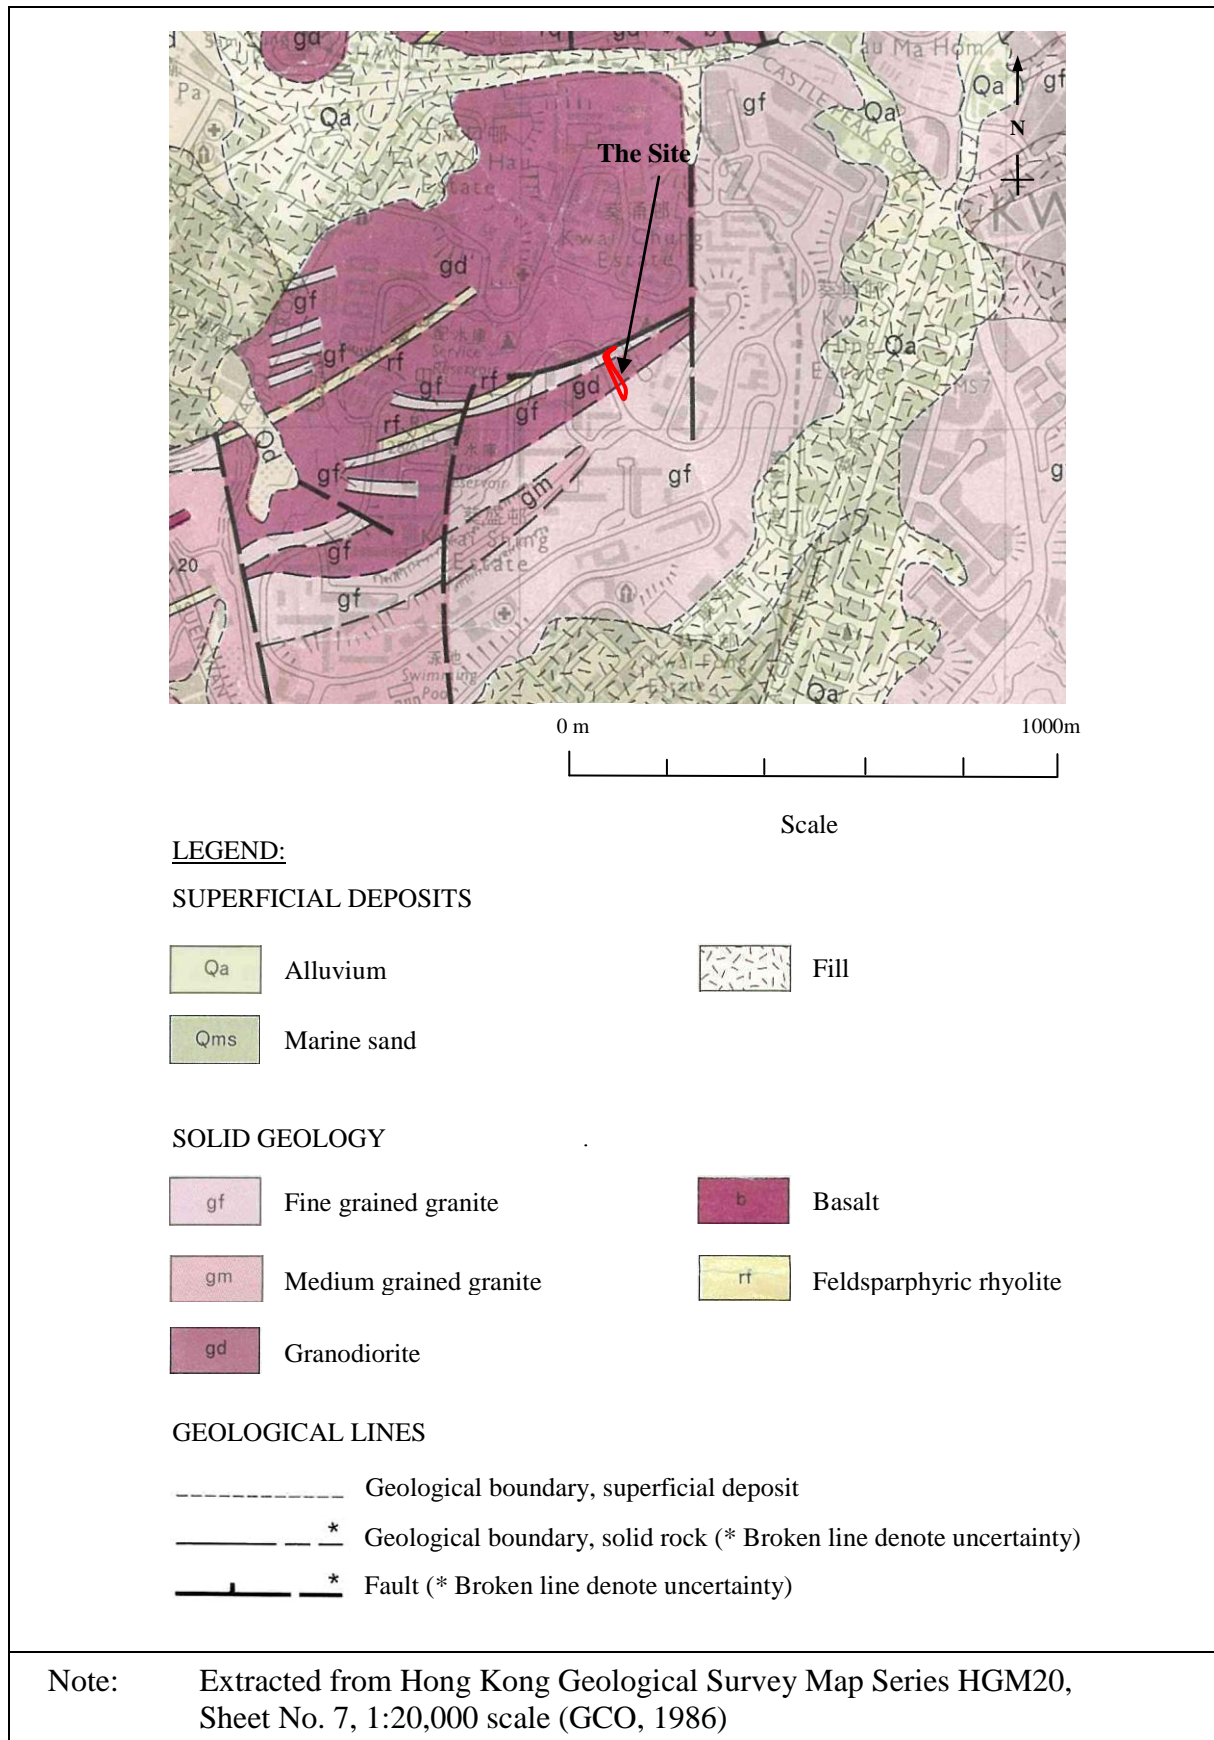
Figure 2.6 Regional Geology

According to Sheet 7 of the Hong Kong Geological Survey (HKGS) 1:20 000 scale map series HGM20 (GCO, 1986), the solid geology at the subject slope comprises granodiorite at the central portion and fine grained granite at the ends of the slope (Figure 2.6). A southwest-northeast trending fault is shown at the northern end of the slope.

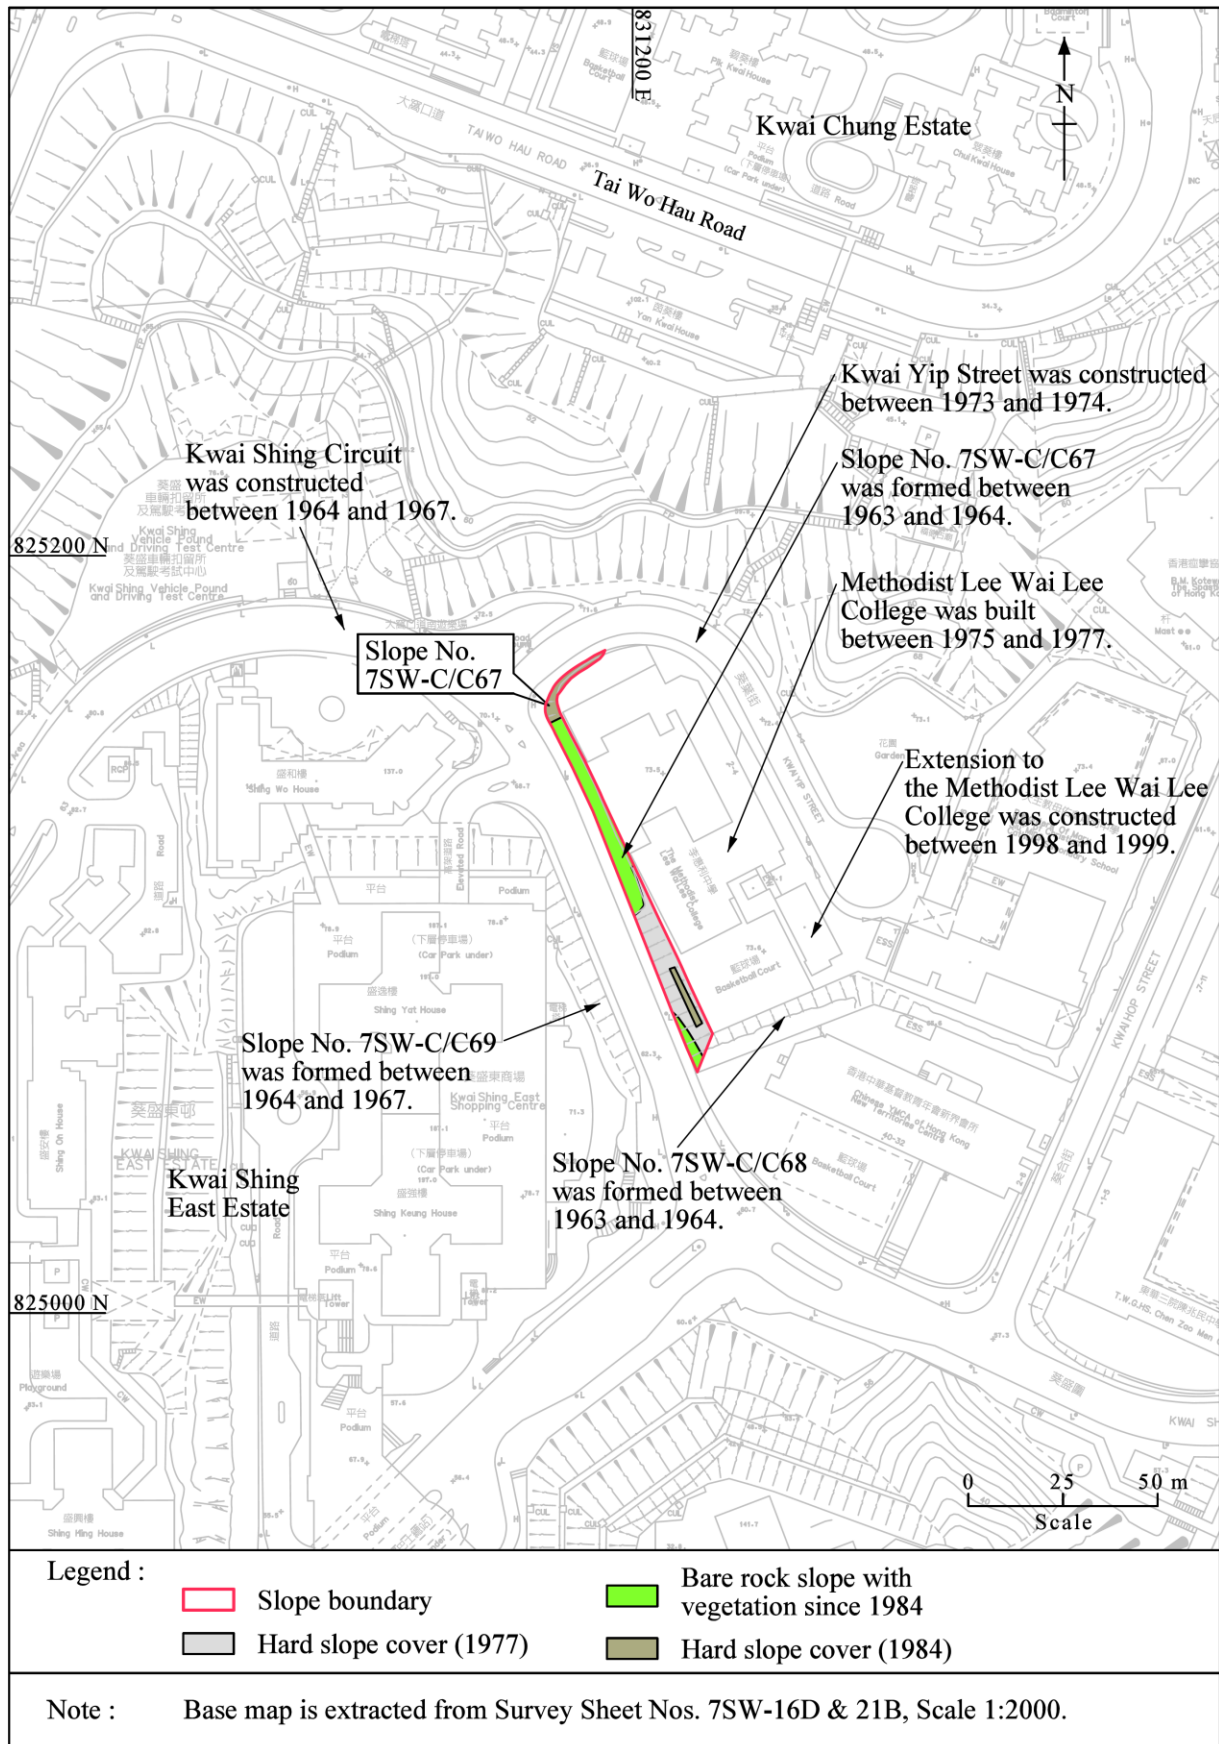
Figure 3.1 Site Development History

The development history of the site has been established from a review of aerial photographs and inspection of the available relevant documentary records (Figure 3.1). A detailed account of the aerial photograph interpretation (API) is presented in Appendix A. Salient aspects of the key observations are summarised below.

By 1964, the subject slope and the adjoining slope No. 7SW-C/C68 had been formed and the formation of the platform above these slopes commenced. The northern portion of the slope is observed to have an irregular, rugged surface, which suggests this portion is in rock. Also, the smooth appearance of the southern portion indicates that this portion of the slope is in soil.

By 1975, the foundation works for the School above the subject slope crest has commenced. The construction of the School was completed by 1977. Moreover, the southern portion of the slope is covered by a hard slope surface.

In the 1991 aerial photographs, over-growth of vegetation is observed at the southern portion of the slope, probably indicating inadequate maintenance. In the 1994 aerial photographs, such vegetation appears to have been cleared.

Between 1994 and 2006, little change is observed, other than a general increase in vegetation density, especially at the location of the 2007 rockfall.

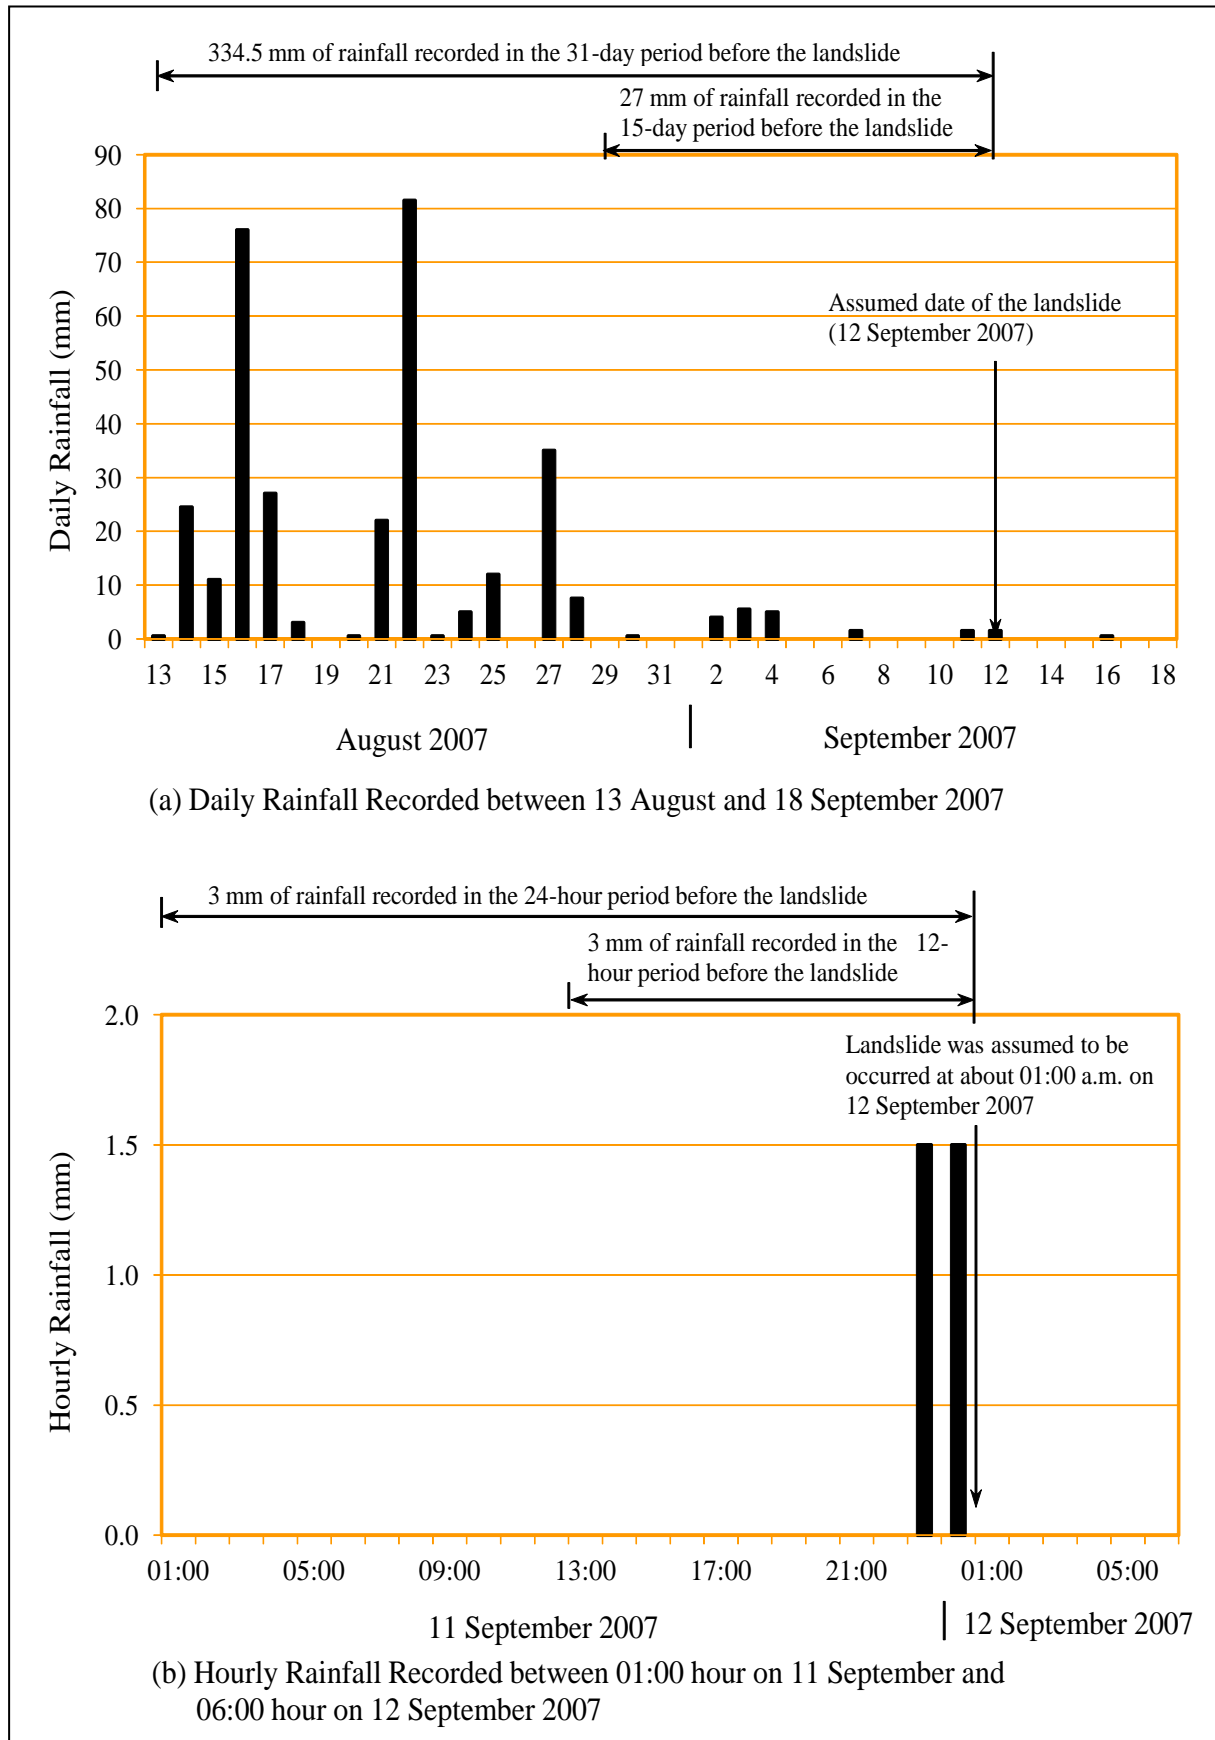
Figure 6.1 Daily and Hourly Rainfall Recorded at GEO Raingauge No. N03

Based on limited information available, the rockfall might have occurred during rainfall at about 1:00 a.m. on 12 September 2007. The daily rainfall for the period of 31 days before the incident and the hourly rainfall between 11 and 12 September 2007 are presented in Figure 6.1. The record of the daily rainfall shows that relatively light rainfall occurred during the 12 hours preceding the rockfall, with the maximum 1-hour rolling rainfall of about 1.5 mm between 11:00 p.m. on 11 September 2007 and 1:00 a.m. on 12 September 2007.

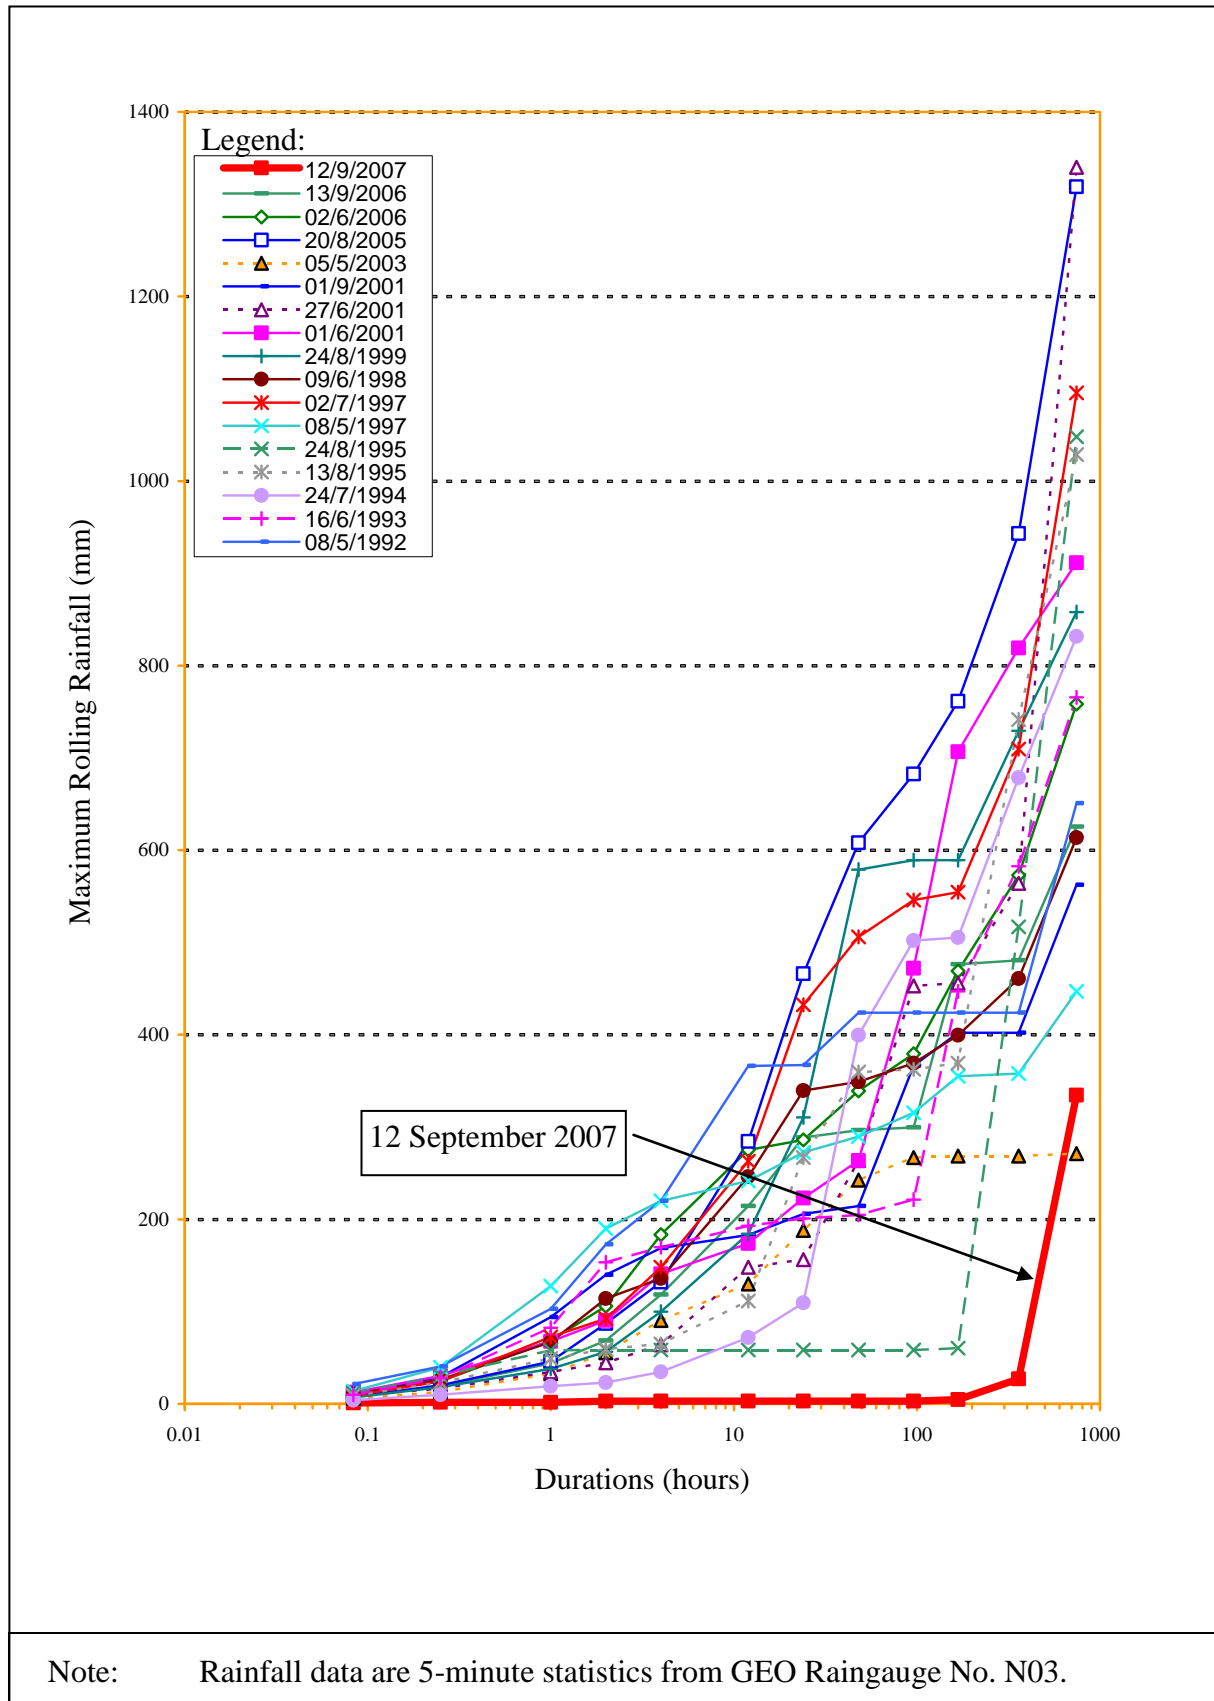
Figure 6.2 Maximum Rolling Rainfall for Previous Major Rainstorms at GEO Raingauge No. N03 between 1984 and 2007

A comparison of the maximum rolling rainfall on 12 September 2007 with that of the past major rainstorms recorded by Raingauge No. N03 is presented in Figure 6.2. The rainstorm of 12 September 2007 was insignificant.

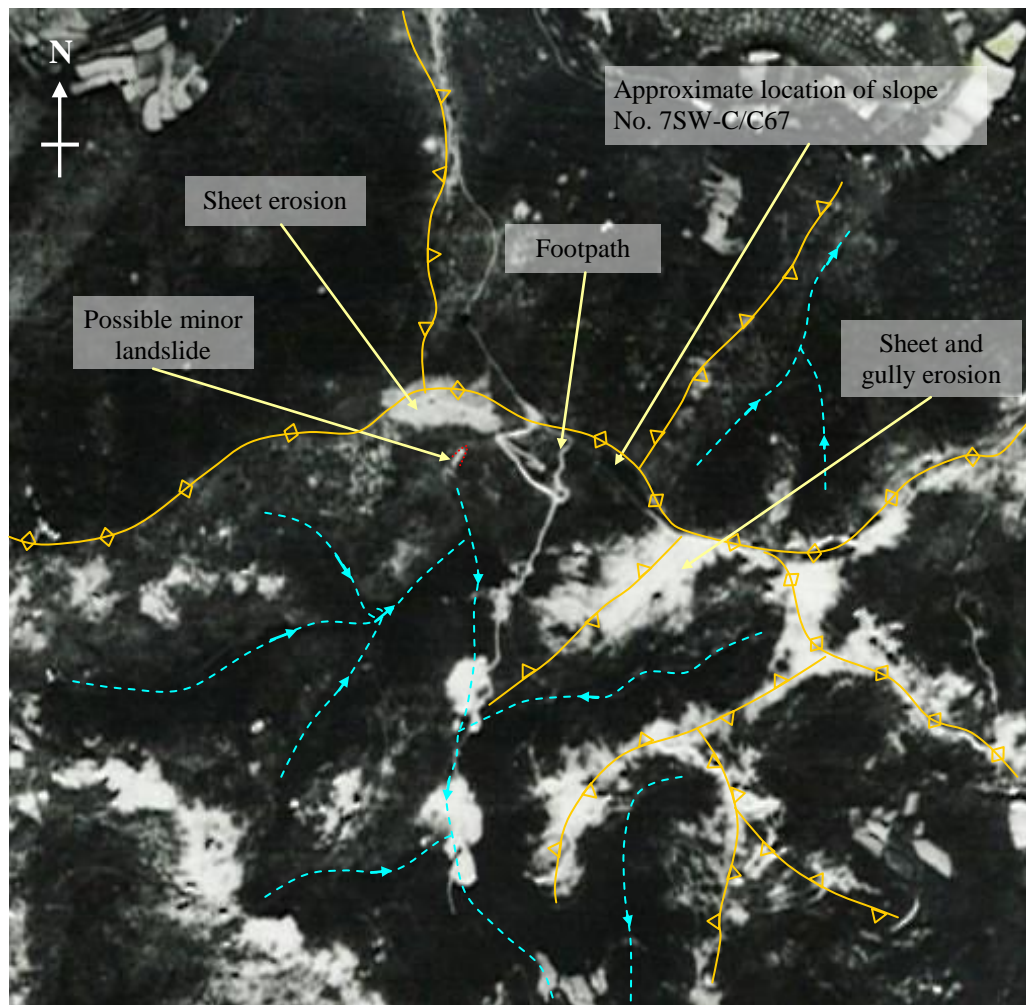
Figure A3 Interpretation of 1949 Aerial Photograph

From the earliest available aerial photographs taken in 1949, the whole area of Kwai Shing is undeveloped. The subject slope is at the mid-slope of a gentle southwest-facing concave natural hillside below a sub-rounded ridgeline, which trends from northeast to southwest. A ridgeline exists to the northeast and southeast of the subject slope. No drainage line is observed in the vicinity with the subject slope.
