**REVIEW OF THE  
24 JUNE 2005 LANDSLIDE  
ON SLOPE NO. 7SW-C/CR564  
TO THE NORTH OF  
TZE CHUK LAM  
FU YUNG SHAN, TSUEN WAN**

**GEO REPORT No. 266**

**Halcrow China Limited**

This report presents the findings of a review of a landslide (Incident No. 2005/06/0181) which occurred on slope No. 7SW-C/CR564 and an adjoining sloping ground to the north of Tze Chuk Lam, Fu Yung Shan, Tsuen Wan on 24 June 2005. The incident involved the failure of an approximately 5.5 m high slope portion and a 2 m high masonry toe wall, with a total failure volume of about 100 m<sup>3</sup>. The failed mass hit a squatter structure at the slope toe, broke two columns of the structure and piled up against the rear wall which was severely damaged. A portion of a flimsy squatter structure at the crest of the sloping ground in the western end was undermined. Both the squatter structures were evacuated as a result of the incident. No casualties were involved.

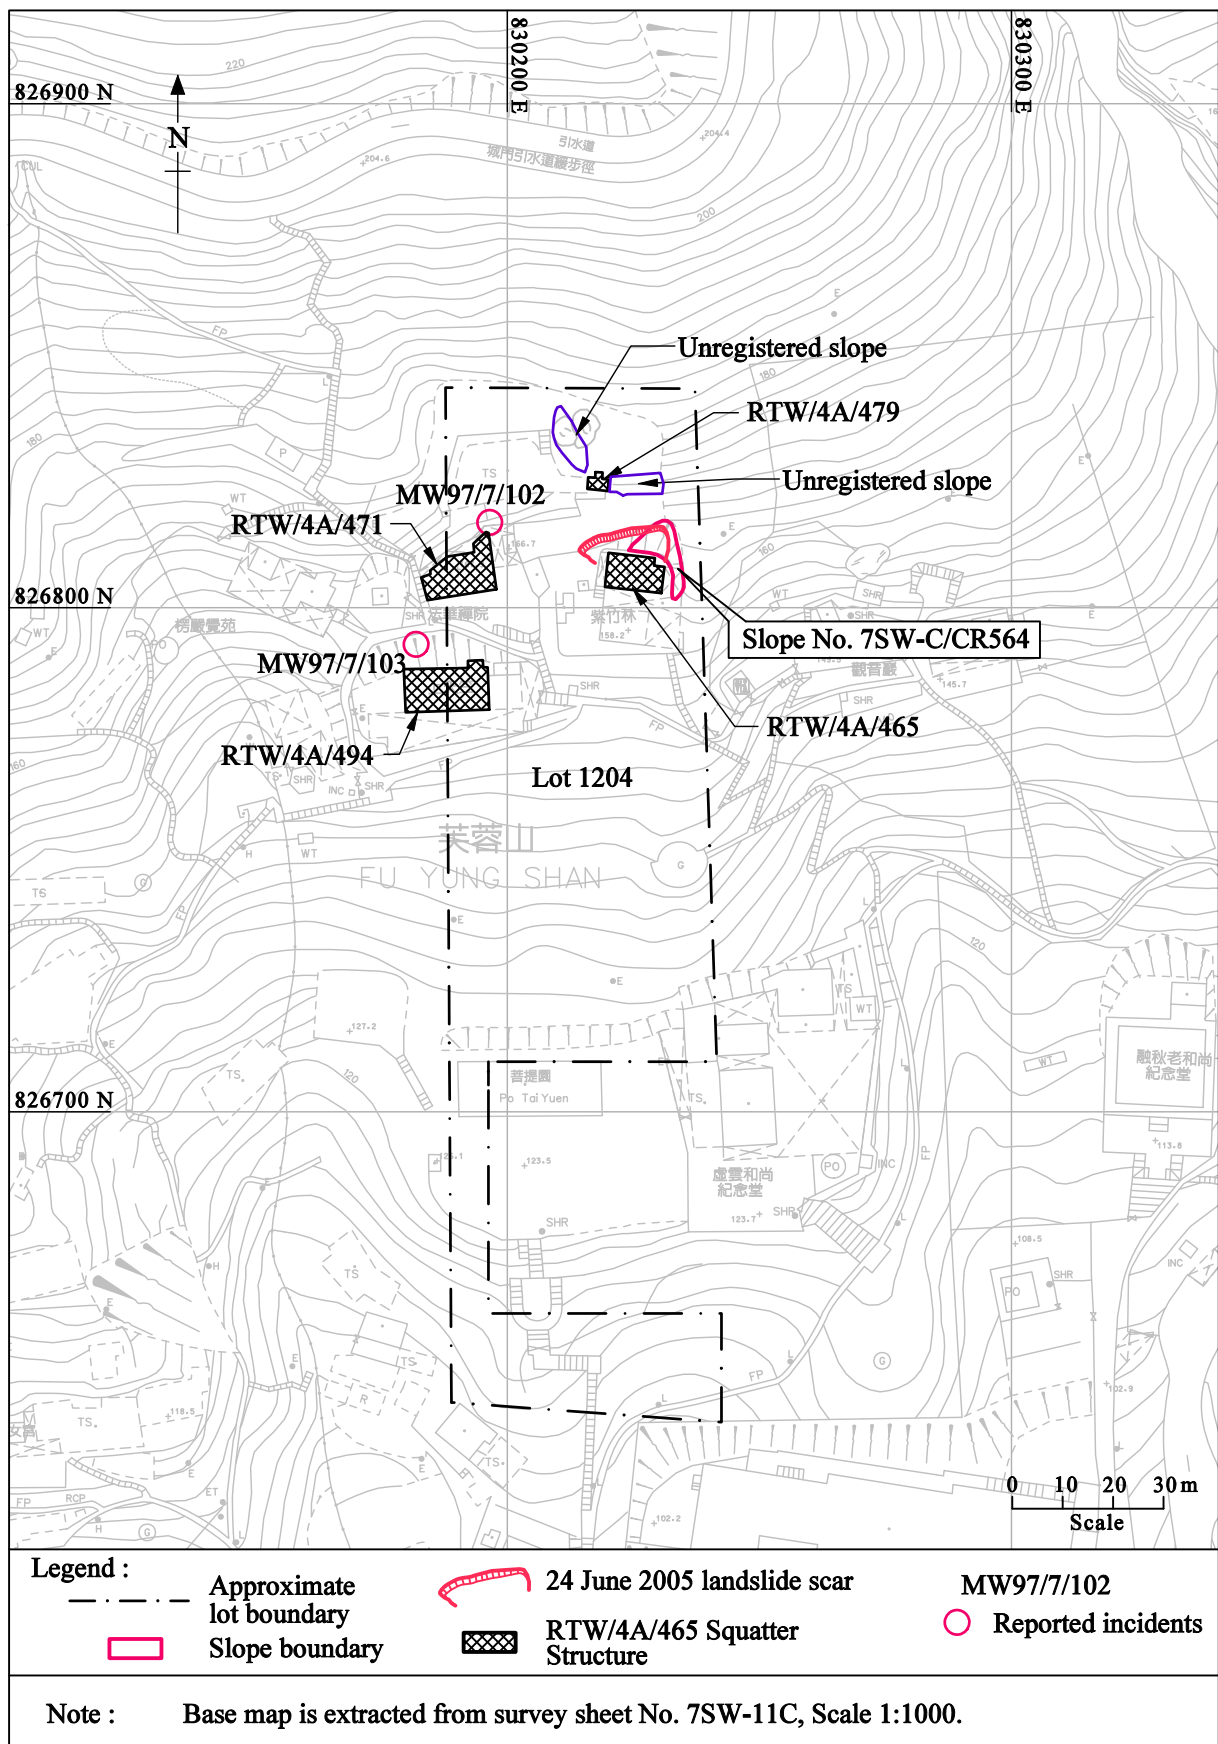
Figure 4 - Past Instabilities

2005 landslide, and are shown in Figure 4. Both the landslide incidents are also observable in the 1998 aerial photographs (Section 3.1).

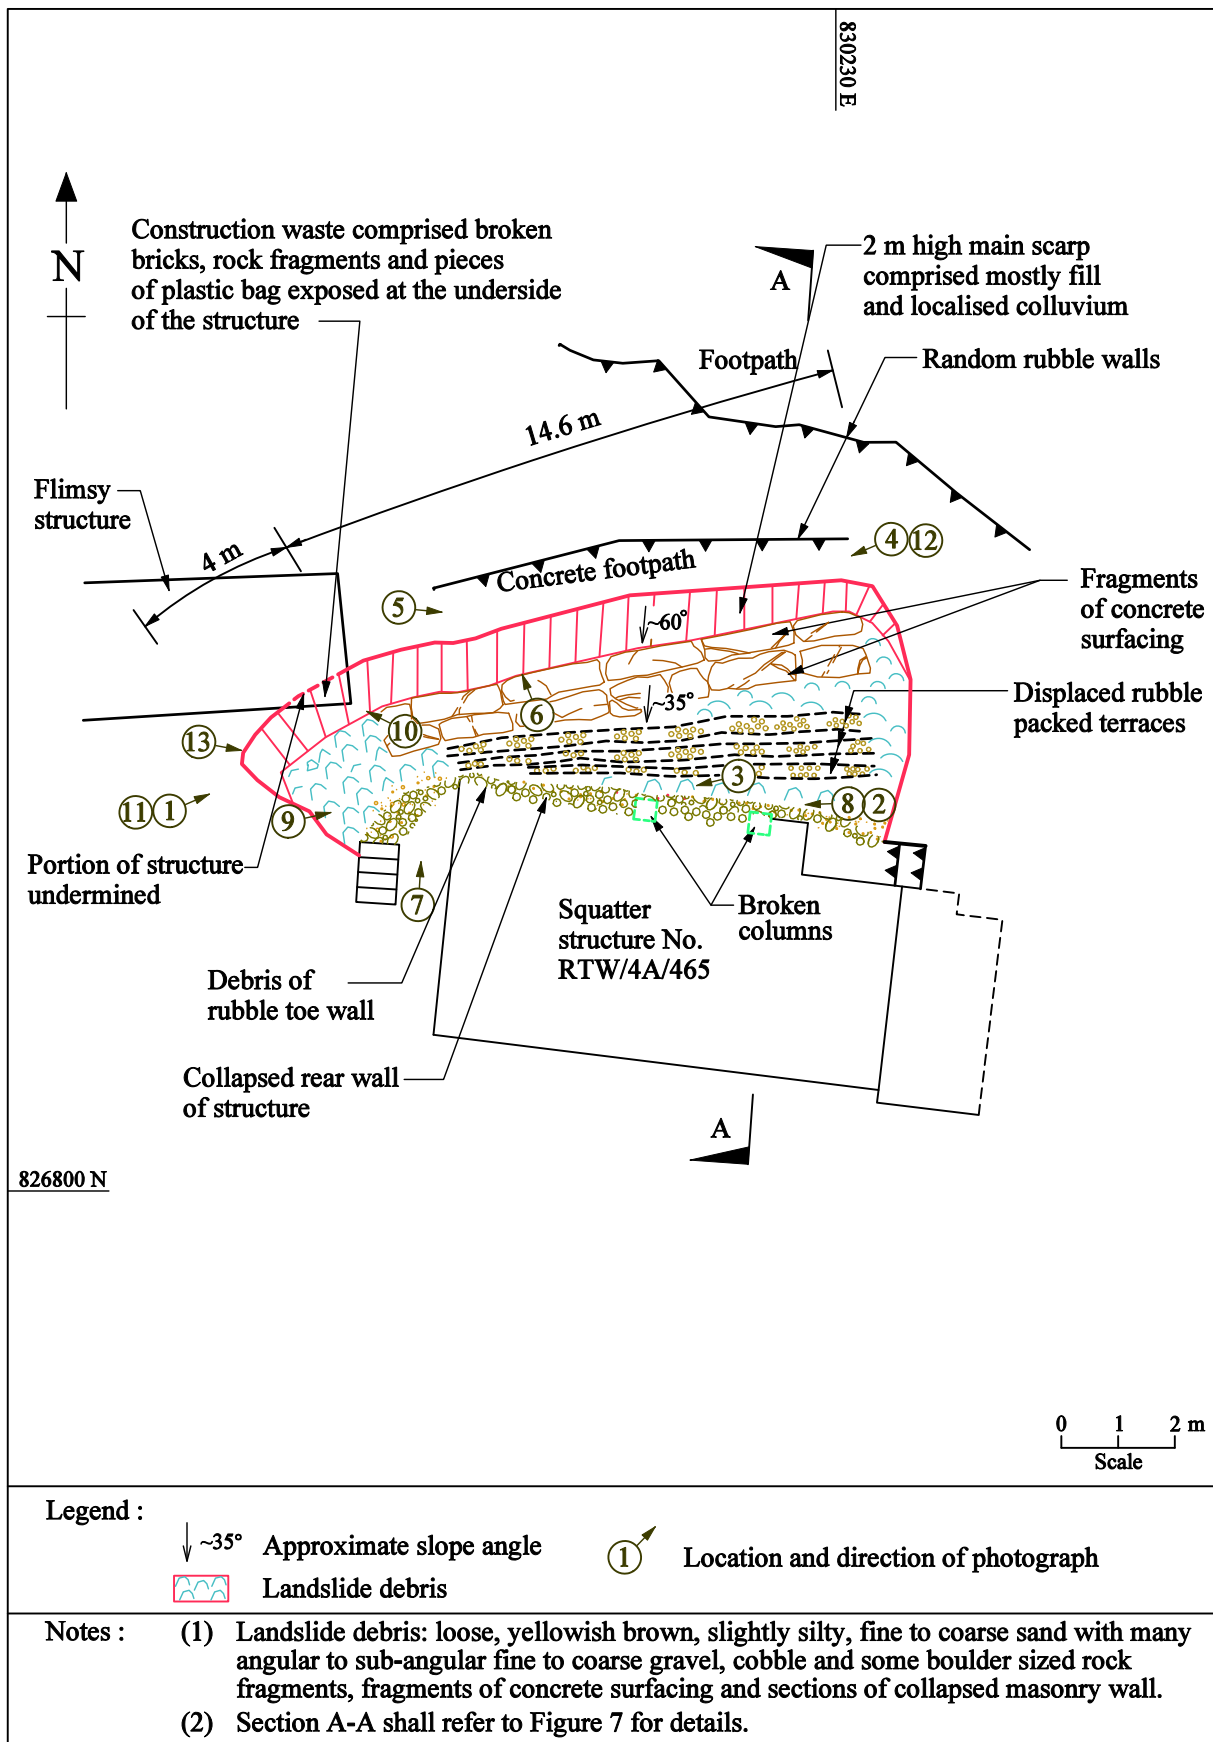
Figure 6 - Plan of the 24 June 2005 Landslide Site

No. CE 15/2004 (GE), first inspected the landslide site on 29 June 2005 at about 3:00 p.m. Key observations made by MGSL are presented below and in Figure 6.

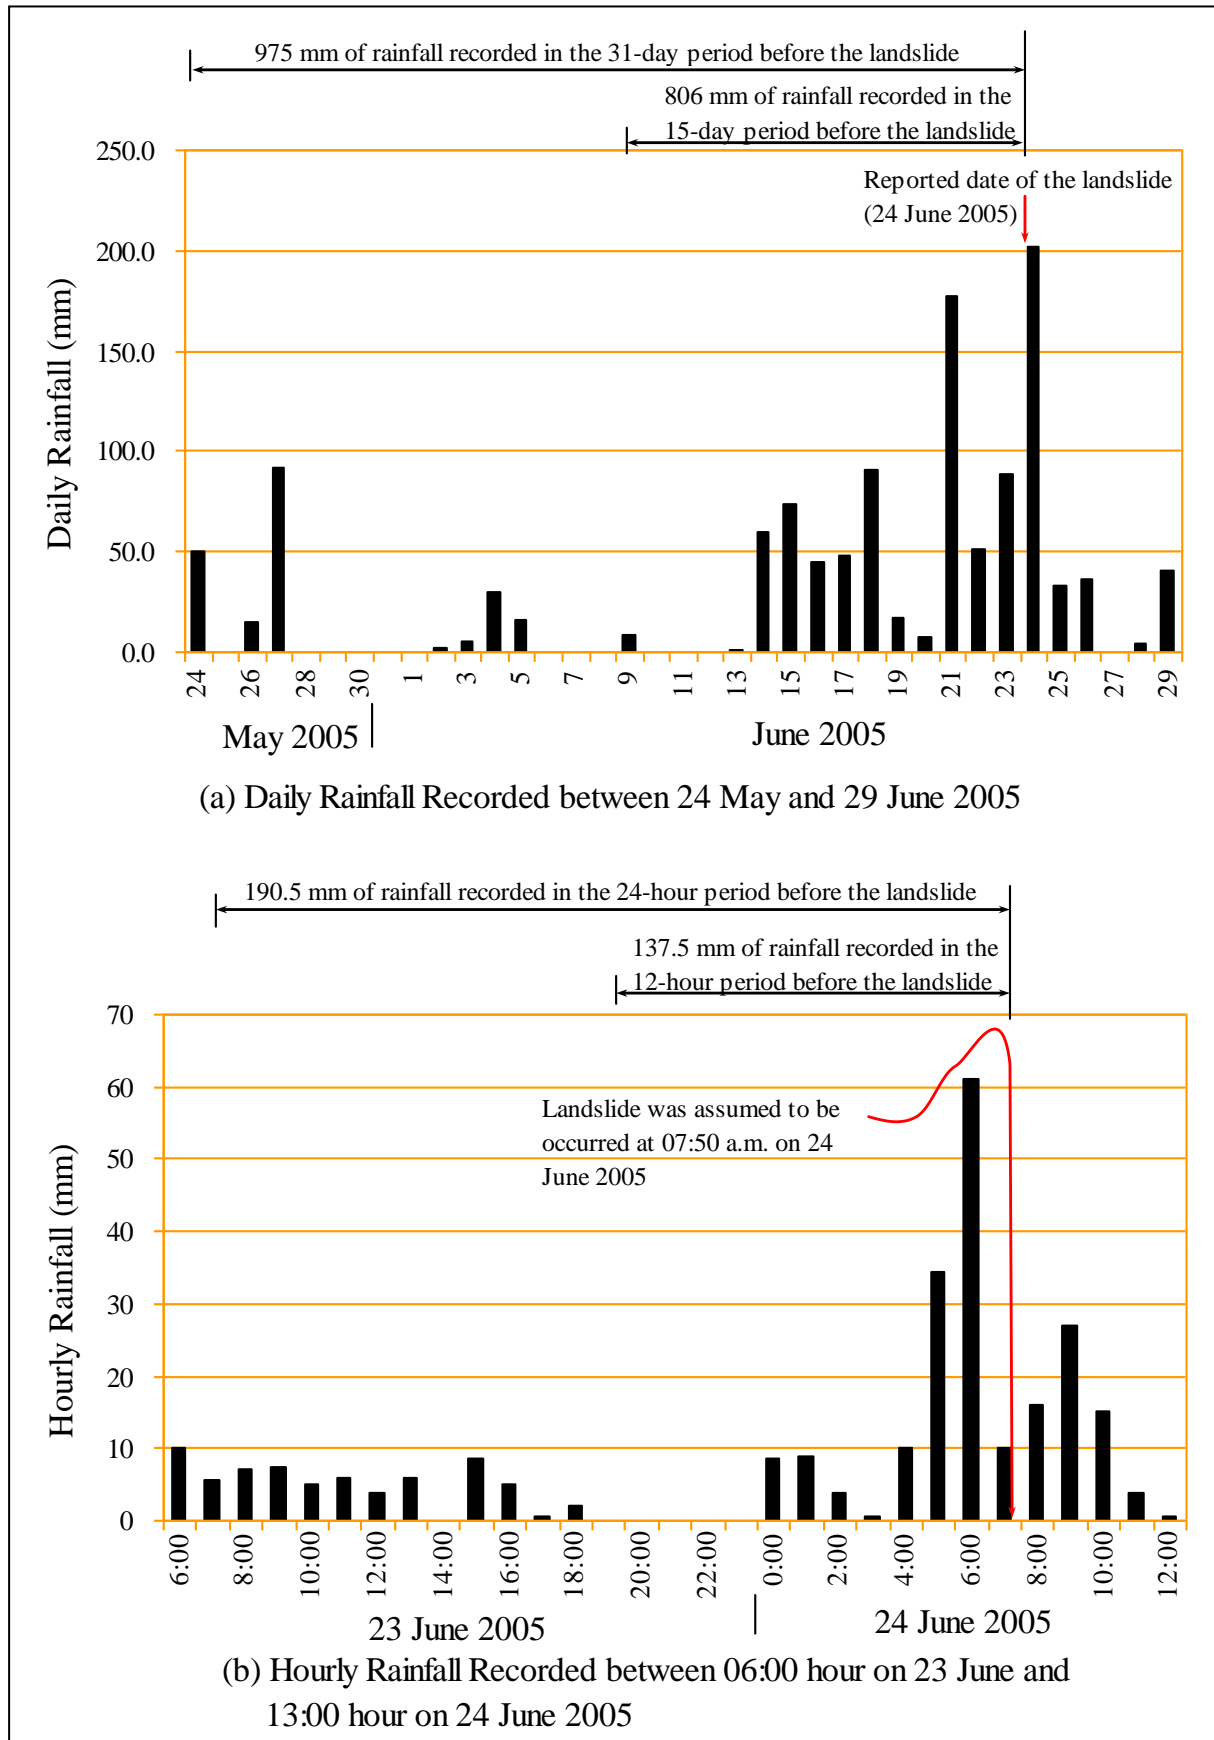
Figure 8 - Daily and Hourly Rainfall Recorded at GEO Raingauge No. N38

The daily rainfall for the 31-day period before the incident and the hourly rainfall between 23 and 24 June 2005 are presented in Figure 8. The records show that 89 mm of rainfall was recorded on 23 June 2005, the day before the incident. On the day of the incident, the record of the hourly rainfall shows that a total of 137.5 mm of rainfall was recorded from midnight to 7:50 a.m.

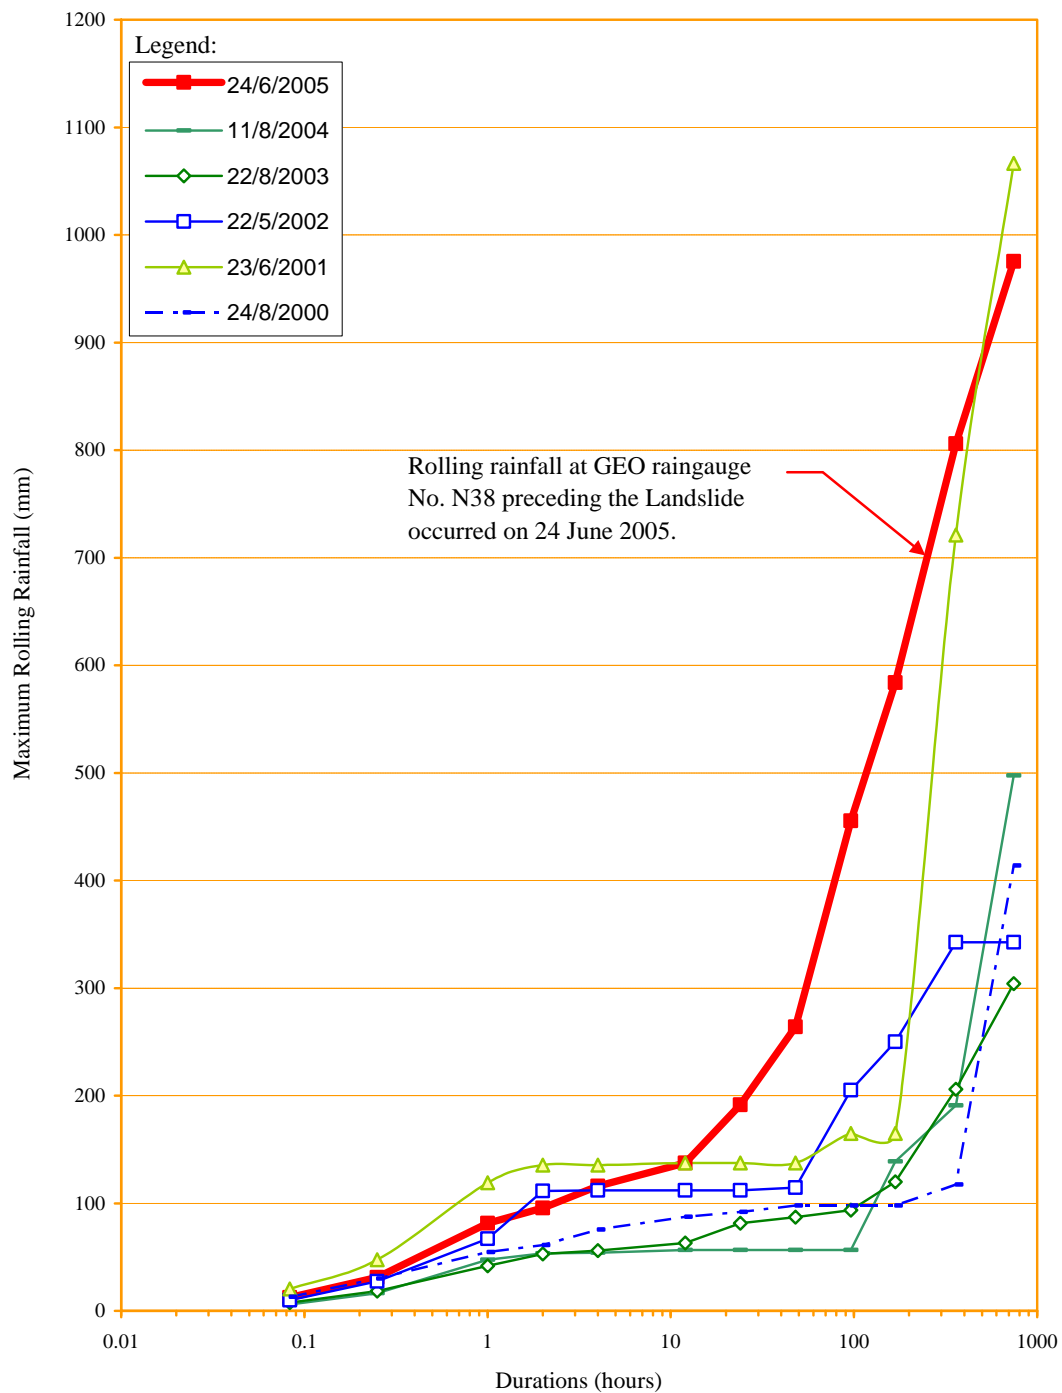
Figure 9 - Maximum Rolling Rainfall for Previous Major Rainstorms at GEO Raingauge No. N38 between 2000 and 2004

A comparison of the maximum rolling rainfall of the 24 June 2005 rainstorm with those of the past major rainstorms between 2000 and 2004 recorded by raingauge No. N38 since November 1999, when it became operational, is presented in Figure 9. The maximum rolling rainfall of the 24 June 2005 rainstorm is the most severe rainstorm recorded since 2000 for rainfall durations of more than 12 hours and less than 15 days.

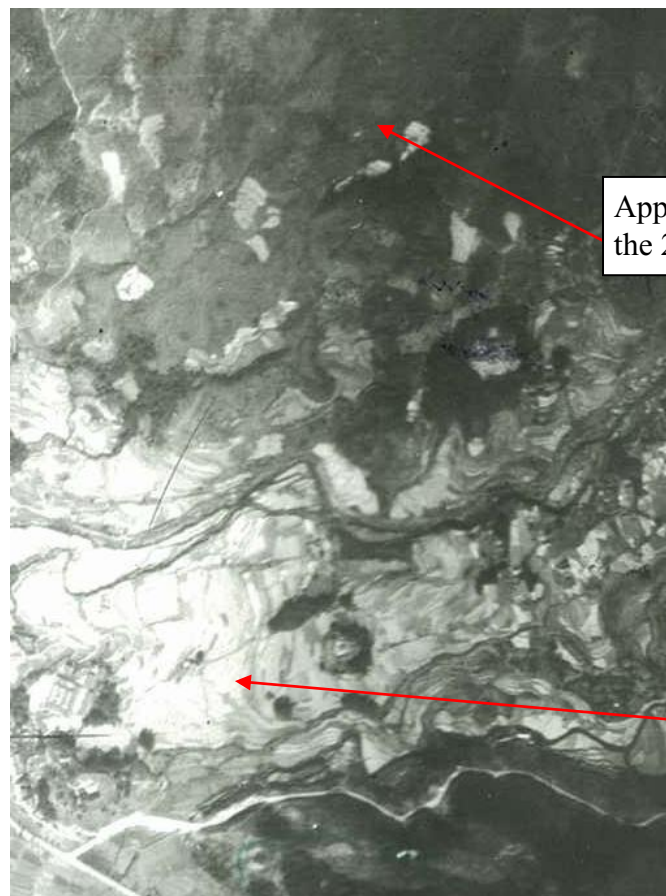
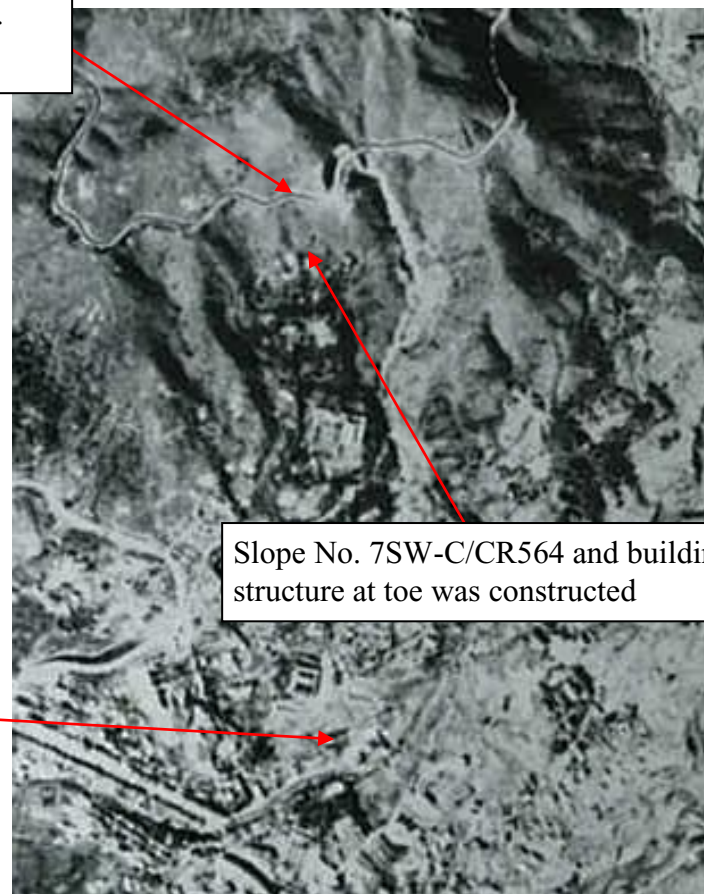
Plate A1 - Extract from 1924 and 1954 Aerial Photographs

Approximate location of  
the 24 June 2005 landslide

Slope No. 7SW-C/CR564 and building  
structure at toe was constructed

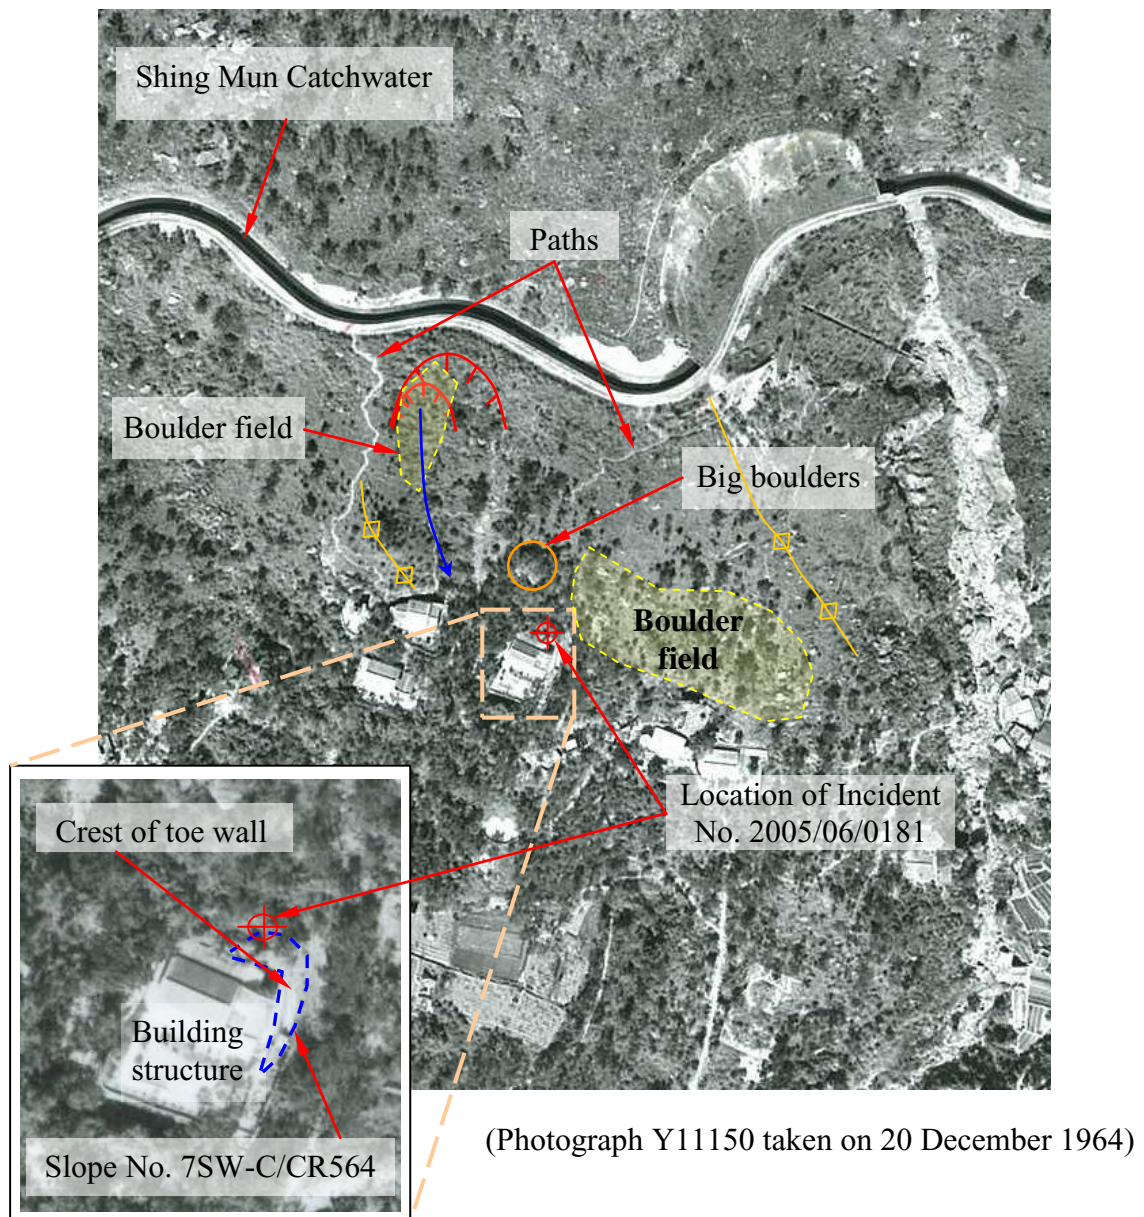
Plate A2 - Extract from 1964 Aerial Photograph

- Relict landslide
- Incident No. 2005/6/0181

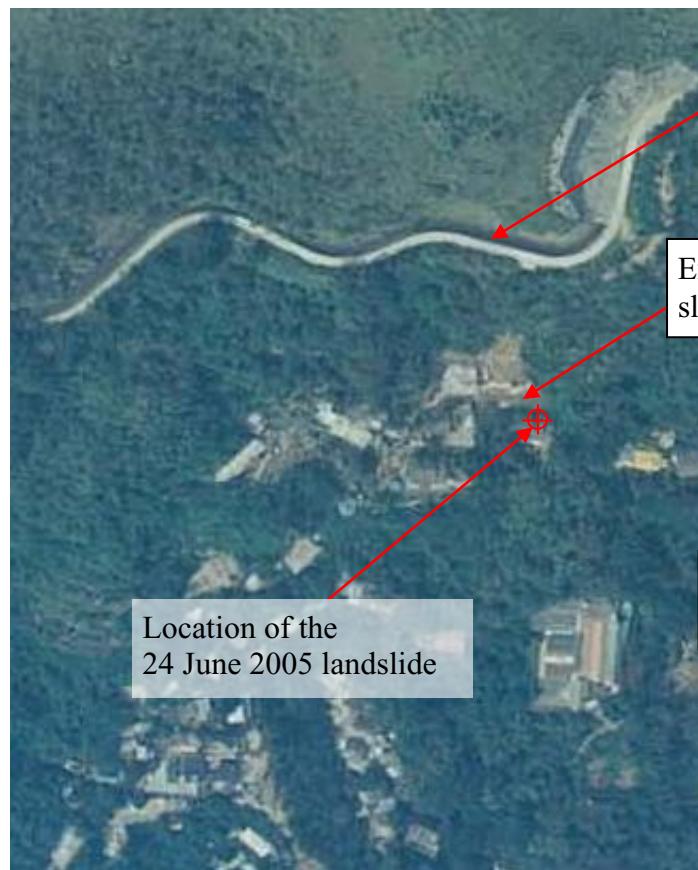
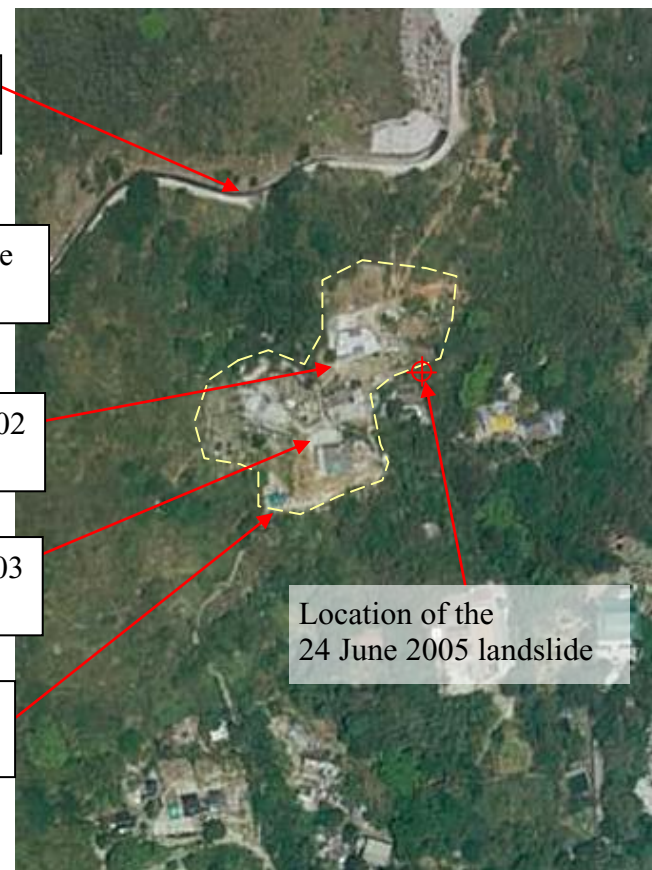
Location of the  
24 June 2005 landslide

Incident No. MW97/7/103

Approximate extent of  
development of hillside
