REVIEW OF THE DISTRESSED HILLSIDE NEAR KWU TUNG RESERVOIR

GEO REPORT No. 267

Halcrow China Limited

**This report was originally produced in August 2009
as GEO Landslide Study Report No. LSR 5/2009**

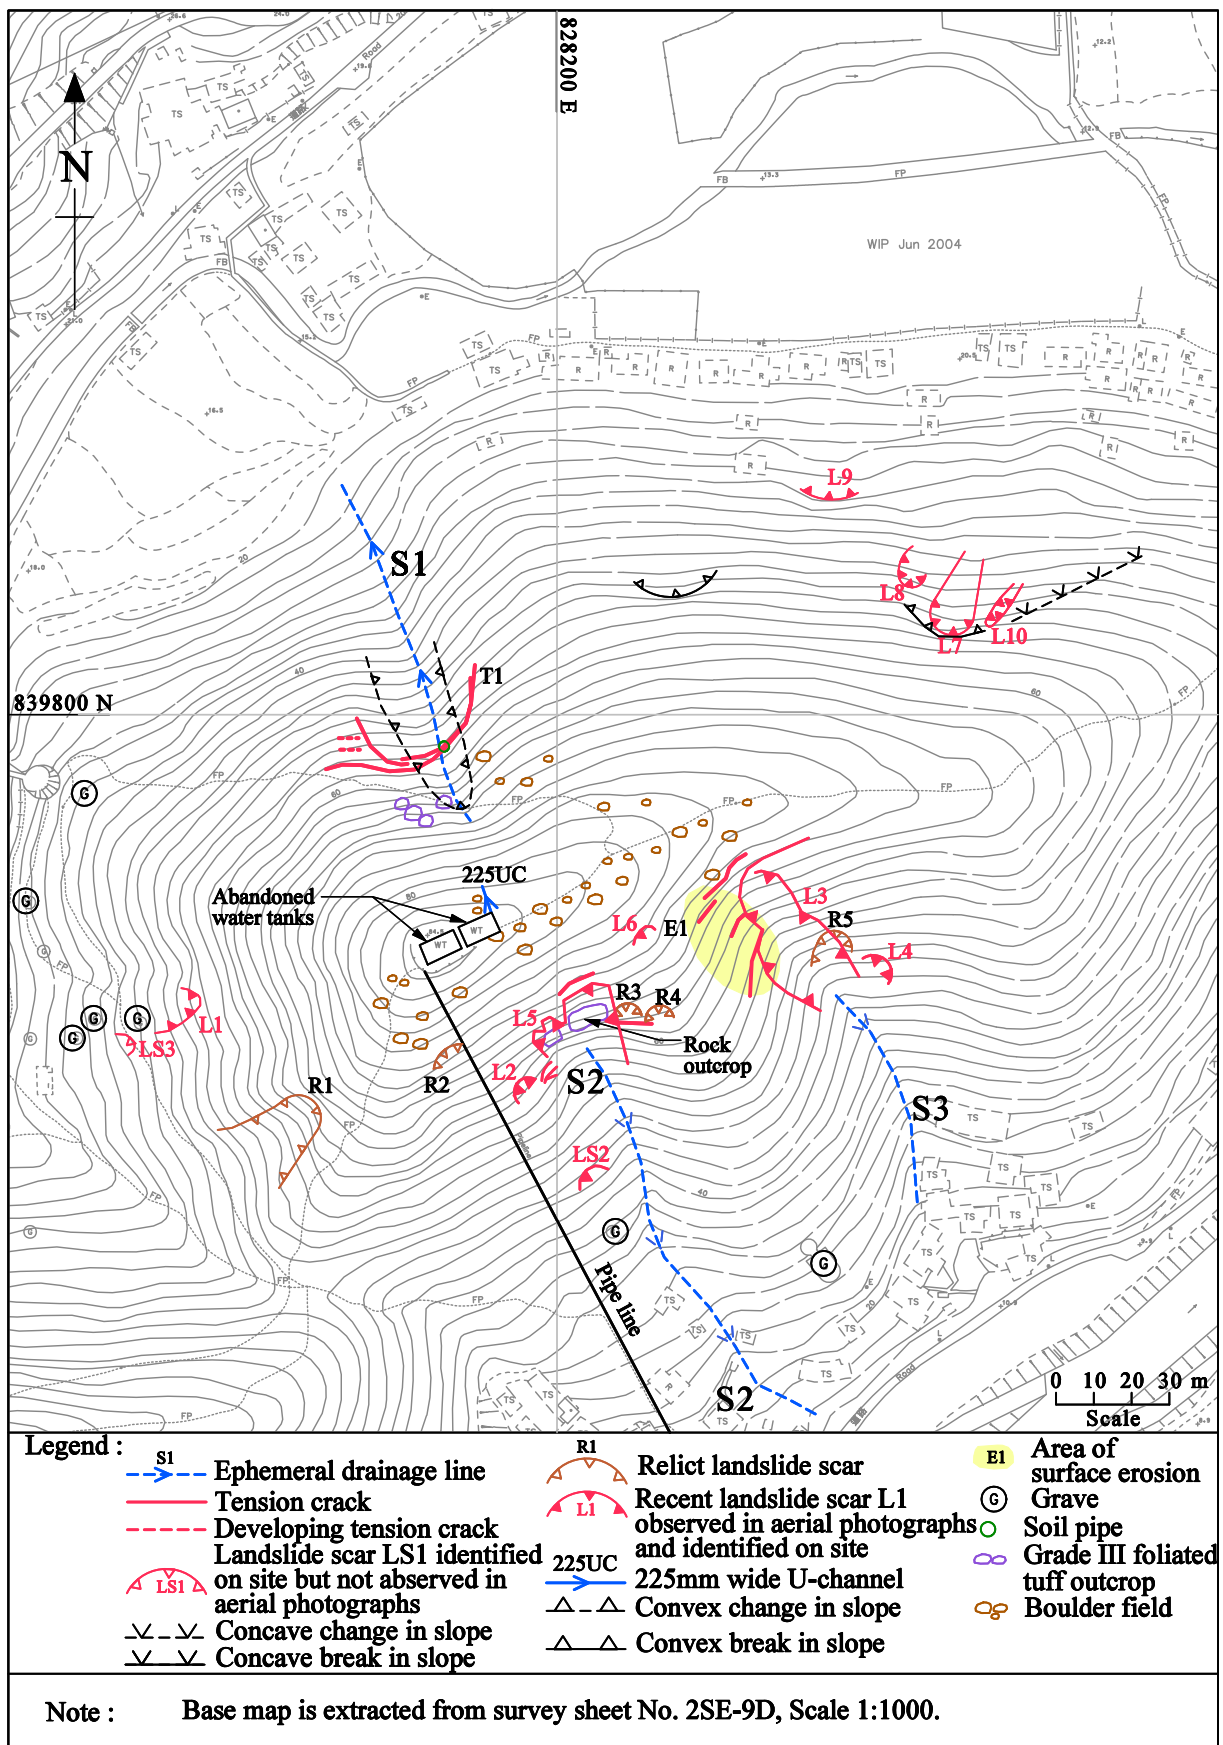
Figure 9 - Aerial Photograph Interpretation

Two ephemeral drainage lines run from northwest to southeast at the central and eastern portions of the hillside (Figure 9). After the hillfire, several recent landslide scars were exposed towards the head of these ephemeral drainage lines on the steeper part of the hillside where gradient is up to about 40° locally (Figure 5, Plate 3 and Plates 8 to 11).

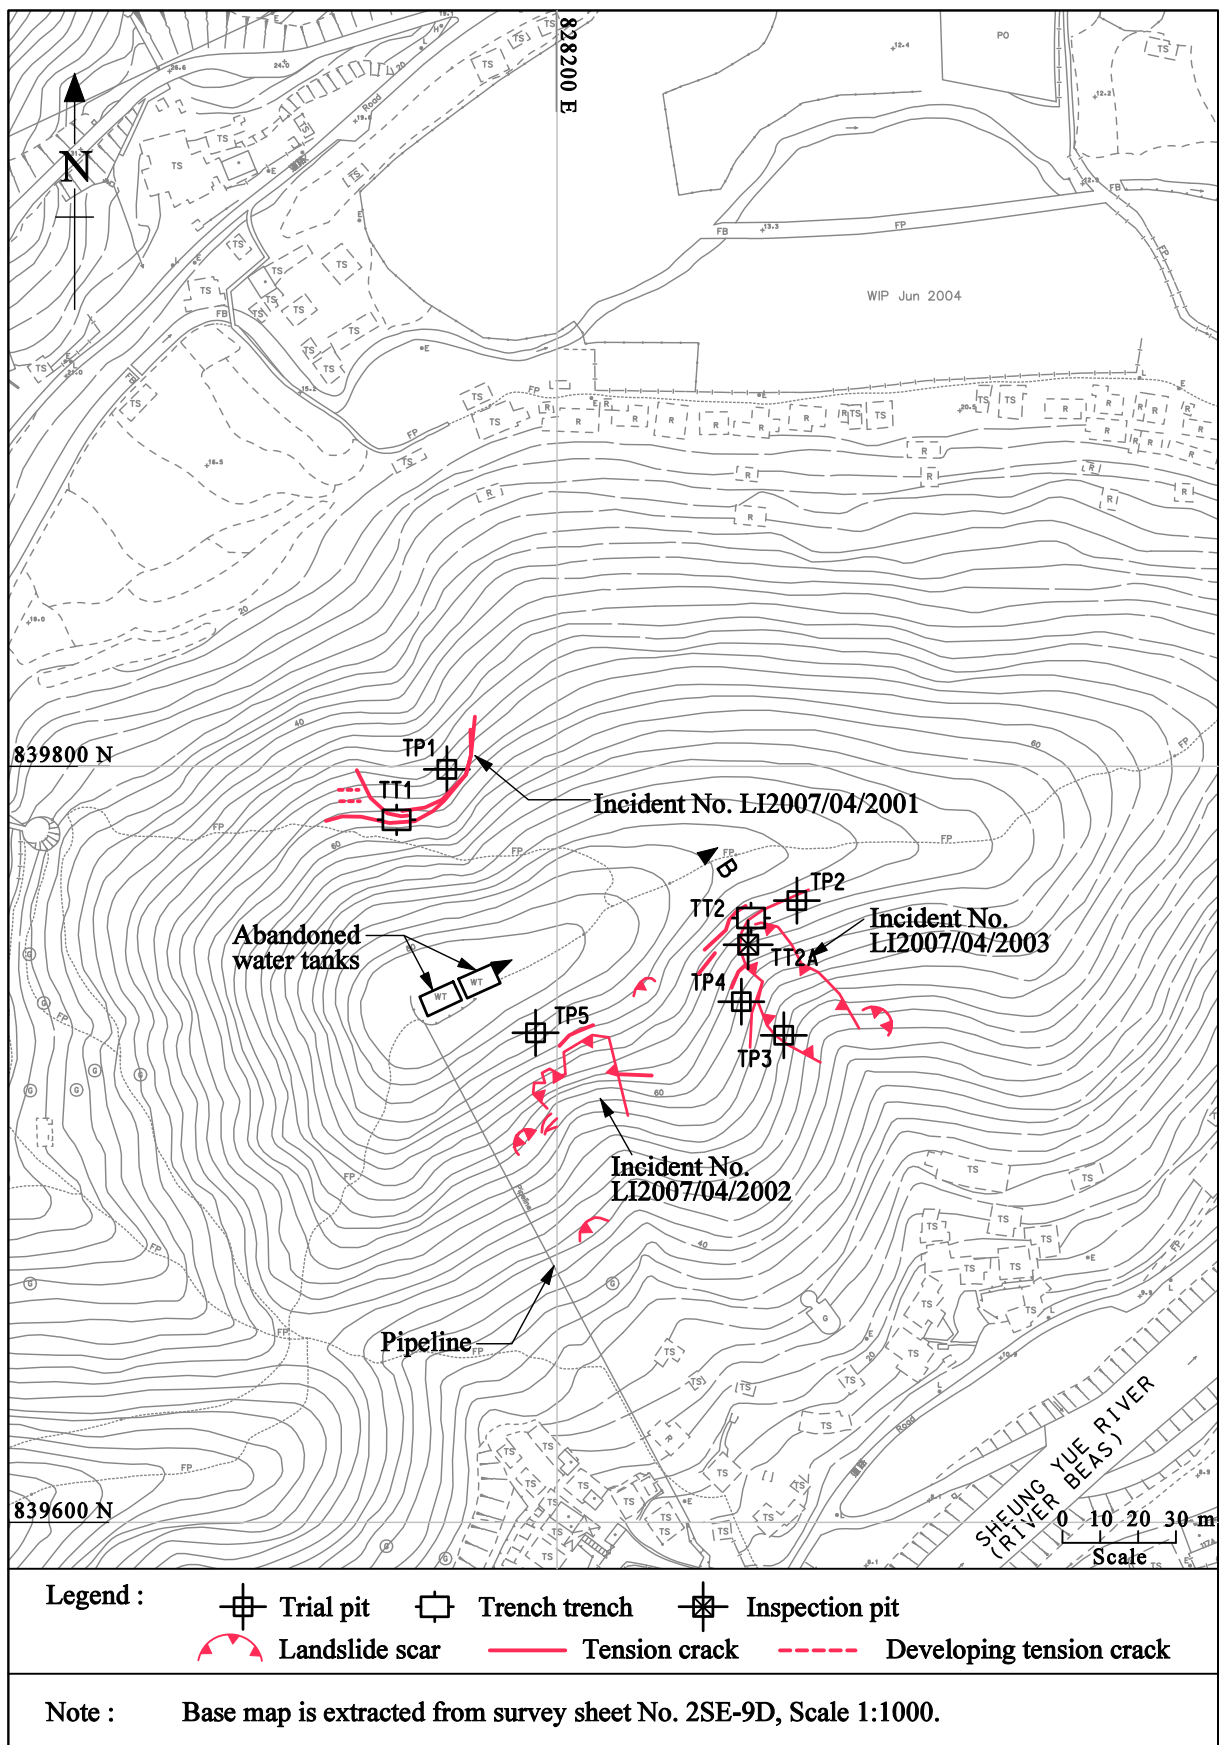
Figure 11 - Ground Investigation Location Plan

The locations of the ground investigation stations are shown in Figure 11 and detailed logs are included in Appendix B. The findings from the trial pits and trial trenches are summarized at the following sections.

Trial Pit TP1 was positioned on the eastern flank of a tension crack on the north-facing hillside (Figure 11) and encountered colluvium of up to 0.8 m thick, comprising gravelly sandy silt with cobbles of tuff overlying Grade V/IV tuff. Tension cracks ranging from 8 mm to 300 mm wide and pervaded by rootlets were identified extending into the colluvium to 0.4 m below ground level. Several voids with maximum dimensions 0.45 m (W) x 0.15 m (H) x 0.25 m (D) were also encountered within the colluvium to depths of up to 0.4 m.

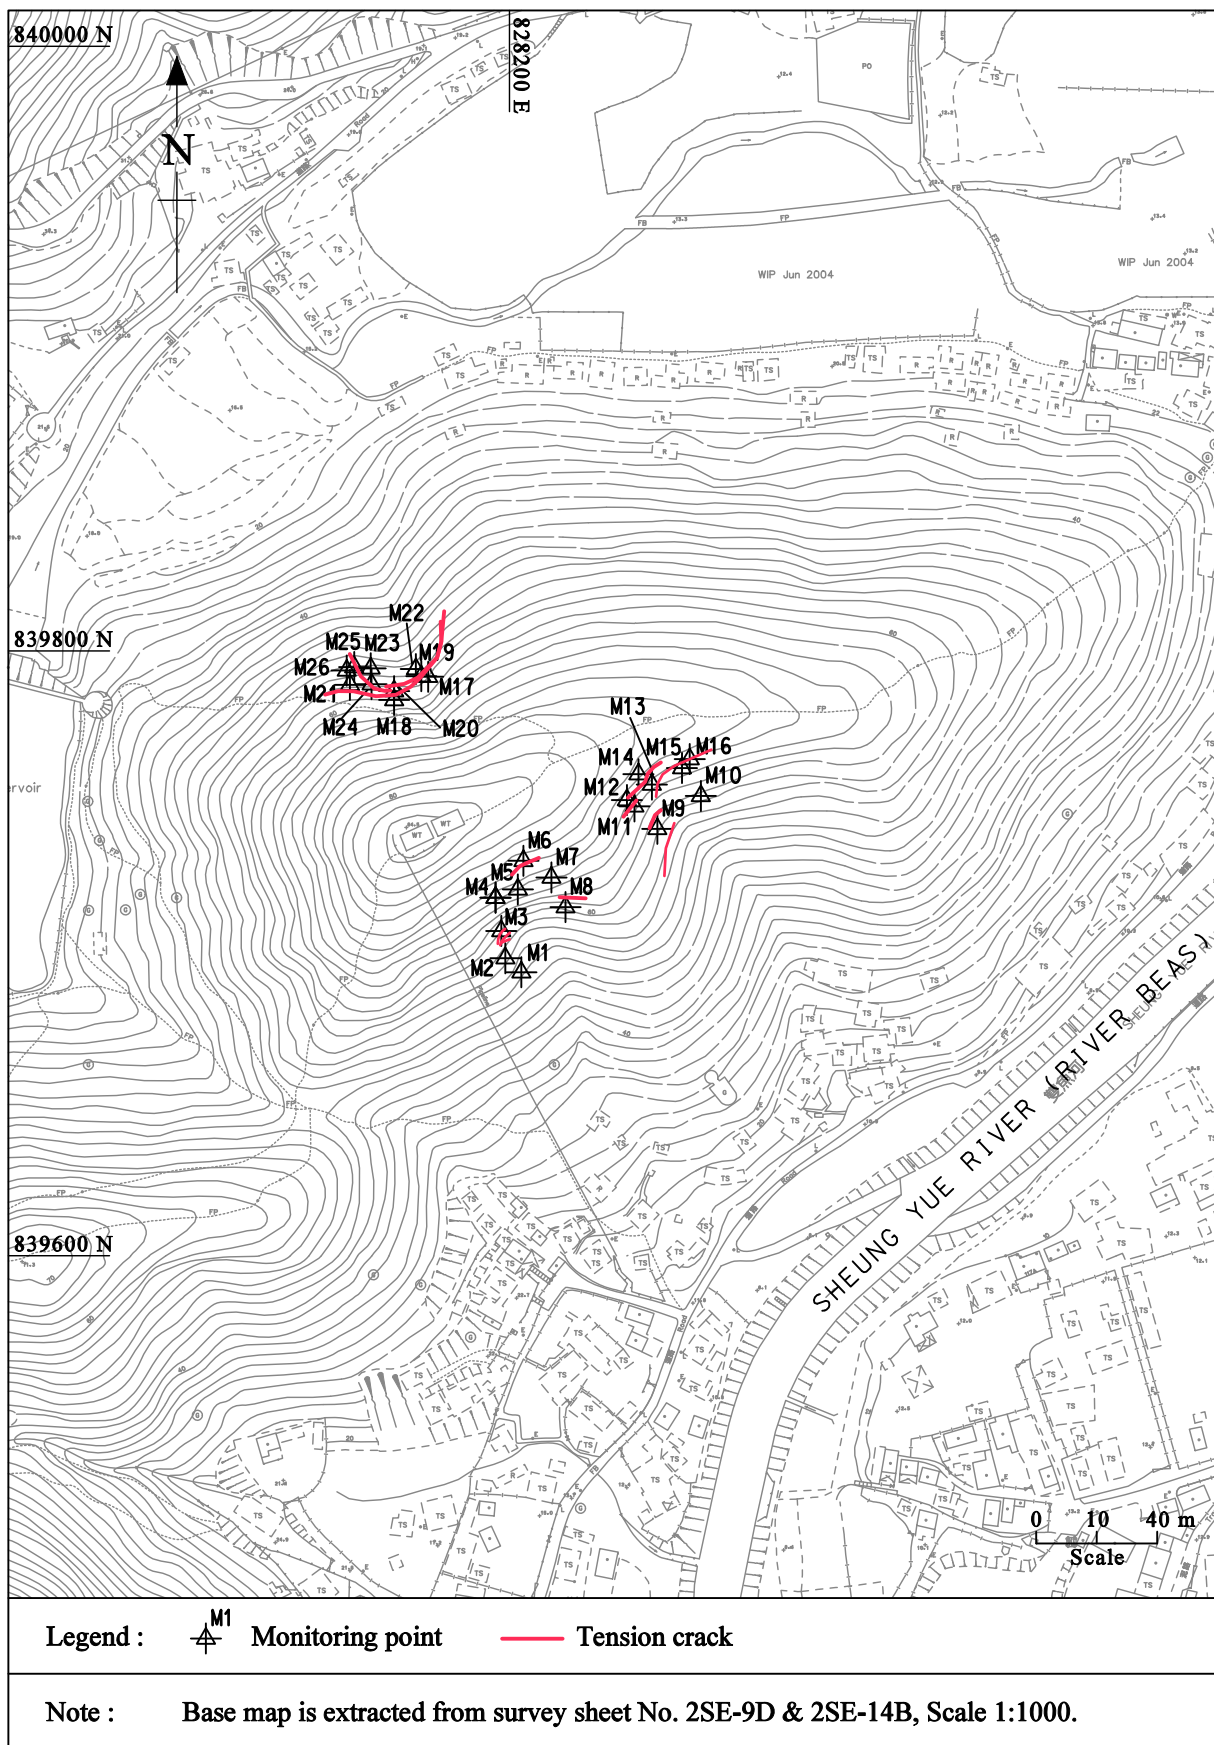
Figure 12 - Location of Ground Movement Monitoring Points

In November 2007, 26 survey monitoring stations (sixteen at the south-facing hillside and ten at the north-facing hillside) in the vicinity of the tension cracks (Figure 12) were constructed by Gammon Construction Limited. Following the installation, measurement of the lateral and vertical displacement was carried out by CEDD's Survey Division using surveying instruments at monthly intervals commencing from January 2008. The range of the surveying instrument's accuracy is ± 10 mm. Monitoring up to the end of April 2009, including the period of heavy rainfall in June 2008, did not show any significant movement nor trend of increasing movement. The results fluctuated between +4 mm (heaving) and -13 mm (settlement). Details of the monitoring results are included in Appendix C.

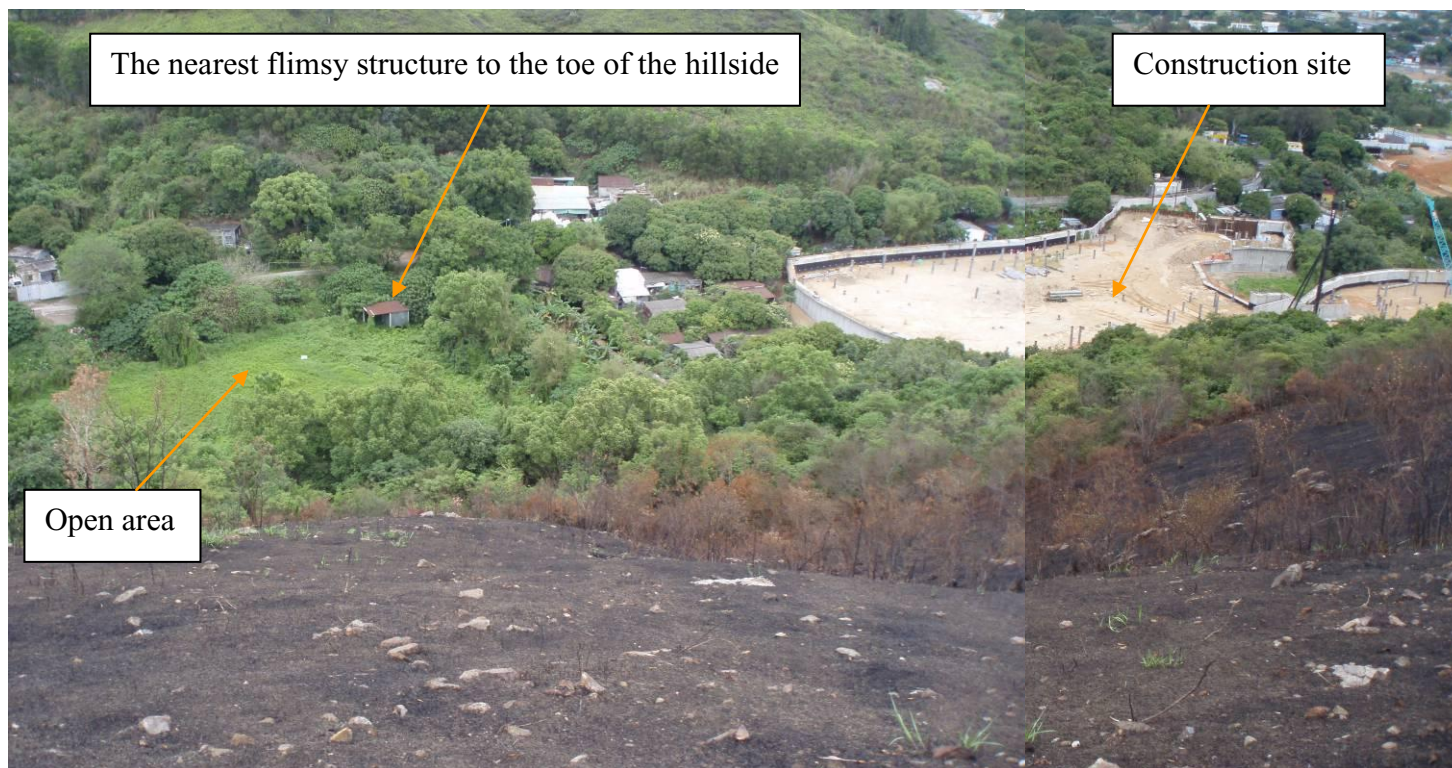
Plate 2 - Facilities at the Toe of the North-facing Hillside (Photograph taken on 23 April 2007)

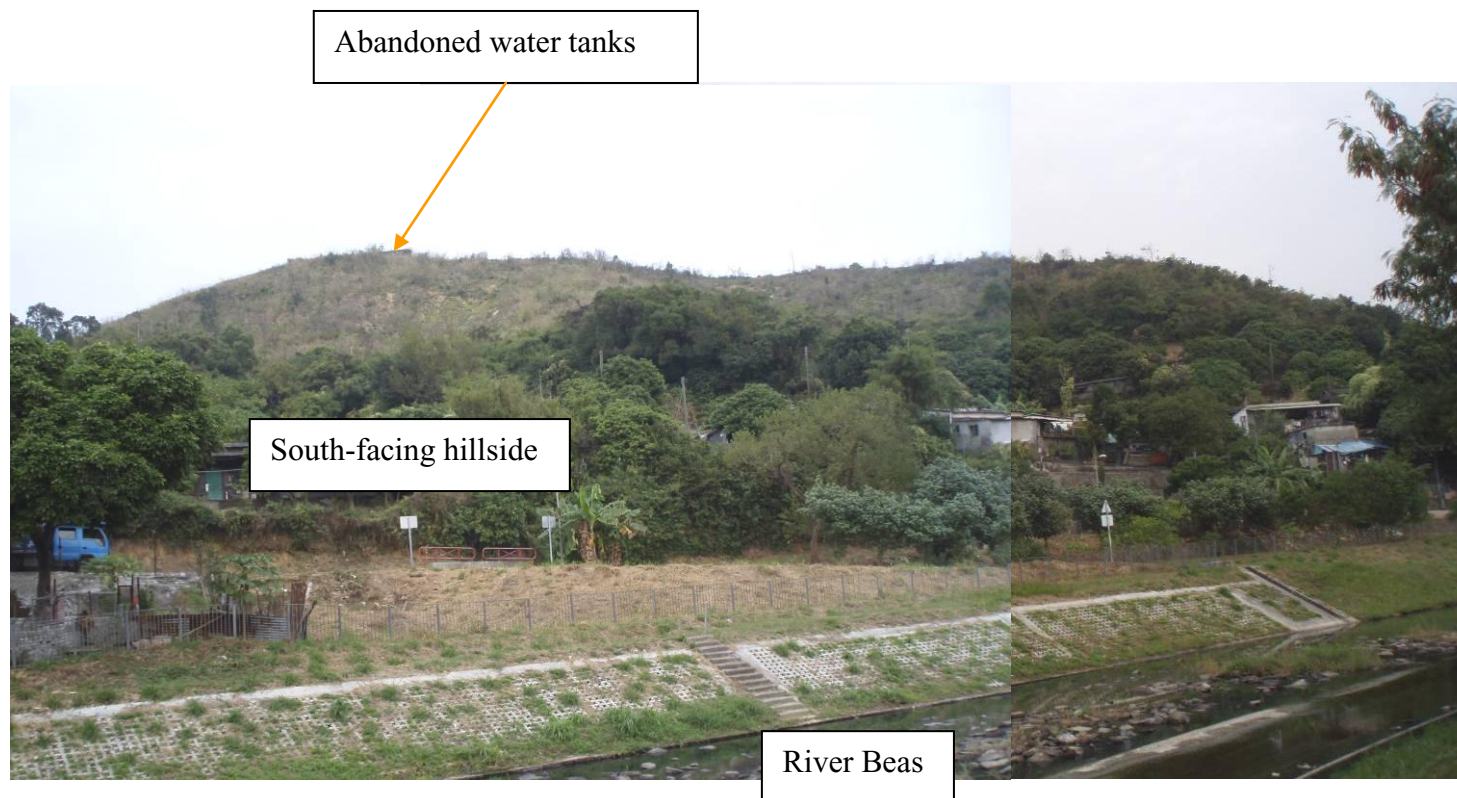
Plate 4 - Facilities at Toe of the South-facing Hillside (Photograph taken on 26 November 2007)

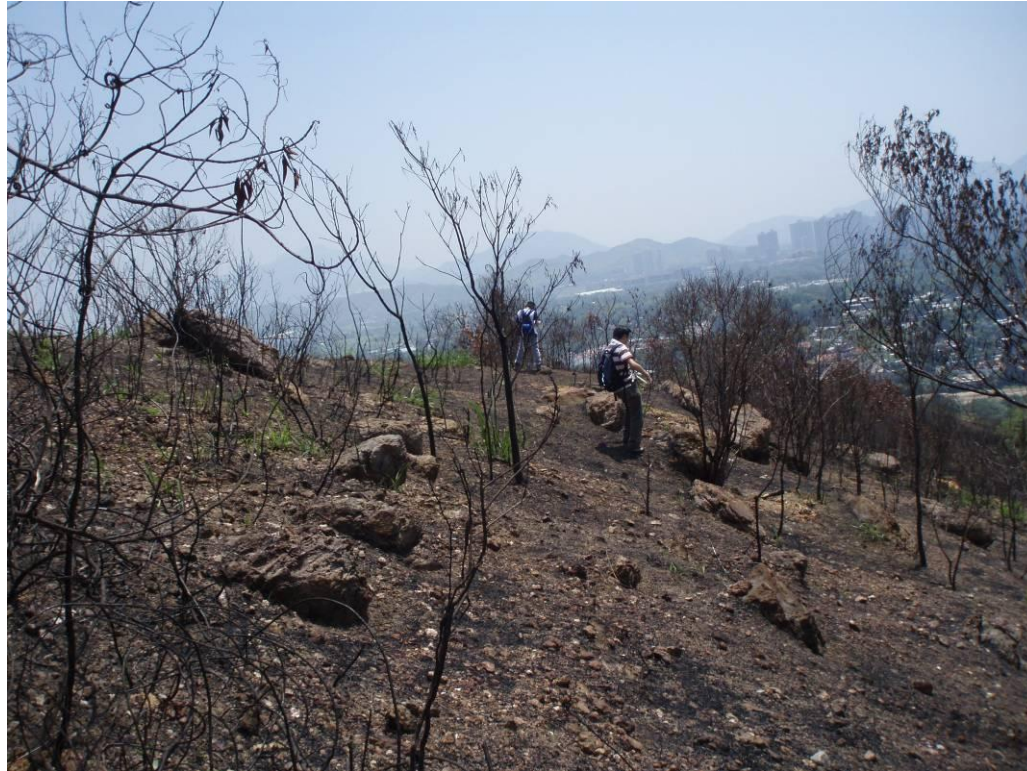
Plate 13 - View of Boulders Scattered along the Ridgeline (Photograph taken on 7 May 2007)

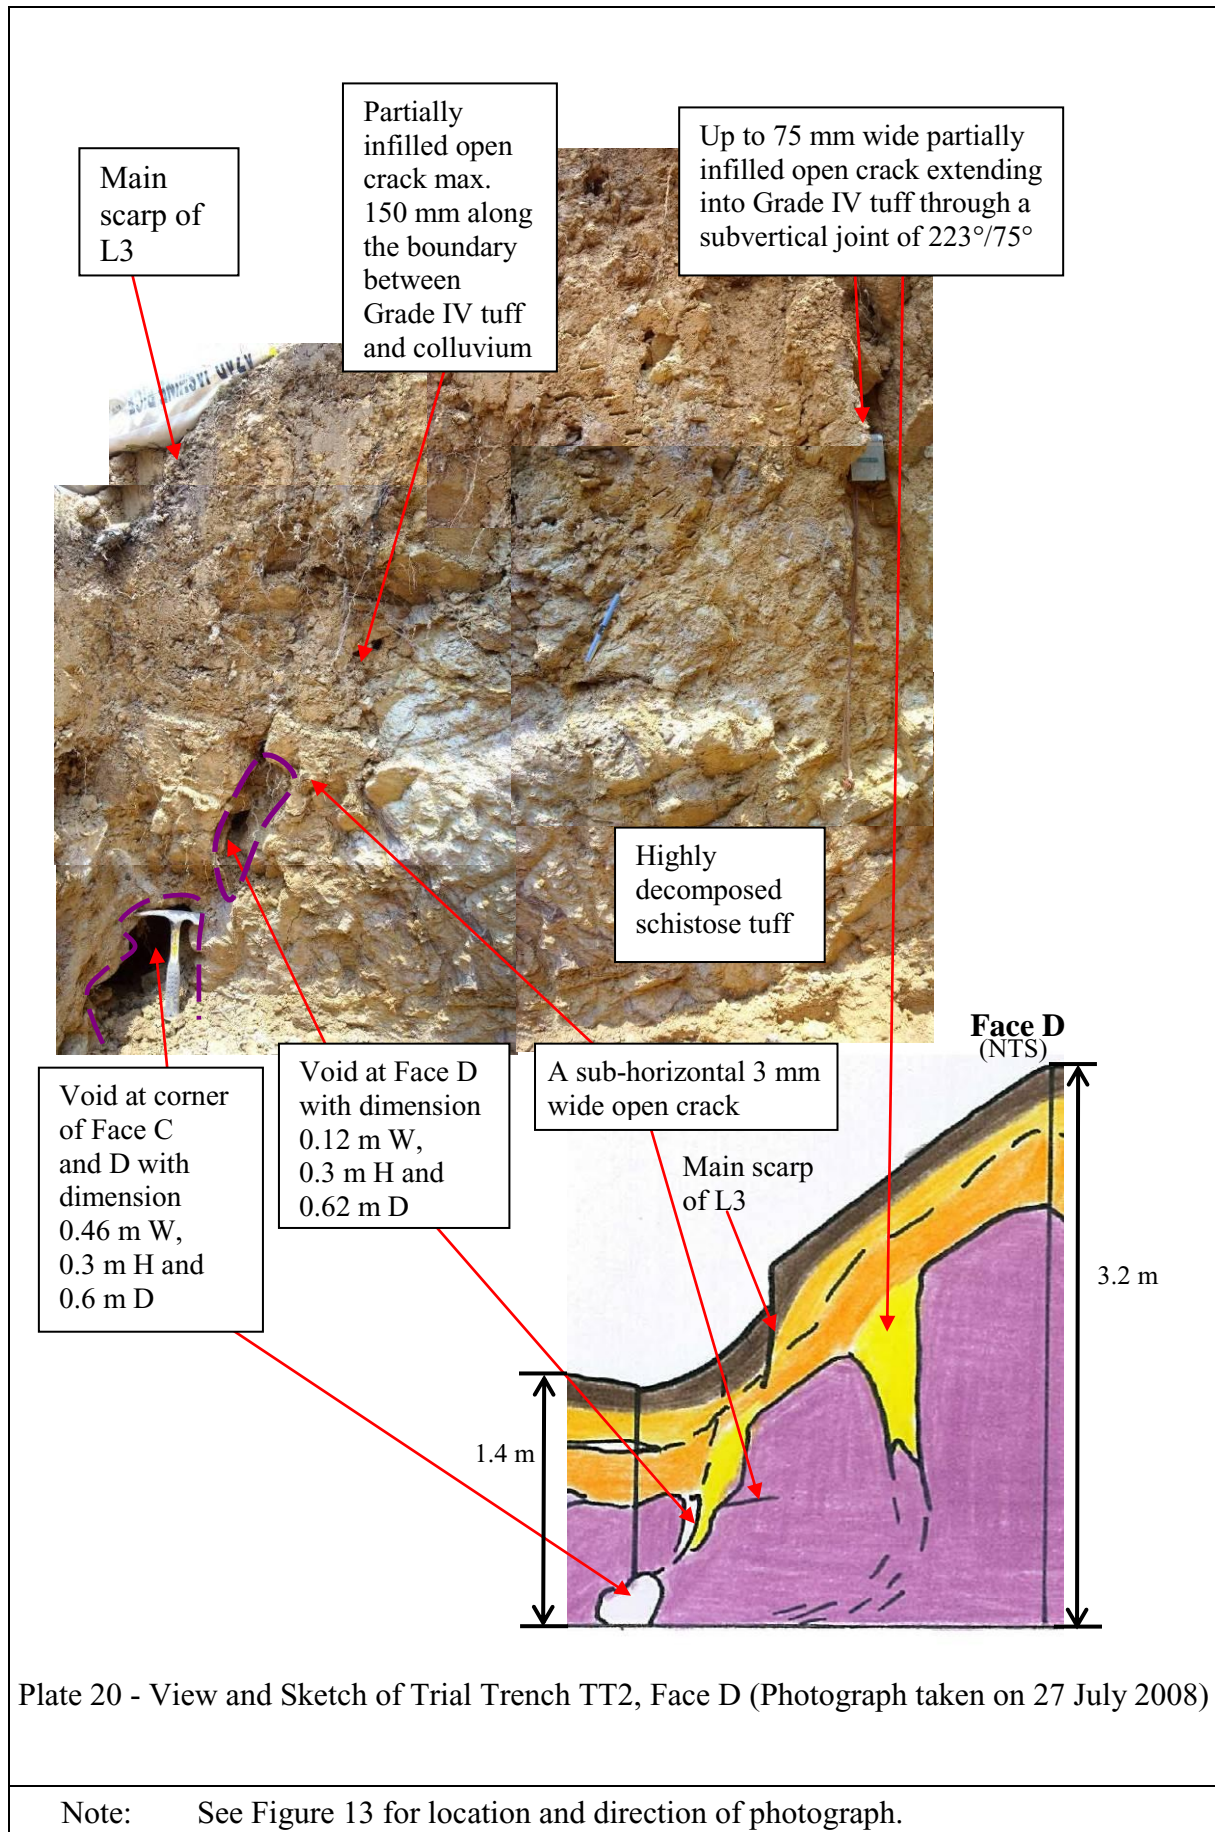
Trial trench TT2 was positioned across the tension cracks and main scarp of landslide scar L3 on the south-facing hillside and encountered two layers of colluvium up to 1.3 m thick overlying Grade V/IV tuff (Plate 19). The upper colluvium layer was up to 1.0 m thick and comprised sandy silt with some coarse gravel and cobble sized Grade V/IV tuff fragments and with several root-filled sub-vertical cracks. The lower colluvium was up to 0.8 m thick and comprised sandy silt with many gravel, cobble and occasional boulder sized Grade V/IV tuff fragments. At Face C, recent movement in the form of discontinuous open cracks with maximum aperture of 25 mm was identified at the interface between the upper and lower colluvium, at about 0.35 m below the ground surface. Evidence of past movement in the form of infilling materials up to 200 mm wide, partially infilled and open cracks between 50 mm and 150 mm wide and voids was identified extending from the base of the lower

Plate 19 - View and Sketch of Trial Trench TT2, Face B (Photograph taken on 27 July 2008)

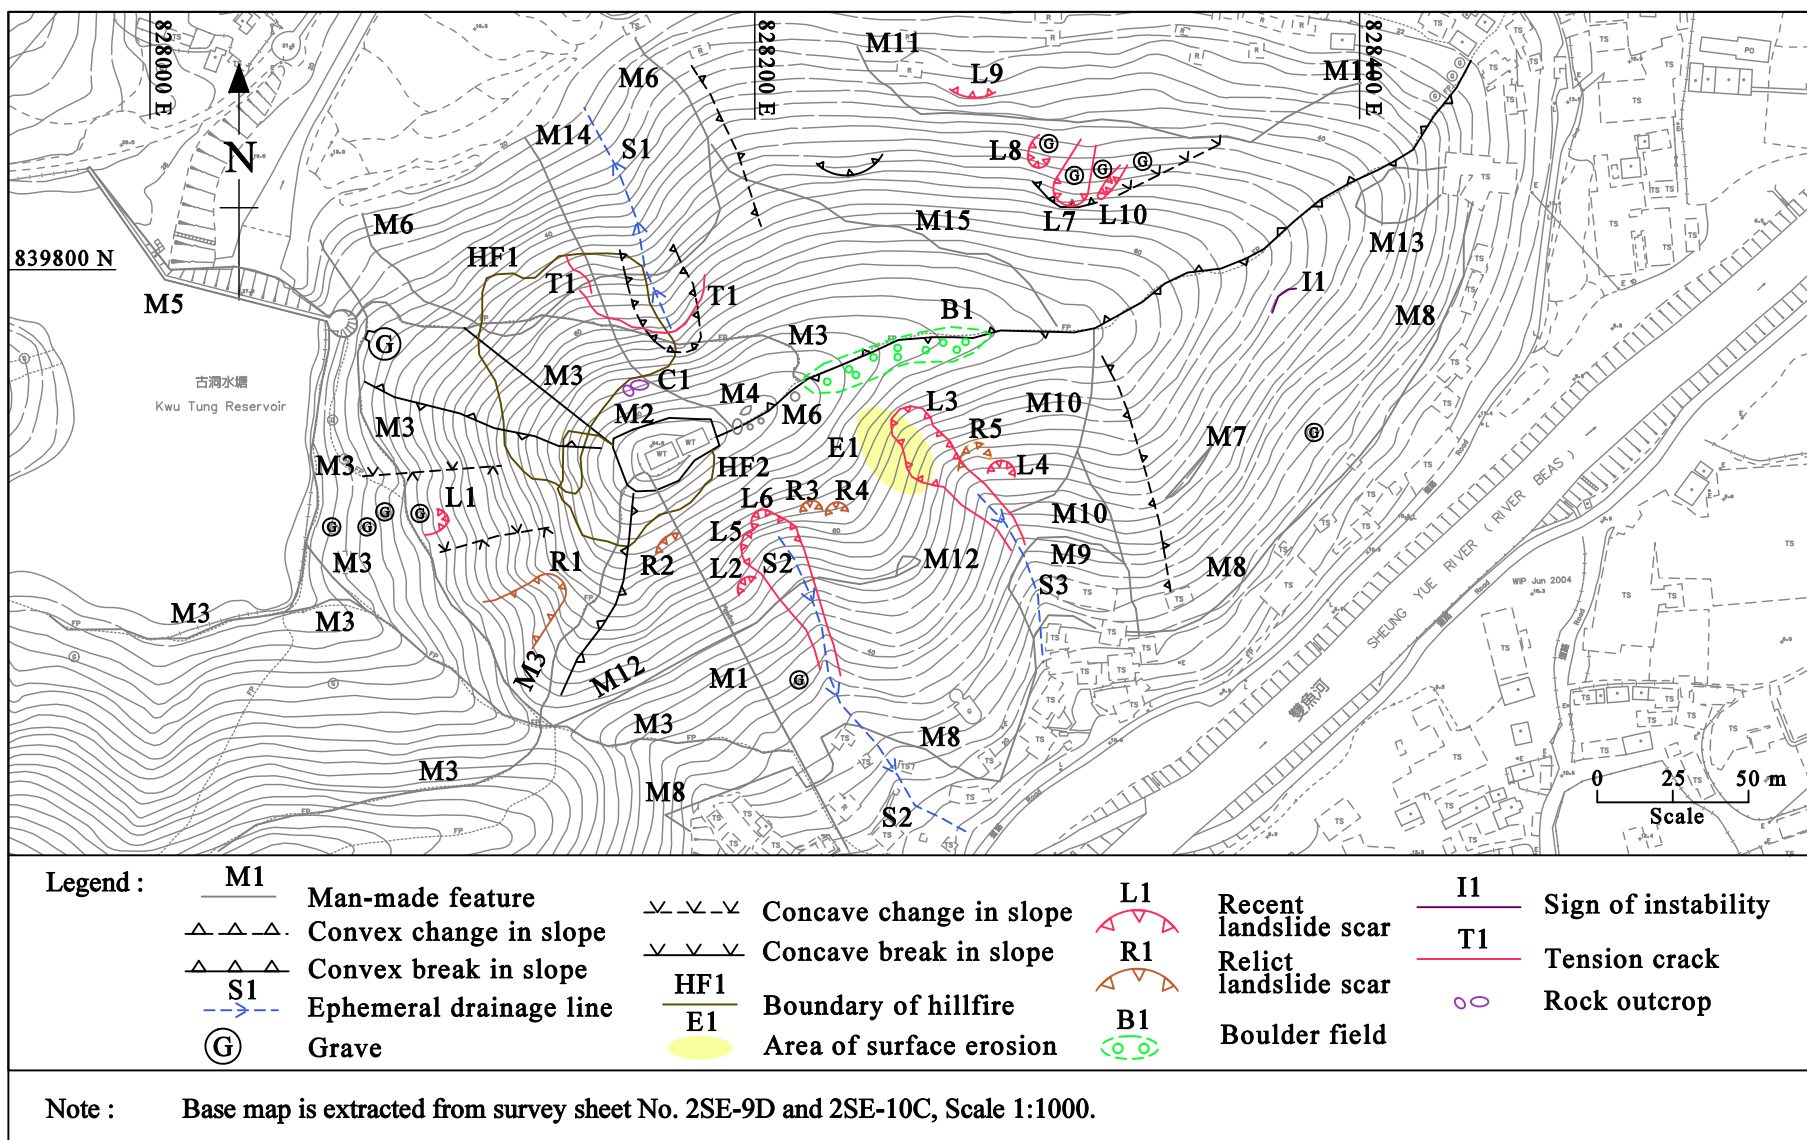
Figure A1 - API Findings

A subtle convex change in slope is observed near the head of the ephemeral drainage line S1. Another well defined convex break in slope is located at the central portion of the northern hillside, possibly associated with previous instability. Further east of this convex break in slope, a concave change in slope is identified above several areas of man-made disturbance, possibly grave sites.

A convex break in slope appears at the upper terrain near the head of S2. Below this break, loose colluvium is accumulated along the ephemeral drainage line. To the northeast of this break in slope, two possible relict

<u>YEAR</u>	<u>OBSERVATIONS</u>
	landslide scars (R3 and R4) are observed as shallow depressions with minor erosion.
	A patch of lighter tone of reflective area located at the head of S3 is possibly indicative of previous minor surface erosion/instability (E1). Immediately to the southeast of this area, a semi-circular depression, probably a relict landslide scar (R5) is observed.
	A man-made structure, probably a rubble wall (M7), is identified at the mid slope of the eastern portion of the southern hillside.
	Disturbed terrain and squatters (M8) occupy most of the hillside at the toe of the southern hillside.
1964	High altitude stereo pairs.
	A break in slope appears at the mid slope of the eastern portion of the northern hillside.
	A high reflective area, probably associated with a grave construction is observed at the eastern lower portion of the southern hillside.
	There does not seem to have been any significant change to the subject hillsides since 1963 except a slight increase of vegetation growth.

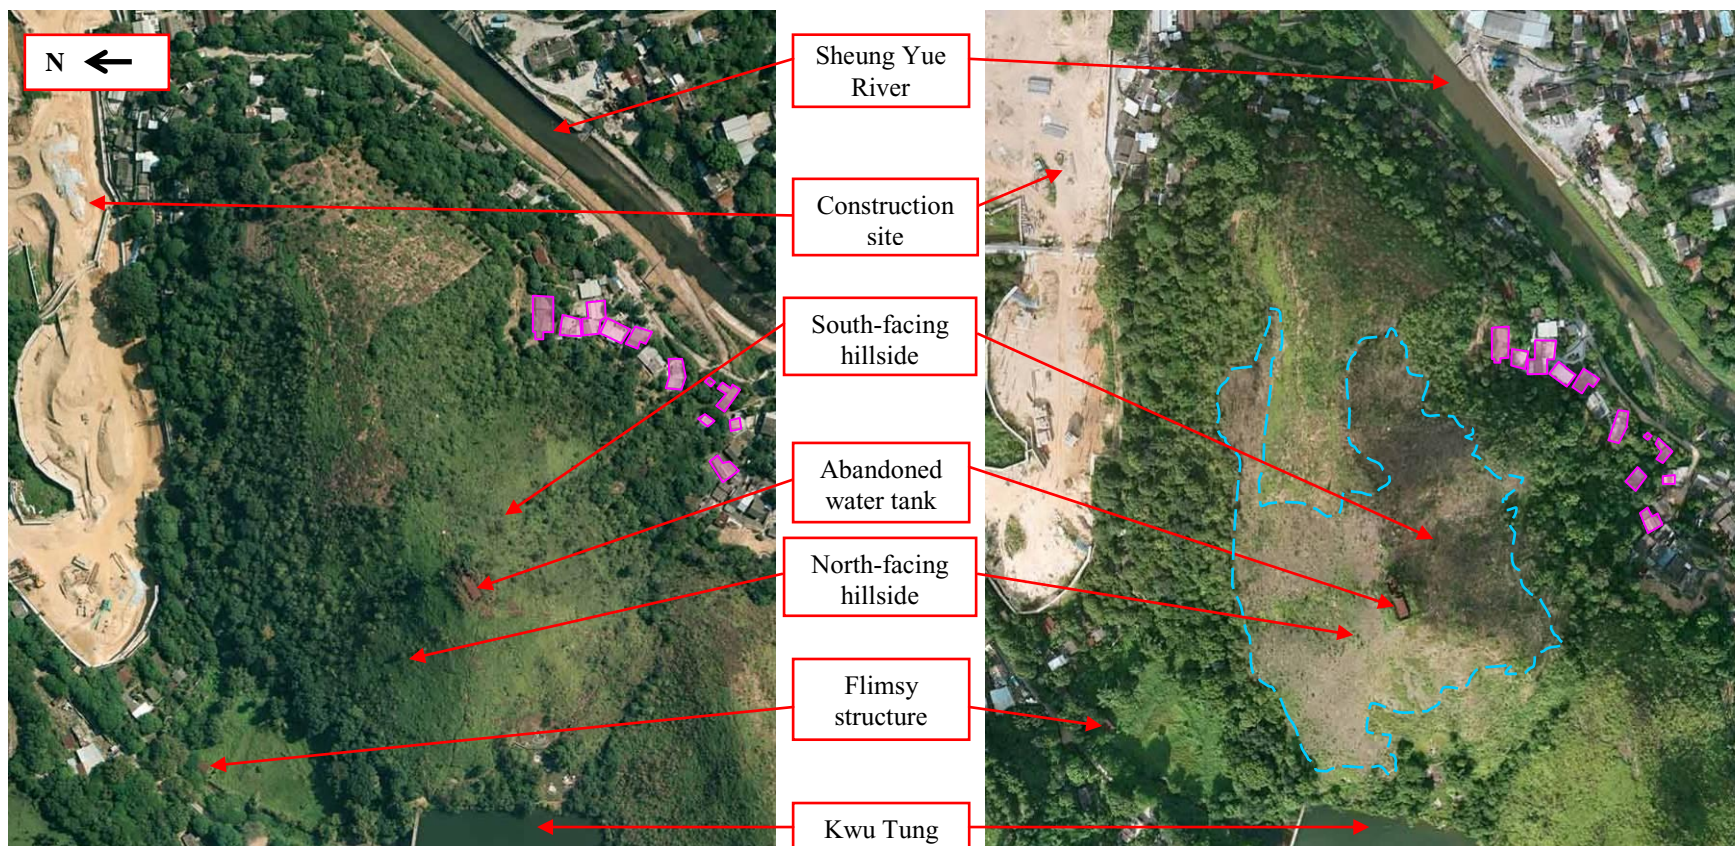
Aerial Photograph no. CS04334 dated 25 December 2006
before the hillfire on 1 April 2007

Aerial Photograph no. CW77713 dated 26 July 2007
after the hillfire on 1 April 2007

Plate A1 - Aerial View of the Distressed Hillsides to the East of Kwu Tung Reservoir (December 2006 and July 2007)
