**REVIEW OF THE 27 MAY 2007  
BOULDER FALL INCIDENT  
ON THE SLOPING GROUND  
ABOVE RETAINING WALL  
NO. 11SW-A/R677,  
PO SHAN ROAD**

**GEO REPORT No. 268**

**Fugro Scott Wilson Joint Venture**

**GEOTECHNICAL ENGINEERING OFFICE  
CIVIL ENGINEERING AND DEVELOPMENT DEPARTMENT  
THE GOVERNMENT OF THE HONG KONG  
SPECIAL ADMINISTRATIVE REGION**

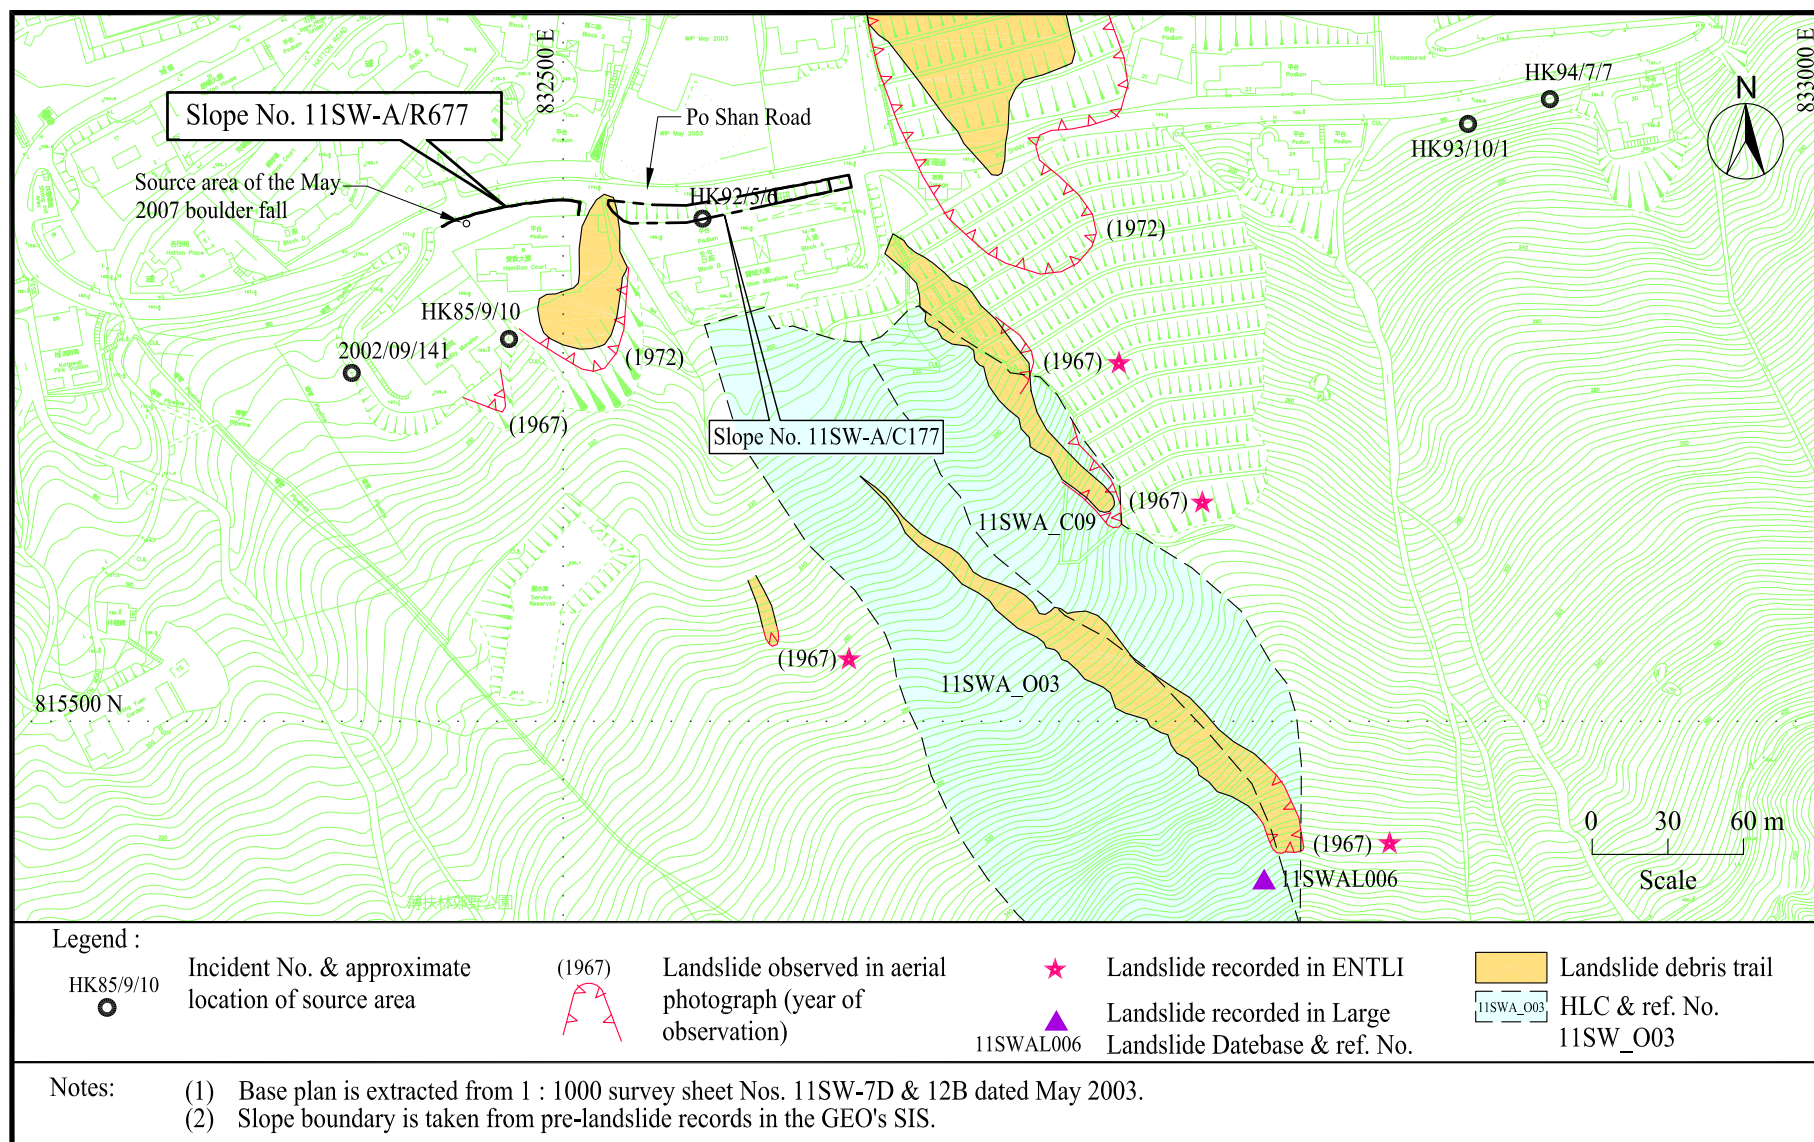
Figure 5 - Previous Instabilities Affecting Slopes and Hillsides above Po Shan Road

The GEO's Enhanced Natural Terrain Landslide Inventory (ENTLI) identifies four previous landslides in the general vicinity of the May 2007 boulder fall incident (Figure 5).

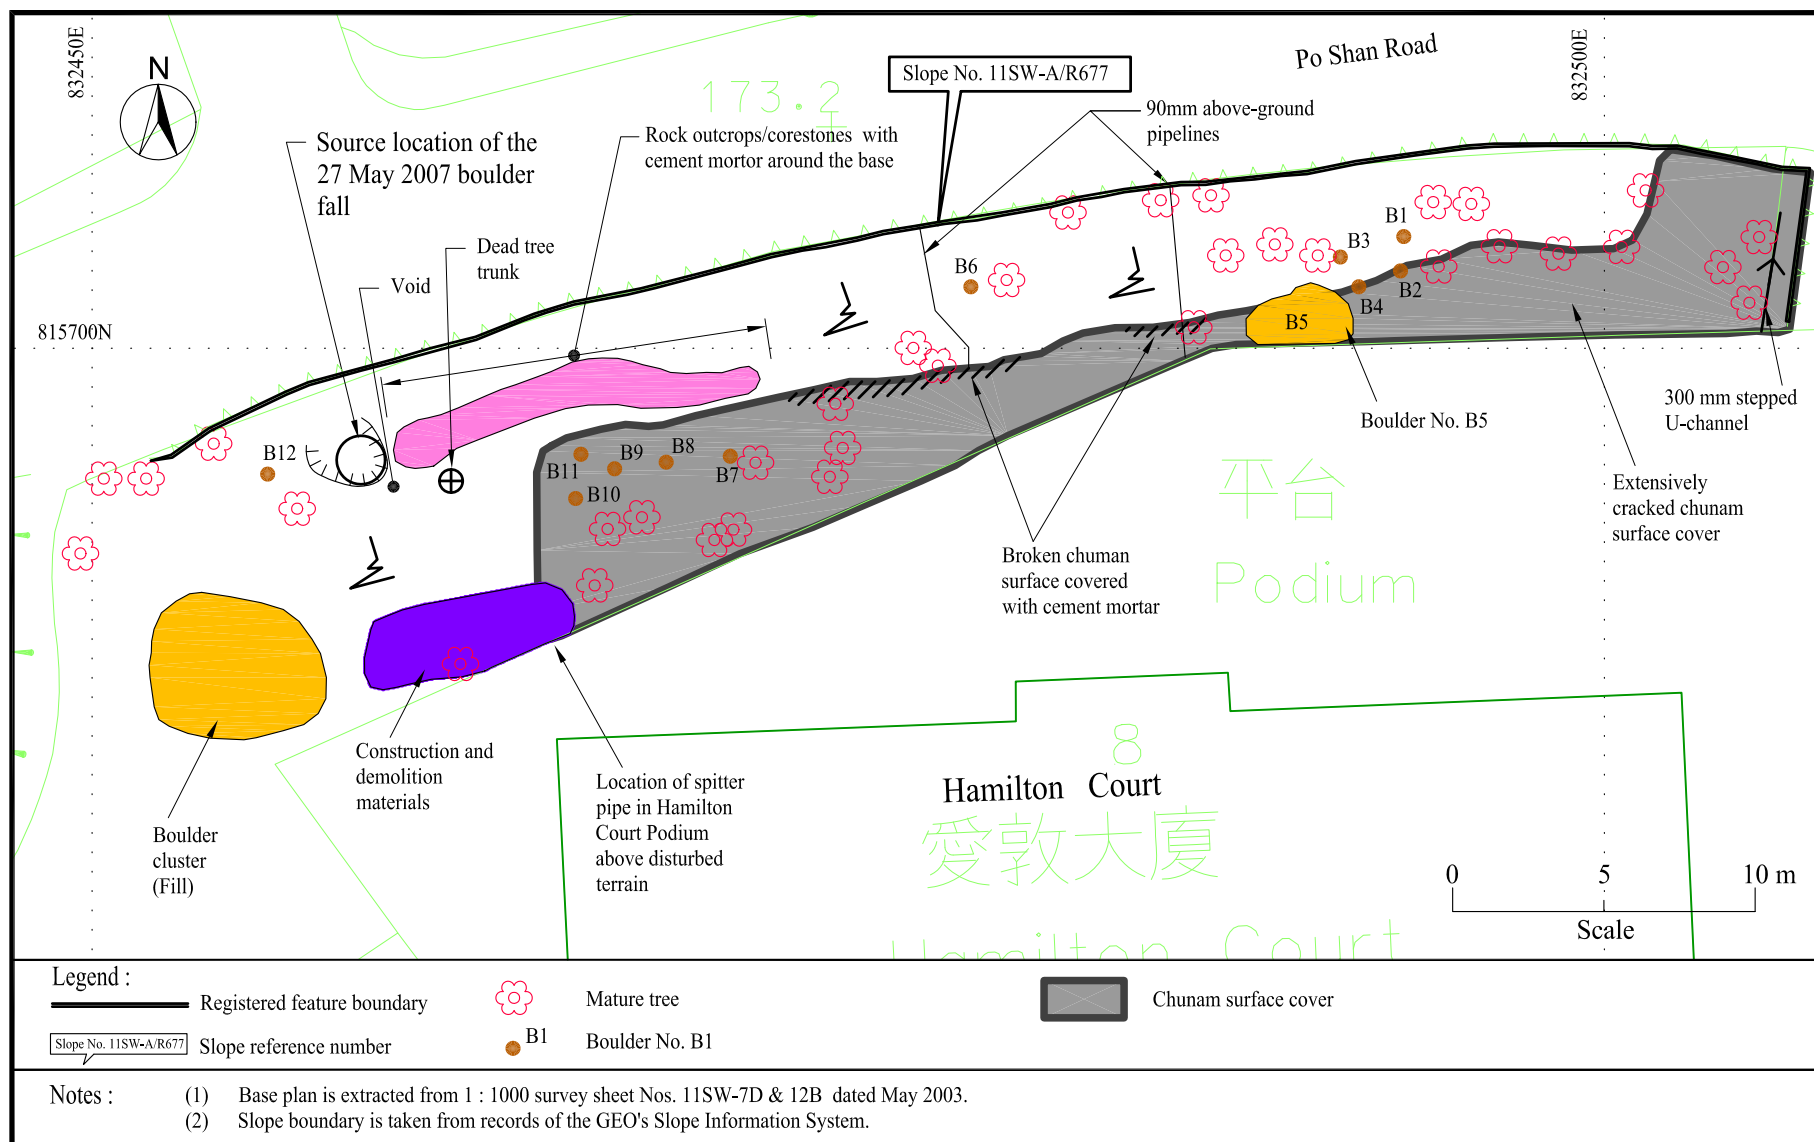
Figure 8 - Detailed Mapping of the Sloping Ground above Retaining Wall No. 11SW-A/R677

Rock outcrops/corestones comprising light brownish grey, moderately decomposed fine ash vitric tuff were observed to be protruding from the ground surface to the east of the May 2007 boulder fall source area (Figure 8). Steeply inclined joints stained with black manganese oxide were observed in the rock outcrops/corestones (Plate 26). The residual soil surrounding the rock outcrops/corestones comprised dense to very dense fine-grained silty sand with some gravel.

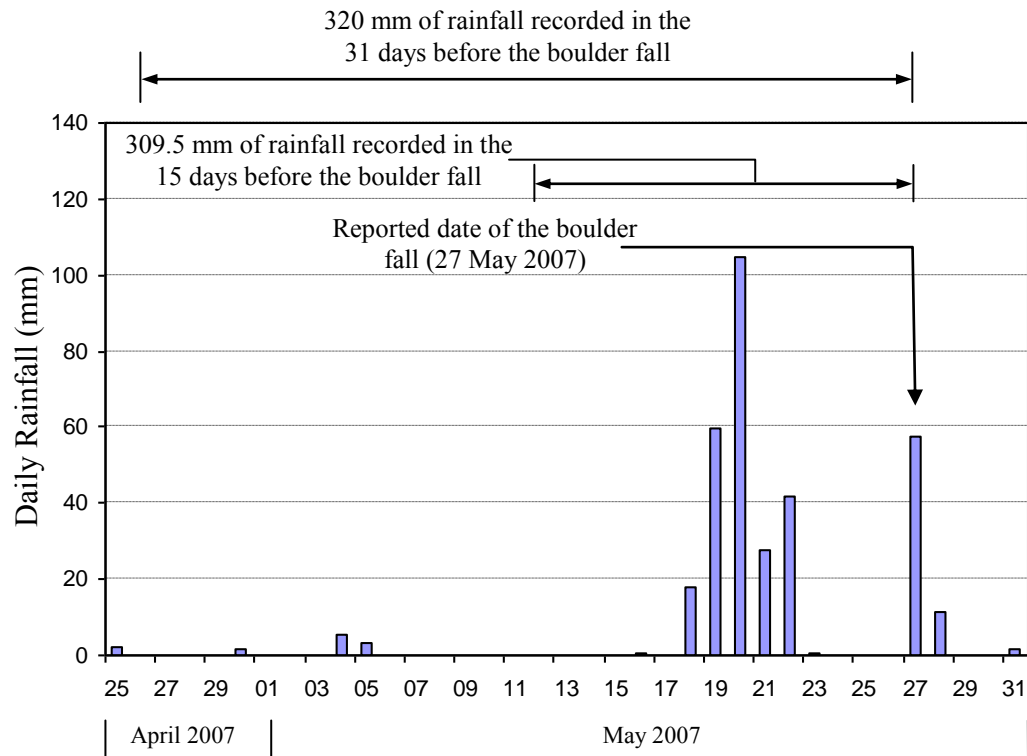
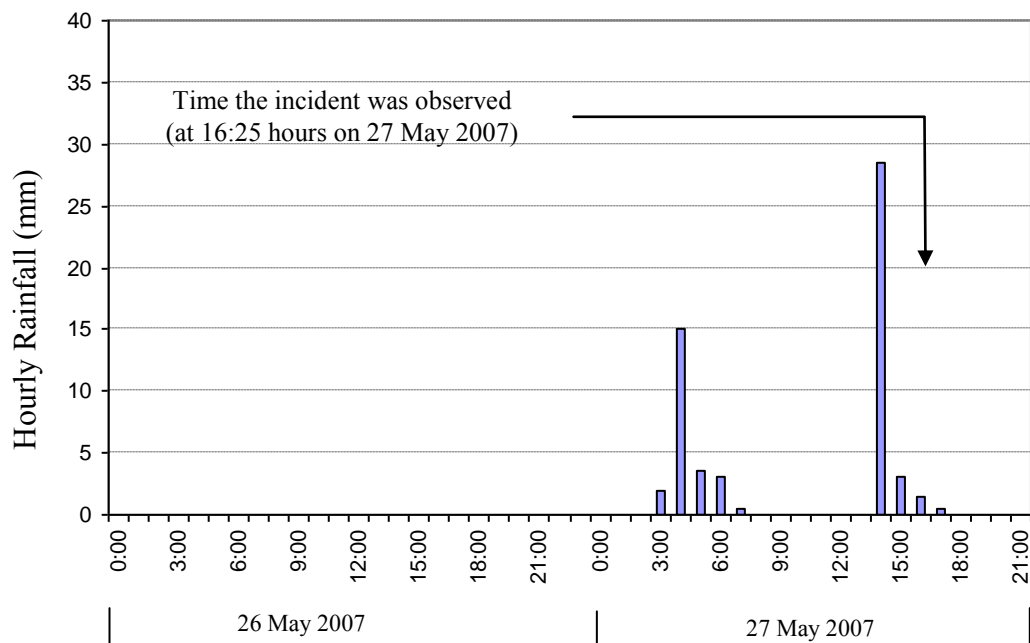
Figure 9 - Rainfall Recorded at GEO Raingauge No. H04

Based on the incident report prepared by the GEO, the boulder fall incident occurred at 4:25 p.m. on 27 May 2007. The daily rainfall recorded by raingauge No. H04 over the month preceding the boulder fall, together with the hourly rainfall readings for the period between 12:00 a.m. on 26 May 2007 and 9:00 p.m. on 27 May 2007, are presented in Figure 9. The maximum 24-hour and 12-hour rolling rainfall before the failure were 56.5 mm and 55 mm respectively.

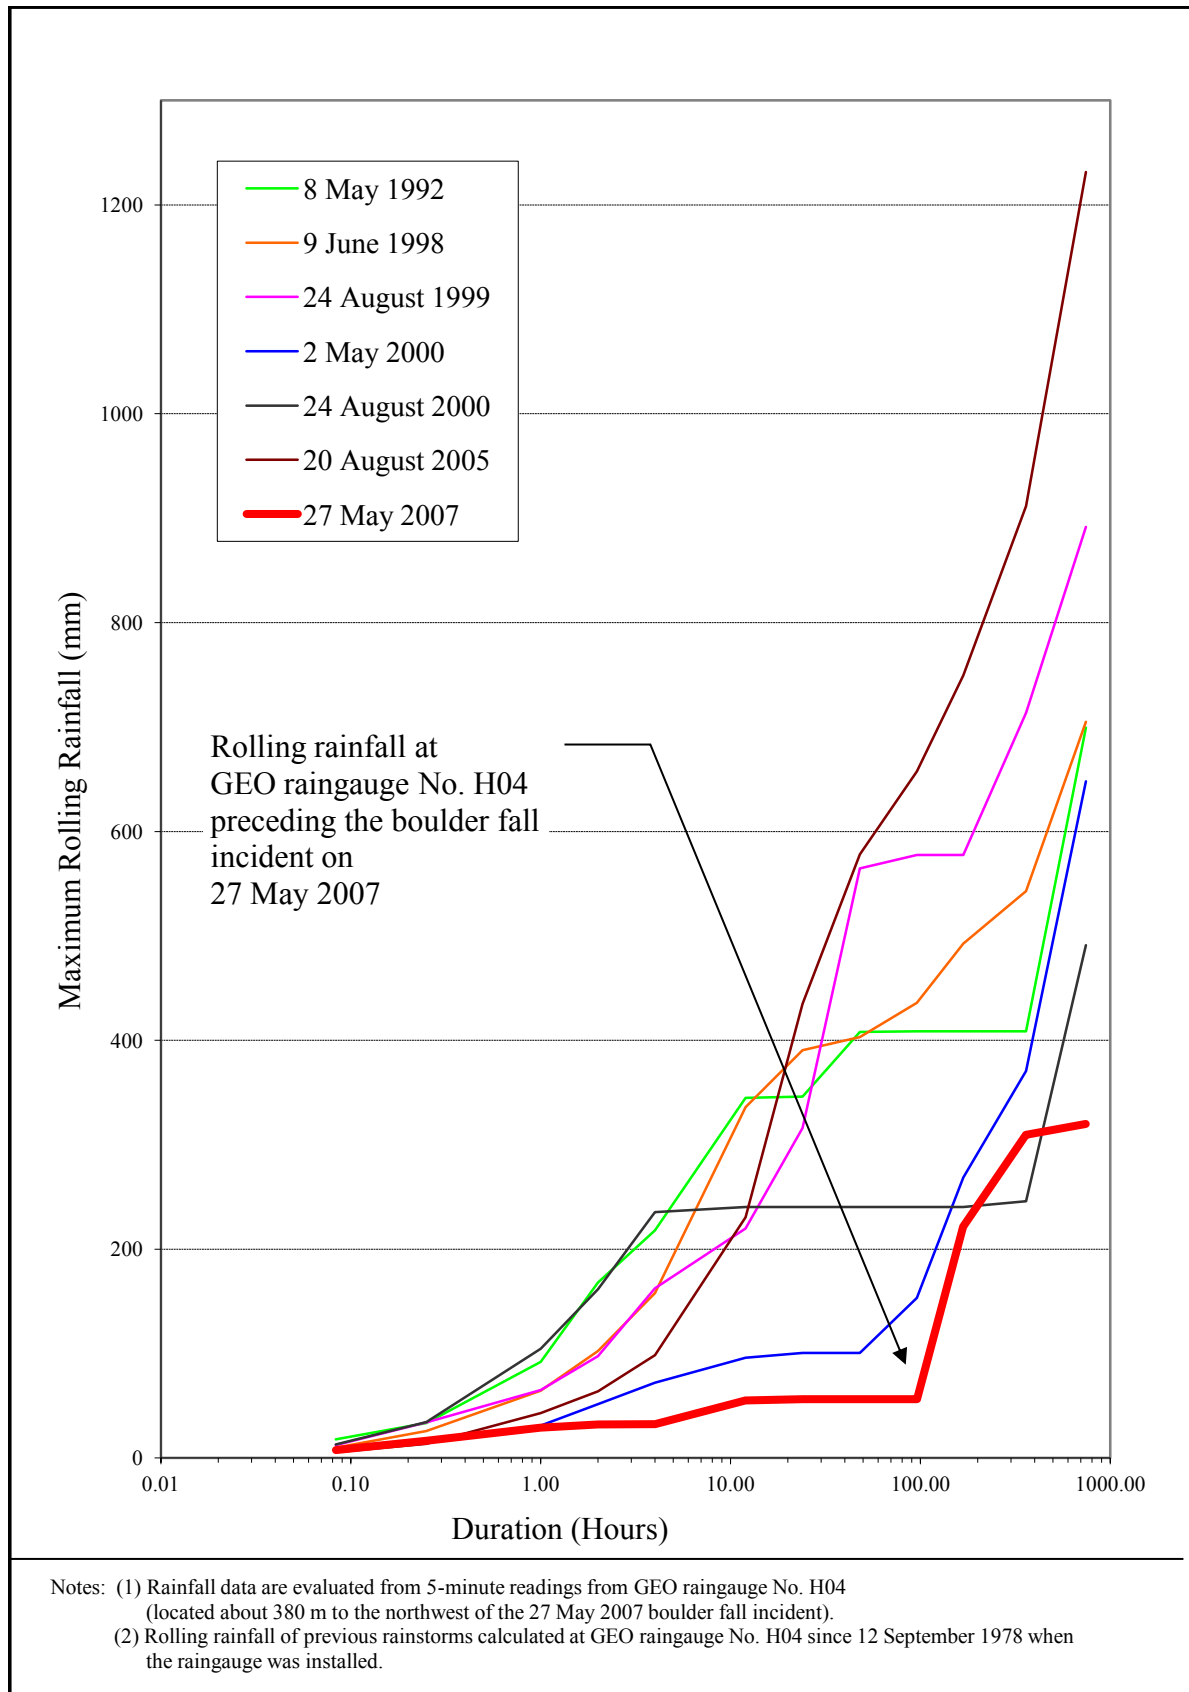
Figure 10 - Maximum Rolling Rainfall Preceding the 27 May 2007 Boulder Fall Incident and Selected Previous Major Rainstorms Recorded at GEO Raingauge No. H04

The maximum rolling rainfall for the rainstorm on 27 May 2007 has been compared with the past major rainstorms between 1992 and 2006 recorded by raingauge No. H04, which came into operation in the late-1970s (Figure 10). The maximum rolling rainfall for the rainstorm on May 2007 is generally much less severe than the previous significant rainstorms.

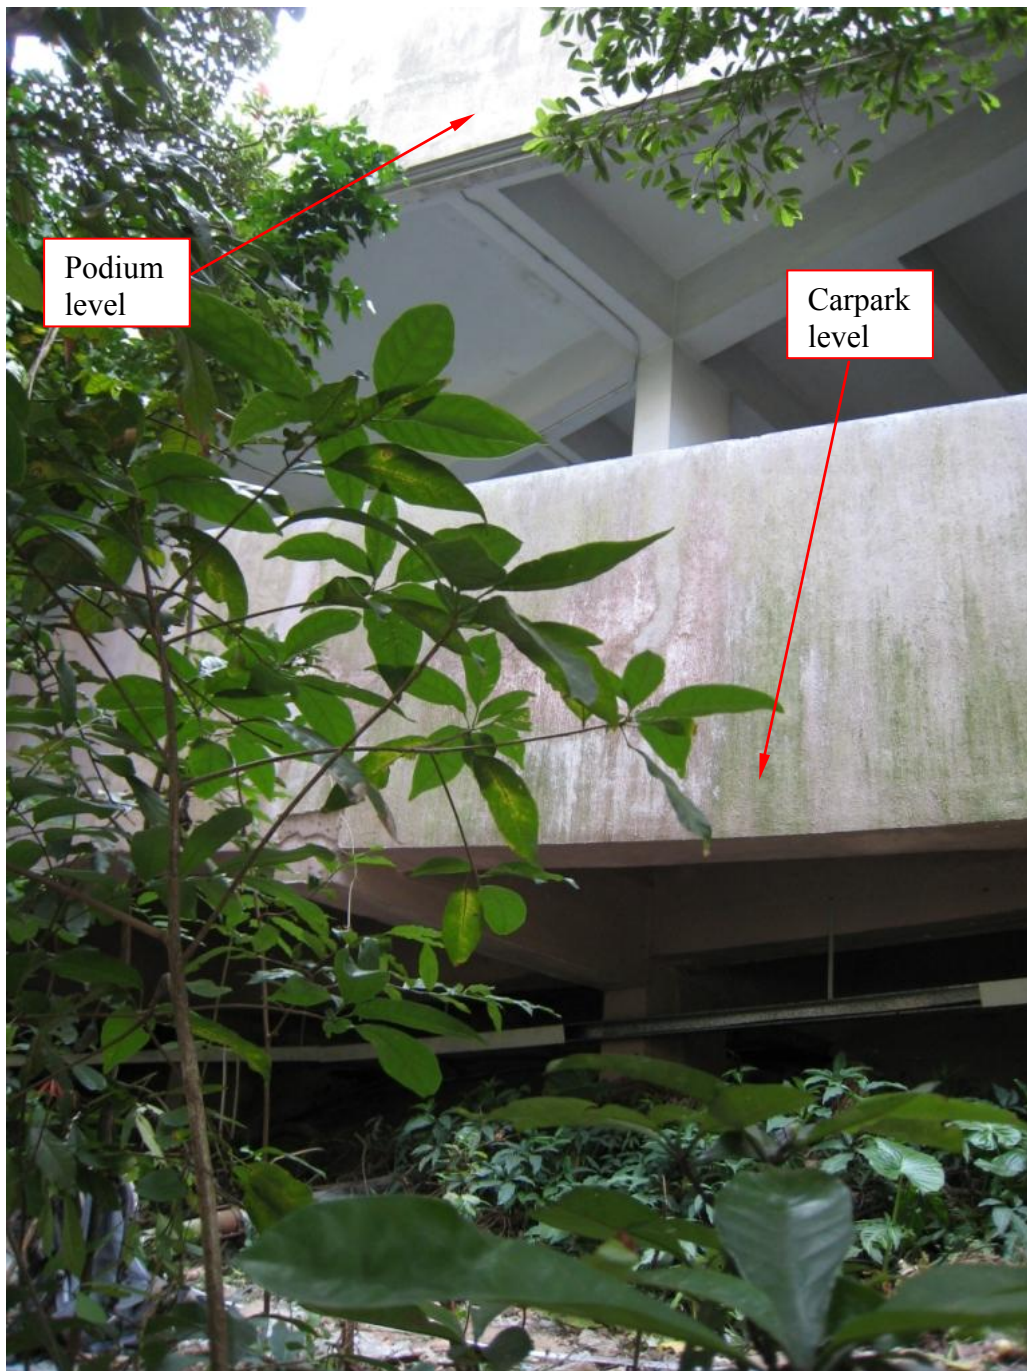
Plate 2 – General View of Hamilton Court Podium (Photograph taken on 13 November 2007)

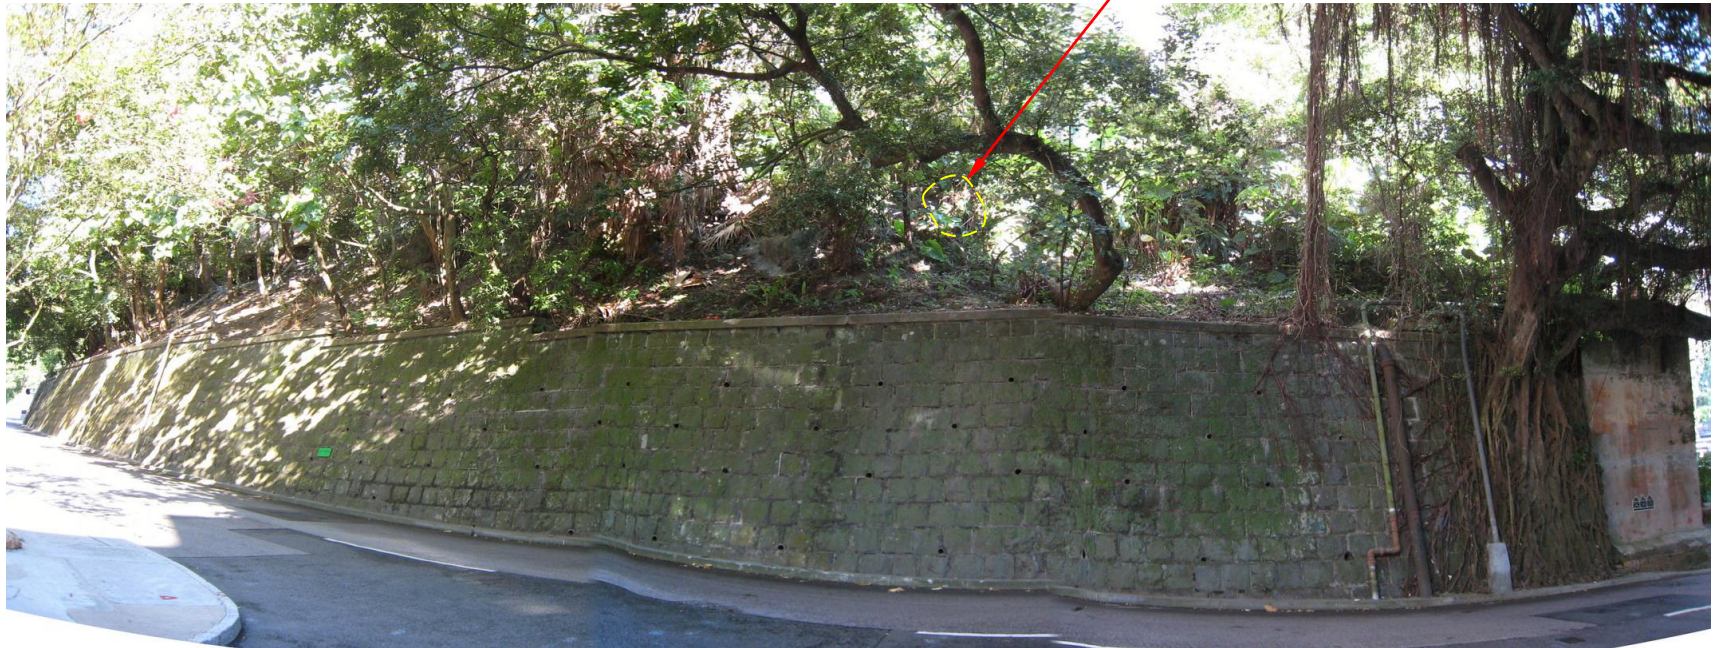
The 27 May 2007 boulder  
fall source location

Plate 3 - General View of Retaining Wall No. 11SW-A/R677 (Photograph taken on 25 July 2007)

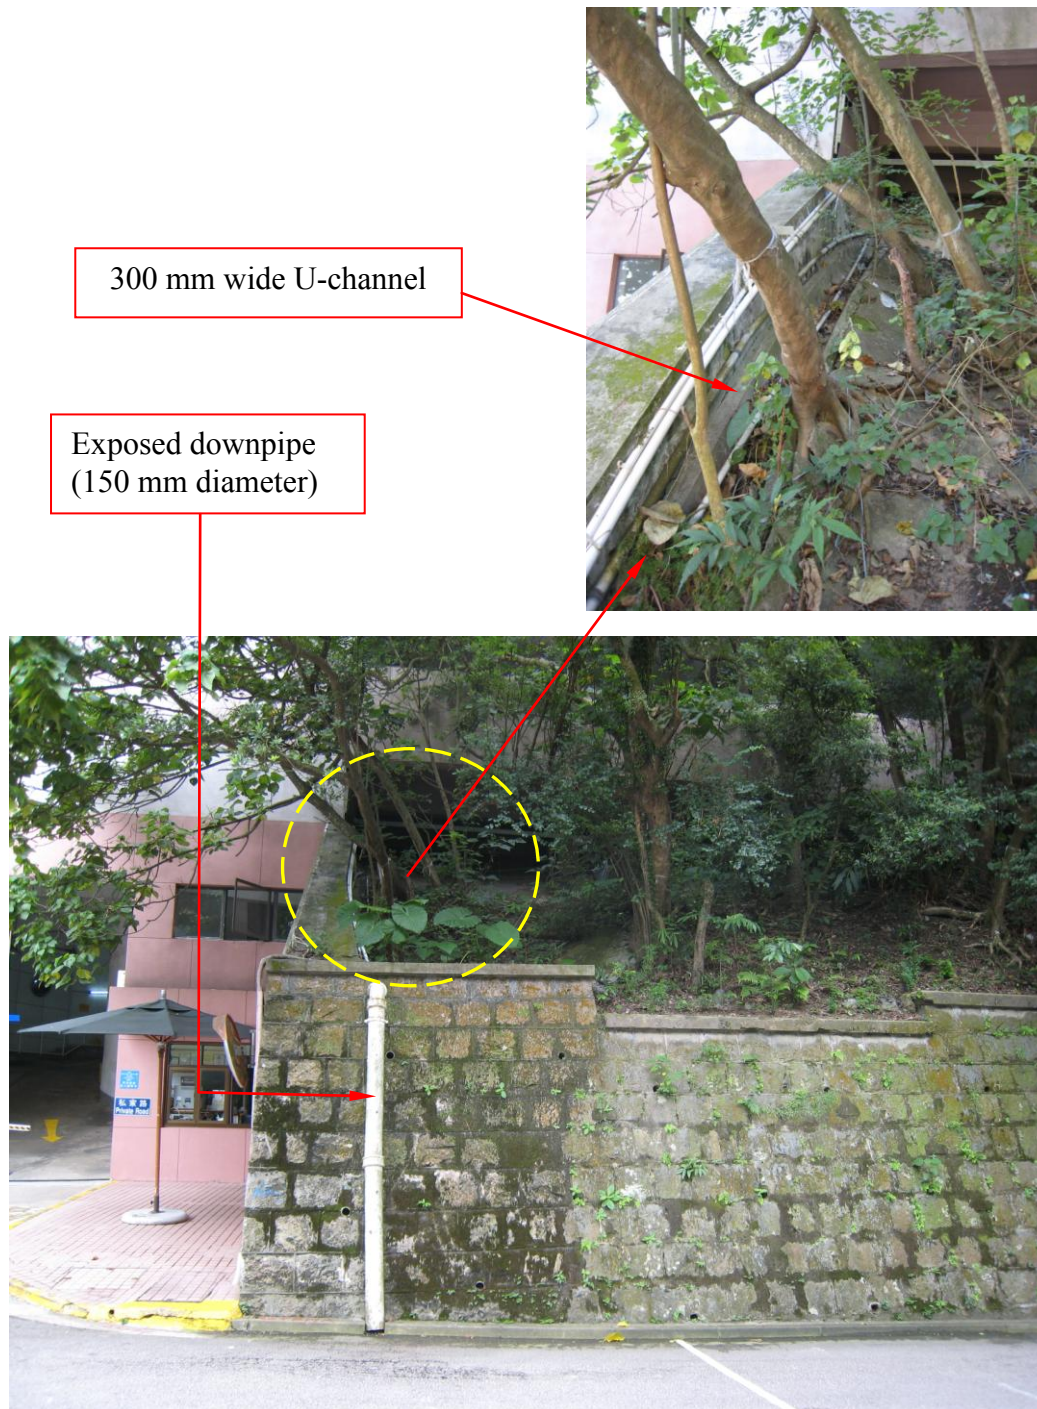
Plate 5 – Exposed Downpipe and U-channel at the Eastern End of Retaining Wall No. 11SW-A/F677 (Photograph taken on 5 September 2007)

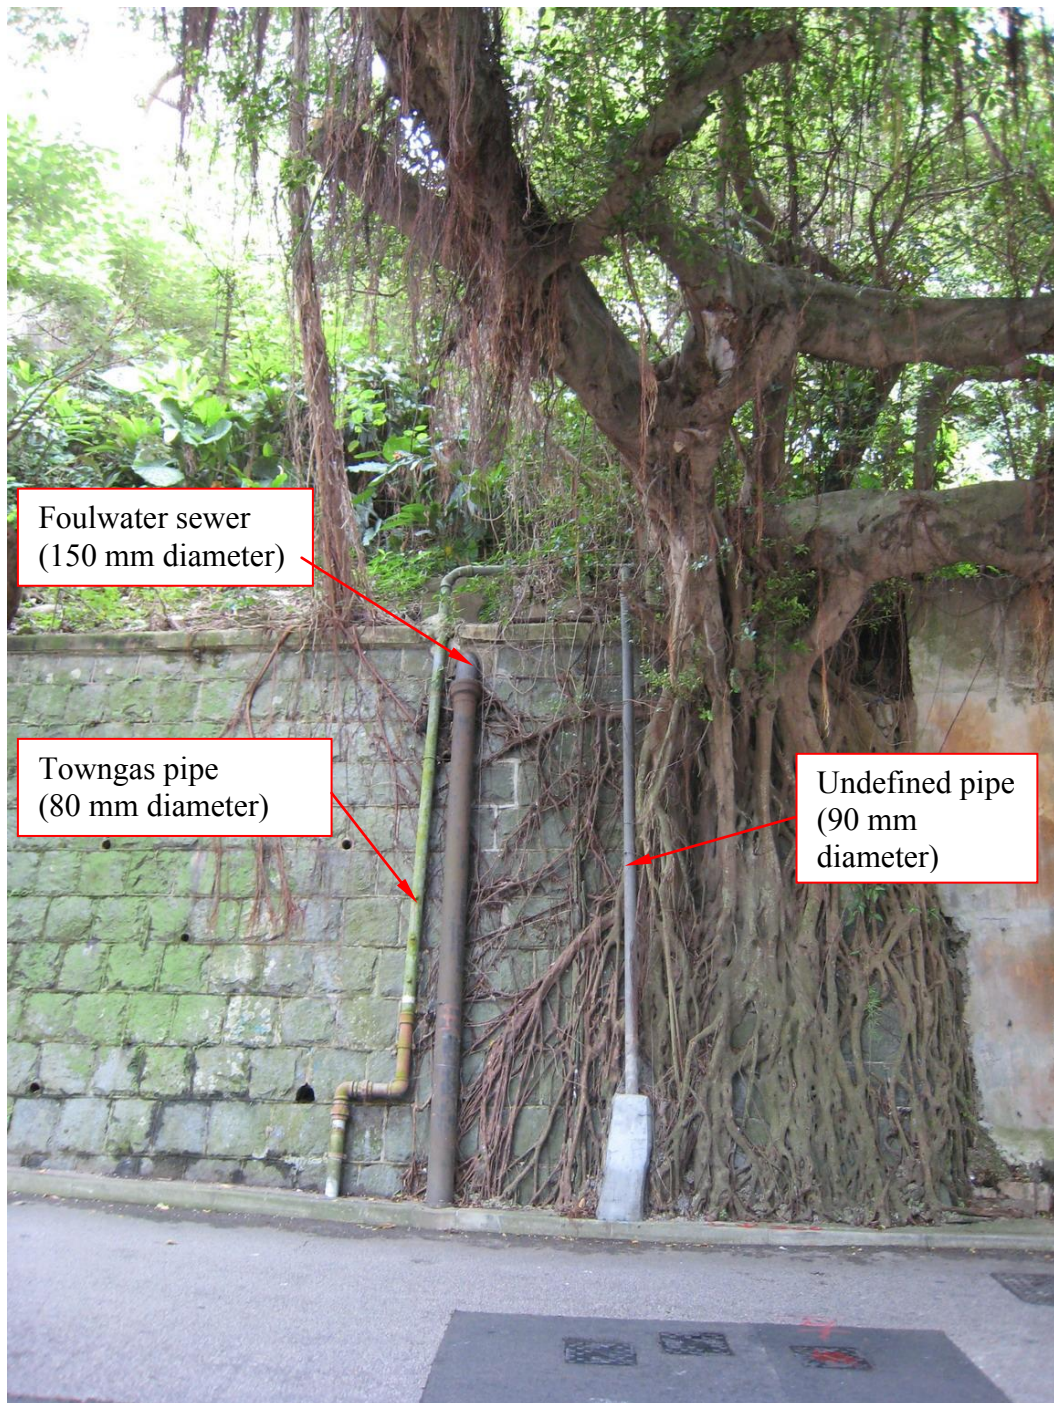
Plate 6 – Exposed Pipelines and Large Tree at Western End of Retaining Wall No. 11SW-A/R677 (Photograph taken on 5 September 2007)
