**DETAILED STUDY OF THE
7 JUNE 2008 LANDSLIDES
ON THE HILLSIDE
ABOVE YU TUNG ROAD,
TUNG CHUNG**

GEO REPORT No. 271

AECOM Asia Company Limited

**GEOTECHNICAL ENGINEERING OFFICE
CIVIL ENGINEERING AND DEVELOPMENT DEPARTMENT
THE GOVERNMENT OF THE HONG KONG
SPECIAL ADMINISTRATIVE REGION**

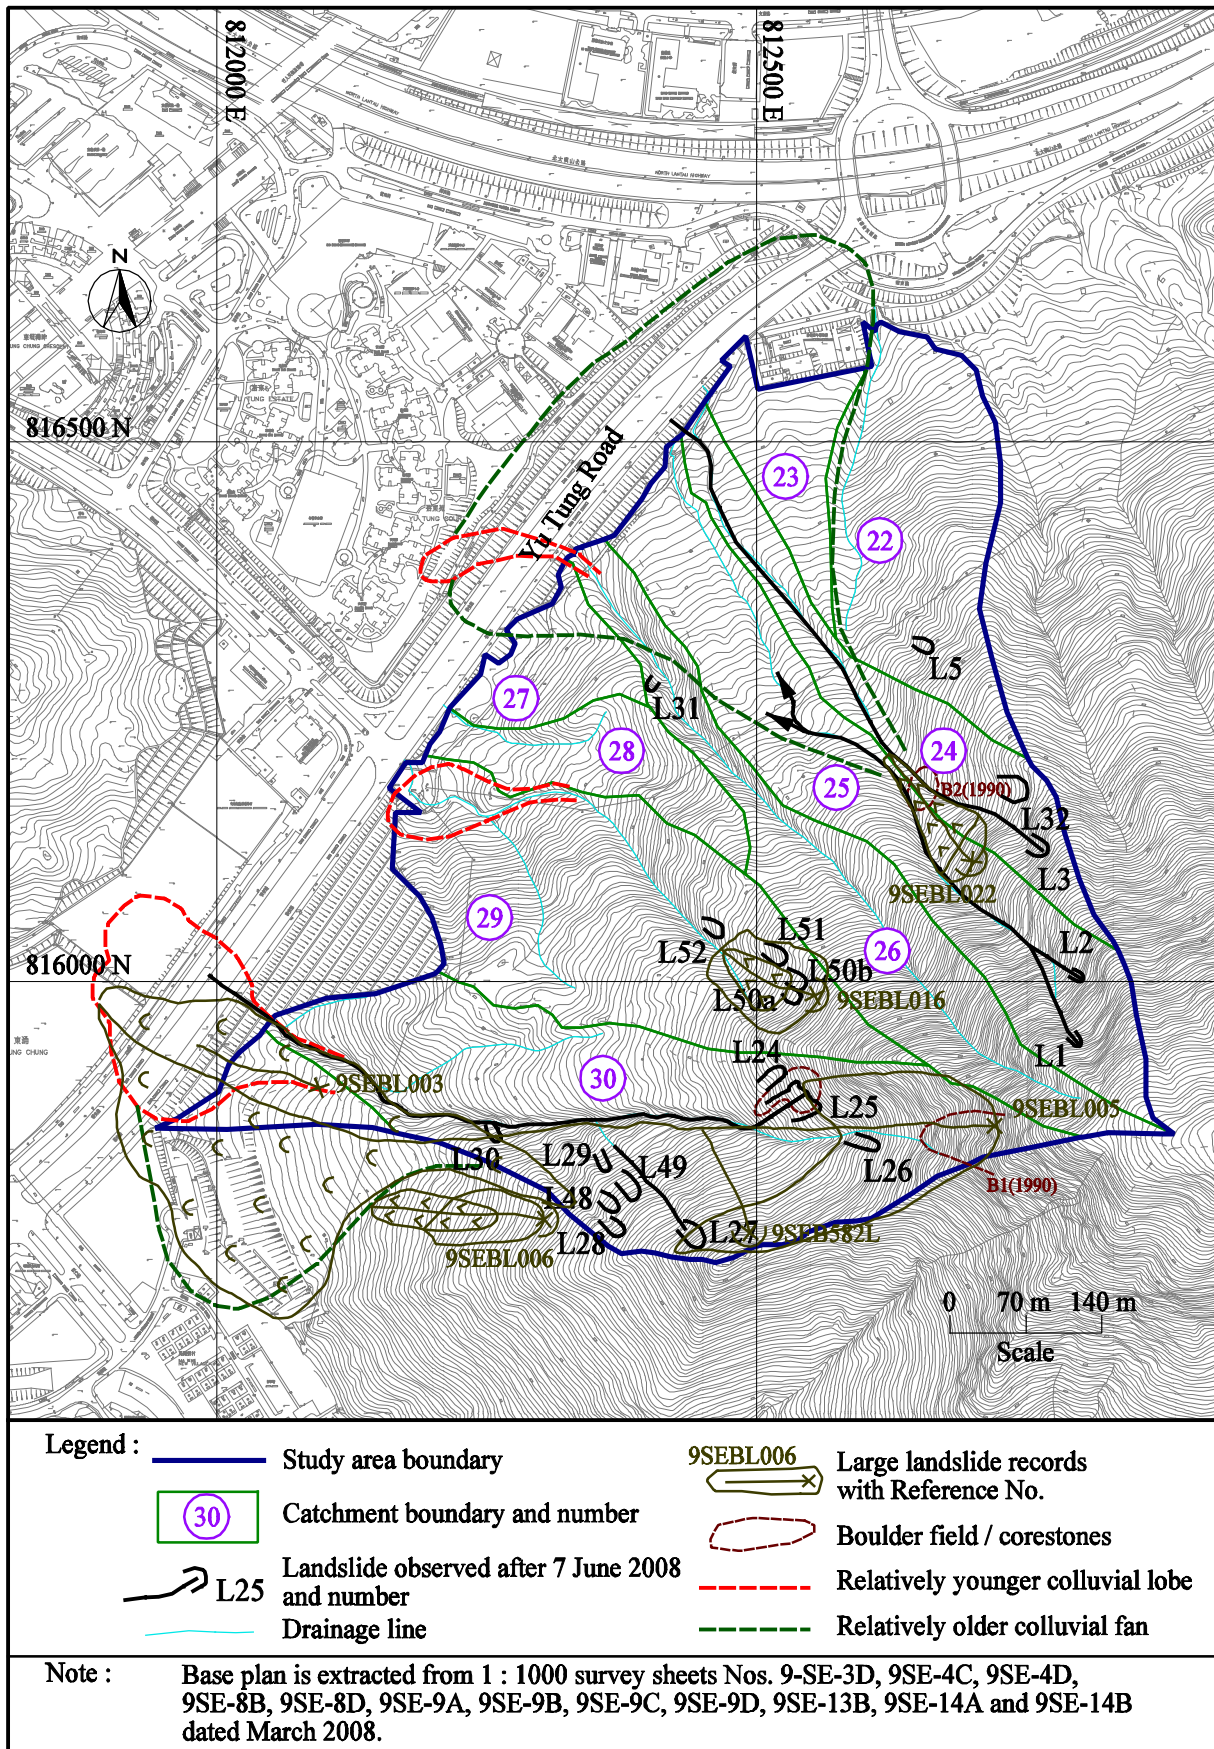
Figure 6 - Large Landslides

at the source area was located within an area of bouldery deposits, where were probably resulted from previous landslides and general mass wasting (Figures 4, 6 and A4).

In contrast to catchment No. 30, the drainage line in catchment No. 24 is generally more open, having a lower degree of channelisation with a typical CR of 6 -7. The debris was largely deposited at the distal end of the relatively older colluvial debris fan (Figures 4 and 6) where the channel opened out and the gradient decreased to about 15°. Parts of the channel in the depositional zone remain relatively confined. This may have enhanced the mobility of the debris, resulting in a deposition zone stretching over a distance of about 200 m.

The 1945 and 1963 aerial photographs show a distinct and relatively more recent debris fan at the outlet of the main drainage line in catchments Nos. 26, 29 and 30 (Figures 4, 6, A2 and A3), as evidenced by the hummocky surface and different vegetation type compared with other parts of the debris fan. The more recent debris fan in catchment No. 30 had possibly been formed as a result of a single large failure, with an estimated volume in the

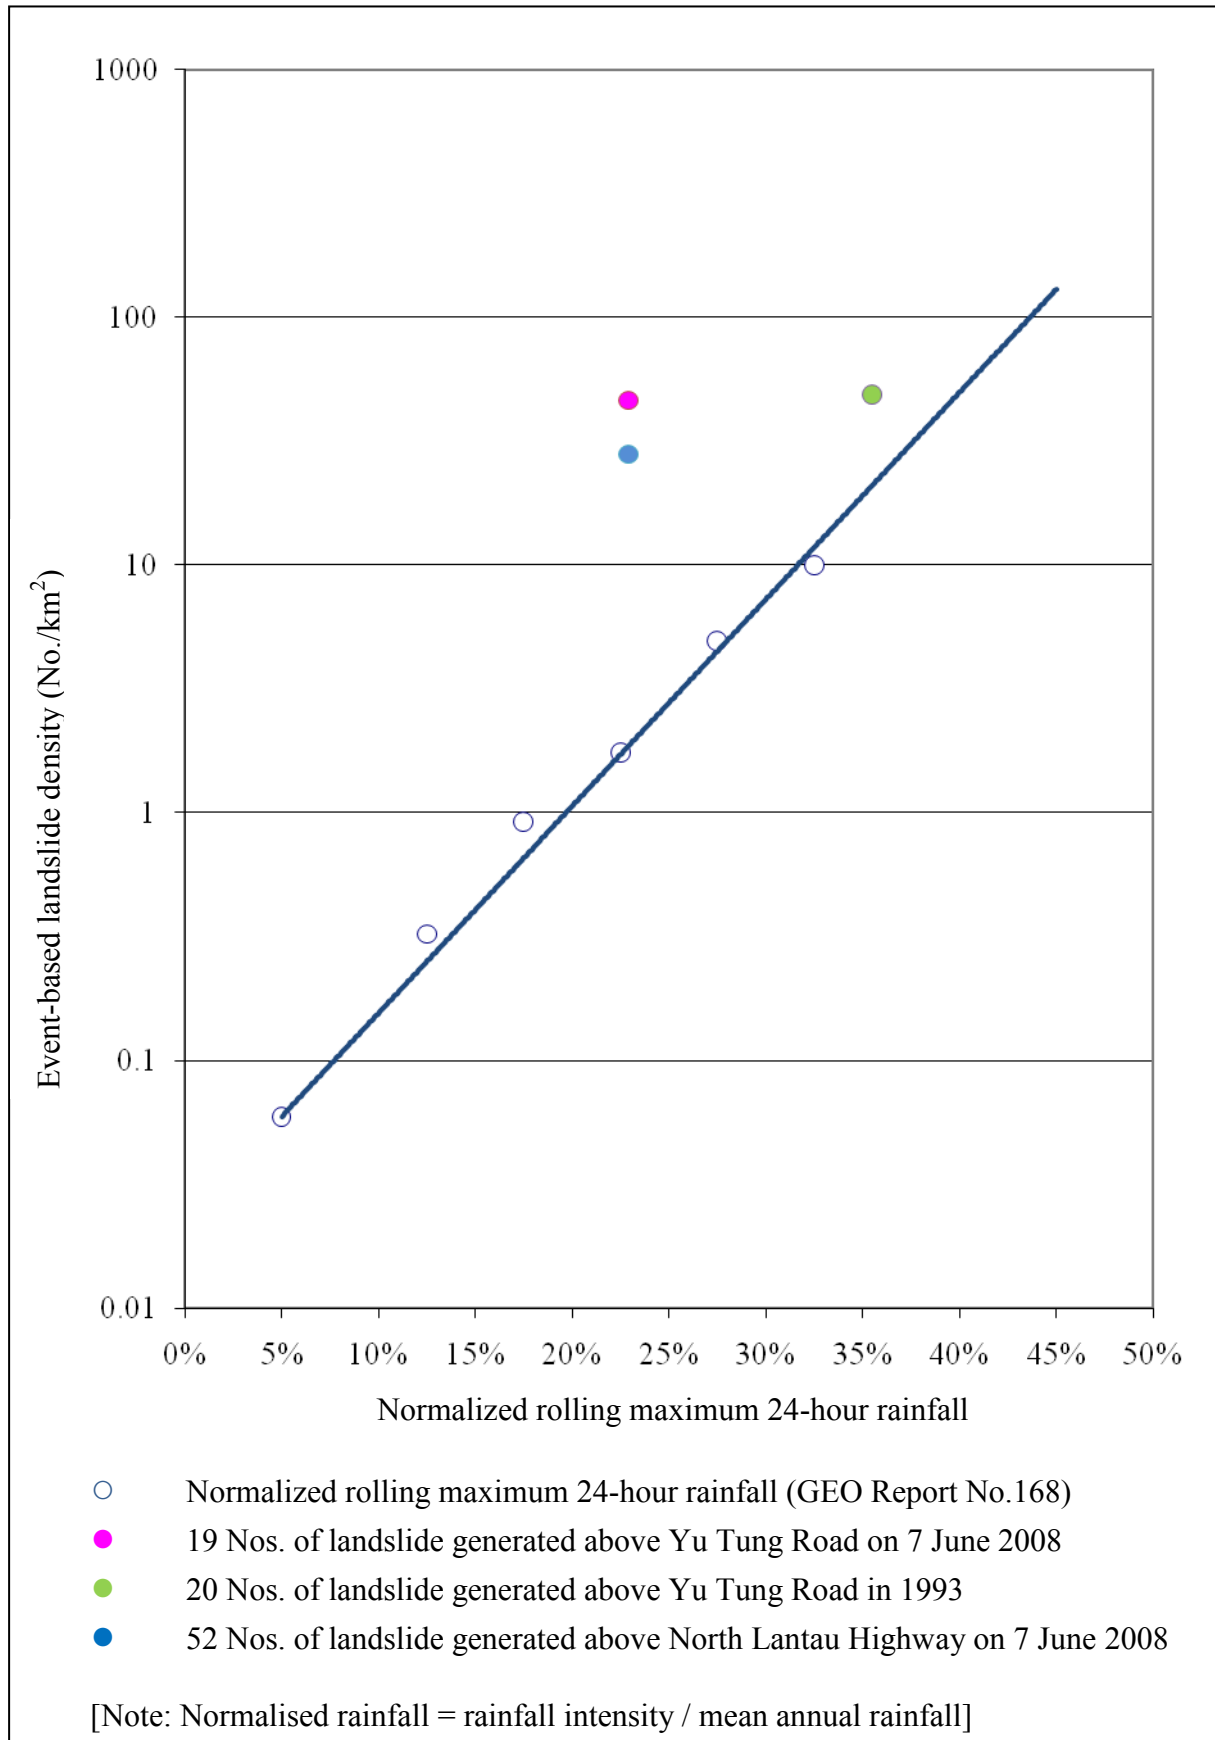
Figure 15 – Rainfall-Natural Terrain Landslide Correlation

The 7 June 2008 rainstorm triggered 19 shallow landslides on the hillside catchments within the study area. The rainfall-landslide correlation in terms of the landslide density (number of landslides per km²) against the normalized 24-hour rolling rainfall derived by Ko (2003) is shown in Figure 15. The average landslide density for natural terrain landslides in Hong Kong is about 2, for a normalized maximum 24-hour rolling rainfall of 20% to 25%. The corresponding landslide density for the 7 June 2008 rainstorm is about 45 landslides per km², which is considerably higher than the average value presented by Ko (2003) but comparable to the landslide density of the 1993 rainstorm (Figure 15). The high landslide density within the study area may have been influenced by the high landslide susceptibility of the hillside in addition to the rainfall characteristics (Figure 14).

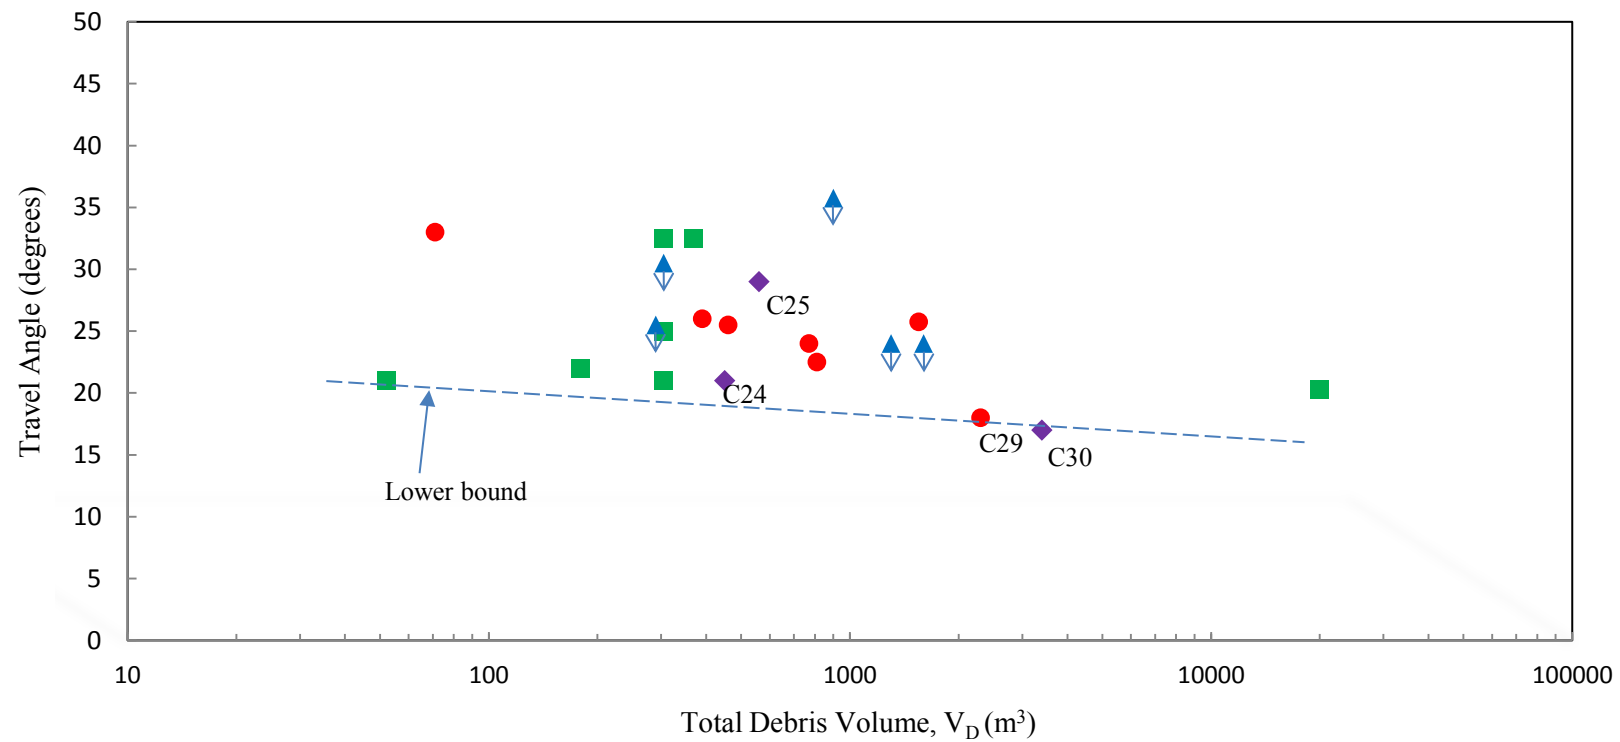
Figure 17 - Data on Debris Mobility for Channelised Debris Flows of Different Scale in Hong Kong

Comparing the debris mobility with previous CDF events of similar scale (Figure 17), the CDF in catchment No. 24 is relatively mobile, with a long runout distance of about 550 m.

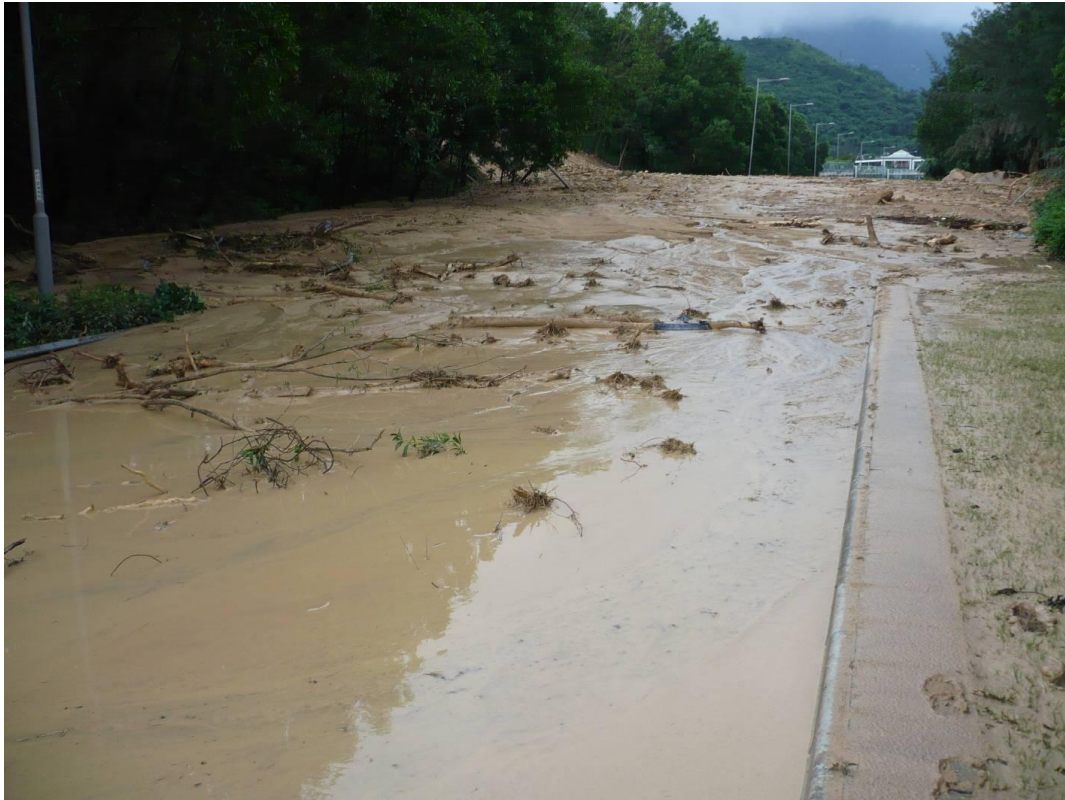
Plate 2 – View of Watery Debris on Yu Tung Road from Catchment No. 30
(Photograph taken on 7 June 2008)

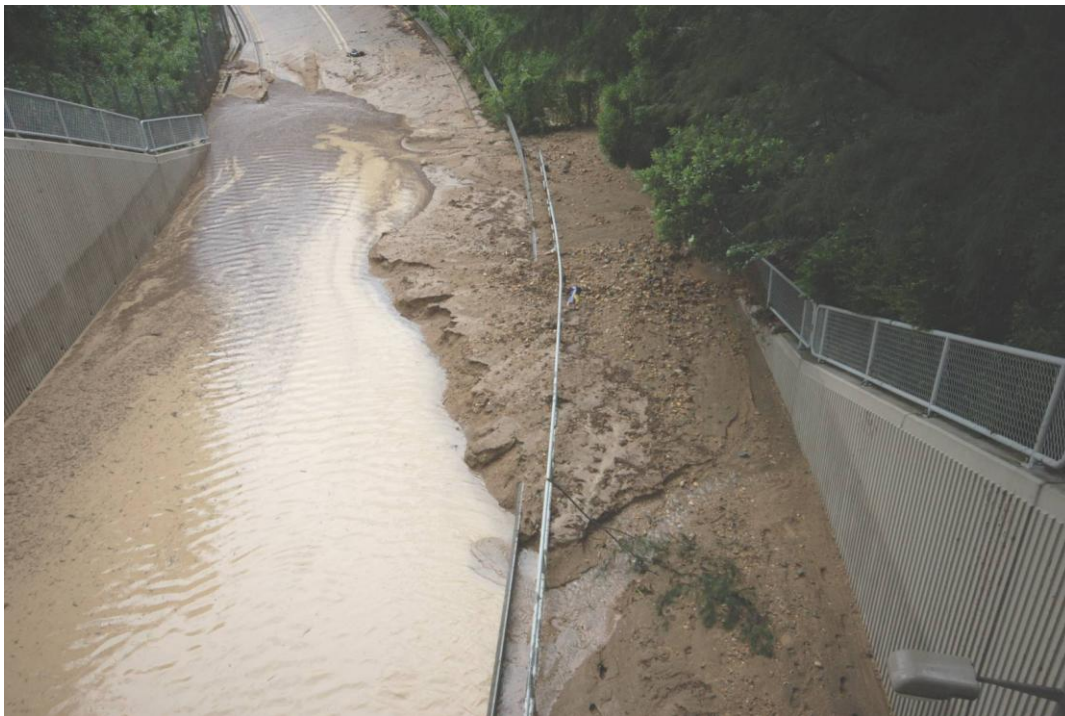
Plate 3 - Outwash from Landslide No. L3 in Catchment No. 24 and Flooding of
Cheung Tung Road (Photograph taken on 7 June 2008)

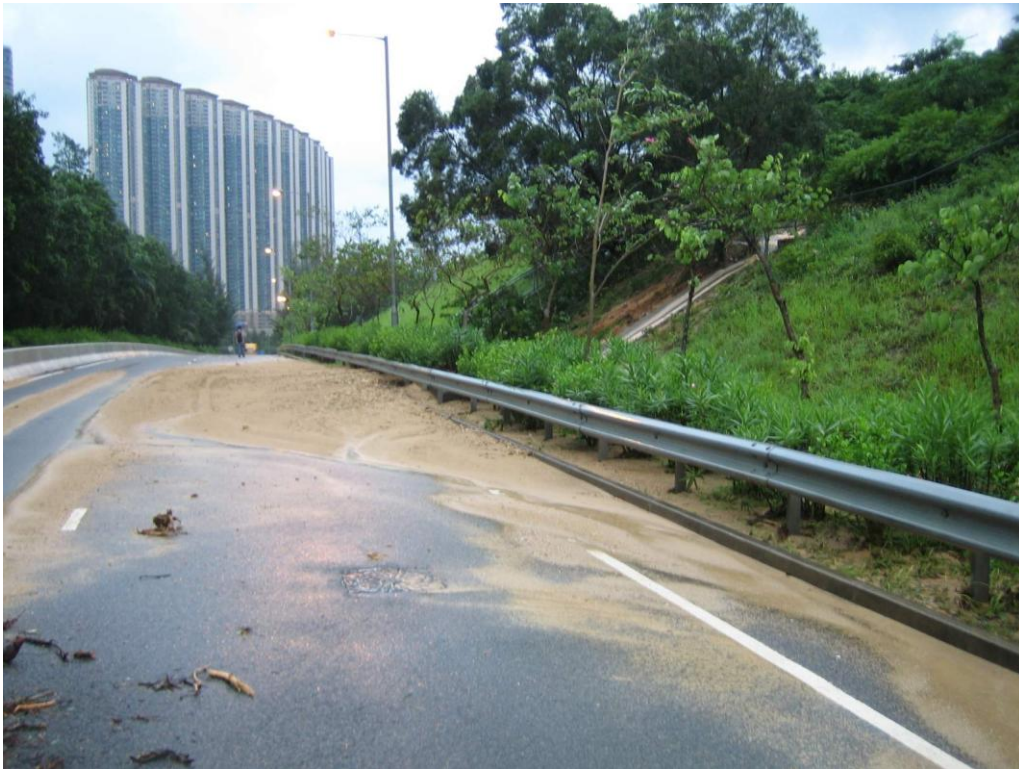
Plate 4 – View of Fine Debris from Catchment No. 26 (Photograph taken on 7 June 2008)

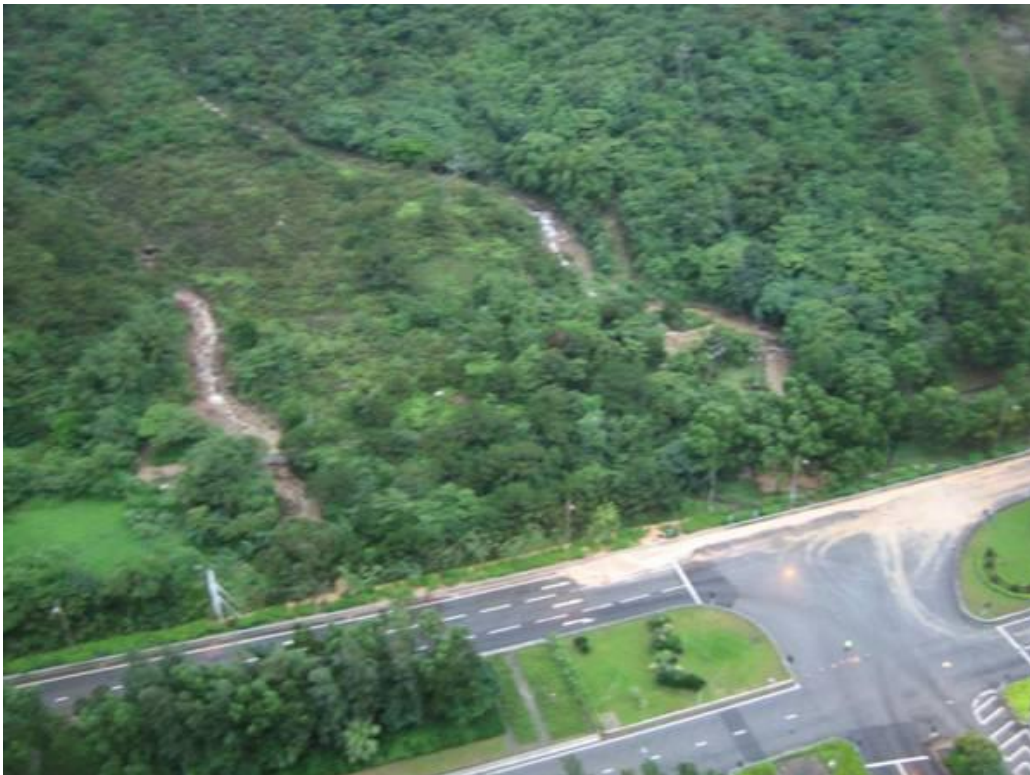
Plate 5 – View of Fine Debris from Catchment No. 29 (Photograph taken on 7 June 2008)

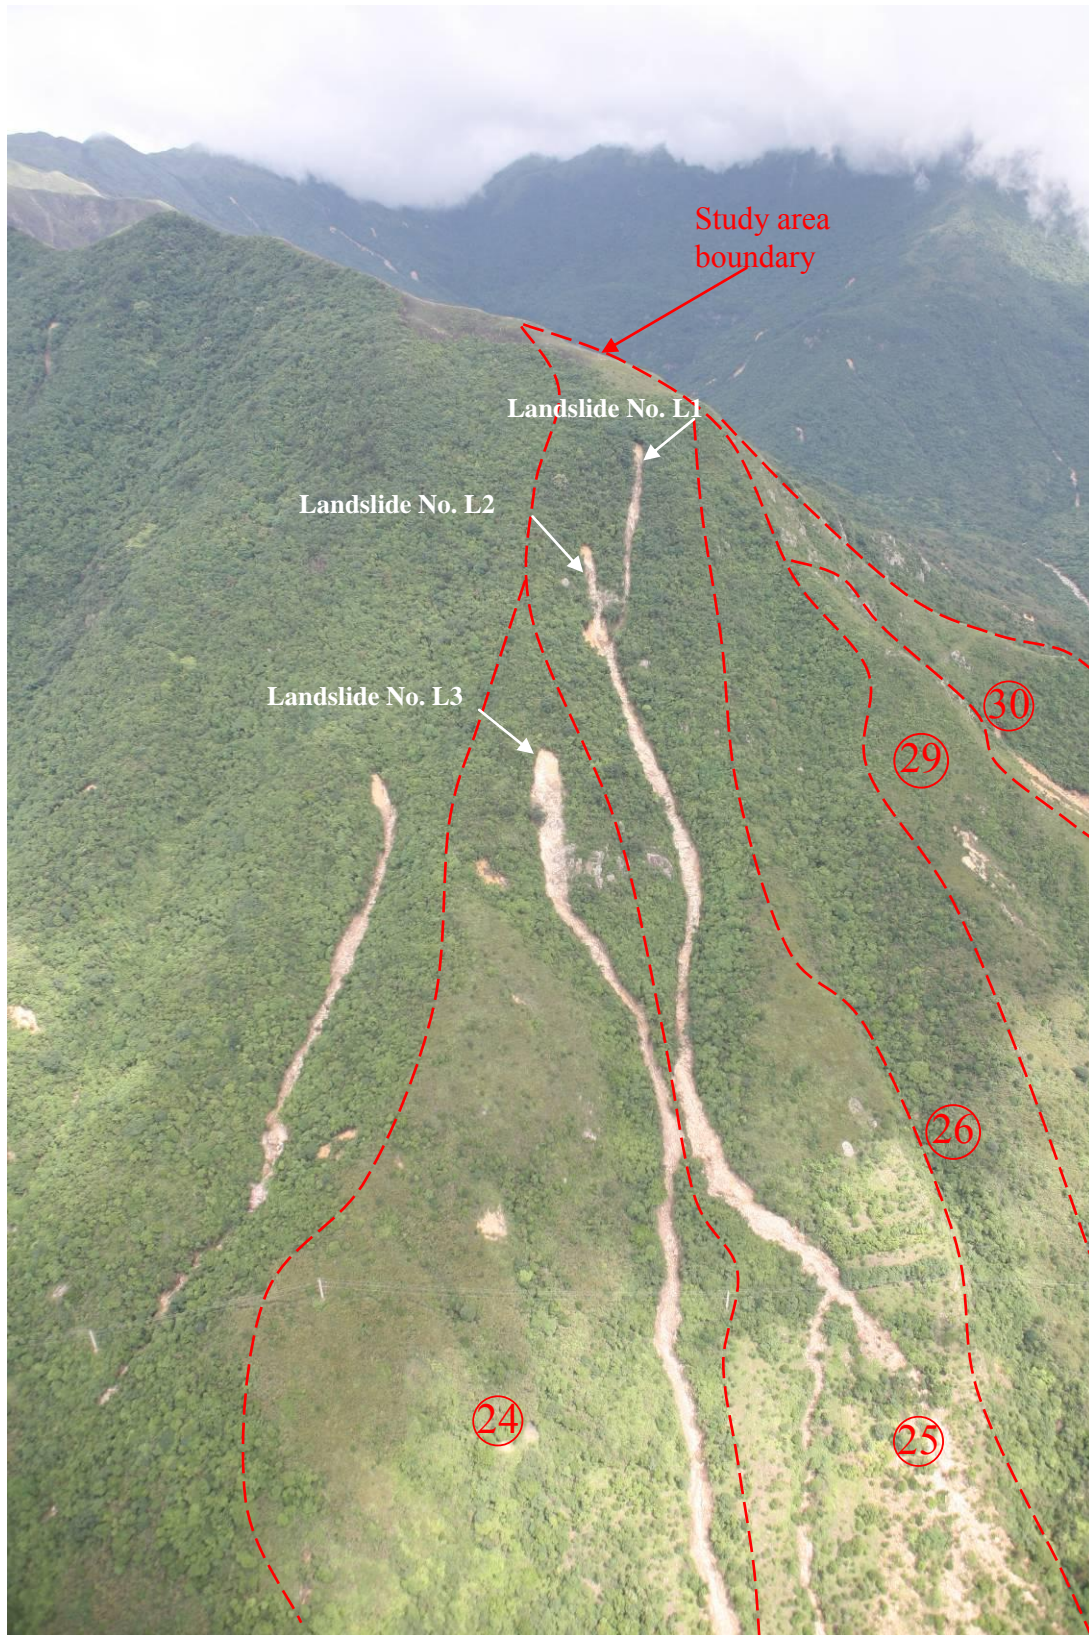
Plate 6 - Aerial View of Catchments Nos. 24 and 25 and Landslides Nos. L1, L2 and L3 (Photograph taken on 13 June 2008)

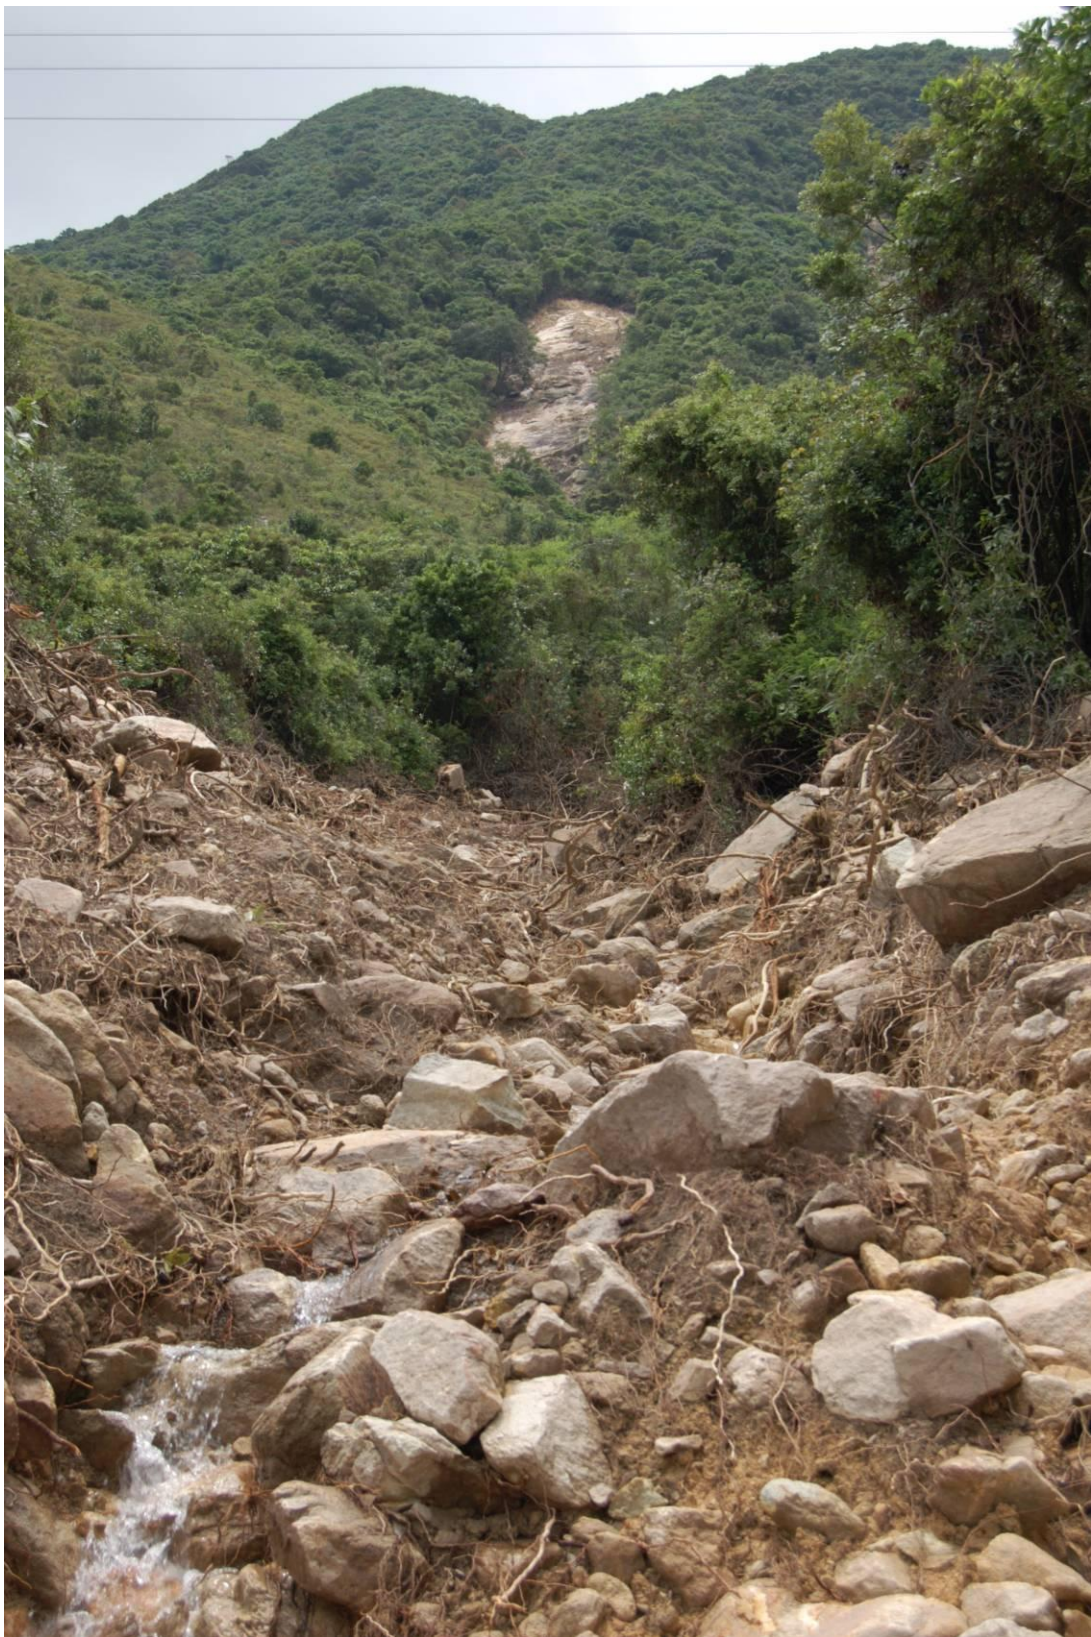
Plate 7 - View of Landslide No. L3 in Catchment No. 24 (Photograph taken on 15 June 2008)

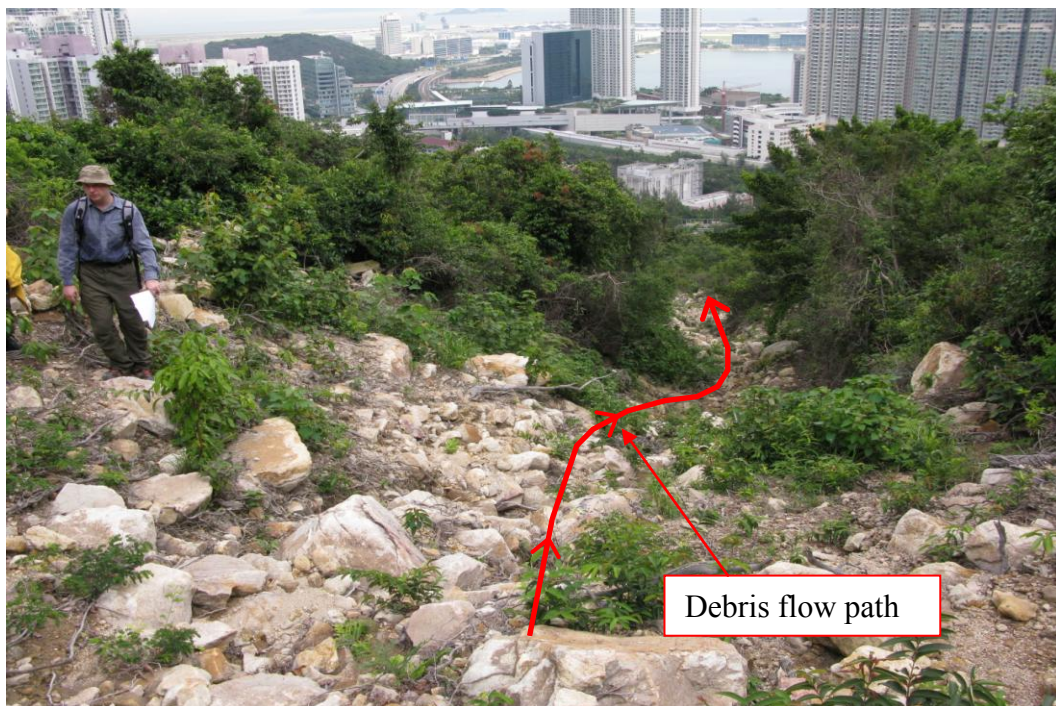
Plate 11 – View of Drainage Line in Catchment No. 24 between CH240 and CH250 Looking Downhill (Photograph taken on 15 June 2009)

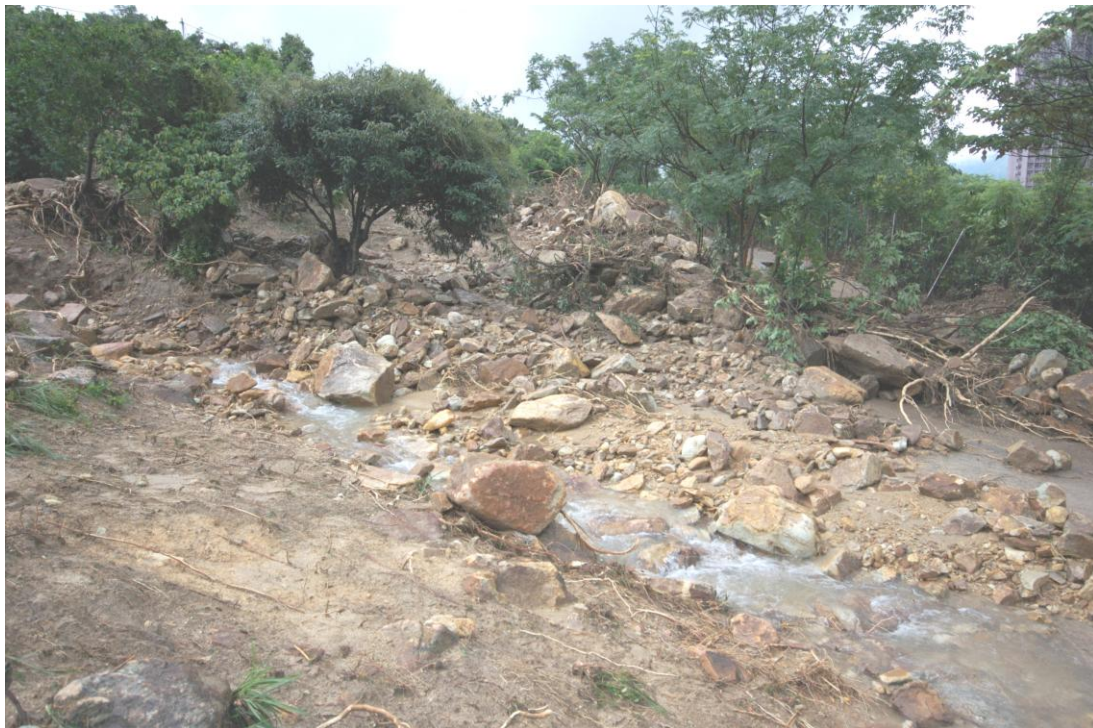
Plate 13 – Debris Deposited along the Southern Side of the Drainage Line between CH547 and CH605 in Catchment No. 24 (Photograph taken on 7 June 2008)

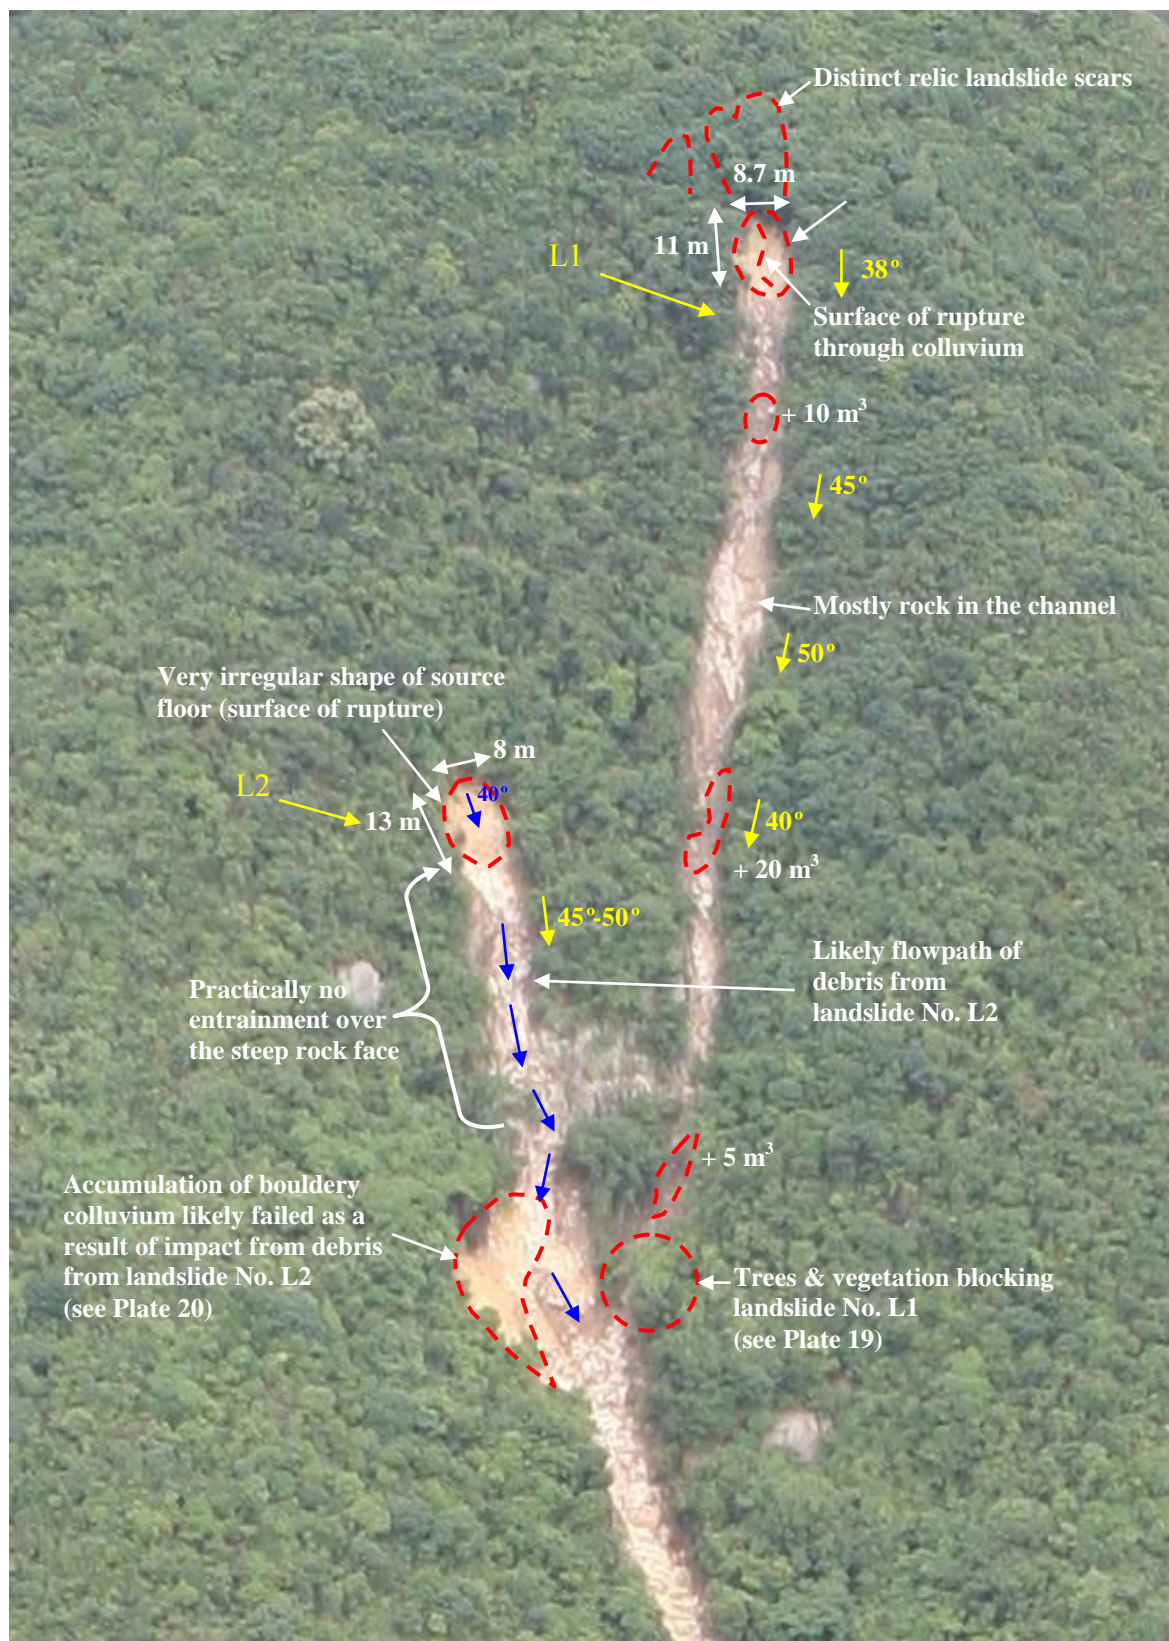
Plate 17 – Close-up Aerial View of Landslides Nos. L1 and L2 in Catchment No. 25 (Photograph taken on 13 June 2008)

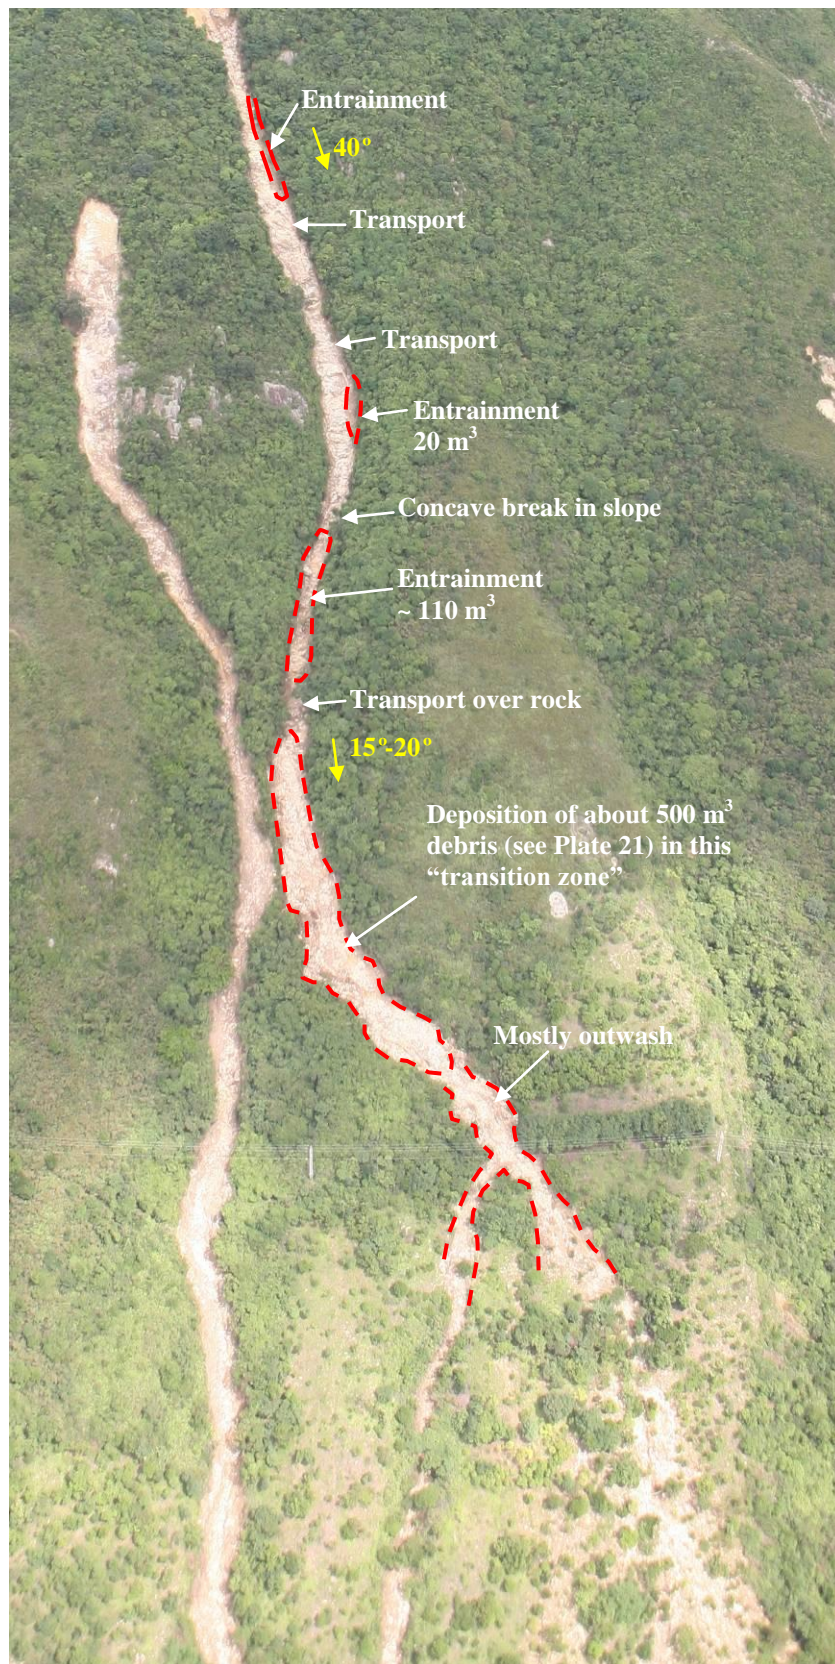
Plate 18 – Aerial View of Lower Portion of the Debris Trail in Catchment No. 25 (Photograph taken on 13 June 2008)

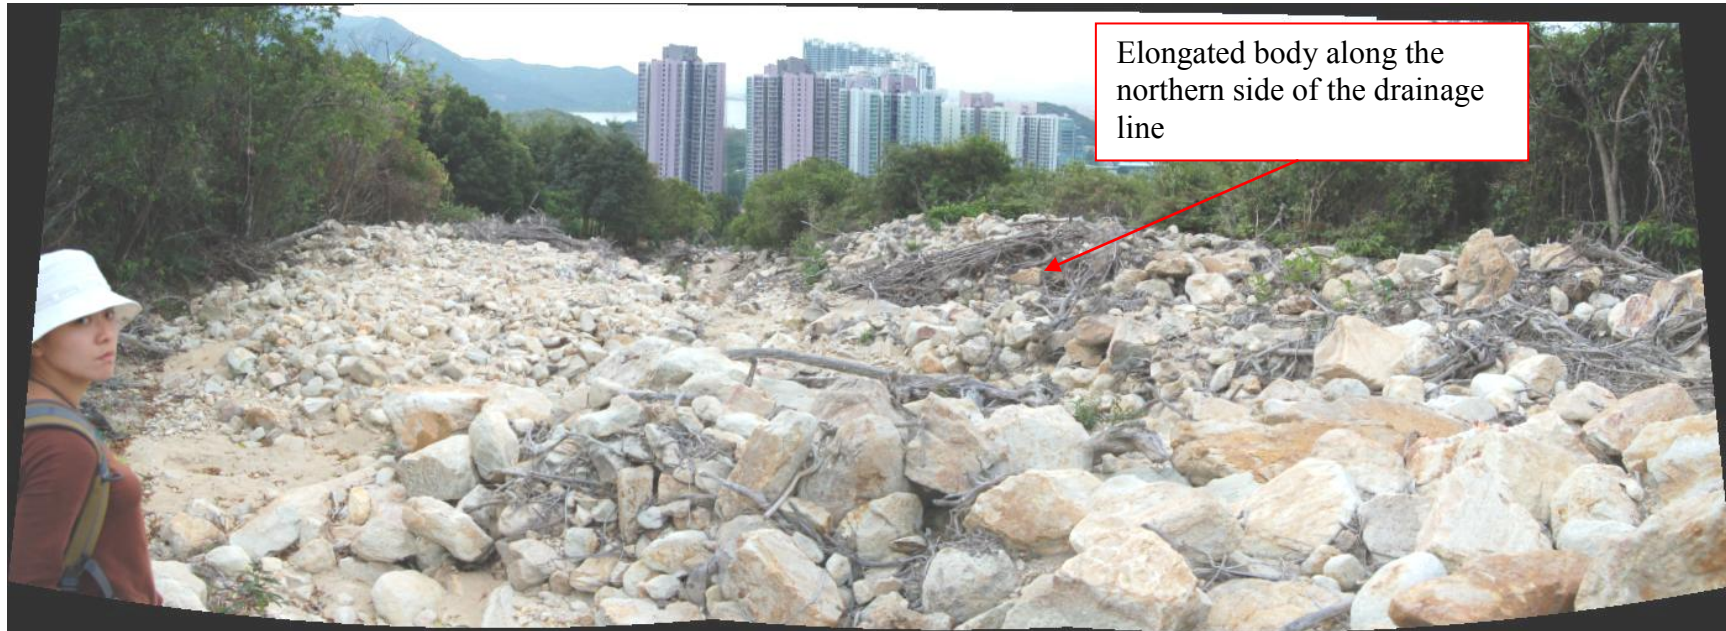
In catchment No. 25, the main body of the debris was deposited where the drainage line became more open with a CR over 8, and the gradient decreased to less than about 15° . The deposition zone corresponded to the head of an old colluvial debris fan and was therefore not a surprise. Comparing the debris mobility with previous CDF events of similar scale (Figure 17), the CDF in catchment No. 25 is not particularly mobile.

Plate 21 - Main Area of Debris Deposition in Catchment No. 25 (Photograph taken on 3 December 2008)

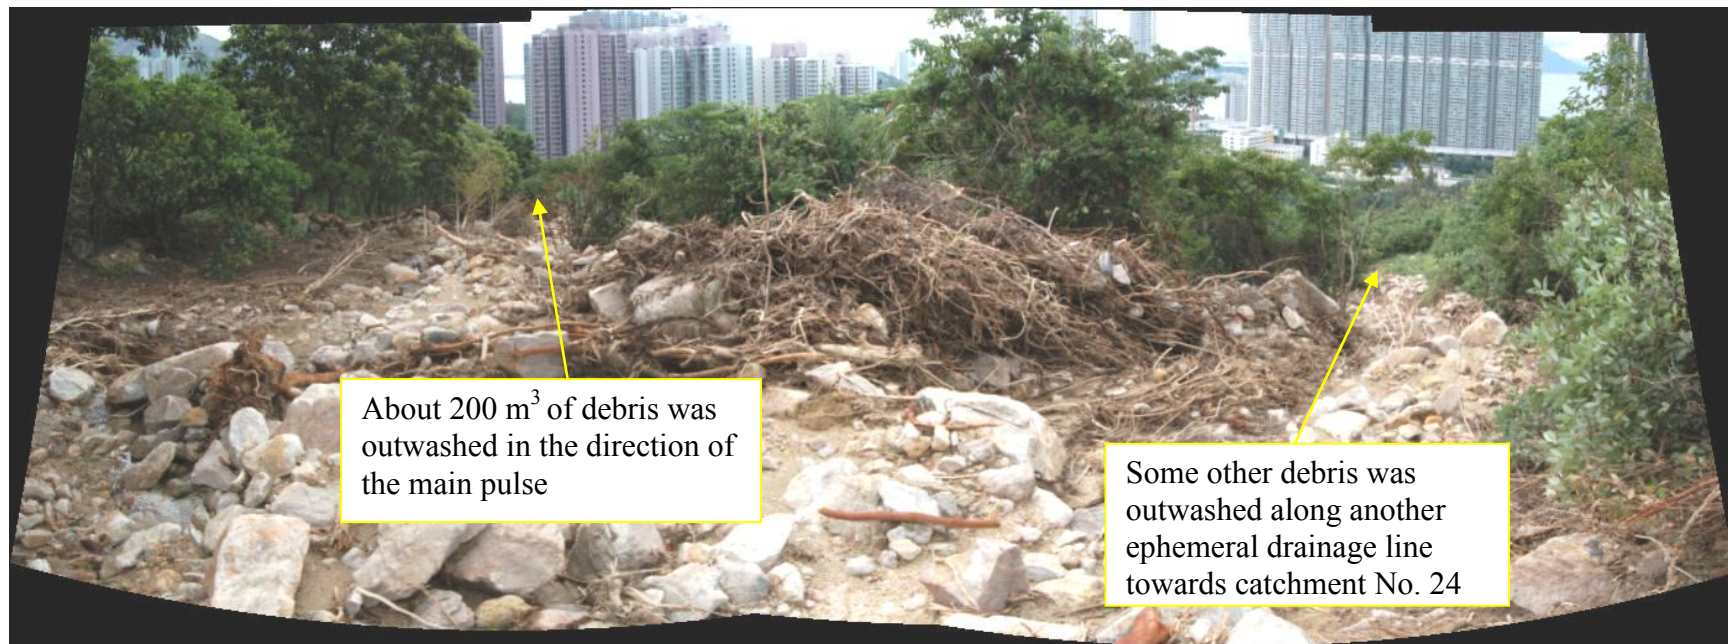
Plate 22 – View of Debris Outwash from Landslide No. L2 Spreading over Hillside and Travelling down Existing Drainage Line in Catchment No. 25 (Photograph taken on 15 June 2008)

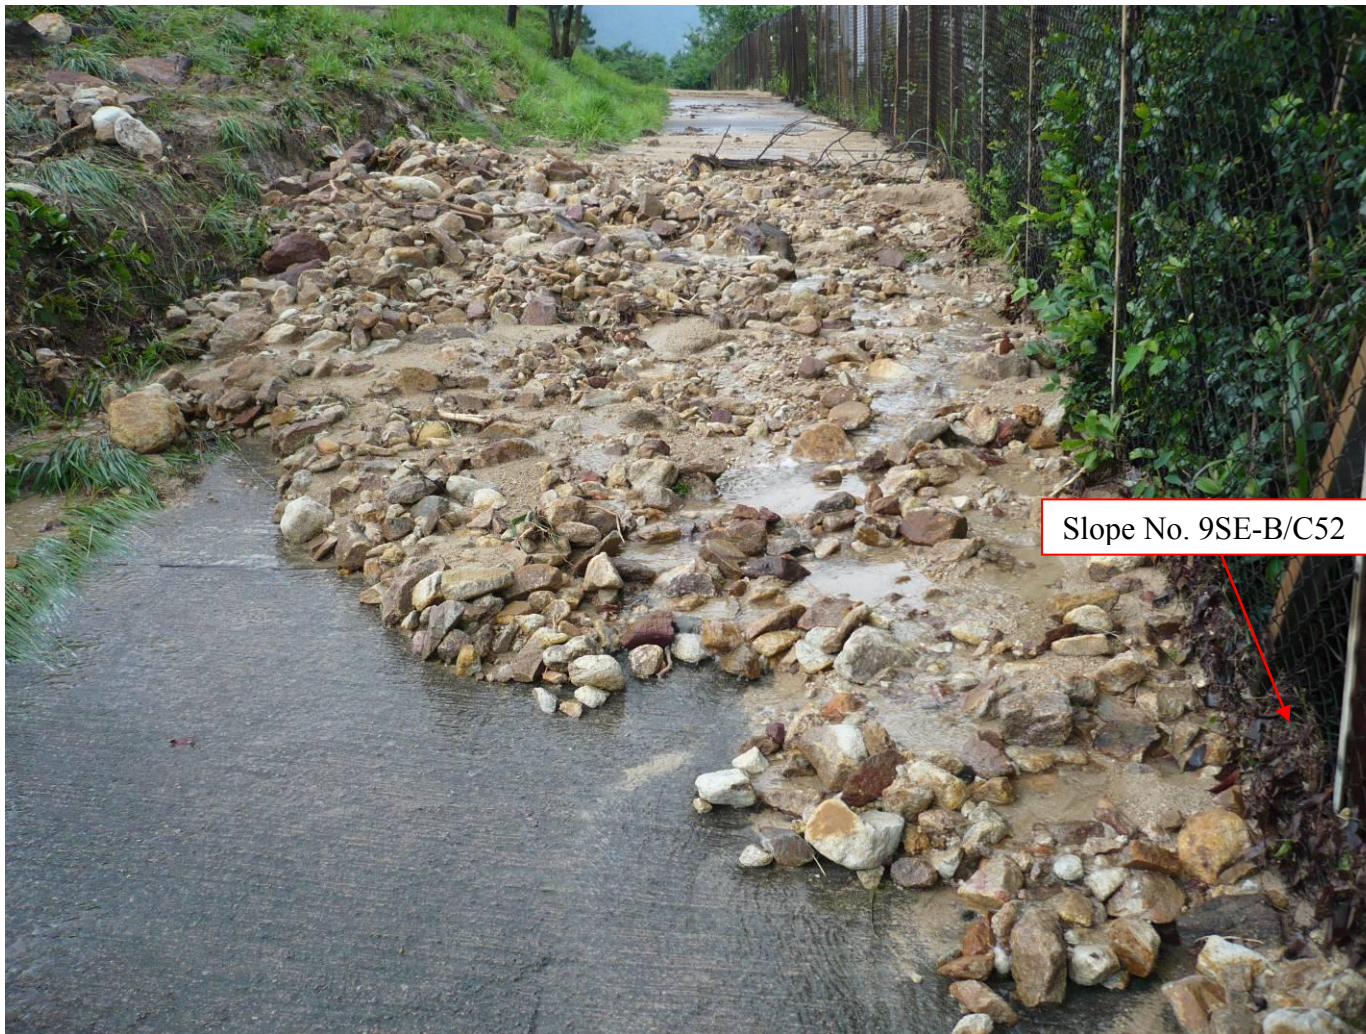
Plate 23 – Small Volume of Outwash from Landslide No. L2 in Catchment No. 25 Deposited on Concrete Path above Crest of Slope No. 9SE-B/C52 (Photograph taken on 7 June 2008)
