**DETAILED STUDY OF THE
7 JUNE 2008 LANDSLIDES
ON THE HILLSIDE
ABOVE YU TUNG ROAD,
TUNG CHUNG**

GEO REPORT No. 271

AECOM Asia Company Limited

**GEOTECHNICAL ENGINEERING OFFICE
CIVIL ENGINEERING AND DEVELOPMENT DEPARTMENT
THE GOVERNMENT OF THE HONG KONG
SPECIAL ADMINISTRATIVE REGION**

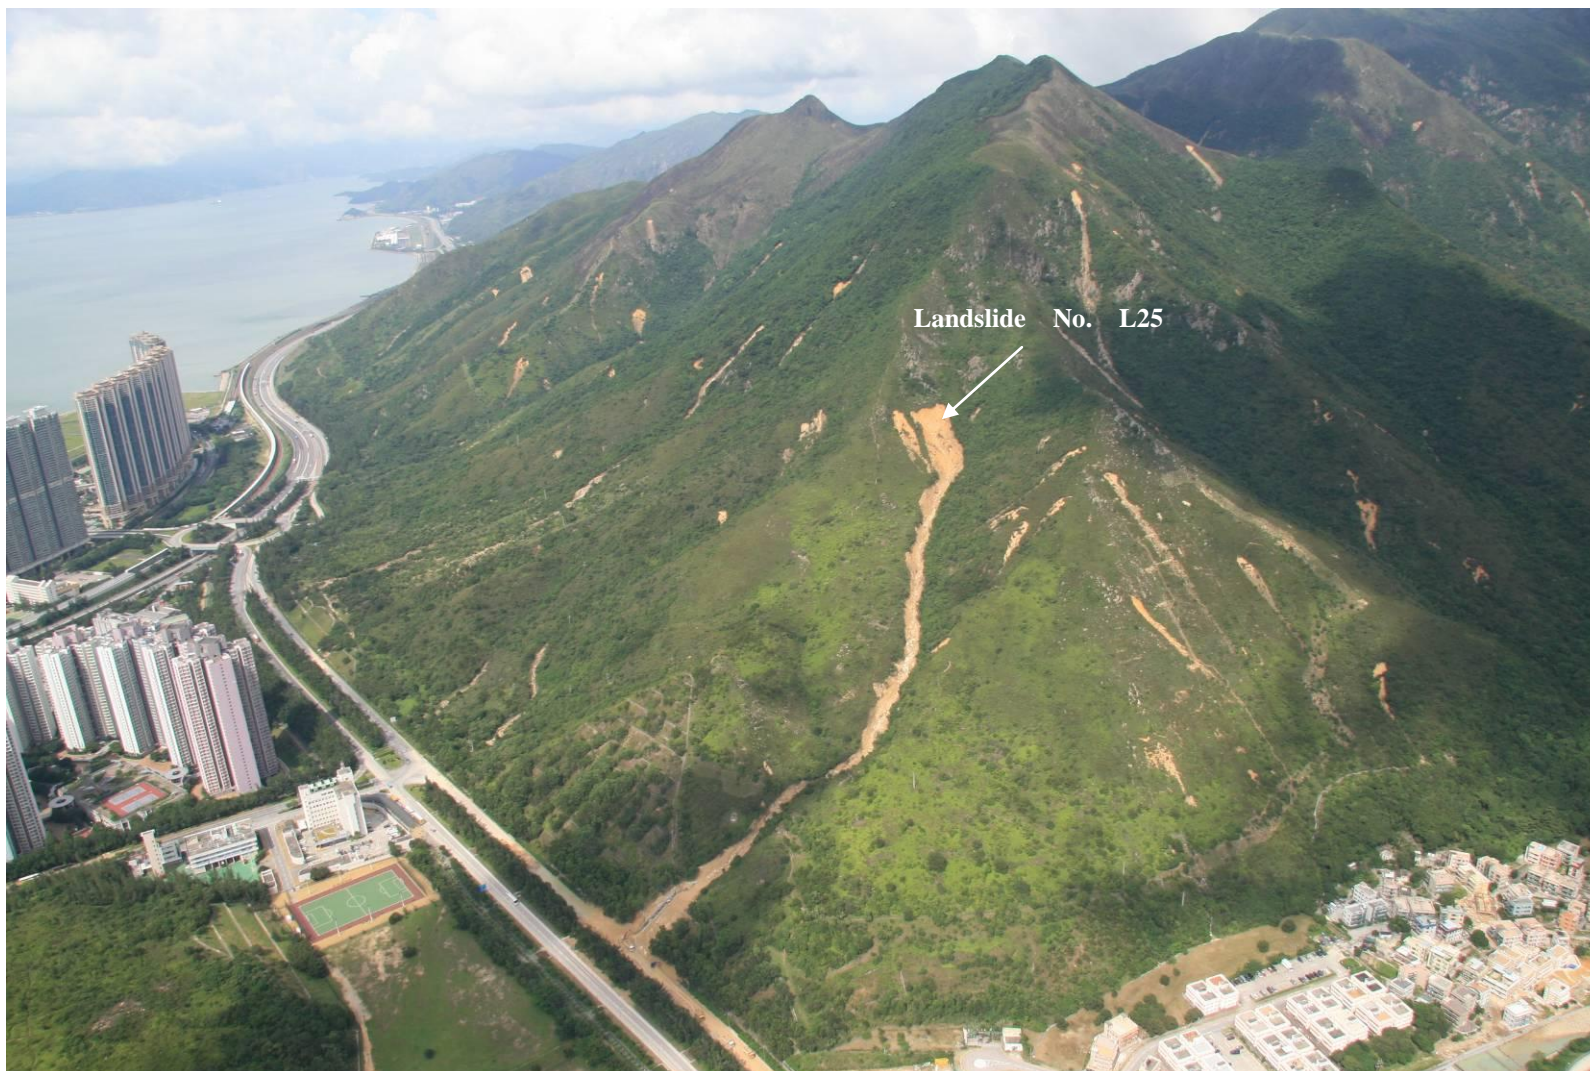
Plate 24 – Aerial View of Catchment No. 30 and Landslide No. L25 (Photograph taken on 9 June 2008)

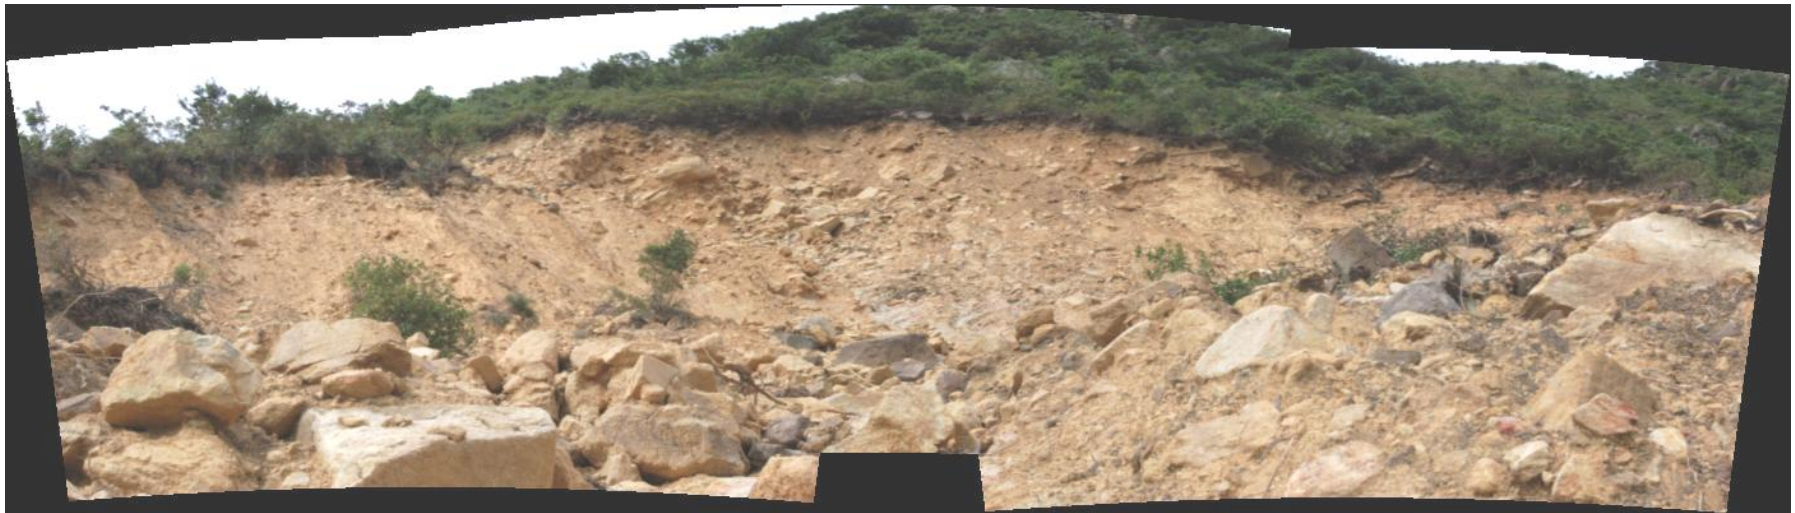
The failure at the source area of landslide No. L25 in catchment No. 30 was shallow but relatively spatially extensive. It occurred on a relatively steep portion of the hillside below a prominent rock outcrop, where a large area of boulderly deposits had accumulated probably as a result of a combination of landsliding activity, boulder fall and general mass wasting. The spatial extent of the failure at the source area appears to have been influenced by the presence of a concave break-in-slope within the accumulated deposits, marking the boundary between talus and alluvium (Figure 18). The rock outcrop above might have directed surface and subsurface water flow to the boulder deposits above and below the concave break-in-slope. While the permeability of the clast supported “talus” above the concave break-in-slope was large enough to dissipate the pore water pressure, the matrix supported alluvium could not. On the other hand, the alluvium was likely more permeable than the underlying insitu decomposed tuff. As a result of the permeability contrast, transient elevated water pressures possibly developed in the alluvium giving rise to the large scale failure.

Plate 25 – General View of Source of Landslide No. L25 in Catchment No. 30 (Photograph taken on 14 June 2008)

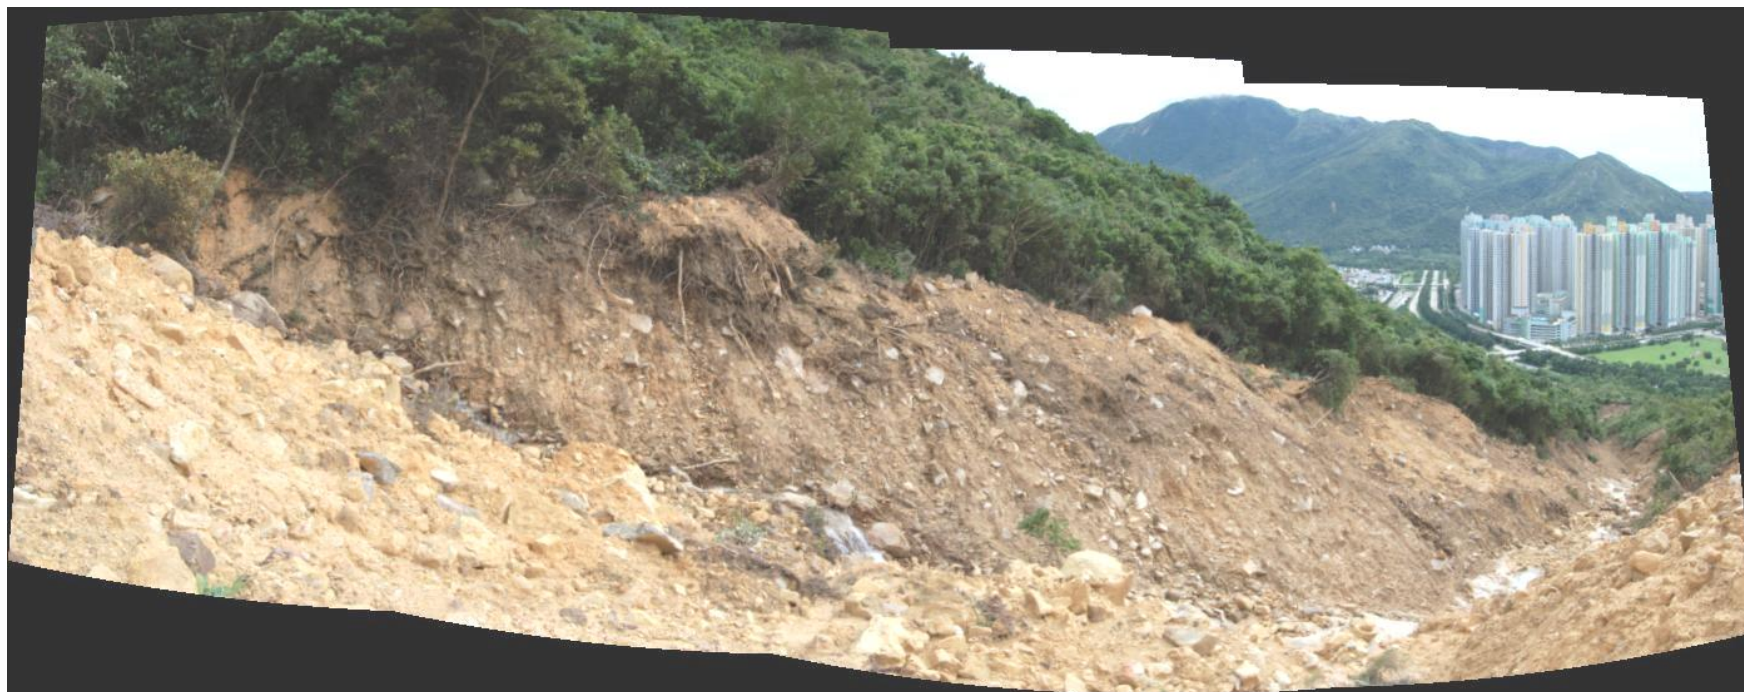
Plate 26 – General View of Western Flank of Drainage Line in Catchment No. 30 below Source of Landslide No. L25
(Photograph taken on 14 June 2008)

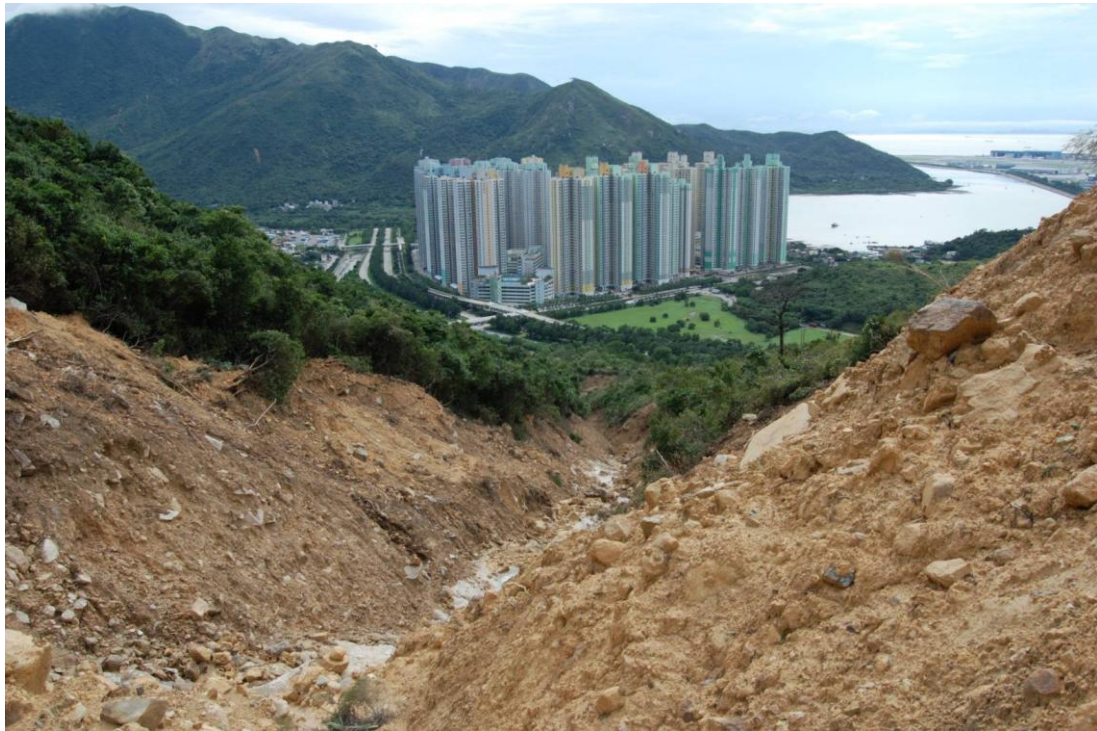
Plate 27 – View down Drainage Line below Toe of Source of Landslide No. L25 in Catchment No. 30 (Photograph taken on 14 June 2008)

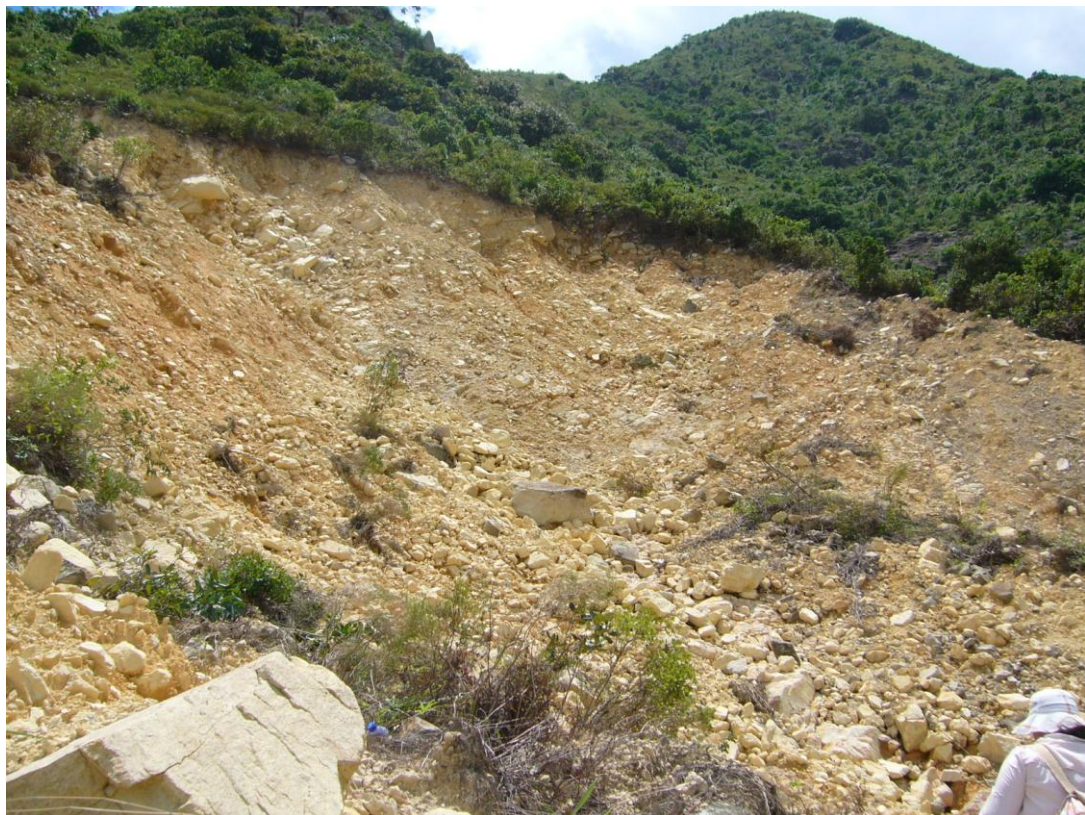
Plate 28 – General View of Source of Landslide No. L25 in Catchment No. 30 (Photograph taken on 8 June 2008)

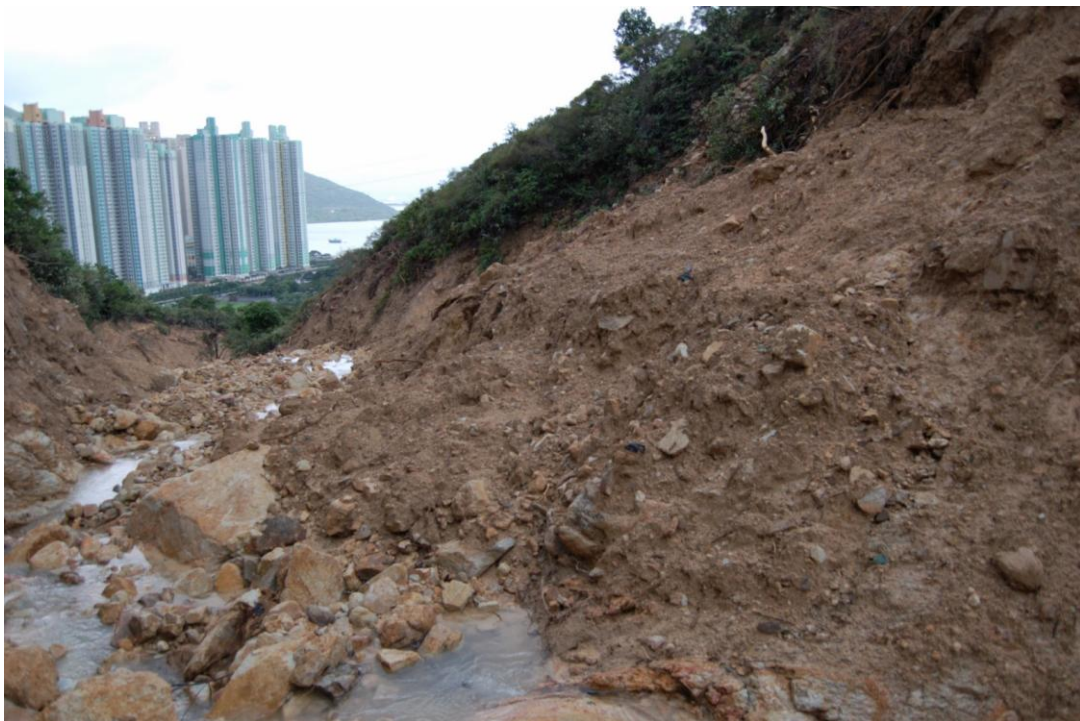
Plate 32 – Broadening of Drainage Line below CH310 in Catchment No. 30 (Photograph taken on 13 June 2008)

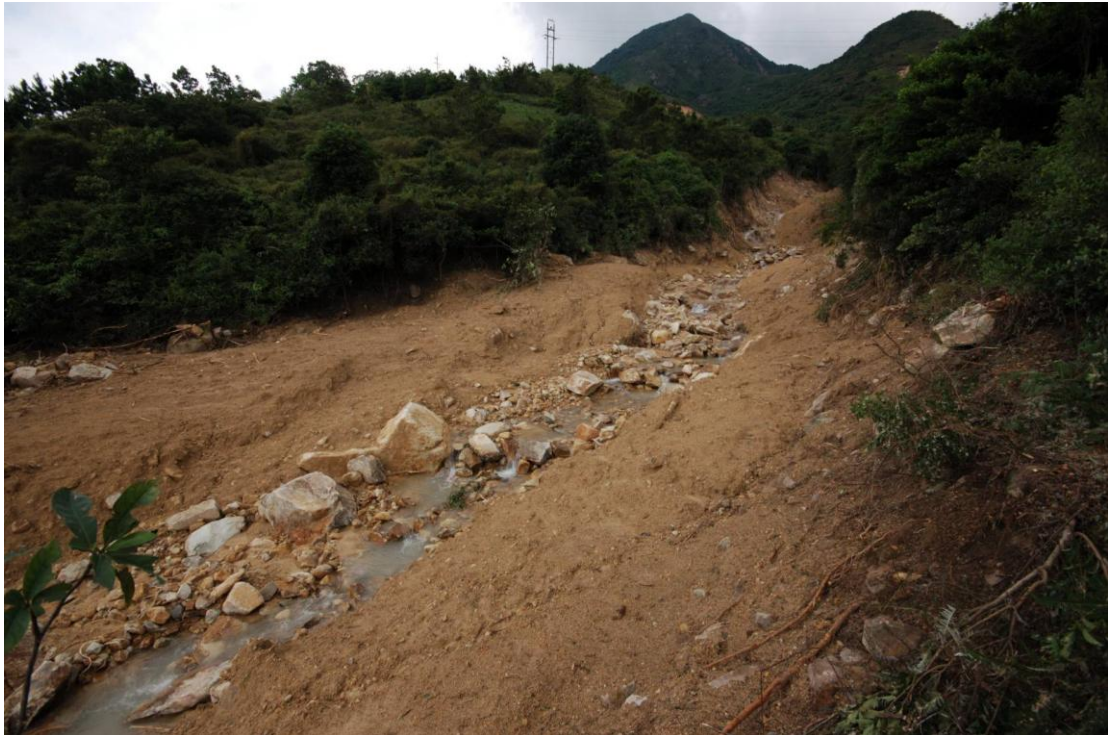
In the deposition zone (CH510 to CH625), the drainage line gradient decreased further to about 12° and opened out, where significant debris deposition occurred along the flanks of the drainage line (Plates 33 and 34). Estimation based on both super-elevation data and the “You Tube” video show that the debris was still travelling at a high velocity of about 10 m/s at around this location. The video also indicated that the main pulse of debris continued at a high velocity towards the crest of the cut slope No. 9SE-B/C27 at the drainage outlet adjacent to Yu Tung Road. This resulted in a large proportion of debris (about 3,100 m³) including many large boulders discharging at a high velocity over slope No. 9SE-B/C27 at CH550, toppling and ripping trees from the surface of the cut slope (Plate 36). All 3,100 m³ of debris finally deposited on the two westbound lanes of Yu Tung Road, at an elevation of about 17 mPD (Plate 37). Some debris also reached the eastbound lanes of Yu Tung Road at CH625 (Plates 37 and 38). The debris contained a significant proportion of boulders (possibly up to 40% boulder content), and some up to 2.5 m in size (Plate 39). Boulder impact during the CDF severely damaged the concrete drainage channel at the western side of slope No. 9SE-B/C27 (Plates 40 and 41).

Plate 33 – View of Lower Portion of Drainage Line and Debris Trail in Catchment No. 30 (Photograph taken on 8 June 2008)

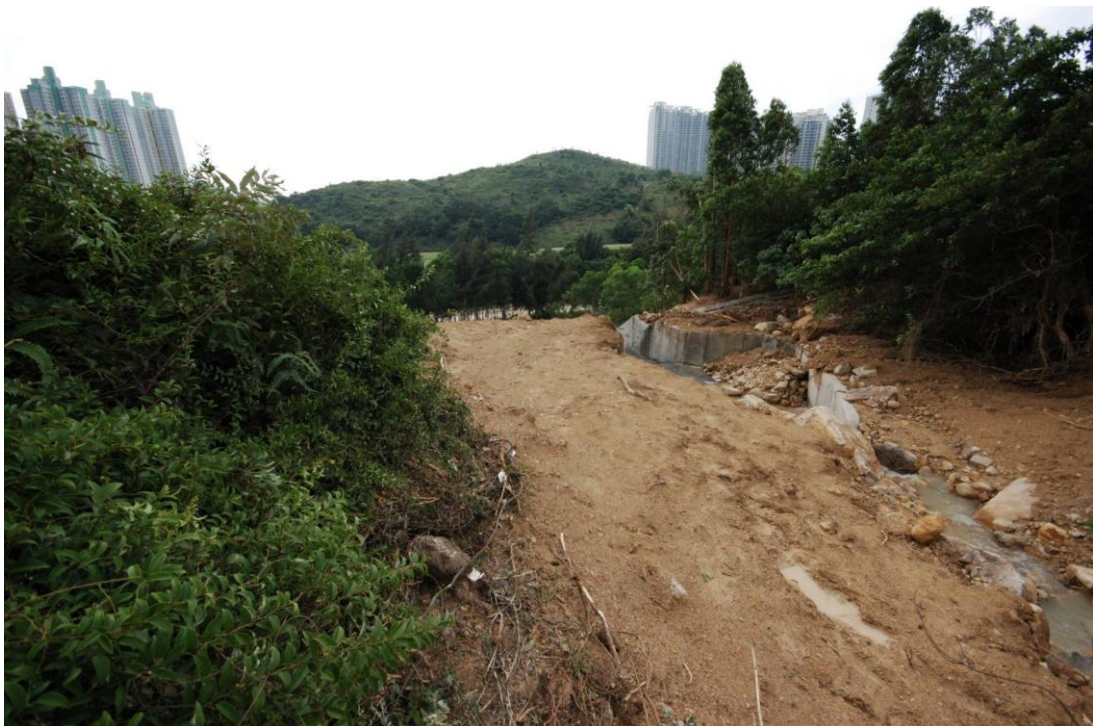
Plate 34 – View of Debris Trail Extending to Crest of Slope No. 9SE-B/C27 (Photograph taken on 8 June 2008)

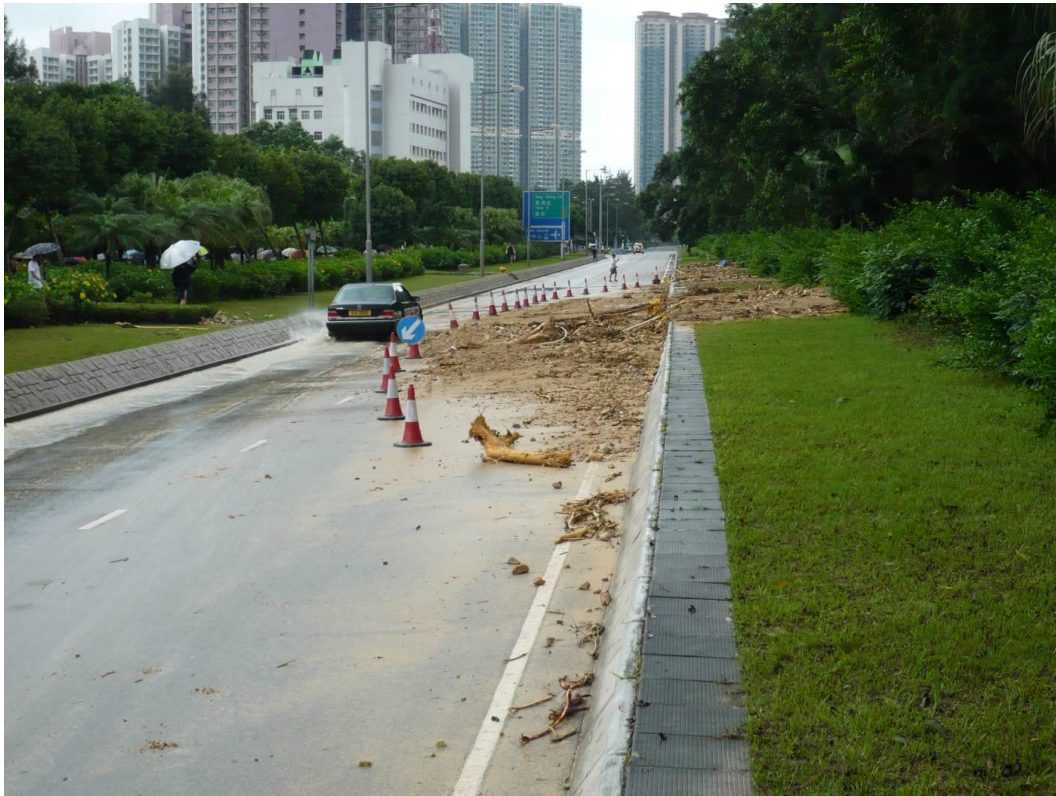
Plate 38 – Debris on Eastbound Carriageway (Photograph taken on 7 June 2008)

water it was also apparent that the debris contained a significant proportion of boulders (possibly up to 40% boulder content), and some up to 2.5 m in size. A small quantity of debris reached the eastbound lanes of Yu Tung Road (Plate 38), which indicated that the debris had slowed down rapidly on impacting with Yu Tung Road. According to the Highways Department, about 3,500 m³ of debris were removed from Yu Tung Road. Following removal of the debris from Yu Tung Road and the drainage channel the damage to the concrete could be observed, which suggested significant boulder impact had occurred during the debris flow.

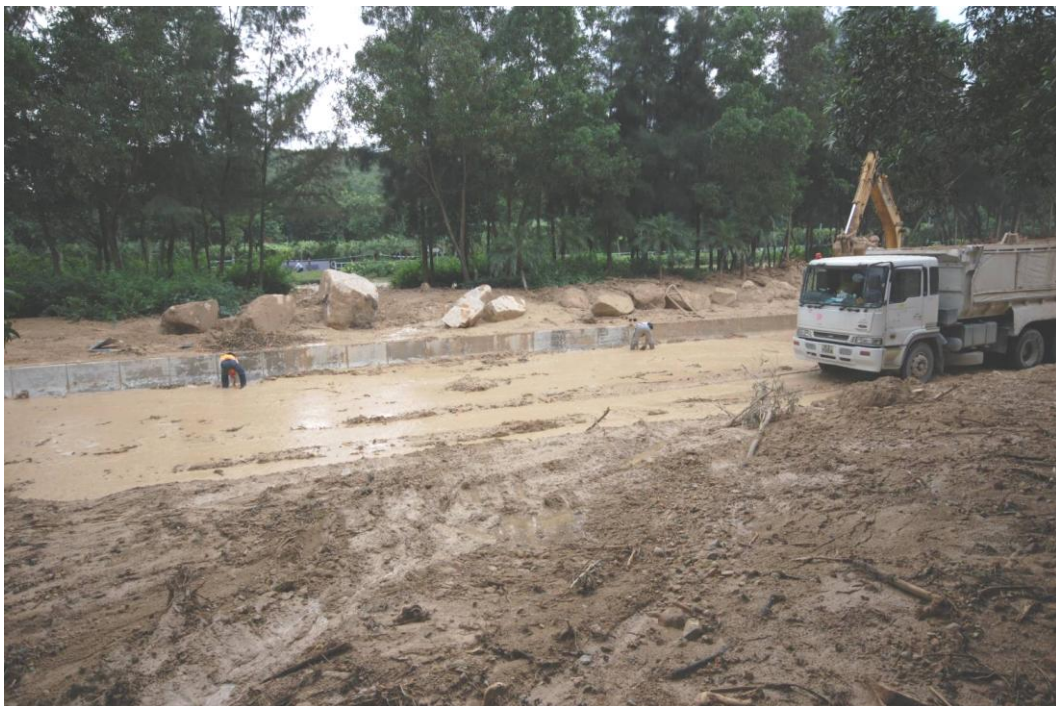
Plate 39 – Clearing Bouldery Debris from Yu Tung Road (Photograph taken on 8 June 2008)

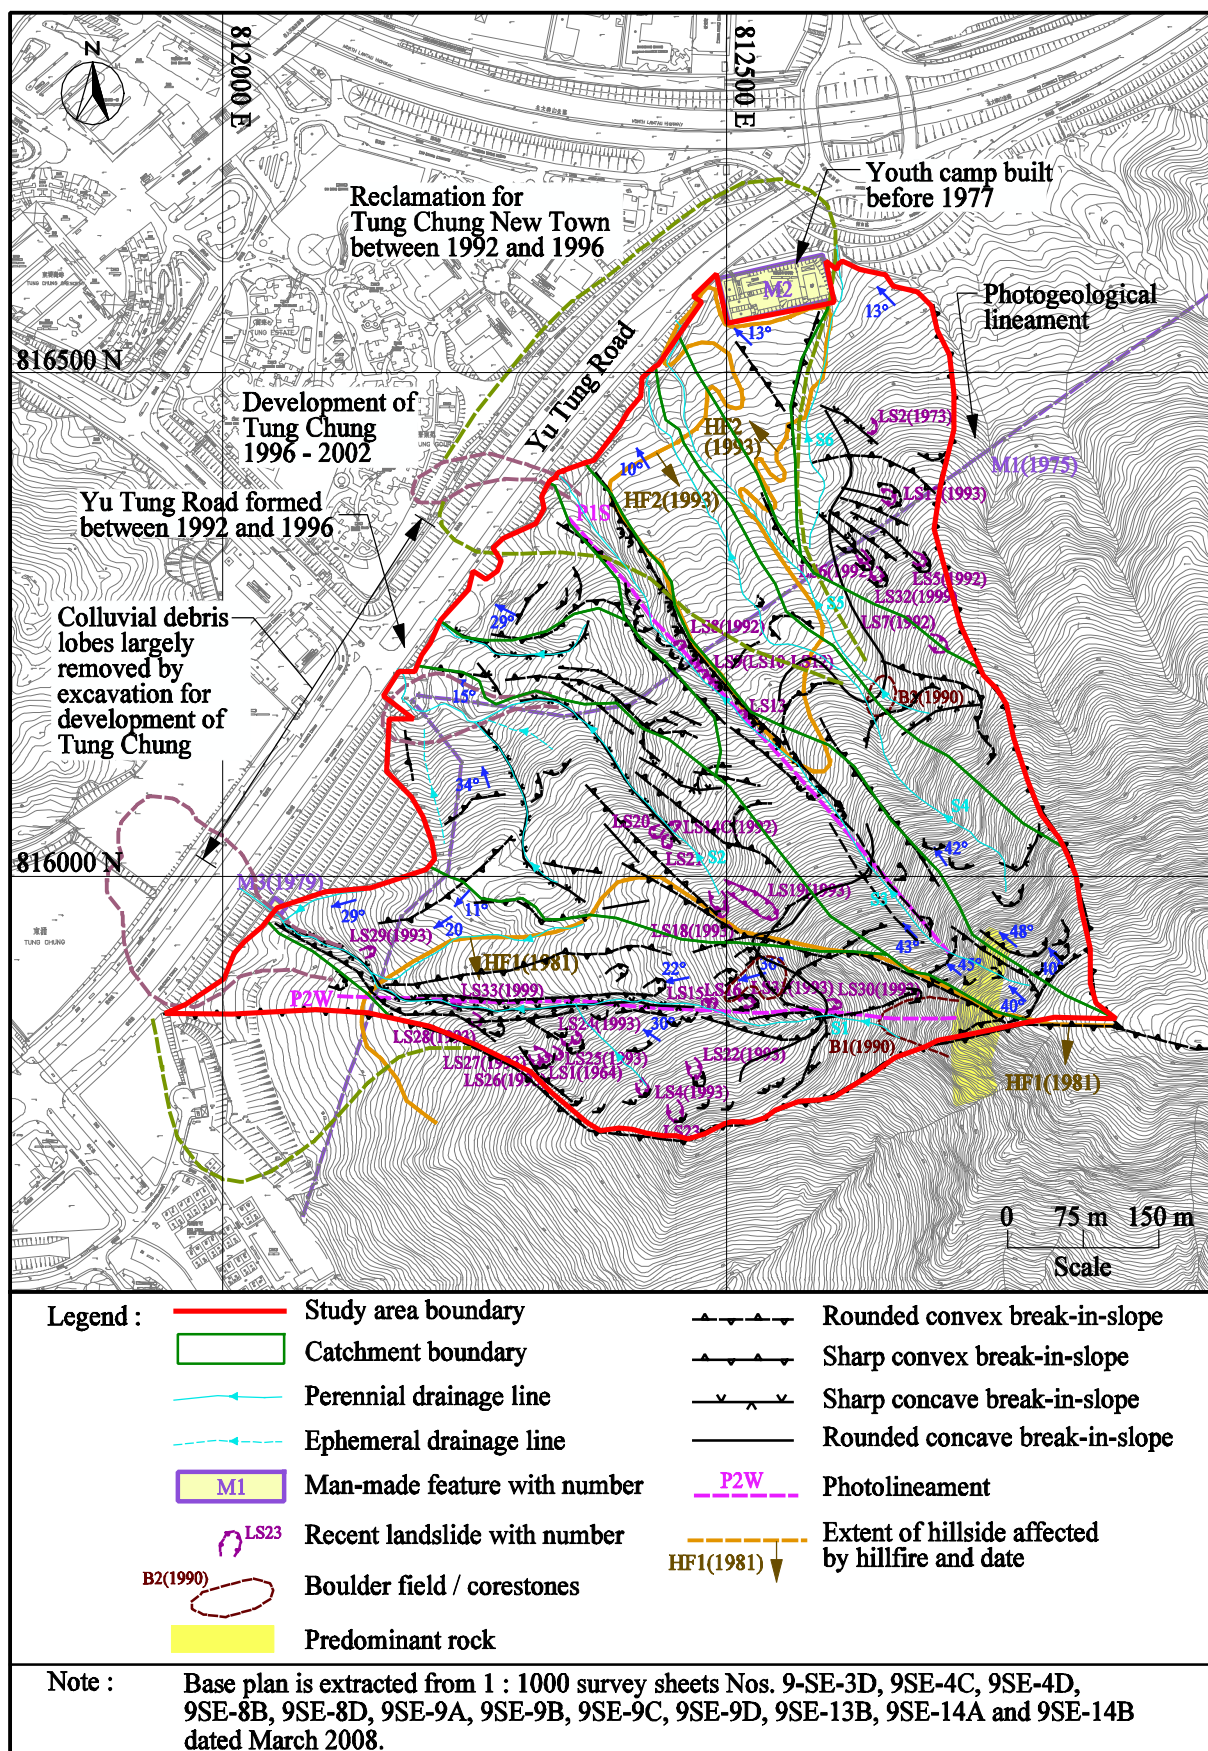
In general, the upper catchment of the study area is delineated by a well-defined ridgeline, with heads of the catchments located immediately below. Extending downslope from the ridgeline are a series of rounded spurlines that from the catchment boundaries within the study area. The terrain immediately downslope from the ridgeline is typically very steep (approximately 40°) and comprises a transportational upper slope terrain morphology. The steepness of the terrain may be associated with the presence of shallow rockhead, as several areas of exposed rock are observed within the zone. The downslope terrain comprises shallower gradient midslope terrain (approximately 20°-36°). The lower slopes are predominantly colluvial with the several large debris fans observed. Boulders are observed to be scattered across the upslope and mid-slope area of the hillside. The general morphology and hydrology of the area is shown on Figure A1.

Figure A1 - Site History and Geomorphology

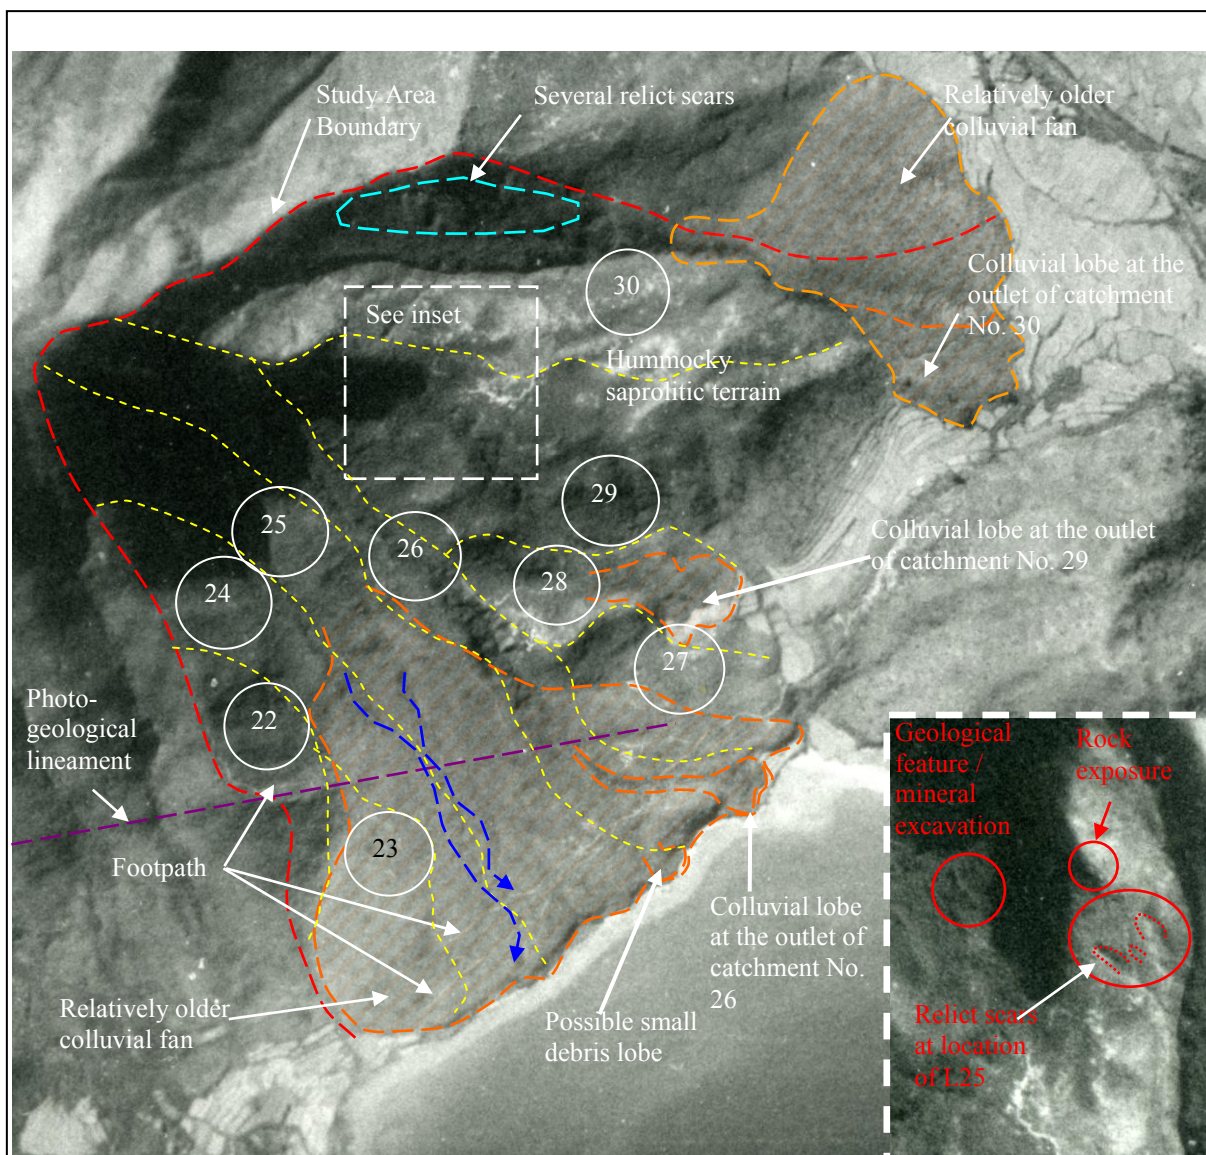
Catchment No. 26 is linear with a relatively confined central ephemeral streamcourse channel, though the drainage line is observed to turn towards the west as it approaches the sea. There is evidence of several relic landslides having occurred along the steep flanks of the drainage, in the form of closely spaced arcuate convex breaks-in-slope (Figure A1). Areas of bare soil are observed on the hillside between catchments Nos. 26 and 29. Notably a small debris lobe is observed emerging from the outlet of the drainage line in catchment No. 26. The debris lobe is distinguished by the darker shade of vegetation and hummocky appearance. Debris from the lobe can also be seen to extend upslope along the drainage line for about 100 m. It is possible therefore that the lobe represents one event, with approximate volume of about 1000 m³ (assuming an approximate scale of 1:20 000 the approximate dimensions of the lobe are a radius of 25 m and an assumed average depth of 1 m. Thus $\frac{1}{2}(\pi r^2 h)$, gives about $1960/2 = 980 \text{ m}^3$). A further possible small fan of colluvium is also observed on the coast directly downslope of the linear portion of the drainage line in catchment No. 26 which may correspond to debris from a landslide that has overrun the sides of the drainage line and travelled directly to the sea (Figure A2).

On the hillside at the south-western portion of the catchment a series of narrow discontinuous ridges are observed (Figure A2). These features may represent the surface expression of a geological feature, such as a dyke or quartz vein, or possibly man-made features such as exploratory mining activities. A probable lobe of debris is observed at the outlet of the catchment where the drainage line runs onto a terraced area of colluvial deposits.

Figure A2 - Interpretation of 1945 Aerial Photograph

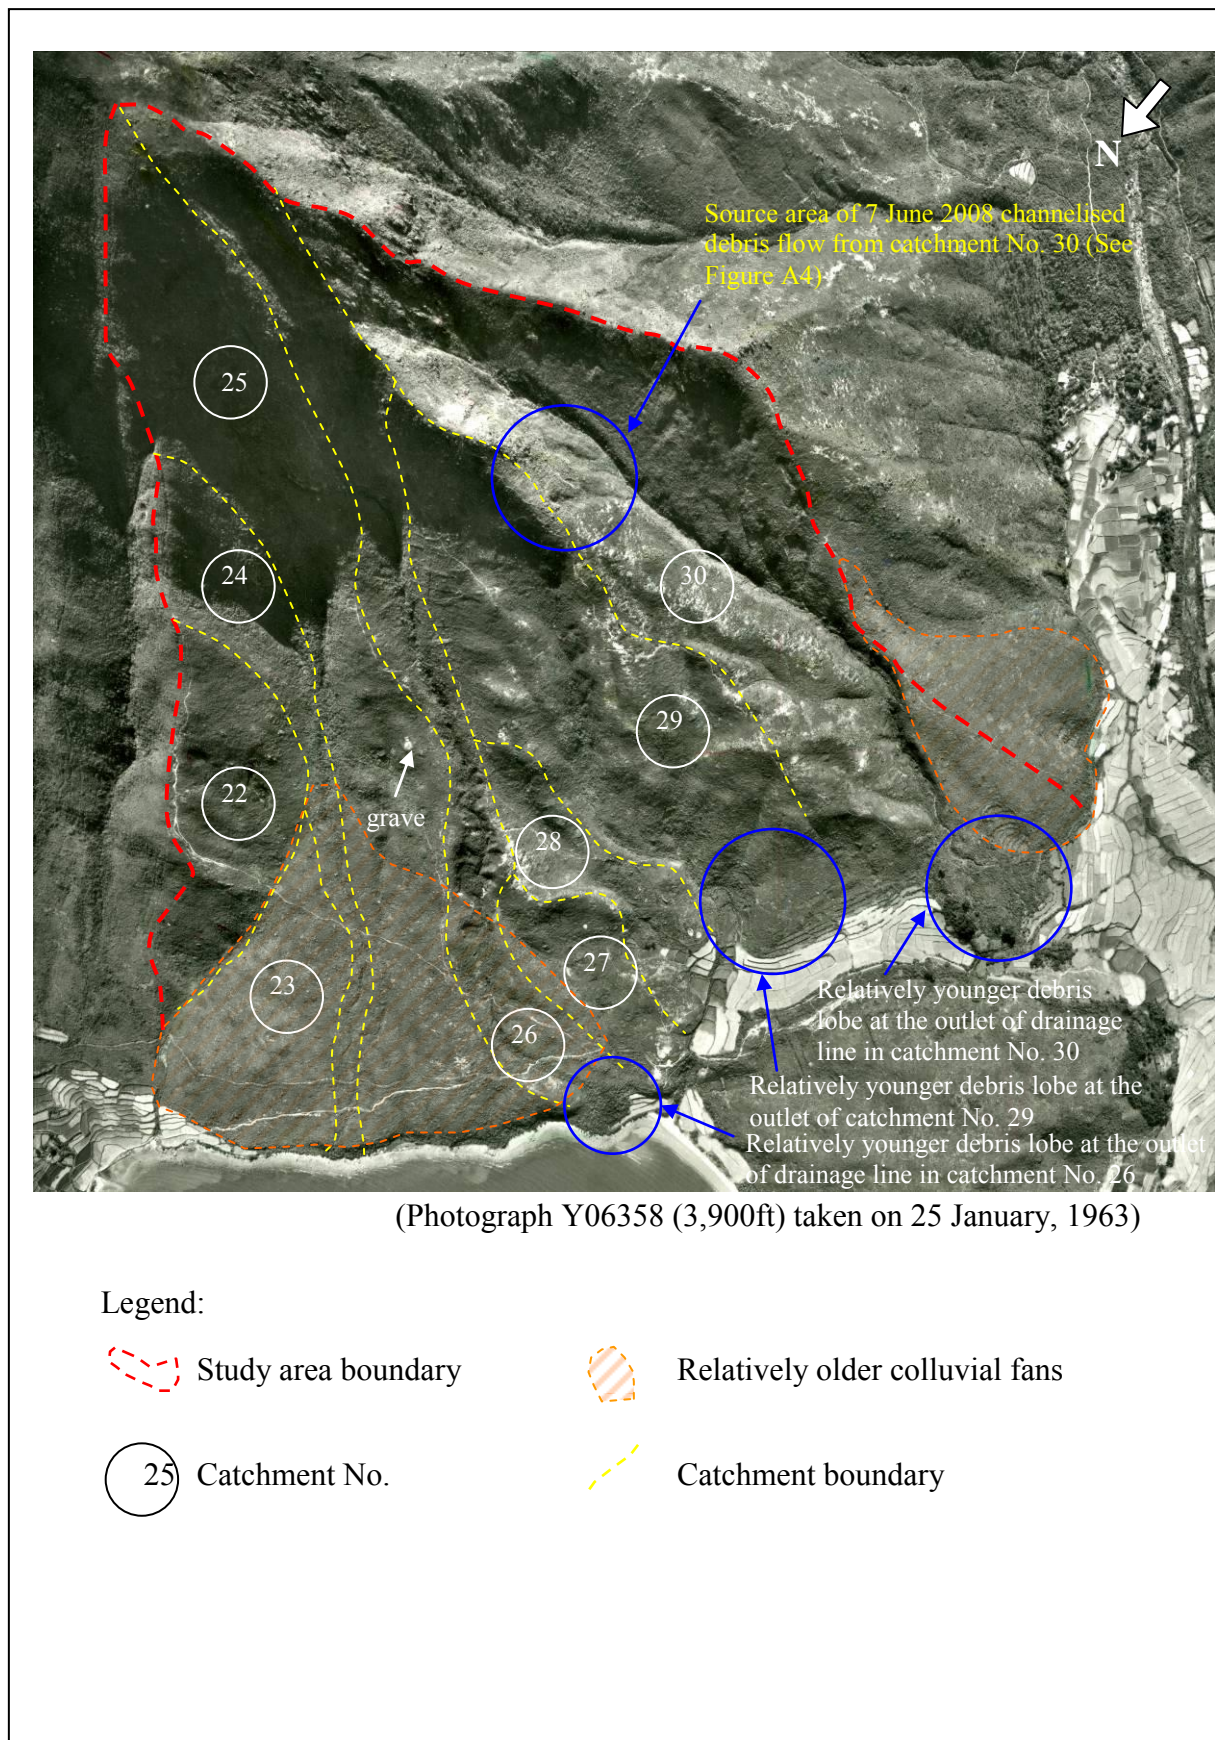
Figure A3 - Interpretation of 1963 Aerial Photograph

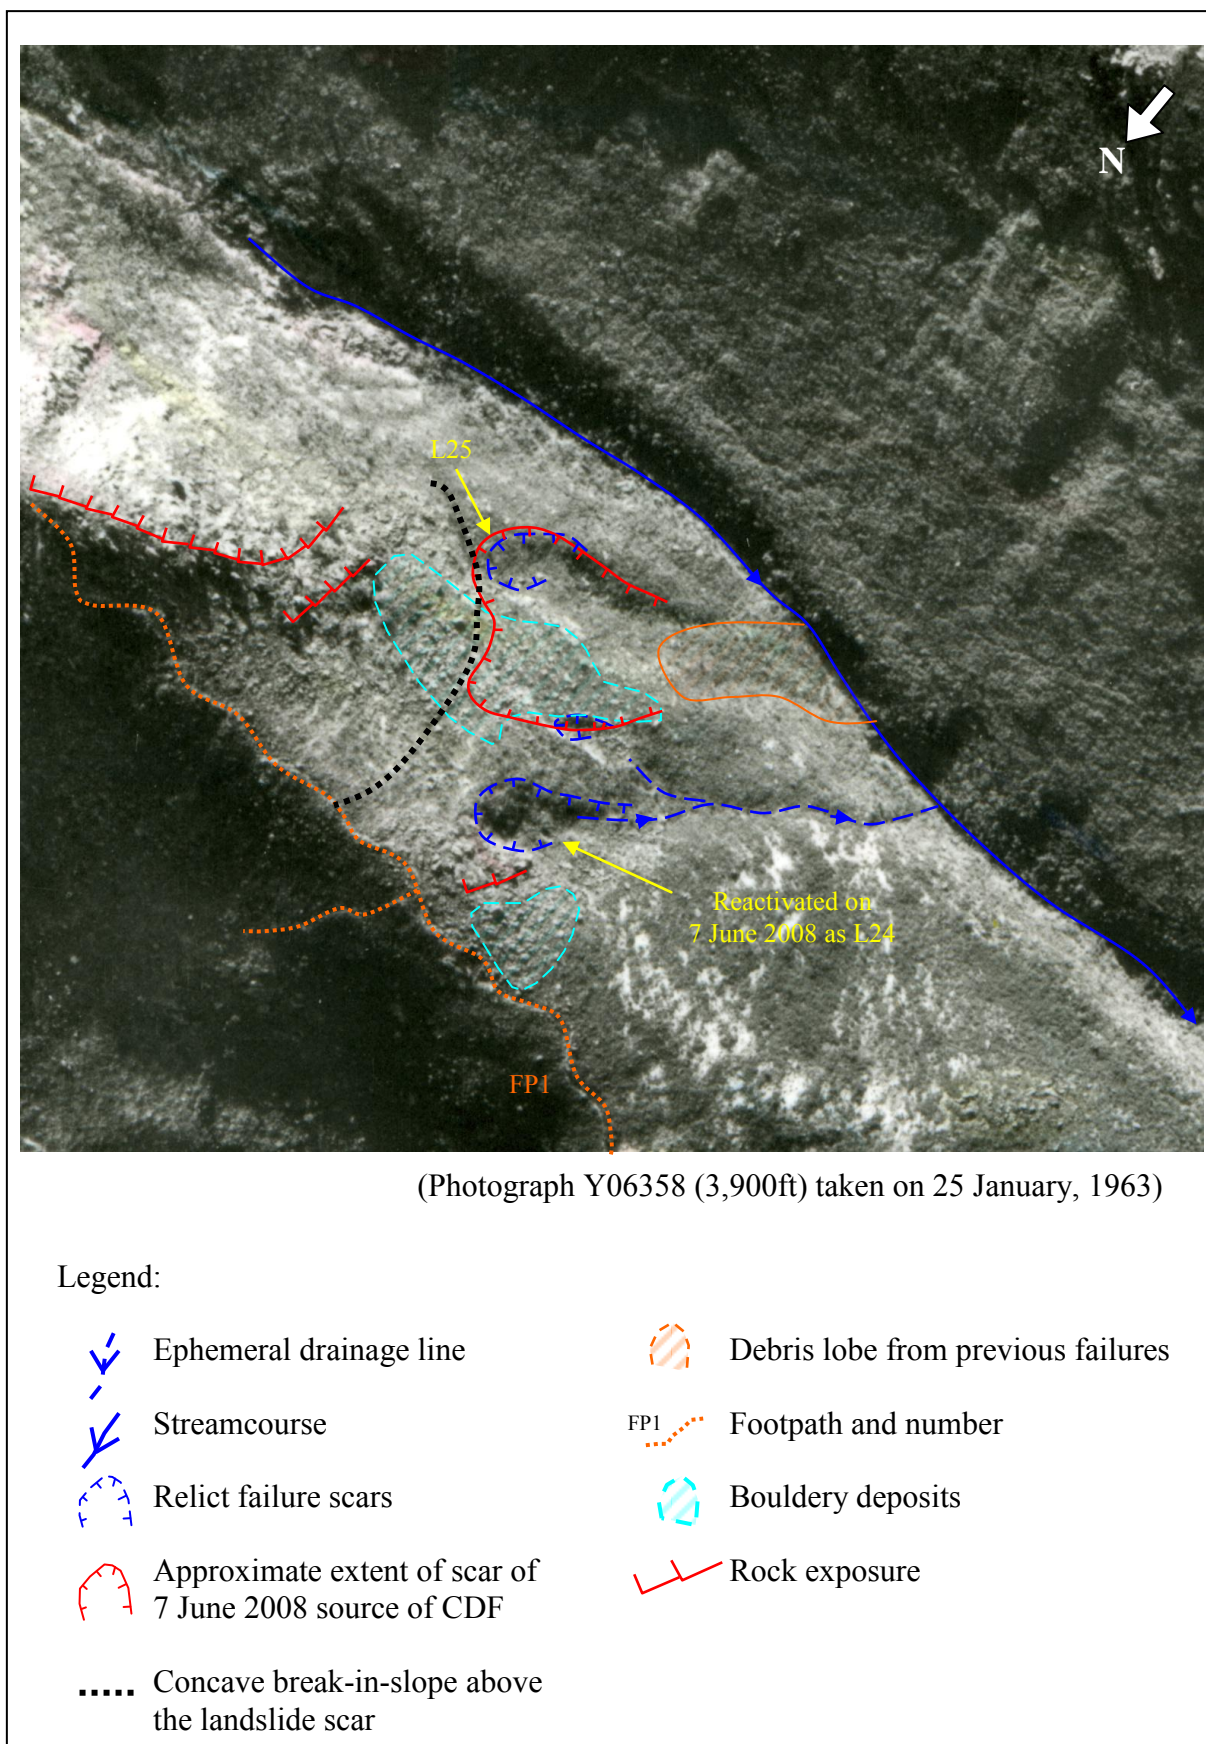
Figure A4 - Close-up of Source Area of the June 2008 Channelised Debris Flow in Catchment No. 30 Extracted from 1963 Aerial Photograph

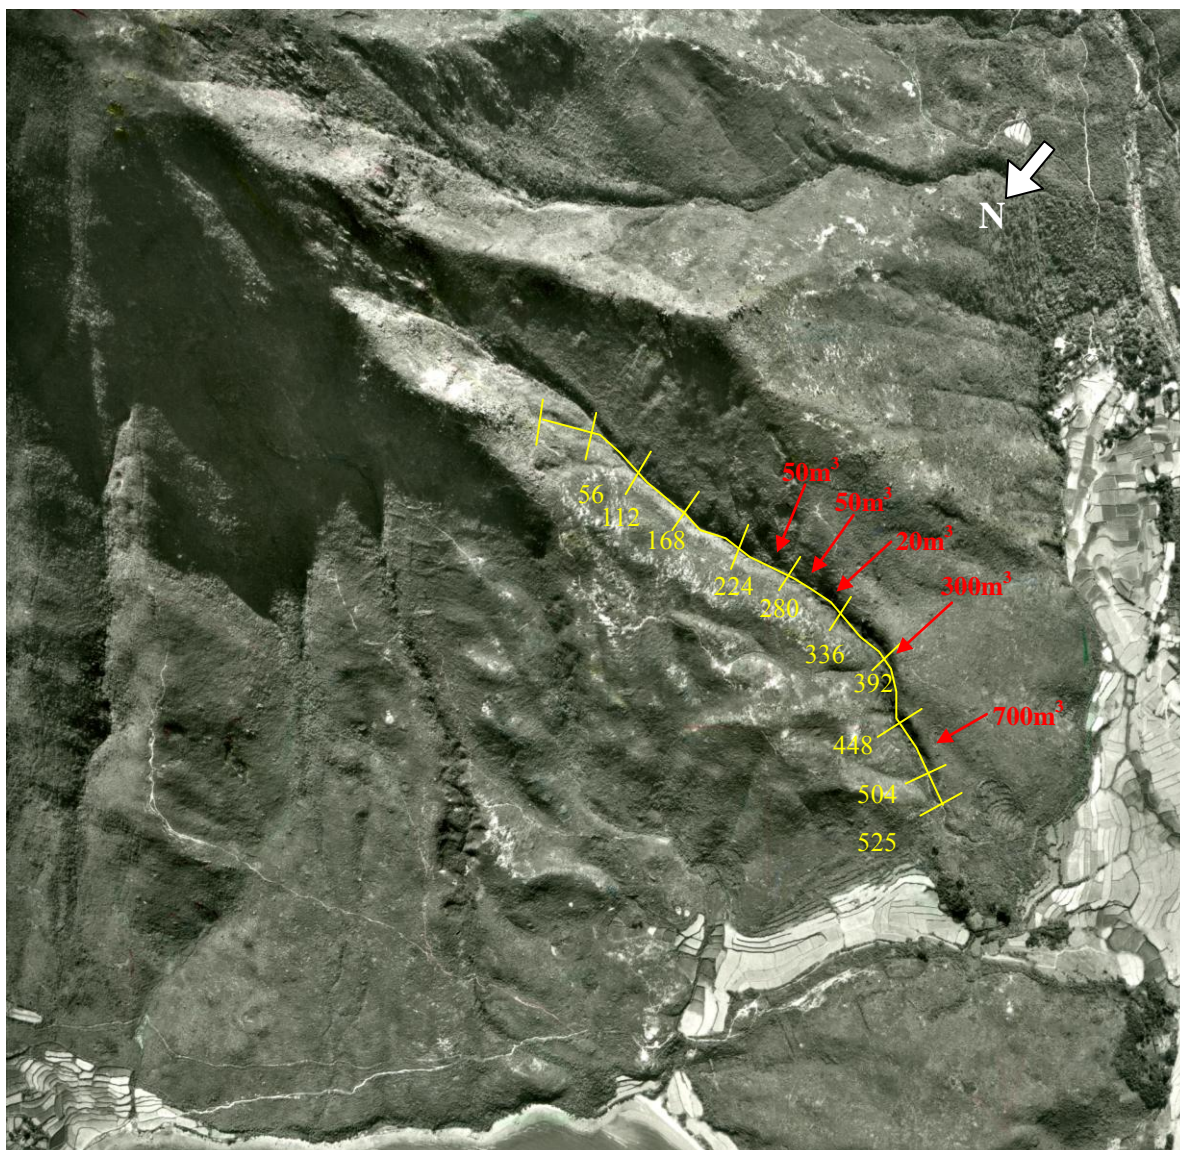
Chainage*	Estimated Volume (m ³)
235-252	50
258-291	50
302-325	20
336-414	300
448-525	700
Notes * Chainage is approximate and refers to plan chainage along 2008 debris flow

Figure A5 - Estimate of Perched Material along Drainage Line from 1963 Aerial Photograph

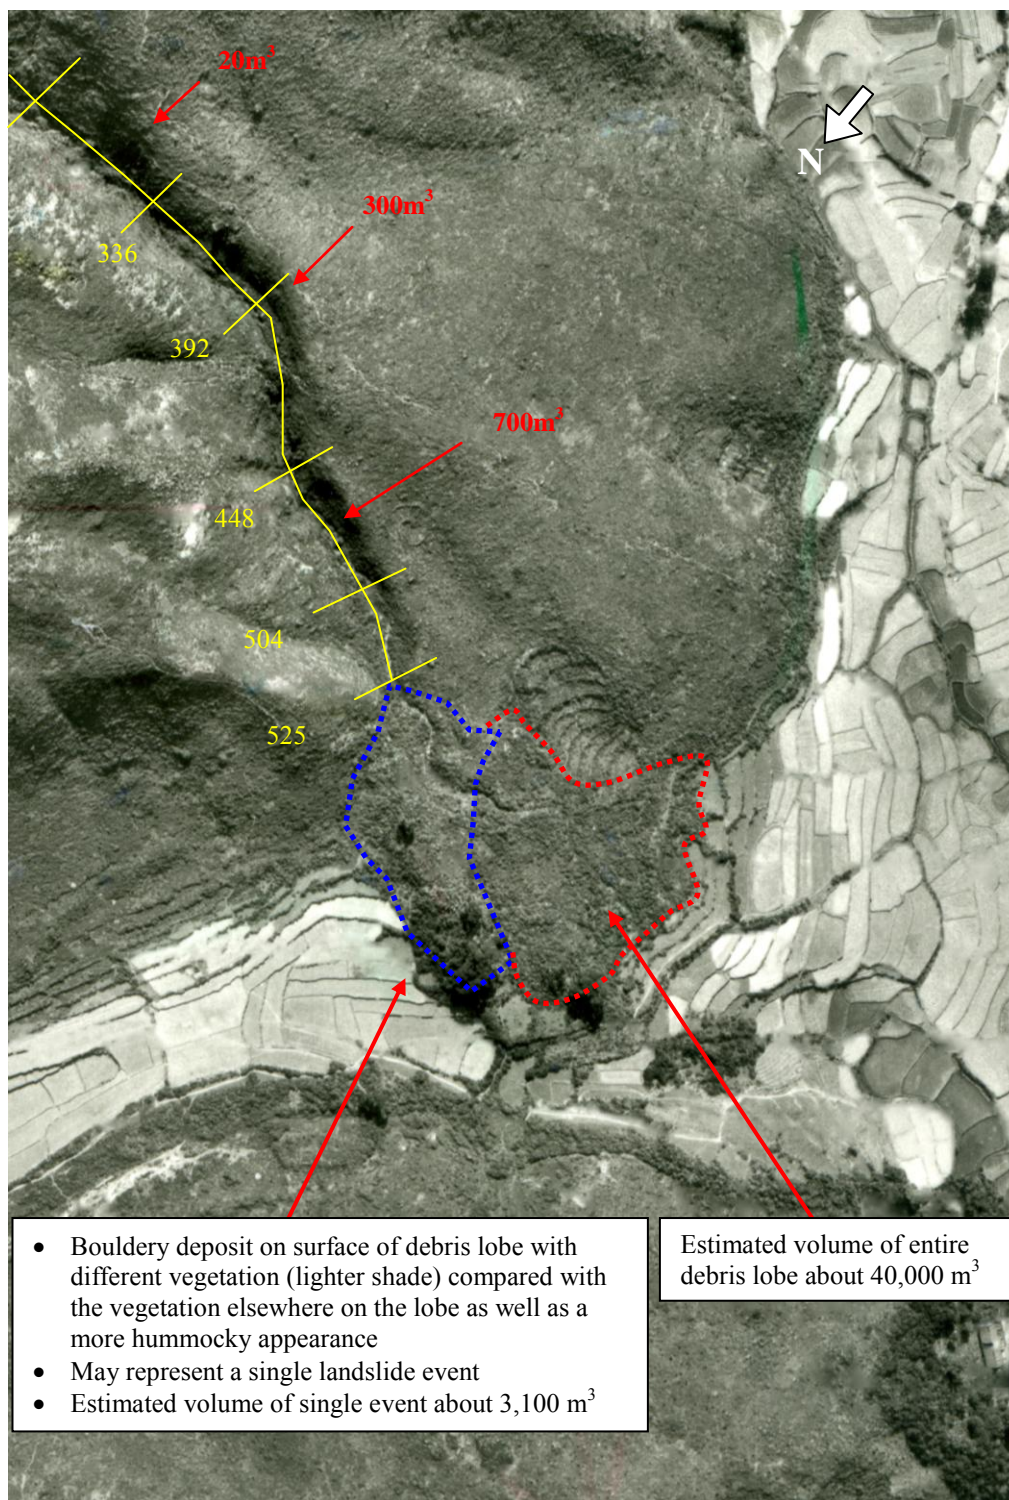
Figure A6 - Extract from 1963 Aerial Photograph Showing Colluvial Debris Lobe at the Outlet of the Drainage Line in Catchment No. 30
