**DETAILED STUDY OF THE  
7 JUNE 2008 LANDSLIDES ON  
THE HILLSIDE ABOVE THE  
NORTH LANTAU HIGHWAY AND  
CHEUNG TUNG ROAD,  
NORTH LANTAU**

**GEO REPORT No. 272**

**AECOM Asia Company Limited**

**GEOTECHNICAL ENGINEERING OFFICE  
CIVIL ENGINEERING AND DEVELOPMENT DEPARTMENT  
THE GOVERNMENT OF THE HONG KONG  
SPECIAL ADMINISTRATIVE REGION**

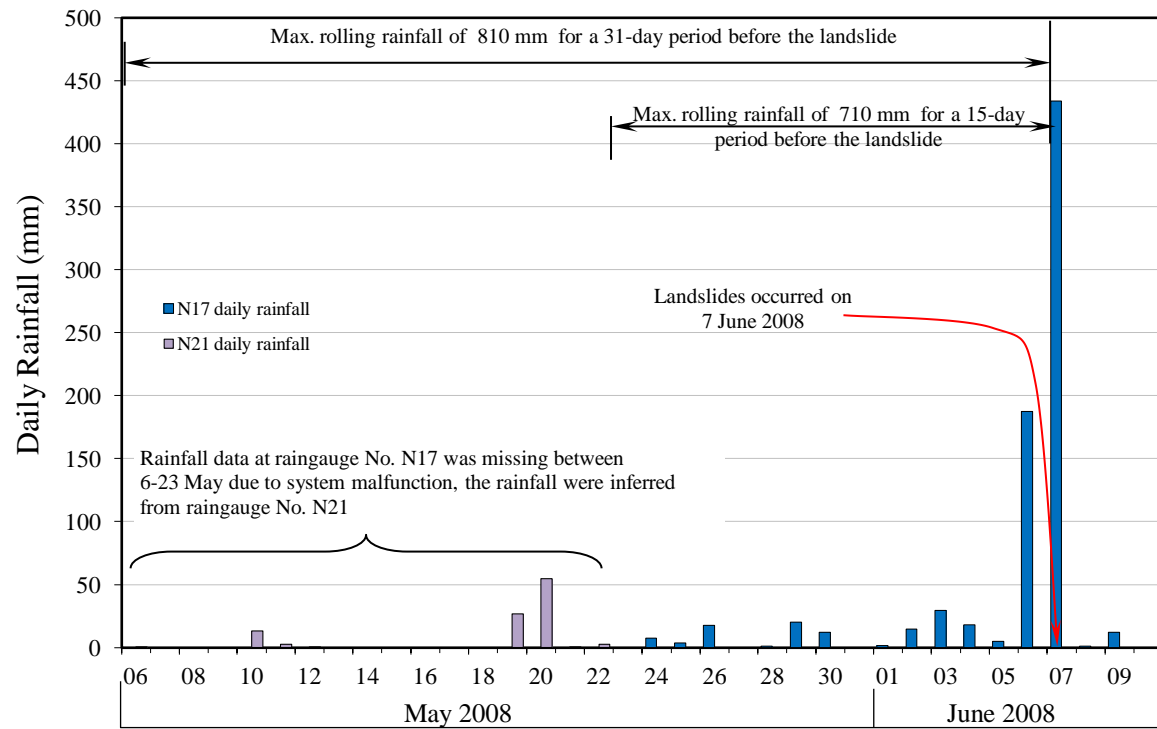
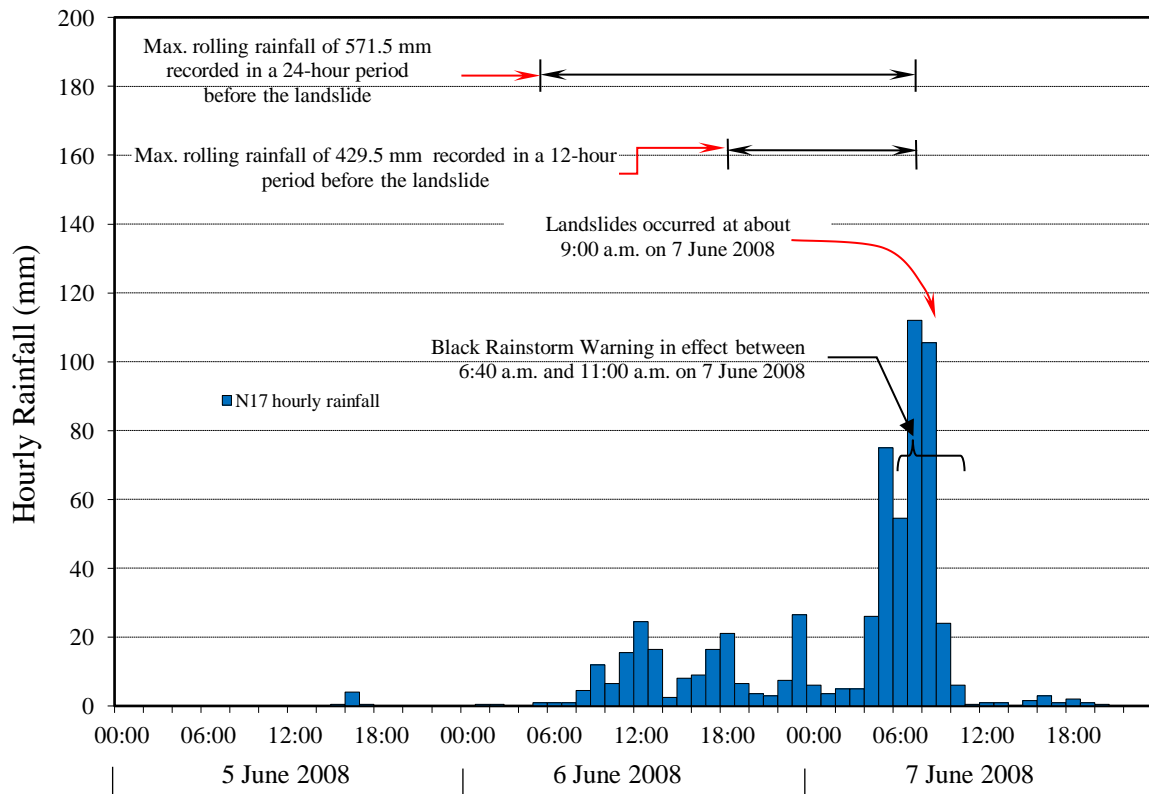
Figure 9 - Daily and Hourly Rainfall Records at GEO Raingauge No. N17

The daily rainfall recorded by the NLH raingauge, and raingauge No. N17 over the month preceding the 7 June 2008 rainstorm, together with the hourly rainfall readings for the period between 5 and 7 June 2008, are presented in Figures 9 and 10. The results show that the intensity of rainfall recorded by raingauge No. N17 is generally higher than that by the NLH raingauge (Figure 10).

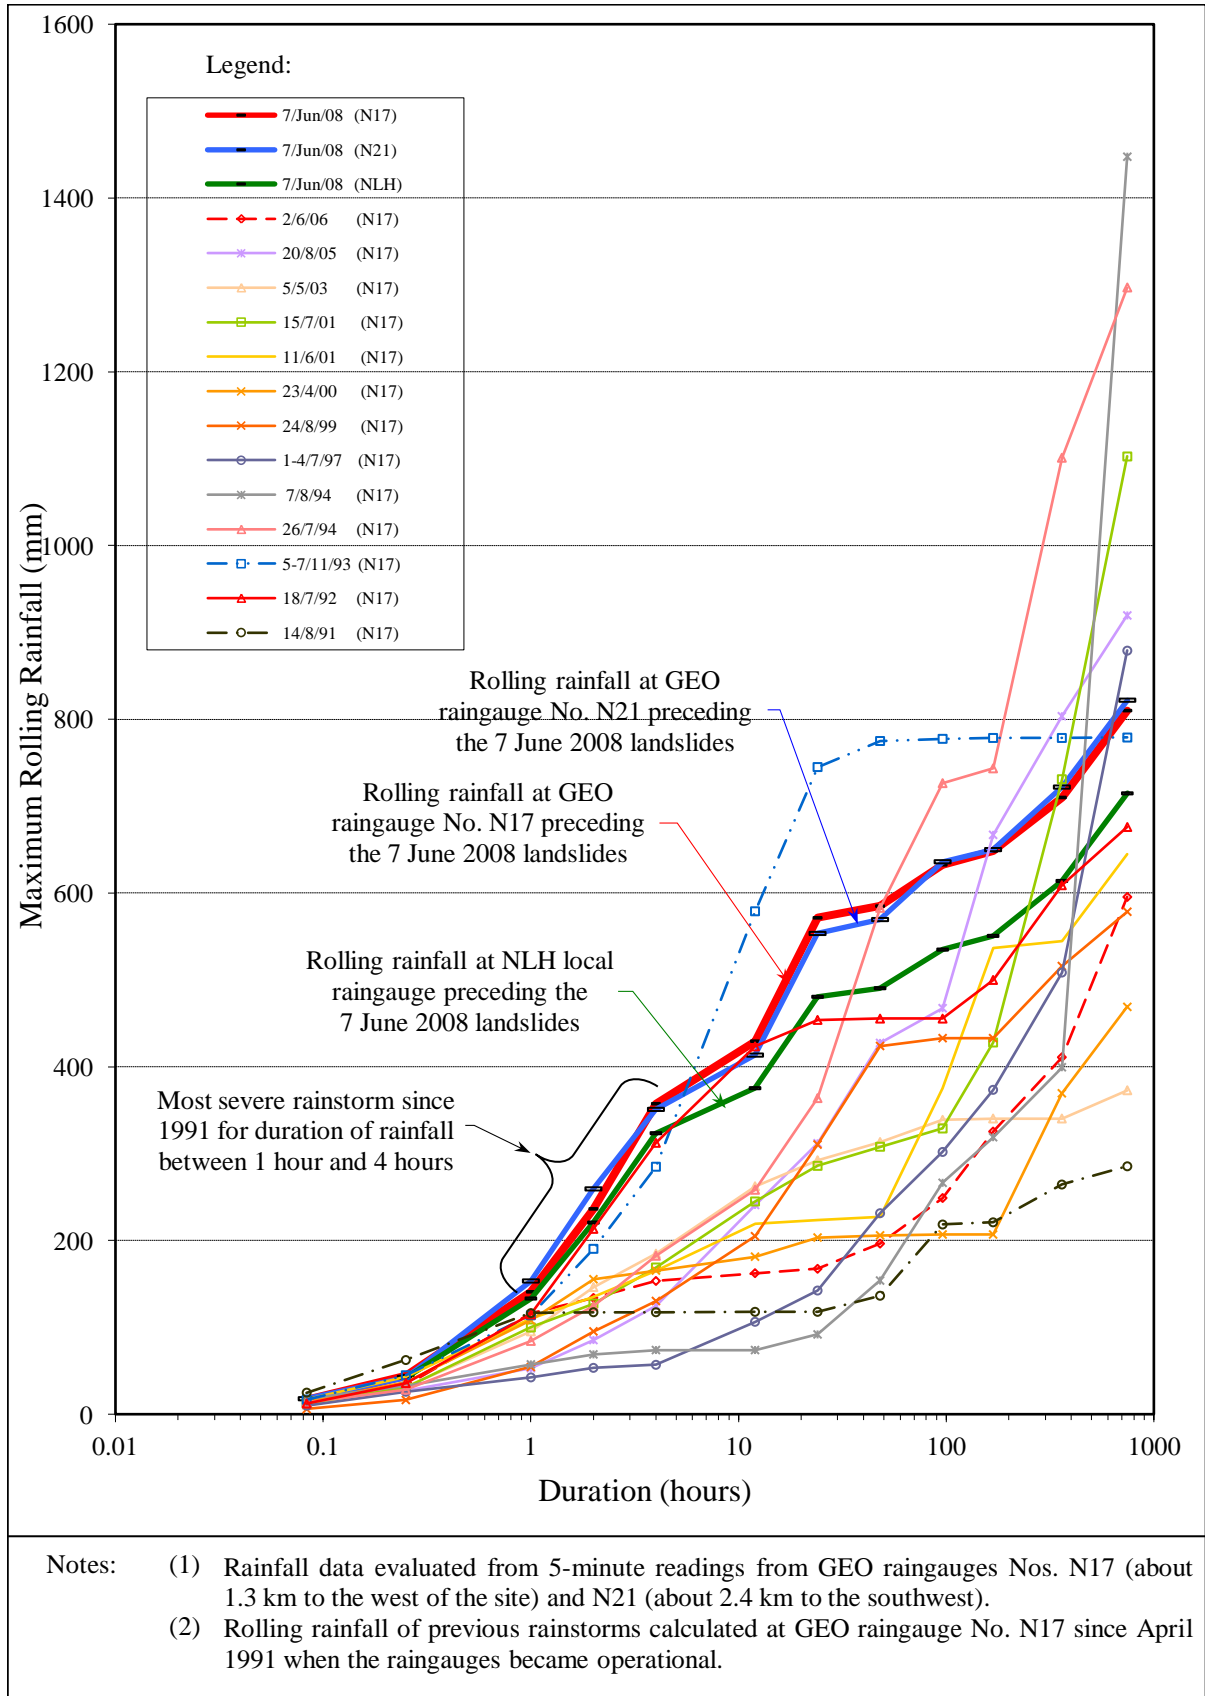
Figure 11 - Maximum Rolling Rainfall for Previous Major Rainstorms at GEO Raingauge No. N17

The maximum rolling rainfall for the 7 June 2008 rainstorm has been compared with the previous major rainstorms recorded by raingauge No. N17, which came into operation in April 1991 (Figure 11). The 7 June 2008 rainstorm is more severe than the previous major rainstorms for rainfall durations between 1 hour and 4 hours.

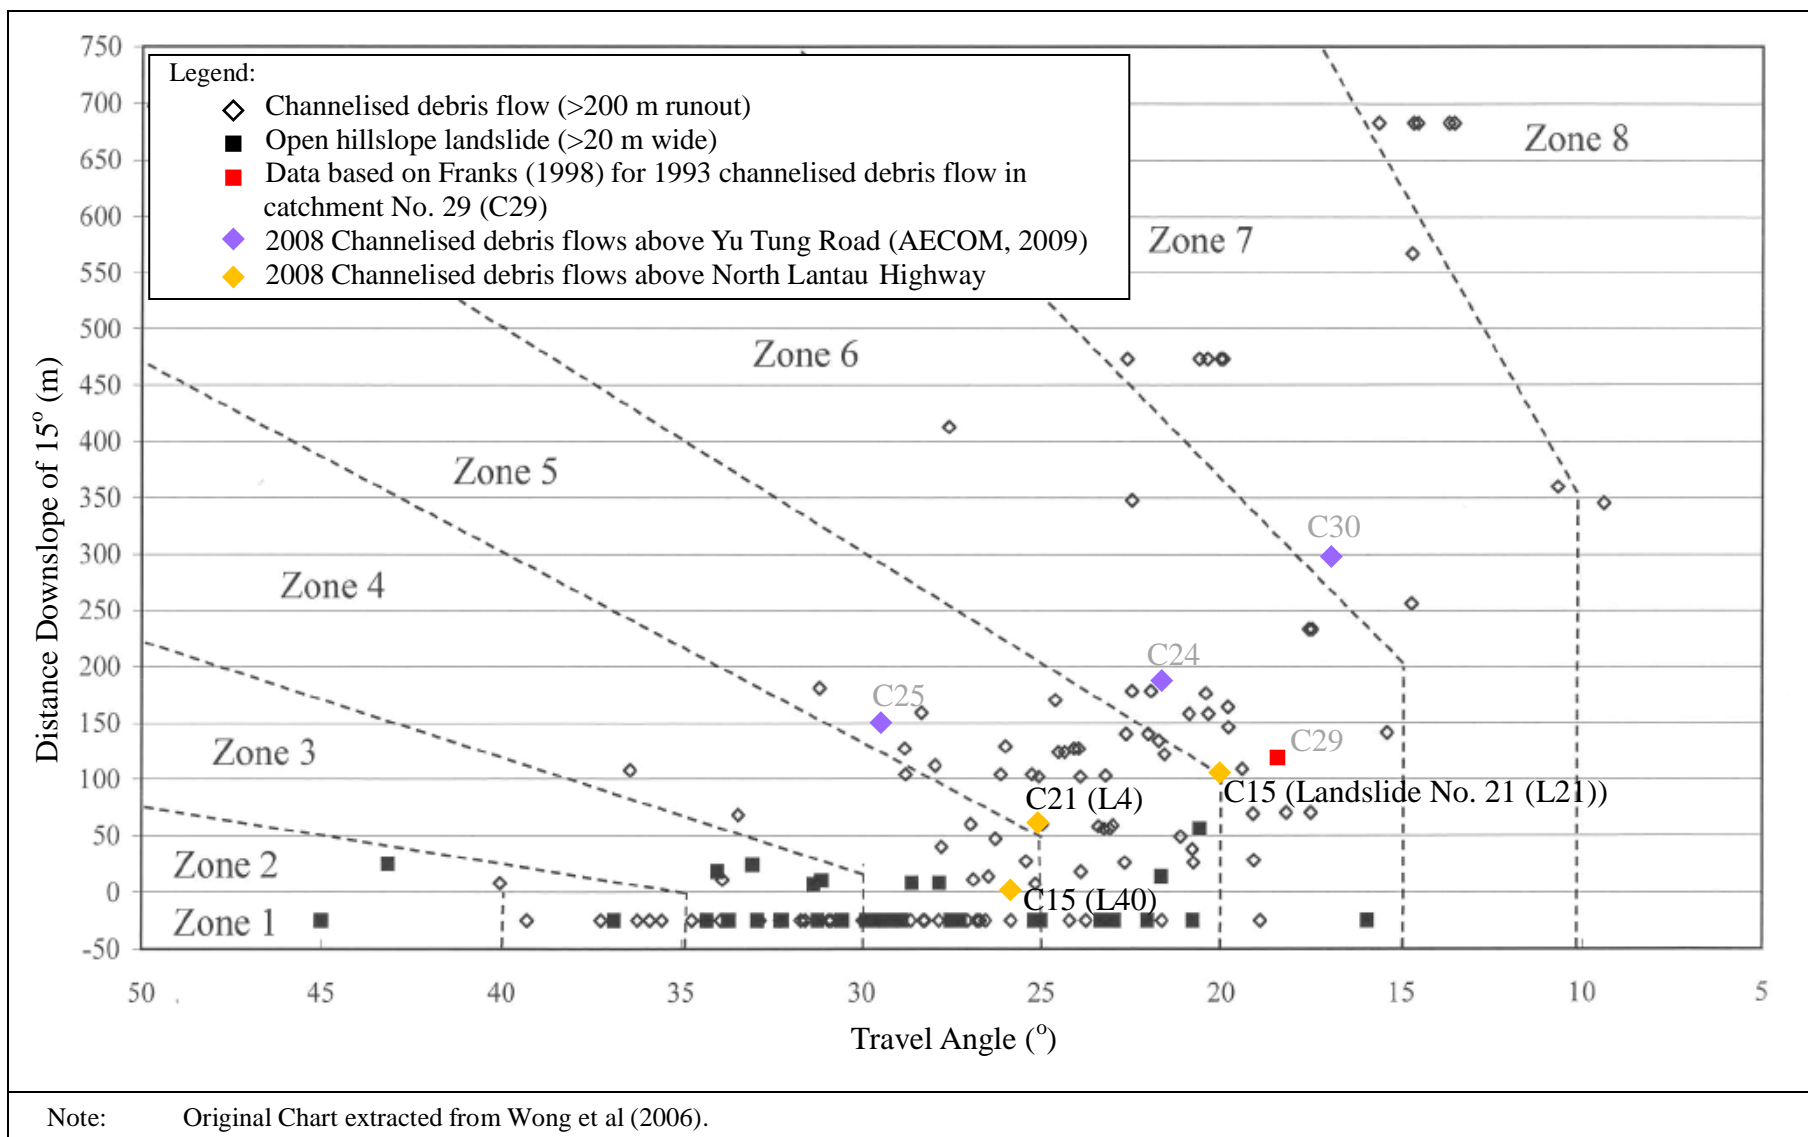
Figure 12 - Proximity Zones and Debris Runout Data from the 2008 Landslides

The CDF from landslide No. L4 travelled a horizontal distance of 320 m, of which about 65 m occurred in the downhill area where the overall gradient is 15° or less. The travel angle<sup>7</sup> of the debris was about 25°. The CDF is not mobile, based on the empirical classification system of Wong (2005) and comparison with previous events of a similar scale in Hong Kong (Figures 12 and 13).

The CDF from landslide No. L40 travelled a horizontal distance of 200 m. The debris was deposited within the drainage line where the channel gradient is about 25°. The travel angle was about 26°. The CDF is not particularly mobile, based on the empirical classification system of Wong (2005) and comparison with previous events of a similar scale in Hong Kong (Figures 12 and 13).

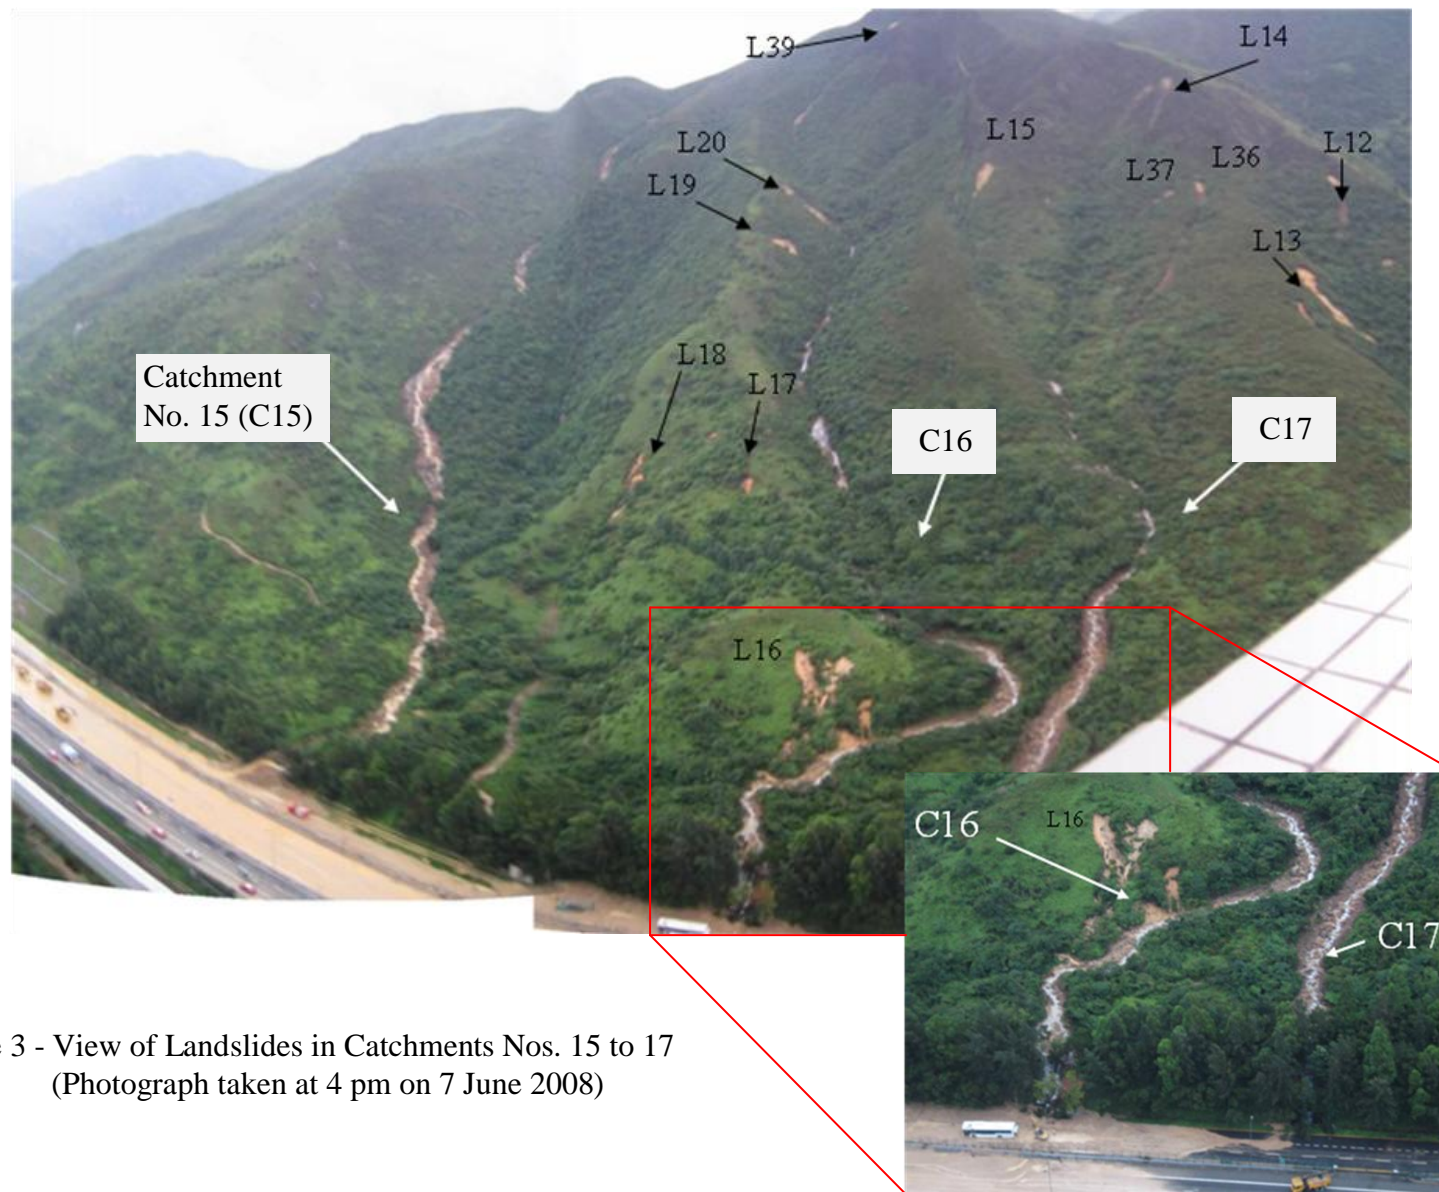
Plate 3 - View of Landslides in Catchments Nos. 15 to 17  
(Photograph taken at 4 pm on 7 June 2008)

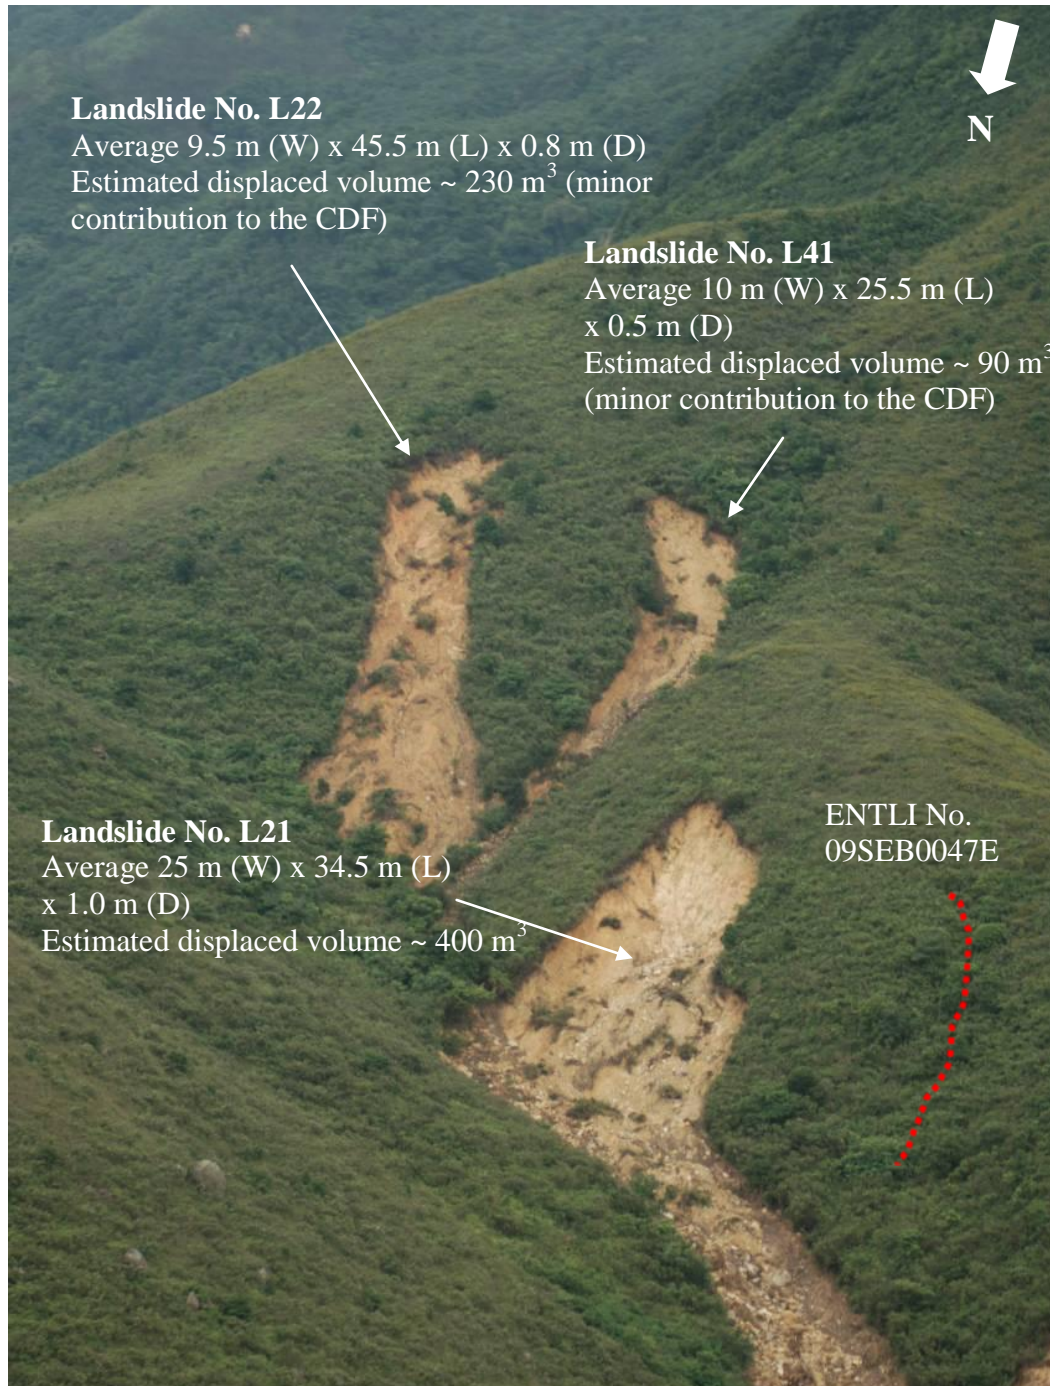
Plate 8 - Oblique Aerial View of Landslides Sources at Head of Catchment No. 15  
(Photograph taken on 16 June 2008)

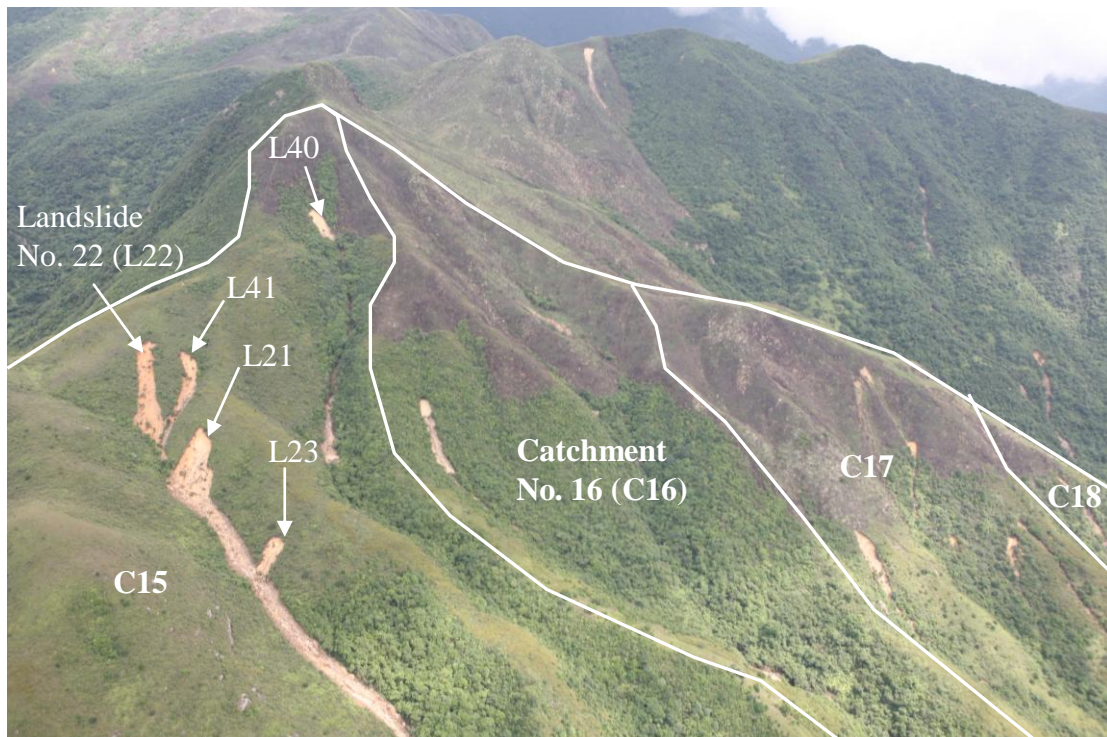
Plate 12 - Oblique Aerial Photograph Showing the Main Landslide Source Areas in the  
Upper Part of Catchment No. 15 (Photograph taken on 12 June 2008)

The remaining five landslides comprised landslides Nos. L40, L17, L18a, L18b and L18c. Landslide No. L40 occurred at the head of the southern drainage line, and developed into a CDF with a runout distance of 200 m (Plate 12). The other four landslides (i.e. Nos. L17, L18a, L18b and L18c) involved open hillslope failures and occurred at the lower part of the terrain (Figure 1).

Landslide No. L40 (Plate 12) occurred at 374 mPD in catchment No. 15, with a failure volume of 115 m<sup>3</sup>. The landslide was located near the head of the southern drainage line in the catchment. The failure source area measured about 22 m long, 10 m wide and up to 1.5 m deep (Plate B1). The rupture surface appeared to be mostly along colluvium/saprolite interface, and partly through the top of the in-situ highly decomposed tuff, exposing some back release joints (325/77). A footpath was observed traversing the source area near CH15, and some minor soil pipes were noted at the main scarp area (Plates B1 and B2).

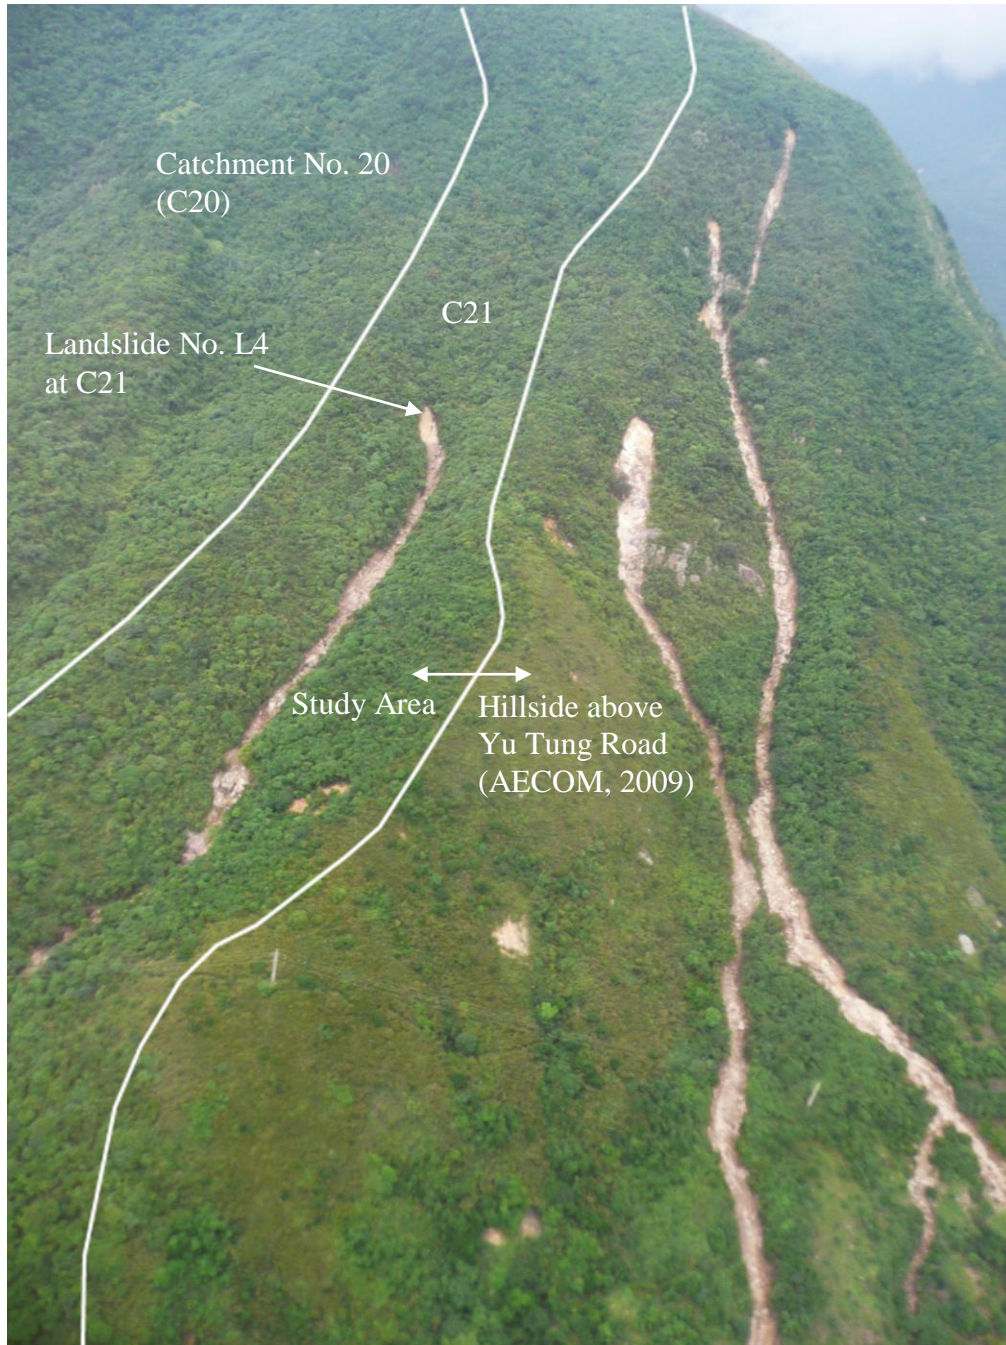
Plate 13 - Oblique Aerial View of Landslide No. L4 in Catchment No. 21  
(Photograph taken on 16 June 2008)

The 7 June 2008 rainstorm triggered two landslides (Nos. L4 and L53) in catchment No. 21. Landslide No. L53 was an open hillslope failure and was located some 70 m away from the drainage line (Figure 1). Landslide No. L4 occurred at an elevation of 230 mPD at the eastern flank of a north-flowing drainage line (Plate 13).

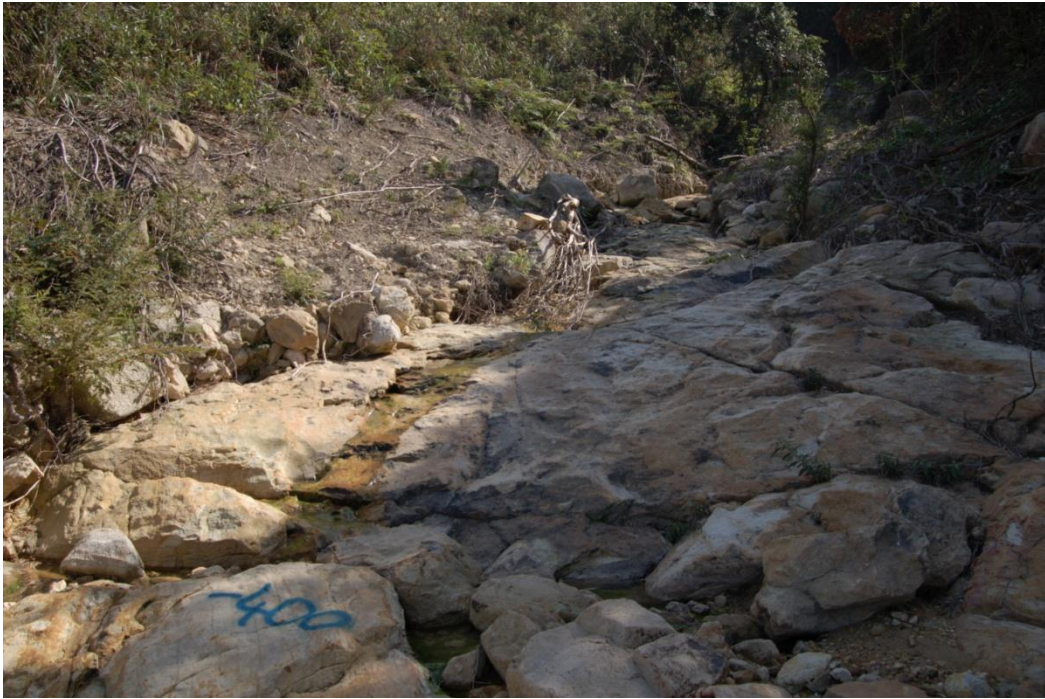
Plate 18 - View at CH340 (Looking Up) Revealing Transport over Topsoil and Rocky Streambed along the Northern Drainage Line in Catchment No. 15 (Photograph taken on 27 November 2008)

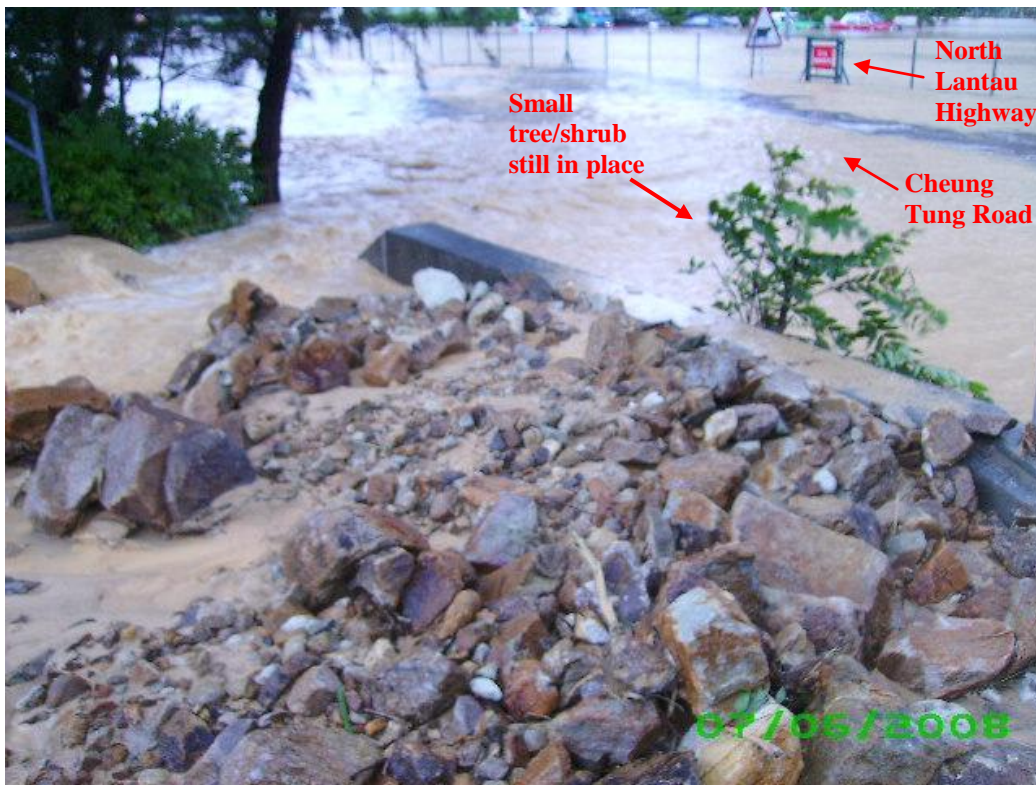
Plate 28 - Drainage Inlet in Catchment No. 15 (Photograph taken at 11:30 am on 7 June 2008)

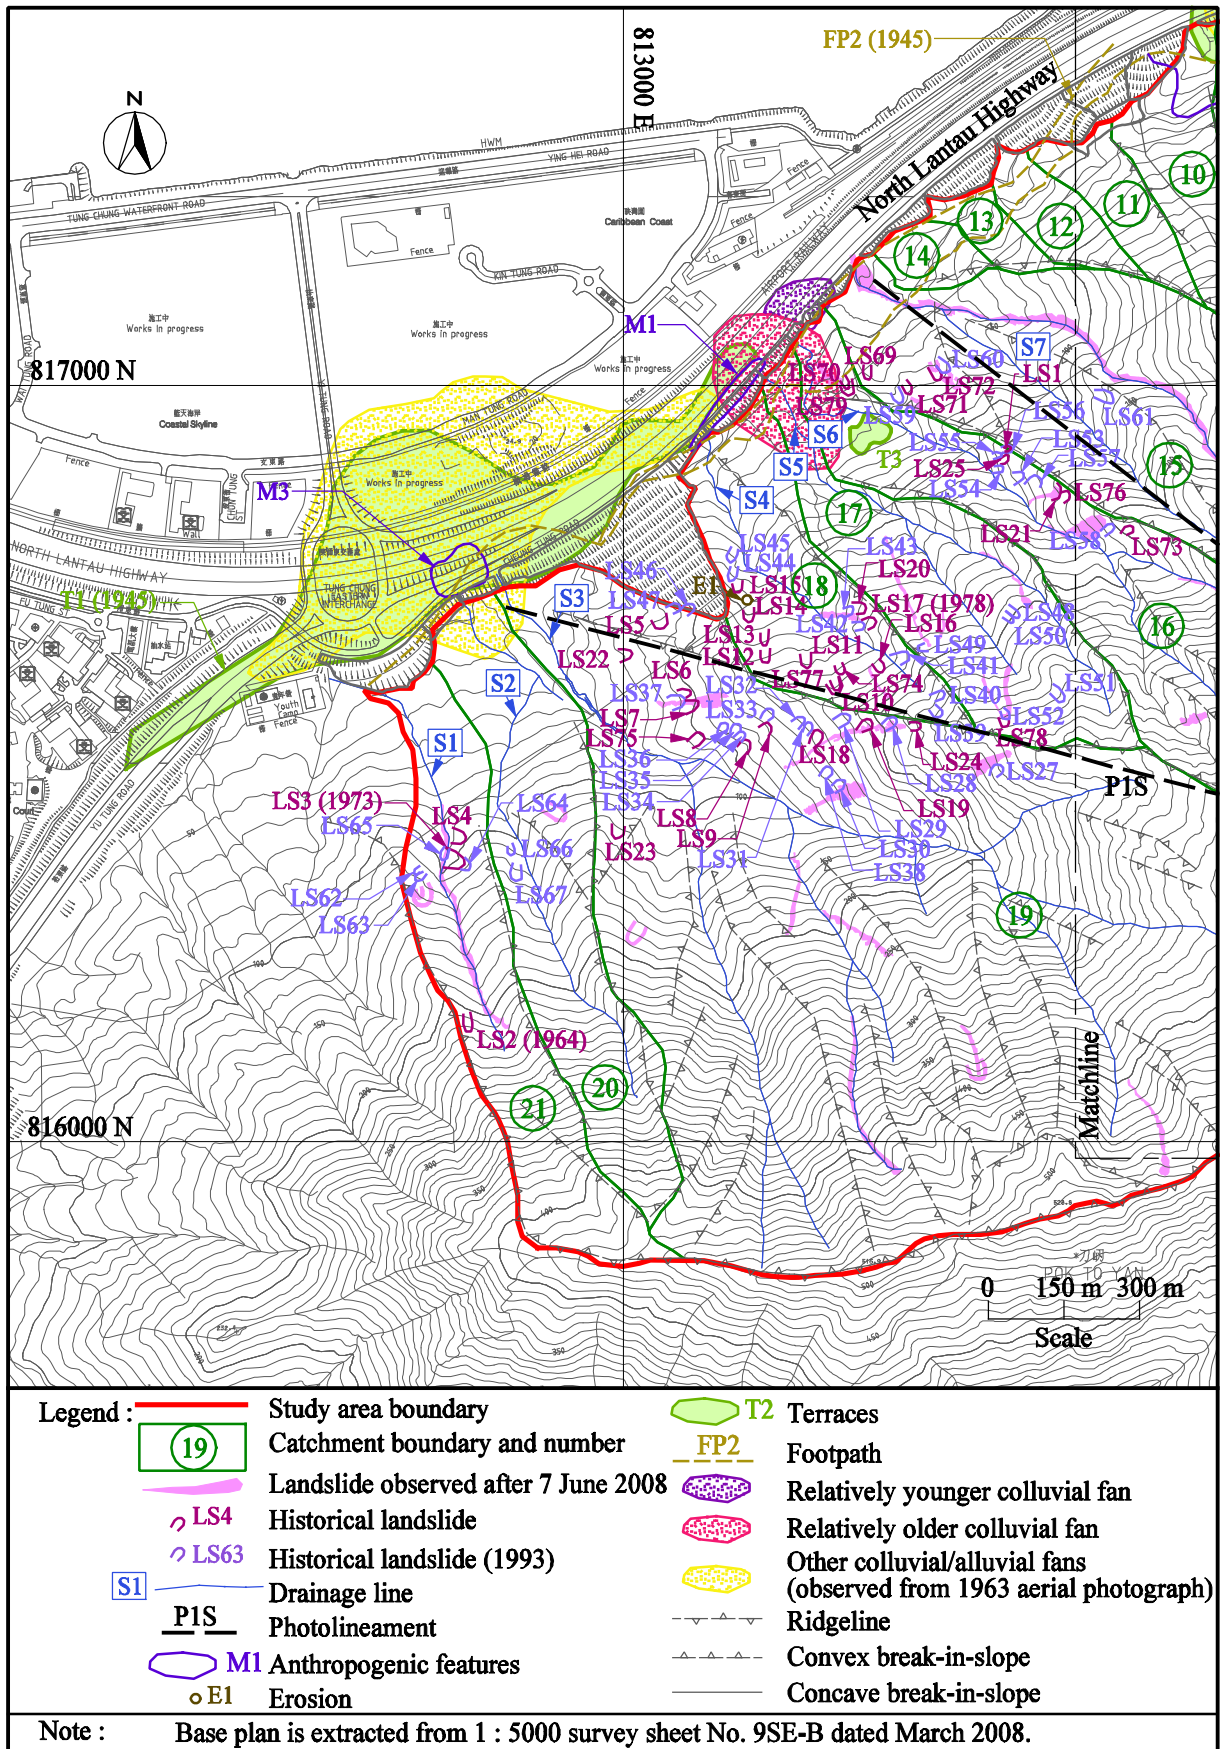
Figure A1 - Detailed Site History and Geomorphological Plan (Western Study Area)

A recent open hillslide (LS1, Figure A1) is observed at the midslope of catchment No. 16. Some dwellings (M1, Figure A1) are evident near the crest of the terraces (T1, Figure A1) in catchments Nos. 16, 17 and 18.

An open hillside landslide (LS2, Figure A1) is observed at the west flank of catchment No. 21.

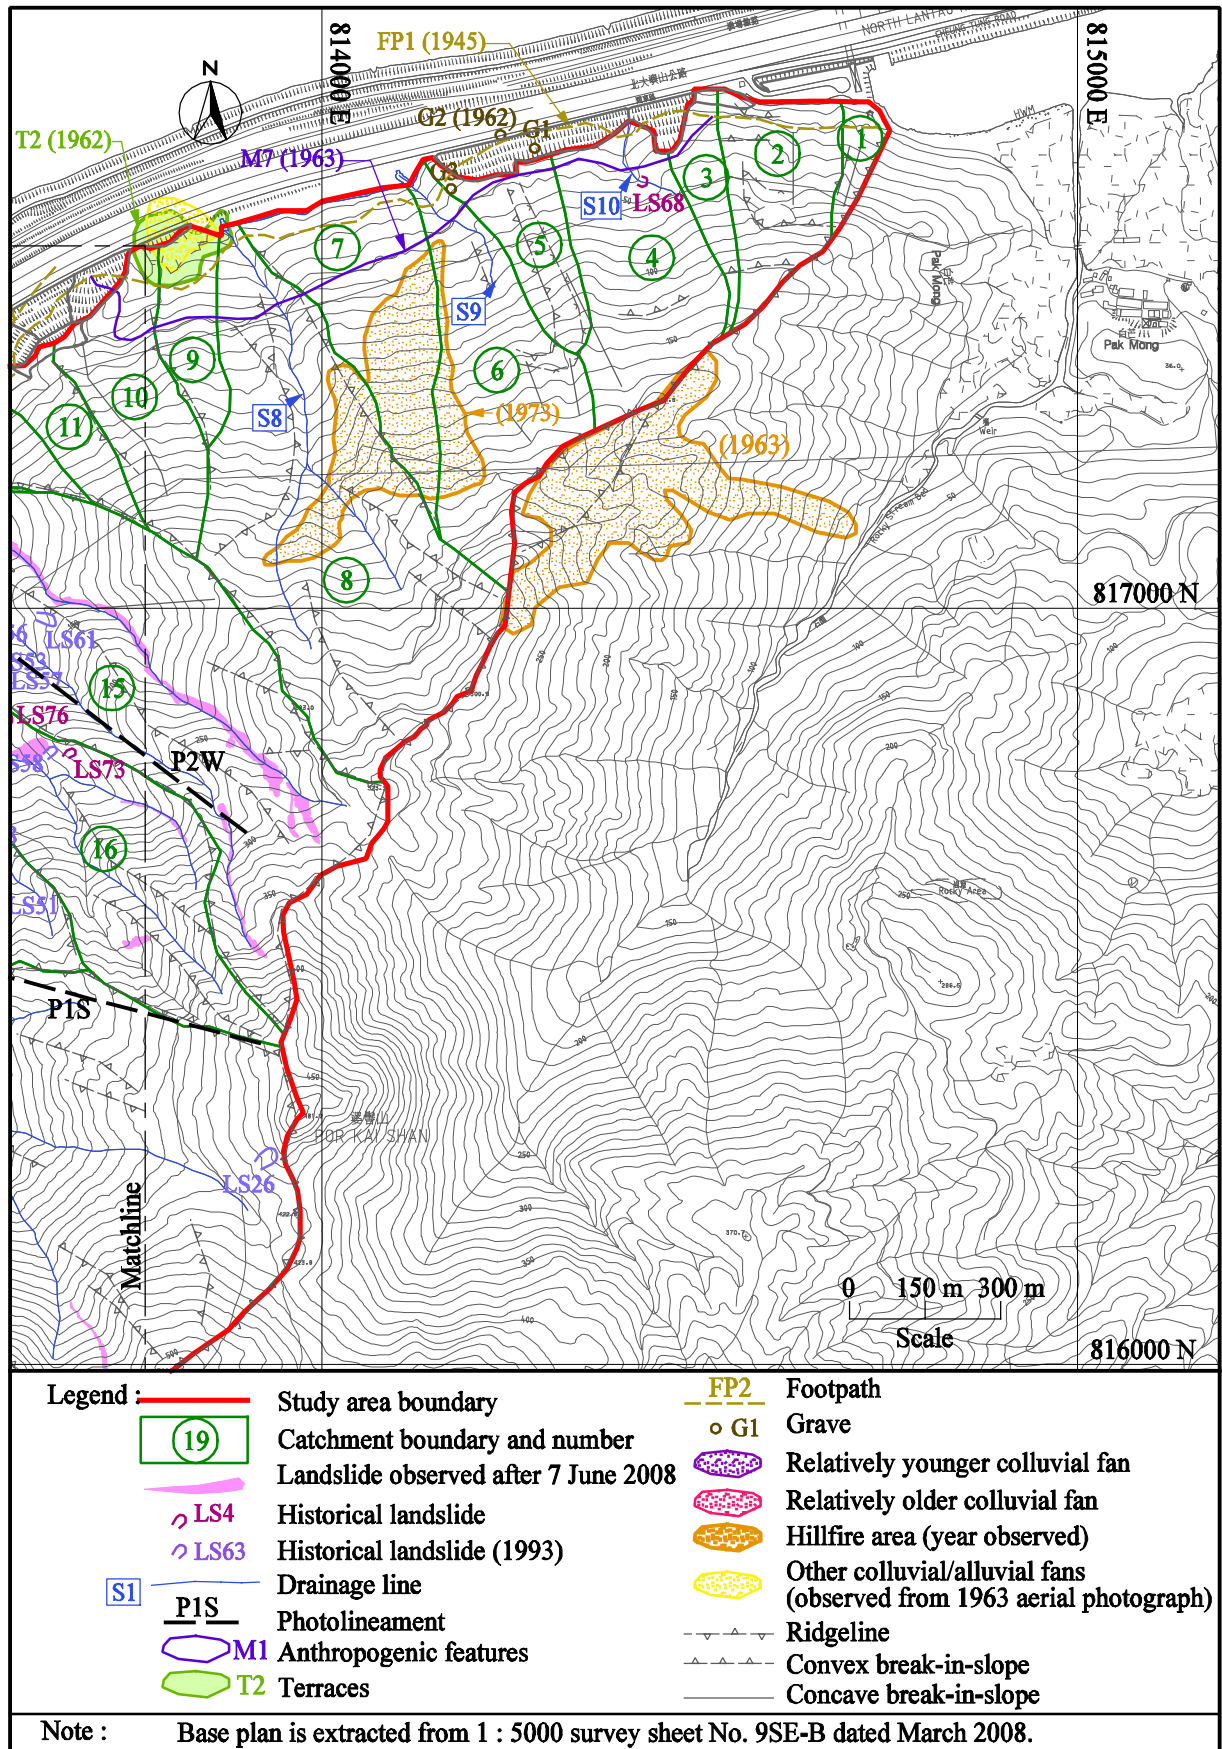
Figure A2 - Detailed Site History and Geomorphological Plan (Eastern Study Area)

Three graves (G1, G2 and G3, Figure A2) are observed adjacent to the footpath (FP1, Figure A2), near the toeslope area of catchments Nos. 4 and 5.

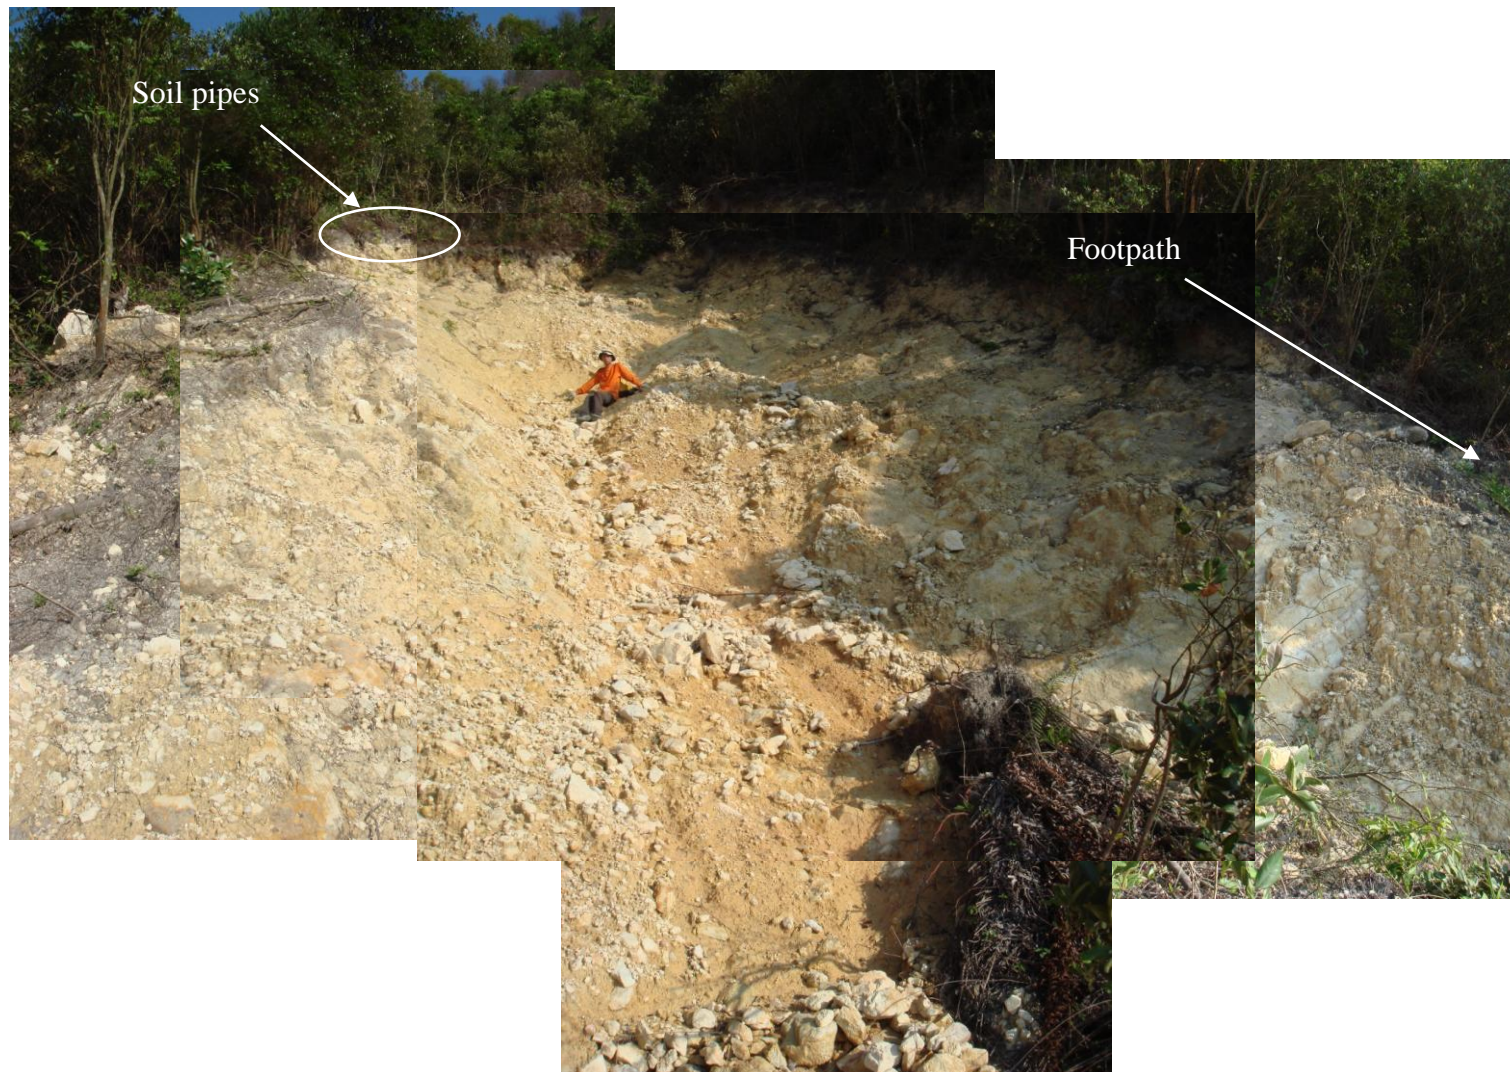
Plate B1 - Source Area of Landslide No. L40 in Catchment No. 15 (Photograph taken on 14 August 2008)

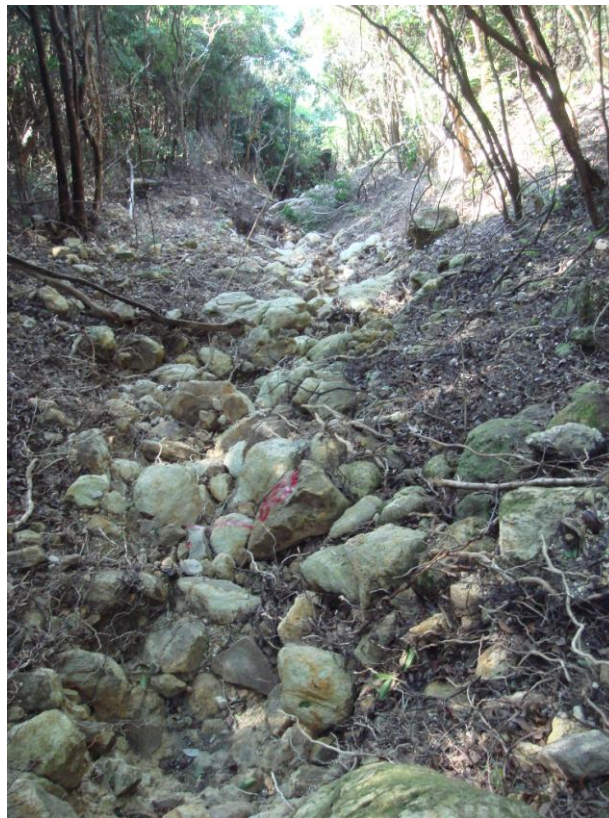
Plate B3 - View at CH100 (Looking Down) in the Southern Drainage Line in Catchment No. 15 Showing the Transport Zone with Limited Amount of Erosion (Photograph taken on 18 August 2008)

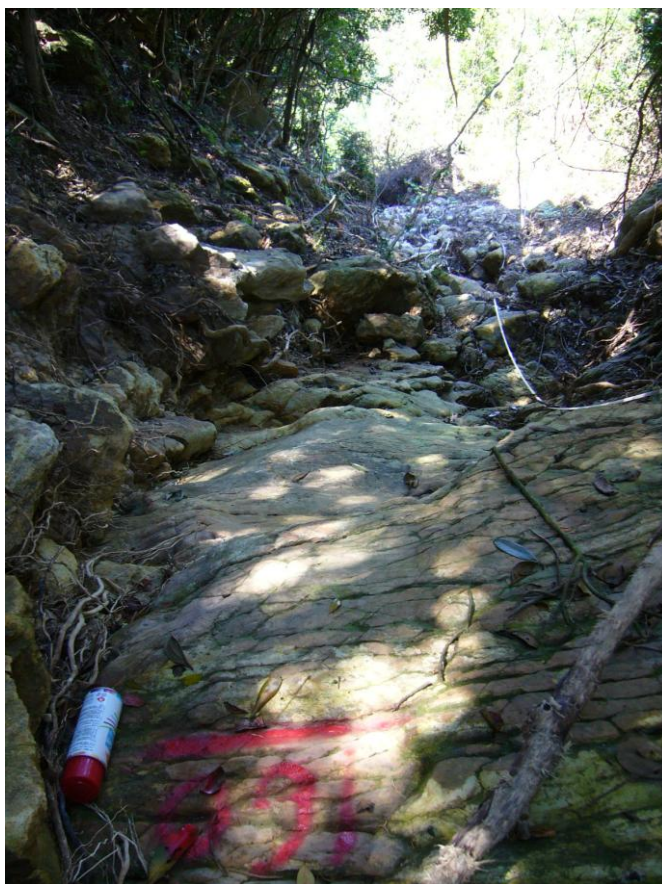
Plate B4 - View at CH150 (Looking Down) Showing Smooth Rocky Streambed in the Southern Drainage Line in Catchment No. 15 (Photograph taken on 18 August 2008)

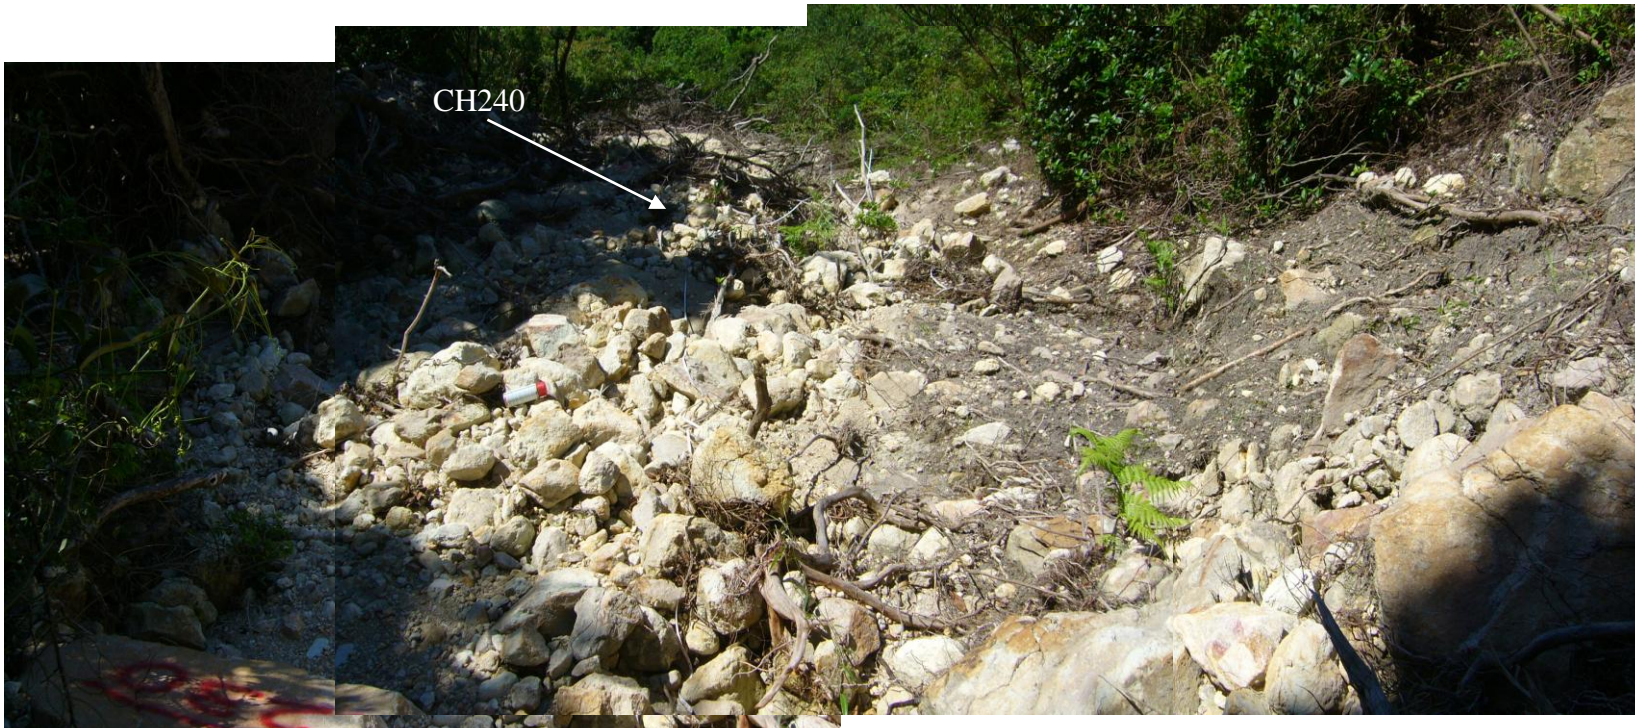
Plate B6 - Main Body of Deposit at CH230 in the Southern Drainage Line in Catchment No. 15  
(Photograph taken on 18 August 2008)
