**DETAILED STUDY OF THE  
7 JUNE 2008 LANDSLIDES ON  
THE HILLSIDE ABOVE THE  
NORTH LANTAU HIGHWAY AND  
CHEUNG TUNG ROAD,  
NORTH LANTAU**

**GEO REPORT No. 272**

**AECOM Asia Company Limited**

**GEOTECHNICAL ENGINEERING OFFICE  
CIVIL ENGINEERING AND DEVELOPMENT DEPARTMENT  
THE GOVERNMENT OF THE HONG KONG  
SPECIAL ADMINISTRATIVE REGION**

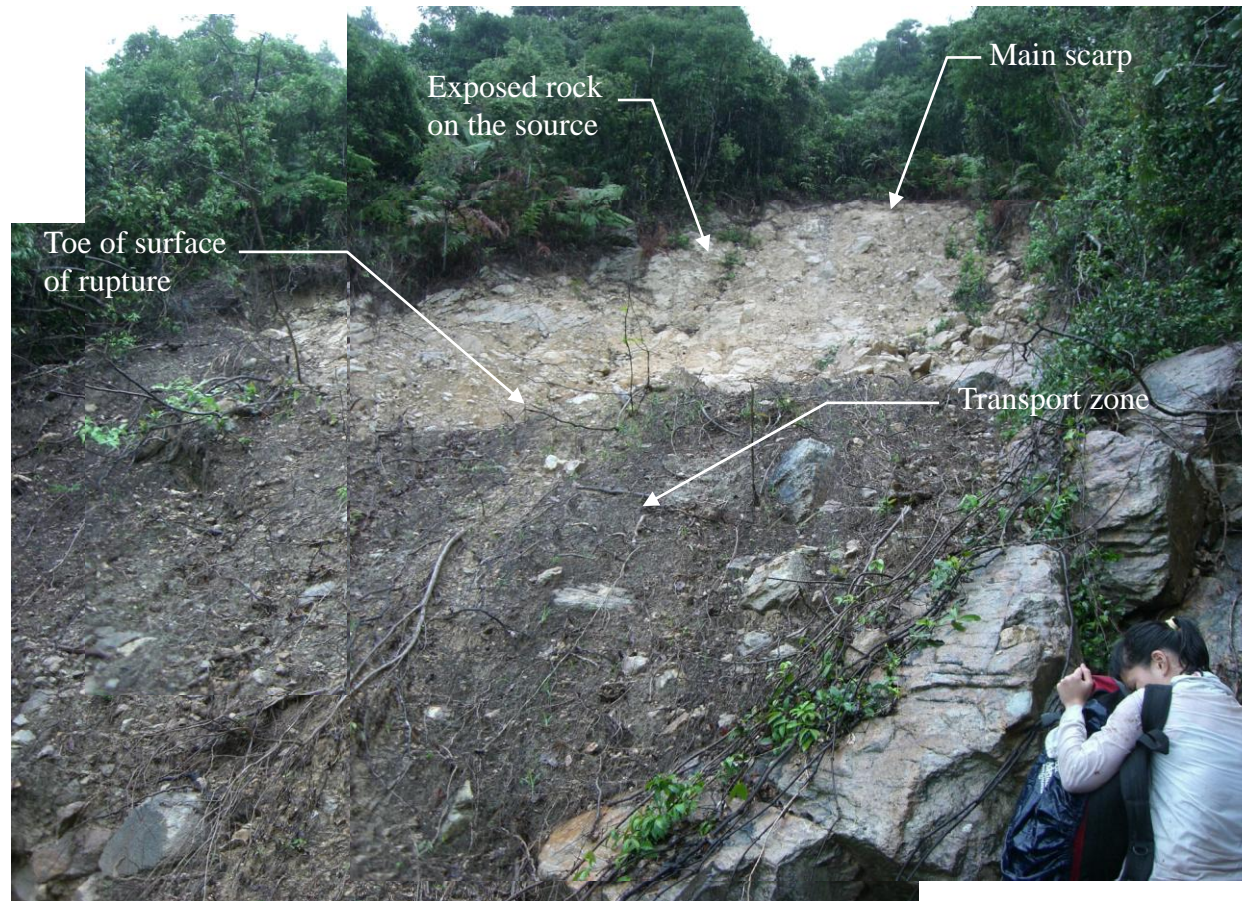
Plate B7 - View of Landslide Source Area of Landslide No. L4 in Catchment No. 21  
(Photograph taken on 11 August 2008)

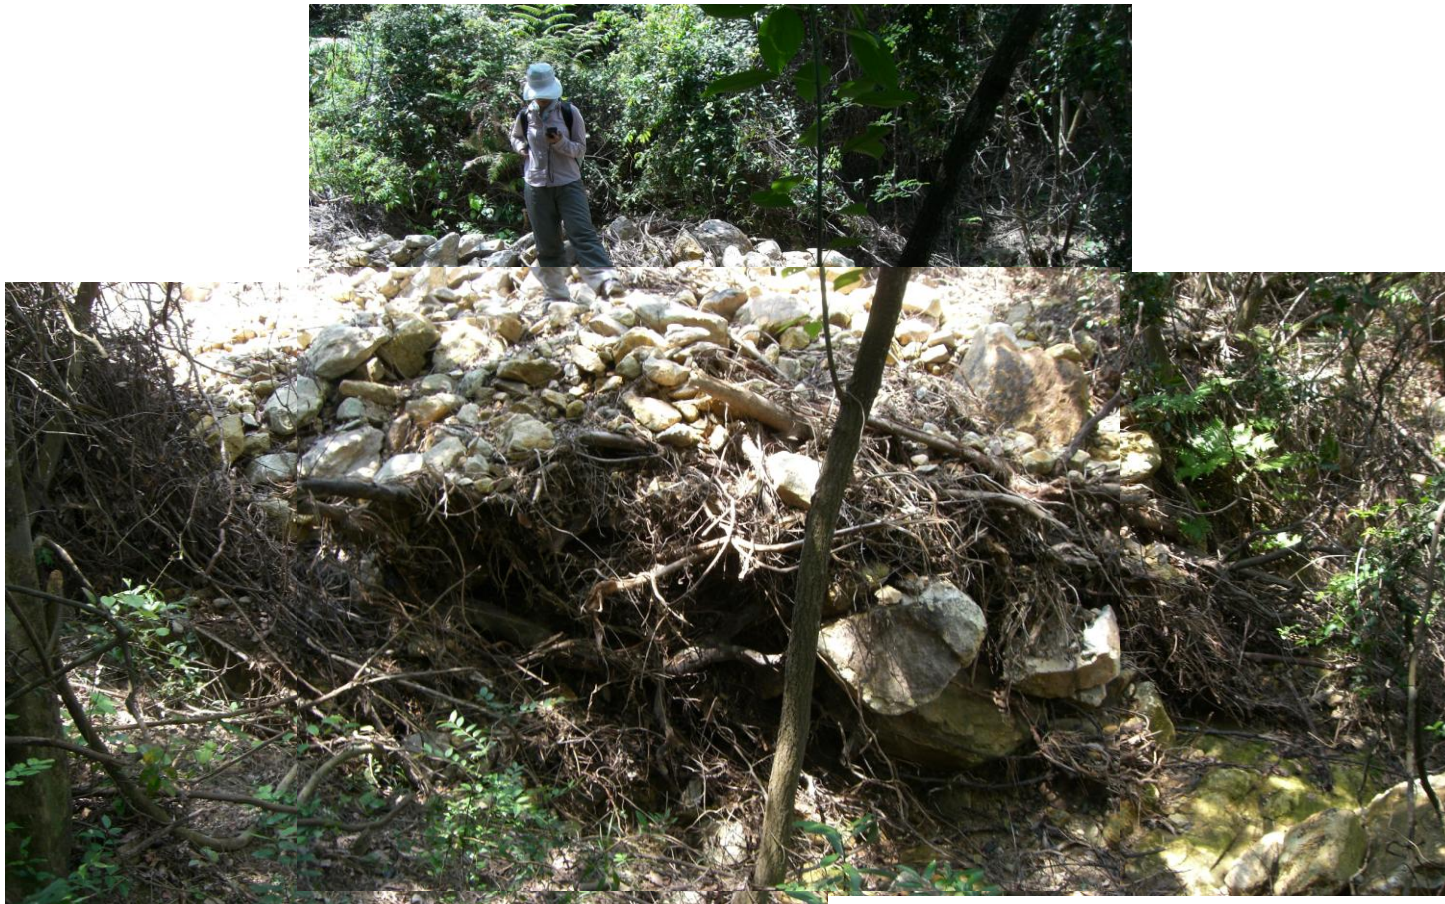
Plate B11 - View of Landslide Distal Toe at CH320 of Catchment No. 21 (Photograph taken on 14 August 2008)
