Review of Landslides in 2008

GEO Report No. 274

**Geotechnical Engineering Office
Civil Engineering and Development Department
The Government of the Hong Kong
Special Administrative Region**

**This report was originally produced in December 2009
as GEO Landslide Study Report No. LSR 15/2009**

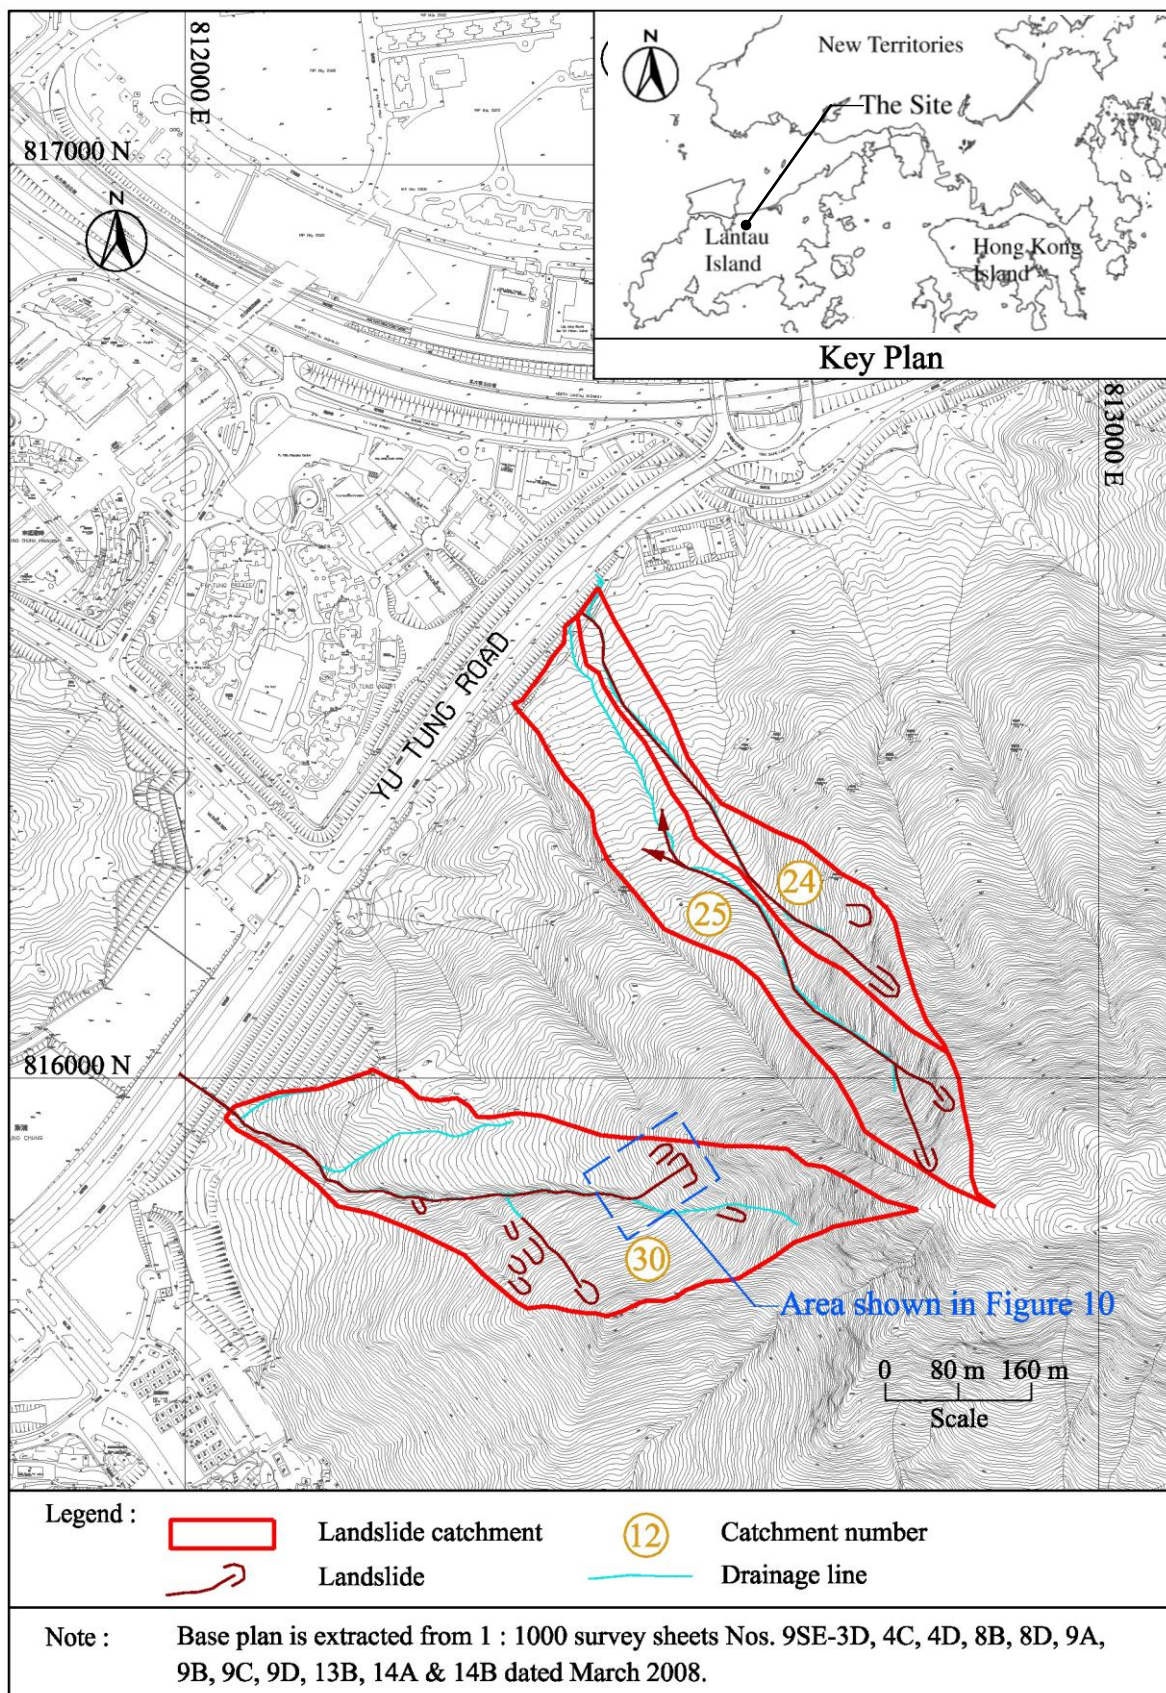
Figure 4.7 Location Plan of the 7 June 2008 Landslides on the Hillside above Yu Tung Road

In both the HKU and Yu Tung Road landslides, the failures were spatially extensive, measuring up to about 30 m wide and 50 long, and occurring at relatively steep parts of the hillside. The HKU landslide occurred at a location where a large area of accumulation of colluvial deposits had been formed over time as a result of relatively frequent, moderate scale landslide activities in the past (Figures 4.5 and 4.6). Similarly, the Yu Tung Road landslide occurred where large areas of boulderly deposits had accumulated (Figures 4.7 and 4.8), as a result of landsliding activities, together with general mass wasting processes. In both cases, the scale of the failures appears to have been influenced by the presence and deterioration of the accumulated debris and site topography, together with the characteristics of the 7 June 2008 rainstorm.

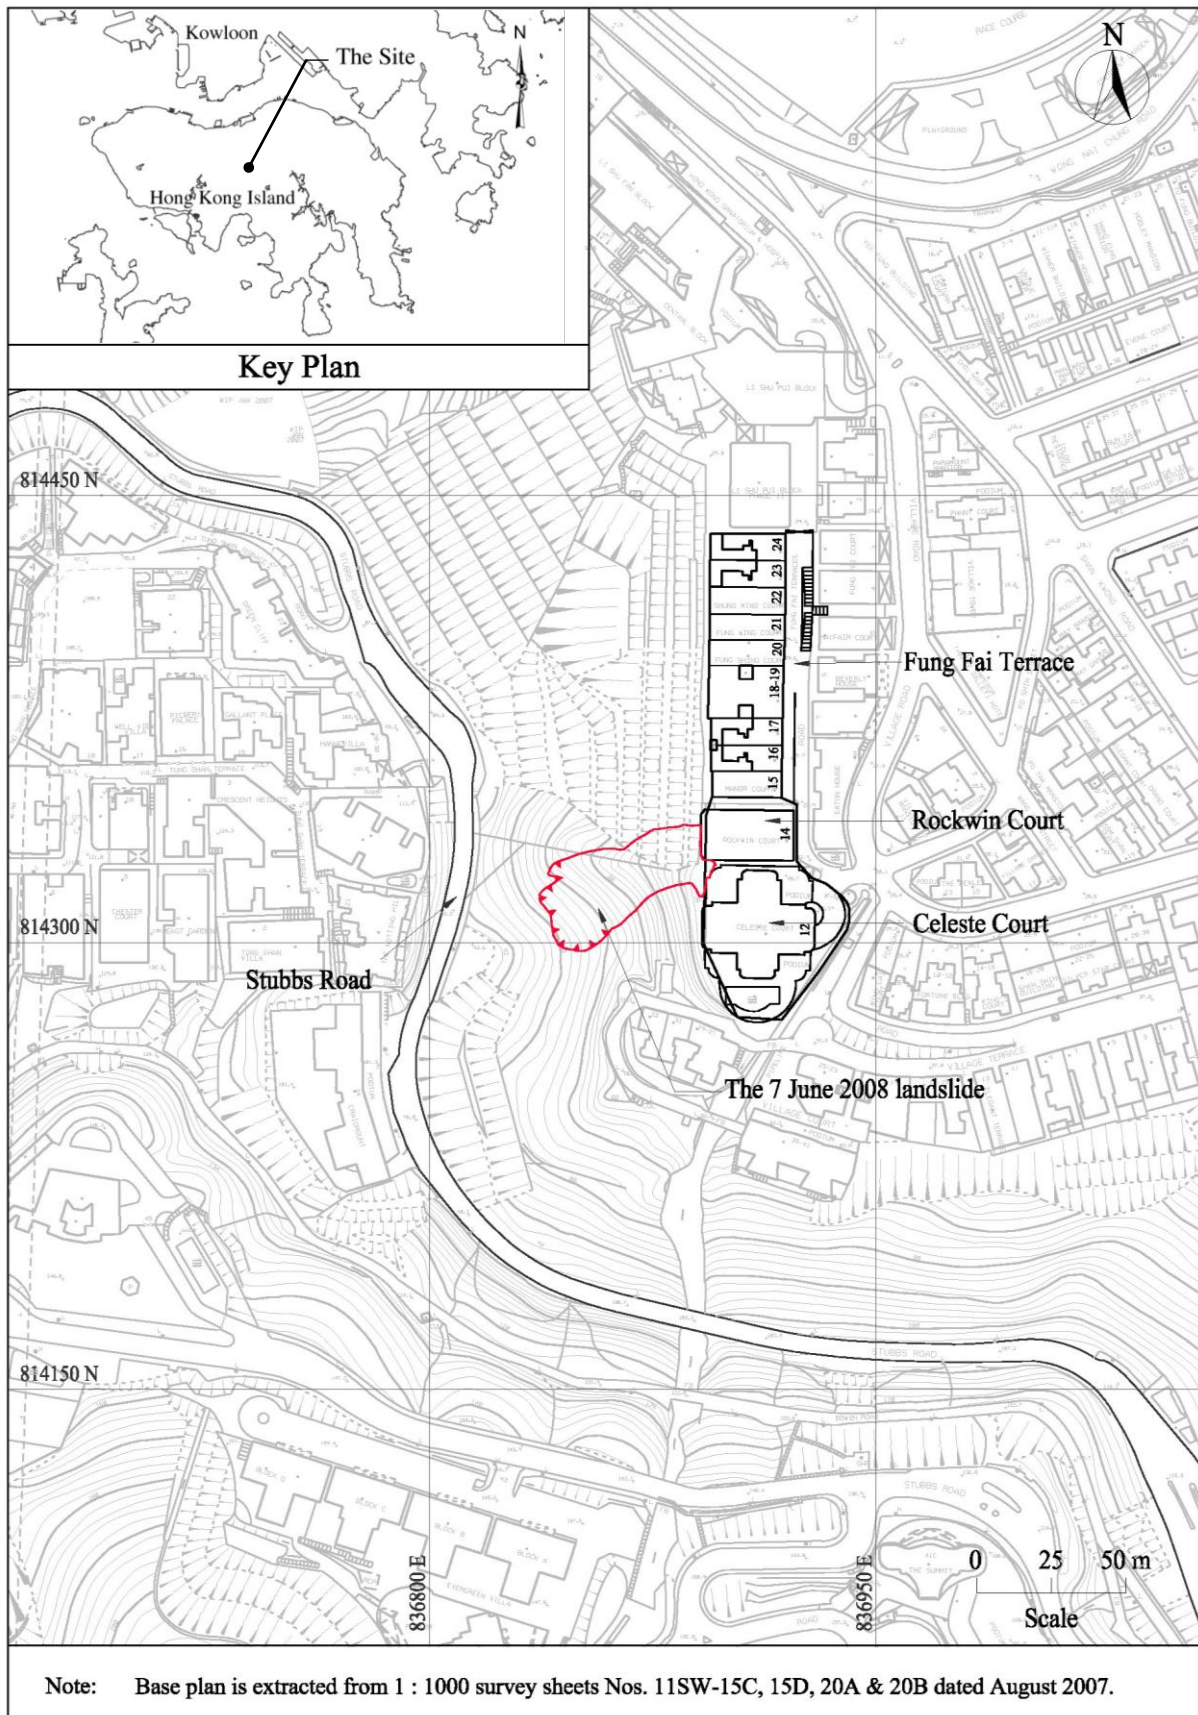
Figure 4.9 Location Plan of the 7 June 2008 Landslide behind Rockwin Court, Fung Fai Terrace

In 2008, some landslides occurred on hillside pockets close to developments in urban areas, and three of them have been identified as major failures and affecting residential buildings. Amongst these three major failures, one notable landslide (Incident No. 2008/06/0156) occurred on 7 June 2008 on the hillside behind Rockwin Court, Fung Fai Terrace, Happy Valley (Figure 4.9). The estimated failure volume was 500 m³. Some landslide debris travelled down to the rear garden of Rockwin Court and went into the flats of Rockwin Court adjacent to the toe of the hillside. Residents in nine affected flats of
