**Review of the  
7 June 2008 Landslide Cluster  
on the Natural Hillside  
above Tai O San Tsuen,  
Tai O, Lantau Island**

**GEO Report No. 275**

**AECOM Asia Company Limited**

Agreement No. CE 41/2007 (GE)  
Study of Landslides Occurring in Kowloon  
and the New Territories in 2008 – 2009

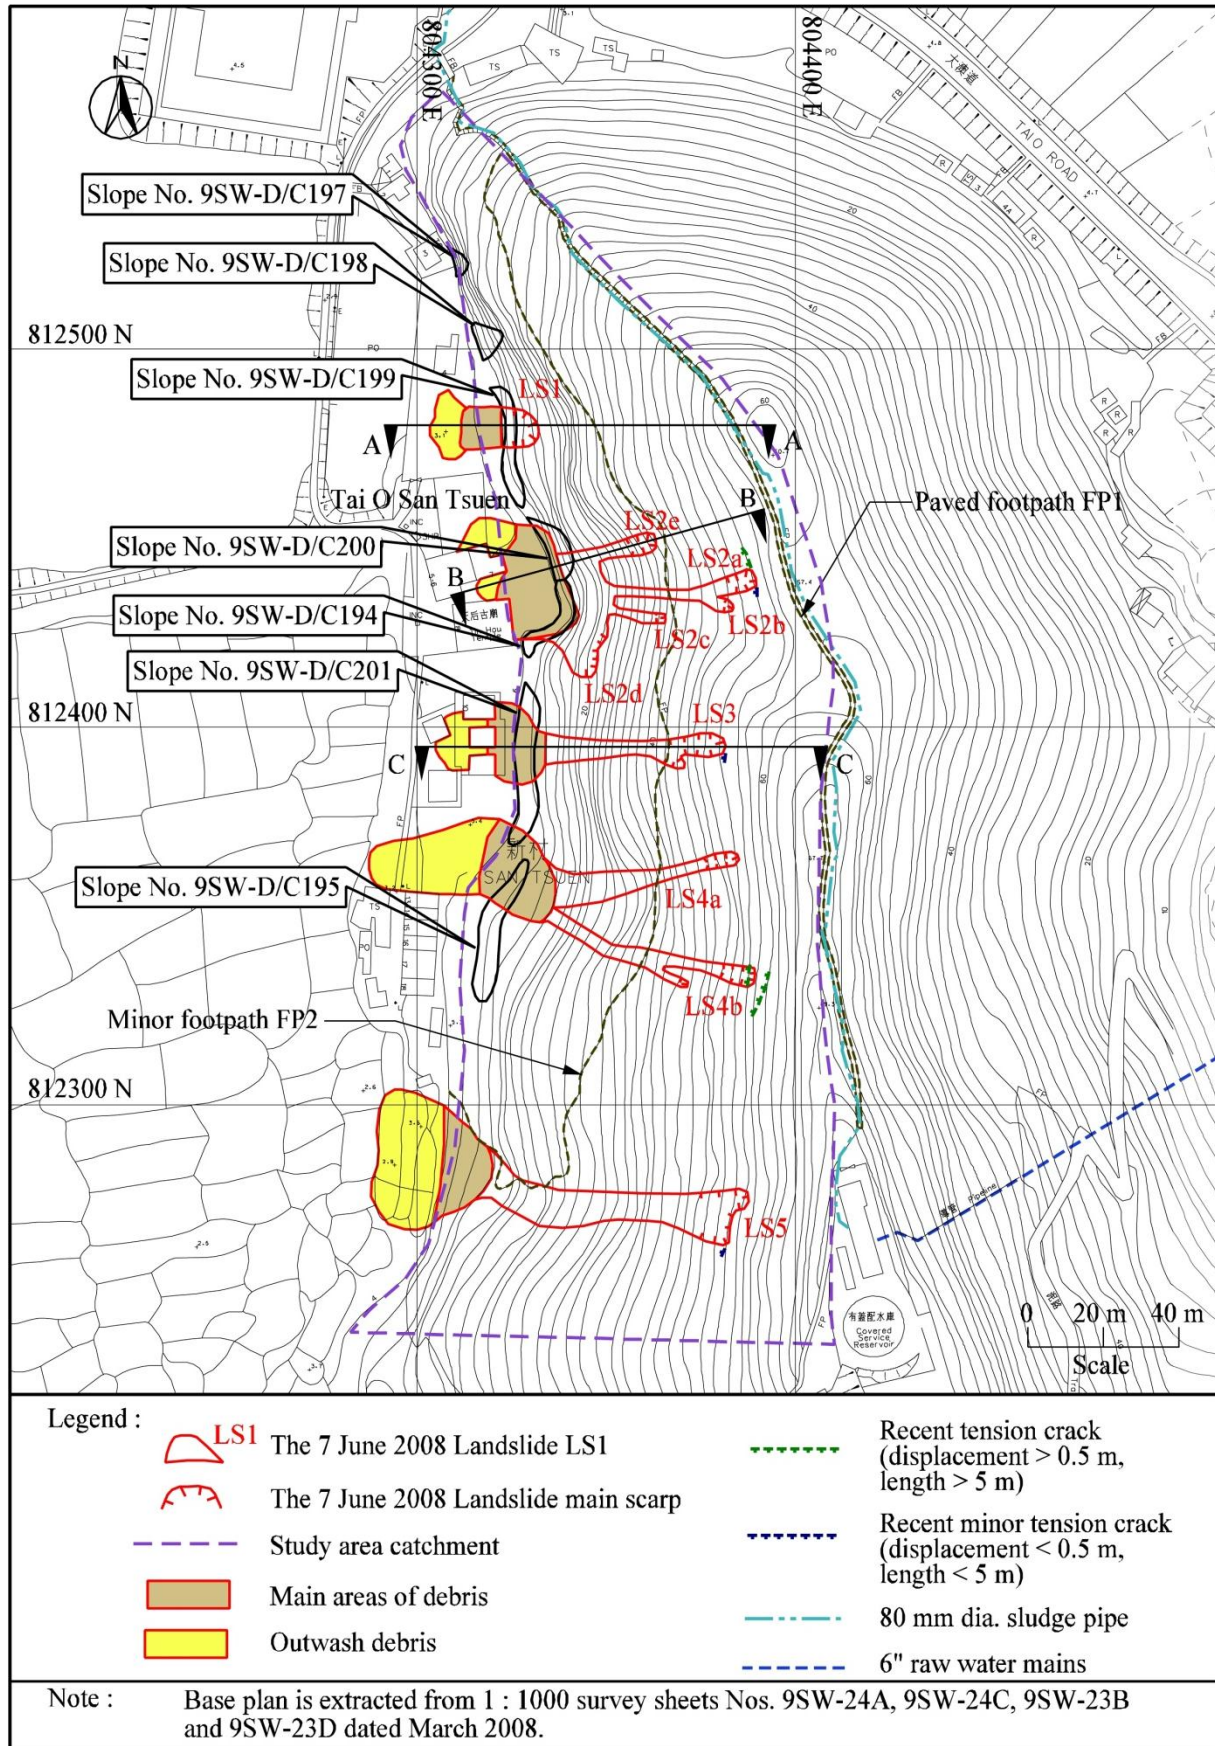
**Figure 2.2 Site Layout Plan and Utilities**

Several tension cracks were observed adjacent to the source areas of landslides Nos. LS2 to LS5 (Figures 2.2, 5.7, 5.8 & 5.9). These cracks were up to about 5 m long with a vertical displacement of 0.5 m and probably extended into the weathered rock mass. The presence of tension cracks, together with the open joints in weathered rock mass, suggests that the hillside may have been undergoing deterioration.

No perennial or ephemeral streams are observed on the hillside, although several topographic depressions may have been present, in particular near landslide Nos. LS4 and LS5 (Figure 2.2).

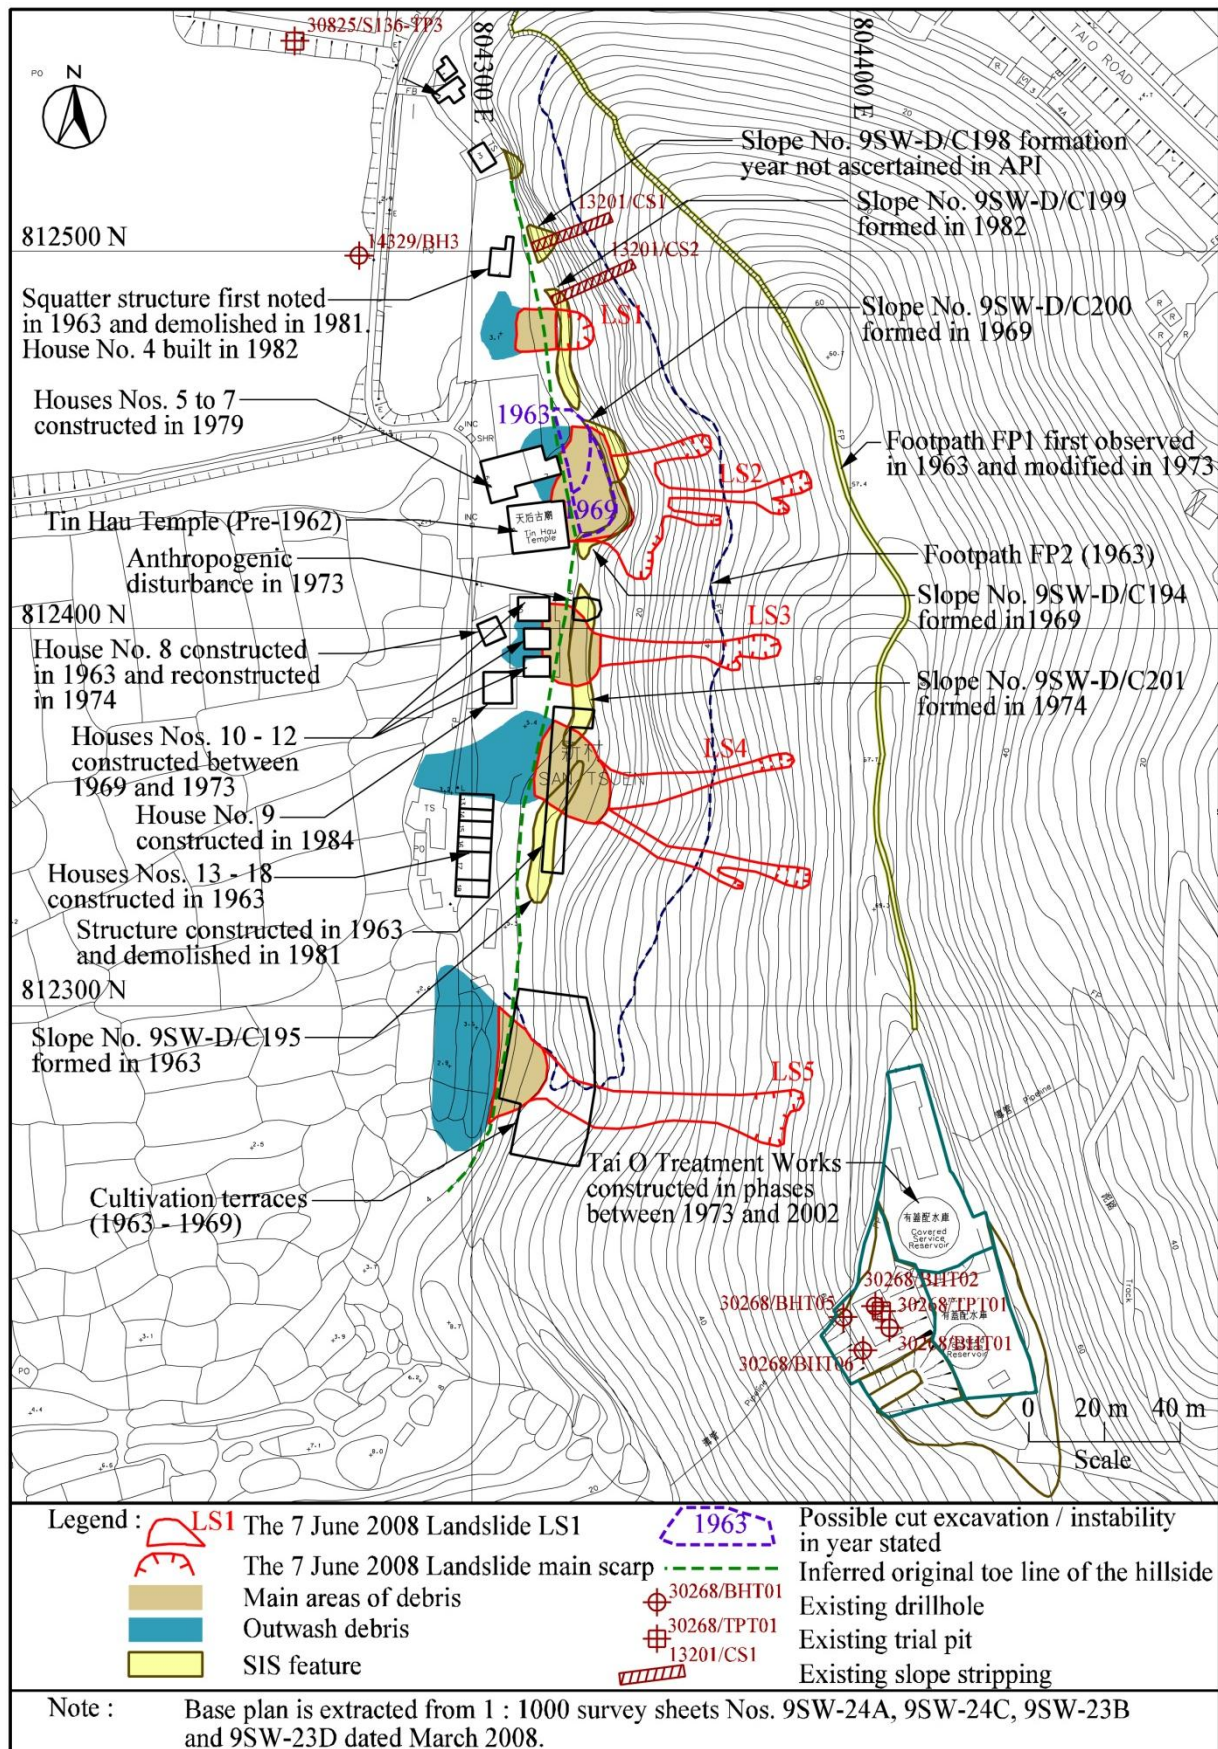
### Figure 4.1 Site History and Previous Ground Investigation Plan

To the west of the study area is a flat low-lying alluvial and estuarine area previously comprising extensive cultivation lands, salt fields and isolated village houses. Several cut slopes located below landslide Nos. LS1 to LS4 were formed by cutting into the toe of the natural hillside during the development of Tai O San Tsuen between 1963 and 1981 (Figure 4.1).

The study area has a history of landslides. In the 1963 aerial photographs, ten relict landslides (namely R1 to R10) are identified (Figure 4.2). Between 1963 and 1969, a possible area of local instability or an excavation was observed near the toe of landslide LS2 (Figure 4.1). Between 1969 and 1990, four recent landslides (namely RL1 to RL4) are visible within the study area (Figure 4.2). According to the GEO's Large Landslide database (Scott Wilson, 1999), there is one large landslide in the vicinity of landslide No. LS4 (Figure 4.2).

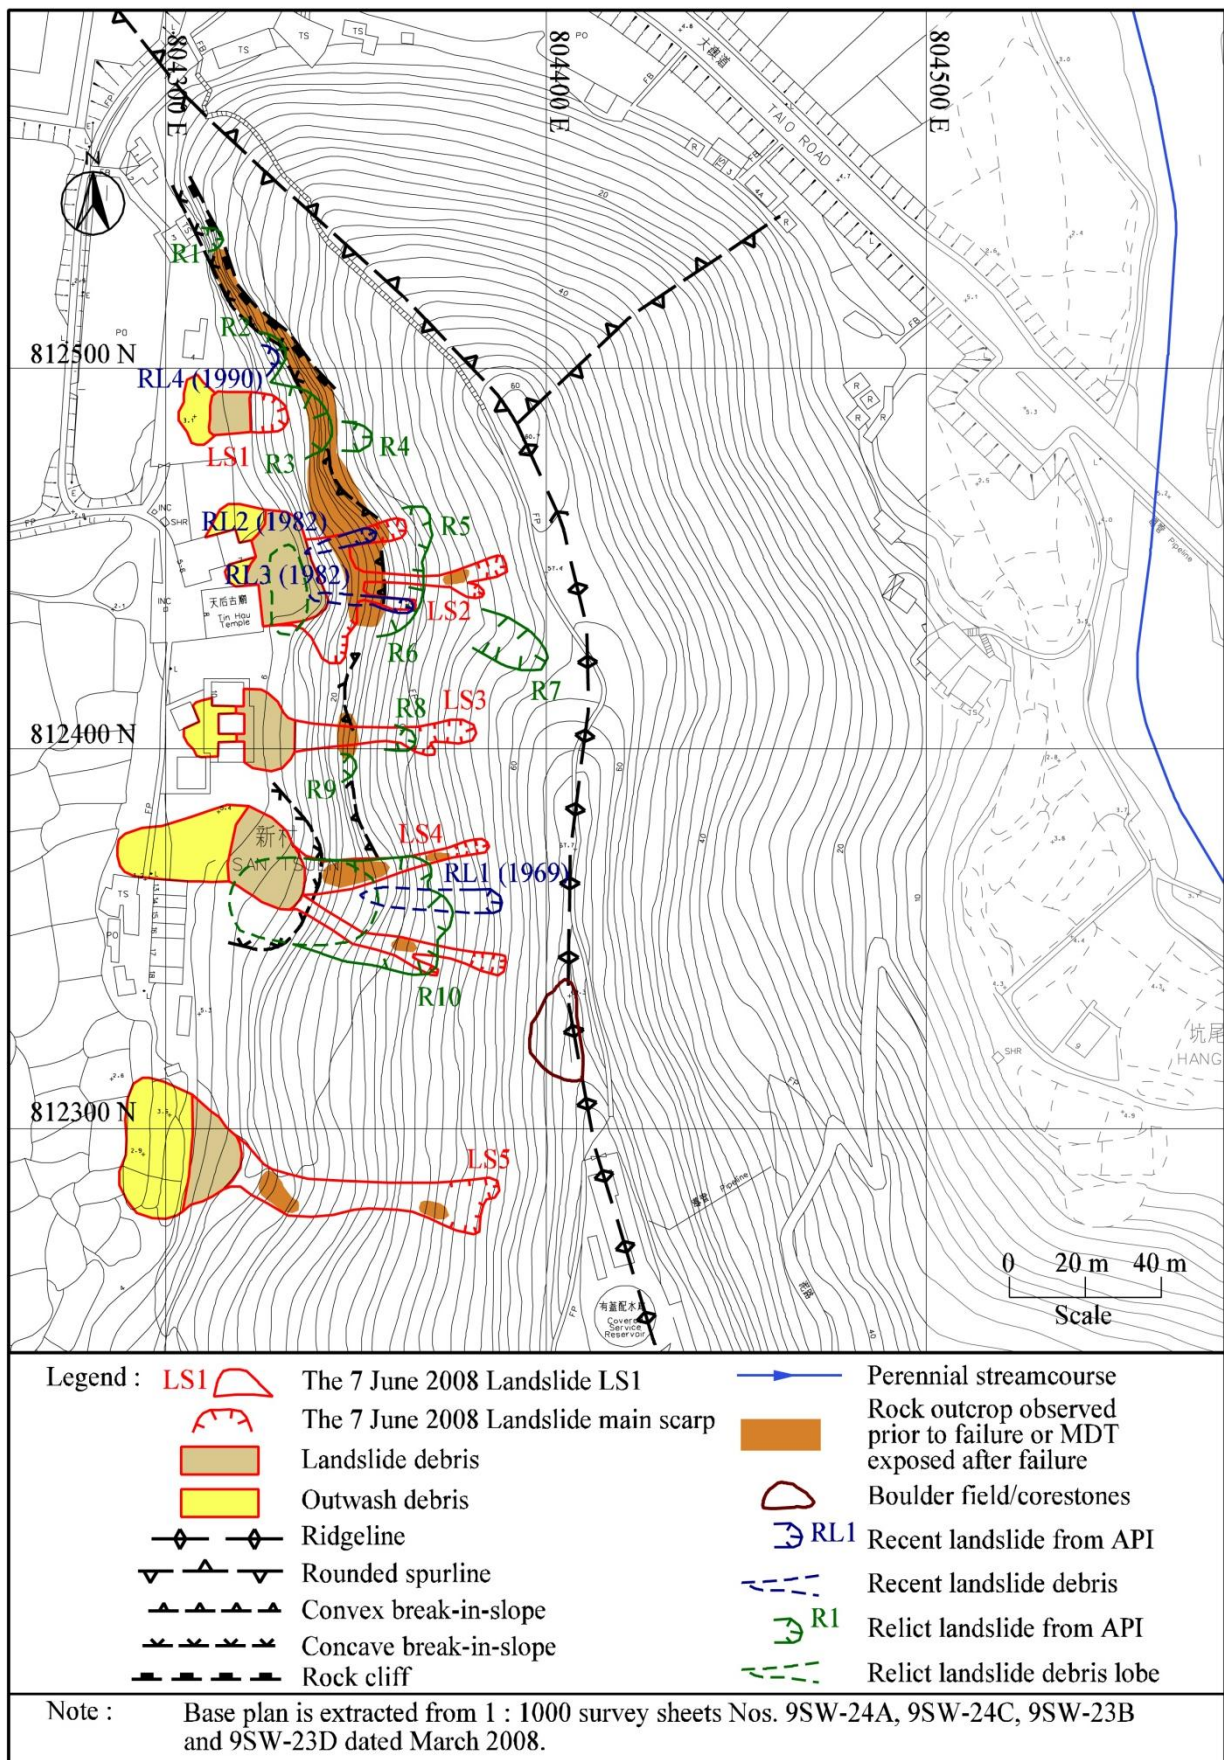
**Figure 5.1 Site Geomorphology and Hydrology**

The landslide source areas were located within the upper hillside above the convex break-in-slope (Figure 5.1). The hillside concerned is relatively steep with a slope angle predominantly ranging from about 30° to over 45° (Figure 5.2). The dimensions (i.e. width x length) of the source areas ranged from 4 m x 8 m (at landslide No. LS2) to 14 m x 15 m (at landslide No. LS5). The failure was shallow with a maximum depth of about 2 m. The source volumes ranged from 25 m<sup>3</sup> to 160 m<sup>3</sup>.

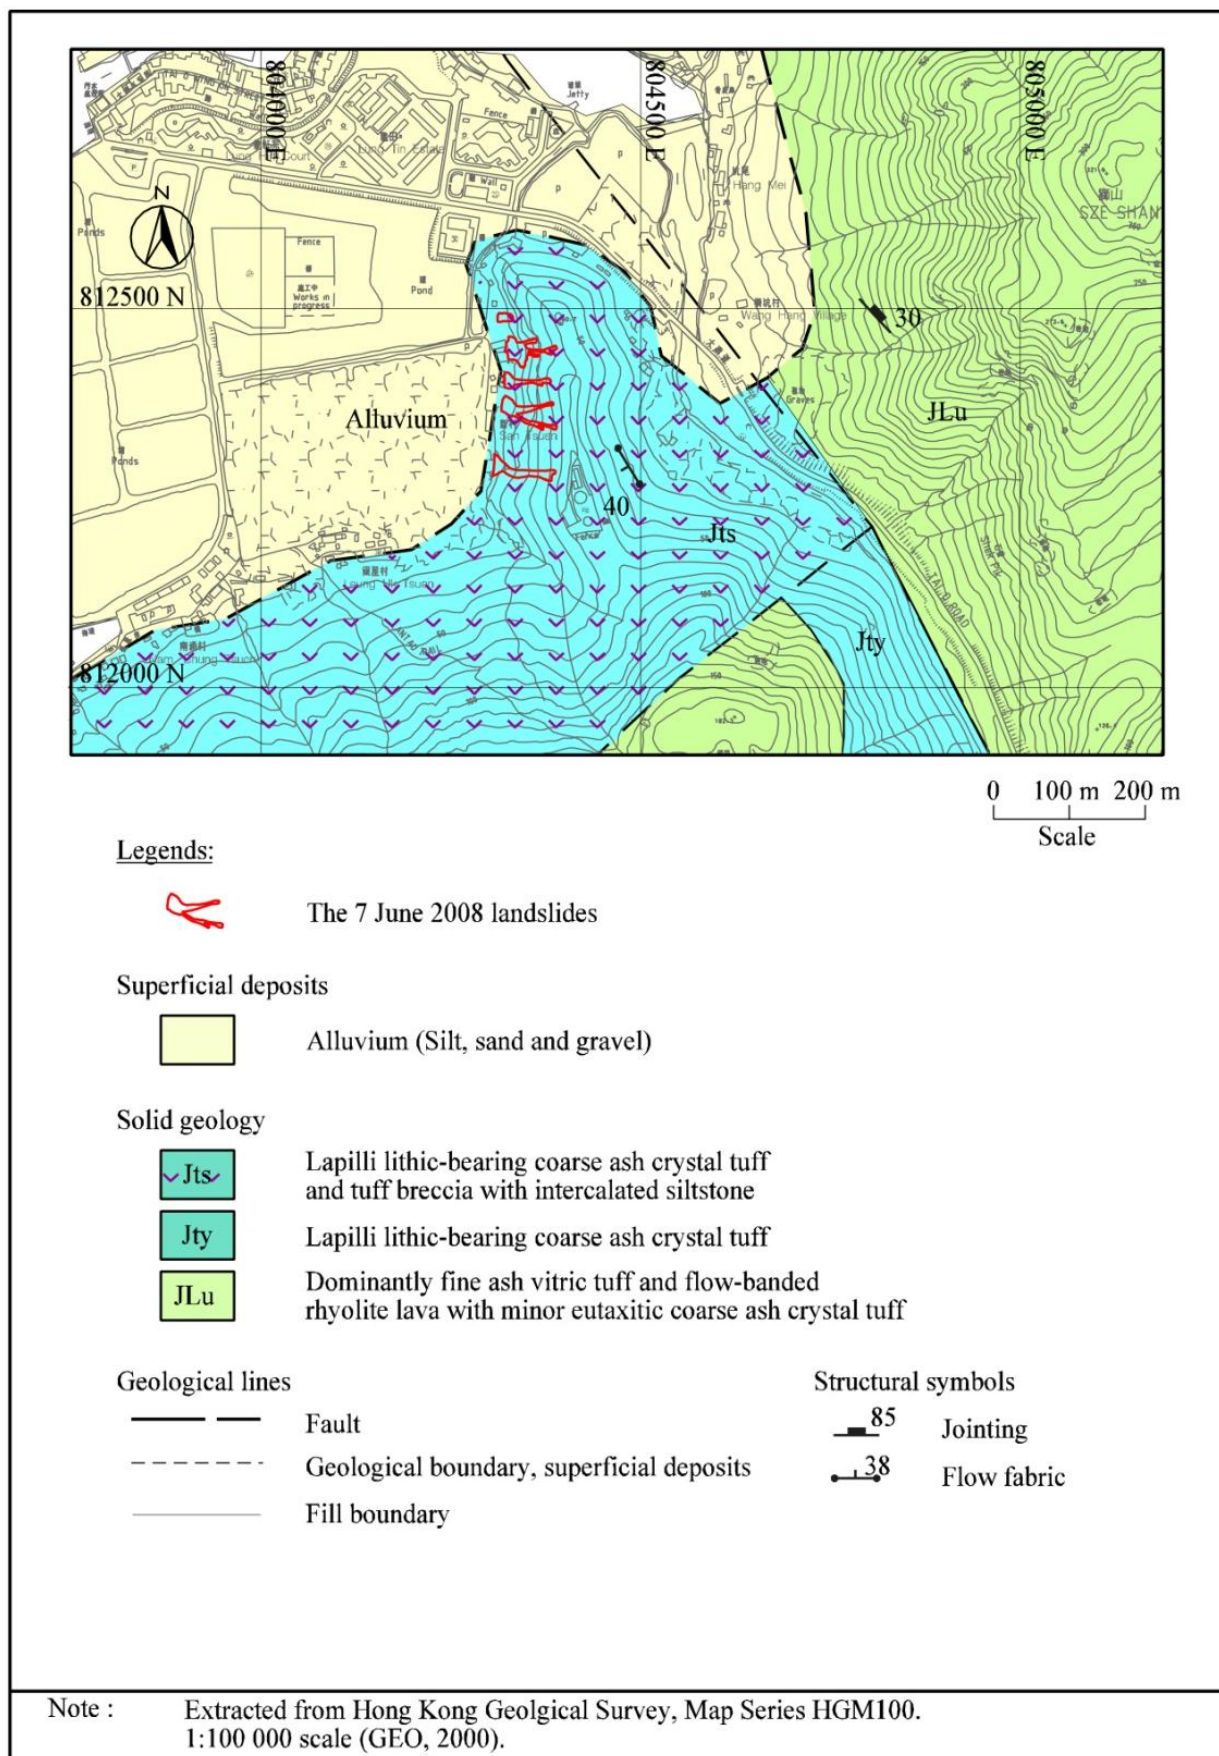
**Figure 6.1 Regional Geology**

According to the HKGS 1:100 000-scale Pre-Quaternary Geology Map of Hong Kong (Sewell et al, 2000) the site is underlain by lapilli lithic-bearing coarse ash crystal tuff and tuff with intercalated siltstone (Jts) of the Tseun Wan Volcanic Group (Figure 6.1). The map also records foliation of the tuff generally dipping to the southwest at about 40°.

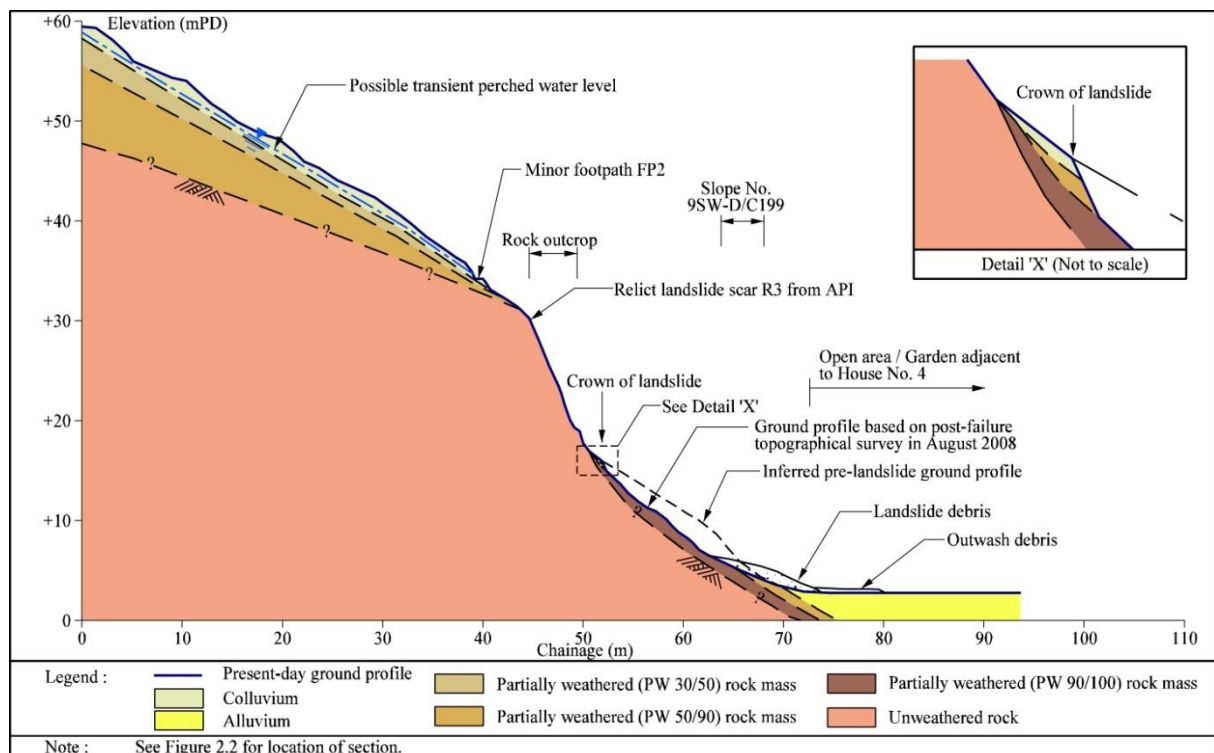
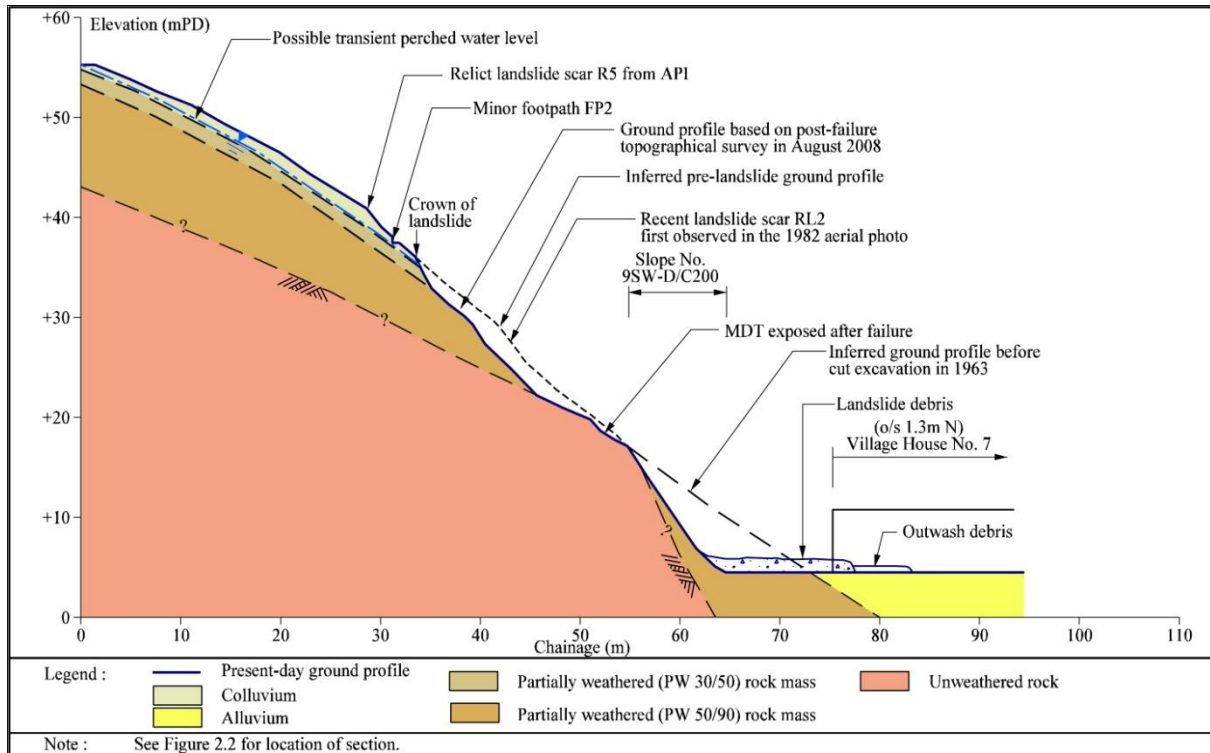
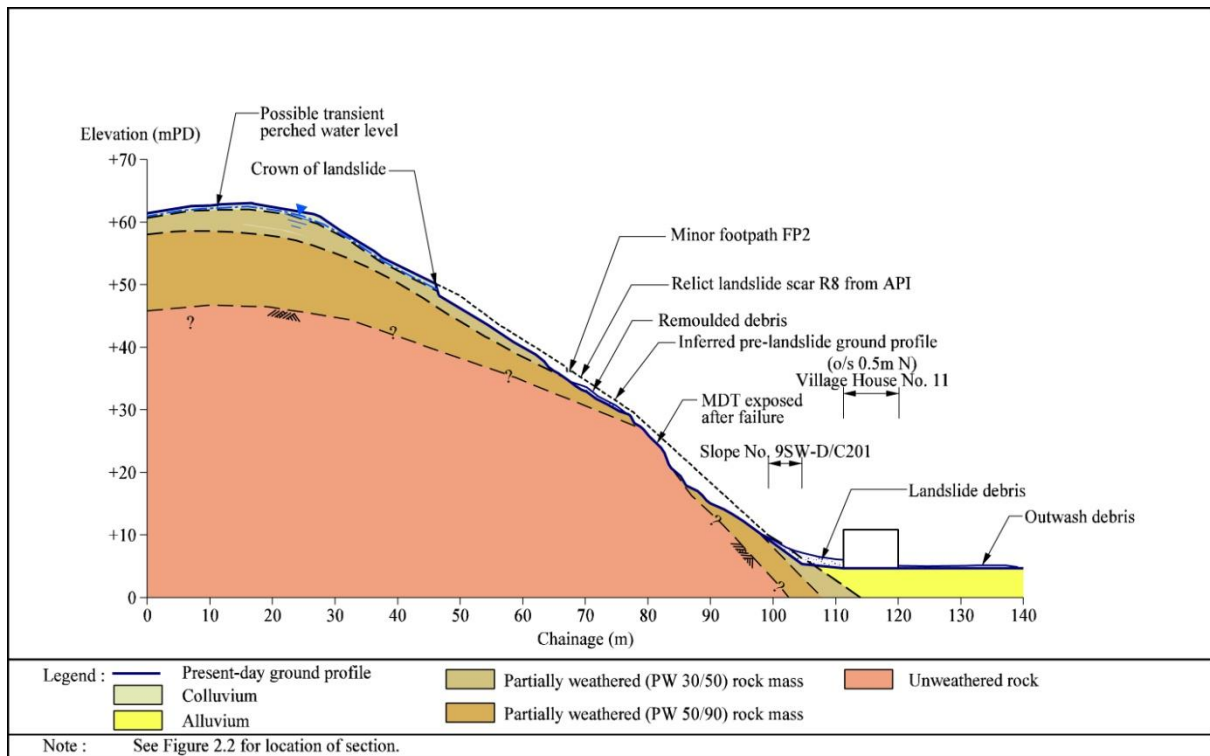
Based on field observations at local rock outcrop and exposed materials at rupture surface at landslides Nos. LS1 to LS3, the site generally comprises a thin veneer (up to 0.5 m thick) of colluvium consisting of firm sandy silt with some gravel and cobble sized rock fragments (Figure 5.3), underlain by partially weathered (PW30/50 to PW90/100) and unweathered coarse ash crystal tuff. Some rock exposures exhibited dilated joints infilled with sediments (Figure 6.2). According to limited GI data (see Figure 4.1), moderately to slightly decomposed tuff with intermittent highly and completely decomposed tuff up to 21 m thick is encountered at the south-eastern part of the study area near landslide No. LS5. The weathering profile appears to become shallower from south to north of the study area. The interpreted geological profiles are shown in Figures 6.3 to 6.5.

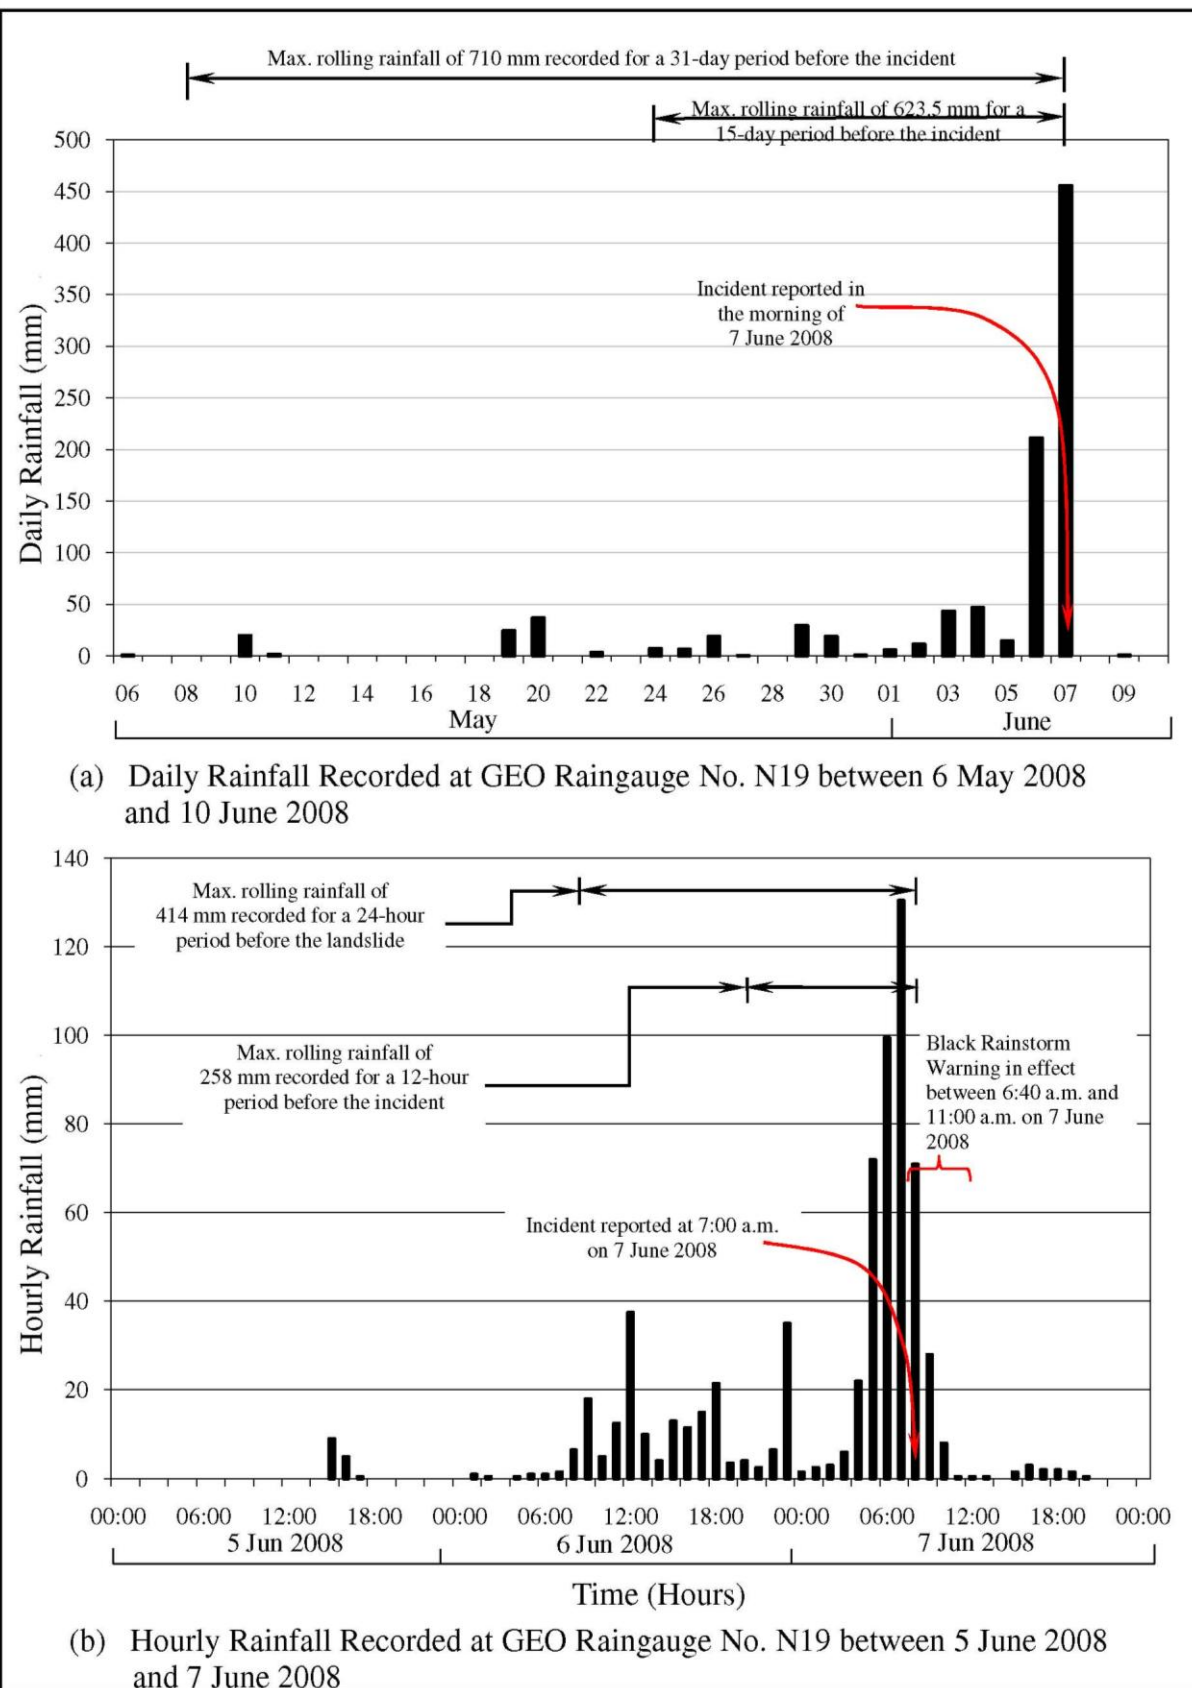
**Figure 7.1 Daily and Hourly Rainfall Recorded at GEO Raingauge No. N19**

Rainfall data were obtained from the nearest GEO automatic raingauge No. N19, which is located about 1.5 km to the southeast of the 7 June 2008 landslides at Tai O San Tsuen. The raingauge records and transmits rainfall data at 5-minute intervals to the GEO and the Hong Kong Observatory (HKO). The daily rainfall recorded by raingauge No. N19 over the month preceding the 7 June 2008 rainstorms, together with the hourly rainfall readings for the period between 5 and 7 June 2008, are presented in Figure 7.1.
