**DETAILED STUDY OF THE  
7 JUNE 2008 LANDSLIDE ON  
THE NATURAL HILLSIDE  
BEHIND CHOW YEI CHING  
BUILDING AT THE  
UNIVERSITY OF HONG KONG,  
POK FU LAM**

**GEO REPORT No. 276**

**Maunsell Geotechnical Services Limited**

**GEOTECHNICAL ENGINEERING OFFICE  
CIVIL ENGINEERING AND DEVELOPMENT DEPARTMENT  
THE GOVERNMENT OF THE HONG KONG  
SPECIAL ADMINISTRATIVE REGION**

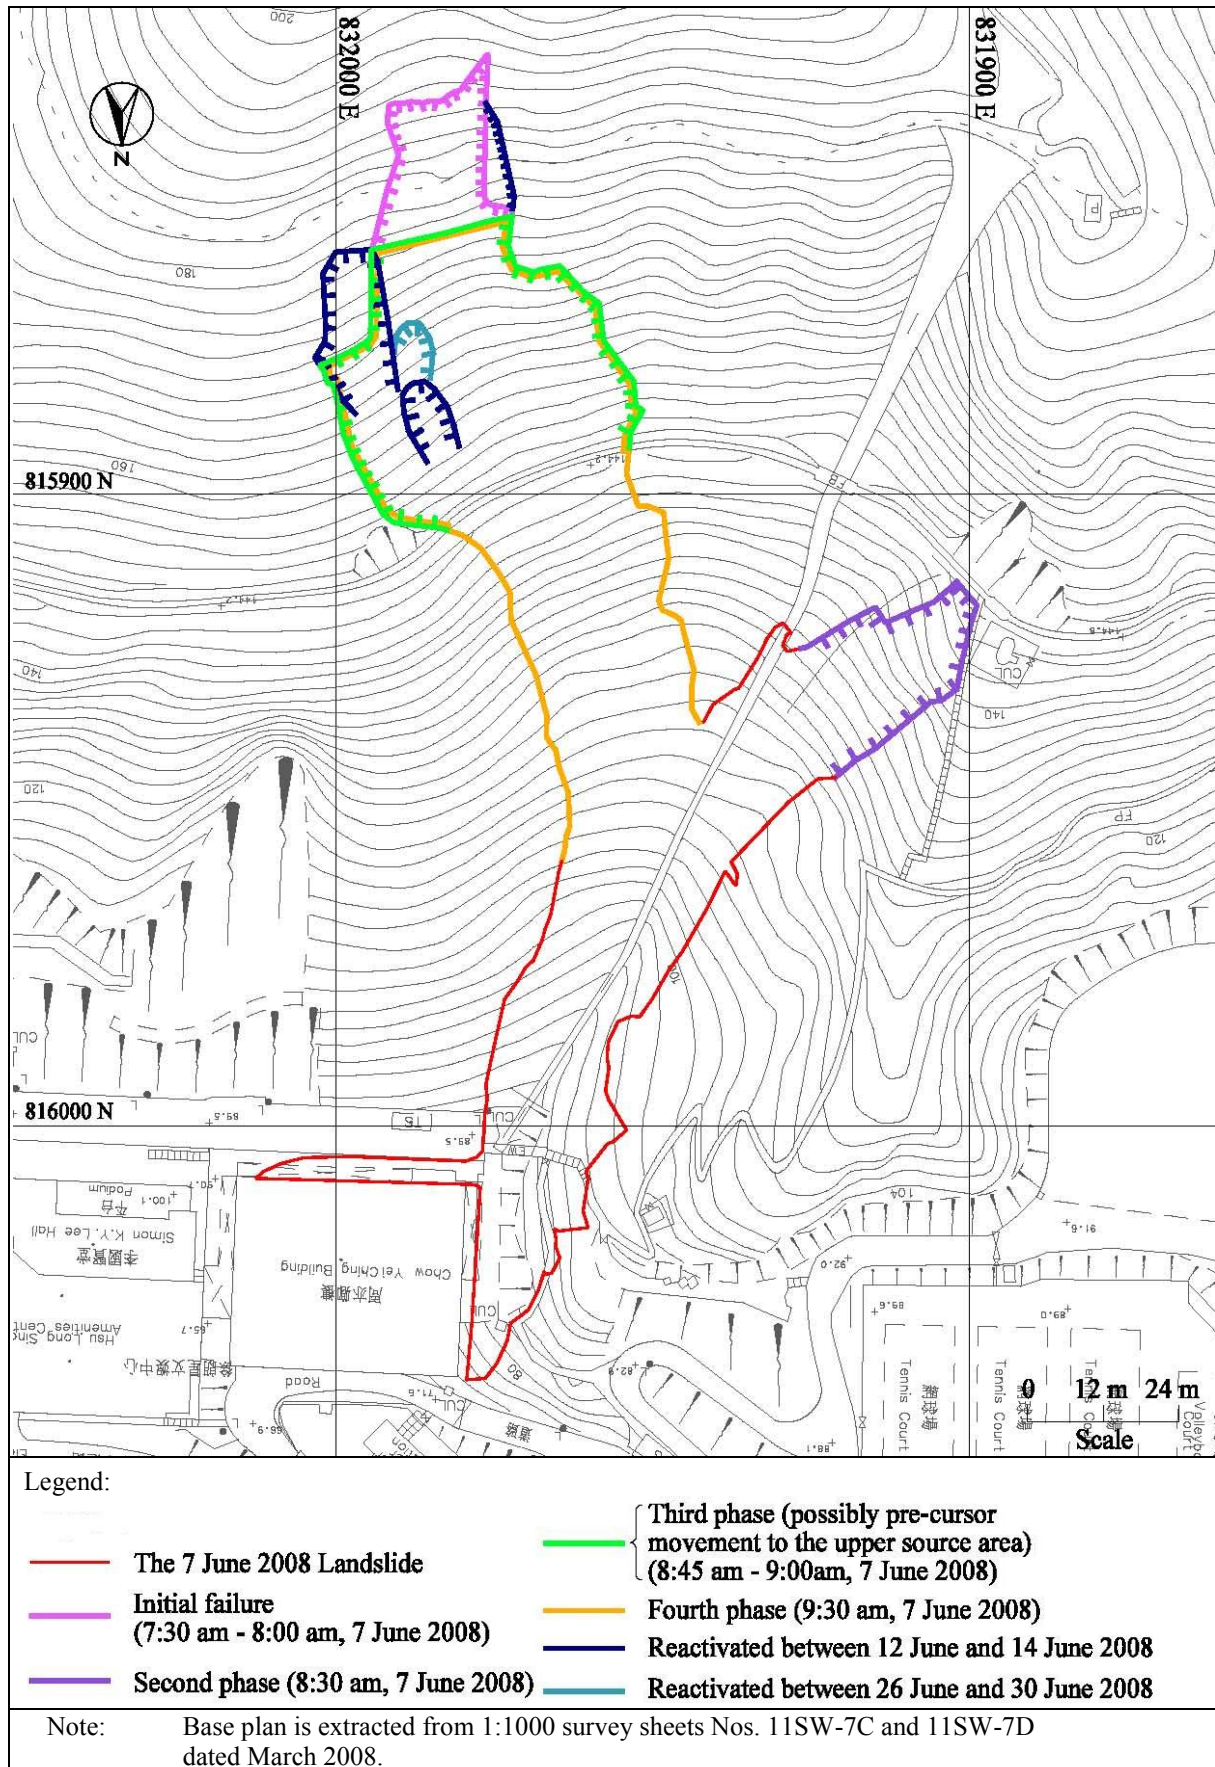
Figure 9 - Probable Sequence of Failure

7 June 2008 landslide. Based on a synthesis of the available information and corroboration of evidence from various sources, it is considered that the landslide probably occurred in four phases in a progressive manner over a period of about two hours between about 7.30 a.m. and 9.30 a.m. (Figure 9).

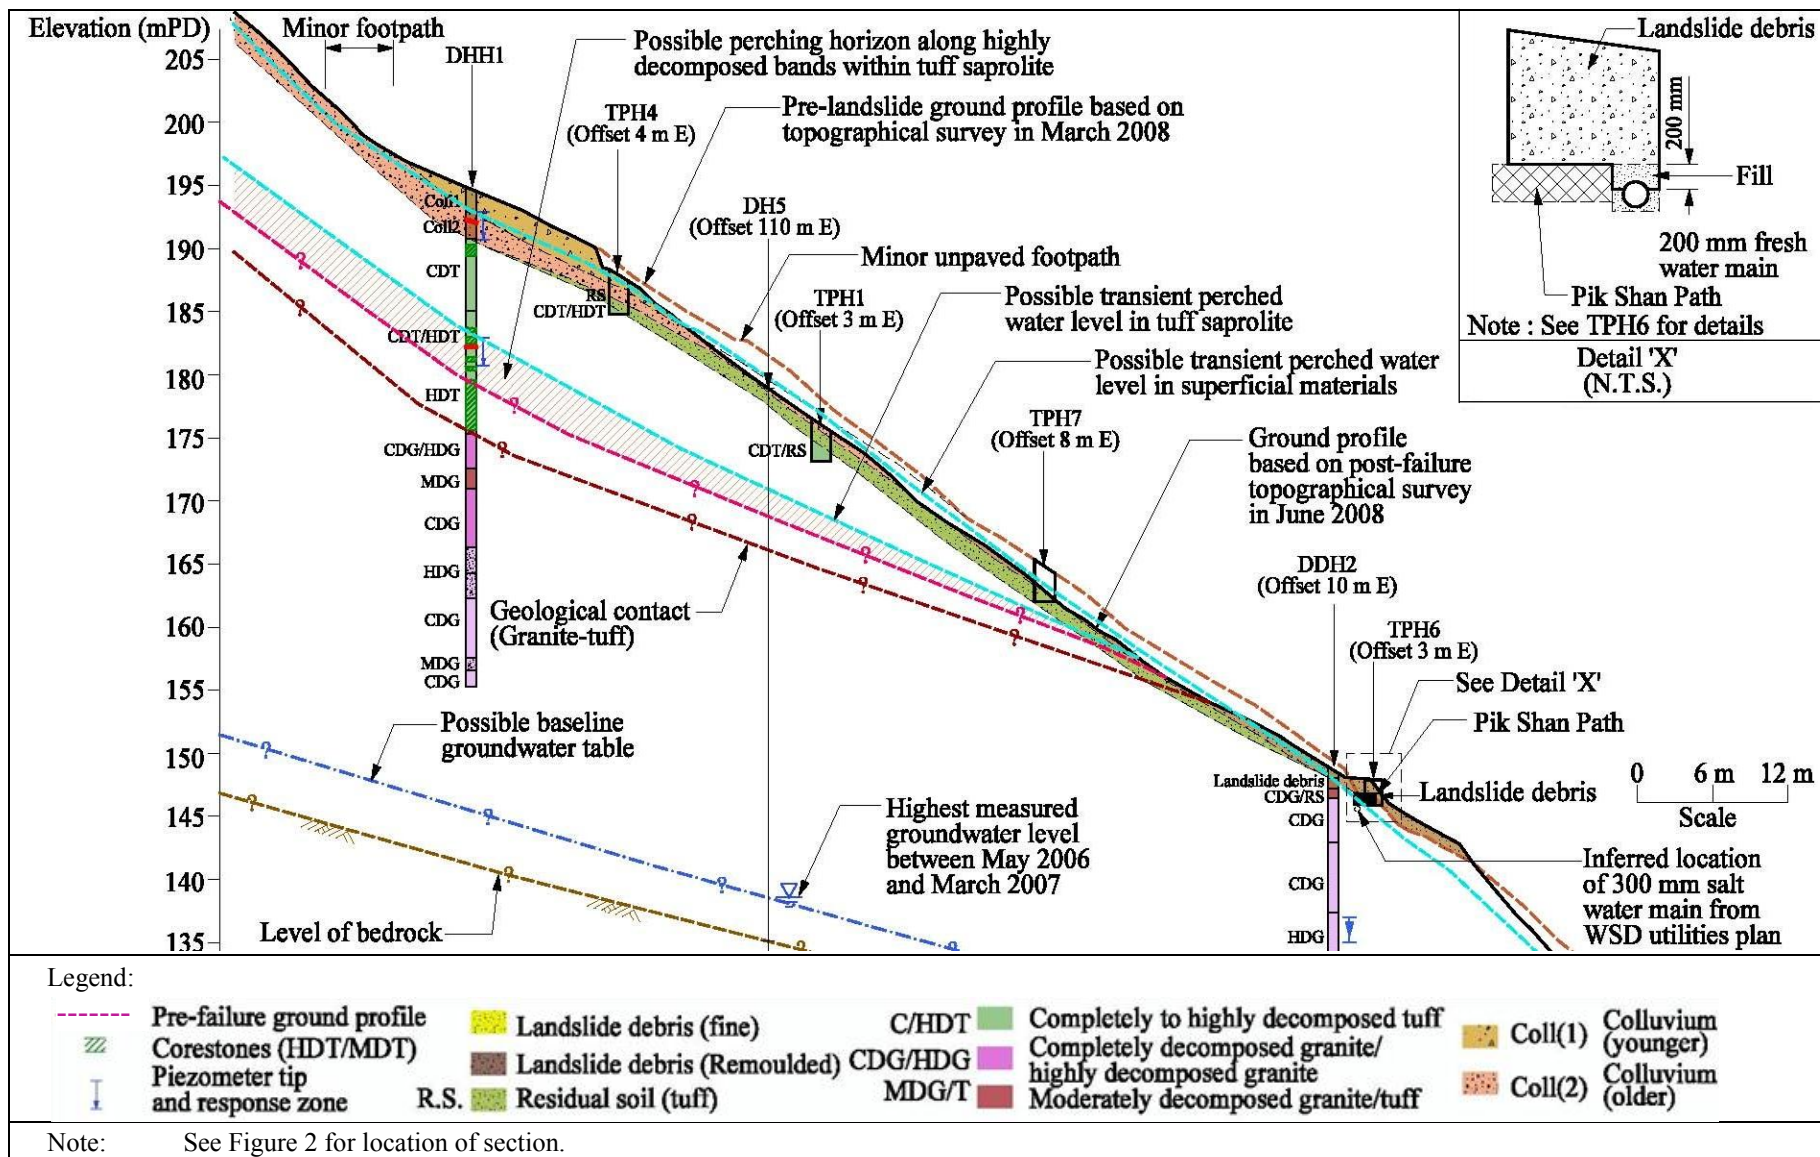
Figure 11 - Geological Section 'B-B' through the Primary Source Area

Section B-B (Figure 11) was adopted in the analysis and two failure modes were considered. Failure mode 1 corresponds to a phased failure where the upper part of the main source area failed first as reported by one of the eyewitnesses (slip surface No. 1 in Figure 20). Failure of the lower part of the main source area was subsequently triggered because of the surcharging by the debris, which came from the upper part of the source area (slip surface No. 2 in Figure 20). Failure mode 2 corresponds to a failure extending over the entire main source area (Figure 21). The potential failure surfaces in both failure modes are located predominately along the old colluvium/residual soil interface and within the residual soil layer. A range of possible transient groundwater profiles was examined in the analyses. The groundwater levels recorded in the primary source area following the 7 June 2008 landslide indicate that the baseline levels are low ( $> 15$  m). However, 'moist' colluvial soil horizons and soil pipes observed in some of the trial pits within the upper 2 m of the regolith indicate that transient perched water levels may have reached the upper regolith layers during heavy rain. It is likely that soil suction reduced to zero in the near-surface groundmass during heavy rainfall and therefore no soil suction was allowed for in the stability analyses.

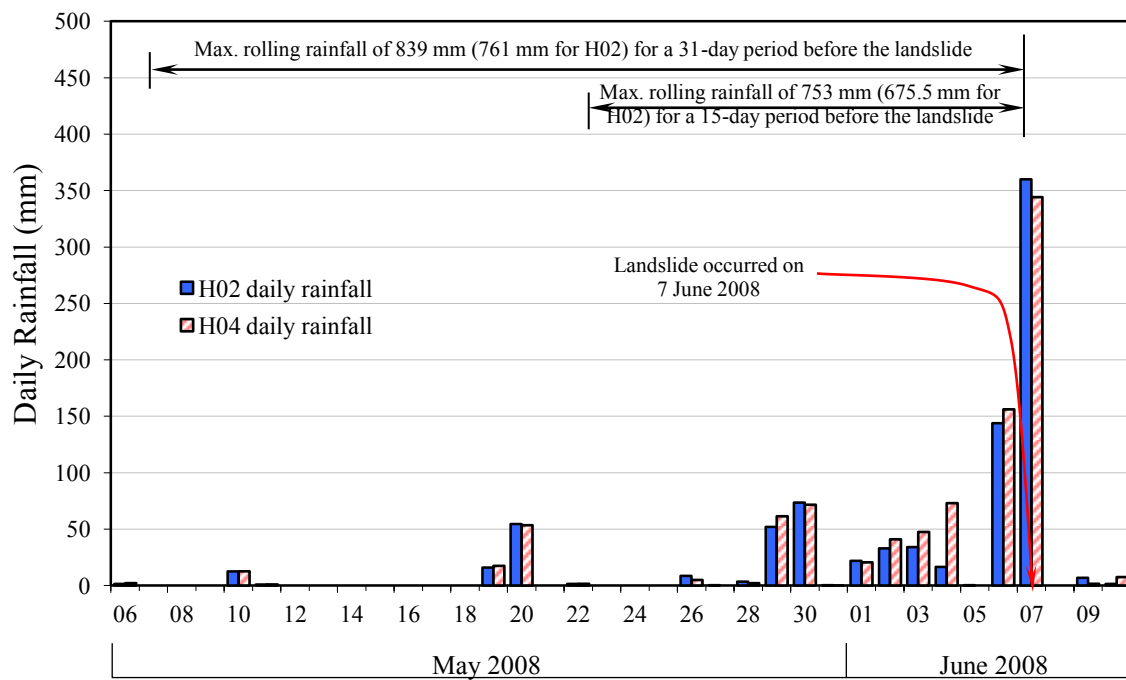
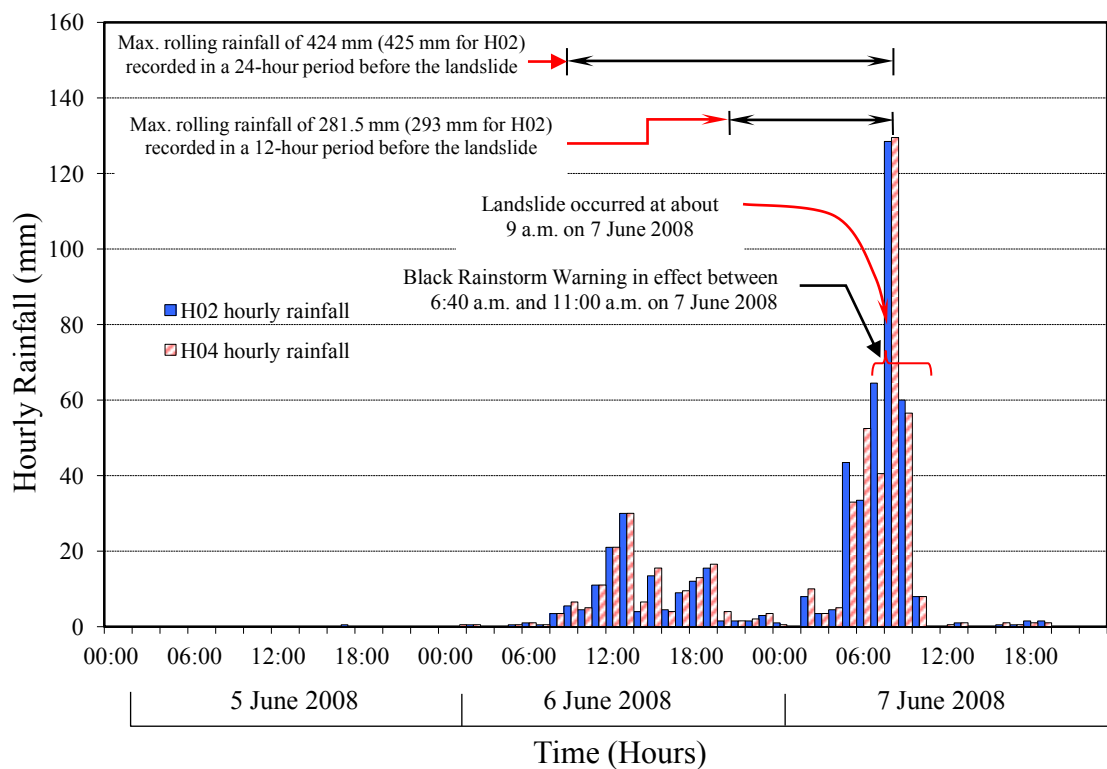
Figure 17 - Daily and Hourly Rainfall Records at GEO Raingauges Nos. H02 and H04

by raingauges Nos. H02 and H04 over the month preceding the 7 June 2008 rainstorms, together with the hourly rainfall readings for the period between 5 and 7 June, 2008, are presented in Figures 17 and 18.

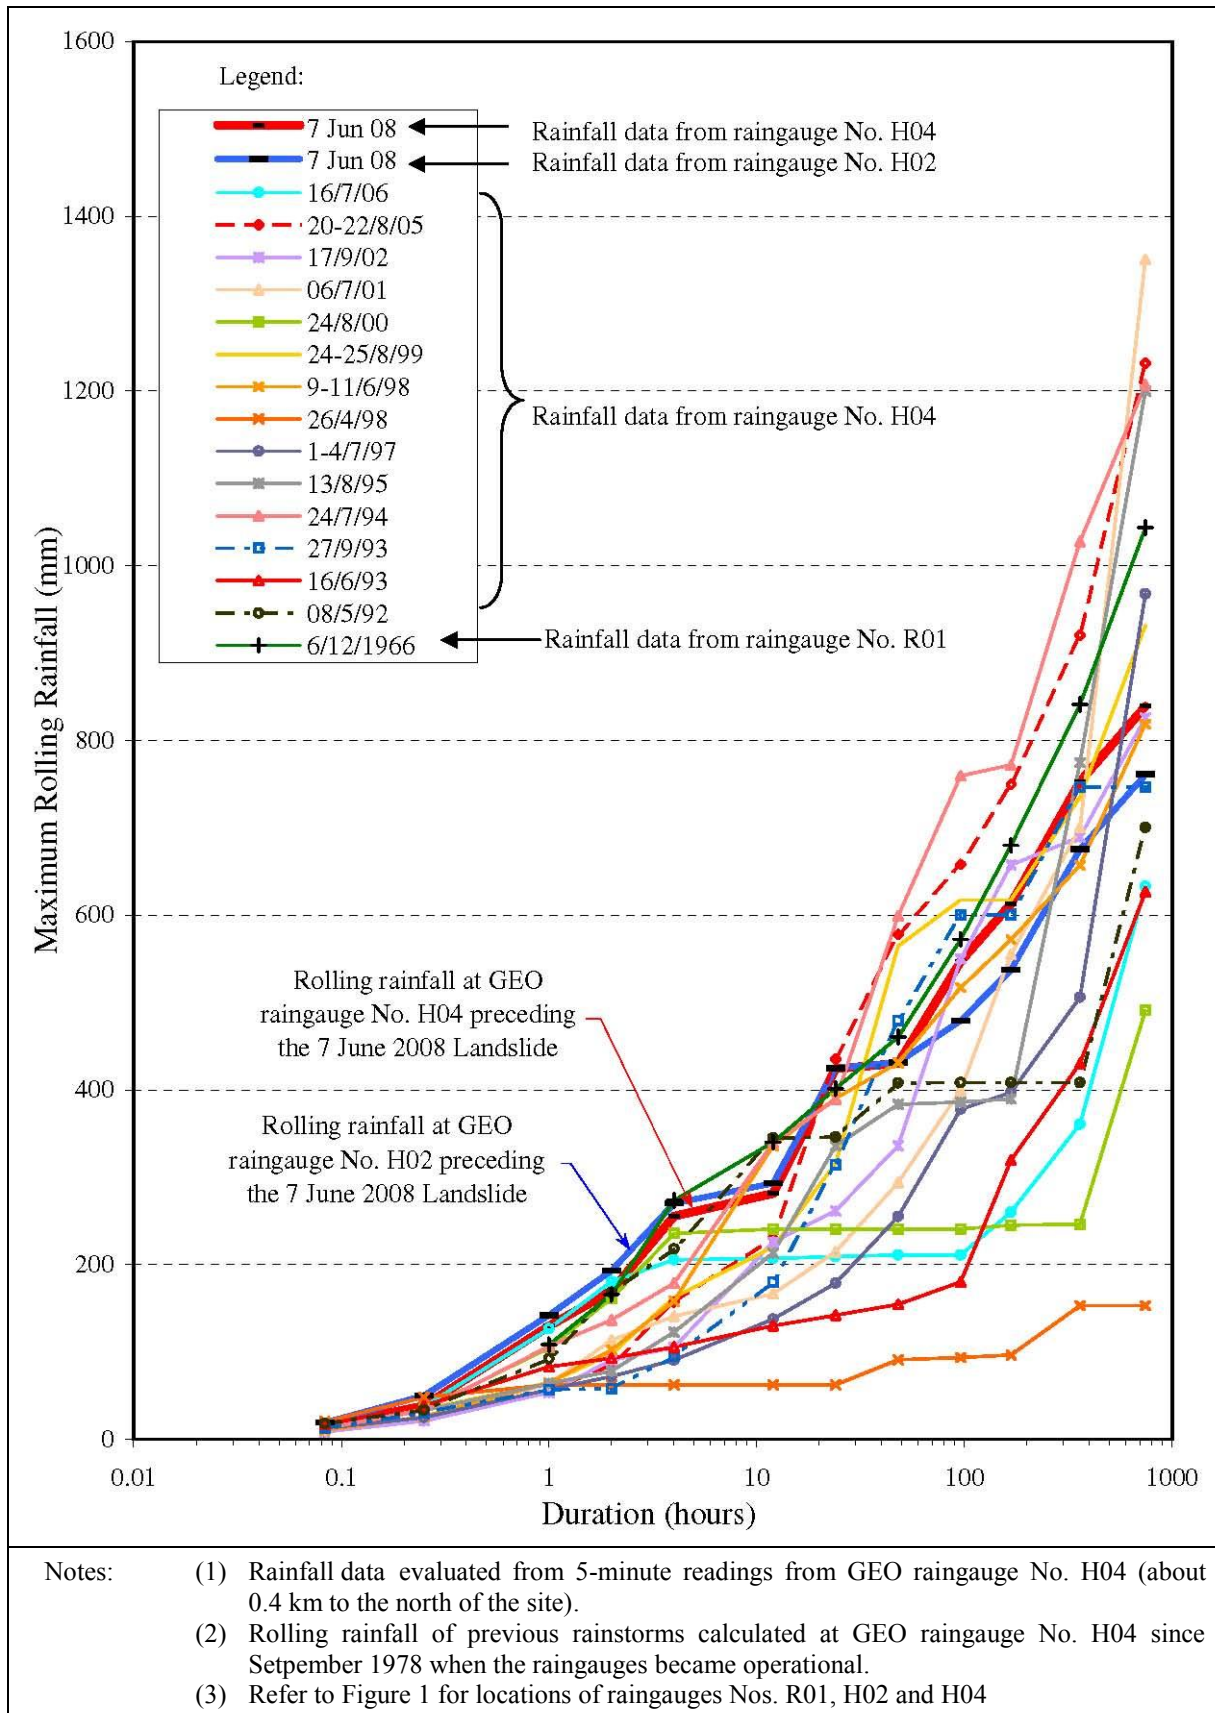
Figure 18 - Maximum Rolling Rainfall for Previous Major Rainstorms at GEO Raingauge No. H04

The maximum rolling rainfall for the 7 June 2008 rainstorm has been compared with the previous major rainfall recorded by raingauge No. H04, which came into operation in August 1978 (Figure 18). The 7 June 2008 rainstorm is more severe than the previous major rainstorms for rainfall durations of 1 hour to 4 hours and 24 hours. The 7 June 2008 rainstorm was also compared with the rainfall data recorded at the HKO in Tsim Sha Tsui in June 1966 (Figure 18). The 7 June 2008 rainstorm is the heaviest ever recorded for rainfall durations of 1 hour and 2 hours.

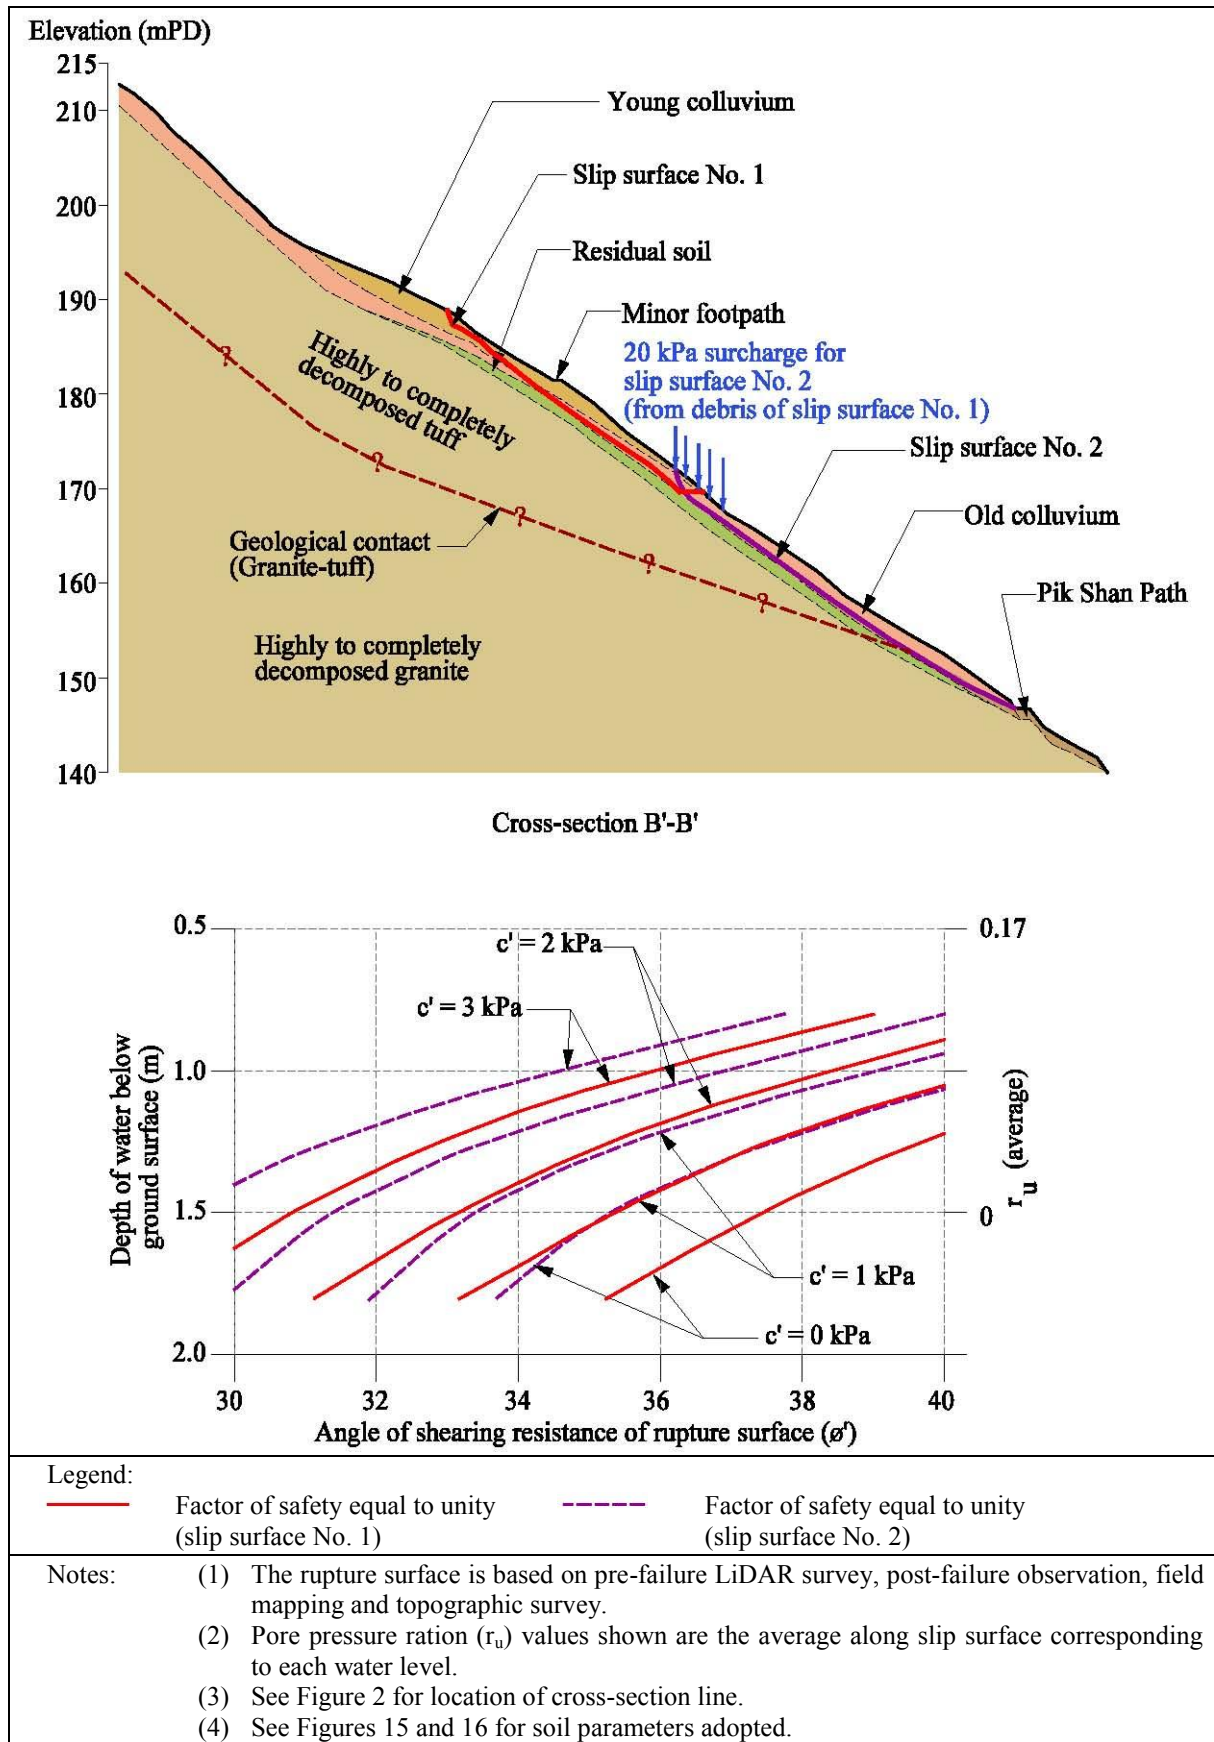
Figure 20 - Summary of Theoretical Stability Analysis of the Primary Source Area - Failure Mode 1

The results of the analyses for failure mode 1 and 2 are presented in Figures 20 and 21 respectively for shear strength parameters of  $c' = 0$  kPa to 3 kPa and  $\phi' = 30^\circ$  to  $40^\circ$  for the colluvium/residual soil interface and residual soil. The results indicate that with the shear strength parameters derived from triaxial tests ( $c' = 2$  kPa and  $\phi' = 35^\circ$  for colluvium and  $c' = 1$  kPa and  $\phi' = 35^\circ$  for residual soil), together with a perched water level of about 1.1 m to 1.5 m below ground surface (i.e. about 0.7 m to 0.3 m above the slip surface), it would have been sufficient for both failure modes 1 and 2 to occur. There was no significant difference in the perched water level profile required to trigger the two failures.

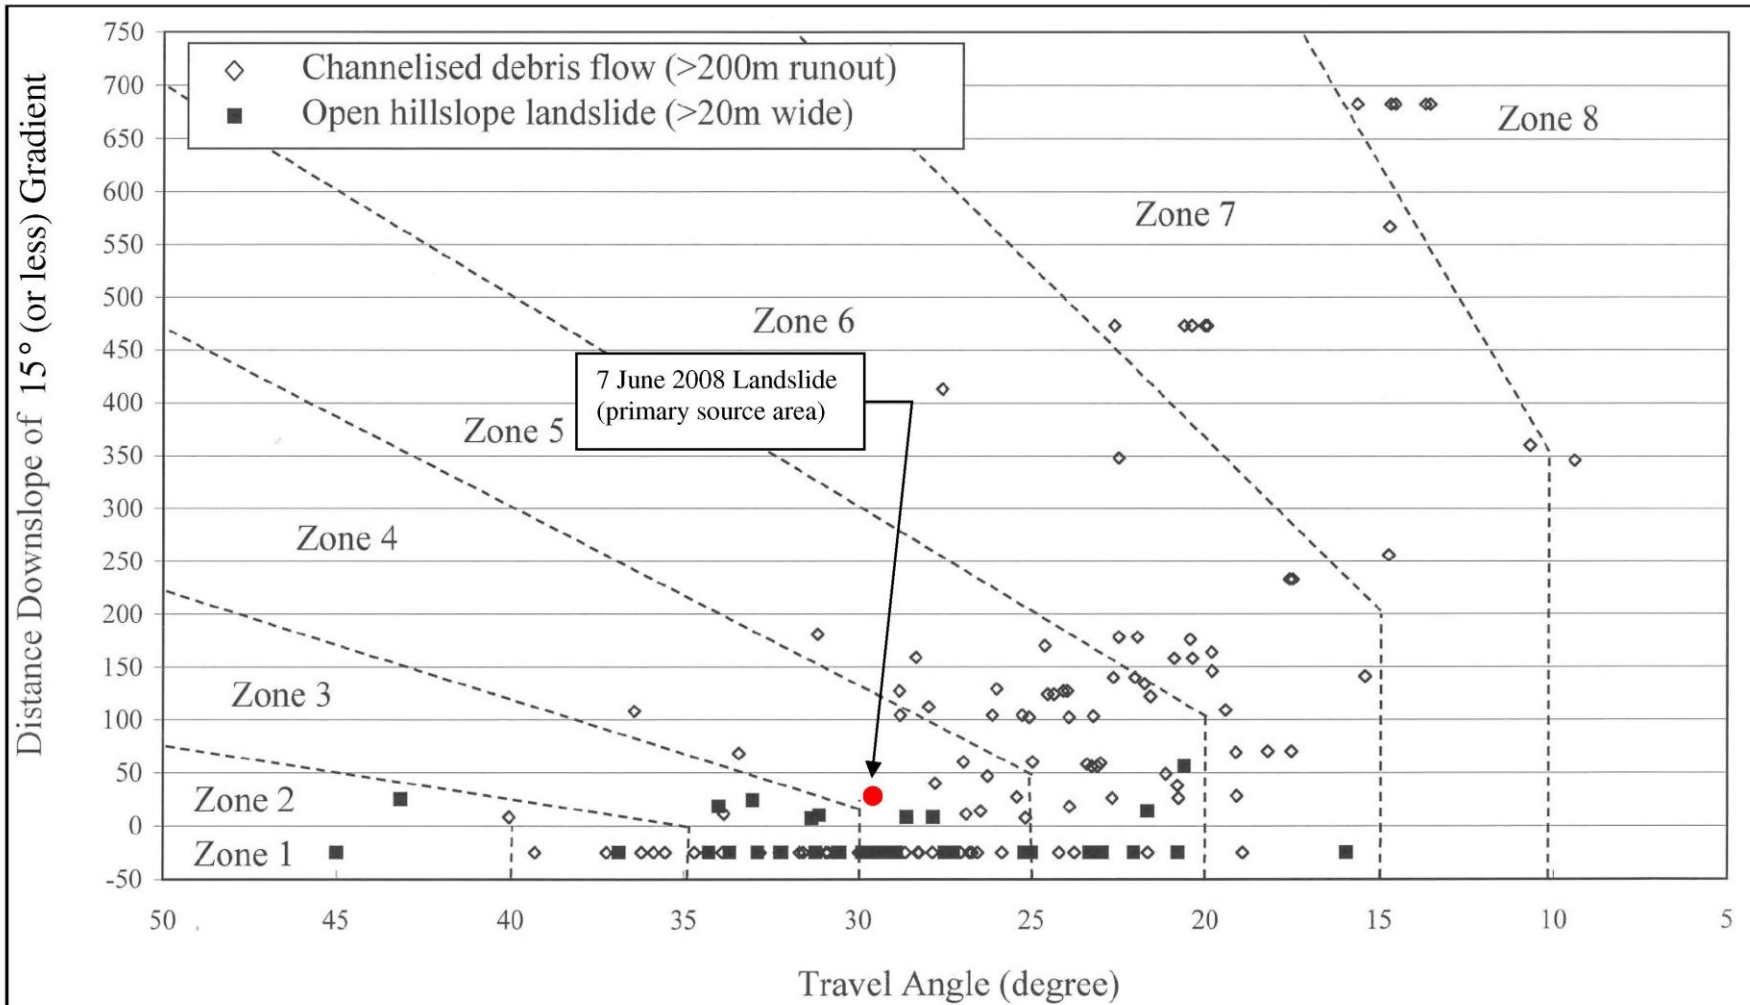
Figure 22 - Classification of Proximity Zone

The debris mobility was also assessed with an empirical method, which considers both the travel angle and the horizontal distance downslope where an overall gradient is 15° or less (Wong et al, 2006). For the 7 June 2008 landslide, the debris travelled a horizontal distance of about 30 m downslope of 15° or less, and the travel angle was about 29° (from the primary source area). The debris mobility is classified as 'Zone 4', indicating that the debris was not particularly mobile (Figure 22).

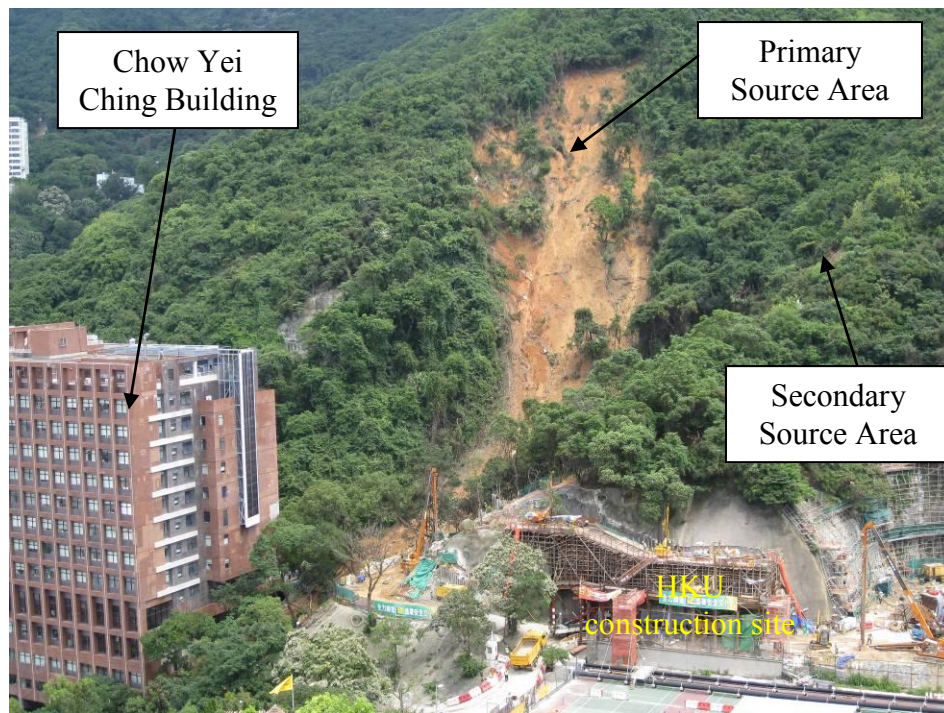
Plate 1 - General View of the 7 June 2008 Landslide from The Belcher's  
(Photograph taken on 10 June 2008 by BV)

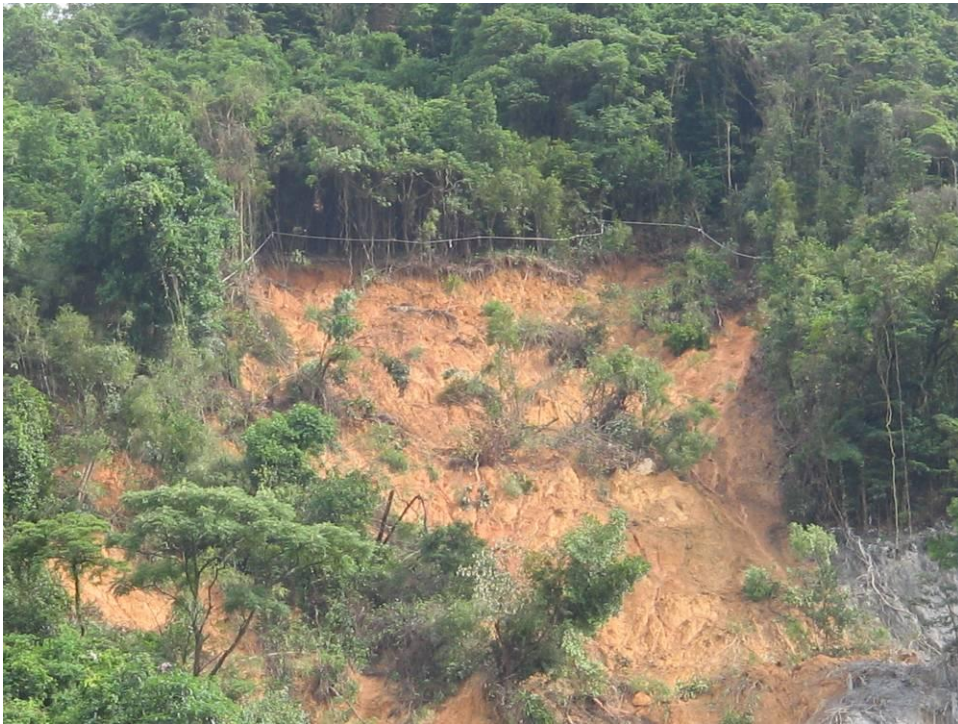
Plate 5 - General View of the Upper Portion of the Primary Source Area  
(Photograph taken on 16 June 2008 by FSWJV)

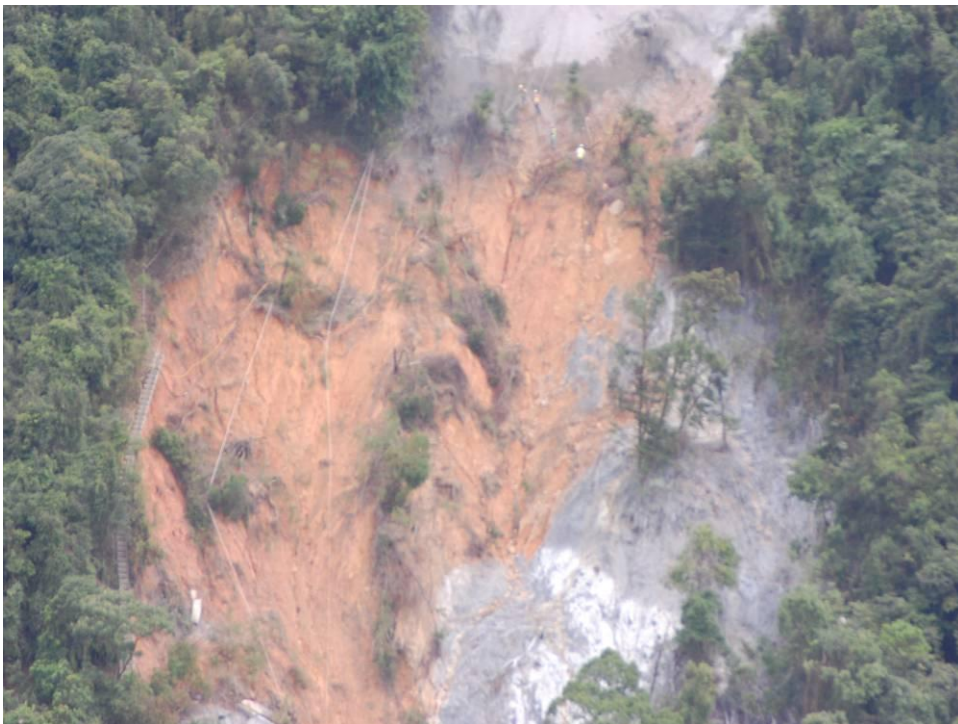
Plate 6 - General View of the Lower Portion of the Primary Source Area  
(Photograph taken on 3 July 2008)

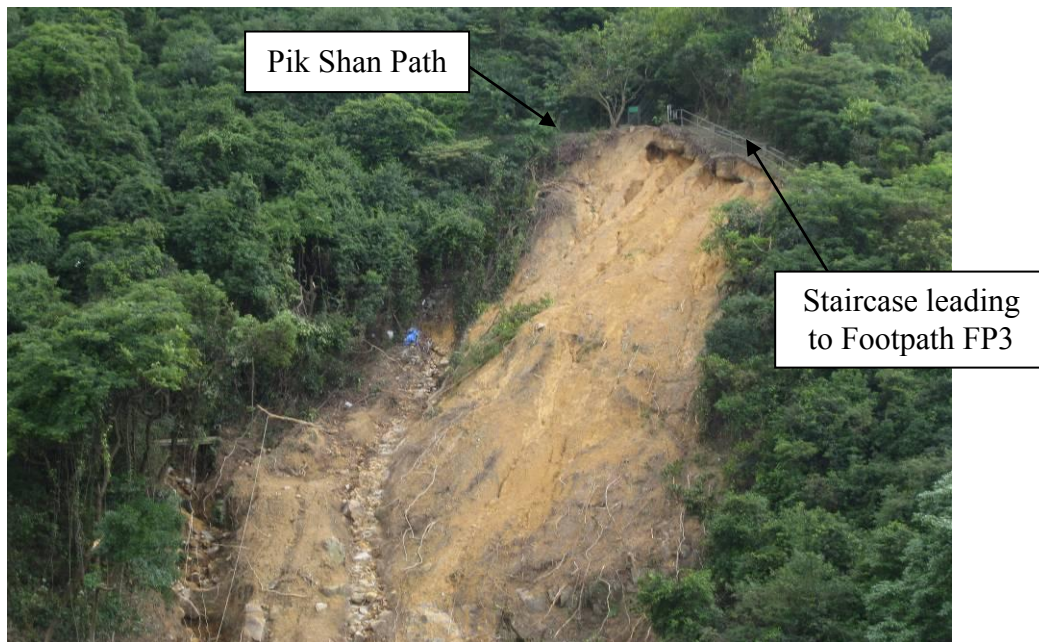
Plate 7 - General View of the Upper Portion of the Secondary Source Area  
(Photograph taken on 10 June 2008 by BV)

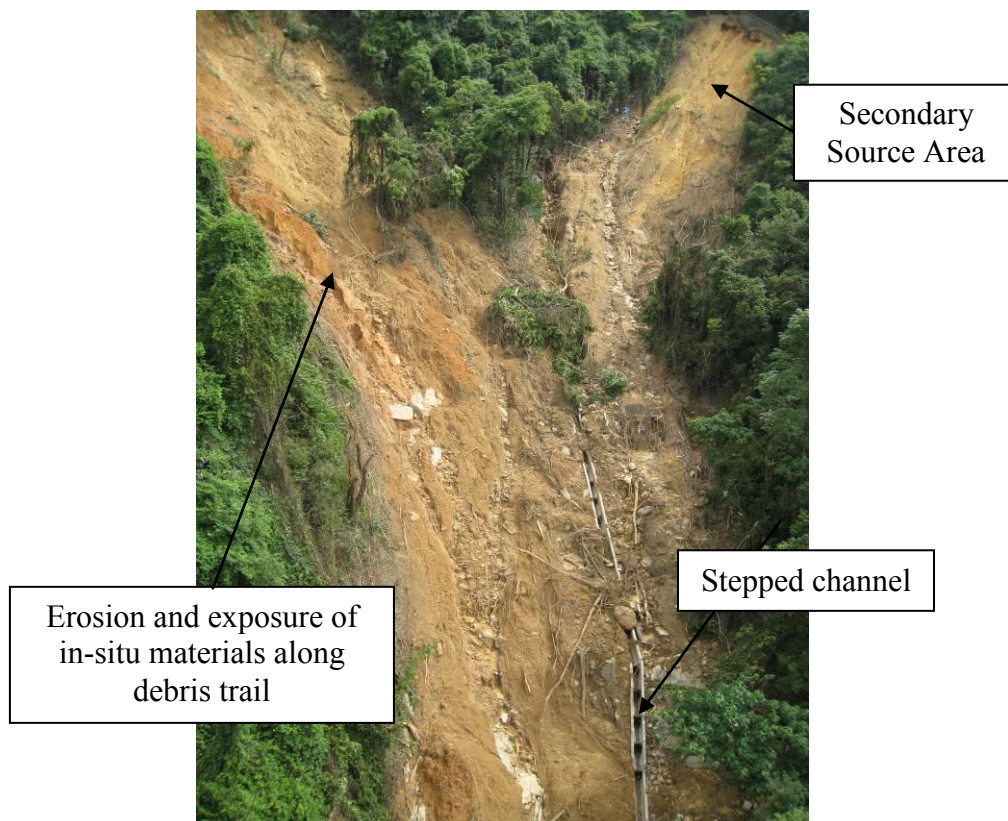
Plate 8 - General View of the Interception of the Debris Trails  
(Photograph taken on 10 June 2008 by BV)

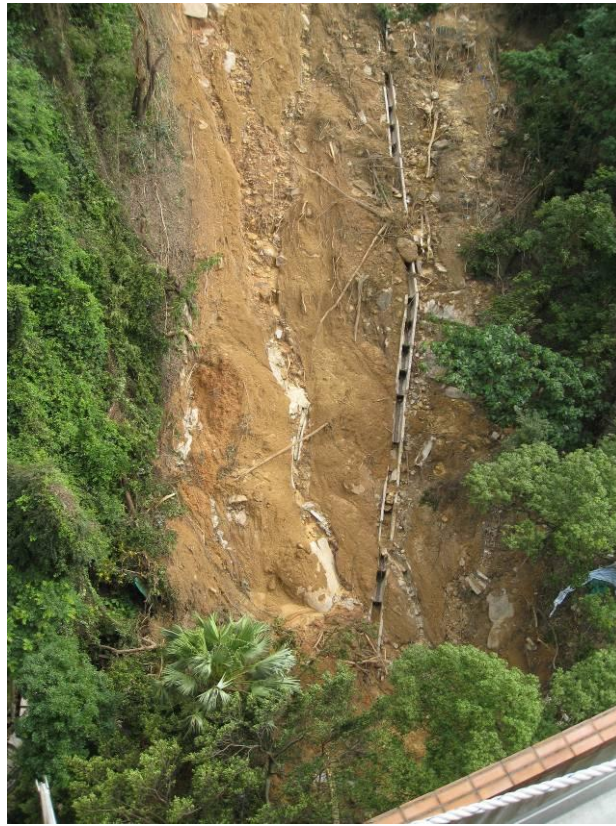
Plate 9 - General View of the Lower Debris Trail  
(Photograph taken on 10 June 2008)

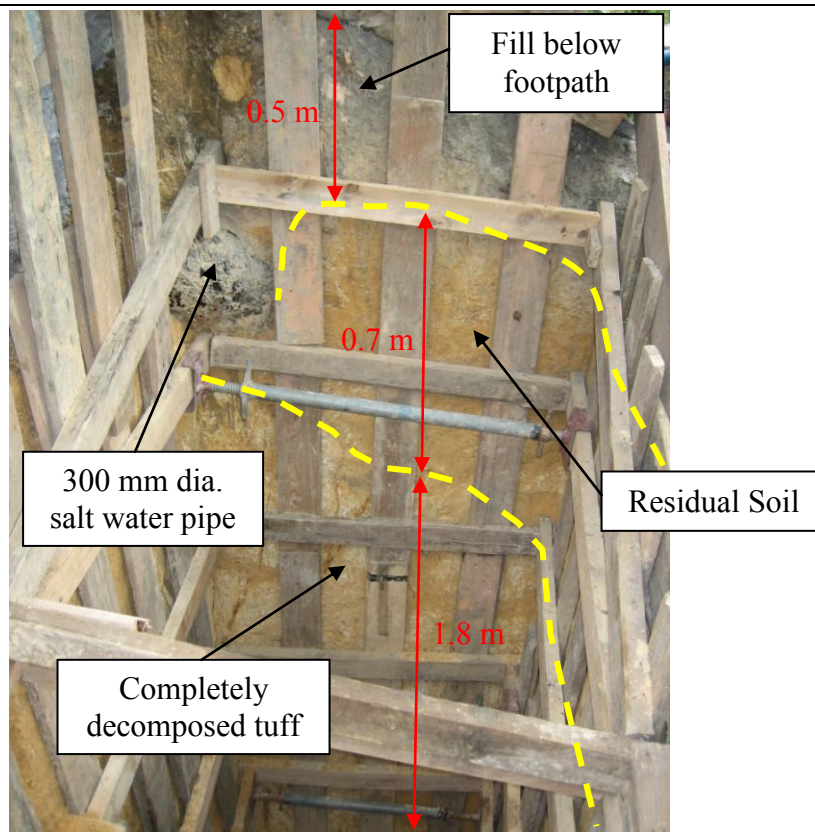
Plate 17 - Trial Trench TTH2 adjacent to the Staircase Leading to Footpath FP3, Showing the Salt Water Pipe Overlying RS and CDT (Photograph taken on 23 September 2008)

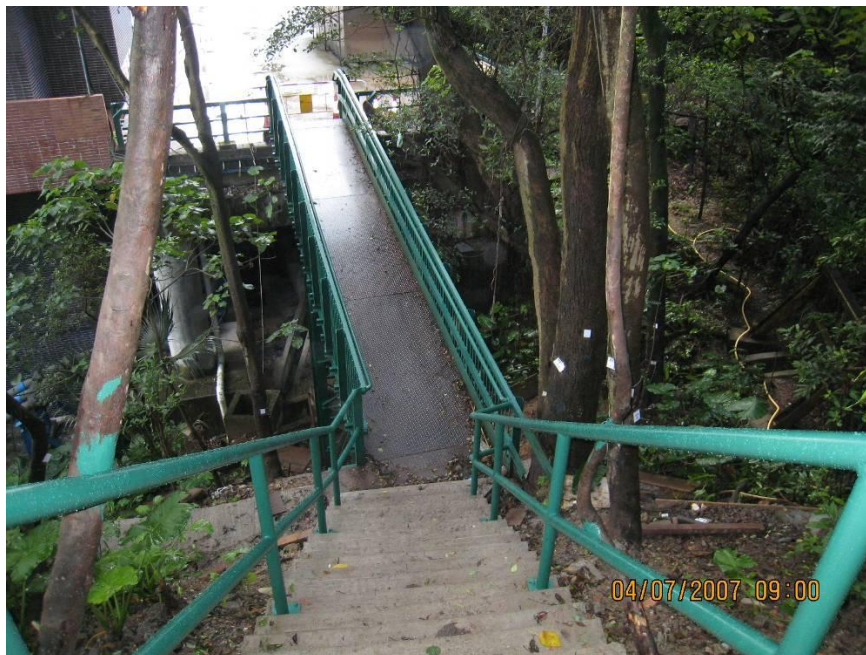
Plate 18 - Pre-failure View of the Temporary Steel Footbridge (Photograph taken on 4 July 2007 by BV)

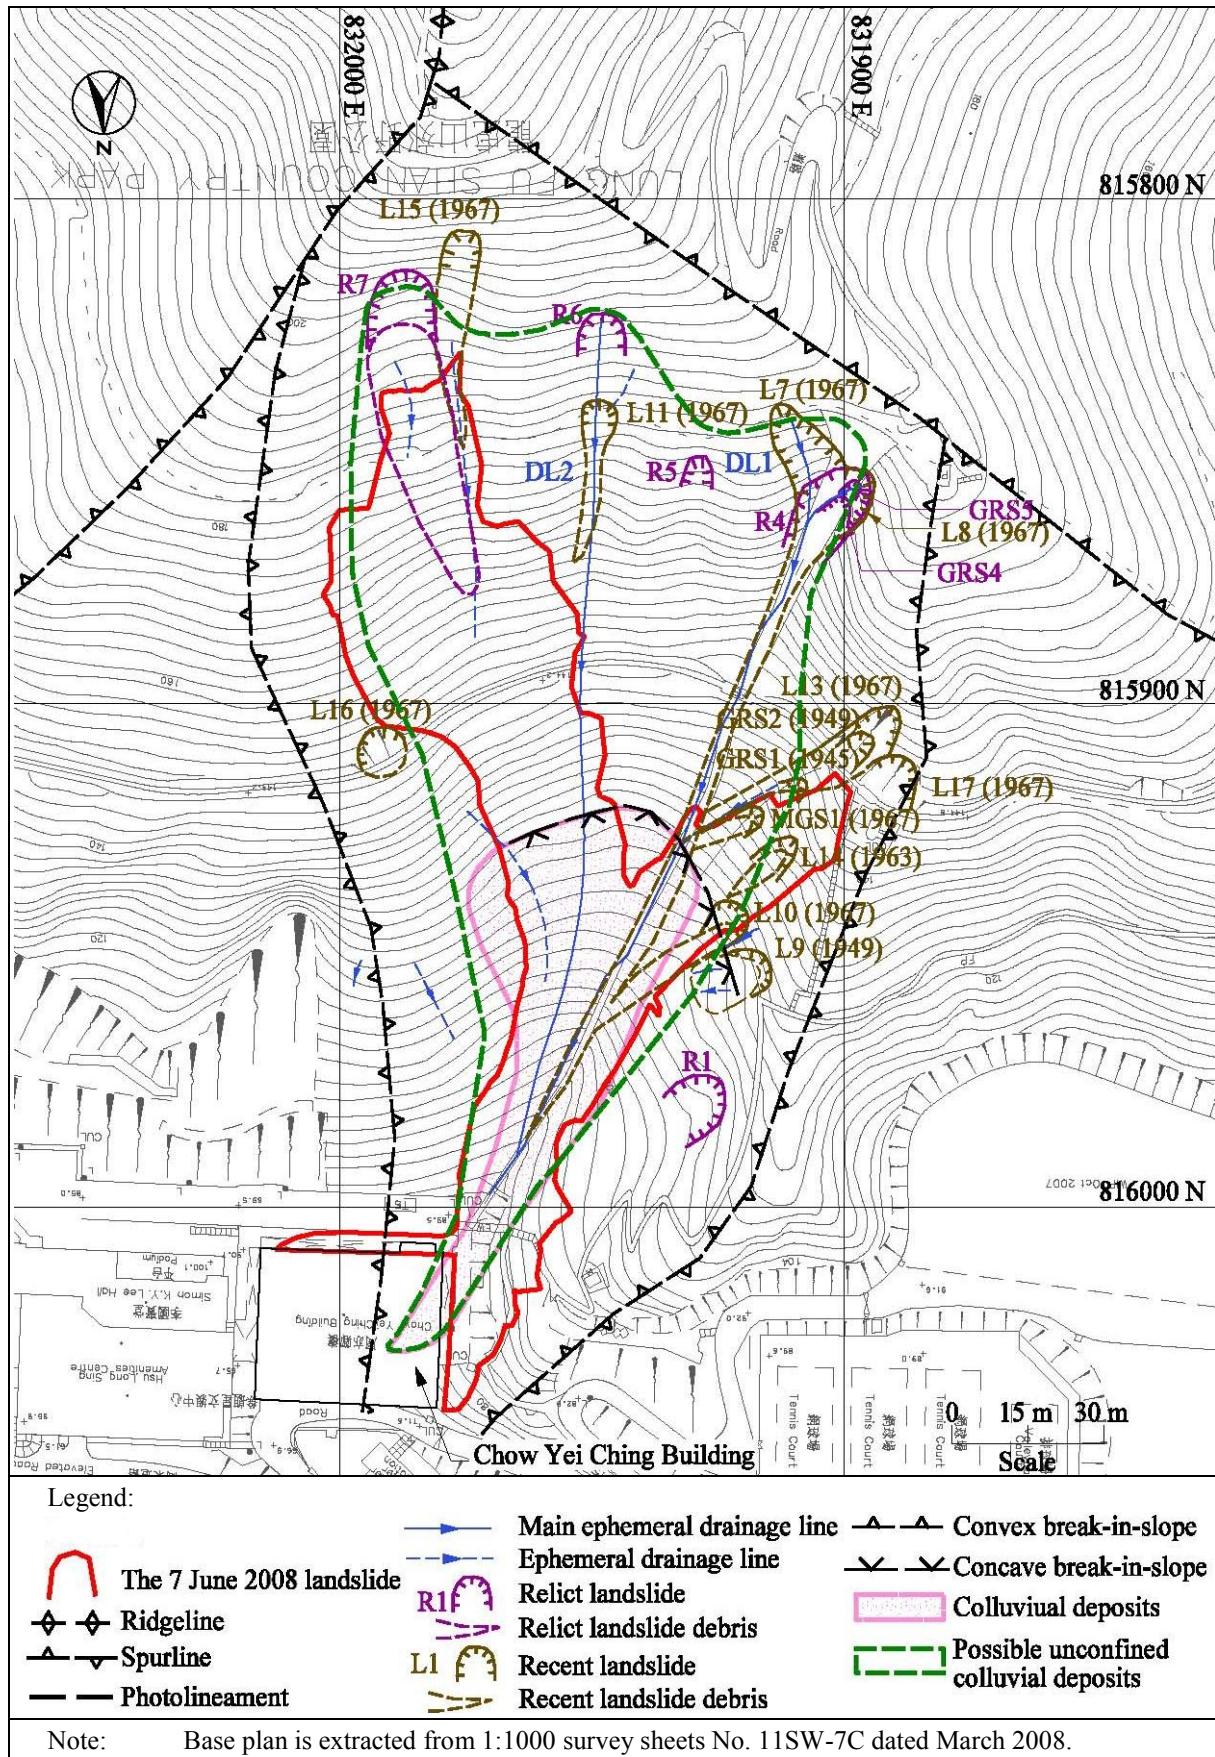
Figure A1 - Aerial Photograph Interpretation

Two main ephemeral drainage lines, DL1 and DL2, are observed adjacent to the west flank and middle of the study area, draining approximately north-northeast and north respectively (Figure A1 and Plate A3). Several minor, discontinuous ephemeral drainage lines are located on the flanks of the study area, two of which are located near the 7 June 2008 landslide primary source area. A convex break-in-slope is discernible near the head of drainage line DL1, which is possibly a relict landslide R4, with two small-scale relict landslides (GRS4 & GRS5) contained within it.

The study catchment shows a history of landslides. About 30 m upslope of the primary source area of the 7 June 2008 landslide, a degraded relict landslide scar R7, approximately 12 m wide by 17 m long is visible, see Figure A1 and Plate A3. Based on the setting and morphology, a lobe of colluvial deposits (about 35 m long) is visible downslope from landslide R7, which forms a footprint to the upper portion of the primary source area. Landslide R7 is identified under the ENTLI as Tag No. 11SWA0022E. Several recent landslides are visible within the study catchment, particularly concentrated on the western flank. After the June 1966 rainstorm, nine recent landslides (L7, L8, L10, L11, L13, L15, L16, L17 and MGS1) are visible on the study area hillside (Plate A4). Landslide L15 (ENTLI Tag No. 11SWA0377E) is located further upslope of the 7 June 2008 landslide primary landslide source area with the debris trail stopping a few metres downslope from footpath FP2.

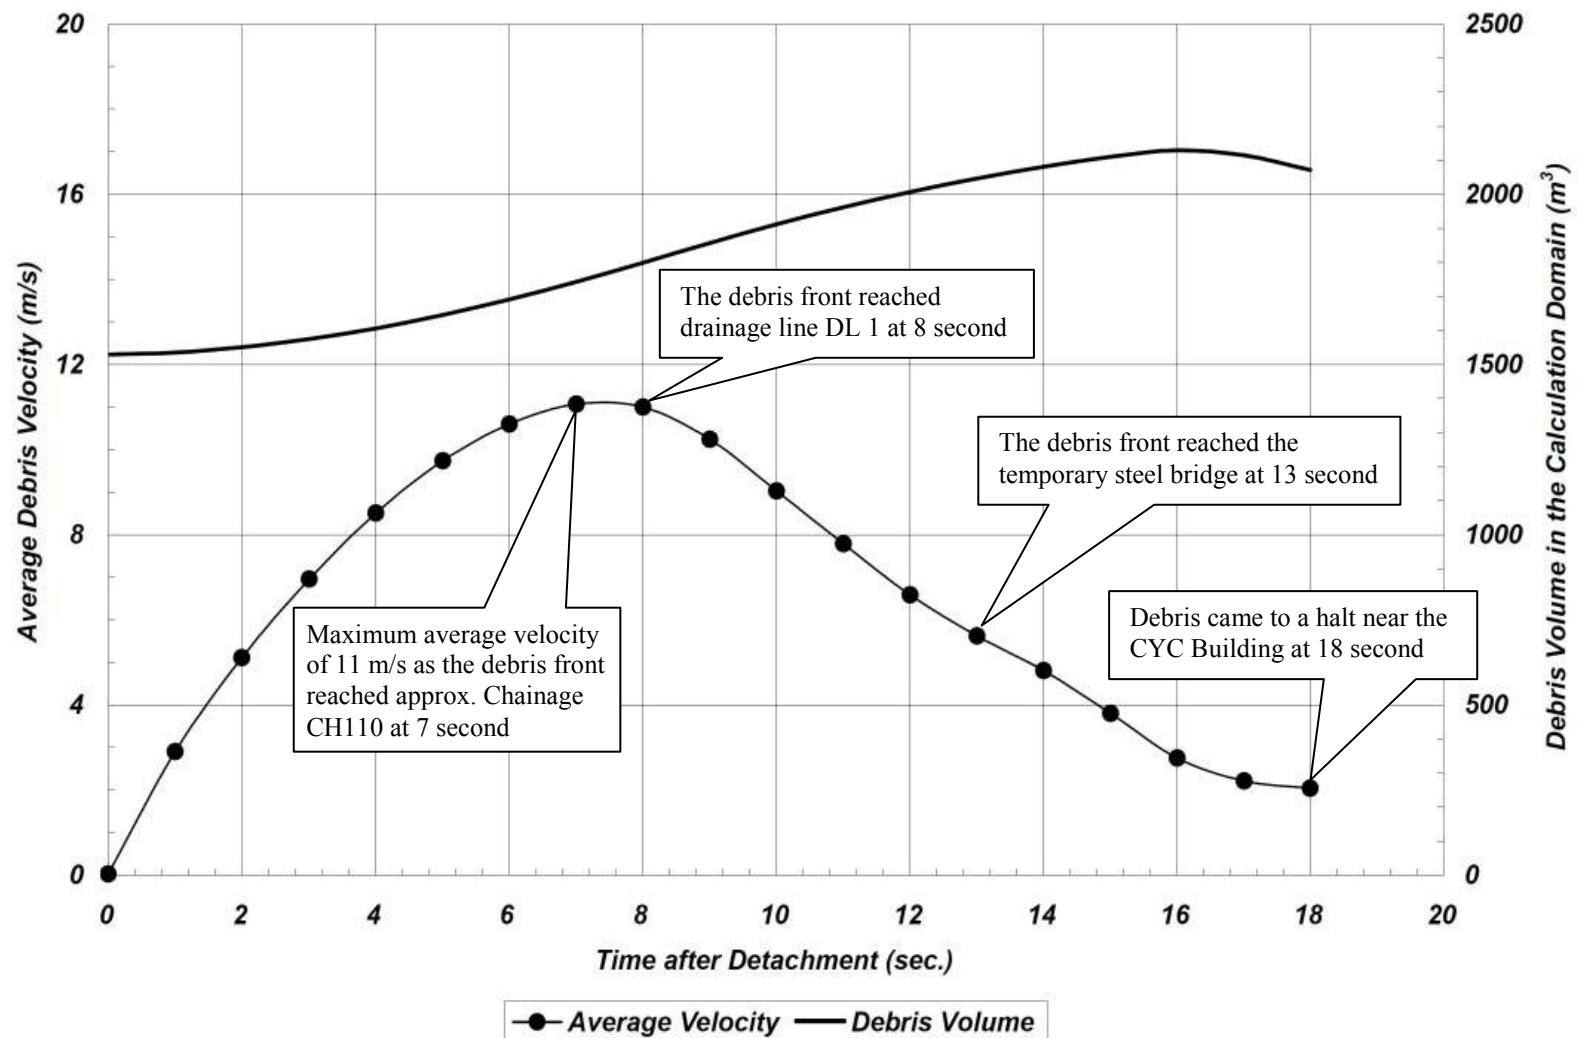
Figure C1 - Average Velocity and Volume of Debris versus Time

Note: Average velocity was calculated for the debris mass as a whole.
