**DETAILED STUDY OF
THE 7 JUNE 2008
LANDSLIDE BEHIND
EWAN COURT,
KENNEDY ROAD,
WANCHAI**

GEO REPORT No. 278

Fugro Scott Wilson Joint Venture

**This report is largely based on GEO Landslide Study Report
No. LSR 8/2009 produced in September 2009**

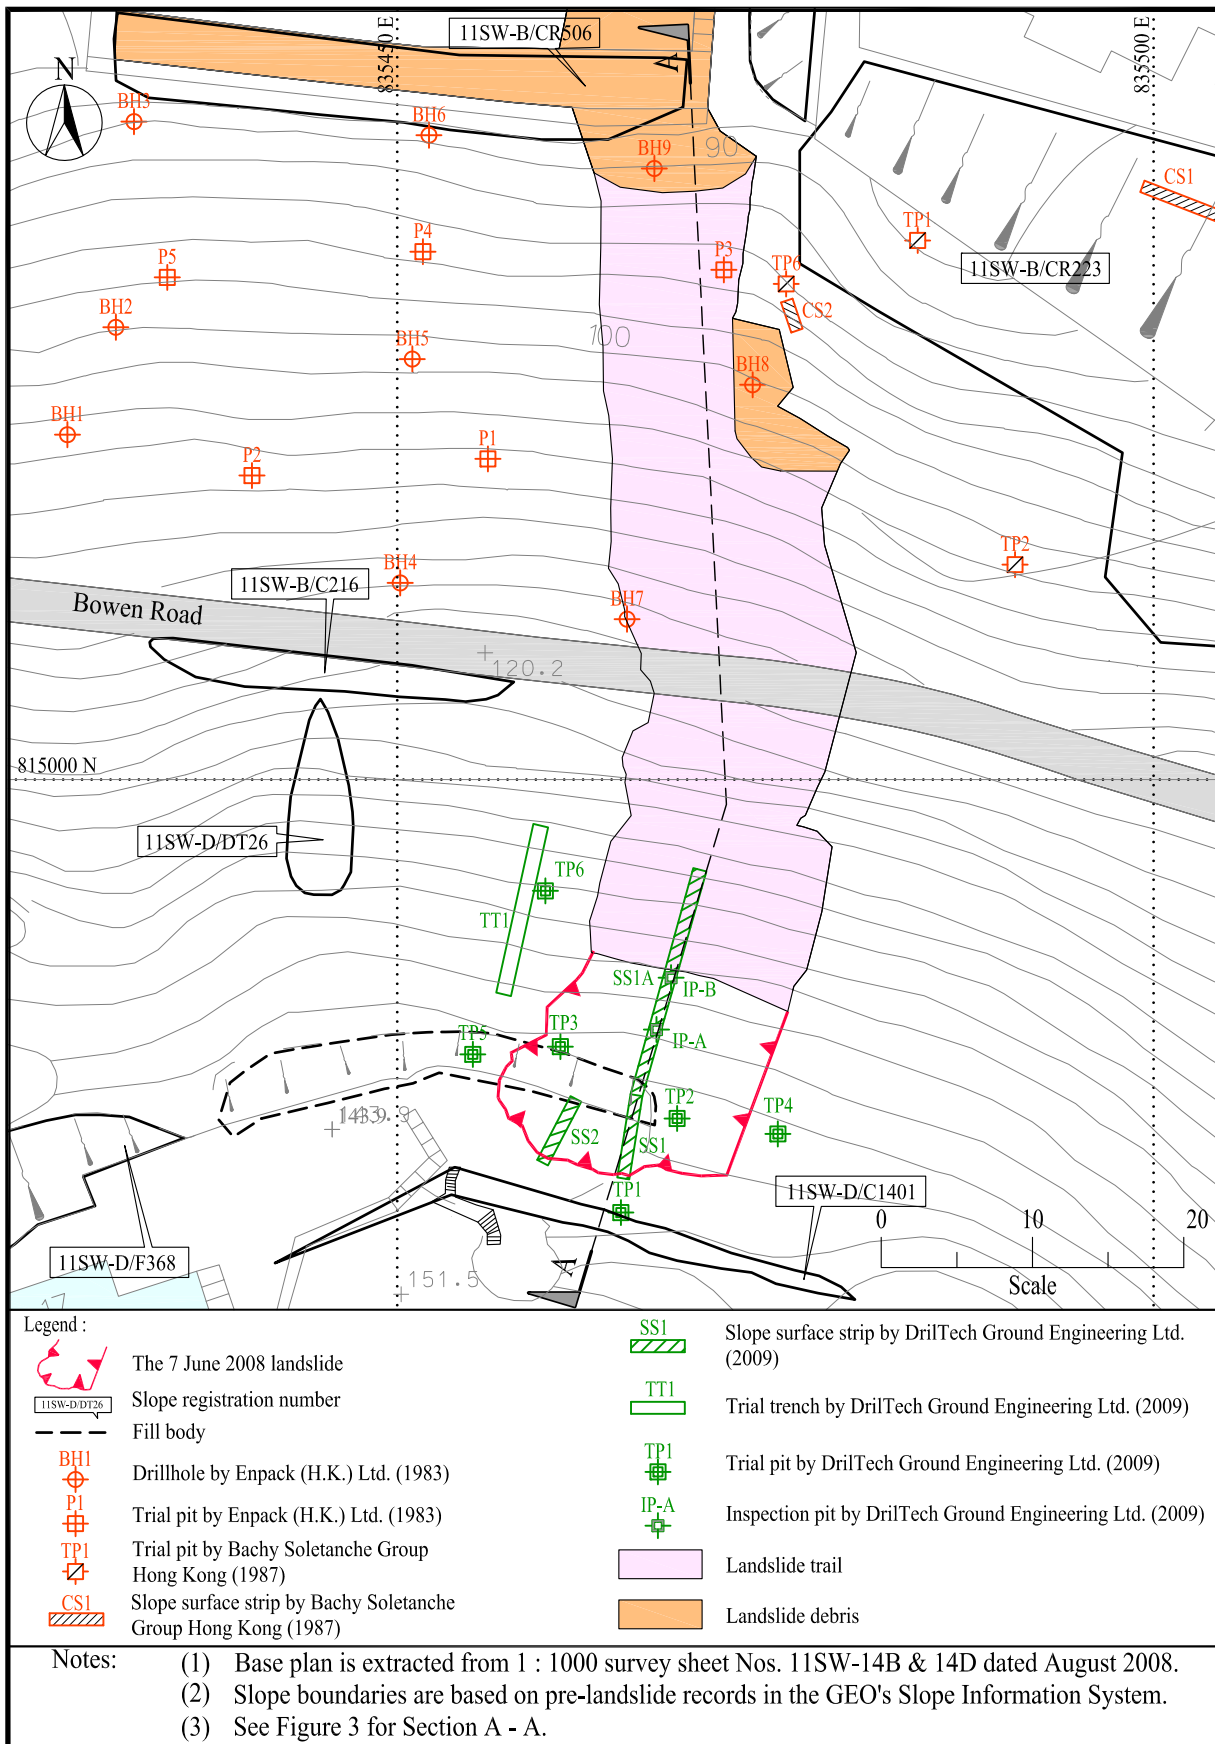
Figure 9 - Location Plan of Ground Investigation Stations

stations were located on the hillside below Bowen Road. The locations of these GI stations are shown in Figure 9. An interpreted geological section through the source area of the landslide is shown in Figure 4, which indicates that the site comprises a layer of colluvium of up to about 1.5 m thick, overlying highly to moderately decomposed tuff (H/MDT) of Ap Lei Chau Formation (Figure 10). The colluvium could be generally described as greyish brown sandy clayey silt with some sub-angular fine to coarse gravel and cobbles.
