**REVIEW OF THE
3 AUGUST 2006
LANDSLIDE INCIDENT ON
SLOPE NO. 11SW-C/FR319,
NO. 131 POK FU LAM ROAD**

GEO REPORT No. 279

Fugro Scott Wilson Joint Venture

**This report is largely based on GEO Landslide Study Report
No. LSR 2/2008 produced in March 2008**

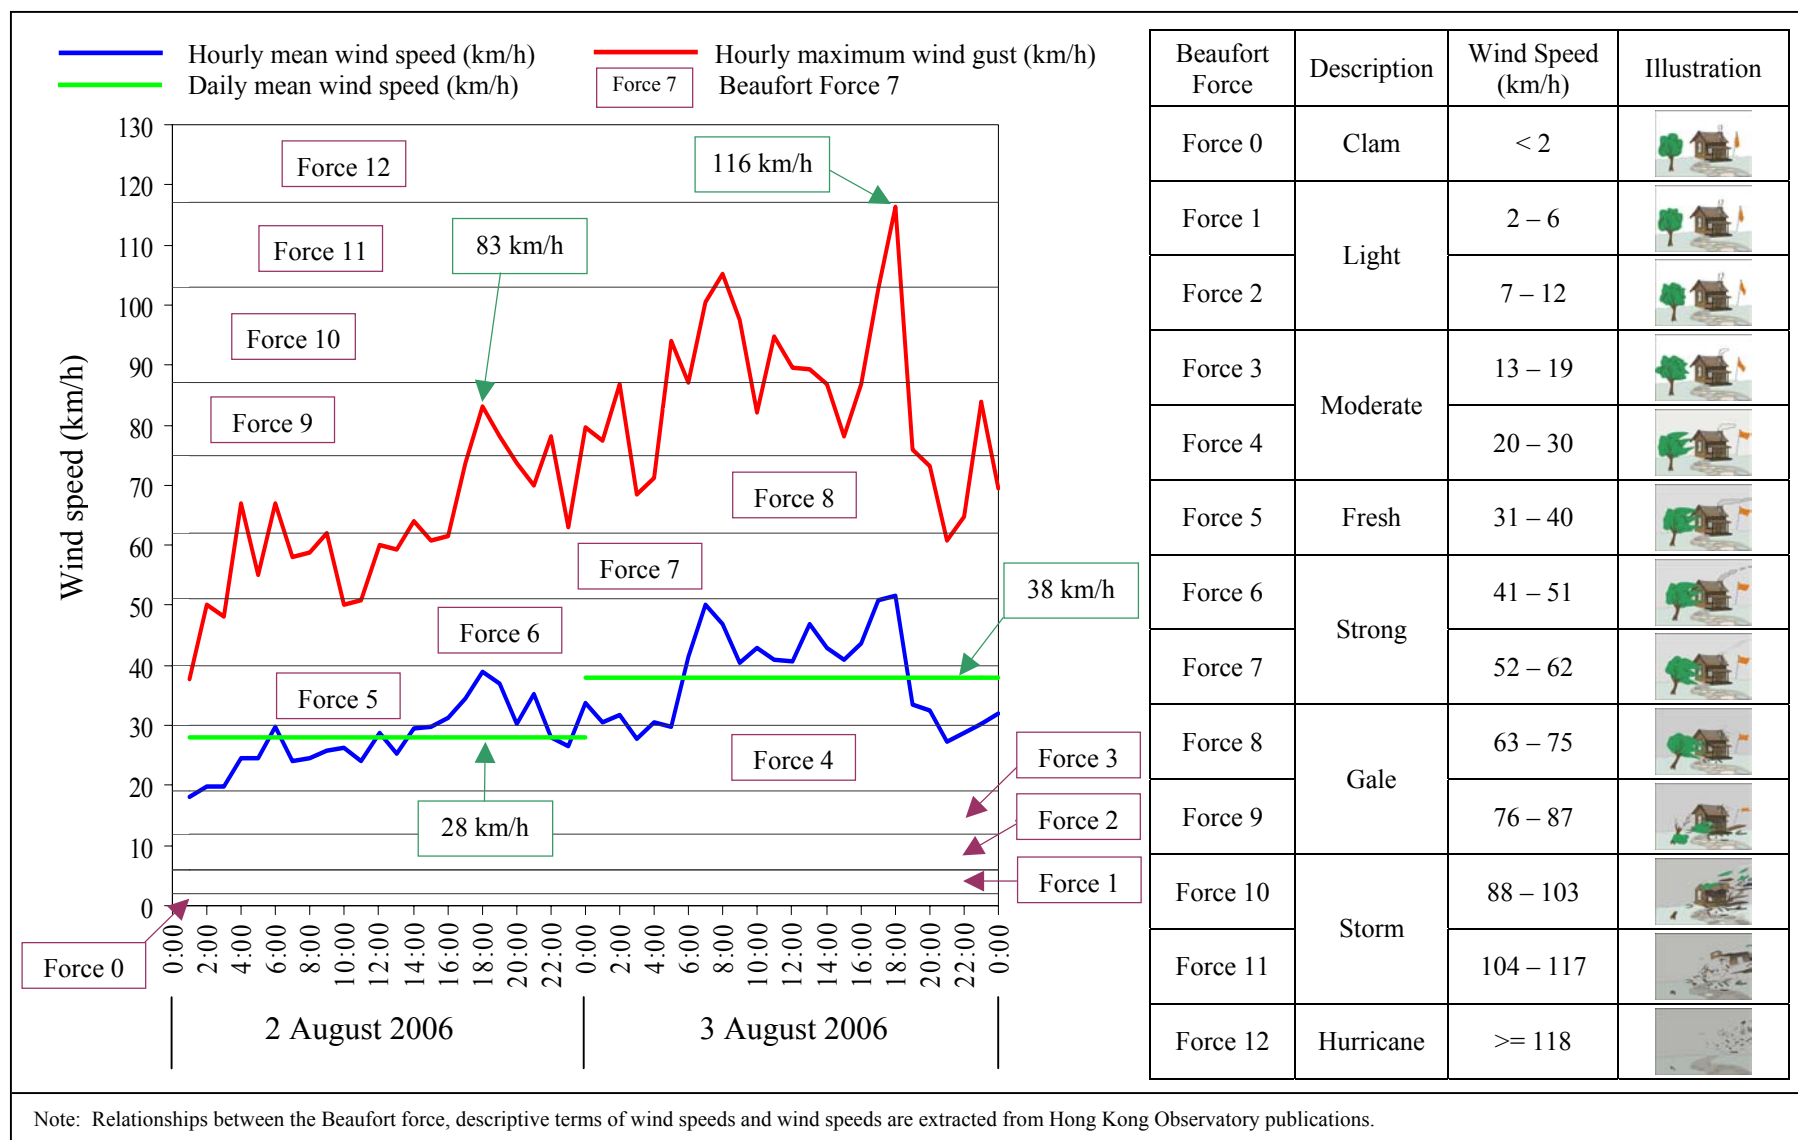
Figure 11 – Wind Speed Data Recorded at HKO Wong Chuk Hang Weather Station

The HKO's nearest monitoring station to the failure site, located at Wong Chuk Hang, about 480 m to the southeast of the failure, recorded mean wind speeds of 28 km/h and 38 km/h for 2 and 3 August 2006 respectively (Figure 11), with peak wind gusts reaching 83 km/h and 116 km/h respectively.

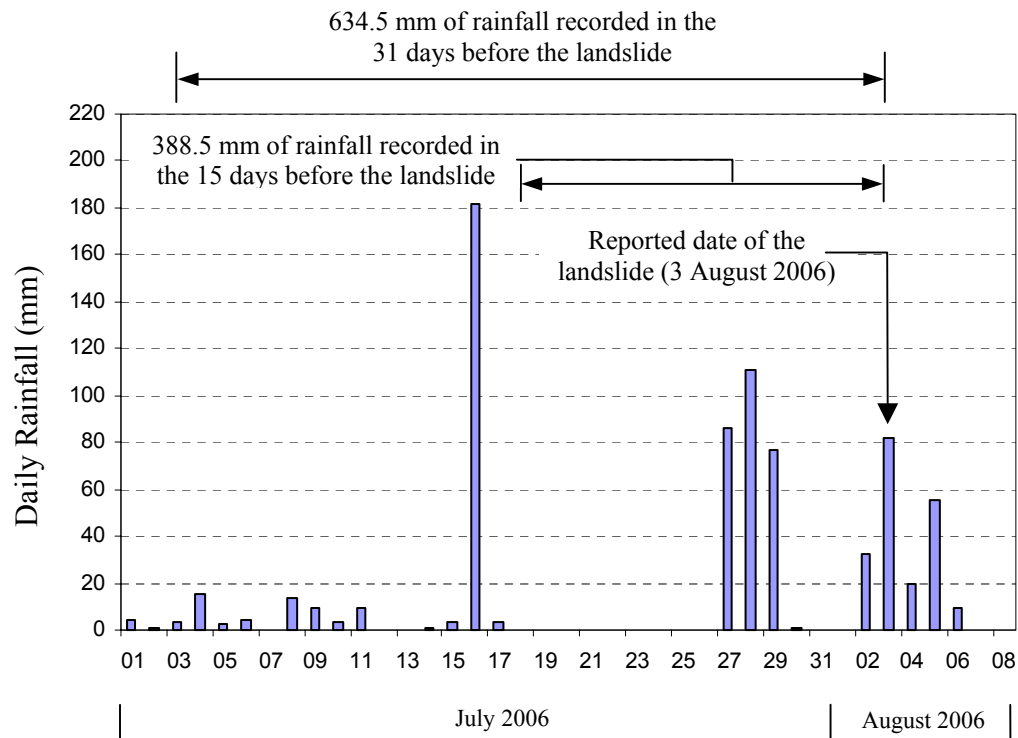
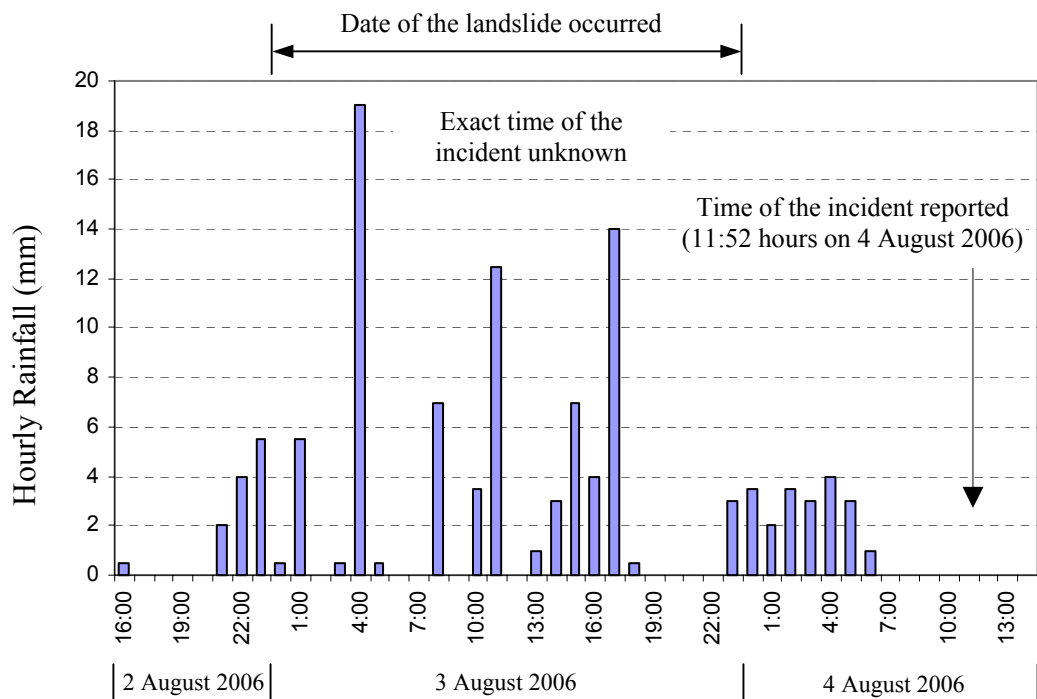
Figure 12 - Rainfall Recorded at GEO Raingauge No. H03

The daily rainfall recorded by raingauge No. H03 over the month preceding the failure, together with the hourly rainfall readings for the period between 4:00 p.m. on 2 August 2006 and 2:00 p.m. on 4 August 2006, are presented in Figure 12. The maximum 24-hour and 12-hour rolling rainfall before the failure was 90 mm and 54 mm respectively.

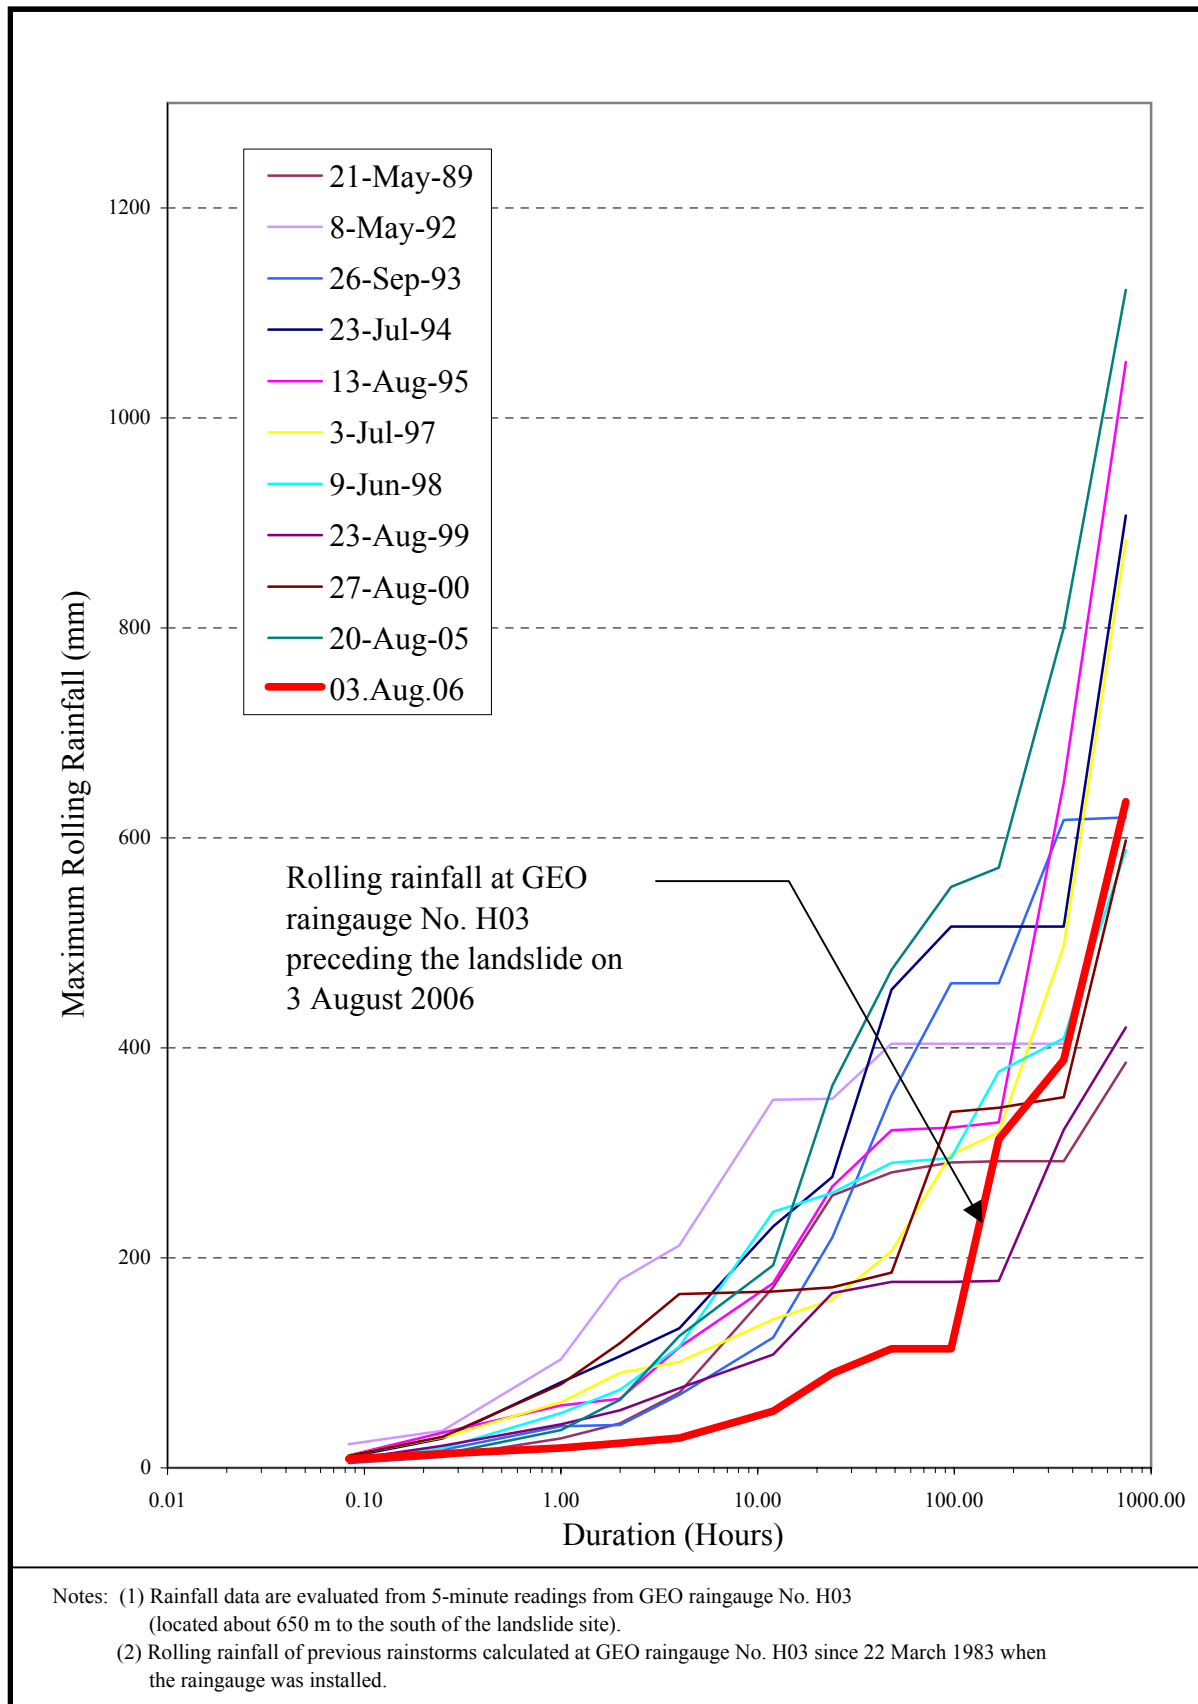
Figure 13 - Maximum Rolling Rainfall Preceding the 3 August 2006 Landslide Incident and Selected Previous Major Rainstorms Recorded at GEO Raingauge No. H03

which came into operation in the mid-1980's (Figure 13). The maximum rolling rainfall for the rainstorm on 3 August 2006 is less severe than the previous significant rainstorms.

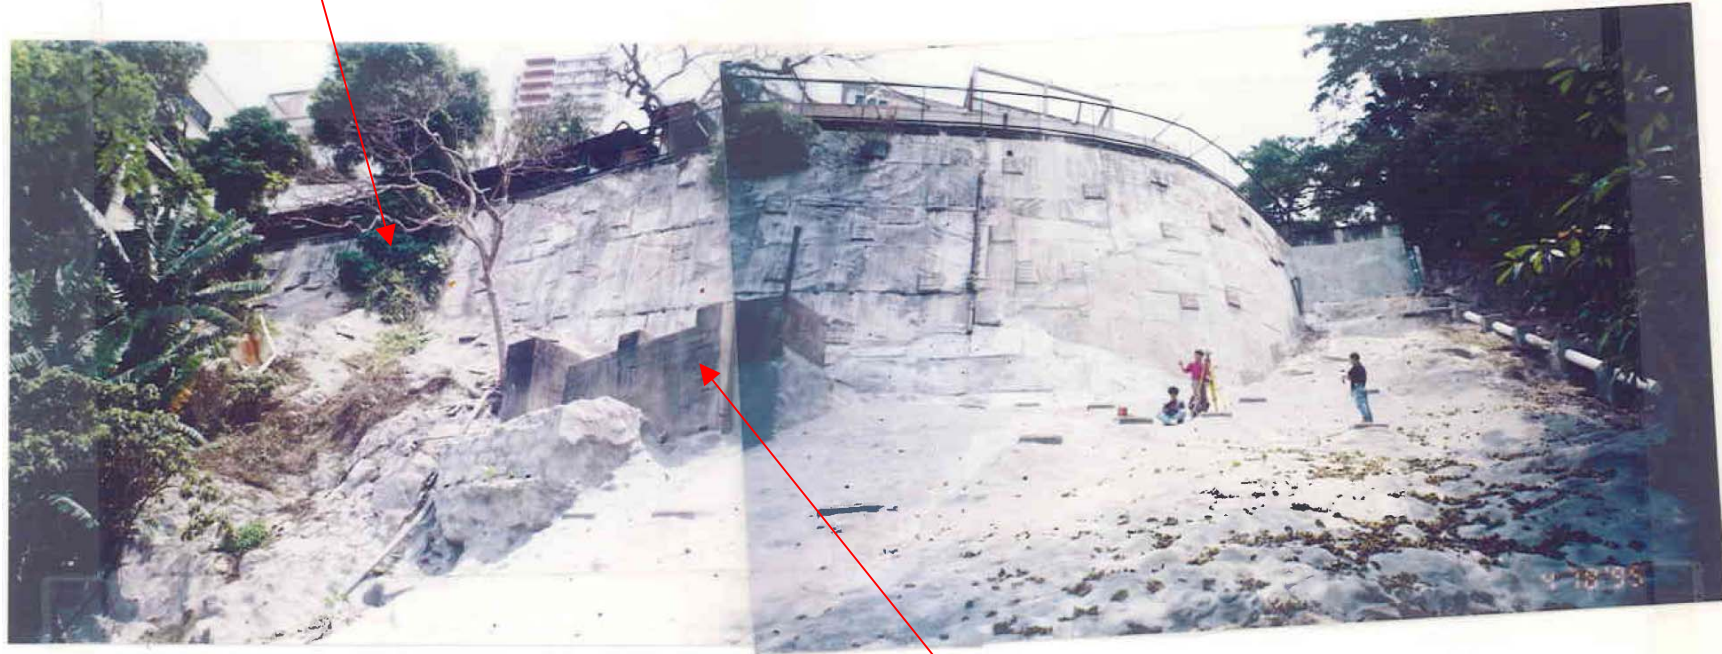
Plate 4 – General View of Slope No. 11SW-C/FR319 after Completion of Slope Upgrading Works in 1995
(Extracted from Photo 2 of Geotechnical Report for Stage 2 Site Formation)

Tree involved in the 3 August 2006 incident

Septic tank
