**REVIEW OF THE  
20 AUGUST 2005 LANDSLIDE  
ON SLOPE NO. 11NW-D/C144  
BEHIND NOS. 12 AND 14  
WYLIE ROAD  
KING'S PARK**

**GEO REPORT No. 283**

**Halcrow China Limited**

**This report is largely based on GEO Landslide Study Report  
No. LSR 9/2009 produced in September 2009**

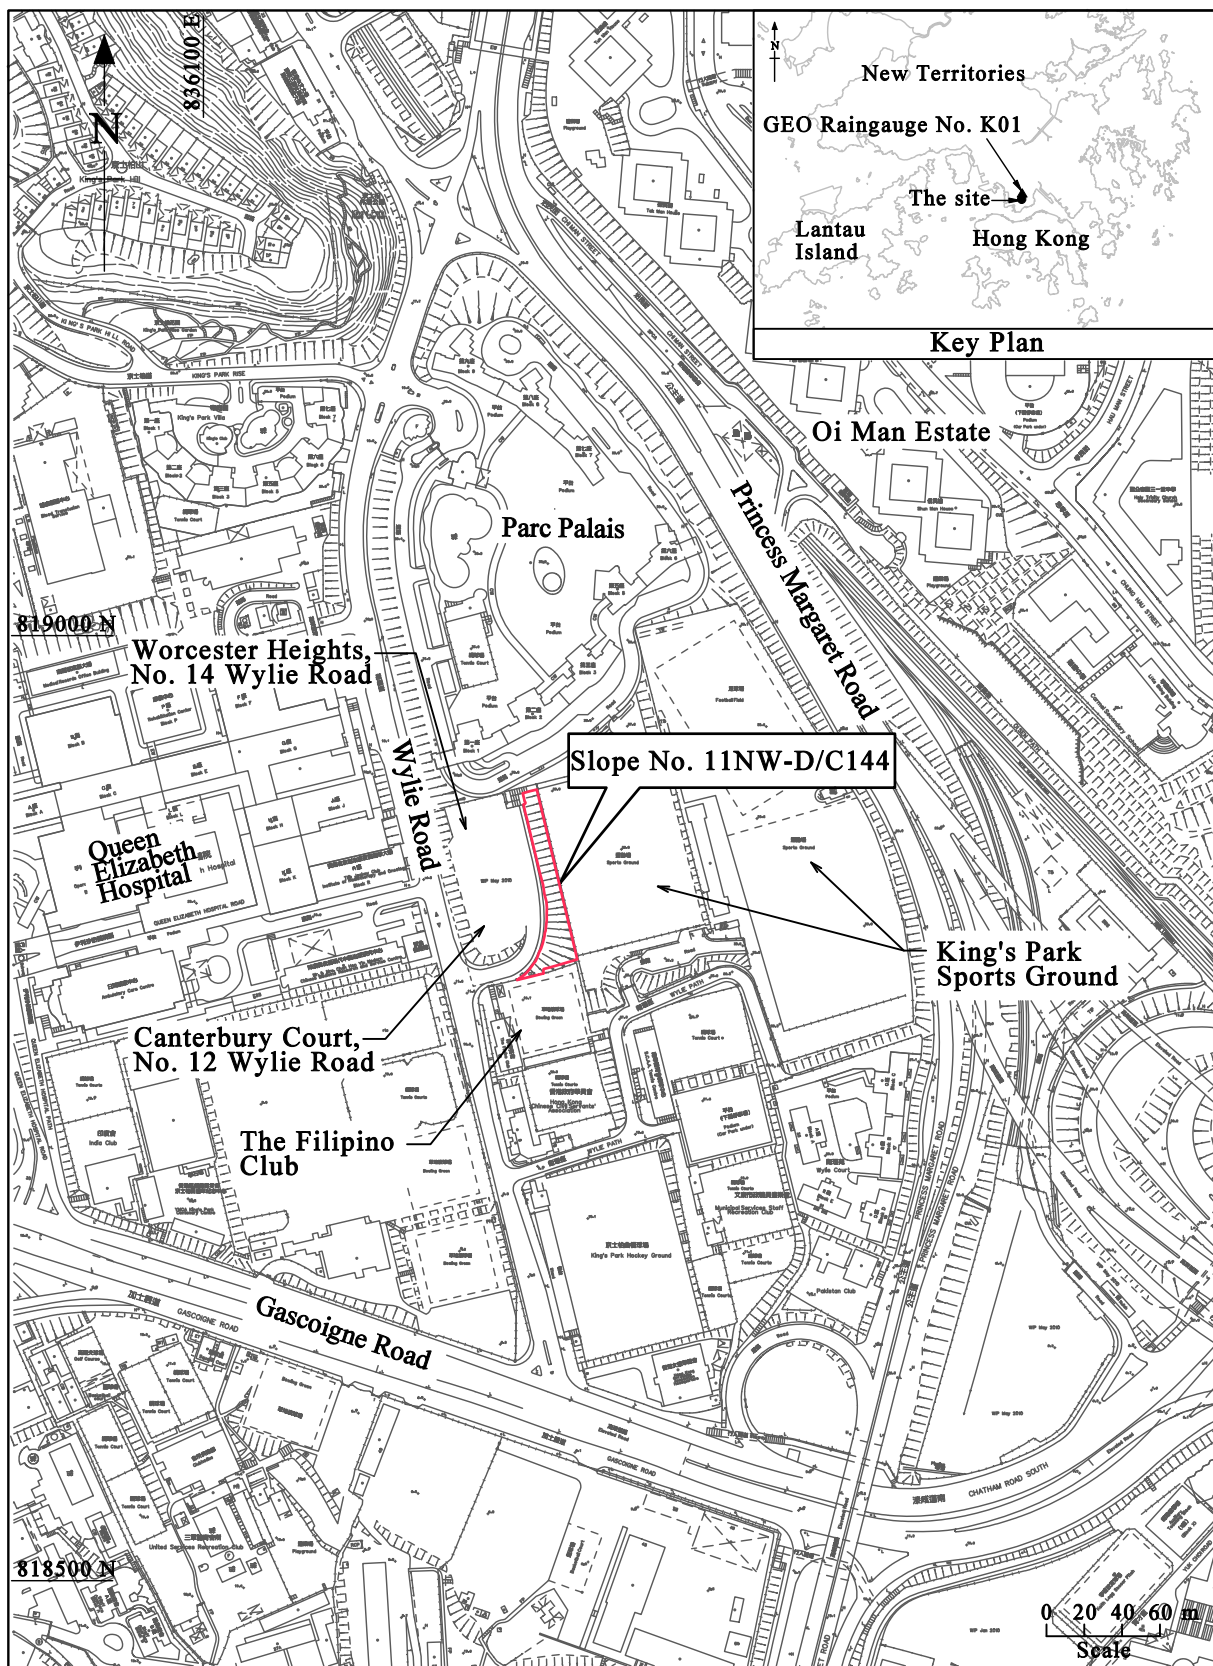
Figure 1 - Location Plan

At about 11:30 a.m. on 20 August 2005, a major landslide (Incident No. 2005/08/0327) occurred on slope No. 11NW-D/C144 behind Nos. 12 and 14 Wylie Road, King's Park, Kowloon (Figure 1 & Plates 1 to 6) when an Amber Rainstorm Warning and a Landslip Warning were in force. The landslide involved a failure volume of about 200 m<sup>3</sup>. The landslide scar extended into a grassed football field of King's Park Sports Ground, at the crest of the slope. The landslide debris was deposited on an access road at the slope toe, near the entrance to a carpark for the residential building, Canterbury Court. Some debris travelled down the access road and came to rest at Wylie Road. The access road was temporarily closed and no casualties were reported as a result of the incident.

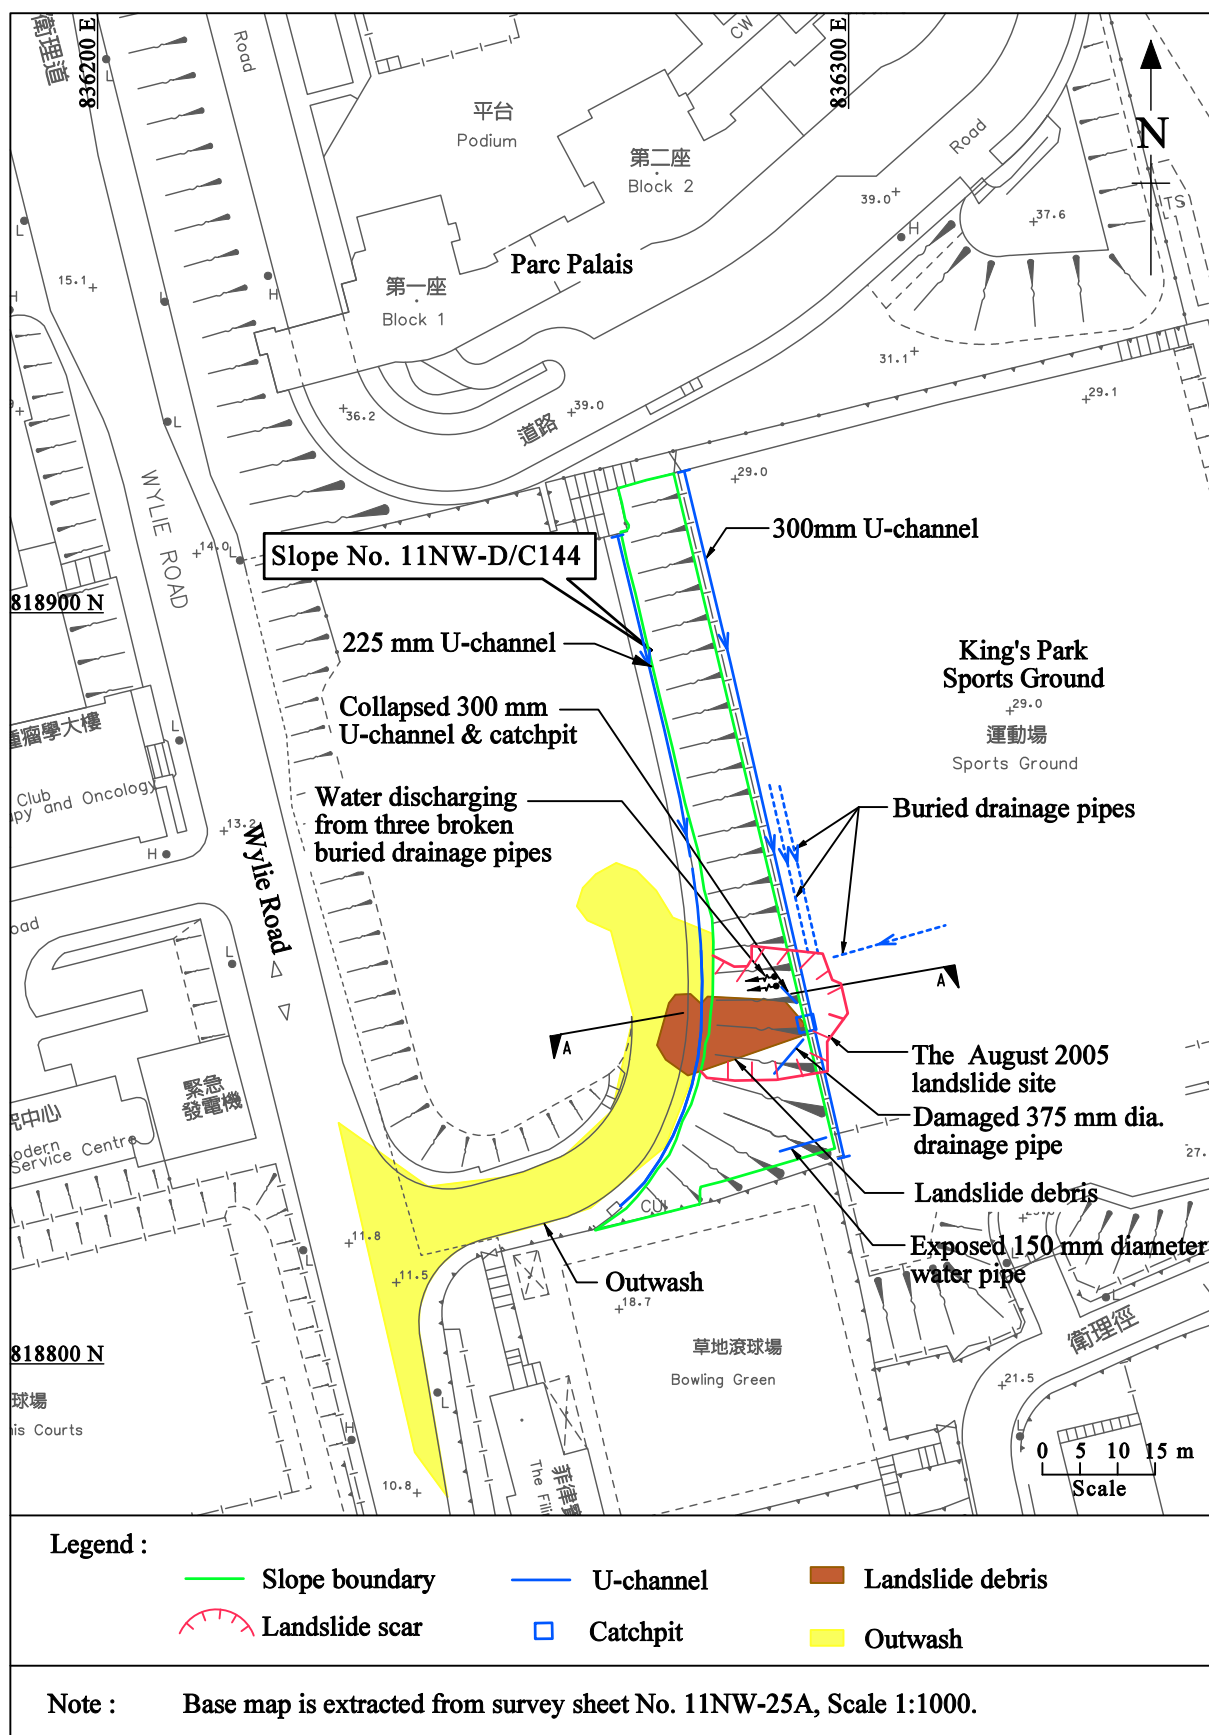
### Figure 2 - Site Layout Plan

Slope No. 11NW-D/C144 is approximately 96 m long and has a maximum height of about 13.5 m. The slope comprises one batter inclined at an angle ranging from 35° to 50°. The slope has a chunam surface cover, with 50 mm diameter weepholes spaced at about 1.5 m centres vertically and horizontally, except for the southern end where the slope surface is covered with vegetation. Some boulders protruding from the slope surface are present at the mid-height of the slope. A site layout plan showing the location of the 20 August 2005 landslide is presented in Figure 2. A cross section through the August 2005 landslide is shown in Figure 3.

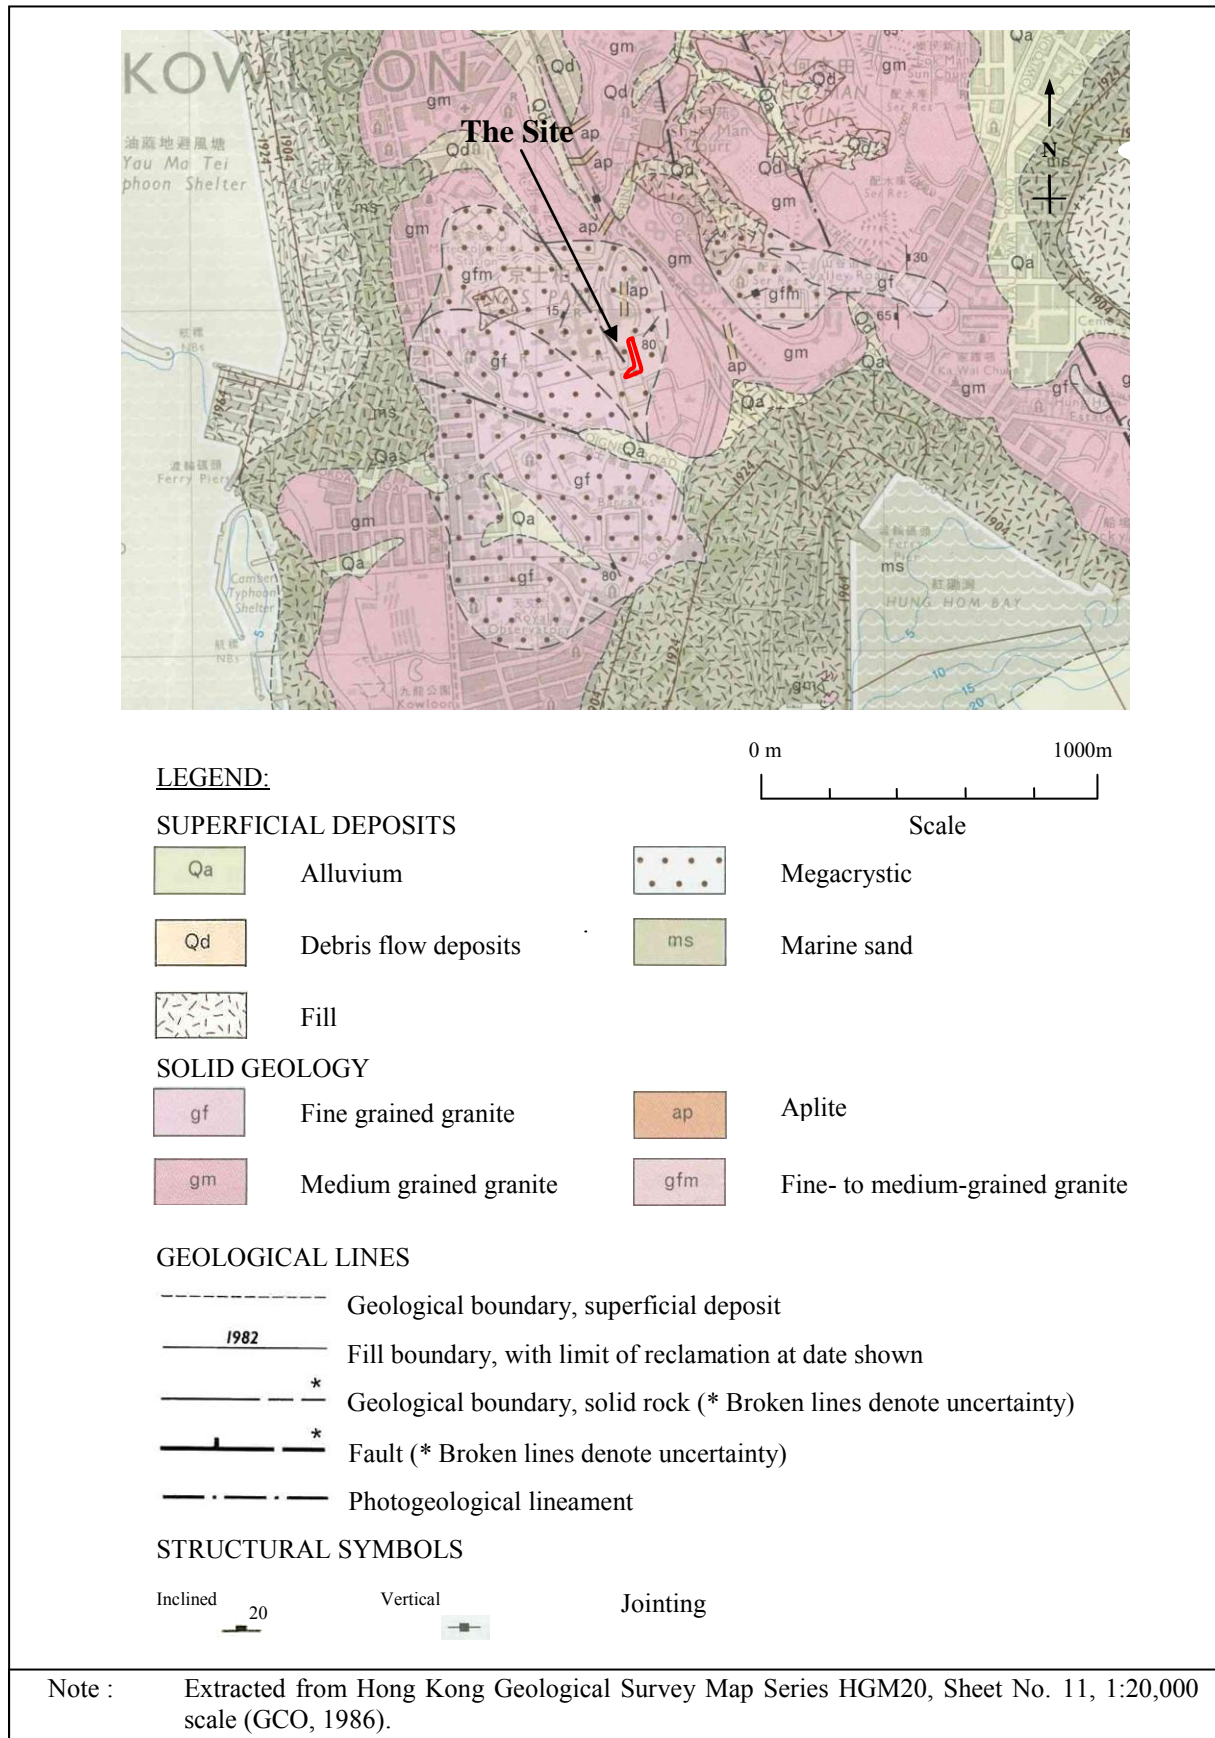
Figure 4 – Regional Geology

According to Sheet 11 of the Hong Kong Geological Survey (HKGS) 1:20 000 scale map series HGM20 (GCO, 1986), the solid geology at the subject slope comprises Megacrystic fine- to medium-grained GRANITE. It is also noted that a northwest-trending photolineament runs close to the slope toe (Figure 4).

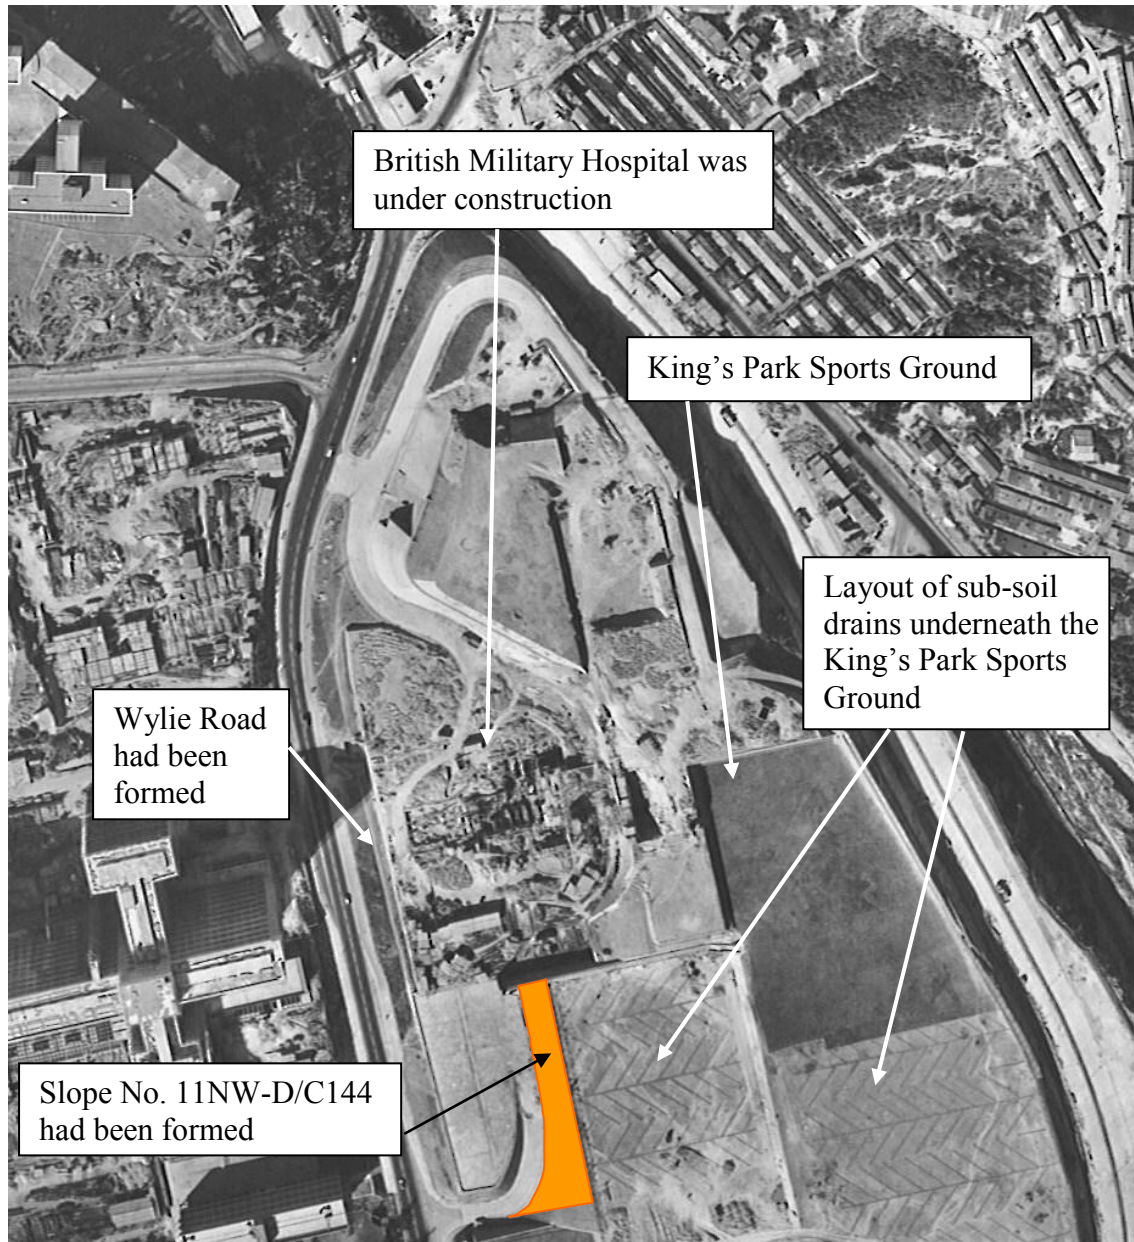
The 1963 aerial photographs and a drainage plan located in Arch SD reveal the layout of herringbone sub-soil drains underneath the King's Park Sports Ground (Figure 5). However, no other surface or underground drainage plans for the subject slope or the sports ground could be located in Arch SD or the Hong Kong Rugby Football Union (HKRFU), the tenant of King's Park Sports Ground under Lands D's STT No. KX2153.

Figure 5 – The 1963 Aerial Photograph Showing Sub-soil Drains Underneath the King's Park Sports Ground

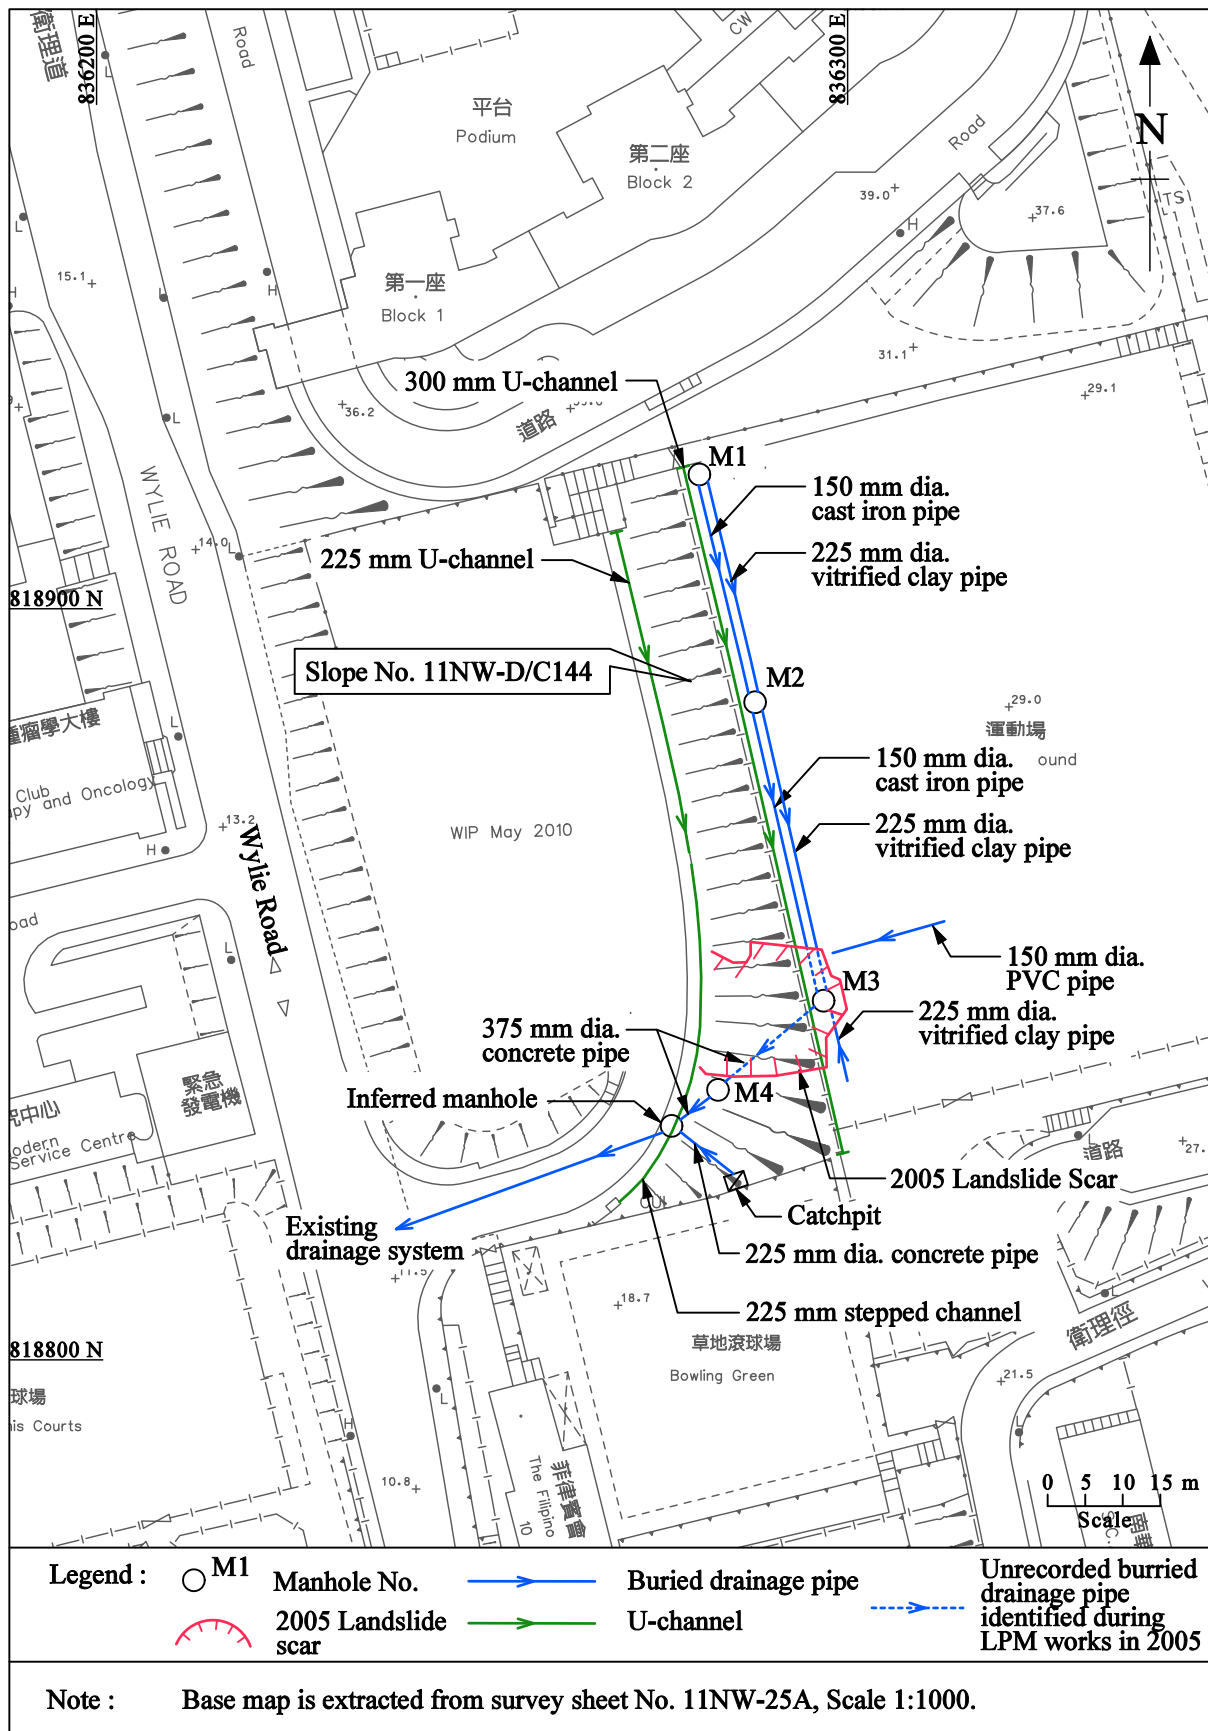
The layout plan of water-carrying services at and in the vicinity of slope No. 11NW-D/C144, which were identified during the course of this study, is presented in Figure 6.

Figure 6 - Layout Plan of Water-carrying Services at and in the Vicinity of Slope No. 11NW-D/C144 before the August 2005 Landslide

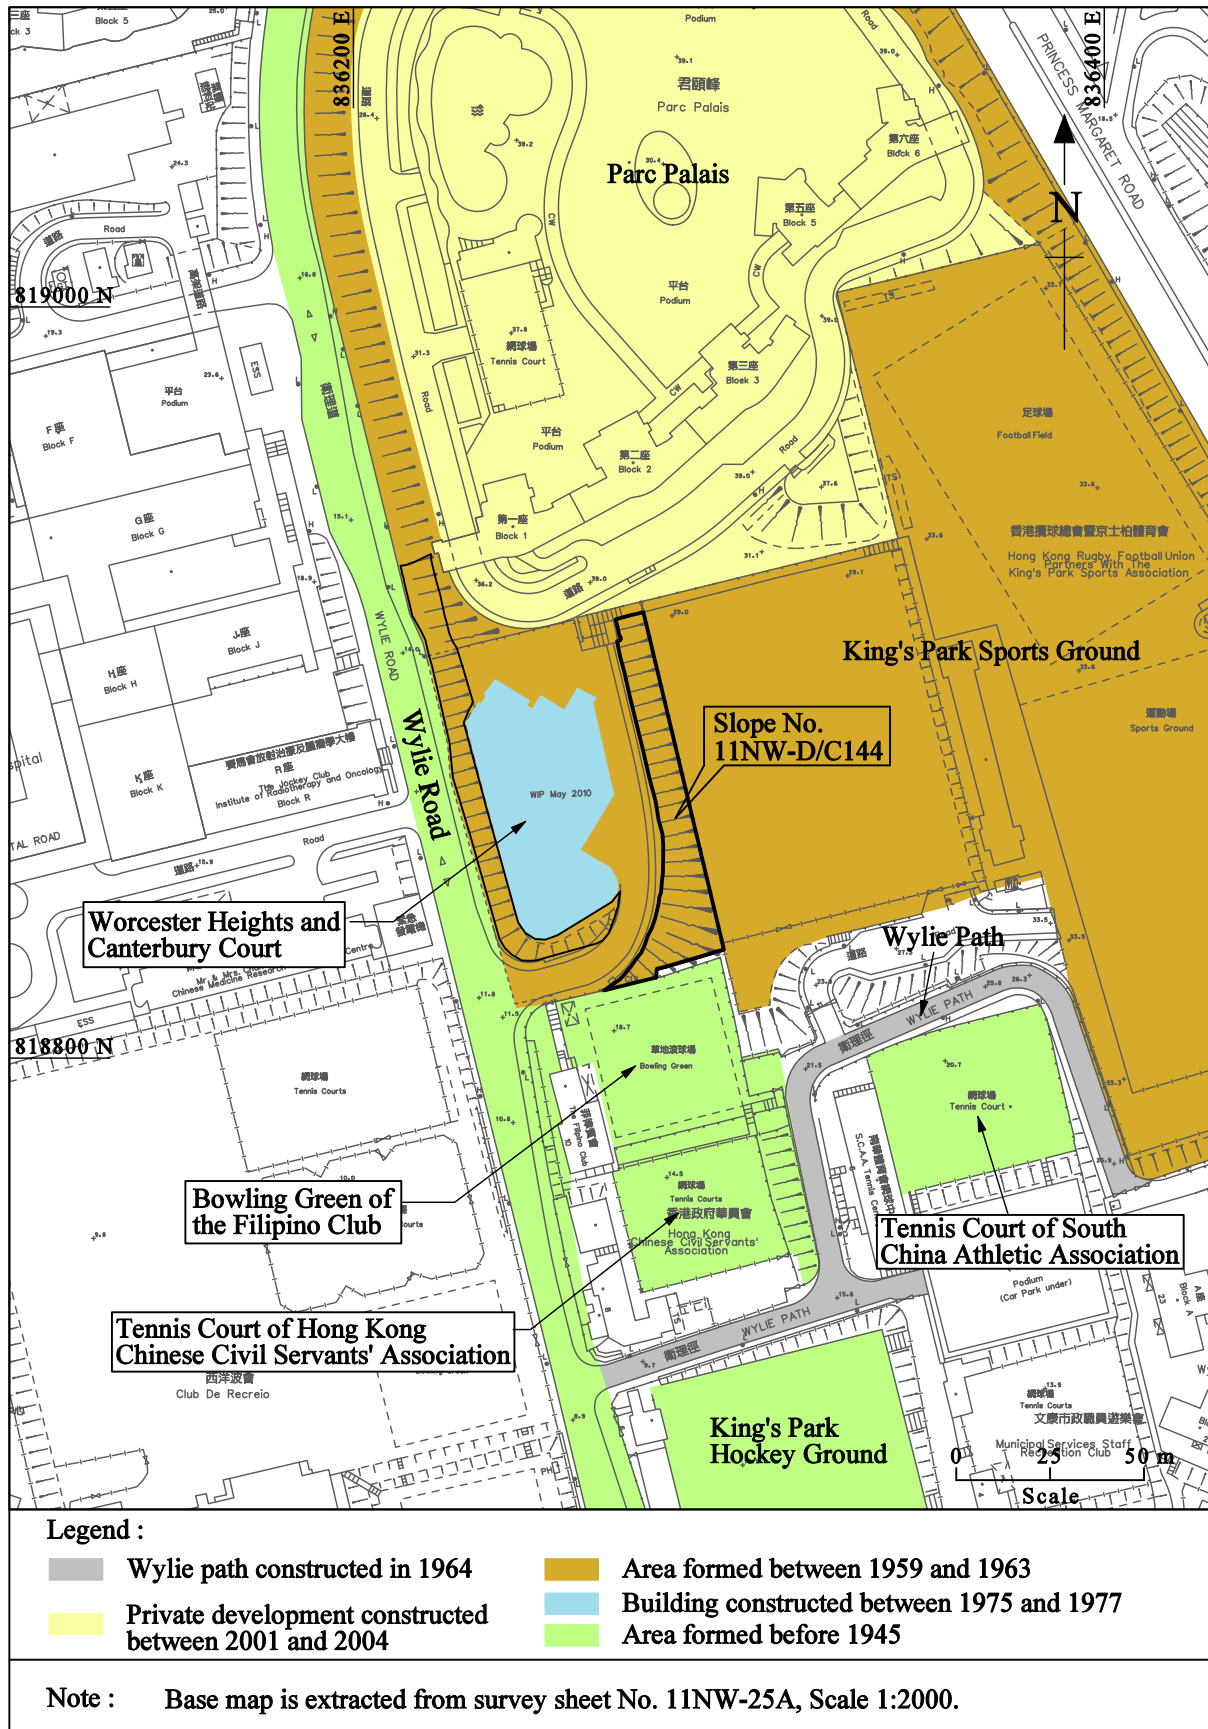
Figure 7 - Site History

The development history of the site (Figure 7) has been established from a review of aerial photographs and inspection of available relevant documentary records. A detailed account of the aerial photograph interpretation (API) is presented in Appendix A. Salient aspects of the key observations are summarised below.

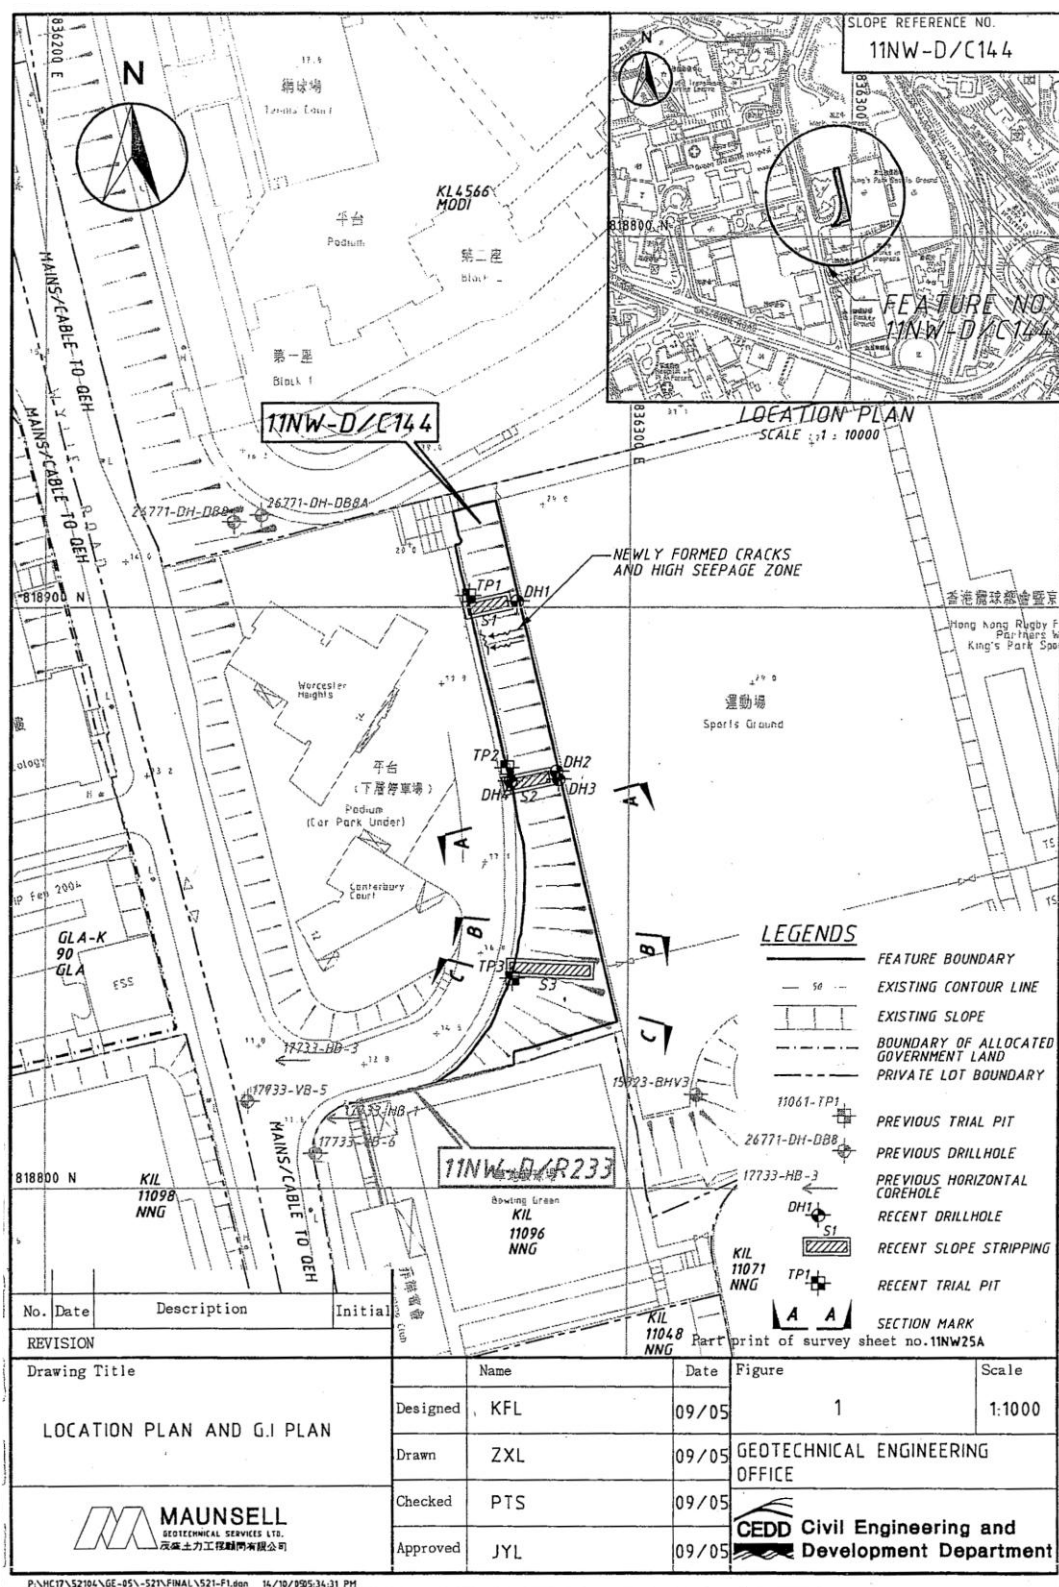
As part of the Stage 3 Study, site-specific ground investigation (GI) works, including the sinking of four drillholes and excavation of three trial pits and three surface strippings, were carried out on the slope before the 20 August 2005 landslide under Contract No. GE/2004/34. The locations of the GI works are shown in Figure 8. The GI results showed that completely decomposed granite (CDG) was encountered from the ground level to the termination depth in all four drillholes (i.e. ranging from 4 m to 9 m below the slope toe) and also in the trial pits and surface strippings, except for the surface stripping (S3) at the southern portion of the slope, where fill material was encountered. The CDG is described in the Stage 3 Study Report as "extremely weak, reddish yellow, occasionally brownish yellow and red spotted grey, slightly clayey silty fine to coarse sand with some angular to sub-angular fine to medium gravel of granite and quartz".

Figure 8 – Location Plan of Ground Investigation Works Extracted from Stage 3 Report (S3R 149/2005) dated October 2005

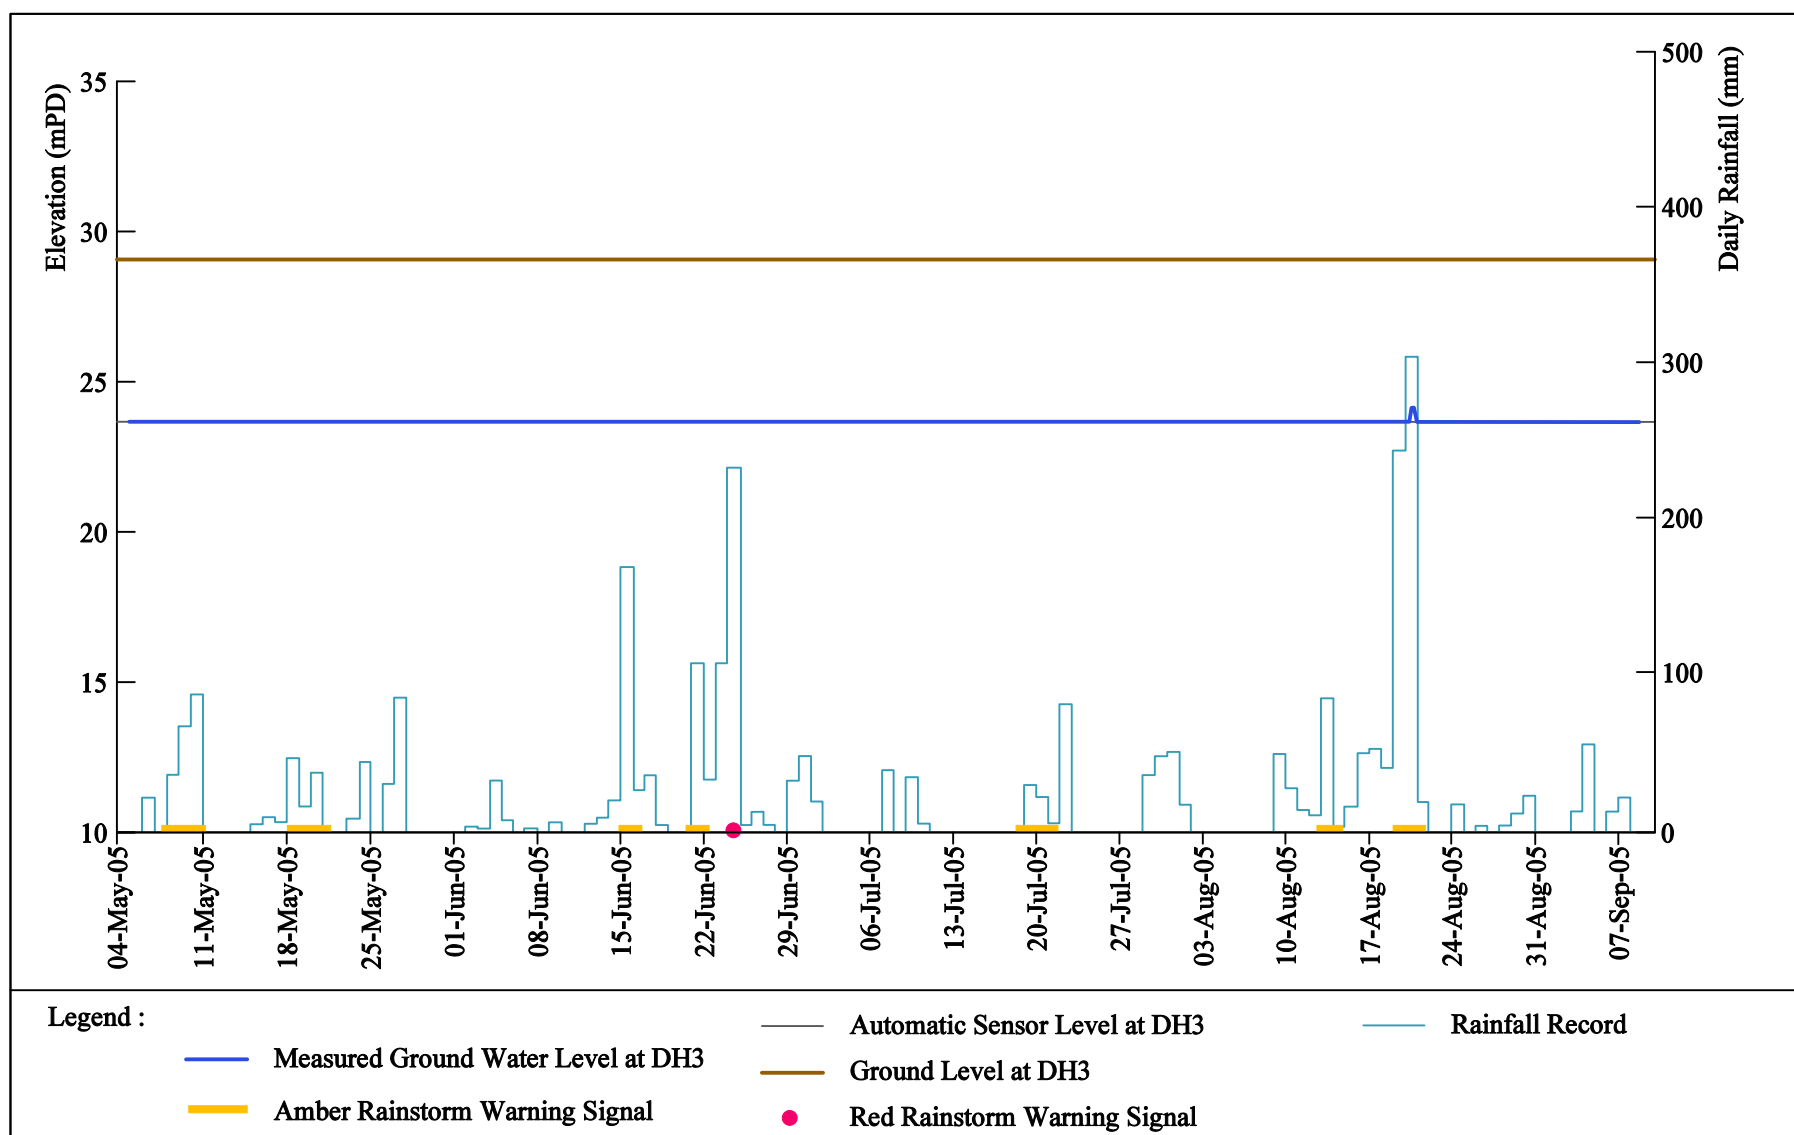
As part of the Stage 3 Study, groundwater monitoring using automatic sensors in the standpipe and in the lower level piezometers of the drillholes was carried out during the period from 4 May 2005 to 8 September 2005. The groundwater monitoring results and the daily rainfall records are presented in Figures 9 to 12. The monitoring records revealed that the highest recorded groundwater level at drillhole No. DH 1 was about 1.5 m below the crest of the subject slope. The highest recorded groundwater levels at drillhole Nos. DH 2 and DH 3 (the nearest drillholes to the landslide) were at about 5.8 m and 5 m below the slope crest respectively. The highest recorded groundwater level at drillhole No. DH 4 was at about 600 mm below the slope toe. All the highest groundwater levels were recorded during the 20 August 2005 rainstorm.

Figure 11 - Ground Water Monitoring Results and Daily Rainfall Records (DH3)

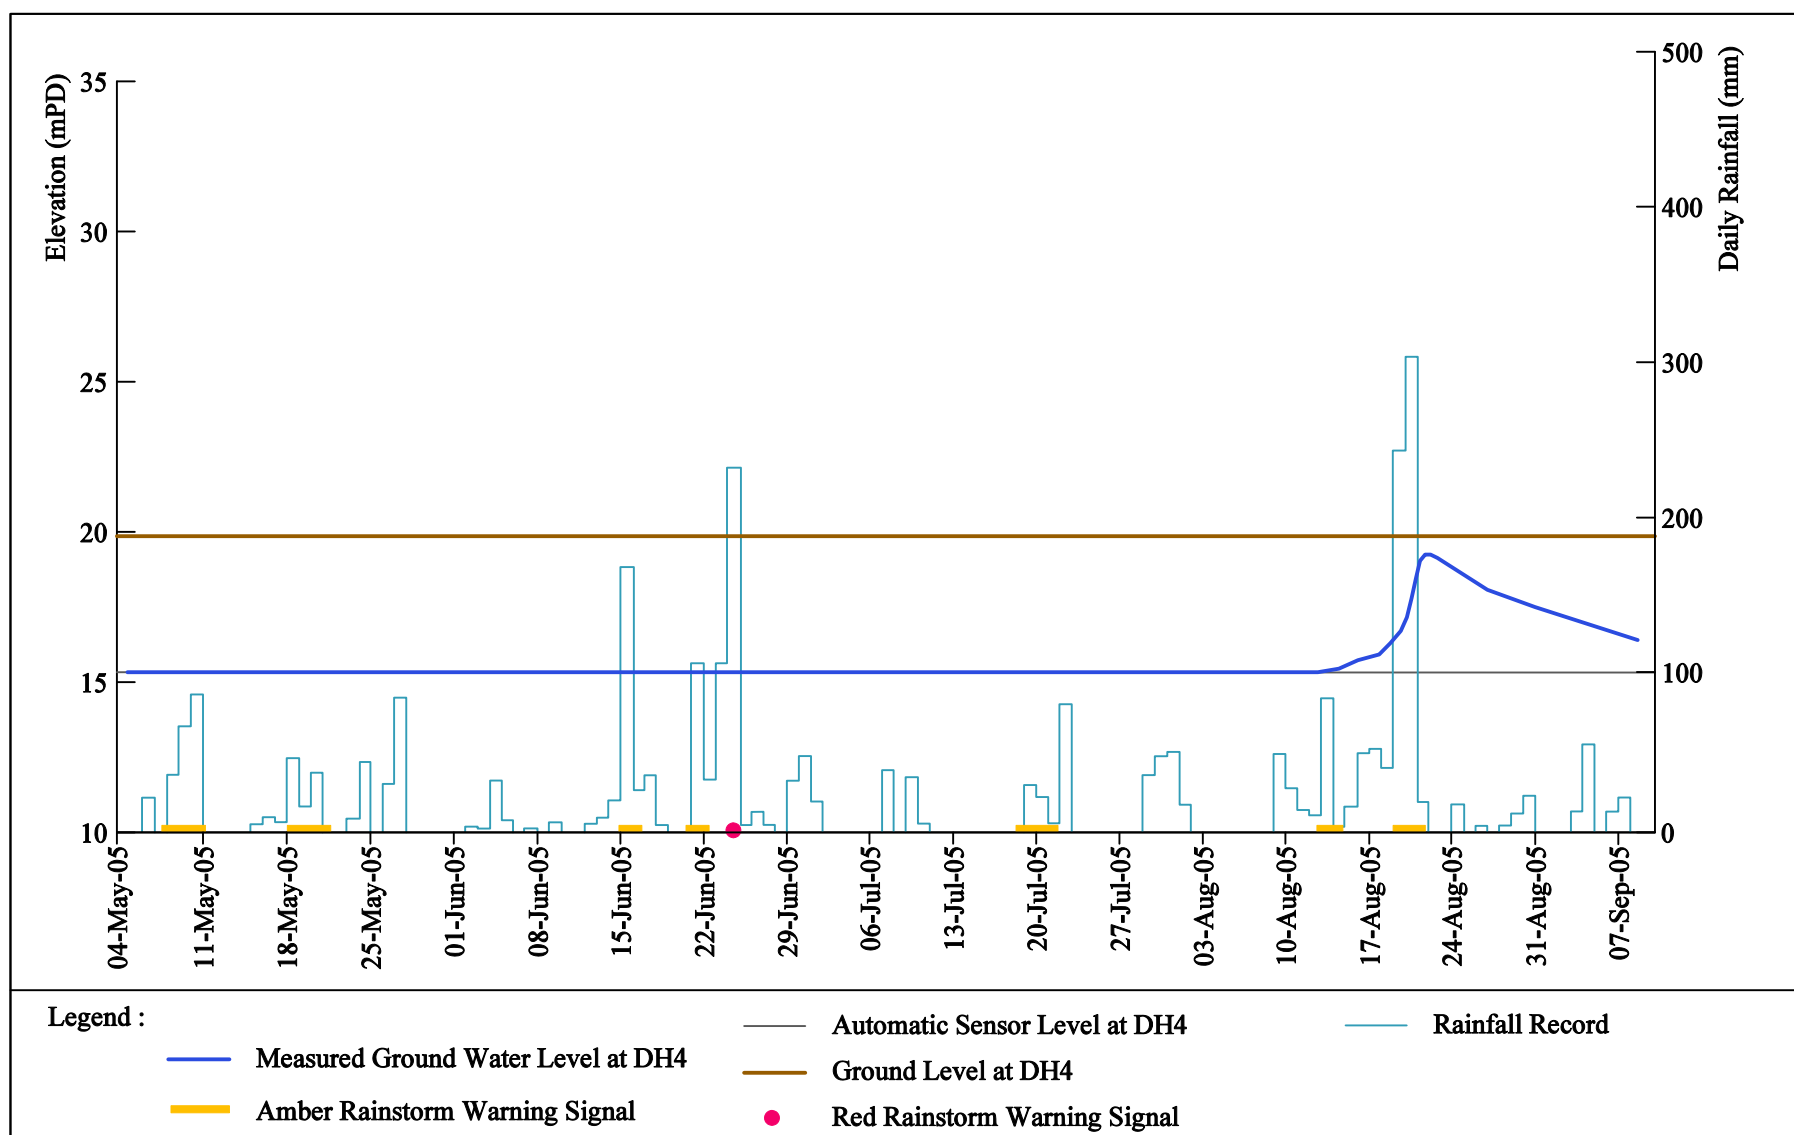
Figure 12 - Ground Water Monitoring Results and Daily Rainfall Records (DH4)

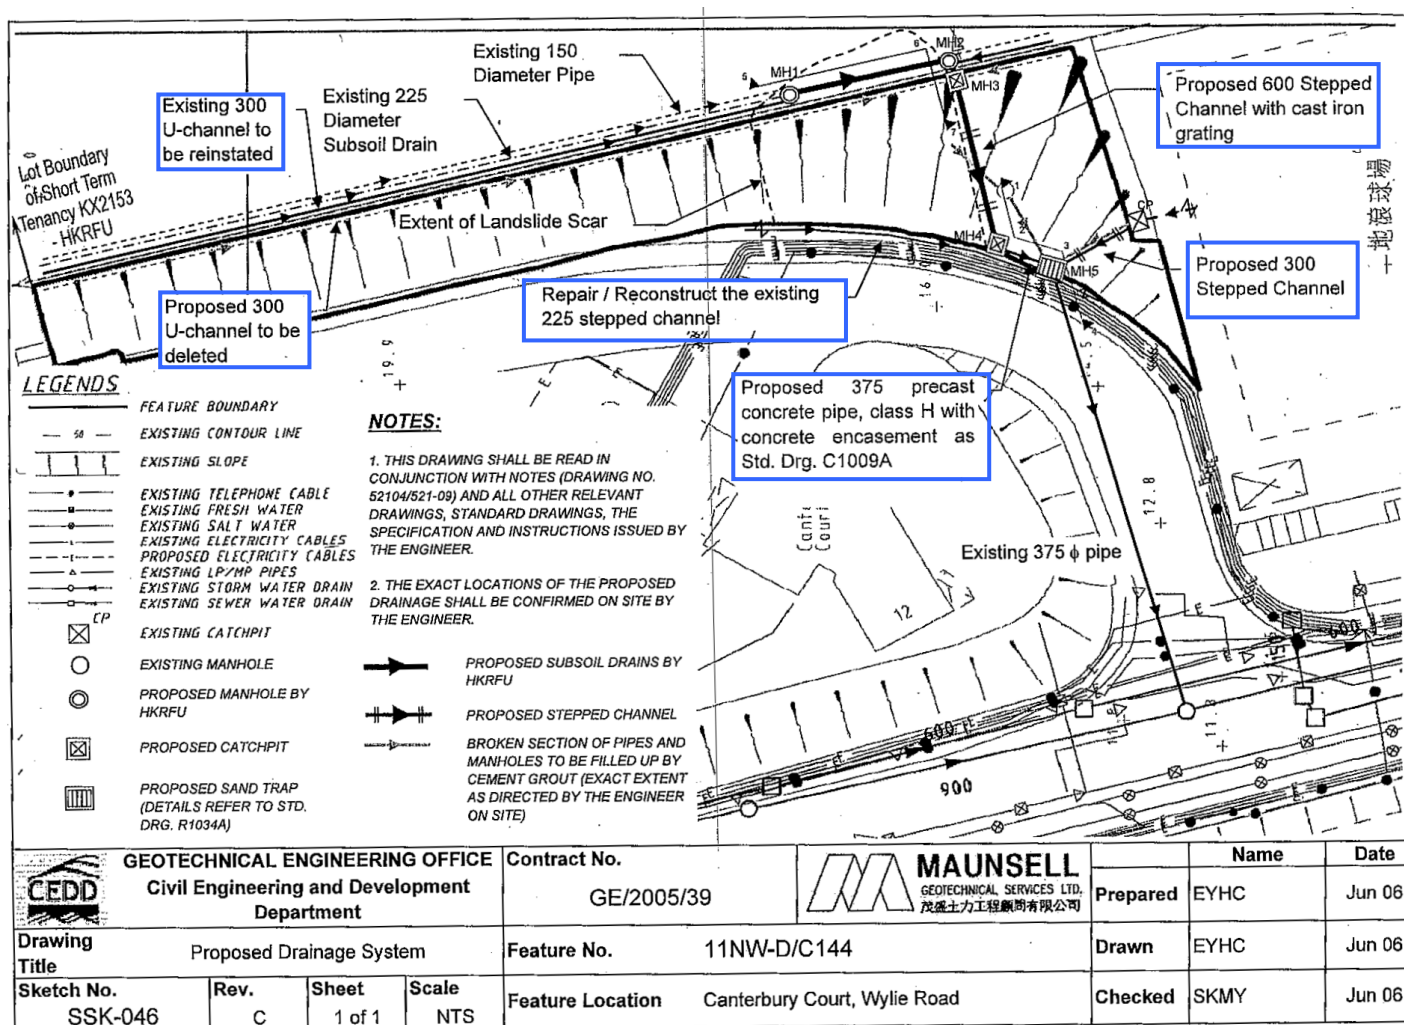
Figure 13 – Proposed Drainage System for LPM Works at Slope No. 11NW-D/C144

According to the information provided by MGSL, two unrecorded underground drainage pipes were identified at the southern portion of the slope after commencement of the LPM works in November 2005. Closed circuit television (CCTV) surveys were then carried out to check the alignment and internal condition of those buried drainage pipes. It was noted that a 375 mm diameter concrete drainage pipe discharging from the King's Park Sports Ground at the slope crest and a 225 mm diameter concrete drainage pipe discharging from the bowling green of the Filipino Club were located in the survey (Figure 6). The drainage pipes were found to be broken and their internal condition was poor. As a result, the 375 mm diameter and the 225 mm diameter concrete drainage pipes were replaced by 600 mm and 300 mm stepped channels respectively, as part of the LPM works. The buried drainage pipes running along the slope crest within the area of the King's Park Sports Ground (i.e. a 150 mm diameter cast iron (CI) drainage pipe and a 225 mm diameter vitrified clay (VC) drainage pipe, see Section 5.3) were not included in the 2005 CCTV survey and no works to these drainage pipes were carried out as part of the LPM works. As the HKRFU, the tenant of the Sports Ground under STT No. KX2153, was responsible for the maintenance of these buried drains, the HKRFU was requested to repair these drains and to upgrade the surface and sub-surface drainage system of the Sports Ground. The broken sections of the 150 mm diameter CI drainage pipe and the 225 mm diameter VC drainage pipe within the landslide scar were subsequently repaired by the HKRFU. The repair works involved the construction of manholes and the replacement of the broken sections of the 150 mm diameter and 225 mm diameter drainage pipes with 225 mm diameter and 400 mm diameter drainage pipes respectively. The 150 mm diameter PVC drainage pipe passing across the sports ground, which was exposed within the landslide scar, was also repaired and connected to a manhole of the new drainage system. The proposed drainage system for the LPM works is presented in Figure 13.

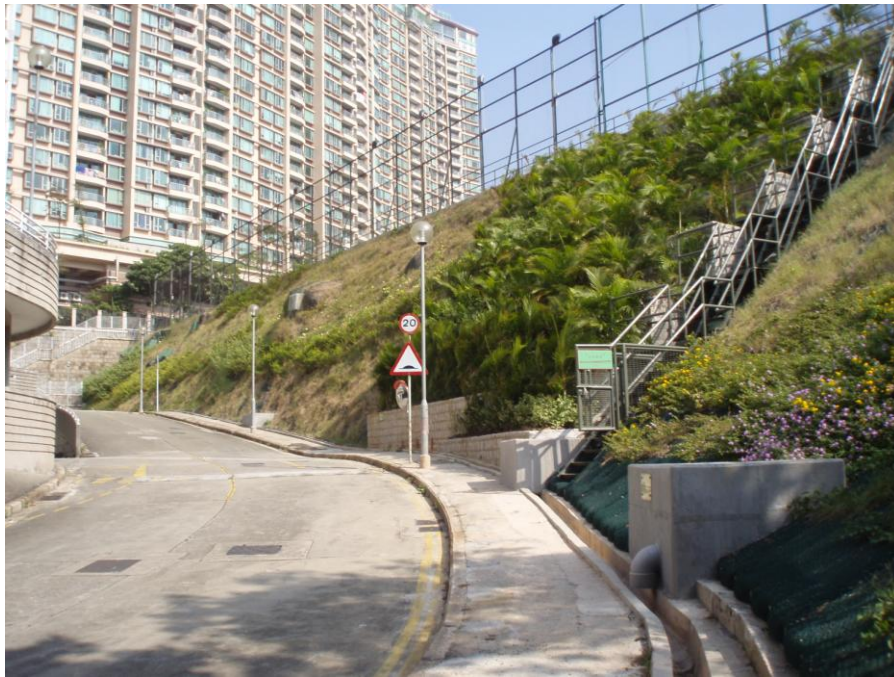
Plate 7 – Northern Portion of Slope No. 11NW-D/C144 after LPM Works  
(Photograph taken by HCL on 12 November 2007)

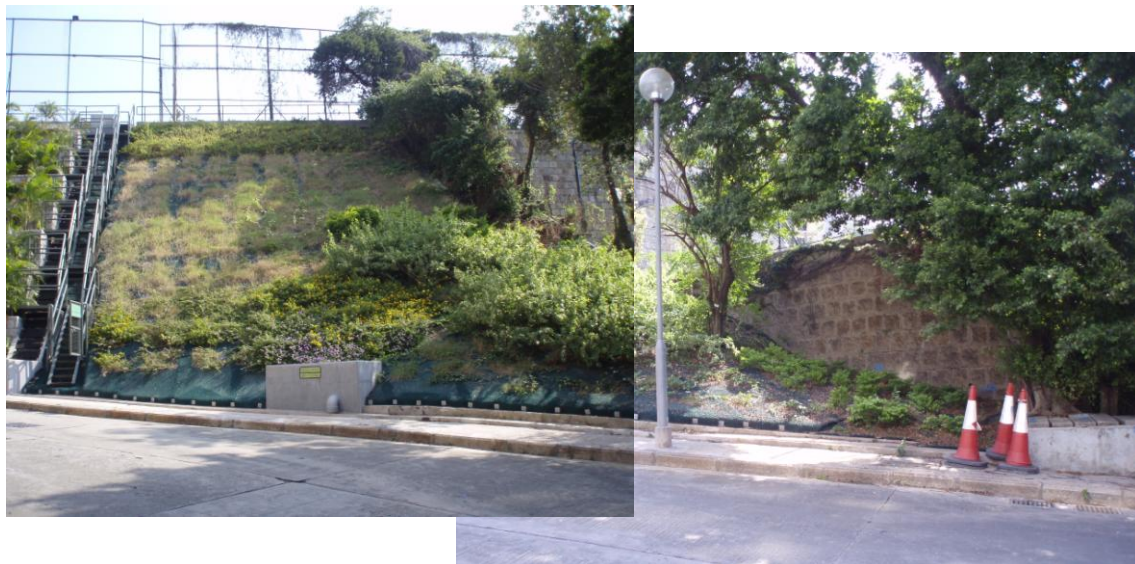
Plate 8 – Southern Portion of Slope No. 11NW-D/C144 after LPM Works  
(Photograph taken by HCL on 12 November 2007)

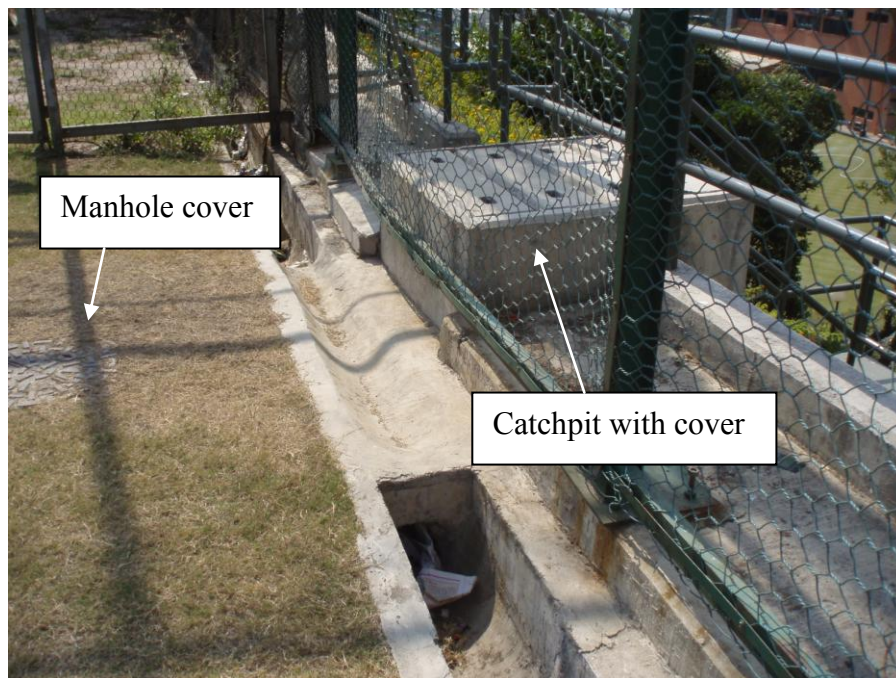
Plate 9 – Manhole and Catchpit Constructed behind the August 2005 Landslide Area after LPM Works  
(Photograph taken by HCL on 12 November 2007)
