**REVIEW OF THE  
20 AUGUST 2005 LANDSLIDE  
ON SLOPE NO. 11NW-D/C144  
BEHIND NOS. 12 AND 14  
WYLIE ROAD  
KING'S PARK**

**GEO REPORT No. 283**

**Halcrow China Limited**

**This report is largely based on GEO Landslide Study Report  
No. LSR 9/2009 produced in September 2009**

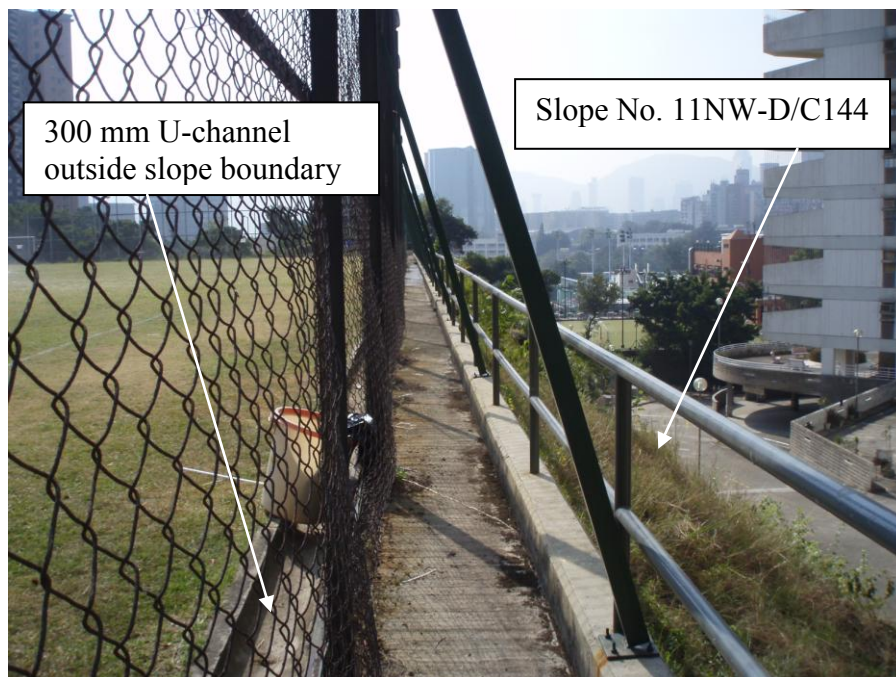
Plate 10 – Crest Condition of Slope No. 11NW-D/C144 after LPM Works  
(Photograph taken by HCL on 12 November 2007)

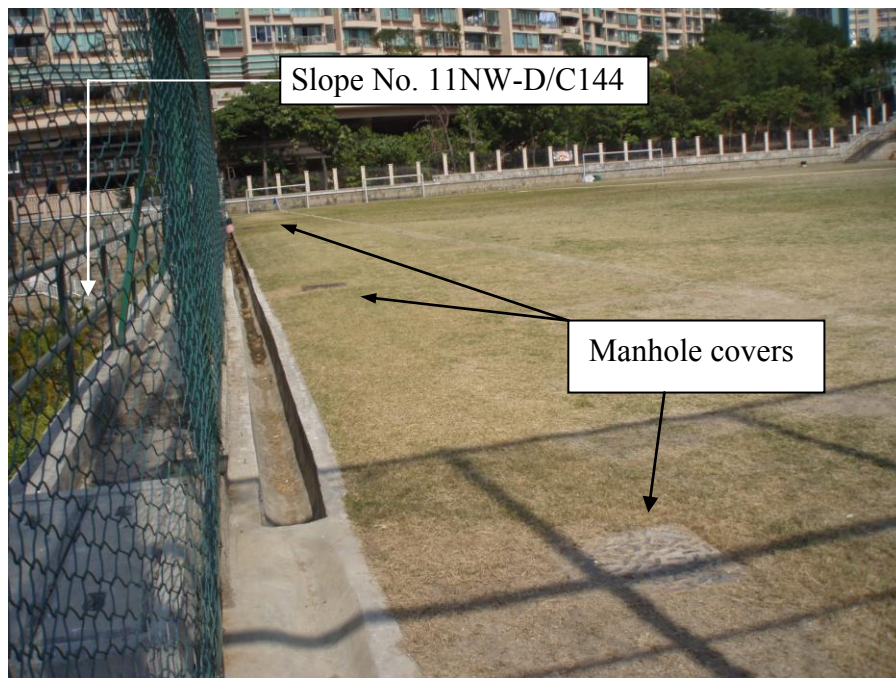
Plate 11 – Manhole Covers on the King's Park Sports Ground above Slope No. 11NW-D/C144  
(Photograph taken by HCL on 12 November 2007)

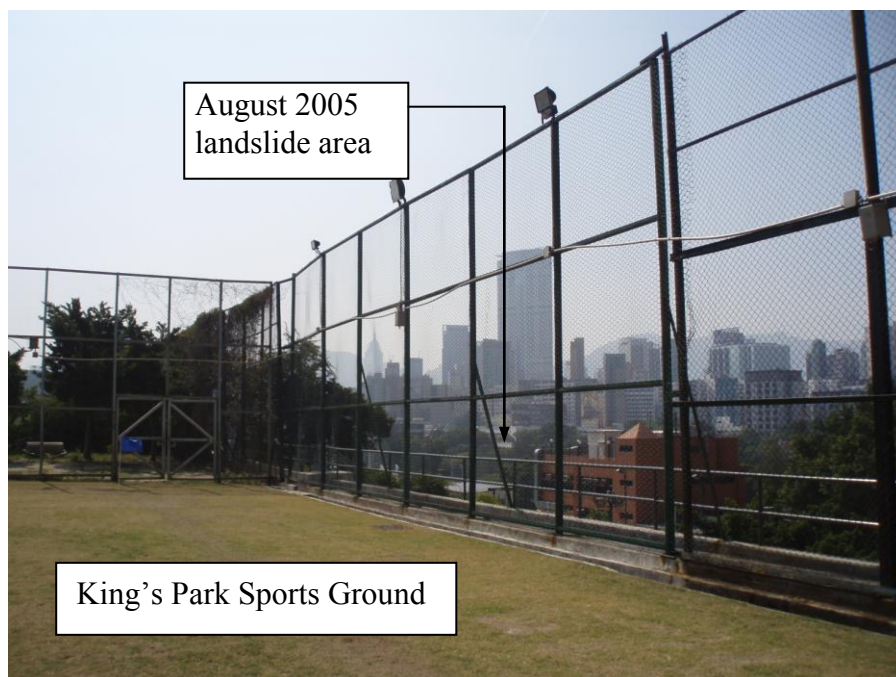
Plate 12 – Repaired Grassed Sports Ground above the August 2005 Landslide Area  
(Photograph taken by HCL on 12 November 2007)
