**DETAILED STUDY OF THE  
7 JUNE 2008 LANDSLIDE  
BEHIND ROCKWIN COURT,  
FUNG FAI TERRACE,  
HAPPY VALLEY**

**GEO REPORT No. 285**

**Fugro Scott Wilson Joint Venture**

**GEOTECHNICAL ENGINEERING OFFICE  
CIVIL ENGINEERING AND DEVELOPMENT DEPARTMENT  
THE GOVERNMENT OF THE HONG KONG  
SPECIAL ADMINISTRATIVE REGION**

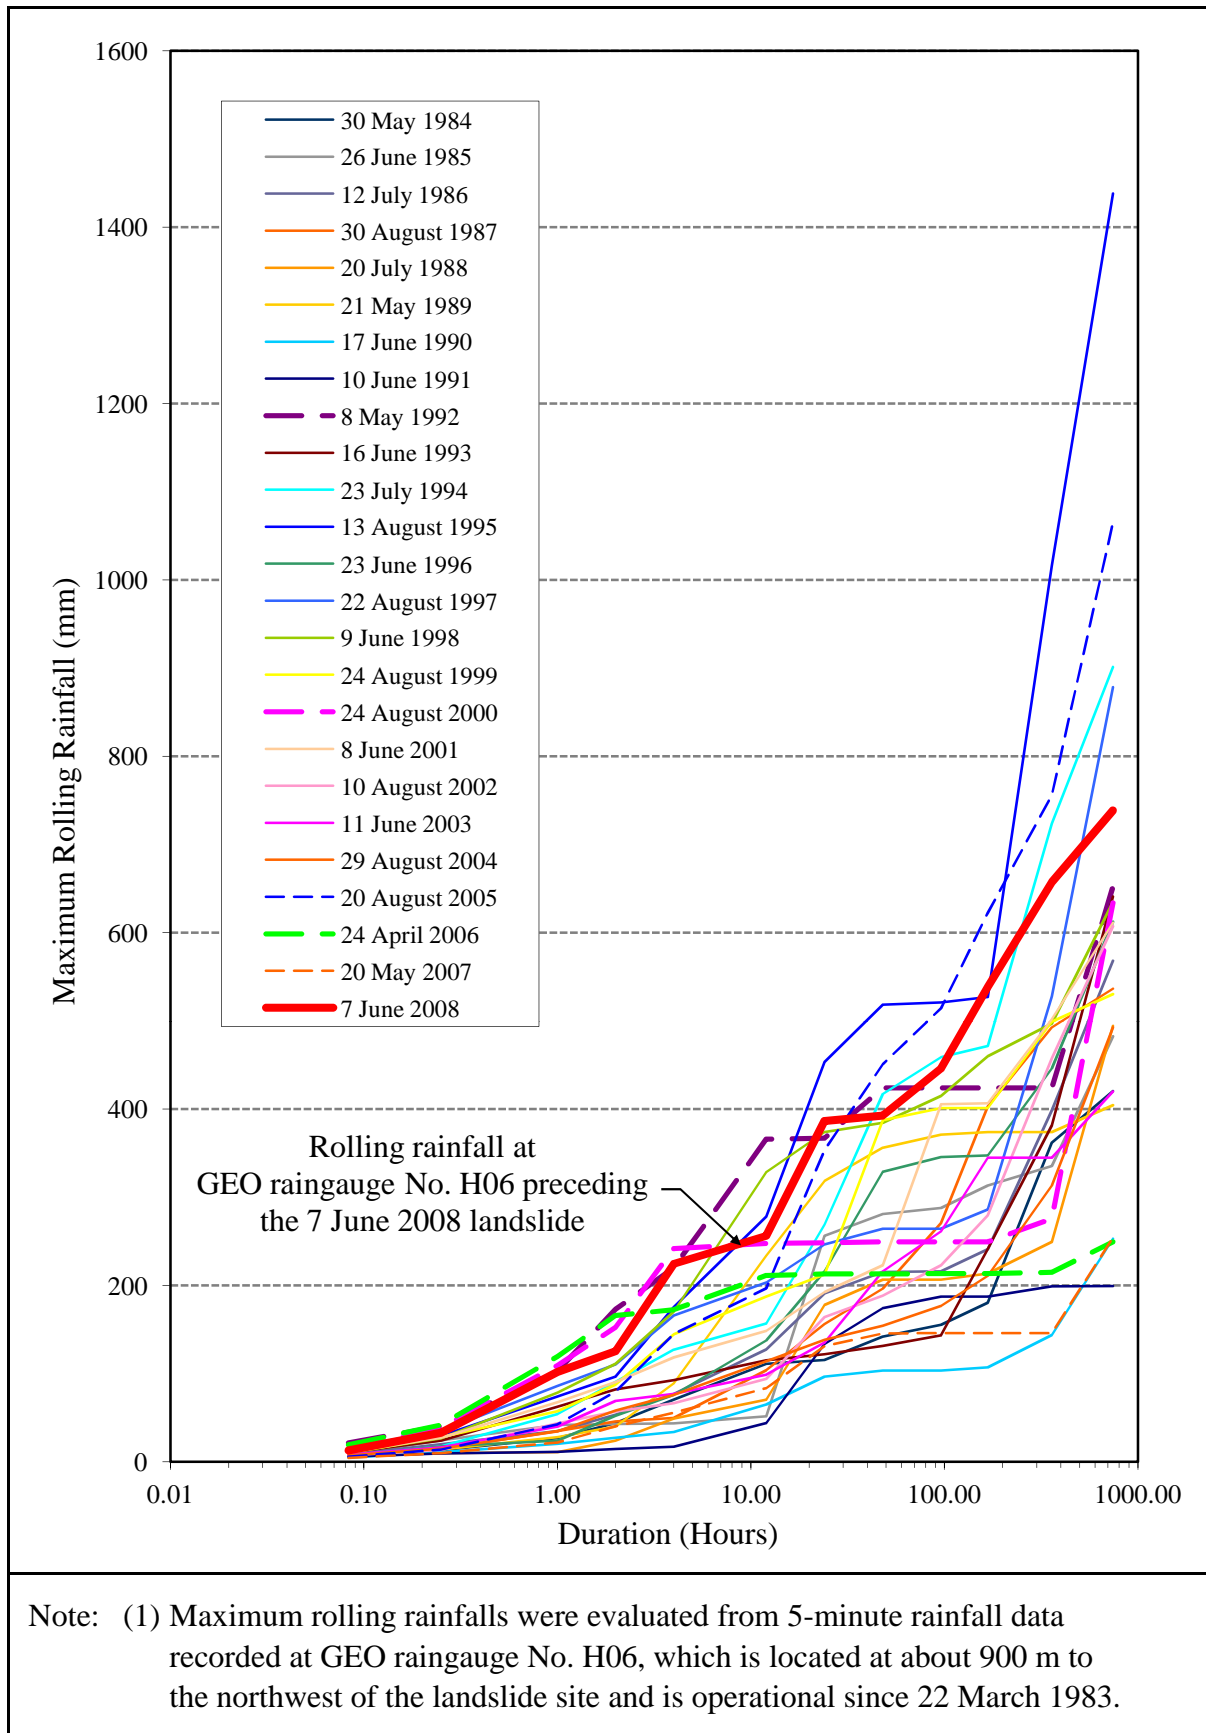
Figure 9 - Maximum Rolling Rainfalls for Major Rainstorms at GEO Raingauge No. H06

The maximum rolling rainfall for the rainstorm on 7 June 2008 has been compared with the past major rainstorms between 1983 and 2007 as recorded at raingauge No. H06 (Figure 9). The results indicate that the rolling rainfalls for short durations of less than about 4 hours preceding the 7 June 2008 landslide are amongst the most severe in the history of raingauge No. H06, which came into operation in 1983.

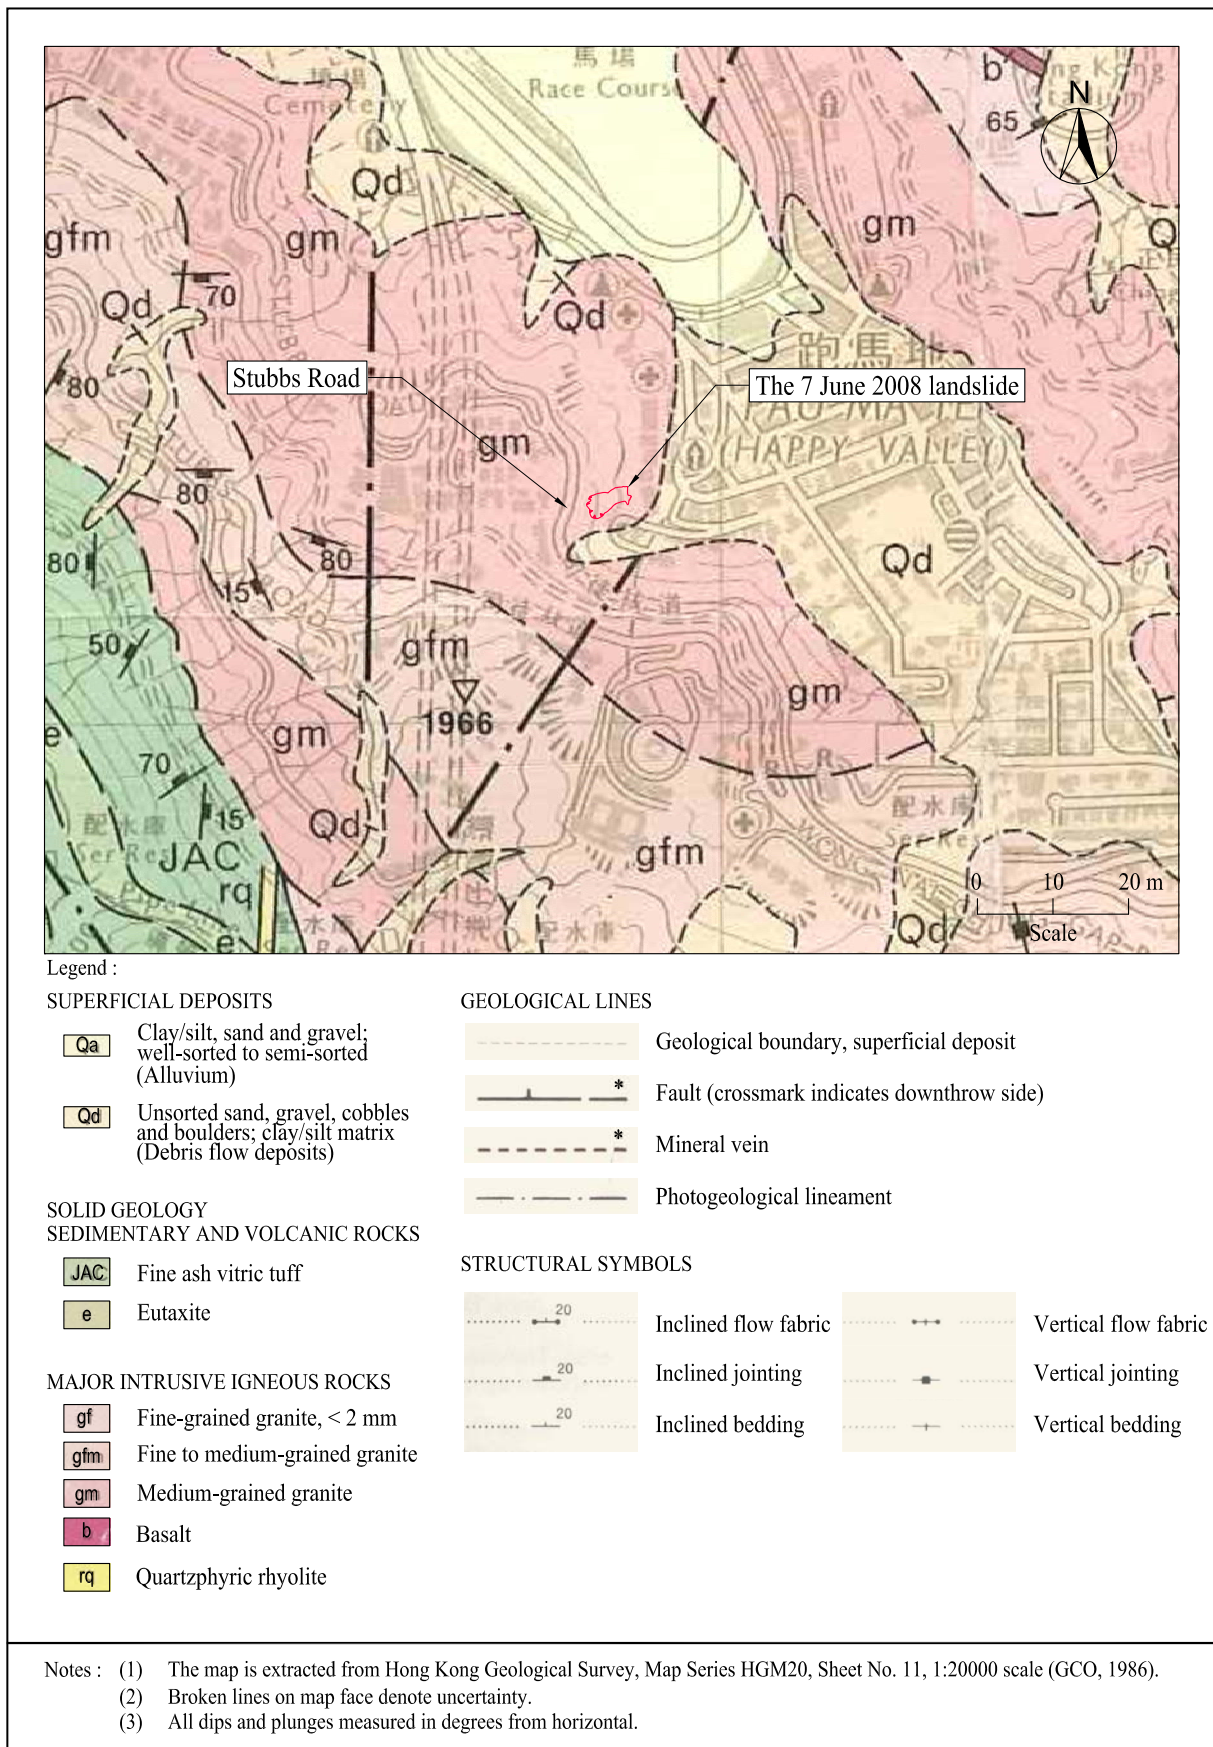
Figure 10 - Regional Geology

The solid geology underlying the site was mapped by the Hong Kong Geological Survey (GCO, 1986) at a scale of 1:20,000 as medium-grained granite of Jurassic-Cretaceous age with debris flow deposits generally to the east (Figure 10).

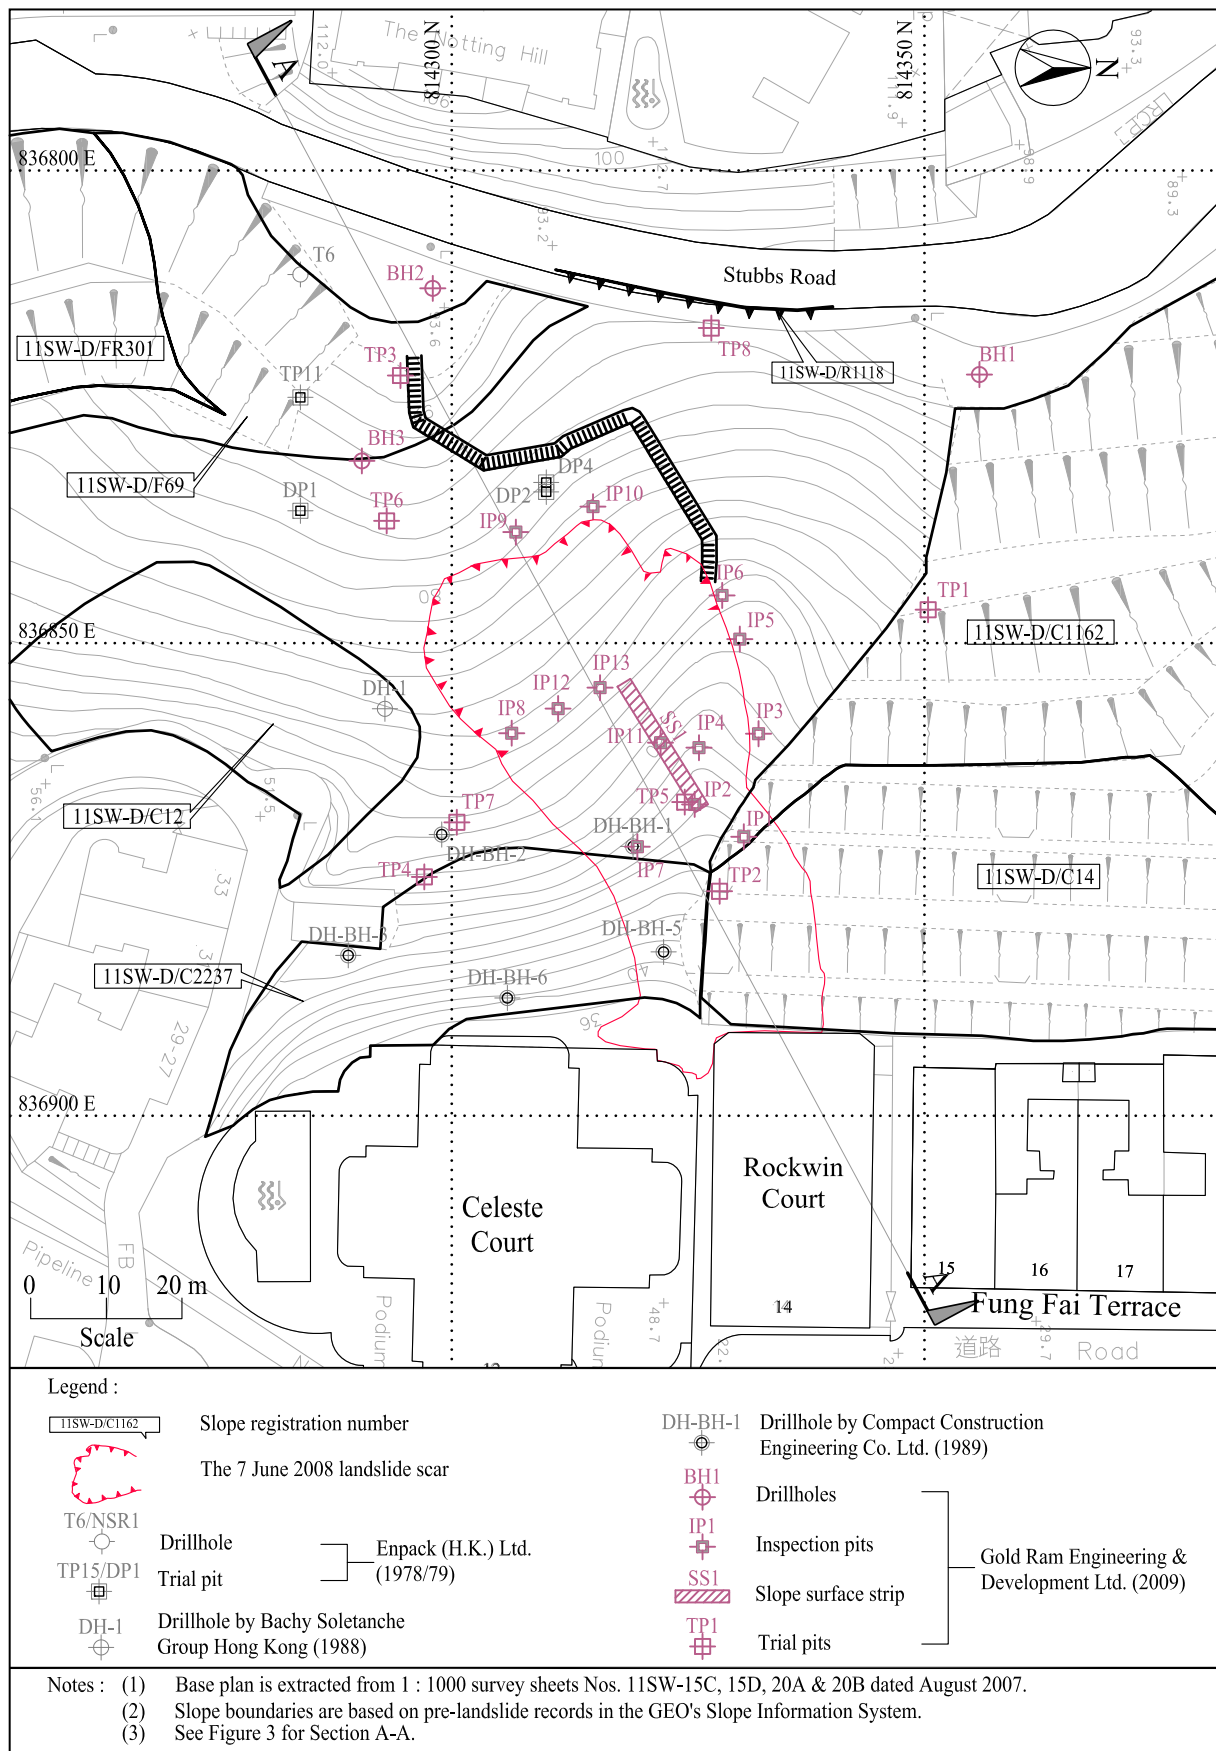
Figure 11 - Location Plan of Ground Investigation Stations

The subsurface geological conditions at the 7 June 2008 landslide site were determined from a review of pre-failure and post-failure ground investigation (GI) information and field mapping of the landslide scar. The post-failure GI works, comprising 3 vertical drillholes, 8 trial pits, 7 coreholes, 13 inspection pits and 1 slope surface strip, were carried out on the landslide scar and its vicinity by Gold Ram Engineering and Development Limited between March 2009 and April 2009. The locations of relevant GI stations are shown in Figure 11.

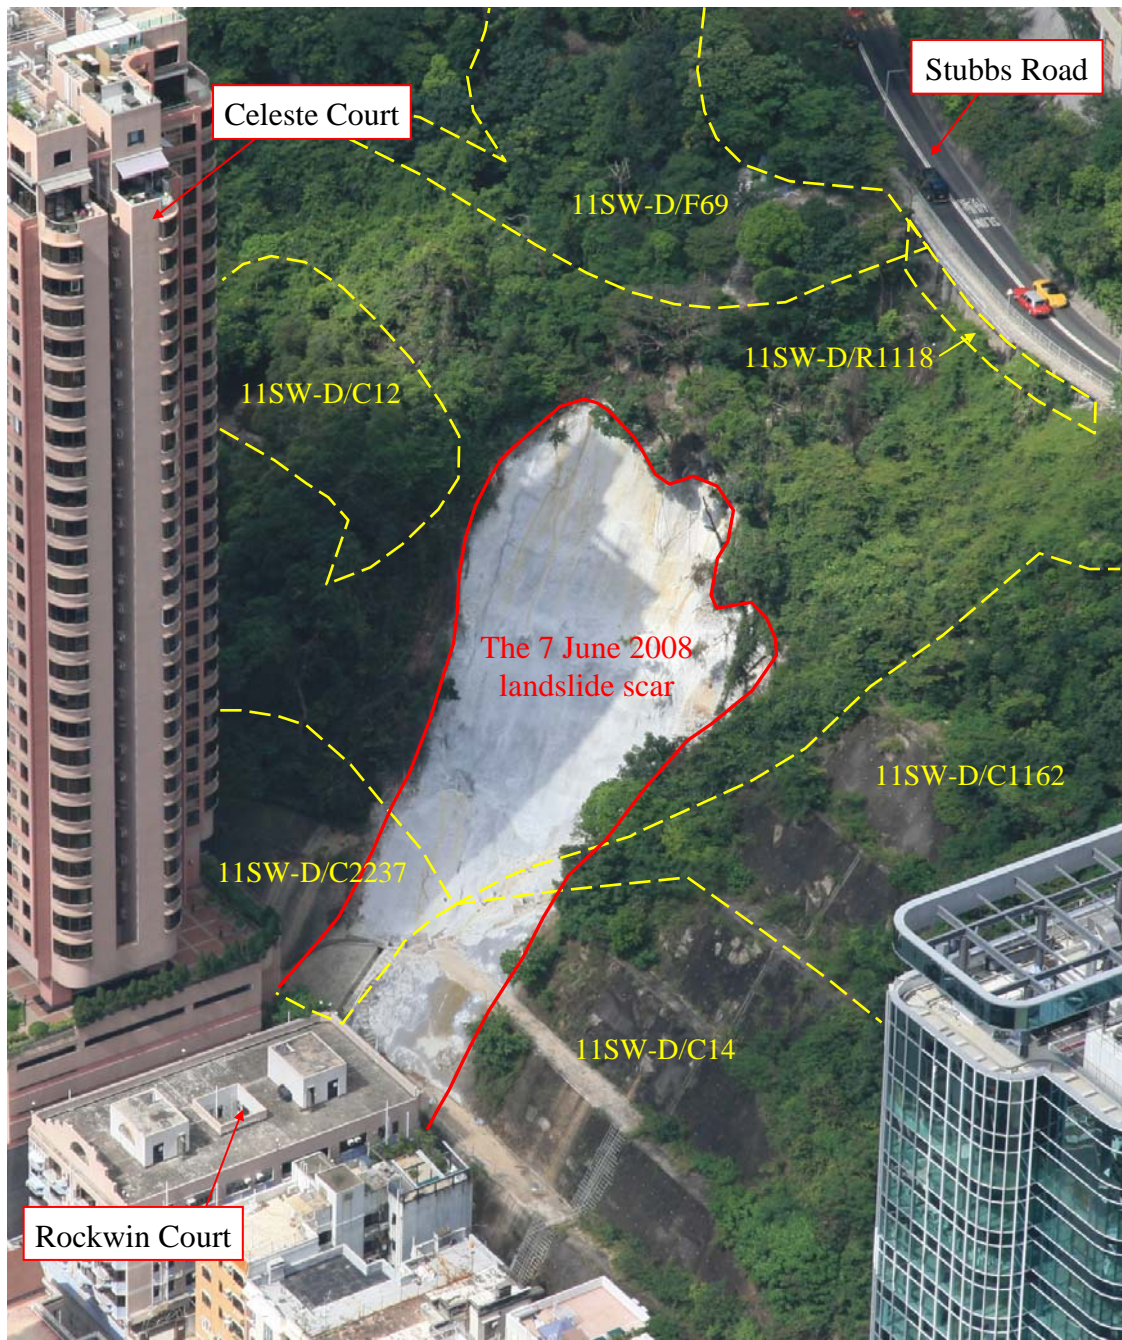
Plate 4 - Overall Setting of the Landslide Site  
(Photograph taken on 23 July 2008)

- Notes:
- (1) See Figure 12 for location and direction of photograph.
  - (2) Indicative slope boundaries are based on pre-landslide records in the GEO's Slope Information System.
