**REVIEW OF THE  
21 AUGUST 2005 LANDSLIDE  
ON SLOPE NO. 3SW-C/C234 AT  
POLICE TACTICAL UNIT DEPOT  
FANLING**

**GEO REPORT No. 286**

**Halcrow China Limited**

**GEOTECHNICAL ENGINEERING OFFICE  
CIVIL ENGINEERING AND DEVELOPMENT DEPARTMENT  
THE GOVERNMENT OF THE HONG KONG  
SPECIAL ADMINISTRATIVE REGION**

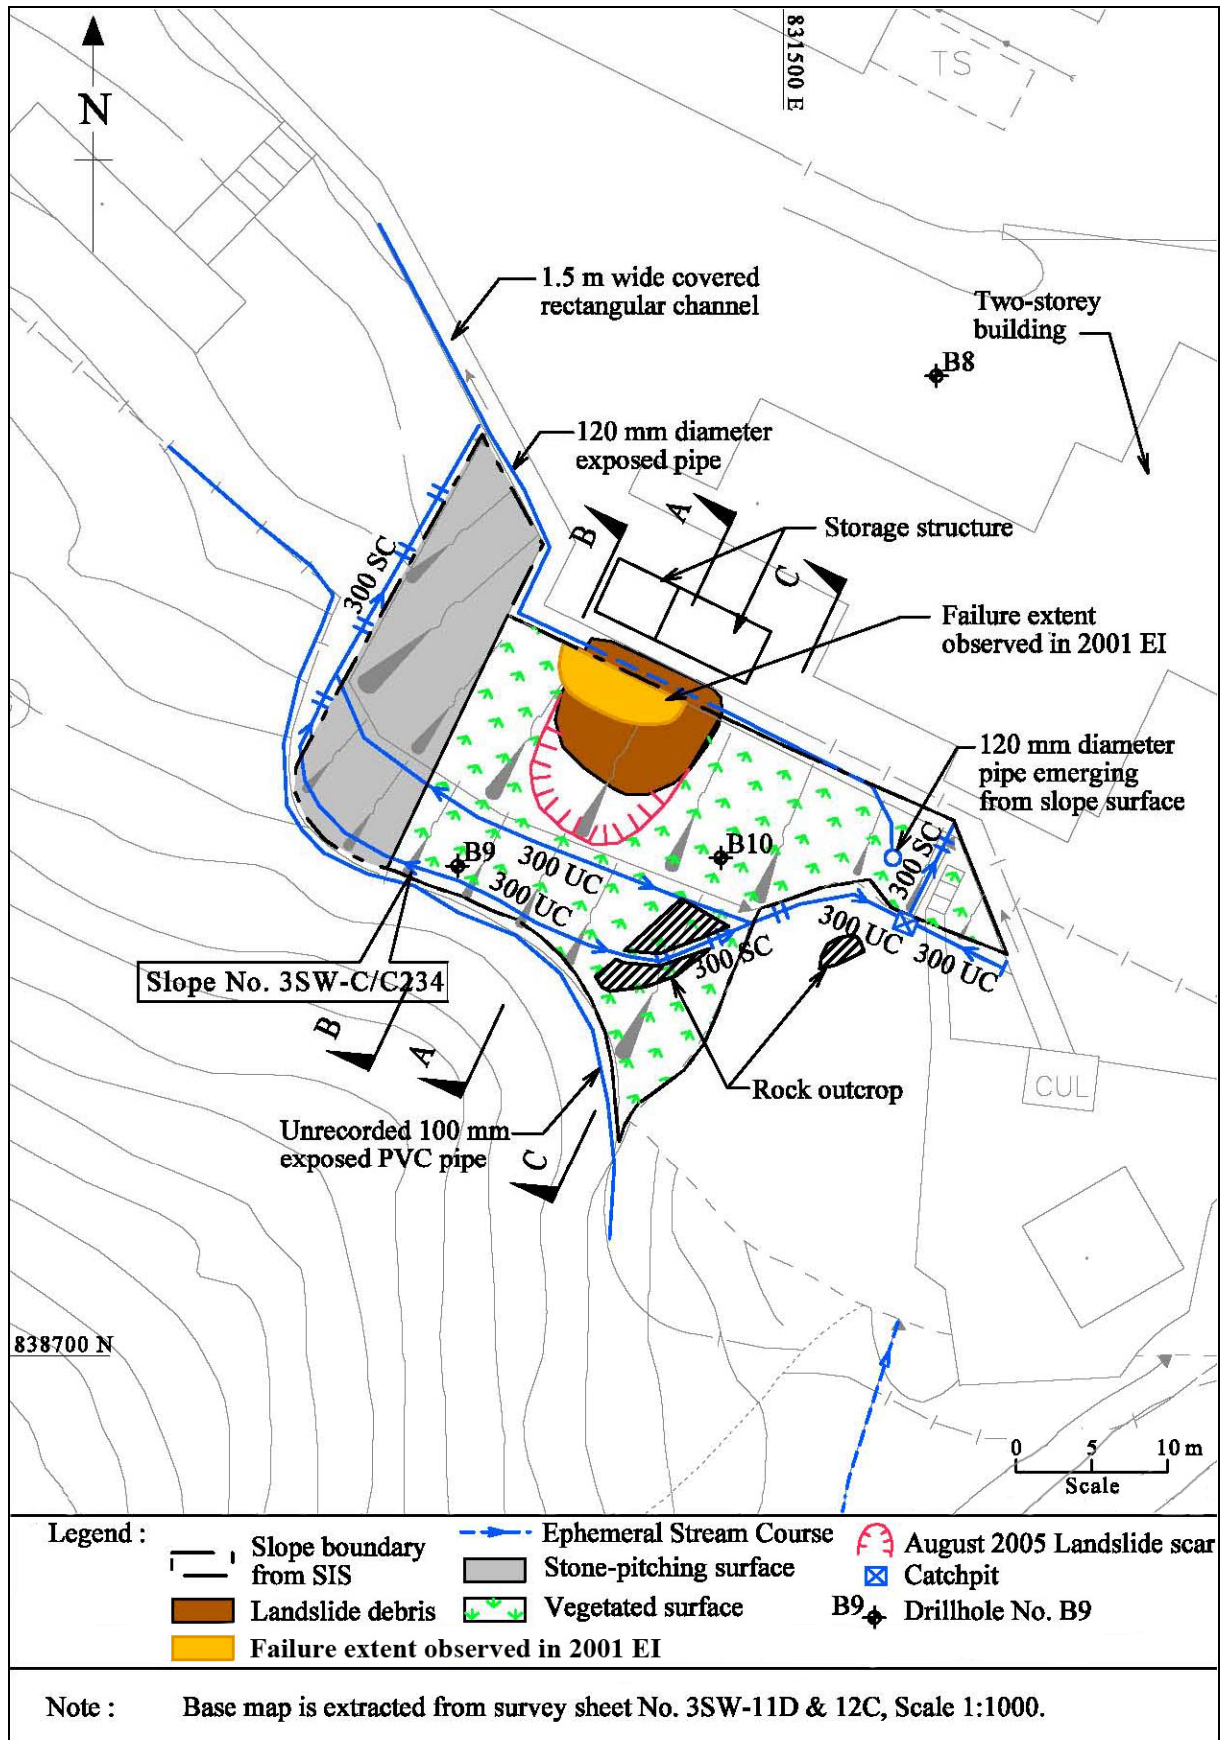
Figure 2 - Site Observations

under Contract No. GC/87/05. Two boreholes (i.e. drillhole Nos. B9 and B10) were sunk within the boundary of present-day slope No. 3SW-C/C234. The locations of these drillholes are shown in Figure 2.

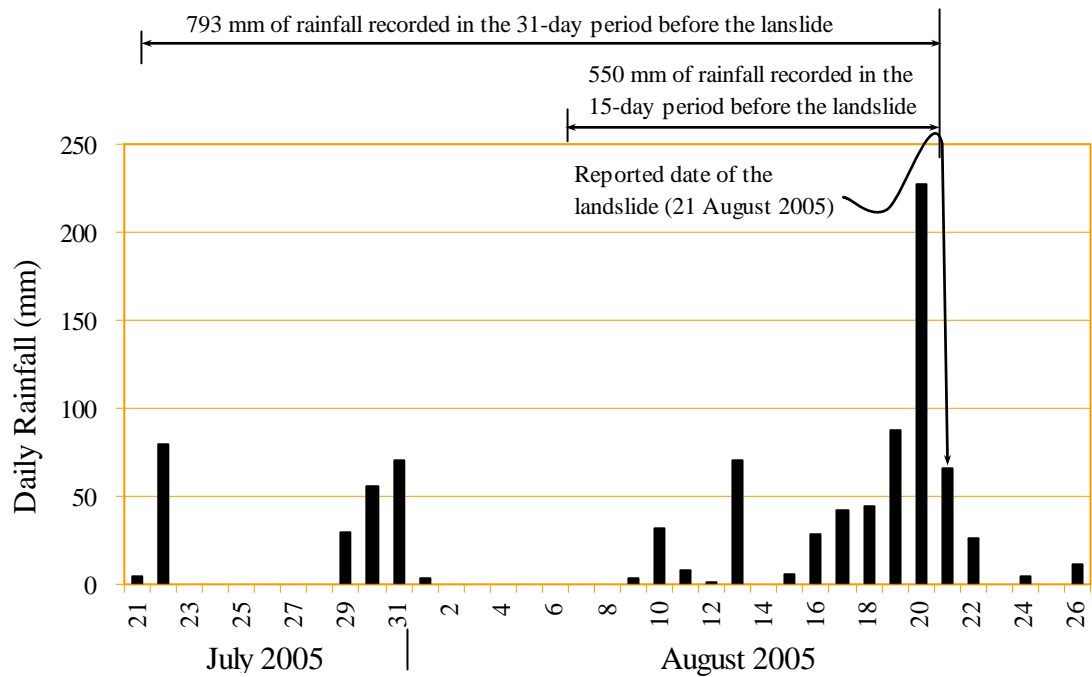
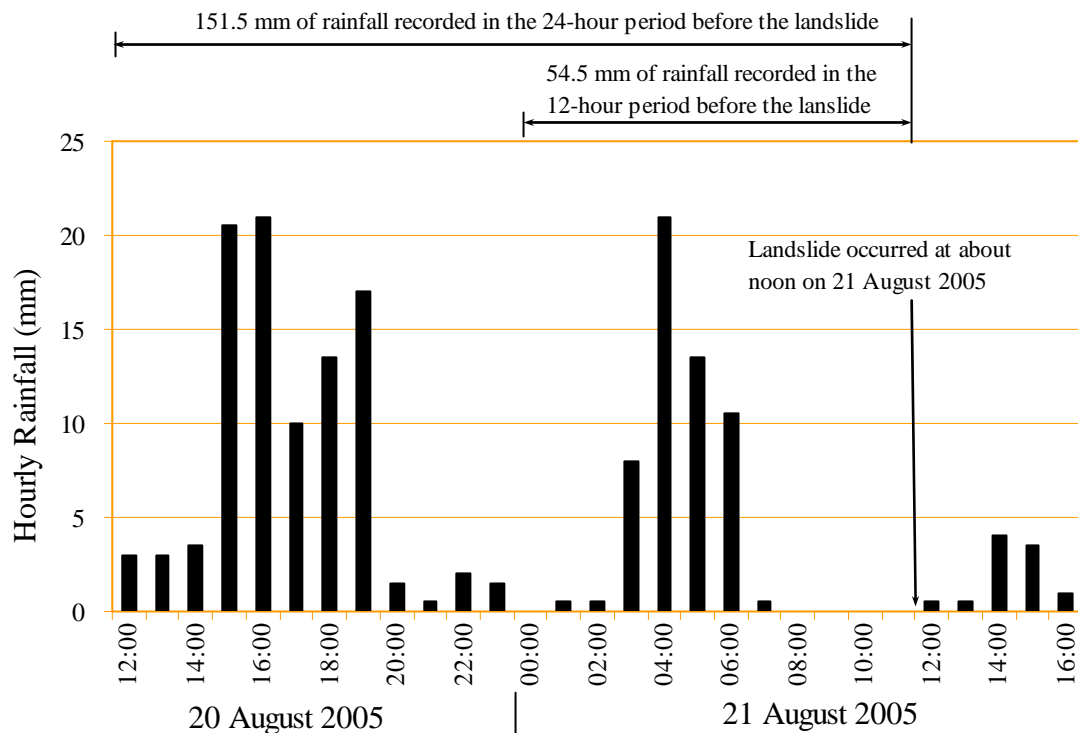
Figure 13 - Daily and Hourly Rainfall Recorded at GEO Raingauge No. N05

According to the GEO landslide incident report, the incident occurred on 21 August 2005 at about noon. The daily rainfall for the period of 31 days before the incident and the hourly rainfall between 20 and 21 August 2005 are presented in Figure 13. The records show that the maximum rolling rainfalls for 24-hour and 2-day periods are 250.5 mm and 355.5 mm respectively. The maximum 1-hour rolling rainfall was recorded as 32.5 mm between 8:35 a.m. and 9:35 a.m. on 20 August 2005 (Table 1).

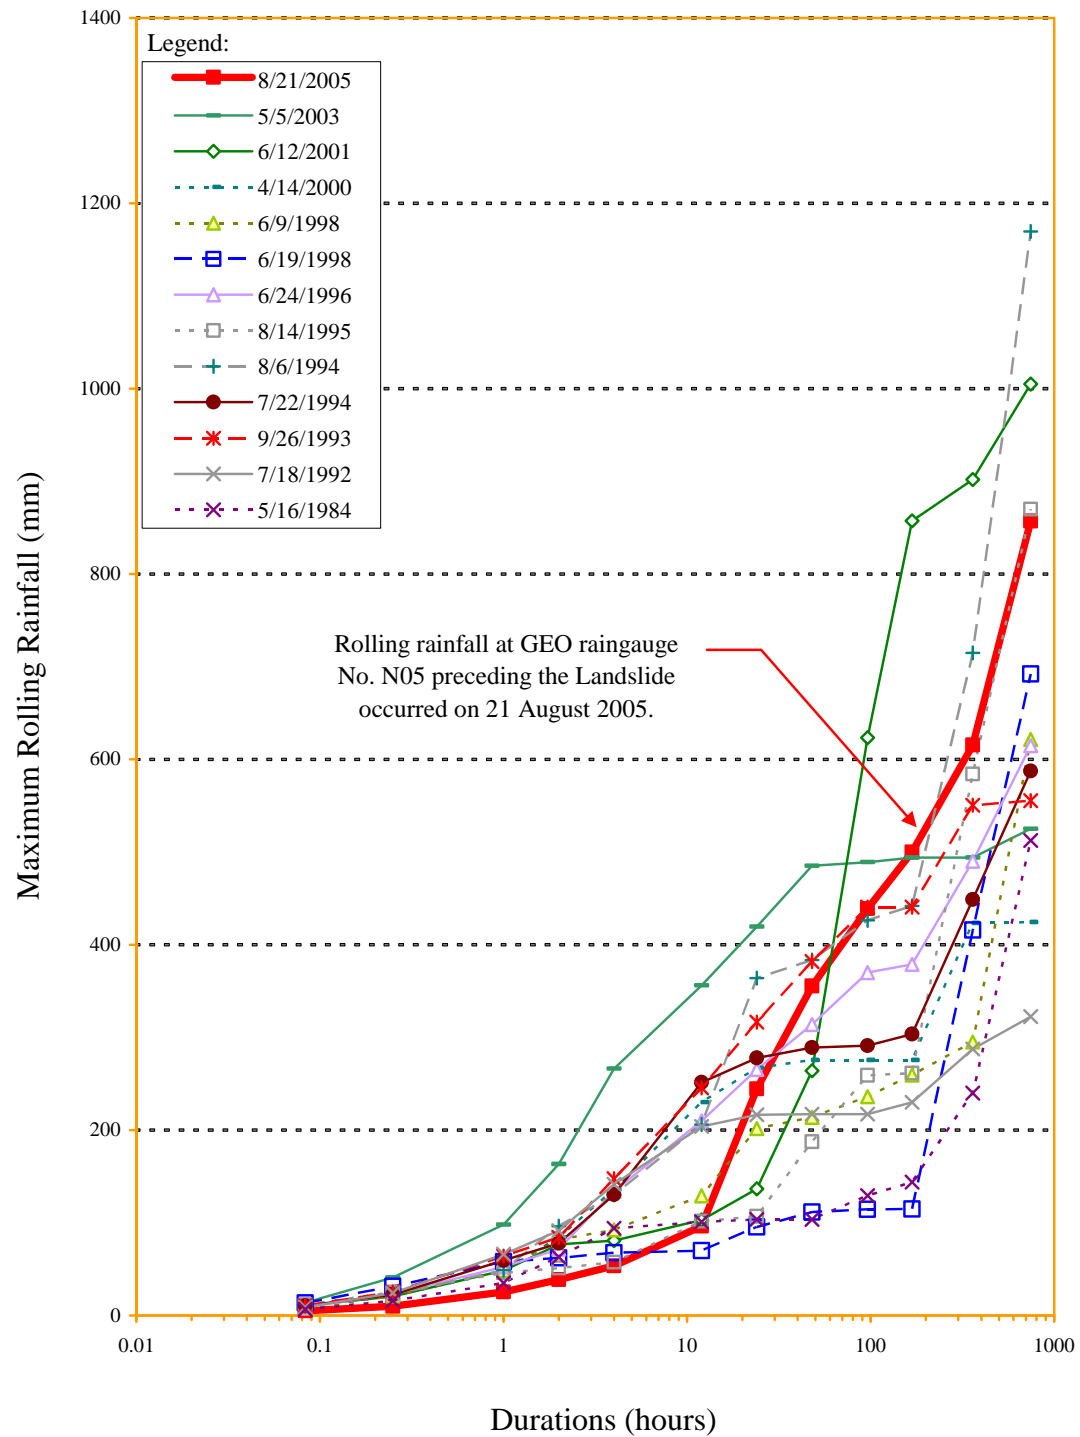
Figure 14 - Maximum Rolling Rainfall for Previous Major Rainstorms at GEO Raingauge No. N05 between 1984 and 2005

A comparison of the maximum rolling rainfall for the 21 August 2005 incident with that of the past major rainstorms recorded by Raingauge No. N05 is presented in Figure 14. The results indicate that the rainfall on 21 August 2005 is less severe than the previous major rainstorms.
