**DETAILED STUDY OF
THE 30 JUNE 2007 LANDSLIDE
ON WALL NO. 11SE-C/R7 AND
THE ADJOINING HILLSIDE
AT REPULSE BAY ROAD**

GEO REPORT No. 287

Fugro Scott Wilson Joint Venture

**GEOTECHNICAL ENGINEERING OFFICE
CIVIL ENGINEERING AND DEVELOPMENT DEPARTMENT
THE GOVERNMENT OF THE HONG KONG
SPECIAL ADMINISTRATIVE REGION**

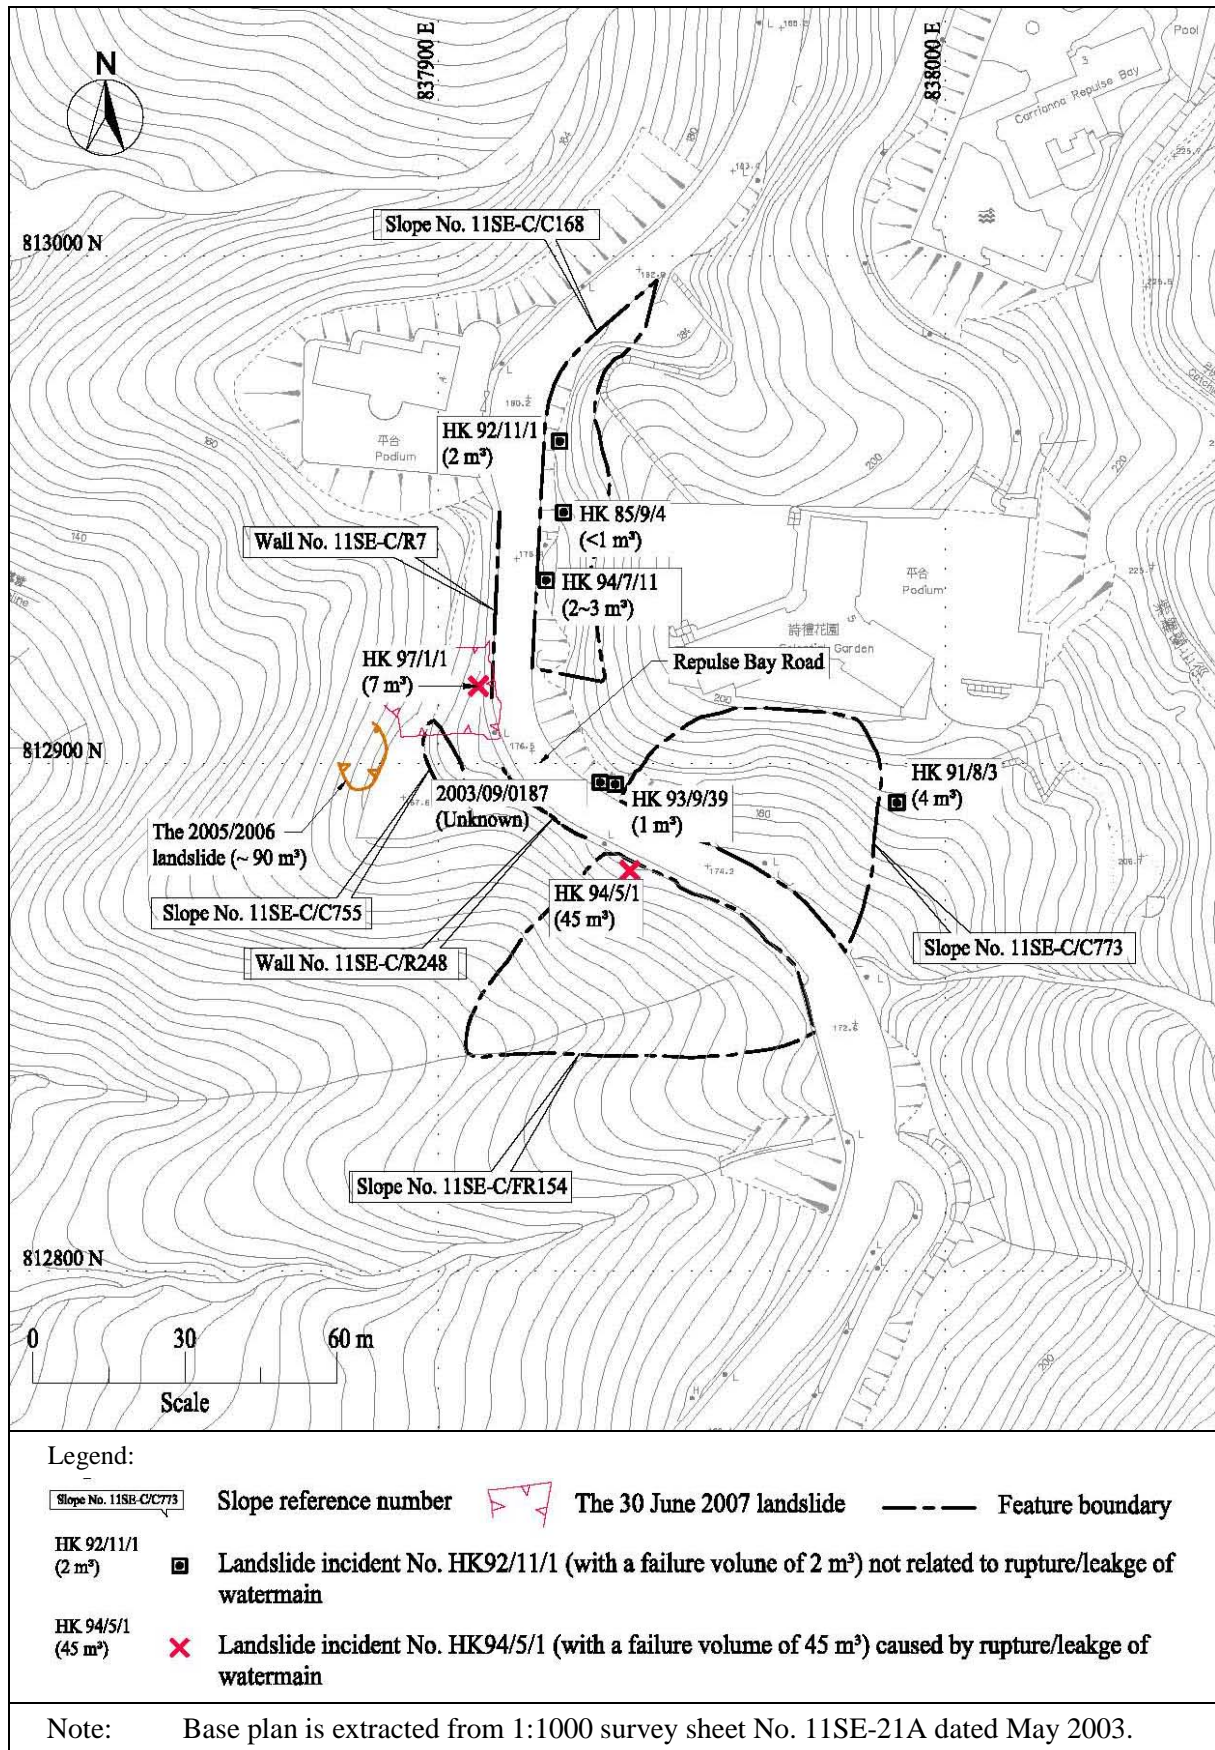
Figure 7 - Past Instability in the Vicinity of the 30 June 2007 Landslide Site

On 22 January 1997, with light rainfall of 5mm recorded within the day, a washout incident (No. HK 97/1/1), involving a failure volume of about 7 m³, occurred on the hillside adjacent to the southern portion of wall No. 11SE-C/R7 (Figure 7 and Plate 9), which was located within the area of the 2007 landslide. The pedestrian footway of the northbound lane of Repulse Bay Road was undermined by the 1997 incident. The incident also caused damage to a "375 mm" diameter cross-road drain (which is the 300 mm diameter cross-road drain now connected to roadside catchpit No. RB5, see Figure 4 and Plate 9). No casualties

The June 2007 landslide occurred at approximately the same location as the washout incident (No. HK 97/1/1) in 1997, and at a location about 45 m to the northwest of another previous washout incident (No. HK 94/5/1) in 1994. Both of these previous incidents were considered to have been induced by bursting of watermains (see Section 3.3 and Figure 7).

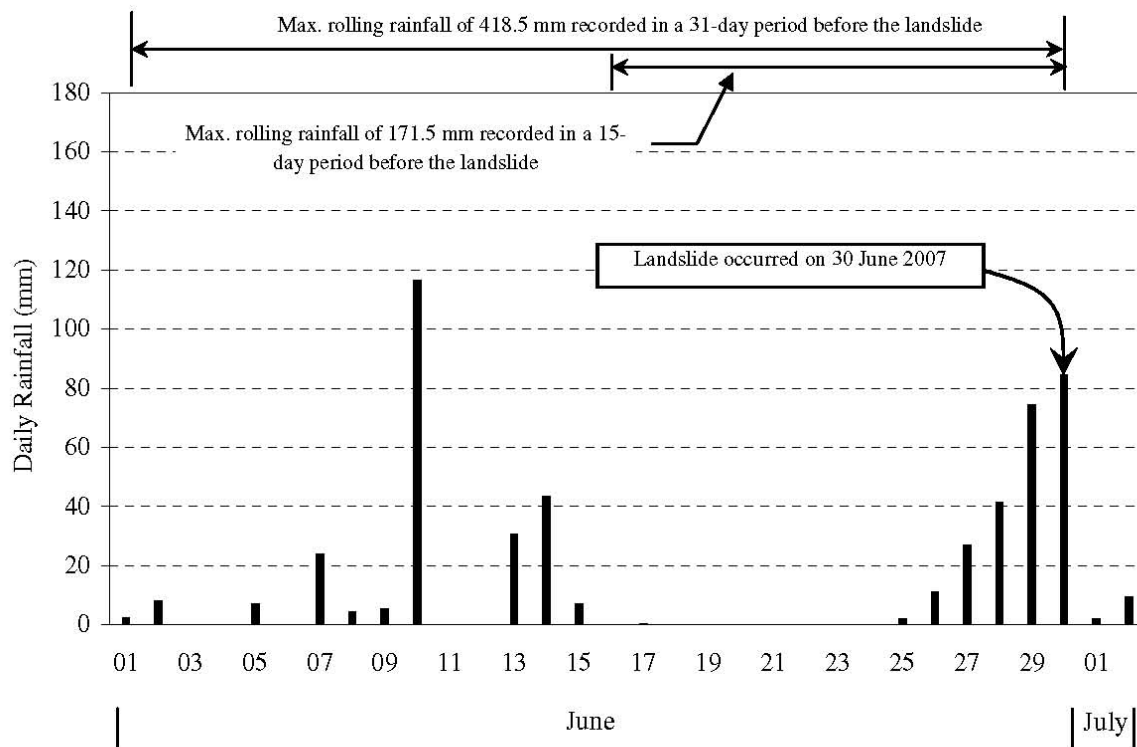
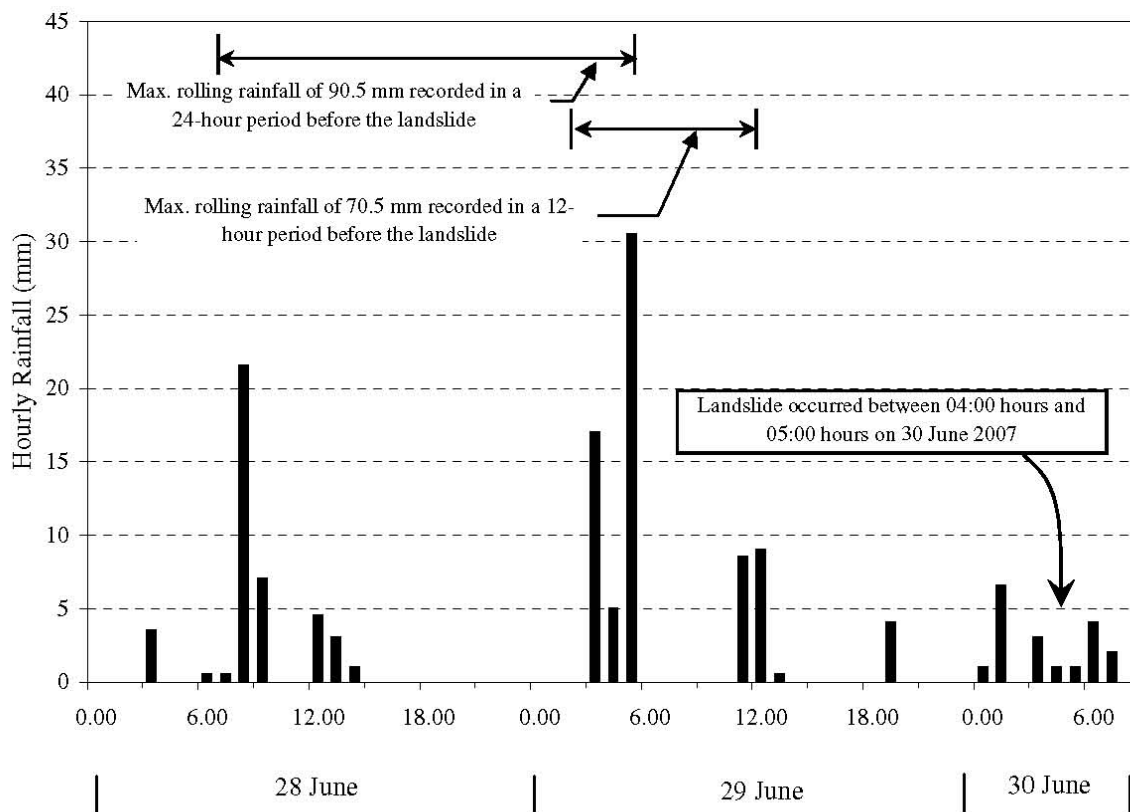
Figure 10 - Daily and Hourly Rainfall Recorded at GEO Raingauge No. H21

three days following the June 2007 landslide incident, together with the hourly rainfall for the period between 28 June and 30 June 2007, are presented in Figure 10. The maximum 24-hour and 12-hour rolling rainfall before the landslide was 90.5 mm and 70.5 mm respectively.

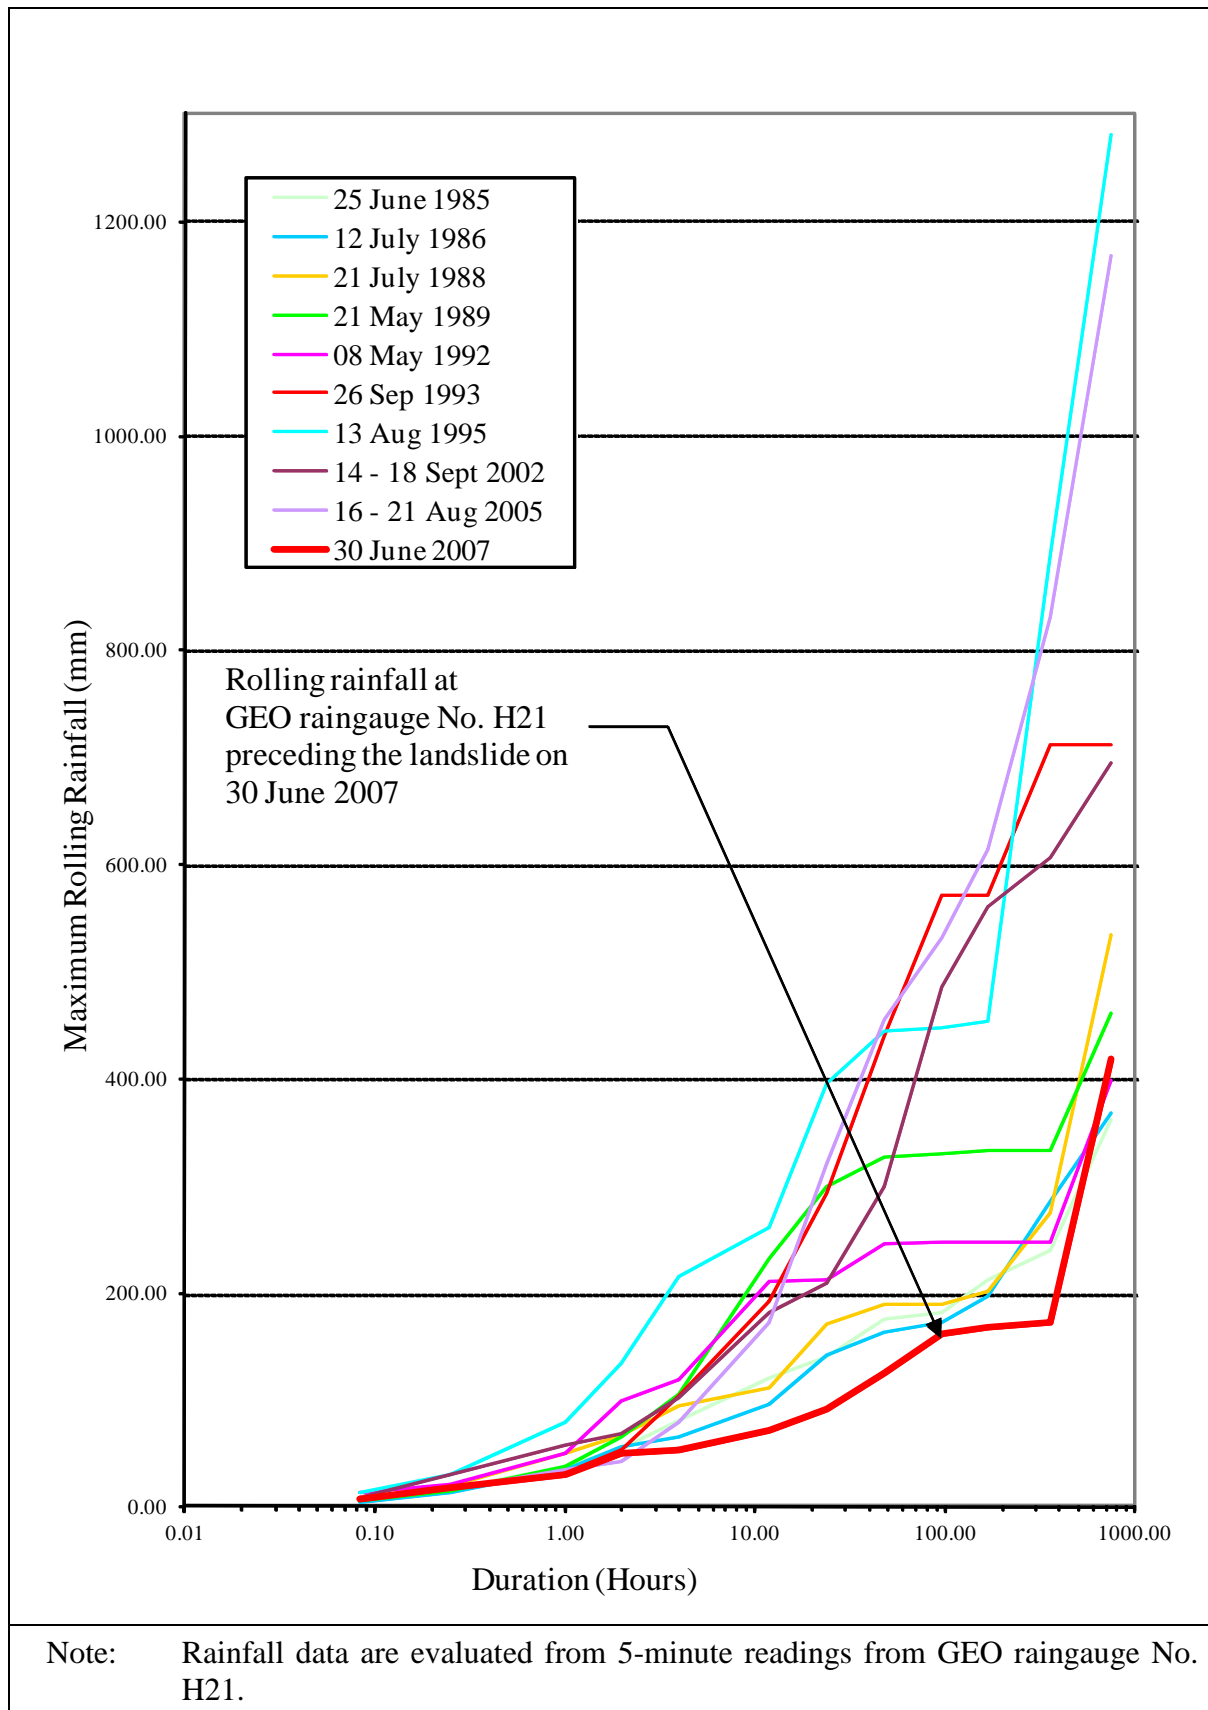
Figure 11 - Maximum Rolling Rainfall Preceding the Landslide Incident and Selected Previous Major Rainstorms Recorded at GEO Raingauge No. H21

The maximum rolling rainfall for the rainstorm on 30 June 2007 has been compared with the past major rainstorms between 1984 and 2006 as recorded at raingauge No. H21, which came into operation in March 1983 (Figure 11). The maximum rolling rainfall for the rainstorm on 30 June 2007 was less severe than that of the previous significant rainstorms.

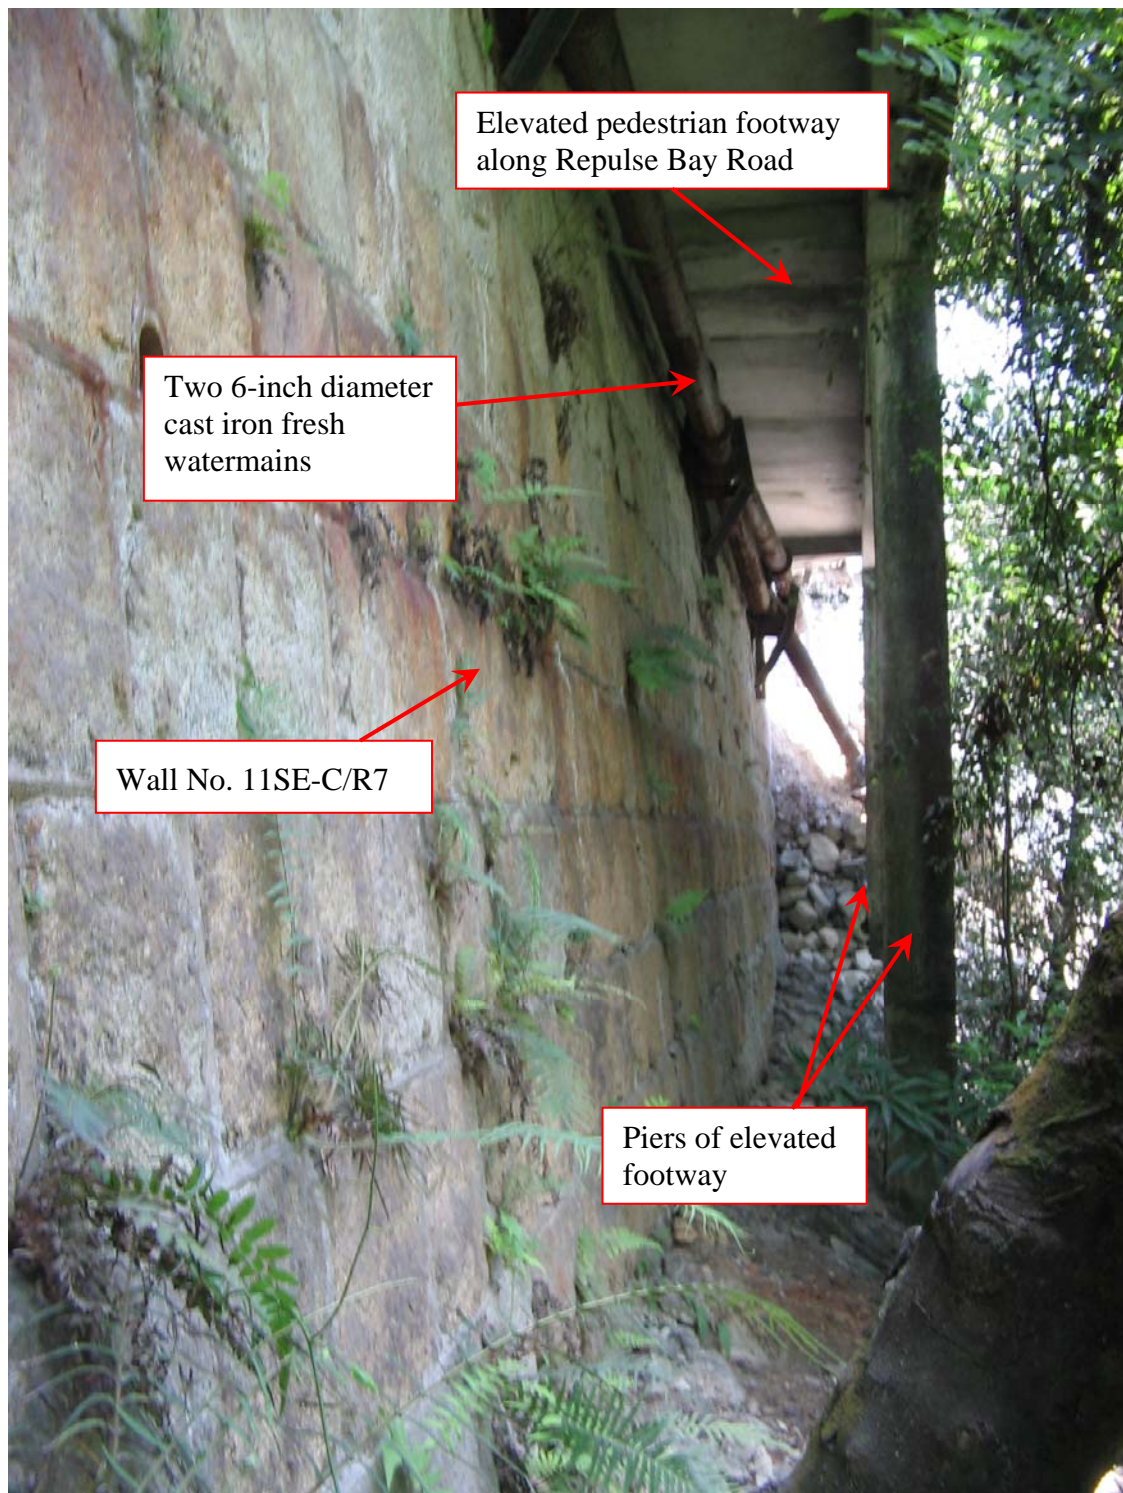
Plate 3 - General View of the Unaffected Portion of Wall No. 11SE-C/R7
(Looking South) (Photograph taken on 12 July 2007)

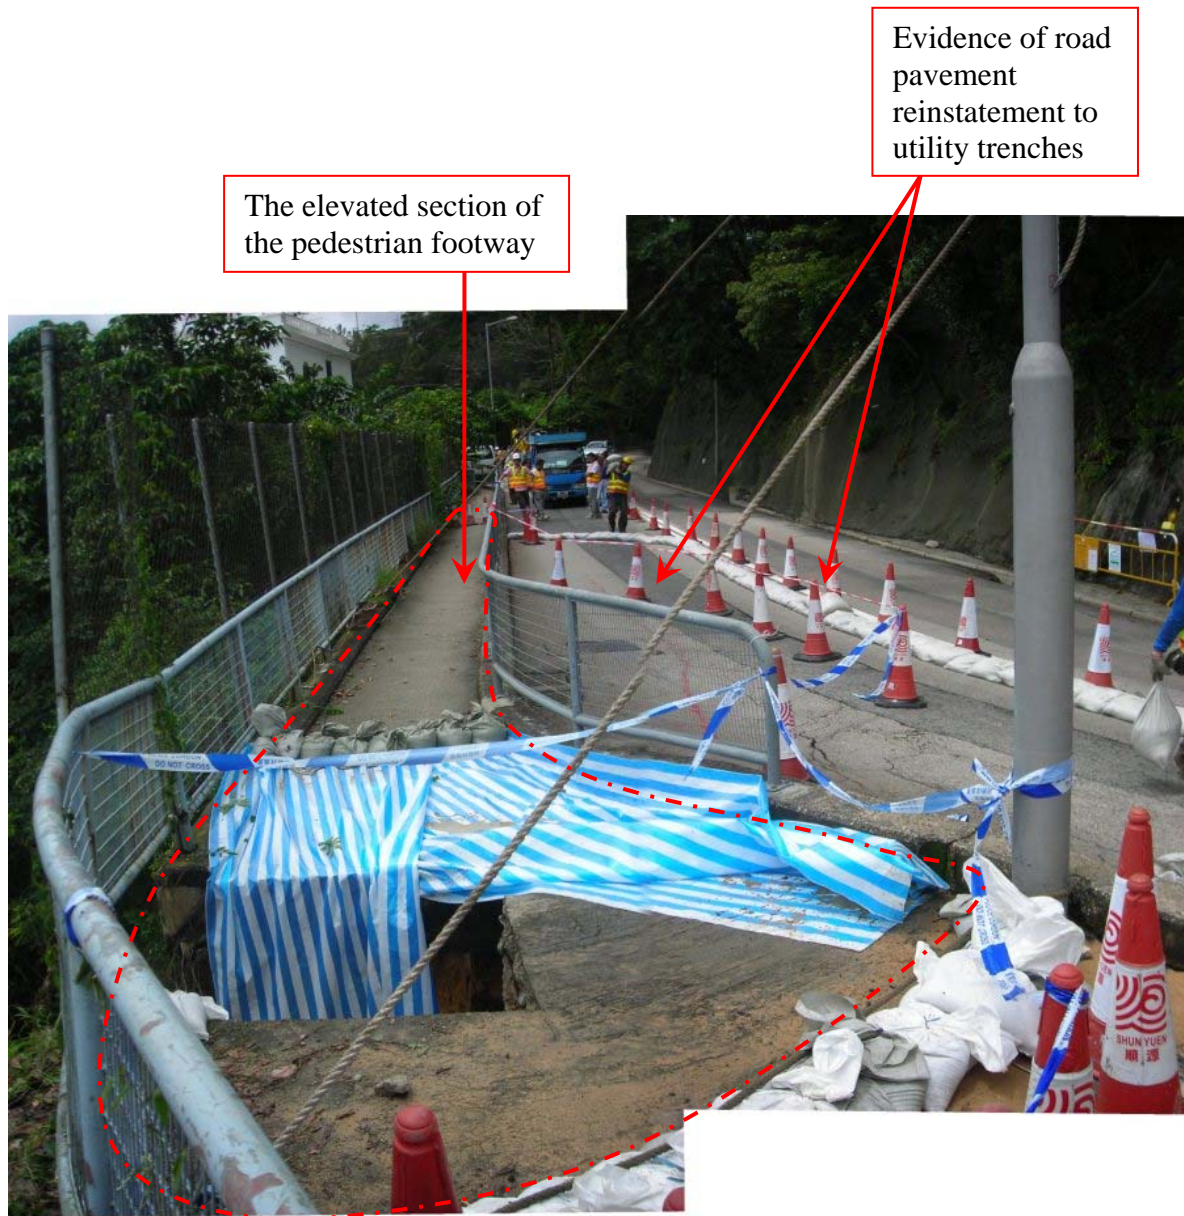
Plate 6 - Section of Repulse Bay Road above the 30 June 2007 Landslide
(Looking North) (Photograph taken on 30 June 2007)

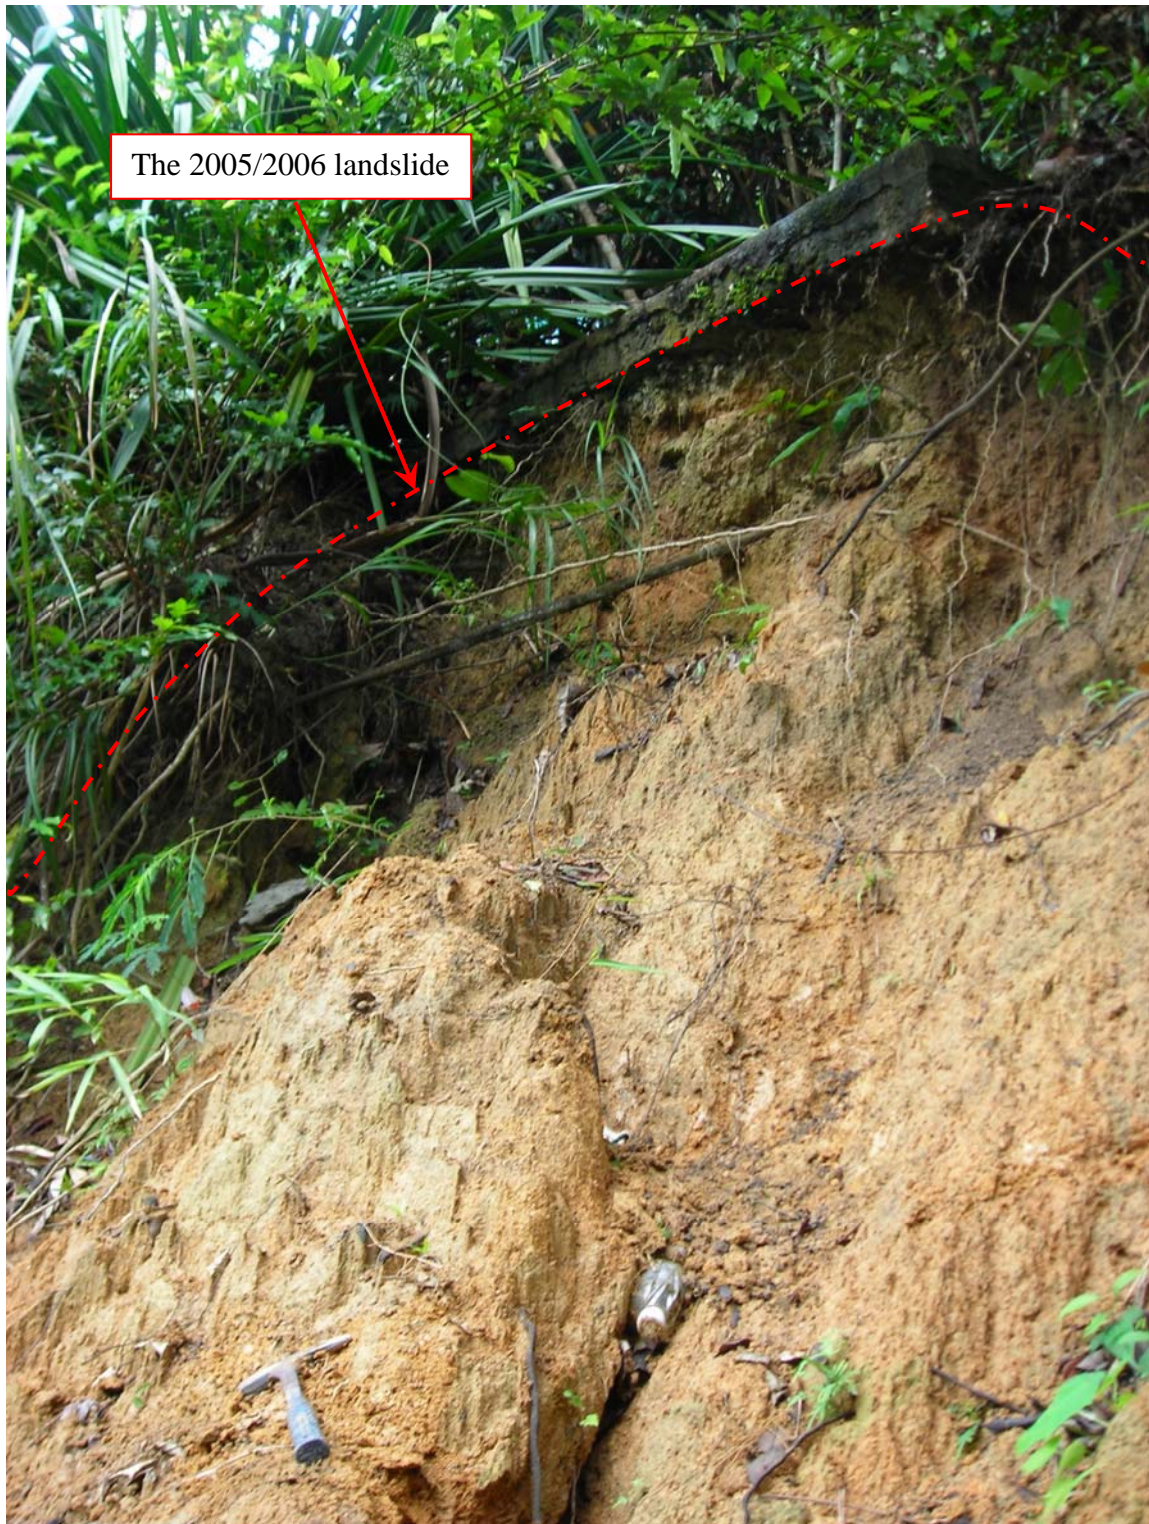
Plate 10 - General View of the 2005/2006 Landslide below Wall No. 11SE-C/R7
(Photograph taken on 3 October 2007)

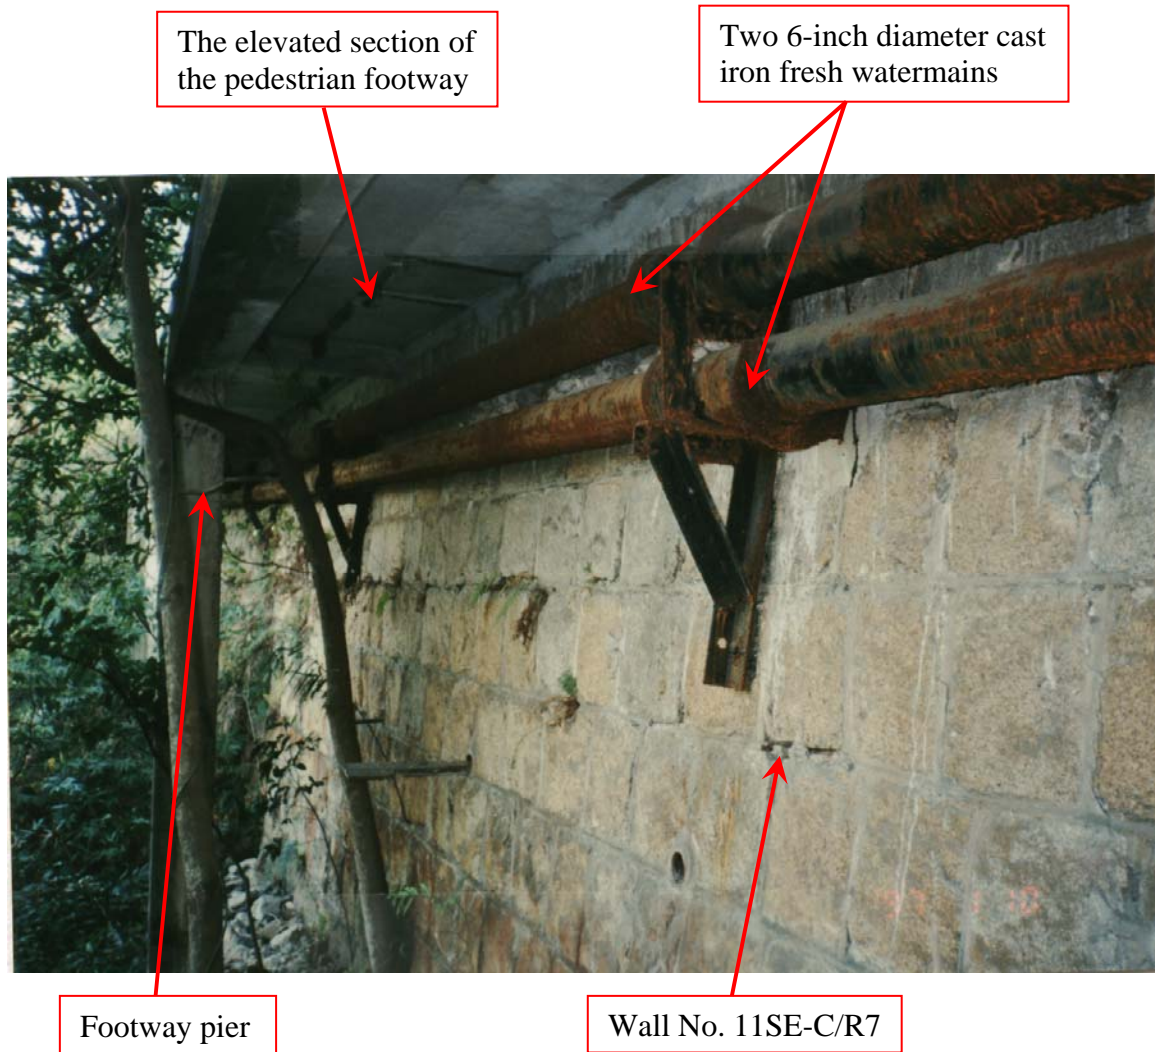
From post-landslide observation by FSW and record photographs of some EI and RMI reports (Plates 13, 14 & 15), the majority of the watermain were supported by brackets mounted on the front face of retaining wall No. 11SE-C/R7. However, towards the southern end, the lower watermain was apparently supported by brackets mounted to the bottom side of the elevated pedestrian footpath and the upper watermain was apparently buried in soil, as shown by a photograph taken on landslide incident No. HK97/1/1 (Plate 18). A schematic plan showing the mounting details of these brackets is shown on Figure 9.

Plate 13 - Condition of Wall No. 11SE-C/R7 in January 1997
(Photograph dated 10 January 1997 extracted from
HyD's RMI Report)

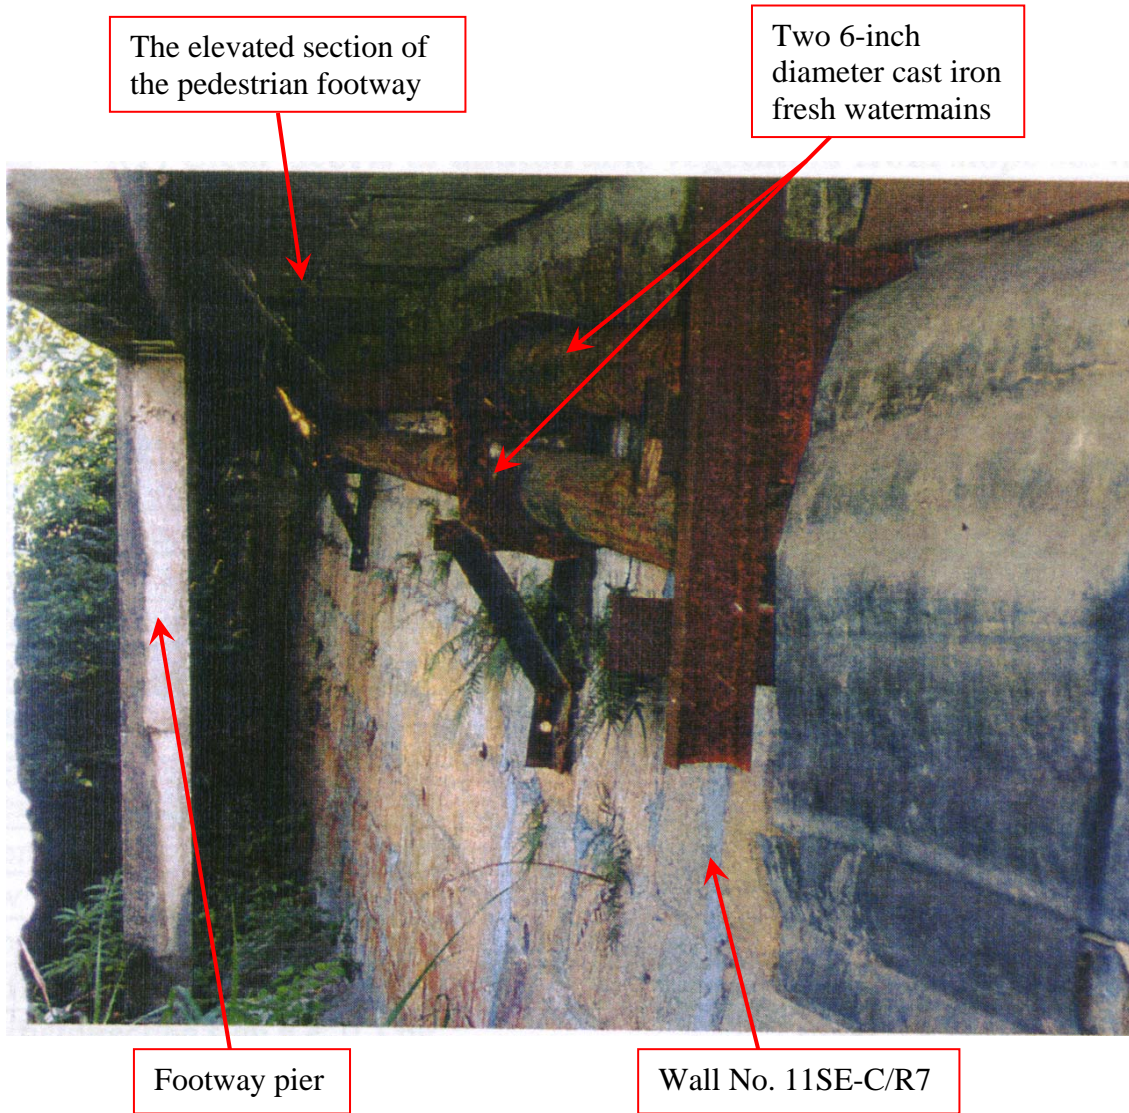
Plate 14 - Condition of Wall No. 11SE-C/R7 in September 2002
(Photograph dated 19 September 2002 extracted from
HyD's RMI Report)

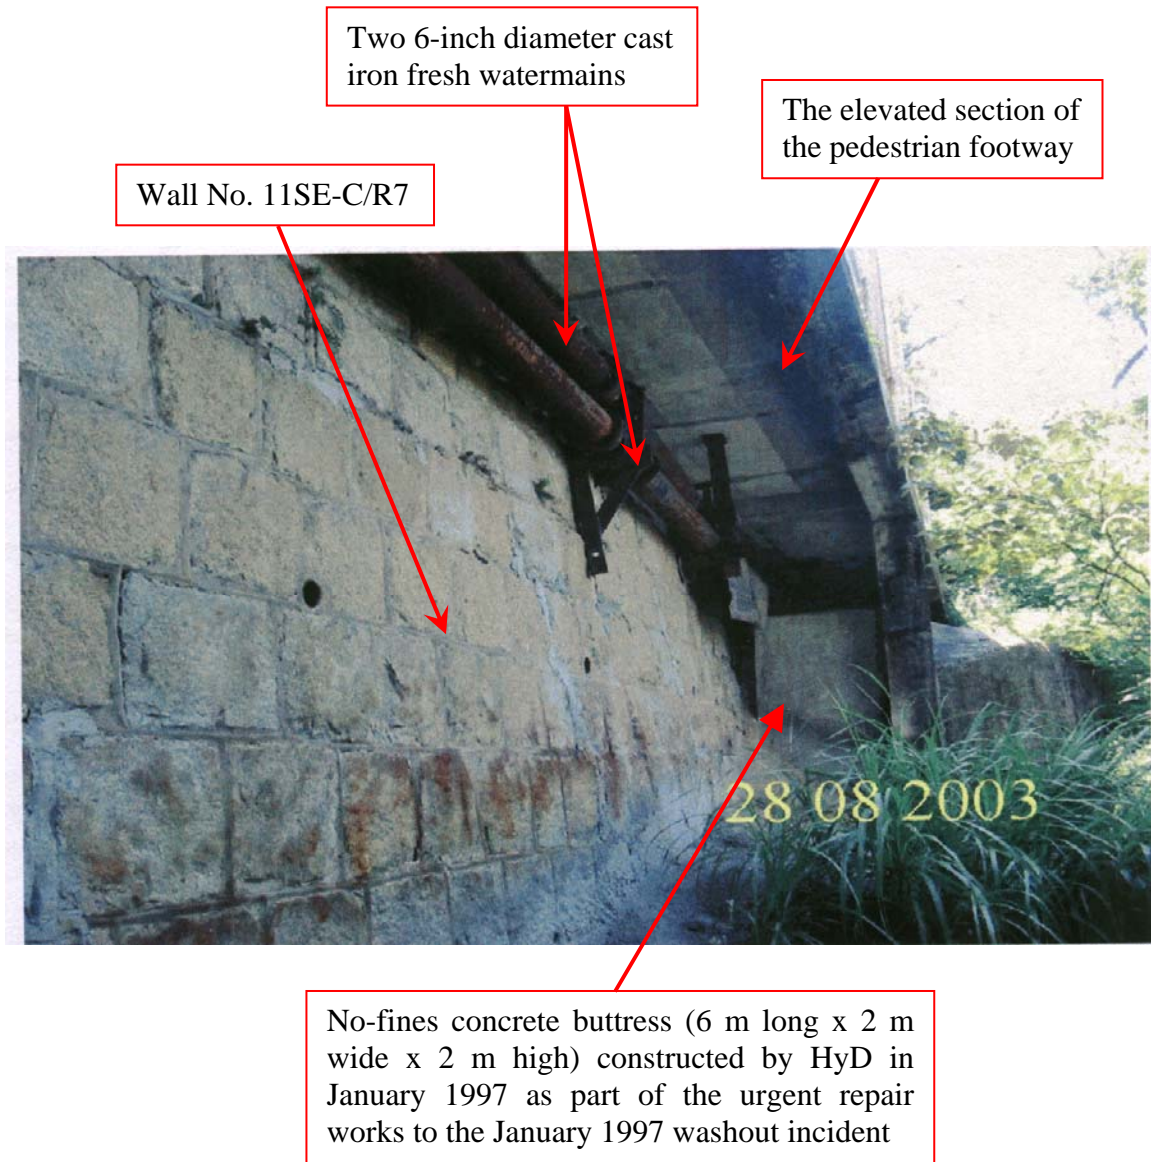
Plate 15 - Condition of Wall No. 11SE-C/R7 in August 2003
(Photograph dated 28 August 2003 extracted from
HyD's RMI Report)
