**REVIEW OF THE
7 JUNE 2008 ROCK SLOPE
FAILURE ON SLOPE
NO. 10NE-B/C56
BELOW TSING YI ROAD**

GEO REPORT No. 288

C.L.H. Lam & H.W.K. Lam

**GEOTECHNICAL ENGINEERING OFFICE
CIVIL ENGINEERING AND DEVELOPMENT DEPARTMENT
THE GOVERNMENT OF THE HONG KONG
SPECIAL ADMINISTRATIVE REGION**

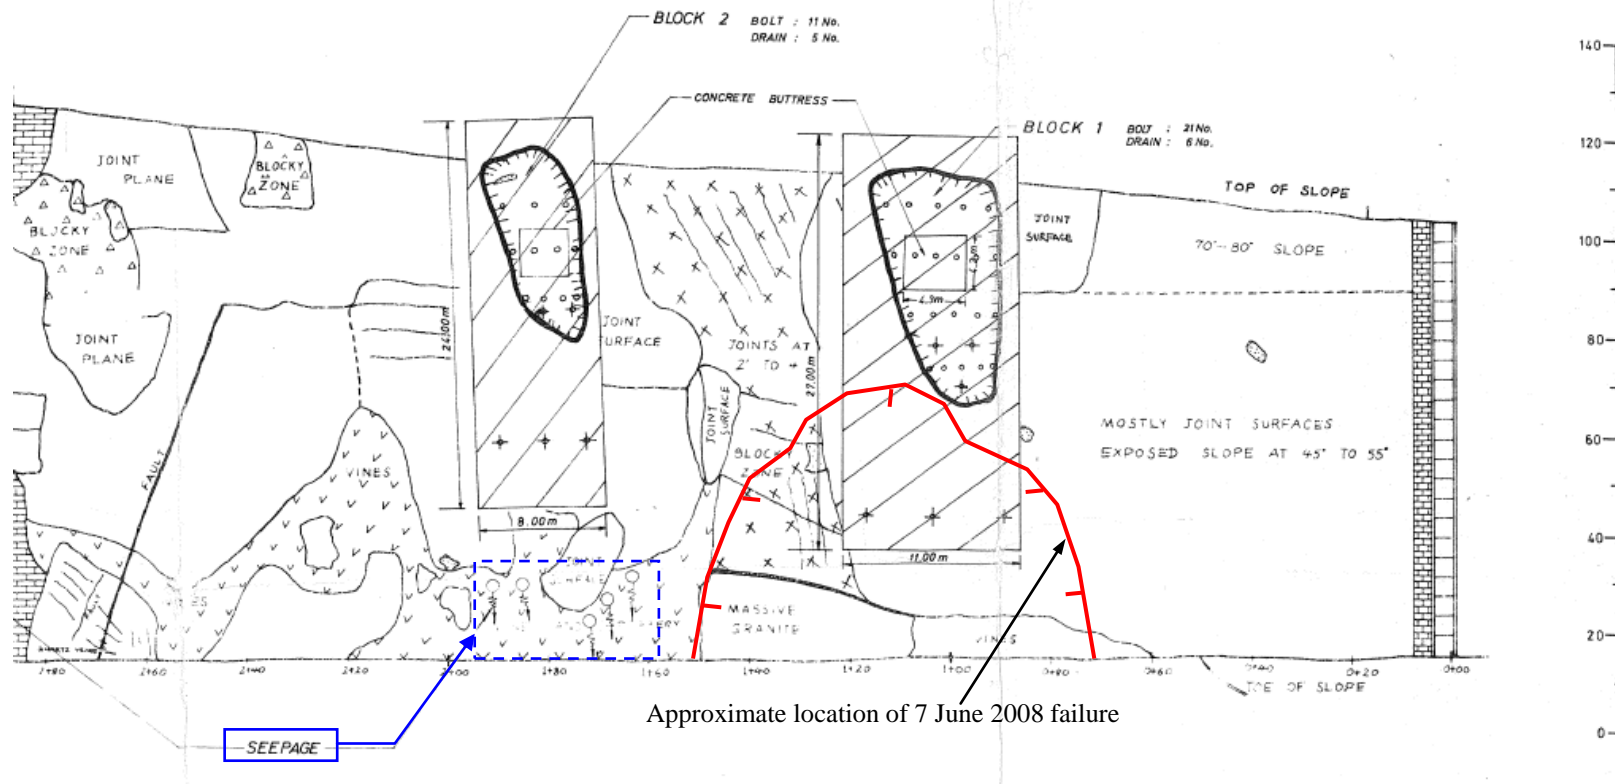
Figure 5a – Stabilization Works (Sheet 1 of 2)

The slope was subject to stabilisation in 1981 and stability assessment in 1999. The rock 'bolts' installed in 1981 were proved to be effective in stabilising the portion of the rock slope above the failure location (Plate 1). However, the critical joint (i.e. the basal slip surface) leading to the 7 June 2008 failure was not identified in the previous assessments. Hence, no stabilization works were applied to the portion that failed.

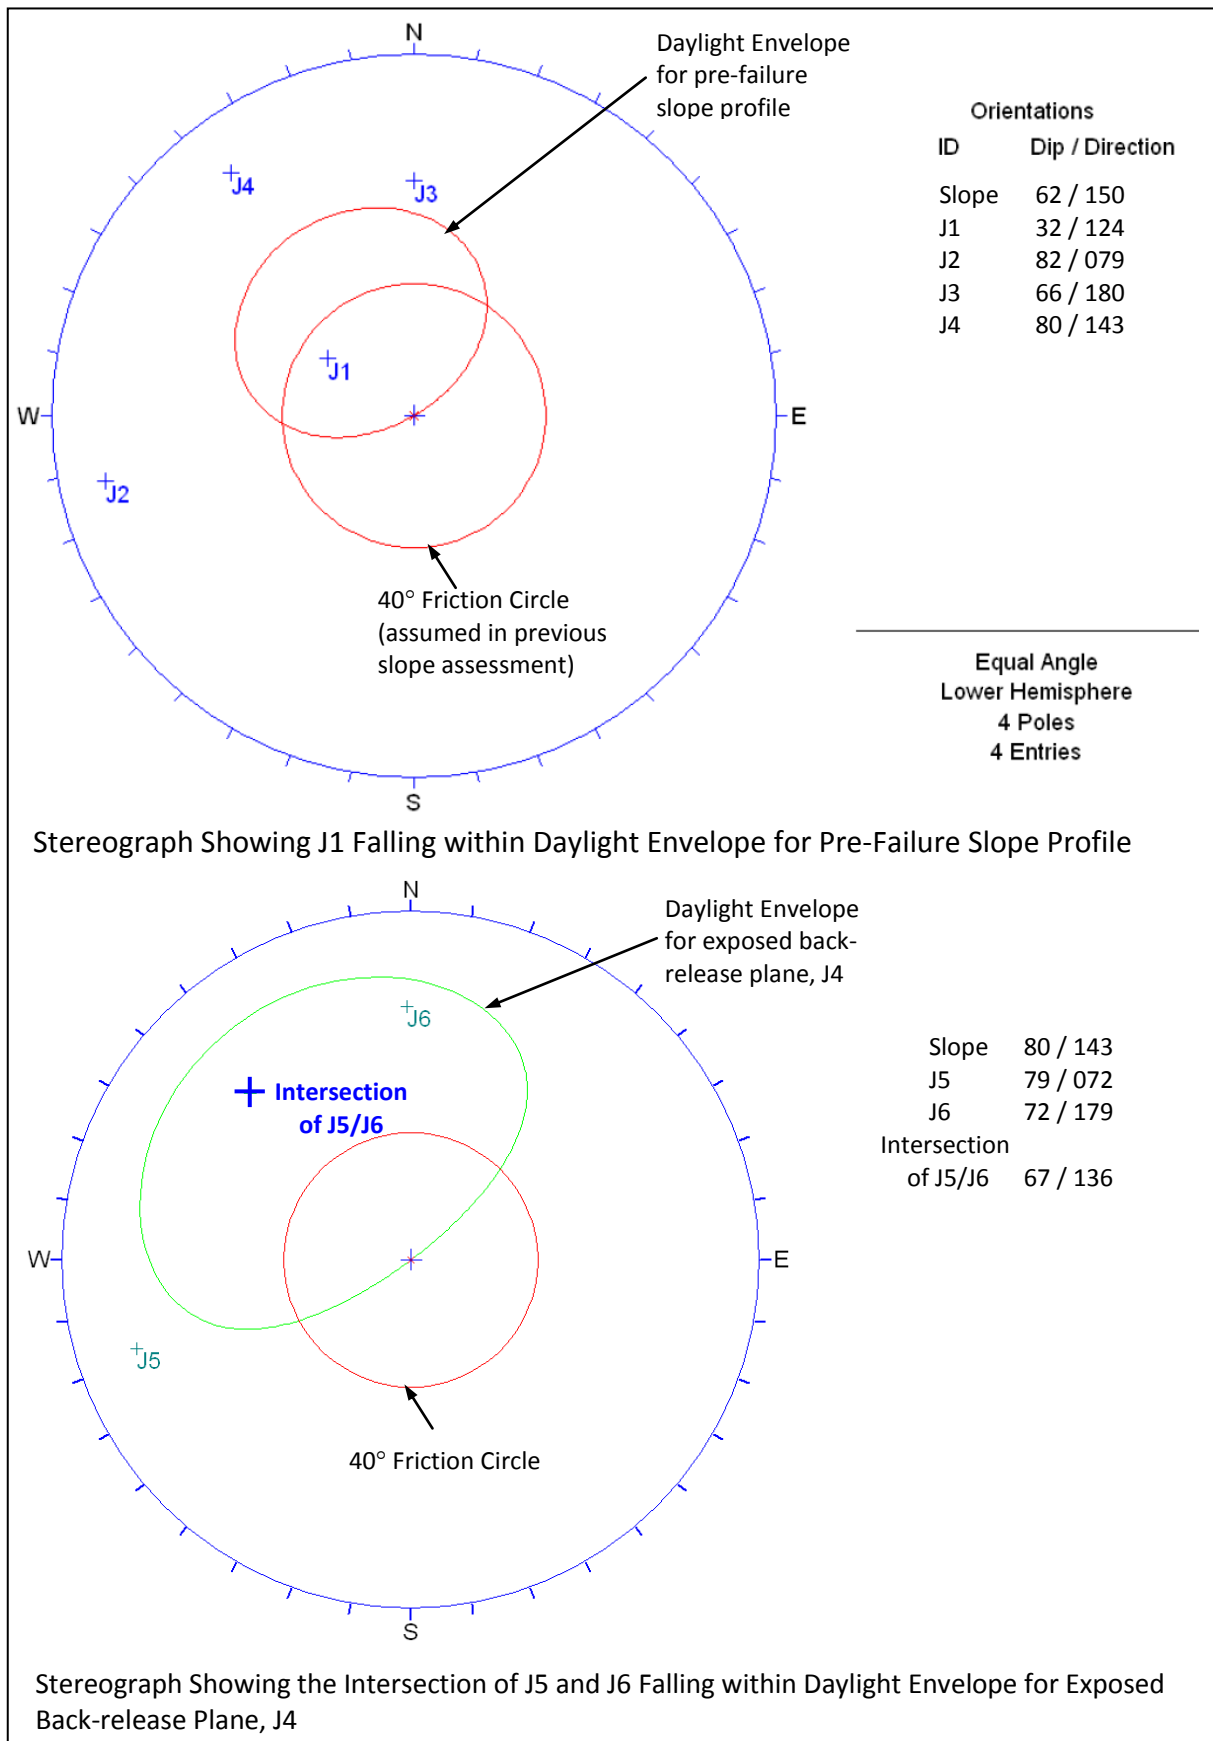
Figure 8 – Stereograph of Rock Joints Bounding the Scar

The 7 June 2008 rock slope failure probably took place in two stages. The main failure might have involved a translational slide with a large rock mass sliding outward along the basal slip surface. The slide mass could have resulted in loss of support to the overhanging rock wedge, and triggered a secondary, minor wedge failure. Debris of the wedge failure came from an elevated height with a higher energy level, and hence travelled further. This could explain why some sizeable rock blocks were deposited further away from the main body of the debris (Plate 2 and Section 7).

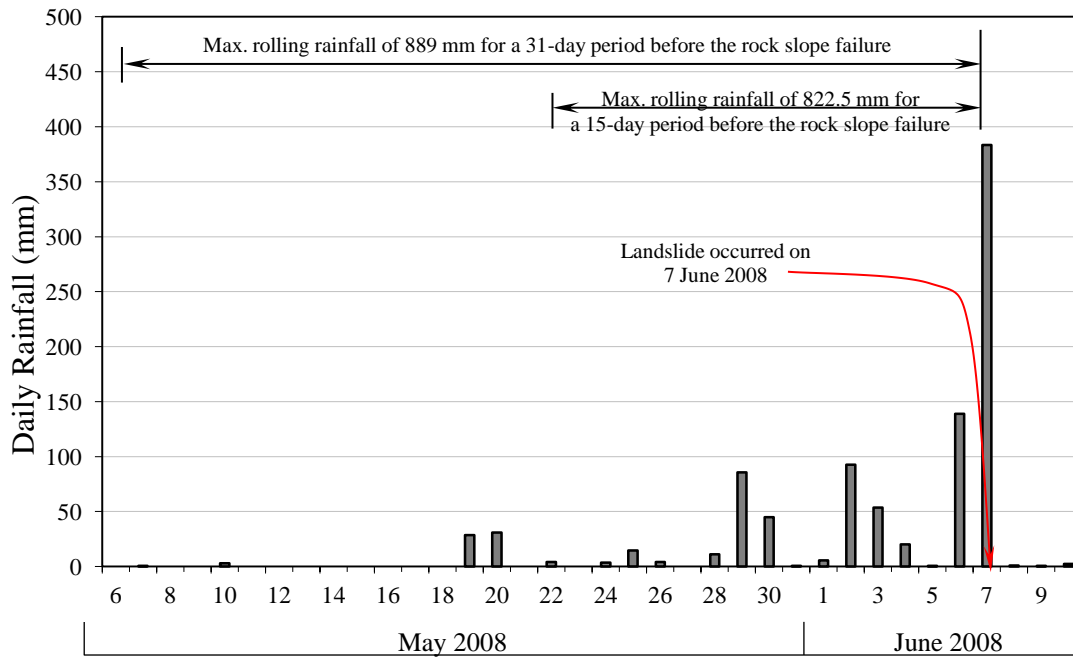
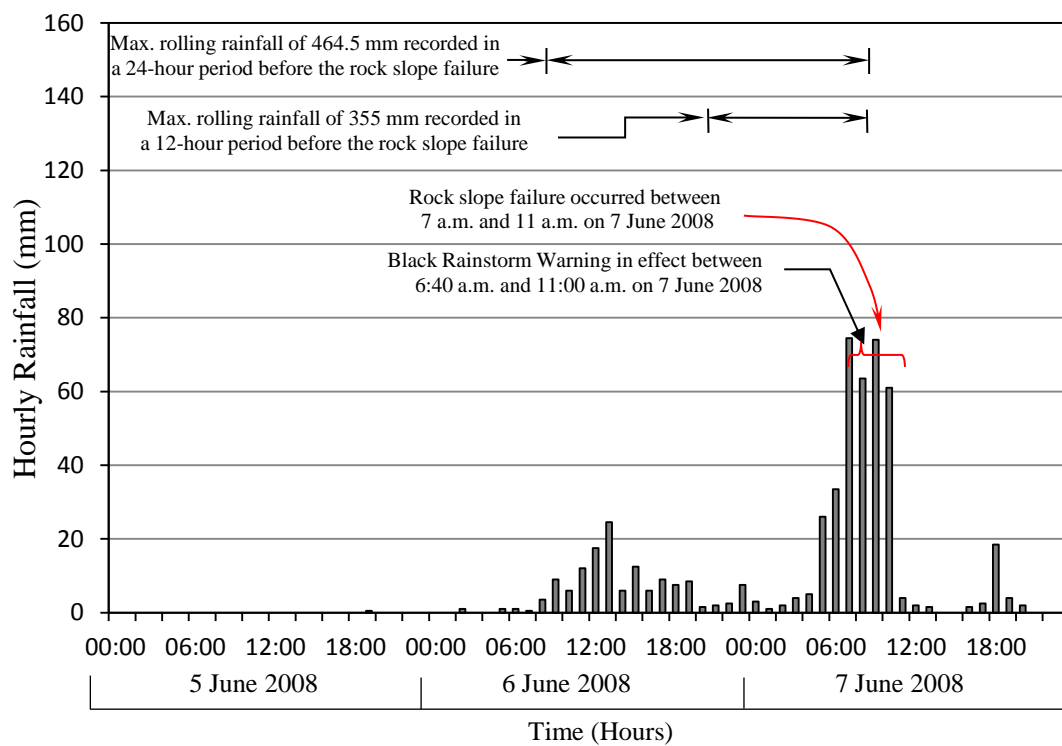
Figure 9 - Daily and Hourly Rainfall Recorded at GEO Raingauge No. N11

Rainfall data were obtained from the nearest GEO automatic raingauge No. N11, which is located at about 800 m northwest of the 7 June 2008 landslide location (Figure 1). The raingauge records and transmits rainfall data at 5 minute intervals to the Hong Kong Observatory and the GEO. Severe rainfall was recorded between 7:00 a.m. and 11:00 a.m. on 7 June 2008. The incident was reported by the HyD at 3:10 p.m. on 7 June 2008, but the exact timing of the landslide was unknown. For the purposes of rainfall analysis, it is assumed that the incident occurred between 7:00 a.m. and 11:00 a.m. on 7 June 2008.

The daily rainfall over the preceding month and three days following the incident, together with the hourly rainfall data for the period between 5 and 7 June 2008, is presented in Figure 9. Table 1 presents the estimated return periods for the maximum rolling rainfall for various durations recorded by raingauge No. N11 with reference to historical rainfall data at the Hong Kong Observatory in Tsim Sha Tsui (Lam & Leung, 1994) and local rainfall data of raingauge No. N11 (Evans & Yu, 2001). The results show that rainfall durations of both 4 hours and 24 hours of the 7 June 2008 rainstorm were most severe with return periods over 100 years.

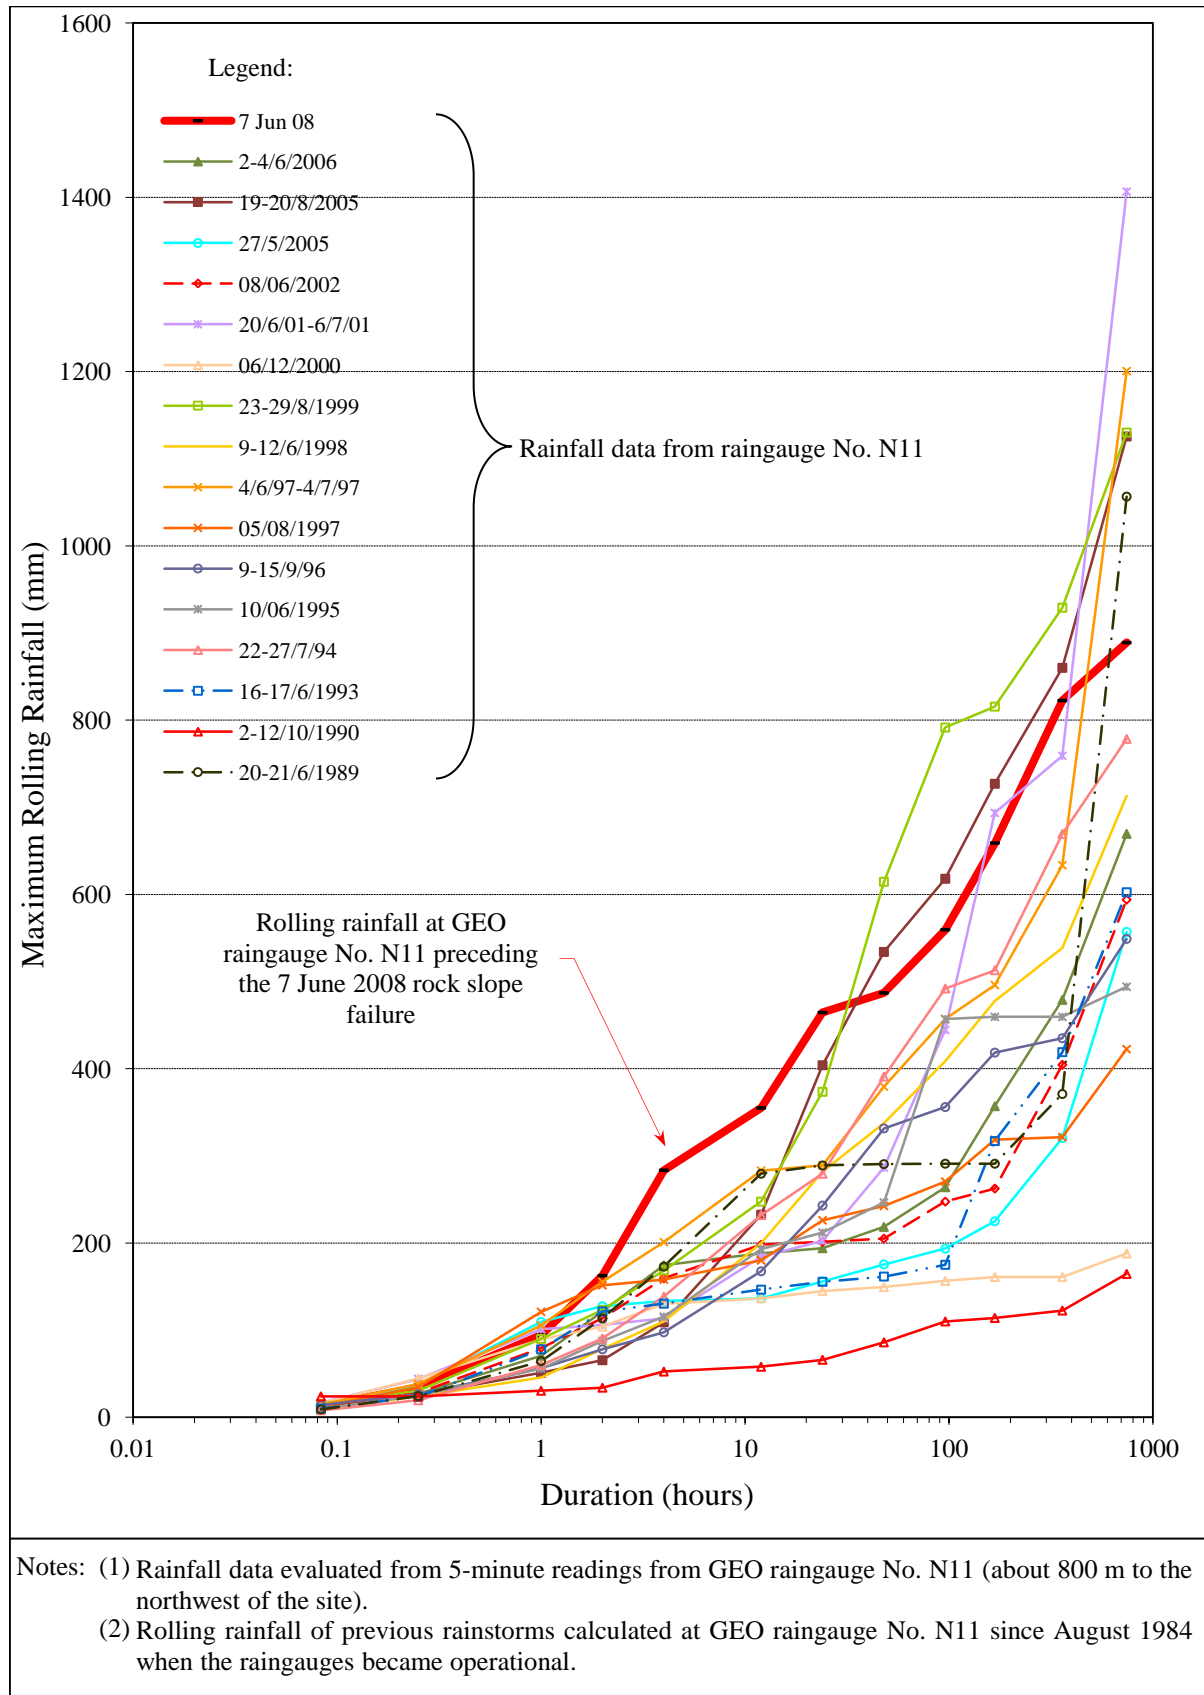
Figure 10 - Maximum Rolling Rainfall for Previous Major Rainstorms at GEO Raingauge No. N11

The 7 June 2008 rainstorm is the most severe in comparison with the previous major rainstorms for rainfall durations between 2 hours and about 24 hours since the raingauge came into operation in August 1984 (Figure 10).

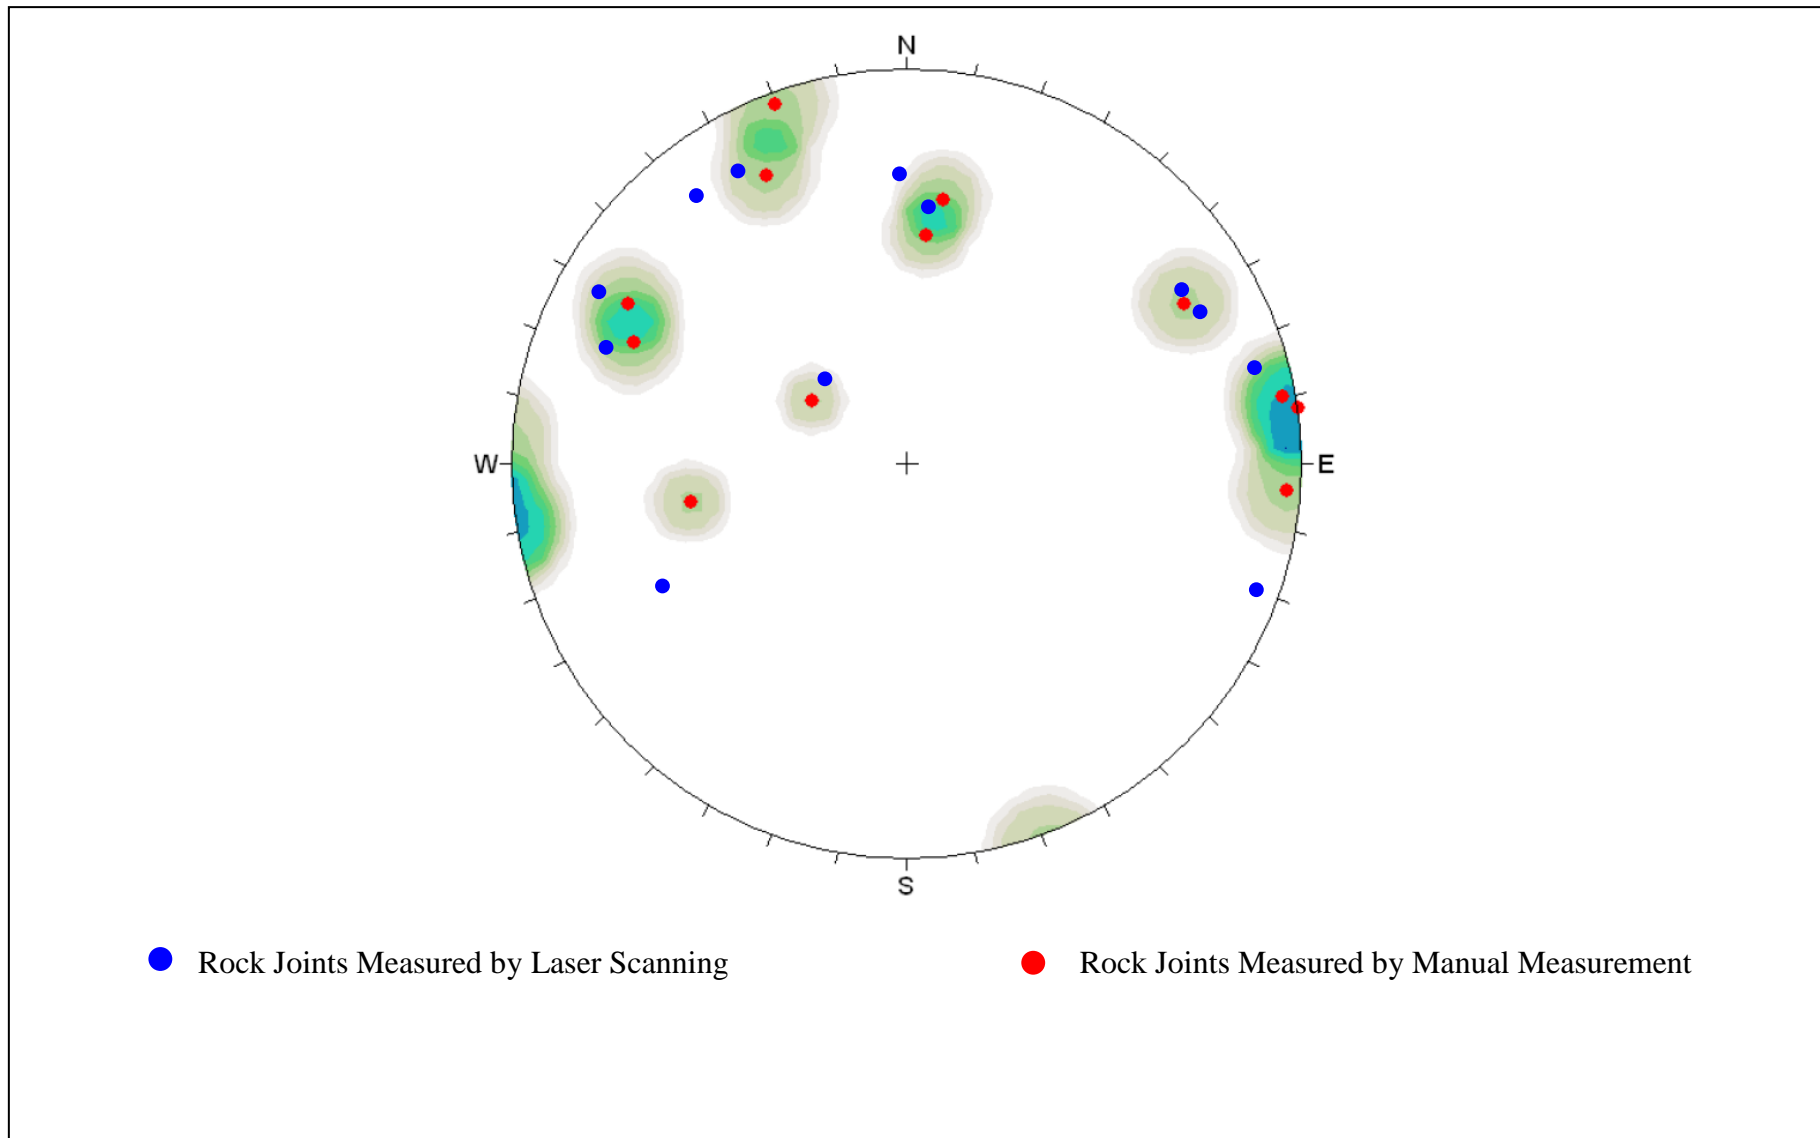
Figure 11 – Comparison of Stereographs of Rock Joints by Laser Scanning Method and by Direct Manual Measurement

The data collected from the scanner have been compared with those obtained from manual measurement using engineering compass. Joint data collected for 12 pairs of rock joints by the two methods are plotted in Figure 11 for comparison. It shows that the two methods give similar results, in terms of dip angle and dip direction of the joint planes.
