**DETAILED STUDY OF THE  
7 JUNE 2008 LANDSLIDE  
ON SLOPE NO. 11SE-A/C502  
AT PAK FUK ROAD,  
NORTH POINT**

**GEO REPORT No. 289**

**Fugro Scott Wilson Joint Venture**

**GEOTECHNICAL ENGINEERING OFFICE  
CIVIL ENGINEERING AND DEVELOPMENT DEPARTMENT  
THE GOVERNMENT OF THE HONG KONG  
SPECIAL ADMINISTRATIVE REGION**

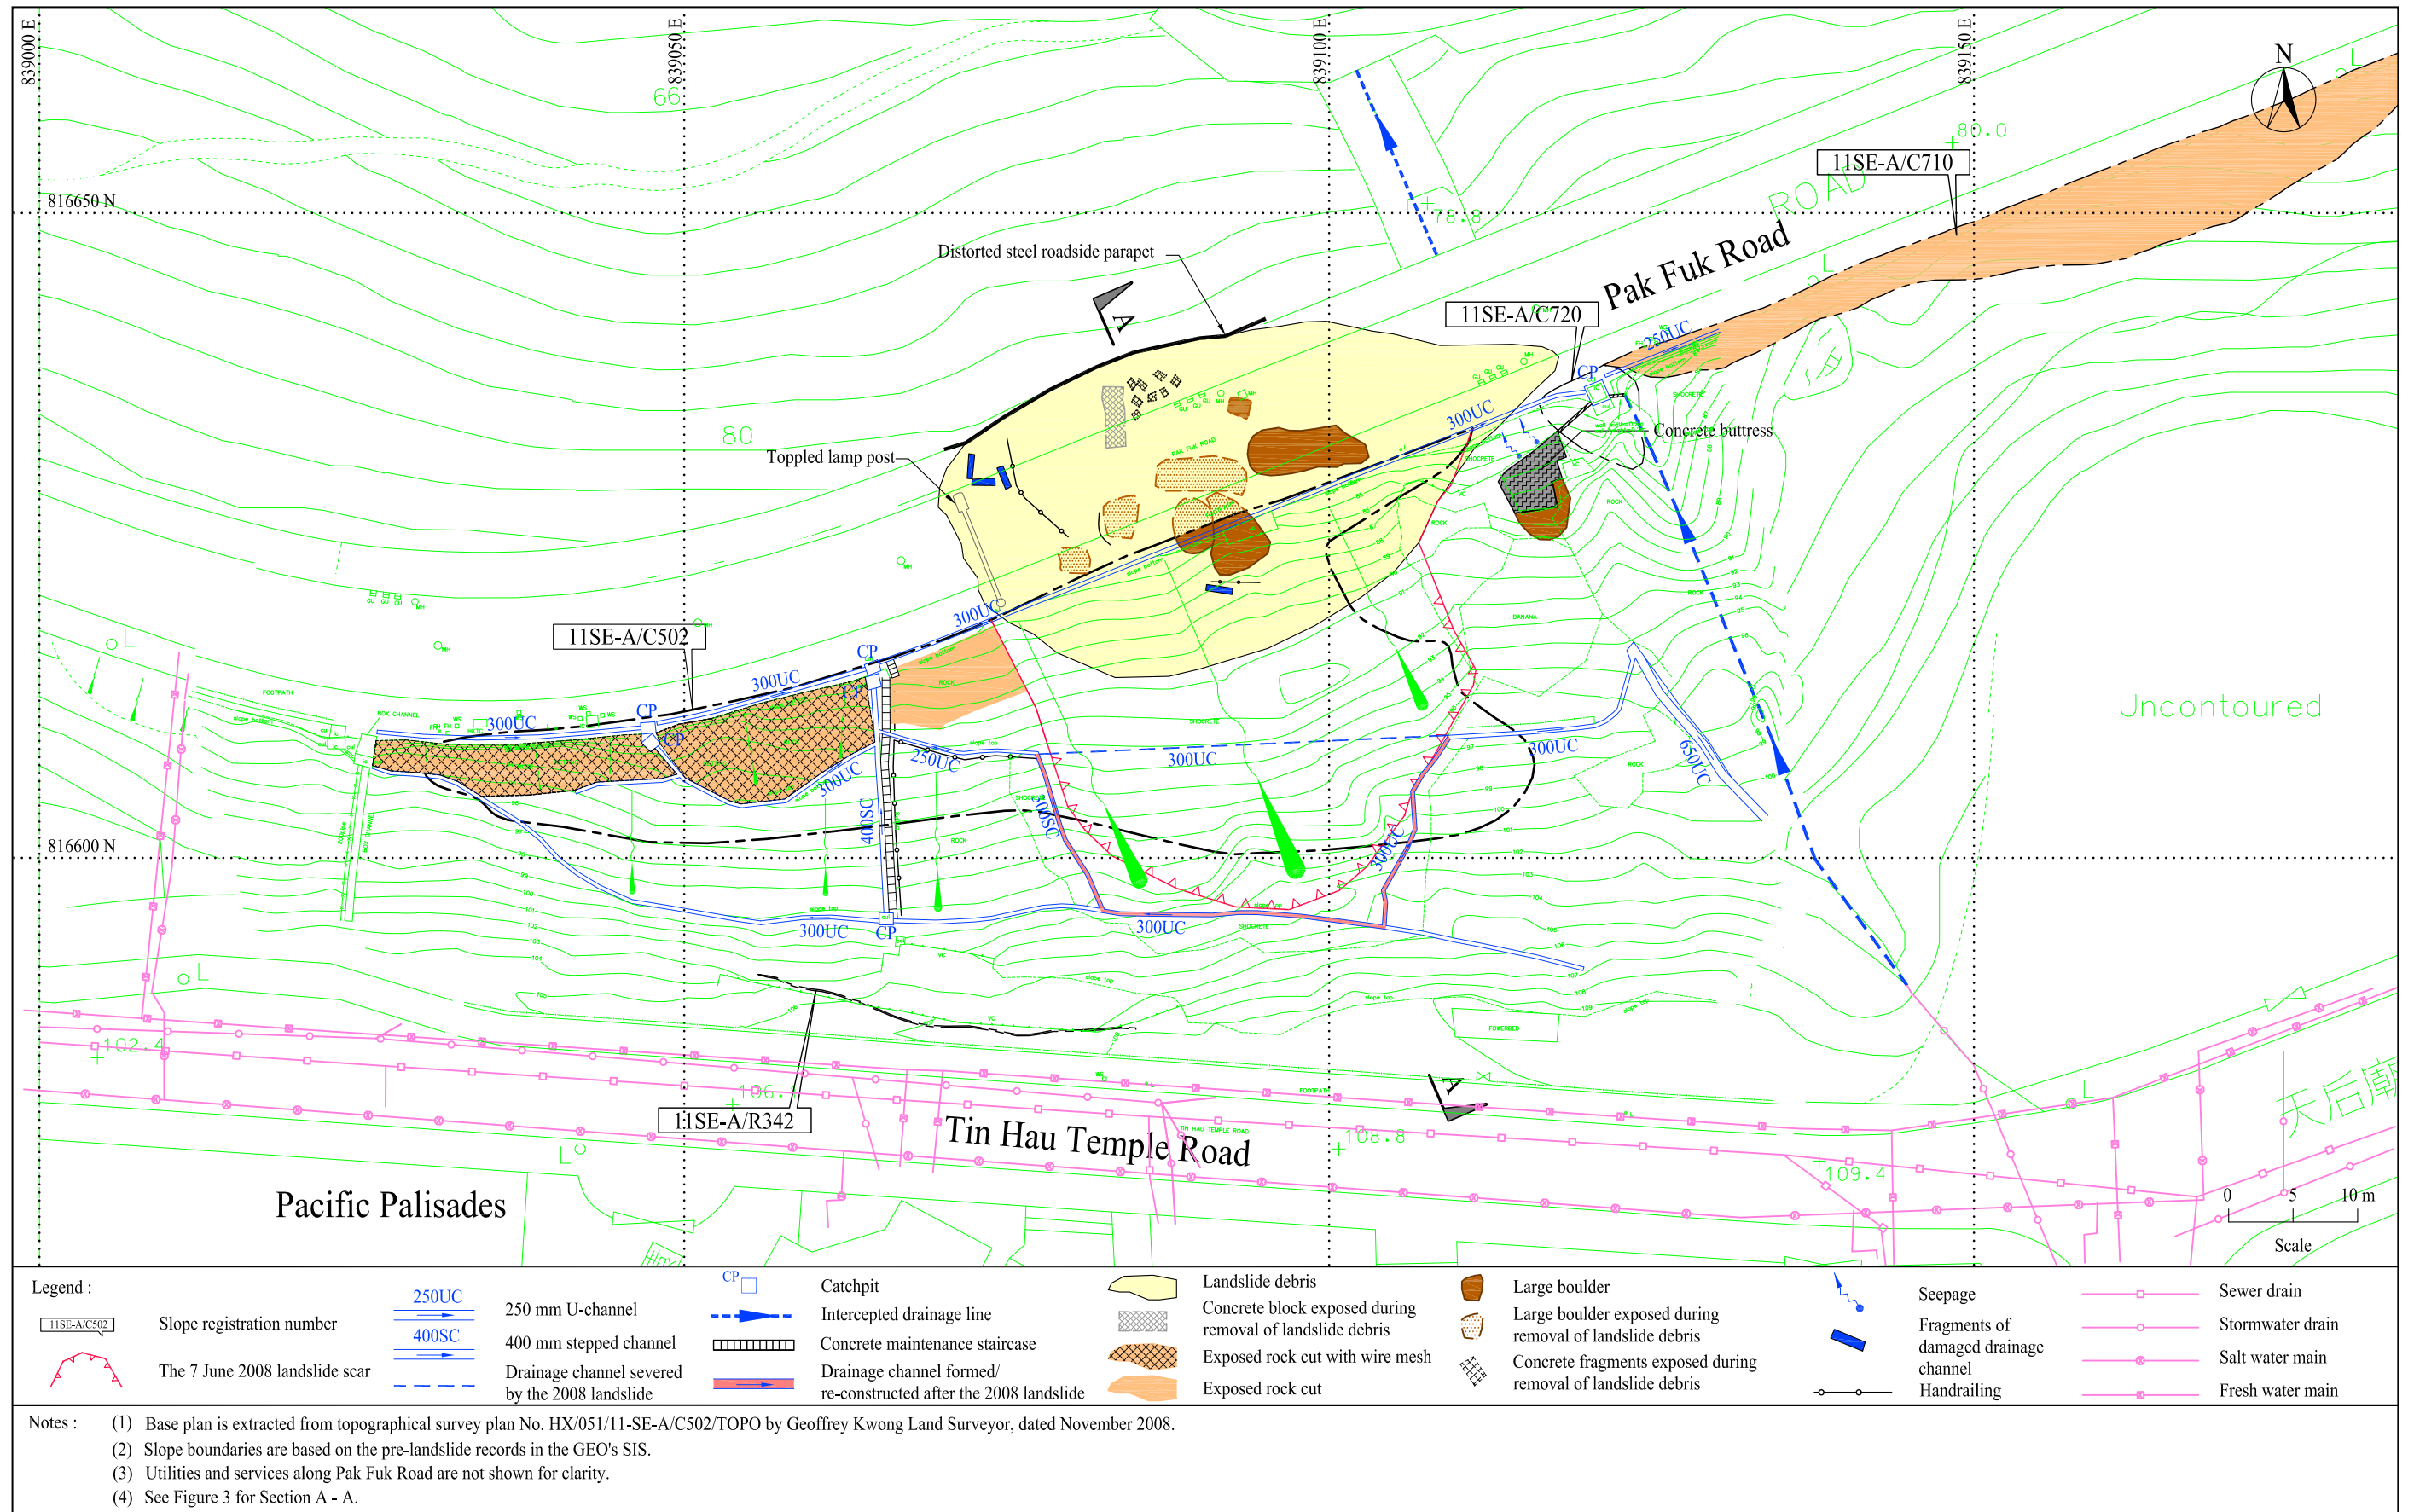
Figure 2 - Site Layout Plan and Field Observations

- (a) On 7 June 2008, heavy seepage was noted flowing from two weepholes on a concrete buttress located immediately to the east of the landslide (Figure 2 and Plate 2), as well as from rock joints adjoining the landslide scar (Plates 27 and 28);
- (b) On 18 June 2008 prior to the provision of the shotcrete cover to the landslide scar, seepage above the colluvium/CDG interface was noted at the western flank of the main scarp (Plate 29) although no soil pipes could be observed;

The 7 June 2008 landslide site is located about 25 m to the east of a natural drainage line (Figure 2). Given its close proximity, the surface flow in the natural drainage line could have been a possible source of water ingress, contributing to the subsurface seepage flows towards the landslide site.

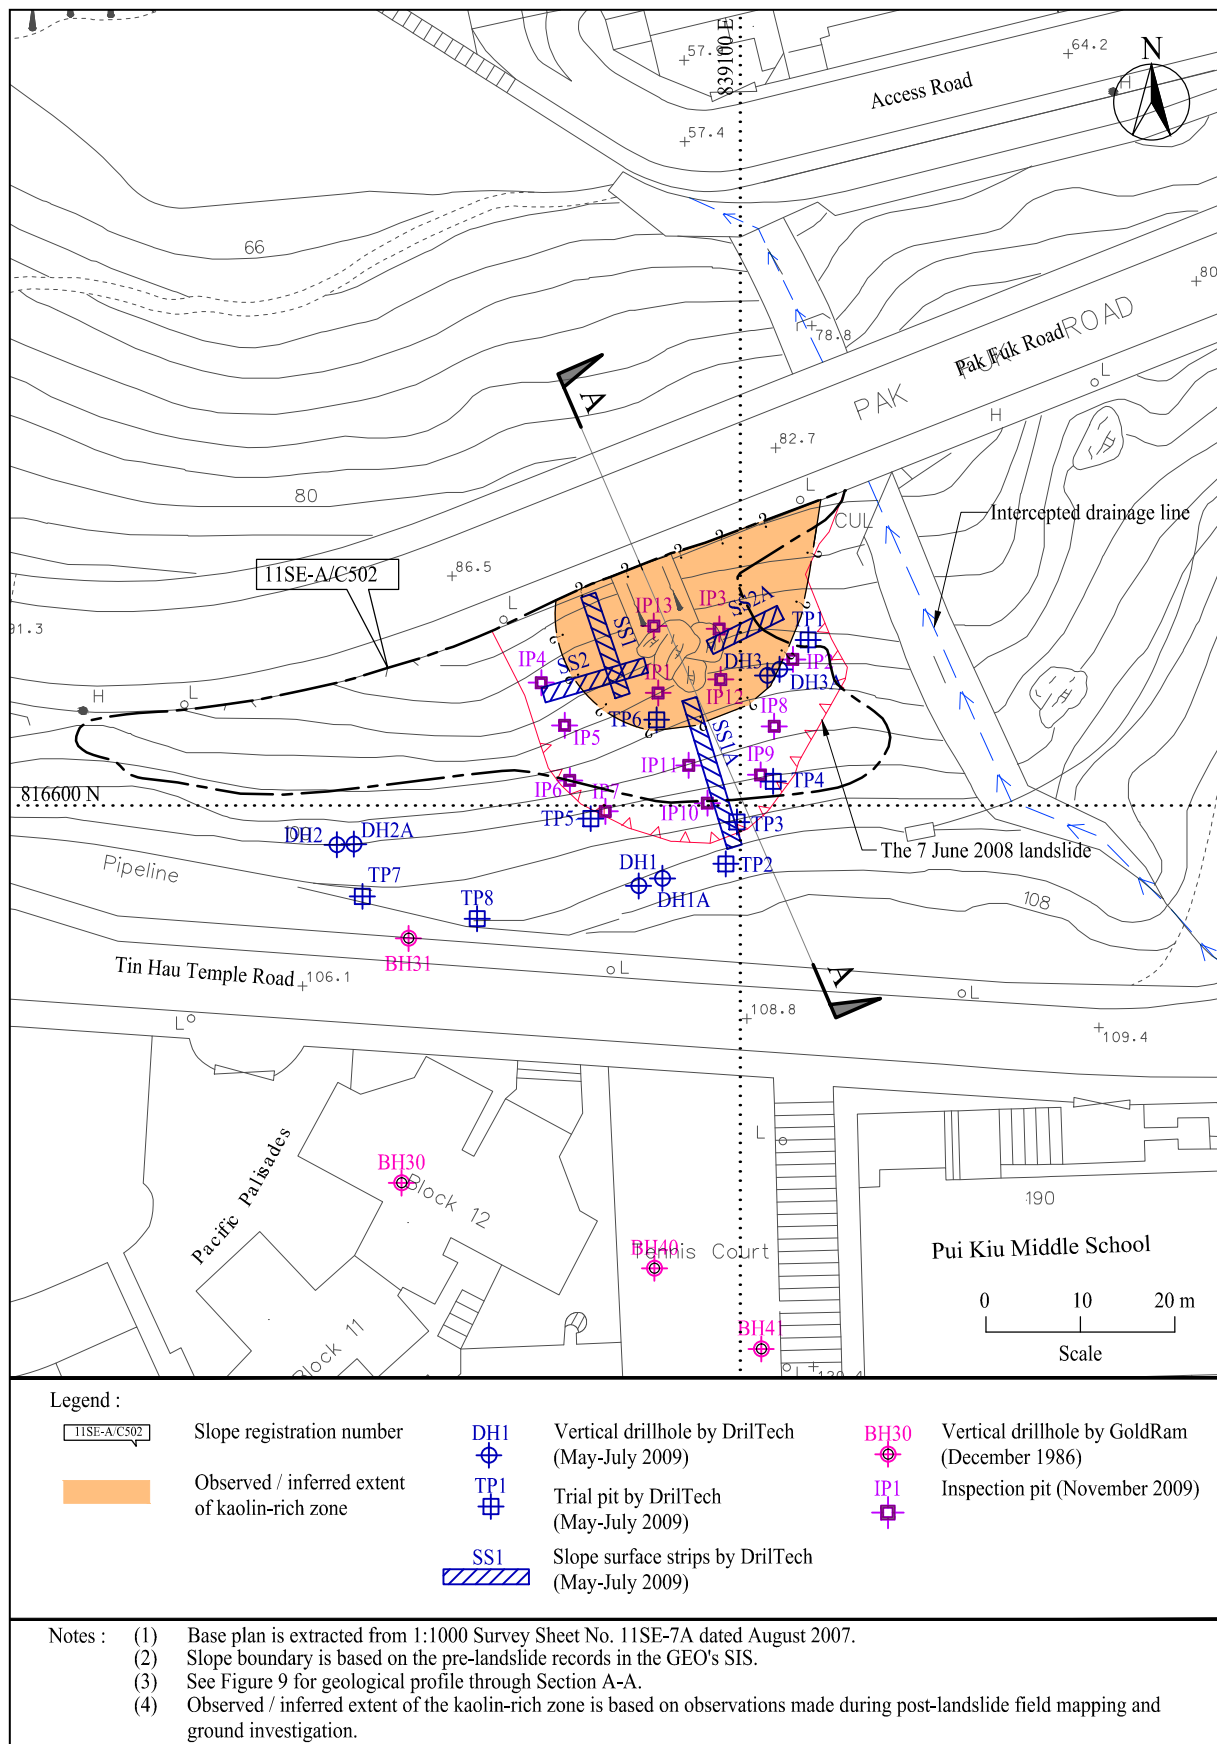
Figure 8 - Location Plan of Ground Investigation Stations

The kaolin-rich zone was laterally-extensive and exposed over the lower central part of the basal slip plane during the subsequent slope upgrading works in mid 2010. The inferred extent of the kaolin-rich zone is indicated in Figure 8. The zone measured about 0.5 m to 1.0 m in thickness and comprised kaolin-infilled relict sheeting joints dipping at 25° out of the slope face (Figure 9). Remnants of the kaolin infill were also exposed in trial pit No. TP6, slope surface strip Nos. SS1 and SS2, as well as inspection pit No. IP13 (Figure 8). The kaolin infill could be generally described as buff, slightly sandy silty clay, within the mottled weathering zone of decomposed granite. The thickness of the kaolin infill varies along the length and width of the landslide, ranging from 10 mm to 50 mm (Plates 21 to 23).

The groundwater conditions at the site were evaluated from a review of the available groundwater monitoring data, together with post-landslide seepage observations. As part of the post-landslide GI, standpipes were installed in 5 drillholes (Nos. DH1, DH1A, DH2, DH3 and DH3A) and 2 trial pits (Nos. TP2 and TP3) (Figure 8). Groundwater monitoring of the standpipes was carried out since May 2009.

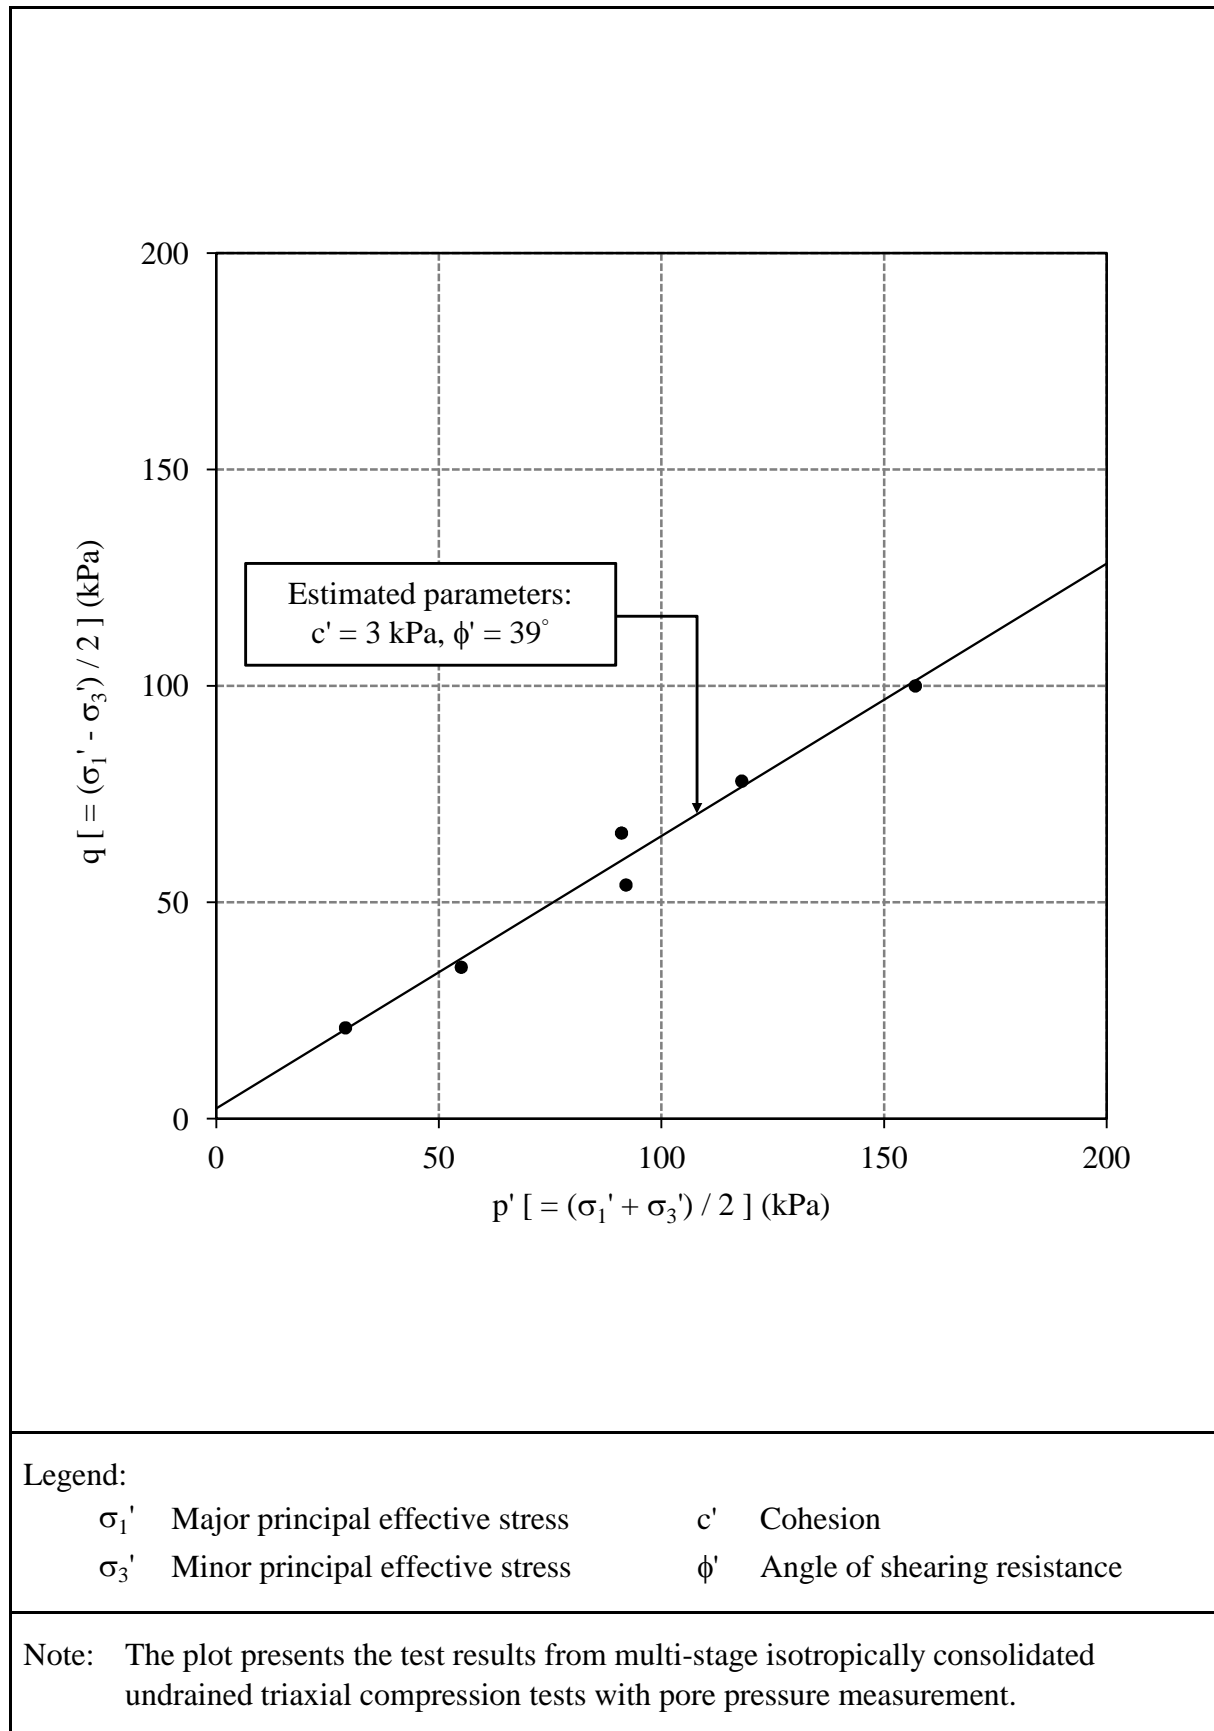
Figure 11 - Triaxial Compression Test Results for Completely Decomposed Granite

during the ground investigation, with an aim to determine the geotechnical properties of the materials at the landslide site. The tests comprised particle size distribution tests, Atterburg limit tests and isotropically consolidated undrained triaxial compression tests. The triaxial compression test results for CDG are shown in Figure 11. The results of the classification and index tests are summarised in Table 2.

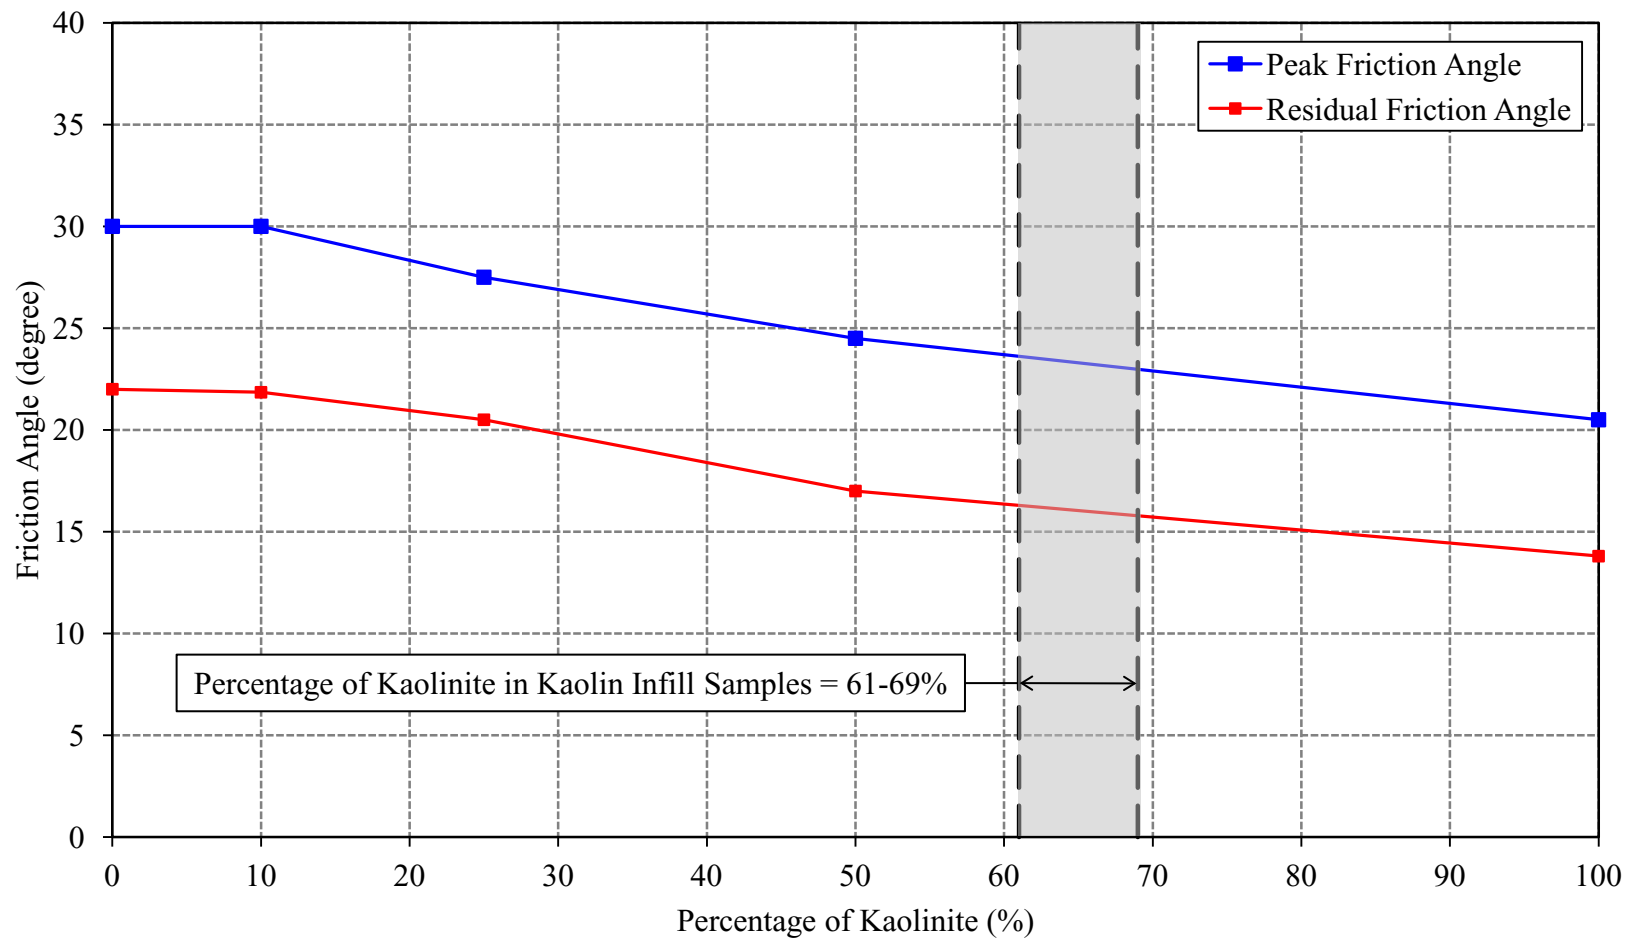
Figure 13 - Peak and Residual Friction Angle of Kaolin Infill

For the purpose of identifying the clay mineralogy of the kaolin infill, clay mineralogical tests, viz. scanning electron microscopy (SEM) and X-ray diffraction (XRD) (Churchman et al, 2010), were carried out on 6 samples of kaolin infill by the University of Adelaide in Australia. The micrographs for the samples, in general, show a mixture of platy particles (i.e. kaolinite) with some small tubular particles (i.e. halloysite) (Figure 12). The XRD results are fairly consistent in that the relative proportion of halloysite and kaolinite in the samples ranges from 31% to 39% and from 61% to 69% respectively. The corresponding peak and residual frictional angle of the kaolin infill is in the order of about  $23^\circ$  and  $16^\circ$  respectively (Figure 13), based on a previous study (Campbell & Parry, 2002).

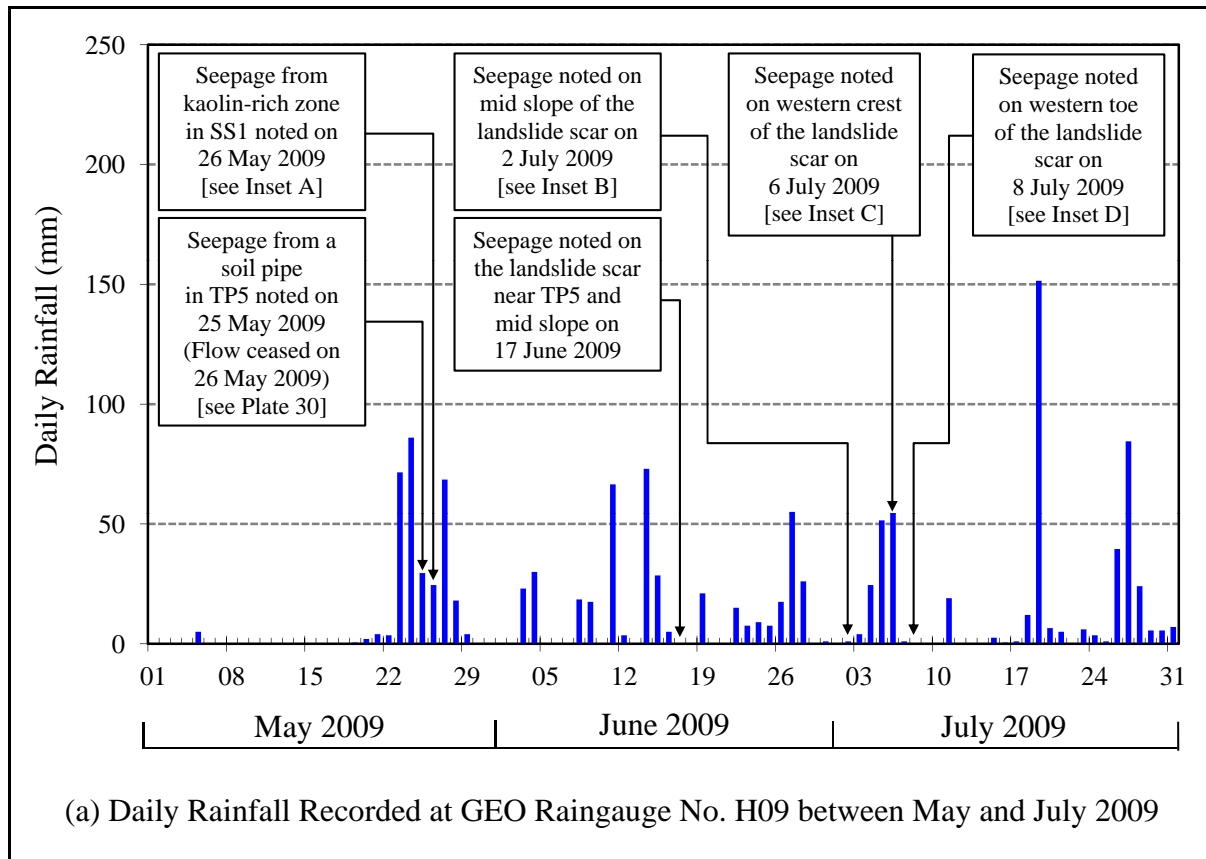
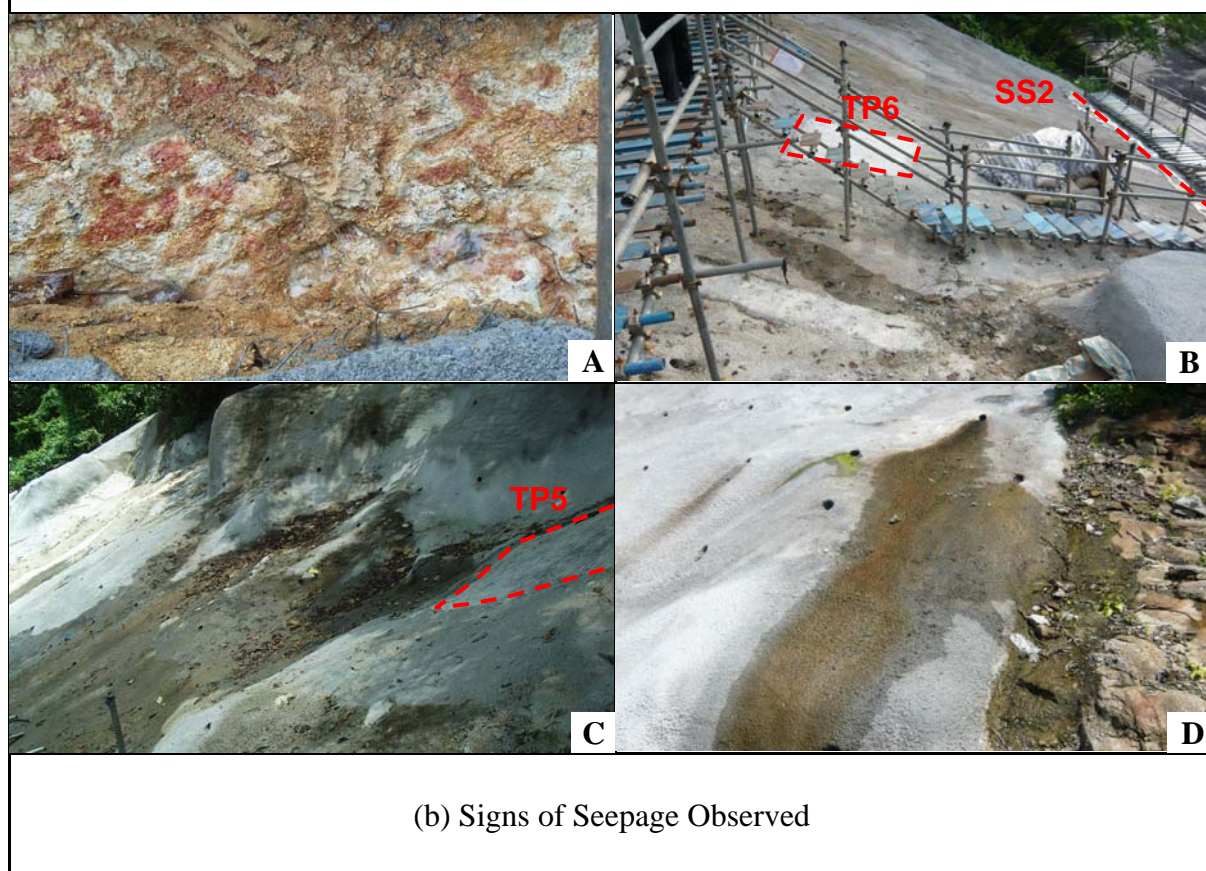
Figure 14 - Signs of Seepage Observed between May and July 2009

- (c) On 25 May 2009 following 157.5 mm of rainfall over the previous two days, heavy seepage from a soil pipe of approximately 12 mm in diameter at the CDG/HDG interface was observed in trial pit No. TP5 (Figure 14 and Plate 30); and
- (d) On 26 May 2009, light to moderate seepage was noted at the kaolin-rich zone within the mottled weathering zone of decomposed granite at slope surface strip No. SS1 (Figure 14).

Moreover, signs of seepage from weepholes and scaffolding supports in the shotcrete cover were noted between November 2008 and November 2009, predominantly over the western flank of the main scarp and the central part of the basal slip plane where the kaolin-rich zone was present (Figure 14 and Plate 31).

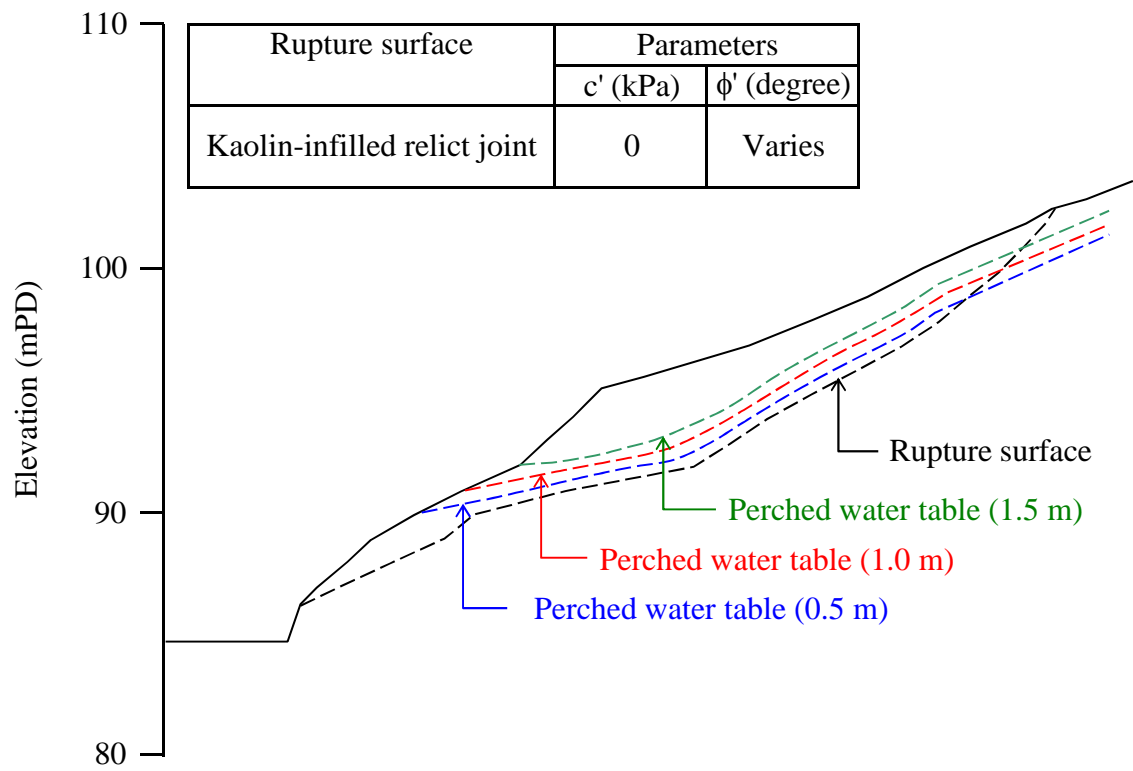
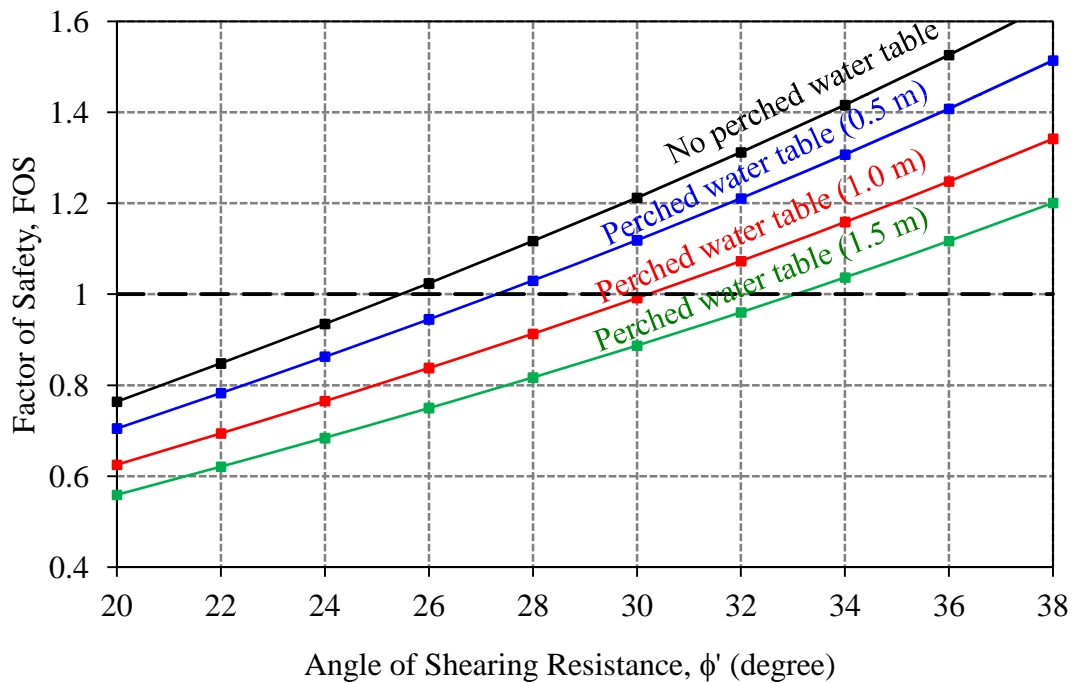
Figure 15 - Summary of Theoretical Stability Analyses

Theoretical stability analyses were carried out to assess the likely range of operational shear strength parameters of the materials along the rupture surface under different perched water levels. The results of the analyses are summarised in Figure 15.

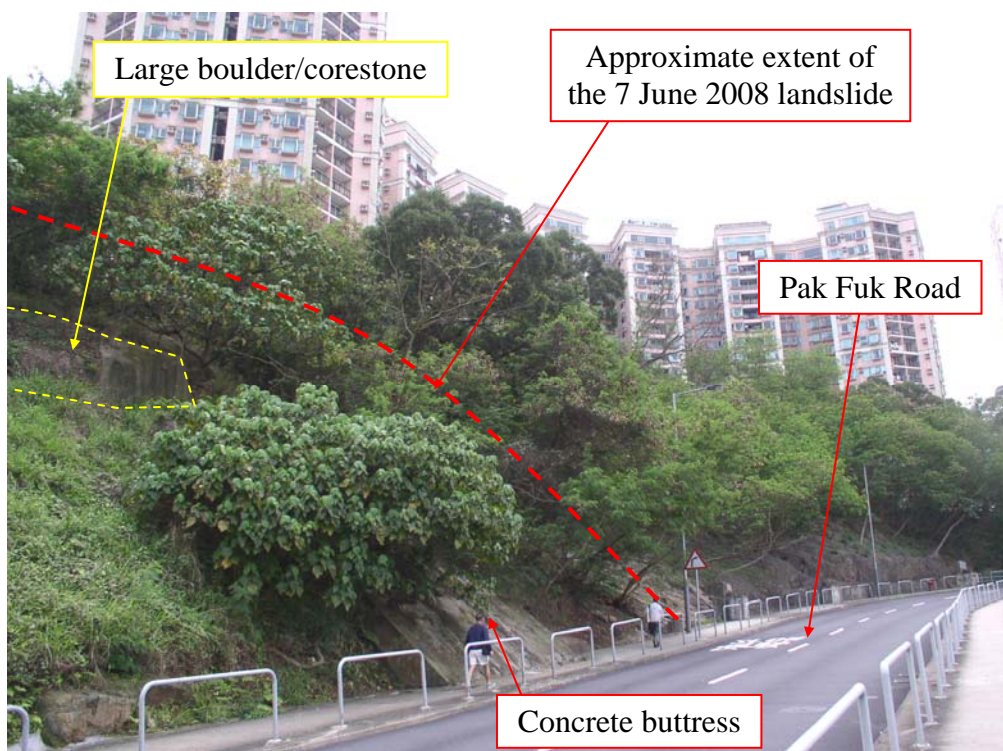
Plate 4 - Eastern Portion of Slope No. 11SE-A/C502 in 2005  
(Photograph taken on 14 April 2005)

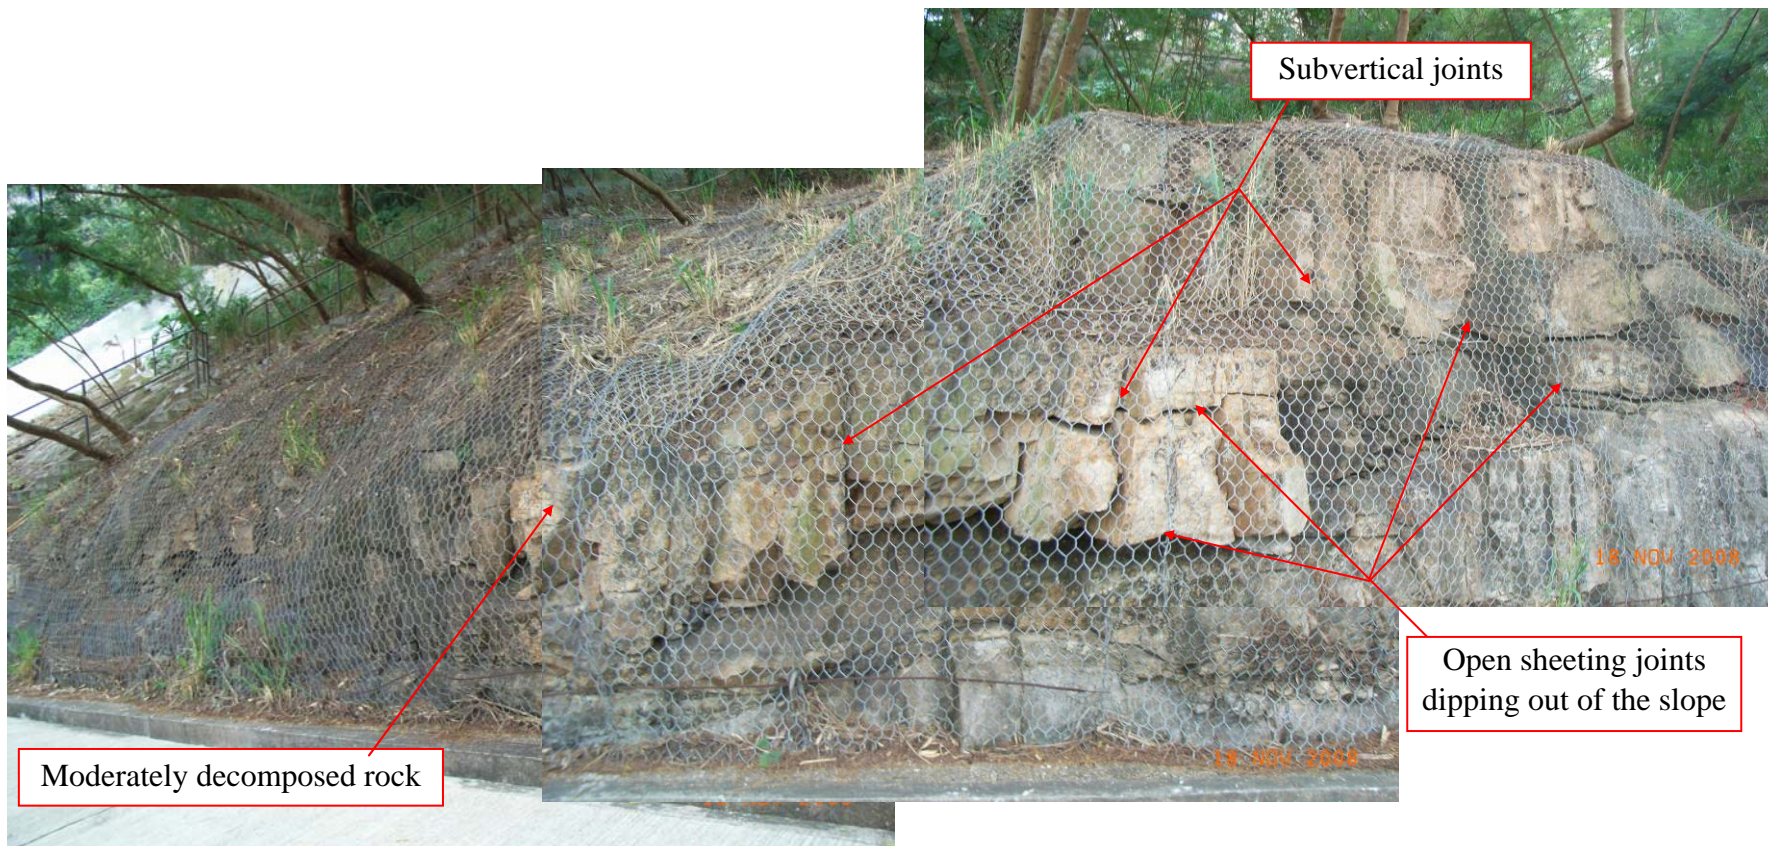
The relict sheeting joints exploited by the basal slip plane were adversely orientated, dipping at 16° to 30° out of the slope with a dip direction of 330° to 010° (Plate 16). Some of the lateral release surfaces exploited subvertical relict joints within the groundmass, dipping at 73° to 90° with a dip direction of 220° to 032°. Similar subhorizontal and subvertical joint sets are also present on the unfailed lower western portion of slope No. 11SE-A/C502 (Plate 5) and on the adjoining slope Nos. 11SE-A/C710 and 11SE-A/C720 (Plate 7). Some of the sheeting joints are open (Plate 5).

Plate 5 - Lower Western Portion of Slope No. 11SE-A/C502  
(Photograph taken on 18 November 2008)

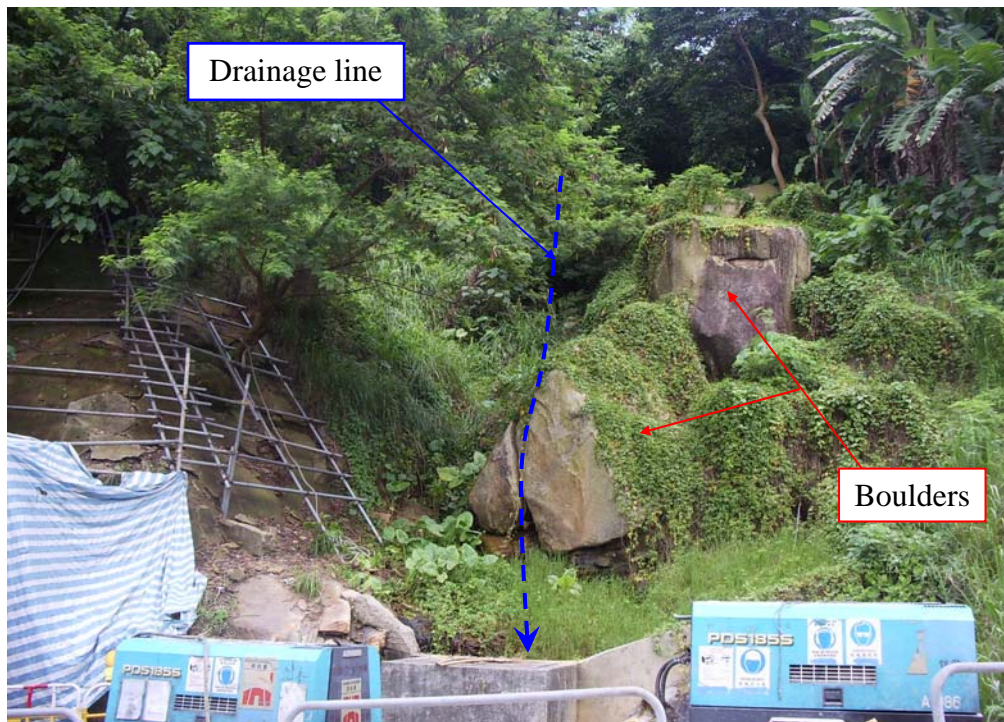
Plate 6 - Intercepted Drainage Line with Large Boulders  
(Photograph taken on 10 June 2008)

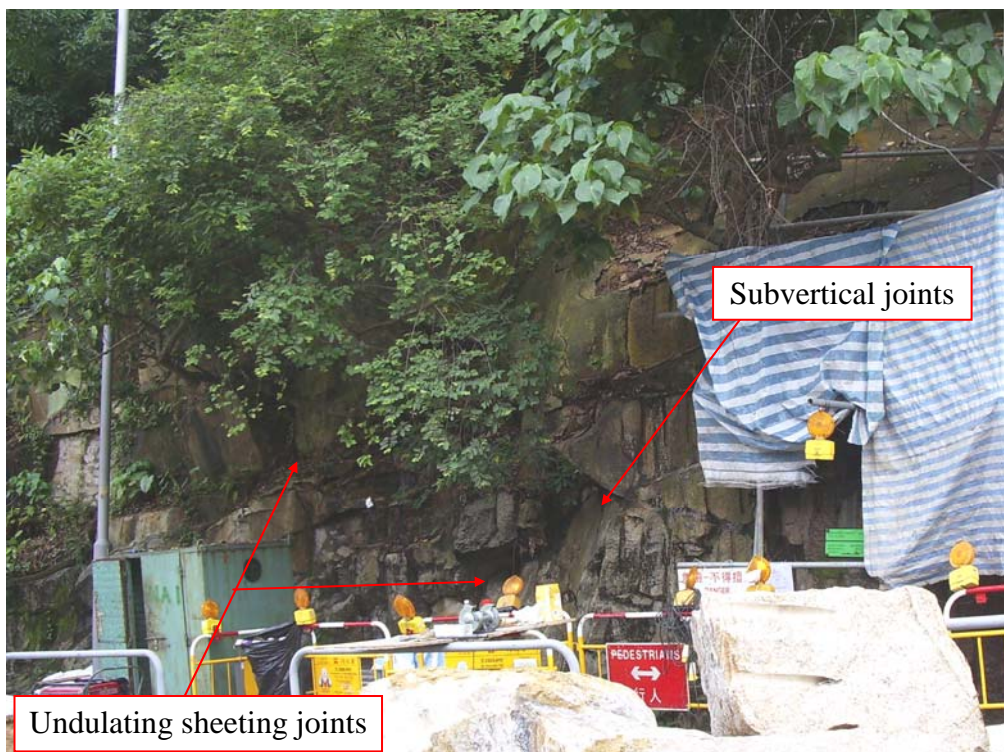
Plate 7 - Rock Outcrop on Slope No. 11SE-A/C710  
(Photograph taken on 10 June 2008)

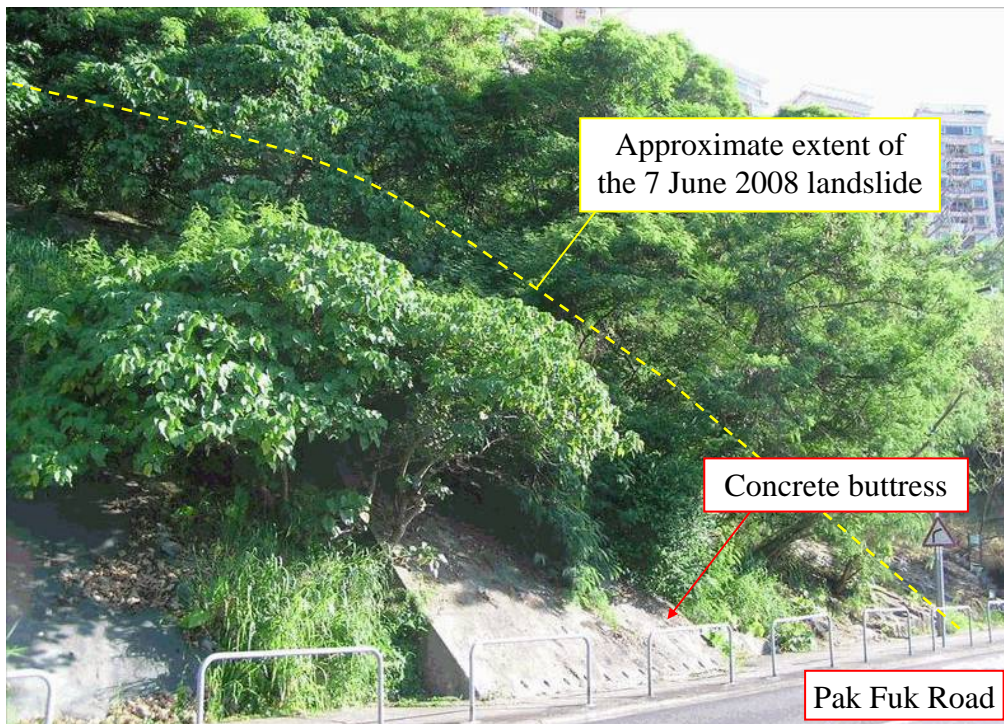
Plate 14 - General View of Slope No. 11SE-A/C502 in 2007  
(Photograph taken during RMI on 23 August 2007)

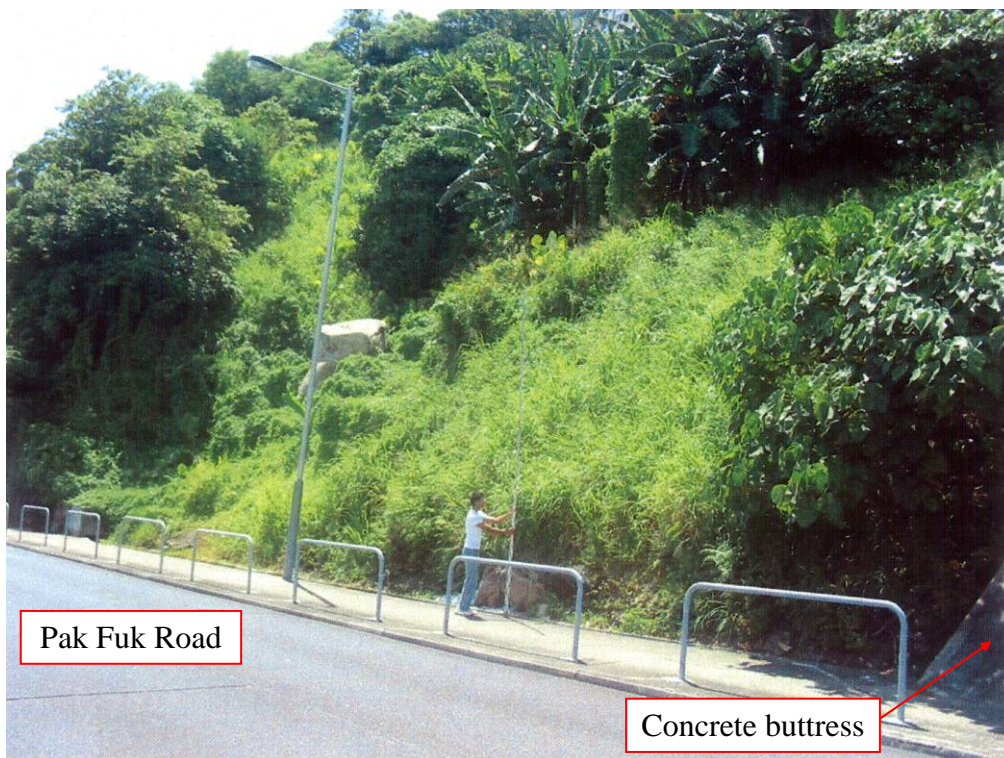
Plate 15 - Eastern Portion of Slope No. 11SE-A/C502 in 2003  
(Photograph taken on 19 July 2003)

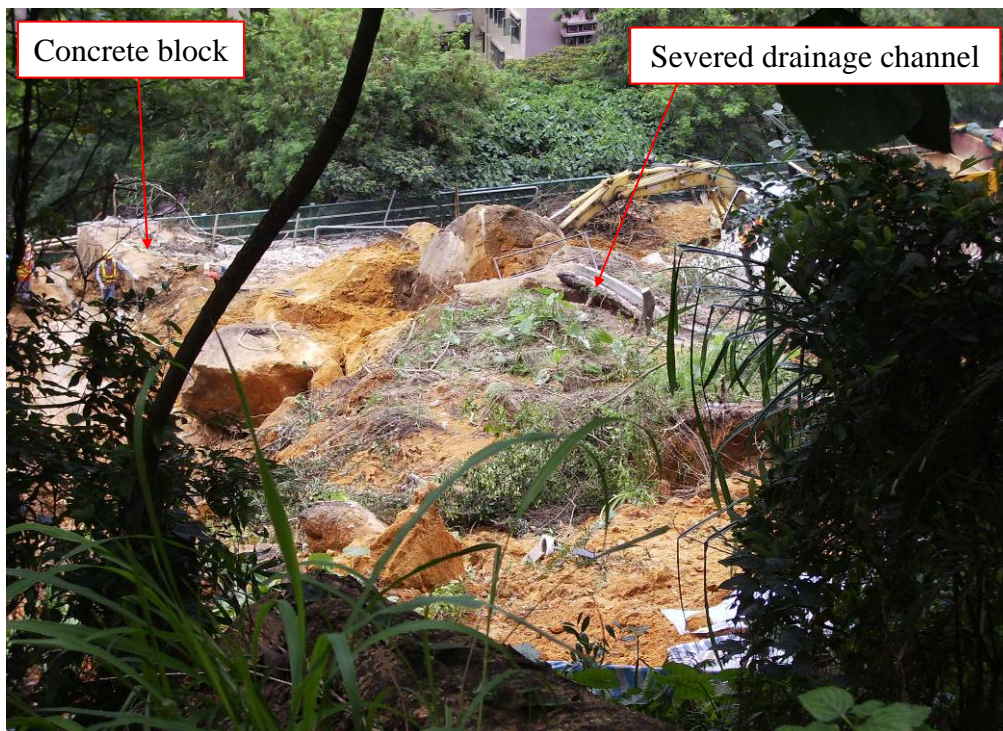
Plate 20 - General View of Landslide Debris from Crest Area  
(Photograph taken on 10 June 2008)
