**REVIEW OF THE
21 AUGUST 2005 LANDSLIDE
INCIDENT ON SLOPES AT THE
SHING MUN CATCHWATER
TSO KUNG TAM
TSUEN WAN**

GEO REPORT No. 291

Halcrow China Limited

**This report is largely based on GEO Landslide Study Report
No. LSR 12/2009 produced in December 2009**

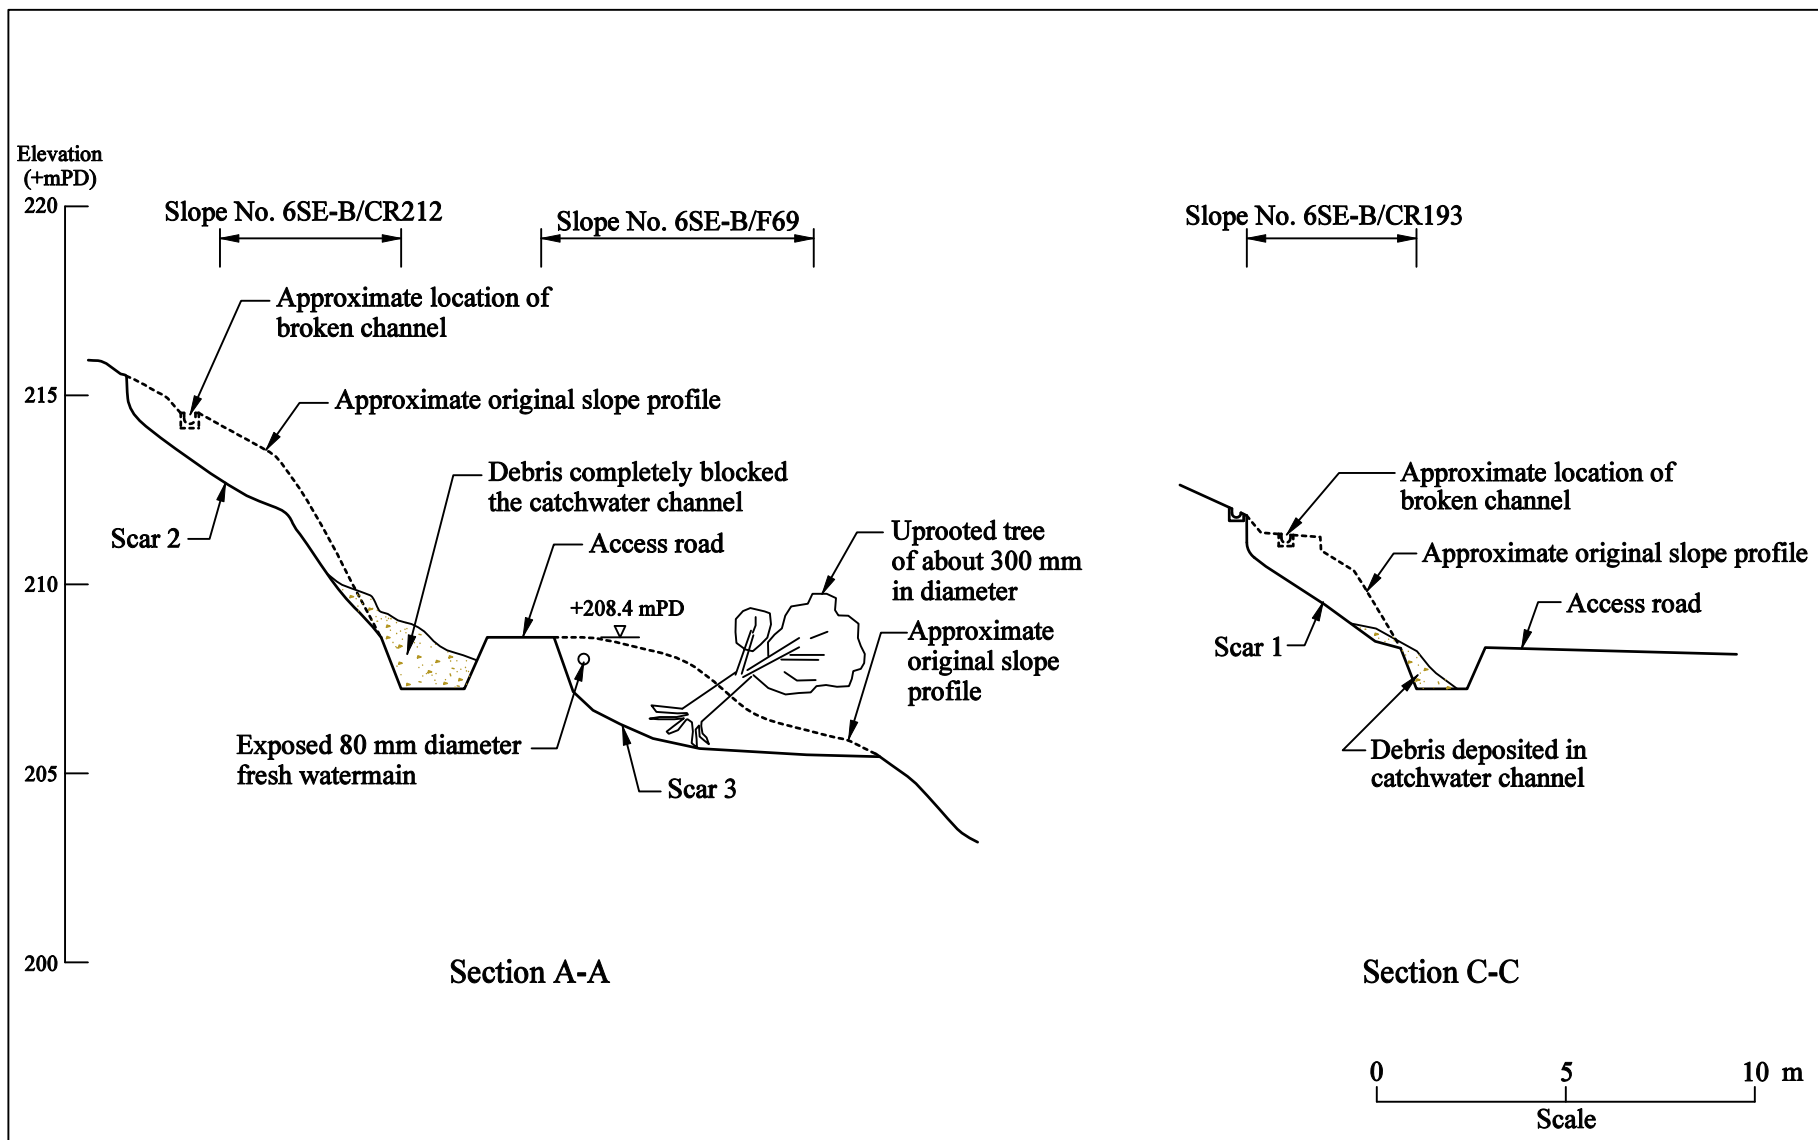
Figure 5 - Sections A-A and C-C through Landslide Scars 1, 2 and 3

The relatively shallow landslides that occurred on the two old, steep soil cut slopes Nos. 6SE-B/CR193 and 6SE-B/CR212 (Scars 1 and 2) were likely triggered by slope saturation and transient build-up of water pressure as a result of infiltration and possible subsurface flow due to water ingress from the drainage lines in the proximity under heavy rainfall (Section 5.1). This would have led to a subsequent reduction in the shear strength of the groundmass. Post-failure site inspection revealed that both failures occurred immediately below the junctions of the slope crest U-channels where there was no provision of catchpits (Figure 2). Overspilling at these particular locations could have occurred during prolonged heavy rainfall, resulting in additional water ingress in the groundmass below.

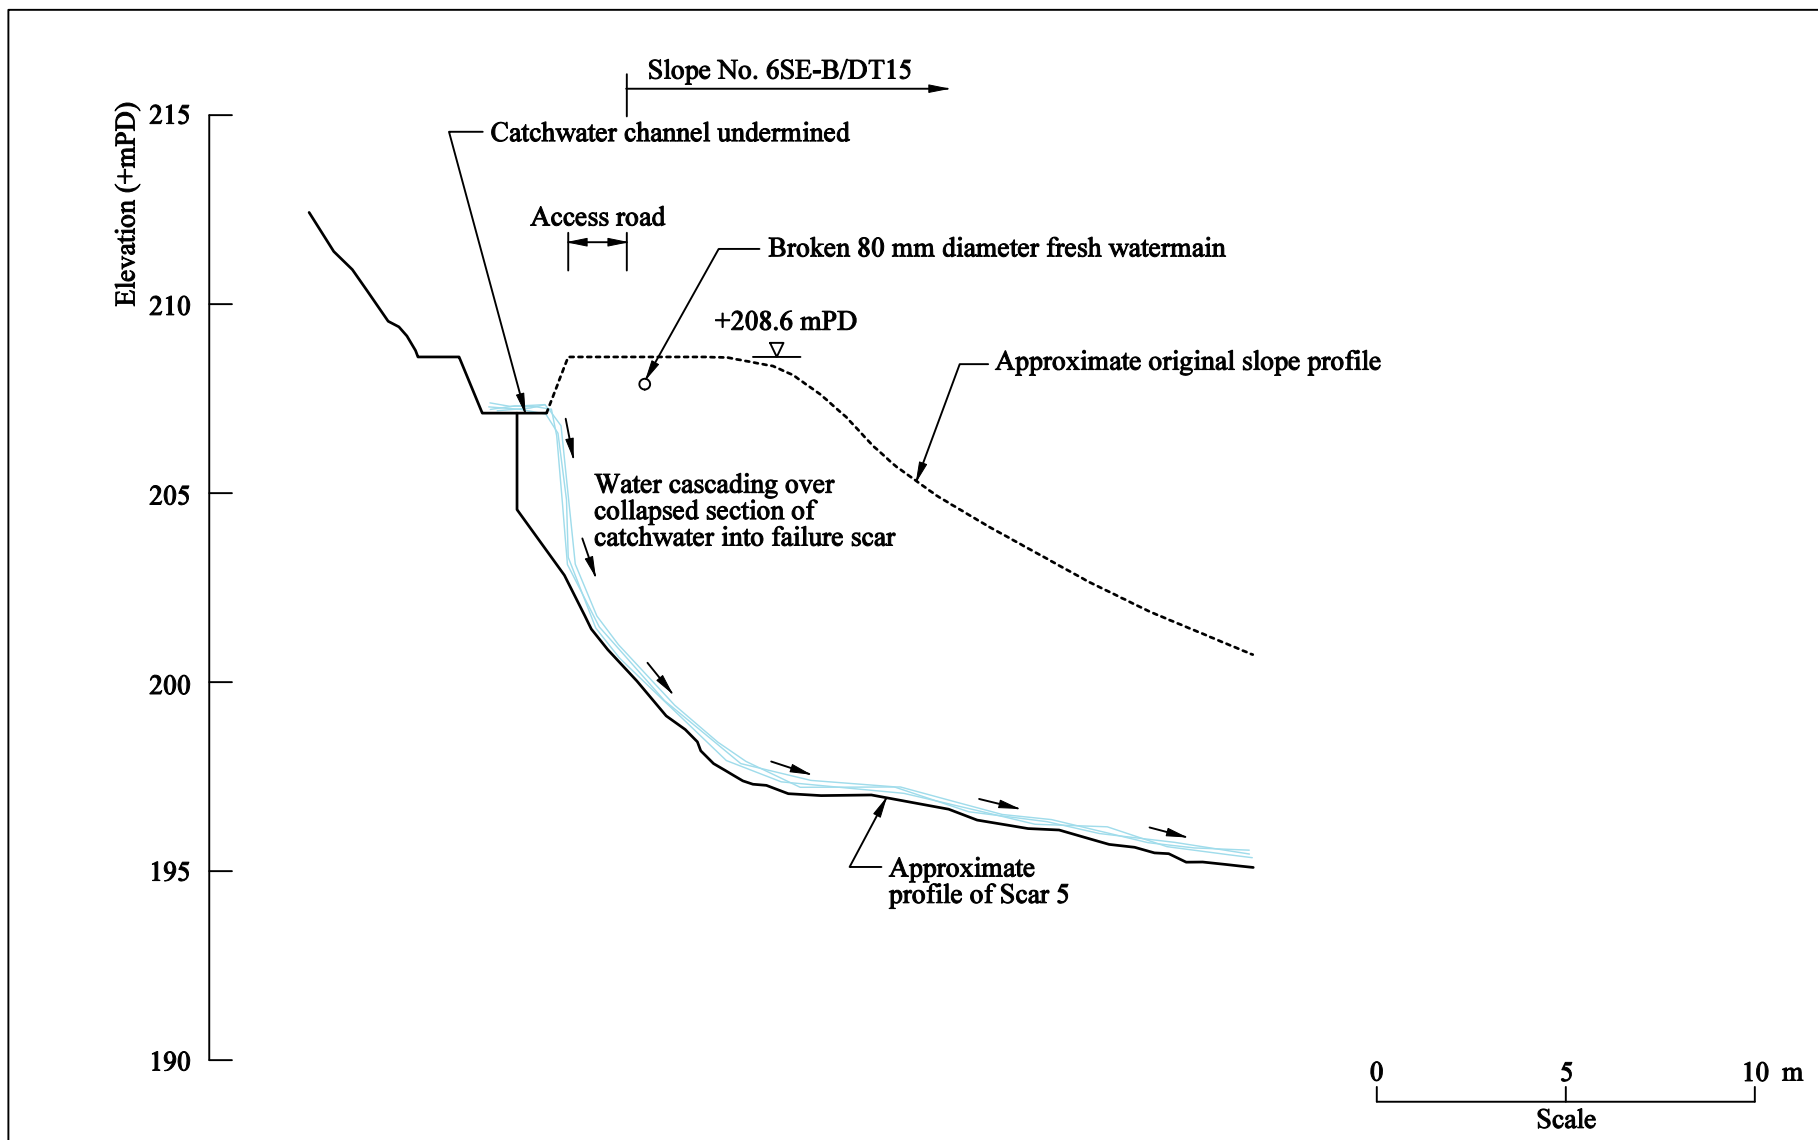
Figure 6 - Section B-B through Landslide Scar 5

Adjacent to the south of the tension crack was the largest landslide scar (Scar 5), which was located at the southern end of slope No. 6SE-B/DT15 (Figure 4). The failure volume was about 900 m³. The base of the scar dipped at about 15° to 20°. The average depth of the main scarp was about 12 m (Figure 6 and Plate 7). A section of about 15 m long catchwater sidewall together with a section of adjoining concrete access road above the back scarp had been washed away (Plate 7). The catchwater channel at this location was also undermined and the scar was flanked by cultivated land near the slope crest (Plates 6 and 8). At the time of inspection, a large quantity of water was still cascading over the collapsed section of the catchwater channel into the failure scar (Plate 8) and most of the debris from the scar had been washed away. A fresh watermain of about 80 mm in diameter (possibly the same as that exposed in Scar 3) was uncovered. The watermain was broken, probably due to the landslide.

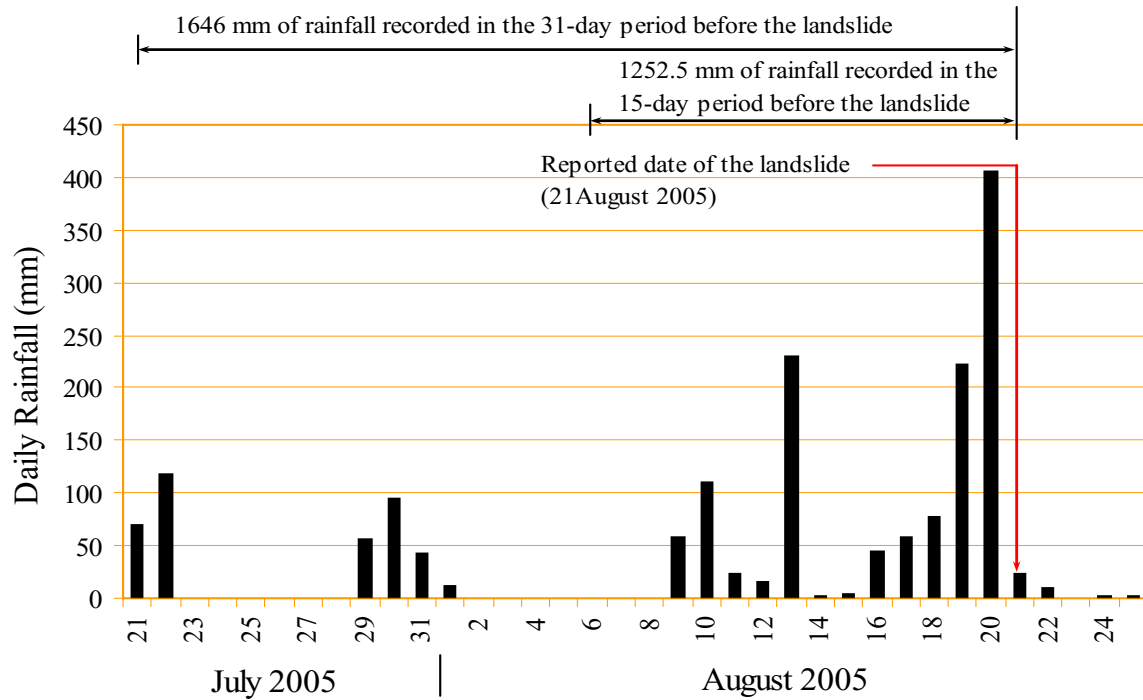
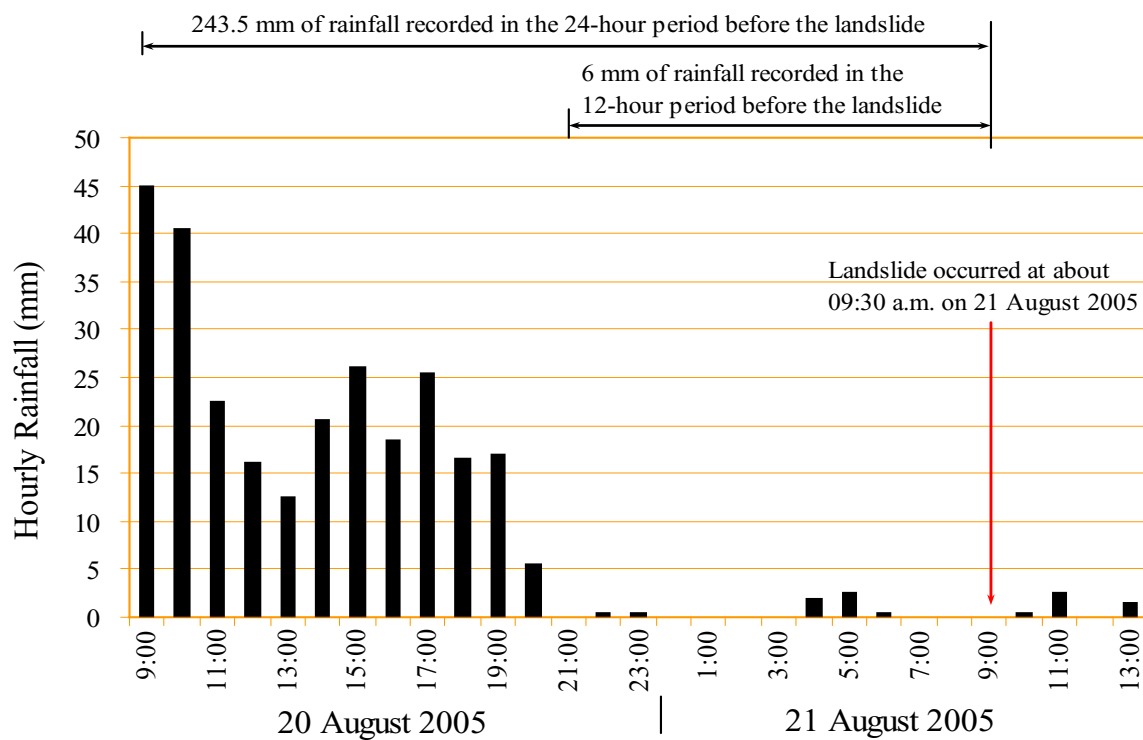
Figure 8 - Daily and Hourly Rainfall Recorded at GEO Raingauge No. N38

The daily rainfall for the period of 31 days before the incident and the hourly rainfall between 20 and 21 August 2005 are presented in Figure 8. Daily rainfall of 405 mm and 22.5 mm of rainfall was recorded on 20 and 21 August 2005 respectively. On the day of the incident, only 5 mm of rainfall was recorded between 4:00 a.m. and 7:00 a.m., some 2.5 hours before the reported time of the landslide.

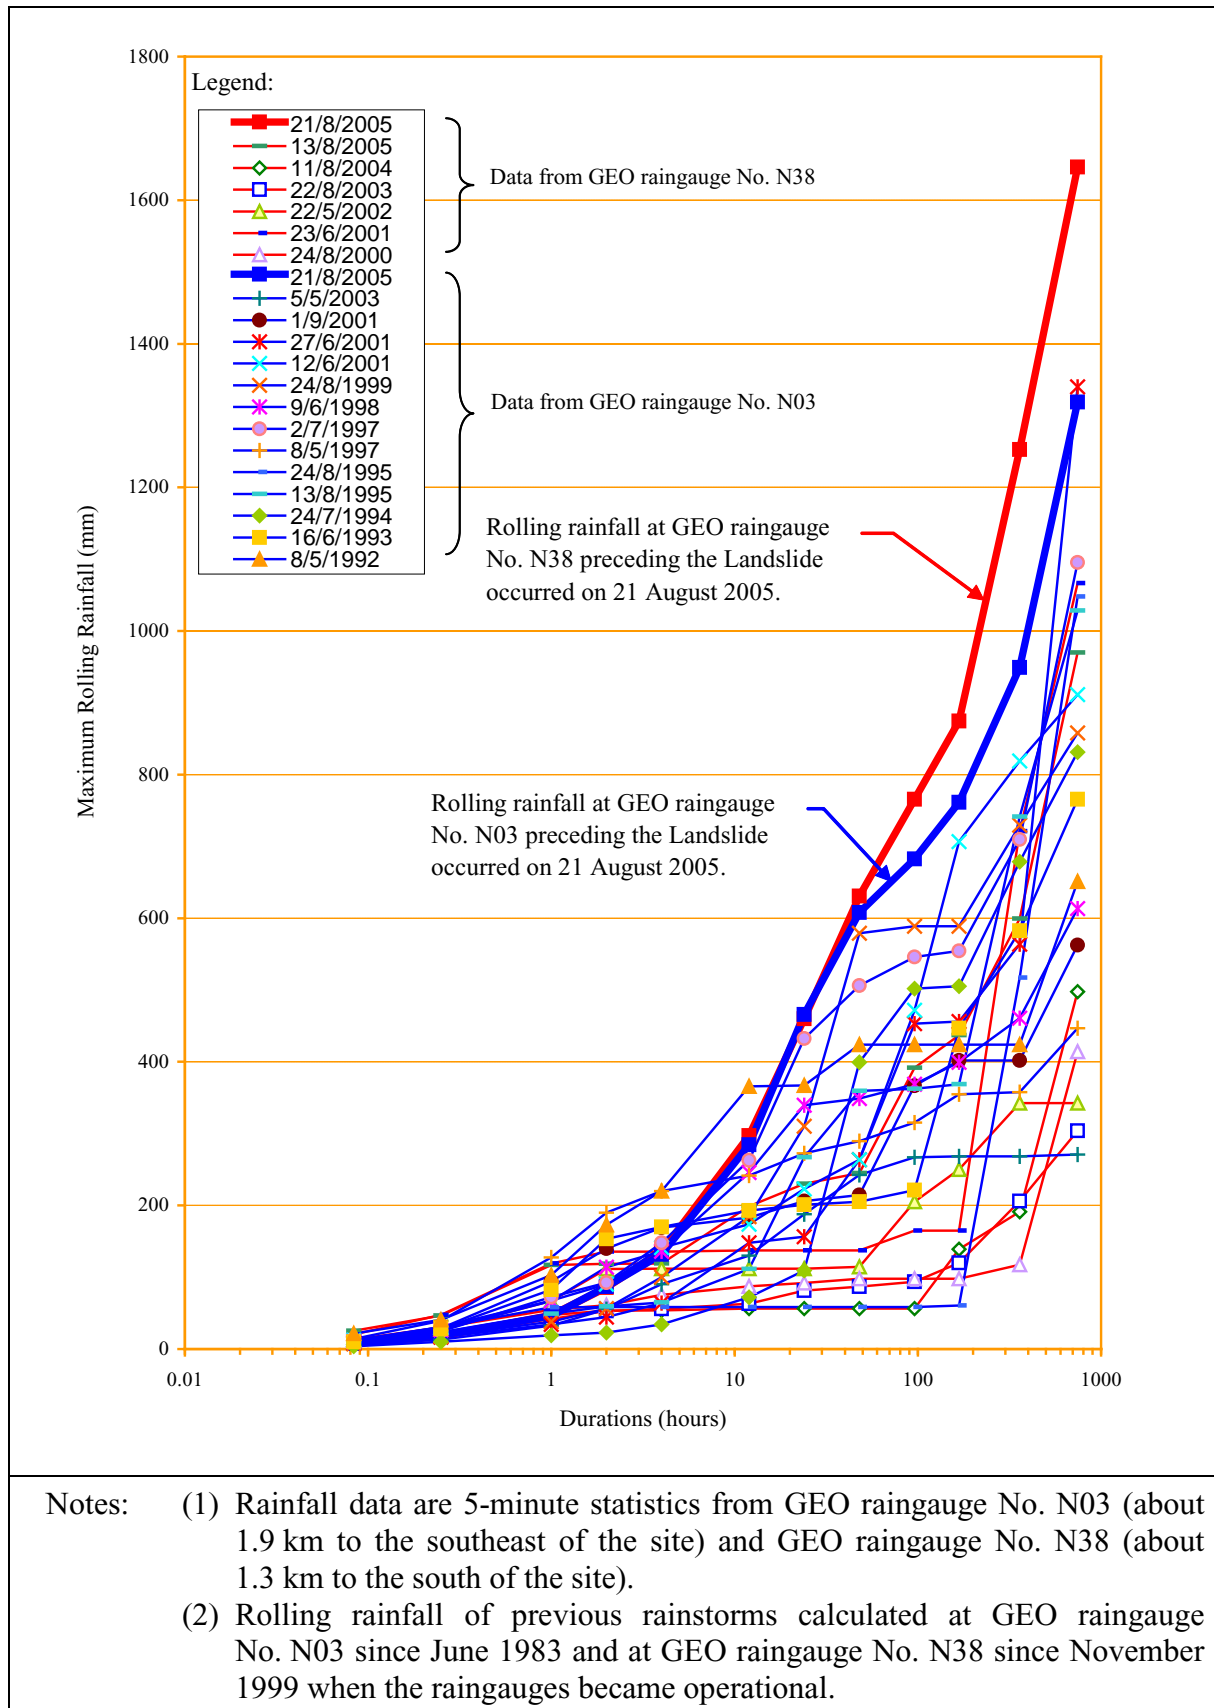
Figure 9 - Maximum Rolling Rainfall for Previous Major Rainstorms at GEO Raingauges Nos. N03 and N38

The maximum rolling rainfall of the 20-21 August 2005 rainstorm has been compared with those of the past major rainstorms recorded by raingauges Nos. N38 and N03 (the next nearest GEO automatic raingauge to the landslide site) between 1992 and 2005 (Figure 9).

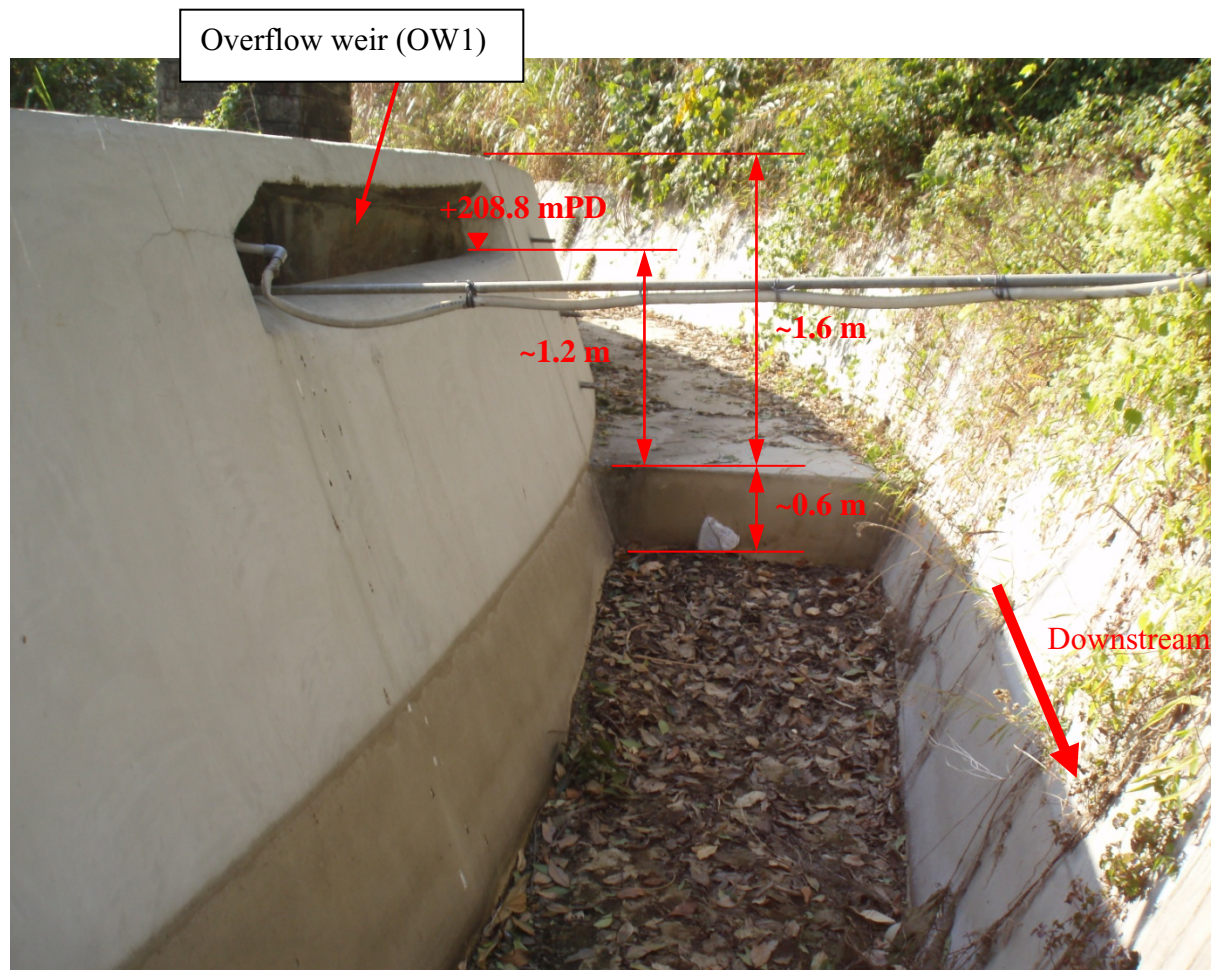
Along the catchwater channel, two overflow weirs were identified in the vicinity of the landslide site (Figure 2). Overflow weir OW1 is located at some 200 m upstream from Scar 2. The invert level of the weir opening was about 1.2 m above the channel bed (Plate 14) at about 208.8 mPD. The concrete access road runs along the catchwater channel from south (upstream) to north (downstream), in the same direction as the water flow in the catchwater channel. According to the as-built records of WSD, the level of the road section along the crest of slope No. 6SE-B/F69 ranged from about 208.4 mPD to 208.6 mPD, i.e. lower than the invert of the overflow weir OW1.

Plate 14 - Overflow Weir (OW1) at Upstream of the Landslide Site (Photograph taken on 28 November 2007 by HCL)
