**DETAILED STUDY OF
THE 15 SEPTEMBER 2006
DISTRESS ABOVE
SLOPE NO. 6NE-B/C44 AT
33A2 SHEK TONG TSUEN,
TA SHEK WU, PAT HEUNG**

GEO REPORT No. 293

AECOM Asia Company Limited

**GEOTECHNICAL ENGINEERING OFFICE
CIVIL ENGINEERING AND DEVELOPMENT DEPARTMENT
THE GOVERNMENT OF THE HONG KONG
SPECIAL ADMINISTRATIVE REGION**

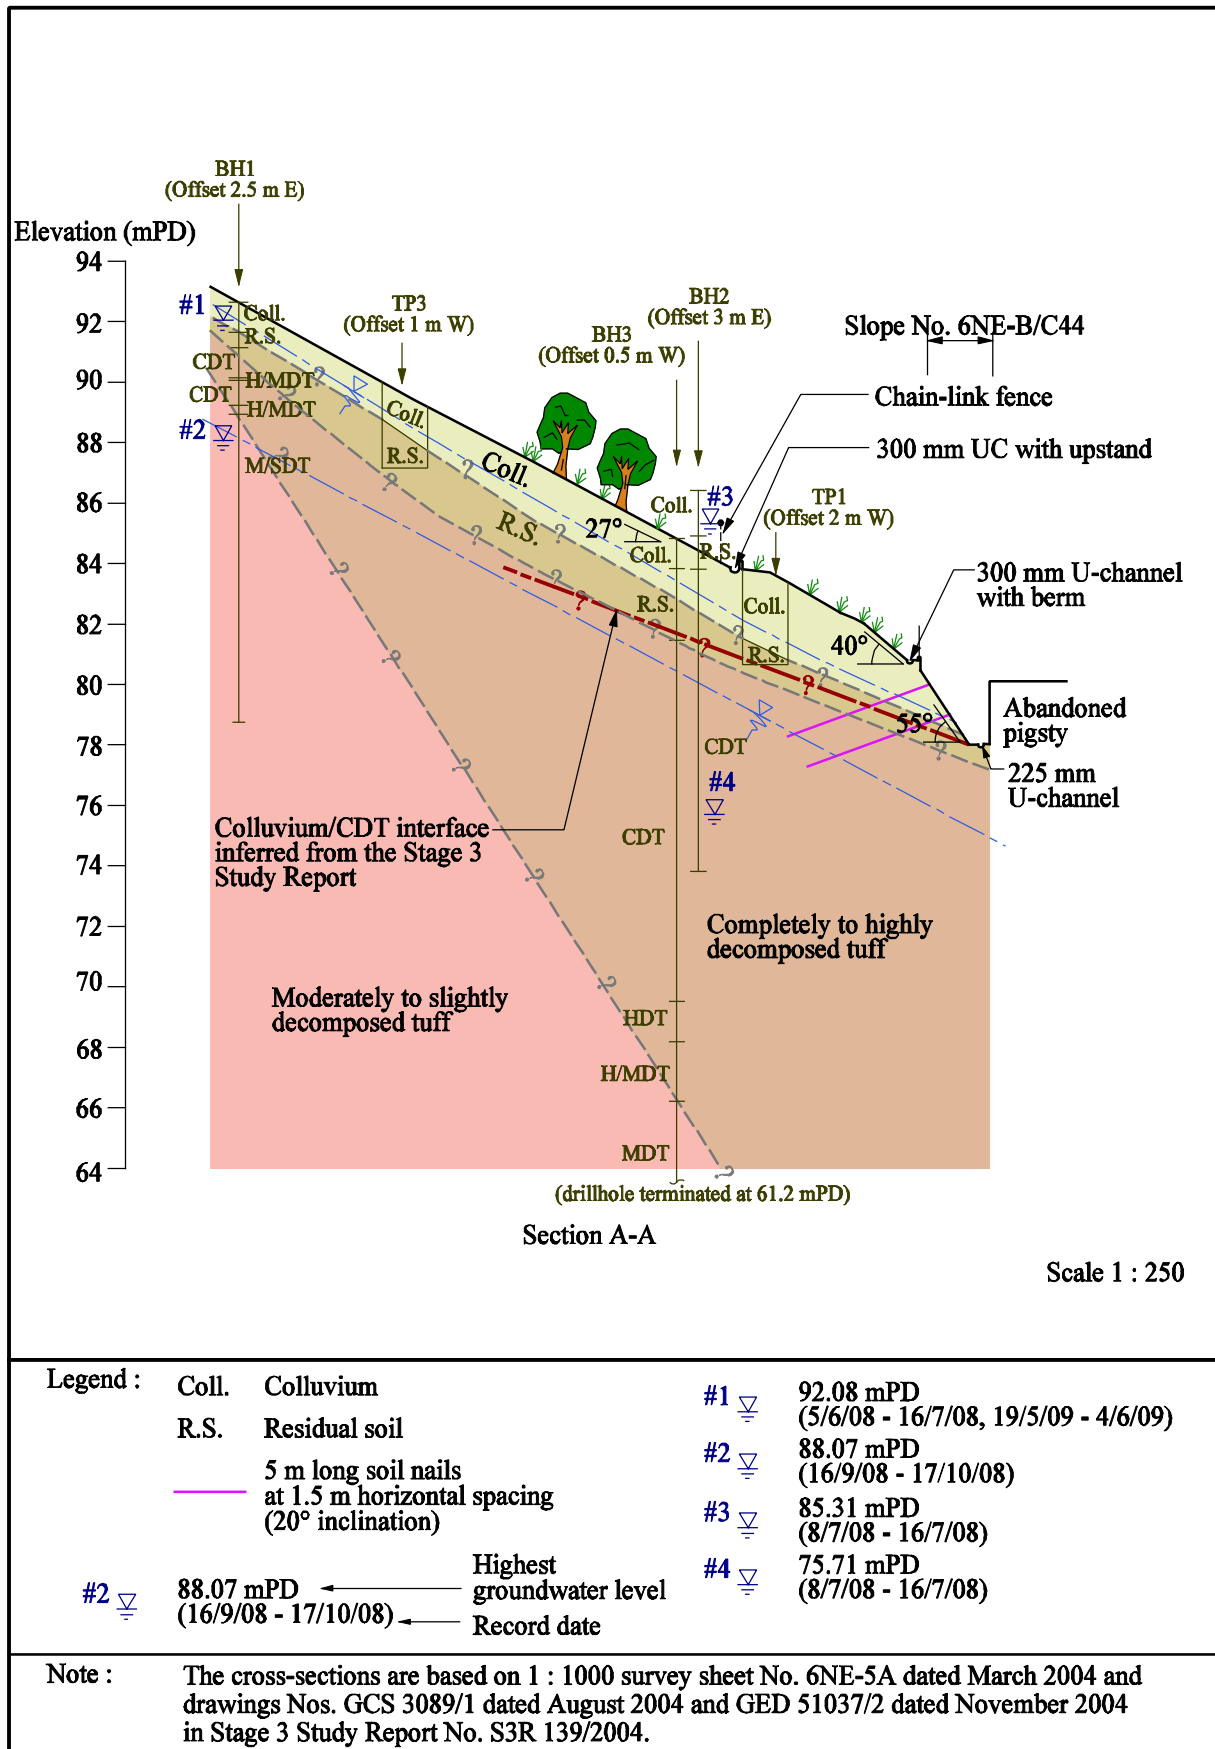
Figure 3 - Cross-Section A-A

Figure 3 shows the groundwater monitoring records in BH1 and BH2. Groundwater levels were recorded on a daily basis for about a week in December 2007 at drillholes Nos. BH1 and BH2, which were sunk as part of the ground investigation for this study. In BH1, a piezometer and a standpipe with buckets were installed at 2.9 m (within the CDT) and 12.6 m depths (within the weathered rock) respectively. Piezometers were installed at 2.0 m and 12.1 m depths in BH2 respectively. All the piezometers and standpipe remained dry during the monitoring period between 16 October and 27 October 2007, except for the lower piezometer at BH2, which recorded a groundwater level of about 11.2 to 11.3 m below ground.

16 July 2008, during which a Black Rainstorm Warning was issued on 7 June 2008. The same piezometer also recorded a groundwater level of 0.61 m below ground between 19 May and 4 June 2009, during which a Red Rainstorm Warning was issued on 4 June 2009. The monitoring results indicated the presence of a perched groundwater table within the colluvium. The buckets of the lower standpipe at BH1 recorded a maximum groundwater level of 4.5 m below ground between 16 September and 17 October 2008. Maximum groundwater levels of 1.1 m and 10.7 m below ground were recorded by the upper and lower piezometers at BH2 respectively, between 8 and 16 July 2008 (Figure 3).

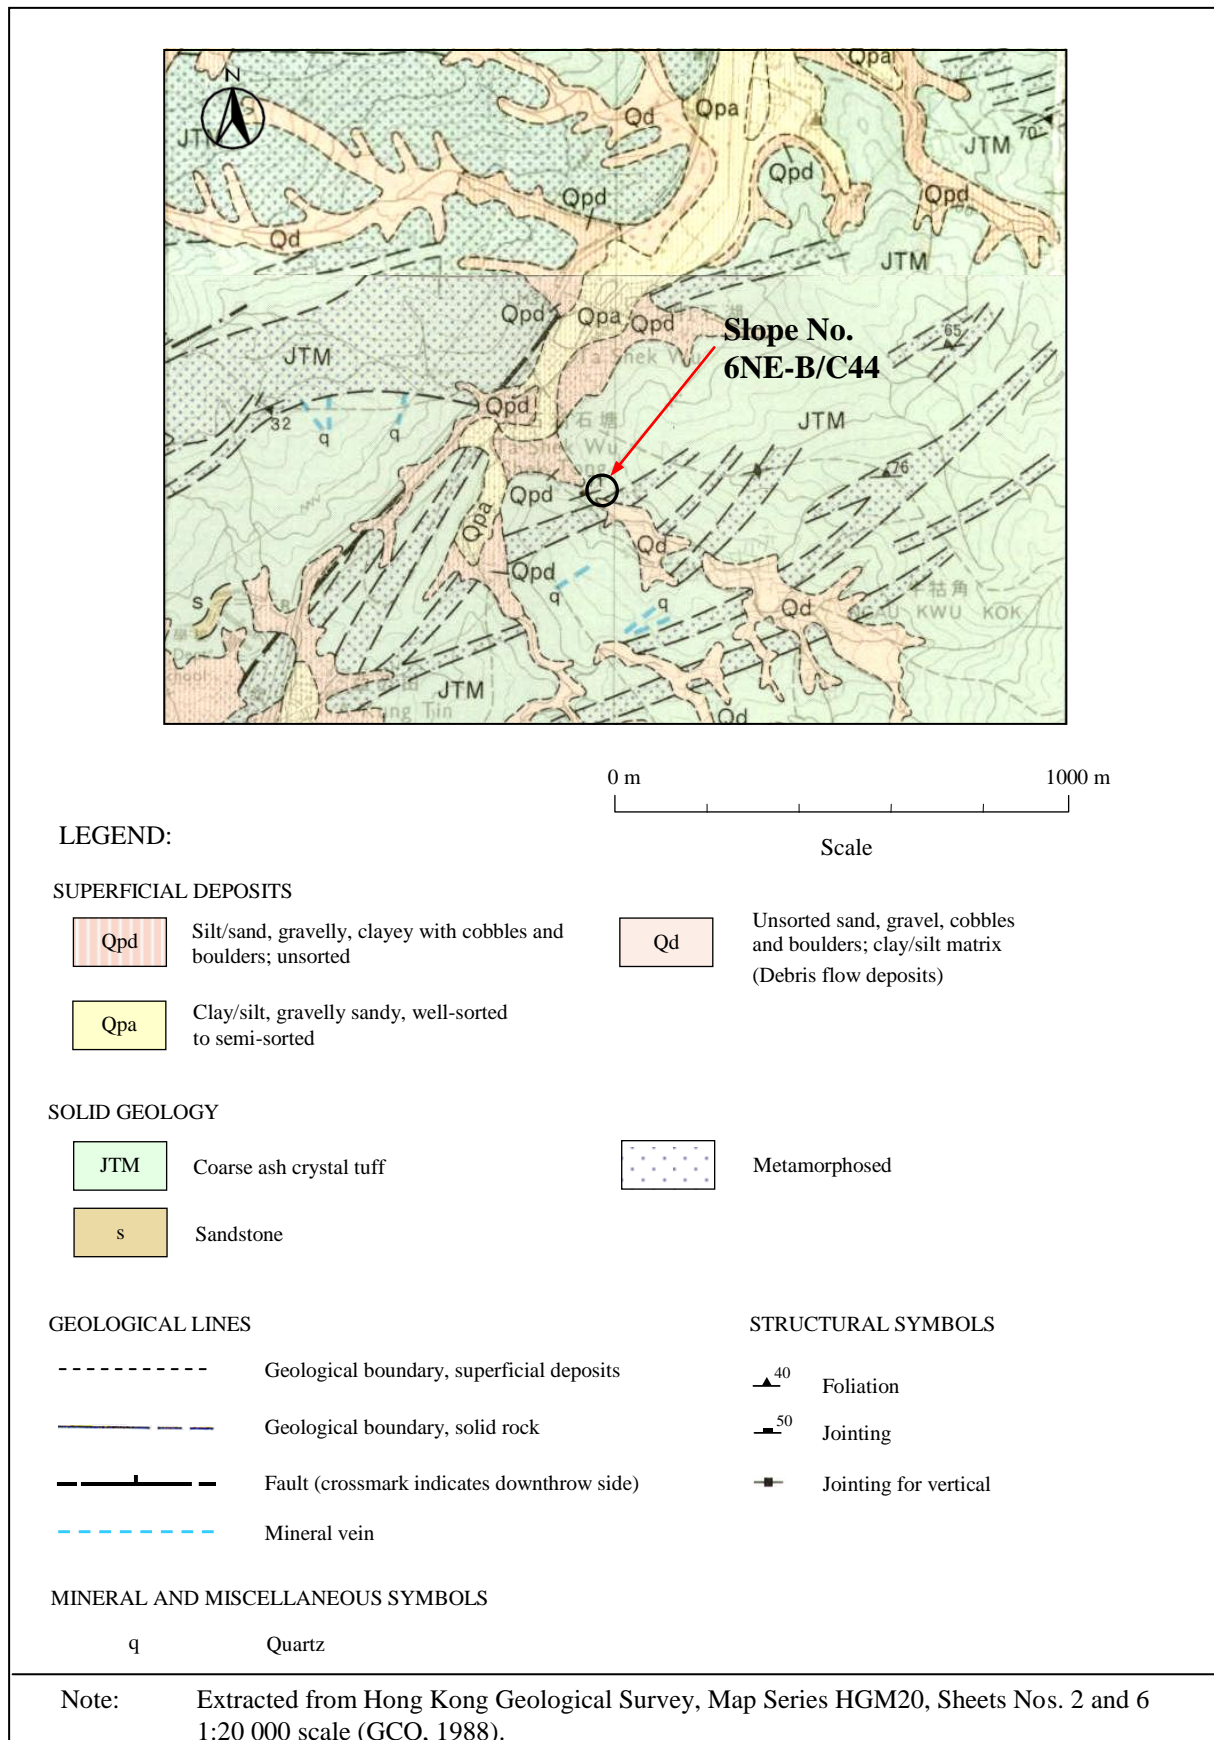
Figure 4 - Regional Geology

Based on the Hong Kong Geological Survey 1:20,000 Solid and Superficial Geology Map Sheet 6 – Yuen Long (GCO, 1986), several metamorphosed tuff bands are indicated within the study area, with one band traversing the upper part of the ground immediately above the subject cut slope (Figure 4). The metamorphism is probably represented by foliation although there is no indication of the orientation in the immediate vicinity.

Pleistocene debris flow deposits are shown in the valley immediately below (to the northwest) the cut slope (Figure 4), on which the larger cultivation terraces have been formed as identified from API (Figure 5). Most of these deposits are likely to have been sourced from the larger hills across the valley to the northeast. The colluvium present at or near the cut slope is possibly 'older' Pleistocene colluvium and some relatively thin recent Holocene colluvium derived locally from relict instability within the catchment.

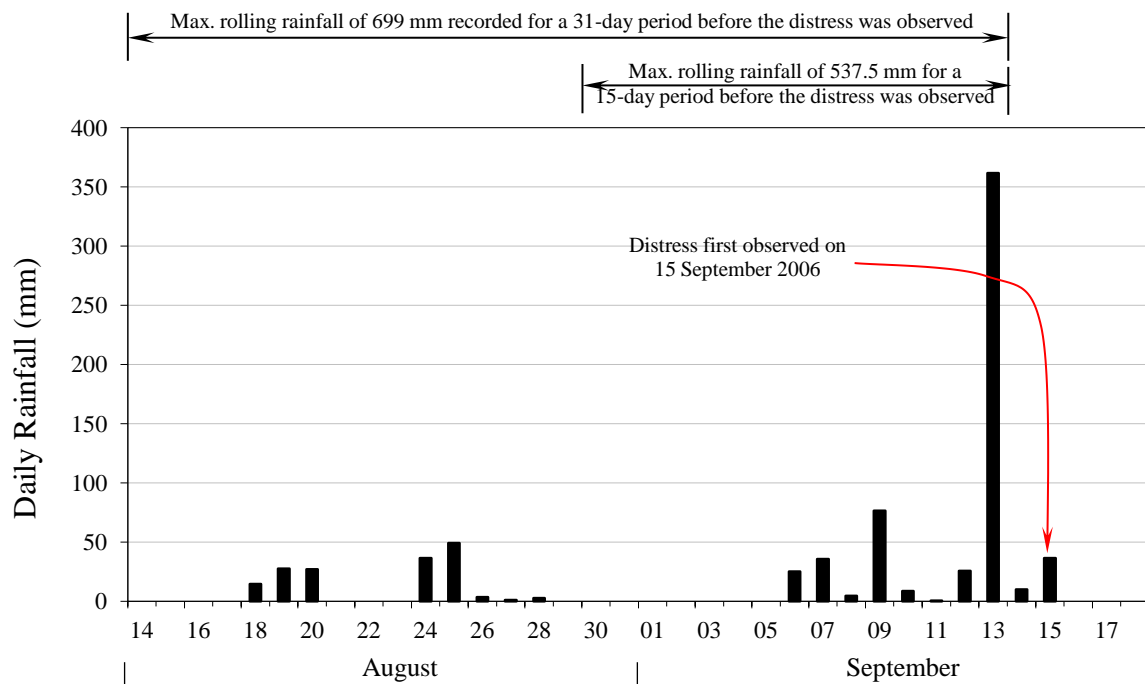
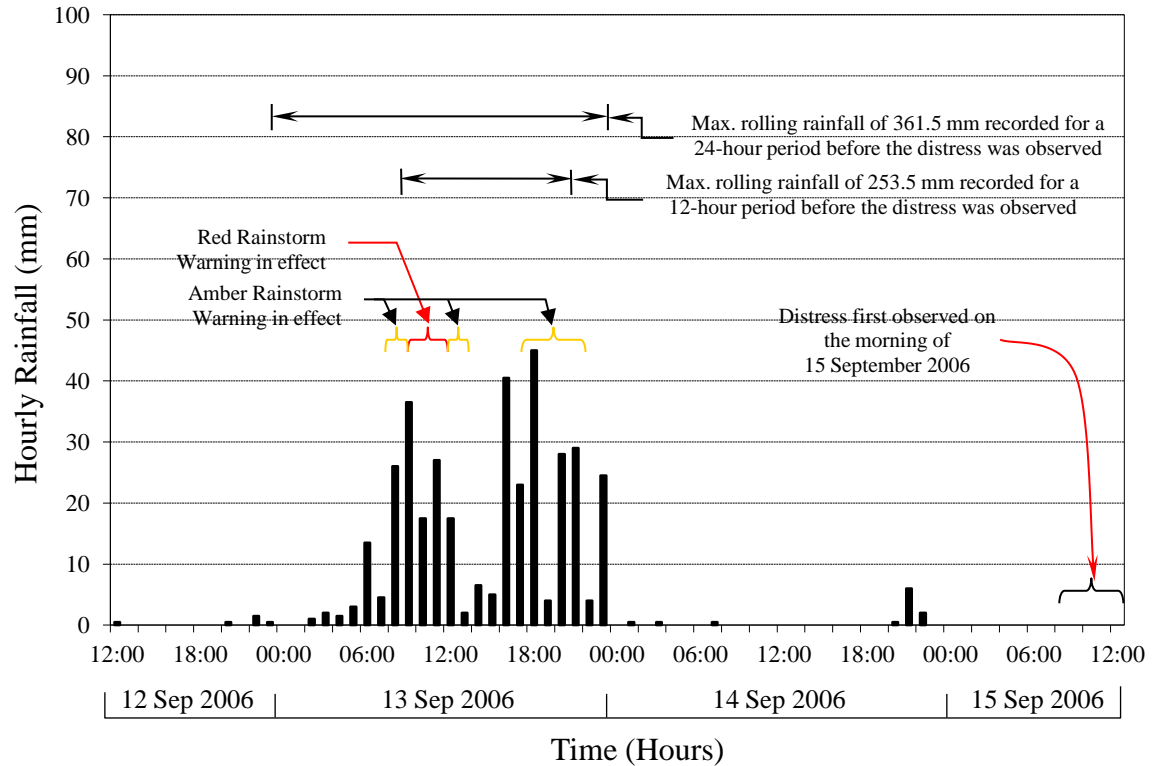
Figure 8 - Daily and Hourly Rainfall Recorded at GEO Raingauge No. N36

Rainfall data were obtained from the nearest GEO automatic raingauge No. N36, which is located about 3.4 km to the southeast of the September 2006 distressed areas, at Kadoorie Agricultural Research Centre, Lam Kam Road, Shek Kong (Figure 1). The raingauge records and transmits rainfall data at 5-minute intervals to the GEO and the Hong Kong Observatory (HKO). The daily rainfall recorded by raingauge No. N36 over the month preceding the observation of the slope distress, together with the hourly rainfall readings for the period between 12 September and 15 September 2006, are presented in Figure 8. Records from another nearby GEO automatic raingauge No. N05, which is about 4.5 km to the east of the September 2006 distress, were also examined. The pattern of rainfall recorded at this raingauge was broadly similar to that recorded at raingauge No. N36.

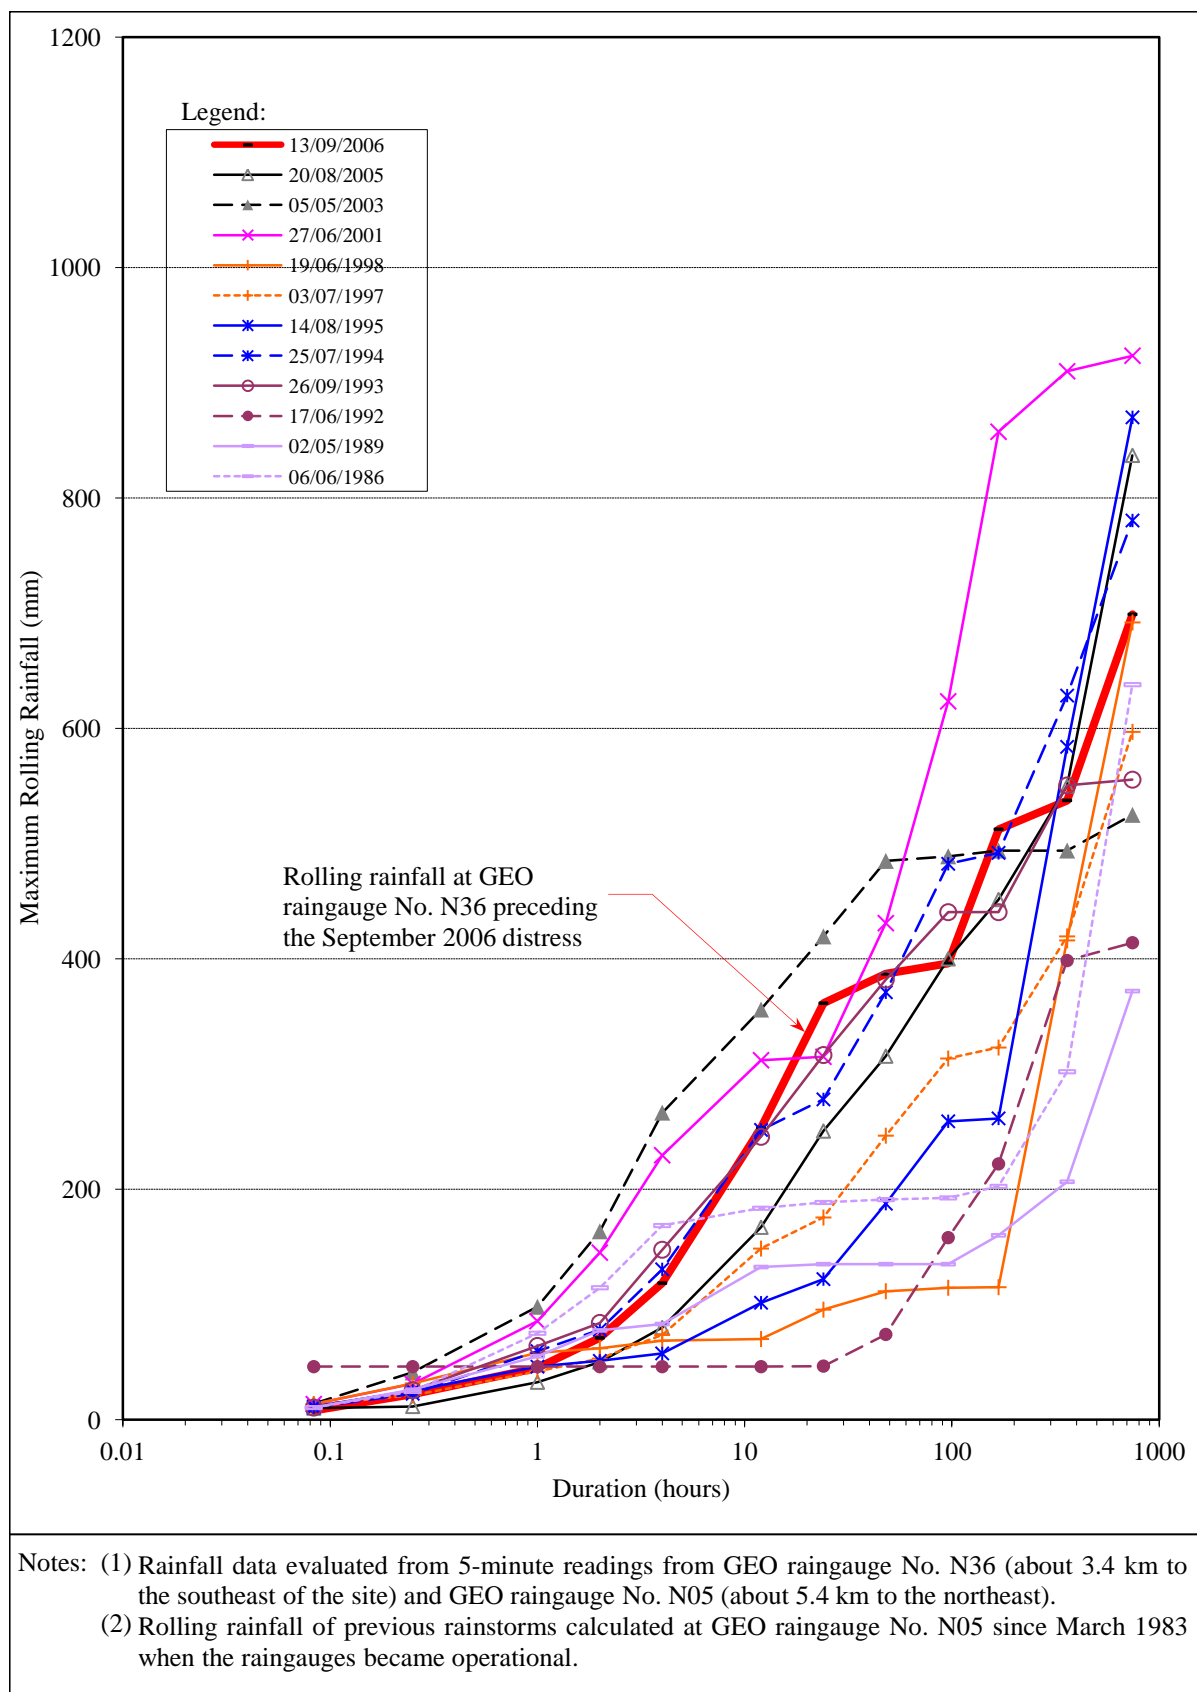
Figure 9a - Maximum Rolling Rainfall for Previous Major Rainstorms at GEO Raingauge No. N05

The maximum rolling rainfall for the 13 September 2006 rainstorm has been compared with the past significant rainstorms recorded by raingauge No. N05 between 1986 and 2005 (Figure 9a), and by raingauge No. N36 between 2000 and 2005 (Figure 9b). Although the 13 September 2006 rainstorm was not the most severe when compared with the previous major rainstorms, the long-duration intensity of the rainfall was on the high side.

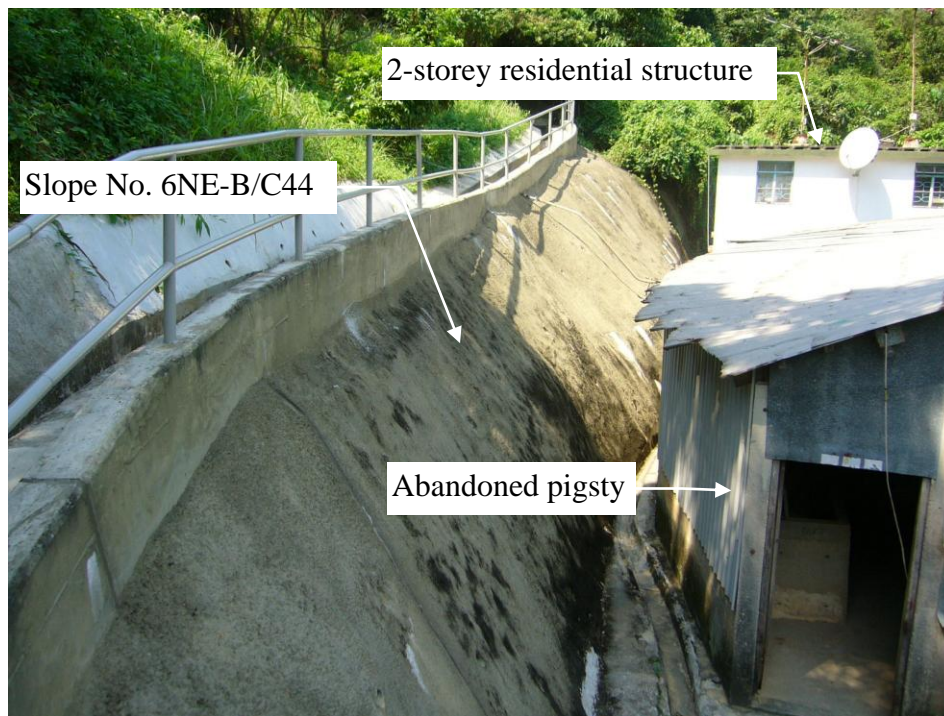
Plate 1 - General View of Eastern Portion of Slope No. 6NE-B/C44 Looking West
(Photograph taken on 26 September 2006)

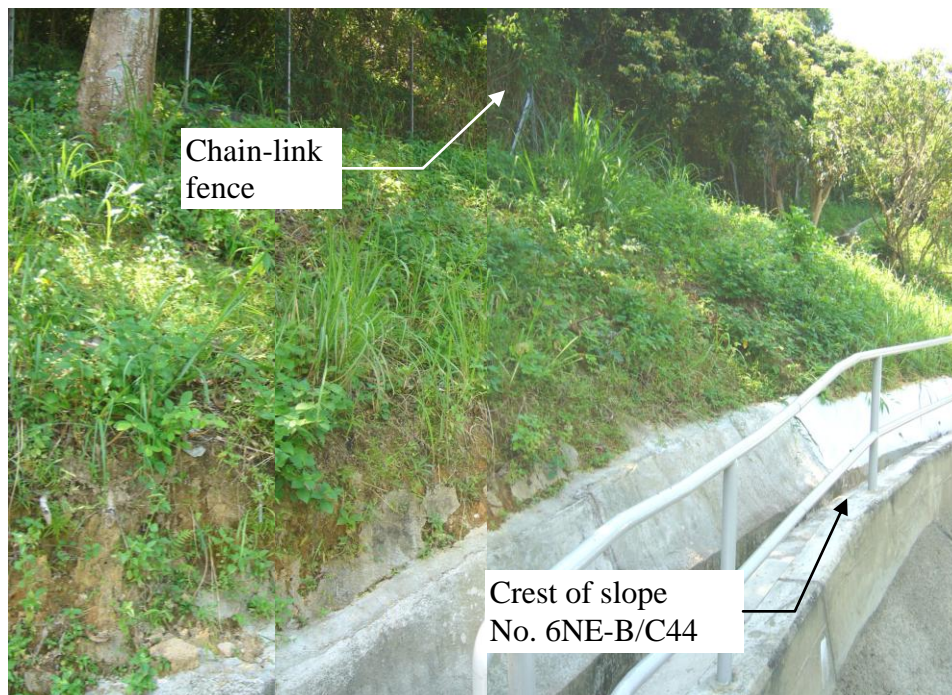
Plate 2 - General View of Area above Eastern Portion of
Slope No. 6NE-B/C44 Looking West
(Photograph taken on 26 September 2006)

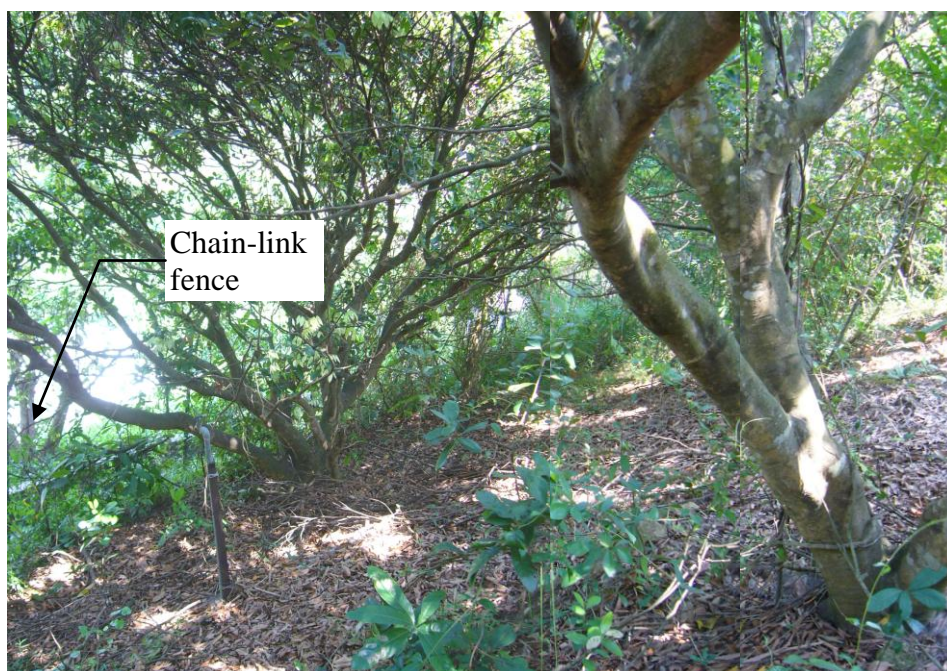
Plate 3 - General View of Area above Eastern Portion of
Slope No. 6NE-B/C44 Looking Northeast
(Photograph taken on 26 September 2006)

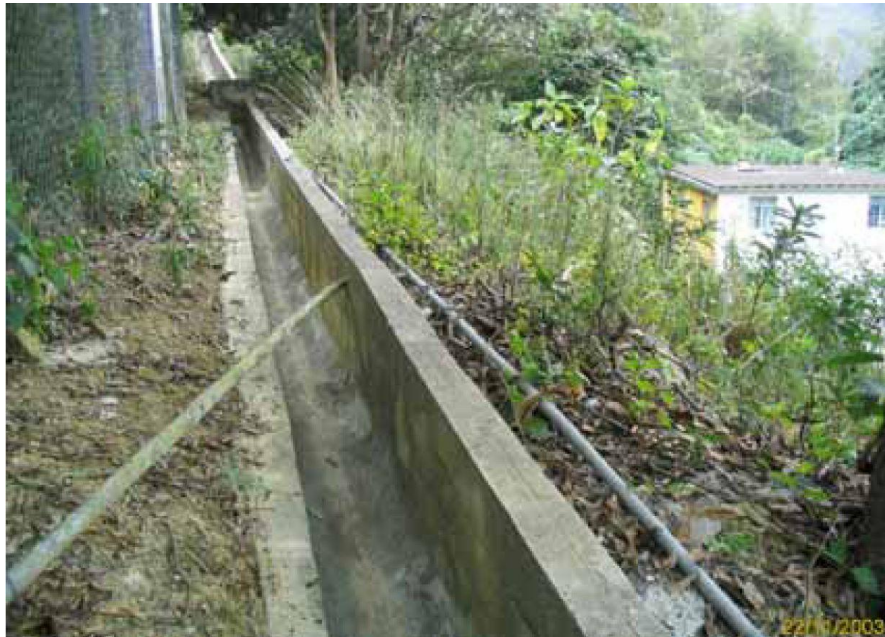
Plate 9 - Upper 300 mm U-channel near the Eastern End of Slope No. 6NE-B/C44 Looking West Showing Its Straight Alignment in 2003
(Photograph taken by OAP on 22 November 2003)

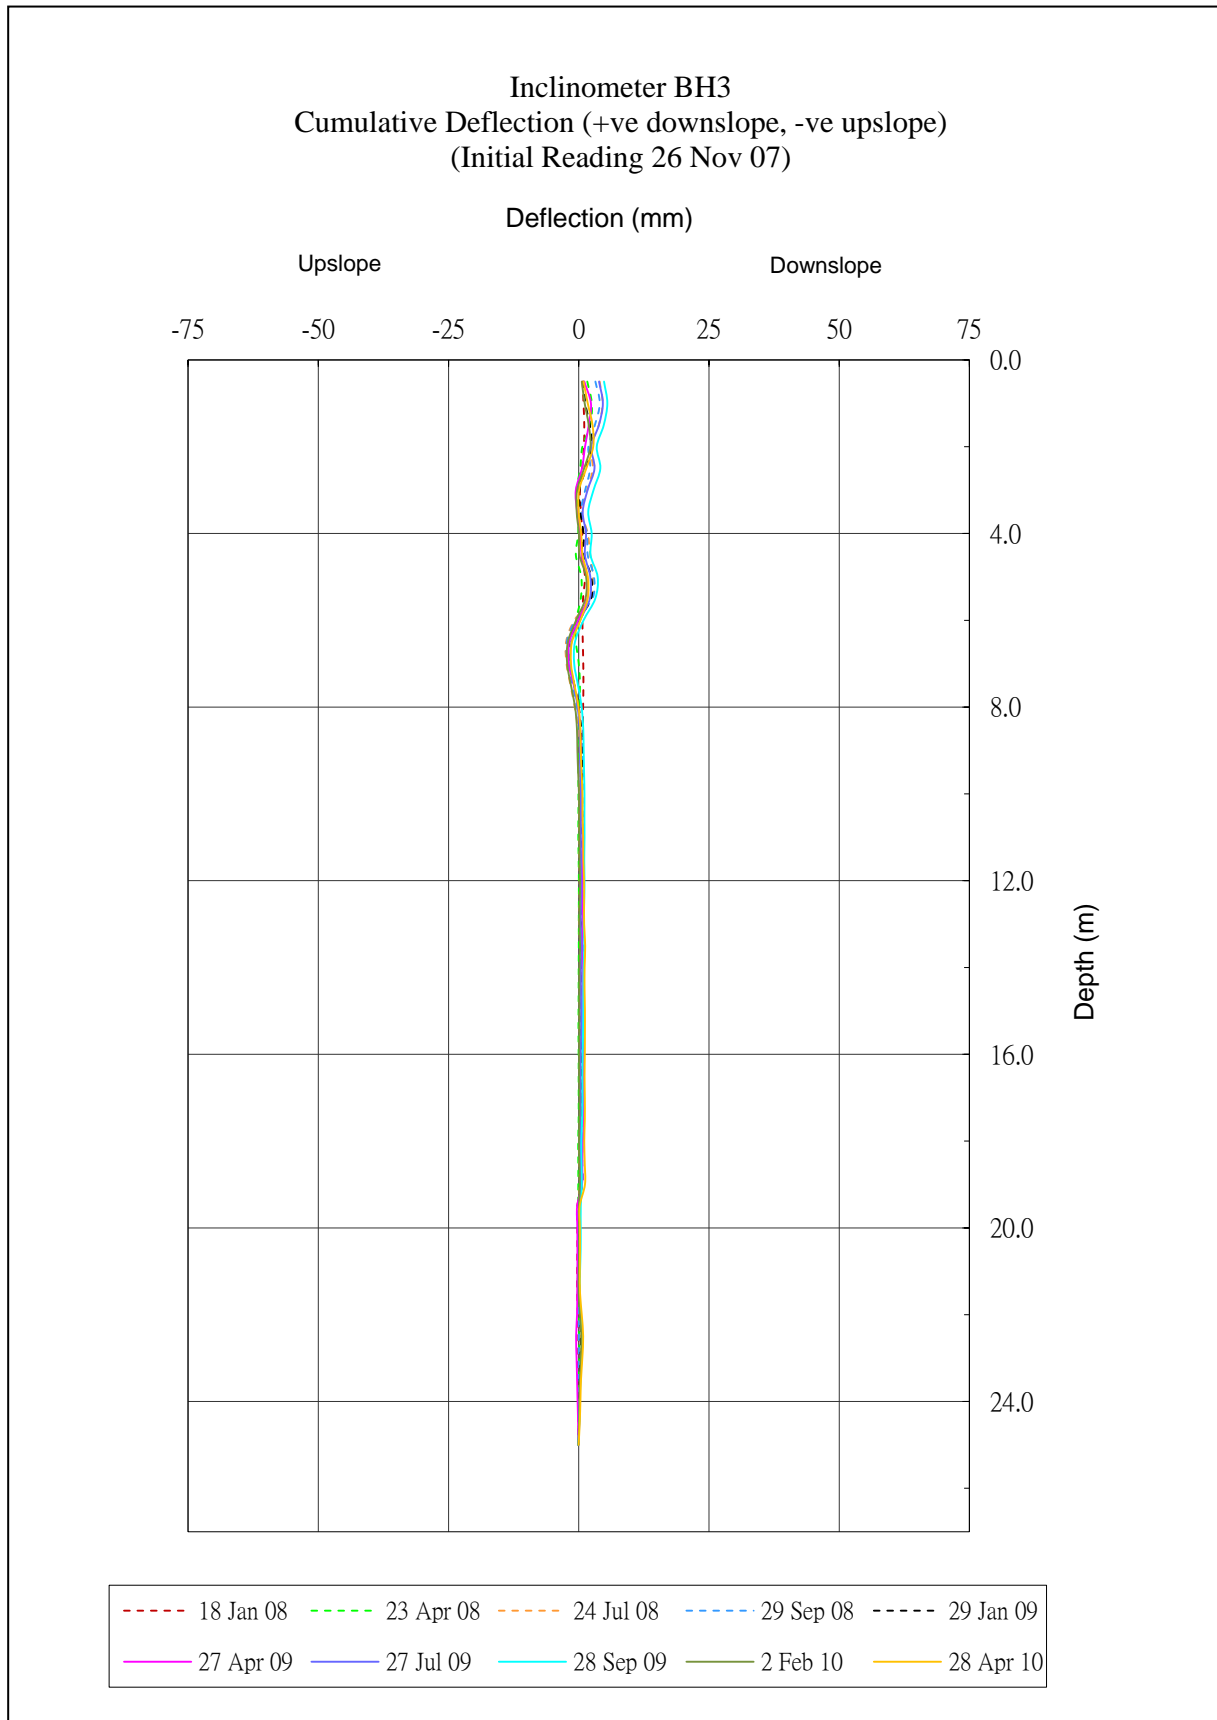
Figure C1 – Summary of Monitoring Records of Inclinometer No. BH3
between January 2008 and April 2010
