Review of the June 2008 Landslide on Soil-nailed Slope No. 7NE-A/C167 at Ting Kok Road Tai Po

GEO Report No. 295

C.L.H. Lam

**Geotechnical Engineering Office
Civil Engineering and Development Department
The Government of the Hong Kong
Special Administrative Region**

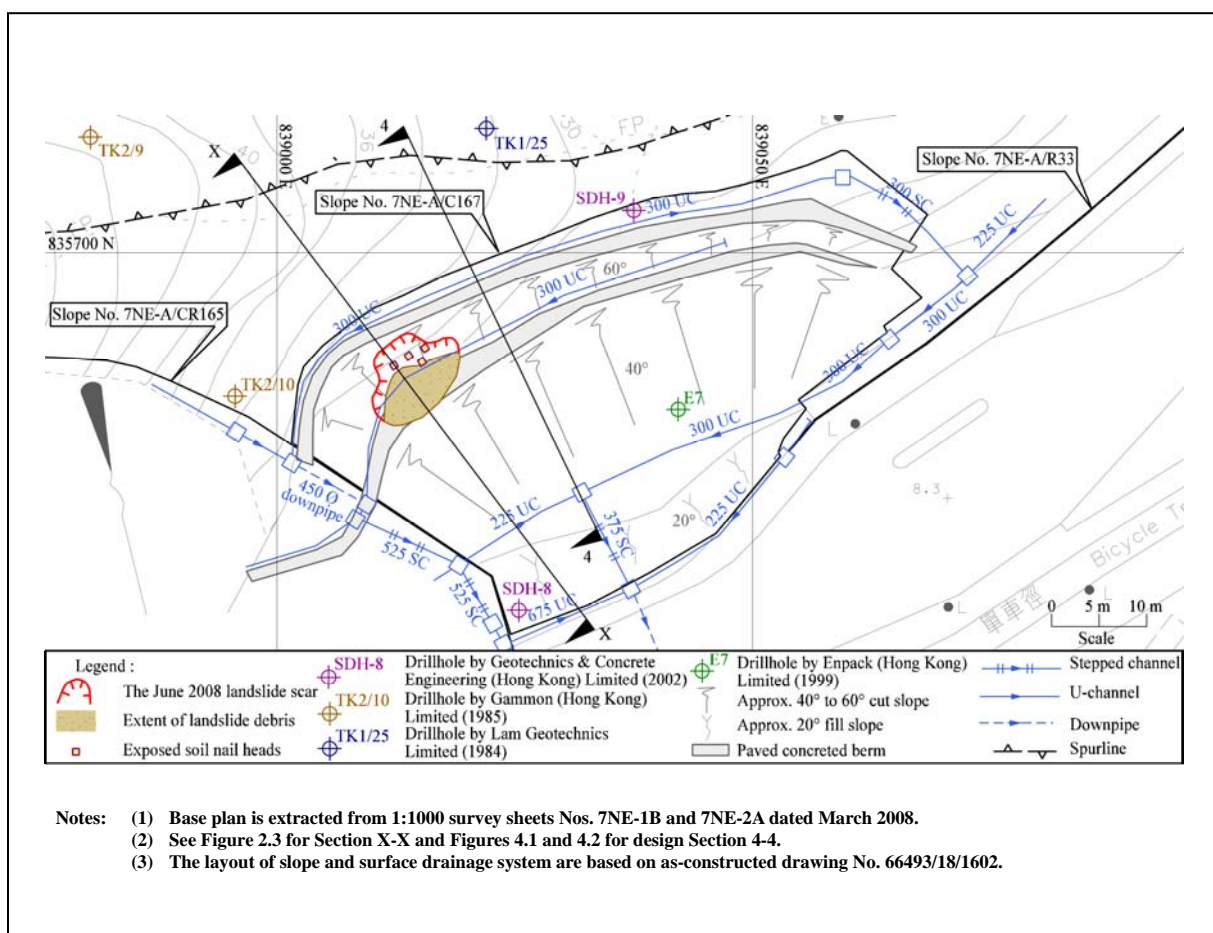
Figure 2.2 Layout Plan with As-constructed Drainage System and Ground Investigation Stations

The landslide was shallow, comprising a central portion and two “wings”. The central portion of the landslide measured about 8 m wide by 7 m long, up to 0.5 m deep. The detached portions on both sides (i.e. the “wings”) measured about 5 m wide by 4.5 m long (Figures 2.2 and 5.1). The total failure volume was about 20 m³.

Four soil-nail heads of 400 mm x 400 mm were exposed on the landslide scar (Figures 2.2 and 5.5). No damage to the exposed soil nail heads was observed during the post-failure inspection on 19 June 2008. Above the nail heads, the landslide scar involved a 4 m high unsupported portion of the cut slope, immediately below the crest channel (Figure 5.6).

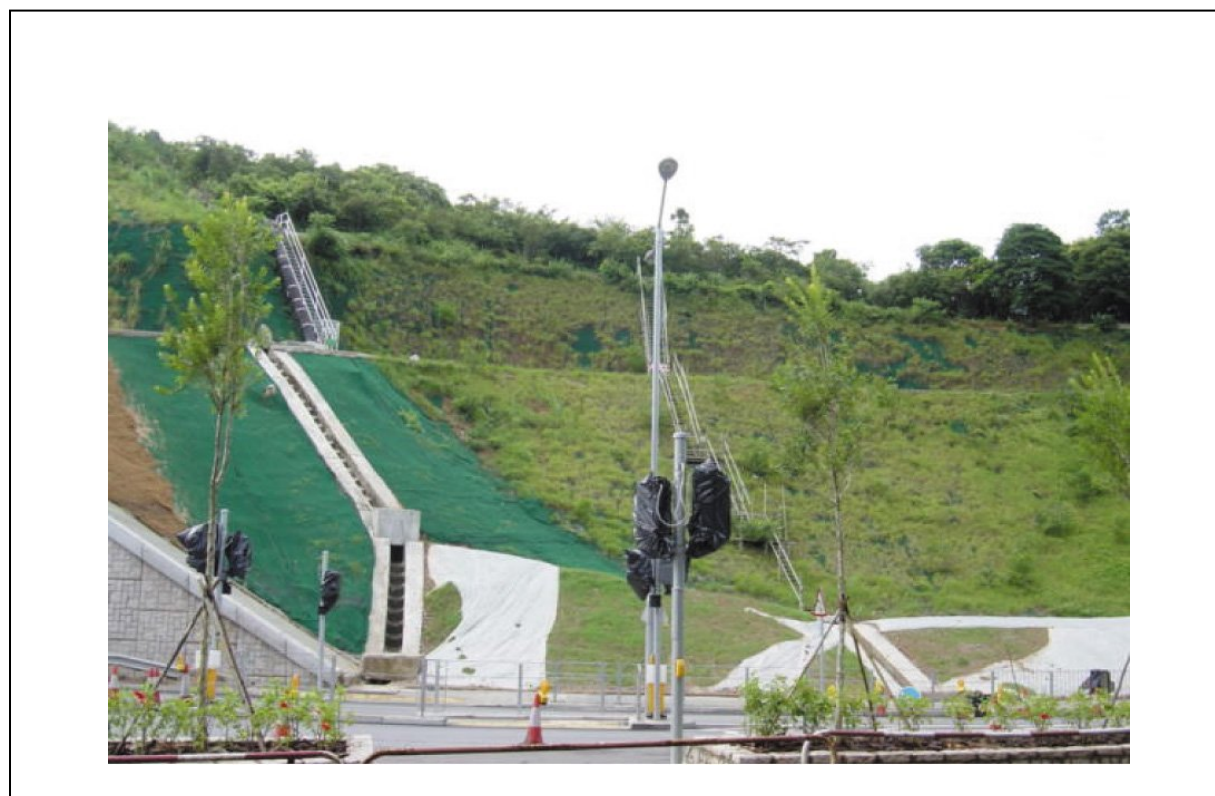
Figure 2.4 View of Slope No. 7NE-A/C167 before Failure (Photograph extracted from Slope Maintenance Manual taken on 30 April 2006)

The slope has perimeter channels and U-channels along the slope berms and toe (Figure 2.2). The channels discharge to the public stormwater drainage system, and were constructed as part of the Ting Kok Road widening project (see Section 4). The slope surface was covered with erosion control mats (Figure 2.4), and was heavily vegetated (Figure 1.1) prior to the failure.

The slope (No. 7NE-A/C167) was handed back to the maintenance office, HyD, in December 2007. At the time of the handover, the slope was covered by vegetation (Figure 2.4).

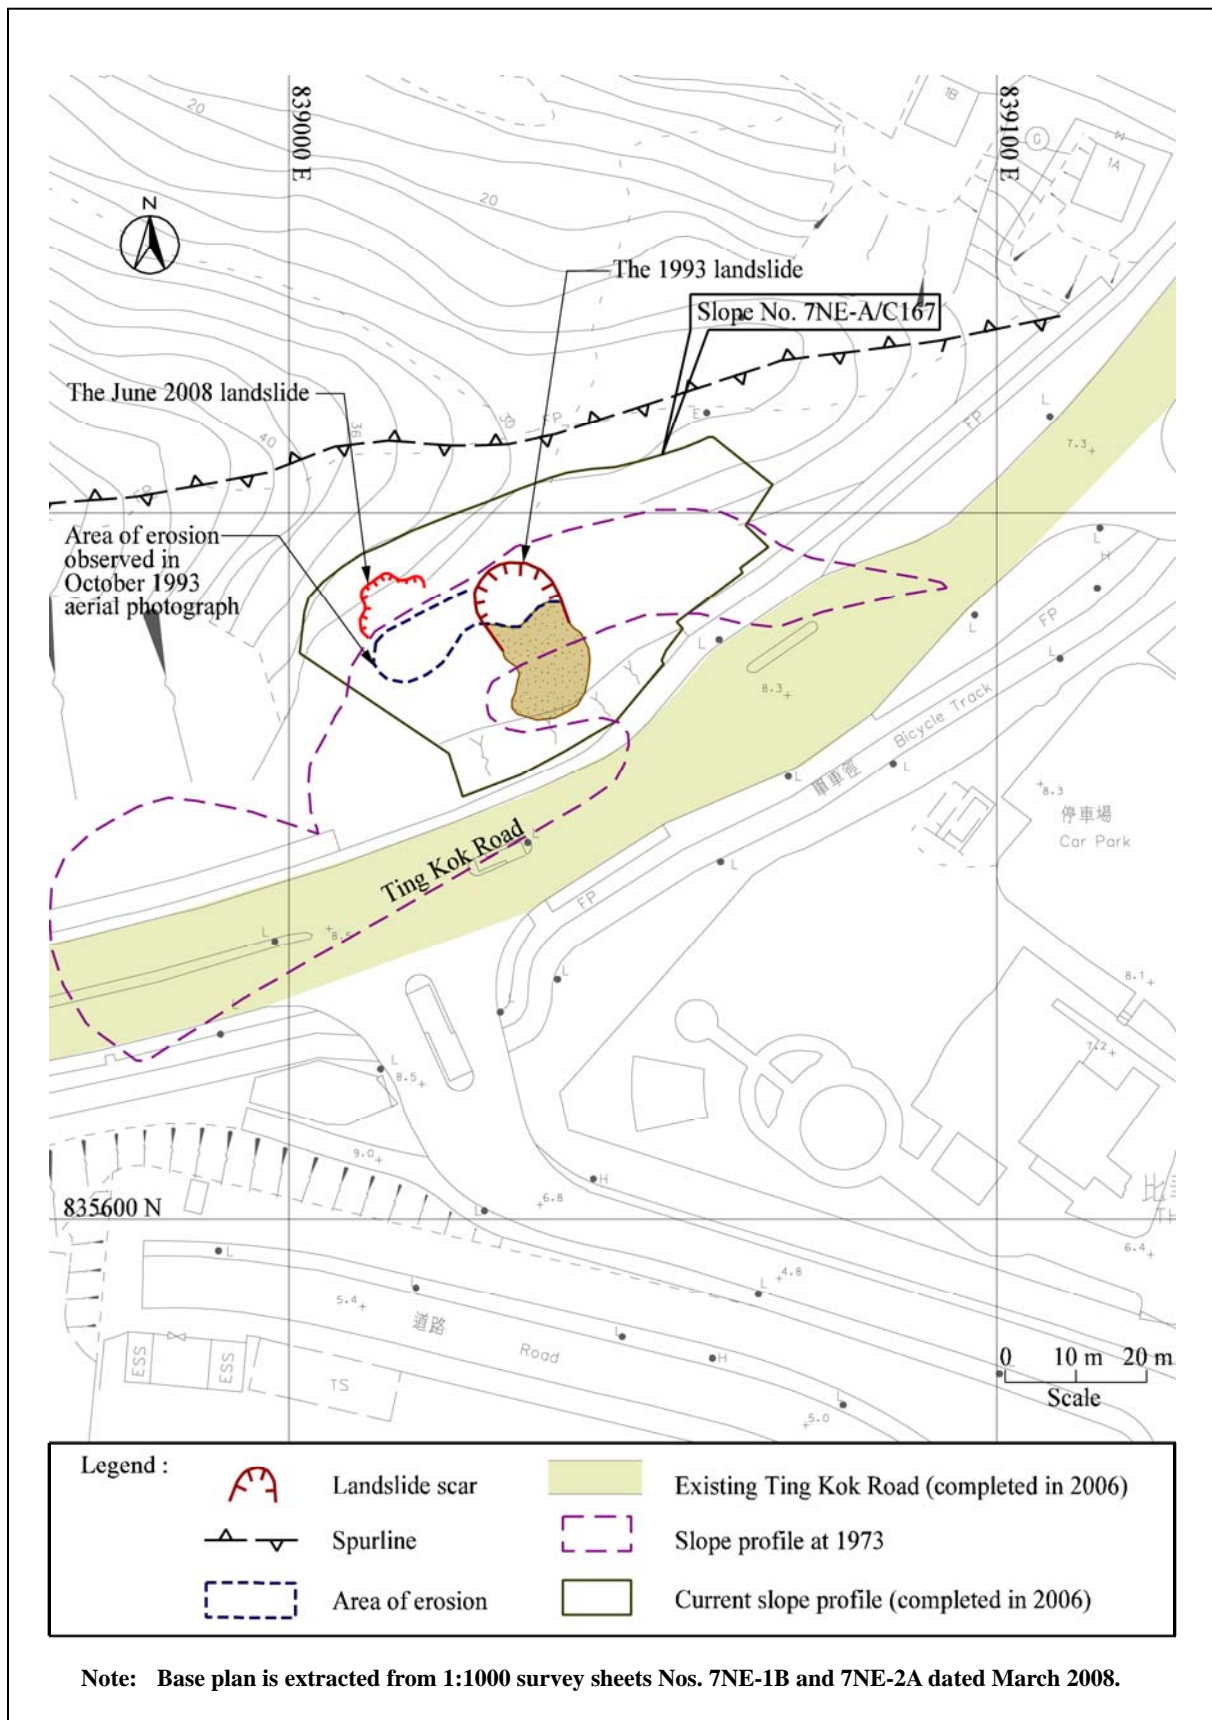
Figure 3.1 Site History and Past Instability

Based on API, a minor landslide was identified in the October 1993 aerial photographs (Figures 3.1 and A3). The failure occurred on a cut slope about 10 m to the east of the June 2008 landslide, prior to the formation of the present-day profile of slope No. 7NE-A/C167. The failure was shallow and linear in shape, measuring about 12 m wide by 8 m long. Extensive erosion was also observed to the west of the scar (Figure A3).

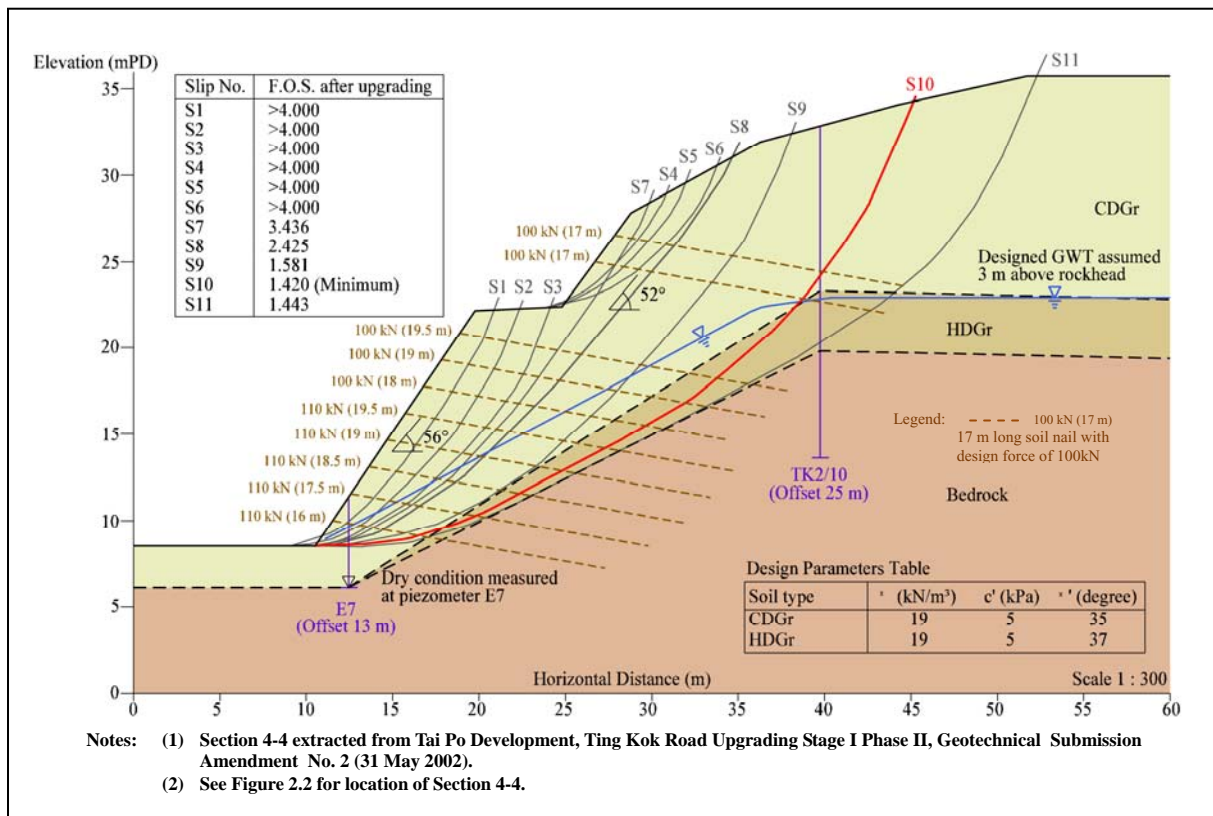
Figure 4.1 Original Design Geological Section 4-4

The simplified geological section (Figure 4.1) adopted in 2002 for the design of the slope upgrading works is located about 10 m to the east of the June 2008 landslide (Figure 2.2). The lower and upper batter of the slope was assumed to be inclining at 56° and 52° respectively. Soil nails of 16 m to 20 m long, spaced at 1.5 m to 2 m centre-to-centre were proposed. The minimum factor of safety (FoS) was 1.42 (MGSL, 2002a).

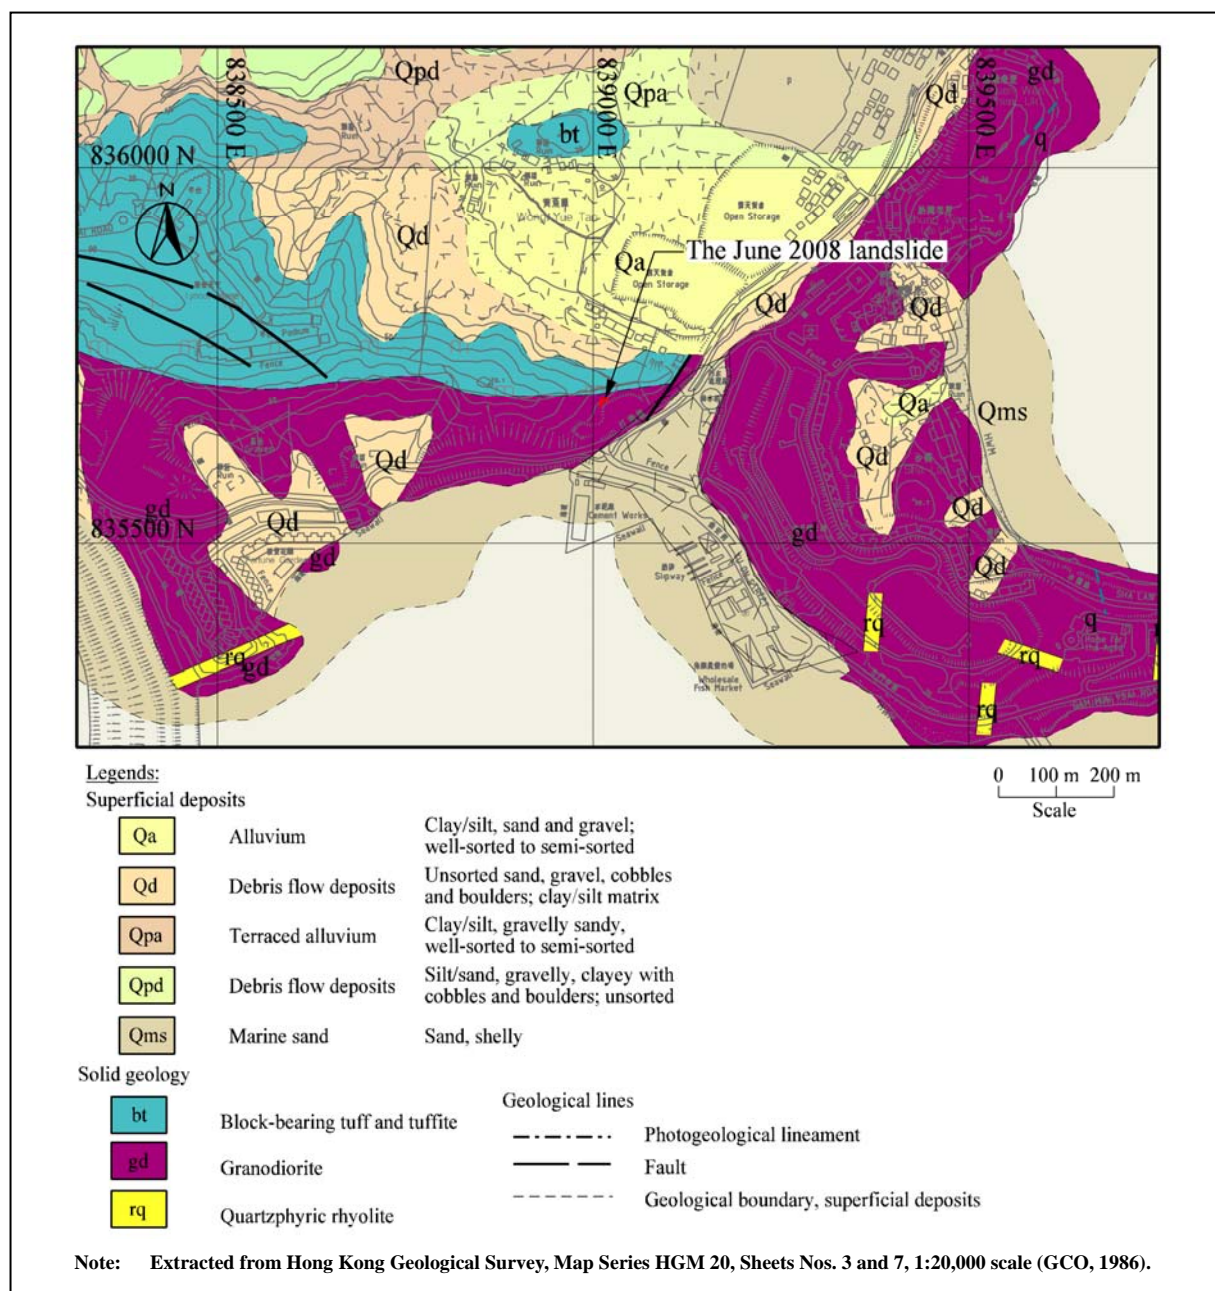
Figure 6.1 Regional Geology

According to the Hong Kong Geological Survey (HKGS) 1:20,000 Solid and Superficial Geology Map Sheet Nos. 3 and 7 (GCO, 1986), the site is underlain by Jurassic granodiorite (Figure 6.1). The geological map also shows a contact zone between block-bearing tuff/tuffite and granodiorite close to the crest of the failed slope No. 7NE-A/C167, and a northeast-southwest striking fault at approximately 60 m to the southeast of the slope (Figure 6.1). The presence of the fault in the vicinity may influence of the structural geology of the regional terrain.

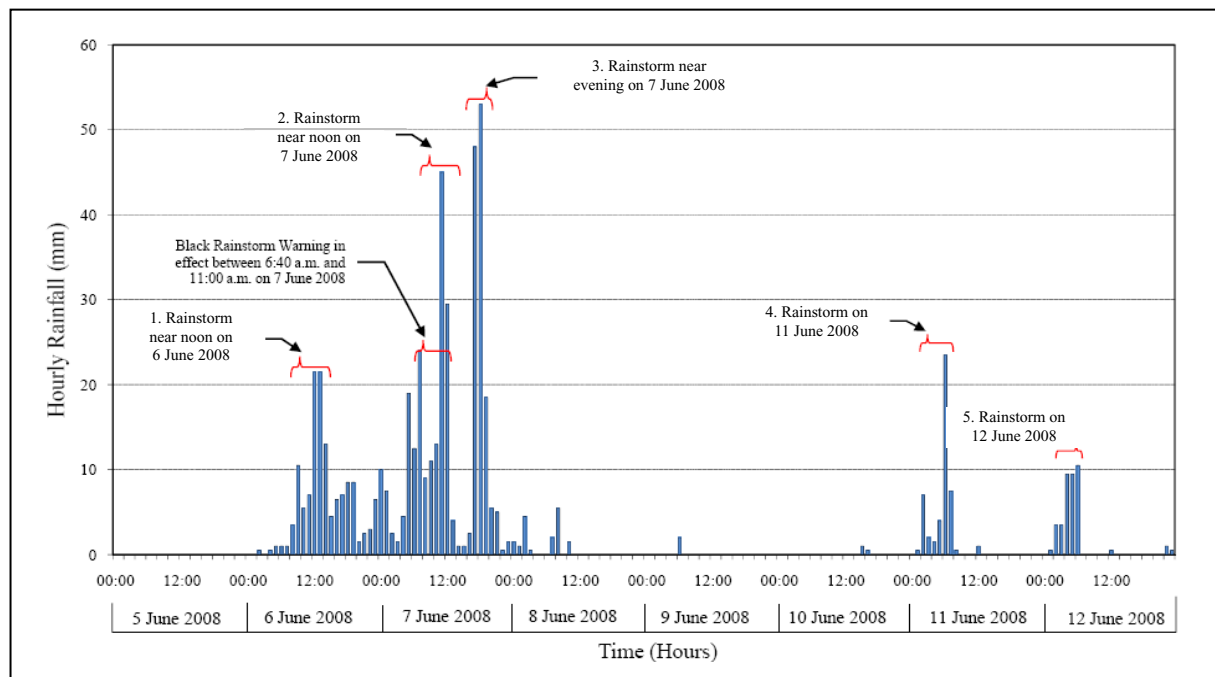
Figure 7.1 Five Rainstorms Recorded by GEO Raingauge No. N45 before 12 June 2008

According to the incident record, the landslide was reported on 12 June 2008. As the exact date and time of the landslide is not known, an analysis (Appendix C) was carried out to deduce the maximum rolling 1-hour, 2-hour and 4-hour rainfall, of five rainstorms that occurred between 6 and 12 June 2008 (Figure 7.1). Results of the analysis indicate that the 2-hour rolling rainfall in the evening of 7 June 2008 was the most severe.

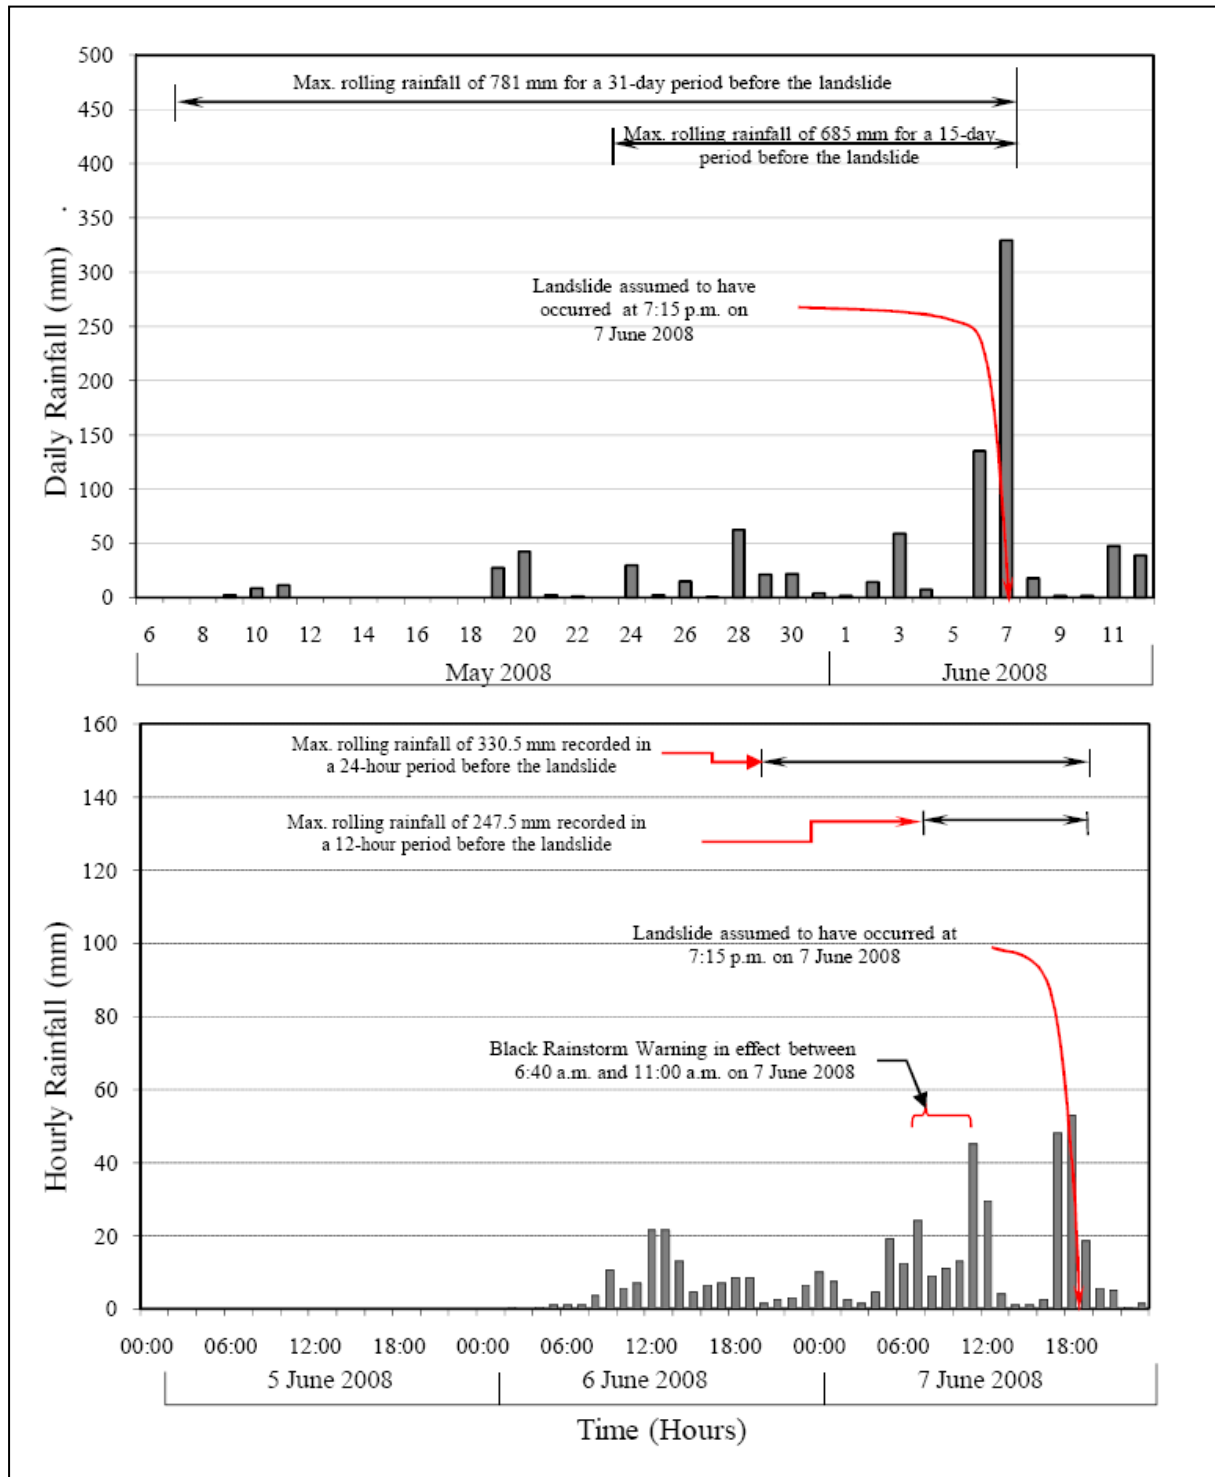
Figure 7.2 Daily and Hourly Rainfall Records at GEO Raingauge No. N45

For the purpose of the rainfall analysis, the landslide was assumed to have occurred at 7:15 p.m. on 7 June 2008 (Figure 7.2). With reference to historical rainfall data at the HKO in Tsim Sha Tsui where records began in 1884 (Lam & Leung, 1994) and local rainfall data from raingauge No. N45 (Evans & Yu, 2001), the short duration rainfall of the 7 June 2008 rainstorm had a return period of less than 6 years (Table 7.1).

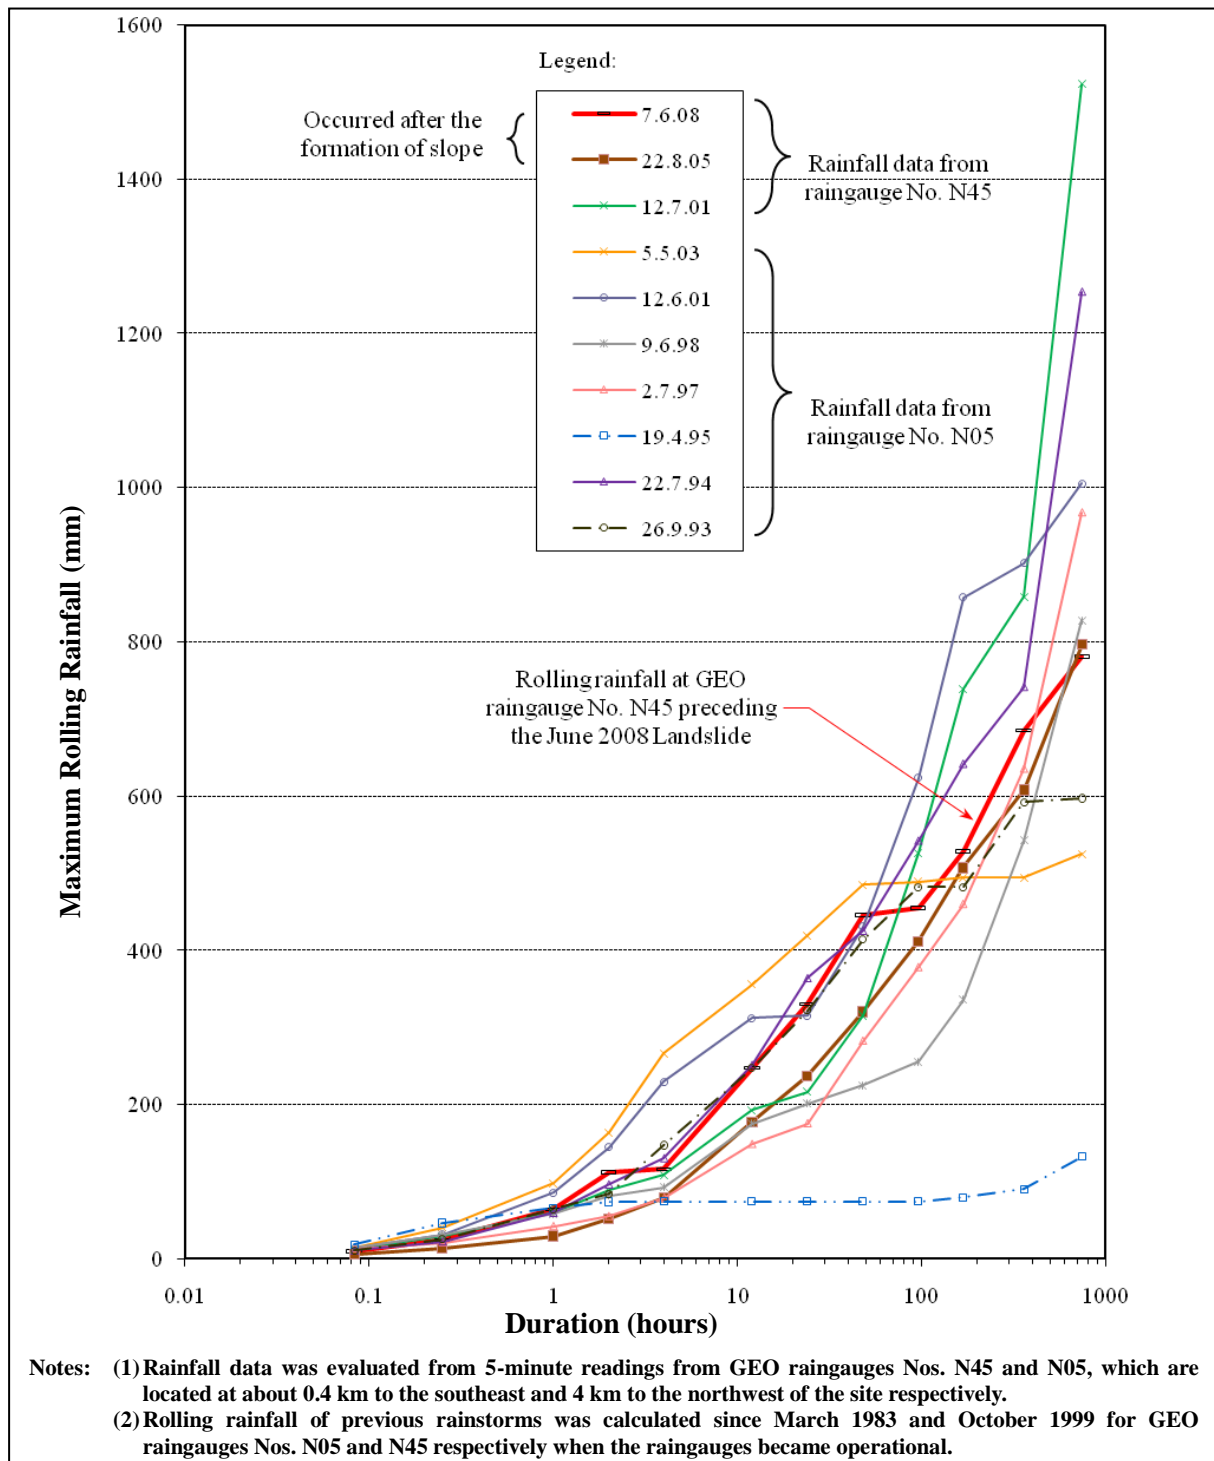
Figure 7.3 Maximum Rolling Rainfall for Previous Major Rainstorms at GEO Raingauges Nos. N05 and N45

The rainstorm of 7 June 2008 has been compared with previous major rainstorms recorded at raingauge No. N45. The results indicate that the 7 June 2008 rainstorm was the most severe that the upper batter of the slope (where the June 2008 landslide occurred) had experienced after its formation between June 2004 and April 2005 (Figure 7.3). Other rainstorms that had occurred prior to June 2004 were also shown in Figure 7.3 for reference. Further details of the rainfall analysis are given in Appendix C.

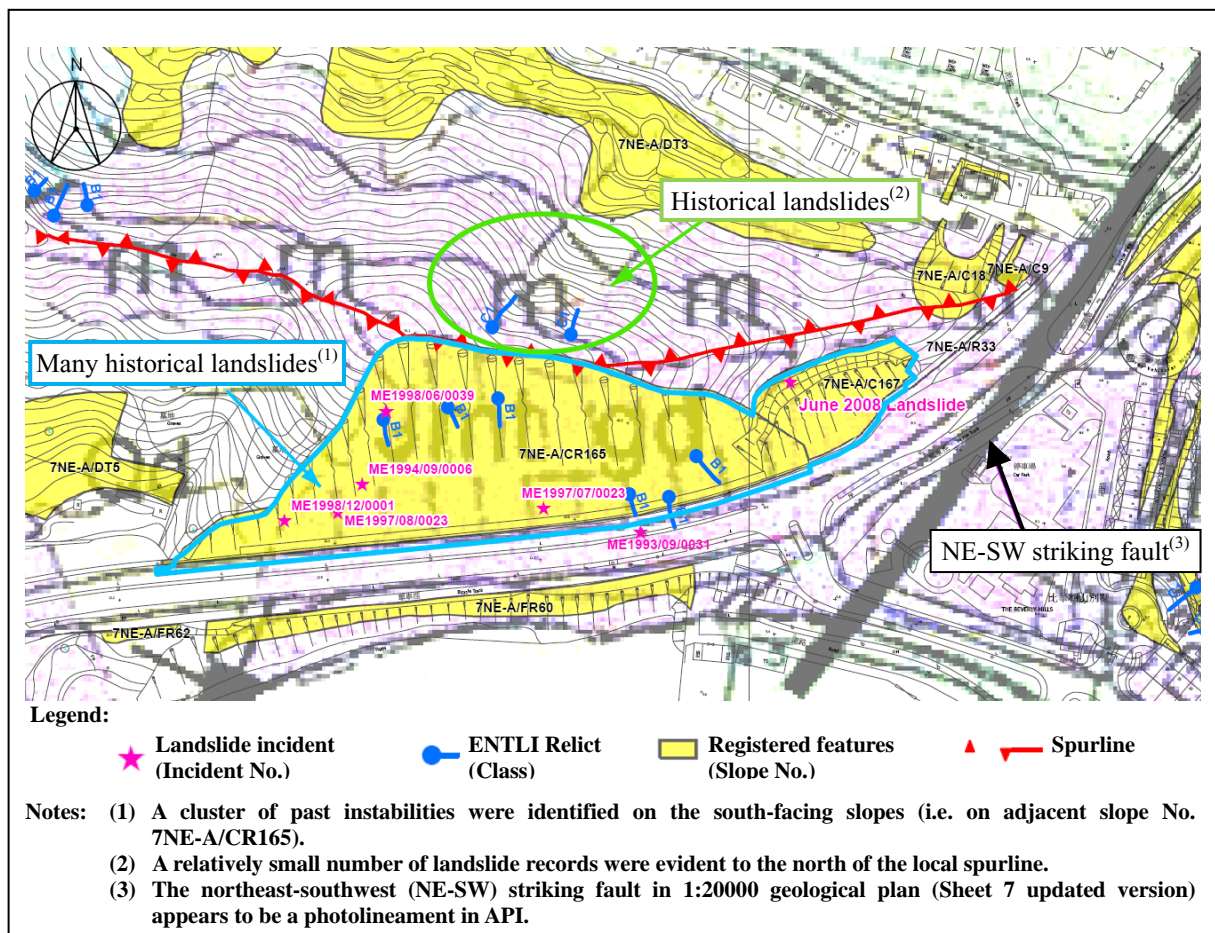
Figure A2 Occurrence of Many Historical Landslides on South-facing Slope Contrast to a Few Landslides within North-facing Slope

The possible influence of the fault on the structural geology of the regional terrain is further supported by the occurrence of many historical landslides (including relict and landslide incidents after 1993) on the adjacent south-facing slope (No. 7NE-A/CR165) contrast to a few landslides identified within the north-facing slope to the north of the spurline (Figure A2).

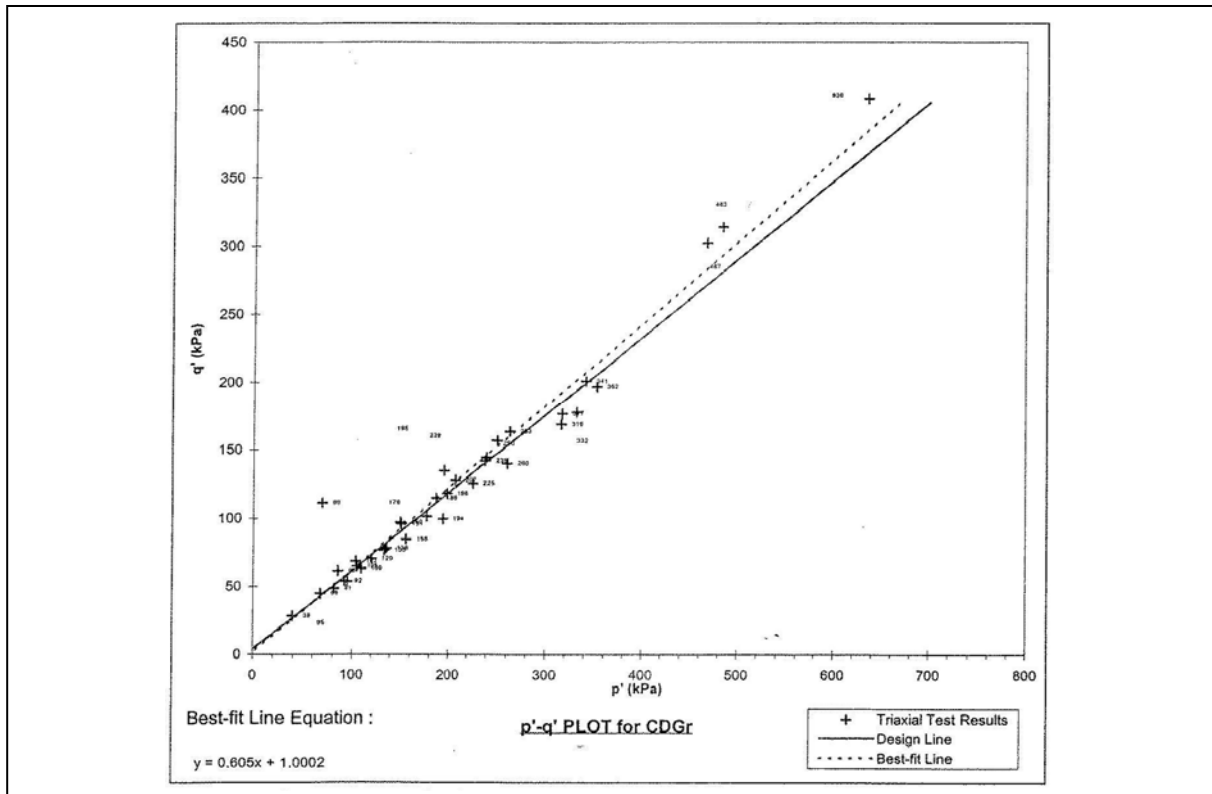
Figure B1 p'-q Plot for CDGr (Extracted from Ting Kok Road Upgrading Stage I Phase III, Geotechnical Submission, Supplementary No. 1 (MGSL, 2002))

The designed shear strength parameters for CDGr and HDGr were determined to be $c' = 5 \text{ kPa}$, $\phi' = 35^\circ$, and $c' = 5 \text{ kPa}$, $\phi' = 37^\circ$ respectively (see p' - q plots extracted from the geotechnical submission (MGSL, 2002) as shown in Figures B1 and B2).
