**REVIEW STUDY OF THE
7 JUNE 2008 LANDSLIDE
ON SLOPE NO. 11NE-A/C351
AND THE NATURAL HILLSIDE
ABOVE SHATIN PASS ROAD,
TSZ WAN SHAN**

GEO REPORT No. 302

AECOM Asia Company Limited

**This report is largely based on GEO Landslide Study Report
No. LSR 4/2010 produced in August 2010**

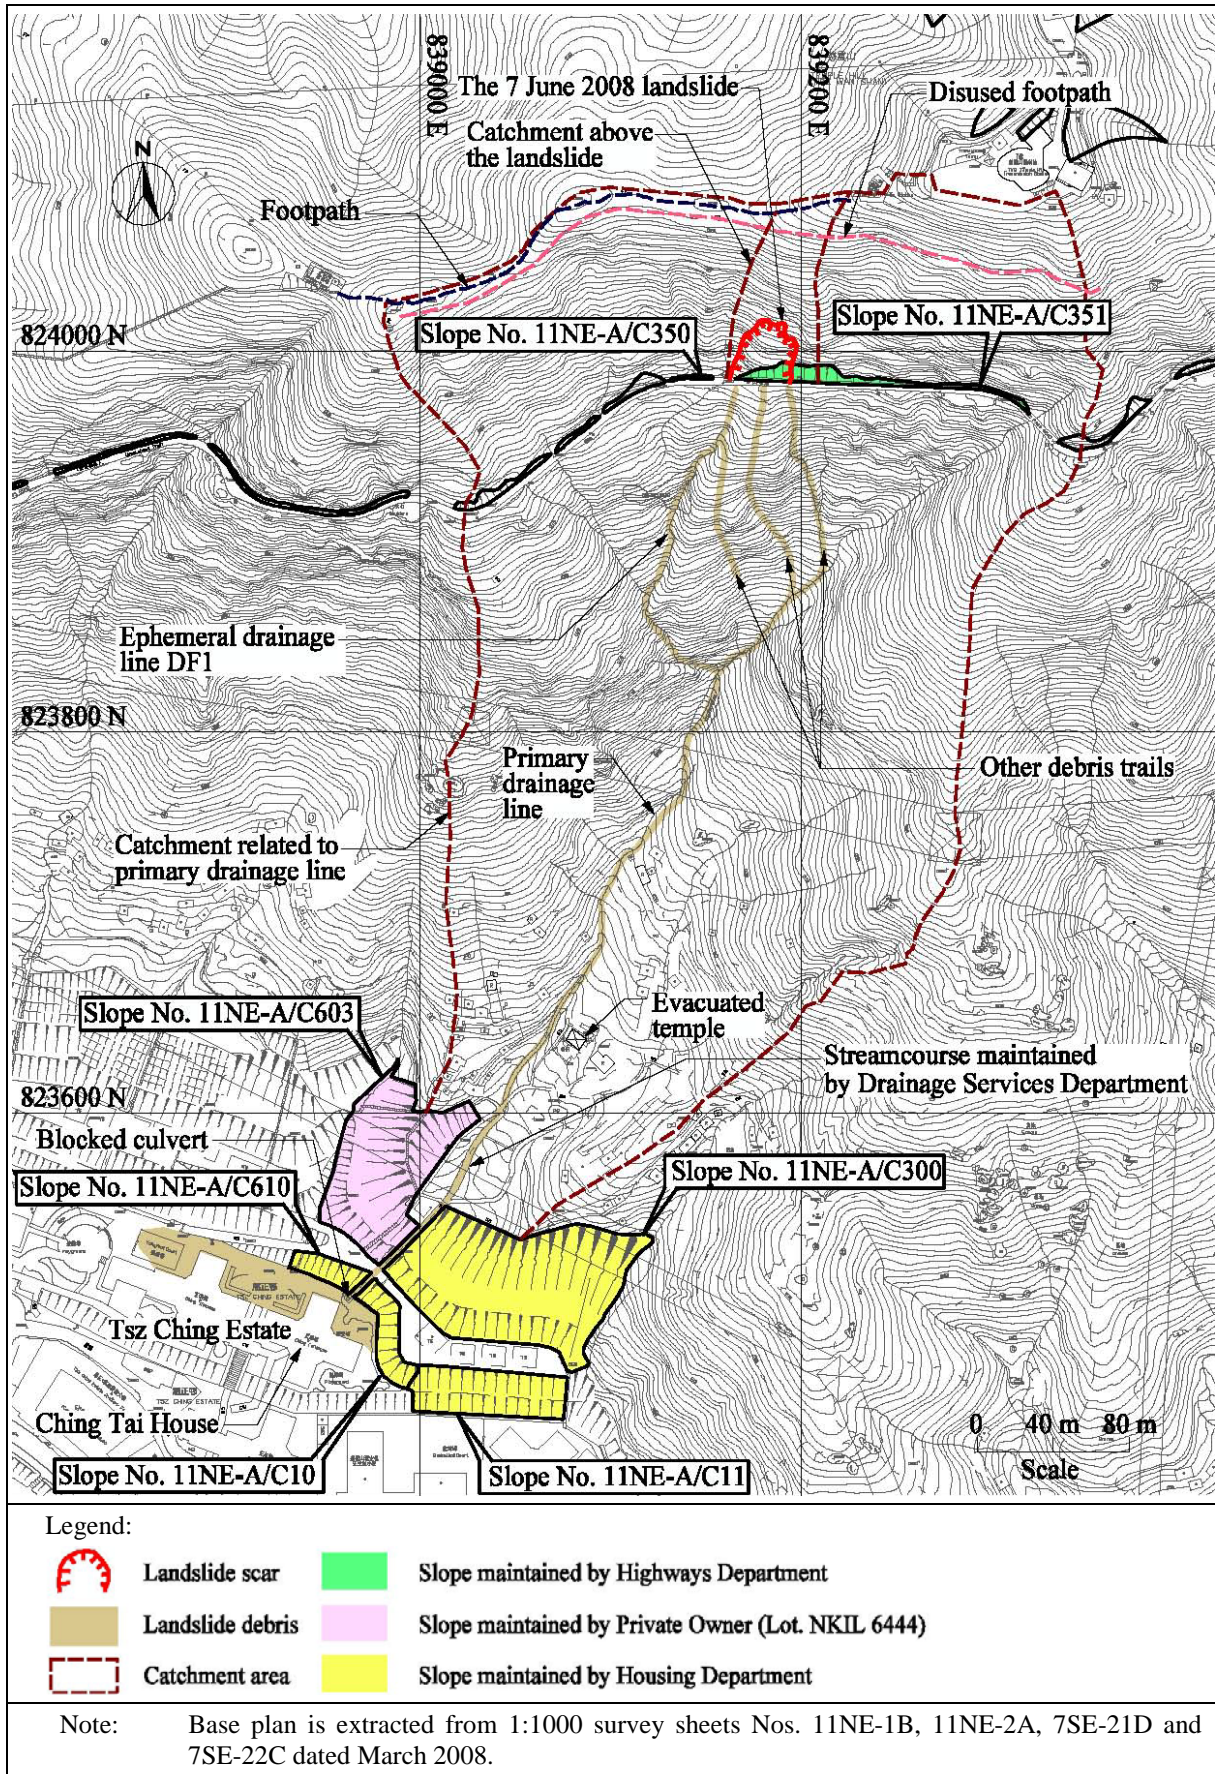
Figure 2 - Site Layout Plan

Subsequent water flow in the primary drainage line washed a large amount of fines and cobbles downstream, inundating an access road and open area behind Ching Tai House, Tsz Ching Estate in three other occasions after the 7 June 2008 landslide (Figure 2). There was no reported casualty due to the June 2008 incident.

The hillside above Shatin Pass Road is mostly vegetated with grass and shrubs, and inclined at about 40°, with a catchment area of about 4,500 m² above the 7 June 2008 landslide (Figure 2). The top of the catchment has an elevation of about 440 mPD.

The 7 June 2008 landslide was first observed by the security officer of Tsz Ching Estate at 12:05 pm. The landslide involved the western portion of cut slope No. 11NE-A/C351 and the natural terrain above. The failure volume was about 3,500 m³, of which about 1,500 m³ came to rest on Shatin Pass Road. The remaining (about 2,000 m³) continued downslope, with about 1,200 m³ travelled as debris avalanche and deposited over a large area of the hillside below Shatin Pass Road. The rest travelled along an ephemeral drainage line (labelled DF1, Figure 2) below the road (Plate 1).

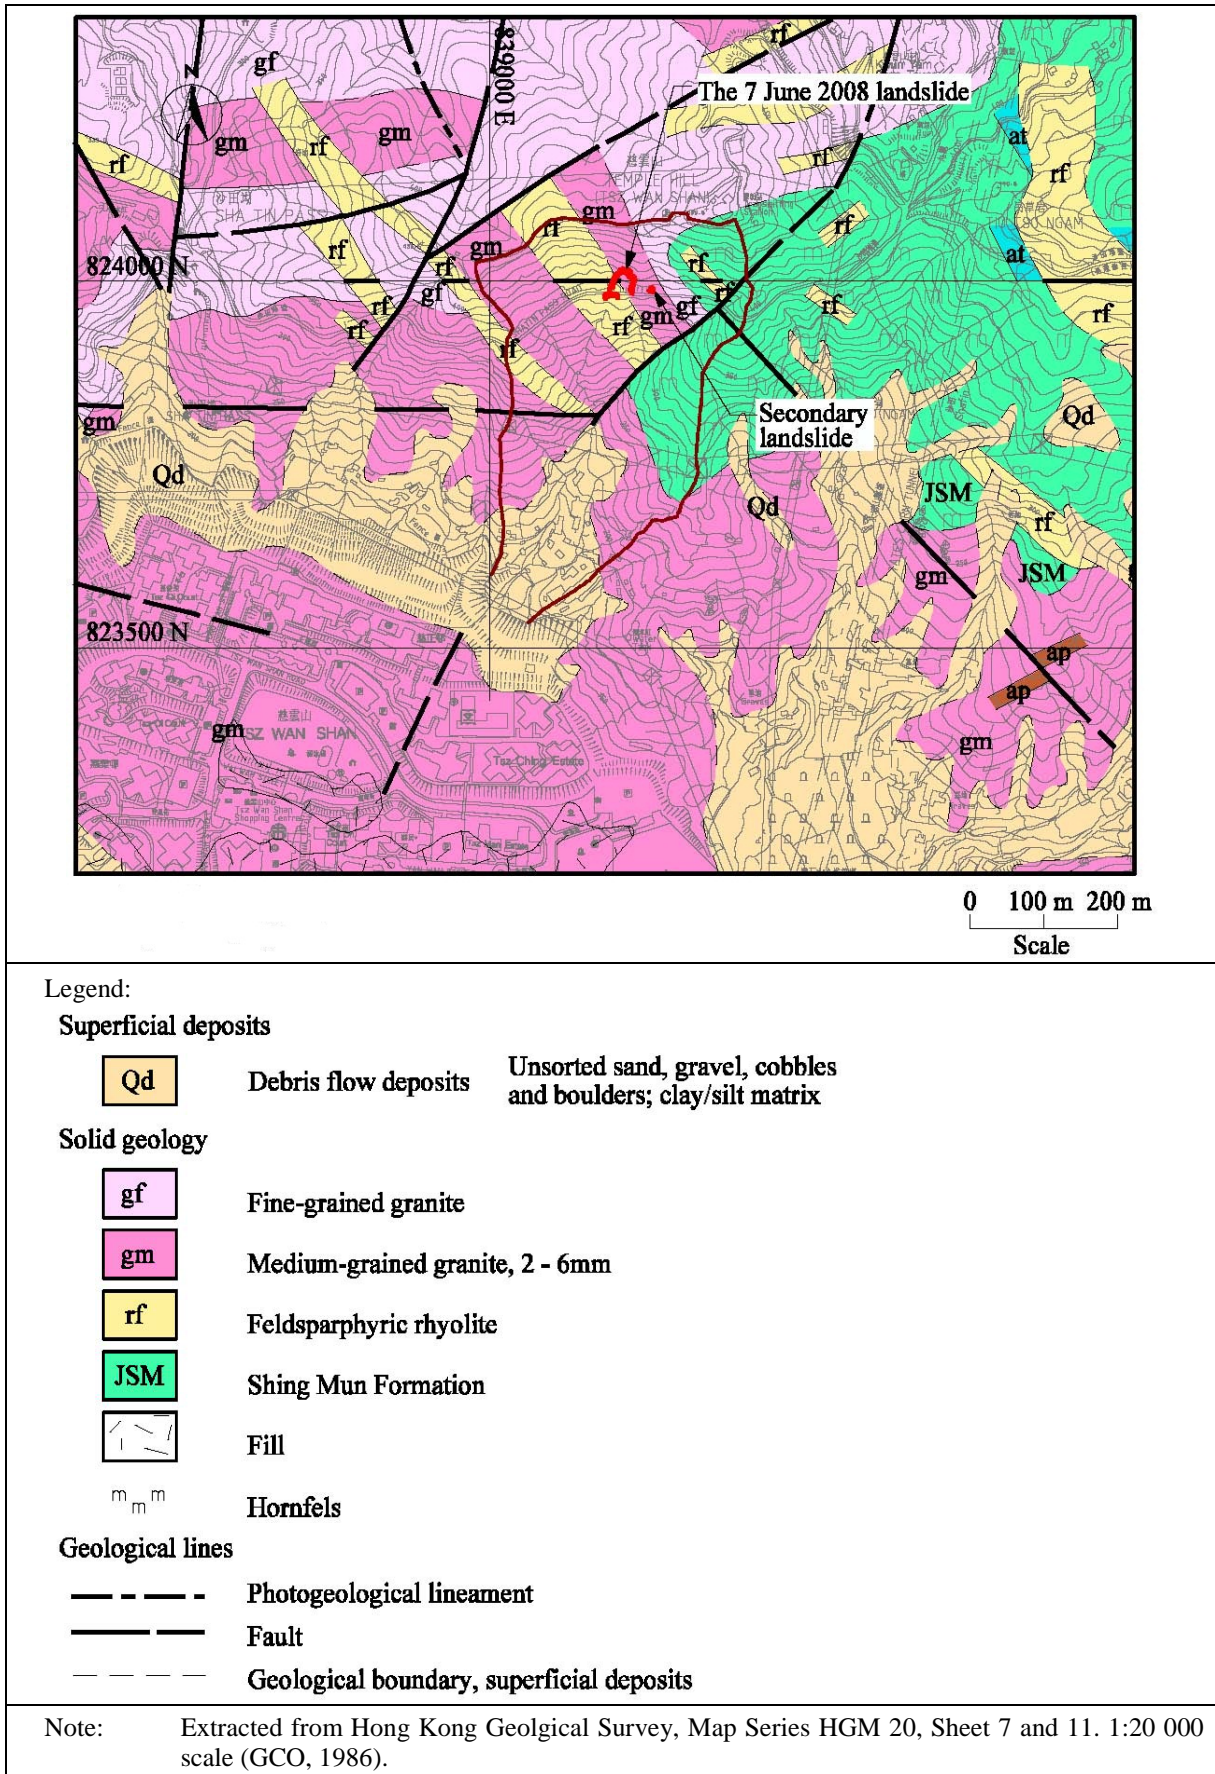
Figure 3 - Regional Geology

A number of poorly-defined ephemeral drainage lines are present within the hillside above and below Shatin Pass Road, near the 7 June 2008 landslide source area. The primary drainage line of the catchment begins some 110 m to the east of the landslide, trending southwest along a fault line (Figure 3). Some ephemeral drainage lines typically trending south or southeast intercept the primary drainage line within the central and lower portions of the hillside (Figure 4). The lower section of the primary drainage line is lined with stone

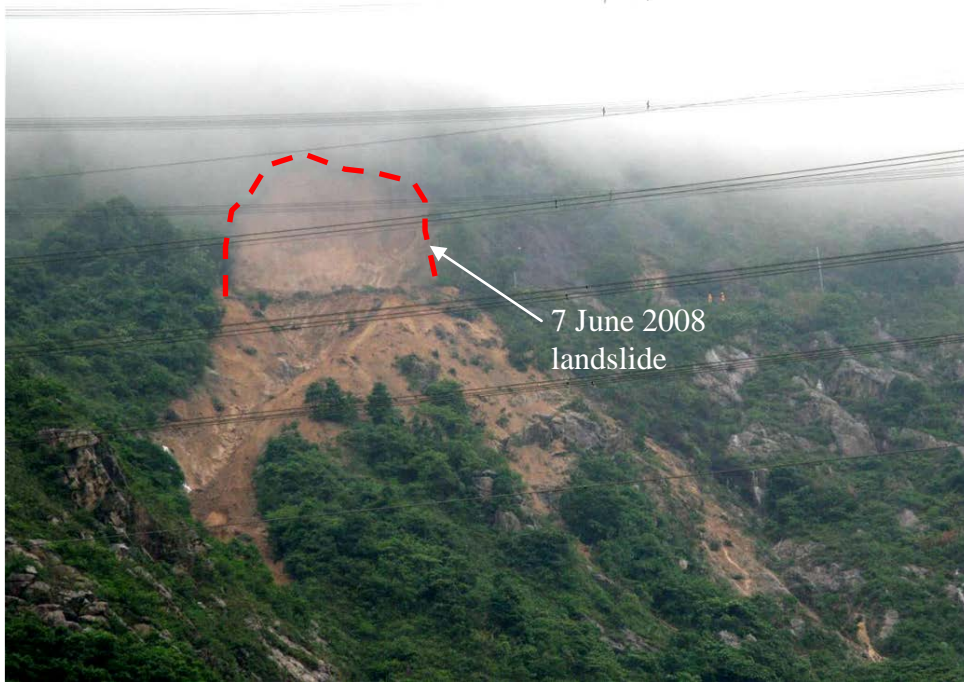
The landslide involved the western portion of a registered cut slope No. 11NE-A/C351 and the natural hillside above, with a total displaced volume (terminology after Cruden & Varnes, 1996) of about 3,500 m³ (Plates 1 and 2). Majority of the debris was deposited on the hillside and some in the primary drainage line. Another minor landslide with a failure volume of about 6 m³ (Secondary landslide, Figure 1) occurred on the middle portion of slope No. 11NE-A/C351, which was also reported in the incident. This landslide investigation report focuses on the larger landslide.

Plate 2 - Earliest Photograph of the Source Area of the 7 June 2008 Landslide Taken from the Roof of Ching Tai House (Photograph taken on 7 June 2008)

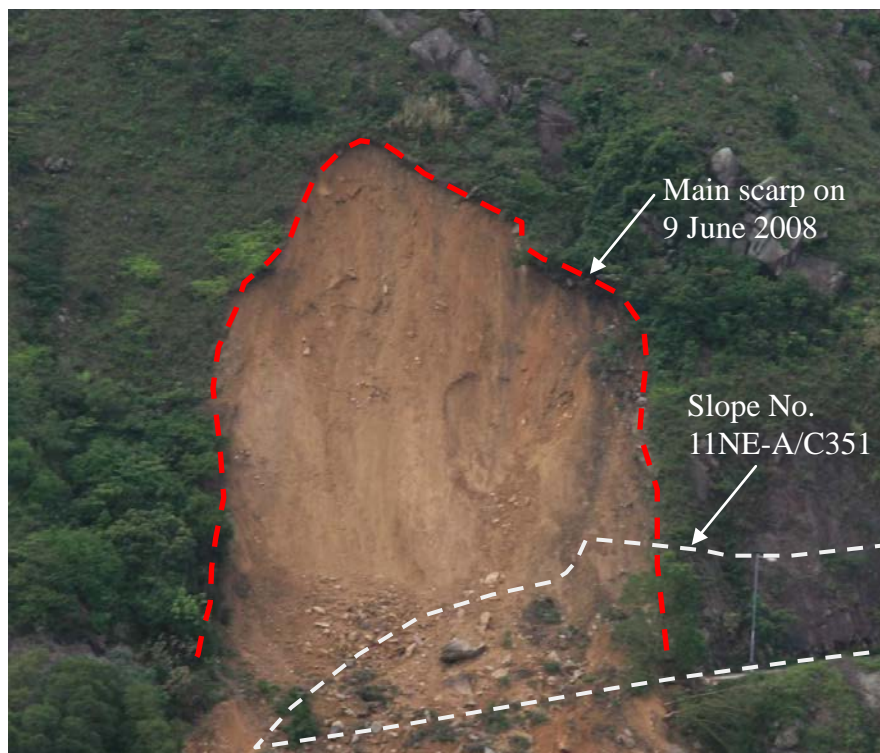
The 7 June 2008 landslide involved part of slope No. 11NE-A/C351, above Shatin Pass Road and a large area of the hillside above (Plate 3). The cut slope is very steep with a slope angle of about 70°. At the location of the failure, the slope is up to 10 m high and covered with shotcrete.

Plate 3 - Oblique Aerial View of the Landslide Source Area (Photograph taken on 9 June 2008)

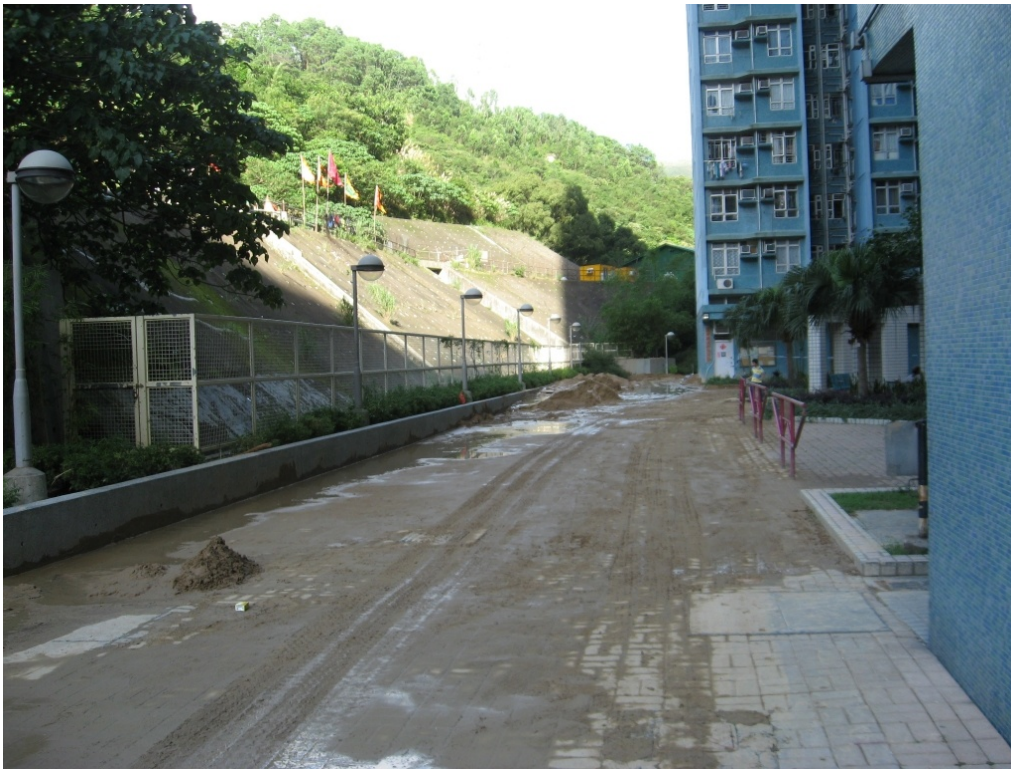
Plate 8 - Some of the Outwash Debris within Tsz Ching Estate was Partially Removed (Photograph taken on 12 June 2008)

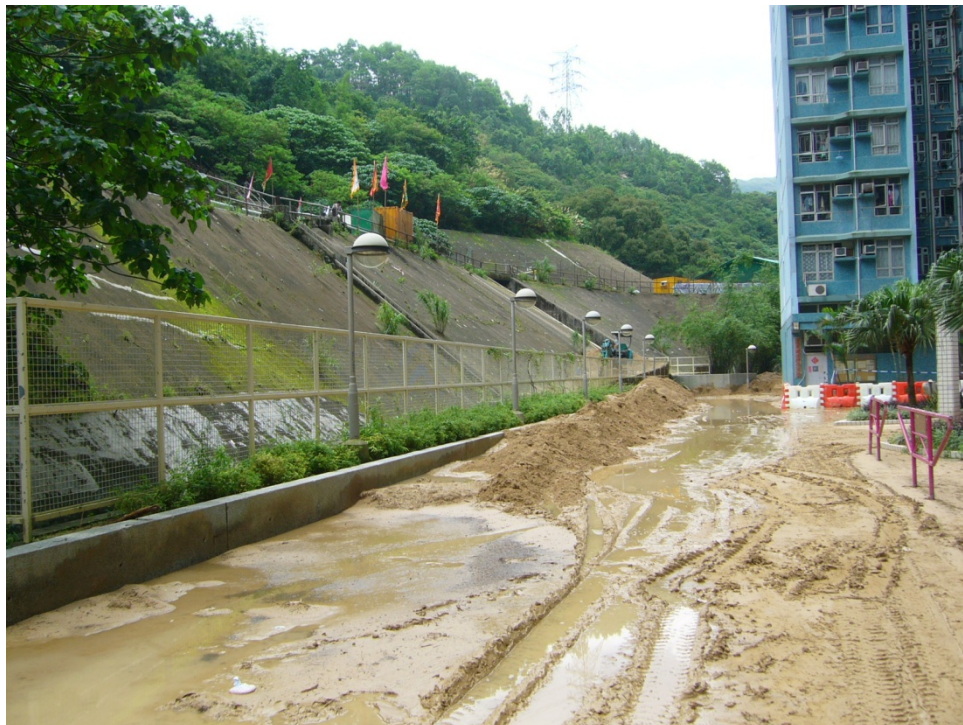
Plate 9 - Debris Outwash within Tsz Ching Estate after the 13 and 14 June 2008 Rainstorm (Photograph taken on 15 June 2008)

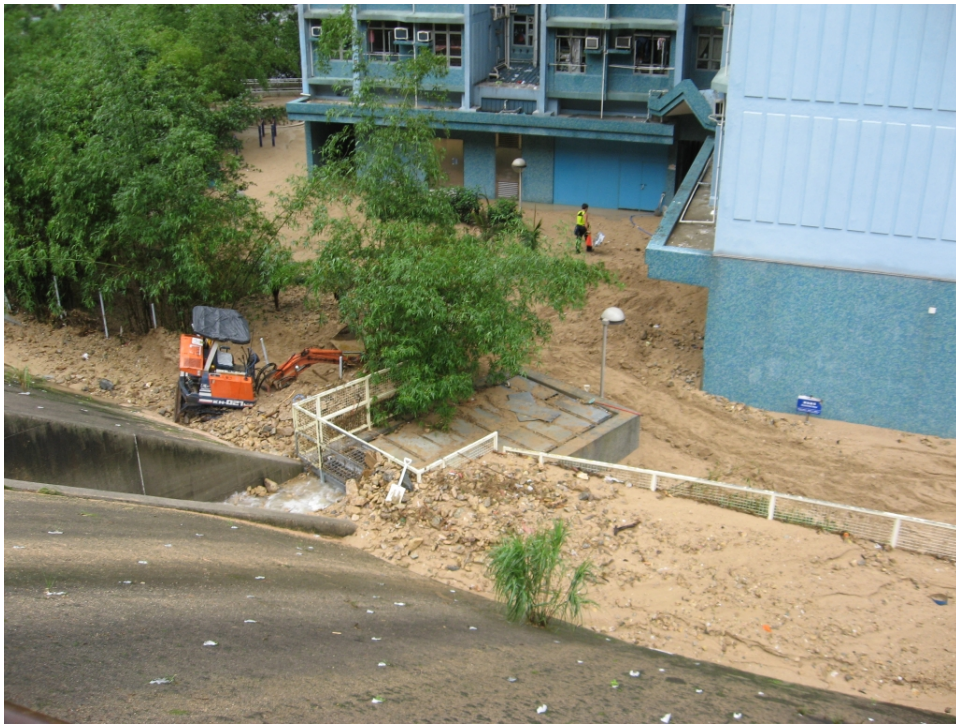
Plate 10 - Debris Outwash Accumulated behind Fence above Tsz Ching Estate after the 13 and 14 June 2008 Rainstorm (Photograph taken on 16 June 2008)

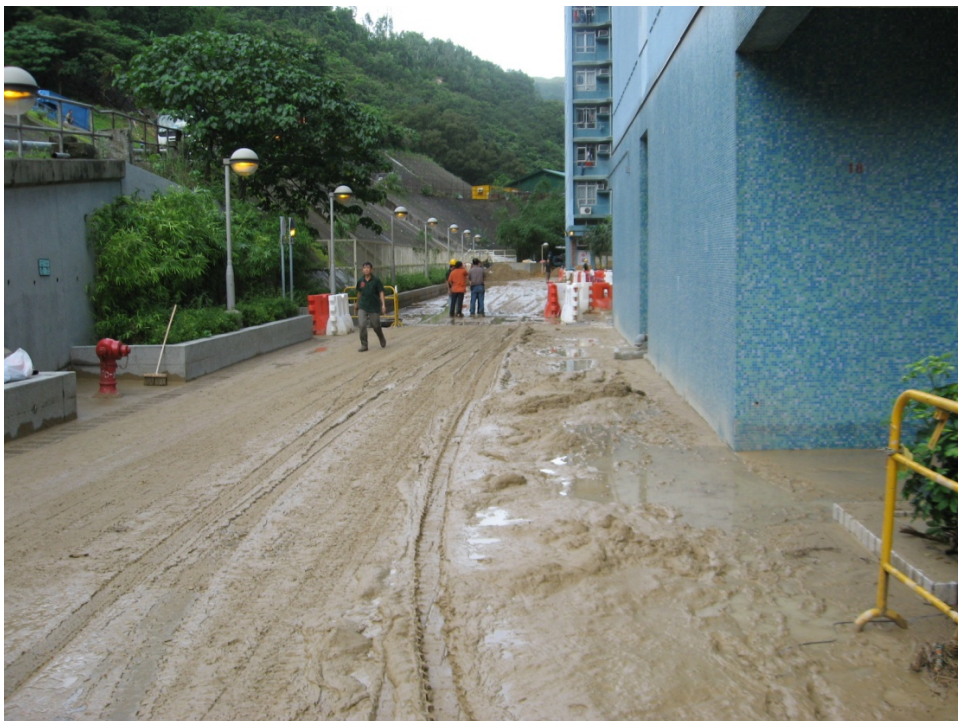
Plate 11 - Debris Outwash within Tsz Ching Estate after the 12 July 2008 Rainstorm (Photograph taken on 12 July 2008)

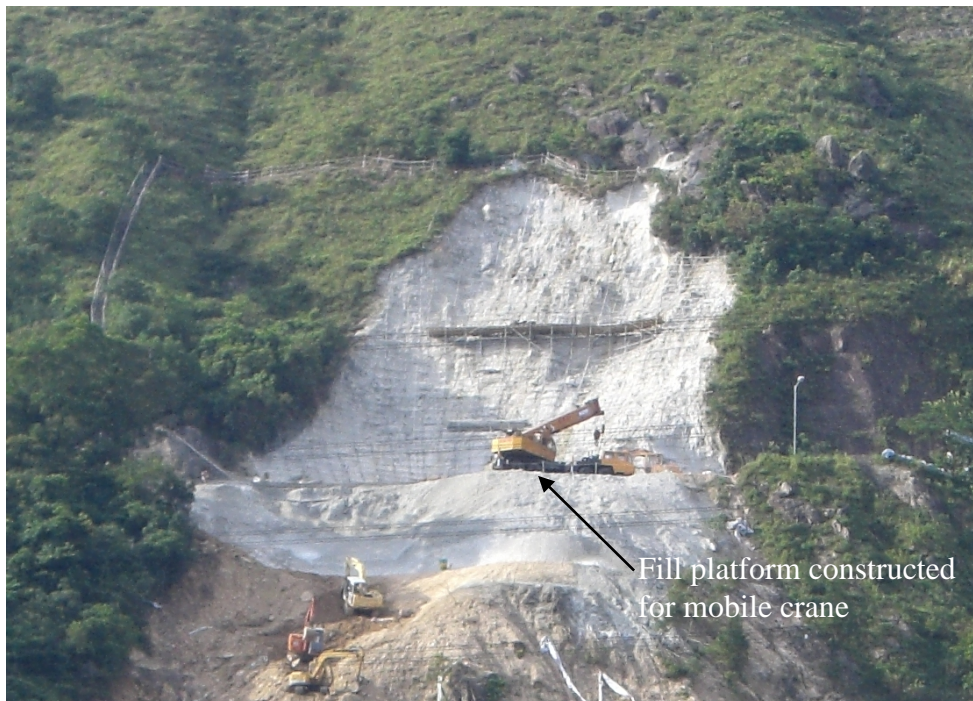
Plate 13 - Ongoing Remediation Work of the Source Area
(Photograph taken on 22 July 2008)

The emergency repair works for the landslide was carried out by Highways Department (HyD). The works comprised removing about 1,500 m³ of debris from Shatin Pass Road, and installing soil nails and raking drains at the landslide source area. The works were completed in August 2008 (Plate 13).

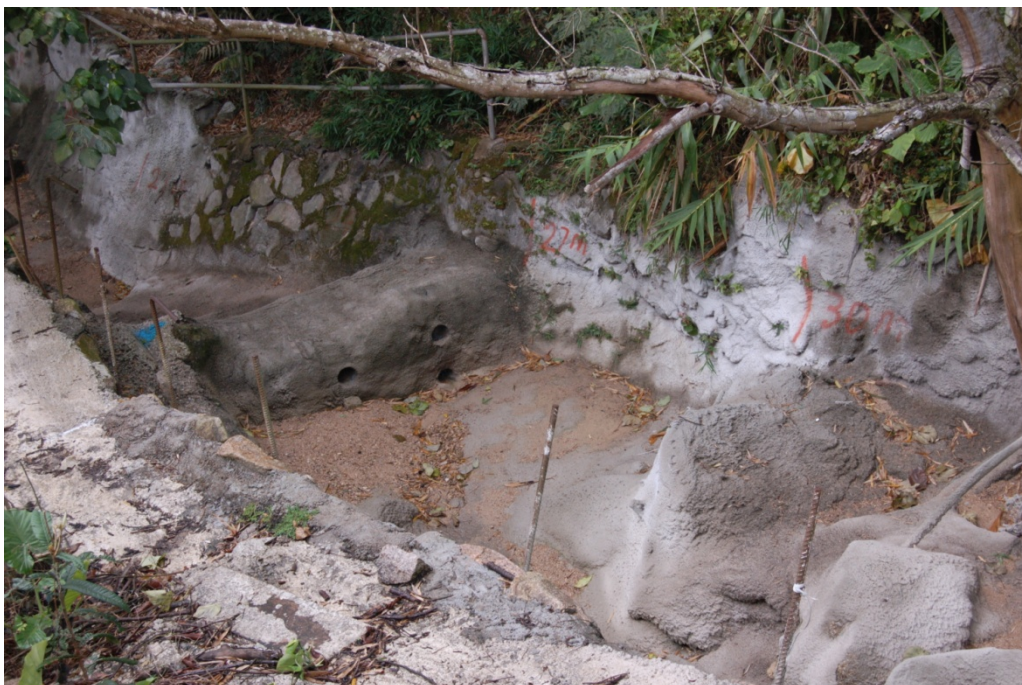
Plate 15 - View of Sedimentation Steps Constructed after 7 June 2008 Landslide Incident (Photograph taken on 6 January 2010)

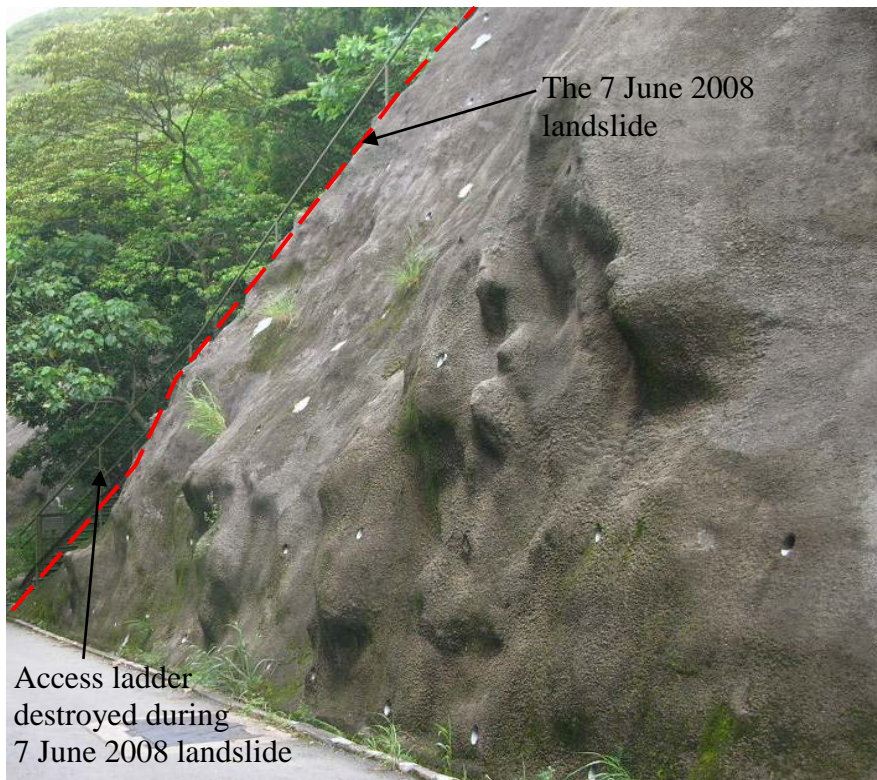
The slope has been subjected to routine maintenance inspections (RMI) and Engineer Inspections (EI) since 2001 (Plates 16 and 17). Potential unstable boulders and localized fractured zone were observed in several occasions. However, no seepage was noted, probably due to the presence of the newly applied shotcrete (Section 5.2). Available records show that routine maintenance works as well as preventive maintenance works including provision of wire mesh on the rock slope portion, shotcreting, and installation of pattern rock dowels were carried out after the inspections.

Plate 17 - Record Photograph from 2007 RMI for Slope No. 11NE-A/C351 Showing Vegetation Removal (Photograph taken on 16 June 2007)

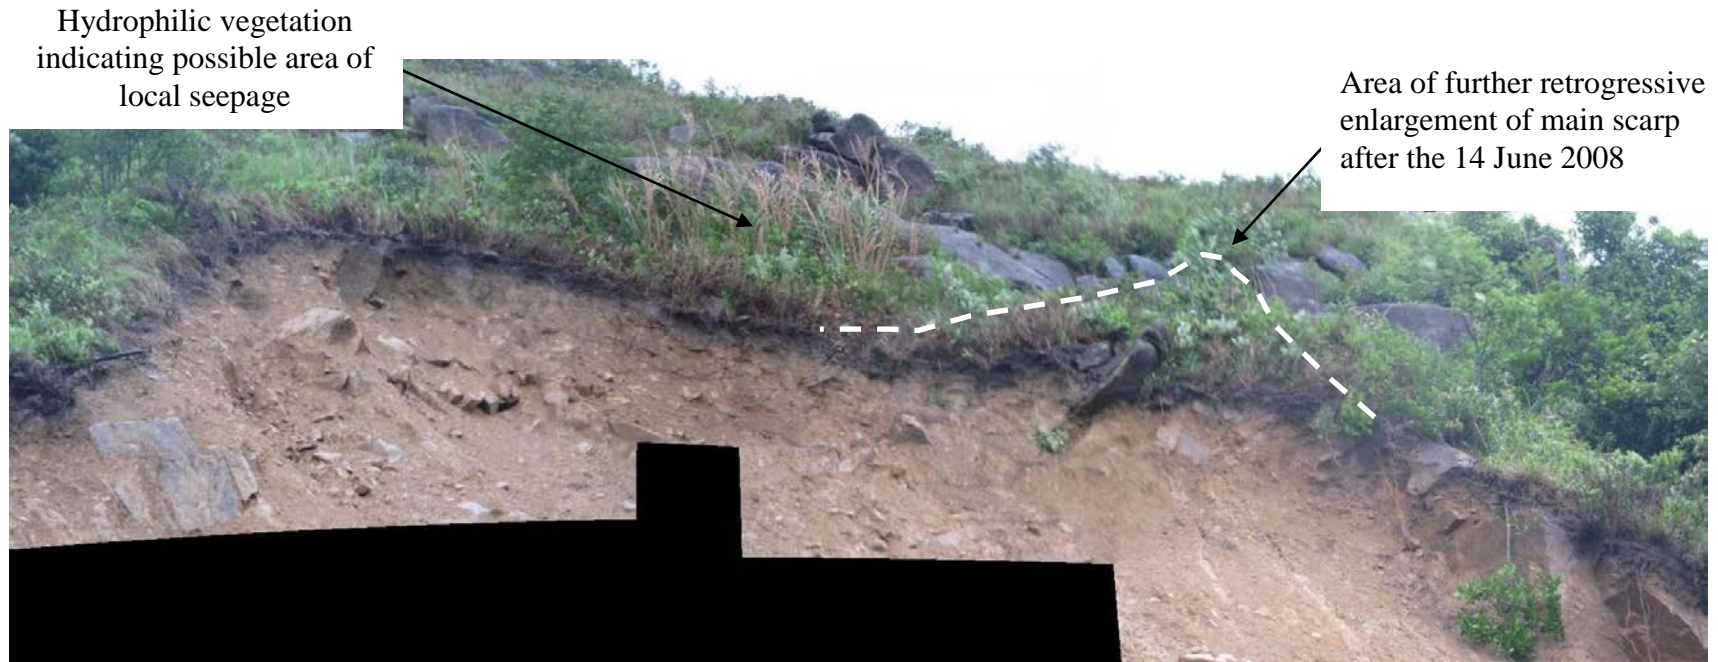
Plate 23 - Detailed Panoramic View along the Crown of the 7 June 2008 Landslide (Photograph taken on 13 June 2008)

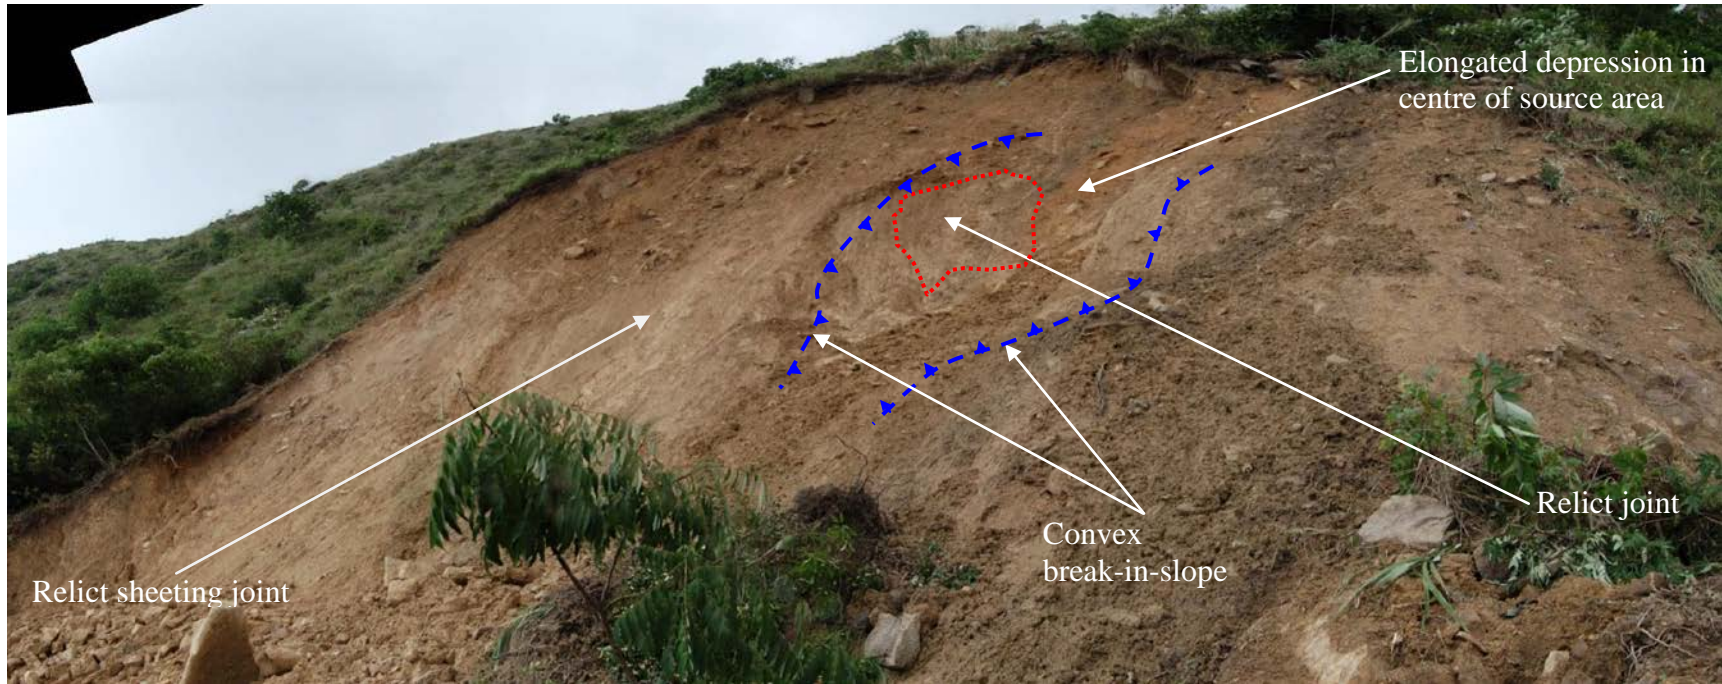
Plate 24 - Panoramic View of the Source Area from the East Flank (Photograph taken on 10 June 2008)

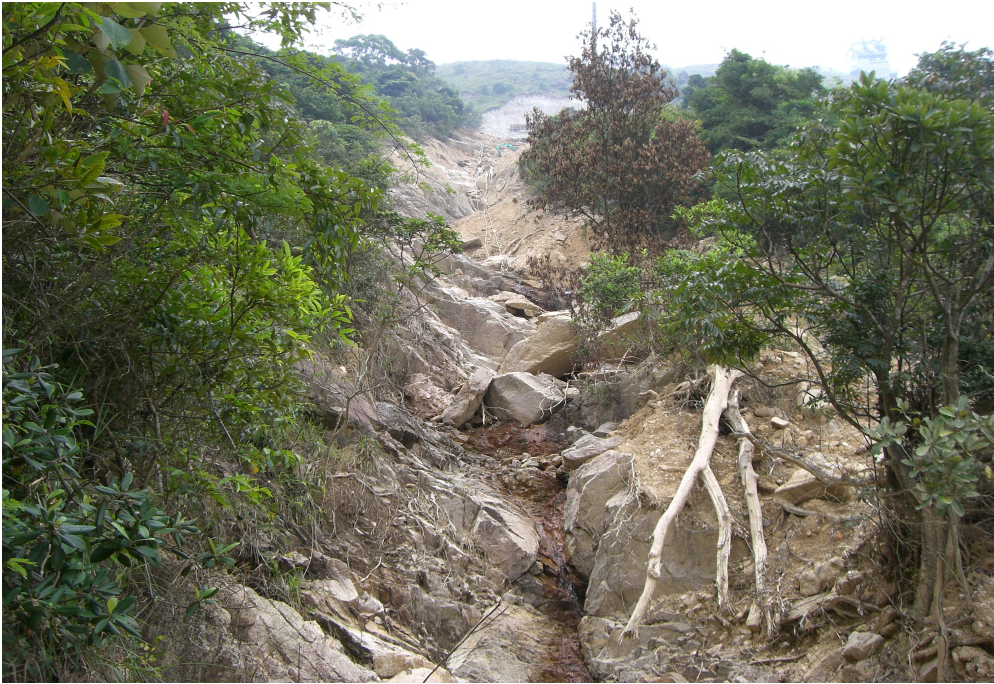
Plate 32 - Upslope View along Channelised Debris Flow Path at about CH185
(Photograph taken on 29 July 2008)

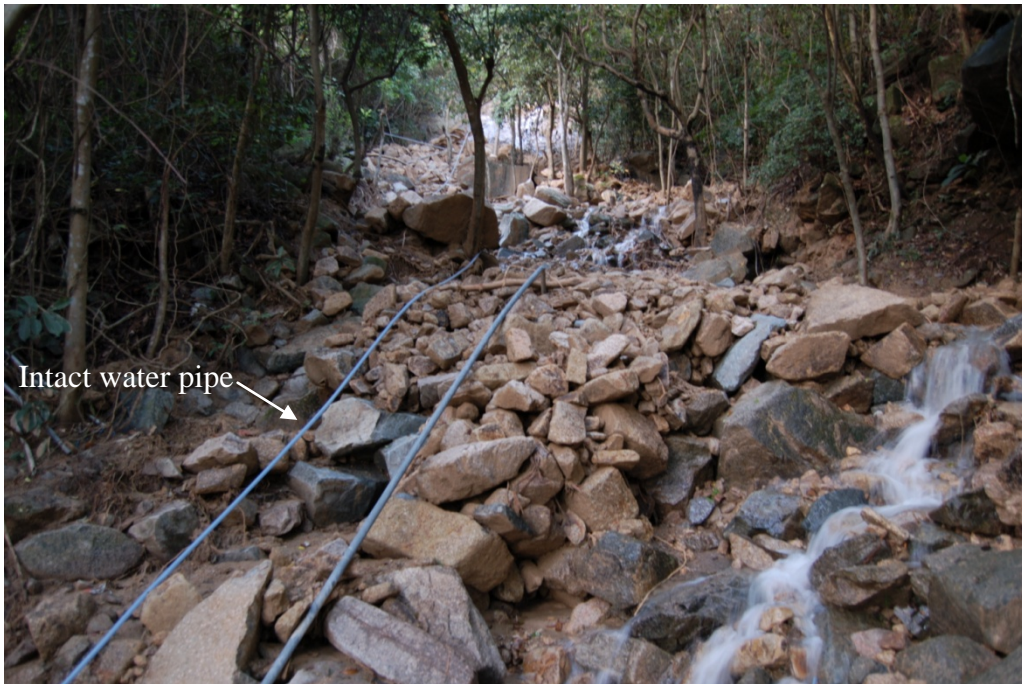
Plate 38 - Upstream View of Primary Drainage Line at about CH320
(Photograph taken on 11 June 2008)

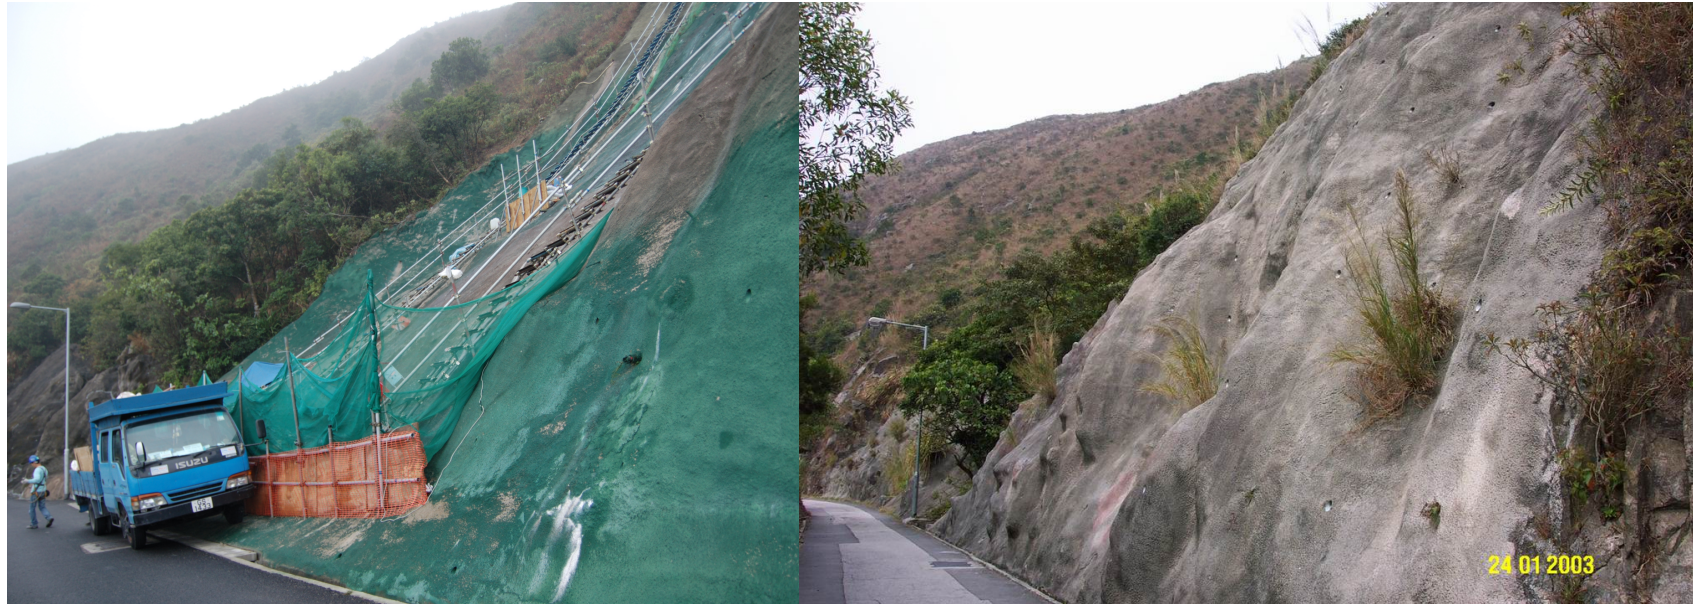
Plate 41 - Post-landslide Slope Profile in January 2010 when the Ground Investigation Works were Undertaking, and Contrasting with the Pre-failure Slope Profile in 2003

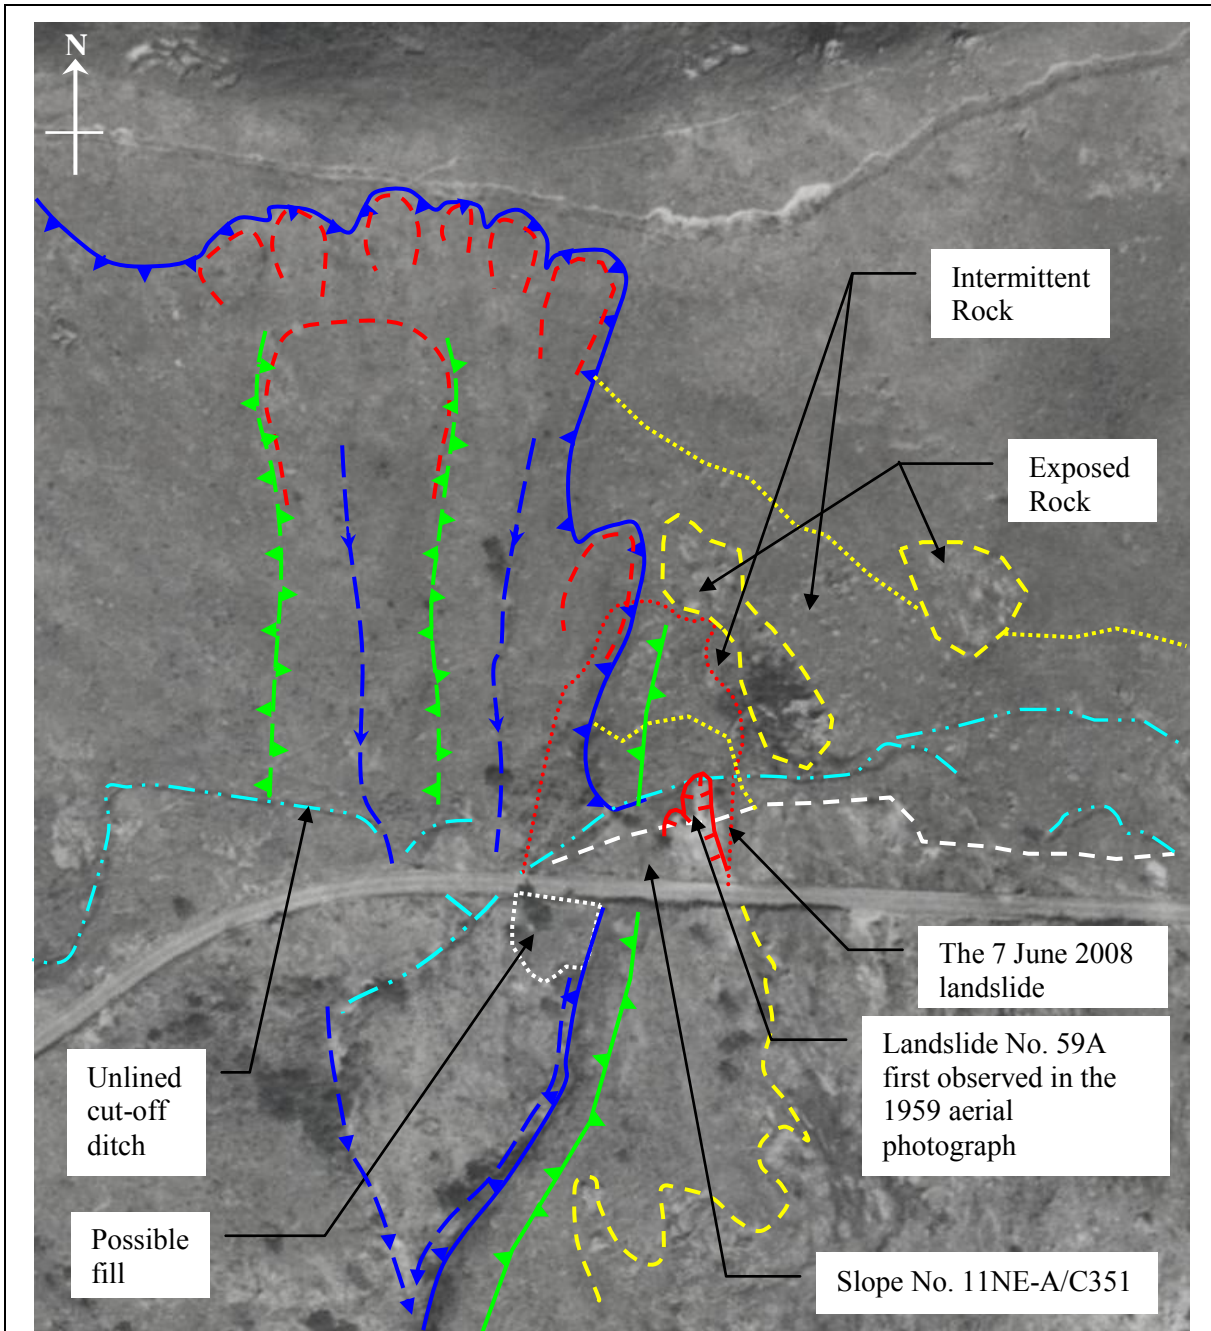
Plate A4 - Interpretation of the 1963 Aerial Photograph Showing the Landslide Source

An unlined drainage channel or ditch, located about 5 to 10 m above the crest of the failed slope No. 11NE-D/C351, is visible in the 1963 aerial photographs (Figure A1 and Plate A4). Similar unlined drainage channels are also visible above many of the slopes along Shatin Pass Road. The alignment of the drainage ditches is broadly parallel to the crest of the cut slopes formed along Shatin Pass Road. Two recent landslides that occurred right below the drainage ditch (labelled 59A and 93A in Figure 4) on the failed slope are identified (see Section 5.3).

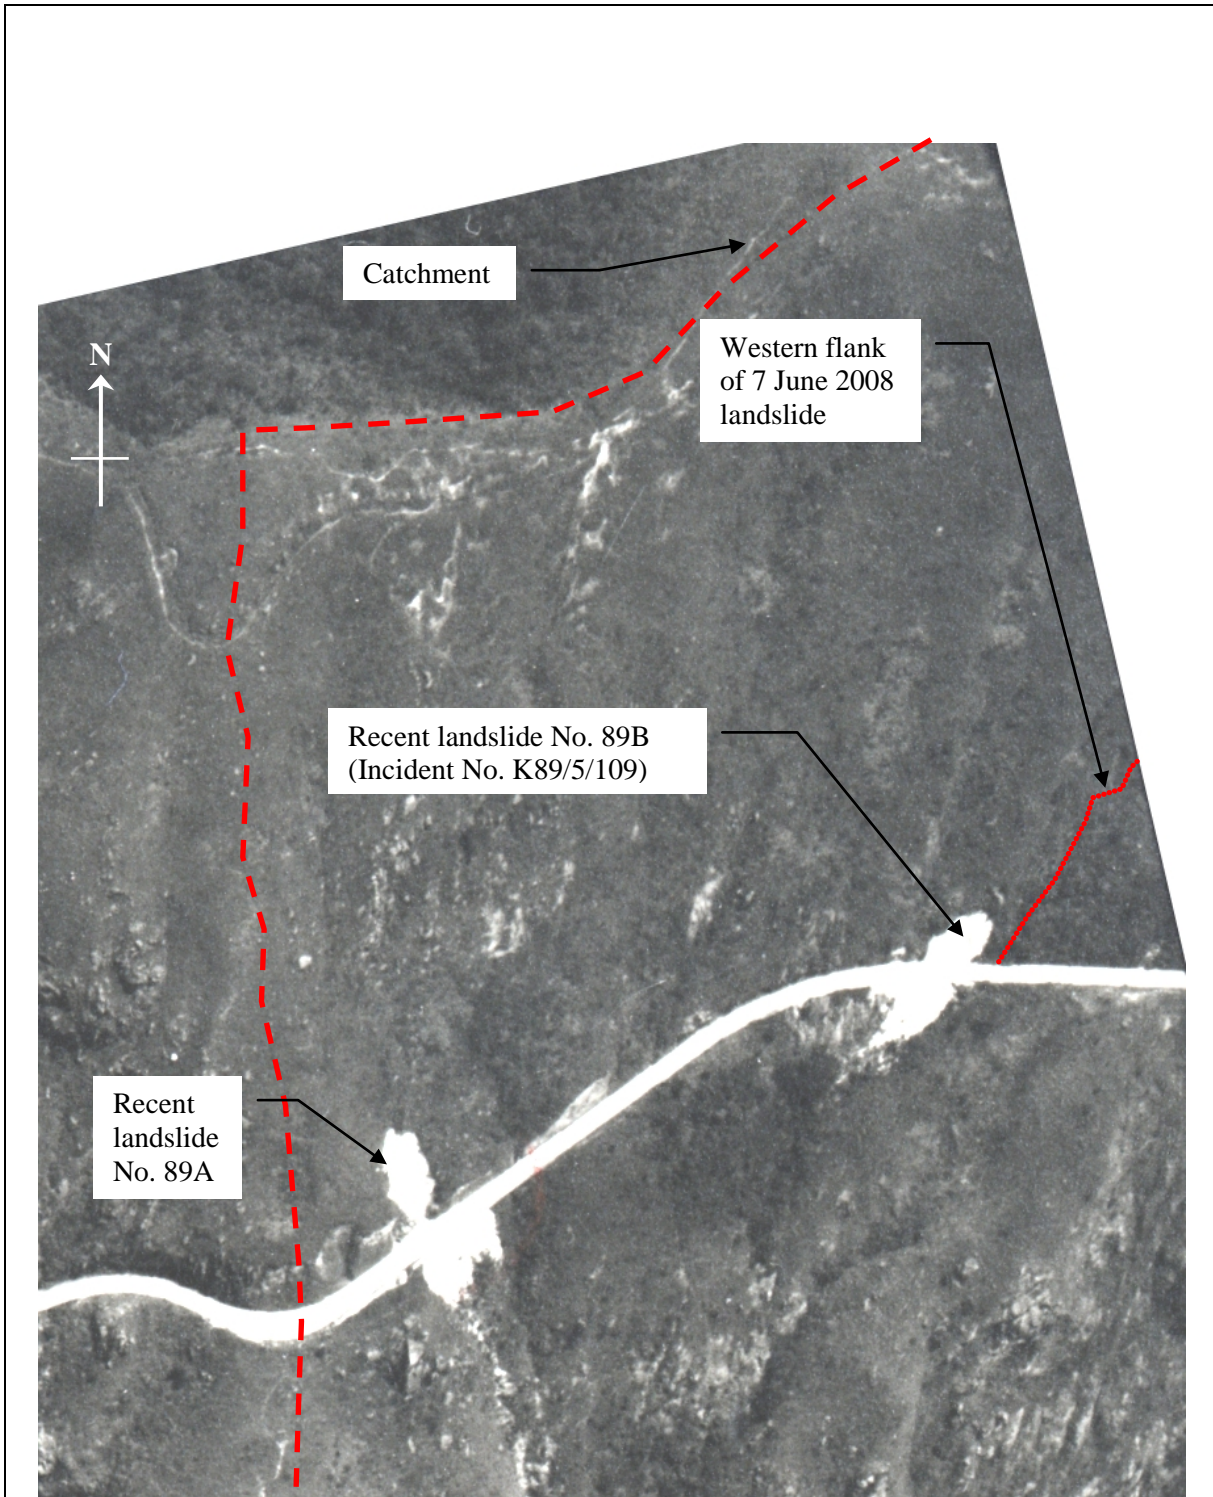
Plate A6 - Interpretation of the 1979 Oblique Aerial Photograph Showing the 7 June 2008 Landslide Source

Above the eastern portion of slope No. 11NE-A/C351 the exposed rock forms an irregular crenulated boundary with the saprolite above (Plate A6). This is probably due to a series of failures of the natural terrain above the cut slope which probably occurred during and soon after construction.

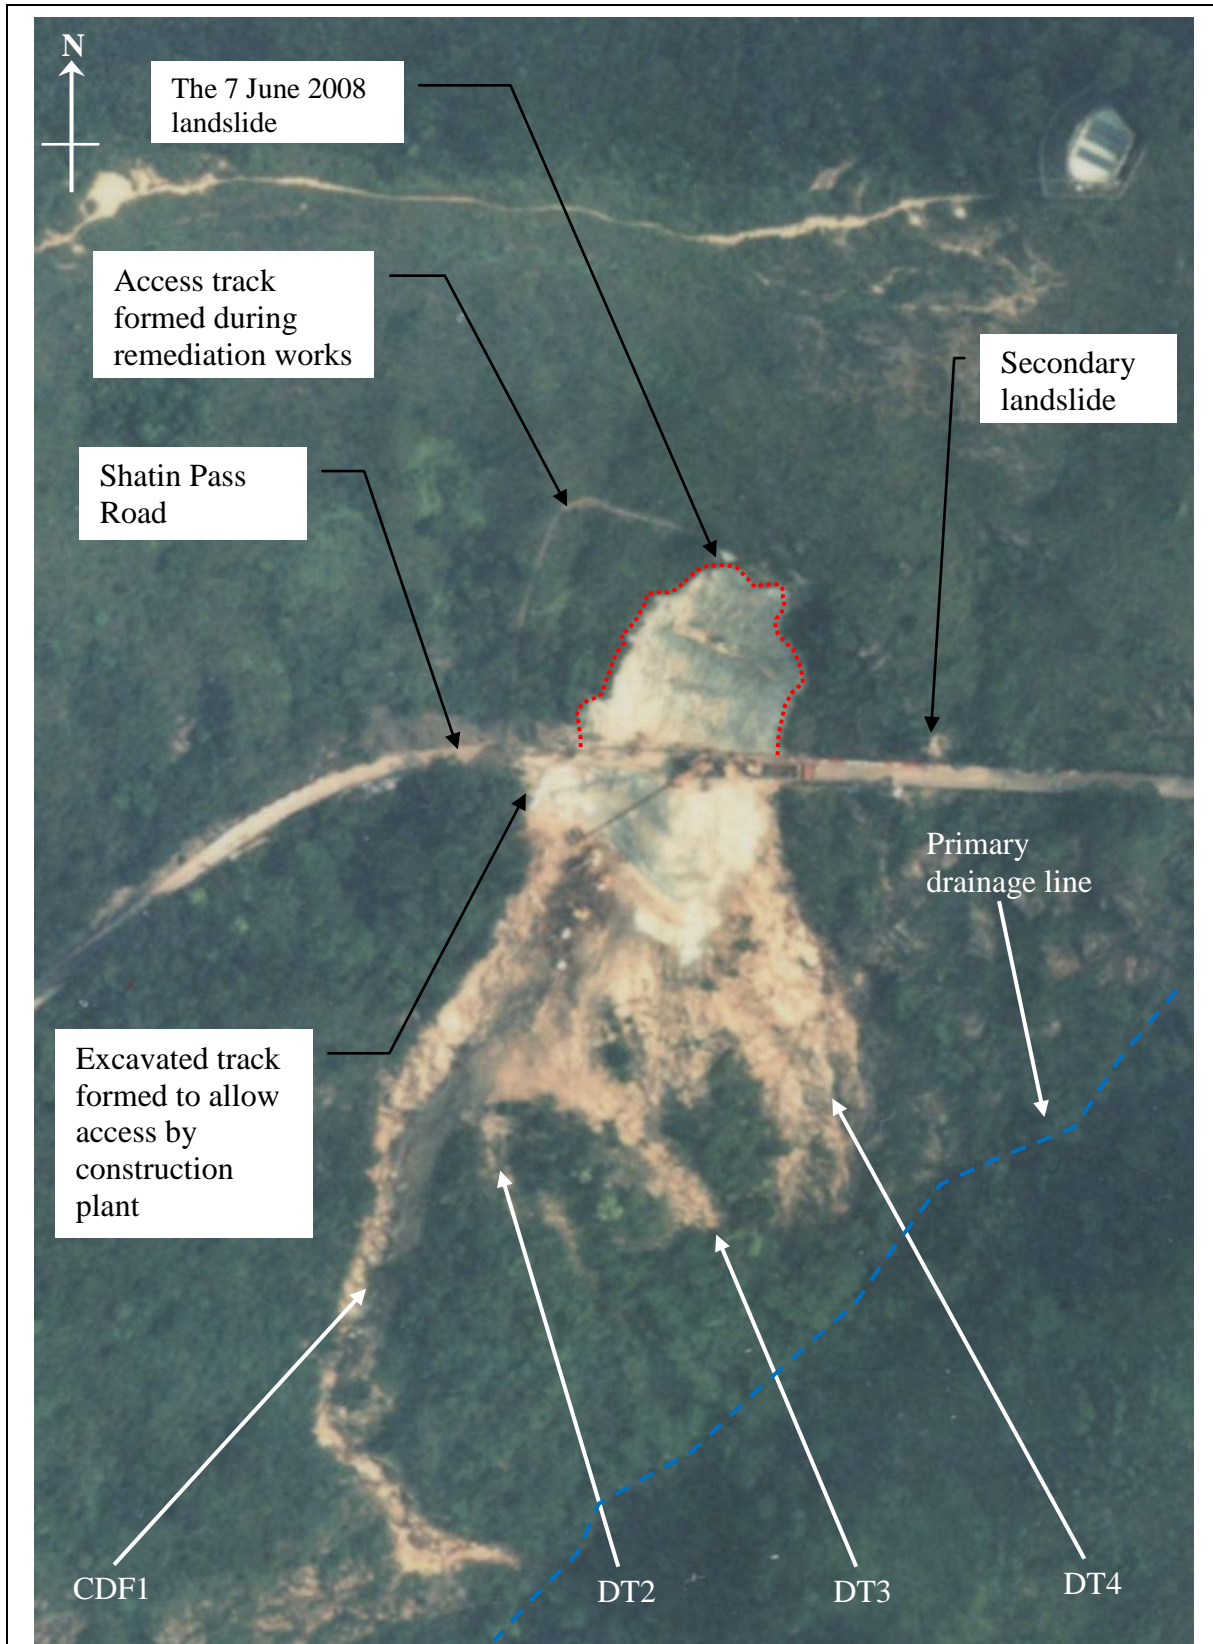
Plate A8 - Interpretation of the 1999 Aerial Photograph Showing the Landslide Source

The extent of the recent shotcrete is clearly visible (Plate A8). The scar of the 1989 landslide (labelled 89A on Figure A1) is largely clear of vegetation indicating further failure or soil erosion has occurred. A moderately large landslide is visible on the west flank of the primary drainage line in the southern portion of the landslide catchment (labelled 99A on Figure 1A).
