**REVIEW STUDY OF THE
7 JUNE 2008 LANDSLIDE
ON SLOPE NO. 11NE-A/C351
AND THE NATURAL HILLSIDE
ABOVE SHATIN PASS ROAD,
TSZ WAN SHAN**

GEO REPORT No. 302

AECOM Asia Company Limited

**This report is largely based on GEO Landslide Study Report
No. LSR 4/2010 produced in August 2010**

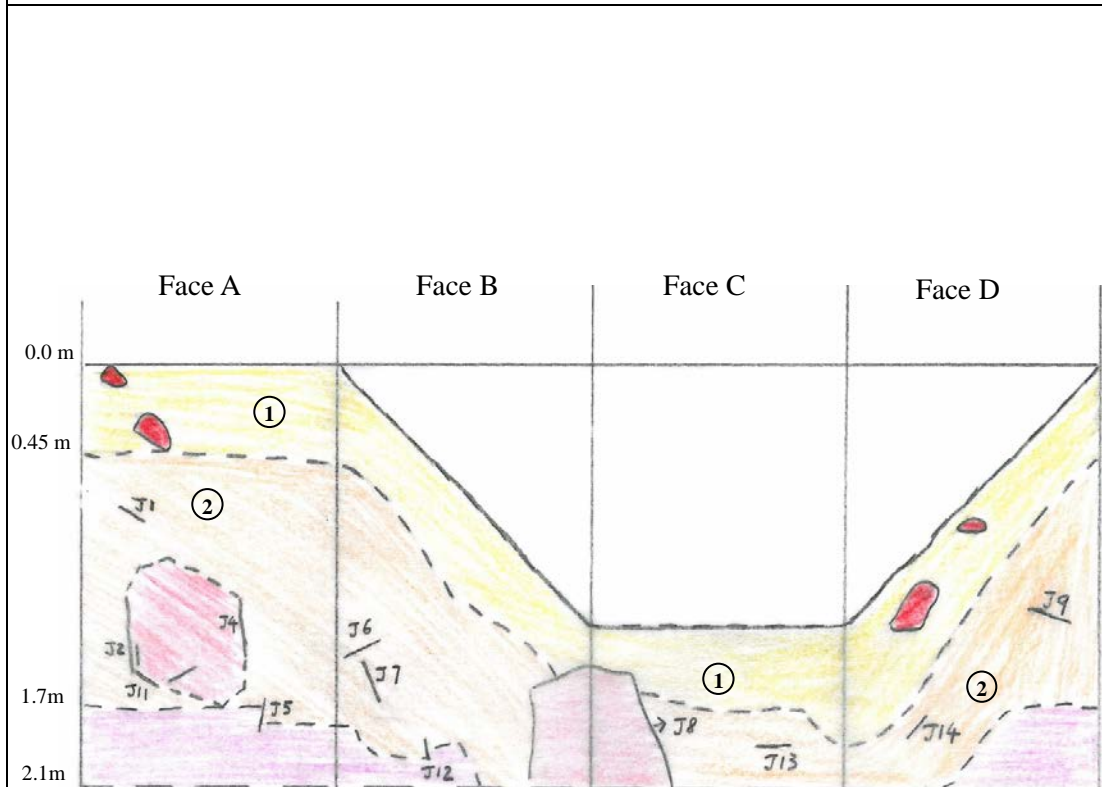
Figure D2 - Trial Pit Record for TP2

- ① Loose, dry to moist, grey (7.5YR6/1), clayey silty fine to medium SAND with some angular to subangular fine to coarse gravel and cobbles, occasional boulders of rock and quartz fragments and rootlets. [TOP SOIL]
- ② Extremely weak to very weak, very pale brown (10YR8/2), completely to highly decomposed medium grained GRANITE. (Slightly silty fine to coarse SAND with some fine to medium gravel) with closely spaced, extremely narrow to very narrow, iron and manganese oxide stained or colluviums soil infilled.
