Preliminary Back Analysis of Open Hillside Landslide Impacting on a Flexible Rockfall Barrier at Jordan Valley

GEO Report No. 308

**Geotechnical Engineering Office
Civil Engineering and Development Department
The Government of the Hong Kong
Special Administrative Region**

**Failure of Boulder Fence No. 11NE-A/ND8
above Slope No. 11NE-A/C872 near Choi Wan Road and Jordan Valley**

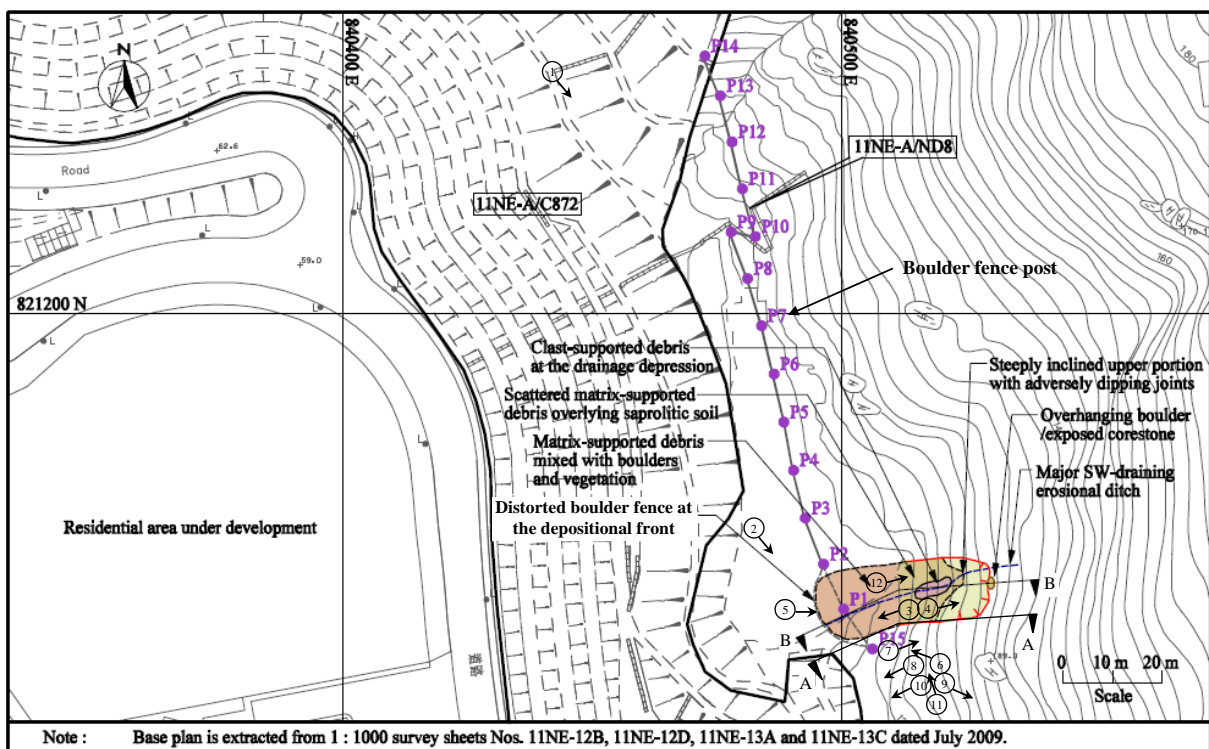
Figure 2.1 Locations of the Landslide Site and Flexible Rockfall Barrier No. 11NE-A/ND8

Site inspections by the LIC were carried out in December 2009 and April 2010. The Standards & Testing Division joined the inspection in April 2010. It was observed that landslide debris struck Post P1 and two ring net panels spanning across Posts P2-P1 and Posts P1-P15 (see Figure 2.1). The debris was largely retained by the barrier. There were no noticeable signs of overflow or marks left behind by a large amount of debris passing through the ring net. Close inspection of the ring net indicated that landslide debris, including fine grains, was arrested by the barrier (see Figure 2.2). Post P1 was severely damaged by debris impact. No signs of damage to Post P2 were evident. Post P15, which was located at the southern end of the barrier, was not subject to any direct impact by the landslide debris. However, Post P15 had bent and failed. It was also observed during the inspections that the energy dissipation devices attached to the uphill cable ropes of the barrier had not been mobilised, and no tensile failure of any cable ropes was apparent. Details of the site observations are presented in an inspection note prepared by the LIC. The inspection note is reproduced in Appendix A.

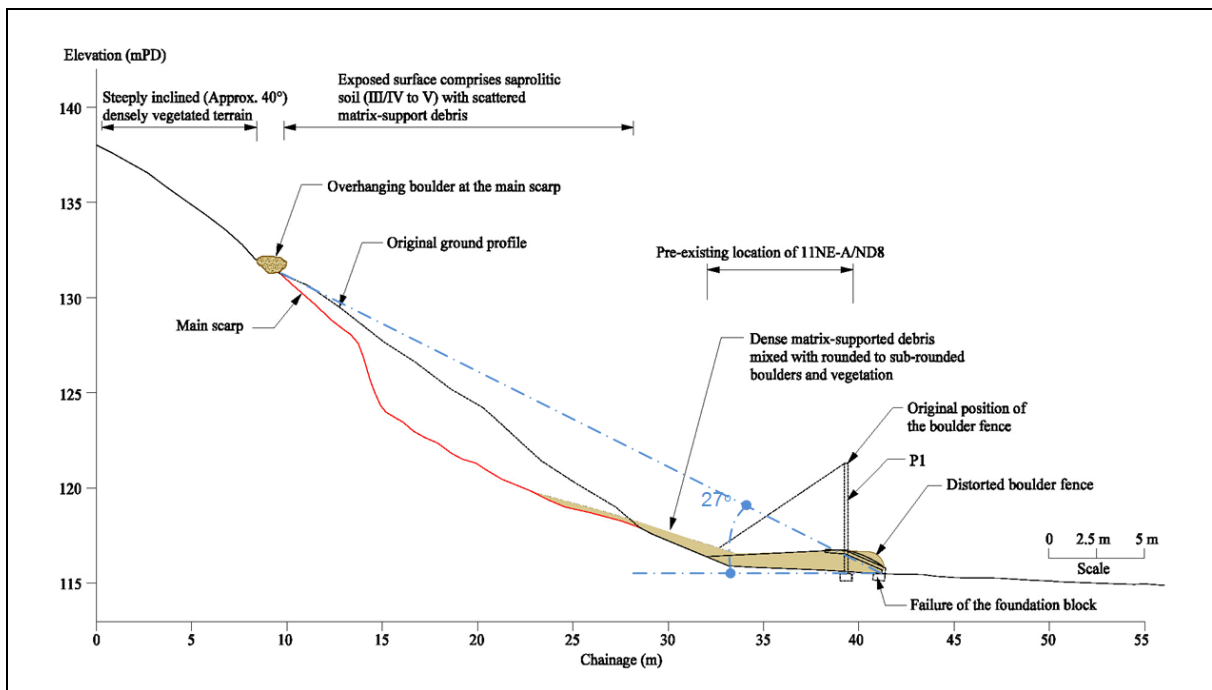
Figure 3.1 Cross-section of the Landslide Debris Trail

Figure 3.1 shows a cross-section (Section B-B of Figure 2.1) along the centerline of the landslide debris trail. The travel angle of the landslide debris, accounting for the retarding effect of the flexible barrier, is about 27° . This travel angle does not represent the

true mobility of the landslide debris because the debris was obstructed by the flexible barrier. If the frictional rheology is adopted to back analyse the landslide mobility, an apparent basal friction angle (ϕ) of less than 27° should be used. GEO (2012) presents a review of the mobility of open hillside failures, which shows that the lower bound value of ϕ for open hillside failures in Hong Kong is 25° for landslide volume less than 500 m^3 . It is therefore assumed that the ϕ value of this Jordan Valley landslide could be around 25° to 26° , and a ϕ value of 25° has been adopted in the back analysis. Computer program 2d-DMM (Kwan & Sun, 2006) was used for the analysis. Table 3.1 shows the debris velocity hydrograph and the debris thickness hydrograph at the original barrier location based on the 2d-DMM analyses.

According to the results of the 2d-DMM analyses, the maximum frontal debris velocity at the location of the flexible barrier was about 4 m/s. After the peak value, the velocity drops to zero within 2 seconds. The calculated maximum debris thickness is about 1.2 m, which is generally consistent with the site observations.

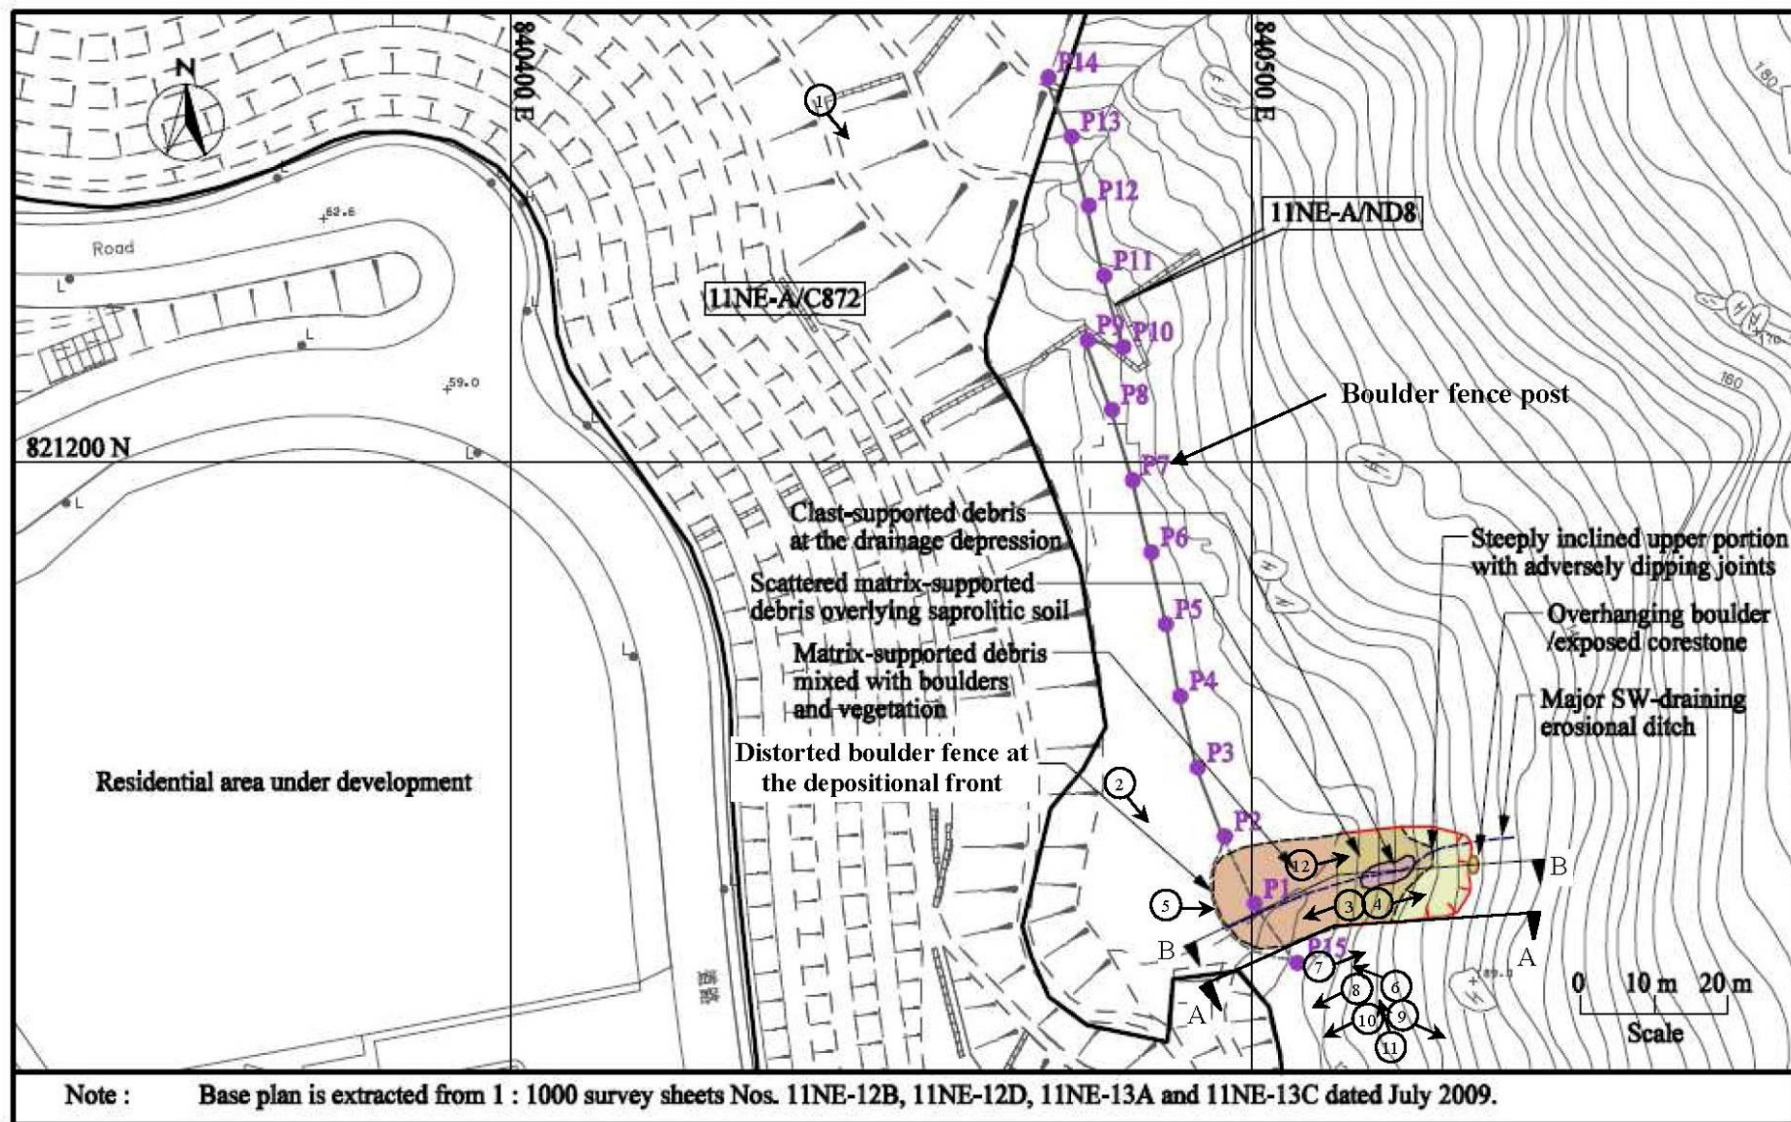
Figure 1 Location Plan

- 1.1 The open hillslope failure (Incident No. LI/2009/12/2001) occurred on a west-facing hillside above Slope No. 11NE-A/C872 (Figure 1 and Plate 1). The failure volume was about 110 m³. The landslide debris damaged an approximately 10 m section of boulder fence No. 11NE-A/ND8 (Plates 2 and 3).

- 4.1 The debris was contained by the first and second span of the boulder fence (Figure 1). The netting of the first and second span, together with the intermediate post (i.e. post No. P1), was pushed forward by the debris and displaced up to 2.2 m in the downslope direction (Figure 4). Post No. P1 was severely deformed (Plate 5). The other components of the system, which have been damaged as a result of the incident, included side post No. P15 in the south (Figure 3 and Plate 6) and the lateral anchor connected to post No. 15 (Plate 8). No apparent signs of damage or movement were observed on Post 2.

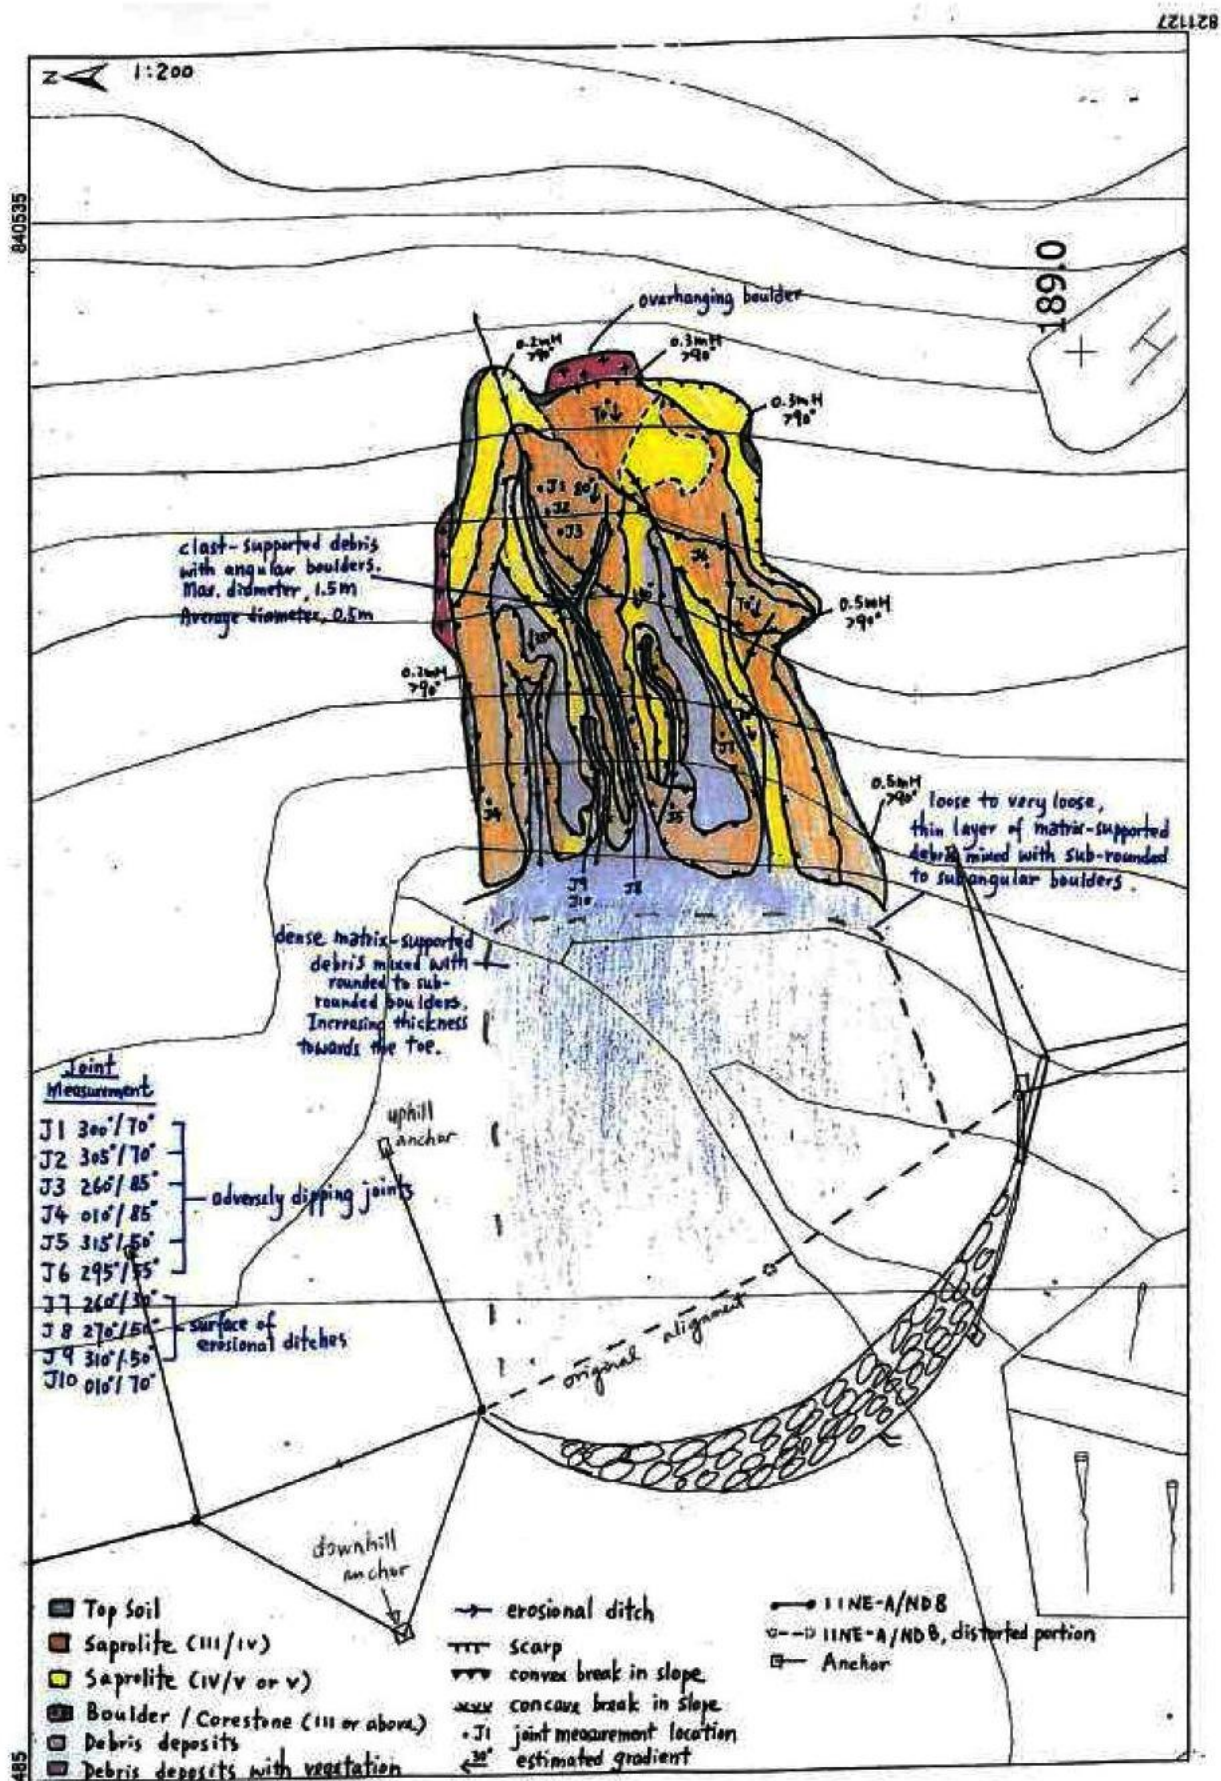
Figure 2 Sketch Plan of the Landslide

- 2.1 The open hillslope failure occurred below an area of exposed rock outcrop with overhanging boulders. The scar measured approximately 18 m long by 10 m wide, up to 3.5 m deep (Figures 2 to 4). The displaced volume is about 110 m³.
- 2.2 The upper portion of the source area comprises predominately saprolitic terrain, and is steeply inclined (> 50°) with adverse dipping joints (Figure 2 and Plate 4).
- 2.3 The lower portion of the source area comprises predominately matrix-supported debris overlying saprolite. The debris was dry at the time of inspection in December 2009. After the debris was removed, it can be seen that the lower portion of the landslide source area is sloping at 30° to 40°.

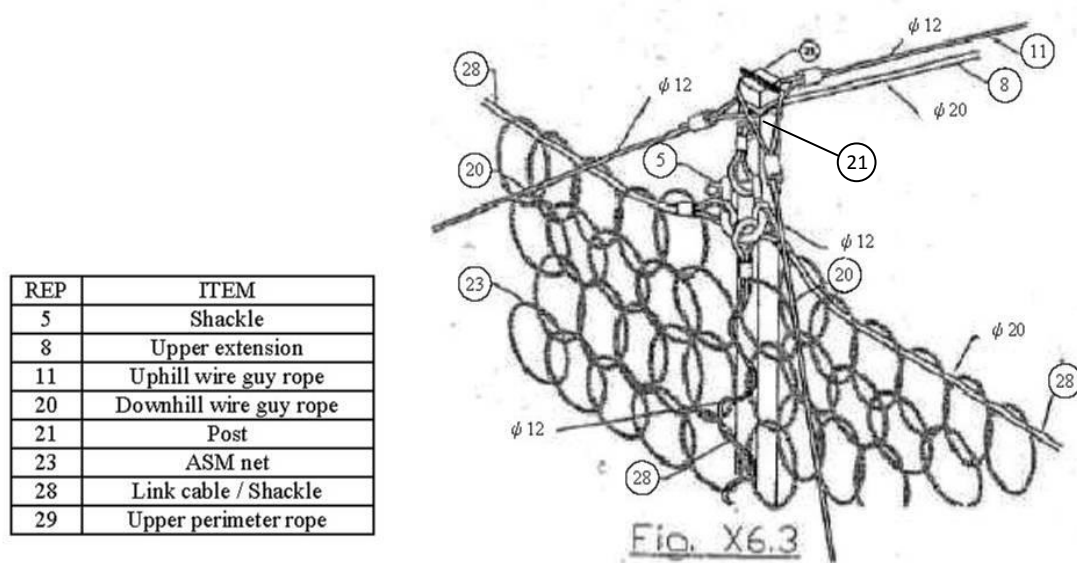
**Figure 6 Details of the Arrangement at the Upper End of a Steel Post
(Abstract of Fig. X6.3 from Drawing No. P-010/AS/02)**

Site inspections revealed that brake elements attached to the uphill anchor cables were not activated and hence item (f) above is pertinent. Based on the details shown on as-built records (see Fig. X6.3 and Fig. X6.4 on Drawing no. P-010/AS/02 in Appendix A), the cables were threaded through small holes (120 mm in diameter) in the barrier posts and were connected to the top and bottom ropes. Activation of the brake elements would have required adequate extension of the uphill cables before failure of the posts. According to LMM (2004), the uphill cables are supposed to slide through the holes in the posts, in order to create sufficient cable extensions so as to mobilise the brake elements (see Figure 6.1). However, it was observed that movement of the cables could have been restrained by the friction between the cable and the post. This might be one of the factors that led to the observed non-performance of the brake elements. Apart from this, there could be other possible contributory factors. The brake elements of the flexible barrier were positioned close to the ground surface and as such, they might have been buried by the landslide debris before or when the barrier was struck, which could impede the mobilisation of the brake elements (see Plates 10 and 11 of Appendix A). Displacement and deformation of the posts resulting in structural failure and foundation failure could also have played a role in this regard, as these could affect the movement of the cable through the hole in the post.

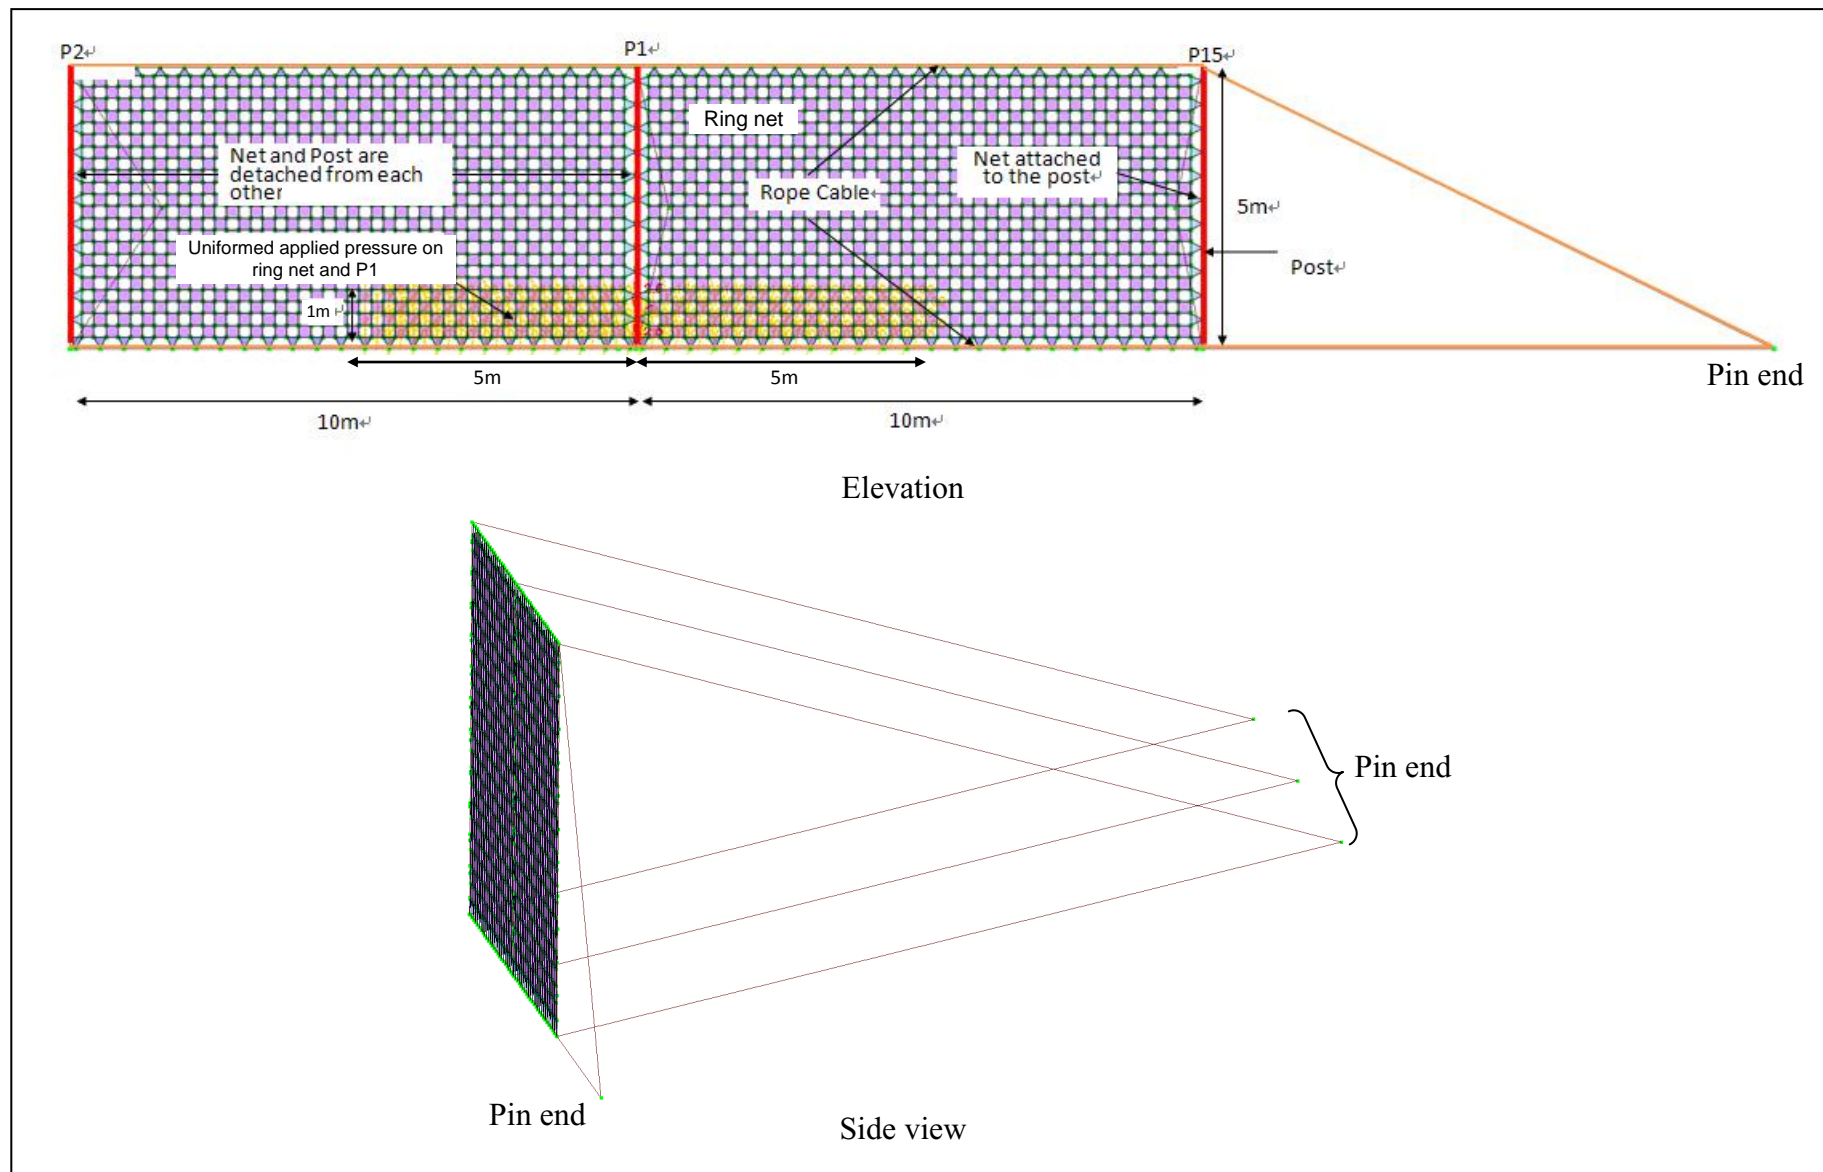
Figure B3 Set-up of the Numerical Model

The two panels of the rockfall barrier spanning across Posts P1, P2 and P15, which were struck by landslide debris, are considered in the numerical analysis. The model set-up and assumed boundary conditions are shown in Figure B3.

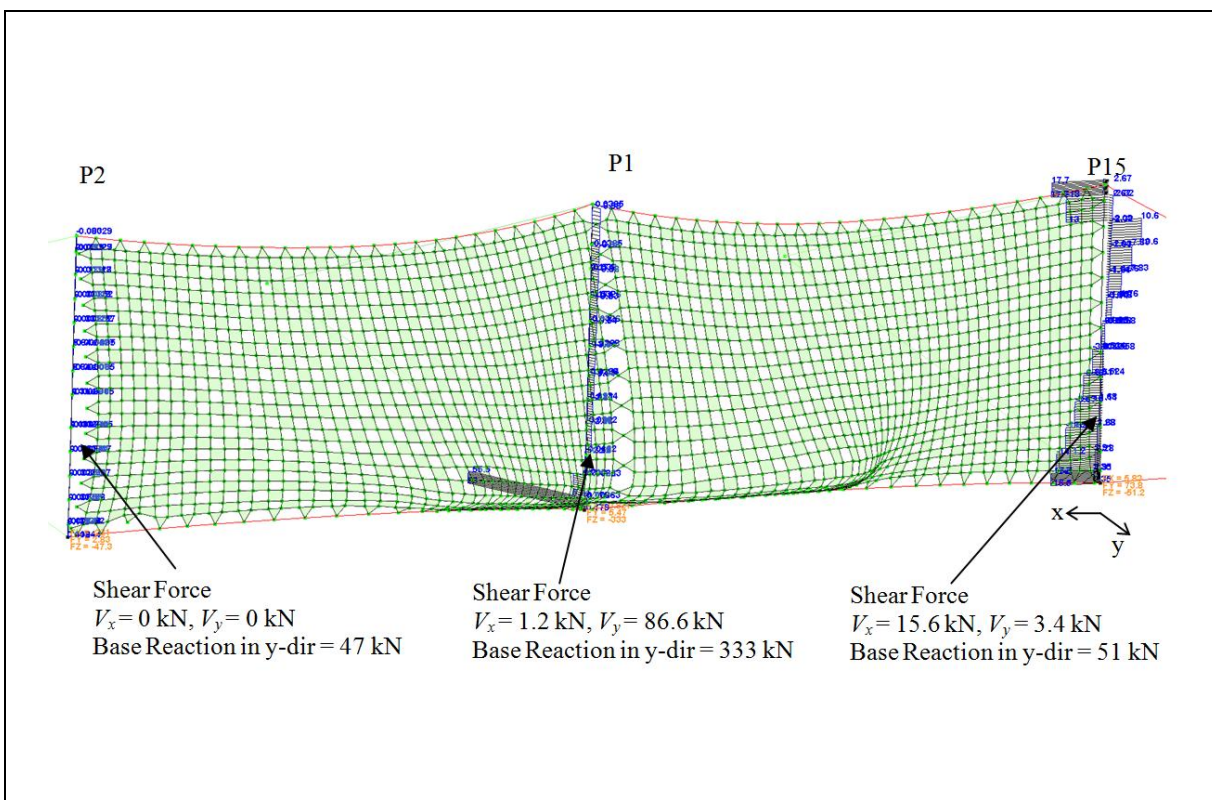
Figure B6 Shear Force Diagrams of the Posts under UDP of 50 kPa

Different magnitudes of UDP are used in the analysis with an aim to replicating the observations numerically. Results show that both Posts P1 and P15 could fail by buckling when the applied UDP was increased to 50 kPa. According to the NIDA-MNN analysis, the large bending moment of P1 could result from the direct impact of landslide debris. For P15, analysis shows that the post is subject to bending moment and shear forces induced by load transferred from the ring net attached to the post. P15 probably experienced an axial compression load larger than that in P1. This larger compression load could be due to the downward forces brought about by the uphill and inclined anchor cables attached to the top of the post, as well as the deformed ring net that is connected to the post. Structural calculations (see Section B.5) show that the combined actions of bending, shear and compression could result in a buckling failure of the post. This is a possible failure mechanism of P1 and P15. In addition, the calculated base shear forces of P1 and P15 exceed the estimated sliding resistance of the footings of the posts. This agrees with the site observations that the corresponding footings had displaced from their original locations.

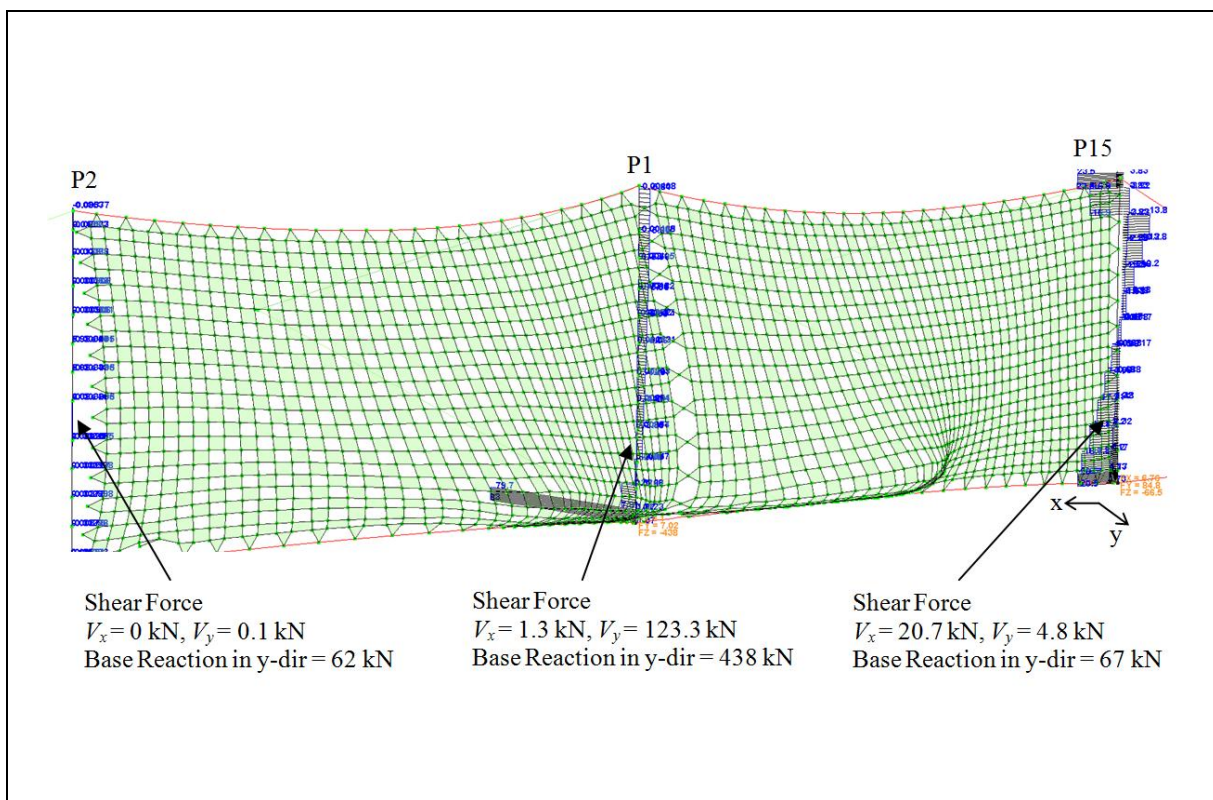
Figure B8 Shear Force Diagrams of the Posts under UDP of 66 kPa

NIDA-MNN analysis assuming magnitudes of UDP higher than 50 kPa has also been carried out. When UDP is increased to 66 kPa, the lower rope cable would be stressed to a level that exceeds the ultimate tensile capacity (270 kN) of the cable as advised by the barrier manufacturer. Therefore, analysis based on UDP of magnitude exceeding 66 kPa has not been undertaken. For this range of UDP (i.e. 50 kPa to 66 kPa), the calculated forces, including the base shear force, of Post P2 are not large, and structural failure or foundation failure of P2 is not likely, which is consistent with the site observation.

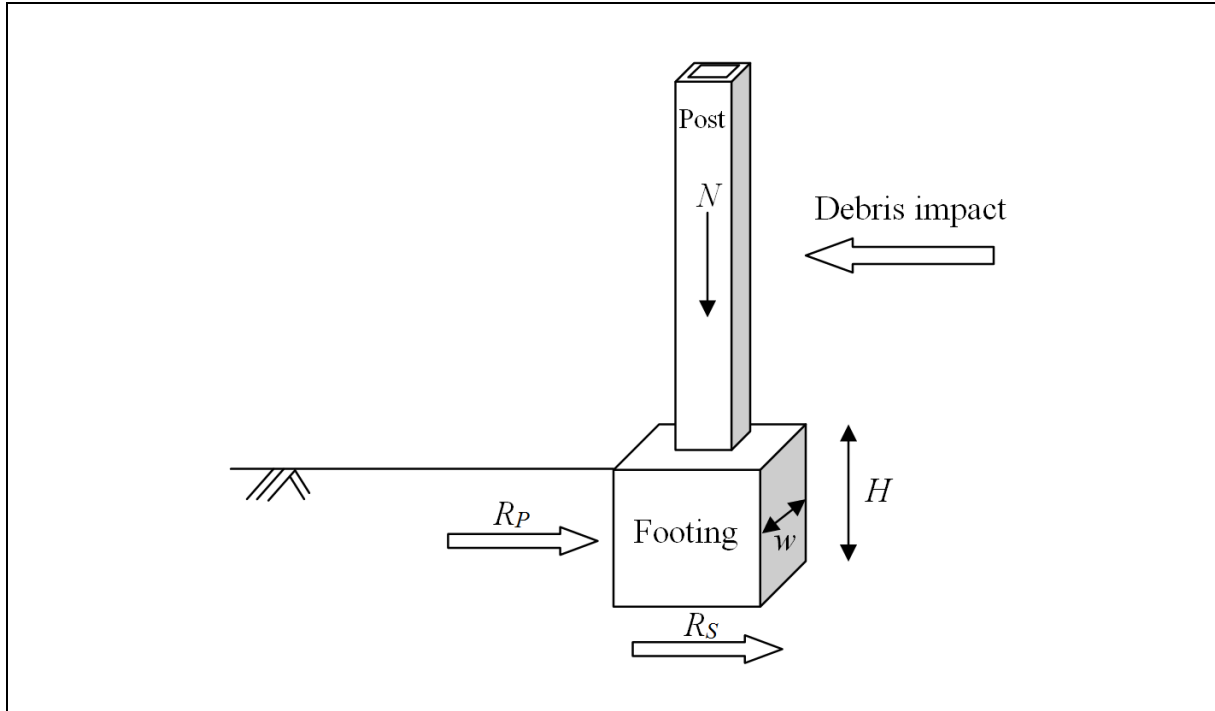
Figure B9 Schematic Drawing for Post and Footing

The calculated base reaction in the debris impact direction at the foundation of Post P1 is 333 kN at UDP of 50 kPa, which is larger than the sliding resistance (R_s) of the shallow footing as estimated below:

Total ultimate sliding resistance of the shallow footing = $7 + 48 = 55 \text{ kN} < 333 \text{ kN}$.
