**Detailed Study of the 21 May 2016
Landslide on the Natural Hillside
above Slope No. 8SE-A/F34
at Sai Kung Sai Wan Road, Sai Kung**

GEO Report No. 336

AECOM Asia Company Limited

**Geotechnical Engineering Office
Civil Engineering and Development Department
The Government of the Hong Kong
Special Administrative Region**

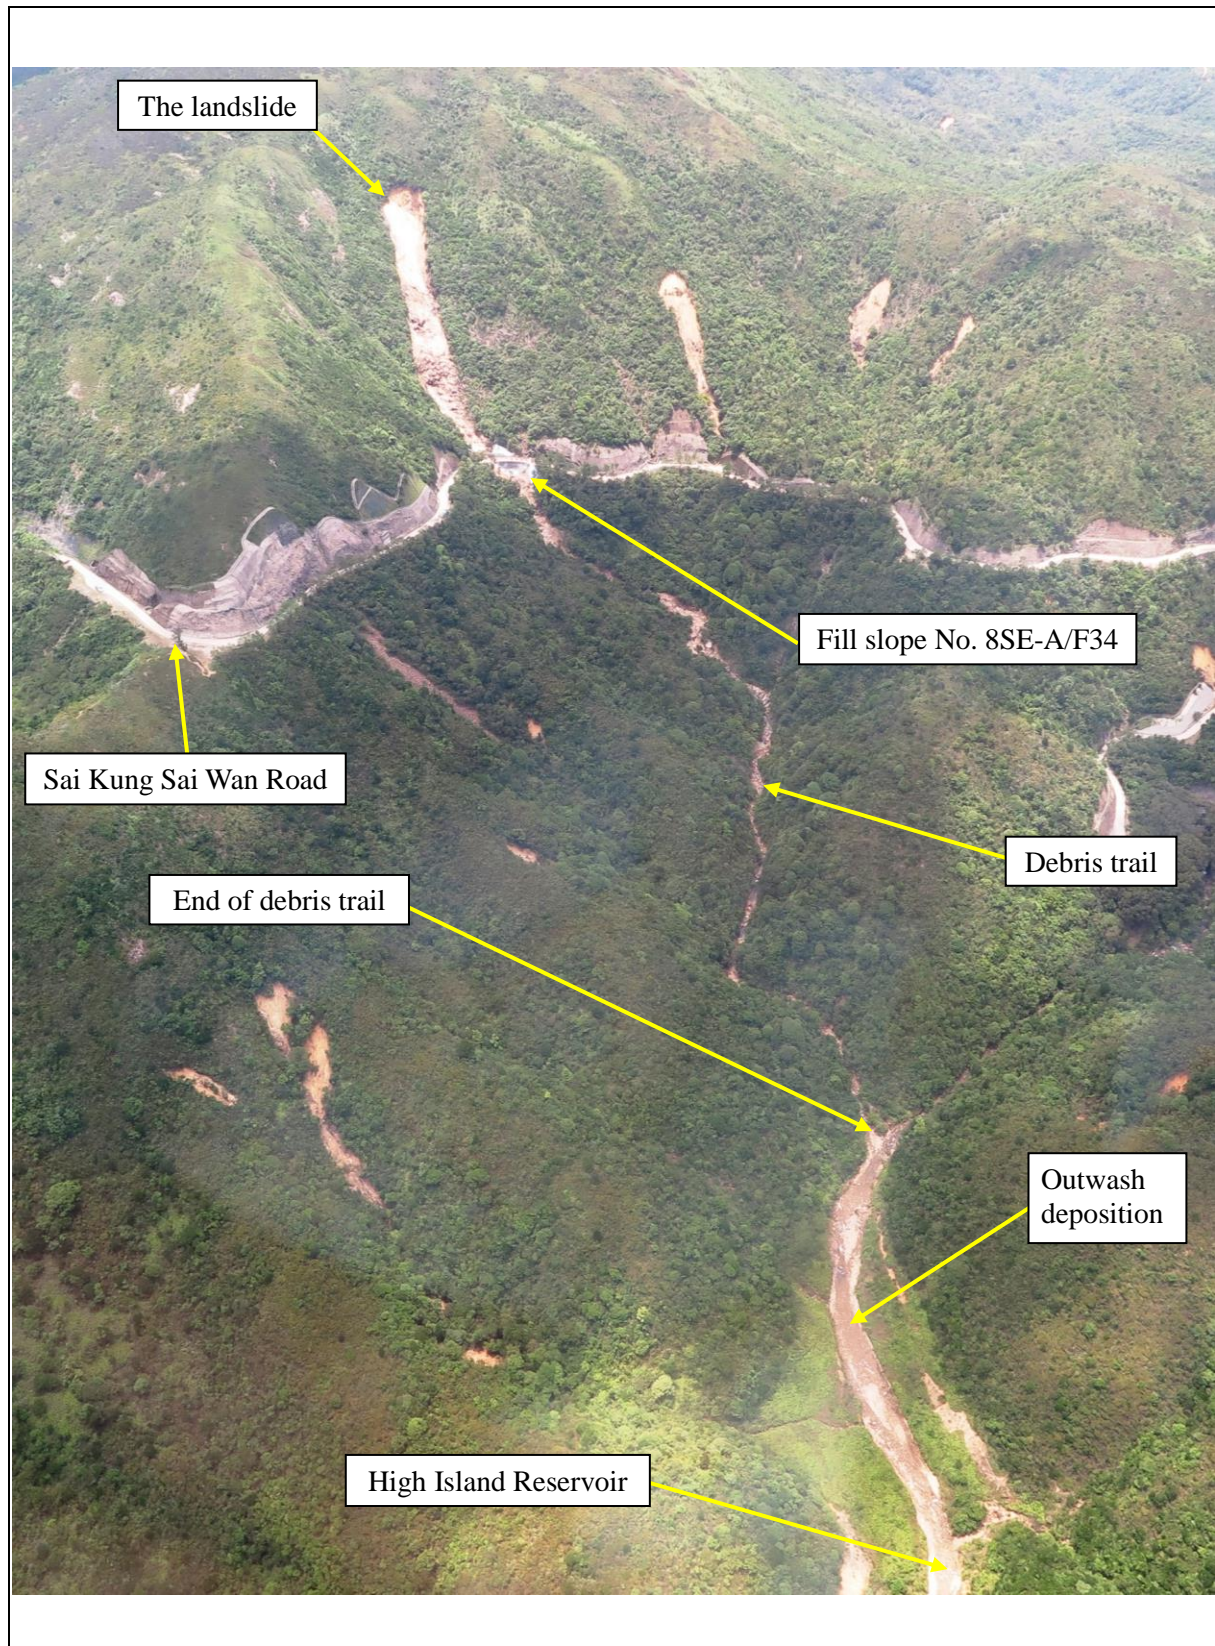
Figure 1.2 General View of the Study Area Showing the Landslide
(Photograph taken on 30 May 2016)

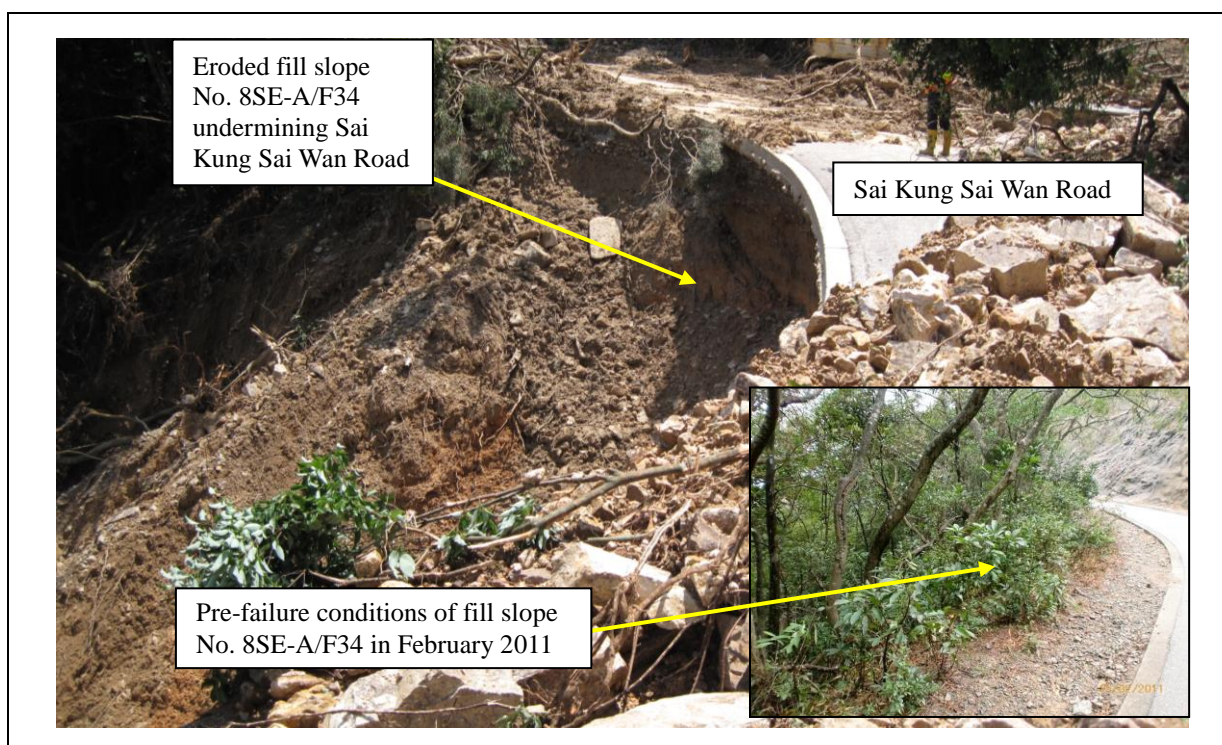
Figure 1.4 View of Slope No. 8SE-A/F34 (Photograph taken on 22 May 2016)

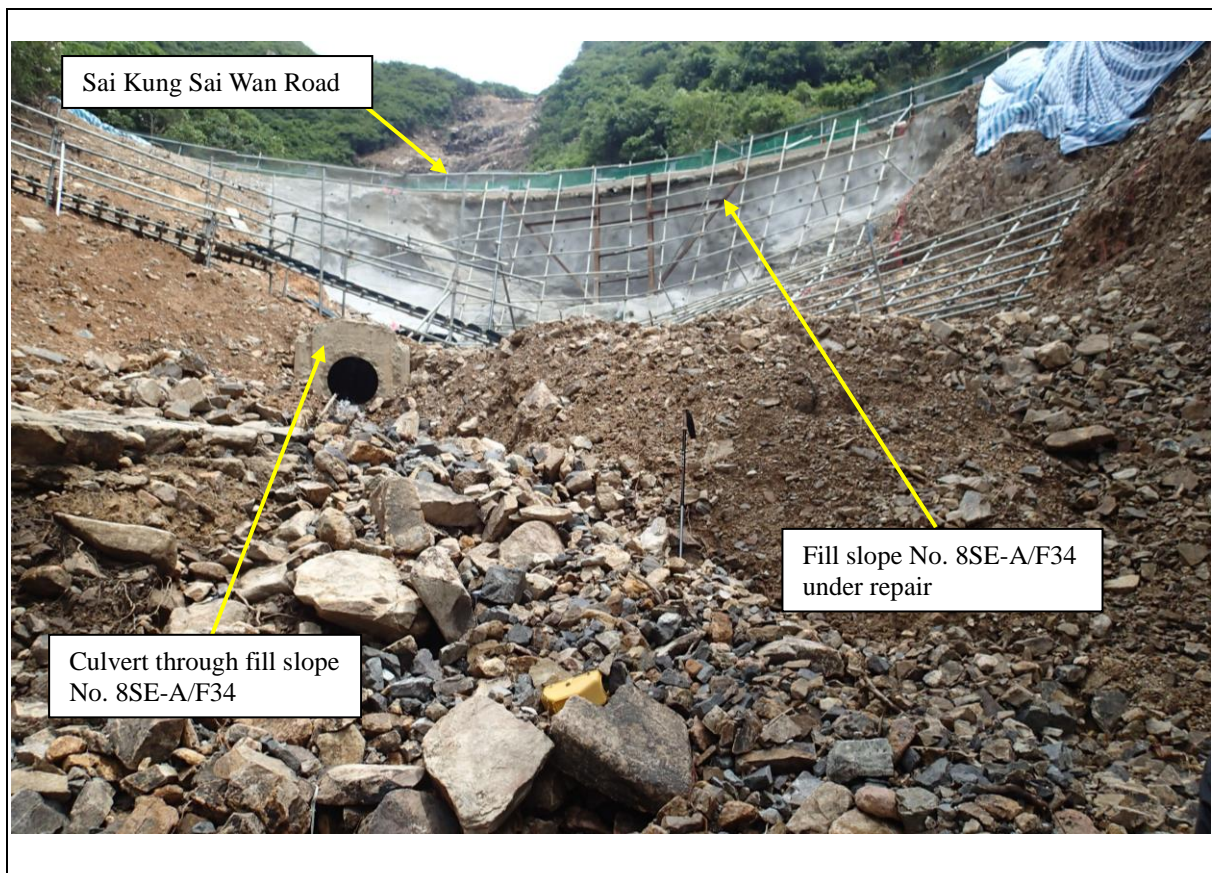
The study area contains several perennial and ephemeral drainage lines which drain down to the northern part of High Island Reservoir (Figure 2.2). The landslide scar intersects one perennial drainage line (DL1) just below the source area and another minor ephemeral drainage line is located along the west flank of the source area. A culvert carries the drainage water below Sai Kung Sai Wan Road, through fill slope (Slope No. 8SE-A/F34), and discharges into the confined natural drainage line below (Figures 2.1 and 2.3).

Figure 2.3 View Upslope from CH136 to CH165 (Photograph taken on 14 June 2016)

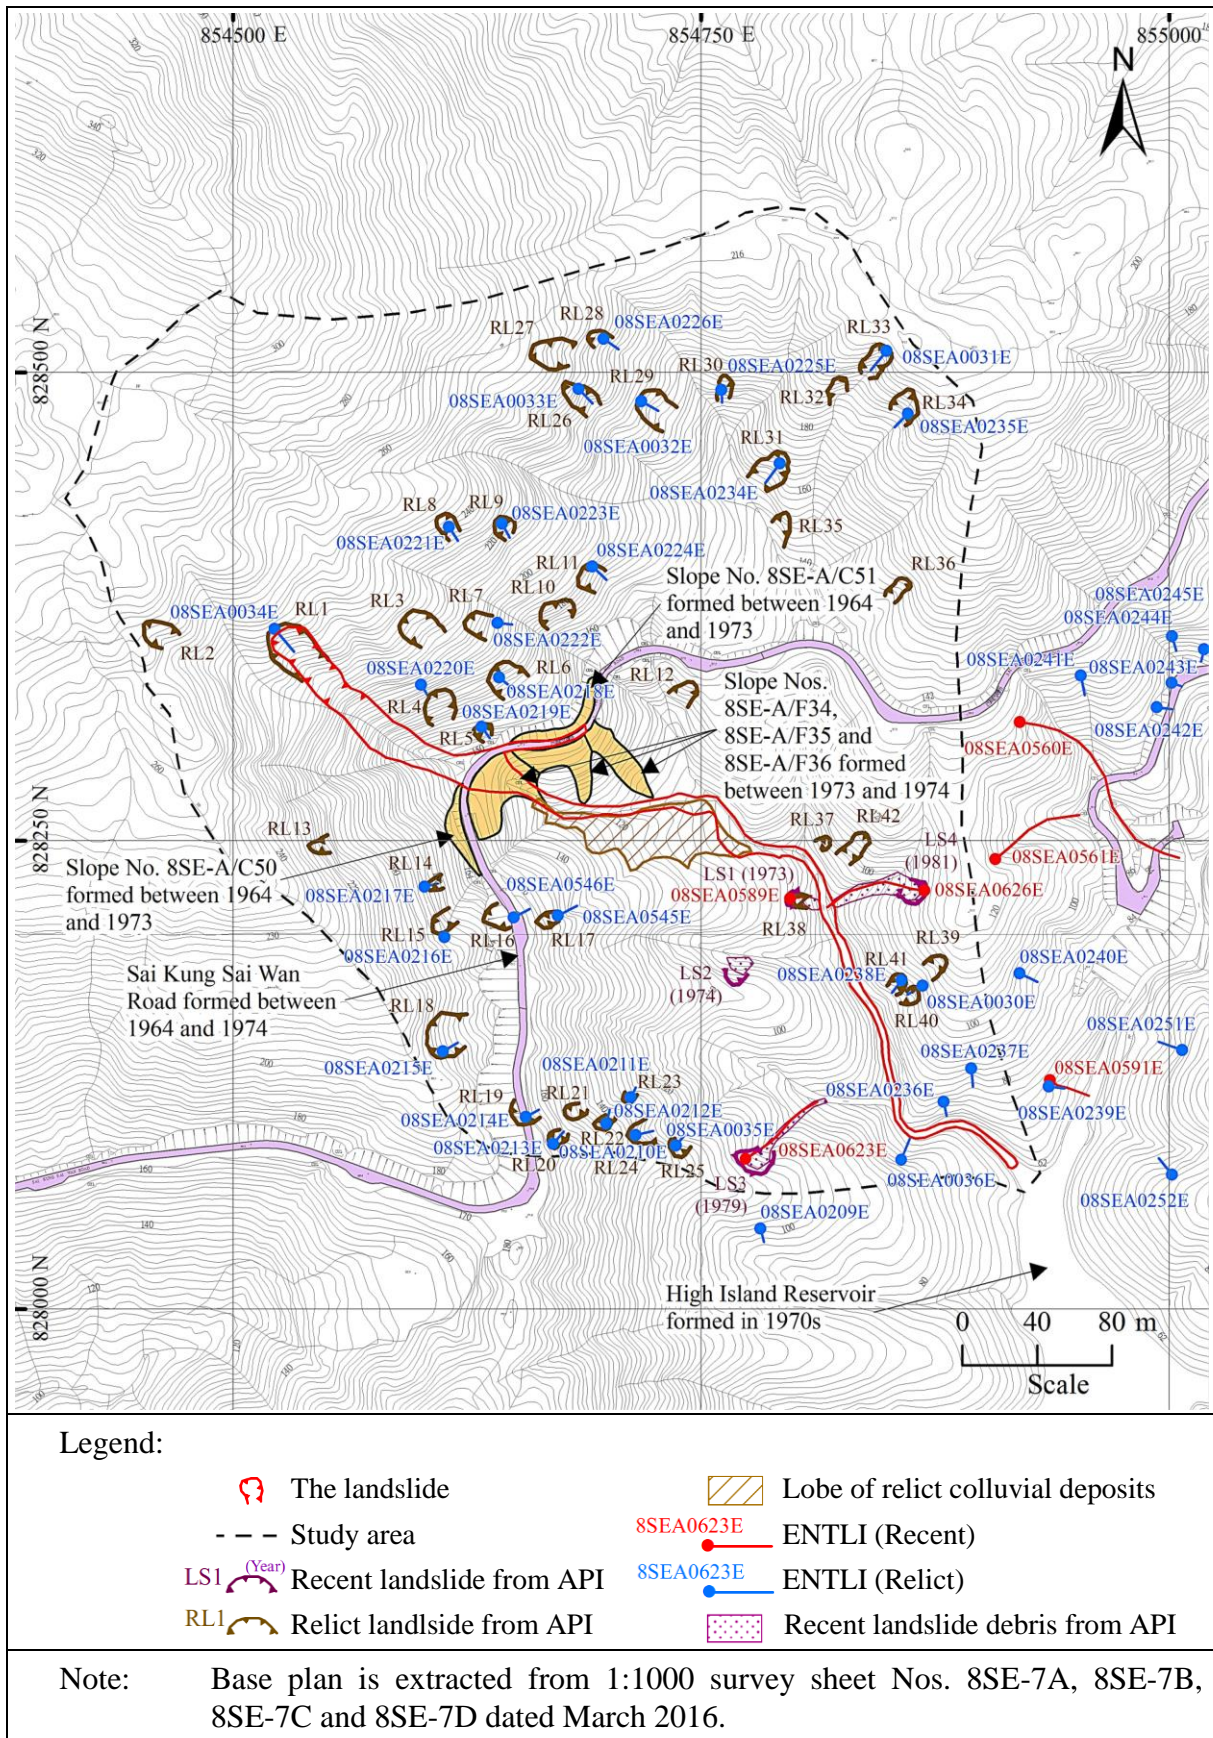
The ENTLI database records 31 relict and three recent landslides within the study area (Figure 3.1). One of the 31 relict landslides (Tag No. 8SEA0034E) has its crown located immediately above the source area of the landslide (Figure 3.1). This relict landslide was likely identified based on the geomorphological depression observed in API under this study. The relict landslide has been assigned 'Class C1' under the ENTLI classification system, which defines it as a poorly defined feature with broad rounded morphology and likely a relatively old feature. The remaining relict landslides are predominately located at the head of drainage lines and along the over-steepened flanks of incised drainage lines.

Figure 3.1 Site History and Past Instabilities

Below Sai Kung Sai Wan Road, hummocky hillside morphology indicates the presence of a distinct lobe of probable colluvial deposits (Figure 3.1) along the debris trail, about 170 m downslope of the landslide crown. The other relict landslides could be seen as shallow depressions covered with thin vegetation, typically on steep valley flanks, and with estimated source volumes ranging from 15 m³ to 260 m³. Four recent landslides, LS1 to LS4 occurring between 1973 and 1981, are visible within the lower portion of the study area with debris probably entering the main drainage line from LS1 and LS4.

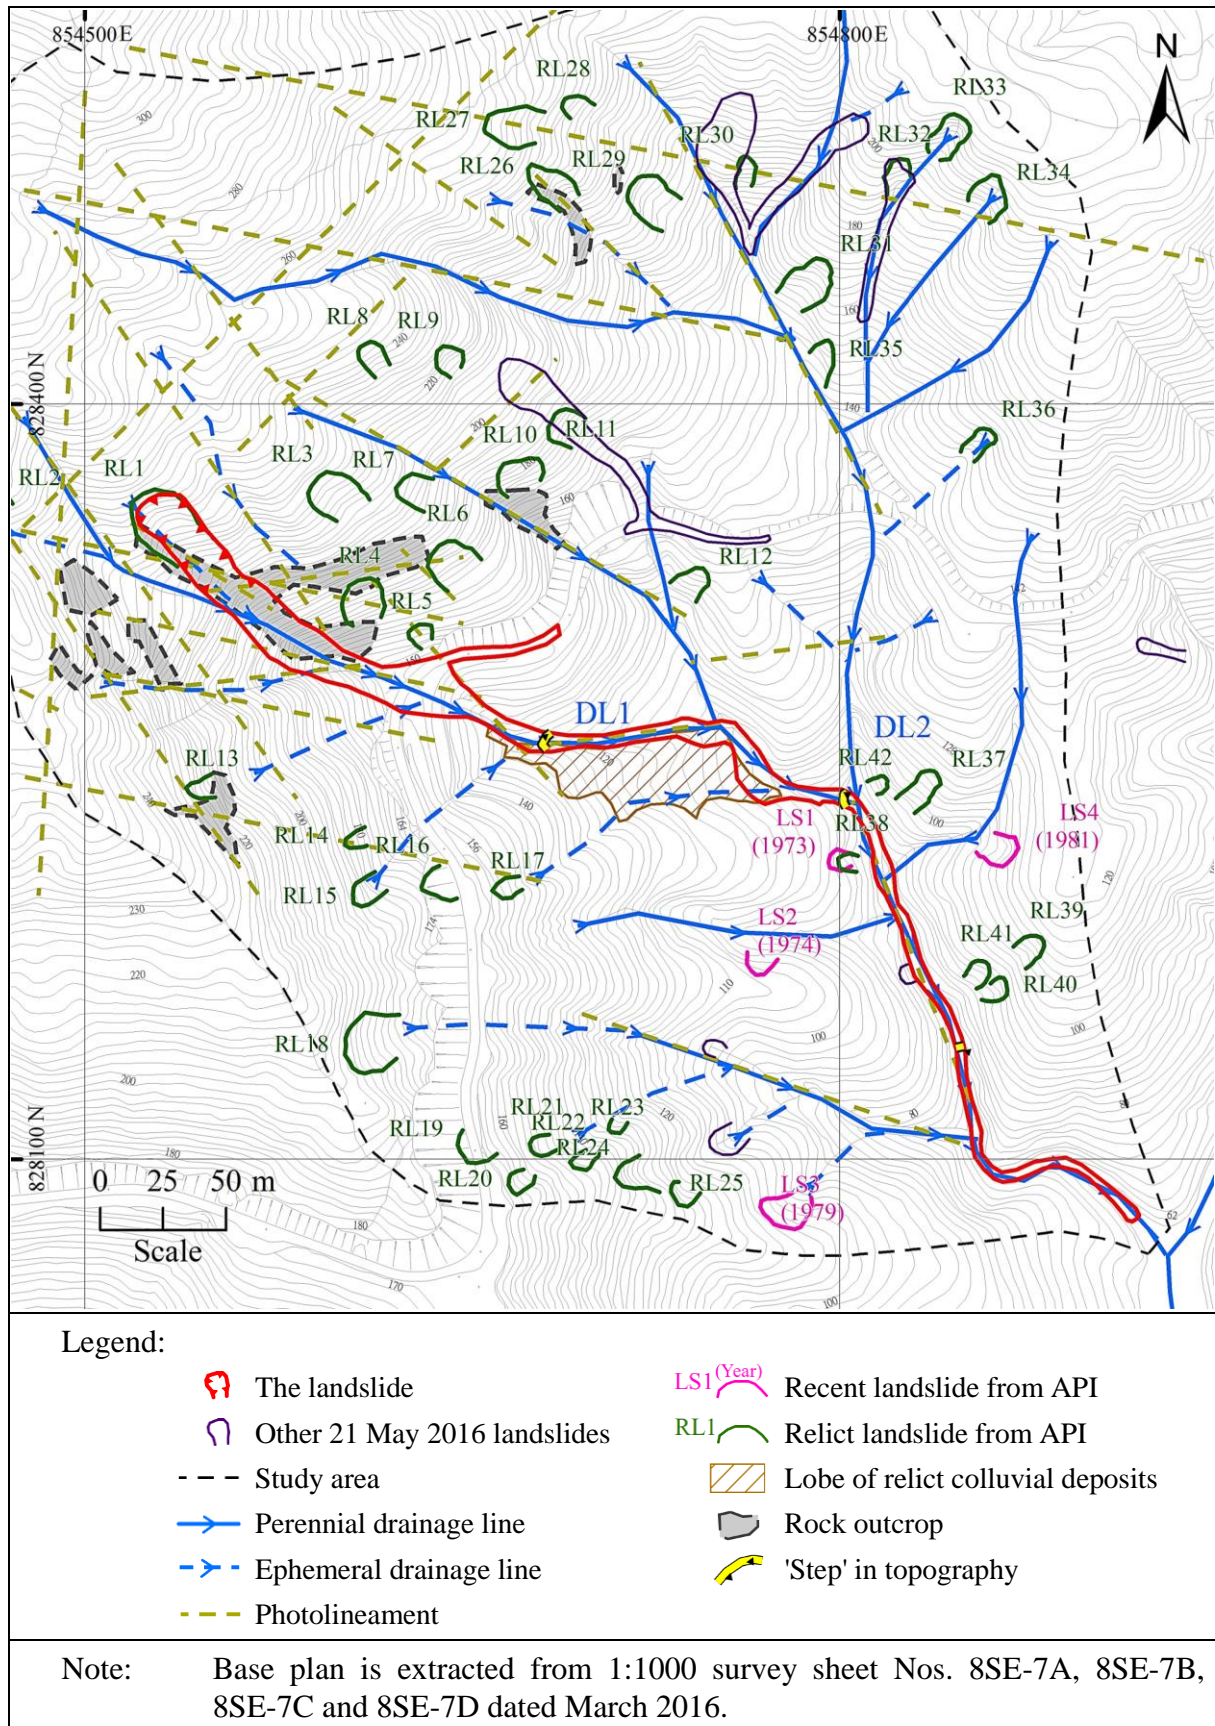
Figure 3.3 Geomorphological Setting

At the west flank of the source area the sheeting joint is exposed along a narrow band of rock outcrop which was the location of an ephemeral drainage line (Figures 3.3 and 4.3). The main scarp and east flank (Figure 4.8) comprise moderately decomposed tuff (up to 8 m deep), partially weathered rock mass (1 m to 2 m deep) and colluvium (2 m to 3 m deep). As a result of the significant portion of columnar jointed tuff rock that detached during failure (estimated at up to 1,200 m³), the debris deposited downslope comprised intact joint-controlled rock blocks, smaller rock fragments that had broken up, and soil from the partially weathered rock mass and colluvium. Following failure, distinct polygonal 'columns' of tuff were partly exposed in the upper area of the east flank, typically with two joint faces (joint orientation approximately 70/300° and 64/285°) exposed over a height of up to 8 m (Figure 4.8) and

An ephemeral drainage line was located along the vertical outcrop of tuff along the west flank of the source area (Figures 3.3 and 4.3). As the sheeting joint was exposed along the outcrop and likely open at this location due to stress relief, it would have facilitated ingress of water into the joint during the rainstorm.

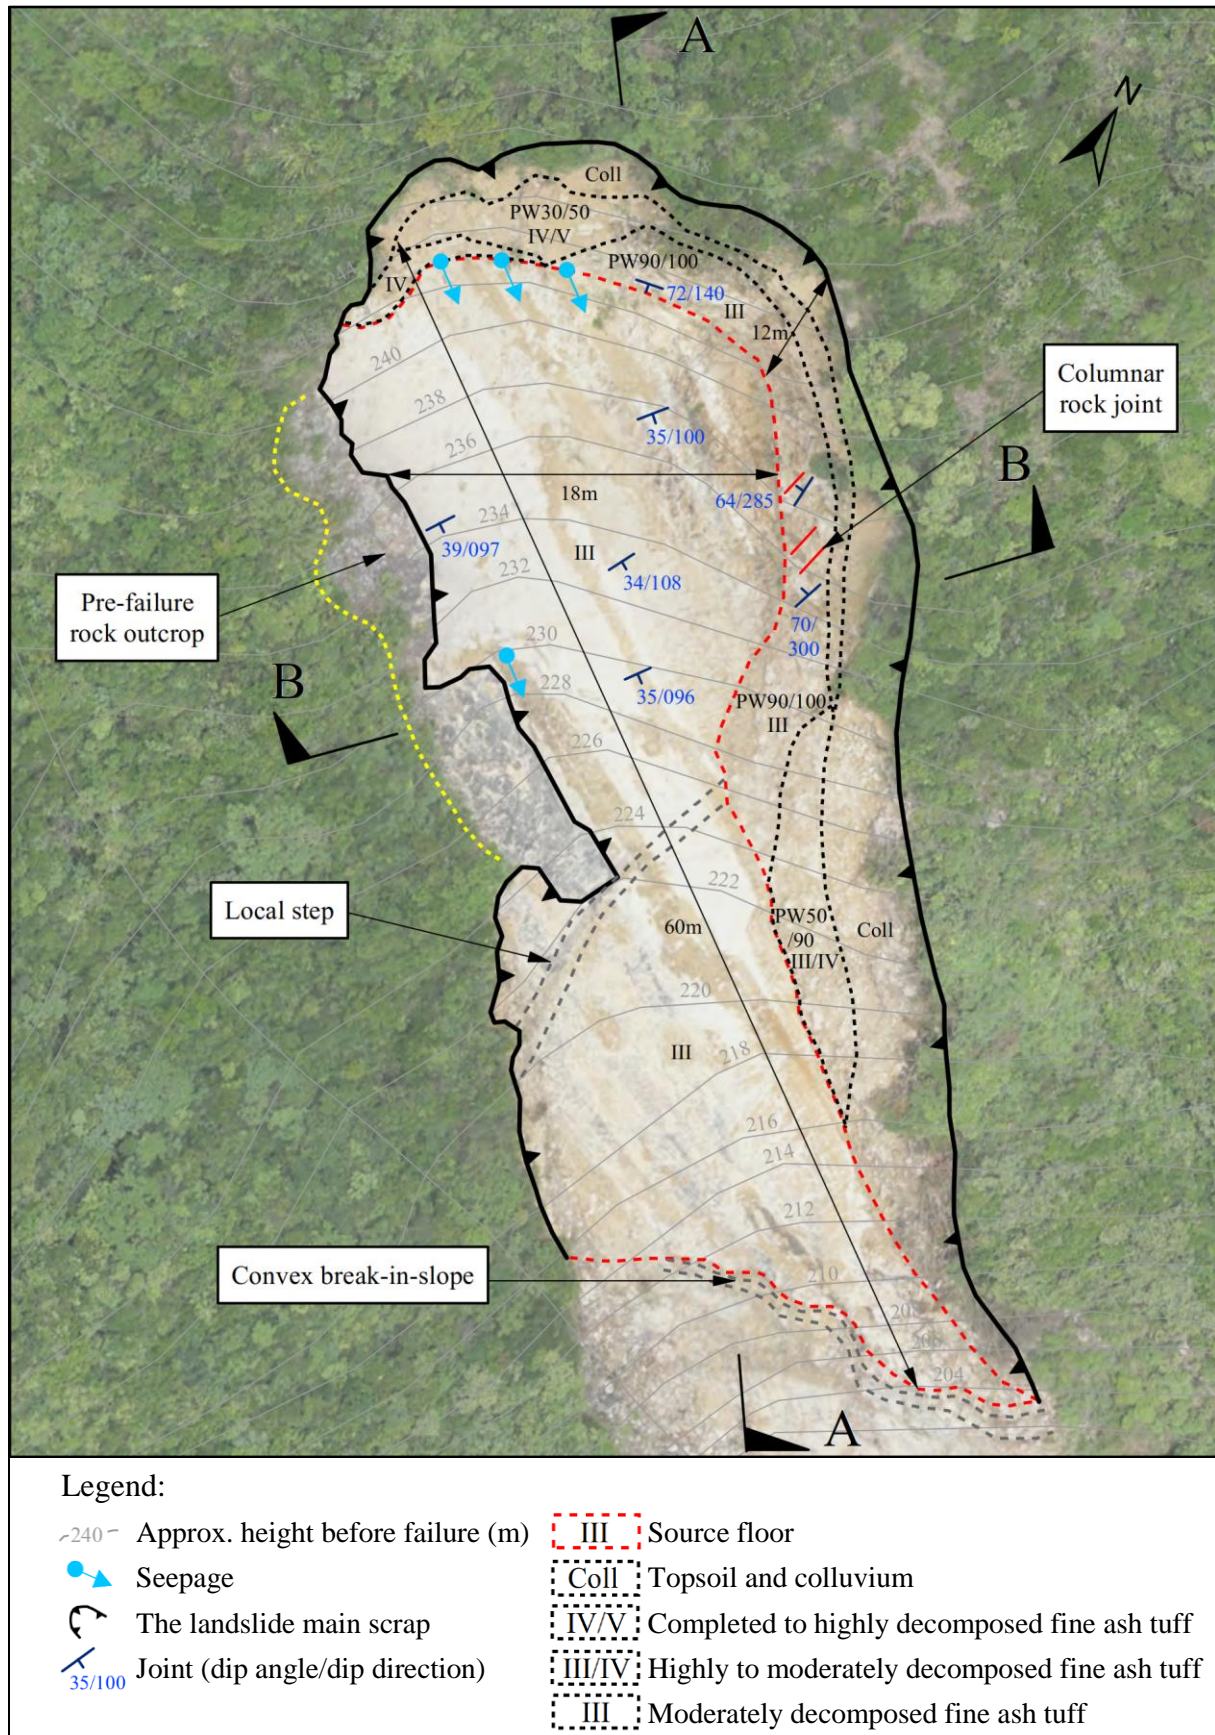
Figure 4.1 Plan of the Source Area

Although the source floor is generally planar, some local, minor steps in the profile were observed (Figures 4.1 and 4.6). Near the base of the source floor, adjacent to the east flank, the dip angle of the surface reduces significantly to around 10° to 15° (Figure 4.7), and this joint orientation was observed to extend laterally eastwards into the adjacent hillside. Immediately below this area there is a convex break-in-slope which allows the sheeting joint to daylight (Figure 4.3). The break-in-slope is probably caused by local weakening of the rock mass along an E-W trending shear zone observed traversing the landslide below the source floor (Figure 4.5).

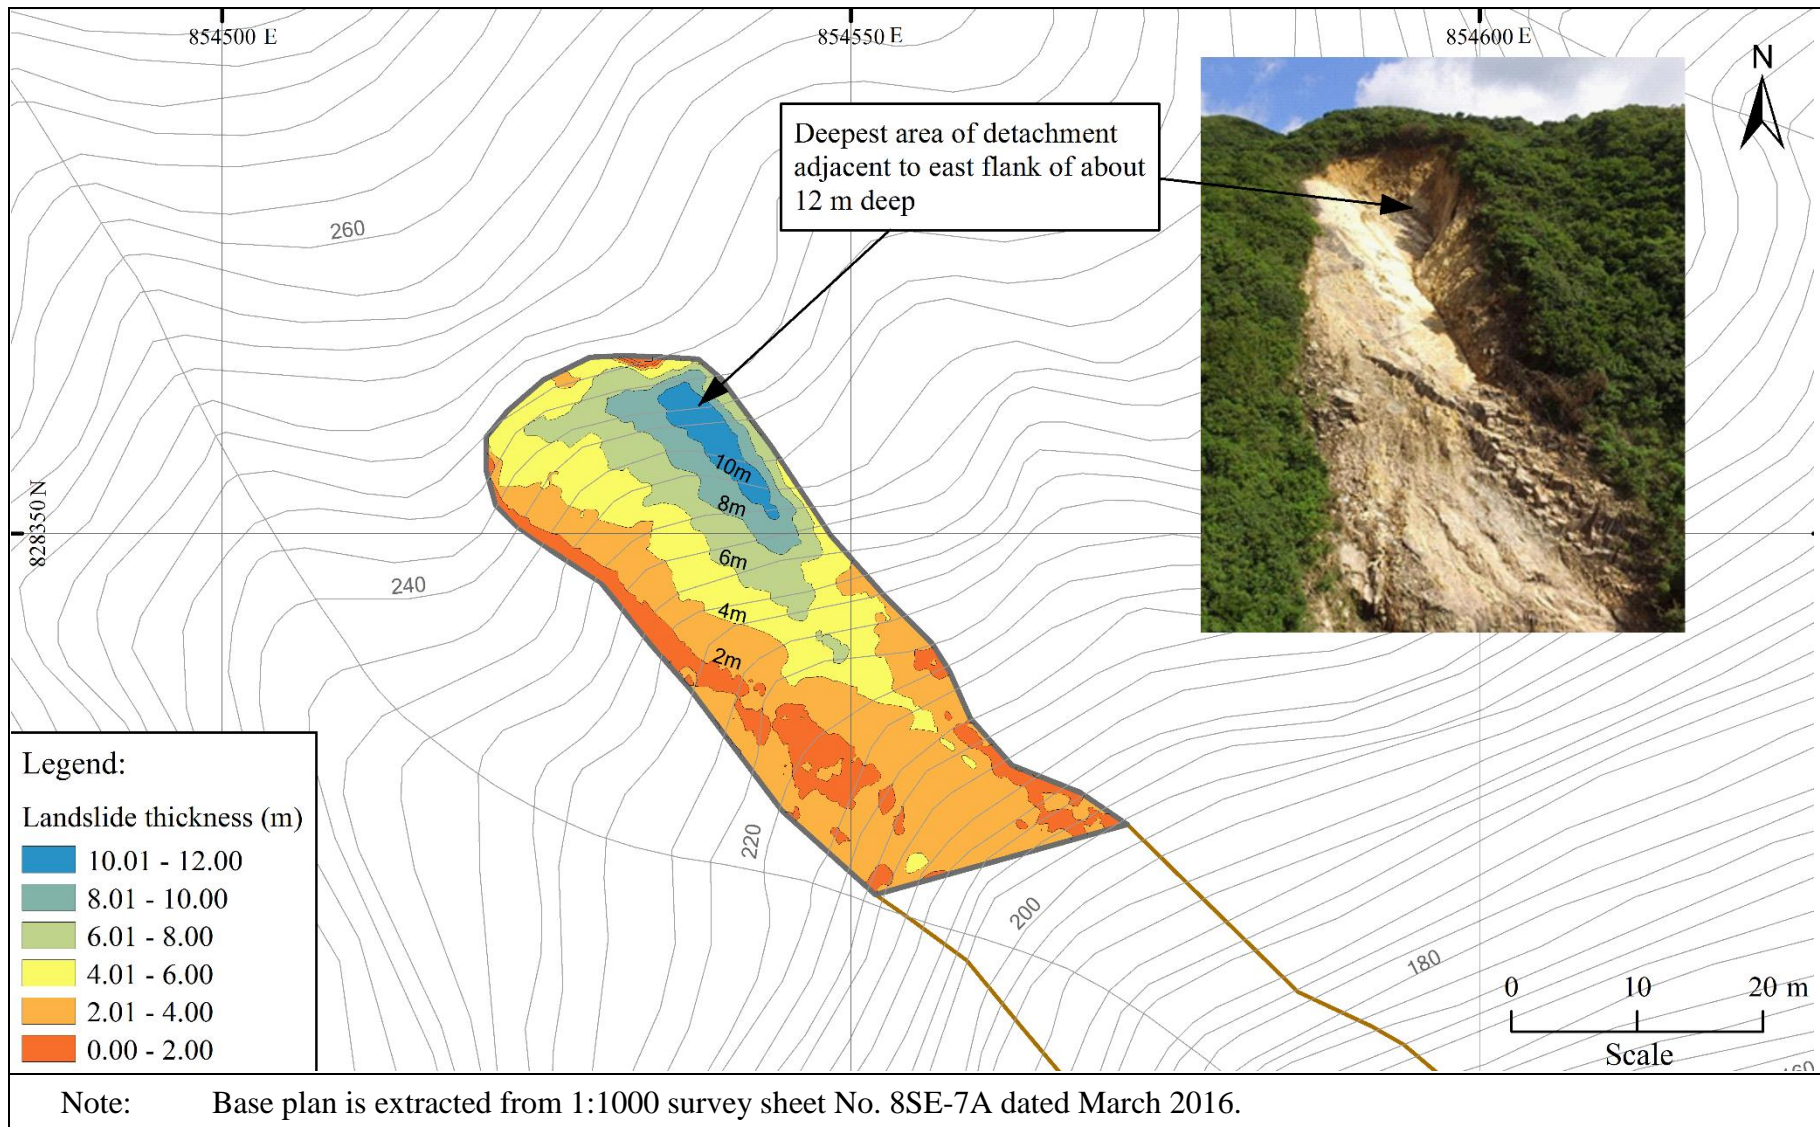
The landslide was a structurally controlled, translational rock slide with a distinctive, planar, basal failure surface (Figure 4.3). The crown of the source area is located at about 250 mPD and the dimensions of the source area are 18 m in width, 60 m in length and 12 m maximum in depth. A plan of the source area is shown in Figure 4.1 and longitudinal and transverse sections are shown in Figure 4.2. The total volume of detached material from the source is estimated at about 2,100 m³ based on field measurements and comparison between pre-failure LiDAR survey data and post-failure photogrammetric topographic survey data obtained by unmanned aerial vehicle (UAV). Images of the actual source area topography and estimated detached material thickness are shown in Figure 4.4.

Figure 4.4 Source Volume Estimate from LiDAR and Photogrammetry

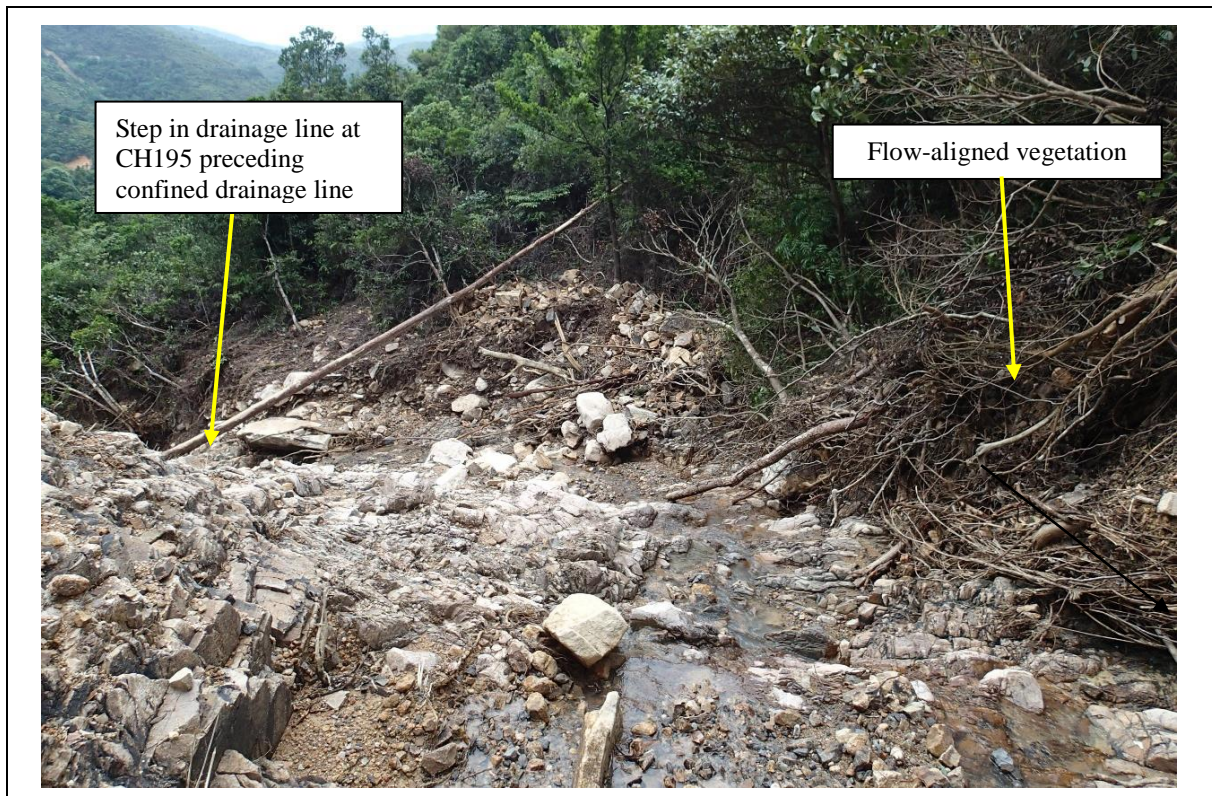
Figure 4.10 View Downslope from CH180 to CH192
(Photograph taken on 14 June 2016)

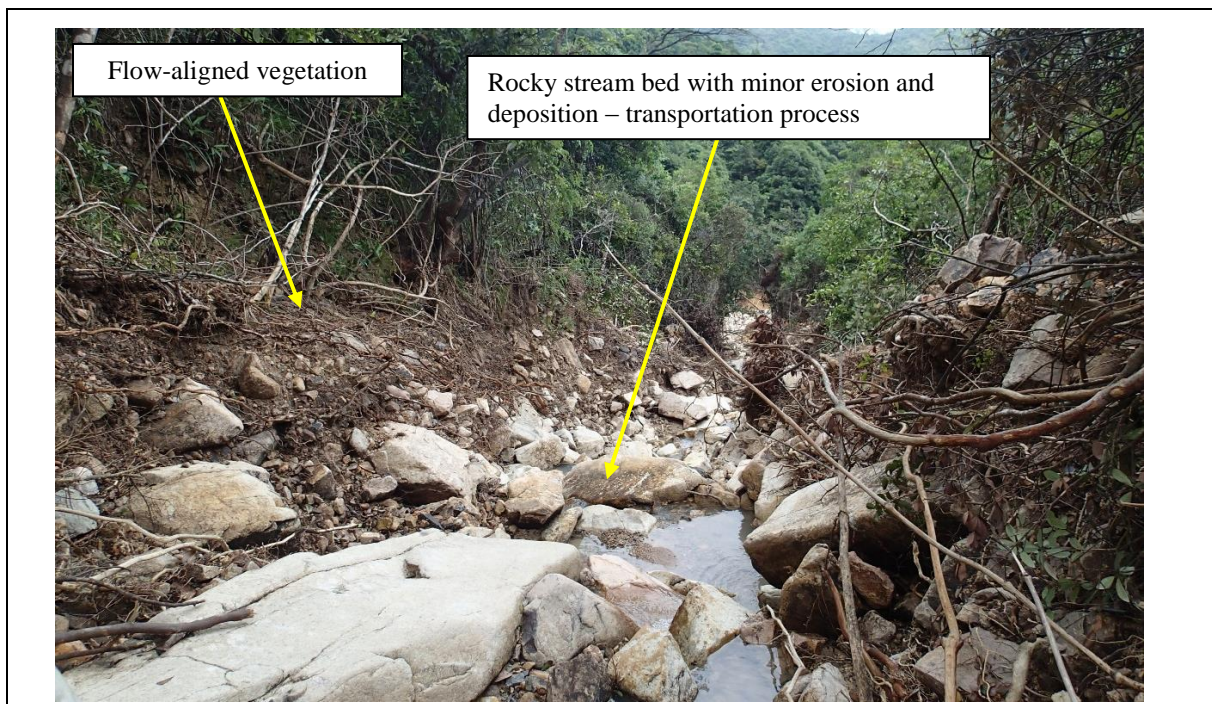
Figure 4.11 View Downslope from CH200 to CH210
(Photograph taken on 14 June 2016)

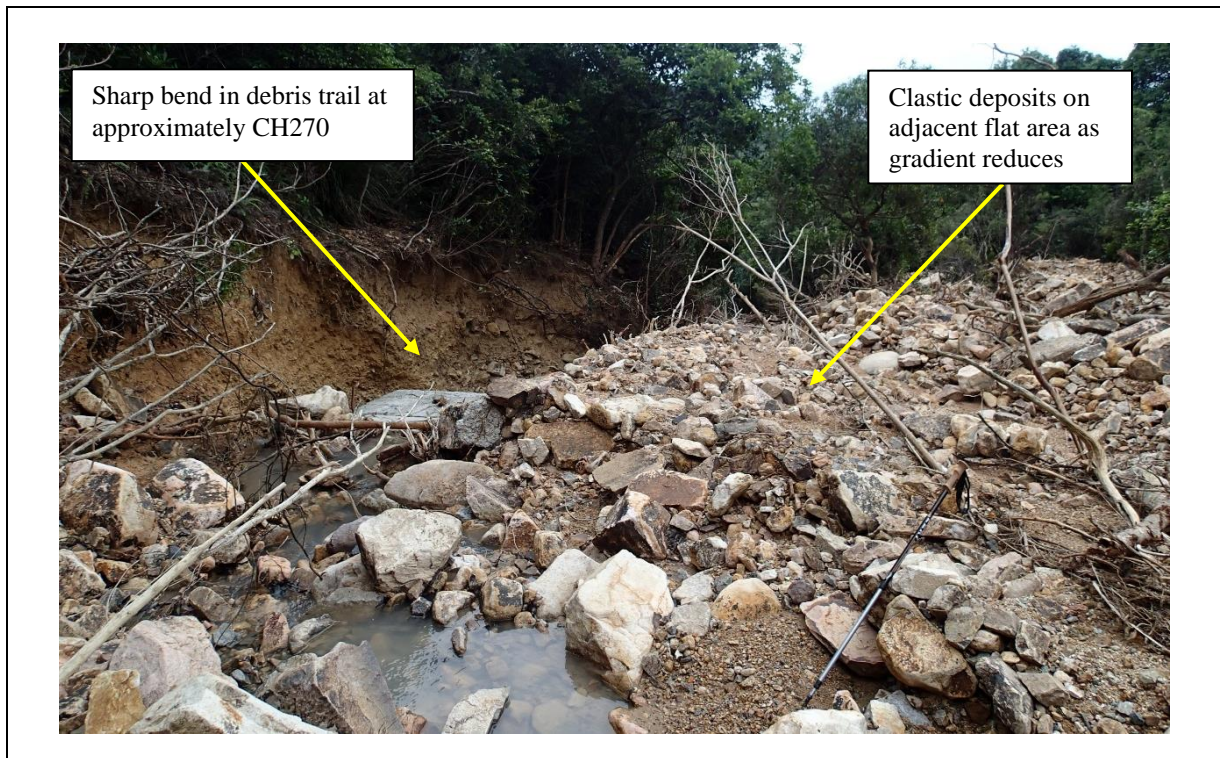
Between Chainage 237 and 300, the debris trail reduces in slope angle to about 15°, negotiates two sharp bends at about Chainage 270 (Figure 4.12) and Chainage 300, and the drainage line becomes less deeply incised, with some relatively flat terrace-like areas on the south side of the drainage line. The change in drainage line morphology and slope angle resulted in the onset of significant deposition. Between Chainage 245 and Chainage 305, over 500 m³ of mainly coarse clastic debris was deposited (Figures 4.12 to 4.14) with minor amounts of finer material and remoulded debris observed towards the flanks of the drainage line as levees (Figure 4.15). Superelevation marks could be observed along the sharp bends at Chainage 273 and Chainage 300 with maximum superelevations of approximately 2.5 m and 1 m respectively (Figure 4.15). A tributary drainage line enters the main drainage line at Chainage 270. Some large concrete fragments, several metres long and probably part of the culvert wing wall or base slab structure, were observed at Chainage 273 (Figures 4.14 and 4.15 and Figure B2).

Figure 4.12 View Downslope from CH260 to CH275
(Photograph taken on 14 June 2016)

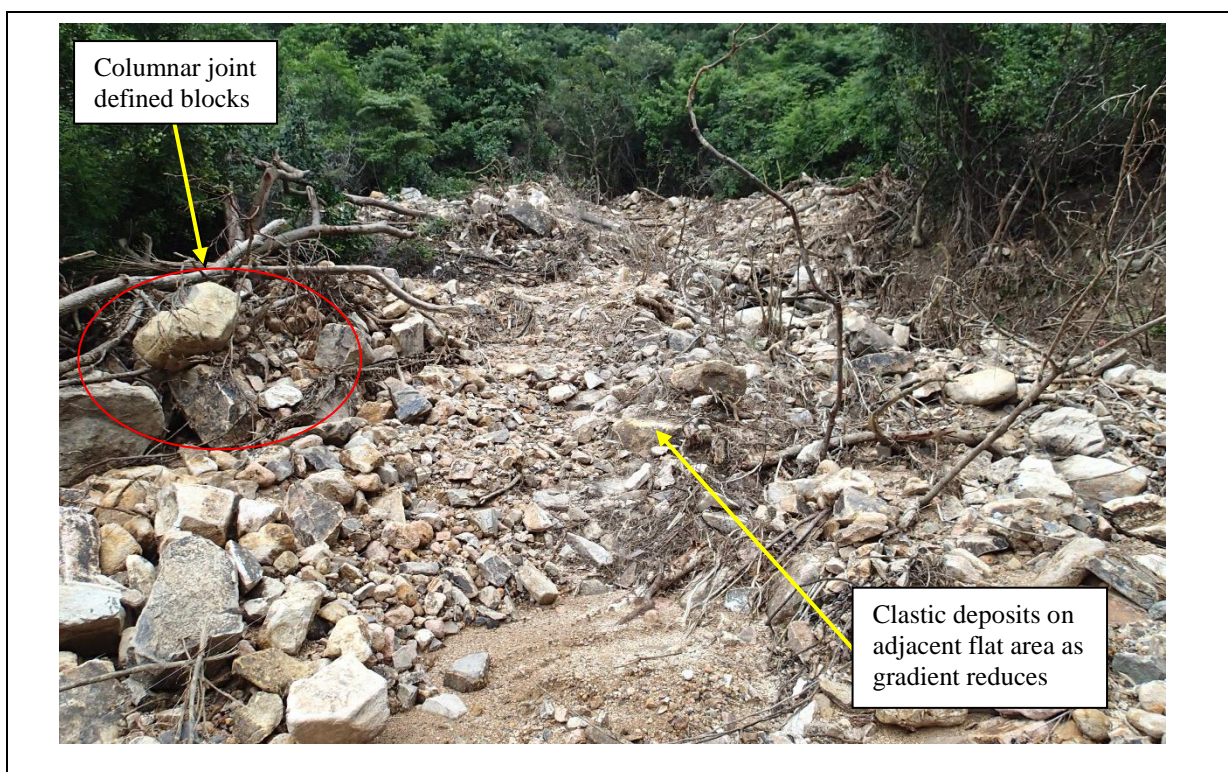
Figure 4.13 View Upslope from CH250 to CH265 (Photograph taken on 14 June 2016)

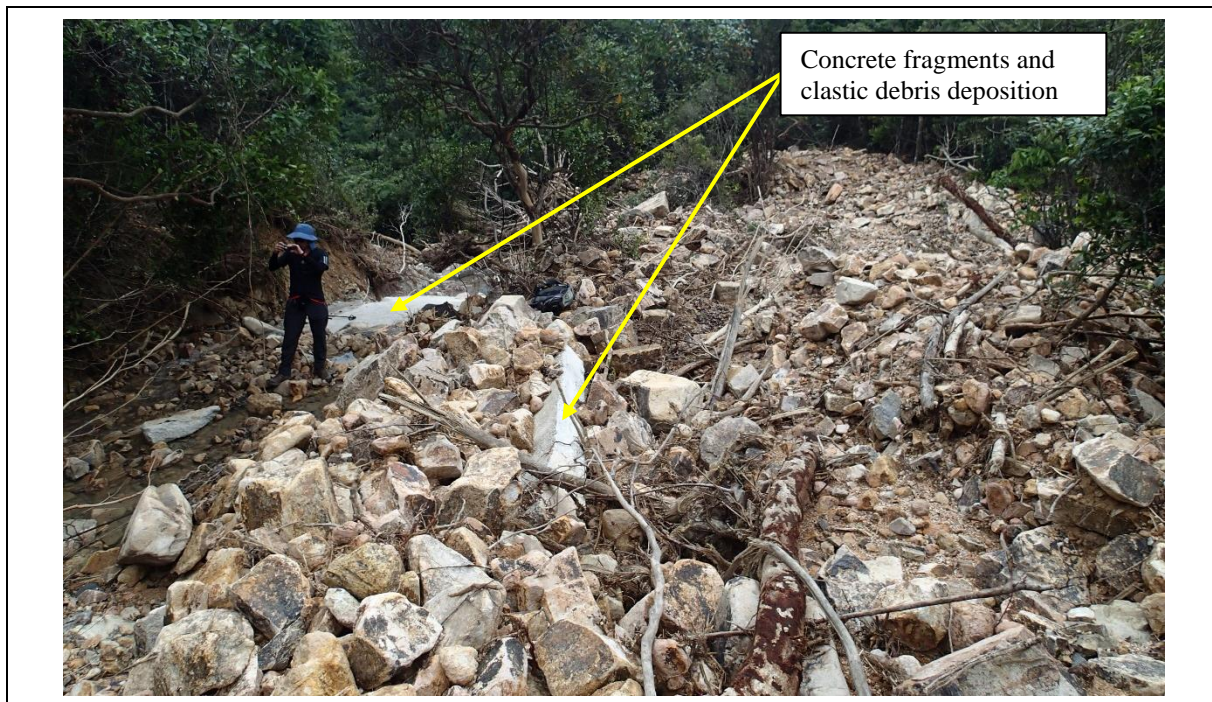
Figure 4.14 View Downslope from CH275 to CH290
(Photograph taken on 14 June 2016)

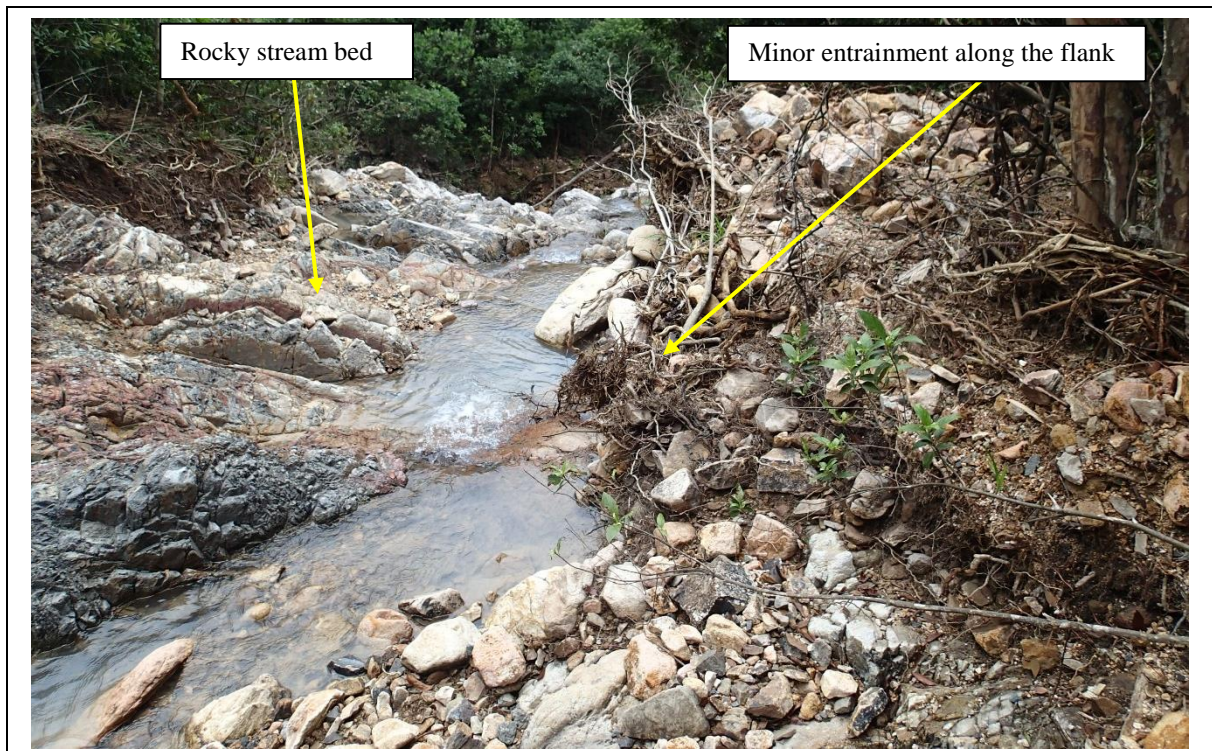
After Chainage 300, the drainage line initially becomes more confined again and more irregular in profile with a series of rocky steps of 2 to 3 m high (Figures 4.16 and 4.17), but with an overall gradient of about 8°. The largest step (about 3 m high at Chainage 325) coincides with a geological boundary between the tuff and trachydacite and rhyolite lava (Figure 4.17). Minor entrainment could be observed along the flanks of the drainage line (Figure 4.16) but deposition is the dominant process, with coarse clastic debris deposited in semi-continuous lobes within the drainage line and local remoulded debris typically forming levees higher up on one flank.

Figure 4.16 View Downslope from CH305 to CH320
(Photograph taken on 14 June 2016)

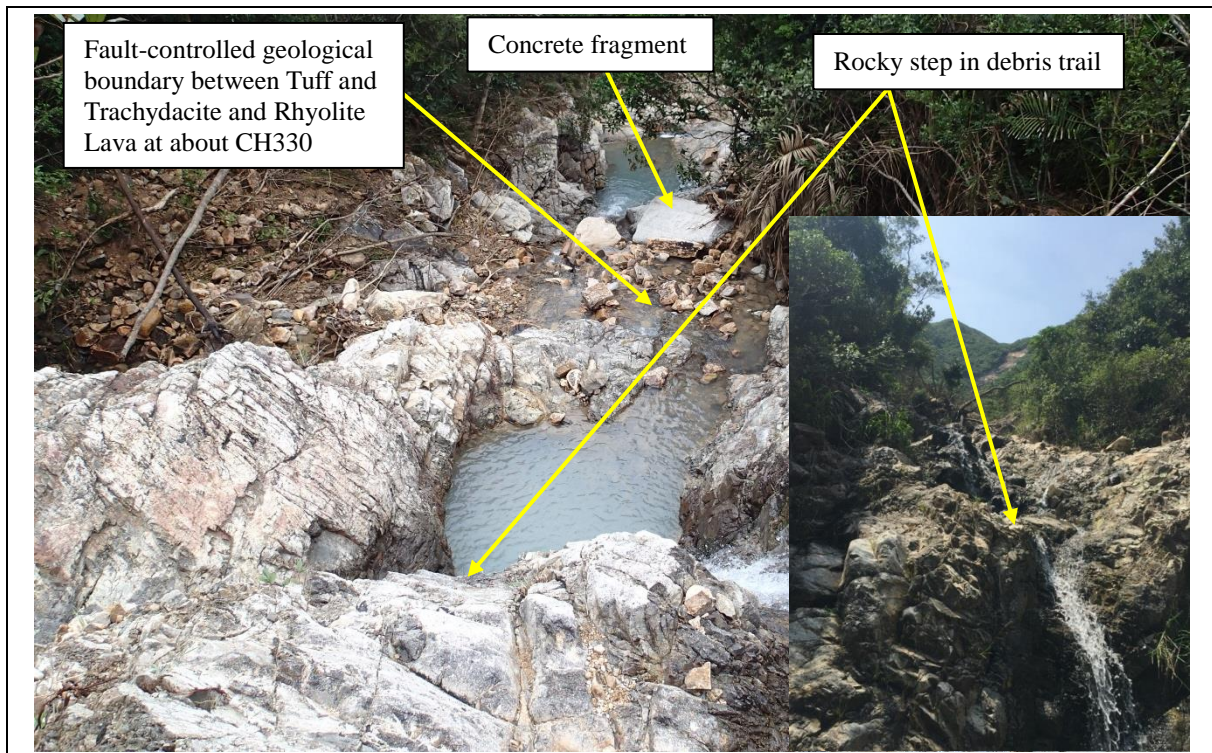
Figure 4.17 View Downslope from CH325 to CH345
(Photograph taken on 14 June 2016)

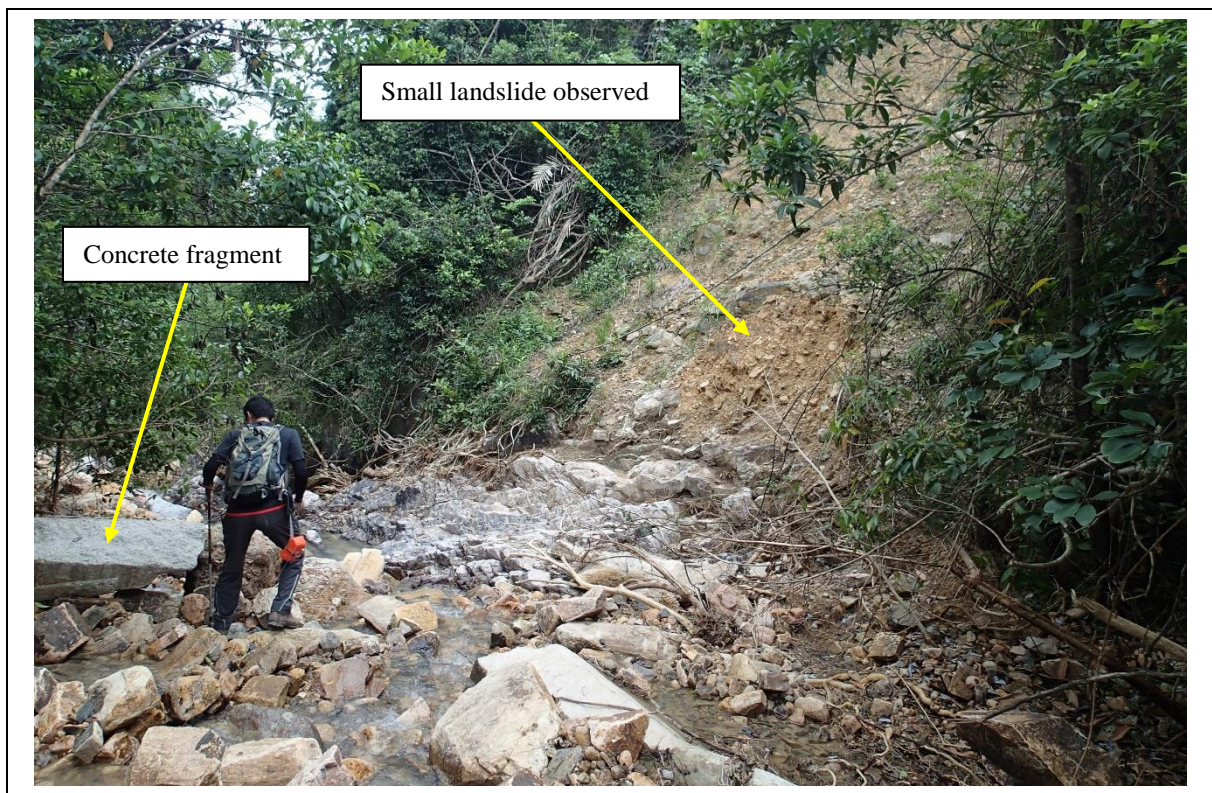
Figure 4.18 View Downslope from CH400 to CH410
(Photograph taken on 14 June 2016)

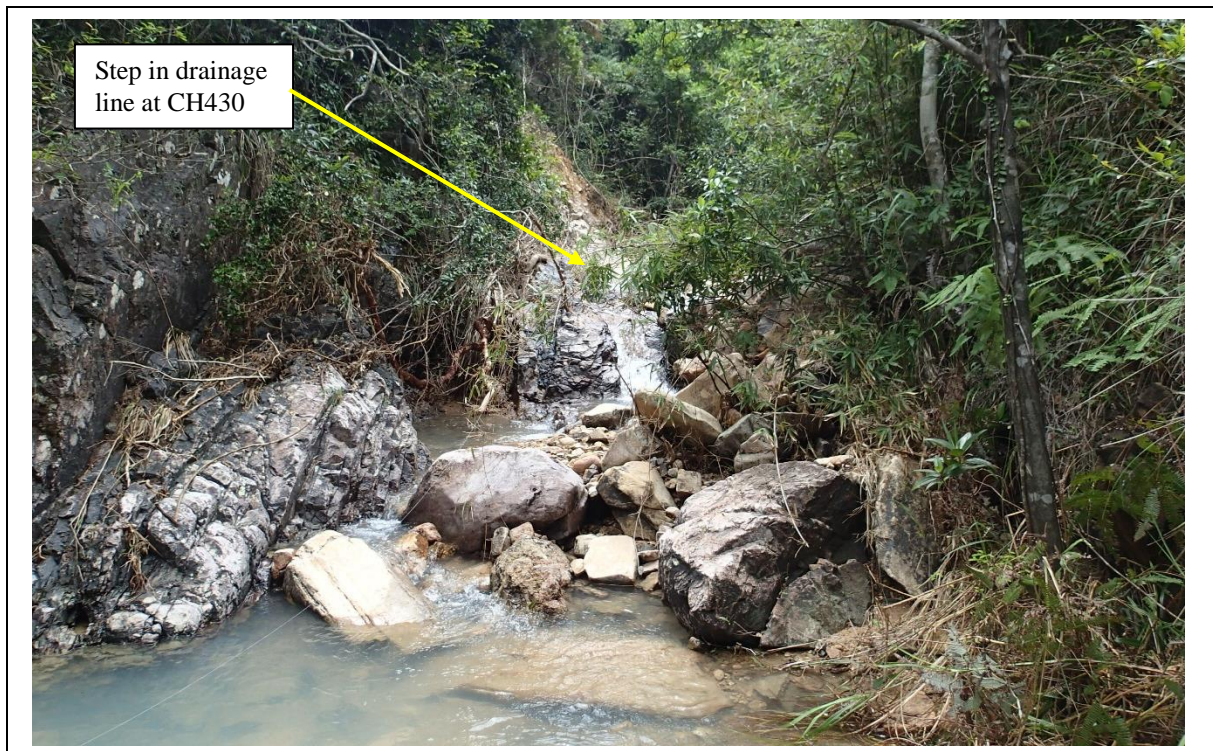
Figure 4.19 View Upslope from CH415 to CH430 (Photograph taken on 14 June 2016)
