**Detailed Study of the 21 May 2016
Landslide on the Natural Hillside
above Slope No. 8SE-A/F34
at Sai Kung Sai Wan Road, Sai Kung**

GEO Report No. 336

AECOM Asia Company Limited

**Geotechnical Engineering Office
Civil Engineering and Development Department
The Government of the Hong Kong
Special Administrative Region**

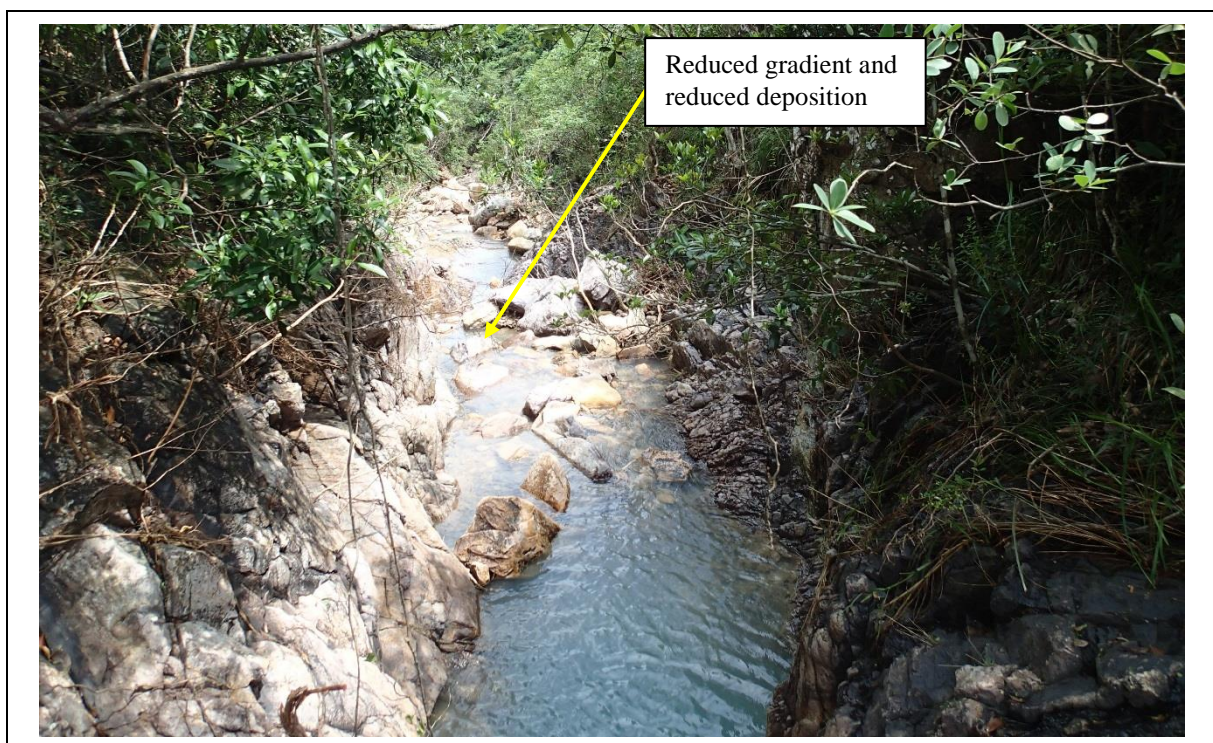
Figure 4.20 View Downslope from CH430 to CH445 (Photograph taken on 14 June 2016)

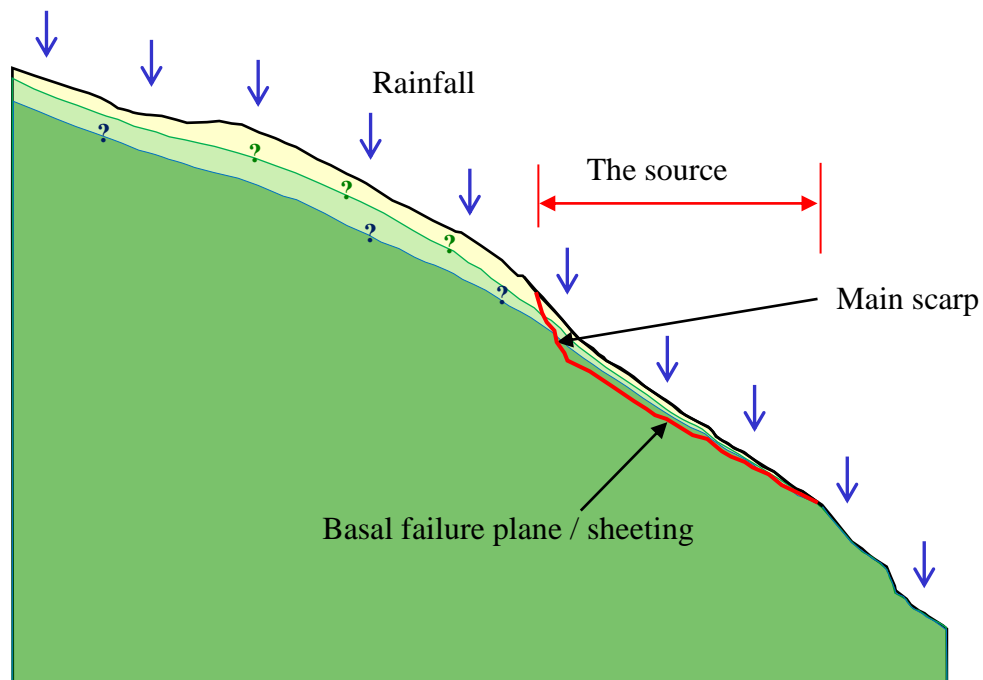
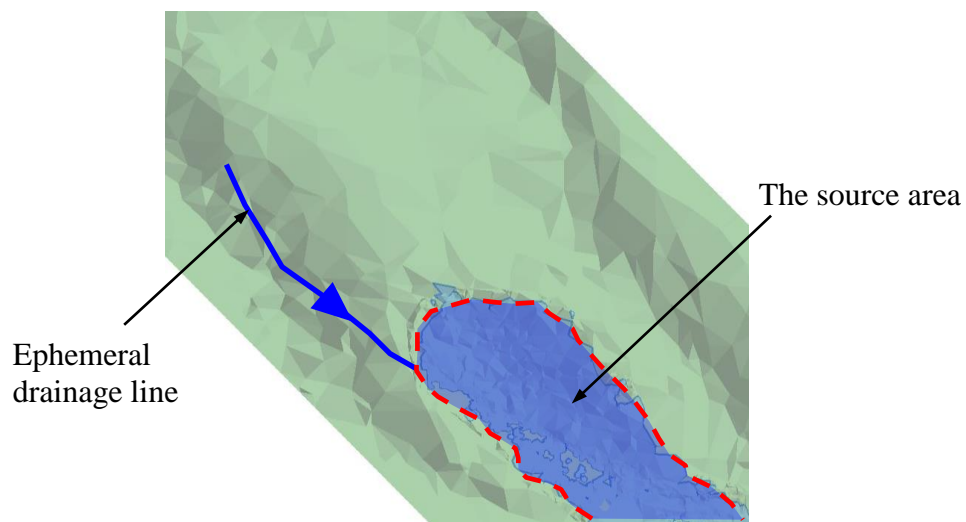
Given the scale and geological setting of the landslide, cleft water pressure was likely to have developed within the planar sheeting joint at the time of failure. Based on the findings from the post-landslide inspections (see Section 4.3), direct water ingress from the ephemeral drainage line at the west flank of the source area and direct infiltration over the entire hillside were two possible water sources for the development of cleft water pressure (Figure 8.1).

(a) Infiltration over the entire hillside including the source area

(b) Direct water ingress from ephemeral drainage line at west flank

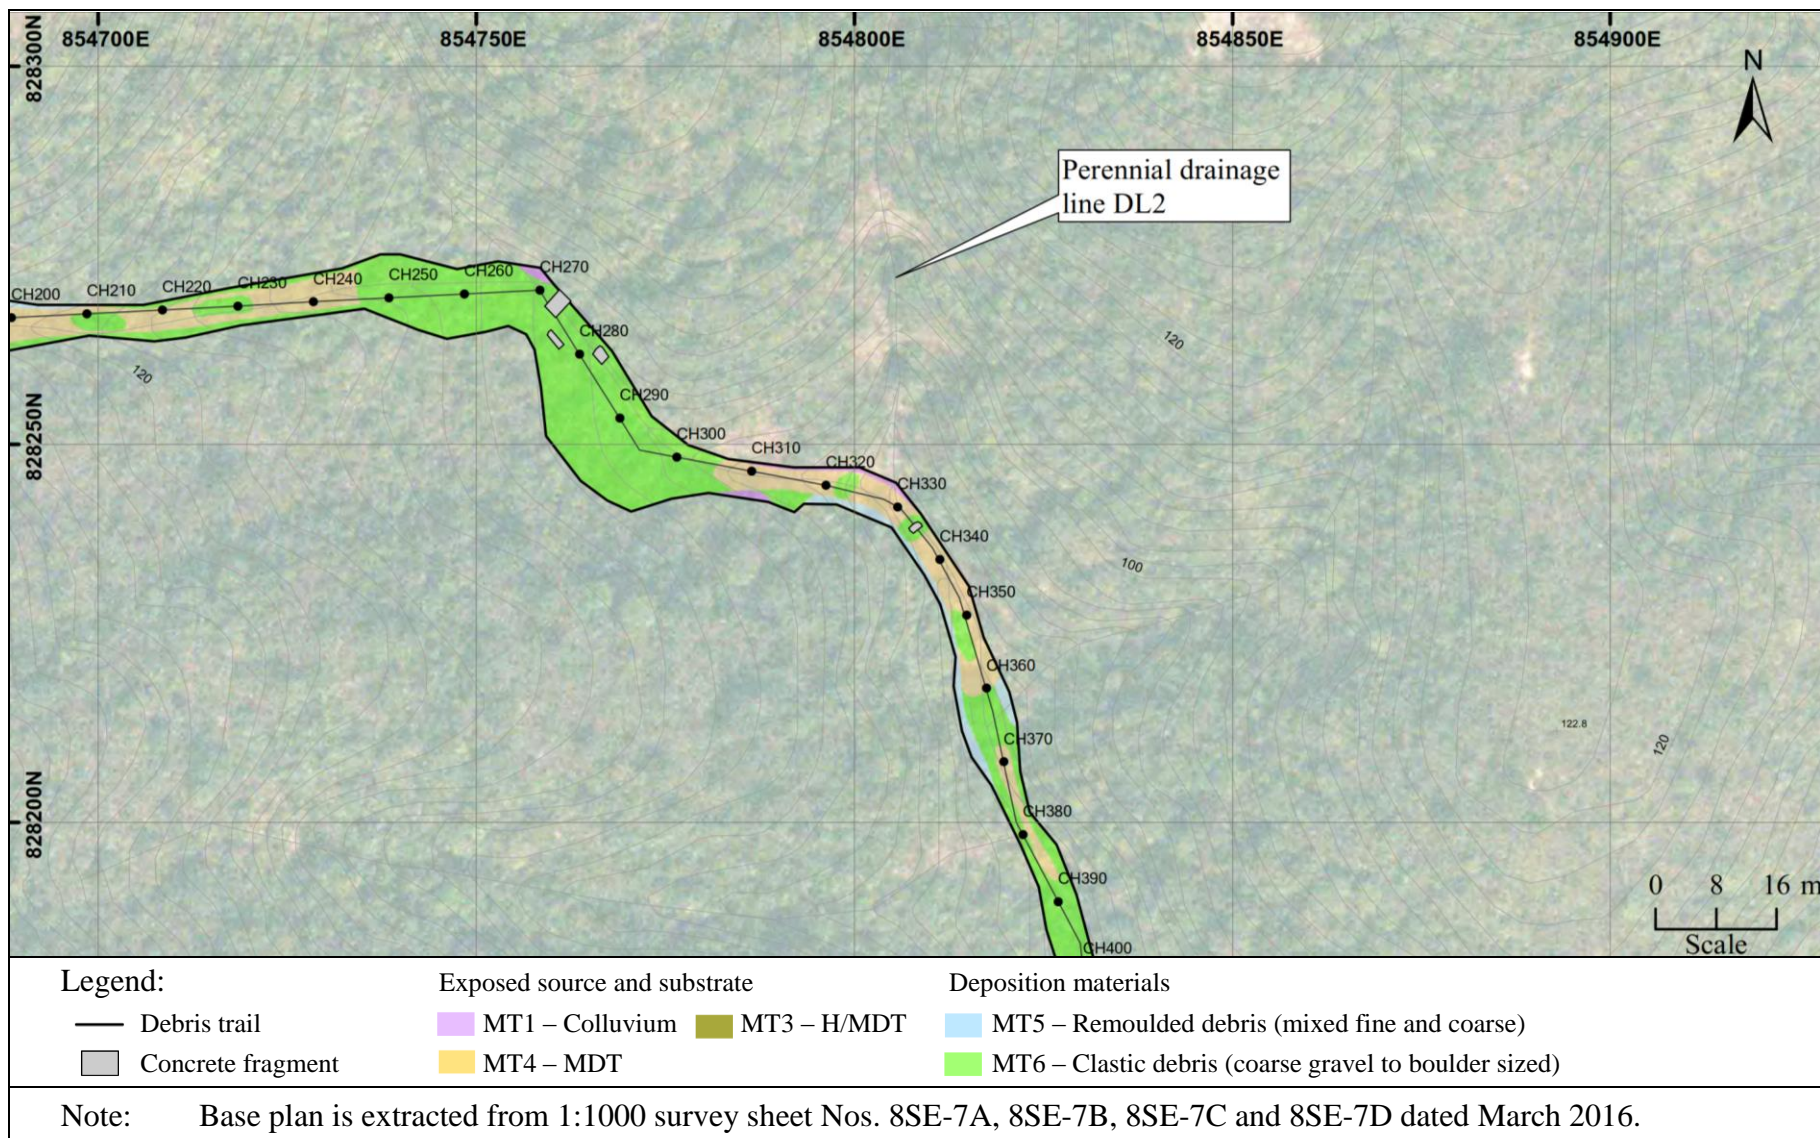
Between Chainage 237 and 300, the debris trail reduces in slope angle to about 15°, negotiates two sharp bends at about Chainage 270 (Figure 4.12) and Chainage 300, and the drainage line becomes less deeply incised, with some relatively flat terrace-like areas on the south side of the drainage line. The change in drainage line morphology and slope angle resulted in the onset of significant deposition. Between Chainage 245 and Chainage 305, over 500 m³ of mainly coarse clastic debris was deposited (Figures 4.12 to 4.14) with minor amounts of finer material and remoulded debris observed towards the flanks of the drainage line as levees (Figure 4.15). Superelevation marks could be observed along the sharp bends at Chainage 273 and Chainage 300 with maximum superelevations of approximately 2.5 m and 1 m respectively (Figure 4.15). A tributary drainage line enters the main drainage line at Chainage 270. Some large concrete fragments, several metres long and probably part of the culvert wing wall or base slab structure, were observed at Chainage 273 (Figures 4.14 and 4.15 and Figure B2).

Figure B2 Sketch Plan of Debris Trail (CH200 to CH400)

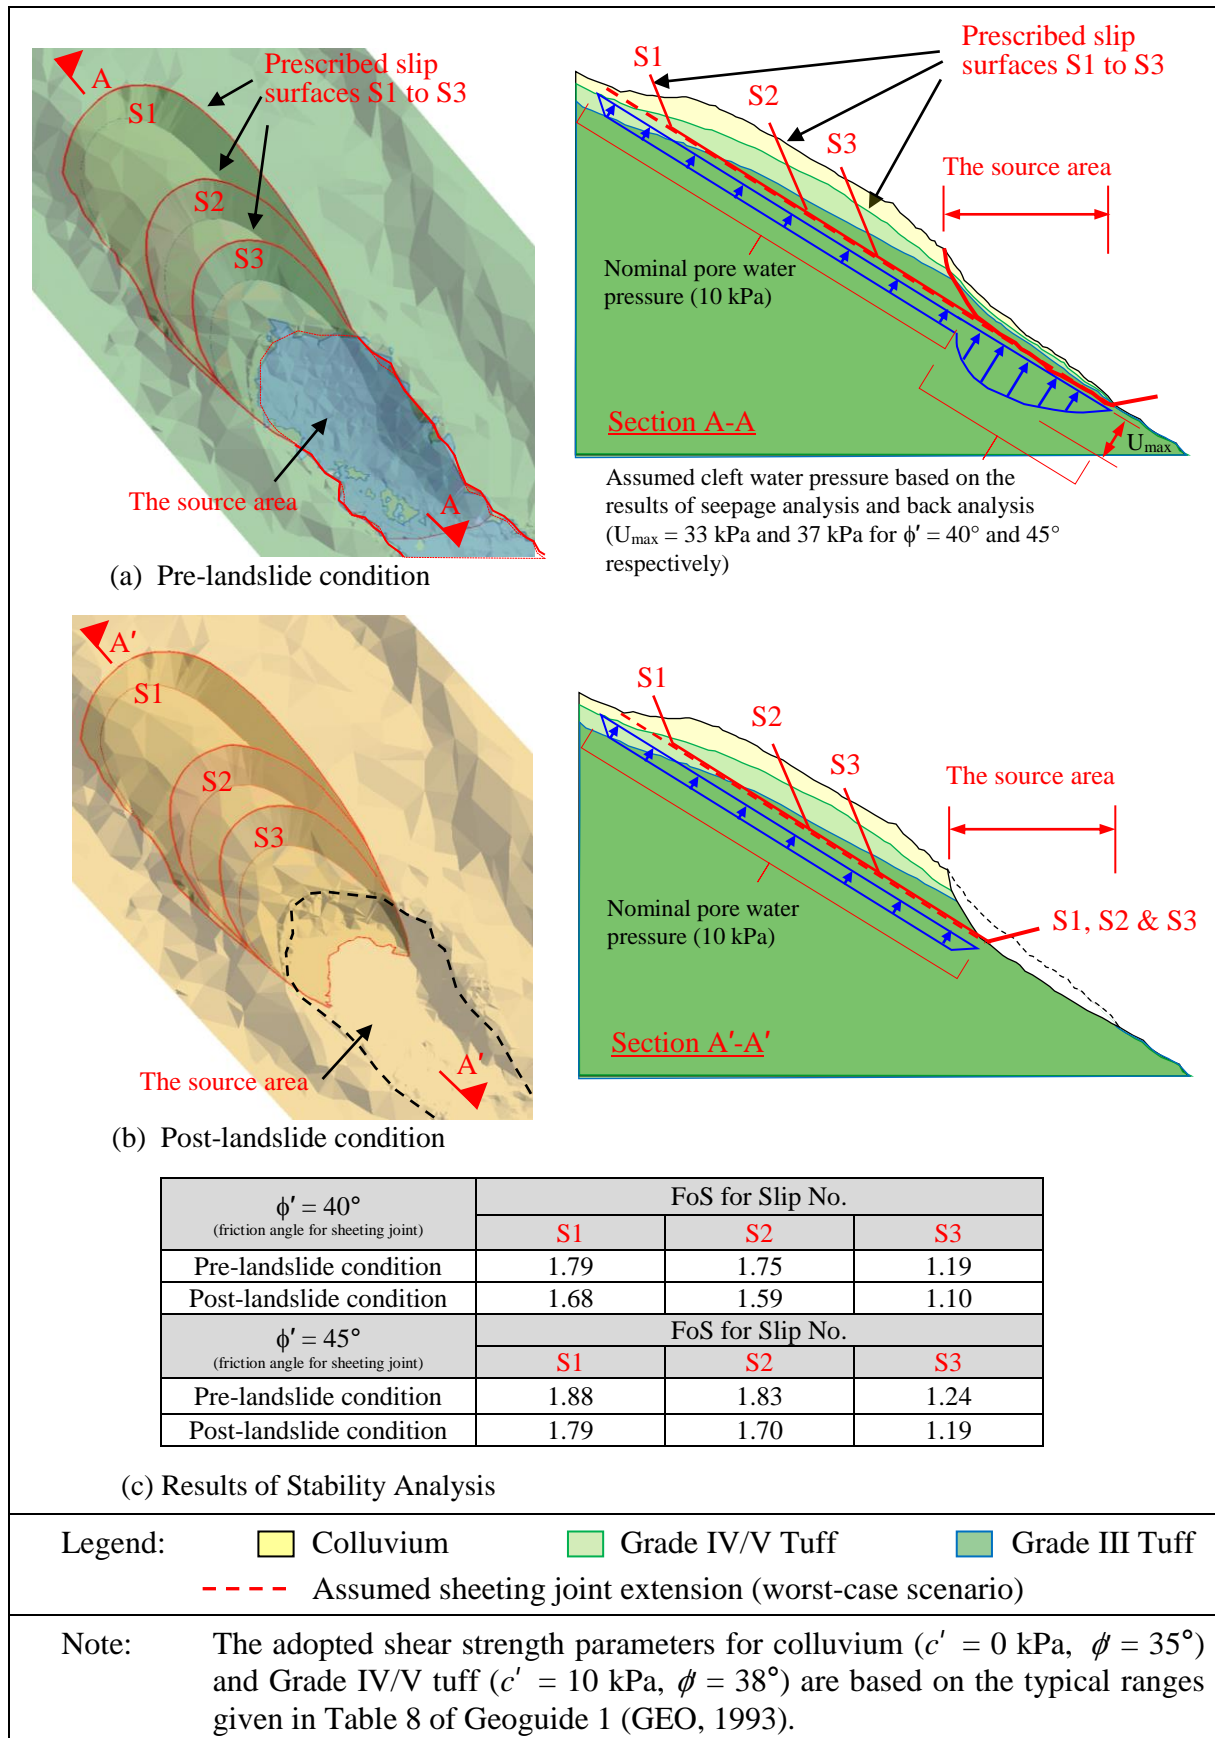
Figure D1 Results of Stability Analysis

The stability of the hillside was assessed for scenarios before and after the landslide, with a view to evaluating the respective stability conditions. To simulate the pre-landslide groundwater condition, the cleft water pressure distribution due to direct water ingress as obtained from seepage analysis (see Section 8.2.2) was applied to the source area and a nominal water pressure of 10 kPa on the hillside above the main scarp was applied to account for any limited groundwater pressure that could develop at the sheeting joint due to direct infiltration. For the post-landslide scenario, as no rock outcrop or evidence of any daylighting joint could be observed at the hillside above the main scarp, direct water ingress

into the sheeting joint is unlikely. Therefore, only a nominal of water pressure of 10 kPa on the hillside above the main scarp was applied to account for any limited groundwater pressure that could develop at the sheeting joint due to direct infiltration.

The computer program 'Slope3D' using Morgenstern - Price approach was employed to better reflect the asymmetric geometry of the landslide source area. The analytical model together with the material properties, groundwater conditions and prescribed failure slip surfaces outlined above, were utilised in the program to compute the respective FoS associated with potential large-scale failure of the remaining hillside. The results of the stability analysis, as shown in Figure D1, indicate that although the computed FoSs decrease slightly (from 4% to 9%) when comparing stability conditions before and after the landslide, all FoSs exceed unity. Considering the hillside as a whole, the hillside is deemed to be less susceptible to large-scale failure after the landslide.
