一九九七年八月三日  
呈祥道山泥傾瀉事件報告  
**REPORT ON THE  
CHING CHEUNG ROAD  
LANDSLIDE OF  
3 AUGUST 1997**

土力工程處報告系列第 78 號  
GEO REPORT No. 78

合樂亞洲顧問公司  
Halcrow Asia Partnership Ltd.

香港特別行政區政府  
土木工程署  
土力工程處  
**GEOTECHNICAL ENGINEERING OFFICE  
CIVIL ENGINEERING DEPARTMENT  
THE GOVERNMENT OF THE HONG KONG  
SPECIAL ADMINISTRATIVE REGION**

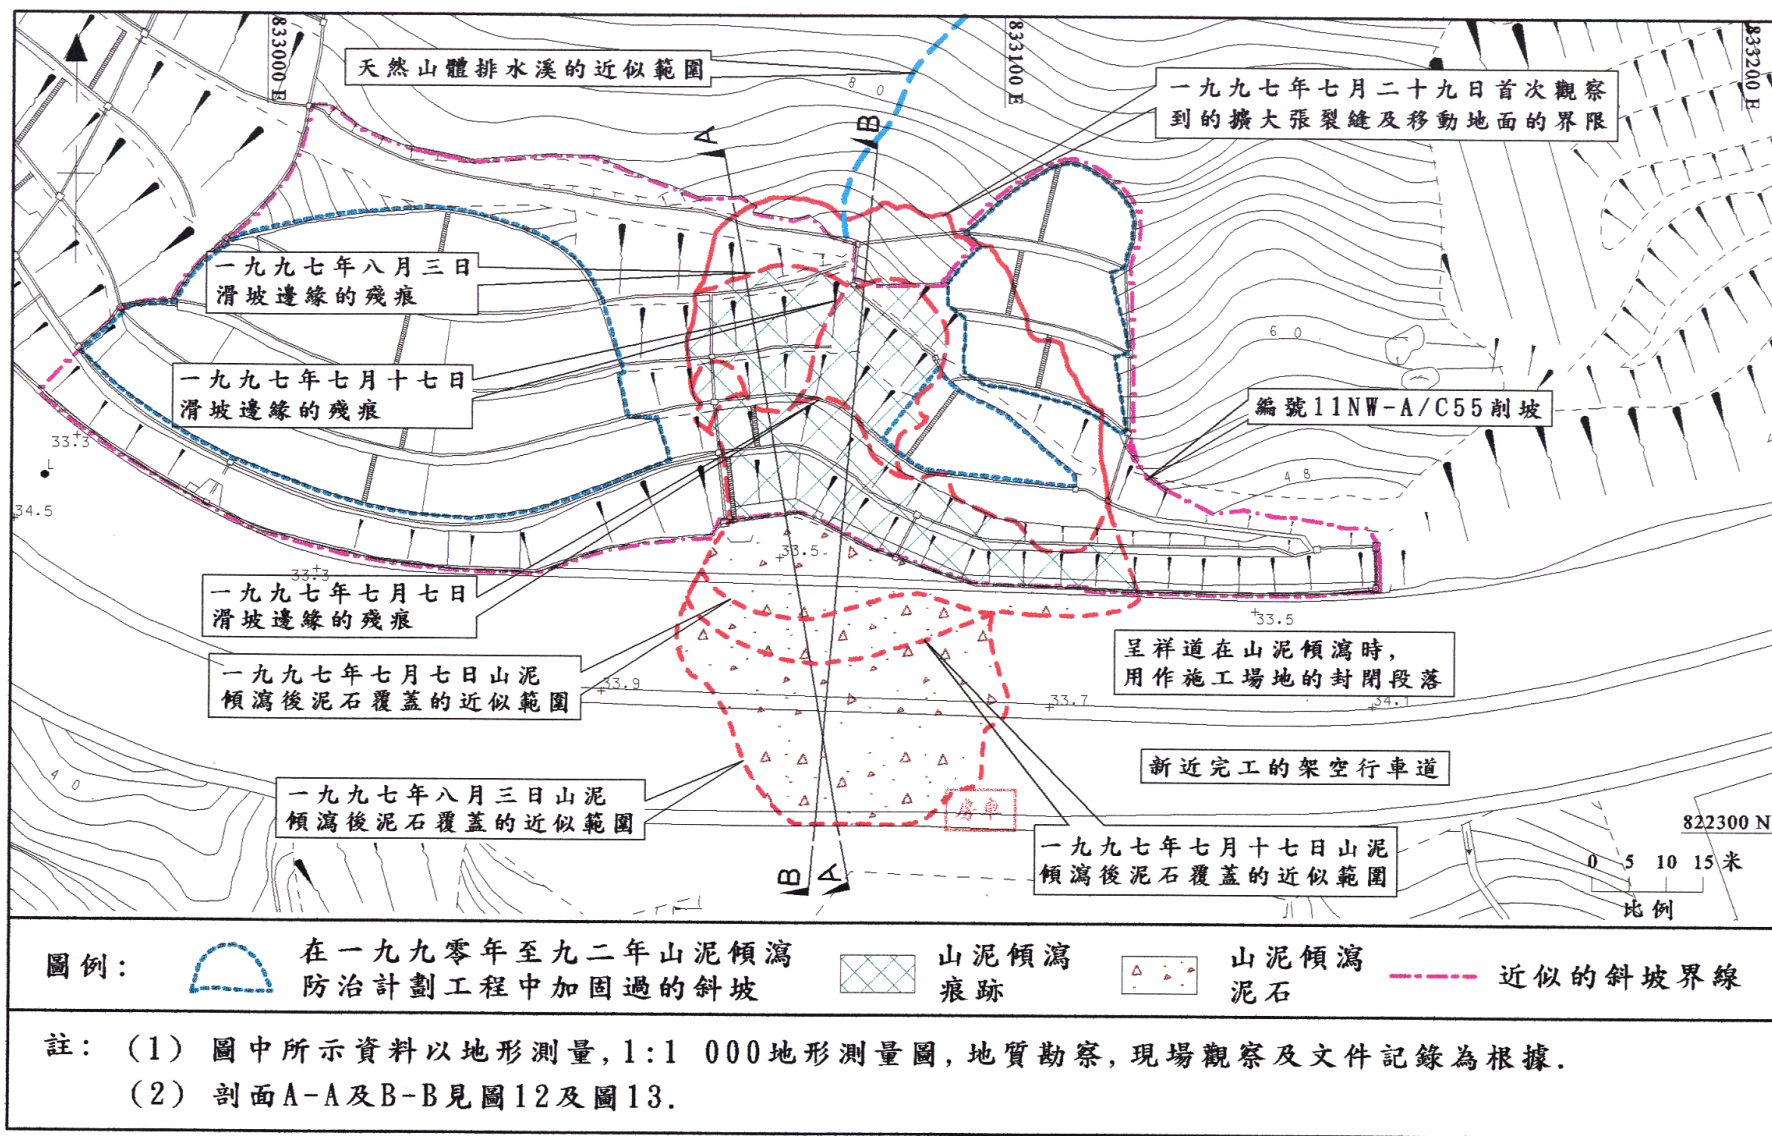
圖2 - 山泥傾瀉平面圖

第一次崩塌發生於一九九七年七月七日上午九時，塌下的泥石（土）體積約為 500 立方米，崩塌的地點為削土坡中偏東部份的下部（圖2）。塌下的泥石覆蓋了呈祥道的封閉段路面（照片3）。觀察到的崩塌殘痕只出現在斜坡最下部兩個傾斜面內，崩塌影響範圍為呈祥道上面一幅 52 米長、15 米高的斜坡。但是，由於當時削土坡的上半部份的茂密植被，這些植被令到崩塌上部的斜坡難於視察。暴露的破裂面很淺，且深度不等，但一般不超過 2 米。塌下的泥石主要來自位於削土坡凹陷部分的崩塌西半部，崩塌東部一般僅為小型的地面破裂。崩塌的東部邊界為一條侵蝕沖溝，此沖溝位於一個有多條排水渠匯流的排水井下面。

第二次崩塌發生於一九九七年七月十七日大約下午三時，塌下的泥石估計為 700 立方米，崩塌的地點為緊接第一次崩塌地點上部的斜坡凹陷部分（圖2和照片4）。塌下的泥石再一次瀉入呈祥道封閉段路面。崩塌產生了兩個相互分離的崩塌殘痕，高度達呈祥道以上 30 米並影響到一幅約 30 米闊的坡面。在天然山體排水溪的下面，那較大的崩塌殘痕形成了一個約 15 米闊的碗型凹地。估計凹地的最大豎向深度為 5 米。在其西側有一個形狀相似而較小碗型凹地。在較大崩塌殘痕的頂部有一條排水渠被切斷，此排水渠是其上面一個排水井的出水口；有多條地面排水渠都匯流於此排水井，與其中一條同被截斷的天然排水溪相連。崩塌殘痕底面的較大侵蝕沖溝，顯示曾有地面水流。在較小的崩塌殘痕頂部也有一條排水渠因崩塌而切斷。

一九九七年七月二十九日，清除了斜坡上的植被之後，在位於先前崩塌位置上面的斜坡上，發現了一個已產生大範圍裂隙和位移的變形區域（圖2和照片5）。這區域包含了前期的崩塌殘痕，在下部傾斜面上的橫向伸展範圍與七月七日崩塌的影響範圍一致。有變形跡象的地面僅限於此削土坡範圍內，面積約為 1800 平方米，包括天然排水溪以下寬度達 52 米的整幅削土坡。

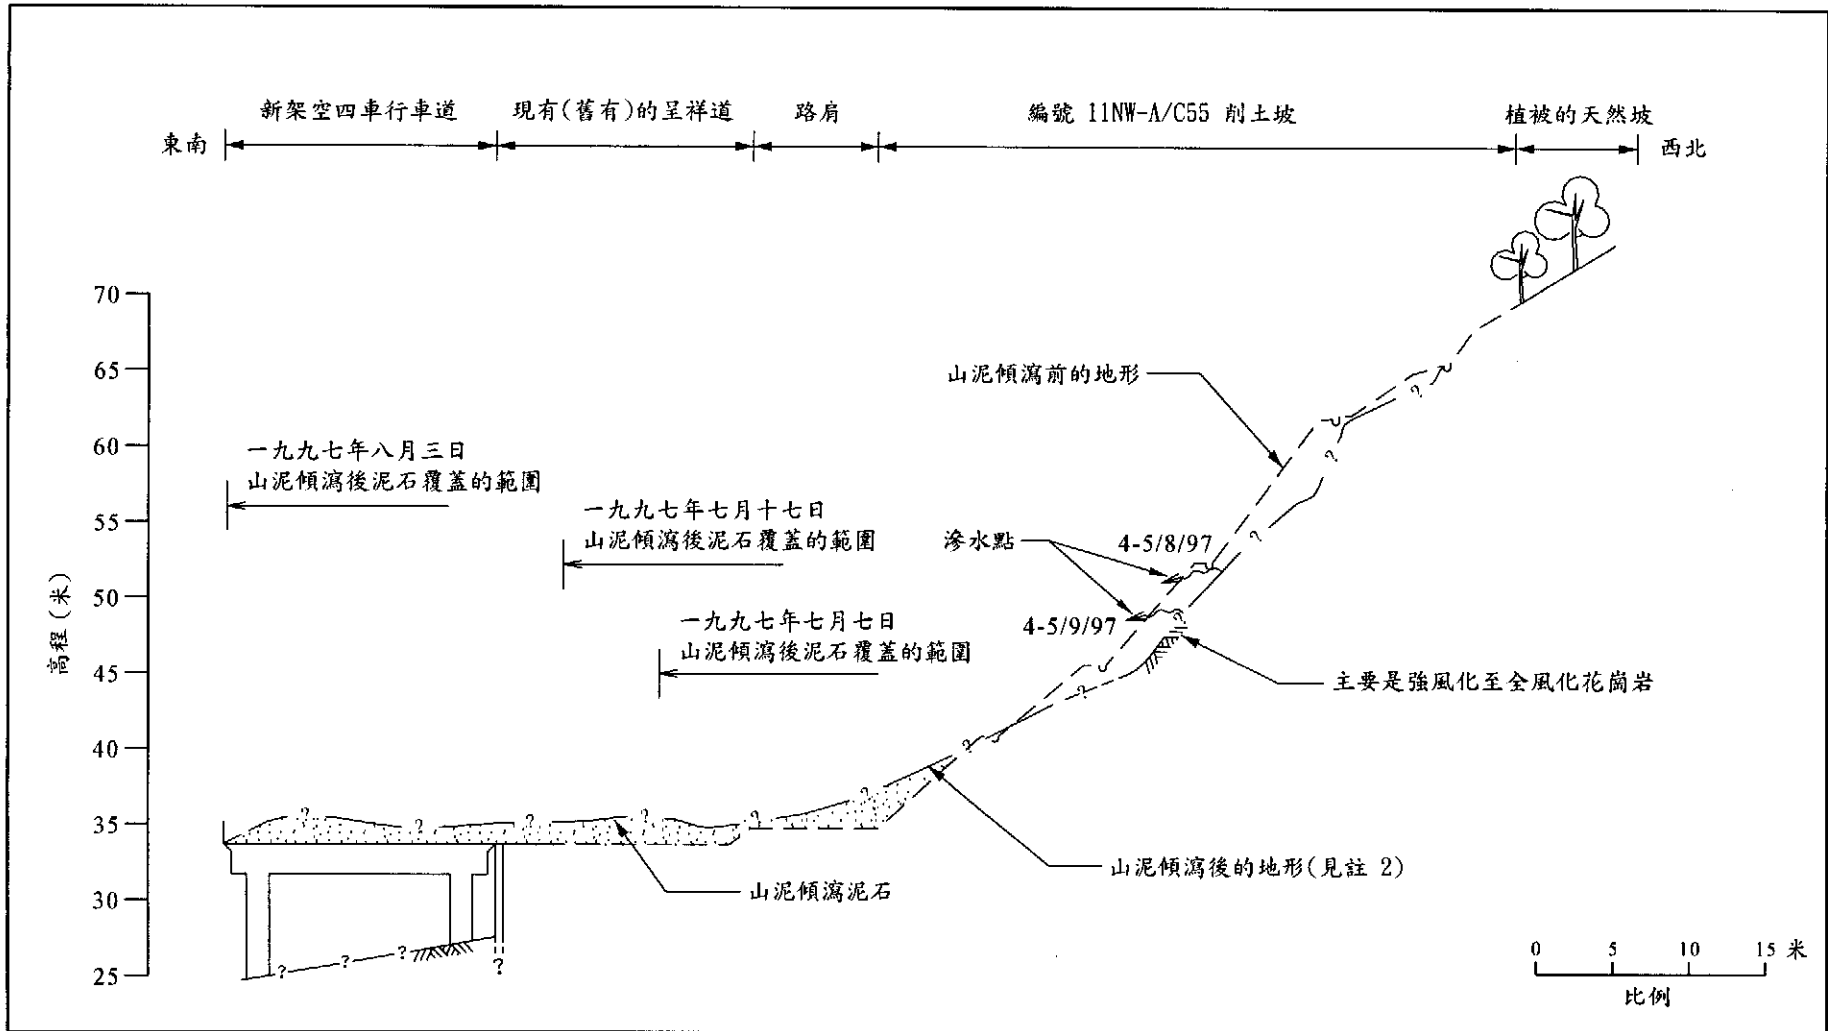
圖3 - 山泥傾瀉地點的典型剖面

第三次崩塌始自變形區域的西上部份，其範圍僅限於前述周界張裂隙內。崩塌形成的凹地達 7 米深 20 米闊，延伸到呈祥道以上 30 米高的削土坡，並將前期形成的崩塌殘痕加深和侵蝕。橫貫崩塌殘痕的典型剖面載於圖3。如照片 7 所顯示，塌下的泥石覆蓋了呈祥道封閉段路面和與其鄰接的新近建成的四車道架空道路，並瀉入南側護欄。路面上的泥石堆最闊估計不超過 50 米，最厚約為 3 米(照片6)。由崩塌殘痕的頂部開始量度，泥石所移動的平面距離最遠約為 78 米。

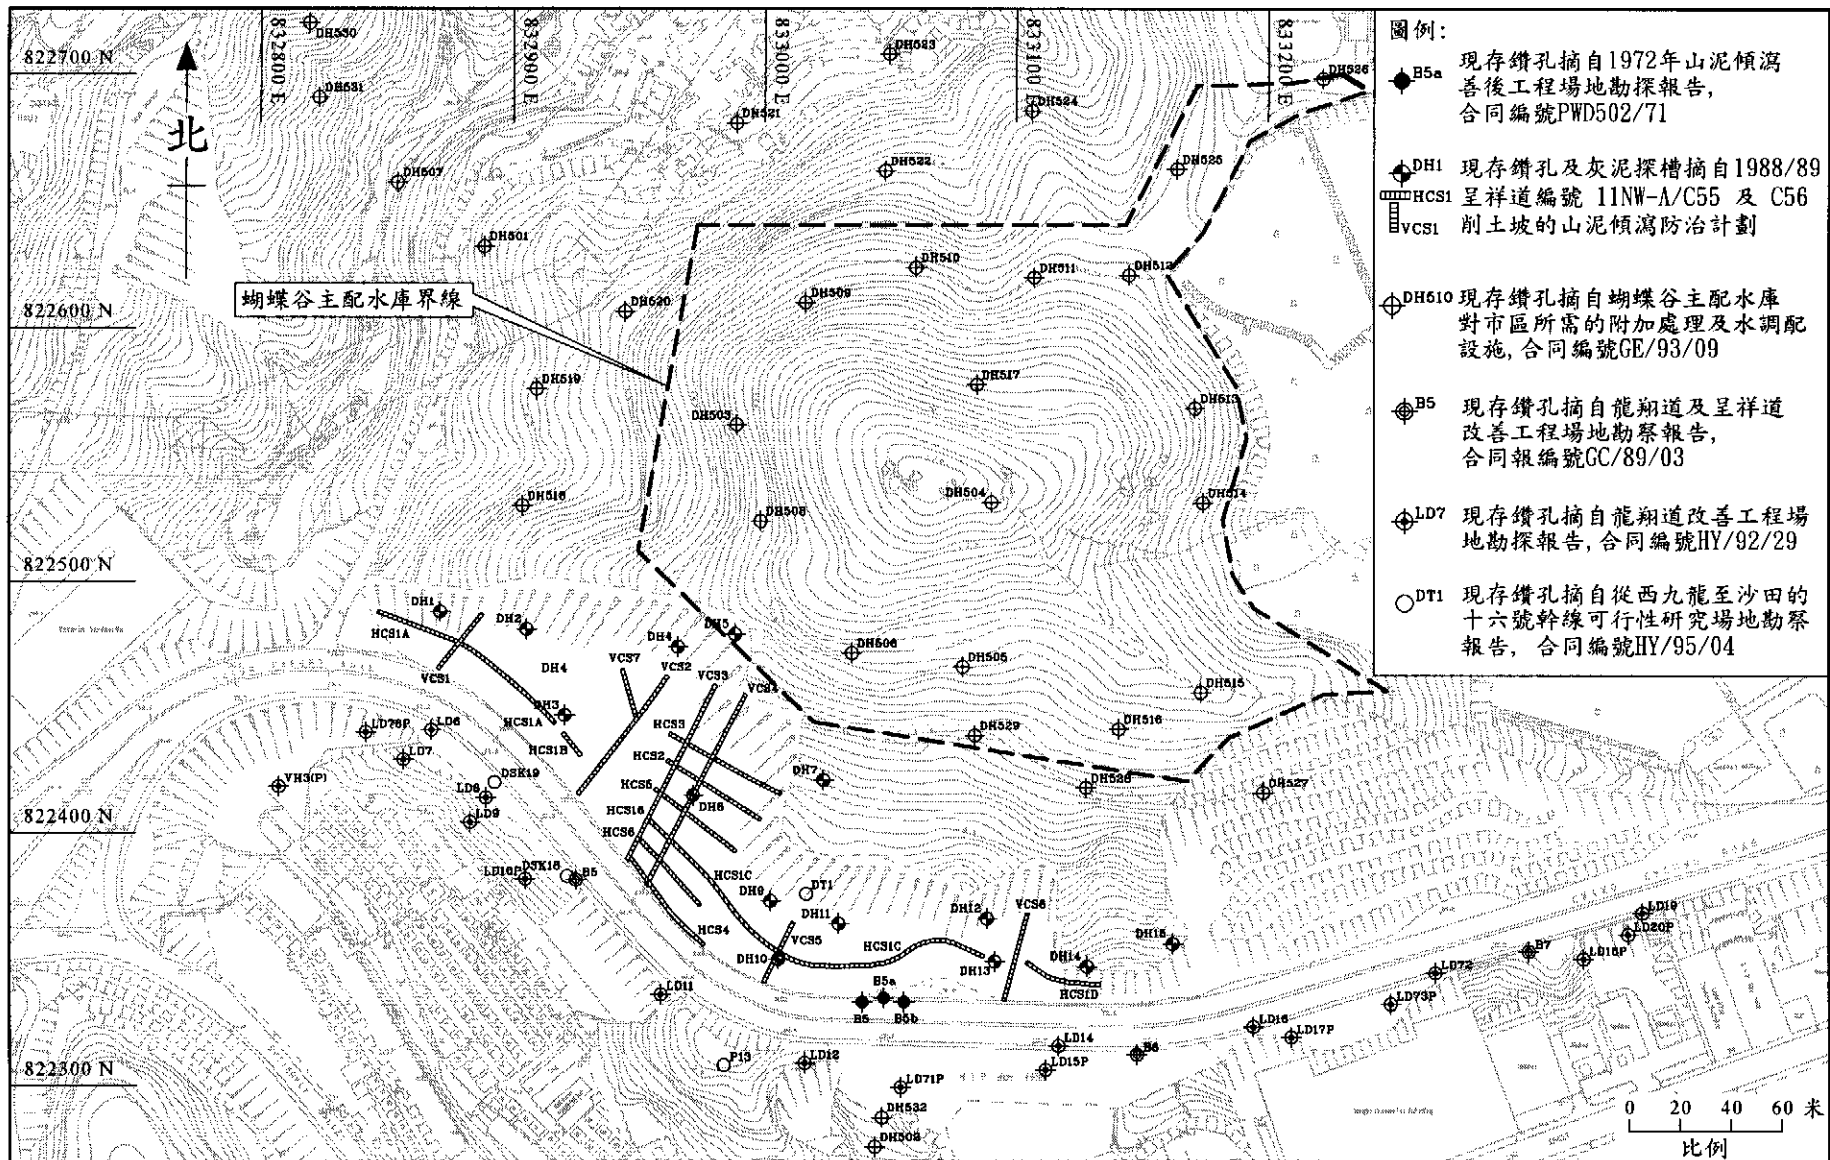
A total of fourteen investigation holes with twenty-seven piezometers installed, seven vertical and six horizontal chunam strips were carried out as part of the Stage 3 Study in the period January to April 1988. (locations are shown in Figure 10 of this report).

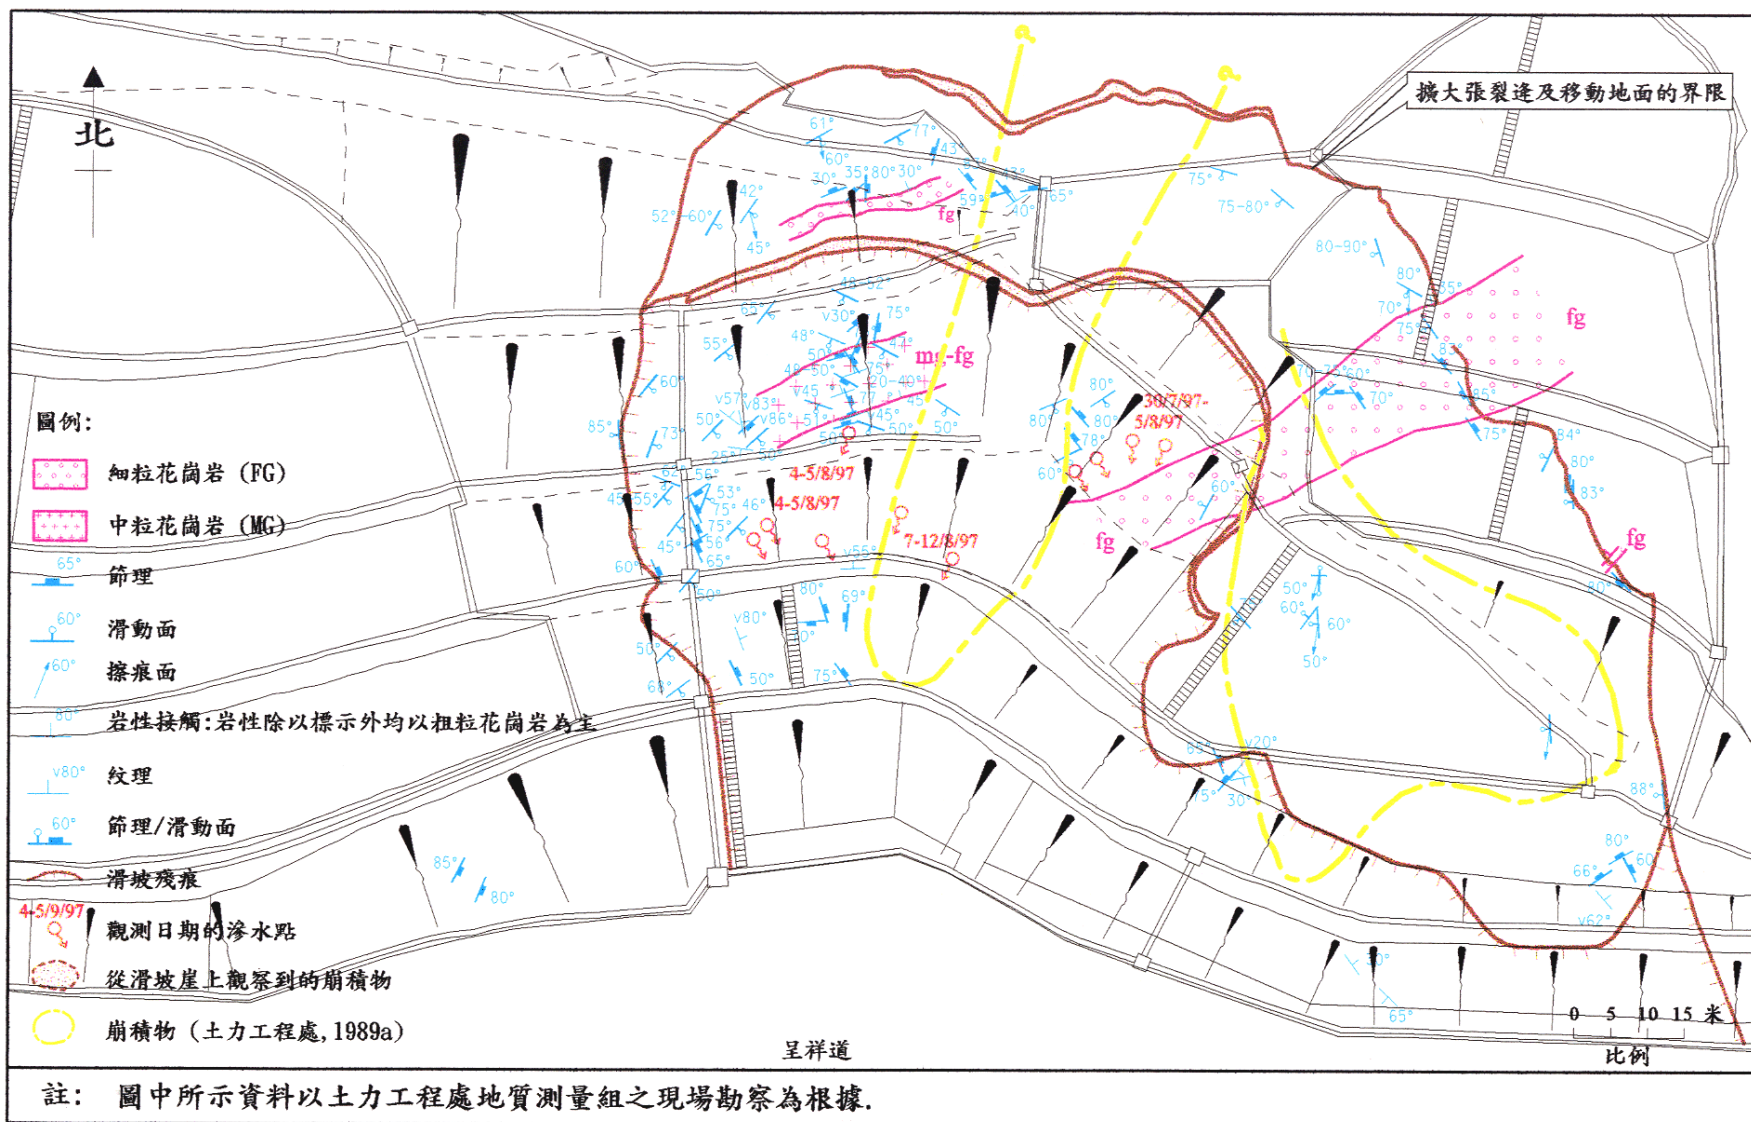
圖11 - 山泥傾瀉範圍地質平面圖

在八月三日的山泥傾瀉以後，在滑坡殘痕，邊坡山脊以下 10 米和邊坡的較低部位，觀察到許多滲水點(圖11)。此外，在一九九七年滑坡之後新安裝在滑坡殘痕中部的三條導水管，一直有水流出(照片12)。

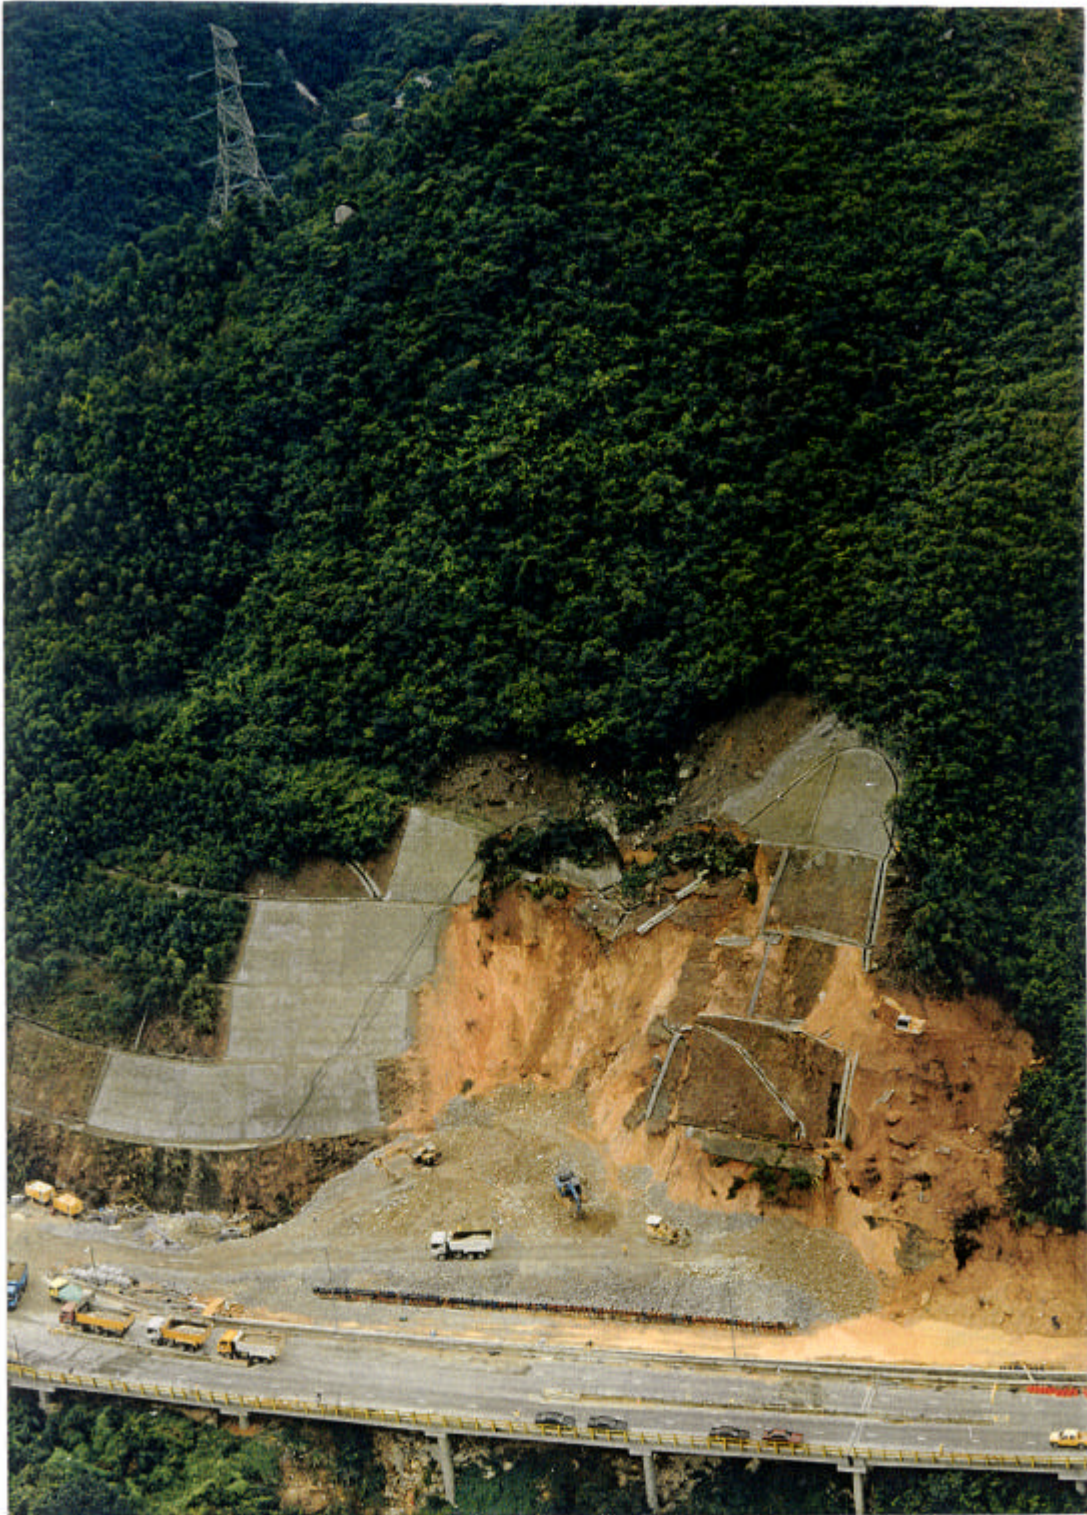
照片1 - 一九九七年八月三日山泥傾瀉的現場景象  
(一九九七年八月八日拍攝)

一九九七年八月三日星期天上午十一時十五分，九龍蝴蝶谷東側呈祥道路邊削土坡發生山泥傾瀉（圖1）。瀉下的泥石完全掩埋了呈祥道一段 50 米長的路面（照片1），並困住一輛沿呈祥道西行的私家車。私家車司機自行逃脫，沒有受傷。呈祥道隨後封閉，進行清理泥石及斜坡的臨時加固工程。

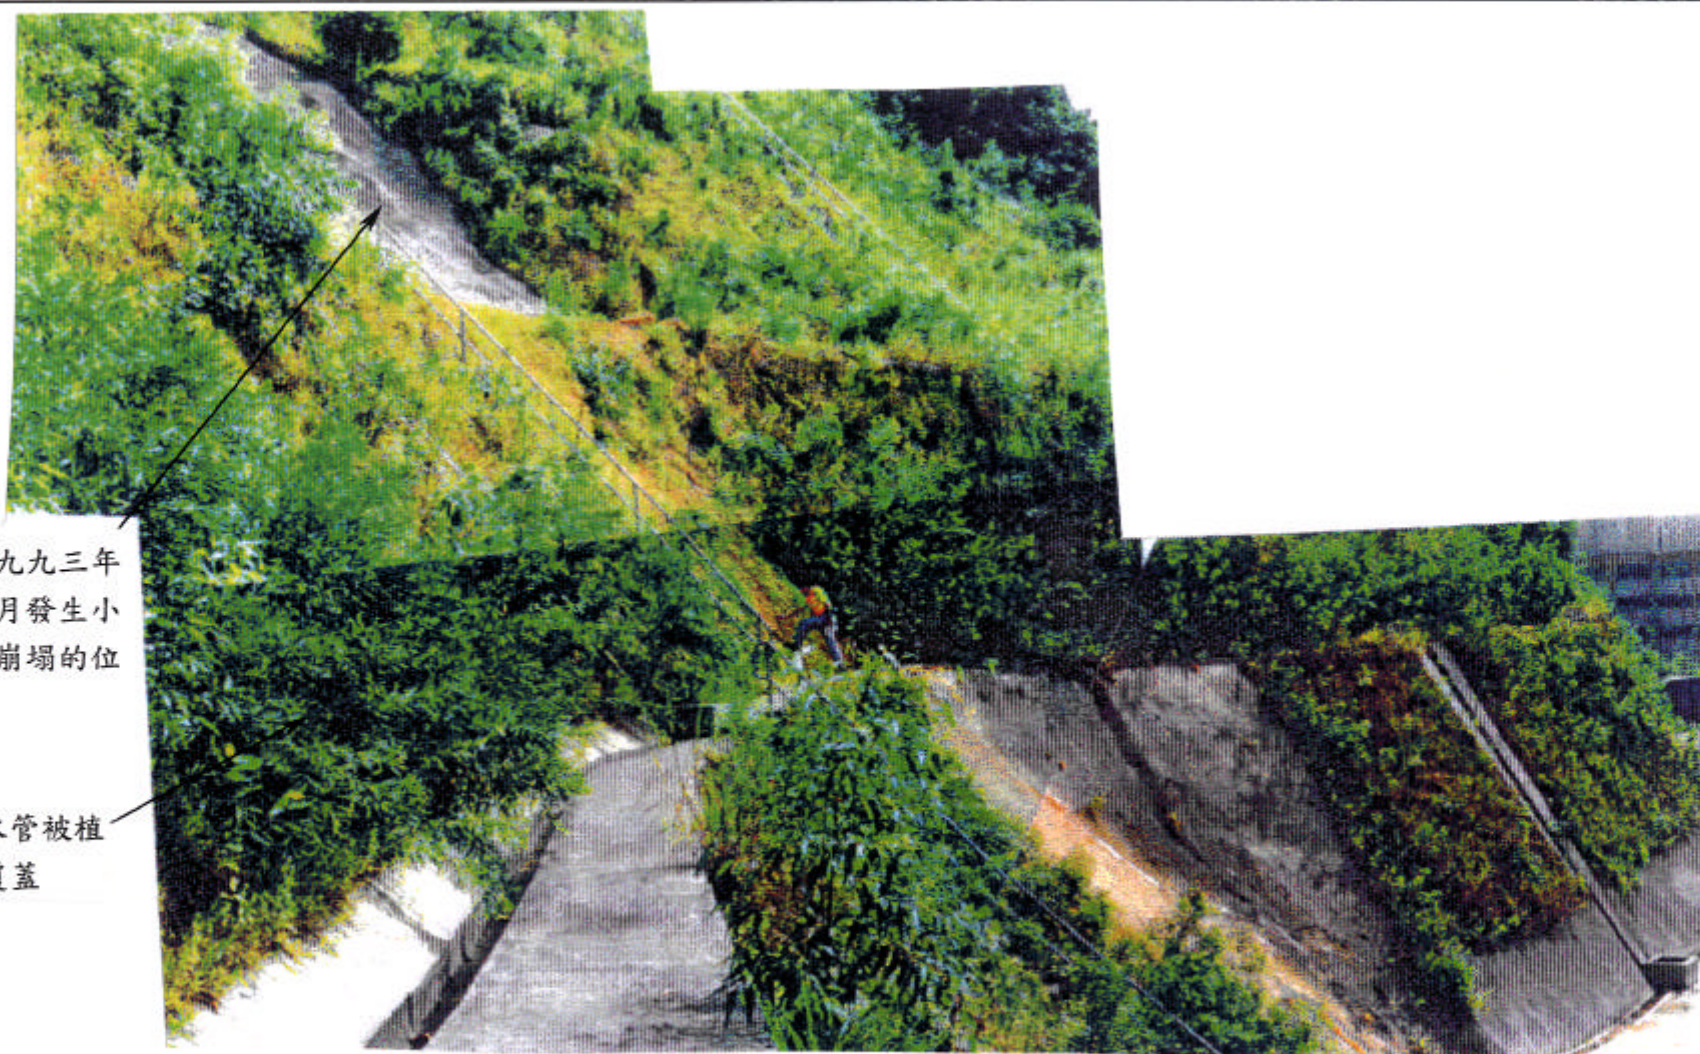
一九九三年  
七月發生小  
型崩塌的位  
置

導水管被植  
被覆蓋

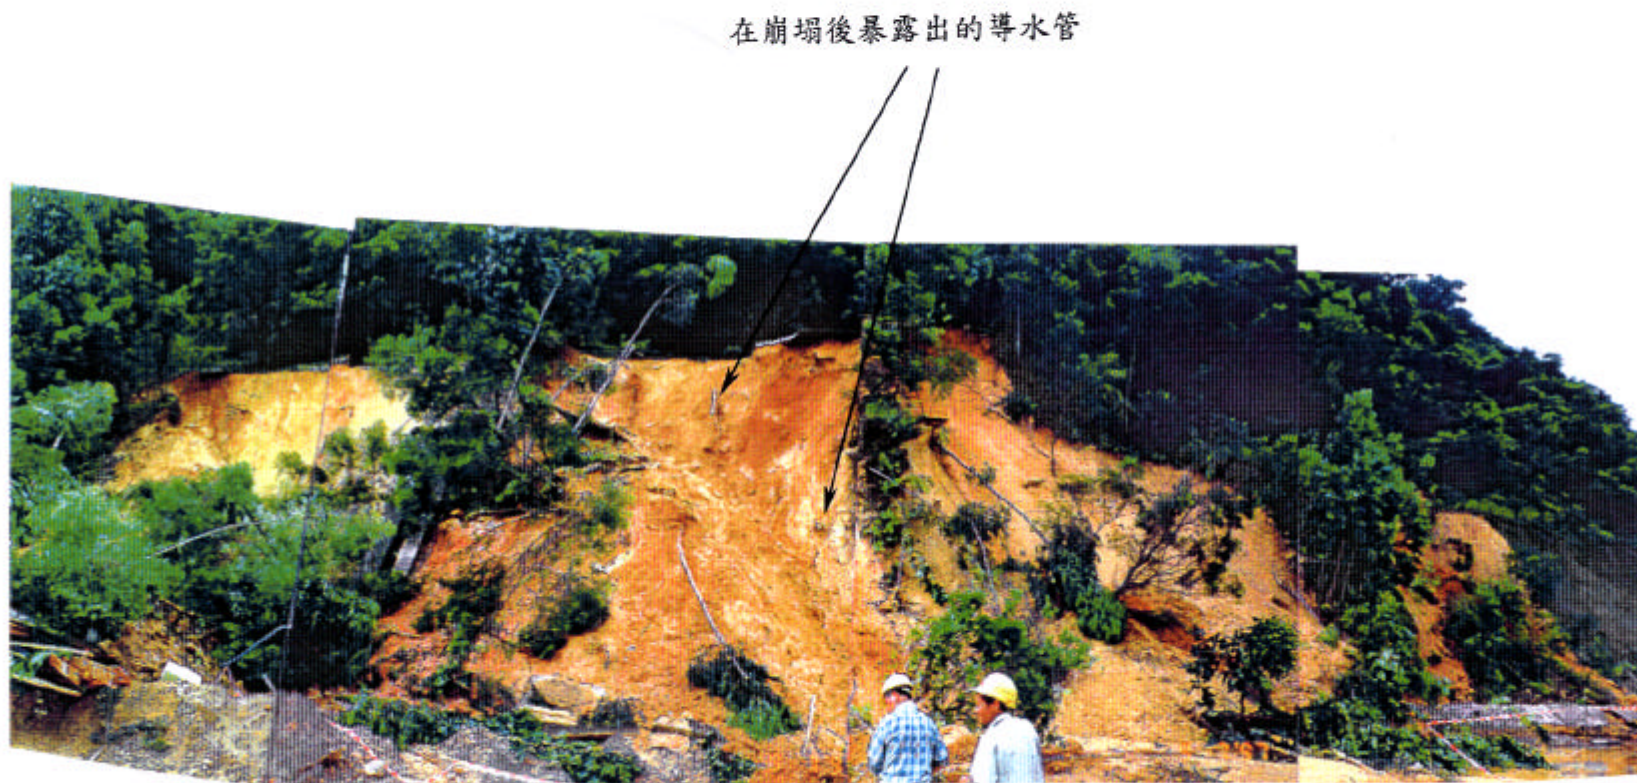
照片2 - 一九九三年九月十五日攝得的編號 11NW-A/C55 削土坡的照片(照片摘錄自土力工程處  
文件編號 GCD2/A1/11NW-A/C55)

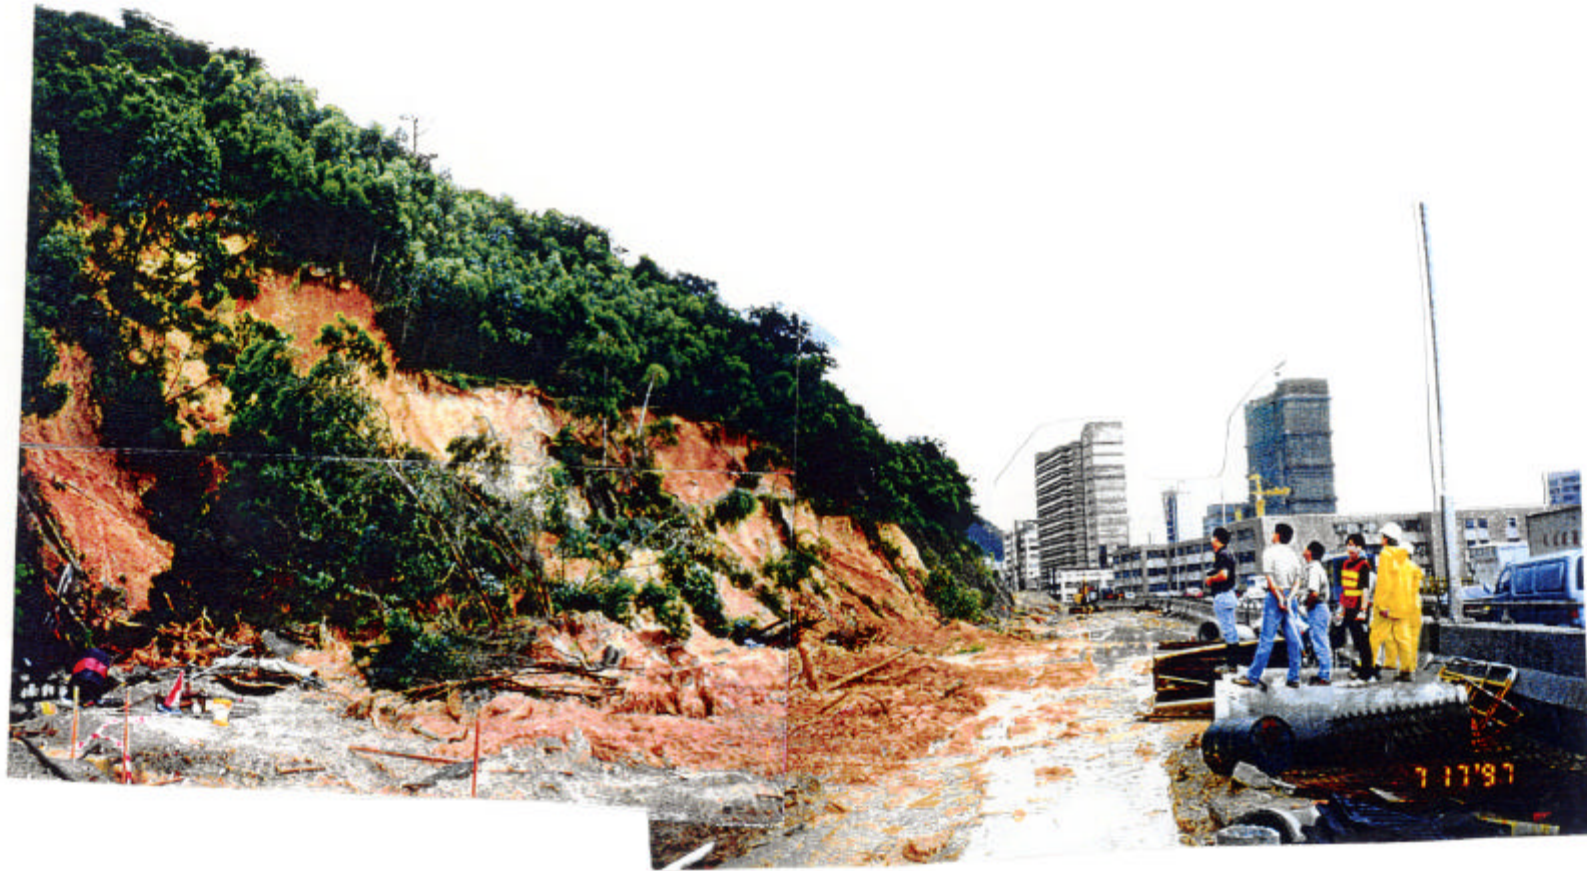
照片3 - 一九九七年七月七日山泥傾瀉的現場景象(一九九七年七月九日拍攝)

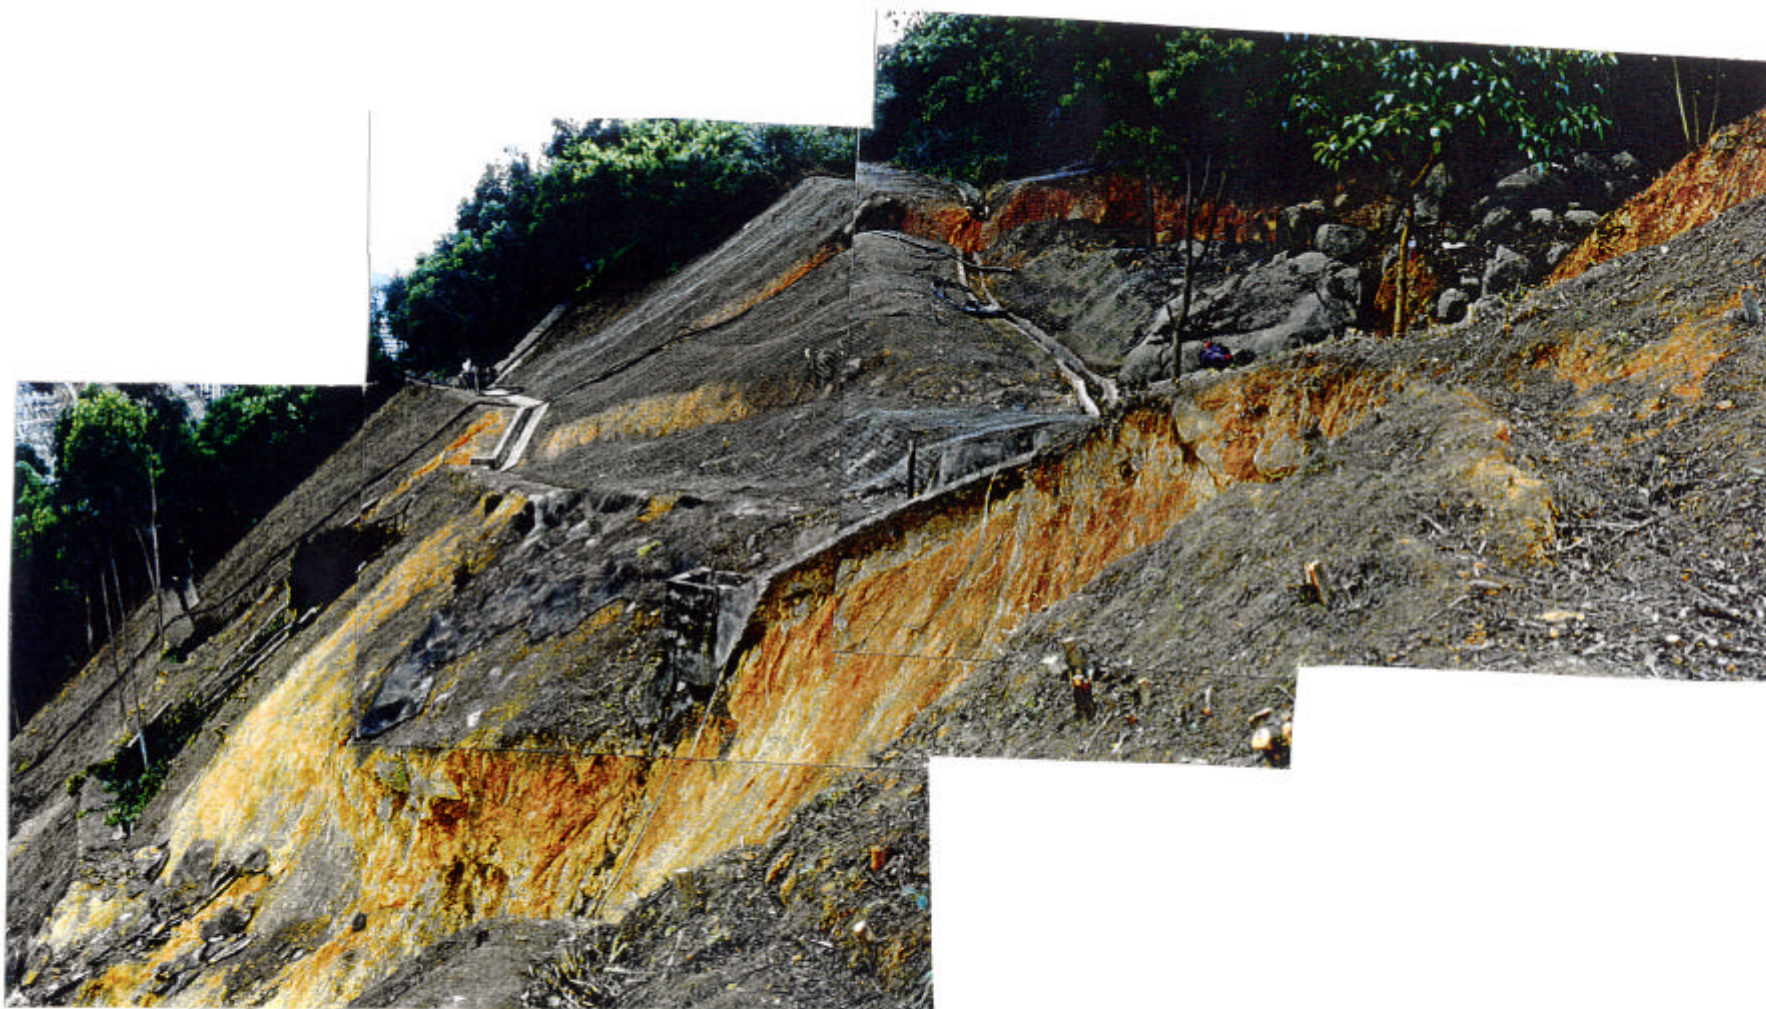
照片4 - 一九九七年七月十七日山泥傾瀉的現場景象(一九九七年七月十七日拍攝)

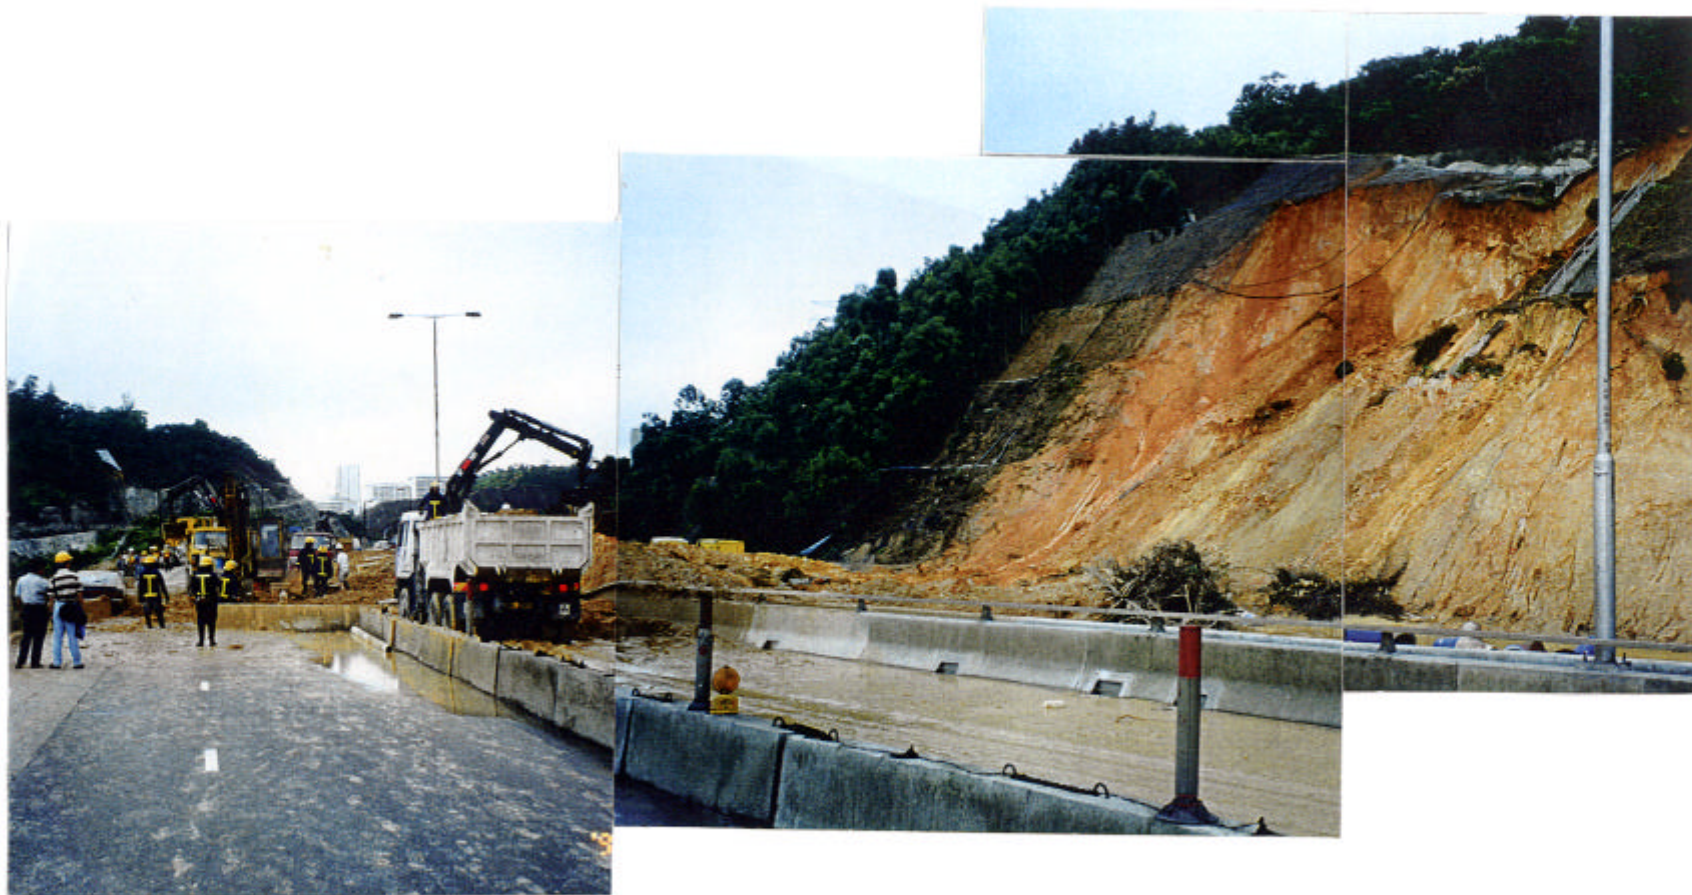
的最大水平位移量達 1.0 米。最大位移量發生於張裂隙的上段邊緣(照片5)。沿張裂隙的西段和北段邊緣，張裂隙面看來為新鮮。然而，一九九七年七月三十日的發現可能預示了崩塌的一個較早期階段位移。張裂隙內局部充填鬆散表土，東段的暴露張裂面上有銹跡；這些情況顯示此張裂隙可能已存在了一段時期。另外，在張裂隙的西上段範圍內，有一處小面積的噴射混凝土護坡，它覆蓋著一處位於一個小的平緩陡坡上面的變形坡台。這再一次顯示此張裂隙可能已存在了一段時期。本報告的後部將會討論到於山泥傾瀉後進行的場地勘探，及發現此斜坡其他先前位移的證據。

照片5 - 坡體裂隙和移動擴展後的現場景象(一九九七年七月三十日拍攝)

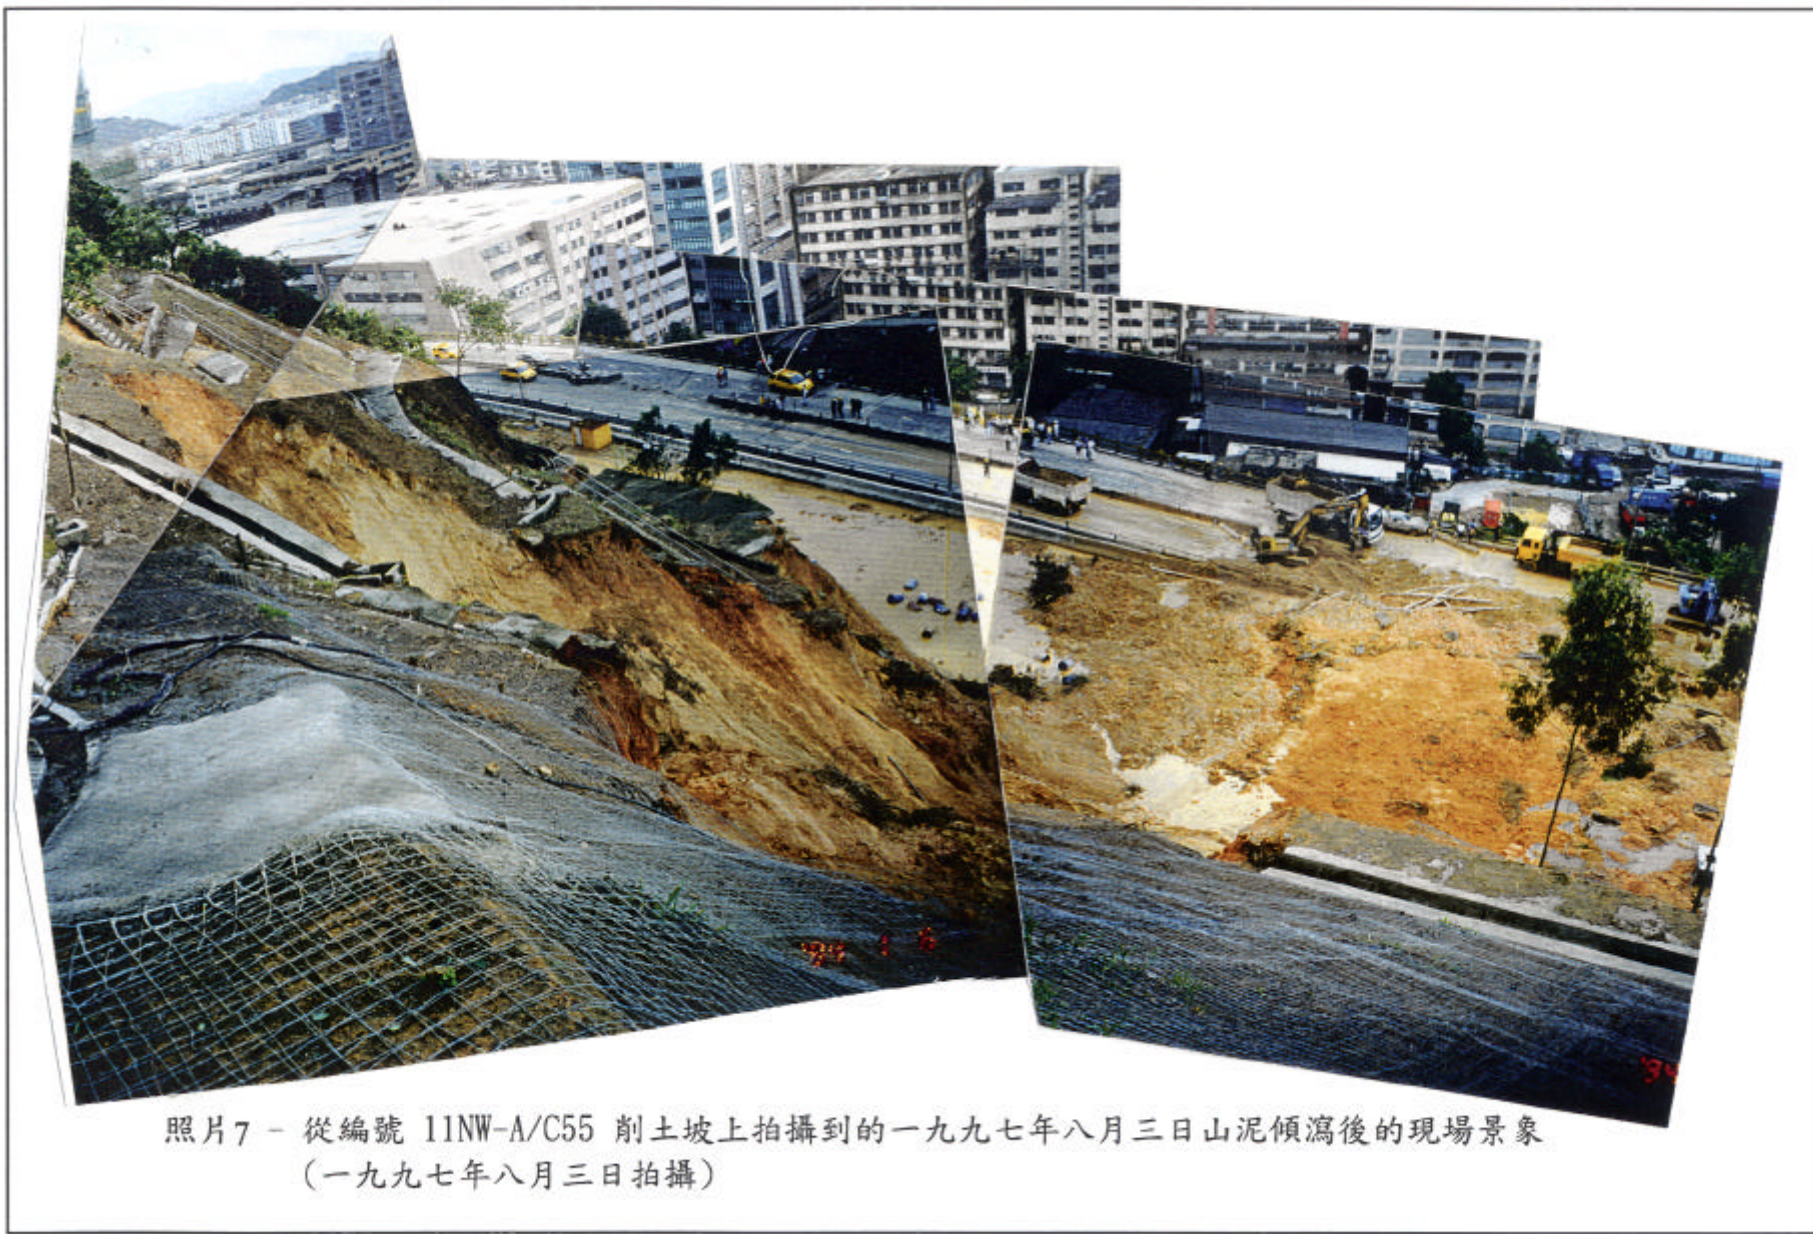
第三次崩塌導致呈祥道被完全堵塞。根據山泥傾瀉目擊人士的描述，山泥傾瀉發生於一九九七年八月三日上午十一時十五分。照片6 是在山泥傾瀉發生後幾小時，那時正在進行現場清理時拍攝的。這次塌下的泥石體積估計有 2000 立方米。

照片6 - 從呈祥道拍攝到的一九九七年八月三日山泥傾瀉後的現場景象(一九九七年八月三日拍攝)

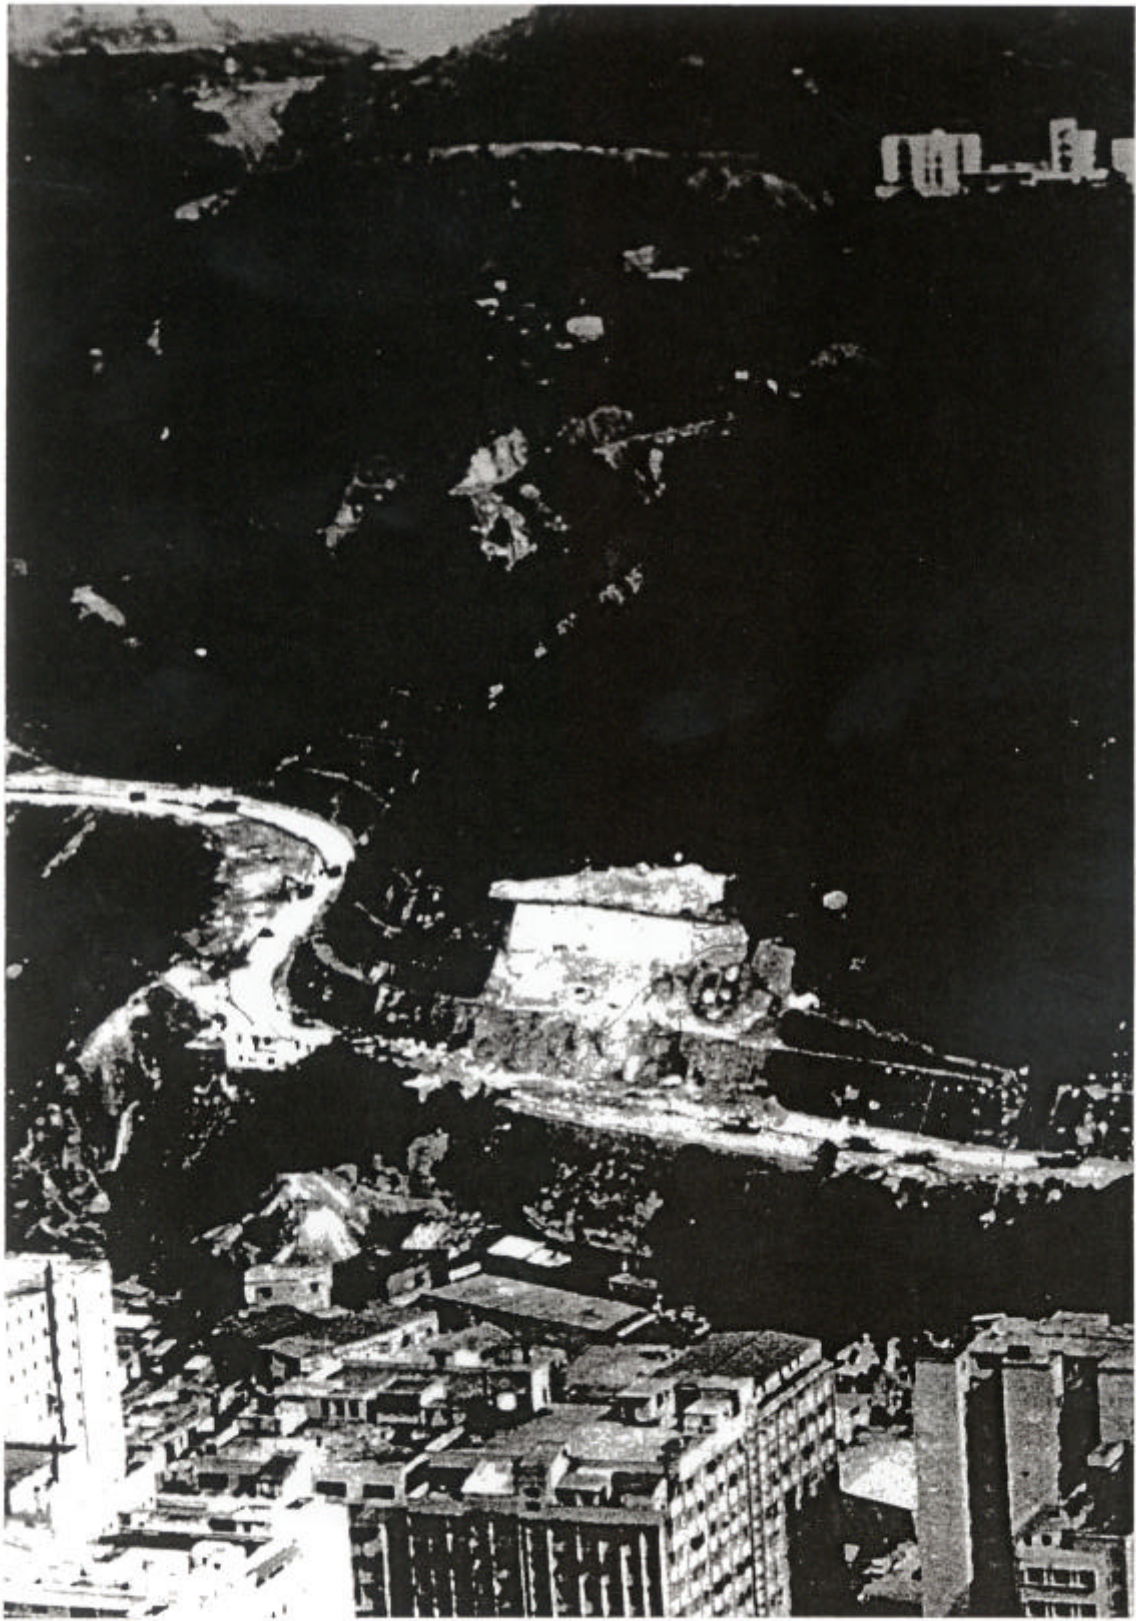
照片7 - 從編號 11NW-A/C55 削土坡上拍攝到的一九九七年八月三日山泥傾瀉後的現場景象  
(一九九七年八月三日拍攝)
