一九九七年八月三日  
呈祥道山泥傾瀉事件報告  
**REPORT ON THE  
CHING CHEUNG ROAD  
LANDSLIDE OF  
3 AUGUST 1997**

土力工程處報告系列第 78 號  
GEO REPORT No. 78

合樂亞洲顧問公司  
Halcrow Asia Partnership Ltd.

香港特別行政區政府  
土木工程署  
土力工程處  
**GEOTECHNICAL ENGINEERING OFFICE  
CIVIL ENGINEERING DEPARTMENT  
THE GOVERNMENT OF THE HONG KONG  
SPECIAL ADMINISTRATIVE REGION**

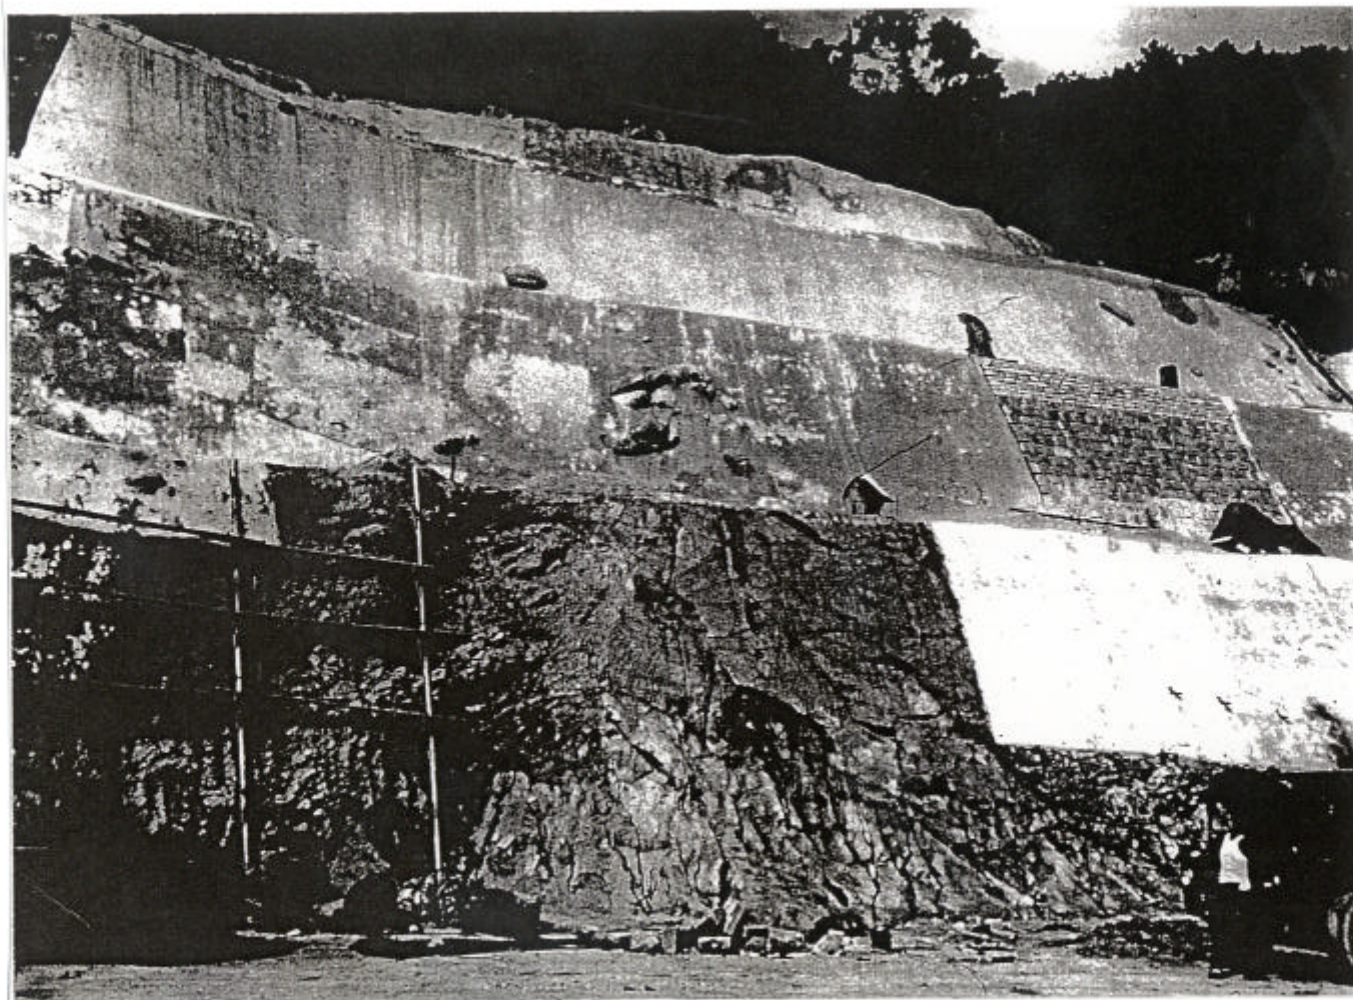
一九七二年呈祥道拓寬工程期間，削土坡發生了一次大型山泥傾瀉（照片8）。崩塌的體積大約為 7500 平方米（茂盛，一九七三a）。修葺工程包括削制斜坡至其原坡度，然而在此期間斜坡又產生了進一步的位移（照片9）。其後的監測錄得平面位移量達 21 毫米，主要產生位於一九九七年崩塌中部的最下一個傾斜面上。在最下部兩個傾斜面安裝了 151 根 16 米長的導水管之後，斜坡最終穩定下來。據茂盛顧問公司報導（一九七三b）約 70% 至 80% 多的導管在安裝後就持續流水，崩塌區中部的導管尤其明顯；顯示導管可有效截斷地下水。測得的最大單管流量為每小時38升。其後十年，斜坡無明顯不穩現象。

照片8 - 一九七二年山泥傾瀉後的現場景象(照片摘錄自  
茂盛一九七二年的呈祥道初步報告的圖一)

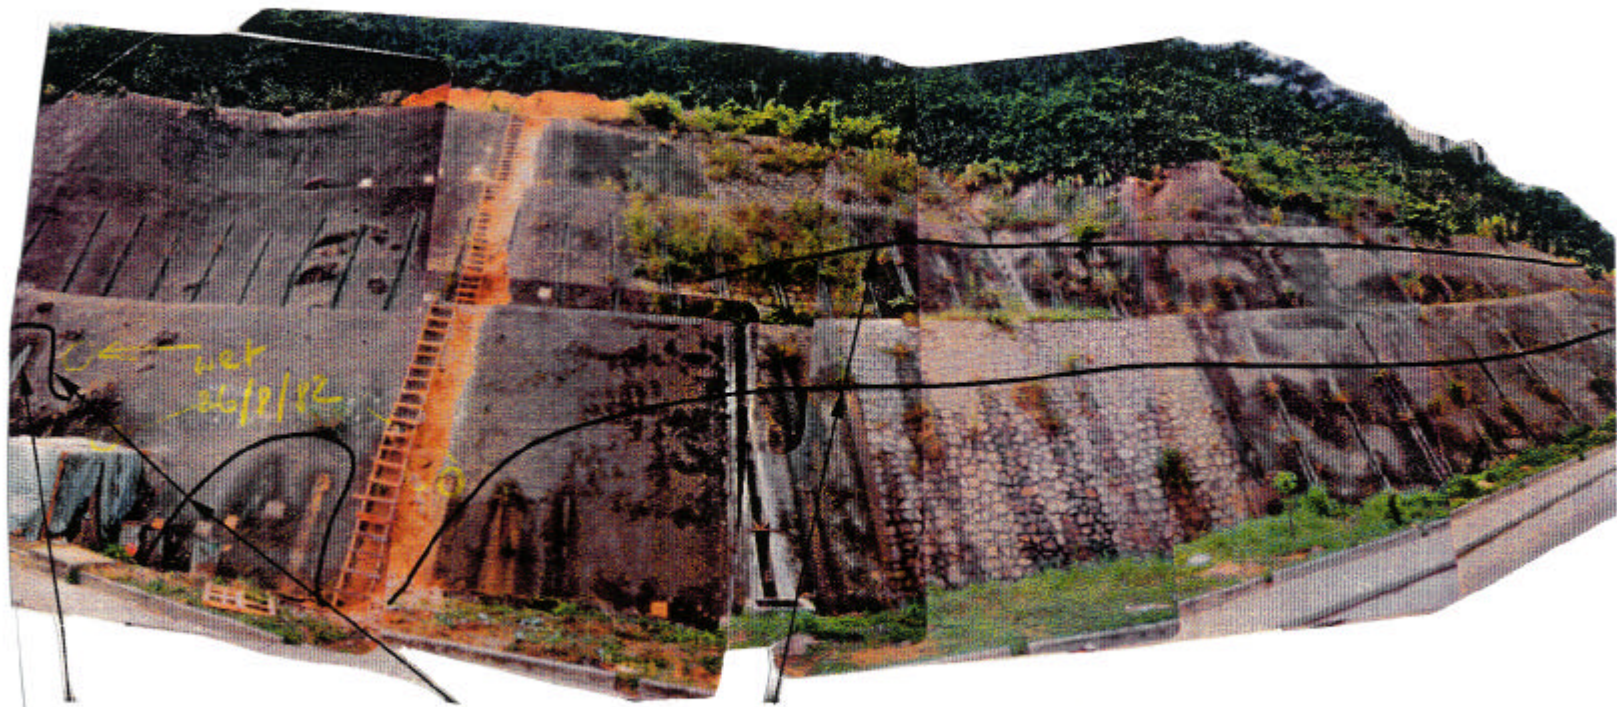
照片9 - 一九七二年山泥傾瀉後的善後工程的景象(照片摘錄自茂盛一九七二年的呈祥道初步報告的圖二至四)

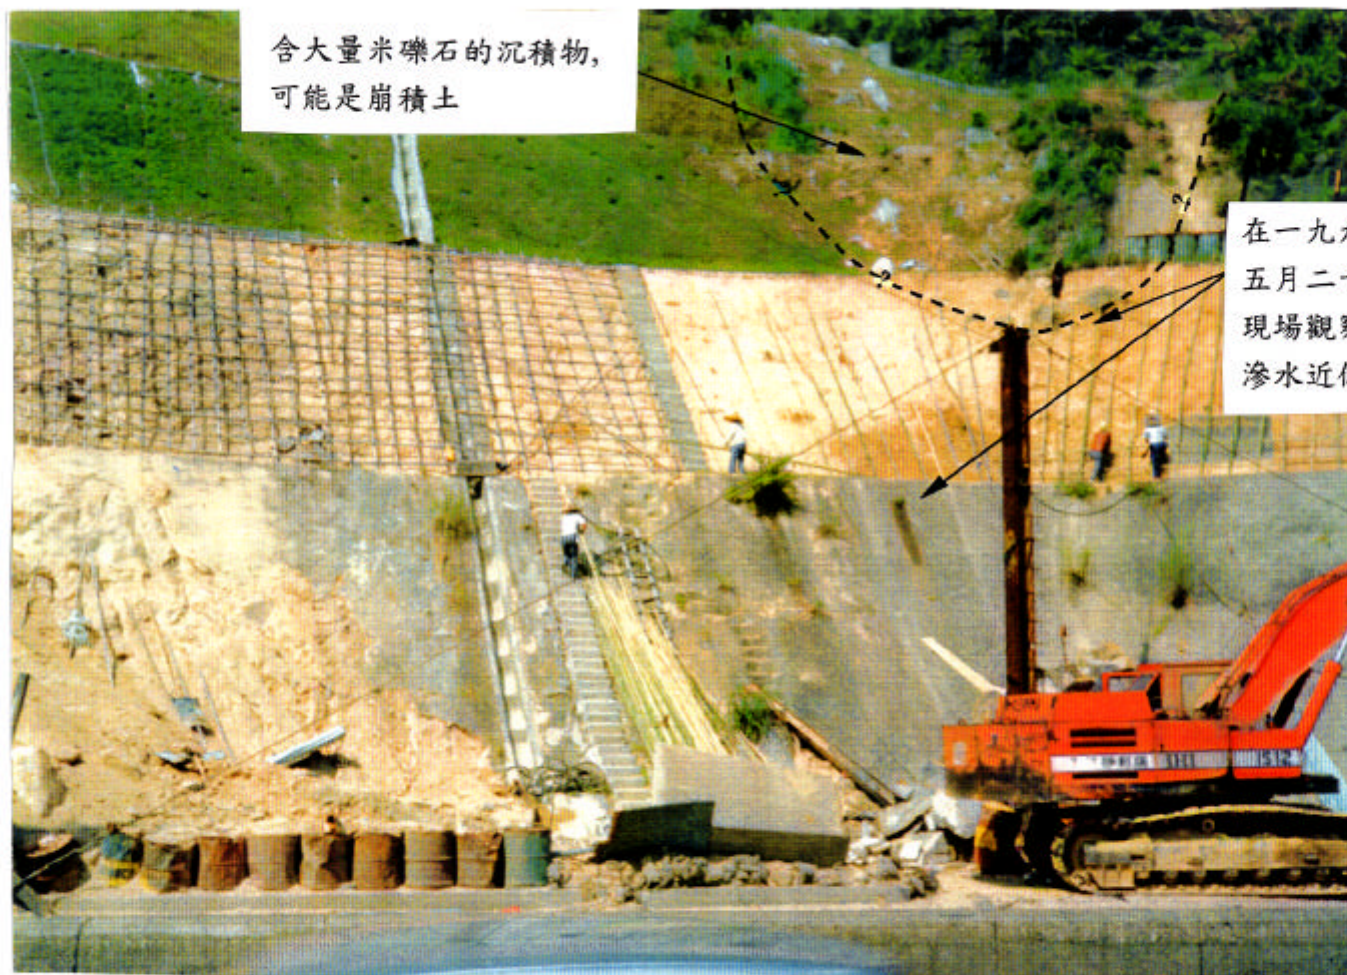
一九八二年八月，一場豪雨之後，鄰接編號 11NW-A/C56 斜坡發生了一次大規模山泥傾斜，這次崩塌涉及多於 1500 立方米的泥石。編號 11NW-A/C55 削土坡沒有發生大的崩塌，只在天然排水溪西側頂部坡台以上的削土坡中上部坡面上有一處很小的表面崩塌（照片10）。從一九八二年山泥傾斜發生後所拍攝的照片中，發現大部份在一九七二年安裝在削土坡中部的排水導管中有水流出。將一九八二年八月所攝照片同其後一個月的照片比較，顯示出從排水導管流出的水有所減少，這證明削土坡在大雨後有瞬變反應。

地下水大量流出

在一九八二年九月六日觀察到滲水的大致範圍

照片10 - 一九八二年山泥傾瀉後的現場景象(照片摘錄自土力工程處一九八二年的追蹤報告)

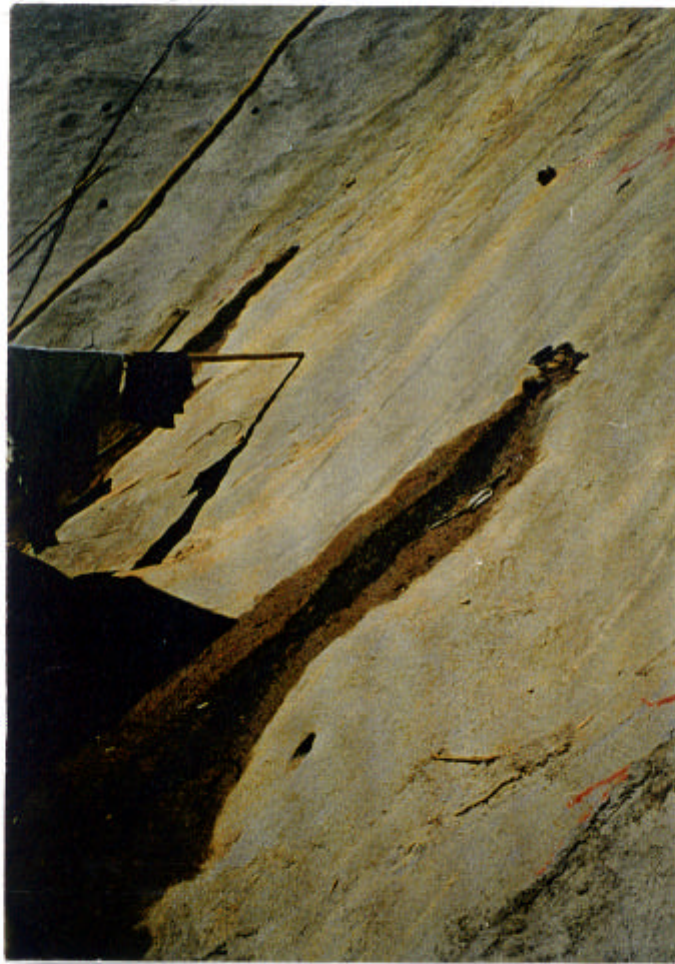
在一九九二年三月五日防止山泥傾瀉 (LPM) 工程雖已驗證完工，但地盤檔案記載在這次一九九七年崩塌範圍內仍有數項工程進行而直至一九九二年五月十五日才完工，一九九二年五月十九日發現兩處地下水滲流，其位置在一九九七年崩塌範圍內的削土坡上(照片11)。隨後對削土坡進行了穩定性分析。分析時假定在每個滲流處的上部有一薄層上層滯水，斜坡的安全系數大過 1.2，因此決定不需任何改善工程。

在位於滑坡崖，於斜坡上中部沿著水流線，觀察到厚度達 2.5 米的崩積土，向東西兩方向逐漸變薄(土力工程處，1997)。崩積土物料組成有棕色至暗棕色含礫石，粉土，黏土的砂，並有大漂石，漂石直徑大到 4 米，成份為輕微至中等風化的粗粒花崗岩。一九八八年(土力工程處，1989a)進行的地面勘察表明，另一層不同的崩積土層延伸到削土坡的第二個傾斜面，這個位置與最近的斷裂是一致的，並為 LPM 的照片證實(照片 11)。地層地貌關係表明，一陡而窄的峽谷堆積有含漂石的土層。在天然狀態下，此處曾經可能是切割峽谷及相應的崩積層土包，但唯一可查到的航空照片所反映的現場是一九四五年之後的，地貌的情況被採石活動所擾動而非天然狀態。此處曾經可能是山體表面排水溪(也許與相應的地下水流有關)。

照片11 - 照片顯示編號 11NW-A/C55 削土坡中部在山泥傾瀉防止工程進行中的現場景象  
(一九九一年十月四日拍攝)

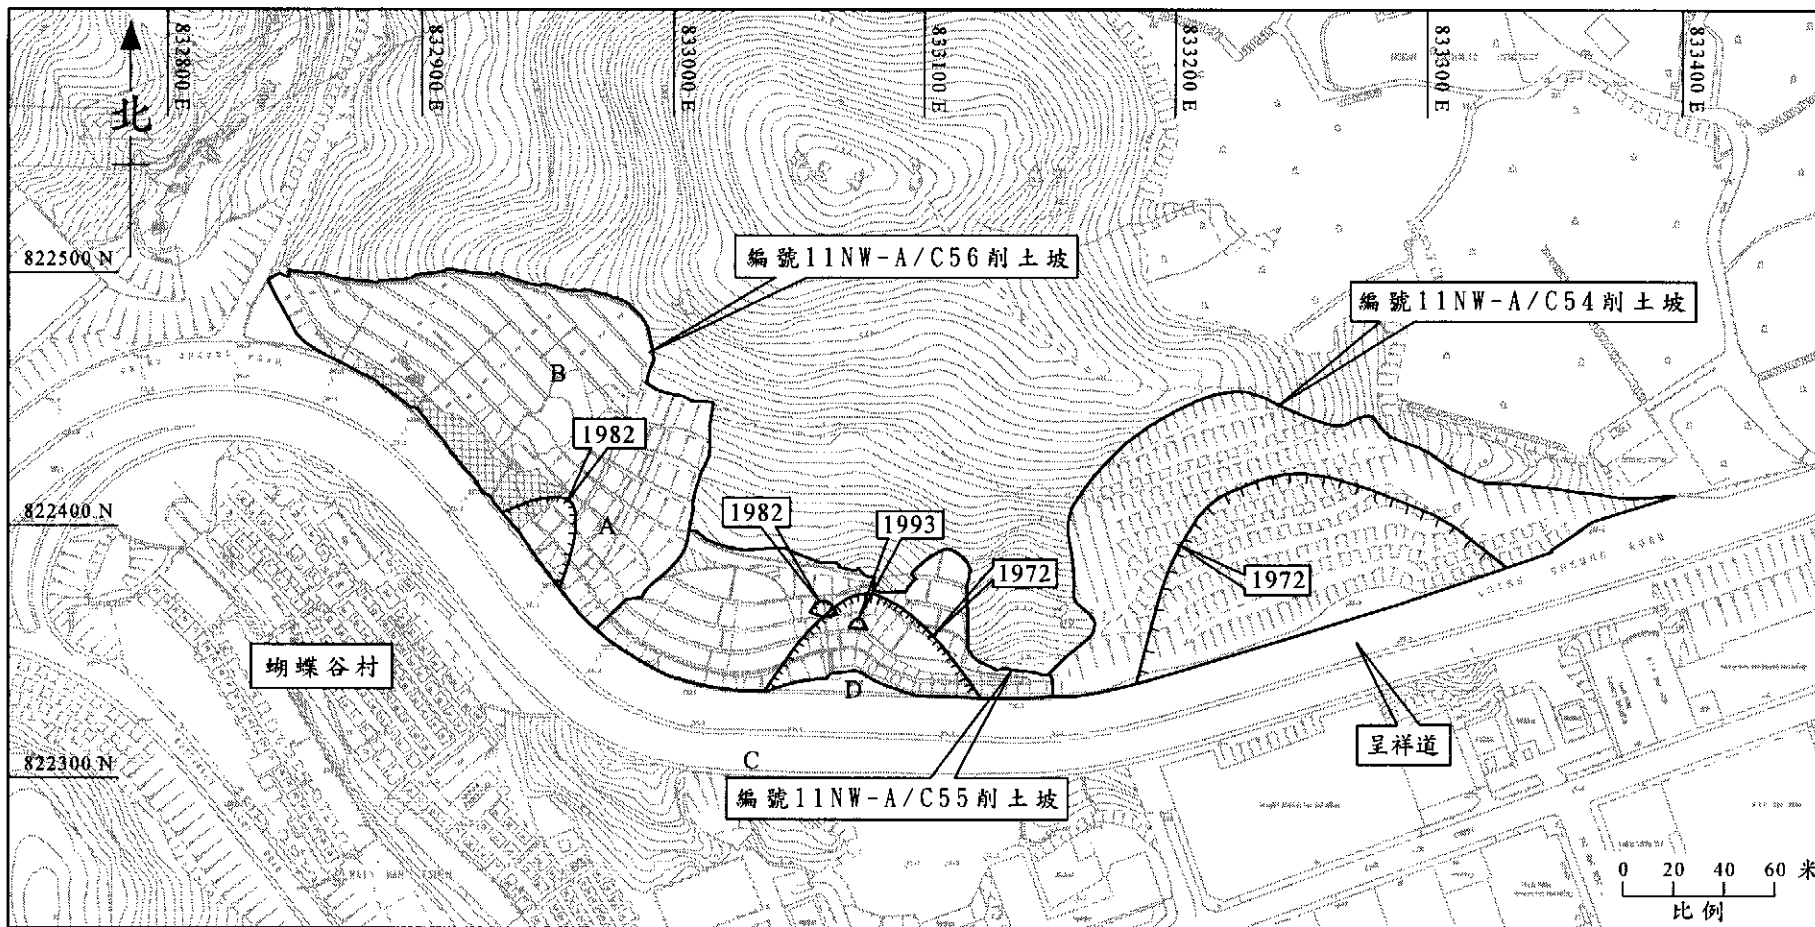
過往幾次的發生在編號 11NW-A/C55 削土坡上及  
周圍削土坡上的山泥傾瀉的地點
