二零零五年八月二十日
芙蓉山村山泥傾瀉事件報告
山泥傾瀉調查結果
**REPORT ON THE LANDSLIDE
AT FU YUNG SHAN TSUEN
OF 20 AUGUST 2005
FINDINGS OF THE LANDSLIDE
INVESTIGATION**

土力工程處報告系列第277號
GEO REPORT No. 277

茂盛土力工程顧問有限公司
Maunsell Geotechnical Services Ltd.

**GEOTECHNICAL ENGINEERING OFFICE
CIVIL ENGINEERING AND DEVELOPMENT DEPARTMENT
THE GOVERNMENT OF THE HONG KONG
SPECIAL ADMINISTRATIVE REGION**

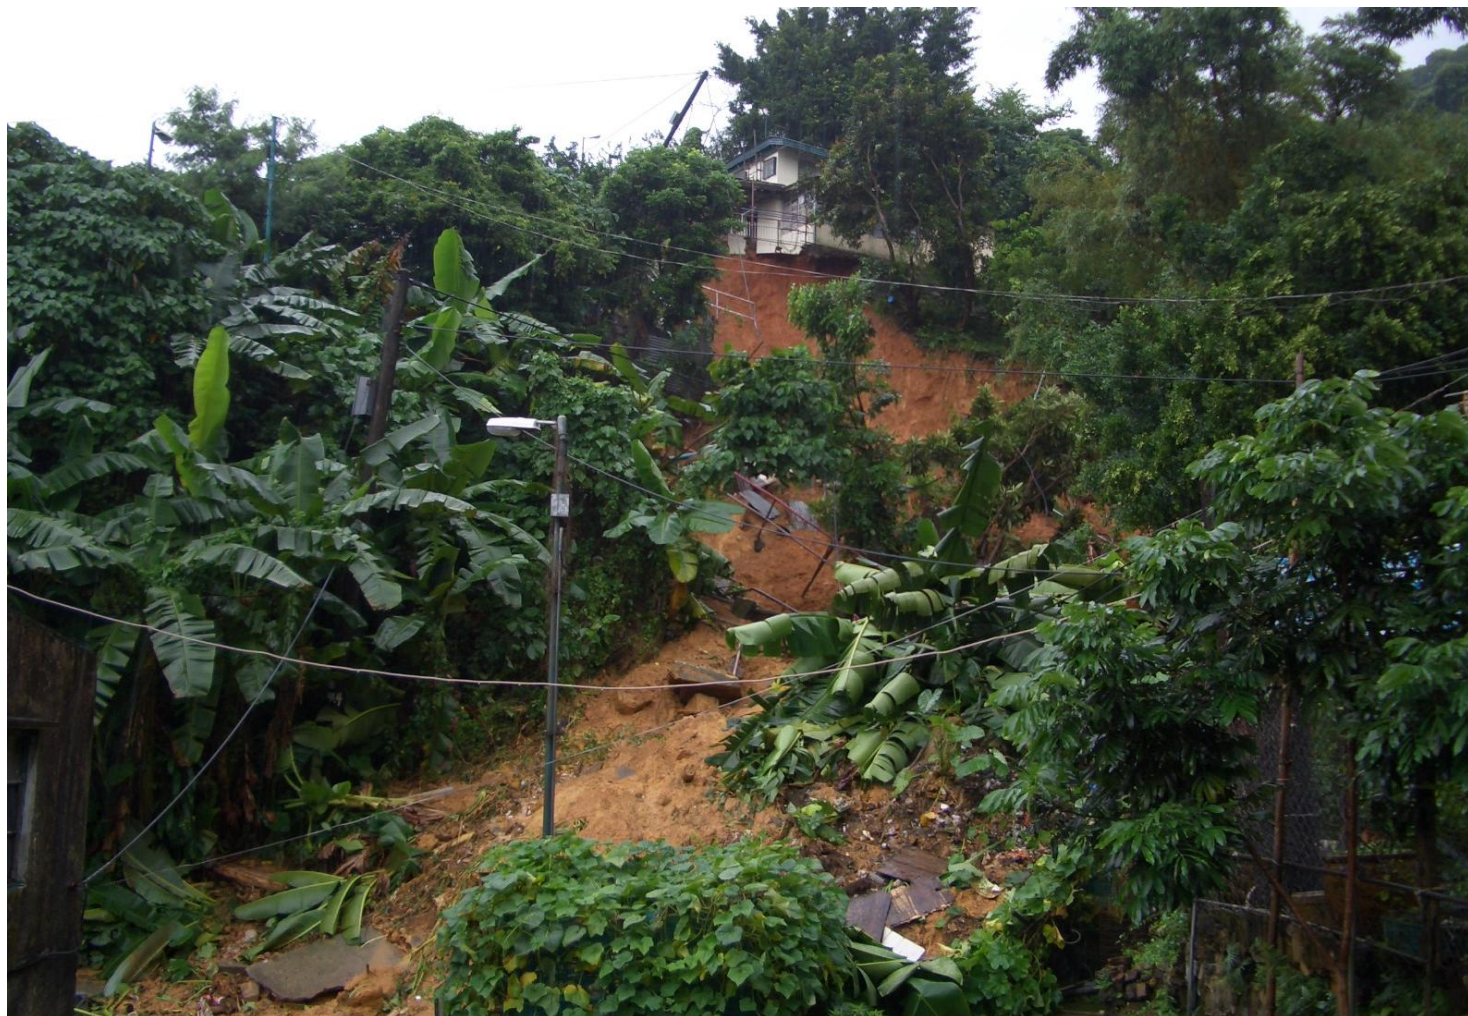
Plate 2 - Front View of the 20 August 2005 Landslide
(Photograph taken on 21 August 2005)

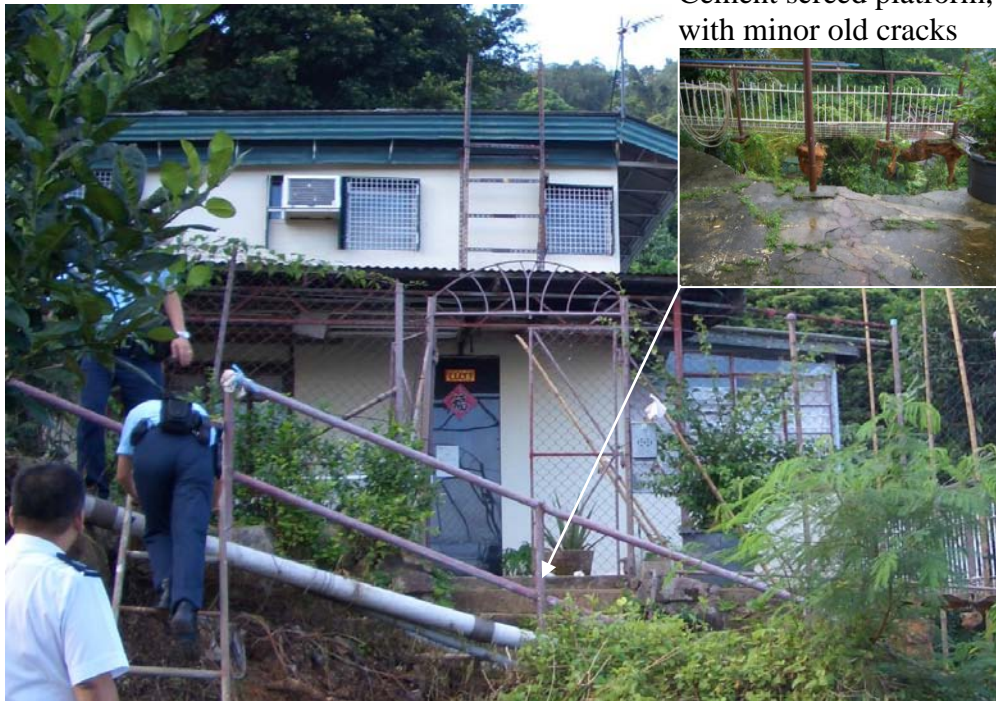
Plate 4 - Registered Squatter Structure No. RTW/4A/388 at the Crest of the Landslide Scarp (Photograph taken on 29 August 2005)

二零零五年八月山泥傾瀉的頂部有一個帶有數條舊微裂縫的水泥板平台和一所兩層高的登記寮屋(於一九八二年的房屋署寮屋調查中登記)(照片 4)。平台由一幅 2.5 米高的不規則砌石牆支撐(圖 2 和照片 5)，由於該砌石牆的高度不符合登記標準(即 < 3 米)，因此並沒有登記入政府斜坡記錄冊。在滑坡上方的登記寮屋(寮屋管制登記編號為 RTW/4A/388，下文將簡稱為 388 號寮屋)由鋼架、夾板牆和波紋狀鐵皮屋頂組成。388 號寮屋後面有一幅 3.5 米高、仰角約為 60°的削坡(照片 6)。削坡以上有一叢單層及簡陋的登記寮屋(寮屋管制登記編號為 RTW/4A/389, 391-393，下文將簡稱為 389, 391-393 號寮屋)(照片 7)。在滑坡西南面上方有一些空置的平台(之前搭建有其他寮屋)，部分平台有鋪築而其餘部分則用作種植果樹(圖 2 和照片 1)。在這些平台和 389, 391-393 號寮屋之間的山坡上有一些大塊孤石(照片 1)。

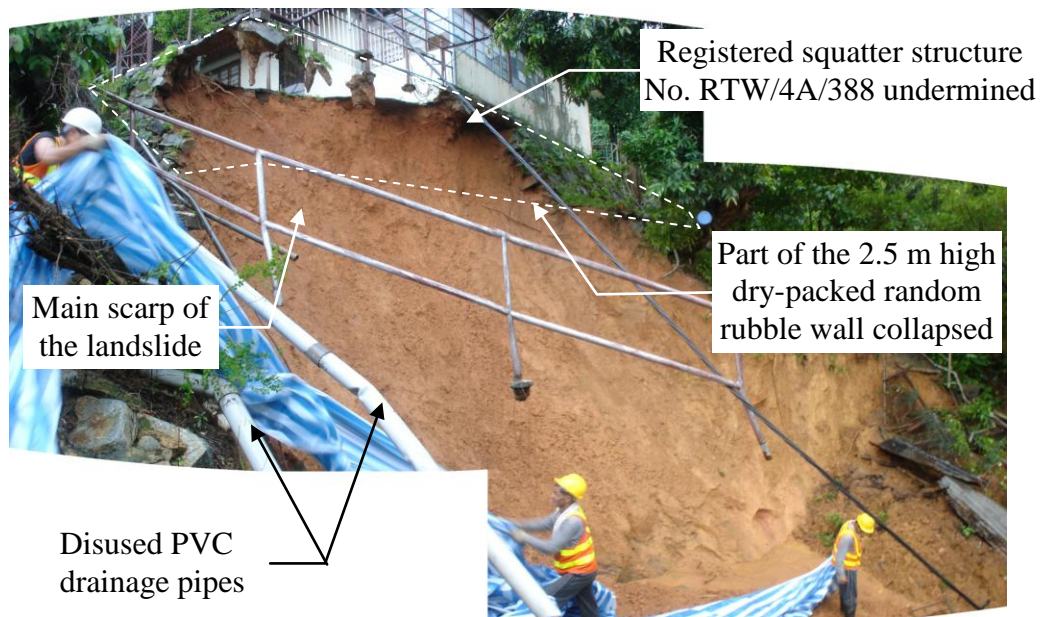
Plate 5 - View of the Main Scarp of the Landslide and the Undermined Registered Squatter Structure No. RTW/4A/388 (Photograph taken on 21 August 2005)

一段 2.5 米高(最厚為 0.5 米)的砌石擋土牆隨同其上邊的一幅面積約 4.5 米乘 2.5 米的平台在山泥傾瀉中倒塌(照片 5)。388 號寮屋的一角在山泥傾瀉中遭到掏蝕，但是其結構表面並沒有明顯的裂縫或破壞。388 號寮屋內的地面狀況屬一般，有一些可能是由於地板曾經輕微沉降而形成的舊裂縫。

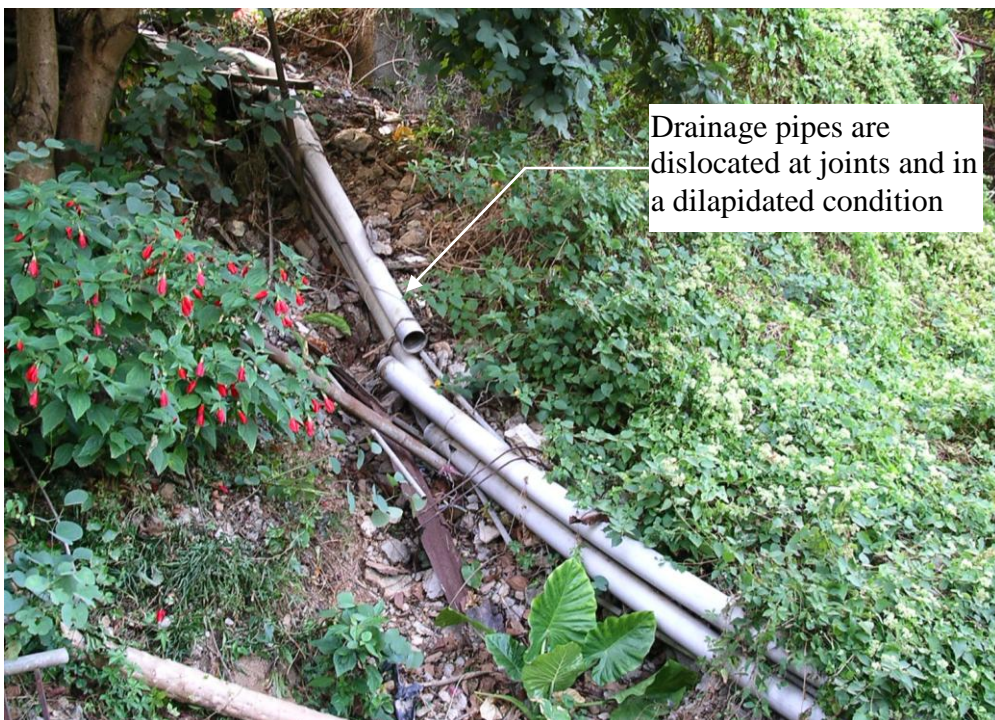
Plate 11 - PVC Drainage Pipes Leading from Squatter
Structures Nos. RTW/4A/389, 391-393
(Photograph taken on 6 December 2005)

在滑坡現場並無屬於渠務署維修範圍的公共雨水溝，可是在現場和其鄰近地方發現有一些可能是由當地居民鋪設的聚氯乙烯排水管(照片 5 和 11)。在山泥傾瀉後的調查中發現，這些排水管大多已棄置、損壞或堵塞，除了 388 號寮屋的排水管，匯集屋頂的雨水後直接排放到滑坡以北的山坡上(圖 2 和照片 6)。在 388 號寮屋的下方有一個化糞池(據 388 號寮屋的戶主所述，這個化糞池近幾年已很少使用)，該化糞池的溢水管將溢流排放至距離滑坡處以北約 10 米外的山坡上(圖 2)。現場並沒有跡象顯示該化糞池曾經漏水。在上方山坡較遠處的 389, 391-393 號寮屋並未設有類似的化糞池。這

些寮屋的污水是通過一條聚氯乙烯管(已損壞不堪)排放到滑坡以北的山坡上(圖 2 和照片 11)。

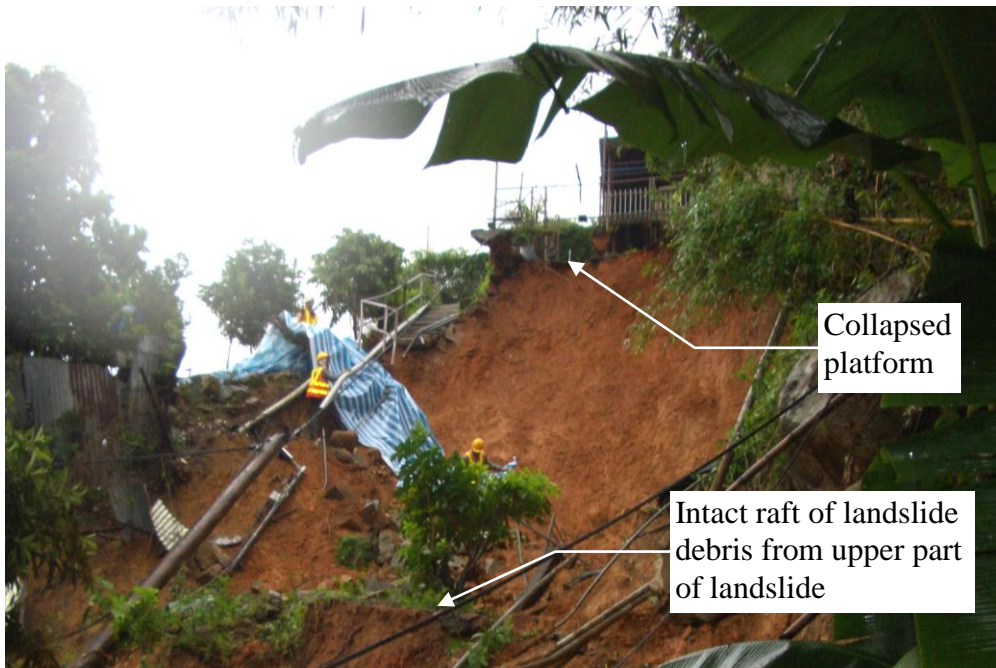
Plate 12 - The Main Scarp and the Southern Flank of the Landslide
(Photograph taken on 21 August 2005)

根據目擊人士描述(包括芙蓉山村居民、消防員、警員和視察現場的土力工程處工程師)、香港警務處的記錄和山泥傾瀉後的實地觀察，二零零五年八月二十日的山泥傾瀉大約在下午五時二十五分到六時三十分之間分階段發生(見第 7 部分)。崩塌發生在曾遭人為活動局部擾動的山坡上(見第 2 部分)。崩塌殘痕約 45 米長(平面圖上)、18 米寬(最大)、最深約為 4 米、崩塌體積約 400 立方米。滑坡泥石流整體的滑動距離約為 20 米(圖 3)；主斷崖約 10 米寬、7 米高、仰角介乎 50°至 65°(照片 5 和 12)。在山泥傾瀉後只有主斷崖外露，其餘的崩塌殘痕均被滑坡泥石流所覆蓋。在主斷崖表面沒有發現不良的地質構造(比如殘留節理、低強度的填充等)。在二零零五年八月二十一日早上的視察中，並沒有發現主斷崖表面有滲流或其他水流的跡象。但是，外露的岩土明顯濕潤，似乎處於飽和狀態。

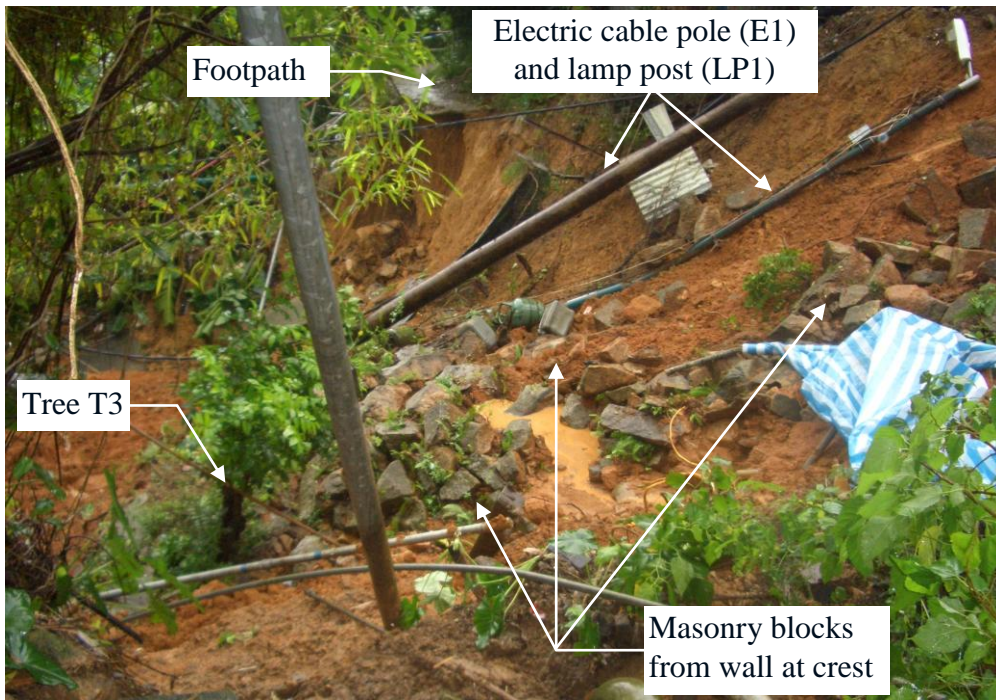
Plate 16 - View of the Upper Part of the Landslide Debris
(Photograph taken on 21 August 2005)

滑坡泥石流軌跡可以分為上、下兩部分，上部主要包括紅褐色含砂的黏質粉土、從砌石擋土牆上掉下來的石塊、混凝土小路和梯級的碎塊及其扶手、電纜杆(標為 E1，圖 3)、燈柱(標為 LP1)和電纜管道、倒下的樹木(標為 T1、T2 及 T3)和斷截的供水管段，還有部分可能是由寮屋居民建造的柵欄和扶手。一整片泥石流(連同樹 T3，見圖 3 和照片 16)以及從滑坡頂部的砌石擋土牆上掉下來的石塊，停在泥石流軌跡的上部。

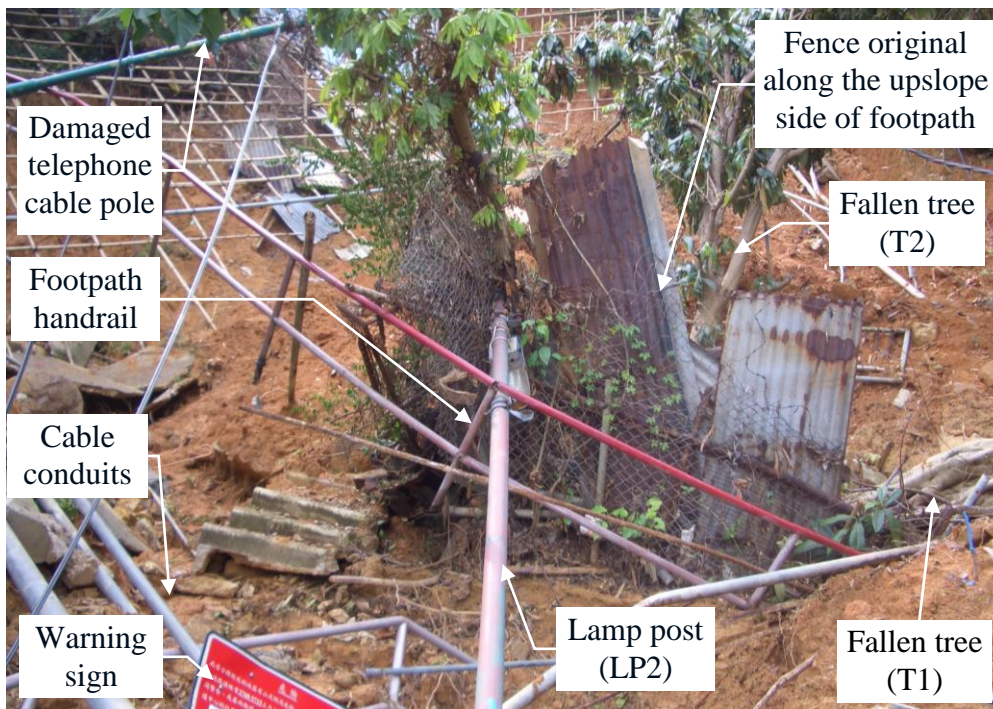
Plate 17 - Lamp Post LP2 beneath the Footpath Handrail
(Photograph taken on 7 September 2005)

位於下部的滑坡泥石軌跡主要包括紅褐色到黃褐色砂質黏土/粉土、小路及梯級的混凝土碎塊及其扶手、一些倒下的樹和損壞的公用設施(照片 15)。燈柱 LP2 被發現倒在一段小路的扶手之下，兩者之前都並排在小路旁(照片 17)。滑坡泥石夾雜著家居垃圾(含有腐爛的有機物質和纖維物質、塑膠袋、瓶子、鐵罐頭、損壞的家居/電器用具、木材等等)，堆積在泥石軌跡下部近東邊及溪流附近的一列圍網(由村民圍起作耕種用途)，達到大約 2.5 米高(照片 18)。家居垃圾似曾被泥石推至圍網處。

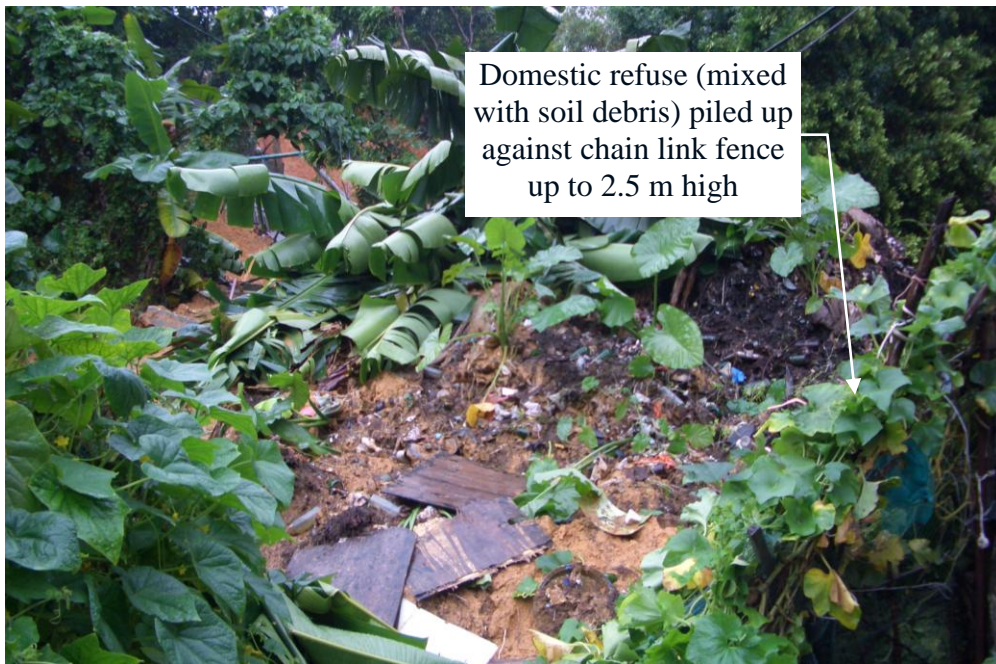
Plate 18 - Domestic Refuse Transported along with the Landslide Debris
(Photograph taken on 21 August 2005)

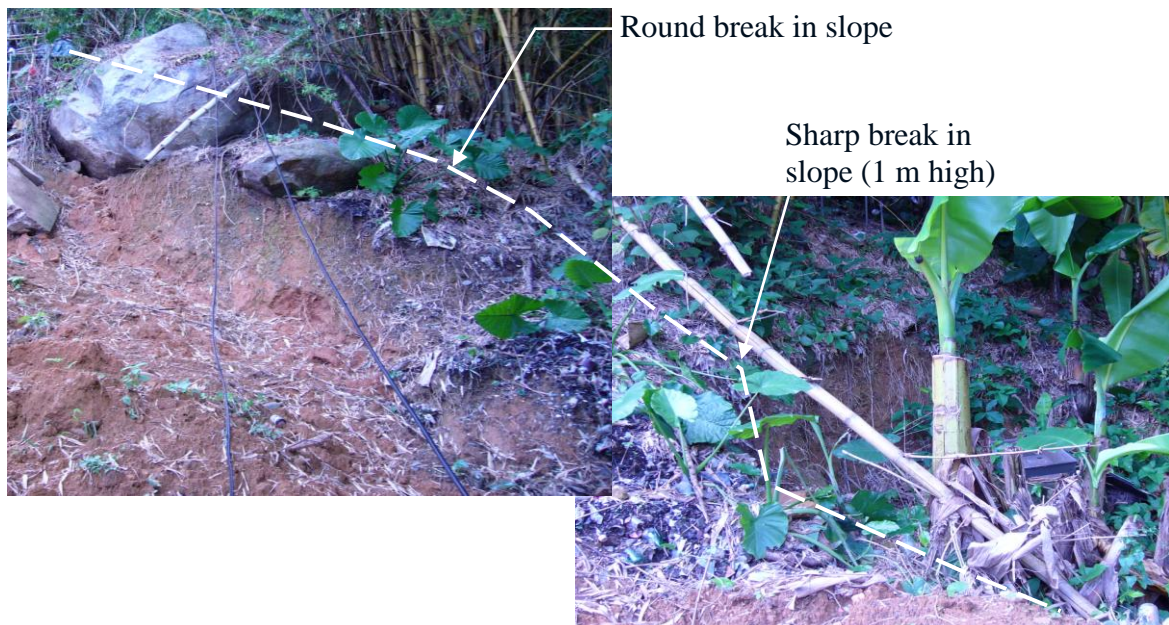
Plate 19 - Break in Slope on the Adjacent Hillside to
the North of the Landslide
(Photograph taken on 13 September 2005)

鄰近山坡沒發現諸如張力裂縫之類的破壞或狀況變壞跡象，在二零零五年八月山泥傾瀉現場附近的溪流旁邊，也沒發現其他明顯崩塌或侵蝕的跡象。在滑坡的北面，溪流高程比較高而其鄰近的山坡整體地勢較平緩。在滑坡南面上方的山坡，由於搭建寮屋已開挖成多個平台，令整體坡度變得較平緩。在滑坡腳北面鄰近的山坡上可以看到一處小的坡度折曲(約 1 米高)，及在滑坡腳南面有一處相關的斷崖(照片 19)。根據一九六四年的航空照片顯示，這些特徵可能和一處局部不穩定有關或曾經被人工開挖(見第 4 部分)。沿著山坡底部的溪流觀察，顯示該山坡底部並沒有到受溪流的侵蝕，這與當地村民描述溪流的流量一直非常少是一致的。

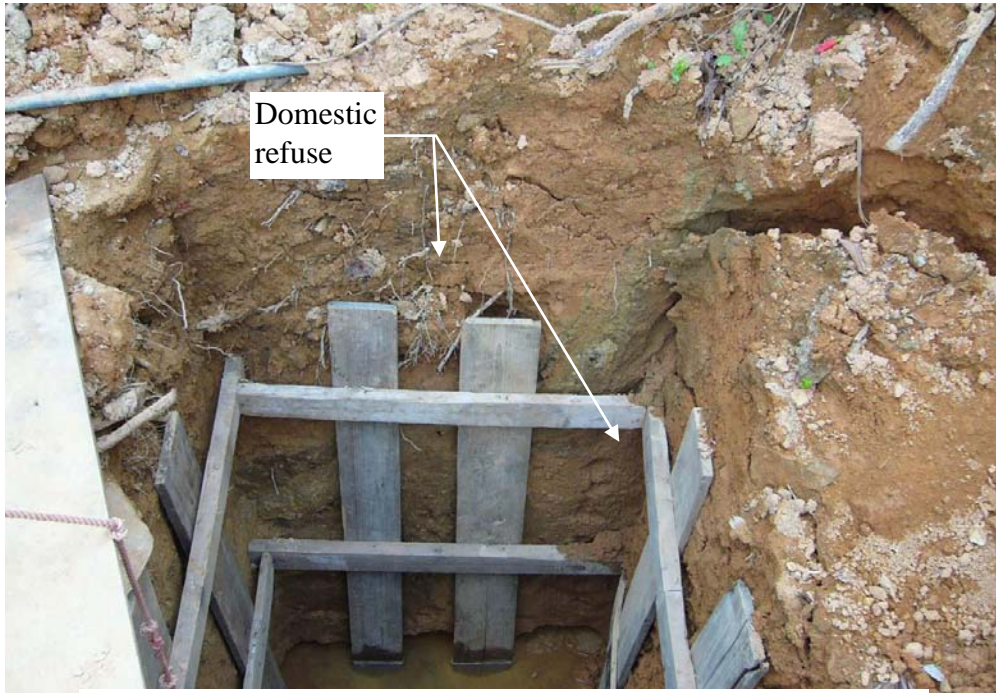
Plate 20 - Trial Pit TP4 Showing Landslide Debris Containing Deformed Domestic Refuse Layers
(Photograph taken on 17 October 2005)

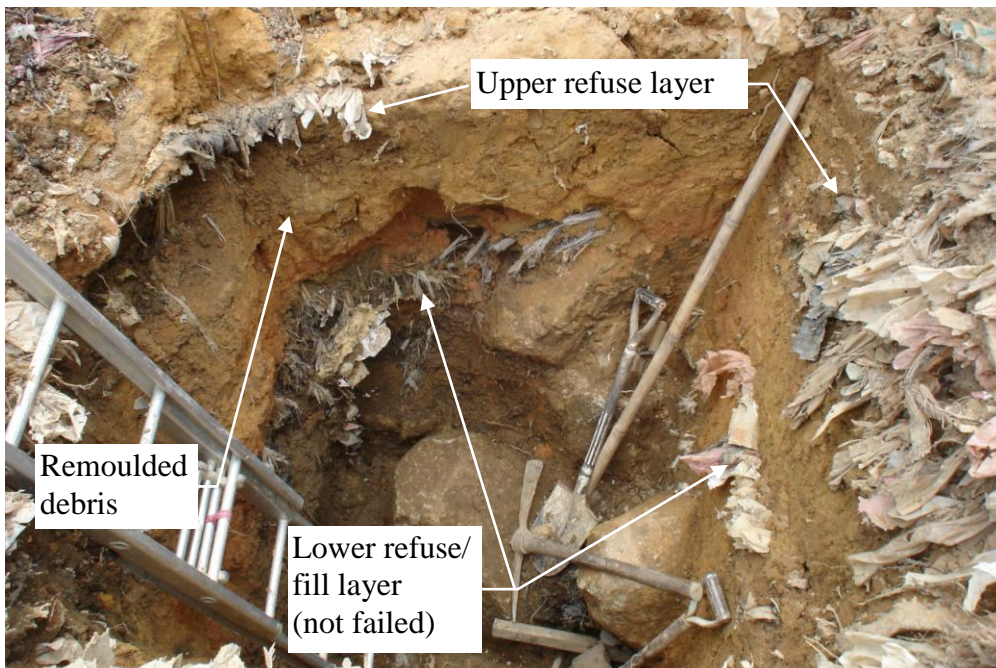
Plate 21 - Trial Pit TP11 Showing Upper and Lower Layers of Domestic Refuse
(Photograph taken on 25 October 2005)

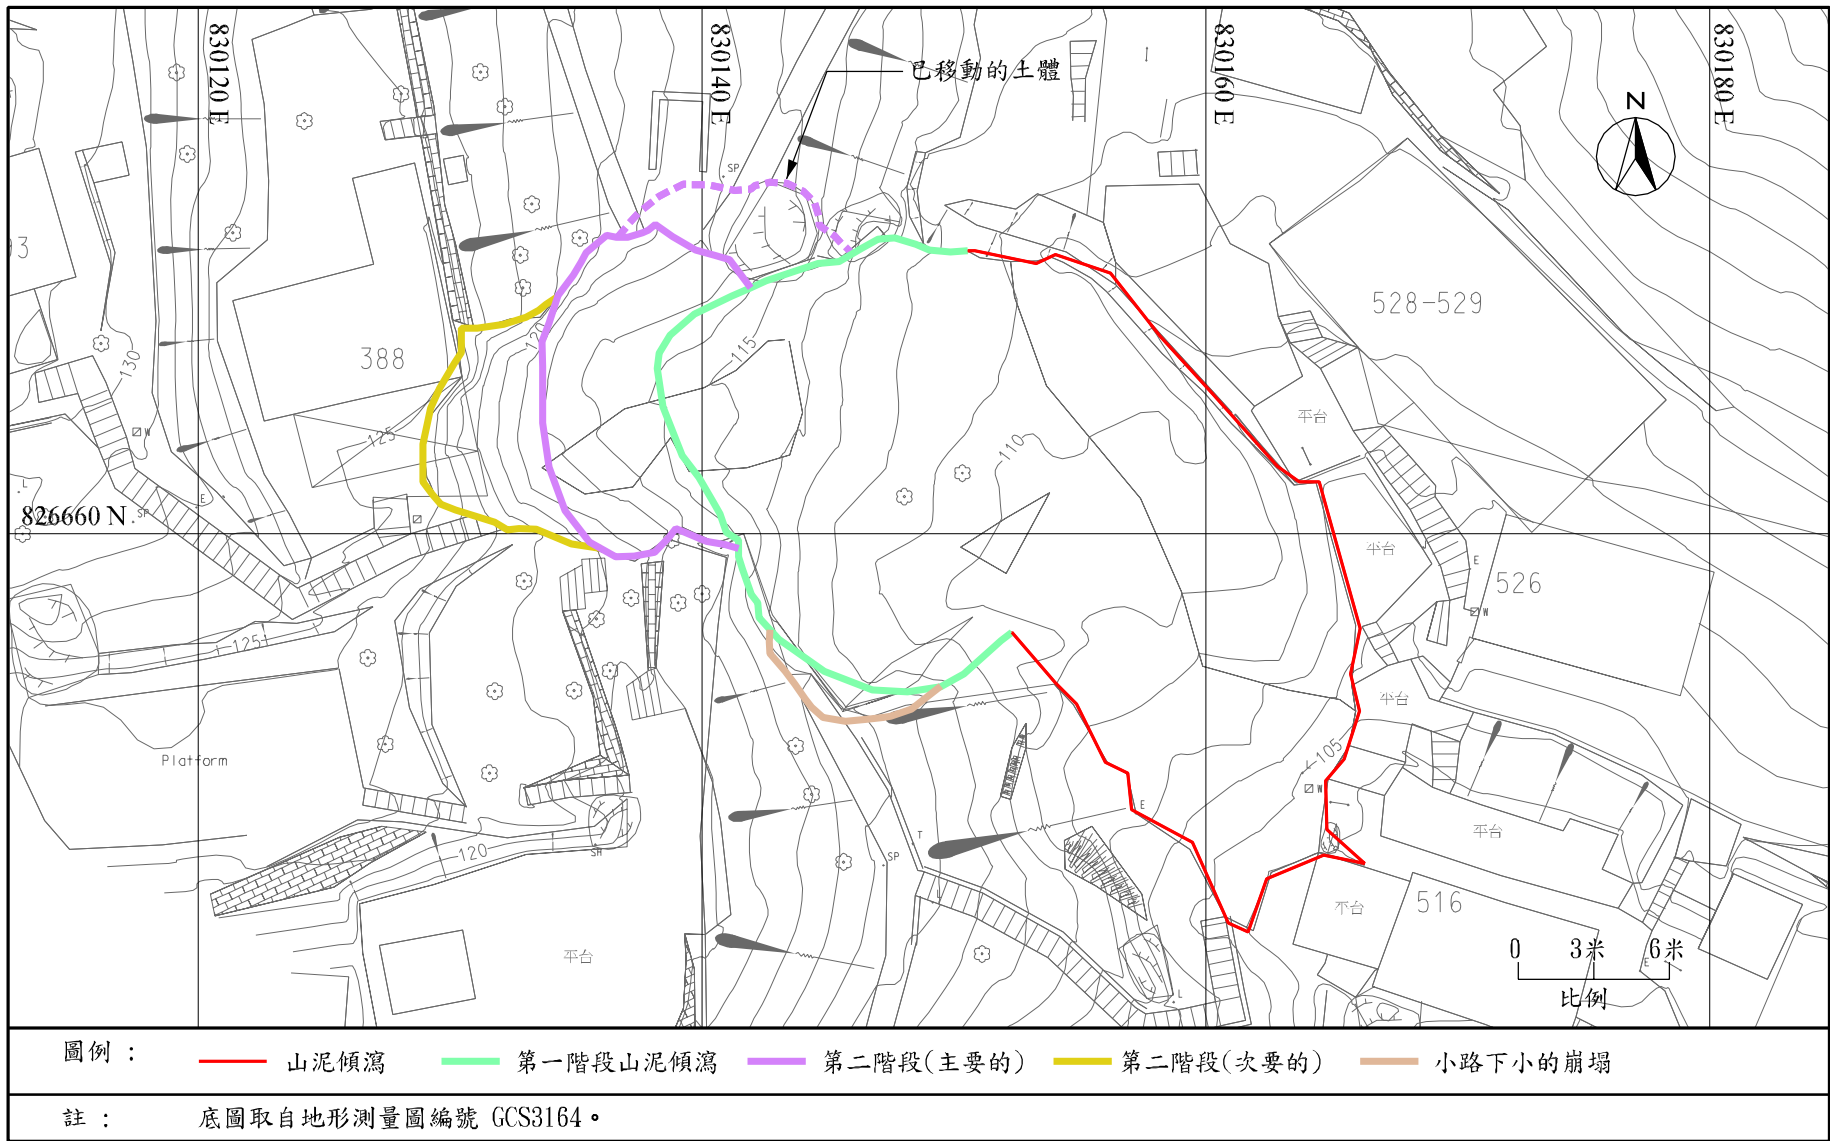
圖19 - 大致的崩塌過程

根據 526 和 528-529 號寮屋居民的描述，在第一階段崩塌發生後約 15 分鐘，即下午五時四十分左右，第二階段崩塌在滑坡的上部、位於小路和上方 388 號寮屋之間的位置發生。第二階段崩塌的泥石，連同倒落的樹 T1，進一步推移小路的欄杆至燈柱 LP2 上方的位置才停下來(照片 17)。滑坡泥石被斷開的供水管流出的水流所影響，進一步向 526 號寮屋移動，並在一片耕種區周圍的柵欄前停下來。與第一階段崩塌的滑坡泥石相比較，第二階段崩塌的滑坡泥石滑動的距離比較短，並在崩塌殘痕的中部和上部停下來，部分堆積在第一階段崩塌的滑坡泥石的上面。現場觀察也證實了目擊人士所述。根據 526 和 528-529 號寮屋居民的描述，第二階段崩塌又可再分成兩次崩塌，但這卻無法從現場的地質測繪而確定。

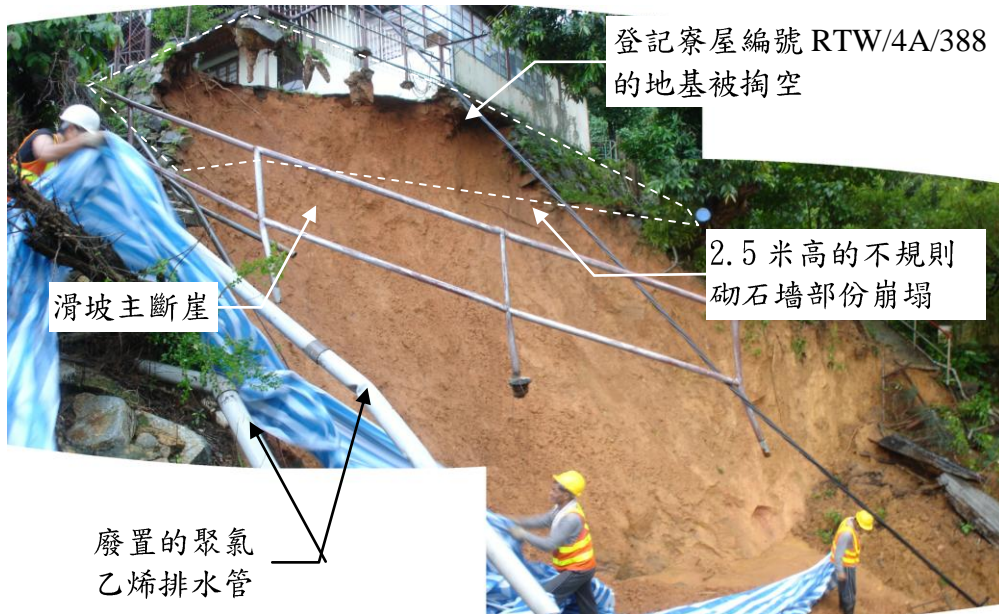
照片 5 - 滑坡主斷崖及地基被掏空的登記寮屋編號RTW/4A/388
(照片攝於二零零五年八月二十一日)

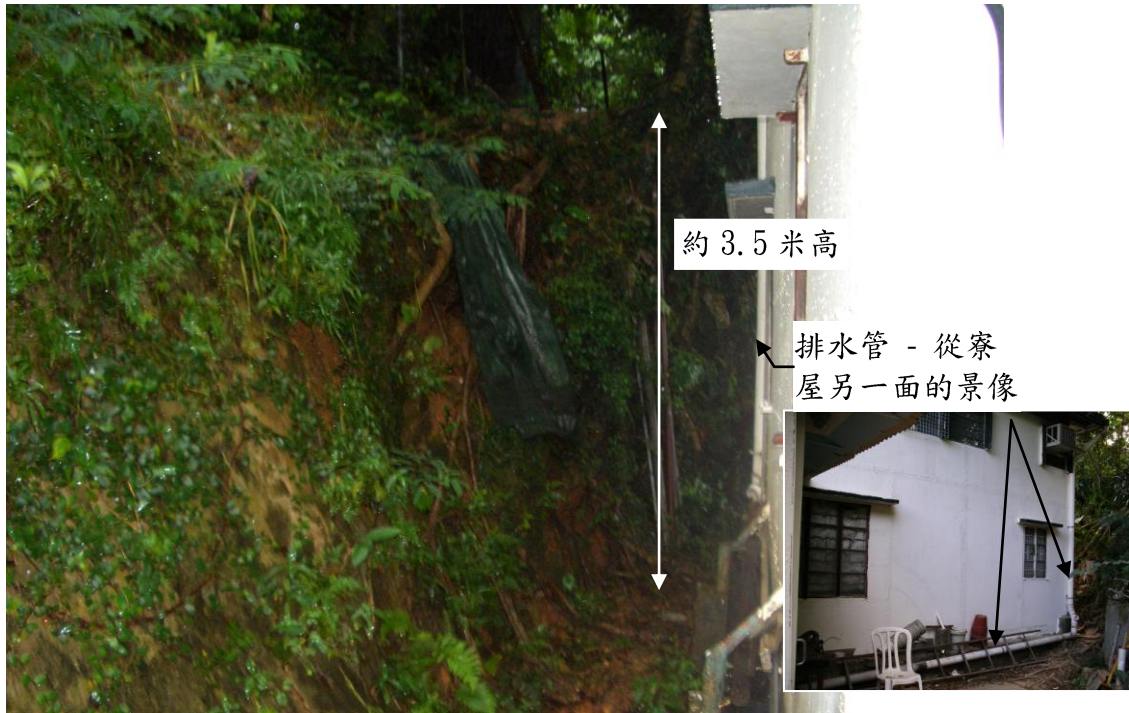
照片 6 - 登記寮屋編號RTW/4A/388 後方的排水管及削坡
(照片攝於二零零五年八月二十一日)

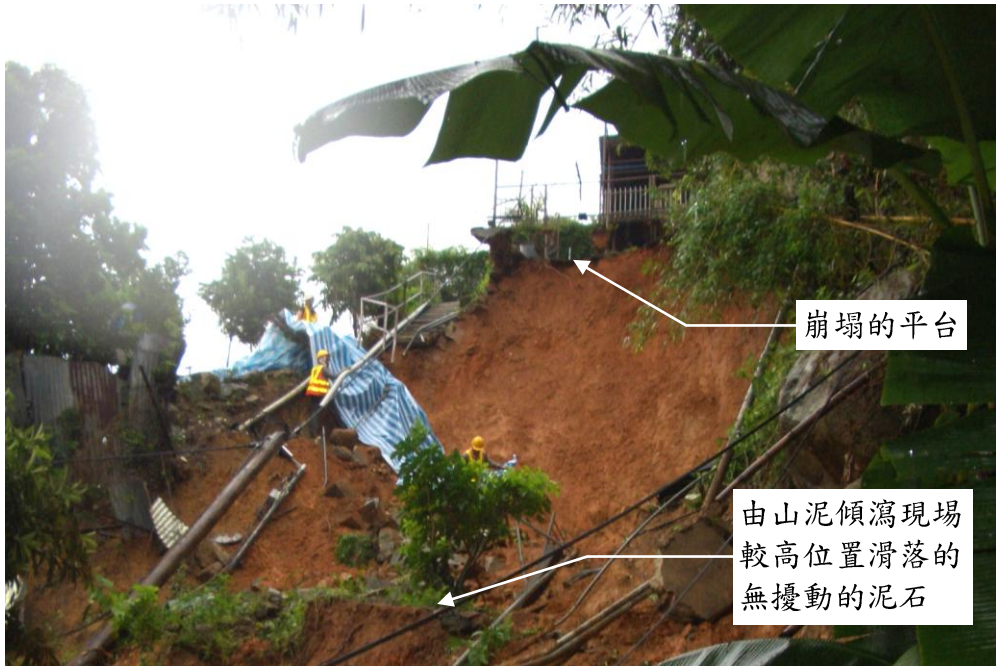
照片 12 - 山泥傾瀉主斷崖及南面斷崖
(照片攝於二零零五年八月二十一日)

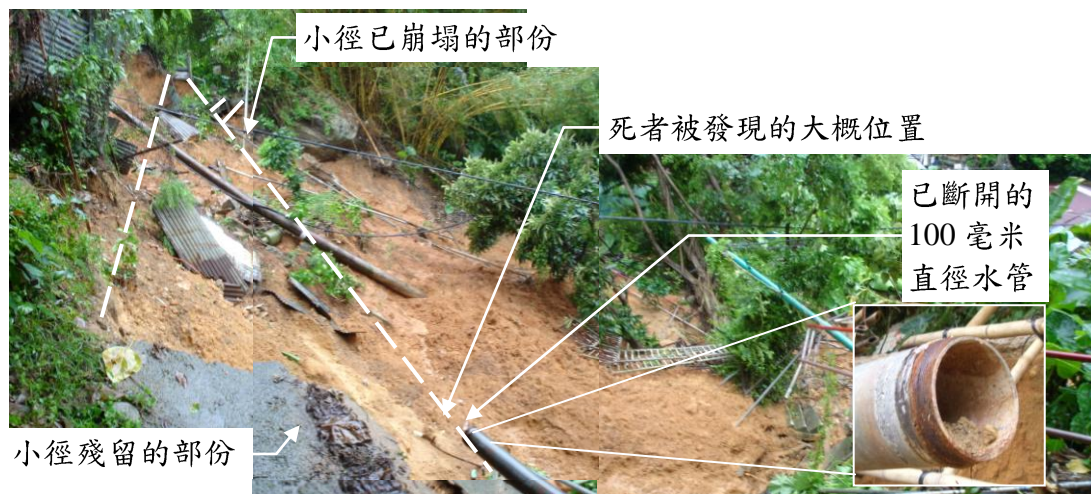
橫跨二零零五年八月滑坡中部的一段 15 米長小路和連接該小路及其上方的寮屋的一段 10 米長梯級均在此次山泥傾瀉中崩塌(照片 13)。在此次山泥傾瀉事件中，鄰近的公用設施亦遭破壞，包括兩條水管、三根電線杆、兩根電話線杆和兩支街燈(包括電線管道及燈柱)(照片 14)。滑坡泥石流在 516 號寮屋前停止，將部分溪流覆蓋了(照片 15)。部分細粒泥石流(沖刷沉積物)沿溪流沖刷至 150 米外的地方，但並沒有造成任何破壞。

根據目擊人士的描述和水務署的記錄，一條直徑為 100 毫米的水管斷開並將水排放至滑坡泥石至少持續五小時，直至二零零五年二十一日凌晨零時零五分水務署切斷供水前為止(但在二零零五年八月二十日晚上大約九時四十五分，當土力工程處緊急事故控制中心人員視察時，現場一條已斷開的、直徑 80 毫米水管並沒有水流出來)。根據山泥傾瀉後的檢查時顯示，供水管是因為山泥傾瀉而導致在螺旋接頭的地方脫位斷開的(接頭的狀況尚可，並沒有毀壞的跡象，例如生鏽、銹蝕孔，見照片 13)。在山泥傾瀉後的檢查期間，所有通往崩塌痕跡的地面排水管都已廢棄、損壞或是堵塞了(照片 11)，當時並沒有任何水流的跡象(圖 2)。在小路和梯級的崩塌邊沿上沒有發現任何明顯的水流跡象(例如滑坡泥石上的侵蝕沖溝)。根據現場觀察和勘察顯示，並沒有其他可能的集中地表水源流進滑坡區域。

照片 13 - 崩塌的小徑及已斷開的 100 毫米直徑水管
(照片攝於二零零五年八月二十一日)

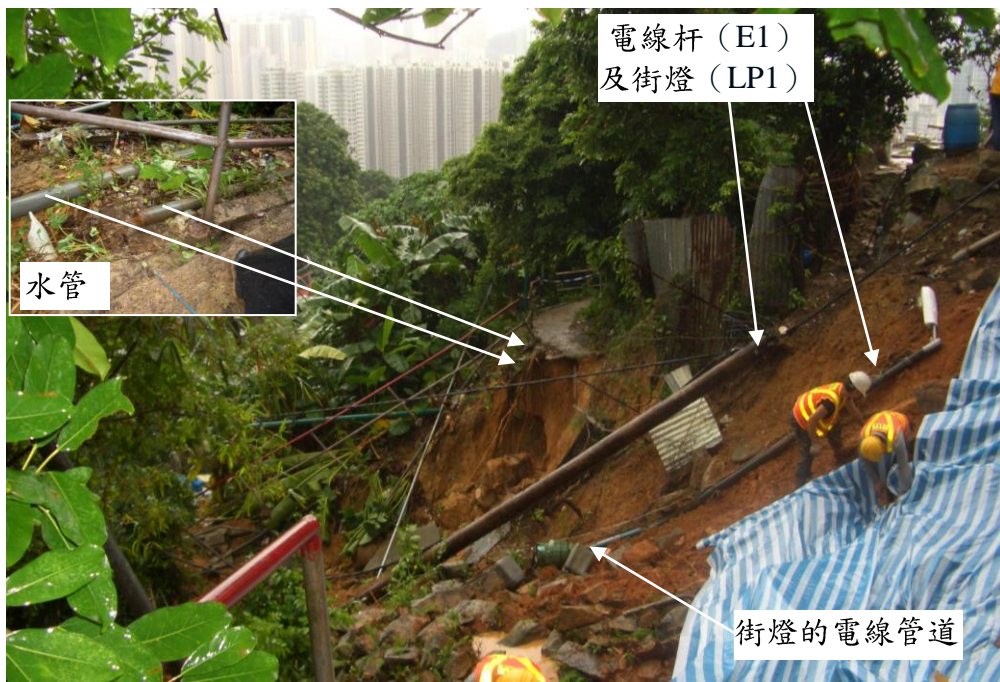
照片 14 - 損壞的公用設施
(照片攝於二零零五年八月二十一日)

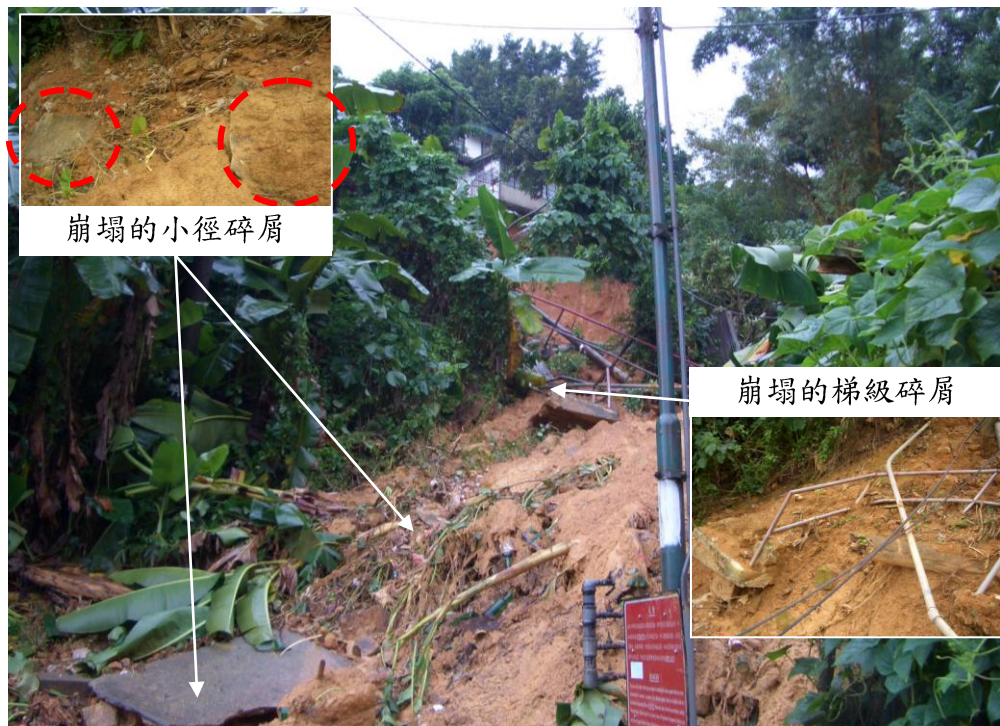
照片 15 - 滑坡泥石下部近滑坡腳的景像
(照片攝於二零零五年八月二十一日)

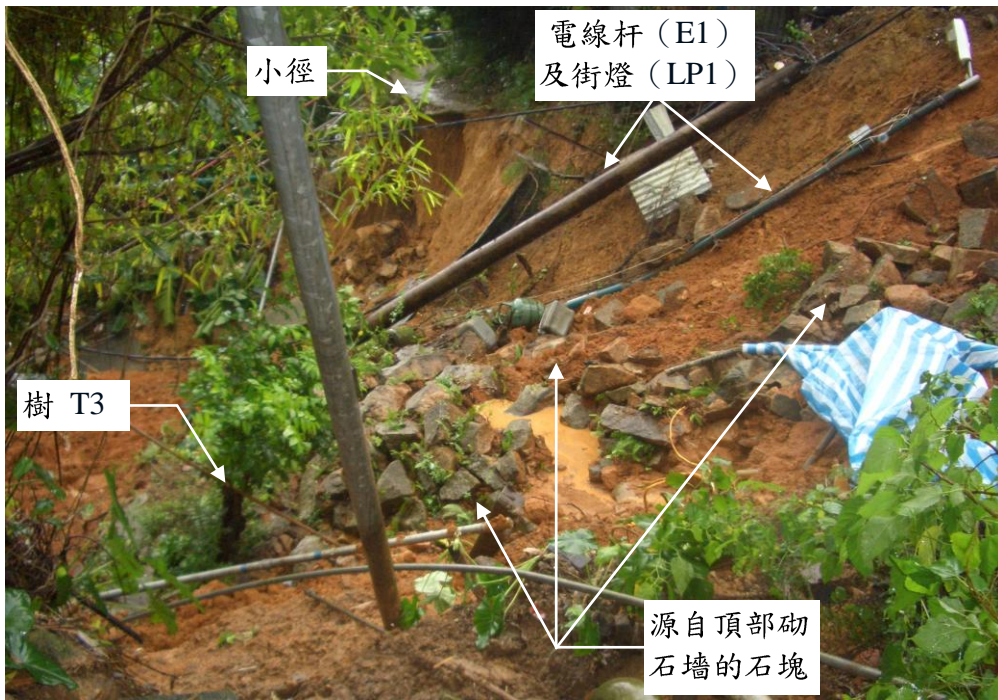
照片 16 - 滑坡泥石上部的景像
(照片攝於二零零五年八月二十一日)

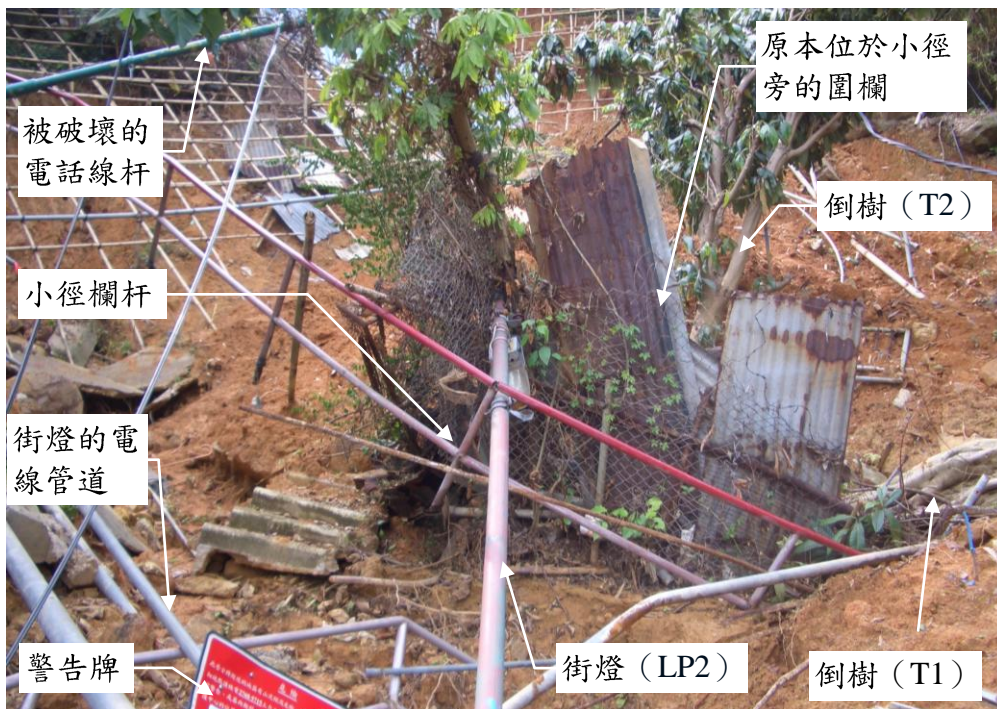
照片 17 - 街燈 LP2 位於小徑欄杆的下方
(照片攝於二零零五年九月七日)

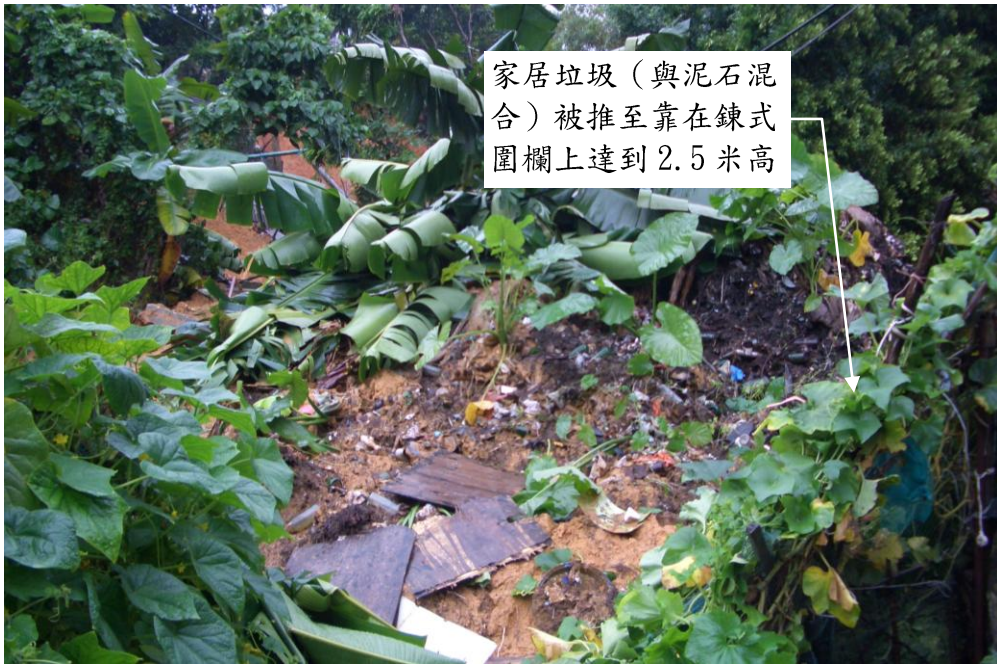
照片 18 - 家居垃圾隨著滑坡泥石一起滑動
(照片攝於二零零五年八月二十一日)

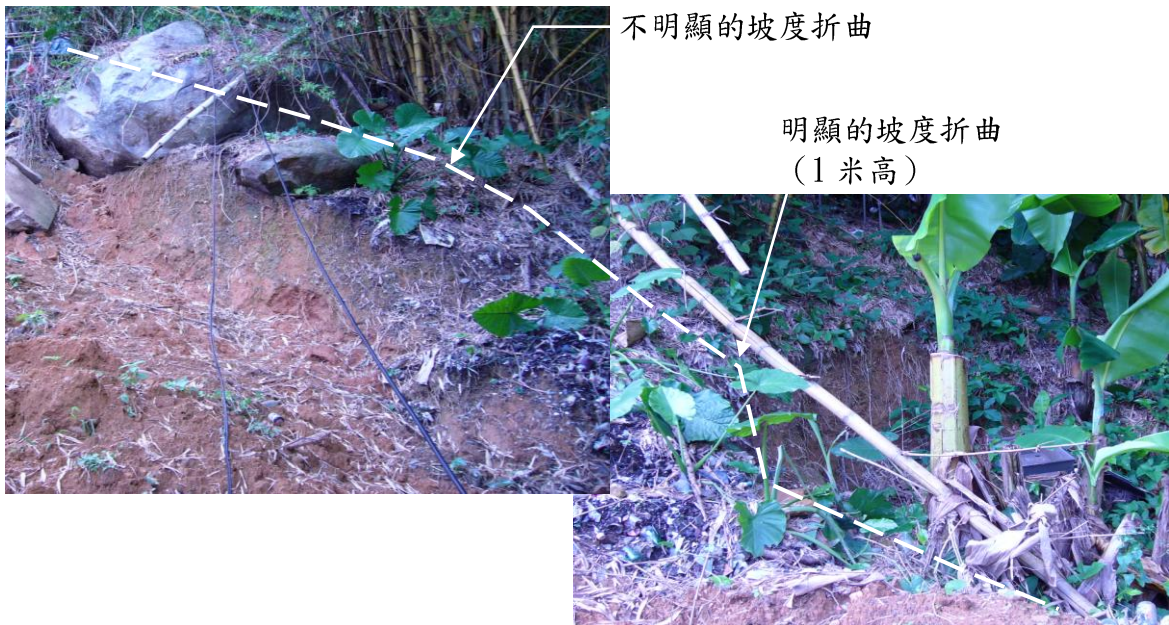
照片 19 - 在滑坡以北鄰近山坡上的坡度折曲
(照片攝於二零零五年九月十三日)

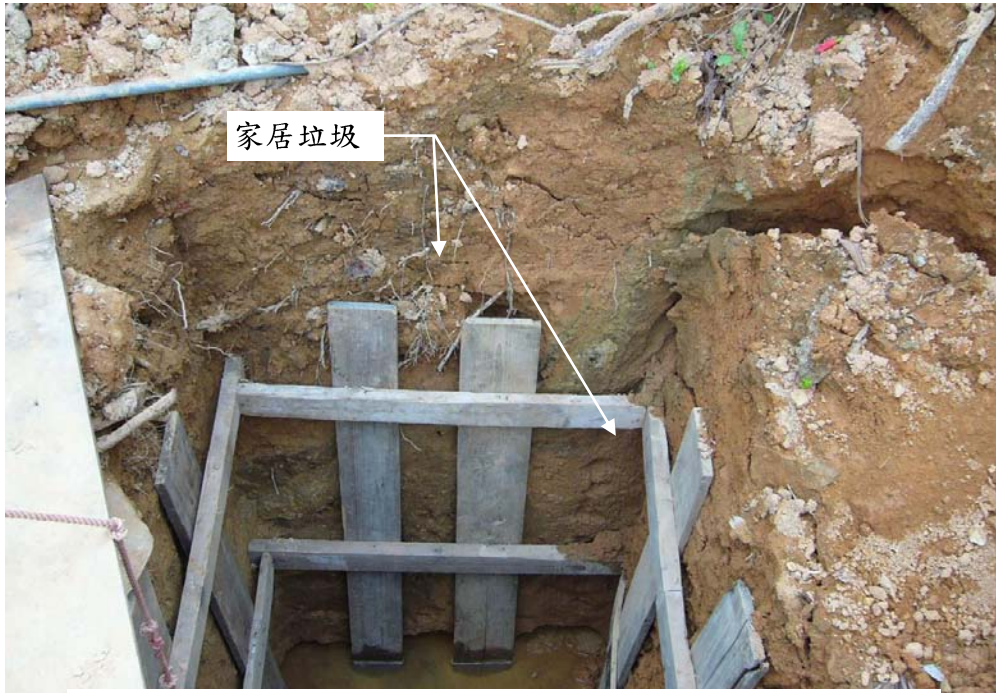
在崩塌殘痕內的所有探槽和探井內都發現滑坡泥石，厚度從探槽編號 TT1(在滑坡主斷崖底部附近)的 0.4 米到探井編號 TP4(在泥石軌跡下部)的 1.8 米不等。滑坡泥石呈多樣性，但一般都為紅褐色含砂的黏質粉土，夾雜著體積如砂礫、卵石、孤石等大小不一的石塊、混凝土碎塊及家居垃圾。家居垃圾(主要由腐爛的有機物質和塑膠袋組成，大概厚 0.5 米到 0.8 米)多數分佈在泥石軌跡下部，並普遍成層狀或與泥土/滑坡泥石混合一起(照片 20 和 21)。

照片 20 - 探井 TP4 顯示滑坡泥石含有已變形的家居垃圾層
(照片攝於二零零五年十月十七日)

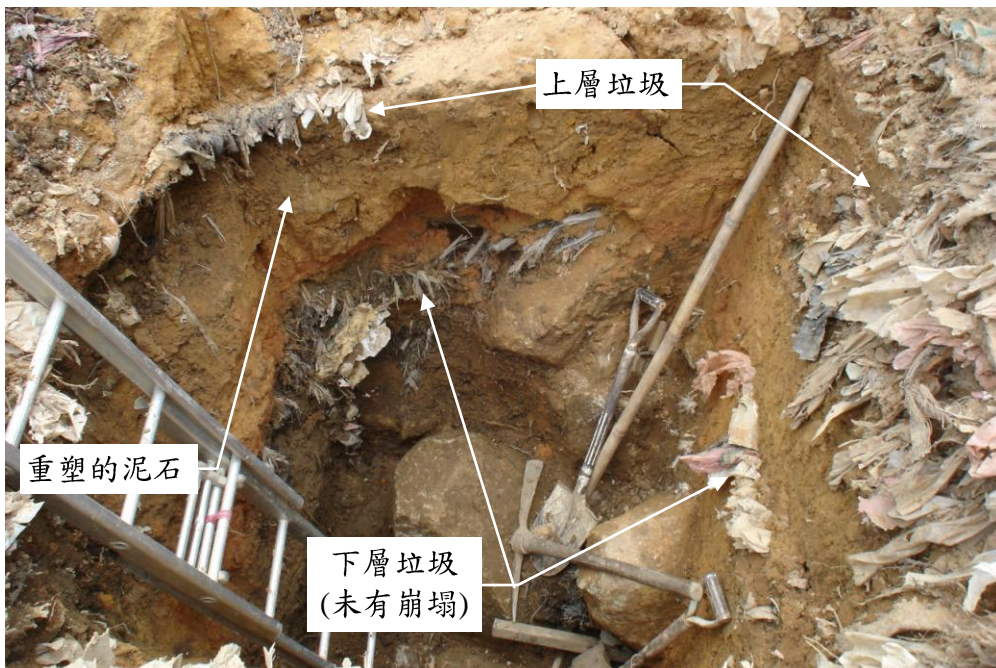
照片 21 - 探井 TP11 顯示上層及下層家居垃圾
(照片攝於二零零五年十月二十五日)

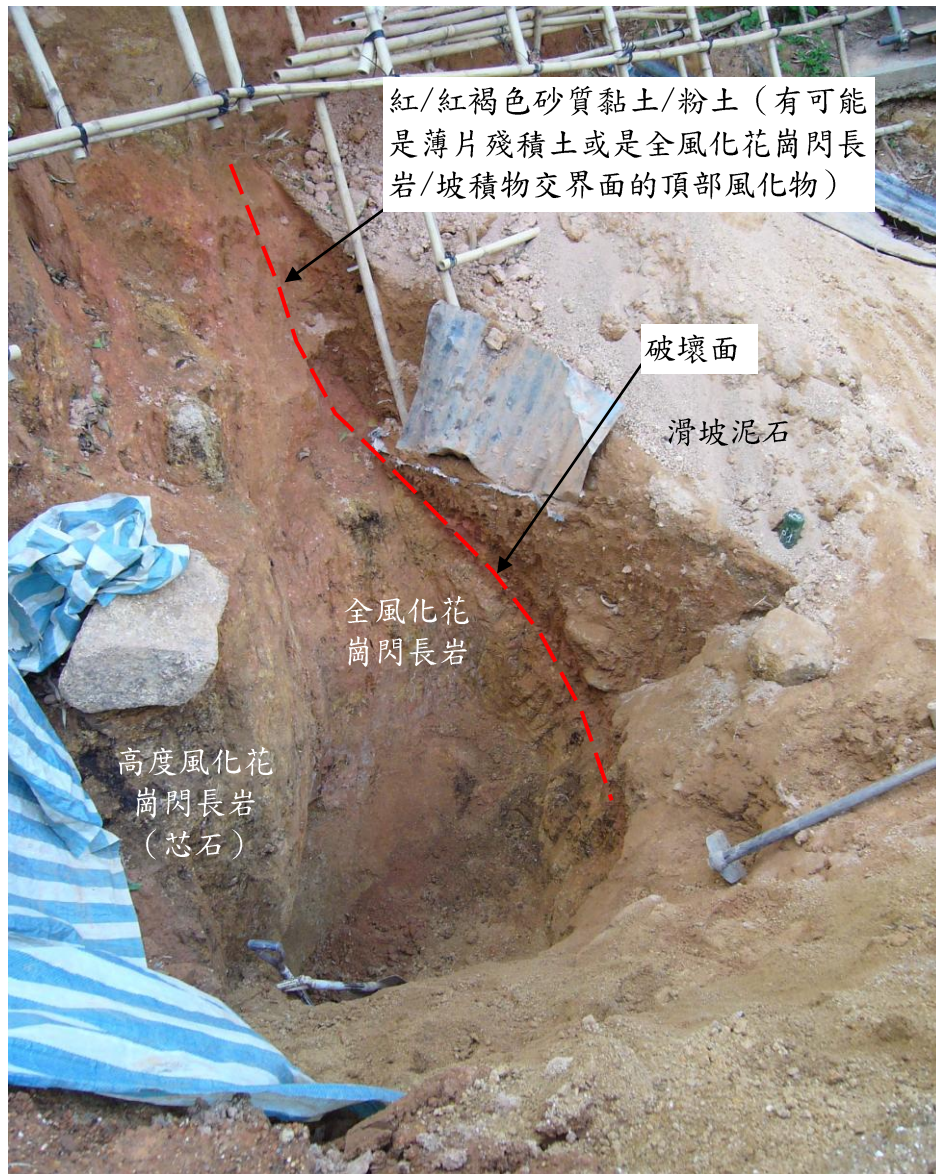
破壞面只有在崩塌殘痕內的探井中顯露(照片 22)，一般是由 20 毫米厚的灰色/褐色砂質粉土/黏土組成，局部包括一個狹長的剪切及層狀土帶(約 0.5 米)，並在探井編號 TP3 中可以清楚看到(照片 23)。破壞面主要在 CDGd 內。在探井編號 TP3 的局部位置可以看到一個剪切/擾動土壤區一直延伸進 CDGd 內約 200 毫米。山泥傾瀉後，破壞面的土壤非常濕潤，並有擾動和重塑的現象。現場沒有發現其他相對移動的證據例如擦痕面等。在剪切及層狀土帶內，破壞面一般位於剪切帶的底部(照片 23)。

照片 22 - 探槽 TT1 顯露的破壞面
(照片攝於二零零五年九月二十二日)
