二零零五年八月二十日
芙蓉山村山泥傾瀉事件報告
山泥傾瀉調查結果
**REPORT ON THE LANDSLIDE
AT FU YUNG SHAN TSUEN
OF 20 AUGUST 2005
FINDINGS OF THE LANDSLIDE
INVESTIGATION**

土力工程處報告系列第277號
GEO REPORT No. 277

茂盛土力工程顧問有限公司
Maunsell Geotechnical Services Ltd.

**GEOTECHNICAL ENGINEERING OFFICE
CIVIL ENGINEERING AND DEVELOPMENT DEPARTMENT
THE GOVERNMENT OF THE HONG KONG
SPECIAL ADMINISTRATIVE REGION**

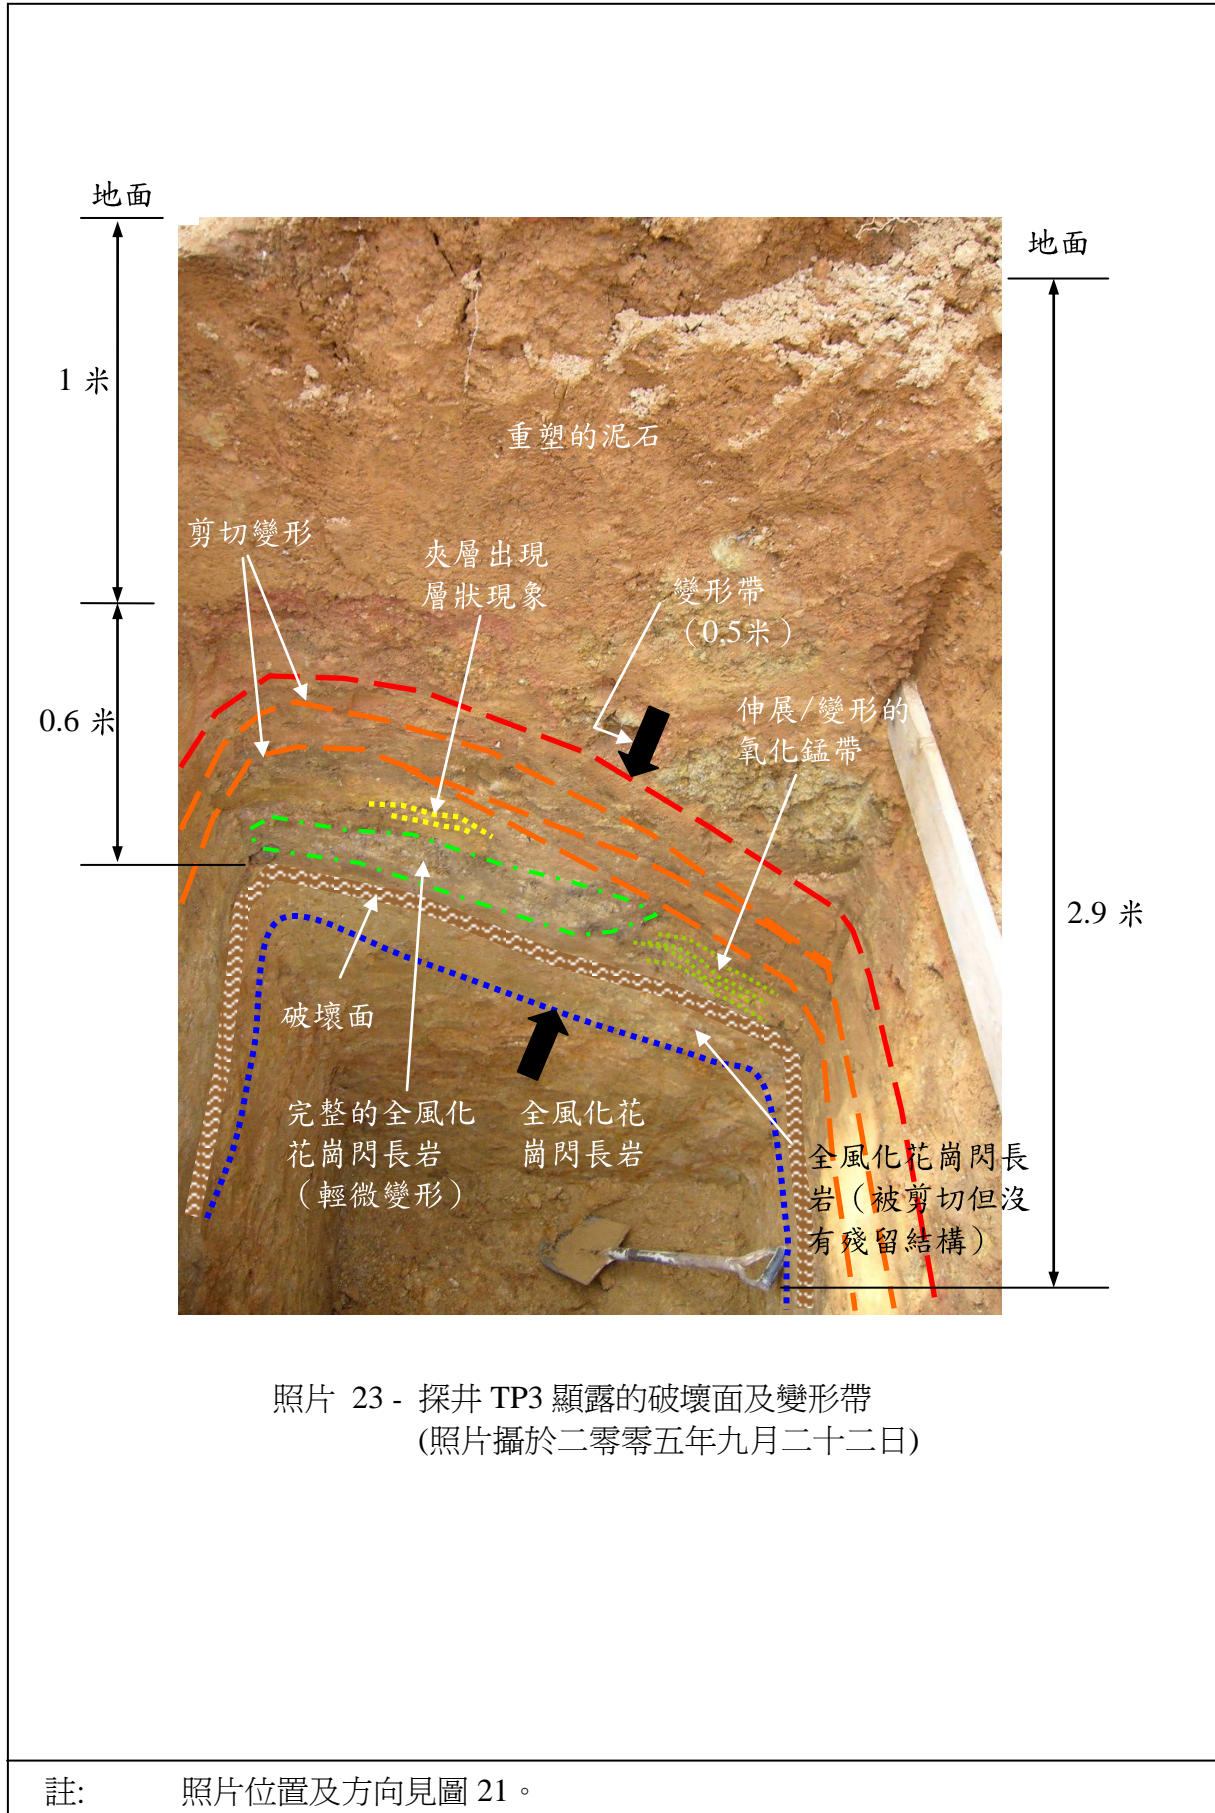
破壞面只有在崩塌殘痕內的探井中顯露(照片 22)，一般是由 20 毫米厚的灰色/褐色砂質粉土/黏土組成，局部包括一個狹長的剪切及層狀土帶(約 0.5 米)，並在探井編號 TP3 中可以清楚看到(照片 23)。破壞面主要在 CDGd 內。在探井編號 TP3 的局部位置可以看到一個剪切/擾動土壤區一直延伸進 CDGd 內約 200 毫米。山泥傾瀉後，破壞面的土壤非常濕潤，並有擾動和重塑的現象。現場沒有發現其他相對移動的證據例如擦痕面等。在剪切及層狀土帶內，破壞面一般位於剪切帶的底部(照片 23)。

照片 23 - 探井 TP3 顯露的破壞面及變形帶
(照片攝於二零零五年九月二十二日)
