一九九五年八月十三日
深灣道山泥傾瀉事件報告
**REPORT ON THE
SHUM WAN ROAD LANDSLIDE
OF 13 AUGUST 1995**

土力工程處報告系列第178號
GEO REPORT No. 178

黎佐賢爵士及土力工程處
Sir John Knill & Geotechnical Engineering Office

**VOLUME 1:
INDEPENDENT REVIEW
OF THE INVESTIGATION
BY THE GEOTECHNICAL
ENGINEERING OFFICE**

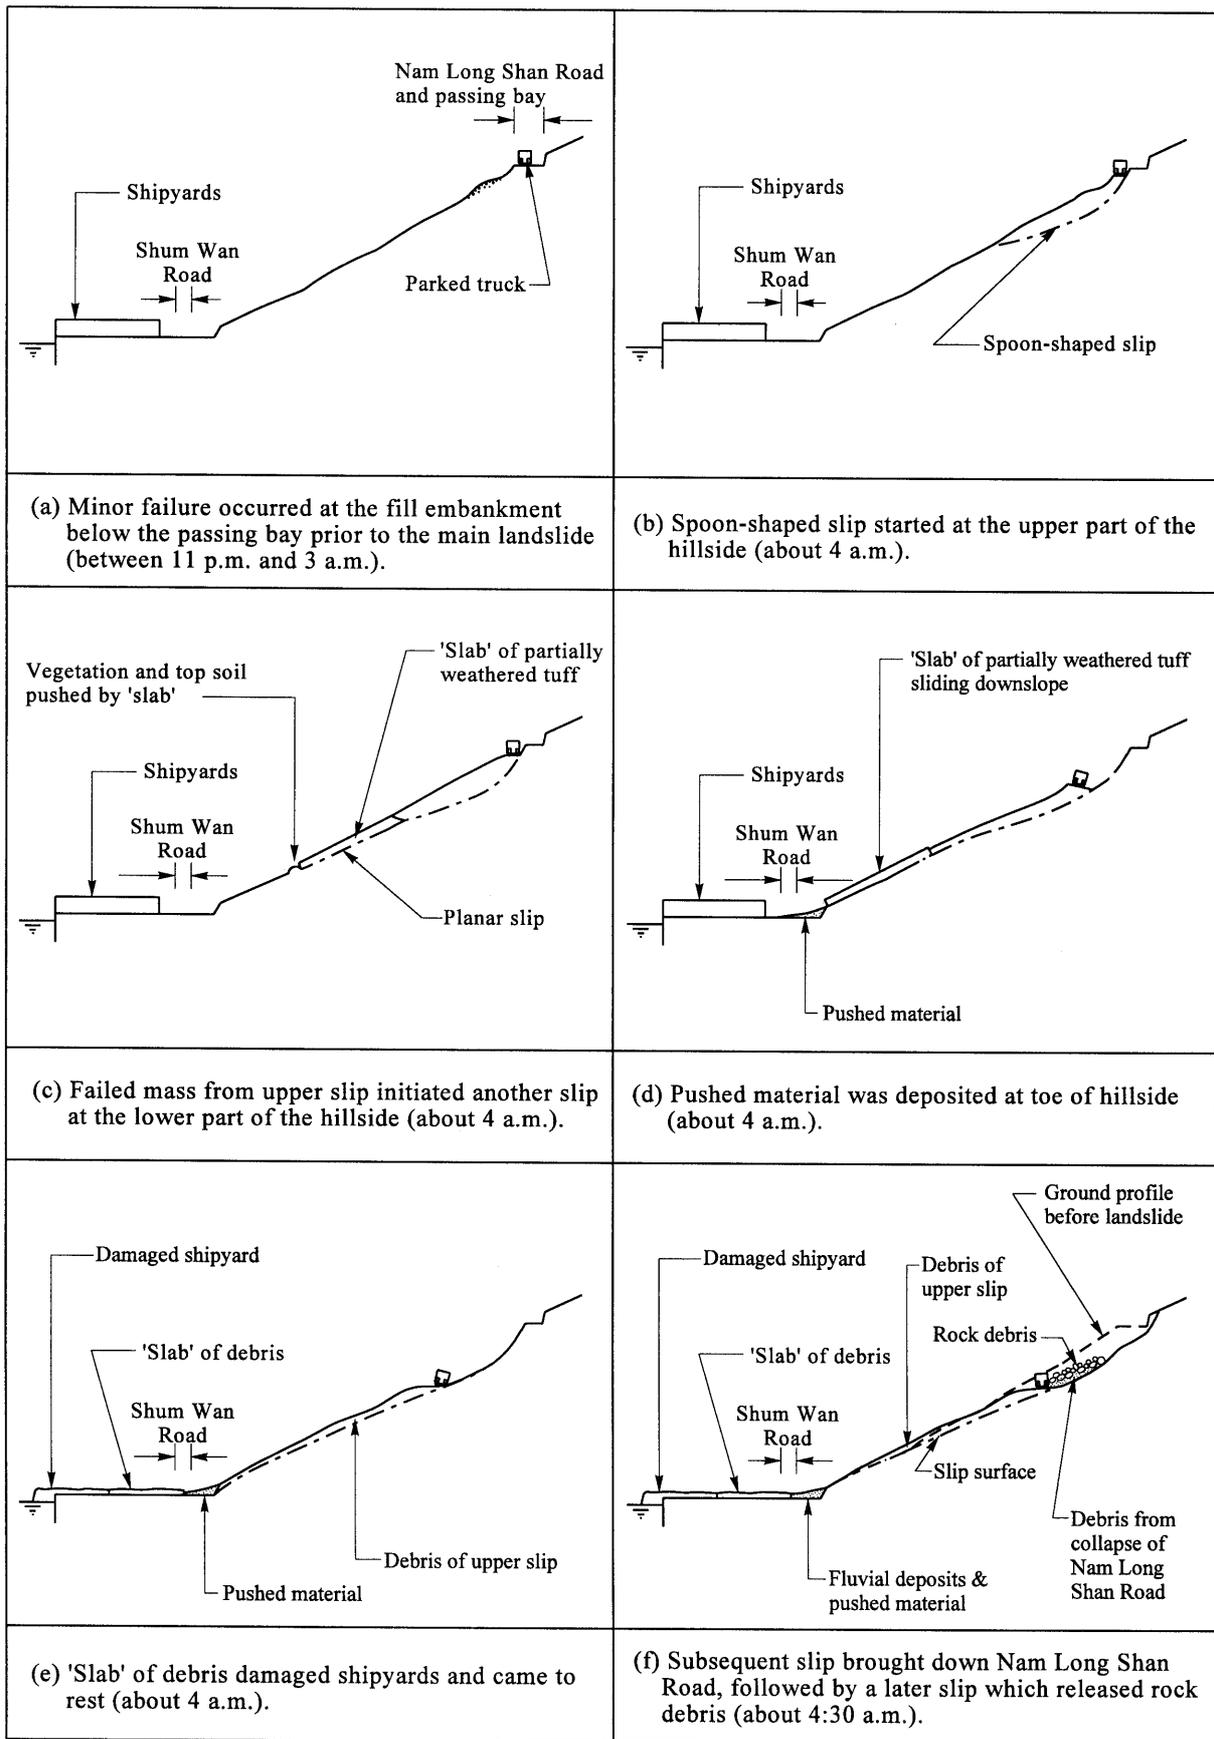
Figure 13 - Schematic Representation of Inferred Sequence of Events

Based on the available information, the most likely mode and sequence of the landslide have been reconstructed and are illustrated schematically in Figure 13.

The main landslide occurred at about 4 a.m. The upper part of the hillside slipped partly on a clay seam in the partially weathered tuff. This failure was approximately spoon-shaped and took with it the passing bay (Figure 13(b)). Movement of the ground associated with this failure was reported by an eye-witness to be not rapid but continuous. It resulted in the deposition of pieces of bituminous pavement and utility pipes on the concave scar. Fragments of the southern concrete retaining wall that were deposited earlier on the upper part of the hillside would have moved with the debris further downhill.

The debris from this spoon-shaped failure loaded the lower part of the hillside and disturbed its equilibrium. The lower part of the hillside failed along a shallow planar surface sub-parallel to the ground surface (Figure 13(c)). This planar failure released a relatively thin layer of partially weathered tuff that slipped largely as an intact unit or 'slab' down the hill. The 'slab' pushed vegetation and top soil in front of it. Some of the pushed material

and the front part of the 'slab' were deposited at the toe of the hillside (Figure 13(d)). The remaining portion of the 'slab' then overrode the deposited material and continued its journey towards the sea. The front of this 'slab' finally came to rest at a maximum distance of about 70 m from the toe of the hillside (Figure 13(e)).

According to eye-witness accounts, Nam Long Shan Road did not collapse in the main landslide. The main landslide was followed by a few small slips cutting retrogressively up the hillside. A notable slip occurred about half an hour after the main event, resulting in the collapse of Nam Long Shan Road and deposition of debris onto the concave scar. The large zone of rock debris that rested on top of the remains of Nam Long Shan Road on the concave scar would have come from a later slip (Figure 13(f)).

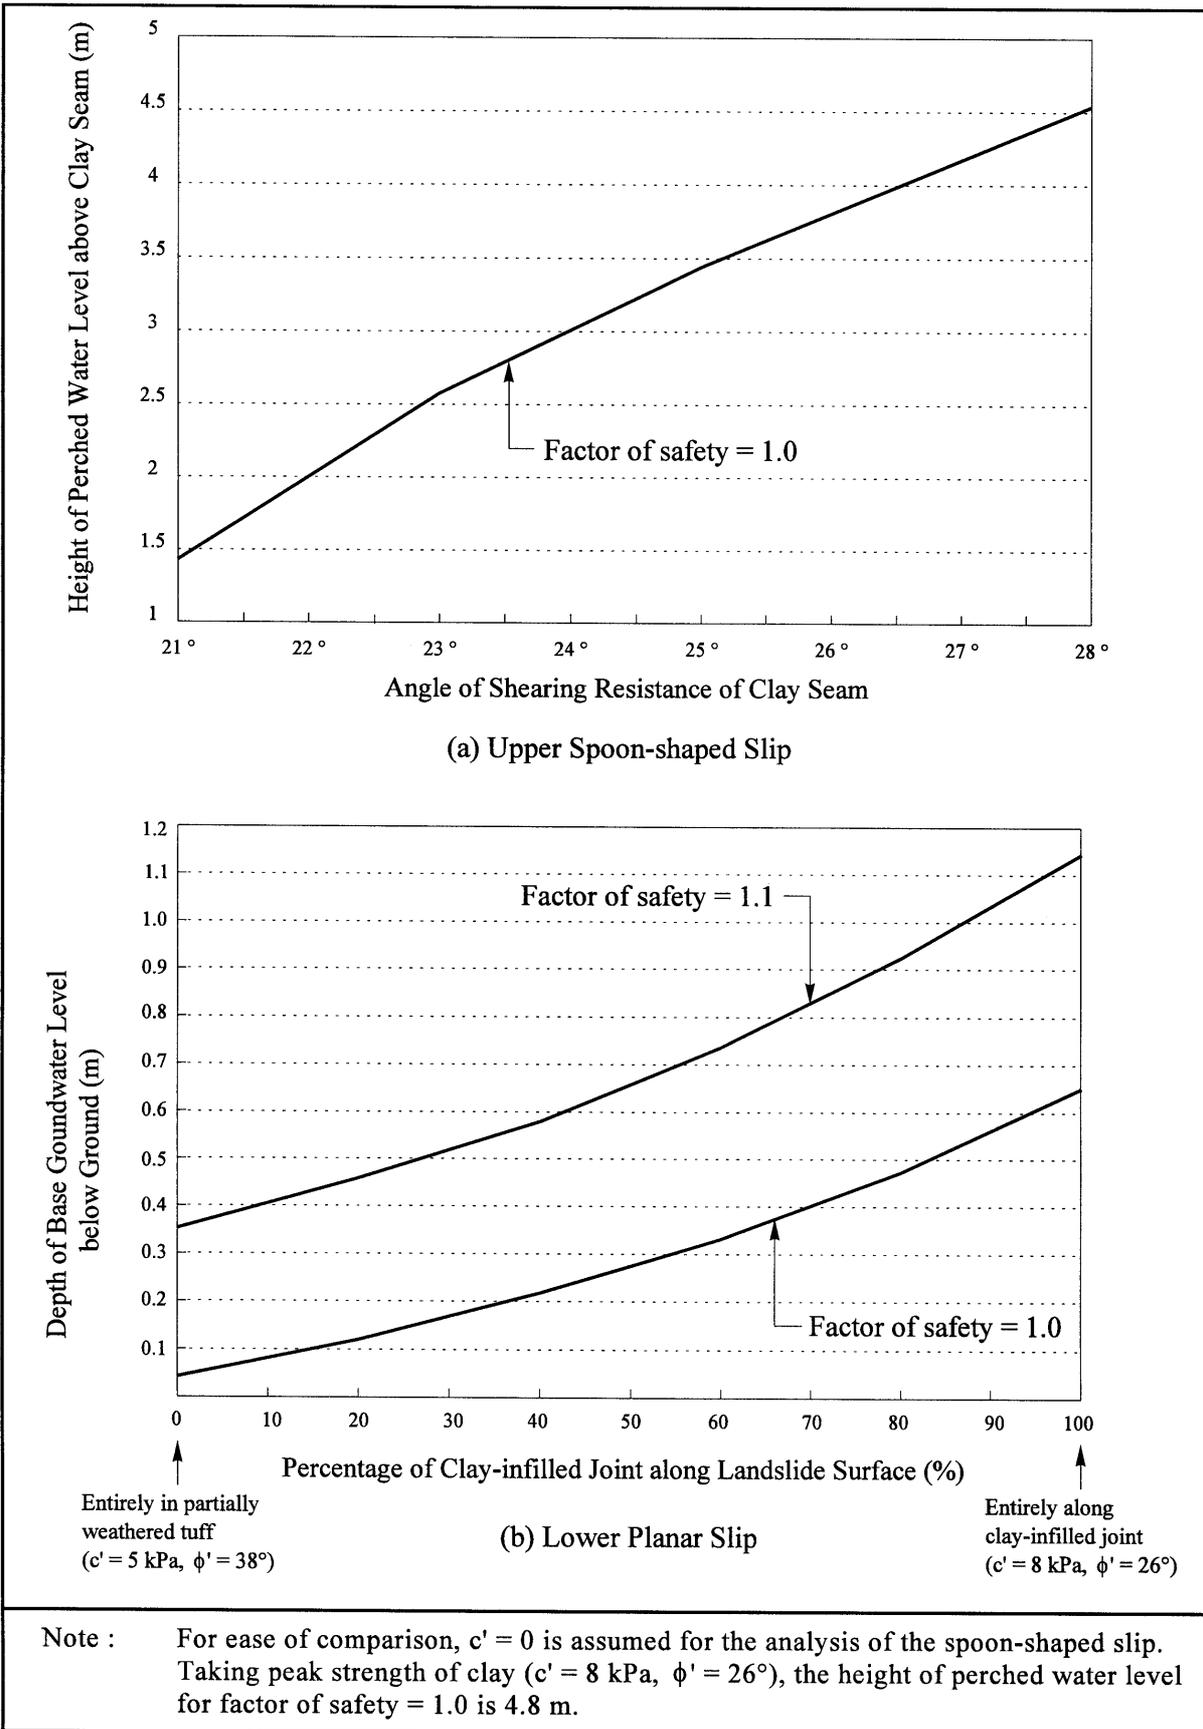
Figure 15 - Results of Slope Stability Analyses for Hillside

In the concave scar area, the post-failure base groundwater level was well below the landslide surface (Section 6.4). Theoretical analyses by the method of slices show that this part of the hillside would be stable under such a deep base groundwater condition. Perched water, however, was observed on the clay seam which formed part of the landslide surface of the concave scar (Section 6.2). The associated porewater pressure could have rendered the ground unstable. The theoretical perched water level needed for limit equilibrium depends on the shear strength of the clay seam. The ground could theoretically have failed under a high perched water level of 4 to 5 m coupled with the peak shear strength for the clay seam, or alternatively under a low perched water level of 1 to 2 m if the clay seam had a shear strength close to that of the clay with slickensiding (Figure 15(a)).

At the location of the planar scar, ground investigation showed that the base groundwater level was closer to the pre-failure ground surface than in the concave scar. Theoretical stability analyses by the limit equilibrium method, using the infinite slope solution, show that the ground could theoretically have become unstable under a range of base groundwater levels between zero and 1 m below ground, depending on the proportion of clay-infilled joints along the landslide surface (Figure 15(b)).

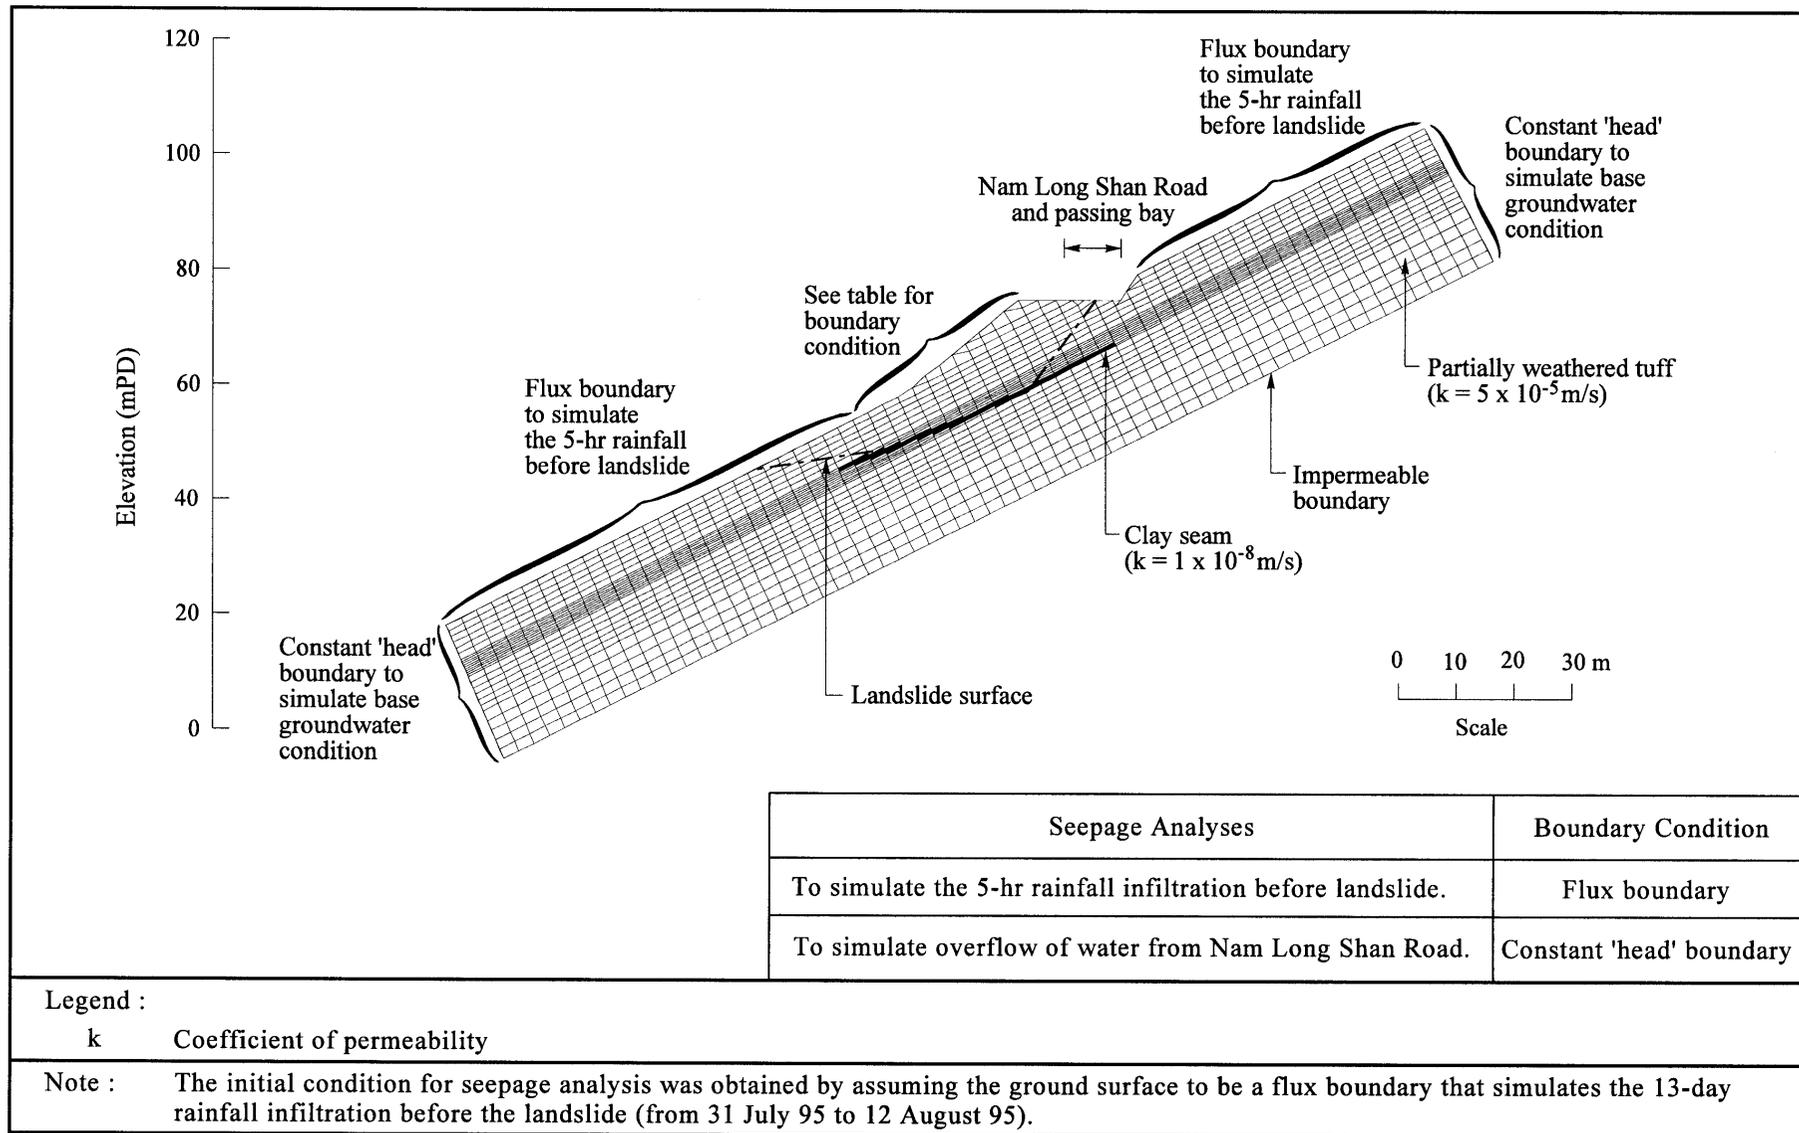
Figure 16 - Analytical Model for Seepage Analyses

About 380 mm of rain had fallen directly on the landslide area during the 30 hours prior to the main landslide. Water could have infiltrated the fill embankment below the passing bay and seep through the underlying partially weathered tuff. Seepage analysis using a finite element computer program (Figure 16) shows that this incident rainwater alone could have caused a low head (about 1 m) of perched water to build up on the clay seam.

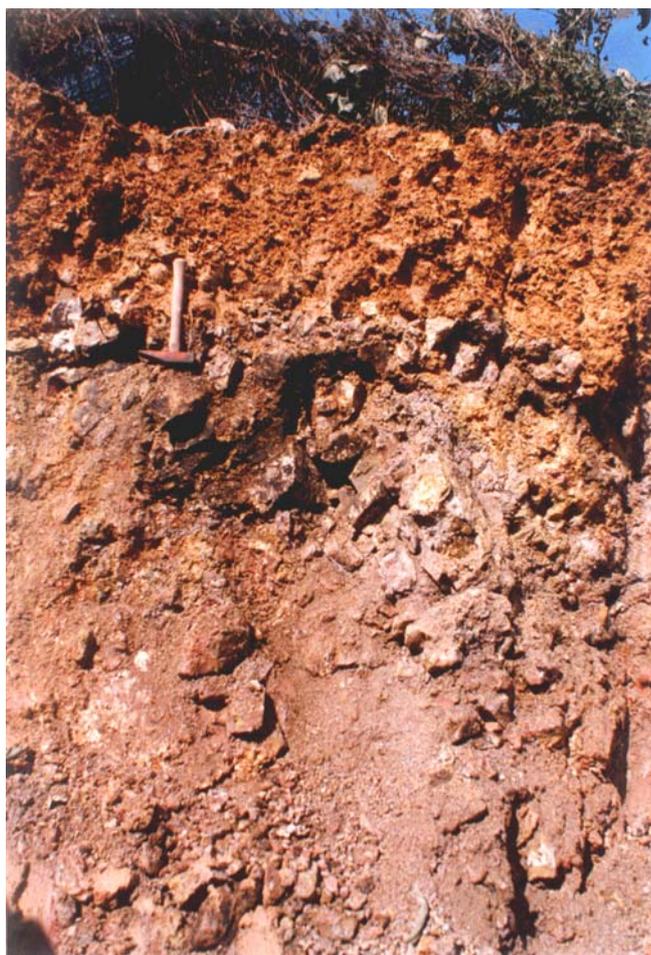
照片2 - 填海區上的
「岩塊」泥石

塌下的泥石可大致分為四個主要類別(圖 7)。在深灣道以西的填海土地上的泥石，是一片近乎完整的「岩塊」，厚度一般約為 2 米，部份達 3 米(照片 2)。該「岩塊」由部分風化凝灰岩組成，並保留了風化岩的原有節理結構。這些節理結構曾受擾動，但仍可辨認。節理的間距很密，部分節理還蓋了白色的高嶺土，約達 10 毫米厚。該「岩塊」在一些地方覆蓋著植物和表土。「岩塊」的頂部有一堆堆的植物，而其外圍邊緣近海處也散佈了植物。

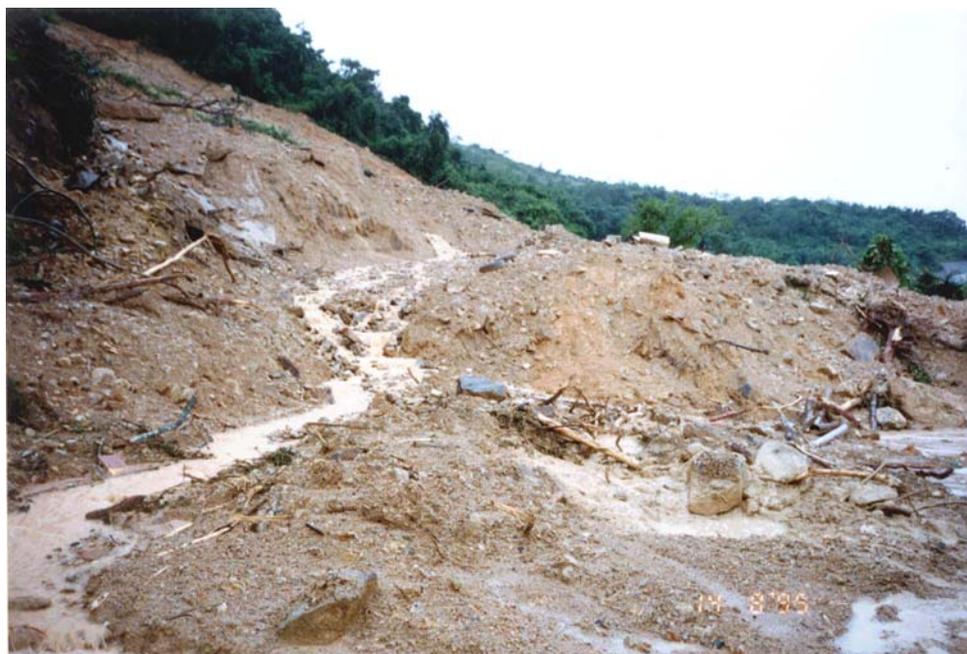
照片3 - 崩塌山坡腳的泥石

位於「岩塊」與山坡之間的泥石，主要是十分鬆軟的沖積物，由黏土、粉砂、砂、礫石，以及一些中礫和巨礫組成(照片 3)。泥石一般約 2 米厚。

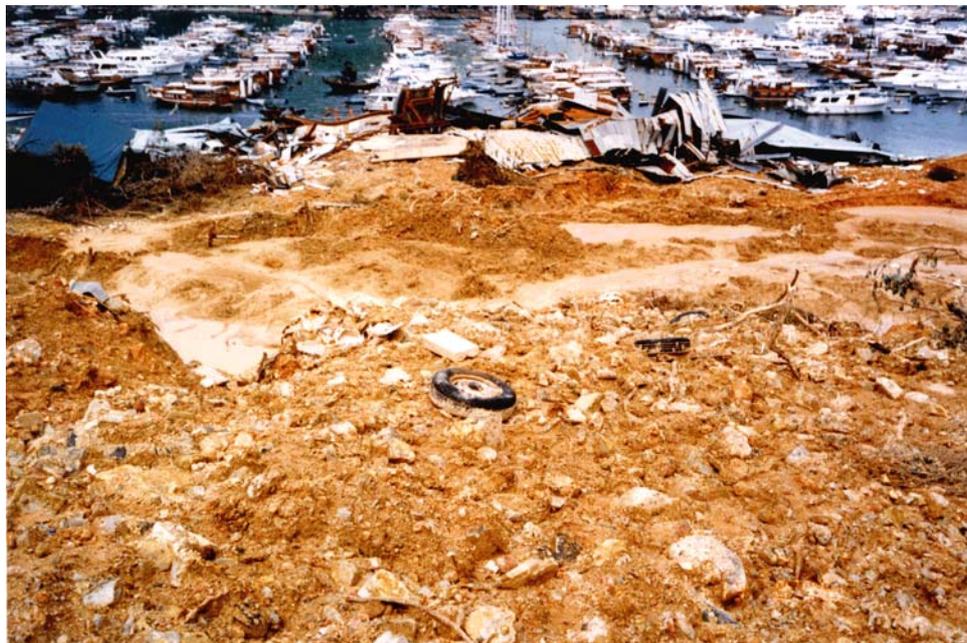
照片4 - 在山泥傾瀉殘痕上帶有填料及廢料的泥石

山泥傾瀉面的平坦部分普遍被厚約 3 米的泥石覆蓋，在凹陷殘痕內，泥石厚達 5 米。泥石主要為土質，內有填土物料和廢料，例如瓶、發泡膠、車胎及建築廢物(照片 4)。泥石中亦發現其他人造物件，包括混凝土擋土牆碎塊、瀝青路面殘塊、數段直徑 225 毫米的陶管、直徑 100 毫米的鍍鋅鐵水管和混凝土板塊等(圖 9)。此外，大部分混凝土擋土牆碎塊(照片 5)，散佈於較低的平面殘痕上，而瀝青路面殘塊(照片 6)則全部散佈於較高的凹陷殘痕上。
