一九九五年八月十三日
柴灣翡翠道山泥傾瀉事件報告
**REPORT ON THE
FEI TSUI ROAD LANDSLIDE
OF 13 AUGUST 1995**

土力工程處報告系列第188號
GEO REPORT No. 188

黎佐賢爵士及土力工程處
Sir John Knill & Geotechnical Engineering Office

**VOLUME 1:
INDEPENDENT REVIEW
OF THE INVESTIGATION
BY THE GEOTECHNICAL
ENGINEERING OFFICE**

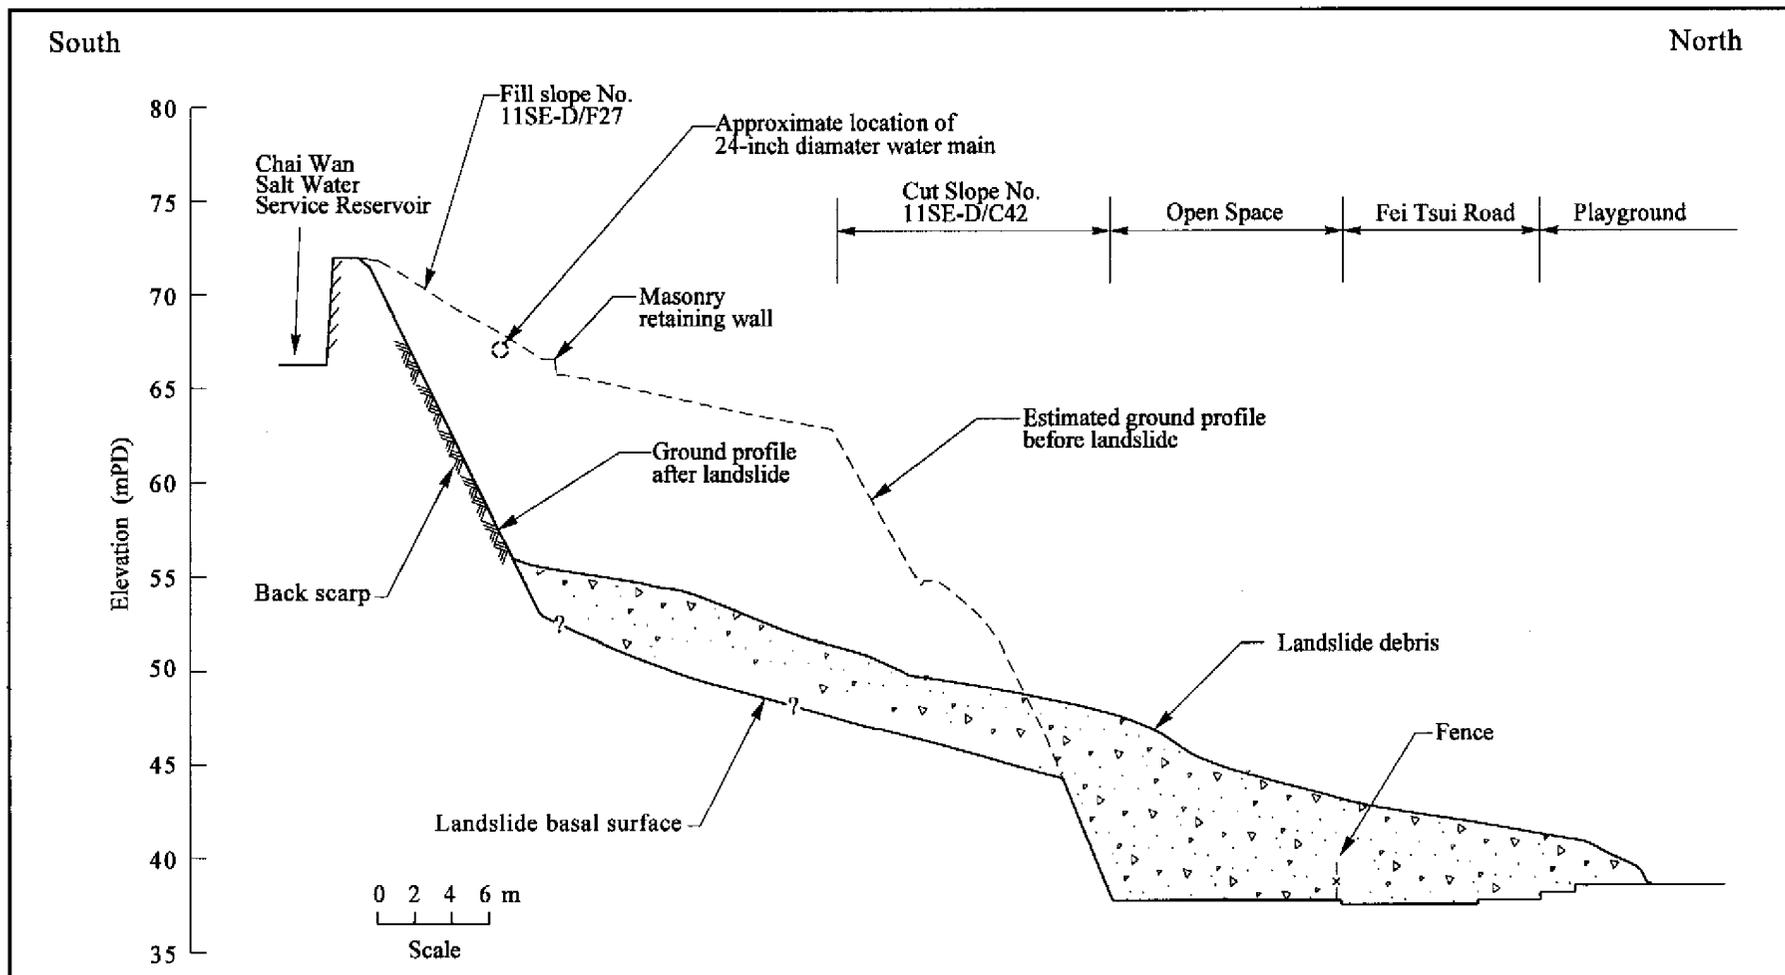
Figure 4 - Section A-A

- Notes :
- (1) See Figure 2 for location of section.
 - (2) Information shown in this figure is based on topographic survey, geological mapping, field observations and documentary records.
 - (3) The location of the abandoned 6-inch diameter water main, which cannot be ascertained, is not shown in this figure.

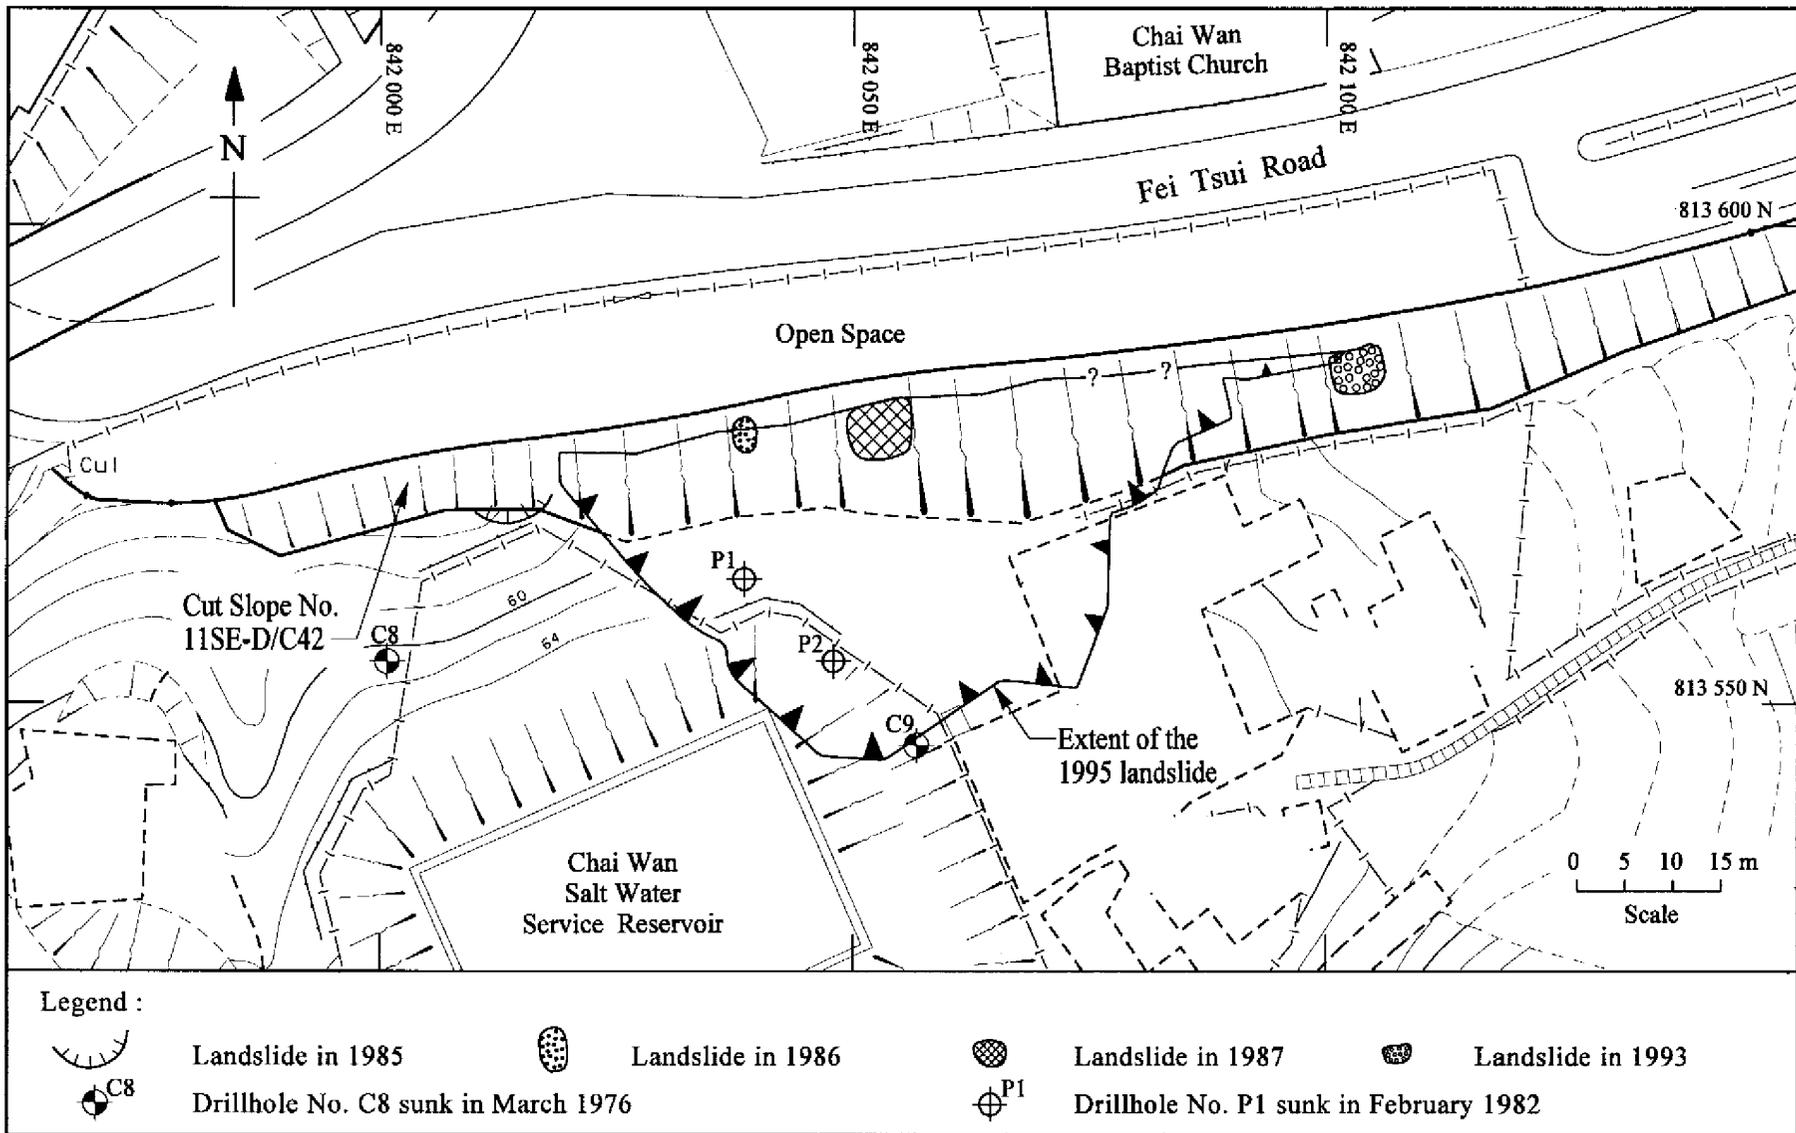
Figure 6 - Locations of Previous Landslides at Slope No. 11SE-D/C42

Four previous landslides occurred at the cut slope in 1985, 1986, 1987 and 1993. The approximate locations of these landslides are shown in Figure 6 in this landslide investigation report.

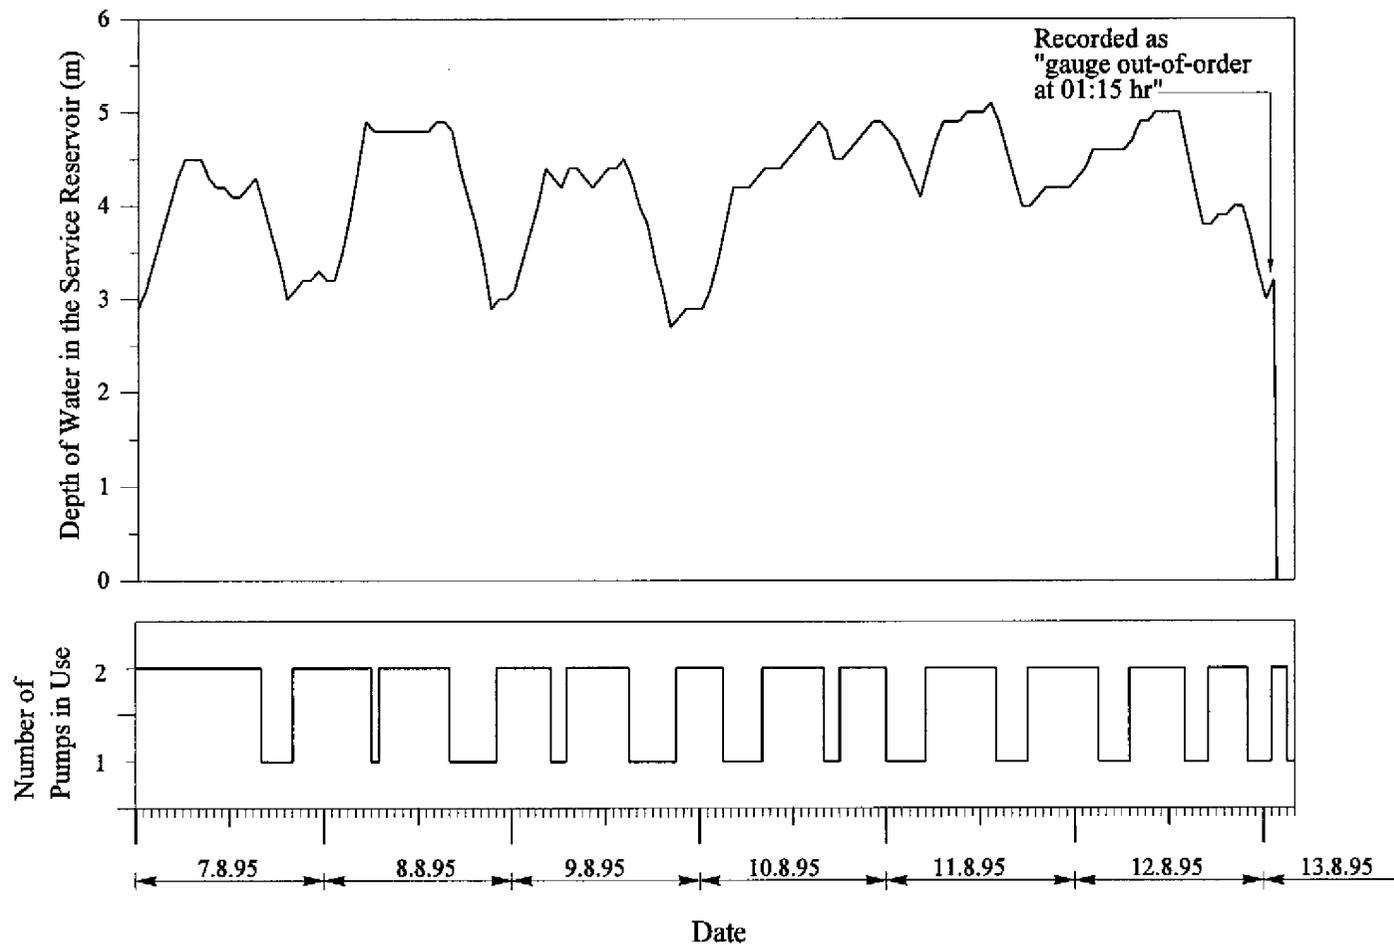
Figure 15 - Records of Water Levels in the Service Reservoir and Number of Pumps in Use

- Notes :
- (1) The pumps are housed in Chai Wan Salt Water Pumping Station. Depth of water in the service reservoir shown is for both its east and west compartments.
 - (2) This figure was based on information obtained from Water Supplies Department (1995).

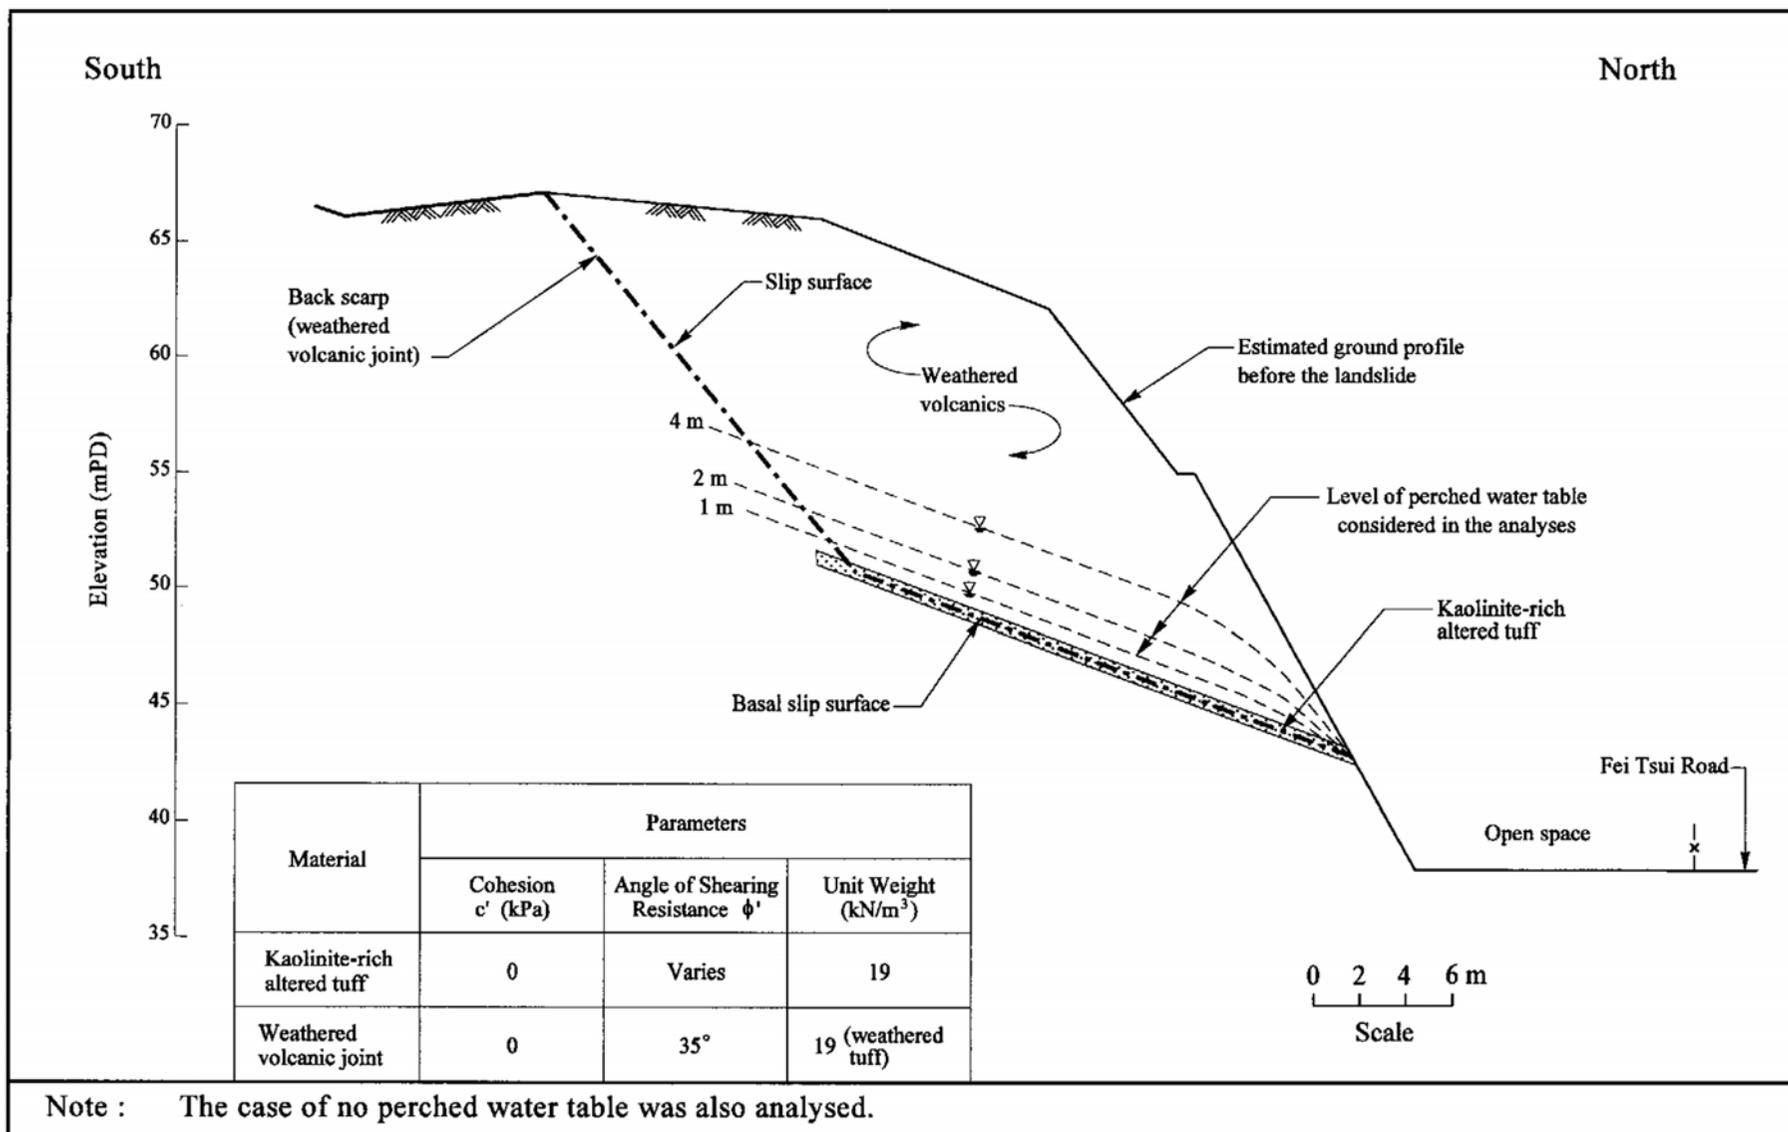
Figure 18 - Representative Cross-section of the Landslide for Theoretical Stability Analyses

in Figure 18. A perched water table up to 4 m above the altered tuff layer at the time of the landslide was assumed in the analyses.

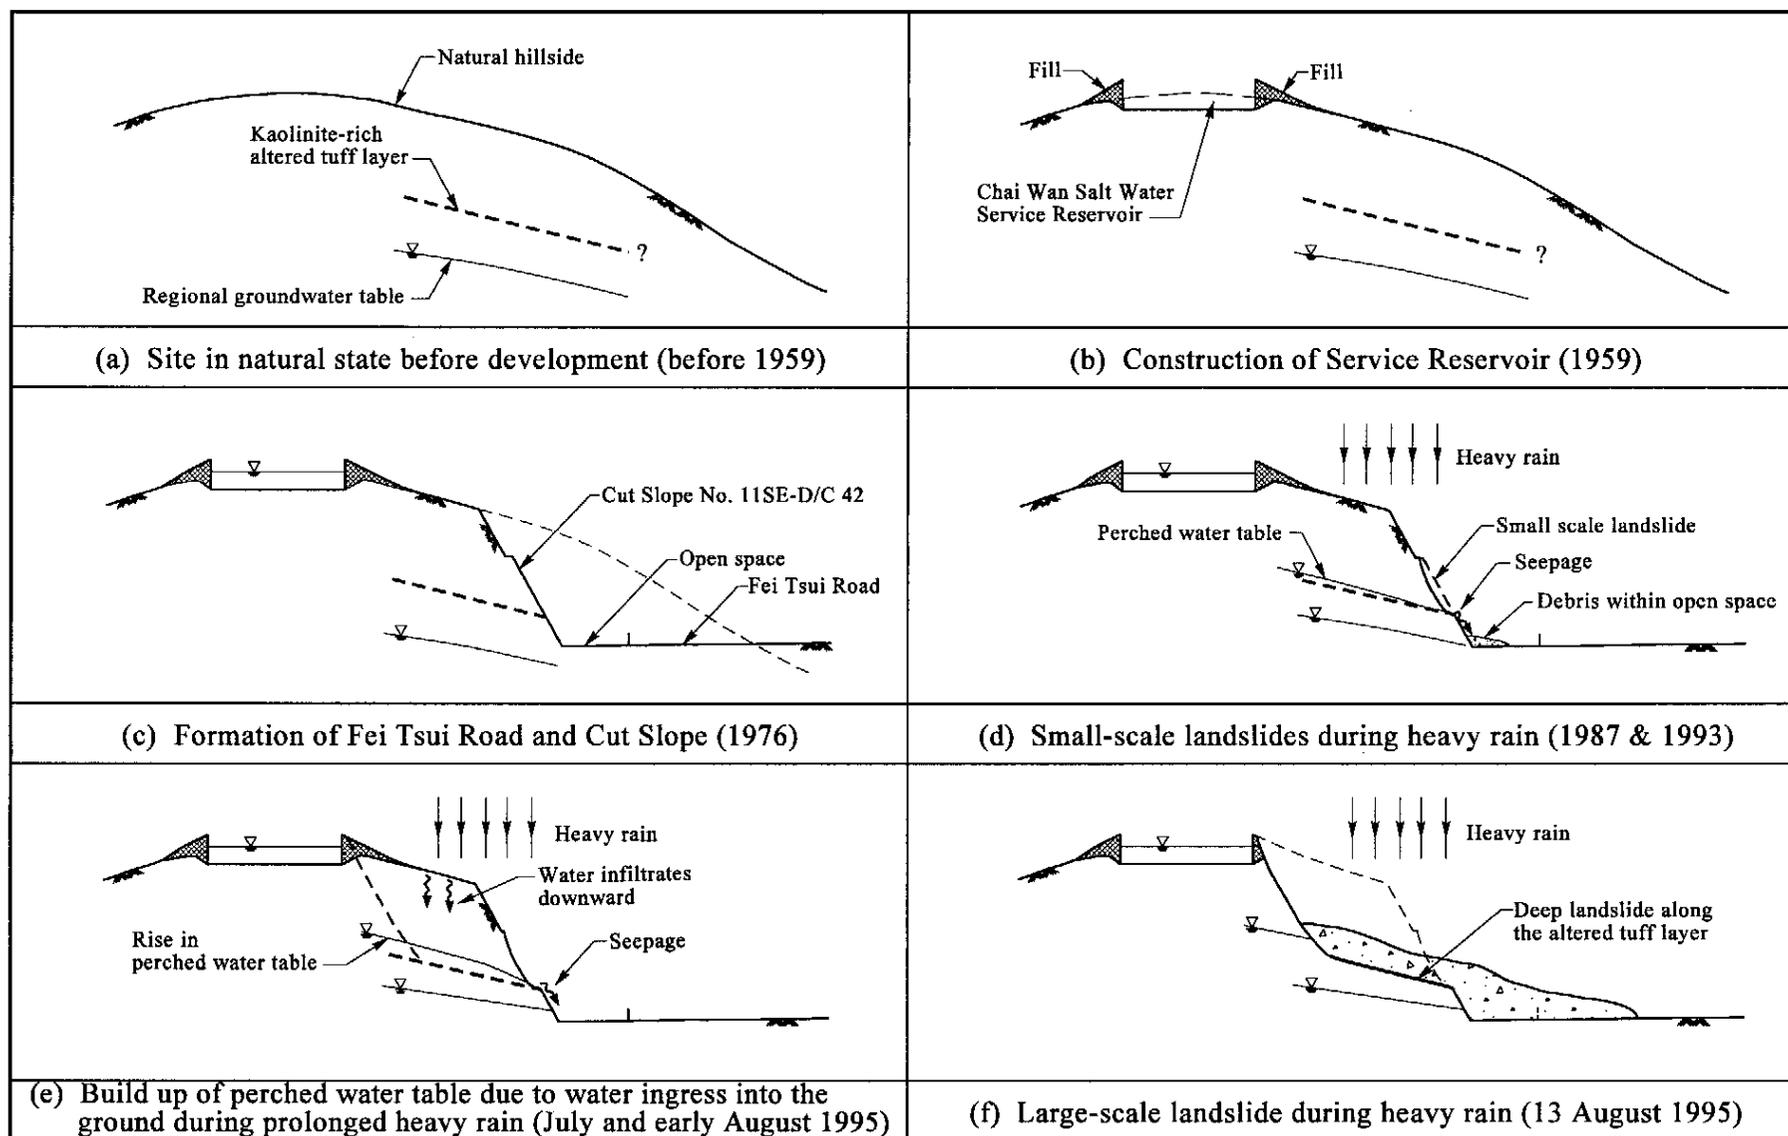
Figure 20 - Probable Sequence of Events

The re-constructed sequence of events which it is believed led to the landslide is illustrated in Figure 20.

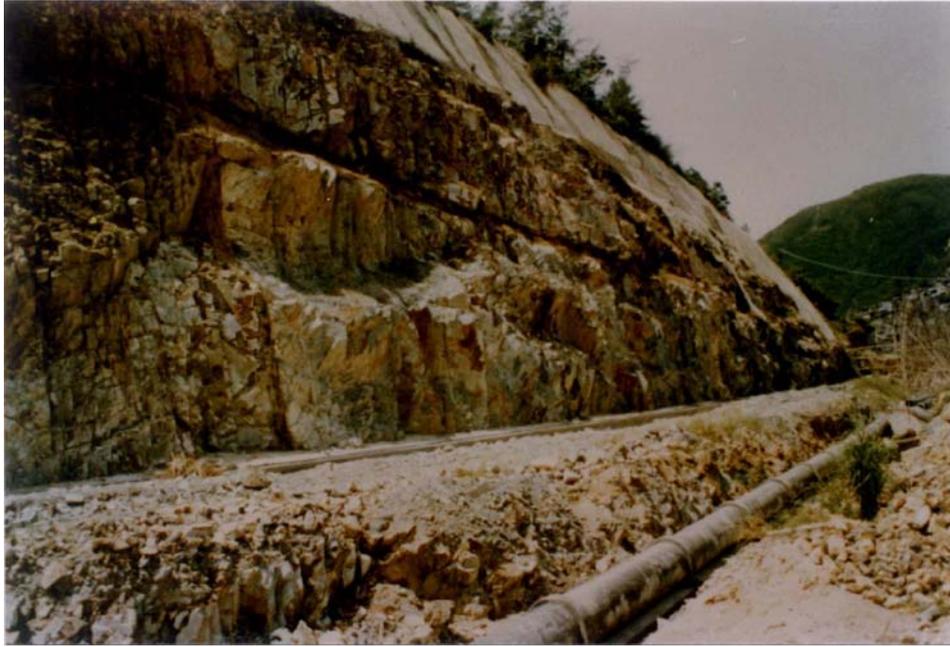
Plate 2 - Photograph of Cut Slope No. 11SE-D/C42 Taken after Slope Formation
(Reproduced from Plate 8 of Binnie, 1977. See Figure 21 for Location)

B&P observed that there was “a 4' wide berm at mid-height” and “beneath the berm the exposed rock face is closely jointed fresh to slightly decomposed volcanic rock with a prominent horizontal weathered seam midway between the road and the berm (plate 8). Beneath the service reservoir we noted seepage along sub-horizontal joints”. Plate 8 in B&P’s report is given as Plate 2 in this landslide investigation report.

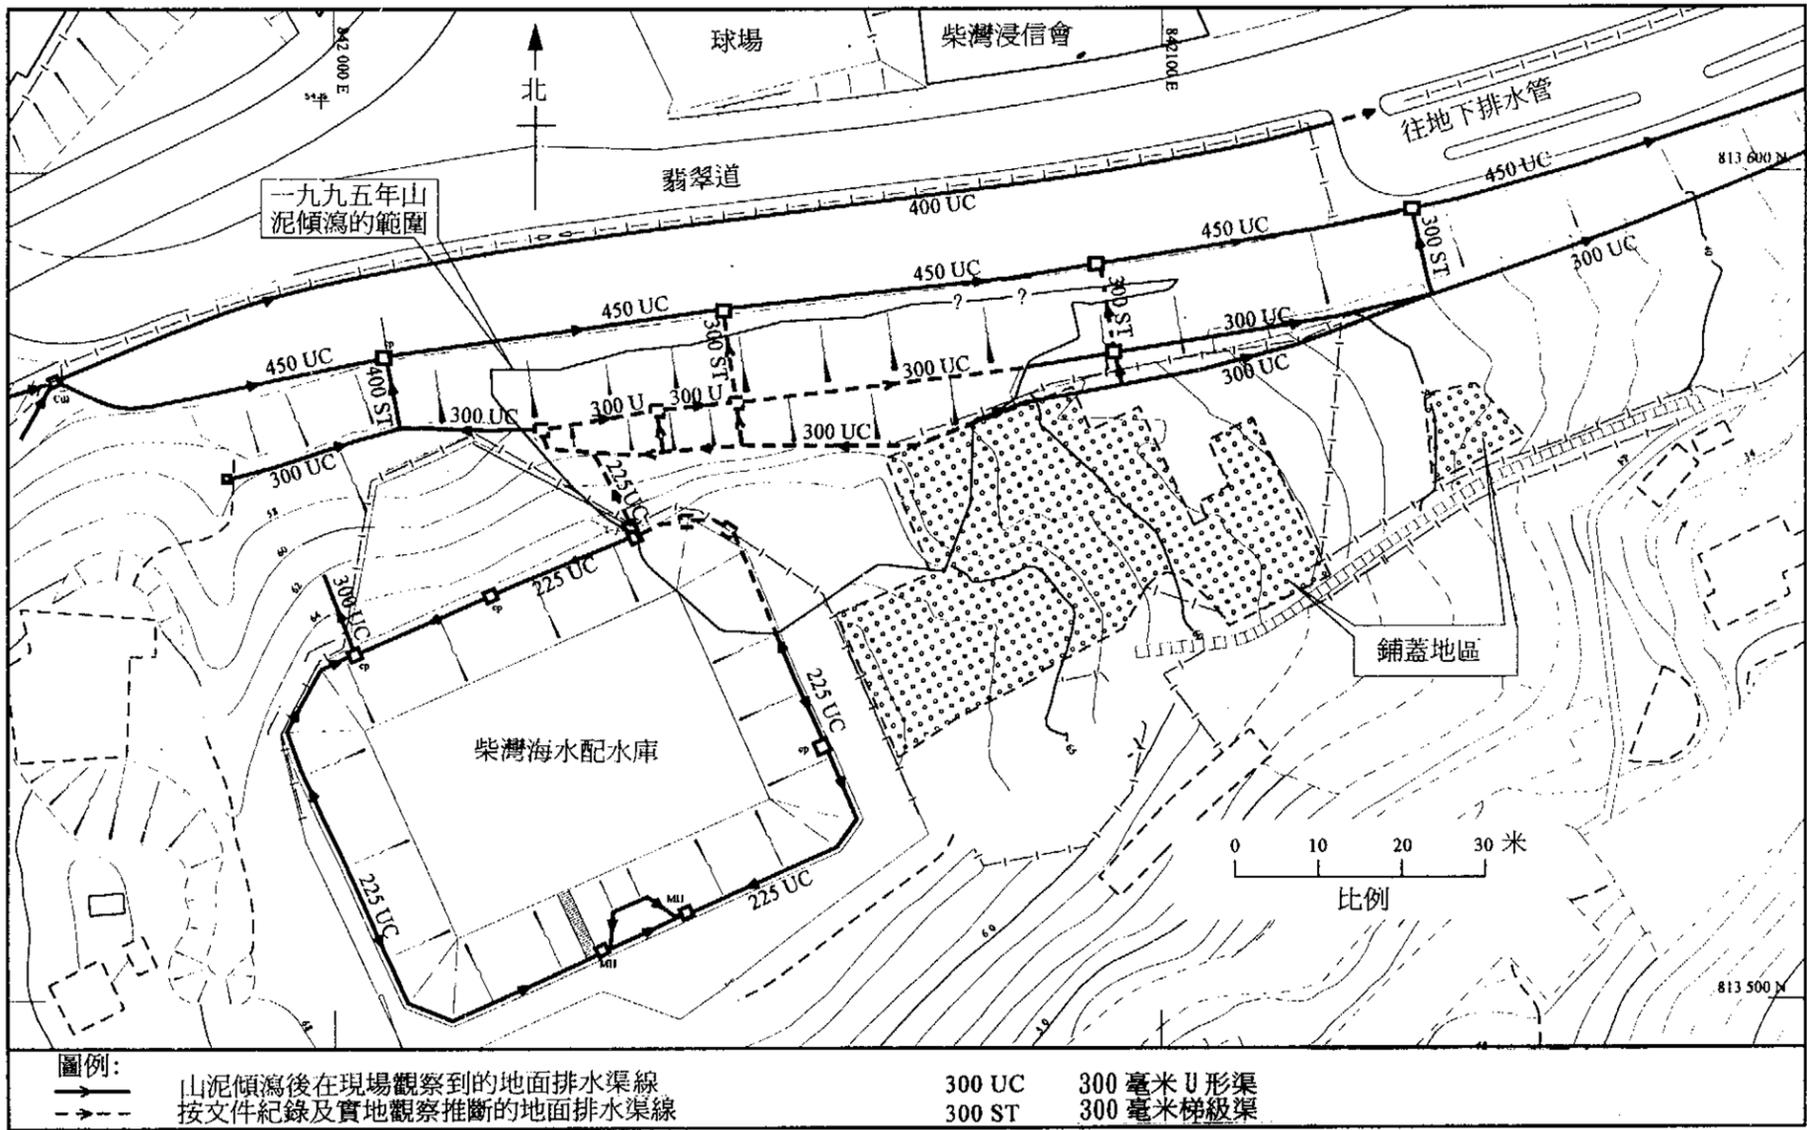
圖 3 - 事發地點排水系統的大概分佈

從可得的文件紀錄和事發後現場觀察結果，可推斷該處的地面排水系統的大概位置，如圖 3 所示。於事發後視察所見，位於削坡未塌下部份的地面排水渠，為腐植土和有黑漬的粉質土淤塞(照片 4)。位於事發地點以西的削坡頂部的排水渠，則積有約 20 毫米深的落葉及粉質土。

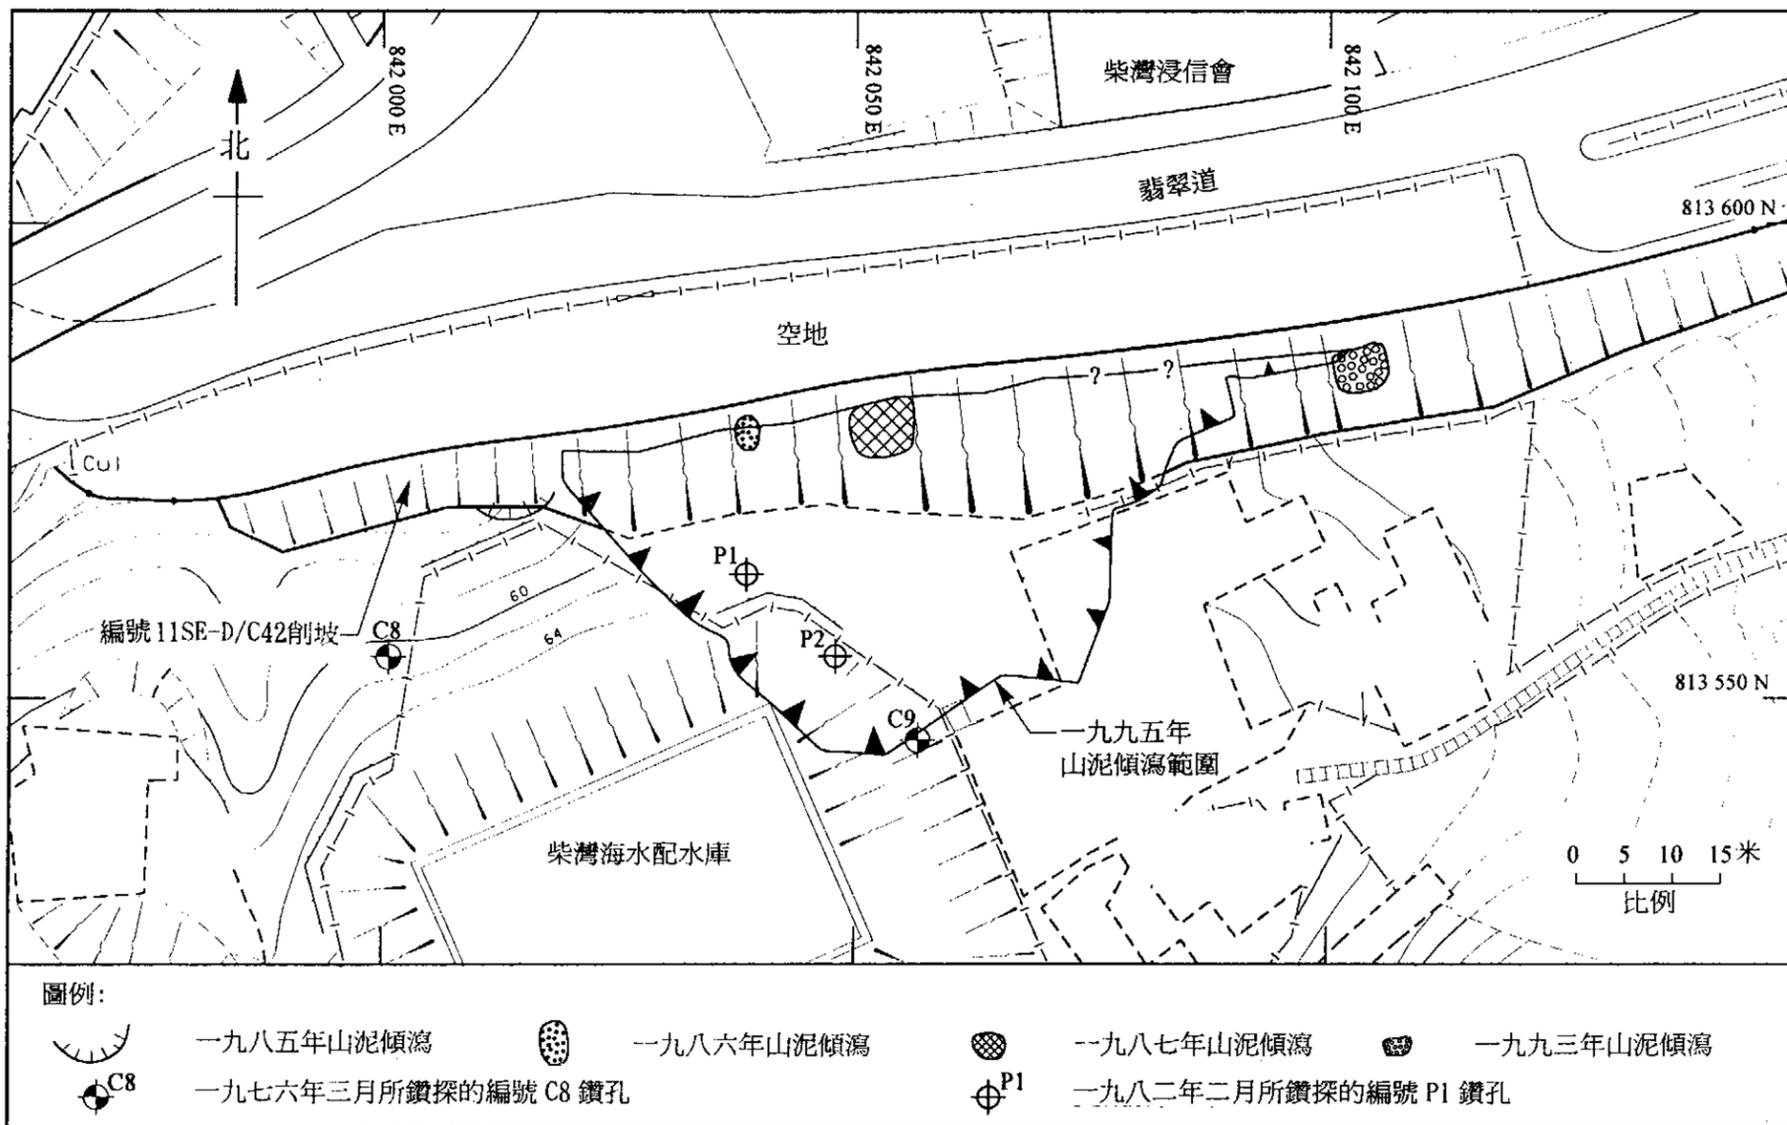
圖 6 - 編號11SE-D/C42削坡以往幾次山泥傾瀉的位置

土力工程處曾分別於一九八七年(照片 6)及一九九三年(照片 7)接獲該處發生山泥傾瀉的報告，場下泥石的體積分別約為 50 和 30 立方米。在兩次事件中，崩塌均發生於削坡的上半部，崩塌的底部露於翡翠道 10 米之上。除了在一九九三年的山泥傾瀉事件中，浸信會有一些窗子被飛濺的碎石所損毀外，其他場下的泥石都落在斜坡前的平坦空地上。

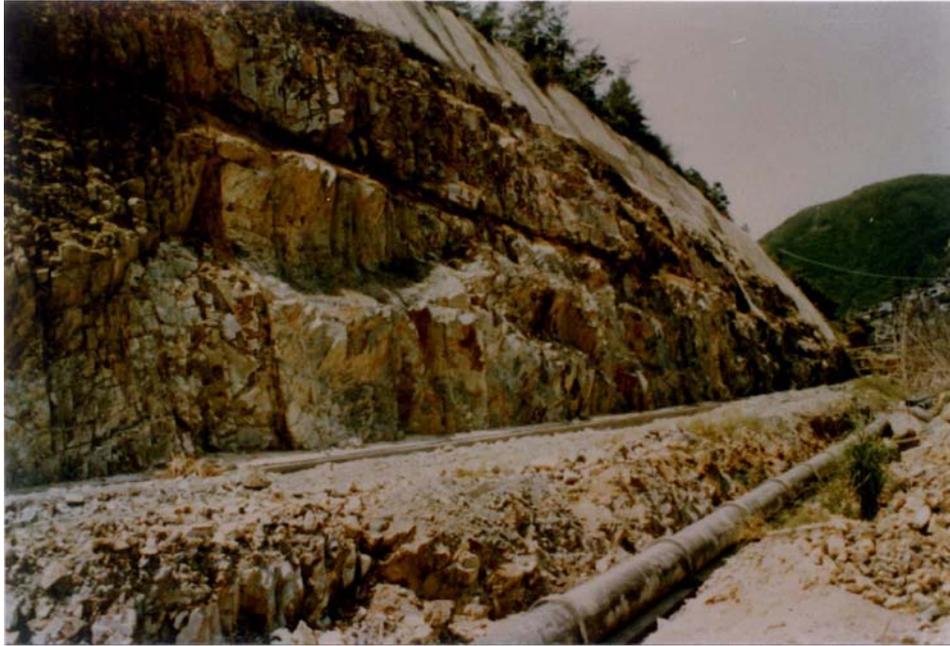
檢閱事發地點的歷史(附錄 A 的 A.2.2 節)，找到有關事發地點過往的文件。在該處進行場地平整工程時，就該斜坡當時情況所撰寫的報告，提到「道路和坡級中間有顯著的水平風化泥層(照片 8)」「約 100 毫米闊及最少 50 米長」。該「照片 8」於一九七六年拍攝，顯示翡翠道山泥傾瀉地點當時的情況。該照片並轉載於土力工程處報告為照片 2。從該張一九七六年照片所見到非常明顯的平直地質結構，可能就是「顯著的水平風化泥層」。但很明顯，這地質結構並不是水平，而是貫穿岩體並向坡面外傾，其傾角可能引致滑動。雖然其後有其他組織曾視察該斜坡，但他們似乎沒有探討過這個地質結構會引致發生大規模平移崩塌的可能性。

照片2 - 於斜坡平整工程後，攝得的編號11SE-D/C42削坡照片
(翻印賓尼(一九七七)的照片 8。其位置見圖21)

賓尼組合指出「於半高度處有 4 呎闊的坡級」，及「坡級下面露出的岩石面為未受風化至輕度風化火山岩，其節理間距極密，而道路與坡級中間有顯著的水平風化泥層(照片 8)。我們留意到配水庫下面近乎水平的節理有滲水現象。」賓尼組合報告內的照片 8，轉載於本報告為照片 2。
