GCO PUBLICATION No. 2/85

# **GROUNDWATER LOWERING BY HORIZONTAL DRAINS**

D. J. Craig & I. Gray

**Geotechnical Control Office  
Engineering Development Department  
HONG KONG**

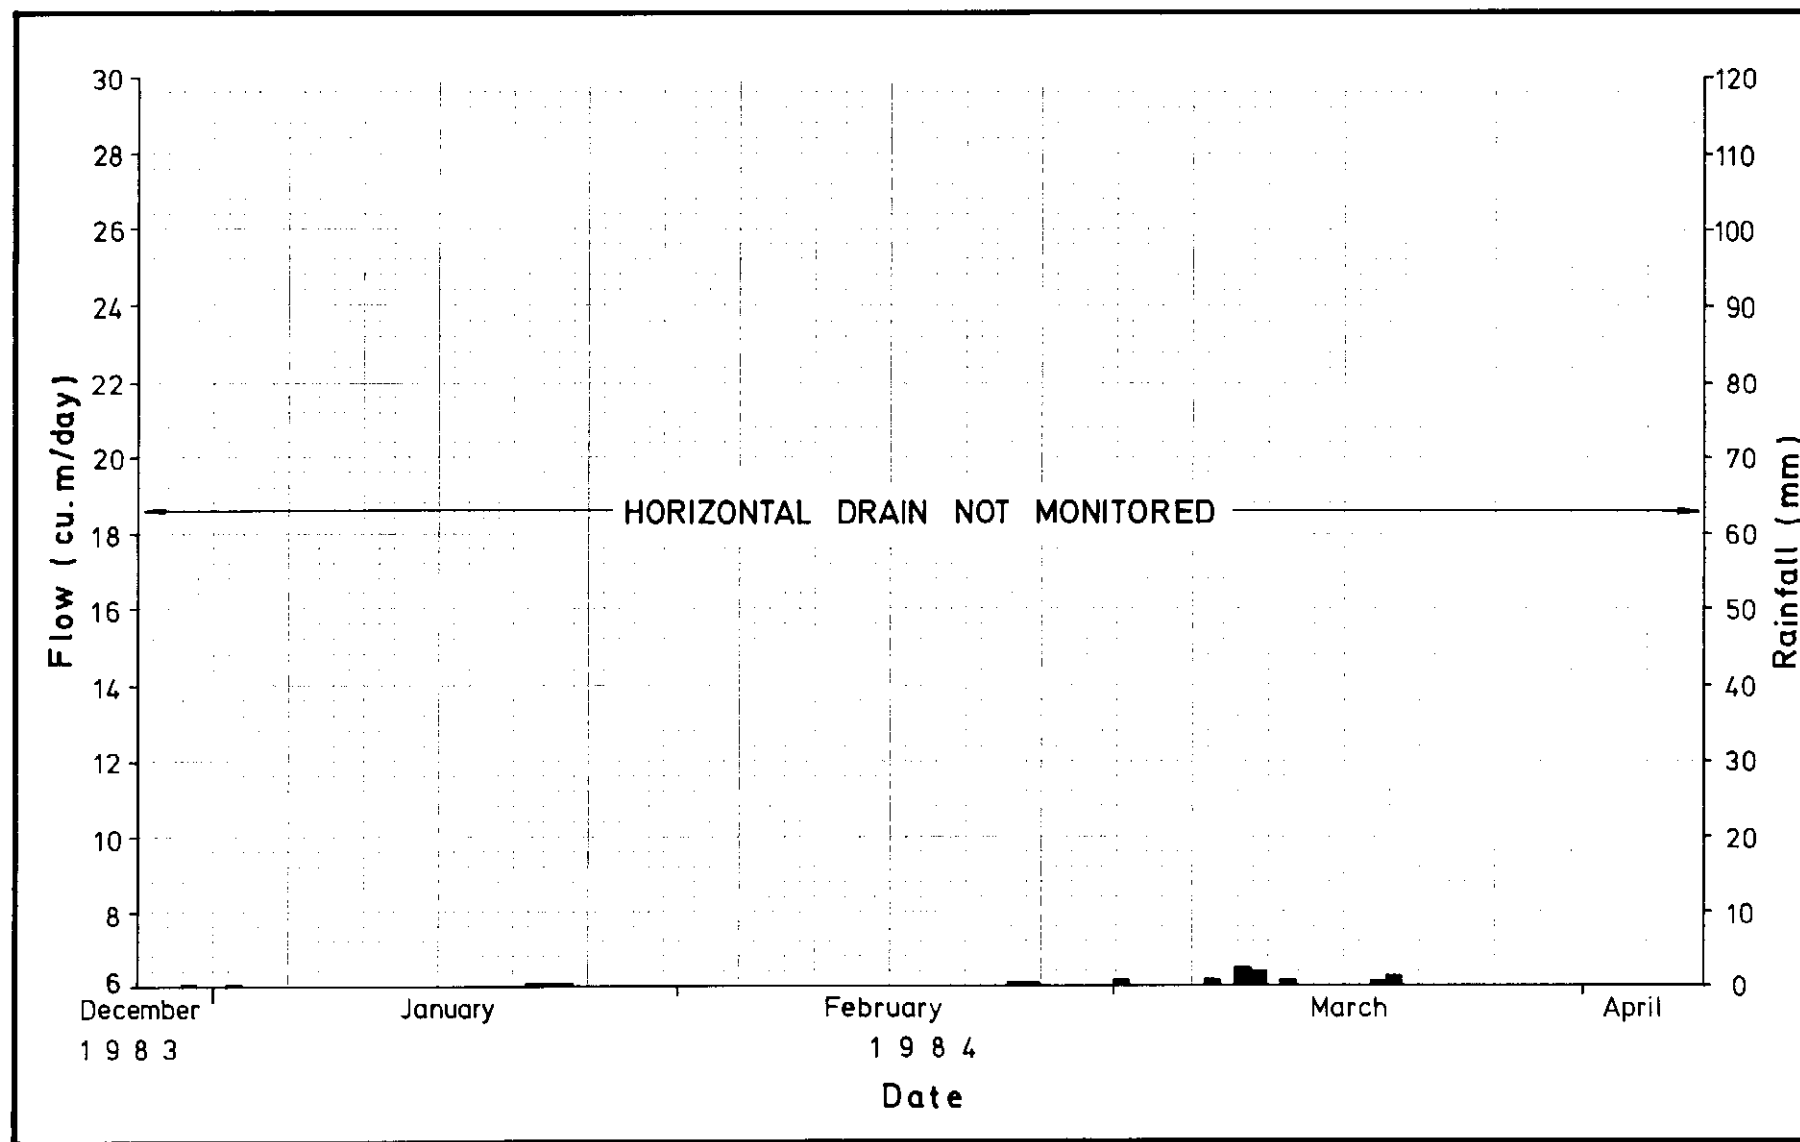
Figure 26 - Flow from Horizontal Drain No. H3A with Associated Rainfall (Jun - Sep 1983)

The flows from the drains are shown in Figures 26 and 27, together with associated rainfall. As may be expected, drain flow is influenced by rainfall. Flows from drains H6, H7 and H8 had reduced to approximately 14 cu m/day by October 20. Throughout the dry season, flows continued to decrease, and in February 1984, flows from drains H6, H7 and H8 were 3.5, 8.0 and 8.4 cu m/day respectively.

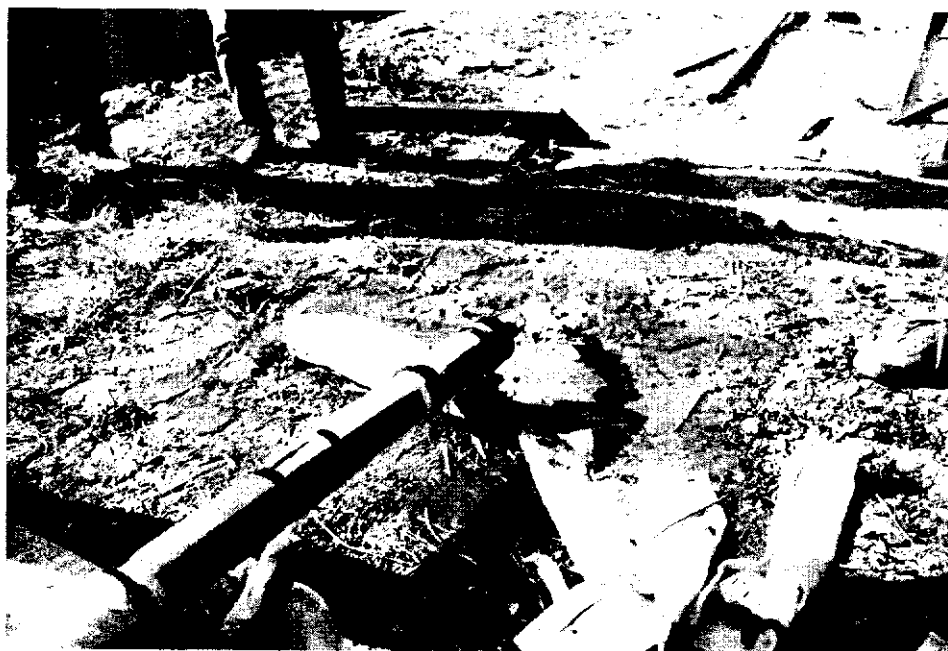
Plate 6 - Water Testing Grouting Nozzle before Drain  
Installation  
(November, 1983)

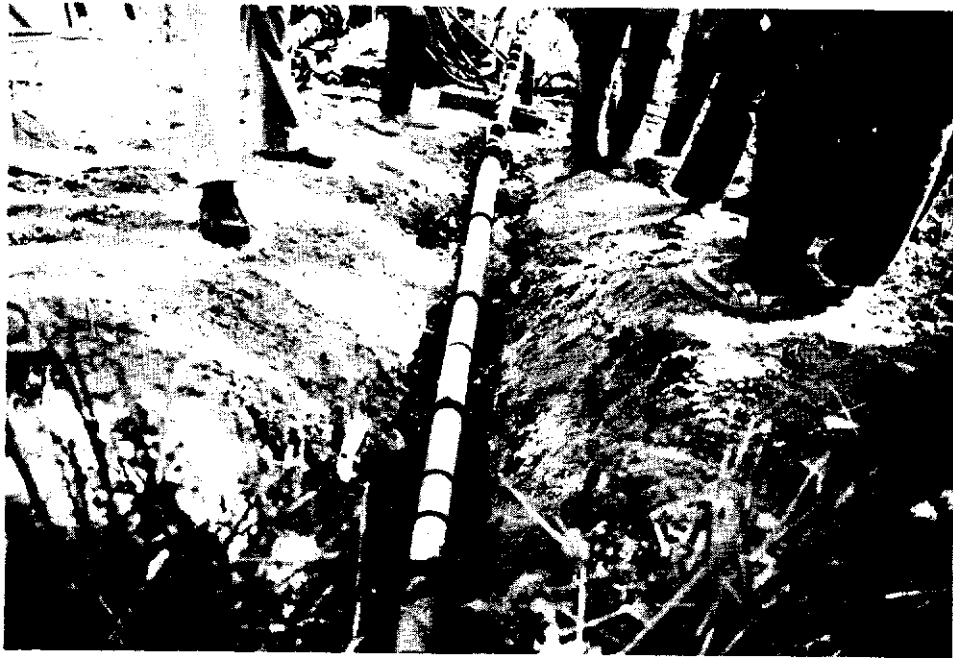
Plate 9 - Horizontal Drain after Exhumation Showing  
Successfully Grouted Invert  
(November, 1983)
